National Park Service  
Cultural Landscapes Inventory  
2010

Ash Mountain Historic District  
Sequoia and Kings Canyon National Parks

RE: Consensus Determination of Eligibility, Ash Mountain Historic District, Sequoia and Kings Canyon National Parks, California

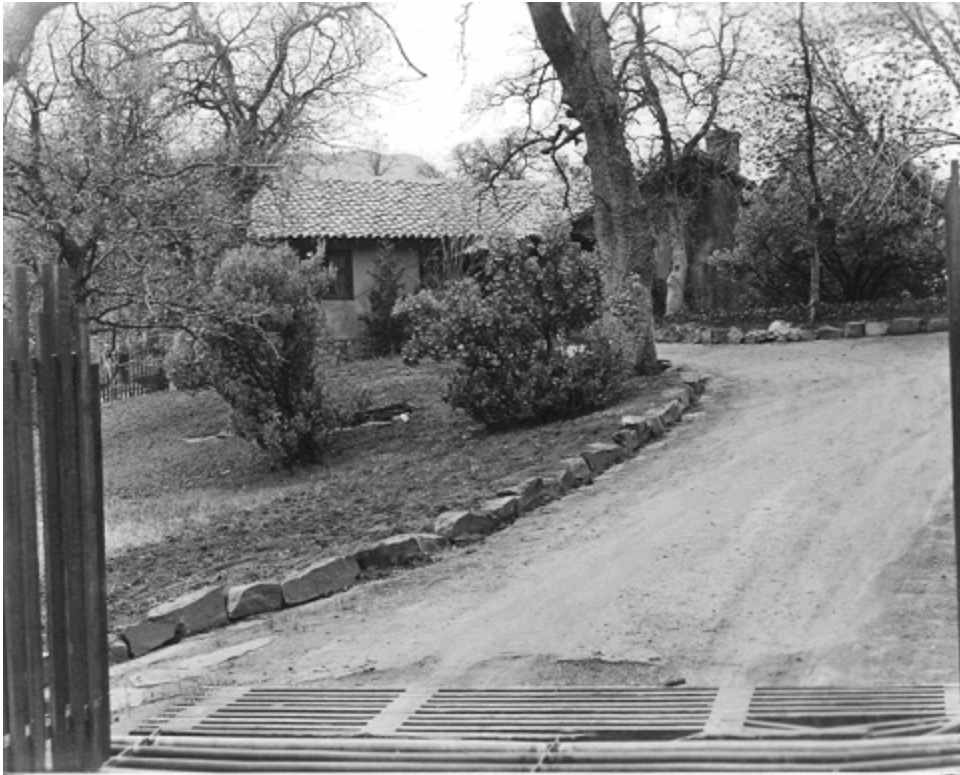
*Physical History #4: Superintendent's residence (#12) and grounds, 1934. The residential areas had a mix of stucco structures in the Spanish Eclectic style (such as this one), and rustic structures with shake siding (SEKI Archives).*

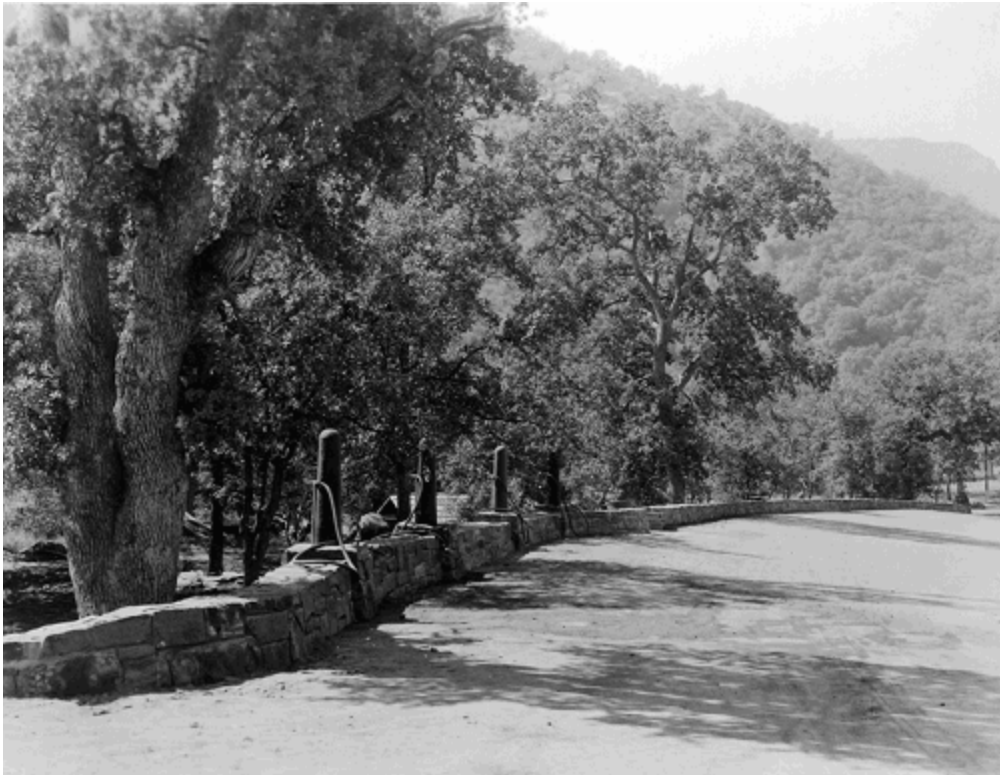
*Physical History #5: Generals Highway through Ash Mountain, 1934, near the current visitor center. This rock wall was constructed by CWA workers, which included water pumps and hoses allowing motorists to fill their radiators (SEKI Archives, Box 104).*

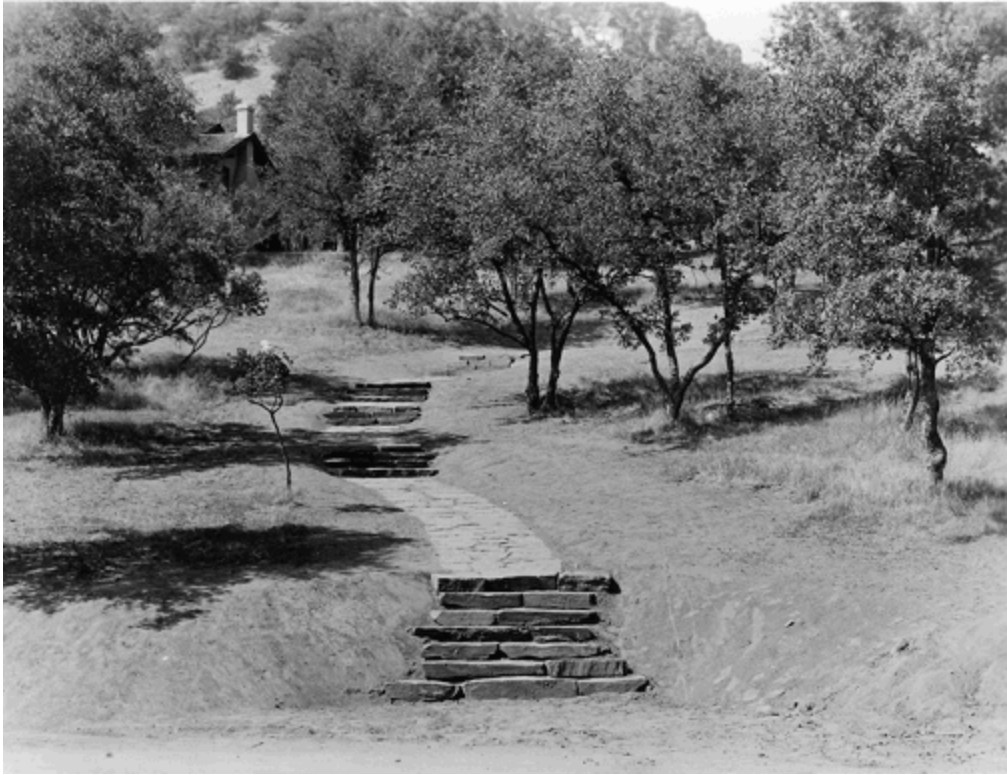
*Physical History #6: Photo showing rockwork pathways installed by CWA workers on Mather Drive near residences #14 and #15, 1934 (SEKI Archives, Box 104).*

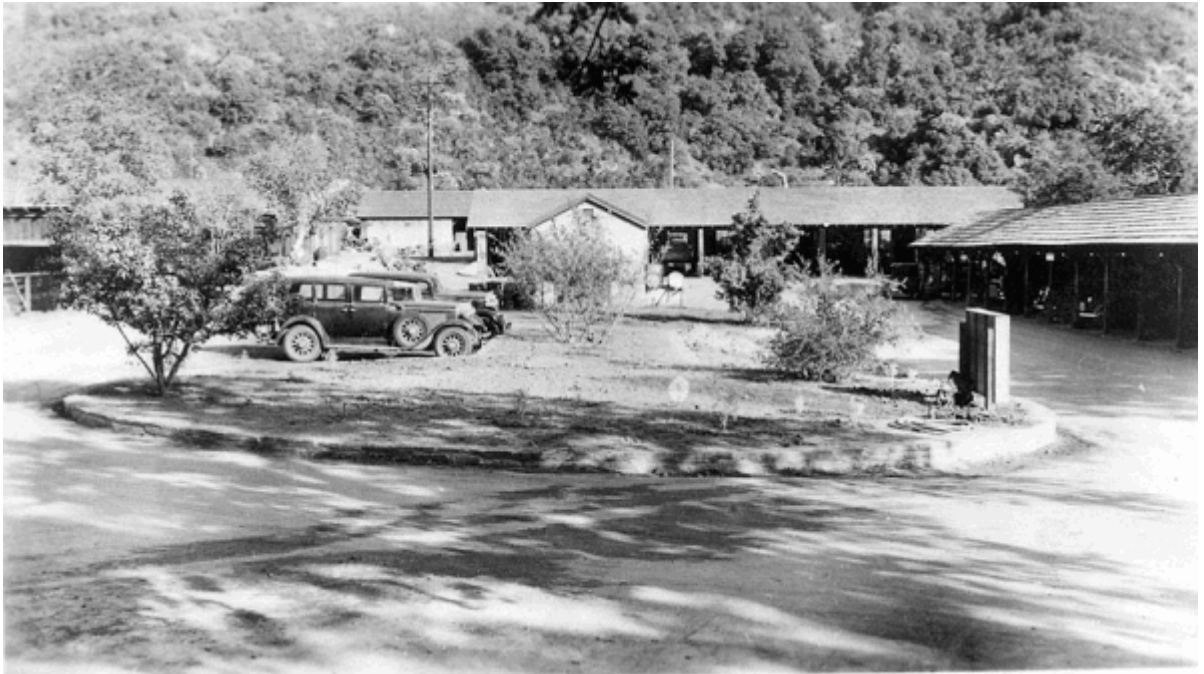
*Physical History #7: Maintenance yard after landscaping improvements by CCC workers, 1937. The service station (#168) visible in the center of the photo and the most distant building, (#159), are extant (SEKI Archives, negative 3054).*

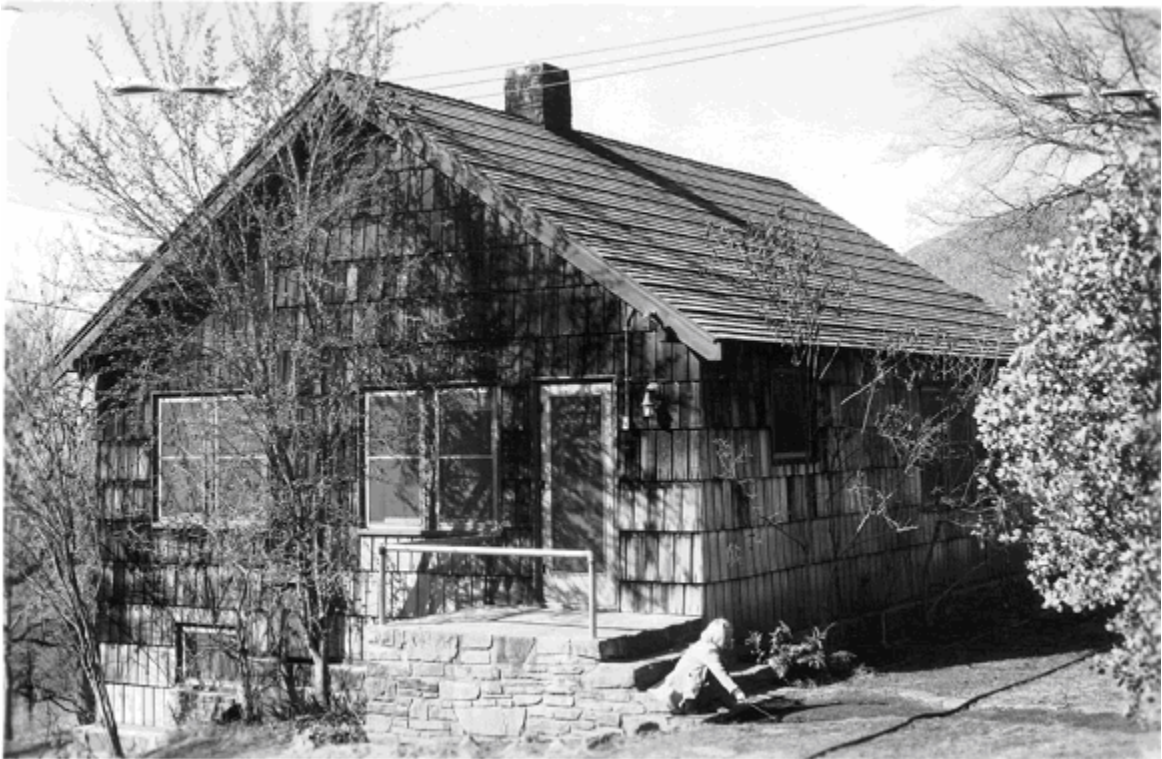
*History Photo #8: Residence #87. This 1938 building was built by the CCC and is typical of the residences from this time. It had a cedar shingle roof with a double coursing of shingles every fourth row for enhanced texture and protection (SEKI Archives).*

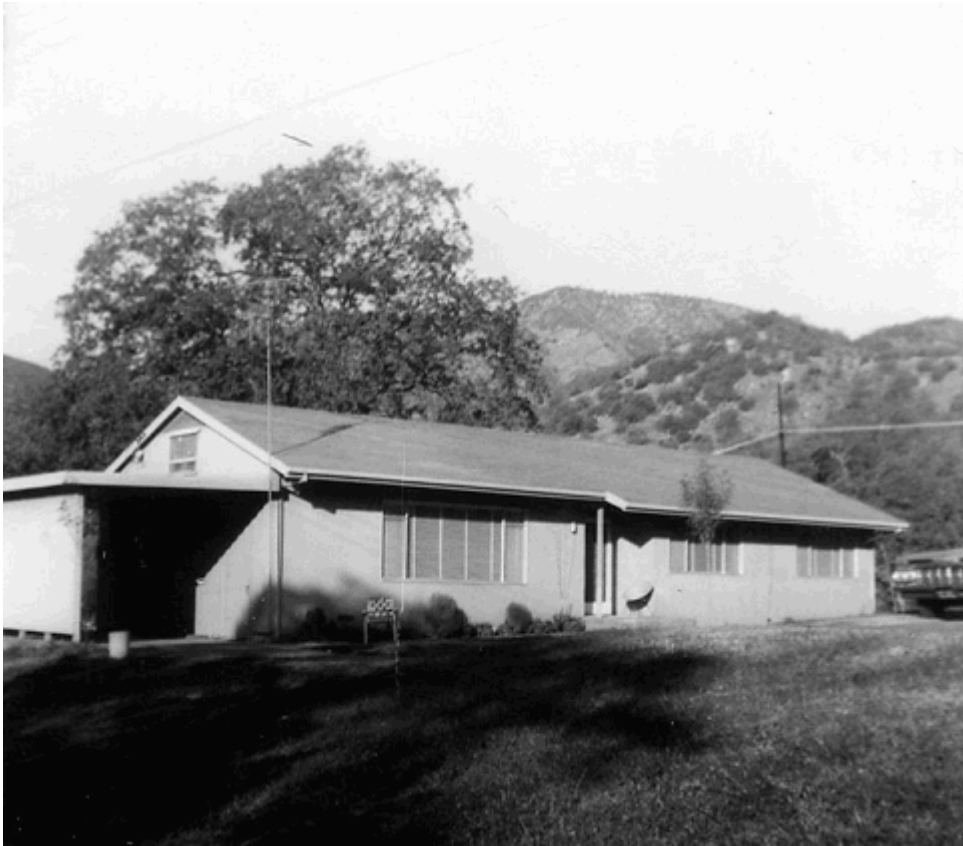
*Physical History #10: Photo from 1961 of residence #1409 at Buckeye Residential Area. This building was constructed in 1959 as part of Mission 66 and remains largely unchanged (SEKI Archives, building files).*

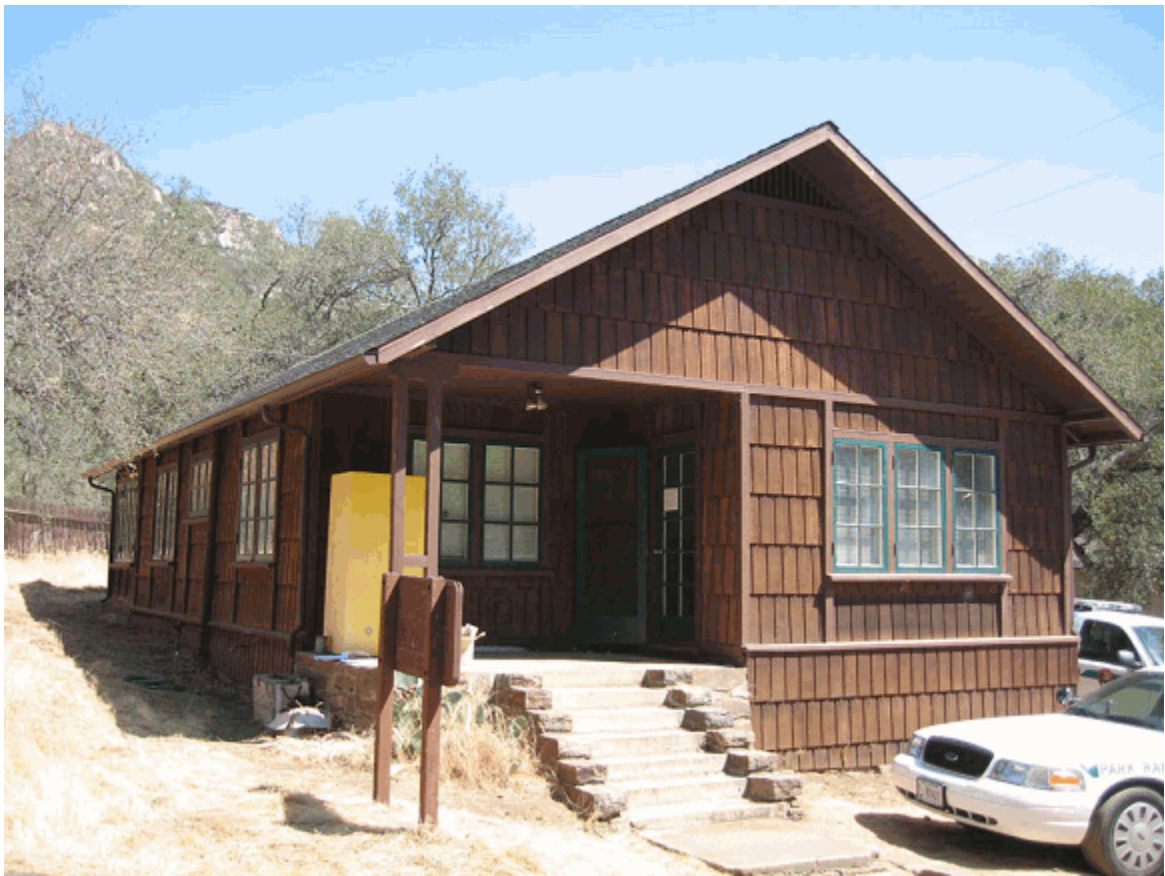
*Buildings and Structures #1: Recently rehabilitated residence within Ash Mountain (bldg. #5). Due to recurrent damage from woodpeckers, it was rehabilitated using a cement fiber shingle that replicates the appearance of redwood shake siding. (SEKI 2008)*

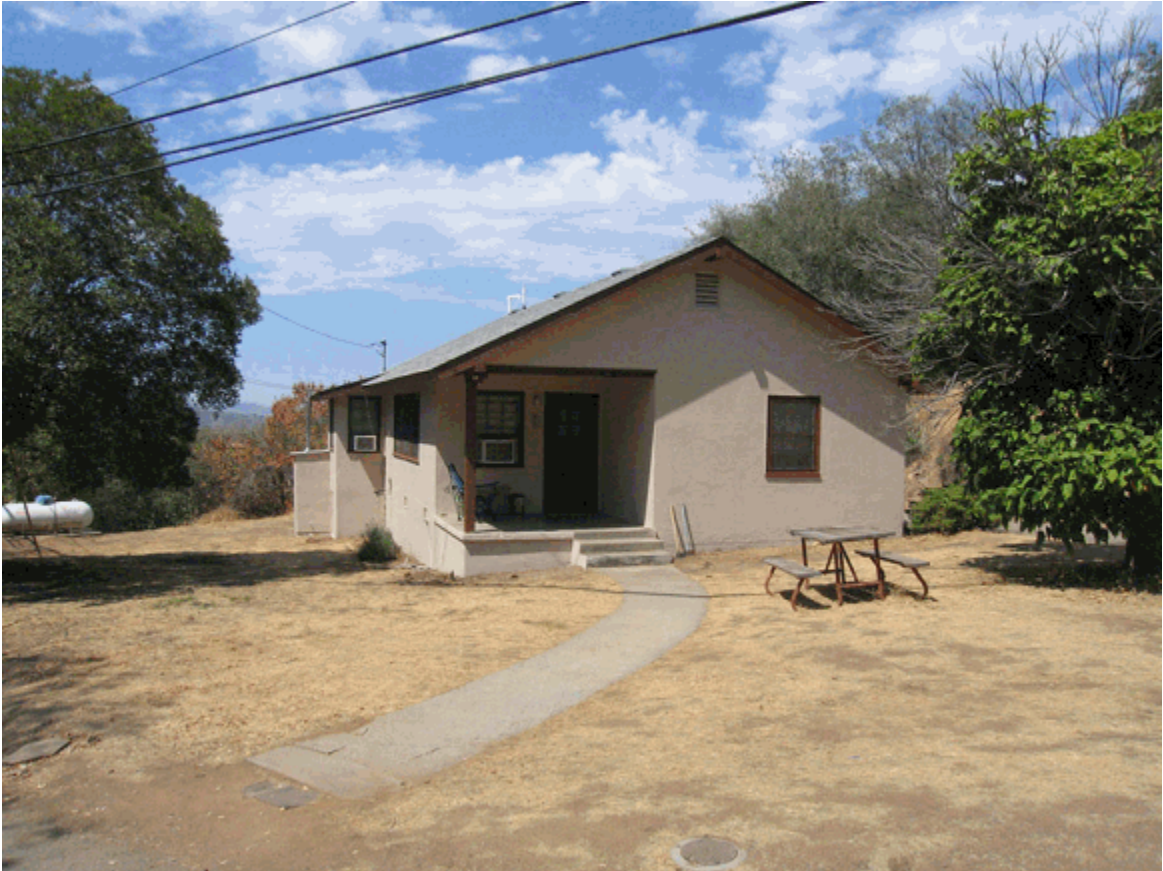
*Buildings and Structures #2: CCC-constructed residence (bldg. #95) within Ash Mountain, built in 1941. This structure retains its original stucco exterior. (SEKI, 2008)*

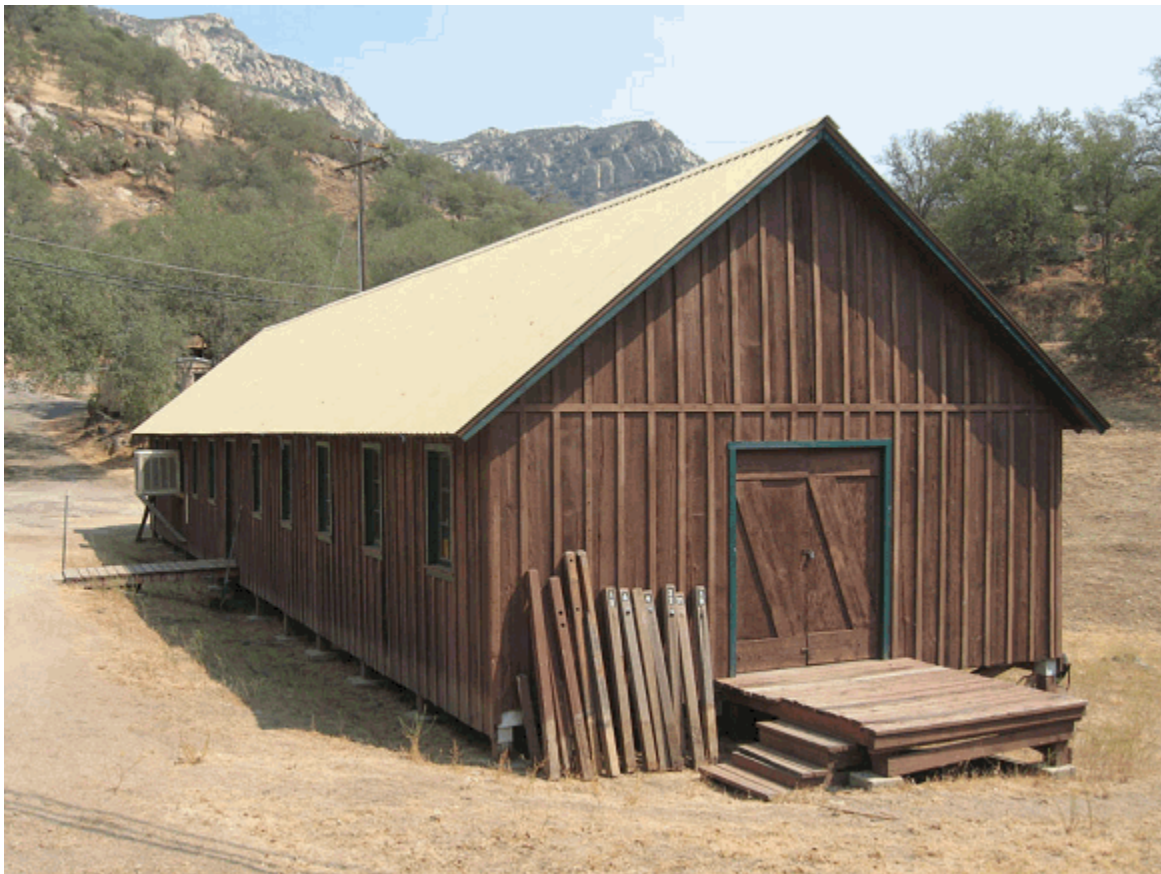
*Buildings and Structures #3: This structure (bldg. 140) was the original messhall of the CCC camp at Sycamore. It was built in 1934 and is currently used as a storage building. (SEKI 2008)*

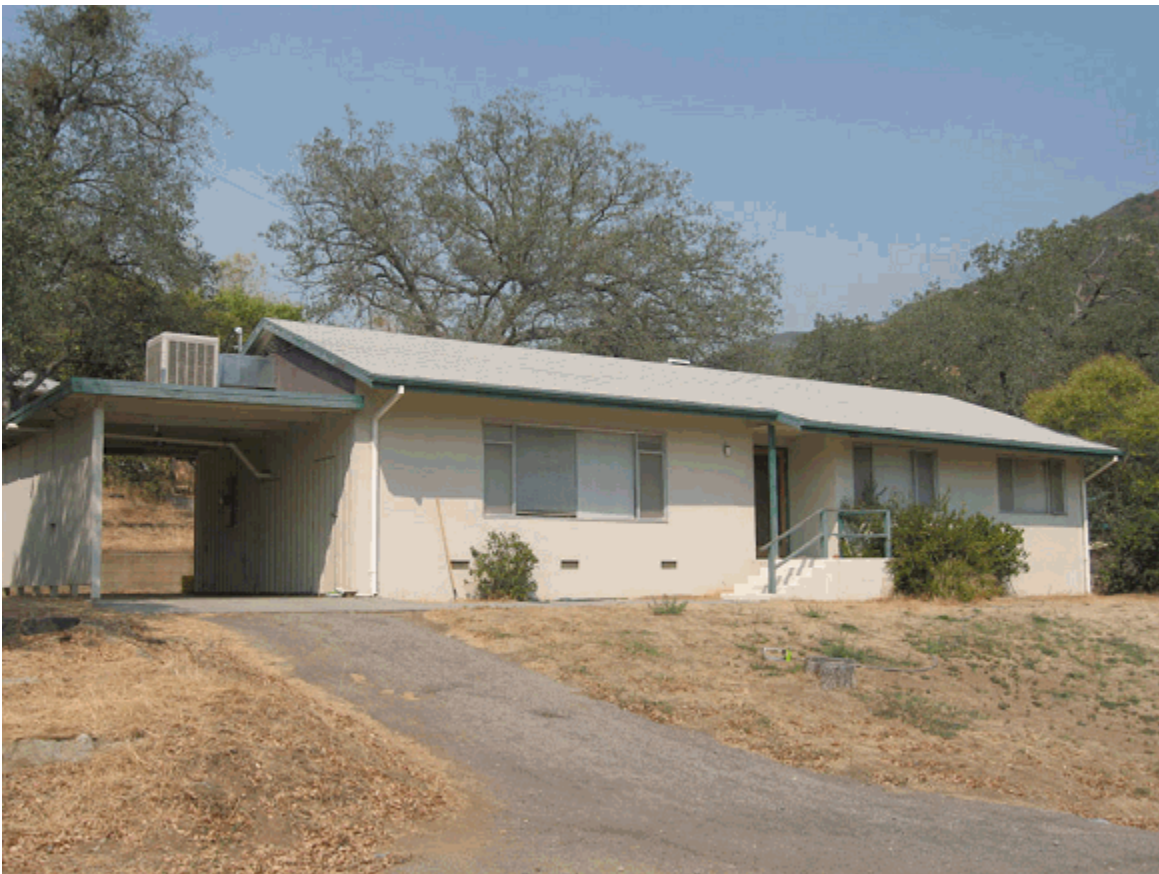
*Buildings and Structures #4: Mission 66 era structure (bldg. #1405) at Buckeye, constructed in 1959. This building is representative of all Mission 66 residences at Buckeye since they were all constructed using the same design. (SEKI, 2008)*

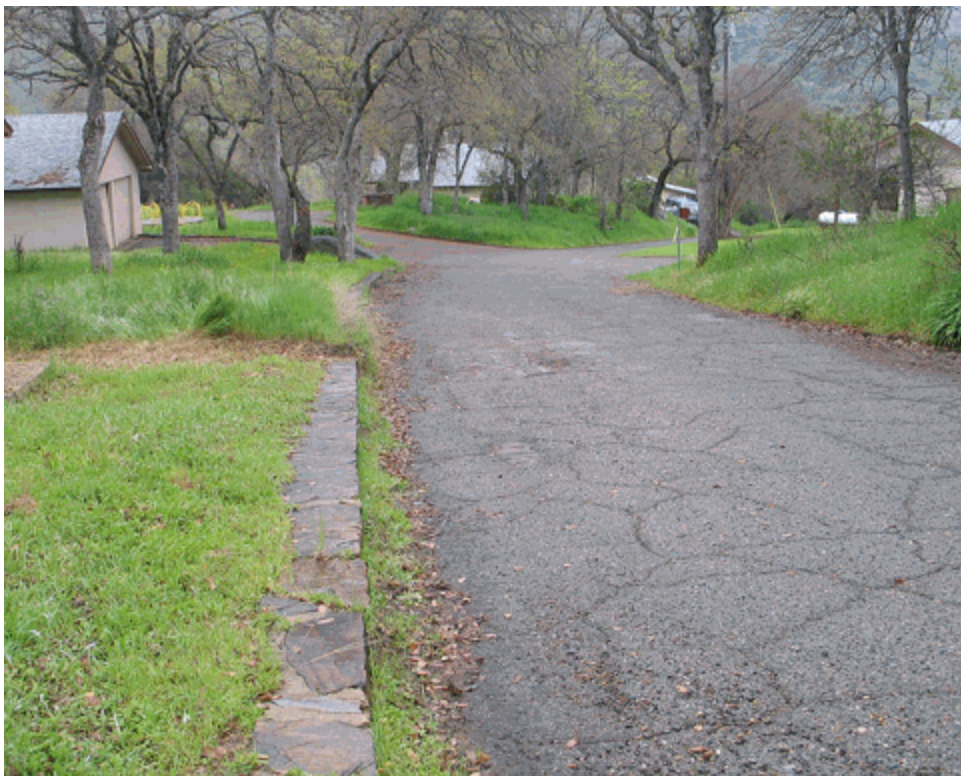
*Drury Lane was constructed in the 1920 and 1930s. This road is typical of contributing residential roads in Ash Mountain proper, with a narrow cross-section, curvilinear alignment and schist curbing. (SEKI 2010).*

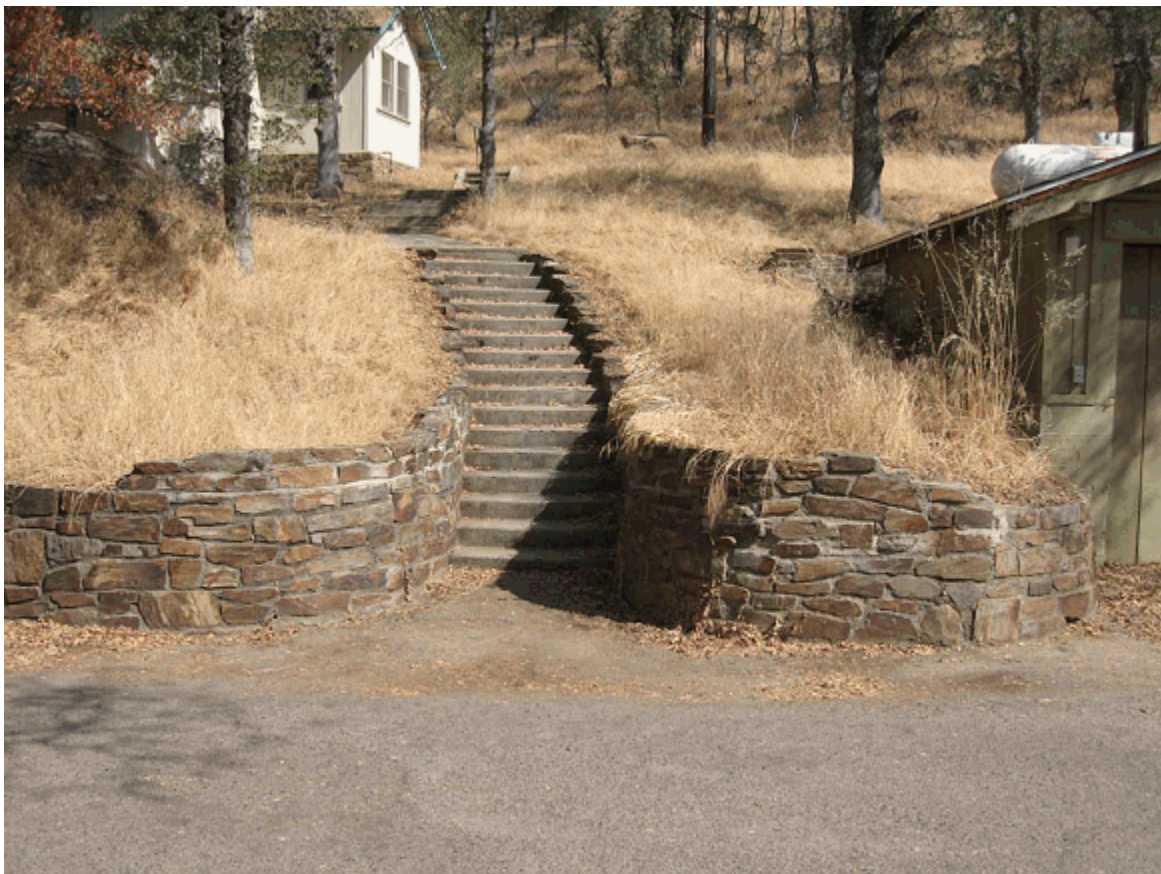
*Small Scale Features #1: Schist retaining wall and stairway leading up to bldg. # 93. Notice how the retaining wall creates a level platform for the garage and seamlessly ties into the stairway. (SEKI, 2008)*
