National Park Service  
Cultural Landscapes Inventory

Headquarters  
Shenandoah National Park

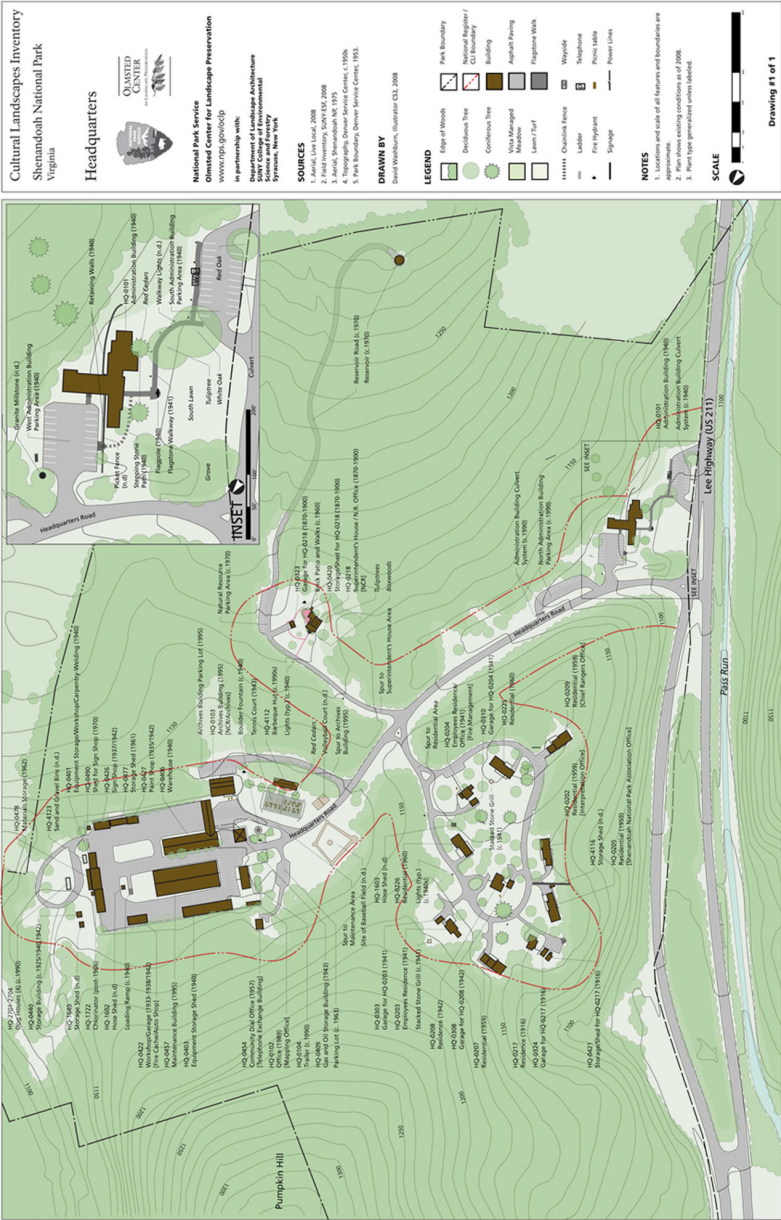
Site Plan

Site Plan. Map 1 of 1 for Headquarters (OCLP, 2008).

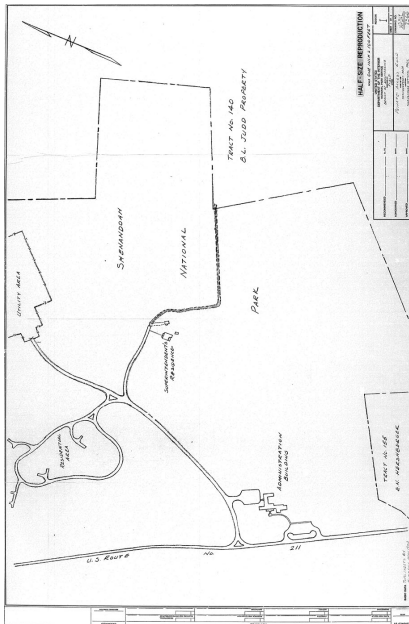
Figure 1. Preliminary site plan from 1938 for the Headquarters site at Shenandoah National Park (SHEN 134-2366, Denver Service Center).

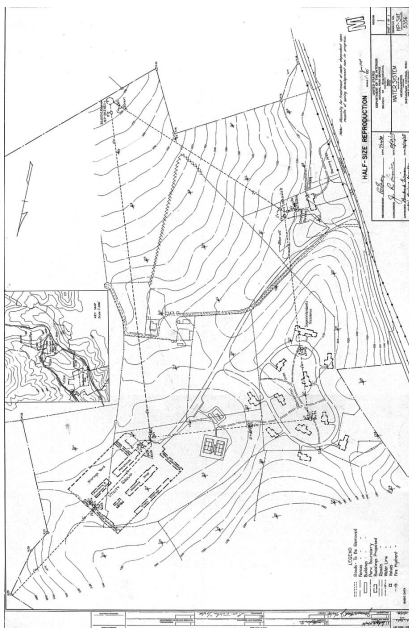
Figure 2. Master Plan from 1938 for the Headquarters site at Shenandoah National Park (SHEN 134-5356, Denver Service Center).

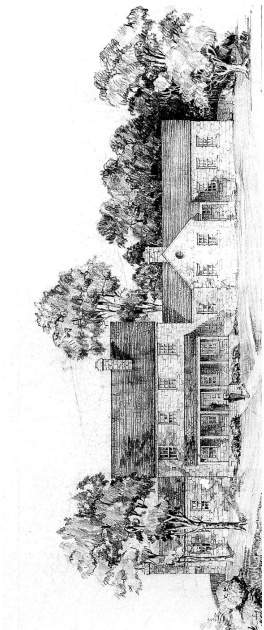
Figure 3. Rendering of proposed Administration Building at the Headquarters site in 1938 (SHEN 134-2025-Z1, Denver Service Center).

In 1939, the NPS constructed the Headquarters Administration Building, located north of Route 211, on land previously occupied by a farmhouse and associated buildings. The new building was designed in the rustic style developed by the NPS with the purpose to "blend unobtrusively into the natural setting" (Figure 3) (NHL Documentation 2008:34). The design principles associated with the rustic style called for using native materials and traditional building techniques to create buildings that were subordinate to the surrounding landscape. The NPS designed the building as a two-story stone structure with a slate roof built on concrete foundations based on the traditional "I" type house plan with separate single story gable-roofed sections on either side (Figure 4). The five-bay wide central section had a single story wood porch. To the west of the central section was a two-bay wide, single story gable-roofed section. To the east of the central section was a longer section, composed of a narrow single-bay cross-gable section, and a final three-bay-wide, gable-roofed section. A long wood addition extended from the rear of the building and was constructed shortly after the completion of the main building. The rough-faced, random laid stone work on the building's facades was from locally quarried sandstone (National Register 9/1997:Section 7, 67). The Administration Building faced Route 211 to be visible by motorists, with the back of the building set into a small knoll. The building also functioned as a contact station for visitors, providing park information and restrooms. The CCC was involved in the excavation of the basement and used it as a borrow pit for grading the visitor parking area south of the building (Historic Resource Study 1997:77, citing interview with Baughan, Sept. 21, 1995). The CCC also constructed stone retaining walls on the east and west sides of the building for soil retention and erosion control.

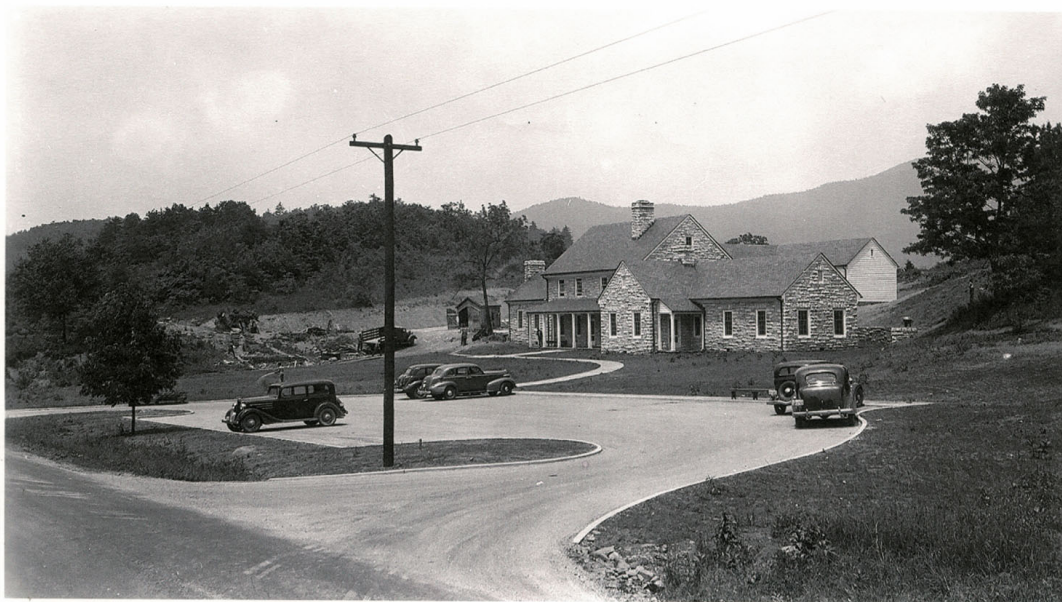
Figure 4. View of newly constructed Administration Building in the early 1940s with visitor parking lot in front (Shenandoah NP Archives, Negative No. not found).

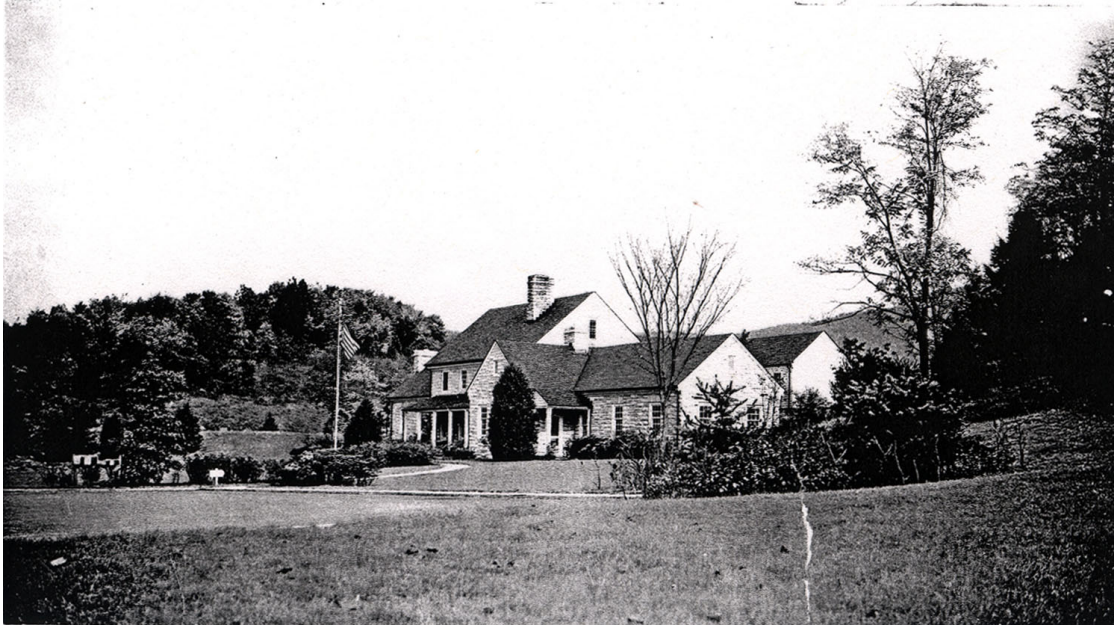
Figure 5. View of the Administration Building at the Headquarters site in 1944, including the visitor parking lot and flagpole near the main entrance (Shenandoah NP Archives, SHEN Classification 0-145, Negative No. 621-19).

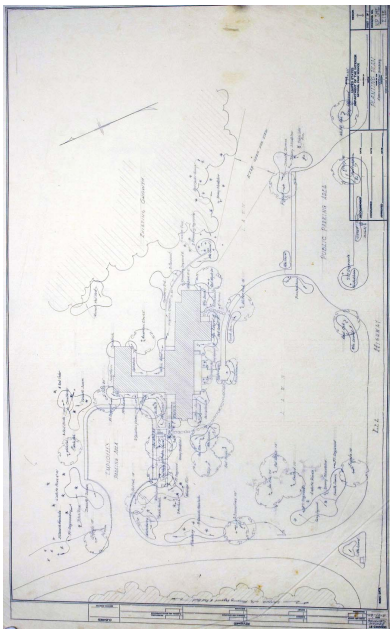
Figure 6. Proposed planting plan for Administration Building in 1940 (SHEN 134-2195, Denver Service Center). Note the proposed view from the southeastern corner of the building.

Historic Condition (through 1952):  
The only historical reference to views at the Headquarters site appeared on a planting plan from 1940 that proposed maintaining a view from the Administration Building to the southeast along Route 211, enhancing its visibility from the road and providing visitors their first glimpse of the building before reaching it.

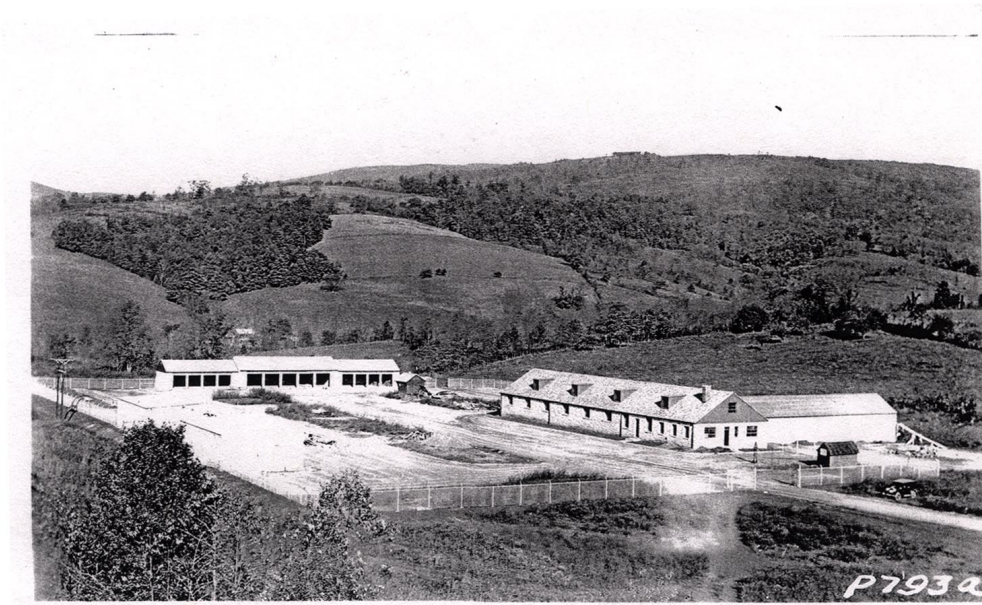
*Figure 7. View of maintenance area at the Headquarters site in 1940, including the Warehouse to the right, the Equipment Storage/Workshop furthest back and the Equipment Storage Shed to the left (Shenandoah NP Archives, Negative No. 15365).*

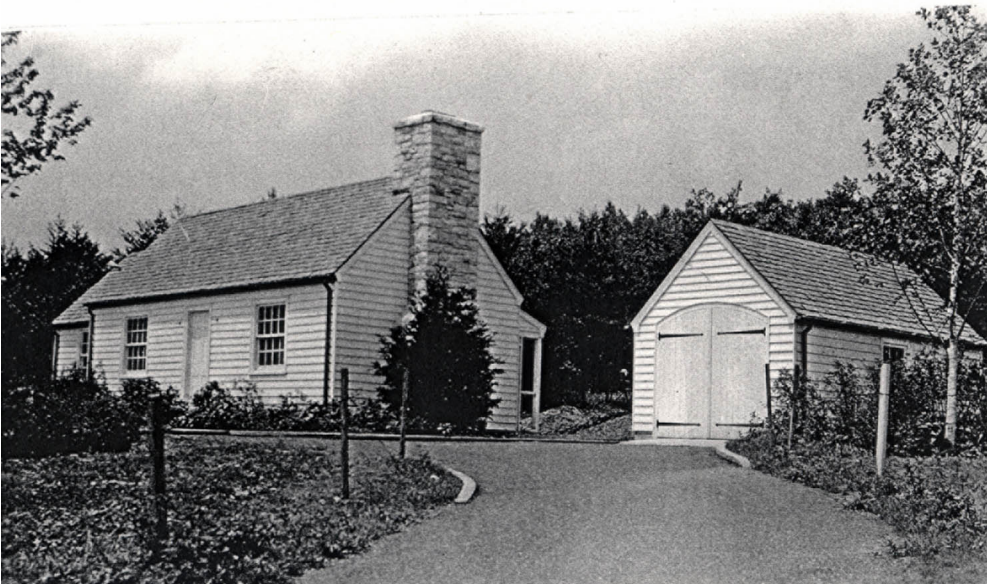
*Figure 8. View of one of the employee residences constructed at the Headquarters site in 1941 (Shenandoah NP Archives, Negative No. 627-5). Note the variety of shrubs and trees planted, including a newly staked tree to the right.*

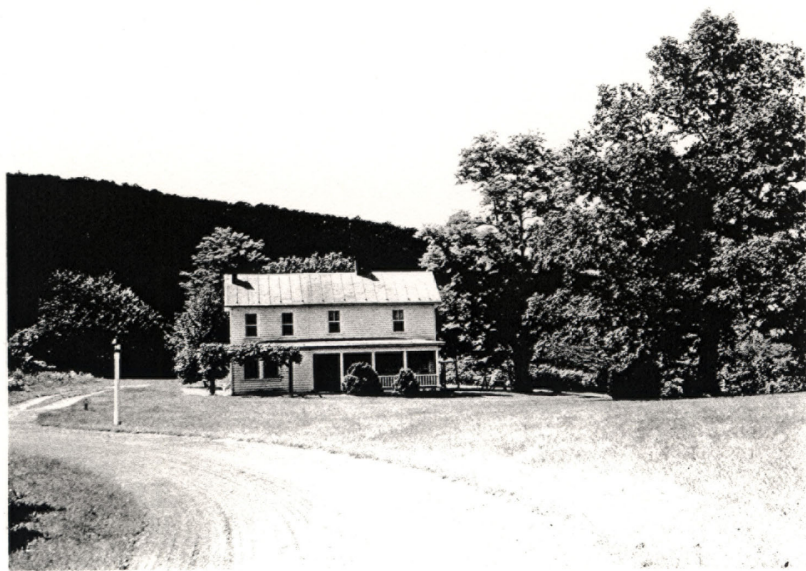
*Figure 9. View of 1916 farmhouse used as a residence, one of two pre-existing park buildings at the Headquarters site (Shenandoah NP Archives Negative No. 627-30B). Note the wooden lightpost to the left along the access road.*

The residential area included four buildings from the period of significance, one of which was a farmhouse that pre-dated the park's development. The farmhouse consisted of a two-story wood frame "I" type structure, constructed around 1916, with painted clapboard siding, a stone foundation and a gable-end exterior chimney, and a covered porch extending across half of the front façade (National Register 1997:7-8-9). There were also several associated buildings, including a garage and shed. G.E. Baughan, a landscape architect with the NPS, designed the other three residences which were constructed in 1941 and 1942. Influenced by local traditional architecture, Baughan designed two of the residences in the Colonial Revival style and the third in a vernacular cabin style (National Register 9/1997: Section 7, 8). All three buildings reflected local building traditions and had identical wood frame garages with segmented arched double doors and strap hinges. The residences were side gable structures with wood siding, slate roofs, and prominent sandstone chimneys (National Register 9/1997:7-9).

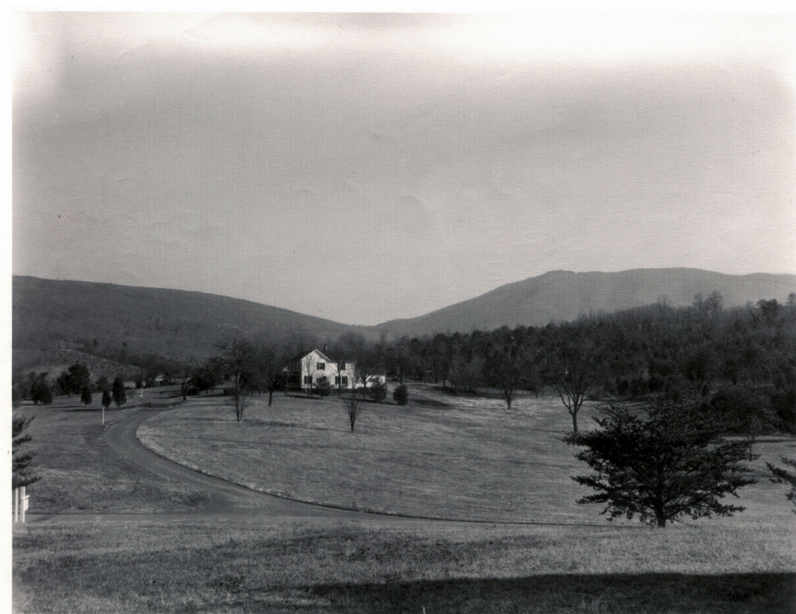
*Figure 10. View of c.1870s farmhouse used as Superintendent's Residence (Shenandoah NP Archives Negative No. 627-30B).*

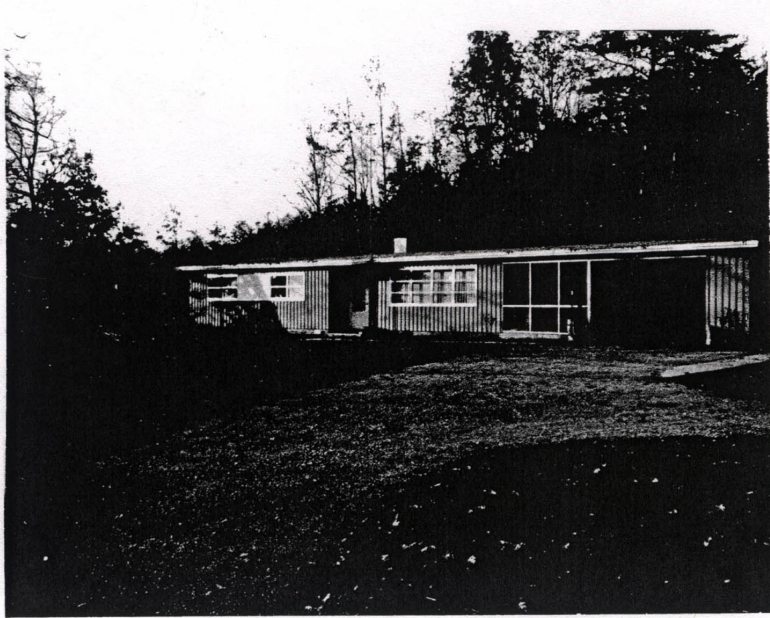
Figure 11. View of one of six ranch-style homes built at the residential area at the Headquarters site in the mid-1960s (Shenandoah NP Archives, Negative No. 8828).

At the Headquarters site, the residential area expanded with six new buildings sited amongst the existing 1940s houses around and within the loop road. The new buildings were designed as ranch-style houses according to Mission 66 guidelines, comprised of slab-on-grade wood frame buildings with attached carports (Figure 11) (National Register 9/1997: Section 7, 8). Plans prepared by the NPS Landscape Architecture Division from 1958 and 1959 designated areas around the new houses for “family recreation” and “service areas” for clothes drying (Figure 12). Among the proposed plantings were white pines, hemlocks, sugar maples, flowering dogwood, and oak as well as a variety of shrubs including bittersweet, holly, winterberry, mountain laurel, spicebush, and flame azaleas. At the maintenance area, additional storage buildings were constructed at this time.

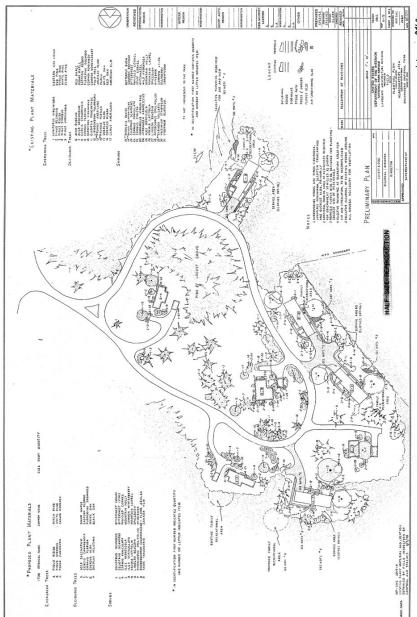
Figure 12. Planting plan, 1958 for the residential area at Headquarters, with new homes designed according to Mission 66 guidelines (SHEN 134-2469, Denver Service Center). Note the areas designated for recreation and clothes drying.

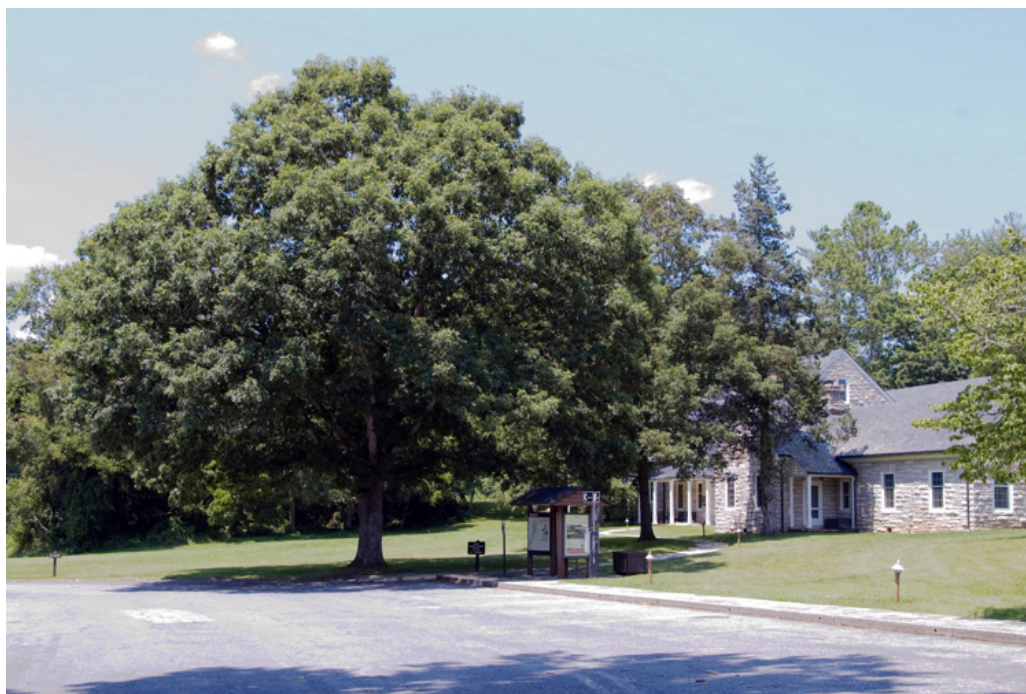
*Figure 13. View of public parking lot with mature oak and tulip trees and open lawn south in front of the Administration Building (OCLP, 2008).*

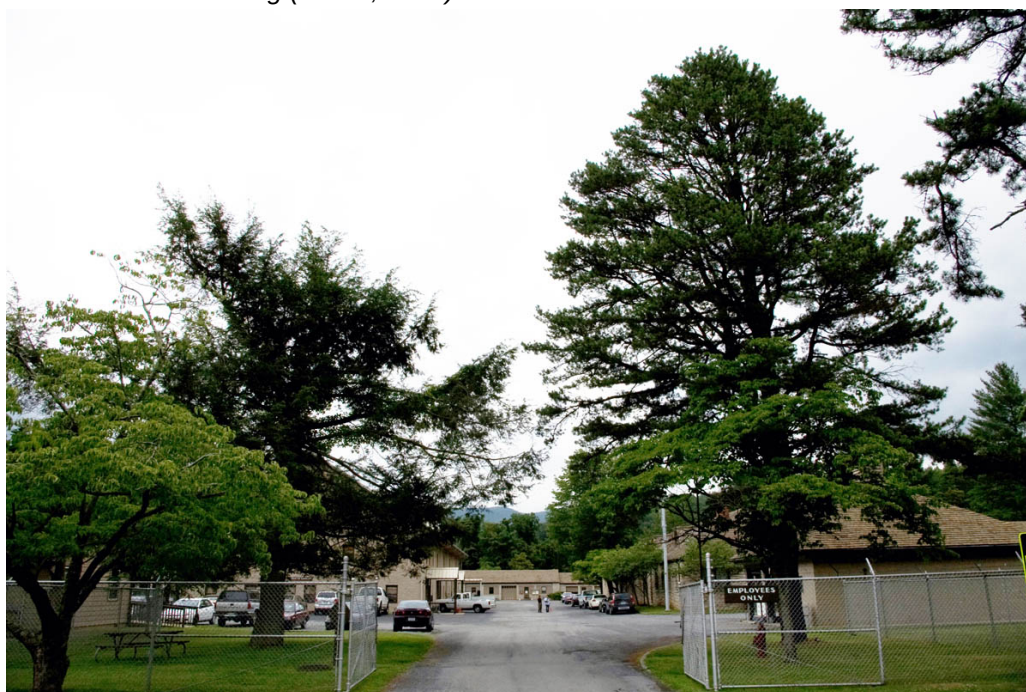
*Figure 14. View of pitch pine trees and security perimeter fence at the maintenance area at the Headquarters site (OCLP, 2008).*

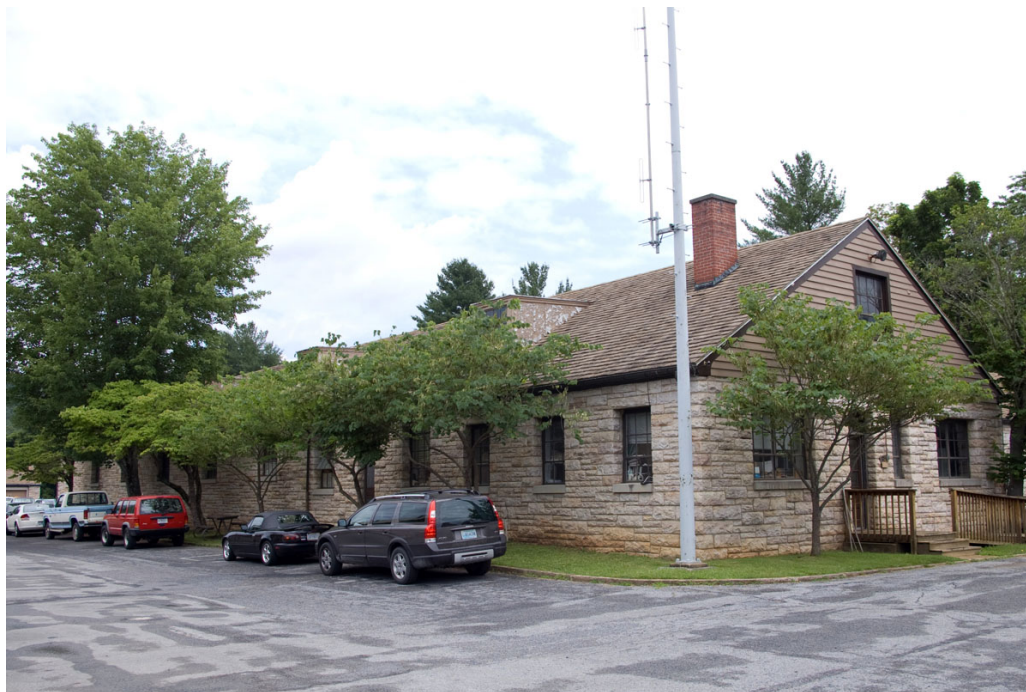
*Figure 15. View of redbuds and dogwoods along the west and south sides of the Warehouse in the maintenance area (OCLP, 2008).*

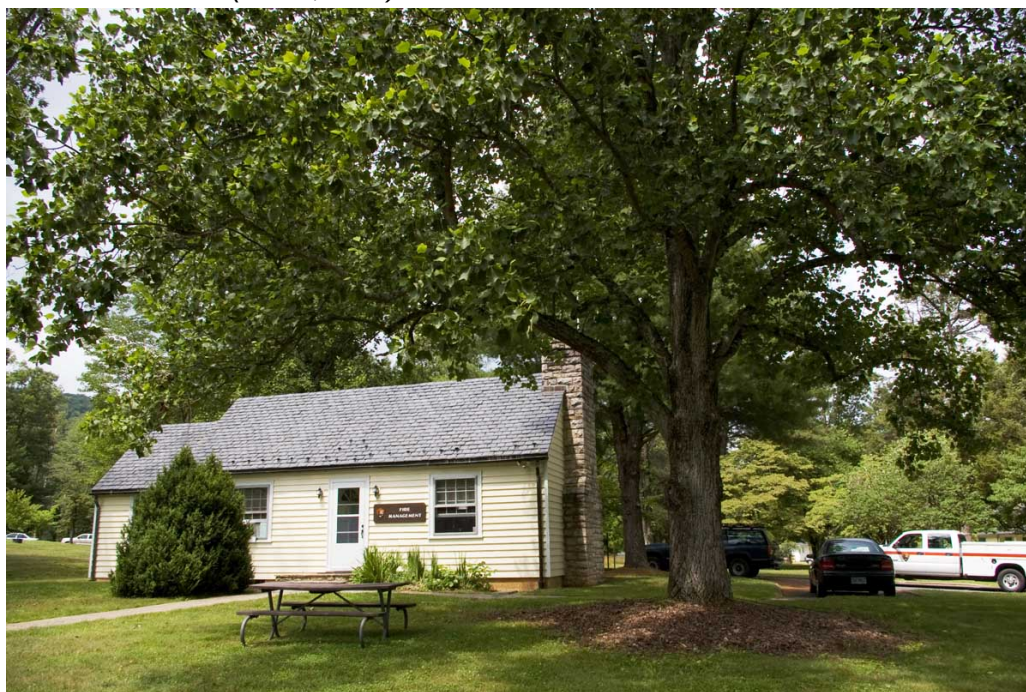
*Figure 16. View of mature tulip tree by a former residence building, now the Fire Management Office, in the residential area of the Headquarters site (OCLP, 2008).*

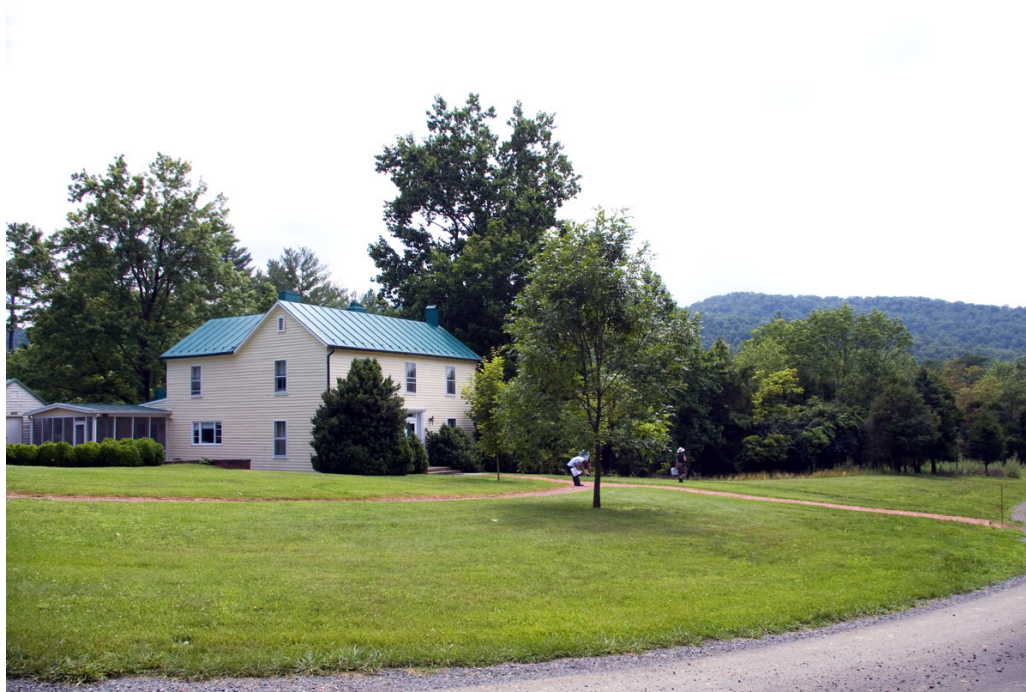
*Figure 17. View of open lawn at the former Superintendent's Residence (OCLP, 2008).*

Since the period of significance, successional plant communities have evolved on portions of the Headquarters site, such as the growth of black locust and black walnut trees, along with blackberry, bittersweet, and native redbud as an understory. Many of the originally installed plantings around the buildings have not survived, but some of the original specimen trees and shrub plantings still remain. At the administration area, a tulip tree and an oak tree near the visitor parking lot date to the period of significance, as well as some of the foundation plantings, consisting of dogwoods and Eastern red cedars. The area in front of the Administration Building continues to be maintained as an open lawn dotted with shade trees (Figure 13). Adjacent to the lawn is a grove composed of walnut, white pine, Eastern red cedar, and Virginia pine, which may contain period plantings. At the maintenance area, plantings that date to the period of significance include specimen trees such as pitch pine near the entrance gates, flowering dogwoods and redbuds along the eastern and southern facades of the Warehouse, and a planting of eastern red cedars as a windbreak along the western side of the tennis court (Figures 14, 15). Around the residential area, surviving trees from the period of significance consist of a tulip tree by the Fire Management building and a Virginia pine within the roadway loop of the residential area (Figure 16). The periphery of the residential area contains stands of mature trees including pines, tulip trees, oaks, maples, walnut, dogwoods, and red cedars. At the Superintendent's Residence area, original tree plantings include a tulip tree and a silver maple. The area is maintained as an open lawn in keeping with the historic character of this landscape component, but boxwood hedges have been added around the house and patio that are non-historic (Figure 17).

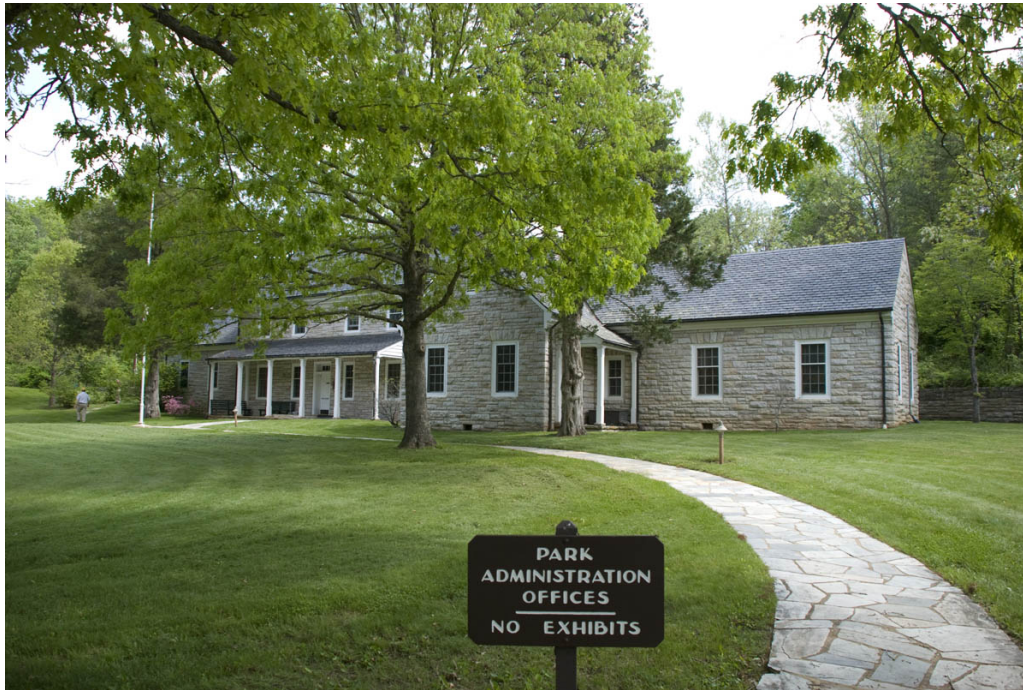
*Figure 18. View of flagstone walkway at the Administration Building (OCLP, 2008).*

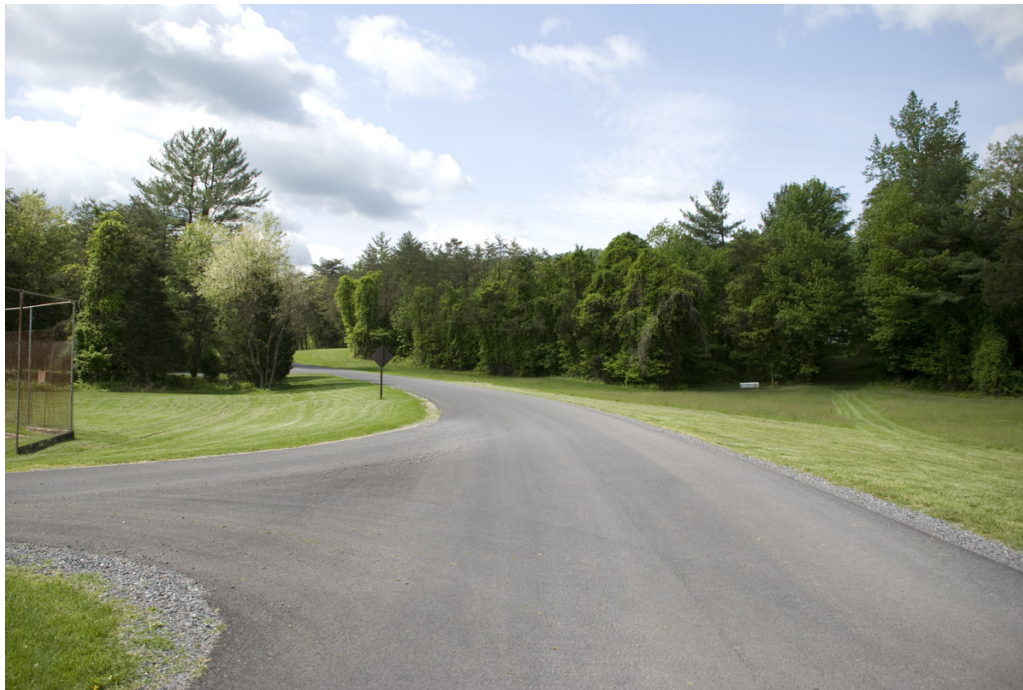
*Figure 19. View of Headquarters Road from the maintenance area looking south. The edge of the tennis court area is to the left (OCLP, 2008).*

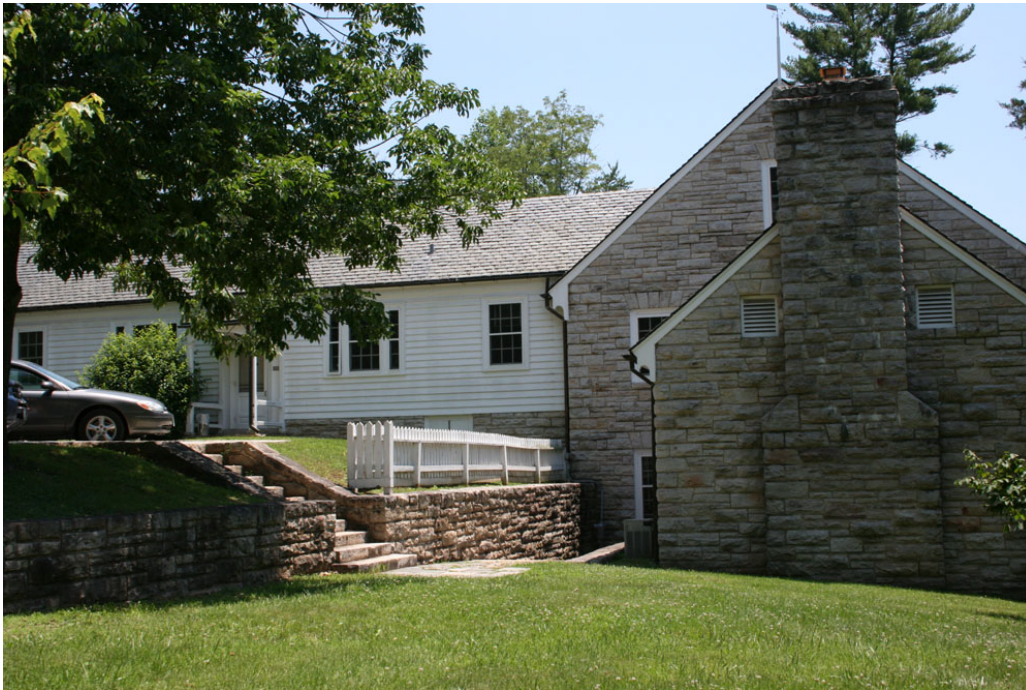
*Figure 20. View of stone retaining wall and steps at the west side of the Administration Building (OCLP, 2008).*

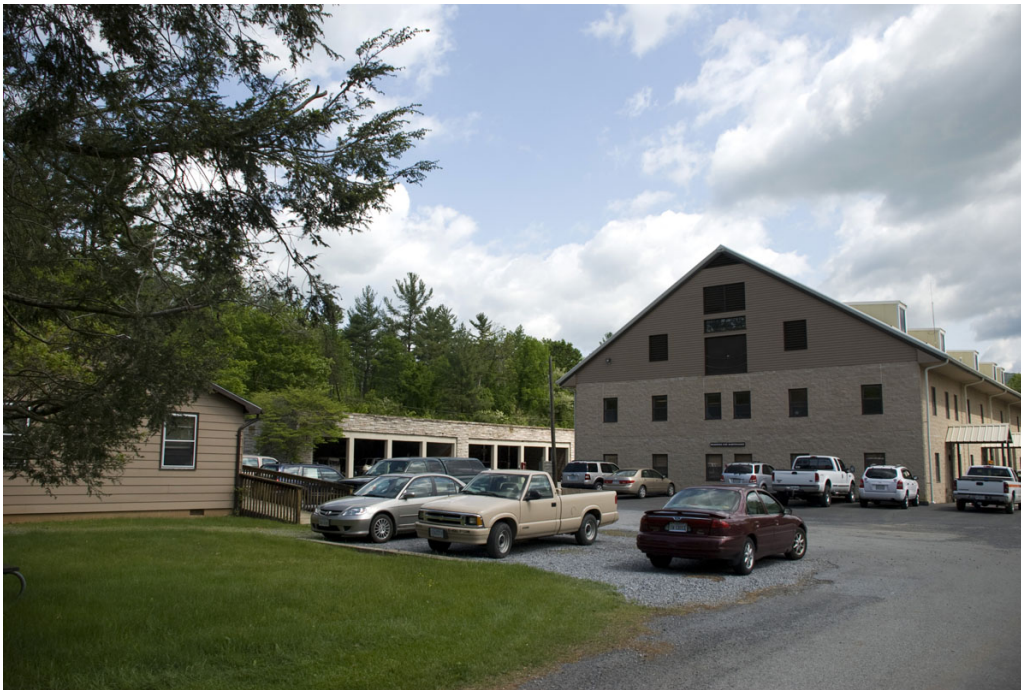
*Figure 21. View of the Maintenance Building constructed in 1995 with the Equipment Storage/Workshop beyond (OCLP, 2008).*

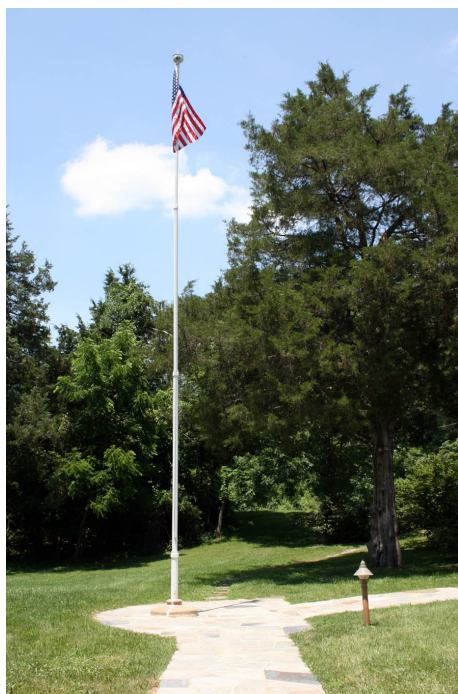
*Figure 22. View of flagpole and flagstone walkway in front of the main entrance to the Administration Building (OCLP, 2008).*

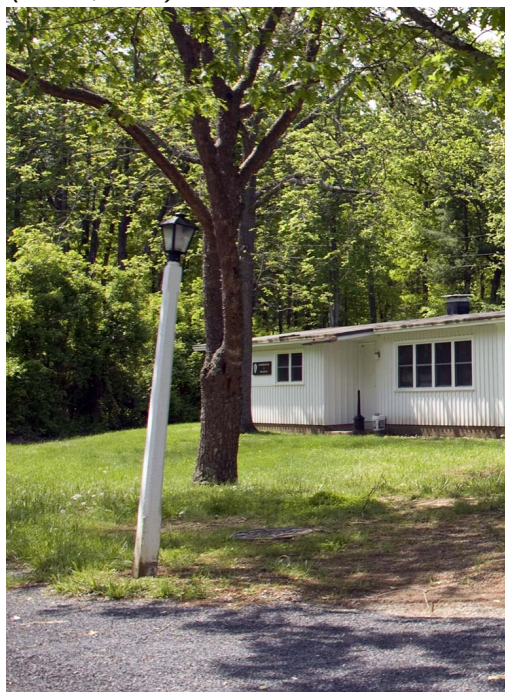
*Figure 23. View of one of seven original wood lamp posts in the residential area of the Headquarters site (OCLP, 2008).*

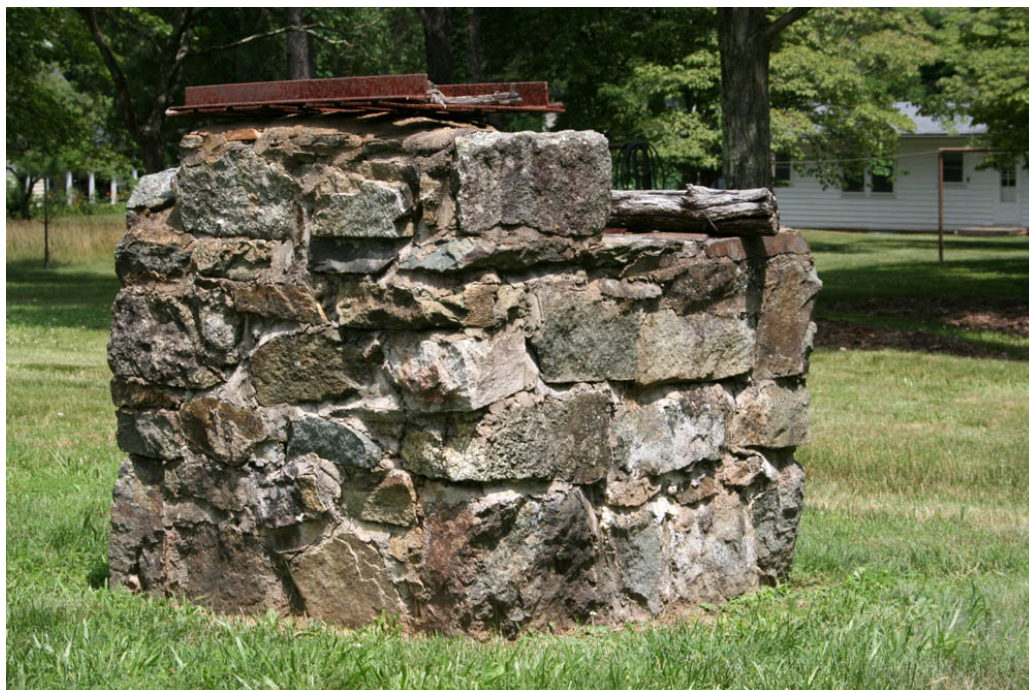
*Figure 24. View of one of two stacked stone grills located in the residential area at Headquarters (OCLP, 2008).*

Workmanship refers to the physical evidence of the construction techniques at the Headquarters site. The stacked stone grills and boulder drinking fountain exemplify the typical rustic style in which site amenities were constructed by the CCC during the period of significance. The Administration Building, Warehouse, and three of the employee residences reflect the NPS philosophy of constructing buildings that are in keeping with the local architectural styles and blend in with the surrounding landscape.

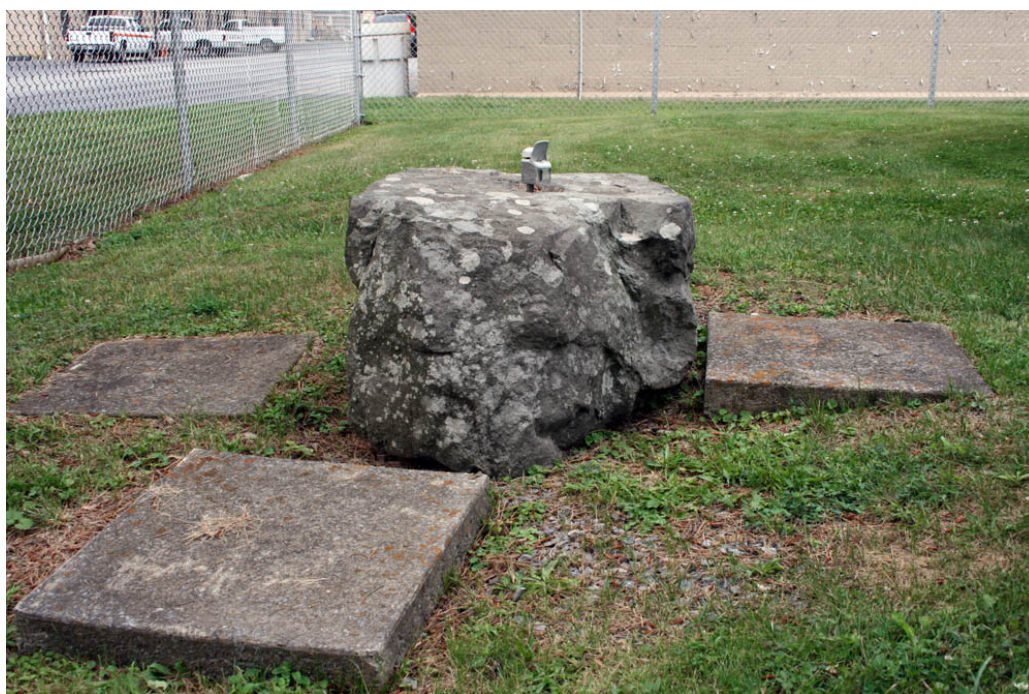
*Figure 25. View of boulder drinking fountain by the maintenance area at Headquarters. The concrete pads were added later (OCLP, 2008).*

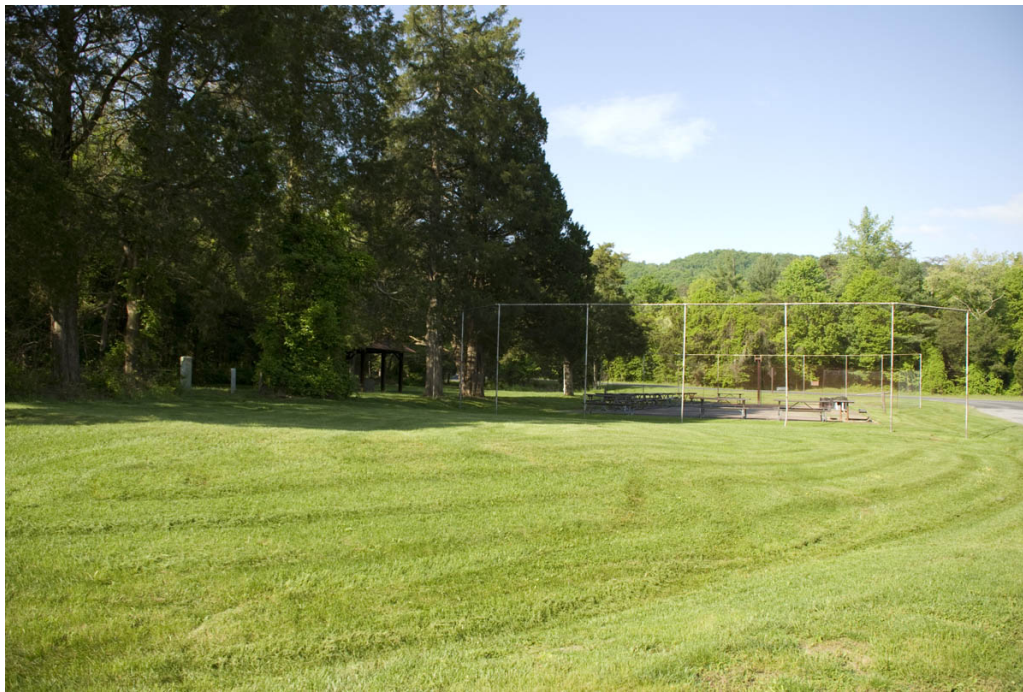
*Figure 26. View of tennis court by the maintenance area (OCLP, 2008).*
