National Park Service  
Cultural Landscapes Inventory

2006

Piney River  
Shenandoah National Park

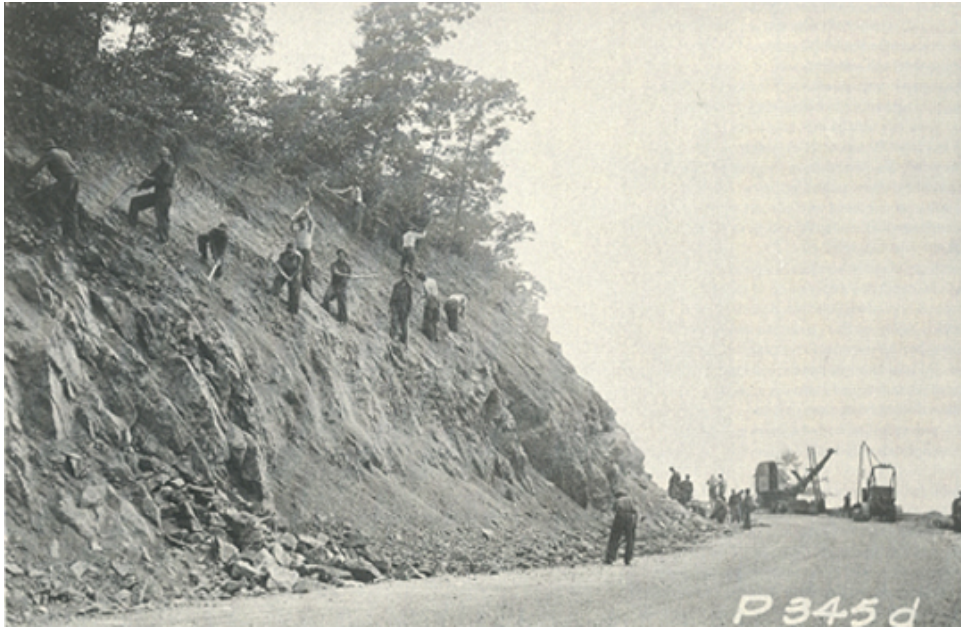
*Fig. 6: The park's landscape architects and CCC crews worked to create beauty from construction scars like this along Skyline Drive. (Engle 1999, 68)*

Once the park was established and adjacent lands were acquired, it was up to the park's landscape architects and the CCC crews to address post-construction design issues along Skyline Drive and create a picturesque scene. Horizontal and vertical curves were adjusted; cut and fill slopes were flattened; overlooks, picnic areas, guardrails, guard walls, and stone gutters were built; and disturbed areas were landscaped with trees, shrubs, and herbaceous plantings. Most significantly, the CCC created framed views to the east and west through the removal, planting, and transplanting of vegetation. (Engle, 1999:66-67) [see Figs. 6, 7]

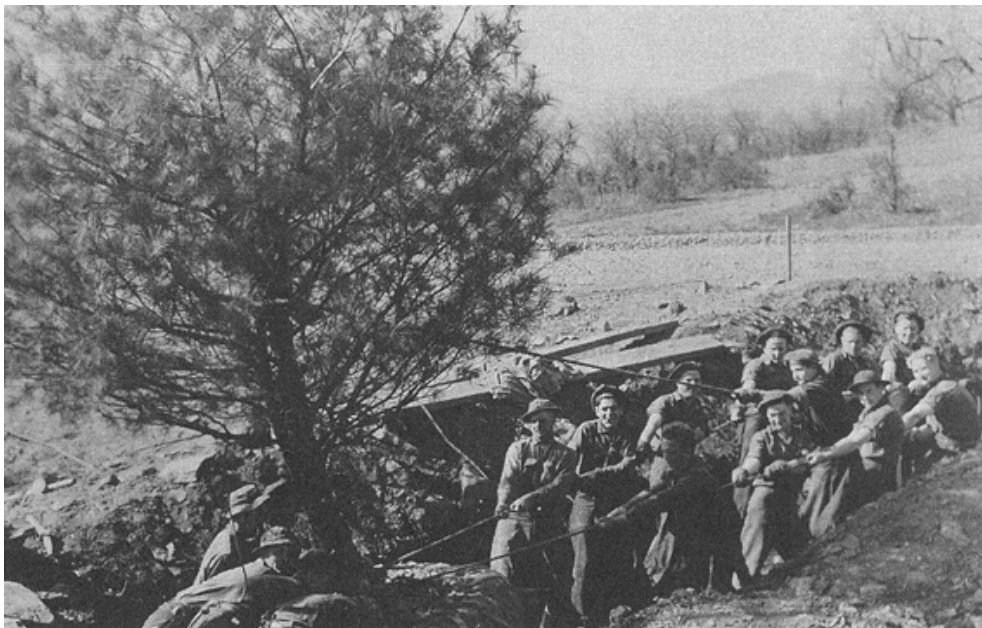
*Fig. 7: CCC crew transplanting a pine tree. (Engle 1999, 85)*

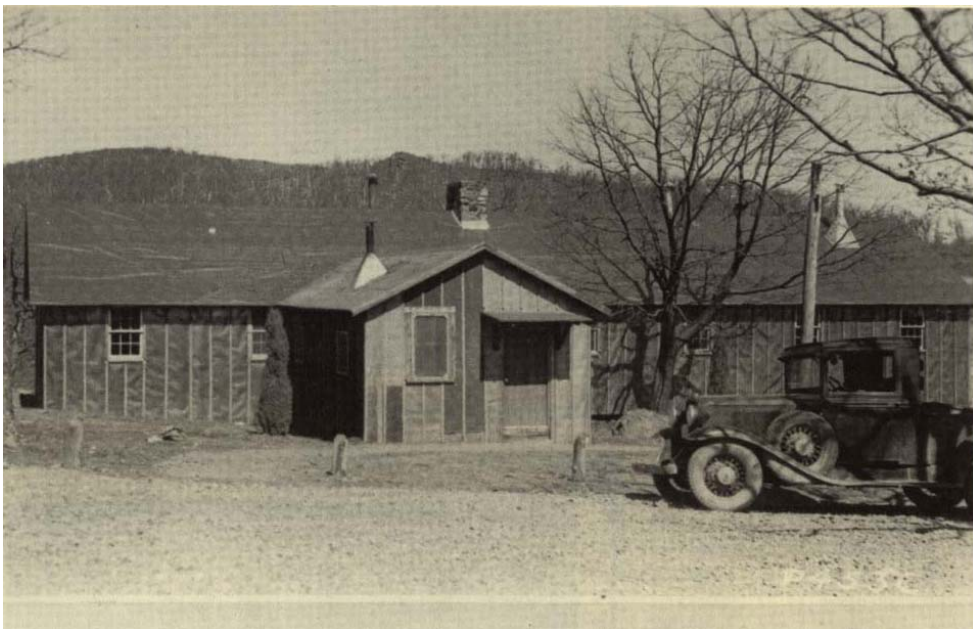
*Fig. 11: Undated view looking northeast at the Maintenance Office/CCC Technical Office, which housed the CCC's architects' and landscape architects' offices. The building is extant today. (Engle 1999, 38)*

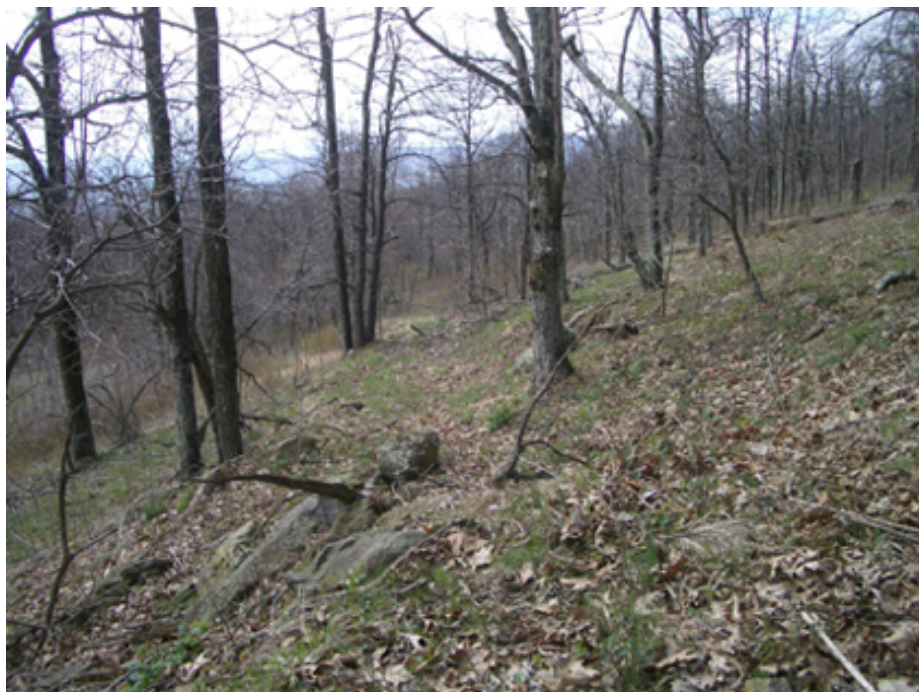
No archeological features are currently listed as contributing resources on the National Register of Historic Places Nomination Form or on the List of Classified Structures. Field investigations revealed subsidence east of the maintenance building parking area that corresponds to the latrine location noted on the 1942 CCC map. (NPS plan, 1942:CCC) The Sinkholes are likely the remains of the stone-lined pits that functioned as septic tanks, and were later filled when the existing septic system was installed ca. 1988. (Engle, 2001) A linear, level area tracking north-south along the slope of Piney Ridge between the maintenance building and the water tank creates a distinct narrow terrace that may have been a road trace used by the CCC.

*Fig. 35: View south at a possible road trace along the ridge. (OCLP 2005)*

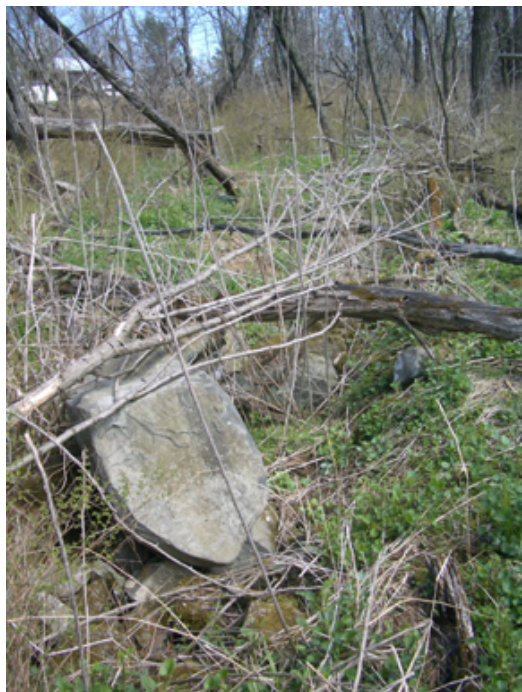
No other potential archeological sites were observed, but archeological explorations at both Big Meadows and Pinnacles indicate that sites of CCC camps retain significant subsurface resources. As the camp's buildings were pole buildings, the postmold evidence of the original buildings remains in situ. An Archeological Overview and Assessment is currently underway. [see Figs. 35, 36]

*Fig. 36: View of one of the stone-lined sinkholes at Piney River. (OCLP 2005)*

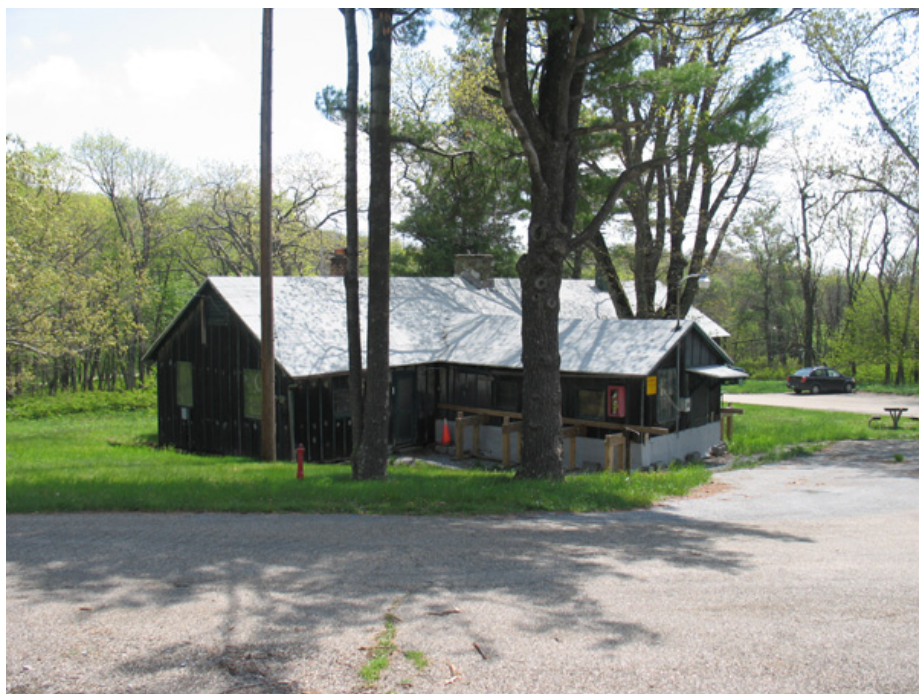
*Fig. 23: Looking southeast at the Maintenance Office-CCC Technical Office. (OCLP 2006)*

According to PMIS 98000, the Maintenance Office/CCC Technical Office will be stabilized, rehabilitated, and restored for adaptive use as either offices or as seasonal housing.. The work will include the replacement of rotted floor sills, joists, and structural support posts, the removal of interior lead paint and asbestos-containing wall and ceiling coverings, the replacement of the non-accessible bathroom, the installation of a new standing-seam roof, the repair and replacement of the exterior tar paper and wood batten finishes, the installation of a new electrical system and fire suppression, and repair/replacement of the historic windows and doors. The Maintenance /Equipment Shed will be documented by HABS/HAER to mitigate its pending loss. (PMIS 98000, [http://165.83.198.10/pmis\\_search/search\\_projectdetail.cfm](http://165.83.198.10/pmis_search/search_projectdetail.cfm))

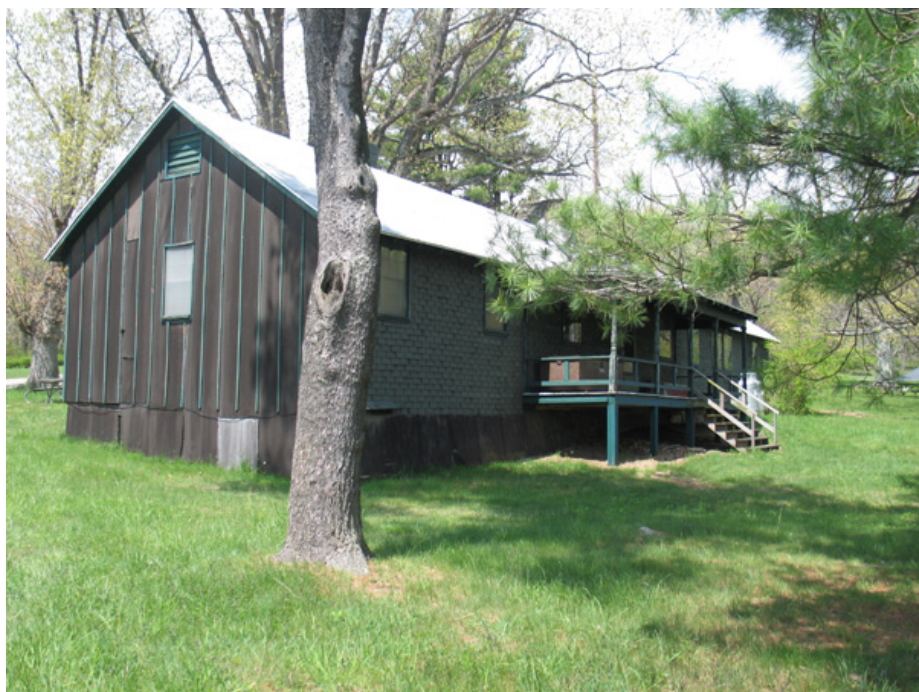
*Fig. 24: View of the Maintenance Office-CCC Technical Office.CCC, looking northwest. (OCLP 2006)*

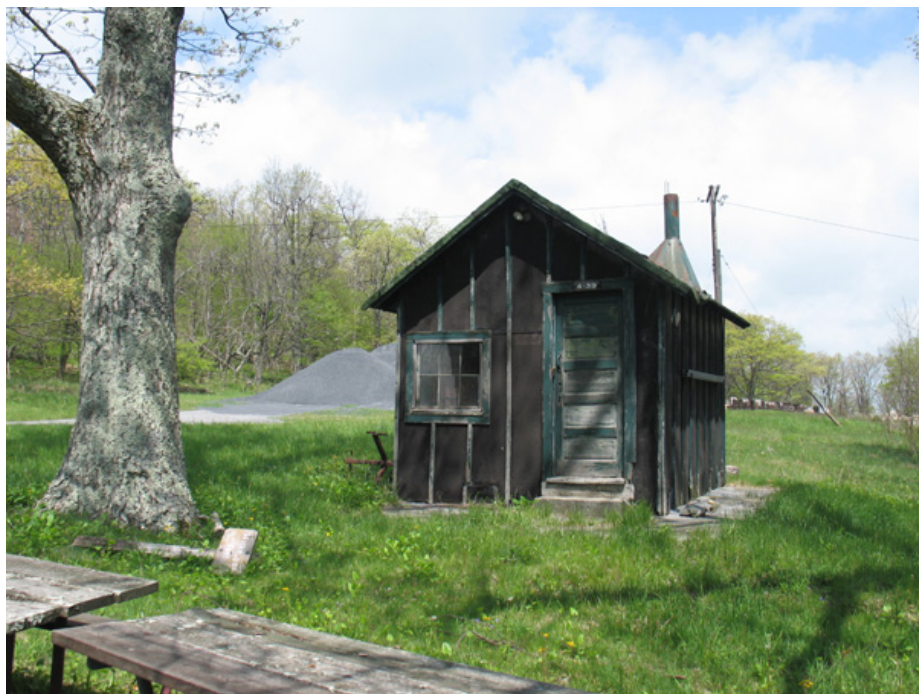
The Naturalist’s Office (PR-0439) was built in 1935 for oil and gas storage. (Hooper, 1997:7-31,32) It was used as a coal storage shed in the 1950s, and then for a naturalist’s office and for storage. The 12x10-42; wood structure sits on a concrete pad with an asphalt gabled roof and exterior walls of tar paper and board and batten. The building is in poor condition and is used for storage. (LCS, 2006:81802) The historic Maintenance/Equipment Shed (PR-0437), constructed in 1937 as a

*Fig. 25: Looking north at the Naturalist's Office-CCC. (OCLP 2006)*

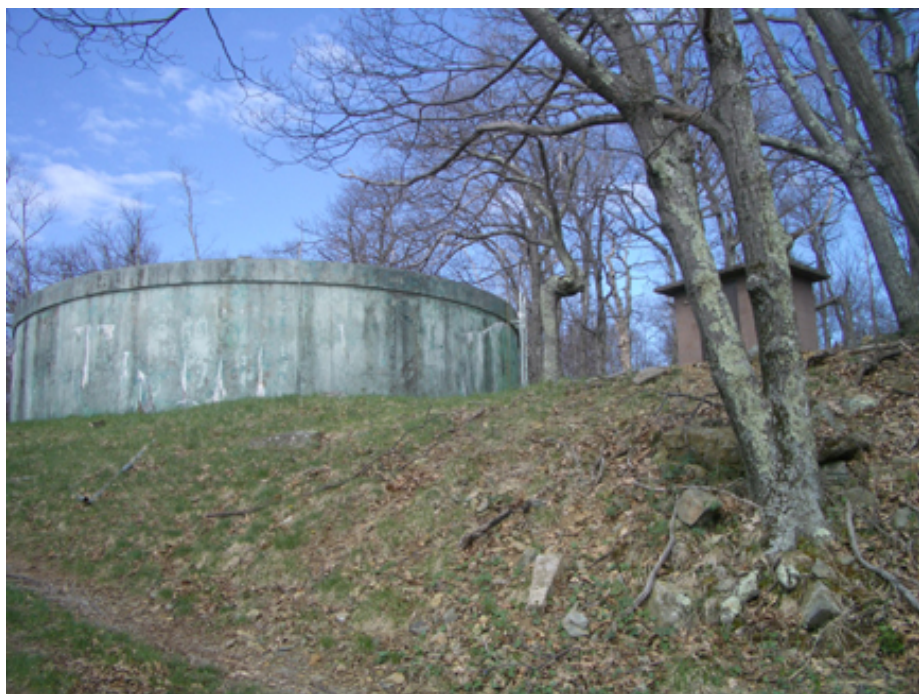
*Fig. 26: Looking west at the water tank and shed on the Piney Ridge. (OCLP 2005)*

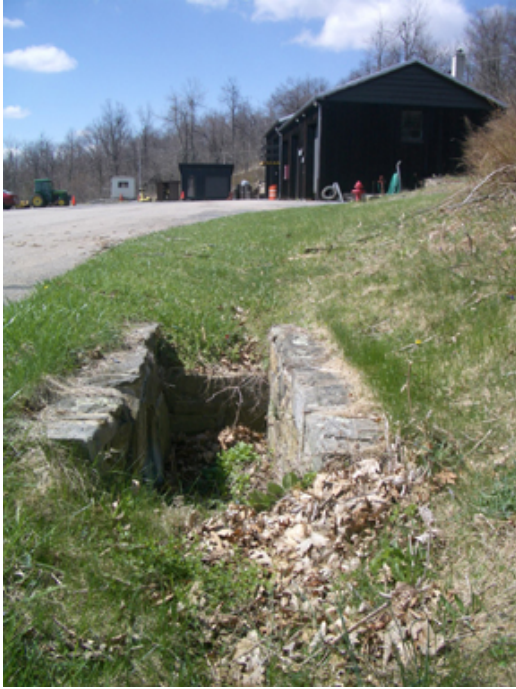
Two culverts can be found on the road to the maintenance building. Both feature corrugated metal pipes, mortared stone drop-inlets, and mortared stone headwalls at the outlets. It is unlikely that the culverts are historic as their outlets would have directed water into the barracks just down the slope. At the maintenance building, floor drains and roof down spouts connect to two cast iron pipes under the parking area that drain into the wooded field. Their outlets feature mortared stone headwalls and splashpans.

*Fig. 27: Looking southwest at the stone culvert inlet along the road to the Maintenance Building. (OCLP 2005)*

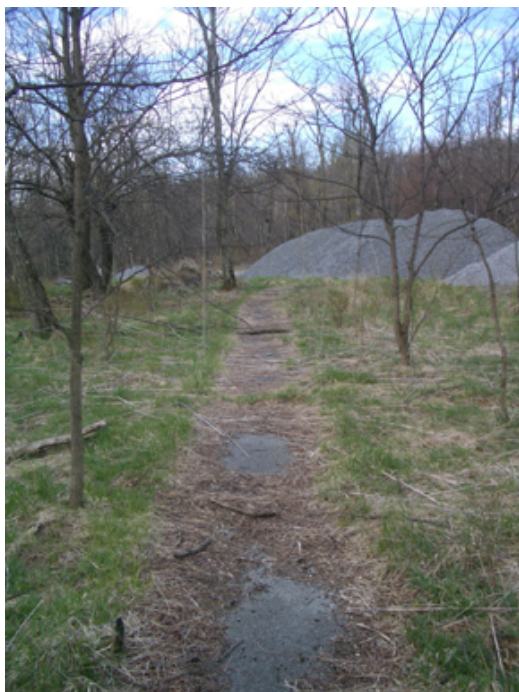
*Fig. 22: Looking northeast at a remnant asphalt path built for trailer housing. (OCLP 2005)*

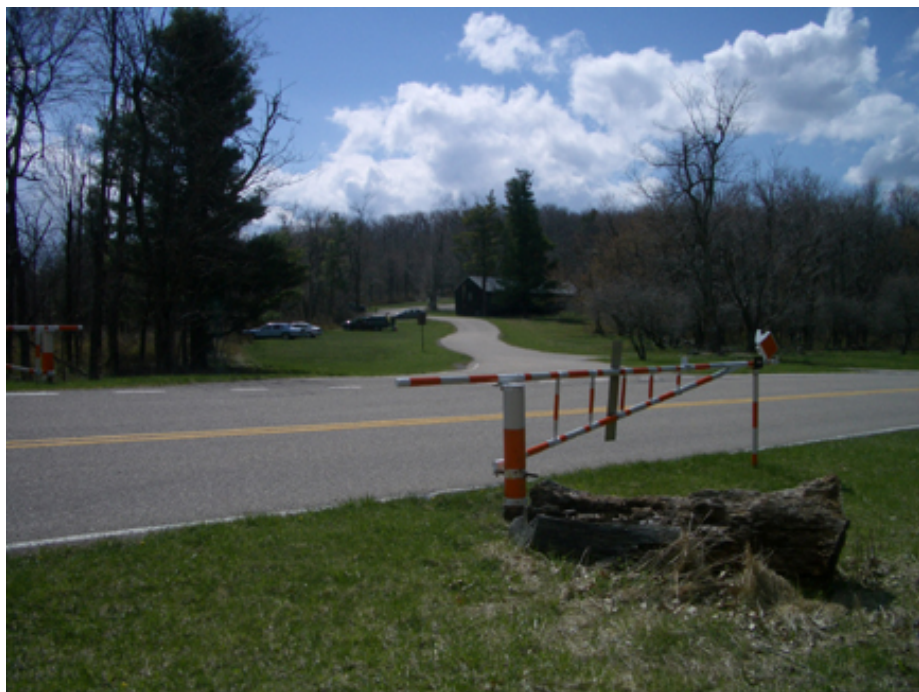
*Fig. 18: View looking west at the access road from Skyline Drive. (OCLP 2005)*

The widest of the three roads is not historic and heads southwest to the new maintenance building where ambulance and fire vehicles are stored. A pull-off area for the modern gas/oil building is to the immediate left and the road ends as large paved parking area. This parking area, and the others described above, is bounded by concrete bumpers. [see Figs. 18, 19, 20, 21, 22]

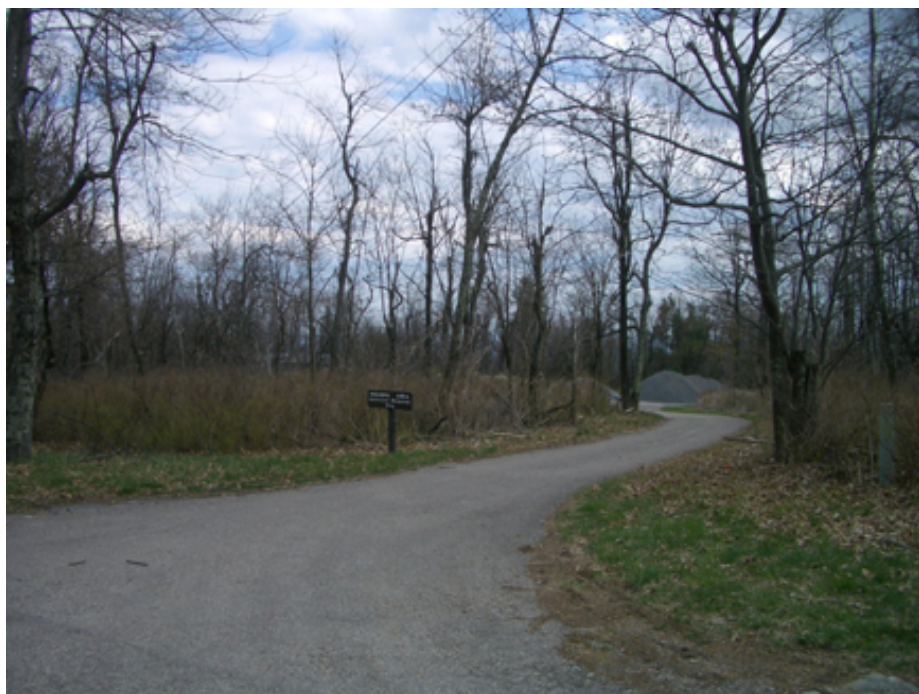
*Fig. 19: View looking south at the road leading to the Residence and fire road. (OCLP 2005)*

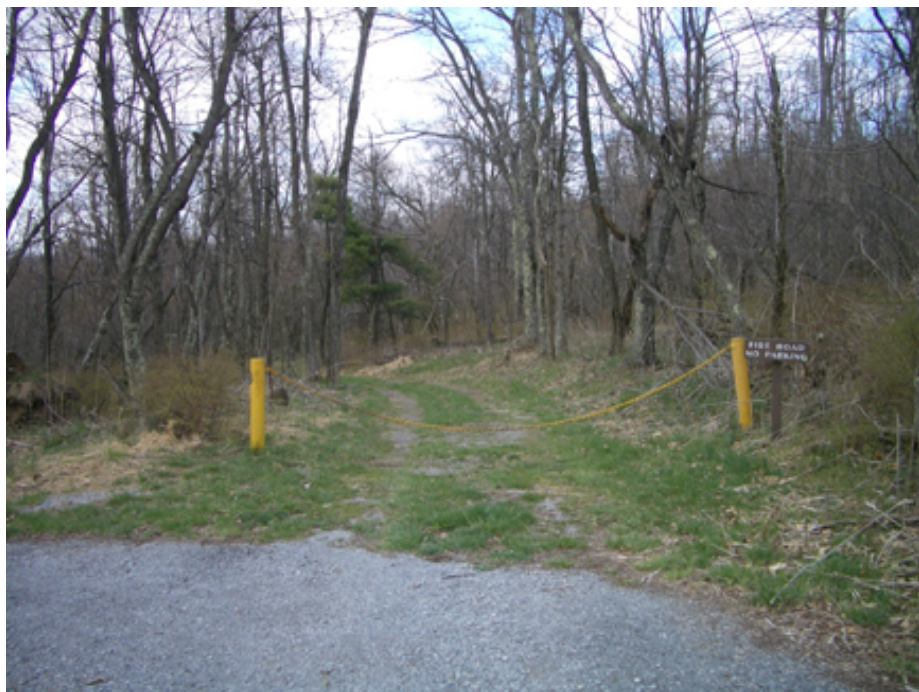
*Fig. 20: View south at the fire road which leads to the Range View Cabin and connects with the Appalachian Trail. (OCLP 2005)*

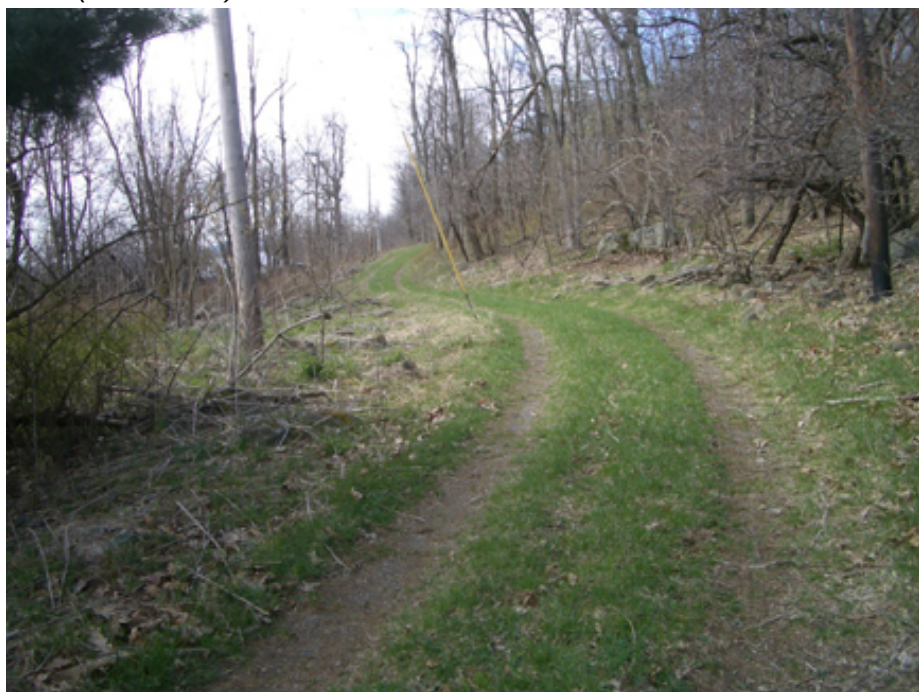
*Fig. 21: View looking southwest at the road leading to the water tank and the ridge. (OCLP 2005)*

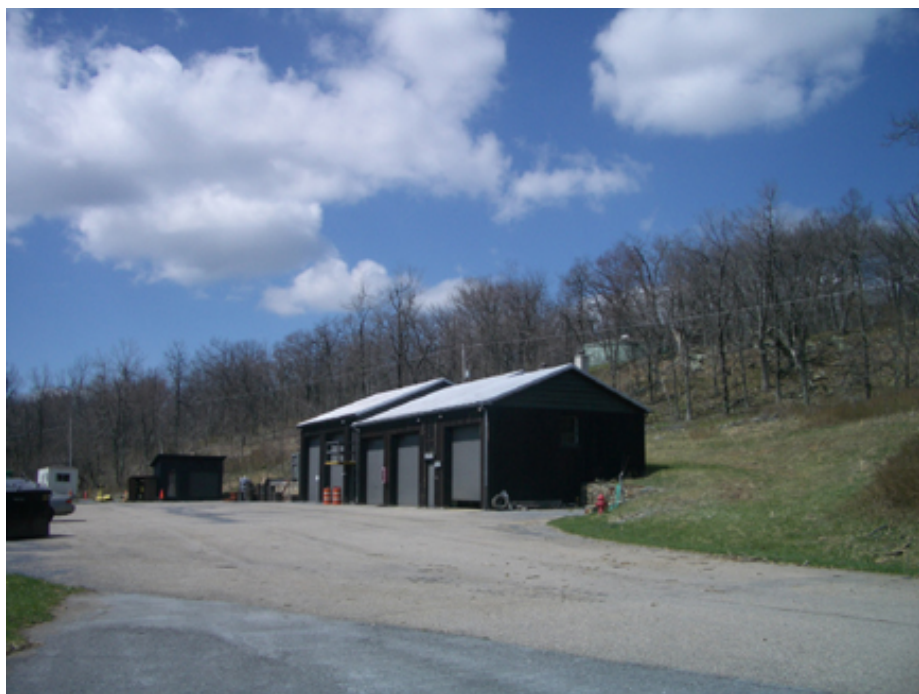
*Fig. 12: View looking southwest at the Maintenance Building area. (OCLP 2005)*

Recreational use of the area is limited. Hikers can access a trailhead for the Piney Branch Trail at the entrance of the site and connect with the AT, which tracks southeast of the site. Both the AT and the Fire Road continue south to where the PATC Range View Cabin is located. The PATC also stores trail supplies in the Maintenance Office/CCC Technical Office and in the maintenance building. [see Figs. 12, 13, 14]

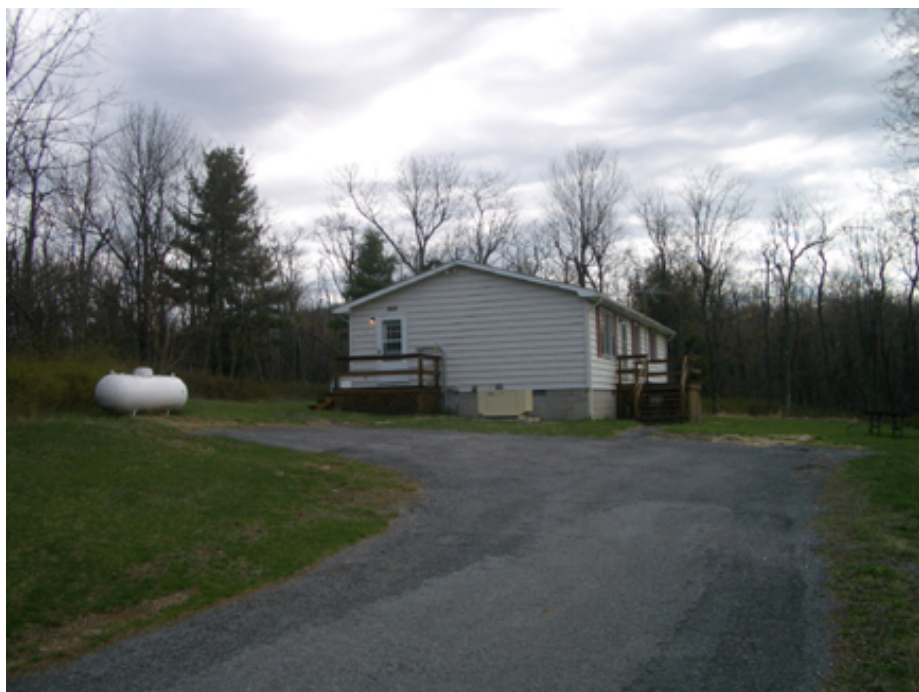
*Fig. 14: View looking east at the Residence. (OCLP 2005)*

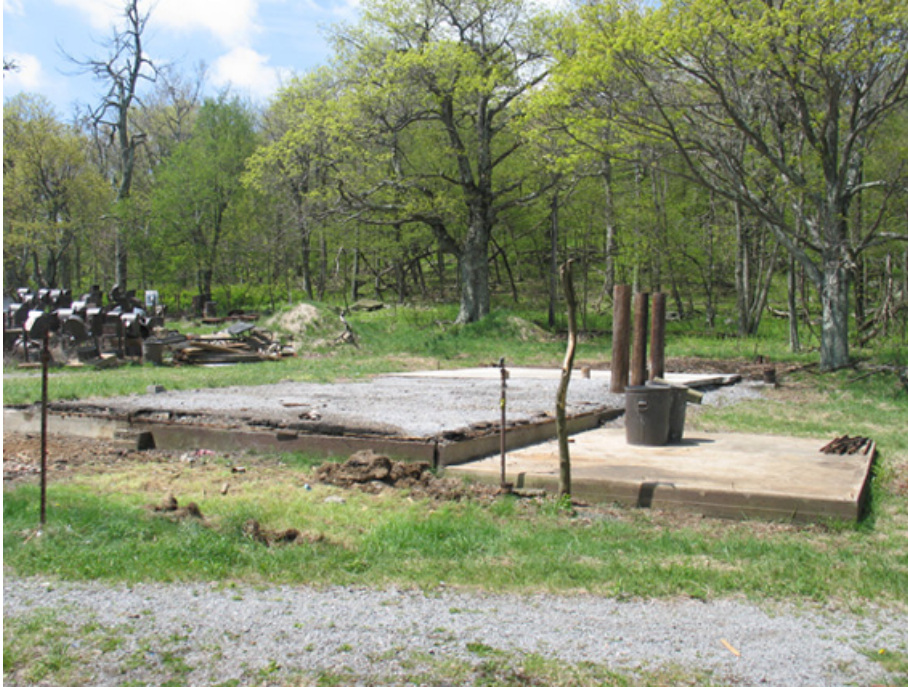
*Fig. 13: View looking southwest at part of the storage area in front of the former Maintenance/ Equipment Shed-CCC. (OCLP 2006)*

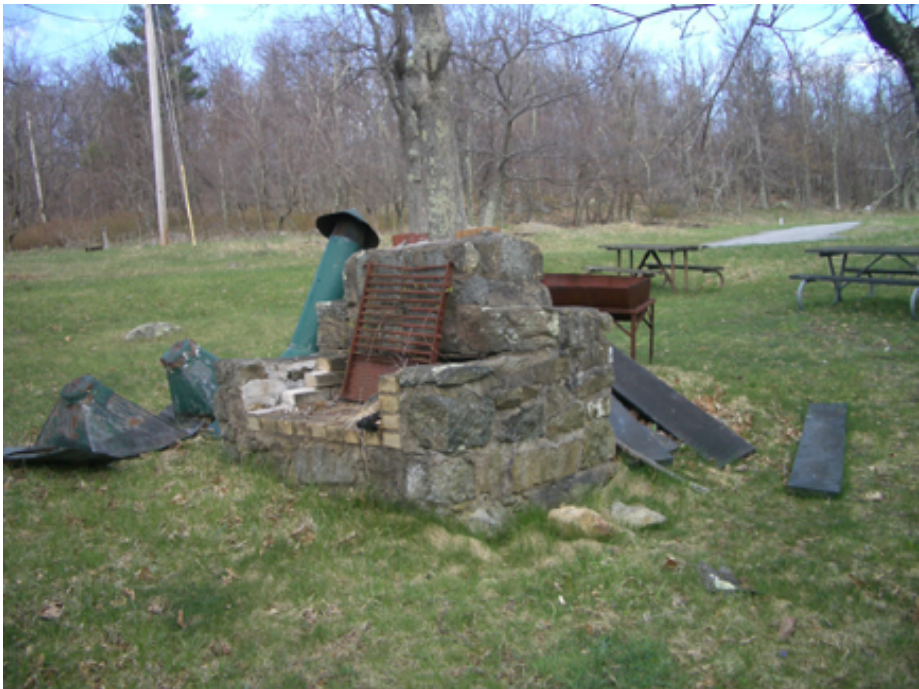
Fig. 30: The grill likely dates to the CCC period. (OCLP 2005)

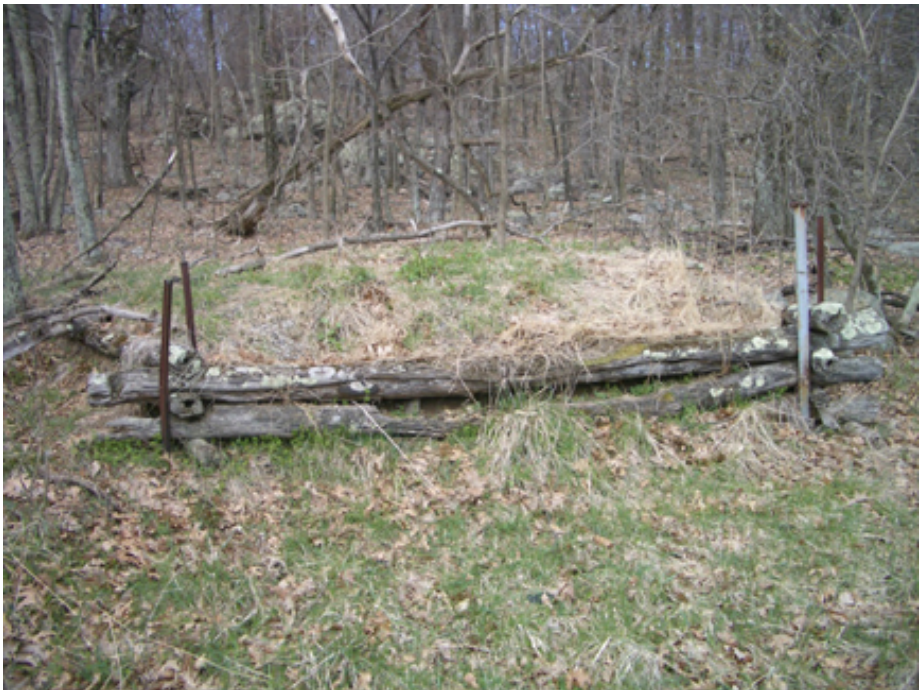
*Fig. 31: The wood loading ramp behind the Maintenance/Equipment Shed-CCC is likely historic. (OCLP 2005)*

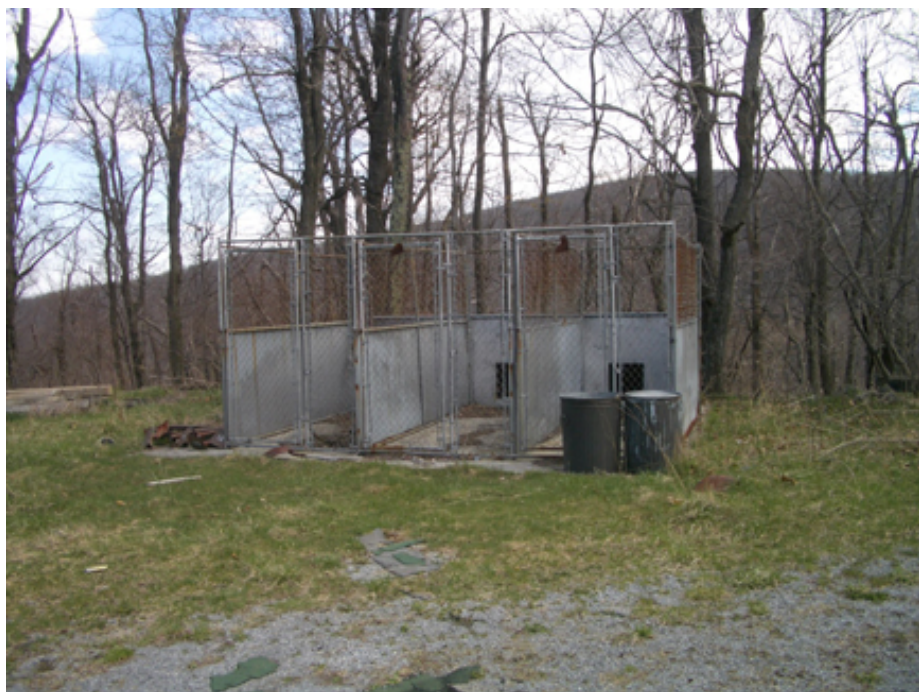
Traces of former park uses are evident throughout Piney River. An abandoned kennel with chain-link fencing and metal dividers sits on a concrete slab behind the former Maintenance/Equipment Shed. On the west side of the Hub is a grass area that was once the location of an NPS building that has since been removed. Concrete footings can be found where a portion of it once stood. (NPS plan, 1982:134-40044) This area also features an abandoned concrete pad formerly for a gas tank, a rectangular grill with a concrete base, and two metal weather devices, and three wooden posts near the tree line that once protected a third weather device. Just west of the residence is a propane tank, and west of there is another abandoned concrete pad used for a gas tank that once served the trailers. Across the road from the pad are steel posts and a chain that restrict vehicular access to the Fire Road.

*Fig. 32: Abandoned dog kennels are located behind the Maintenance/Equipment Shed-CCC. (OCLP 2005)*

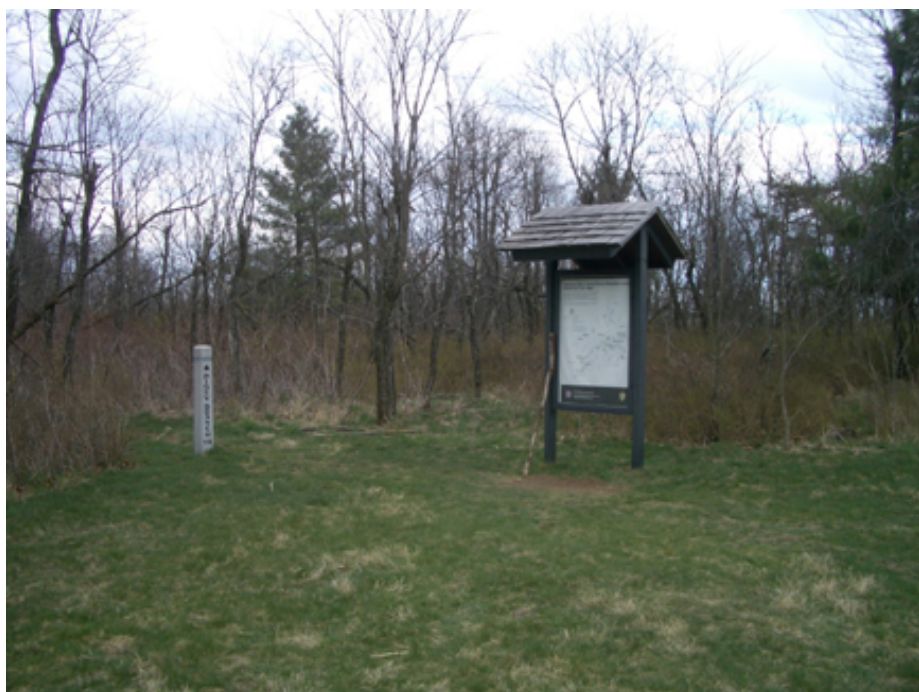
*Fig. 33: The two-side bulletin board and trail marker are located just south of the access road. (OCLP 2005)*

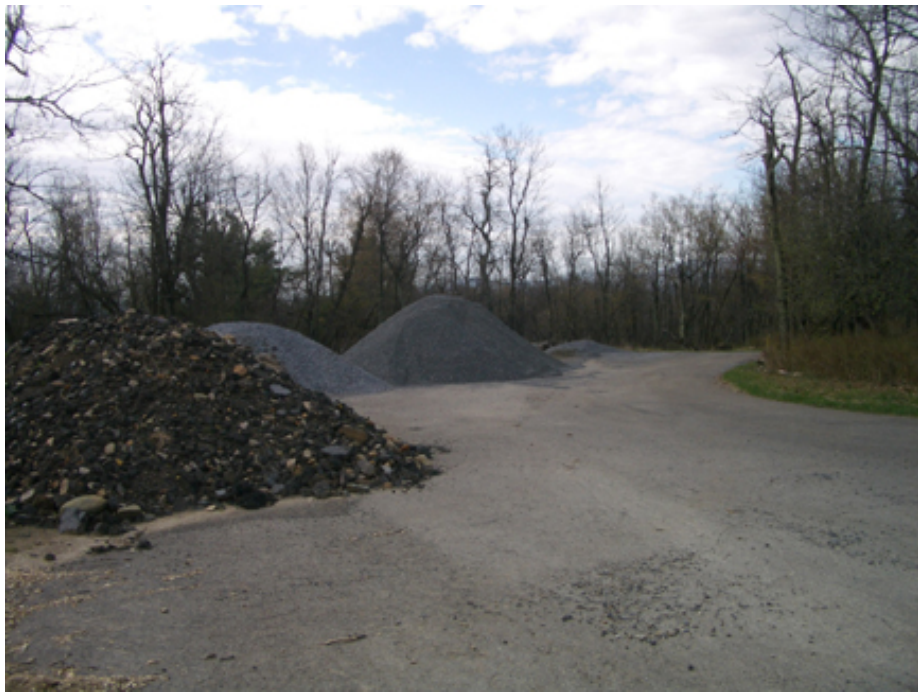
For fire protection, there are three hydrants: a short red hydrant near one of the paths where employee trailer housing once stood, a narrow and tall red hydrant just north of the Maintenance Office/CCC Technical Office, and a red fire hose box and newer fire hydrant at the maintenance building. For septic services, there are tanks and seepage fields south of the Hub for the Maintenance Office/CCC Technical Office; west of the Fire Road for the maintenance building; and southwest of the residence. NPS benchmarks, four-sided concrete aggregate posts with round iron tops, are found at Piney River as well as other areas of Shenandoah NP. A trash dumpster and recycling bin are located at the maintenance building and throughout the site are various storage piles of materials "C primarily mulch, stone, gravel, and debris "Cas well as storage areas of trash cans, logs, and the like. [see Figs. 30, 31, 32, 33, 34]

*Fig. 34: View south at some of the storage piles at Piney River. (OCLP 2005)*

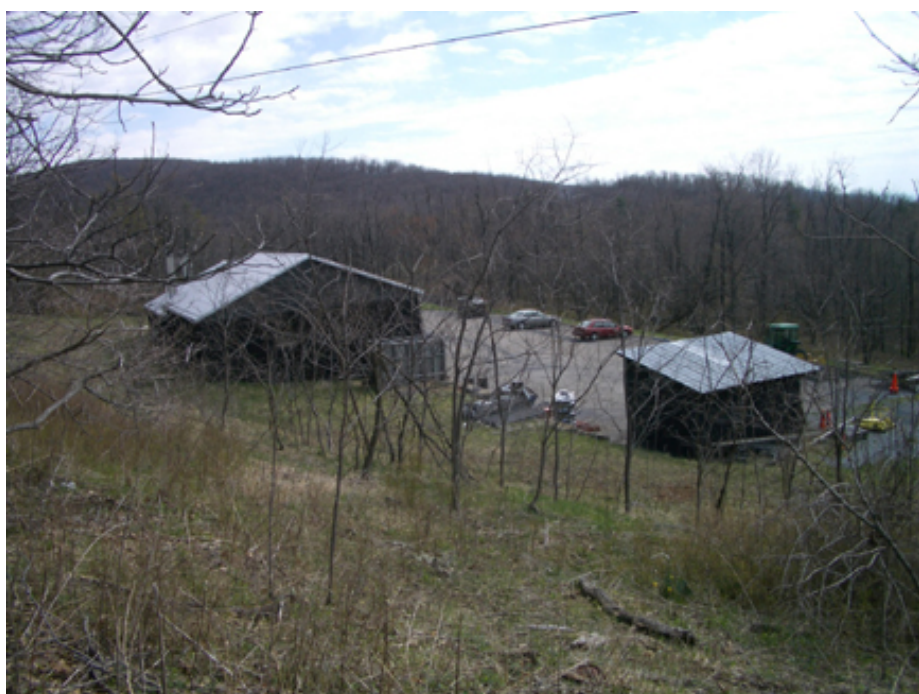
*Fig. 15: View looking northeast from the slope of the ridge to the gently sloped area where the CCC barracks were located. (OCLP 2005)*

Topography played an important role in locating Camp NP-12. The camp was developed on the gently sloped lands below Piney Ridge, with the arrangement of buildings as a whole aligned in blocks along the contours. The locations of a water supply and related domestic features were consistent with topographic conditions; a reservoir was located on the upper slopes of Piney Ridge and connected to the bathhouse on the slope of the ridge, while sewer lines from that building and the mess hall connected to disposal fields farther down the hill to the south and east of the camp. (NPS plan, 1942:CCC) Additionally, the location of the camp east of, or behind, the ridge may have offered some relief from the summer's winds and the late day sun. [see Fig. 15]

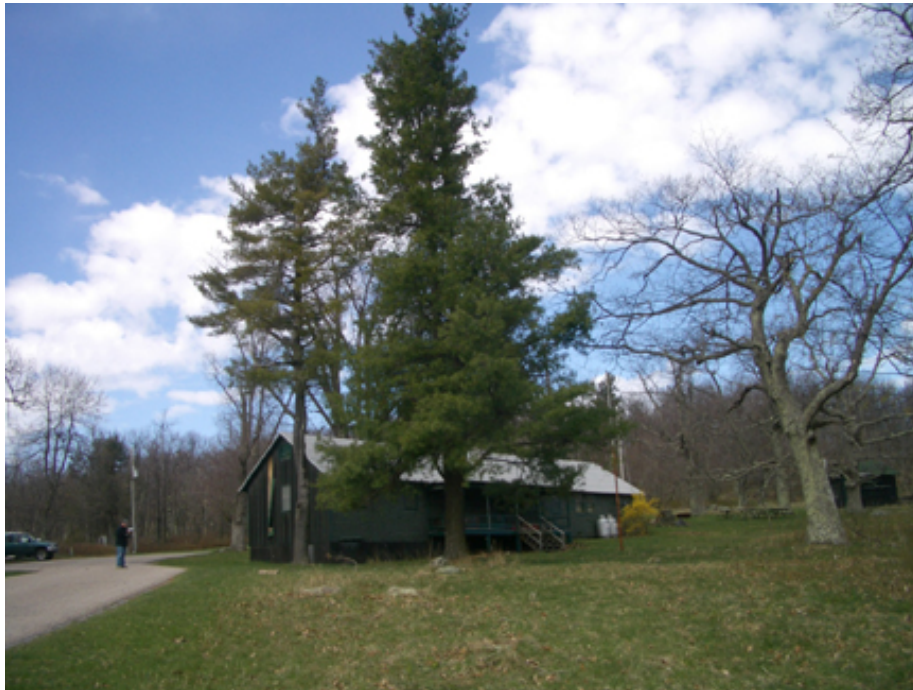
*Fig. 16: View looking west at the two historic pines and oak behind the Maintenance Office/CCC Technical Office. (OCLP 2005)*

On the top of Piney Ridge there is a scattering of large oak and cherry trees across the rocky surface. The shrub layer is thin to non-existent and rocky ridges persist. There is a very large contorted oak tree and a very old cherry tree marking the highest point. The age of the stand appears to be approximately the same as trees planted by the CCC at picnic and campground sites throughout Shenandoah. [see Figs. 16, 17]

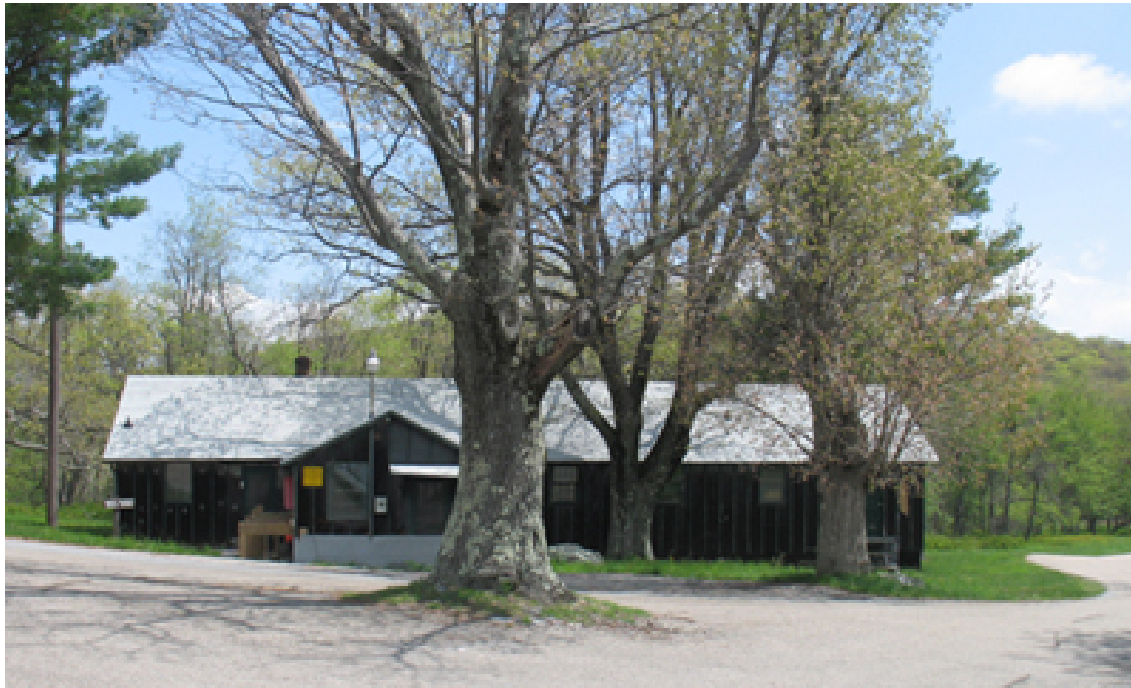
*Fig. 17: View looking northeast at the three historic oaks in front of the Maintenance Office/CCC Technical Office. (OCLP 2006)*

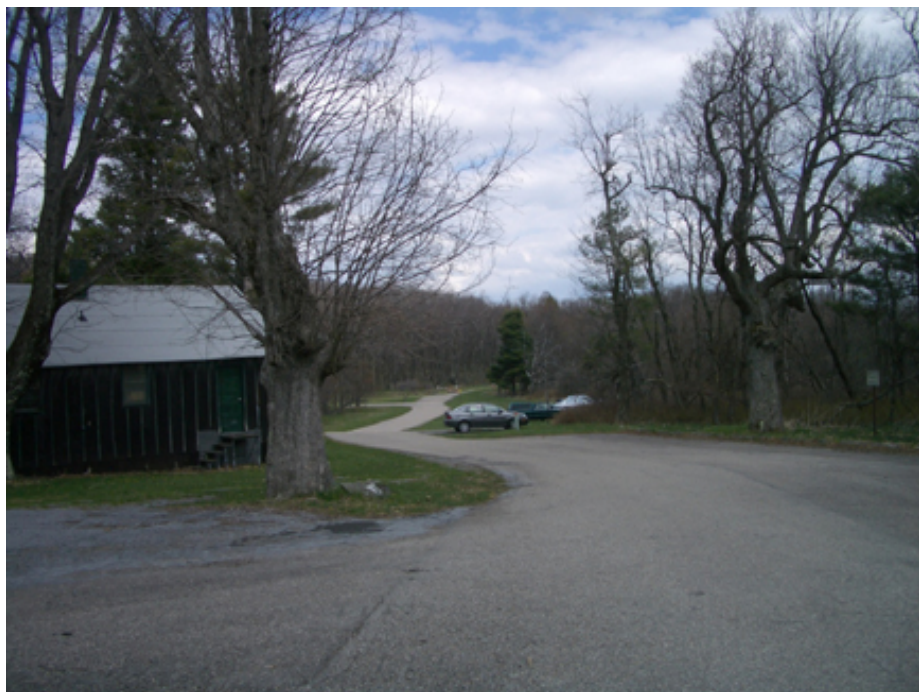
*Fig. 29: Looking east from the Hub toward Skyline Drive. The Maintenance Office/Technical Office is on the left. (OCLP 2005)*

The view east toward Skyline Drive is still present from the Hub but less so from other areas of the former camp due to the presence of the secondary growth woodlands. The spectacular views to the south and east remain intact from the higher slopes of Piney Ridge, but are essentially blocked from the lower slopes from what is now the maintenance building area, also because of the woodlands. In 1984, a proposed employee housing area southeast of the Hub, which was to consist of seven apartment units and three family units, was sited for its potential views to the surrounding environment. (GMP, 1984:141) Views from the employee residence, constructed in this area in 1987, are blocked because of the encroaching woodlands. [see Figs. 28, 29]

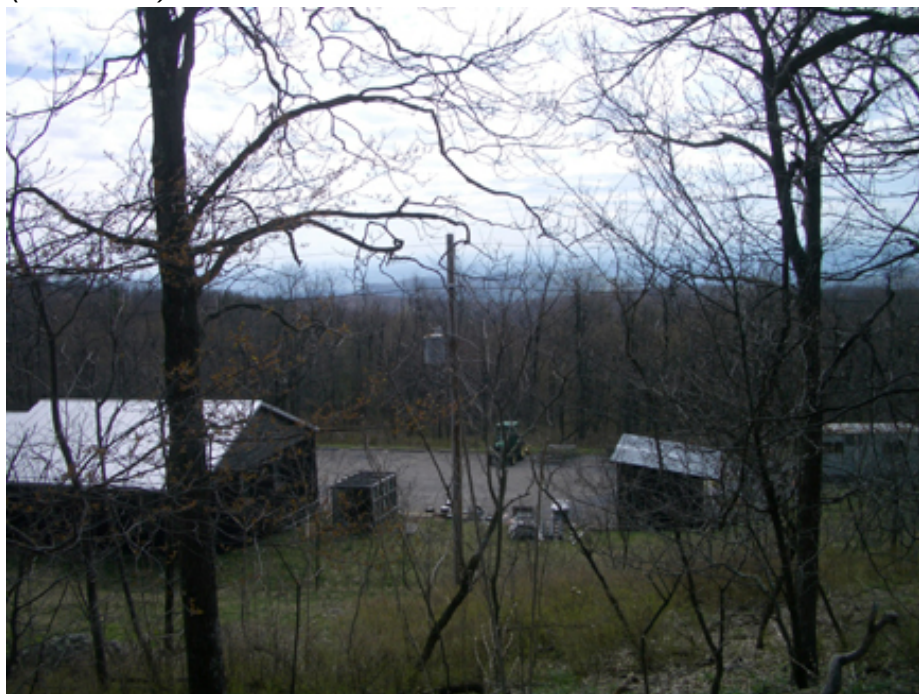
*Fig. 28: Looking southeast from the water tank atop Piney Ridge to the distant mountains. CCC barracks filled the gently sloping land now occupied by the Maintenance Building and parking area. (OCLP 2005)*
