## Introduction

| <b>Inventory Unit Name:</b> | Pinnacles Picnic Grounds |

| <b>Park Name:</b> | Shenandoah National Park |

Site Plan

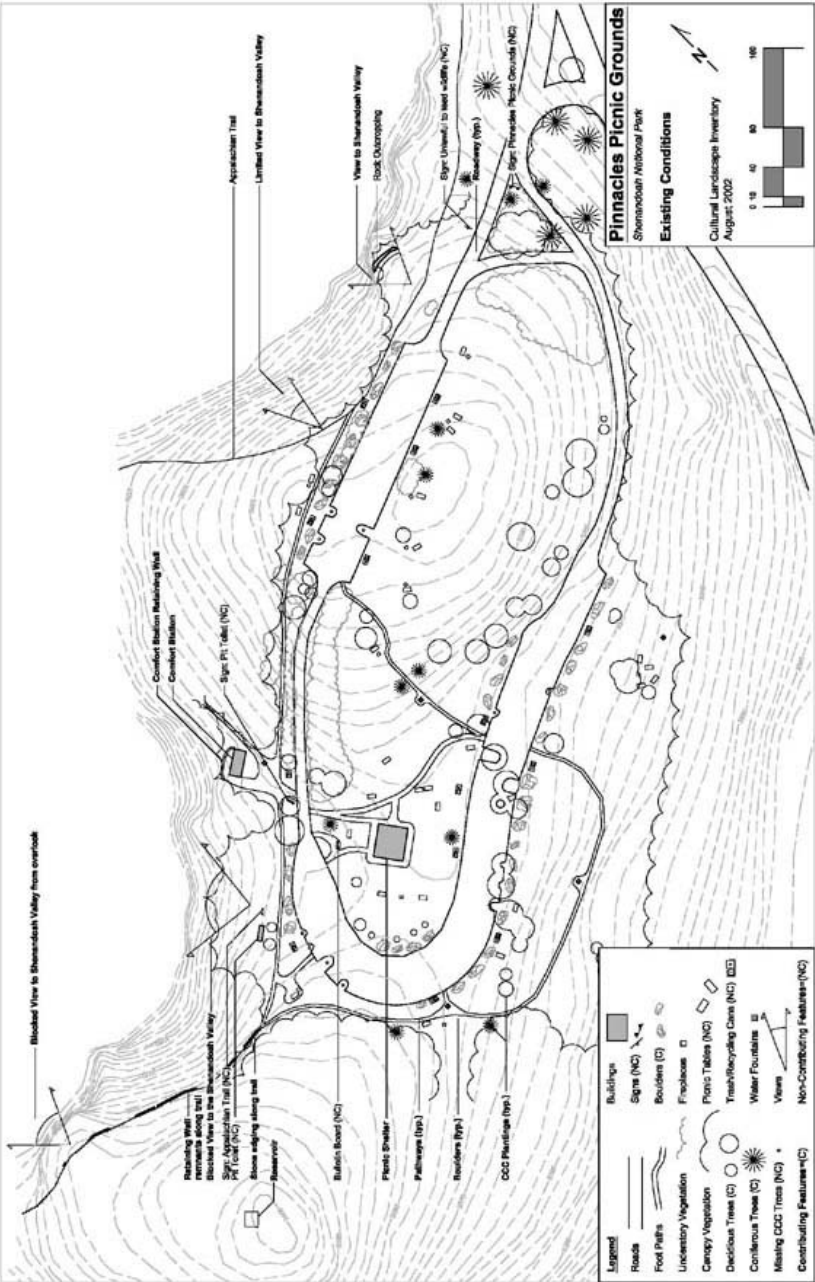
Existing Conditions: Overview (See Addendum for enlargement).

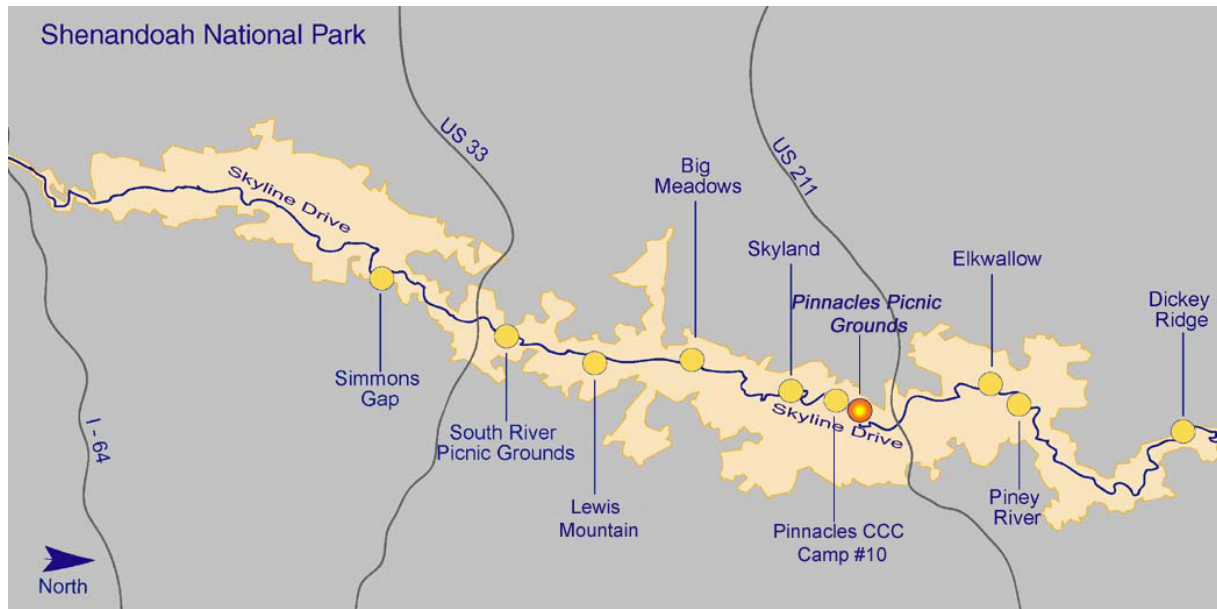
*Illustration of the Skyline Drive component landscapes (PHSO 2002).*

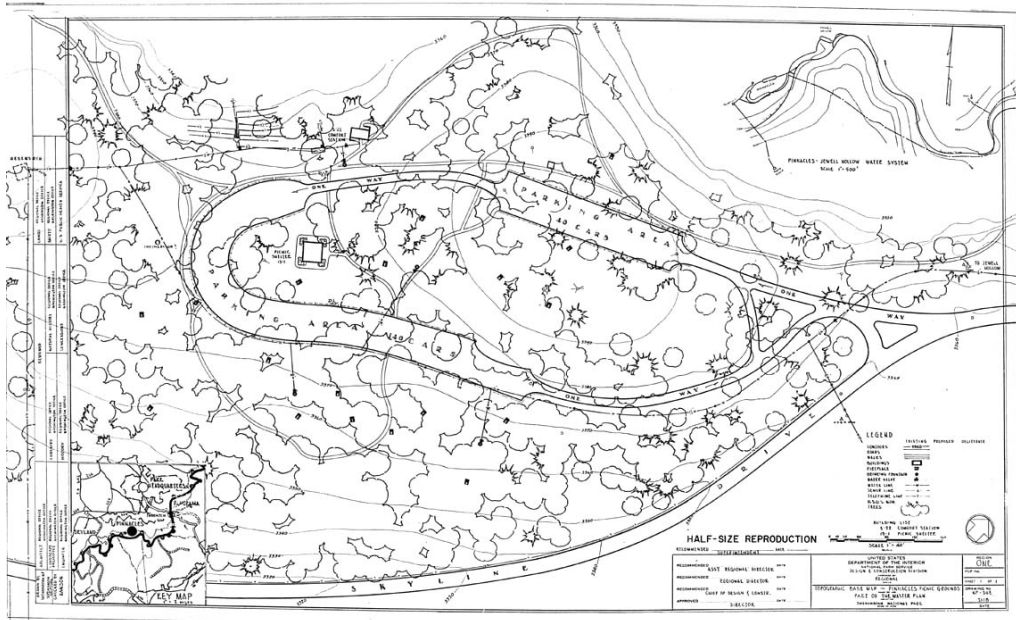
*"Topographic Base Map – Pinnacles Picnic Grounds, Part of the Master Plan". This undated basemap for the picnic grounds was probably created at the time the CCC developed the area (NPS NP-SHE/2118, ND).*

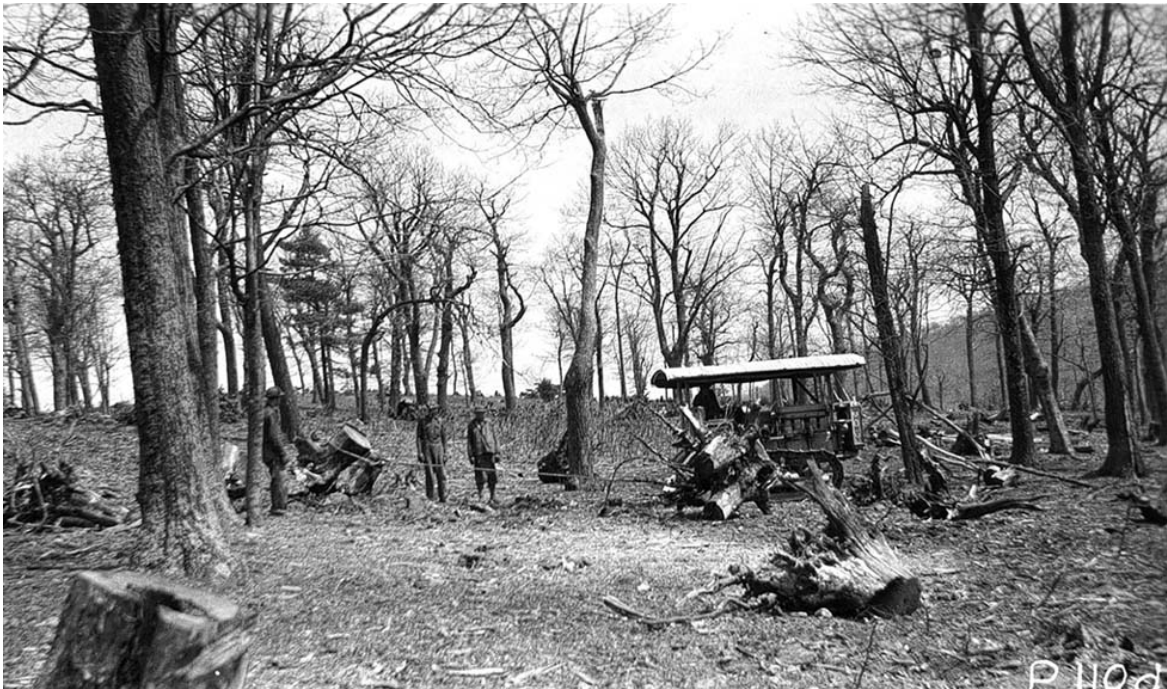
*This 1934 photograph shows CCC workers pulling out tree stumps at the proposed picnic grounds. While wooded, the high canopy created the relatively open nature of the site (SHEN Archives 1934, ANCS 11433).*

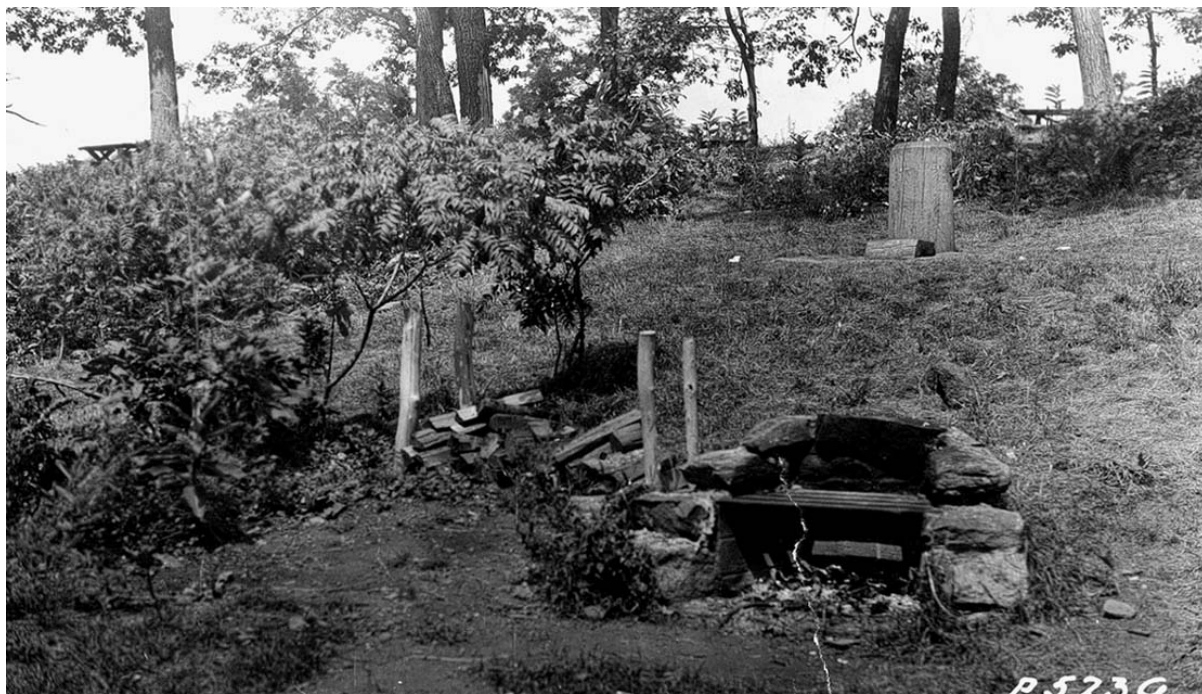
*This is a typical CCC fireplace with a wood rack nearby. In the background there is also a water fountain (SHEN Archives 1936, ANCS 09640).*

Many of the small-scale features originally installed at the Pinnacles picnic grounds have been replaced over time. The CCC installed stone fireplaces with metal grills that are located around the site. Some of these still exist. NPS has also added metal grills mounted on 3' x 4' concrete slabs.

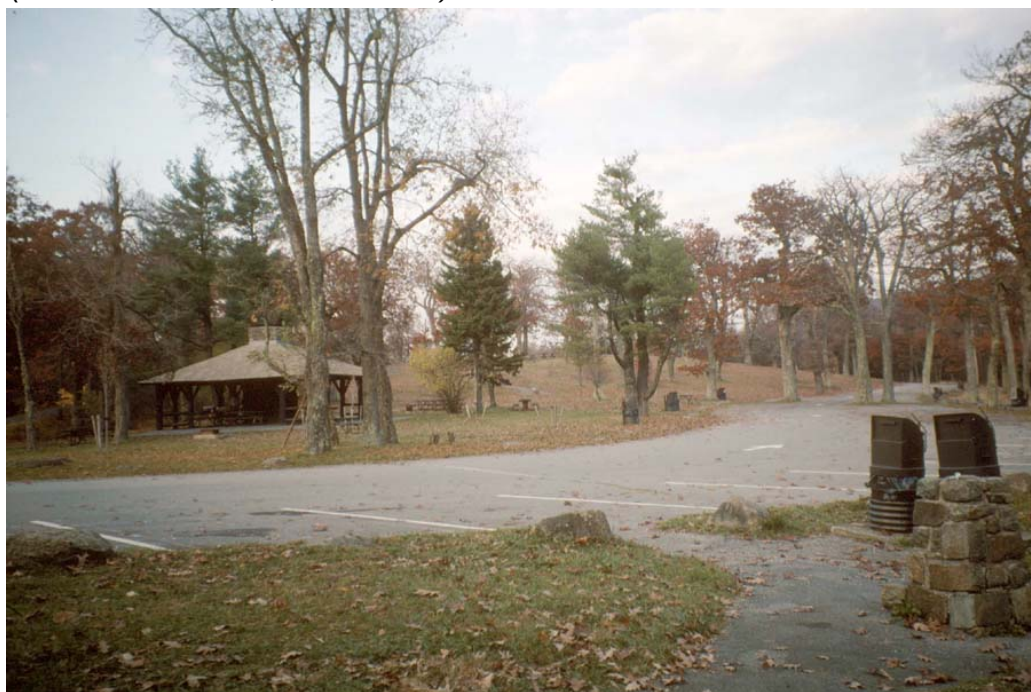
*The Pinnacles site has been used as a picnic grounds since its construction in 1935-1936 (PHSO 1999).*

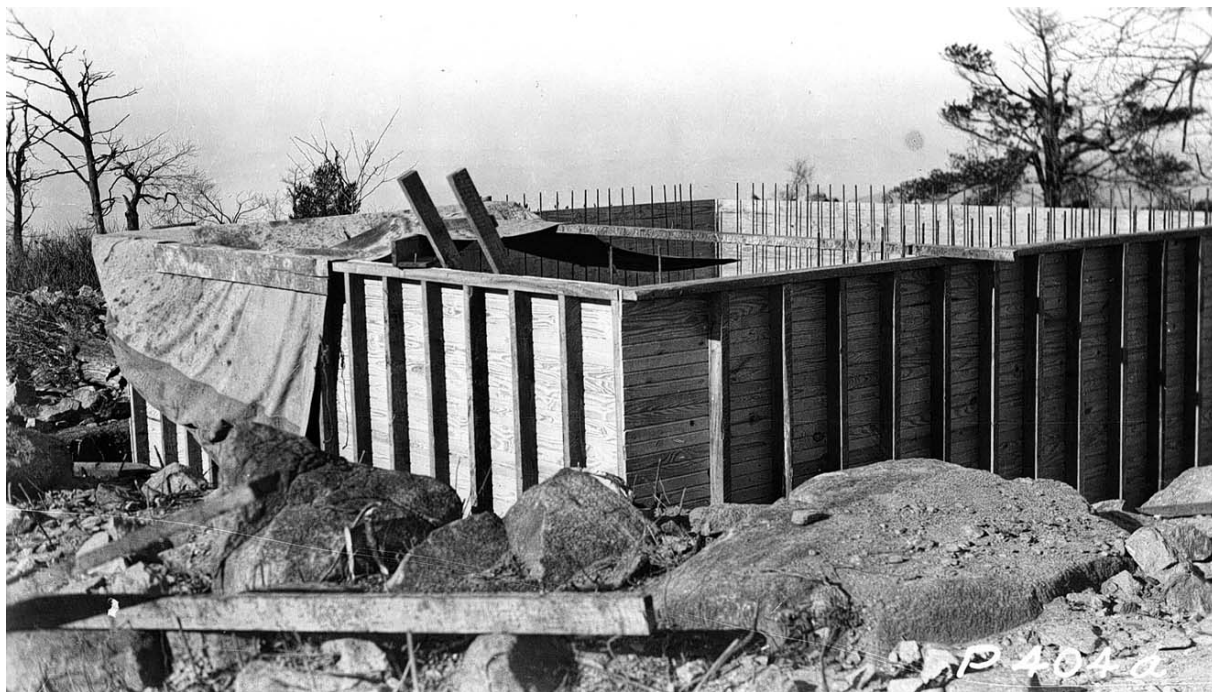
*This 1936 photograph shows the Pinnacles Reservoir under construction (SHEN Archives 1936, ANCS 10415).*

The CCC built an underground reservoir on the hilltop southwest of the picnic grounds to provide water for the comfort station and water fountains. A 1966 plan entitled "Layout of Water System: Pinnacles" indicates the original connection through the pump house east of Skyline Drive was replaced with a pipe directly connecting it to the reservoir at the laboratory/former CCC camp. The plan is hand-labeled "Work done 1976" (SHEN Archives dwg. NP-SHE/2674, 1966). Repair work was done on the system in 2001.

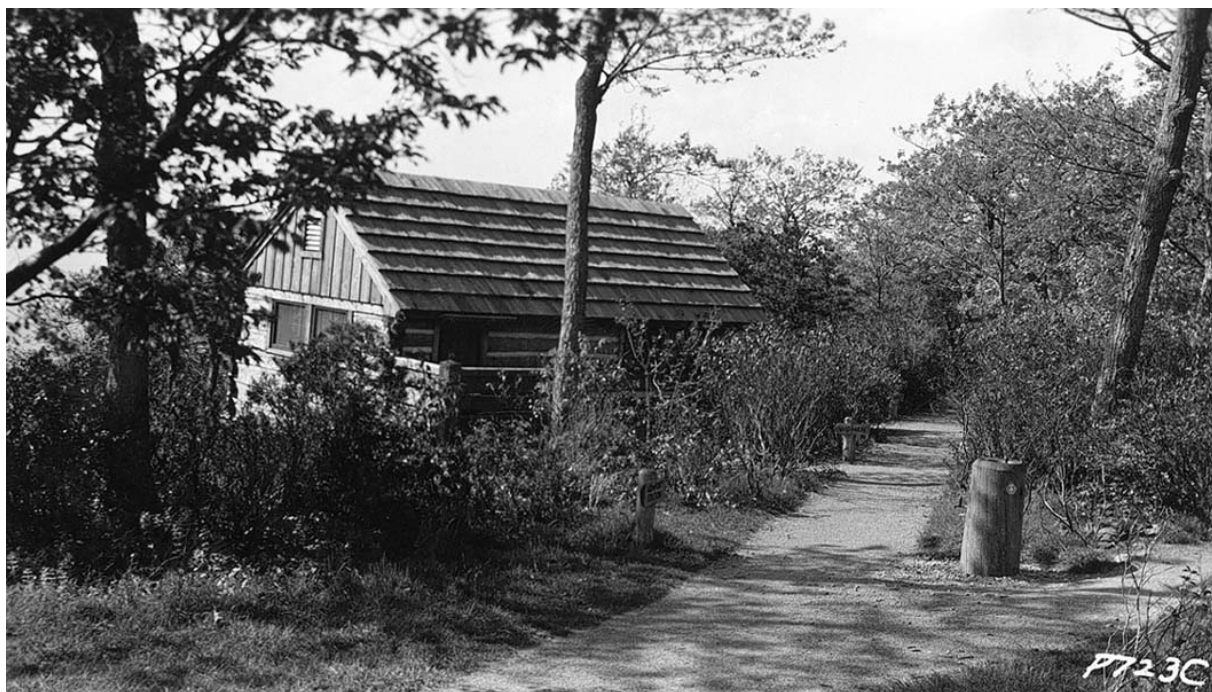
*This 1938 photograph shows paths laid out and constructed by the CCC (SHEN Archives 1983, ANCS 10631).*

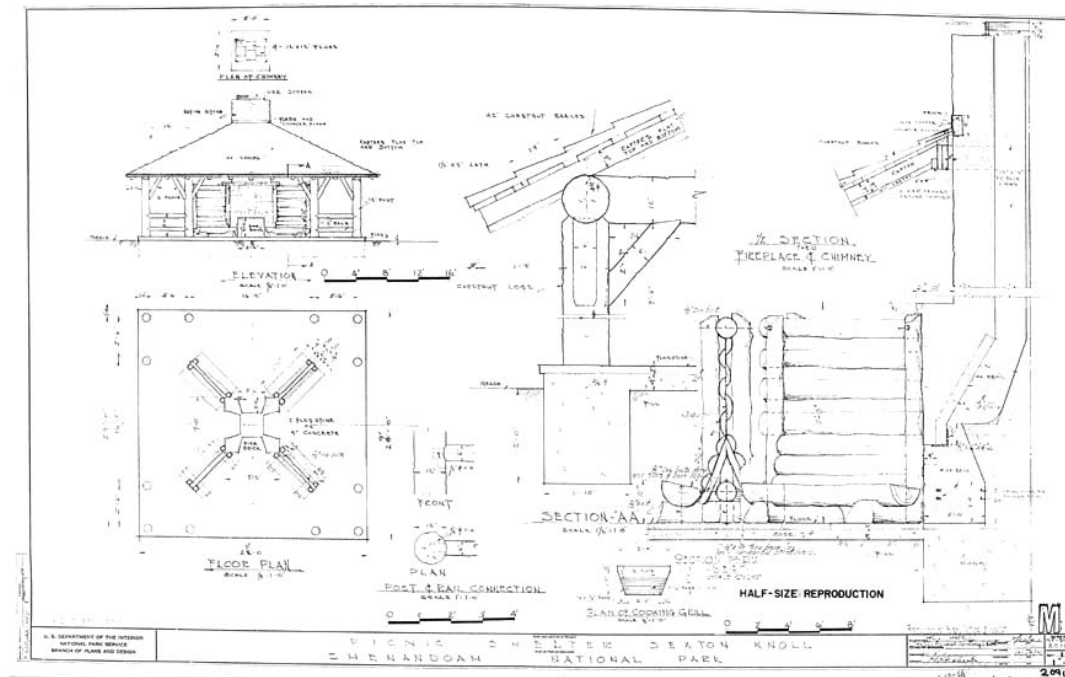
This design drawing for the picnic pavilion shows post and beam construction, chestnut shakes, and two-sided benches (Denver Service Center TIC Files 1940, NPS/SHE dwg. 2091).

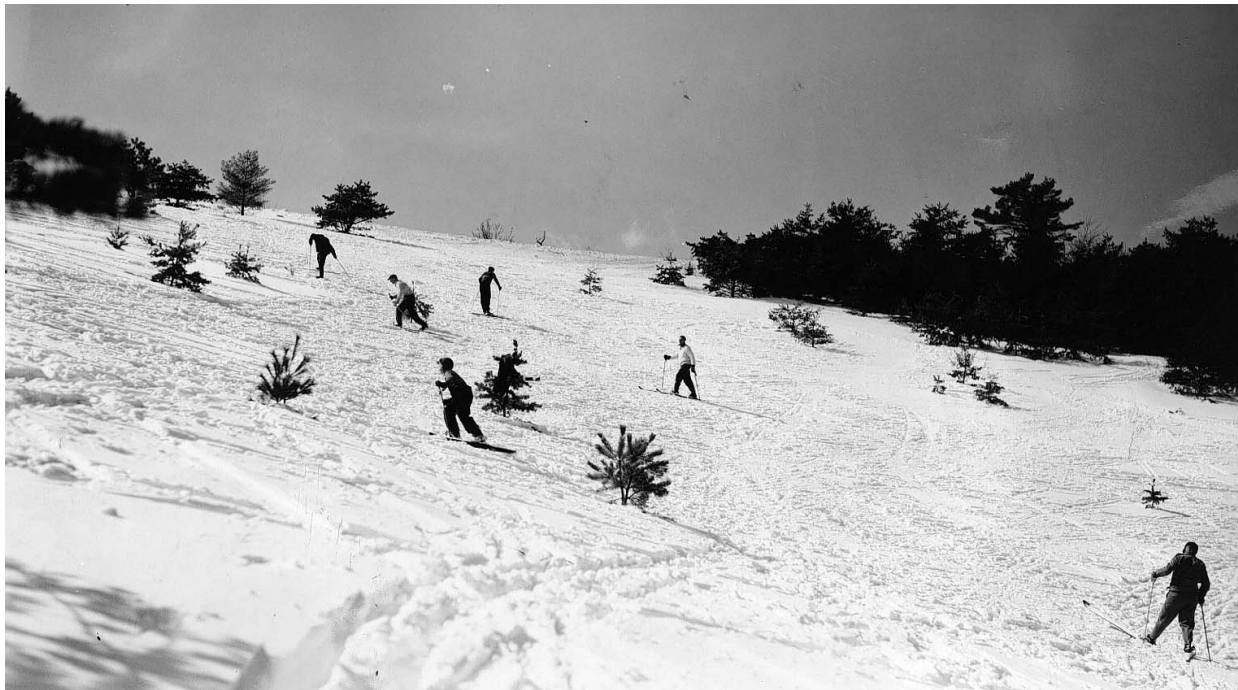
The mountainside at Pinnacles picnic ground served as a ski area at one time (SHEN Archives 1947, ANCS 04408).

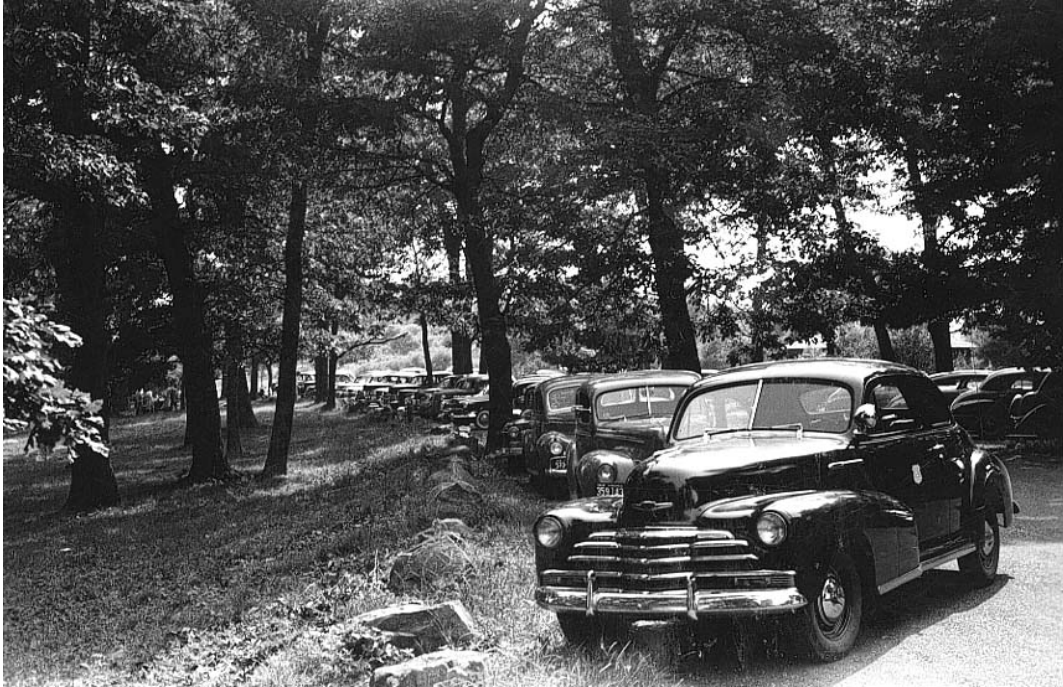
*Boulders were added along some parking areas by 1948, when this photograph was taken (SHEN Archives 1948, ANCS 04329).*

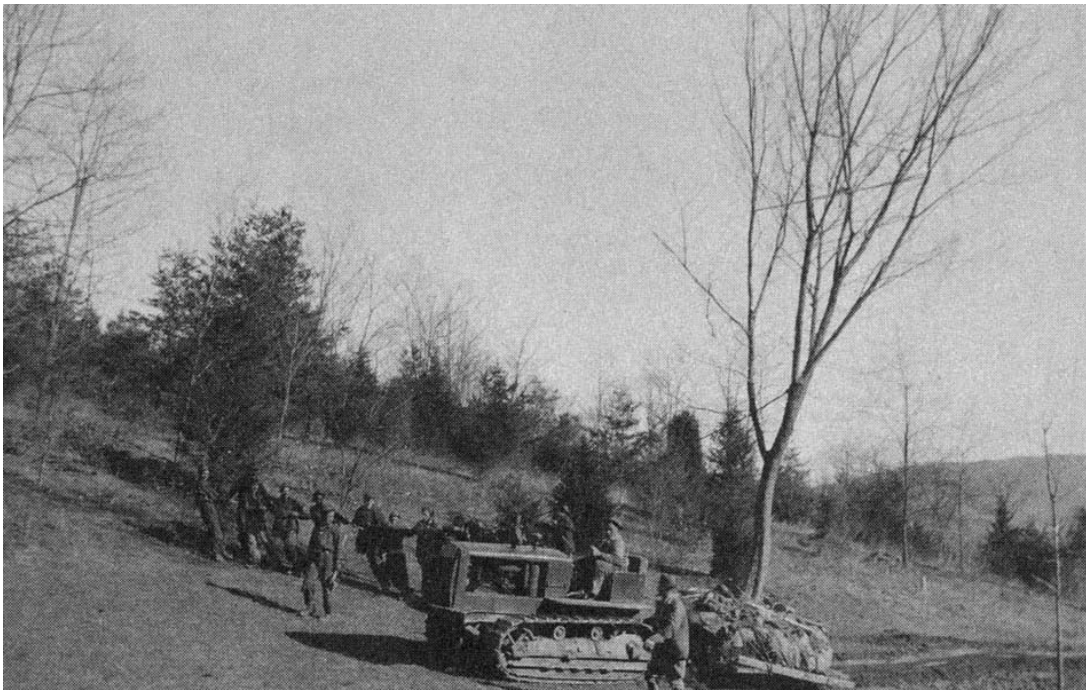
*This tree, balled-and-burlapped by a crew from NP-10 and being moved by a bulldozer, gives an indication of the extent to which the CCC went to create a natural looking landscape (Engle 1999, 85).*

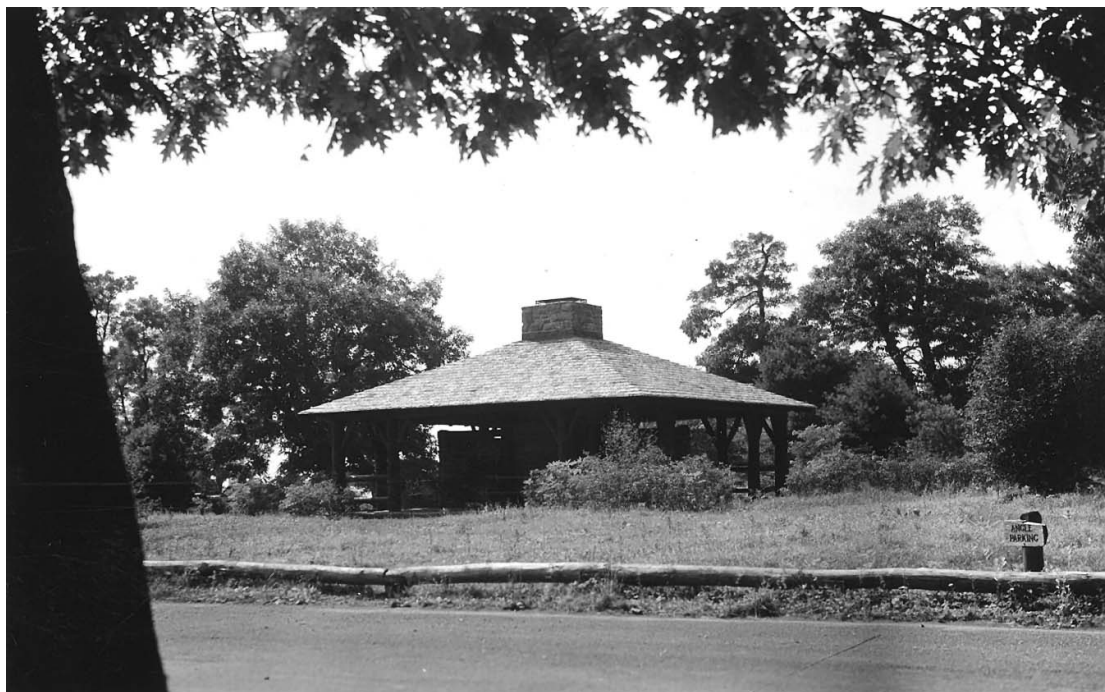
*This photograph shows the Pinnacles picnic shelter in 1941, with a log railing along the road (SHEN Archives 1941, ANCS 10744).*

The CCC installed low log barriers along the parking areas. This is visible in the 1941 photograph of the pavilion (see Buildings and Structures) and seems to be drawn in on the 1938 Sexton Knoll Picnic Grounds plan (NPS plan 1935/1938, "Sexton Knoll Picnic Grounds"). This feature is currently missing from the site. A 1948 photograph of the area shows boulders along the edge of the parking (SHEN Archives 1948, ANCS 04329). It is not clear where exactly these were located at the time or when they were added, but they exist along some of the parking areas today.

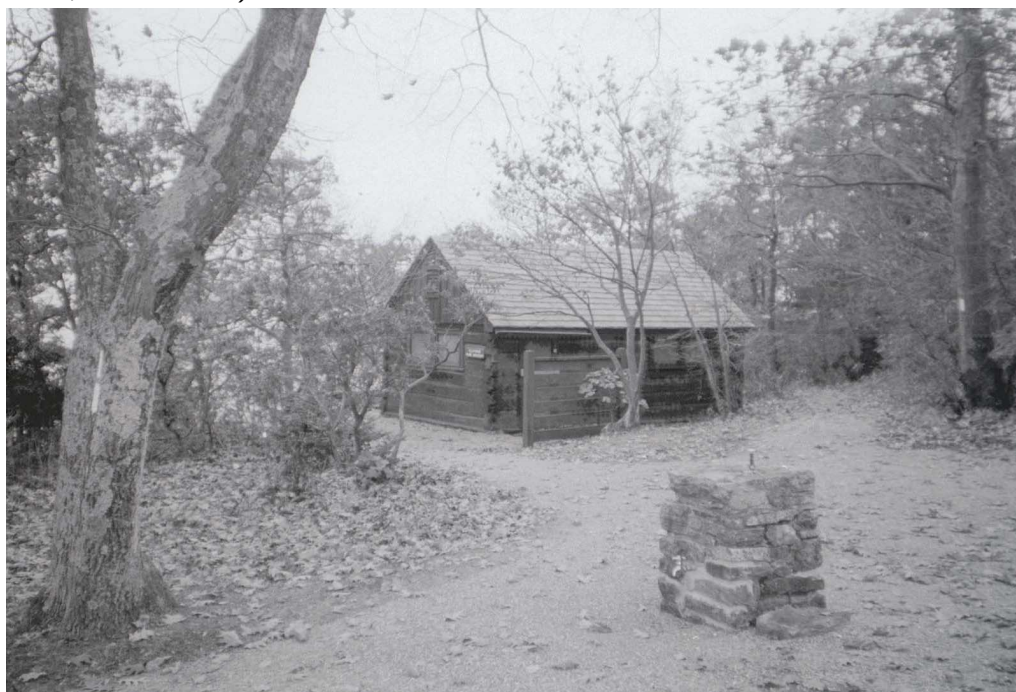
*The log comfort station was built by the CCC and still retains its original character (PHSO 1999).*

Another important CCC building is the comfort station. It was constructed as a 16' x 30' chestnut log building with V-notched corners and concrete chinking. It had a stone foundation and board and batten gables. There were two entrances with a privacy wall at the women's entrance (LCS 1998, 83112). At the men's entrance the CCC constructed a curving stone retaining wall approximately 40' long, 8' high, and 2' wide to provide a barrier and prevent erosion (LCS 1998, 83113). Today the comfort station and retaining wall retain their original character. In 1996 NPS removed the original concrete shingles, replacing them with new concrete shakes. A free-standing wood sight barrier was installed at the women's door and the stone retaining wall at the men's door was repointed.

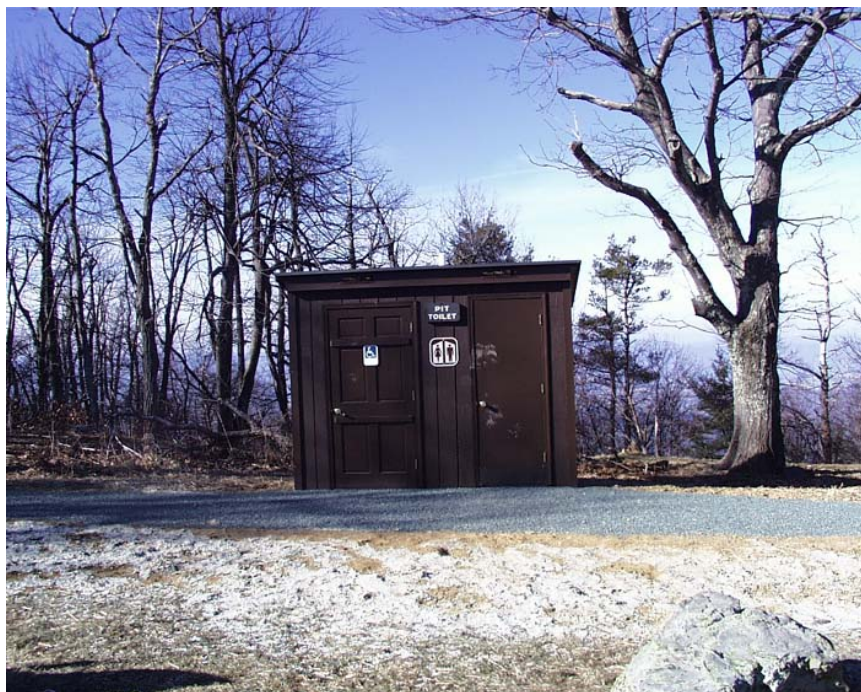
*The pit toilet building was replaced in 2001 with one that is accessible. Historically the view to the valley behind the building was open. (PHSO 2002).*

The Shenandoah National Park "Sexton Knoll Picnic Grounds" plan dated 1935 and 1938 shows a rectangle south of the comfort station that appears to be pit toilets, as it is connected to the septic field. This was installed to provide facilities for hikers and skiers after the comfort station was shut down for the season. In 1999 that was a 3 bay wood building painted dark brown with a Plexiglas roof and signage indicating it was open only out of season when the comfort station was closed. NPS replaced this structure in 2001 with another brown wooden structure with Plexiglas roof that has one handicapped accessible toilet and a storage room. Additional clearing to the west took place at the time this was installed and the septic field was renewed.

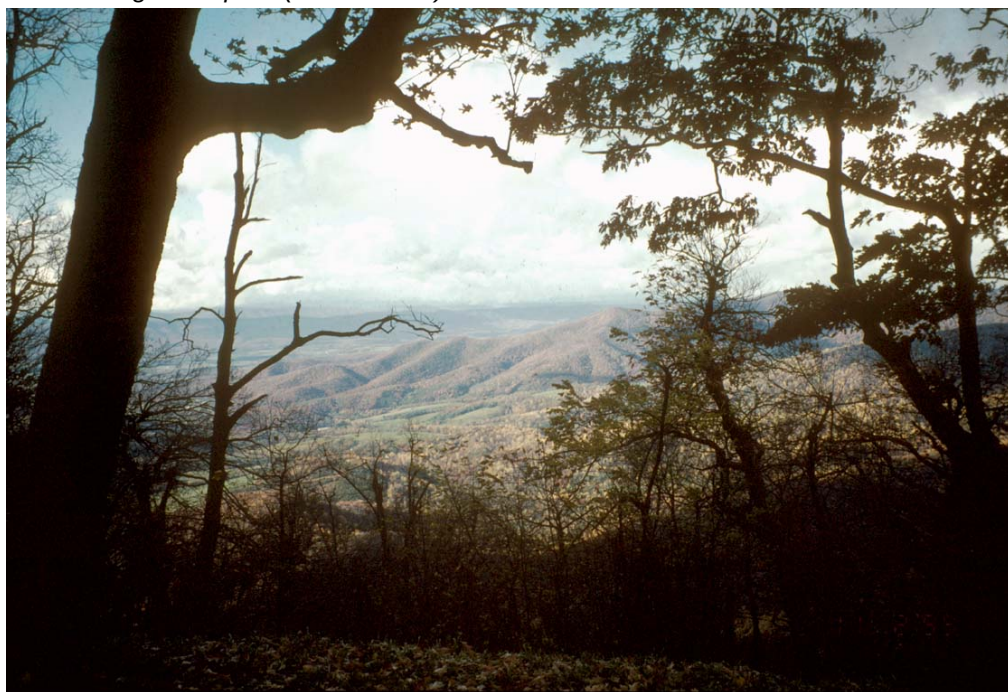
*View to Shenandoah Valley from rock outcropping northeast of picnic grounds entry drive and west parking area (PHSO 1999).*

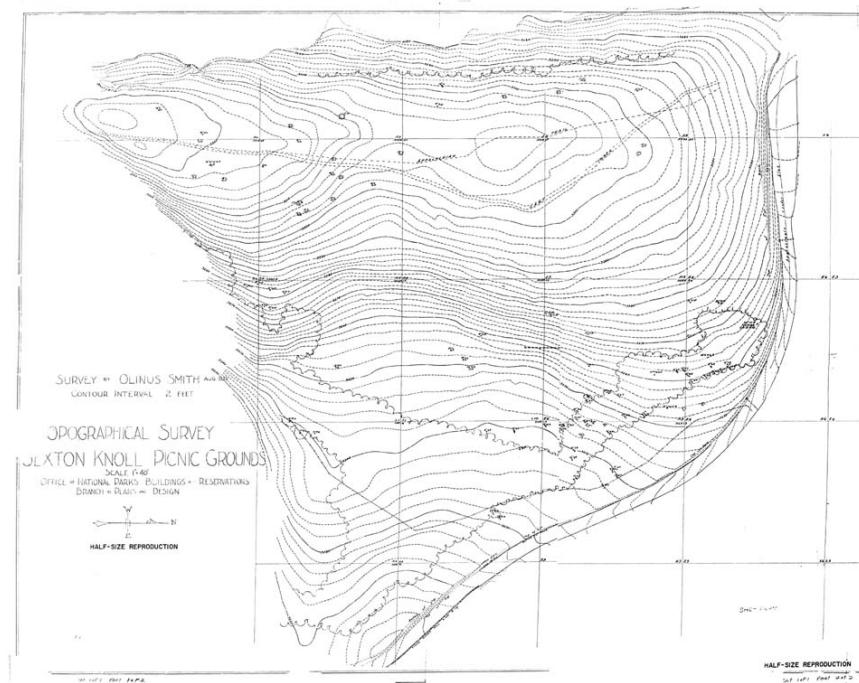
1933 plan shows how clear the site was before construction of the picnic grounds, including the east side almost down to Skyline Drive. It also indicates the treeline west of the picnic area at the 3300' elevation or lower (NPS plan 1933, SHE 134/1204).

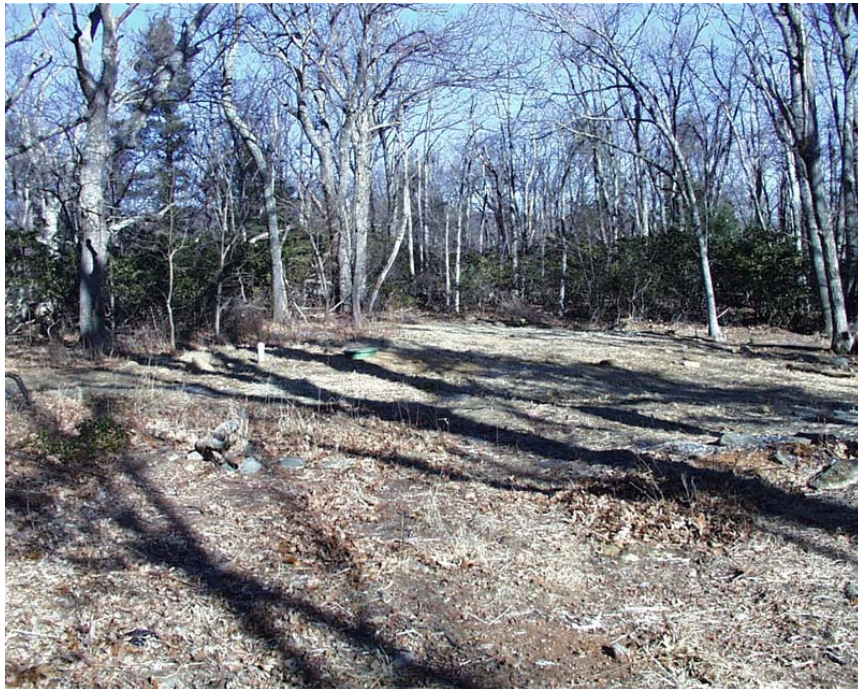
The view from the trail overlook southwest of the picnic grounds has disappeared due to vegetative growth (PHSO 2002).

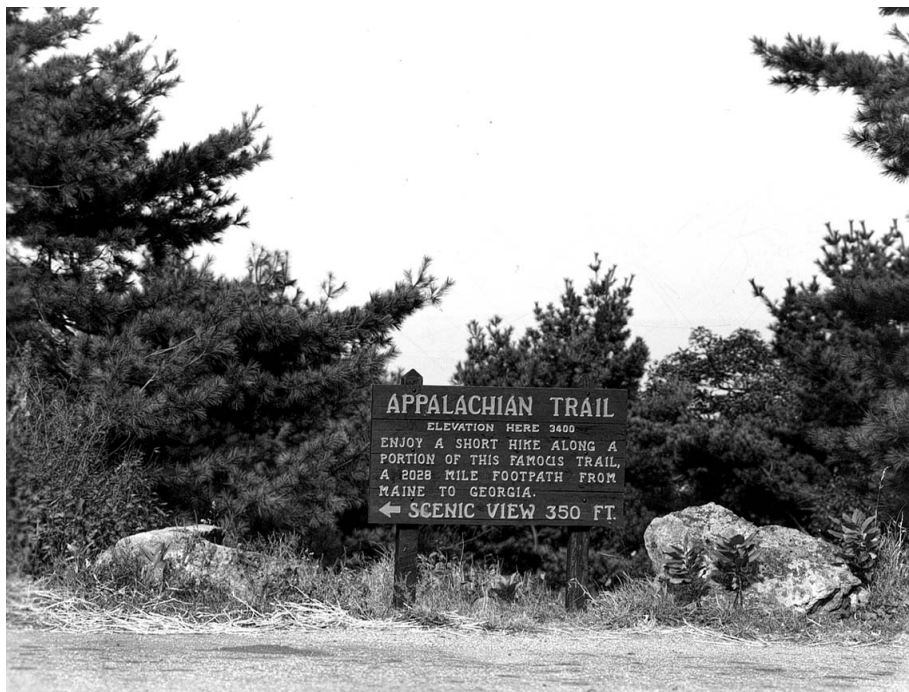
*This sign at the picnic grounds, photographed in 1952, illustrates that there was a scenic view from the overlook to the southwest. Note use of boulders. (SHEN Archives 1952, ANCS 11826)*
