National Park Service  
Cultural Landscapes Inventory

2009

Rapidan Camp  
Shenandoah National Park

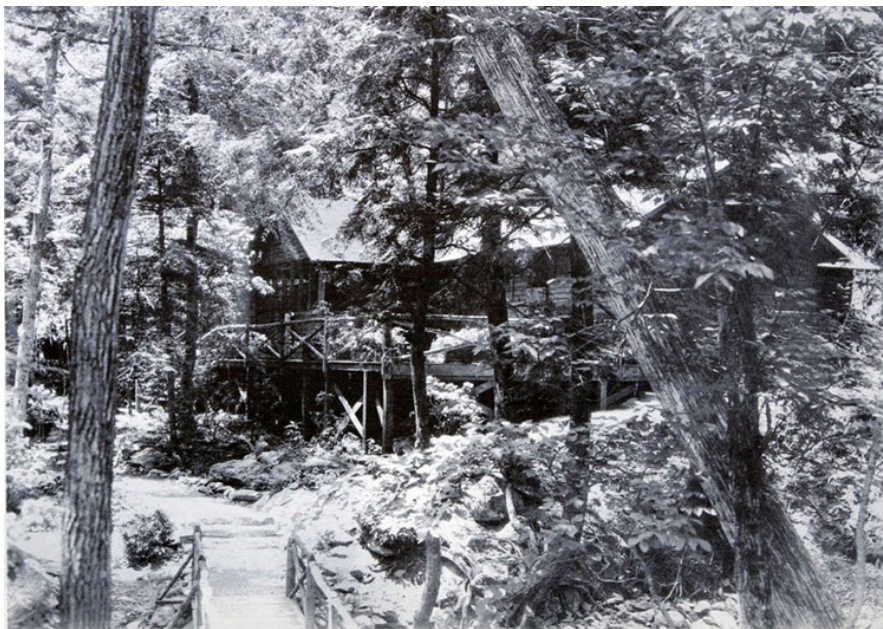
*Figure 1. View looking south at the President's Cabin and the footbridge over Mill Prong, early 1930s (Shenandoah NP, Archives).*

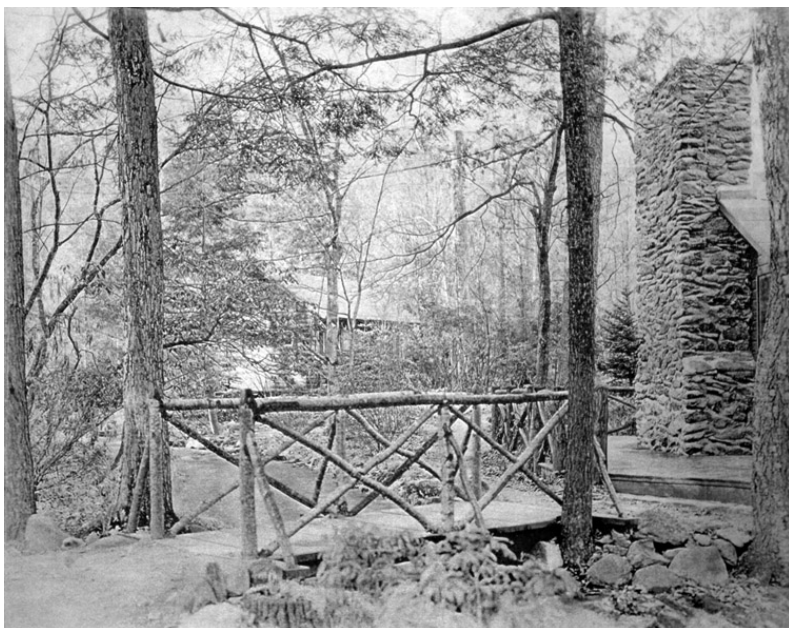
*Figure 2. View looking northeast at a footbridge crossing Hemlock Run, 1932. On the other side of the channel, Town Hall is on the right and the Office is on the left (Photograph by Major Long, USMC, Shenandoah NP, Archives).*

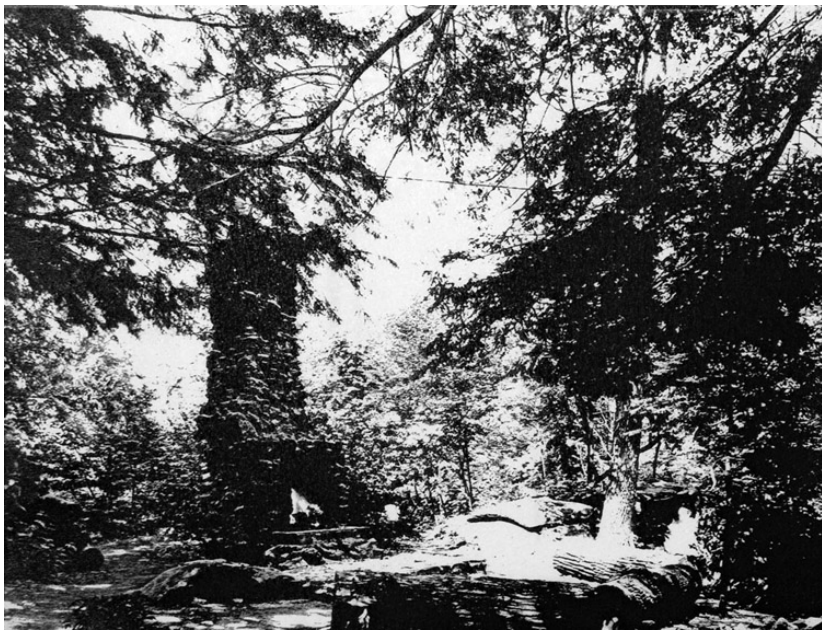
*Figure 3. The outdoor fireplace at Rapidan Camp in 1931, surrounded by fallen logs for use as benches (Shenandoah NP, Archives, Negative No. 1052).*

Only a few small-scale features remain from the Hoover era, although additional features from that period as well as Boy Scout period may be hidden in the dense understory vegetation. Standing at over nine feet tall, the exterior fireplace remains as one of the most visible features in the camp. The fireplace is in good condition, having been restored in 2000, and is kept clear of vegetation (Figure 31). The mounting block is in poor condition and is overgrown, but nonetheless still recognizable for what it is. The hitching post is only a remnant, its piers standing but crumbling and tangled in vegetation. Two lights high up in the trees along the Five Tents Trail are all that remains of the lighting system (Figure 32). They are obviously no longer functional, but still provide a glimpse of the once developed aspect in this natural setting. The original metal gate on the access road/entrance road was removed in 1999 and replaced by another metal gate. The location or remains of the flagpole are not known. A pumphead and pipe on the north bank of Laurel Prong likely dates to the Boy Scout period.

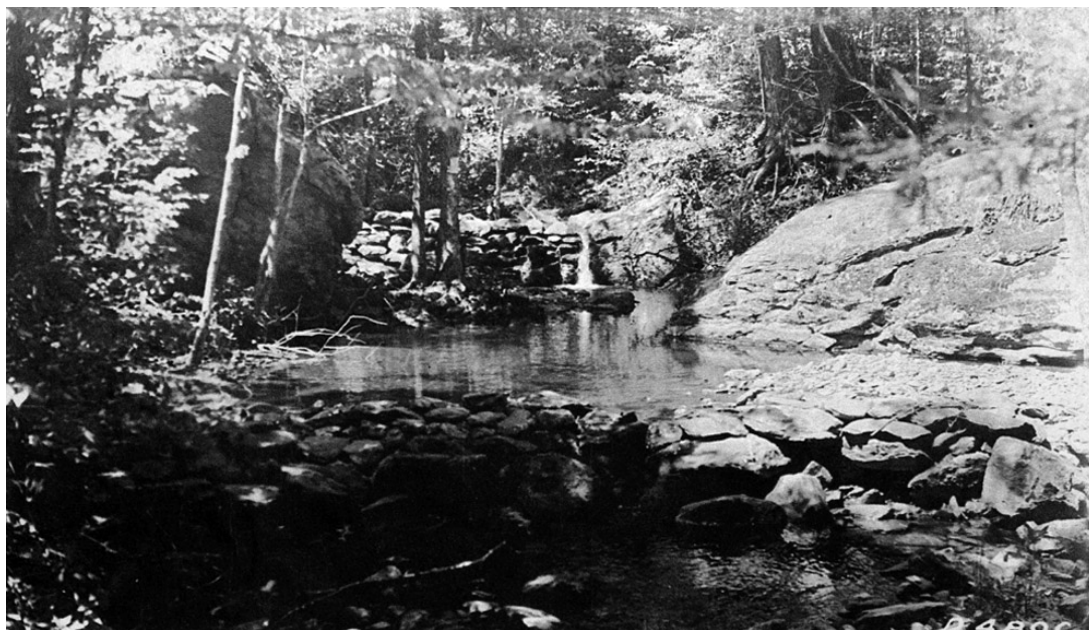
Figure 5. Trout pools were built at various locations along Mill Prong. This location is just upstream from the footbridge at the President's Cabin, 1929-1933 (Shenandoah NP, Archives).

The trout pools along Mill Prong have deteriorated over the years due to the constant flow of the stream and high water events, but some portions of the old stone dams are still discernable upstream from the vehicular bridge. Hemlock Run itself still exists, but the flow of water has been significantly reduced since Hurricane Isabel severely damaged the sluice gate structure in 2003 (Figure 17). Due to the diminished water flow, there is rarely enough water to create visible water falls over the large rocks at the site of Hemlock Run Falls (Figure 18). The channel's mortared stone walls have been restored and reconstructed are in generally good condition. The unmortared stones lining the channel's edge farther upstream are present, but portions are overgrown, although this part of the stream was intended to be more naturalistic in appearance. The troutpool next to the falls is in good condition, though the pipes that once fed it are not functional and the water inside is essentially stagnant (Figure 19). Mrs. Hoover's stone fountain does not currently function, and only a few of the recorded seven pools flowing from it are discernable (Figure 20). Structurally, though, the fountain is in good condition, and one can imagine what it may have looked like when it was turned on.

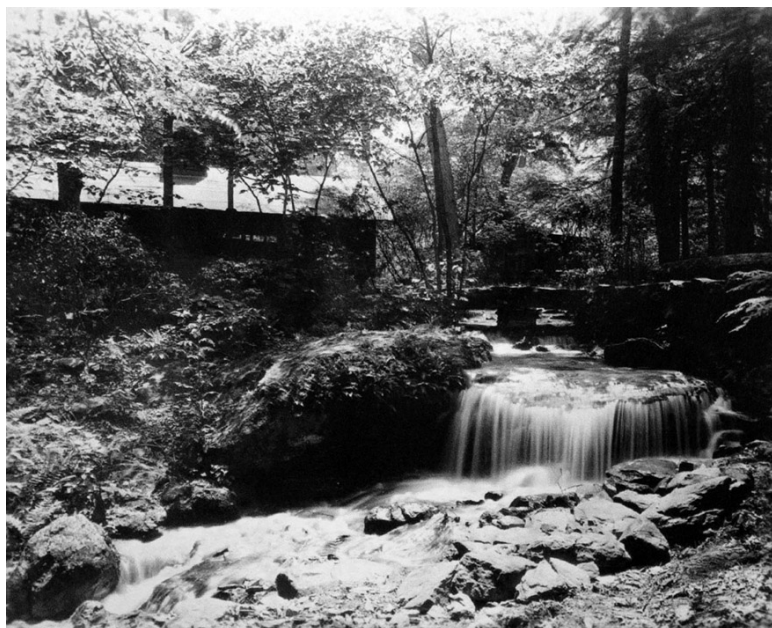
Figure 9. The falls along Hemlock Run, 1929-1933, with the Prime Minister's Cabin accessed by a mortared stone footbridge (Shenandoah NP, Archives).

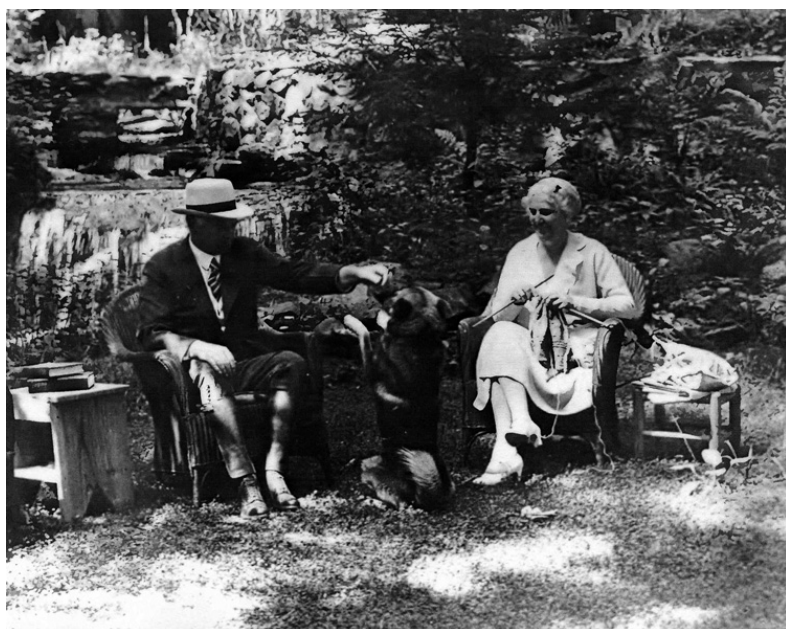
Figure 10. View of the Hoovers in a small grass area below the President's Cabin. In the background are the stone walls of Hemlock Run and water flowing over Hemlock Run Falls (Shenandoah NP, Archives).

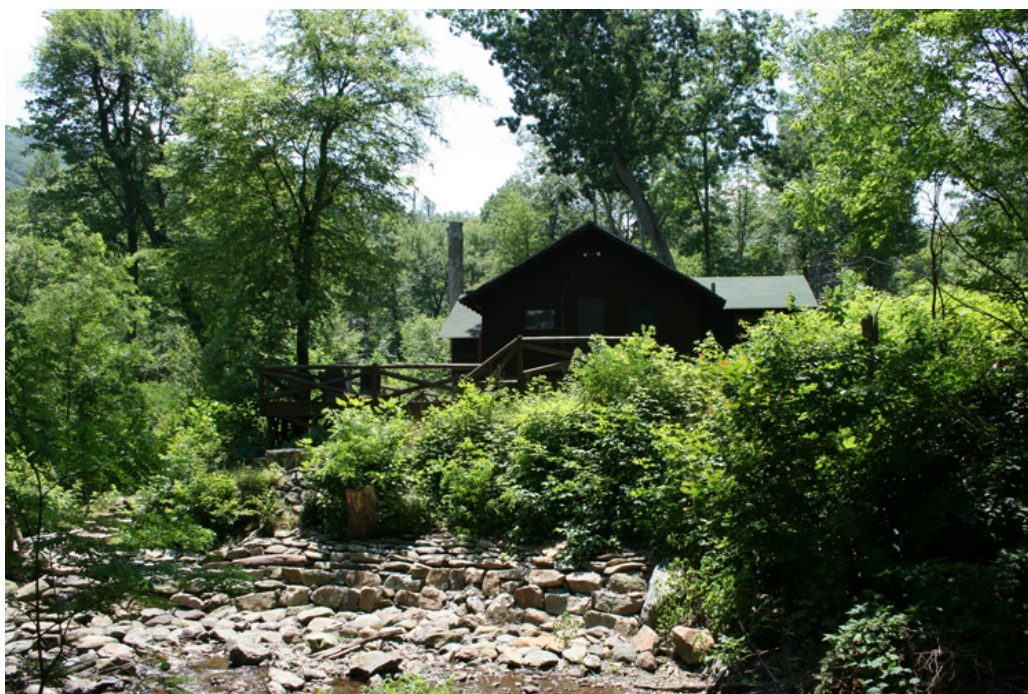
*Figure 13. View looking south at the vegetation around the President's Cabin from across Mill Prong (OCLP 2008).*

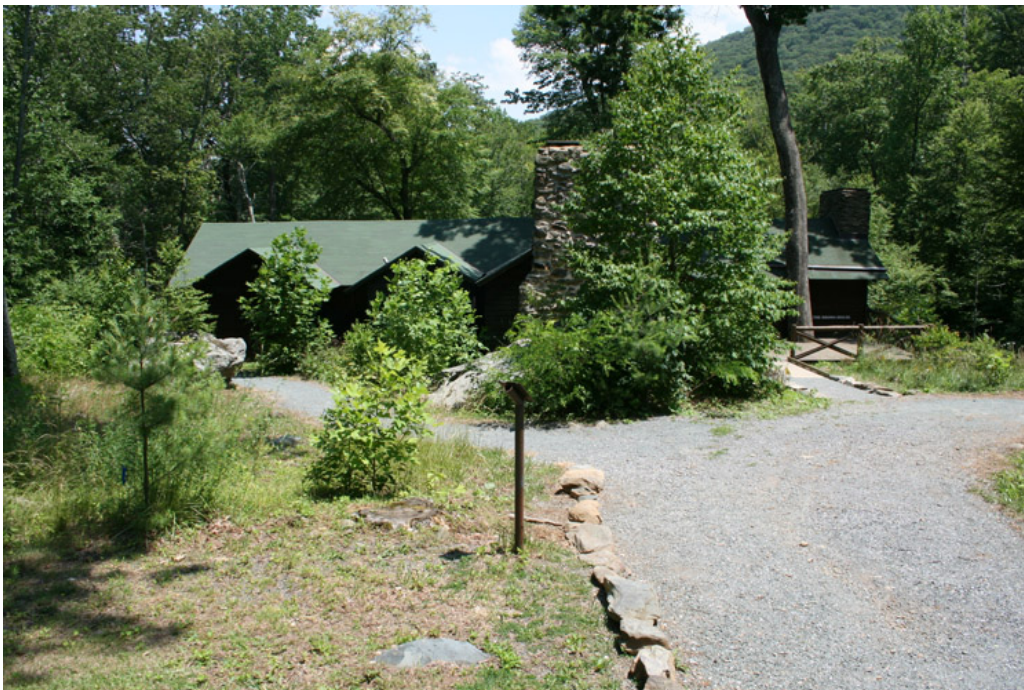
*Figure 14. View of the restored roads and paths leading to the President's Cabin at Rapidan Camp (OCLP 2008).*

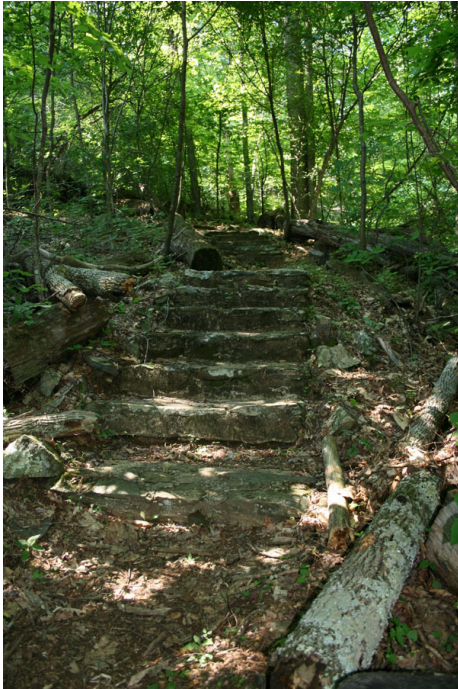
*Figure 15. Stone steps can still be found along the Five Tents Trail (OCLP 2008).*

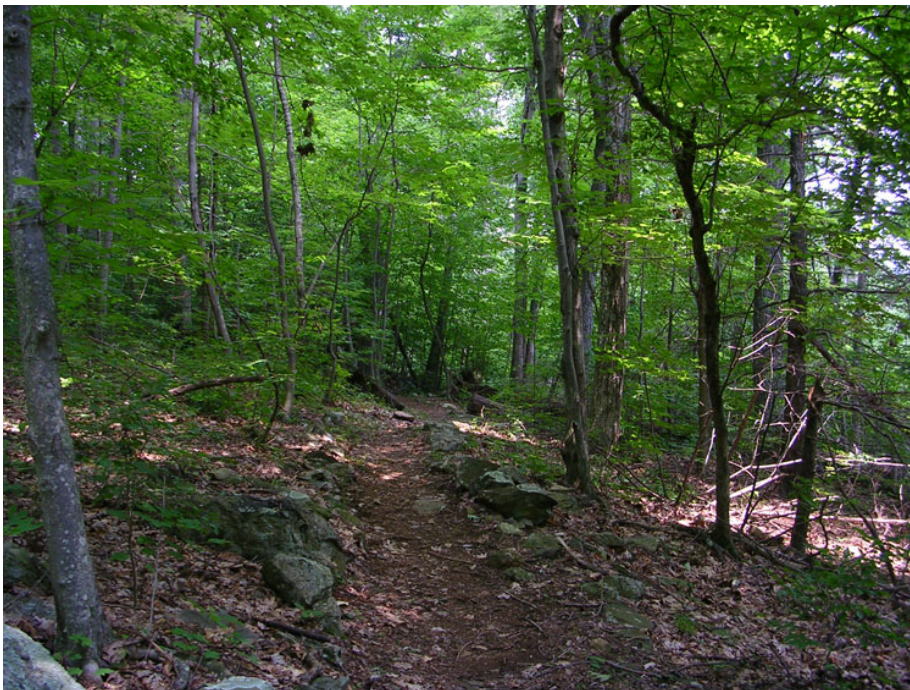
*Figure 16. View of stone edging along the Five Tents Trail (OCLP 2008).*

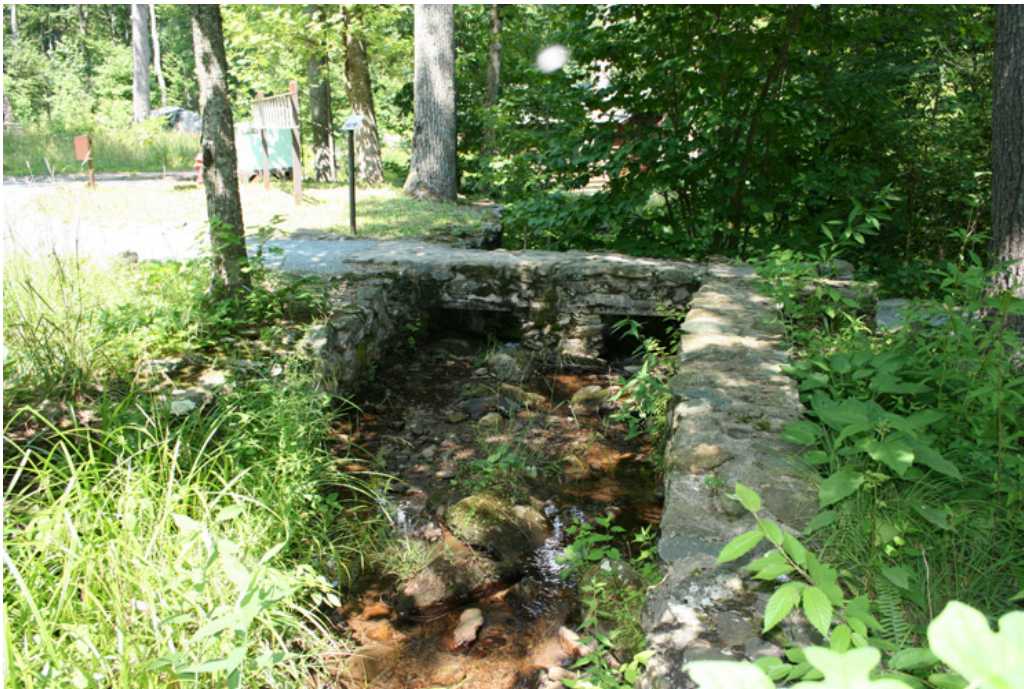
*Figure 17. The mortared stone retaining walls along the man-made water channel, Hemlock Run, have recently been restored. View looking north (OCLP 2008).*

| Year | Event | Major Event Narrative |
|---|---|---|
| CE 1999 - 2000 | Restored | Hemlock Bridges # 1 and 2 are restored, with repointing of the masonry and replacement of missing stones. Retaining walls along Hemlock Run are also repaired/restored. |

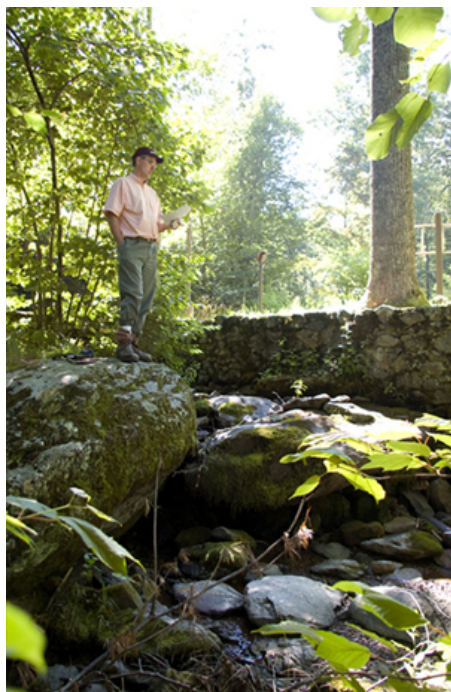
*Figure 18. Due to the damage to the sluice gate upstream, the flow of water through Hemlock Run has been reduced to a trickle that makes for a less dramatic experience at Hemlock Run Falls shown here (OCLP 2008).*

| Year | Event | Major Event Narrative |
|---|---|---|
| CE 2003 | Damaged | Hurricane Isabel damages trees and bridges at the camp. Hemlock Run sluice gate is severely damaged, decreasing water flows. |

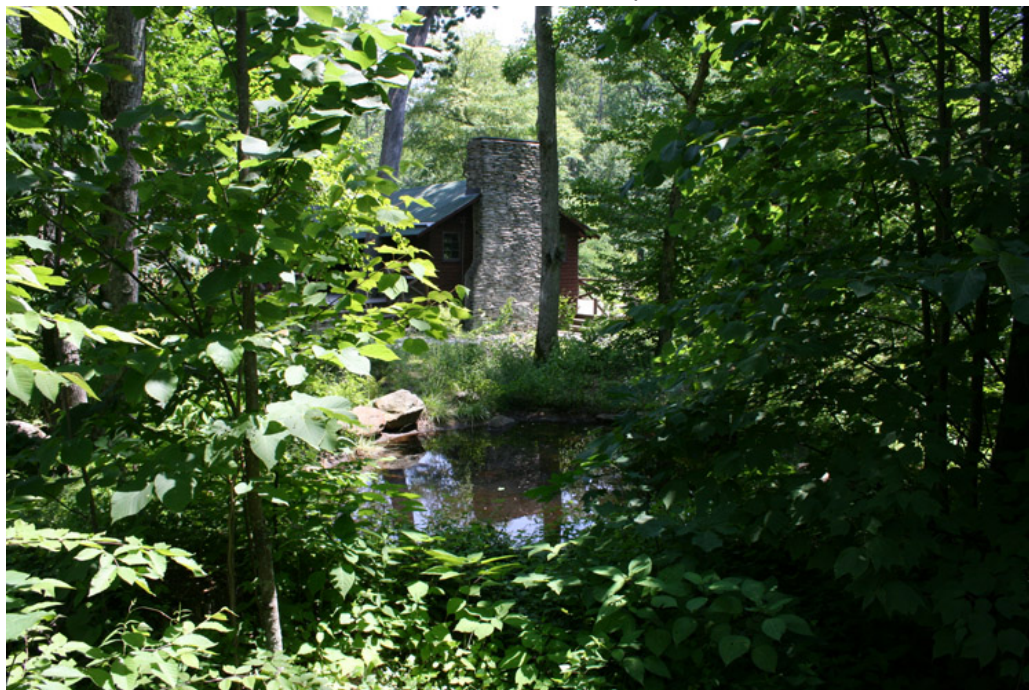
*Figure 19. View looking east at the trout pool next to Hemlock Run, with the President's Cabin in the distance (OCLP 2008).*

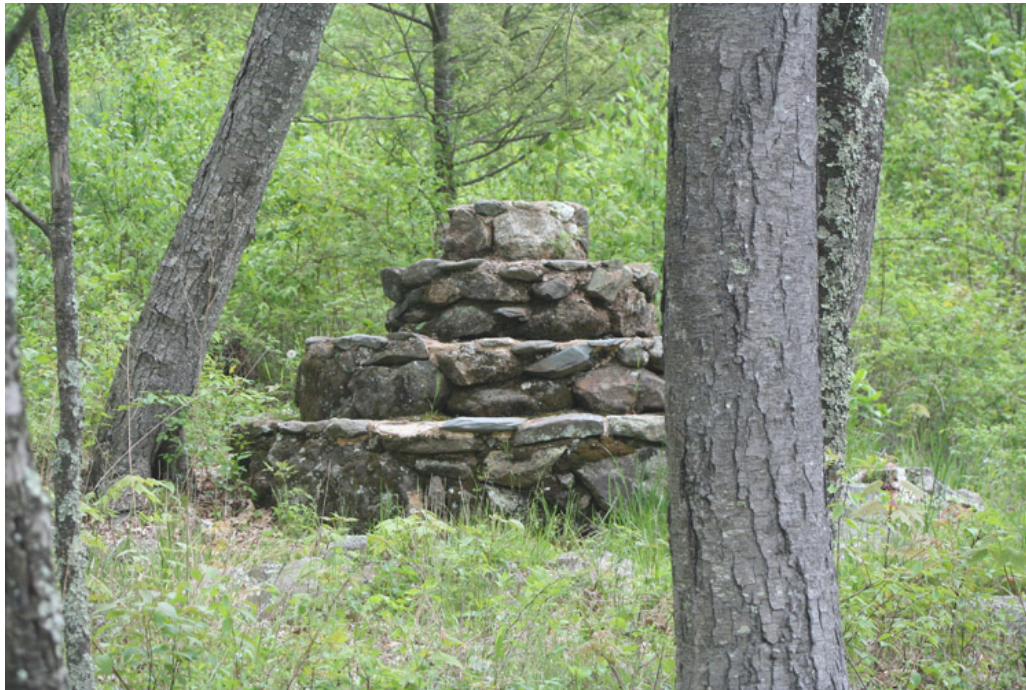
*Figure 20. View looking west at the stone fountain and overgrown adjacent pools (OCLP 2008).*

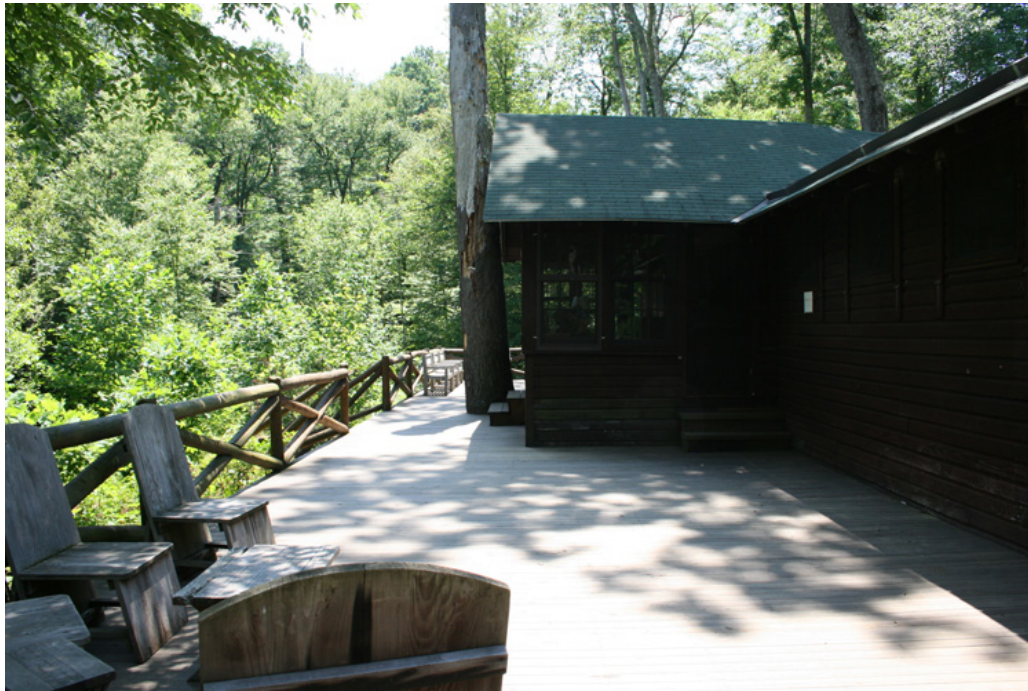
*Figure 21. View looking south from the President's Cabin porch. The tree in the porch has since died and the hole has been patched with contrasting planking to indicate its former location (OCLP 2008).*

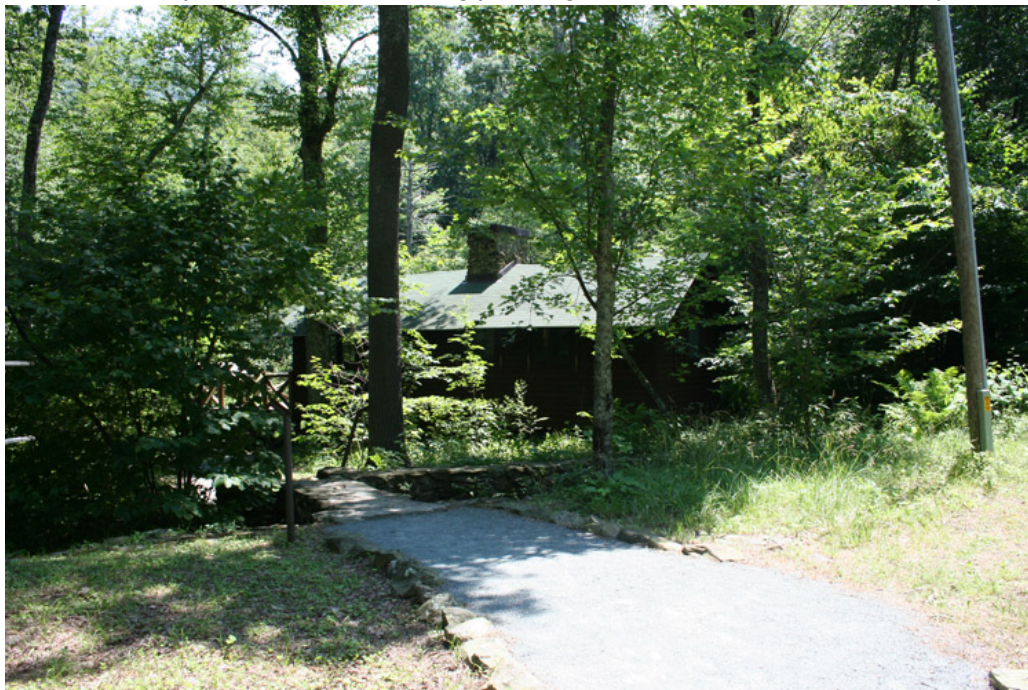
*Figure 22. The exterior of the Prime Minister's Cabin has been restored, while the interior now houses exhibits. In the foreground, a path leads across Hemlock Run via a mortared stone footbridge (OCLP 2008).*

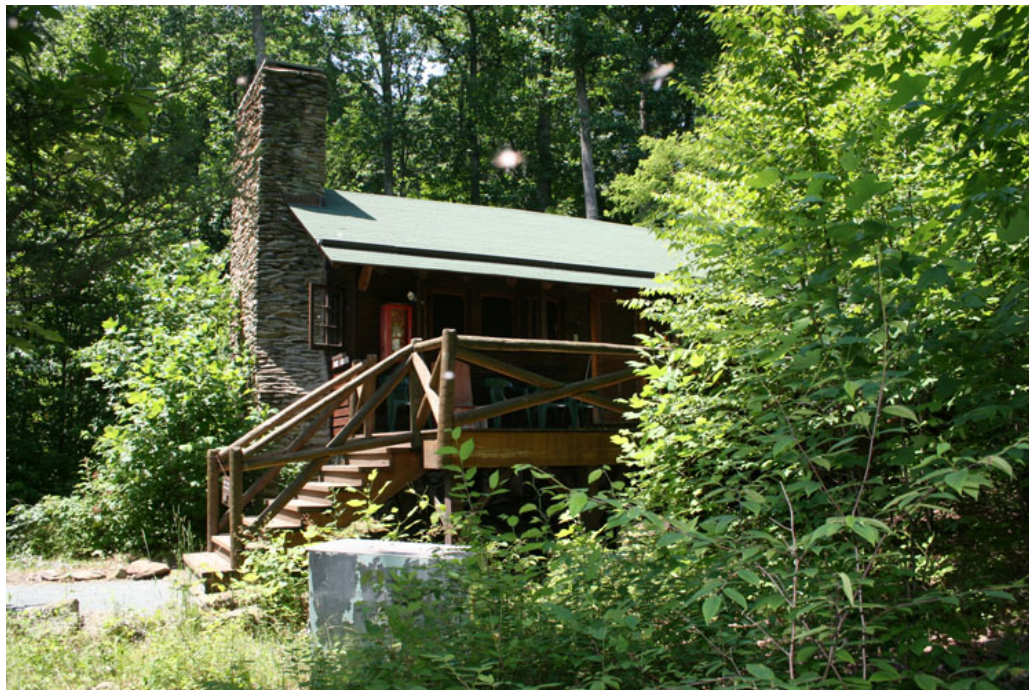
*Figure 23. The exterior of The Creel has been restored. The building now serves as seasonal housing for a park volunteer (OCLP 2008).*

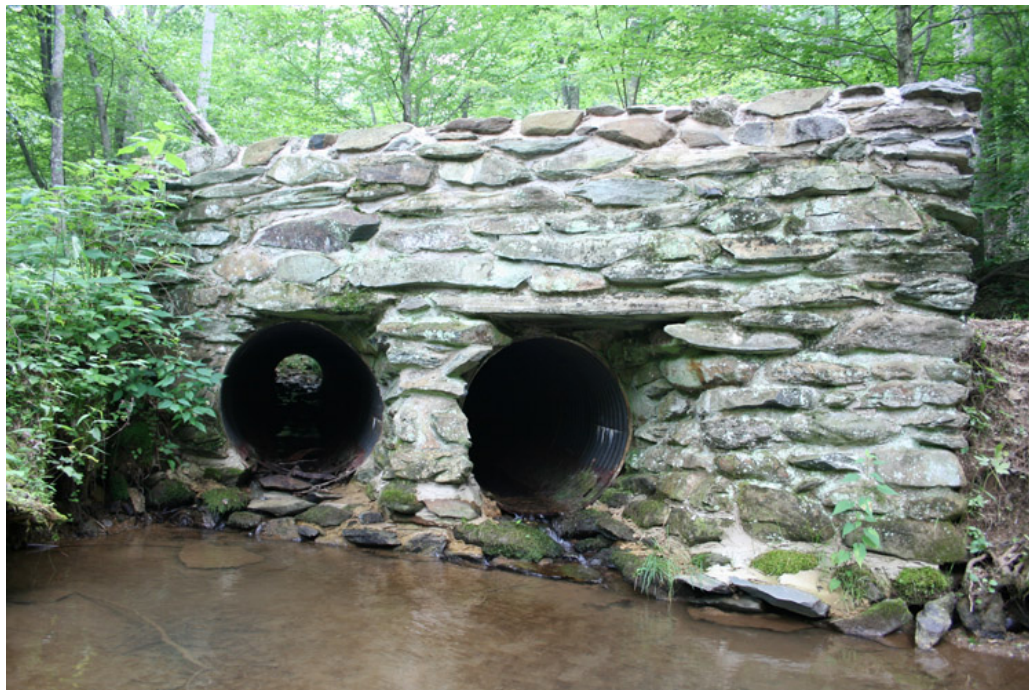
*Figure 25. View from downstream of the recently repaired mortared stone bridge on the Entrance Road (OCLP 2008).*

| Year | Event | Major Event Narrative |
|---|---|---|
| CE 2007 | Restored | Entrance Road bridge is repointed, and missing stones are replaced. |

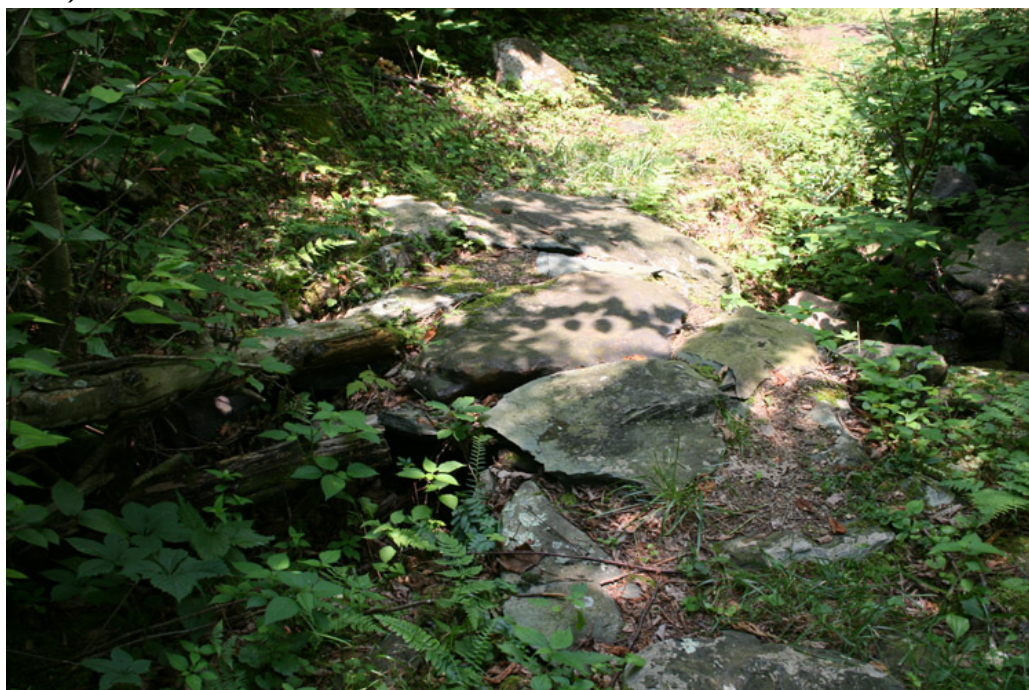
*Figure 26. View of the first crossing from the sluice gate along Hemlock Run (OCLP 2008).*

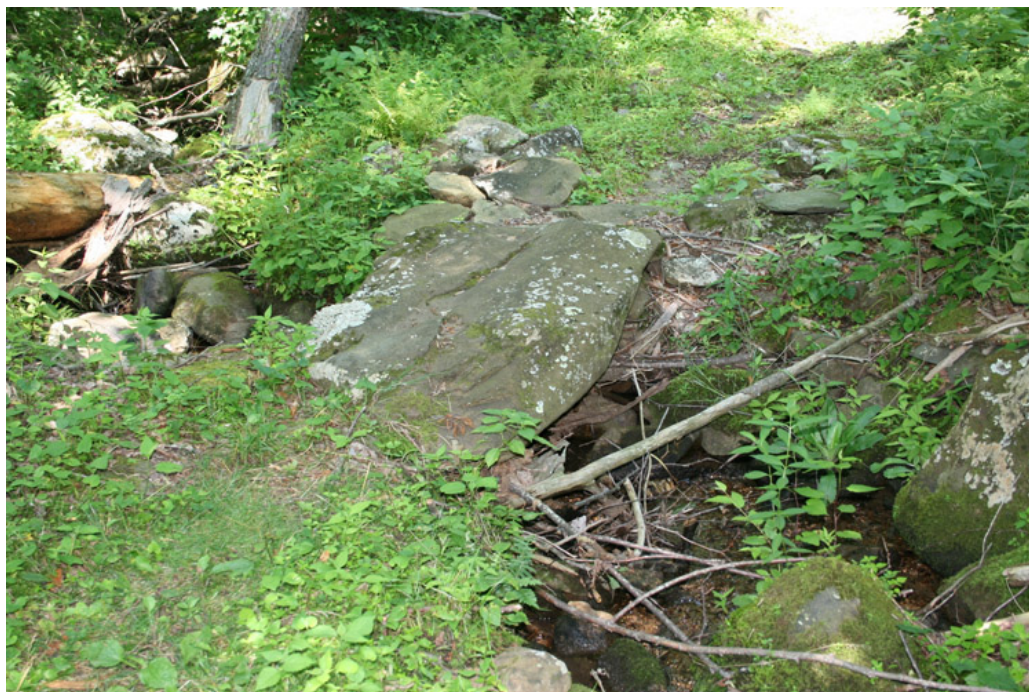
*Figure 27. View of the second crossing from the sluice gate along Hemlock Run (OCLP 2008).*

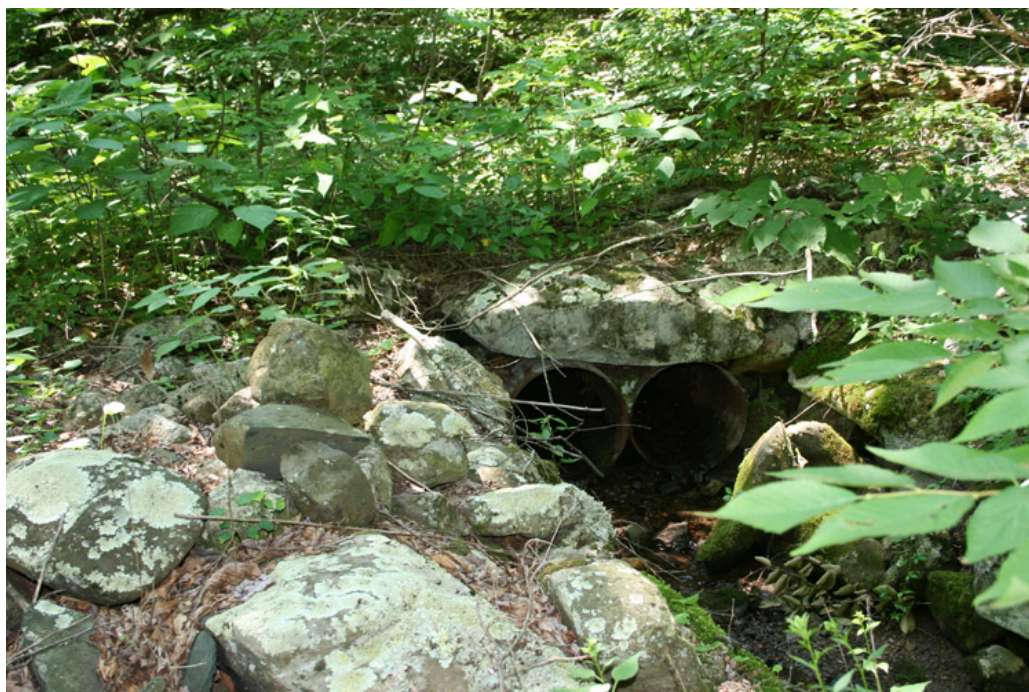
*Figure 28. View of the third crossing from the sluice gate along Hemlock Run (OCLP 2008).*

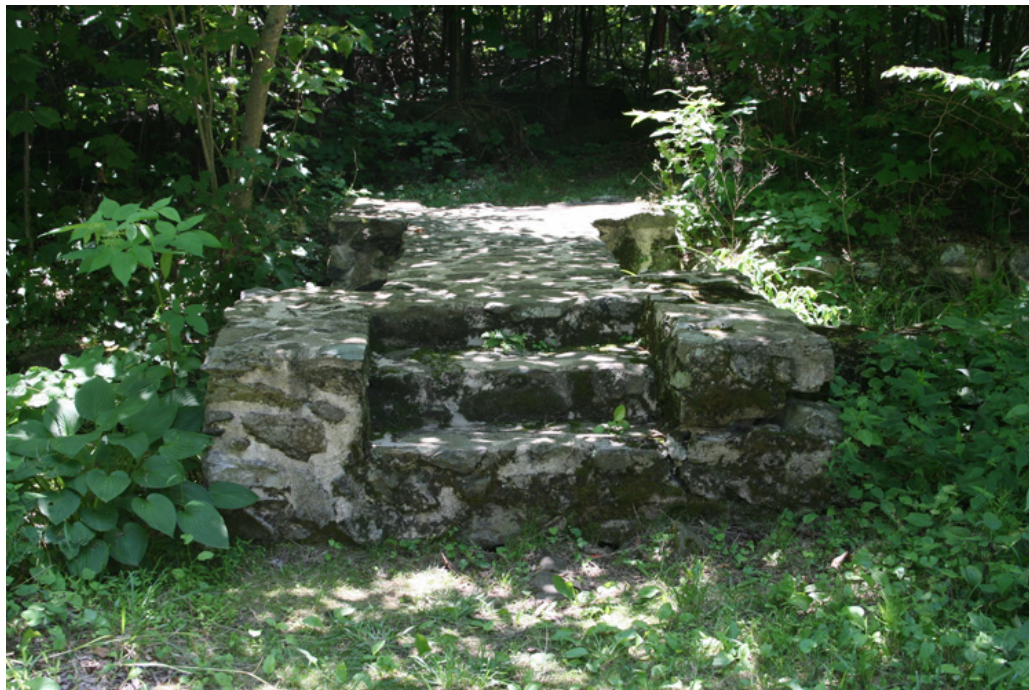
*Figure 29. View of the fourth crossing from the sluice gate along Hemlock Run (OCLP 2008).*

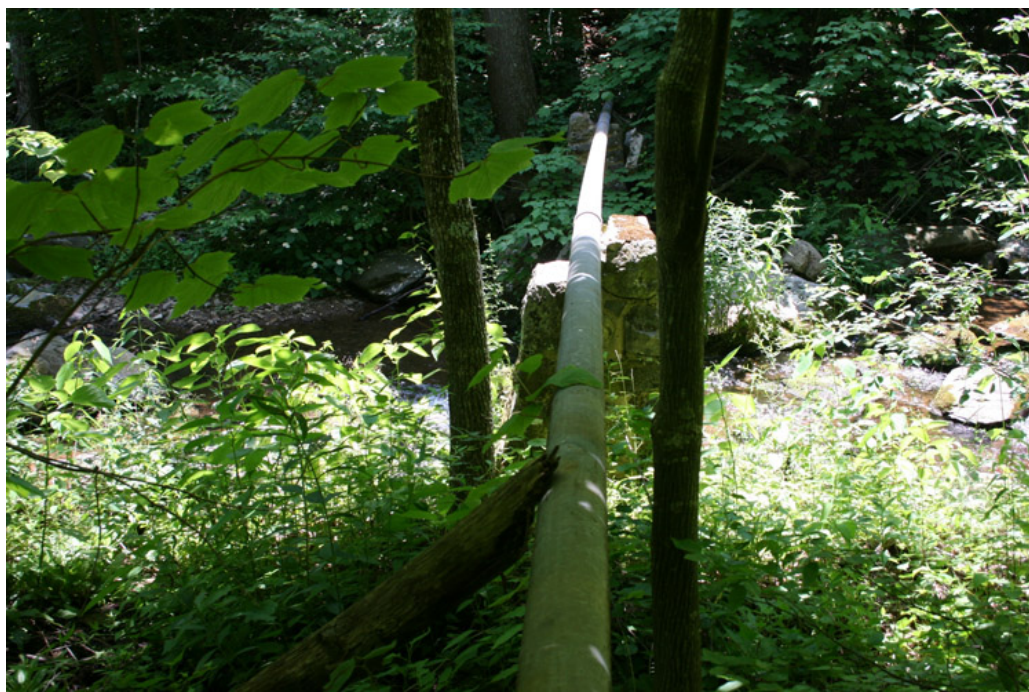
*Figure 30. Although the septic system is no longer used, the sewer pipe and stone supporting piers over Laurel Prong have been retained (OCLP 2008).*

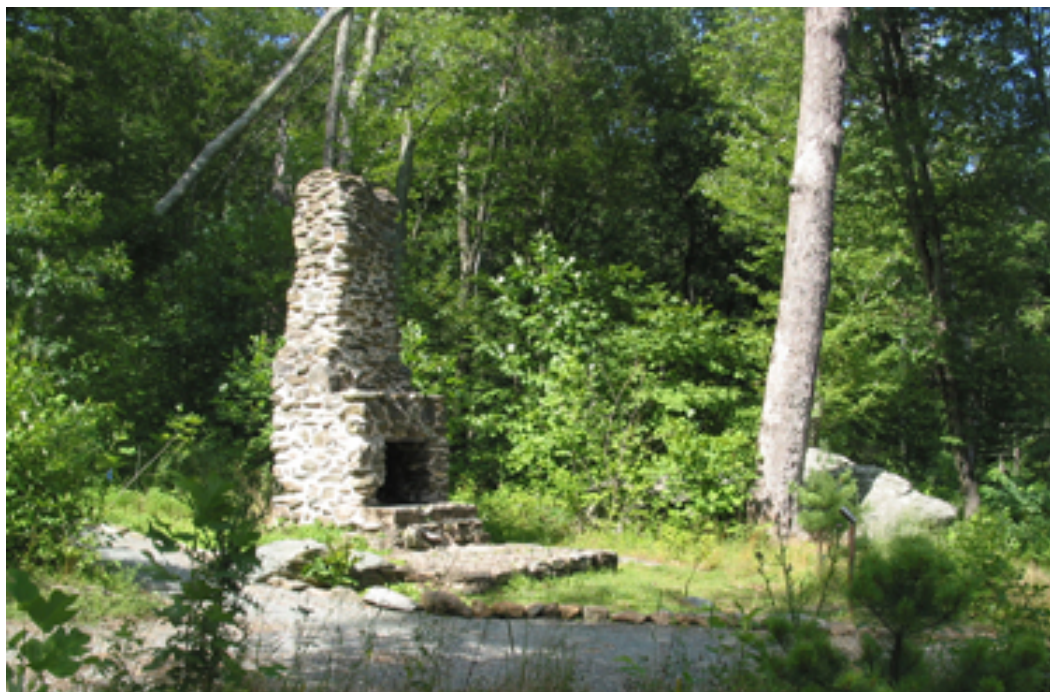
*Figure 31. The camp's exterior fireplace has been restored (OCLP 2008).*

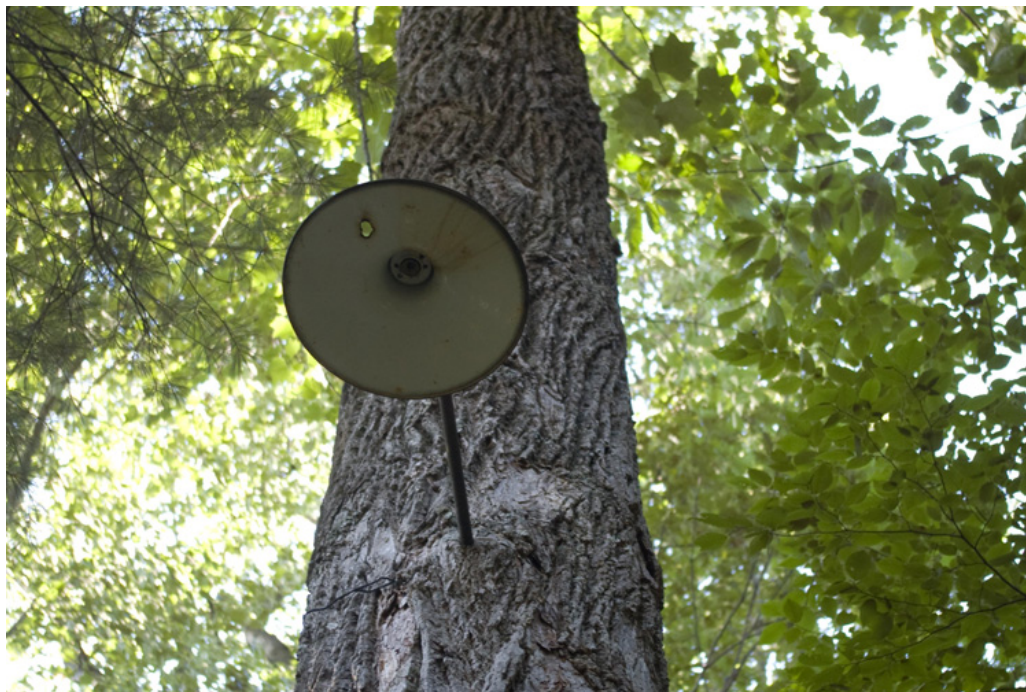
*Figure 32. View of one of two remaining lights along the Five Tents Trail (OCLP 2008).*
