# the Skyline Drive

## Landscape Report

HAZEL MOUNTAIN OVERLOOK

## SKYLINE DRIVE LANDSCAPE REPORT

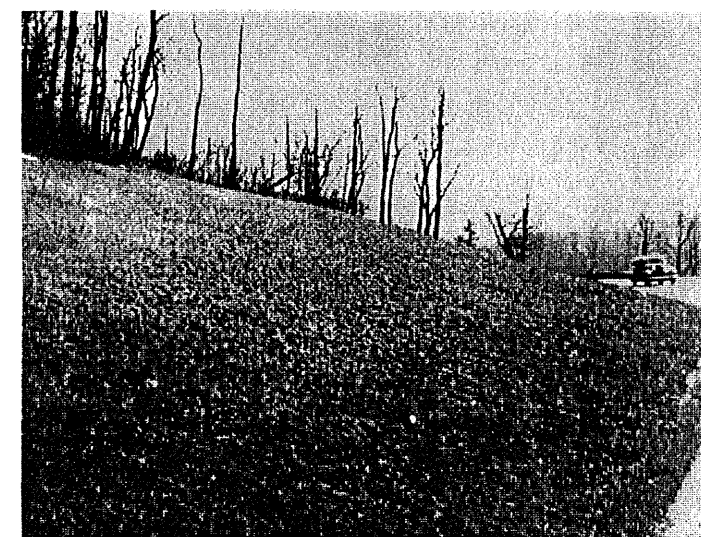
In areas where cut and fill was inevitable the slopes were rounded and warped to fit the natural landform. Vegetation was also planted on the slopes to further reduce the scars and soil erosion. The Civilian Conservation Corps (CCC) enrollees provided the manpower to complete the planting and the erosion control work.

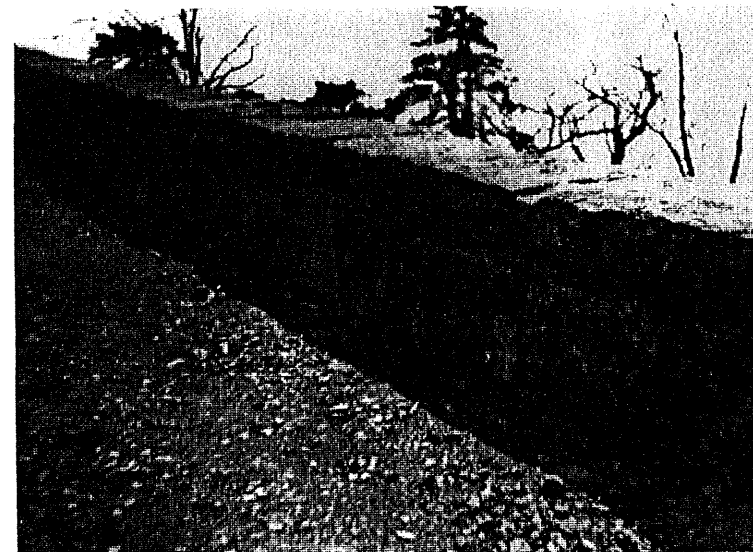
The early walls fit very well with the rustic design scheme that was followed throughout the Drive and Park however they are not strong enough to serve their original purpose and needed to be upgraded to modern standards. The upgraded walls consist of a concrete "Jersey Barrier" faced with a veneer of stone cut from the original stone guardwalls.

The vegetation between the road and the treeline requires routine maintenance. The road shoulders are covered with grass which is mowed 4-6 times a year or as needed to keep sightlines open for motorists. The vegetation between the shoulders and the treeline is mowed with a tapered cut on a yearly basis this keeps the vegetation from growing into the sightpath of motorists using the Drive. Because of the safety standards involved, the maintenance plan for the road shoulders must be strictly followed. The guardwalls along the Drive have been changed because more stringent safety standards have been adopted by the Federal Highways Administration. The original walls were dry laid stone with the top course set in mortar and deeply raked.
