National Park Service  
Cultural Landscape Inventory  
2020

Visitor Center  
Sitka National Historical Park

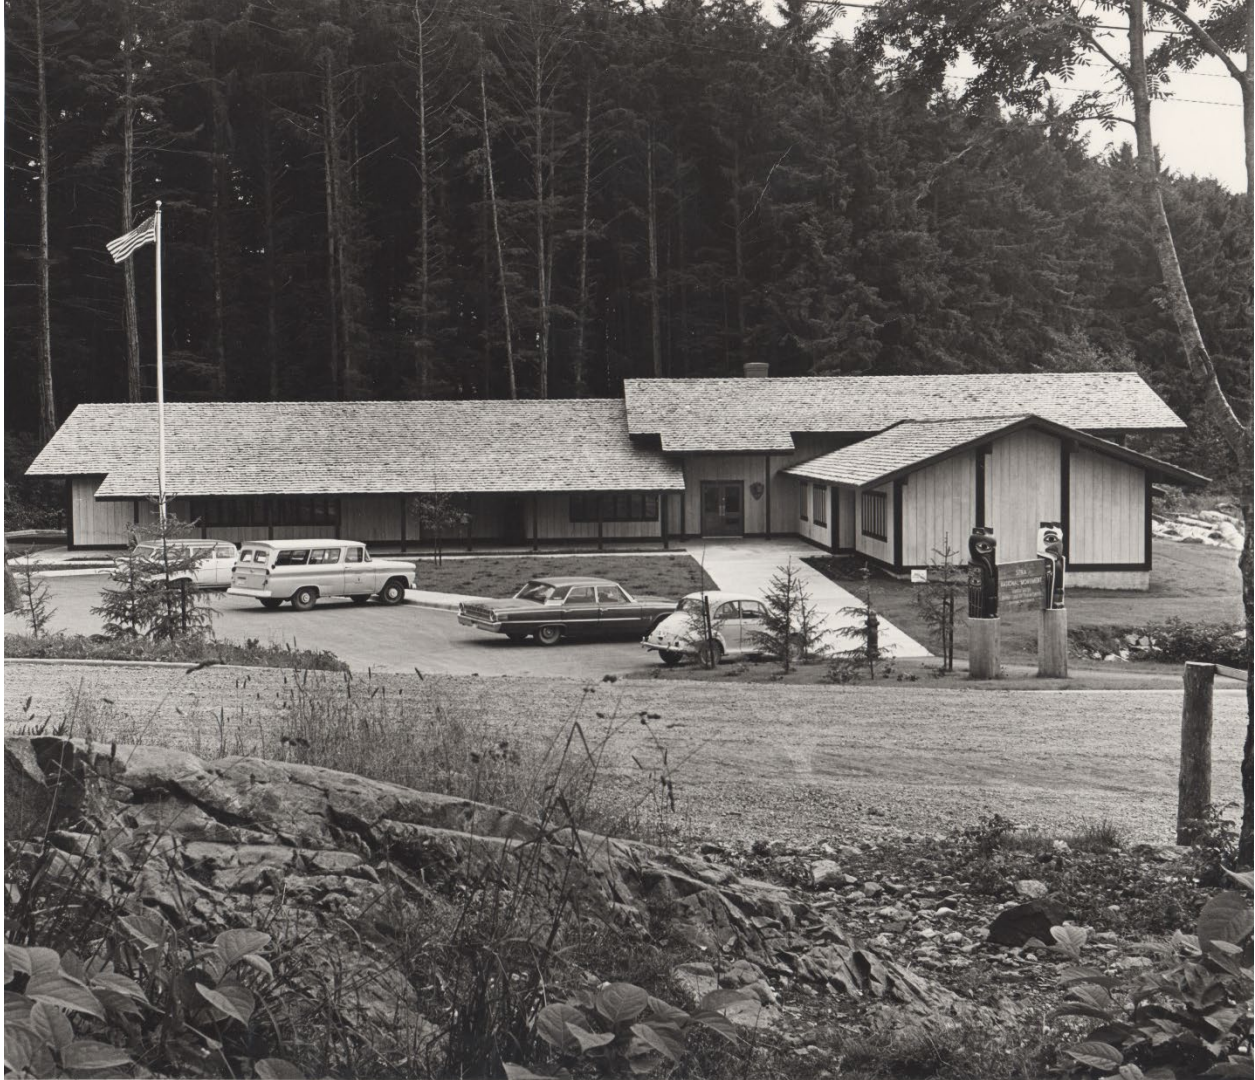
*August 1965 photo by Morse of the visitor center's western façade. Landscape features which were constructed by this time include the flagpole, entry sidewalk, lower parking lot, park entrance sign, and a portion of the inlet with a masonry head wall. Vegetation includes a small deciduous tree located to the right or south of the flagpole, a triangular planting area that could be lawn, Sitka spruce trees flanking the vehicular entrance to the lower parking lot, and small shrubs and groundcover plantings in those planting areas (SITK 15655 C).*

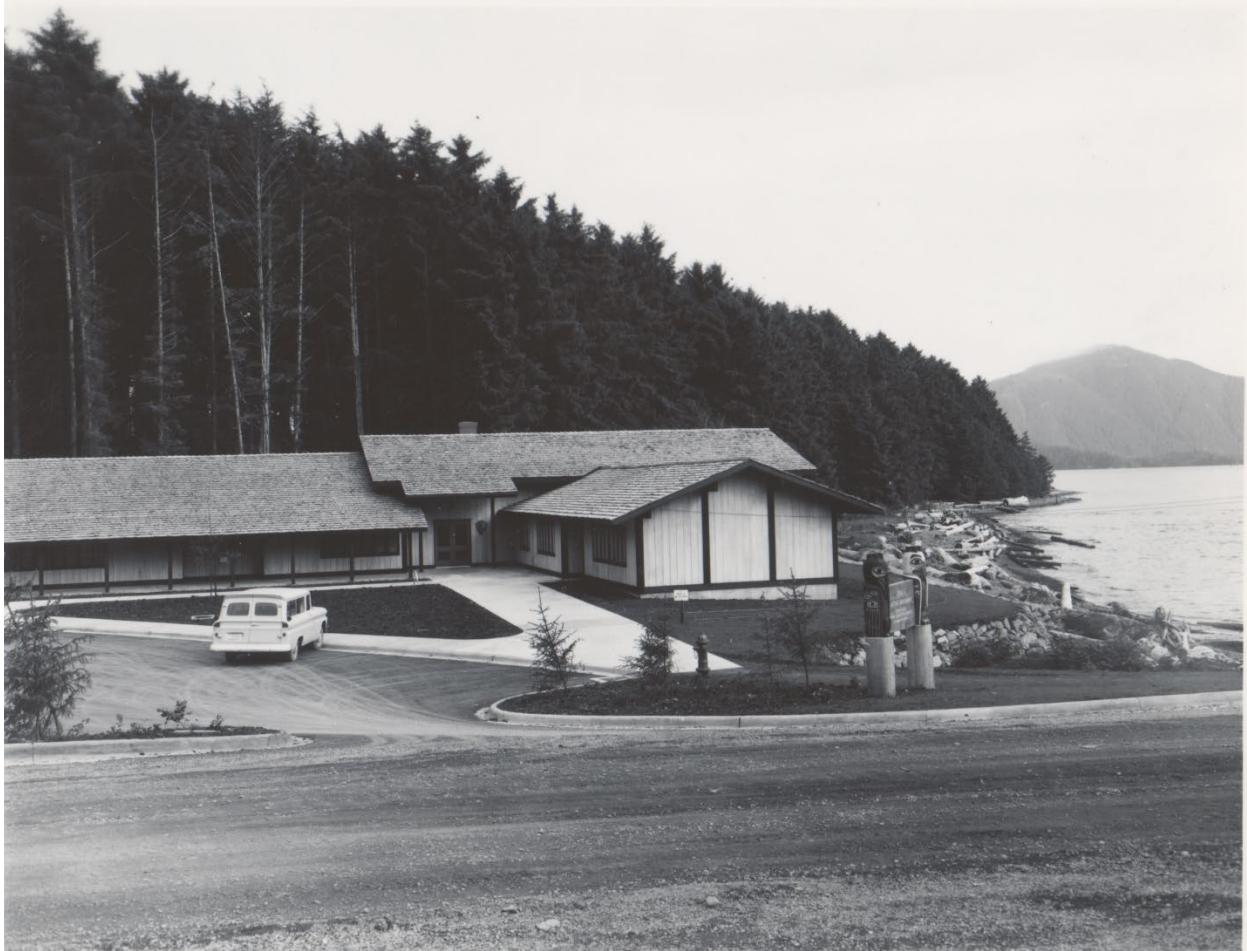
*1965 photo of the completed visitor center with the lower parking lot, entry sidewalk, young Sitka spruce trees, fire hydrant, park entrance sign, and inlet with a masonry head wall visible. The alignment of the Shoreline Connection Trail and path between Metlakatla Street and the entry sidewalk are visible, but their material cannot be discerned. A small deciduous tree is planted in the triangular "lawn" area though it is unclear if grass has been planted. Small groundcover plants are visible in the planting beds with the Sitka spruce trees (SITK 15651 A).*

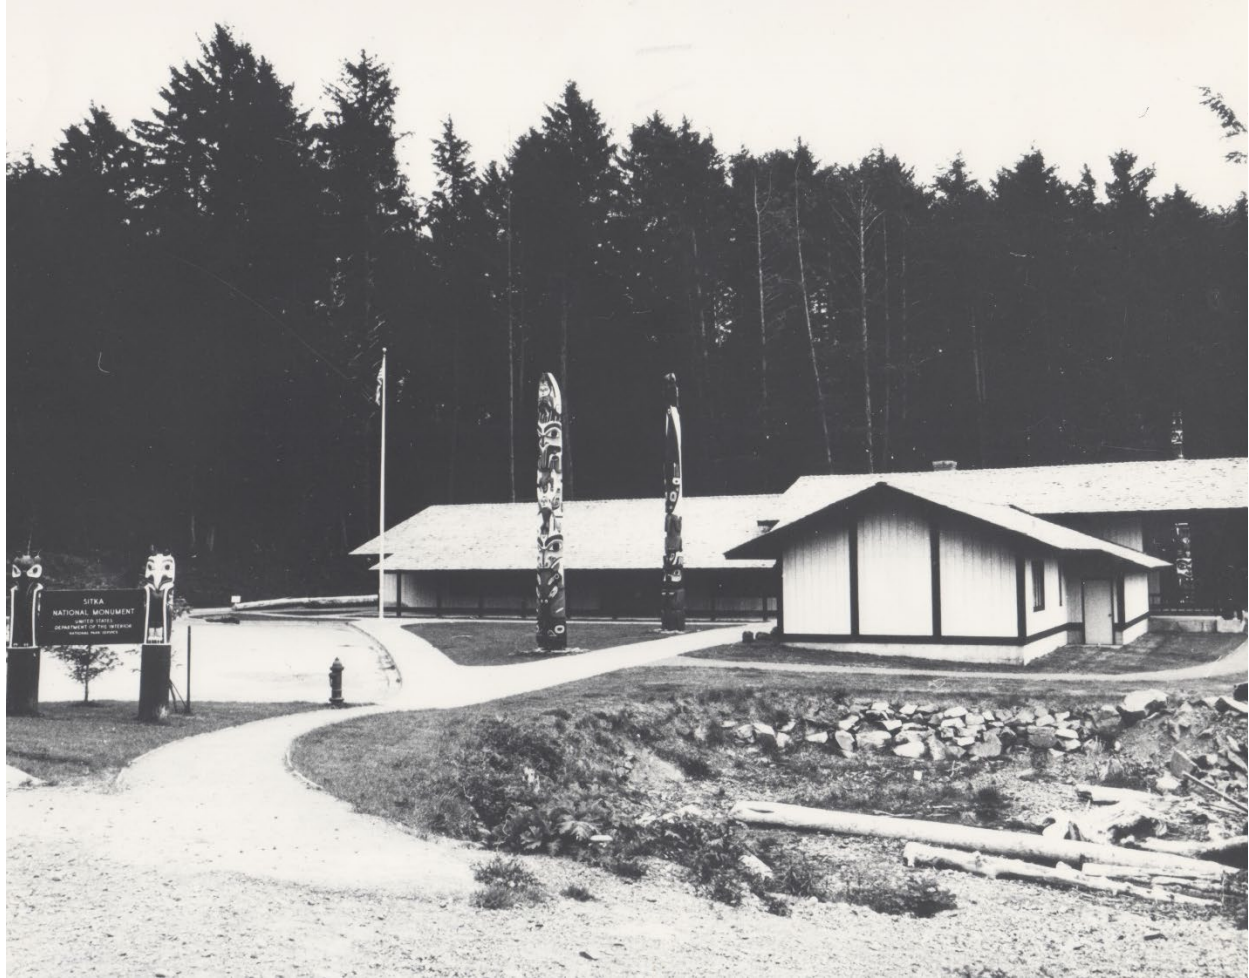
*Circa 1965 photo following the installation of two totems and lawn in the triangular area and around the edges of the visitor center. This photo also provides a good view of the small inlet whose edges were stabilized with logs and a stone masonry wall. The inlet is no longer present. The Shoreline Connection Trail and the path between Metlakatla Street and the entry sidewalk appear paved and edged with metal, though the material of the path nor its edging is clearly discernable (SITK 15654).*

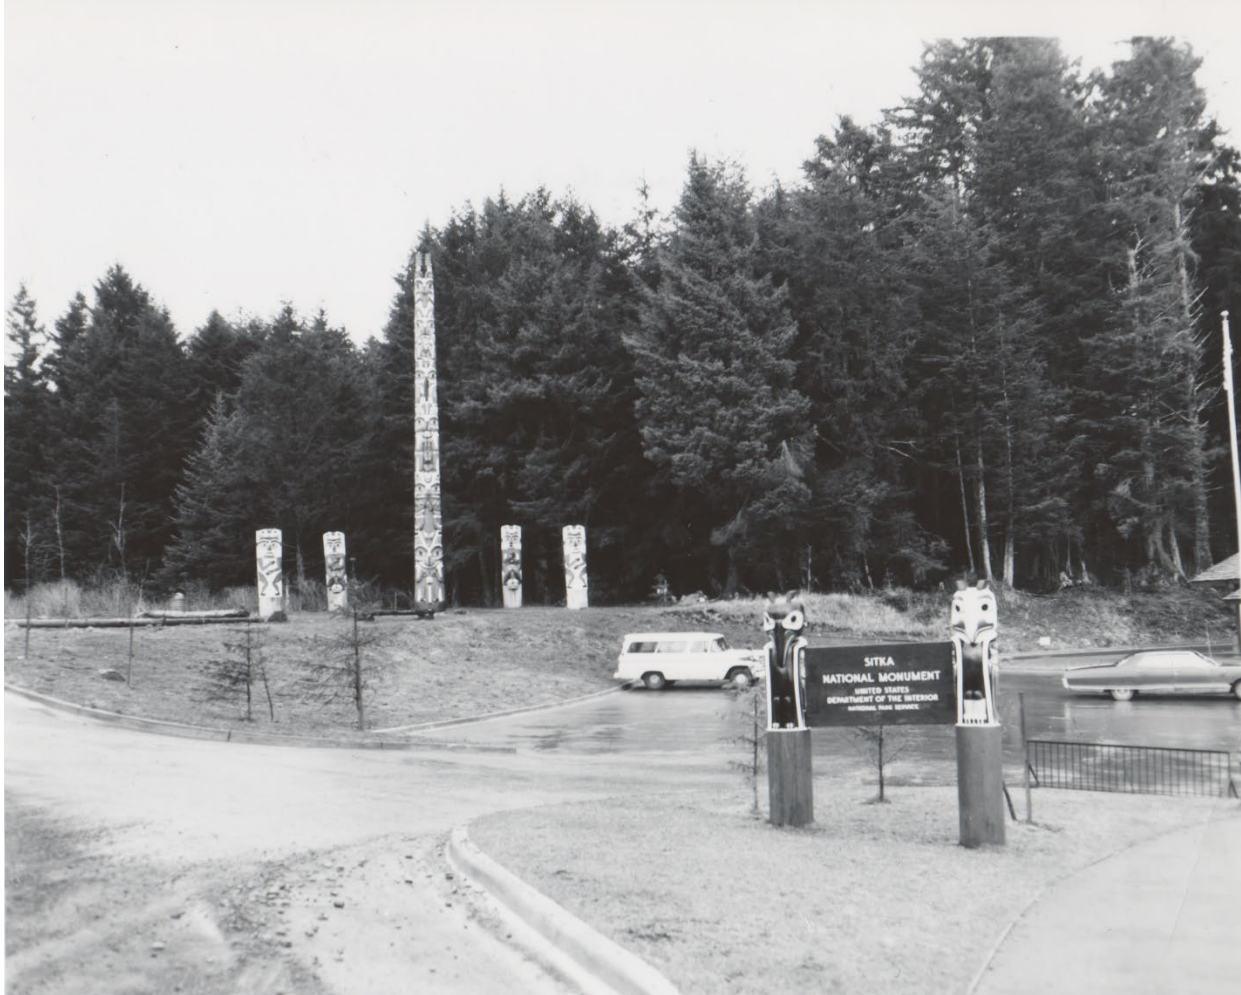
*Circa mid-1960s photo looking northeast towards the lower parking lot and upper terrace with five totems. In the foreground are the Sitka spruce trees flanking the entry to the lower parking lot, the entry sign, and the bike rack. Though its material is still undiscernible, the path between Metlakatla Street and the entry sidewalk is paved, edged, and maintained (SITK 15659 J).*

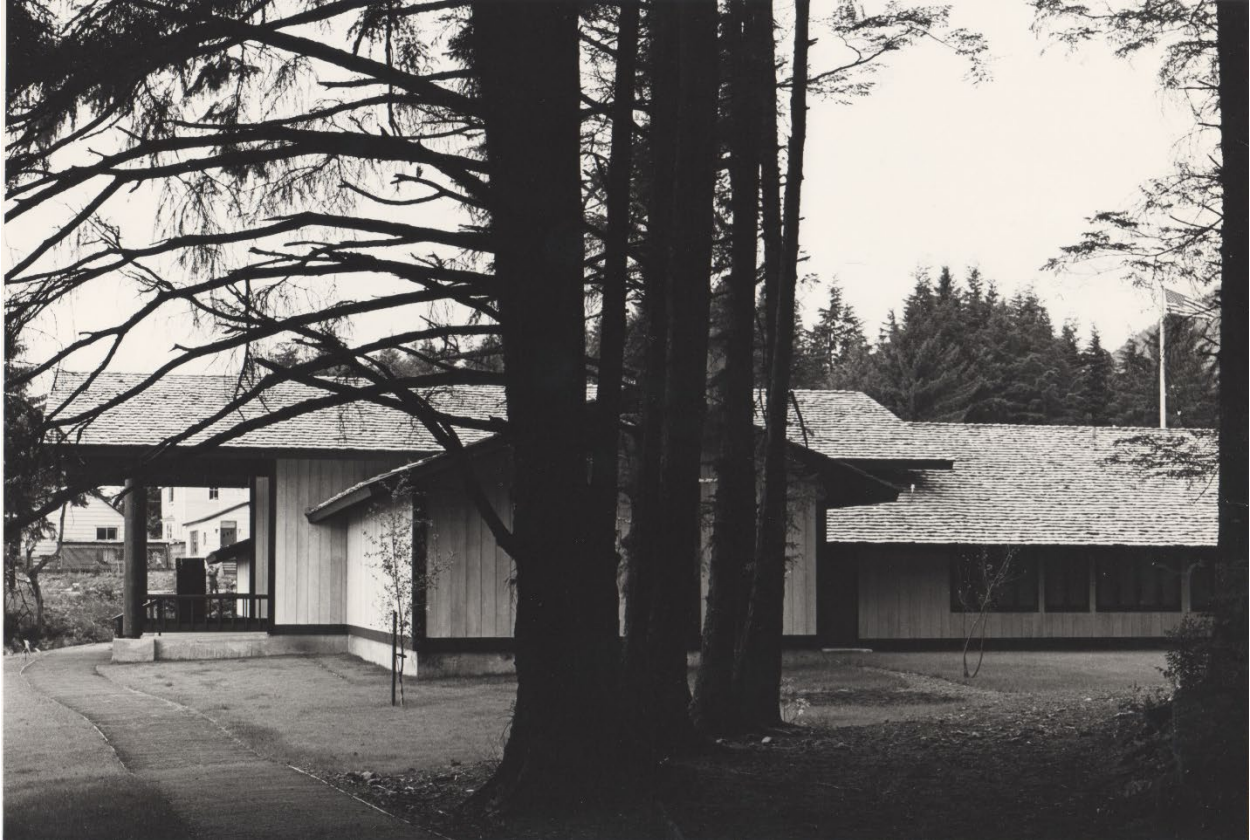
*August 1965 photo by Morse of the landscape around the southeast corner of the visitor center. The Shoreline Connection Trail (left side of the photo) extends past the porch east towards the totem trail (the photograph is standing at that trail's entrance). Though its material is unclear it appears to be paved of crushed gravel. The portion of the Shoreline Connection Trail that extends to the right of the image does not appear as defined or paved. A clump of evergreen trees remain in this location at the intersection of these two paths and the beginning of the totem trail, but the deciduous trees did not survive (SITK 15655 A).*

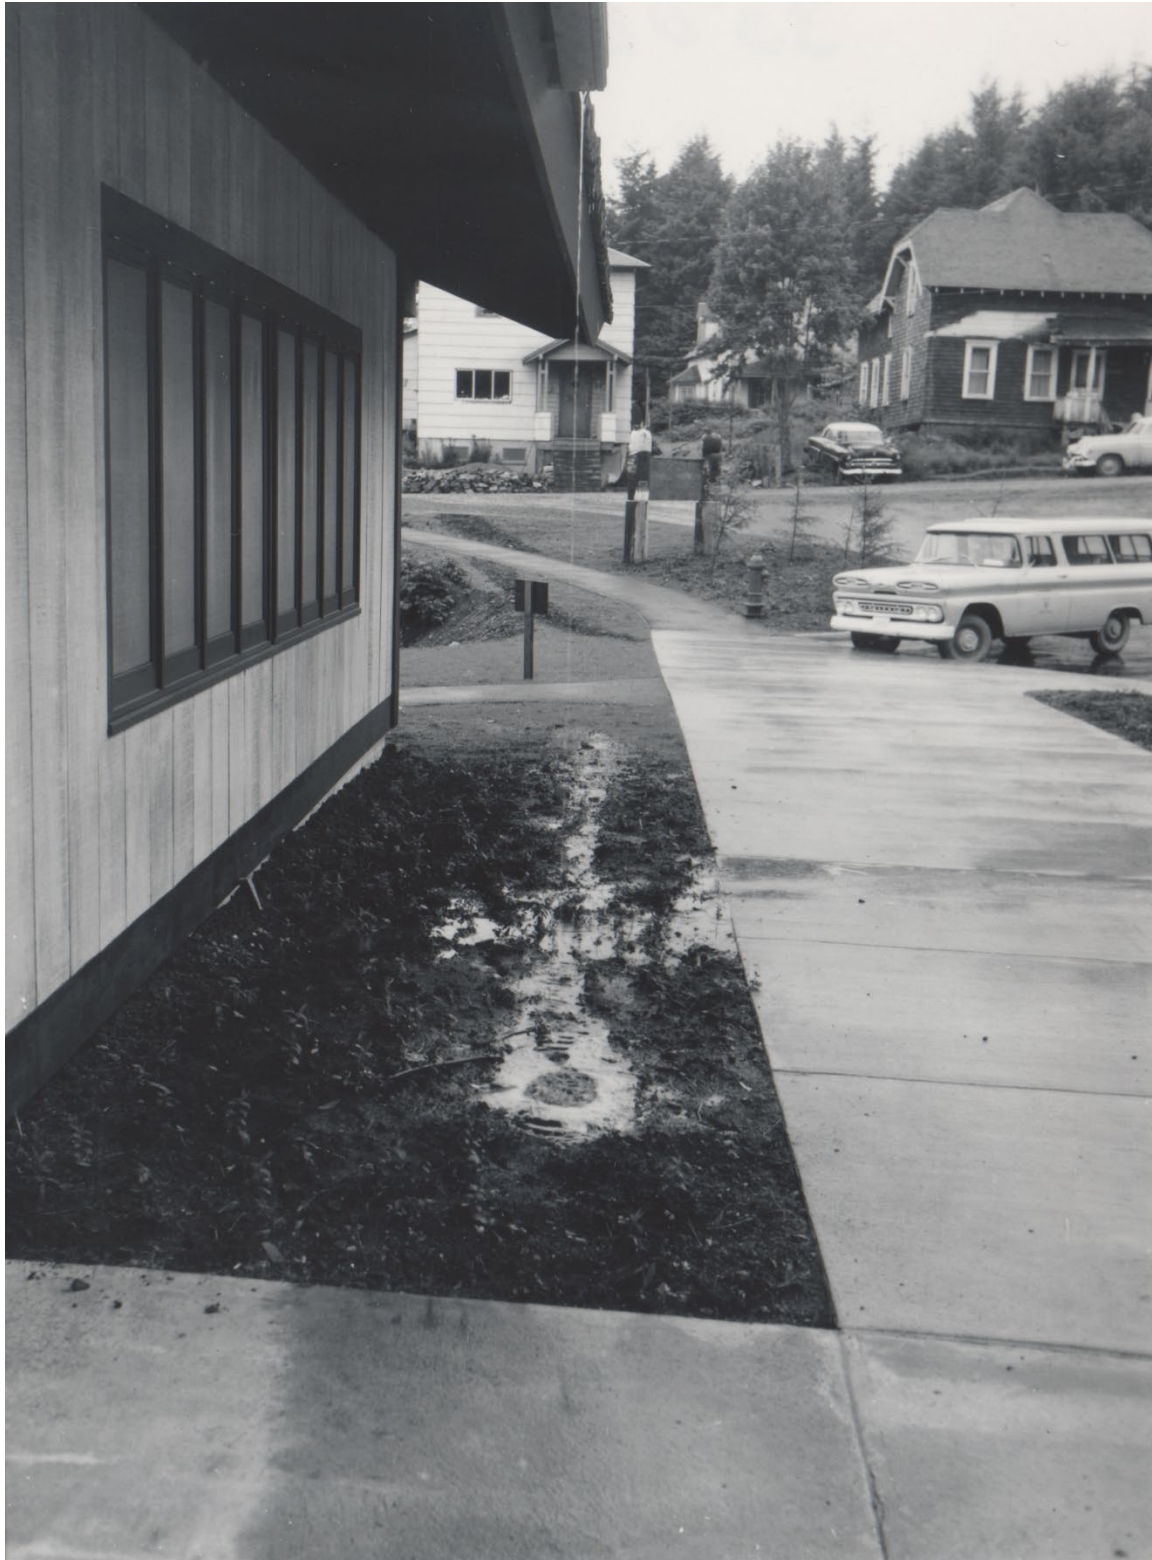
*July 1965 photo looking west of a prepped, but unplanted planting bed and a portion of the entry sidewalk. In the distance are portions of the Shoreline Connection Trail and the path between Metlakatla Street and the entry sidewalk, which appear paved with asphalt. Near the entry sign are the newly planted Sitka spruce and the fire hydrant (SITK 15659 A).*

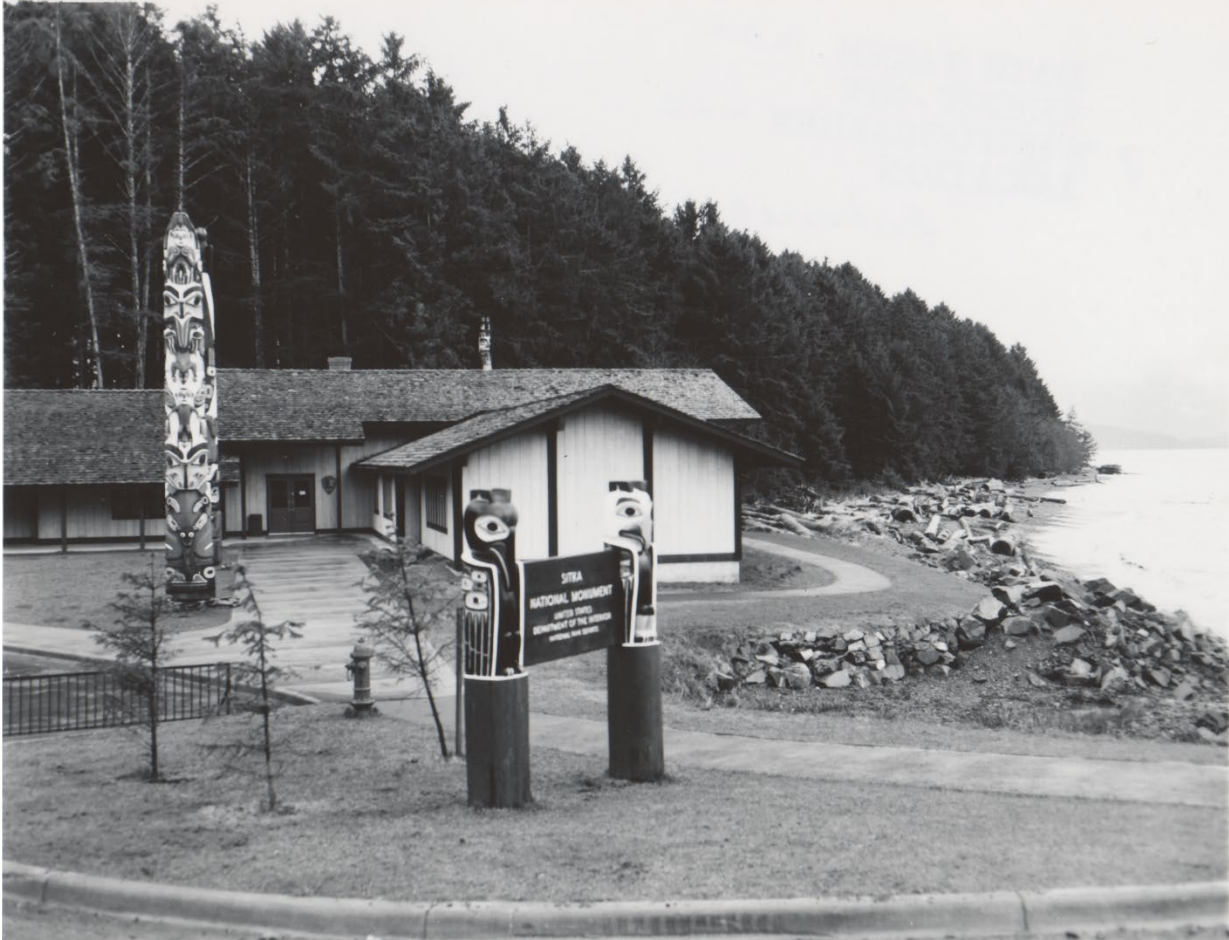
*Circa mid-1960s photo showing a bike rack near the fire hydrant and lower parking lot. A different bike rack is currently located in this same location (SITK 15659 C).*

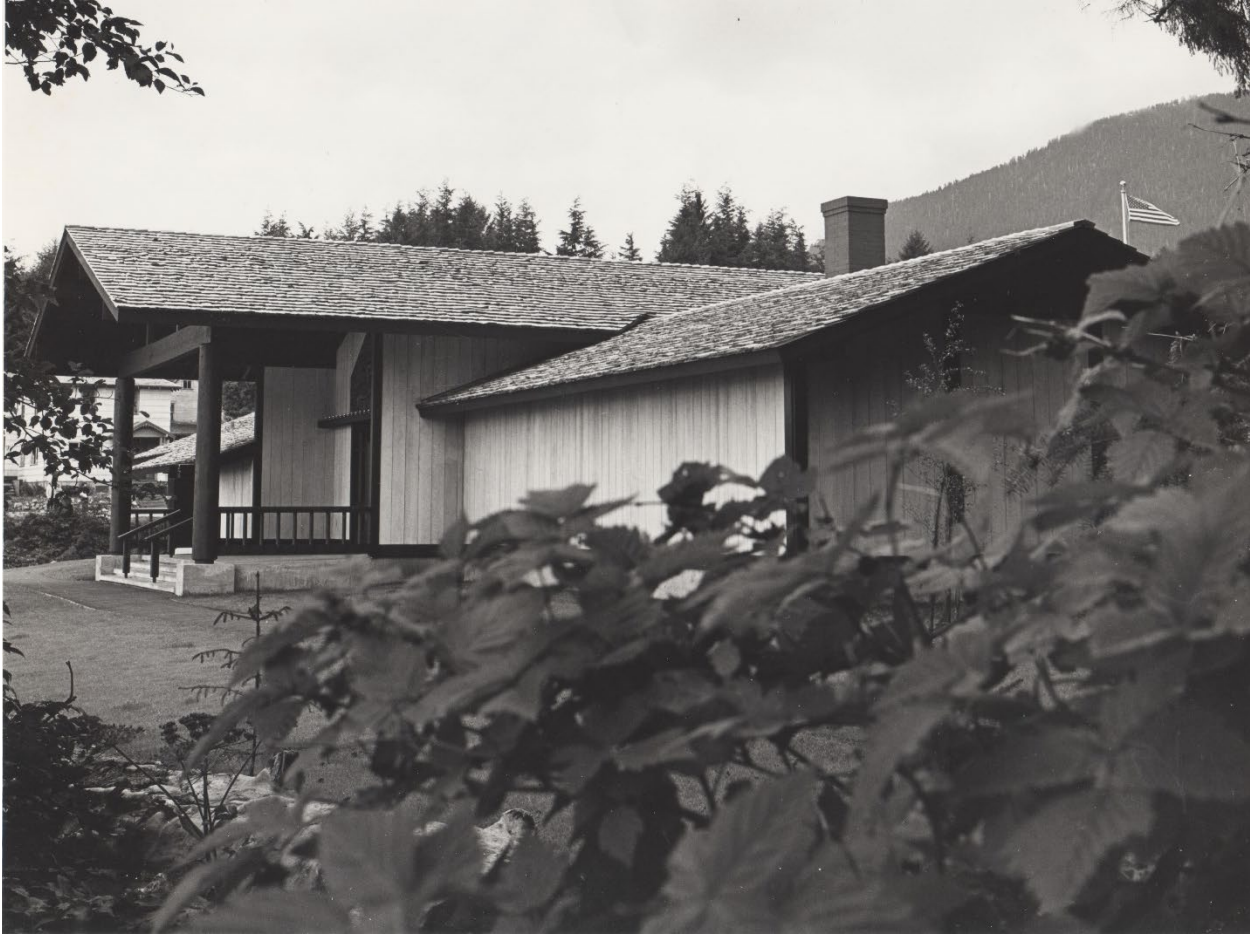
*August 1965 photo by Morse of the visitor center's porch and a portion of the south façade. A small section of the paved Shoreline Connection Trail is visible, along with the lawn planting on the north and south sides of the trail. In the foreground, along the edge of the shoreline are native shrubs (SITK 15655 B).*

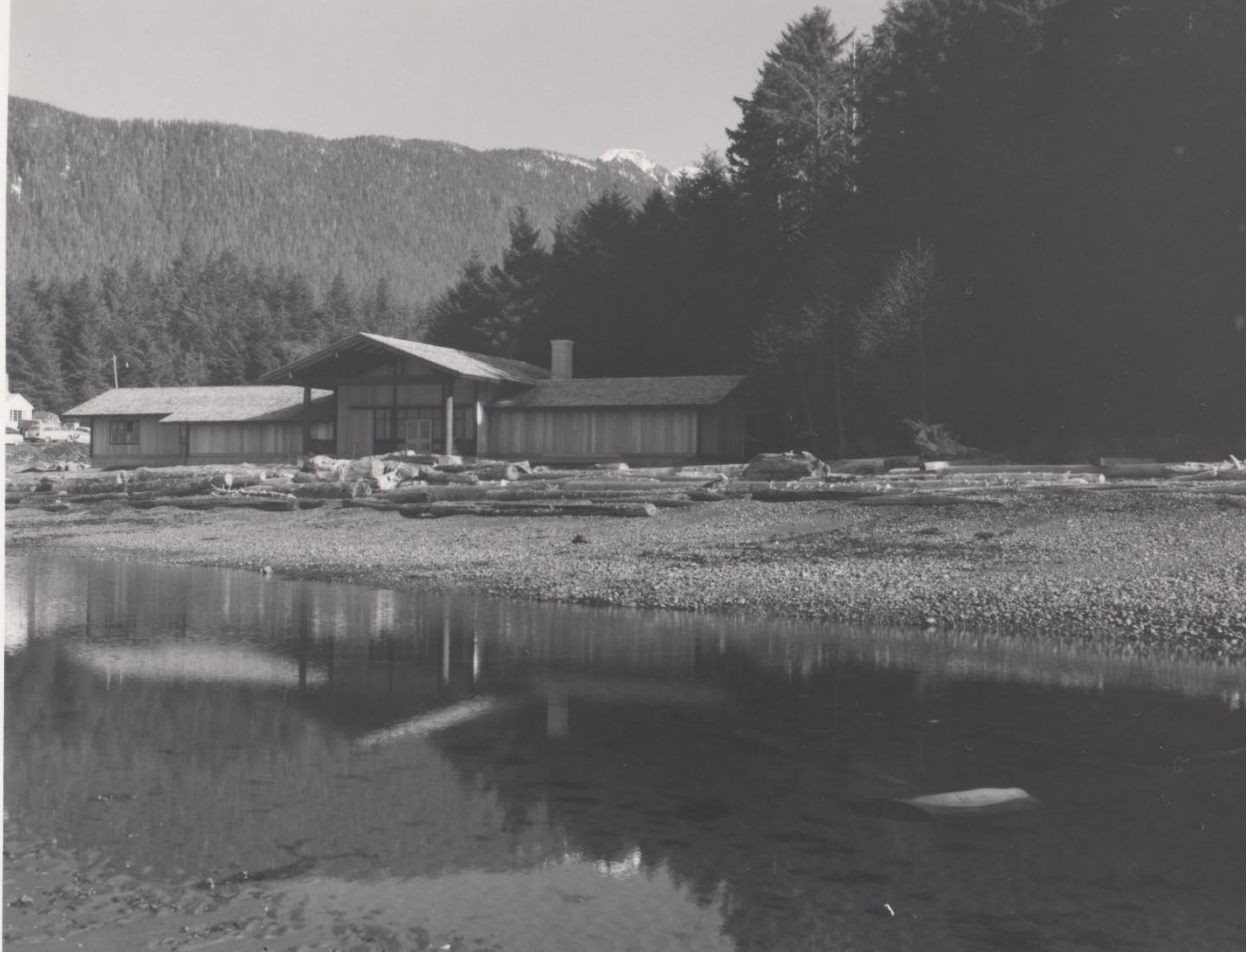
*Circa mid-1960s photo of the rock log riprap that was placed along the shore just south of the visitor center with Sitka Sound in the foreground (SITK 15659 P).*

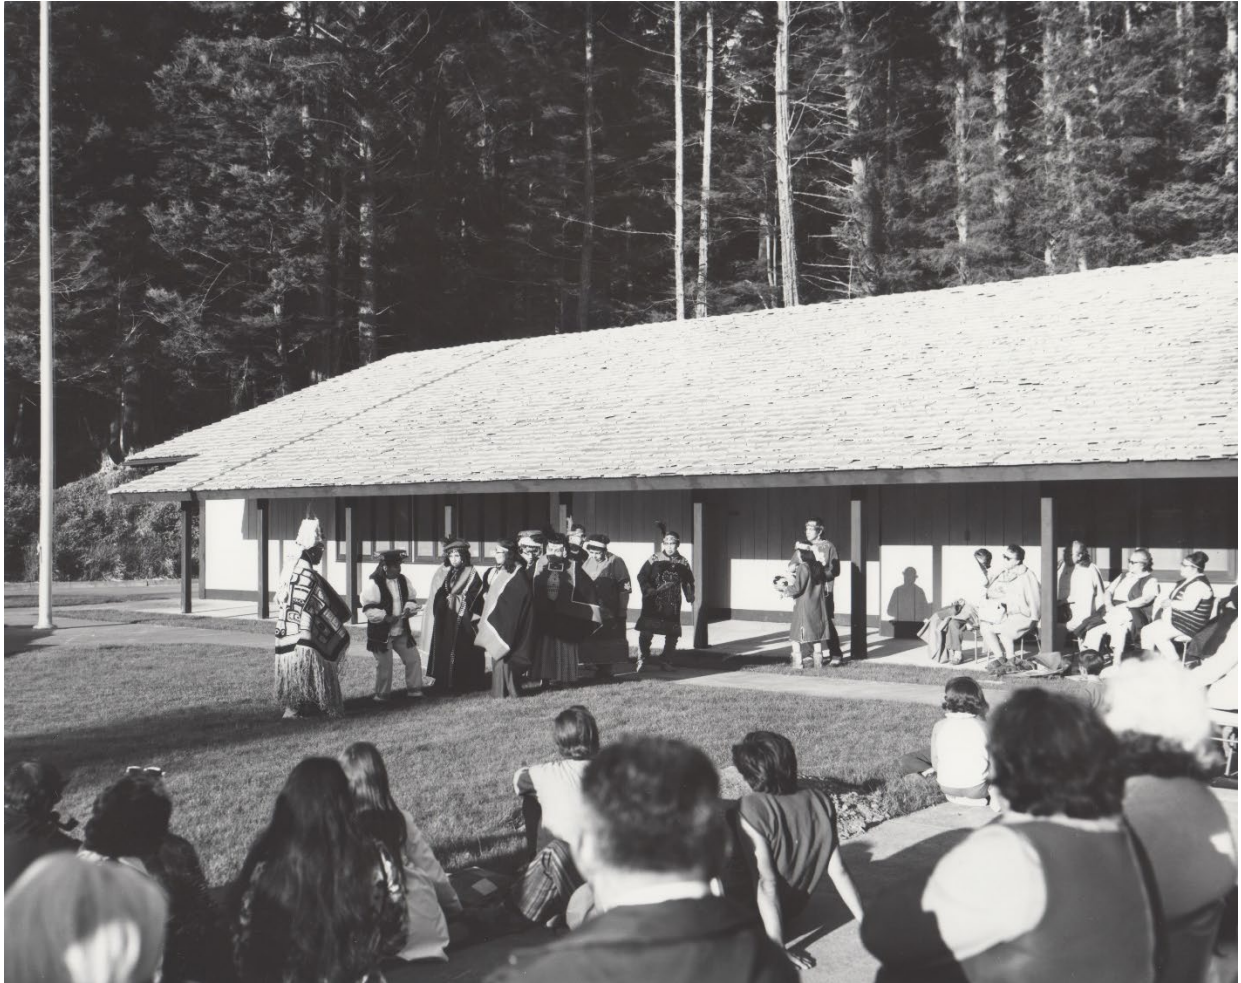
*Circa 1971 photo of the triangular lawn area with the flagpole in its original location and a portion of the concrete entry sidewalk that was removed in the late 1970s. A deciduous tree that was planted near the entry sidewalk and flagpole is no longer present. A pedestrian pathway was installed in 2000 that matches a section of this historic alignment (SITK 15656 D).*

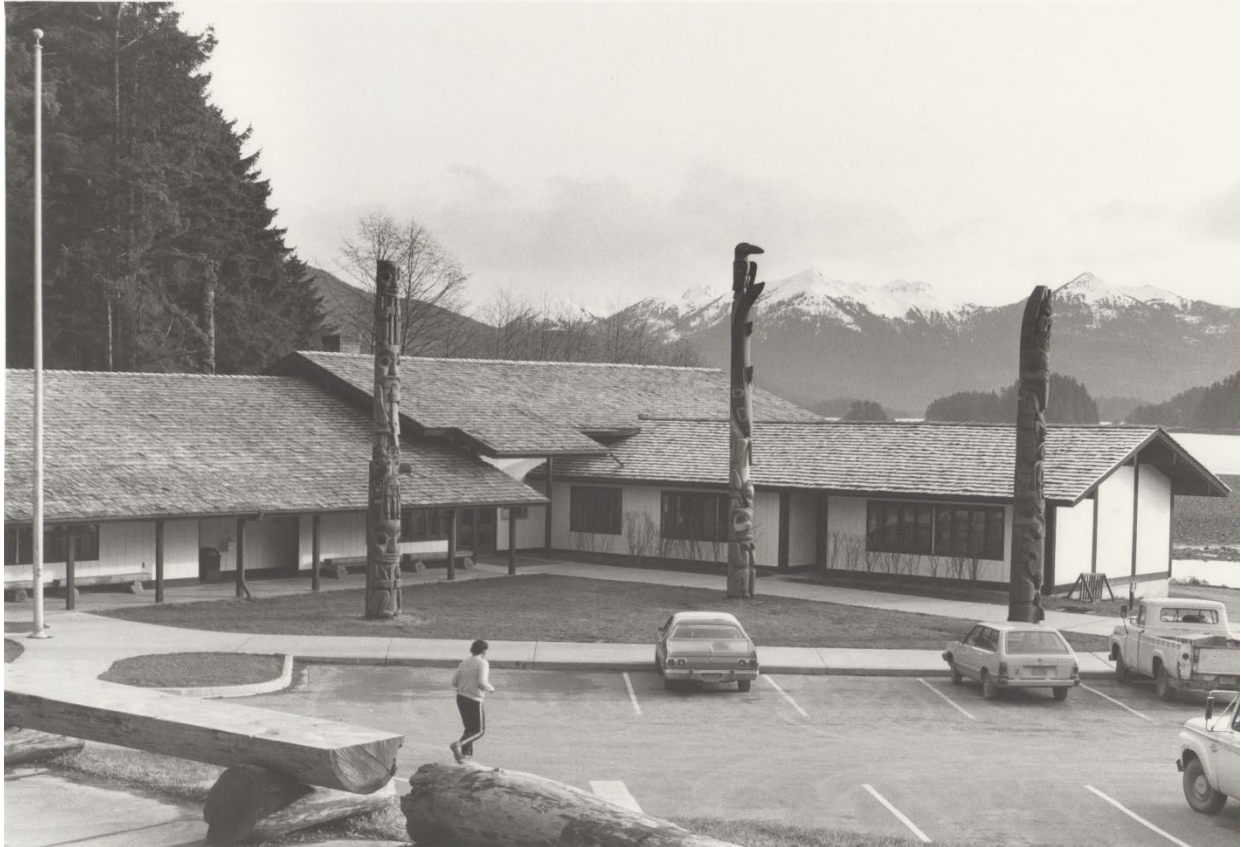
*1983 photo of the lower parking lot from the new curved sidewalk connecting the upper terrace with the lower parking lot and visitor center. The deciduous tree that was in the triangular planting area is gone along with the concrete sidewalk that paralleled the porch, and three totem poles have been added. The parking lot's location, shape and material remain the same from its 1965 construction. Tall deciduous shrubs are planted in the beds located between the entry sidewalk and the visitor center's west wing (SITK 15656 A).*

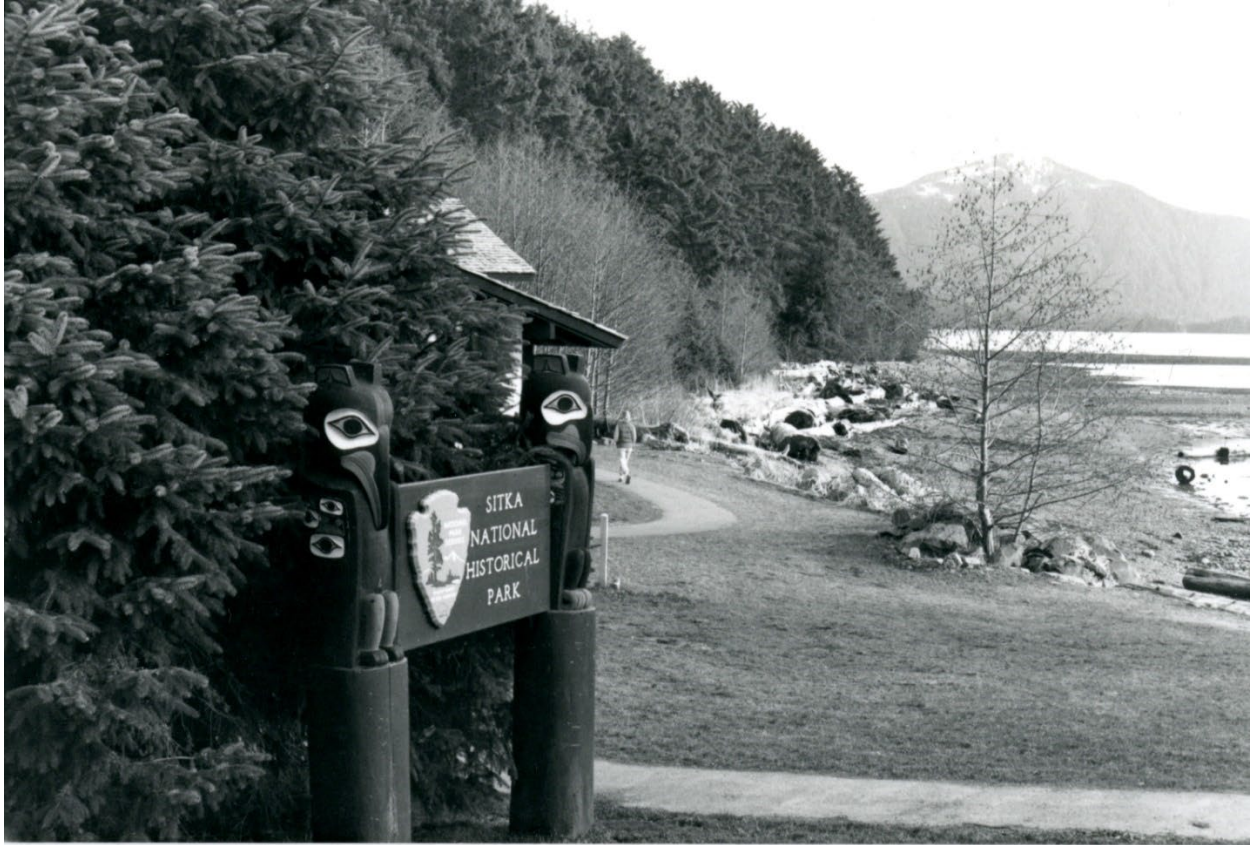
*1983 photo of the rock and log riprap, which is starting to host deciduous trees, including one located near the edge of what used to be the inlet, but is now filled in. The path between Metlakatla Street and the entry sidewalk appears in the foreground and the Shoreline Connection Trail in the background. Both are narrow and appear to be paved, though the material is not discernable (SITK 25380 B178 F021).*

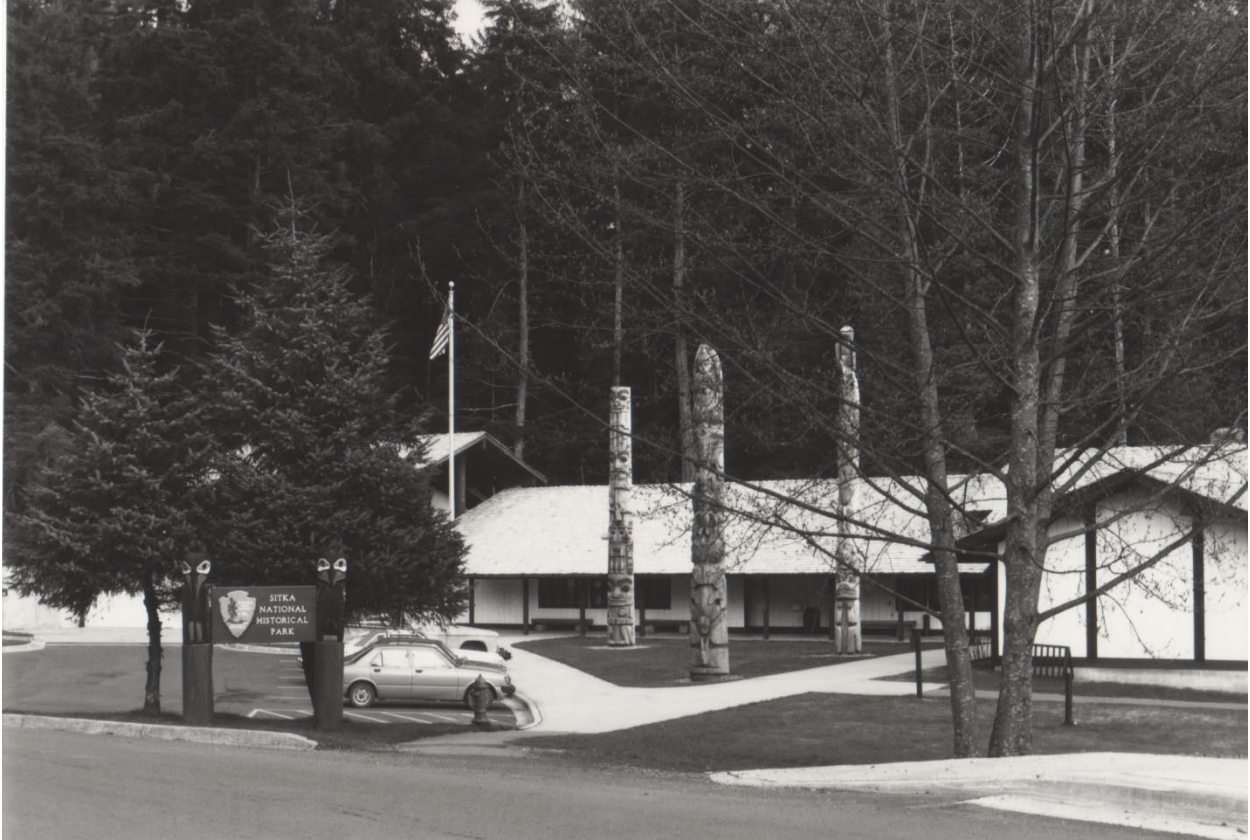
*1988 photo looking northeast showing the position of three totems in the triangular lawn, the entry sign and Sitka spruce, the entry sidewalk, and a portion of the path between Metlakatla Street and the entry sidewalk. The bike rack has moved to a location south of the Sitka spruce trees. The new addition is the sidewalk in the lower right corner which does not align well with the park's pedestrian circulation network and (SITK 15663BB).*

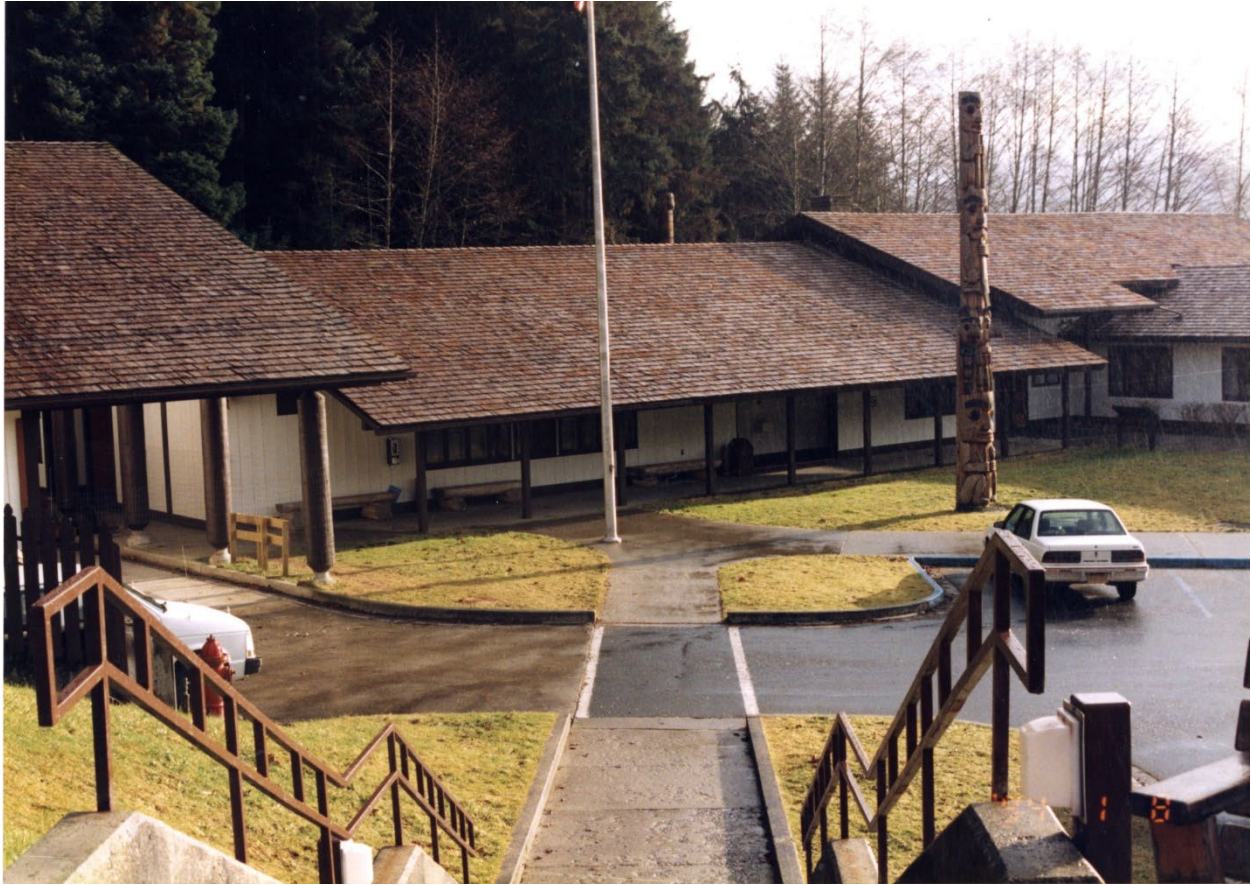
*1994 photo of the stairs and new pedestrian circulation that was constructed in the late 1970s which eliminated a portion of the entry sidewalk that paralleled the porch. A totem is located where a deciduous tree was planted in 1965 (SITK 25380 B025 F09).*

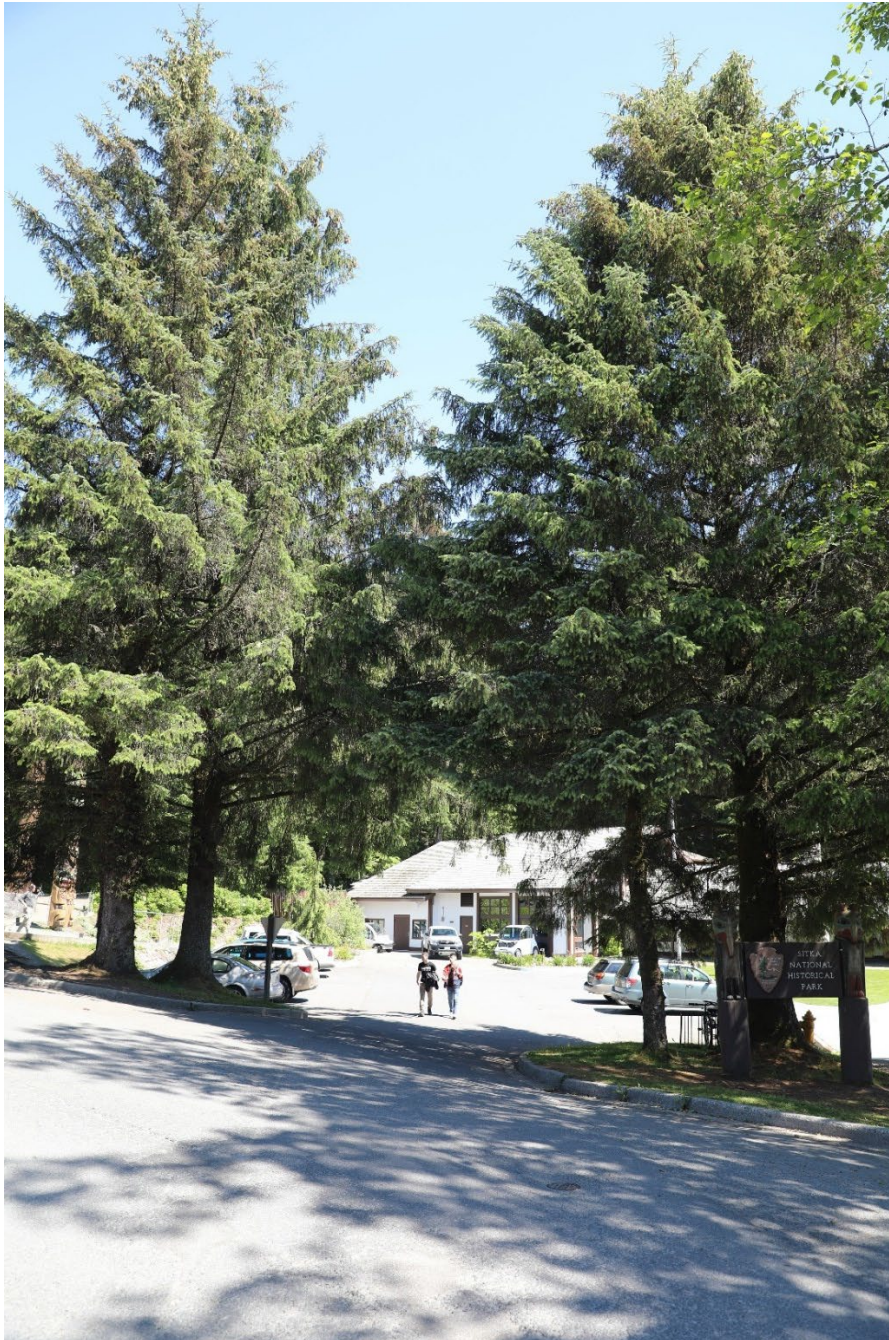
#### **Sitka Spruce**

Part of the original planting plan, eight Sitka Spruce were planted to flank the entrance to the Lower Parking Lot. Five remain today, two on the south side of the vehicular entrance near the entrance sign and three on the north side of the vehicular entrance (MIG, 2019).

*Evaluation: Contributing*

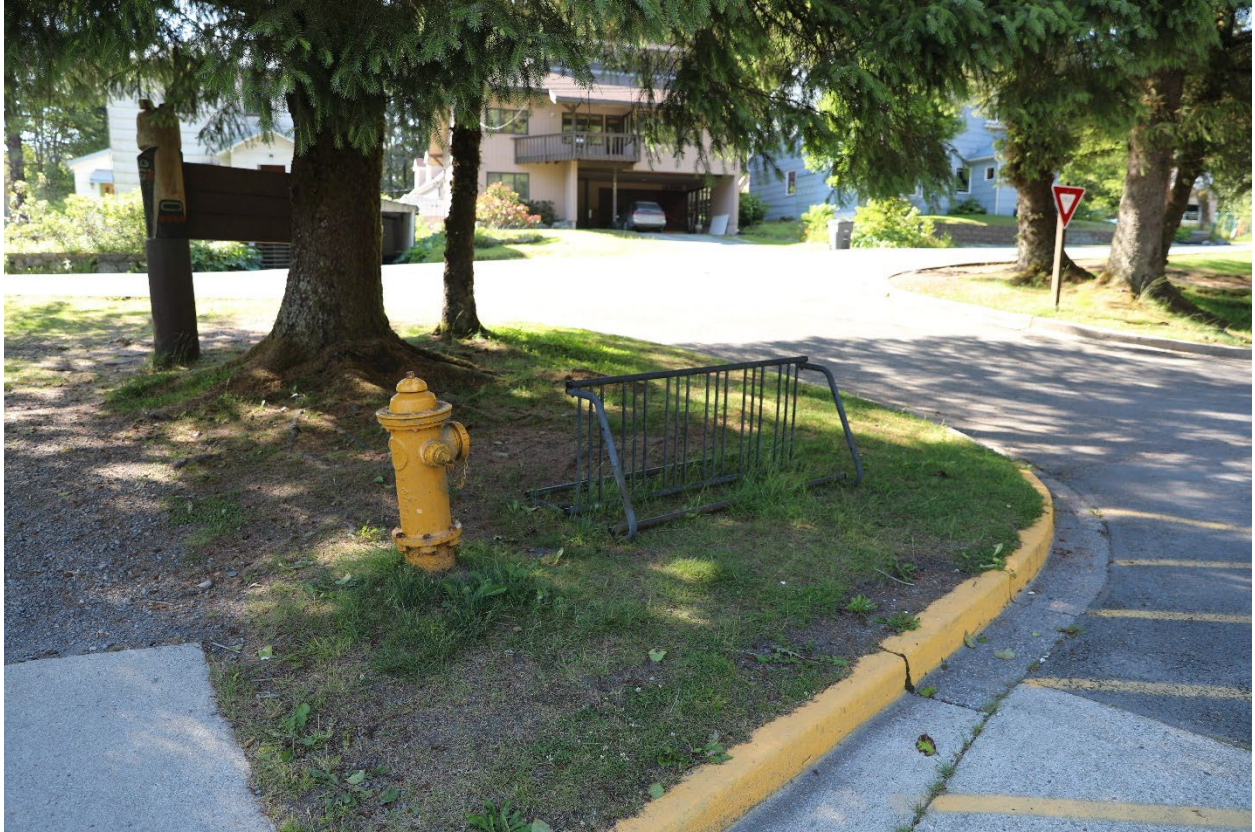
**Entrance Lawn**

In photographs taken at the opening of the Visitor Center, the Entrance Lawn surrounds five Sitka Spruce and forms the setting for the Entry Sign. To mitigate impacts to the lawn by visitors who are standing in front of it to take photos, several circular concrete pavers are located in the lawn in front of the sign. With the exception of this addition, the Entrance Lawn remains in place from the original design (MIG, 2019).

*Evaluation: Contributing*

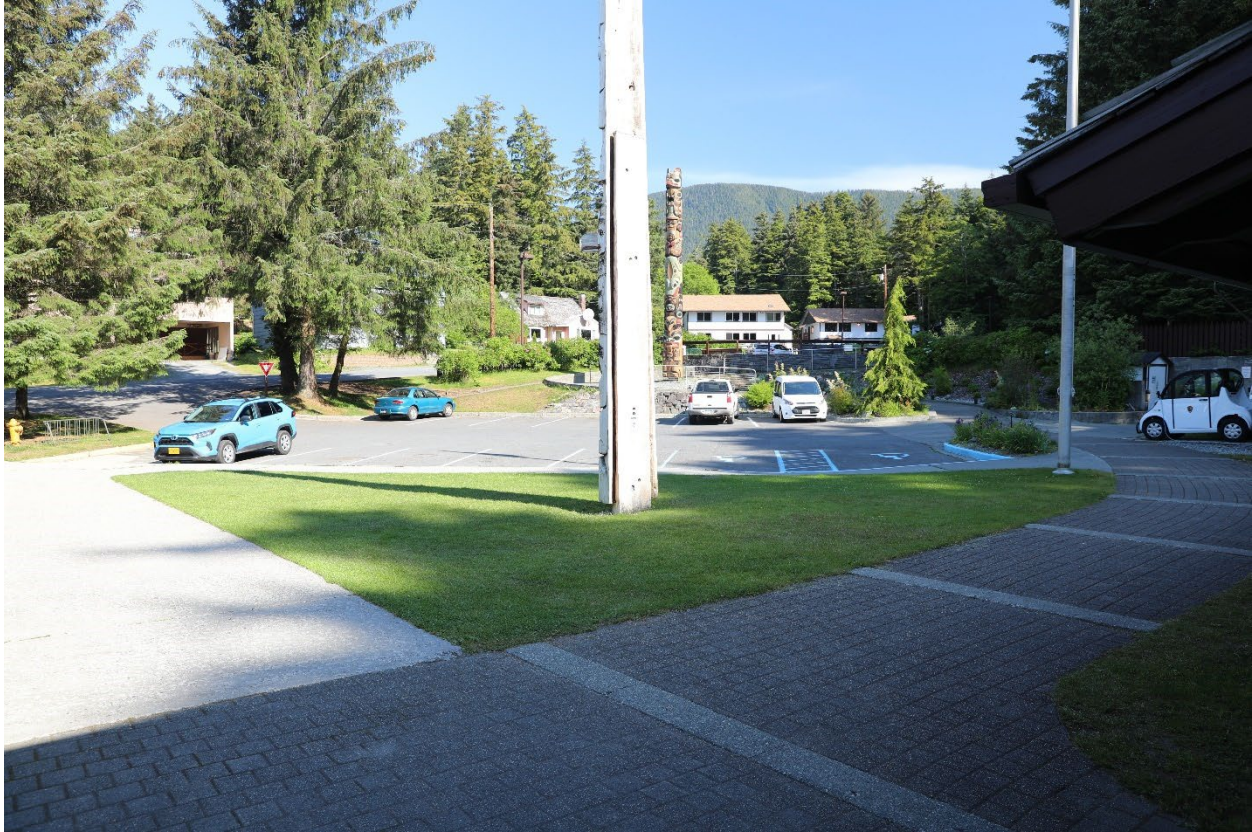
### Triangular Lawn

A triangular-shaped lawn area located north of the Visitor Center's theater wing, is bounded by the Entry Sidewalk and the curvilinear walkway. Original plans show that this area was intended to be planted with a non-native groundcover (*Gaultheria procumbens*), but that was either never implemented or didn't survive. A deciduous tree, possibly a white birch (*Betula pendula*) shown on an original planting plan, was planted on the east side of the lawn in 1965, but it had disappeared by the early 1970s. Alterations have been made to the eastern edge of the lawn on two occasions, when the pedestrian walkway was altered in the late 1970s and again in 2000. The flagpole was originally to the northeast of the lawn and has since moved inside its boundary (MIG, 2019).

*Evaluation: Contributing*
