National Park Service  
Cultural Landscape Inventory  
2020

Visitor Center  
Sitka National Historical Park

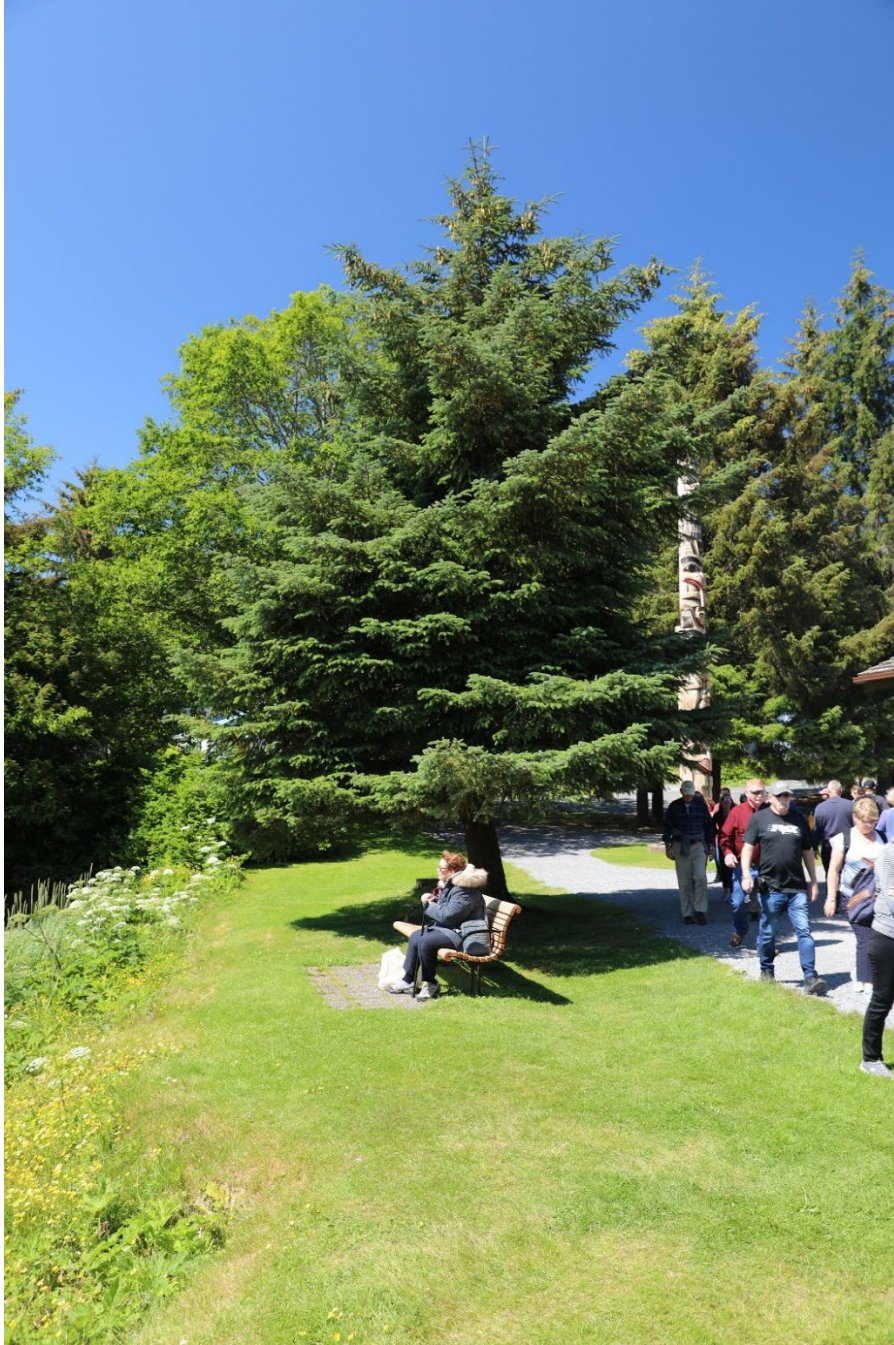
**Shoreline Lawn**

Though originally designed to be restored to native vegetation, a lawn was planted in the linear space between the Shoreline Connection Trail and the Rock and Log riprap. The shoreline lawn initially extended north and west around the inlet, but that has since been filled in and the lawn has expanded into this area. The shoreline lawn contributes to the historic character of the landscape, but three additions that are located in this area do not. Those include: the lawn's expansion into the former inlet area, a Sitka spruce, two tree stumps, and a bench located east of the Sitka spruce (MIG, 2019).

*Evaluation: Contributing*

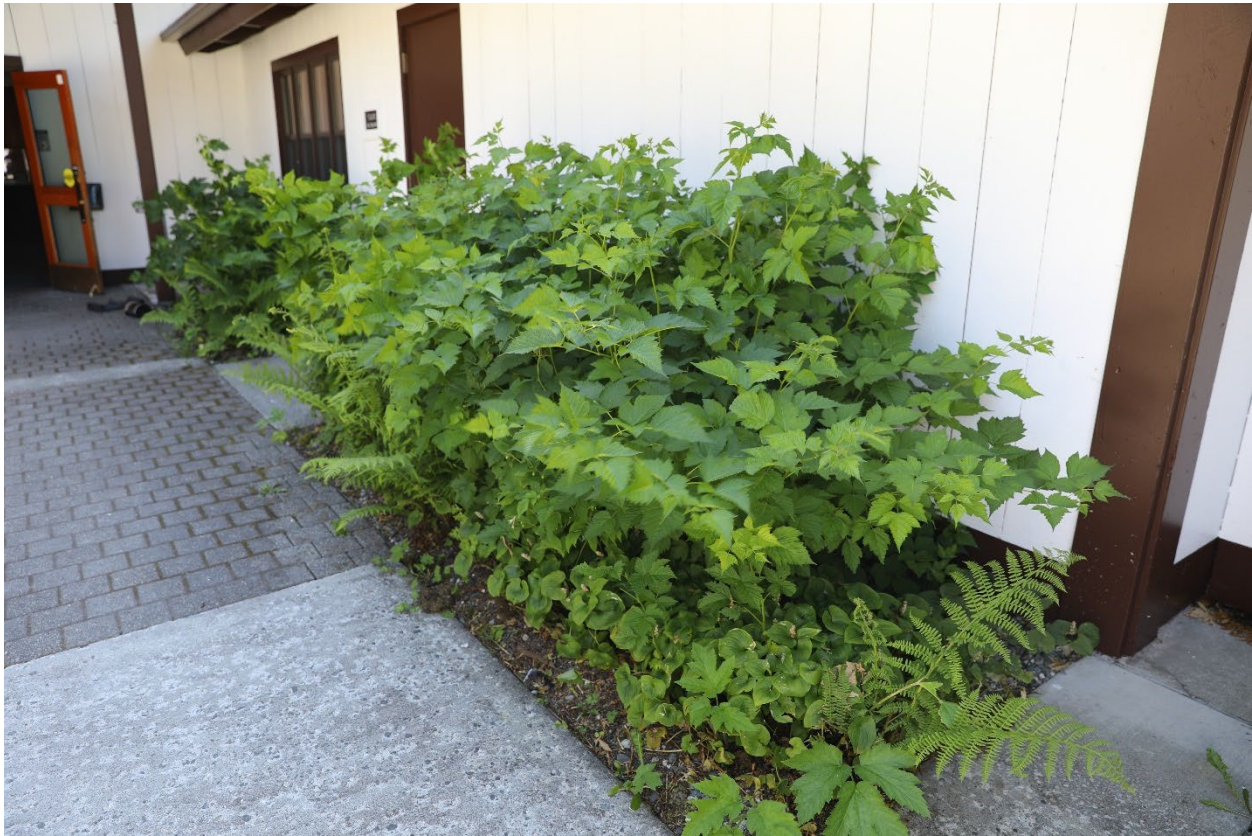
### Planting Beds

Planting Beds are located around the edges of the Visitor Center's theater wing between the building's façade and the pedestrian circulation features. An original planting plan shows that the planting bed on the north side of the building was slated for St. John's wort (*Hypericum calycinum*) and the southern planting bed slated for a non-native groundcover (*Gaultheria procumbens*). However, it does not appear that these were planted. Though photographic evidence is inconclusive, no shrubs or forbs appear in any of the images during the period of significance. Today, these planting beds contain a variety of native shrubs, forbs and lawn including, but not limited to Deer Heart (*Mainantheum dilatatum*), Cow parsnip (*Heracleum lanatum*), Nootka rose (*Rosa nutkana*), and Salmonberry (*Rubus spectabilis*) (MIG, 2019).

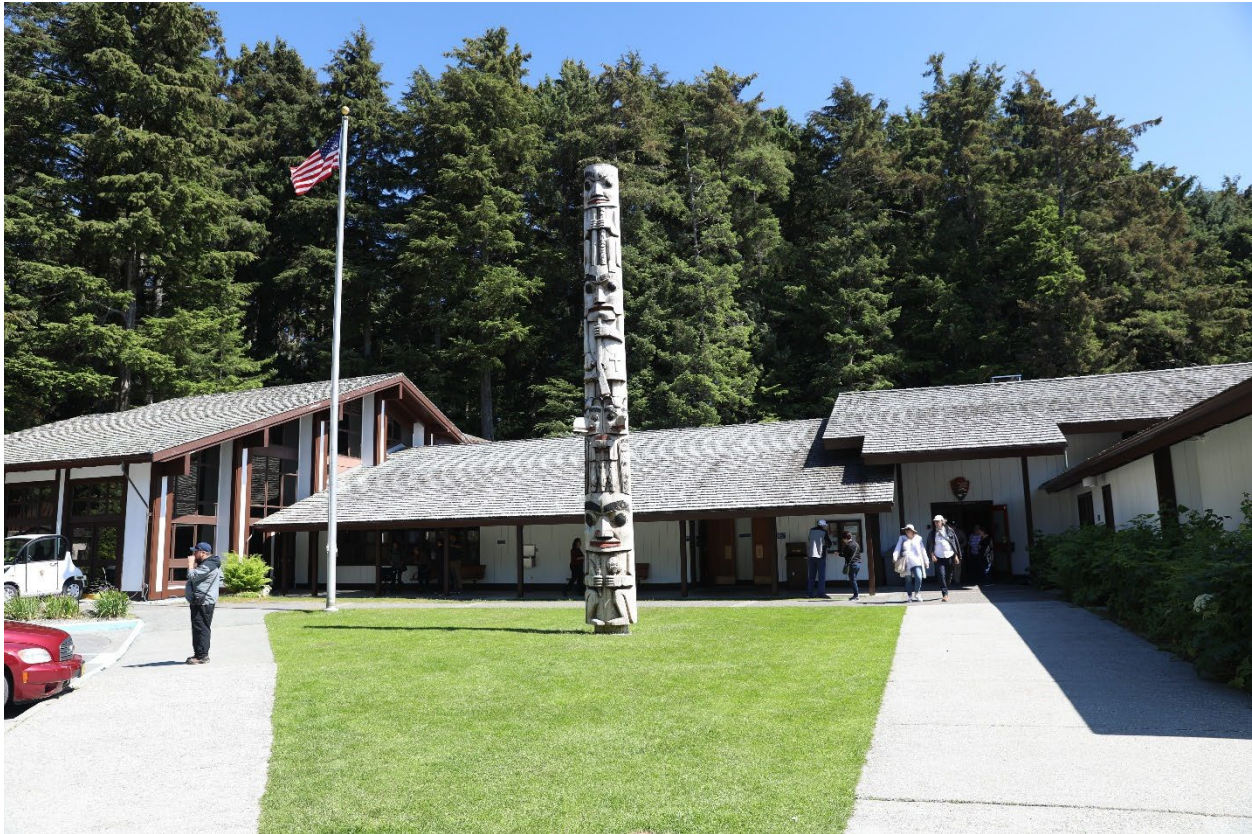
### Entry Sidewalk

The concrete Entry Sidewalk connects the Lower Parking Lot with the Visitor Center. The concrete sidewalk includes a section which borders the Lower Parking Lot's southern end and a section which connects the Path Between Metlakatla Street and the Entry Sidewalk with the Visitor Center entrance. This section initially ended at the southwest corner of the lower parking lot, but now extends a few feet to the west. A third section, which originally connected the southeast corner of the lower parking lot with the Visitor Center's entrance, was removed in the late 1970s and modified in 2000. In the late 1970s, this section was removed, and the sidewalk located under the porch provided a connection between the parking lots and the Visitor Center entrance. In 2000, a new walkway was built just west of the porch in a similar location to the original sidewalk, however the form and materials were not the same being curved (not straight) and built of pavers and concrete (not concrete). Drawings from 1965 indicate the Entry Sidewalk was concrete. Though a portion of the entry sidewalk is missing, and a small section has been added to its western end, the remaining sections associated with the 1965 construction contribute to the historic character of the property (MIG, 2019).

*Evaluation: Contributing*

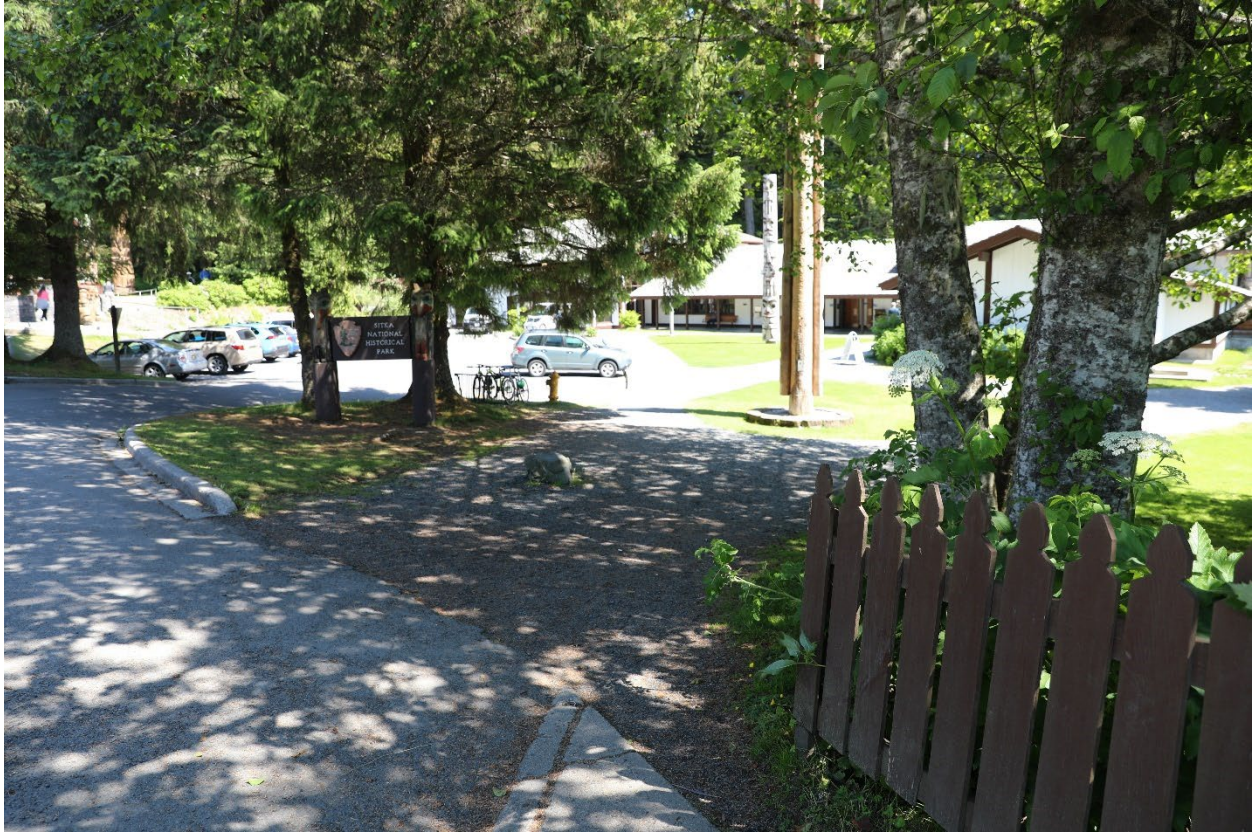
### **Path Between Metlakatla Street and Entry Sidewalk**

This path connects Metlakatla Street and a sidewalk that terminates at the end of Lincoln Street with the Entry Sidewalk, providing a connection for pedestrians who are coming to the park from the city's center. In the 1965 plans this path follows the current alignment but was much narrower and had a more defined edge. Though photographic evidence is not definitive, the path appears paved in asphalt or a fine crushed and binded gravel substance. A circa 1976 existing conditions plan notes that the path is asphalt, but earlier drawings note it was a bituminous paved surface which can sometimes be characterized as asphalt since they are similar. Today, the path consists of a larger sized gravel (roughly half-inch to one inch) that is not edged and has expanded beyond its original width, but it does follow the original path's alignment. Its expanded width is exacerbated by the introduction of the Path Between Metlakatla Street and Shoreline Connection Trail (MIG, 2019).

*Evaluation: Contributing*

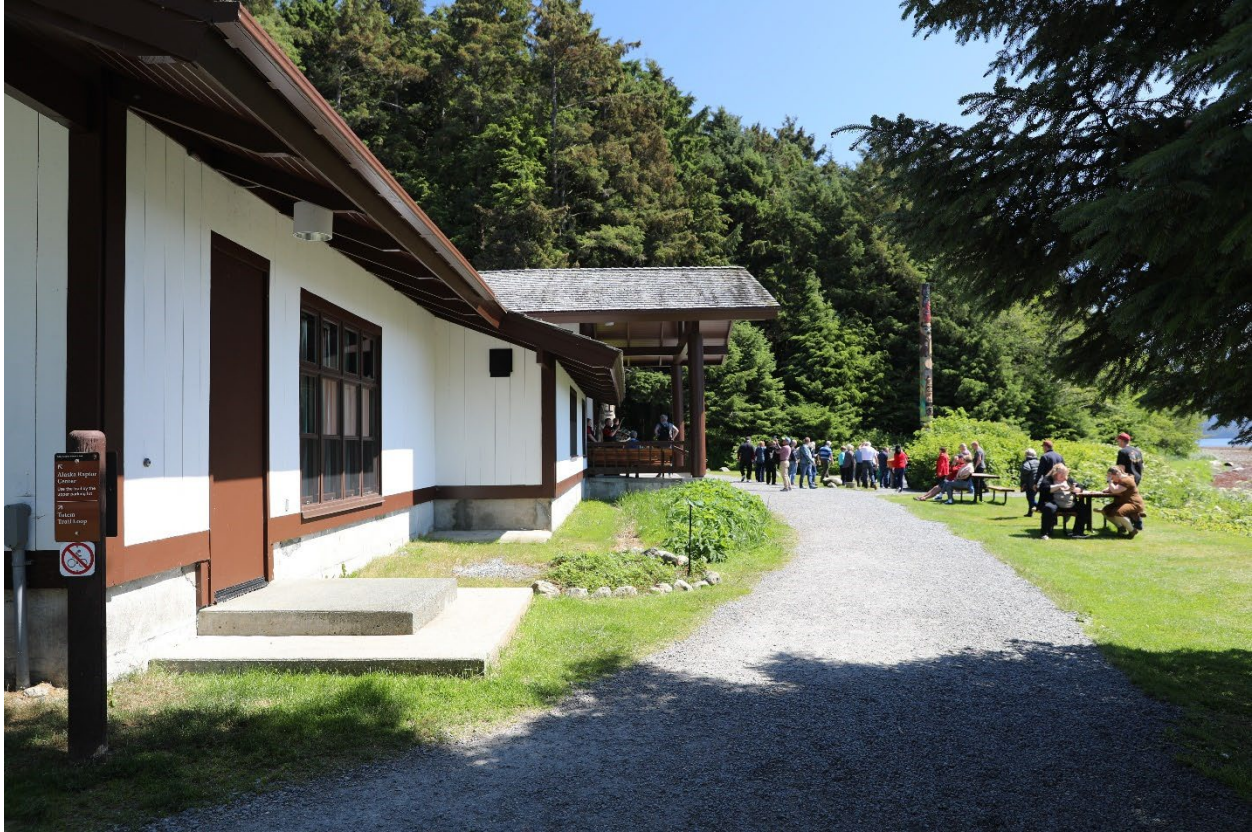
### **Shoreline Connection Trail**

The Shoreline Connection Trail was designed to be a narrow trail tracing around the southern and eastern elevations of the Visitor Center and connecting the Entry Sidewalk with the Totem Trail. Photographs from 1965 indicate that the trail's surface material between the Entry Sidewalk and the Totem Trail was paved in a similar material to the one used for the Path Between Metlakatla Street and Entry Sidewalk. Like that path it was also edged. Later evidence from plans and photographs indicates that the trail was paved between the Entry Sidewalk and the Visitor Center porch. The surface between the porch and the entrance to Totem Trail and extending around the east side of the Visitor Center may have been gravel. It is not clear if this change in surface material occurred before the end of the period of significance. Today, the width of this path has extended beyond its original footprint and it is no longer edged or compacted. Its expansion is due in part to its relationship to the more recently added Path between Metlakatla Street and the Shoreline Connection Trail but is also connected to the trail providing vehicular access to Totem Trail. Following the construction of the Totem Viewing Area, a portion of the Shoreline Connection Trail was moved north and east of the visitor center's new northeast corner location. There is very little documentation of this area throughout the site's history, but 1965 drawings allude to a connection along this side of the visitor center that connected a north entrance to the totem trail and the southern entrance to the totem trail. The trail connection still exists, but its location has been altered (MIG, 2019).

*Evaluation: Contributing*

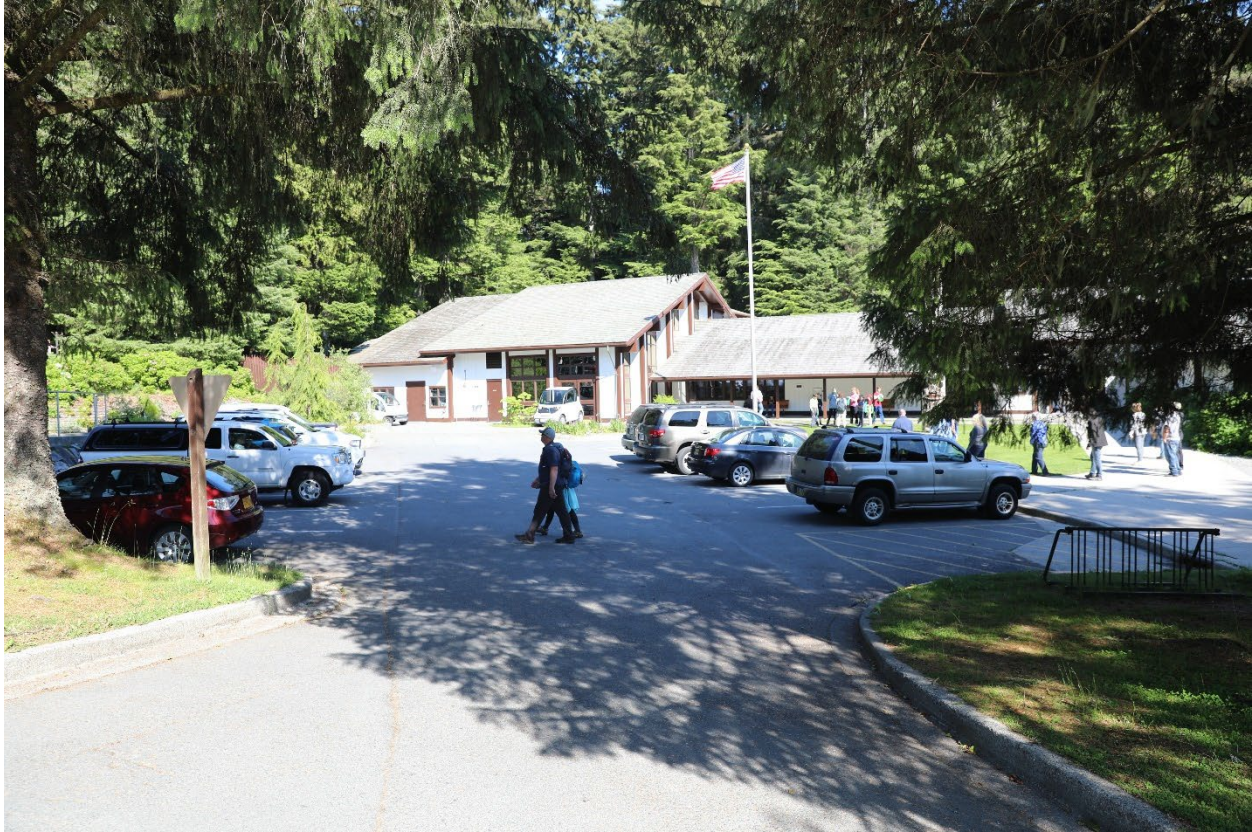
### **Lower Parking Lot**

Designed by Cecil Doty and landscape architects associated with the NPS Western Office of Design and Construction and finalized by John Morse, the location, shape, size, material, and connection to Metlakatla Street remains as it was when it was built in 1965. Drawings from 1964 called for an asphalt paved parking area lined with a curb that would fit 20 automobile parking spaces, a catch basin located in the parking lot's southwest corner, and roads connecting the lower parking lot's west end with Metlakatla Street and the eastern end with a service court. The expansion of the Totem Hall and the curvilinear path that links the lower parking lot to the upper parking lot has impacted the far eastern edge of the road associated with the lower parking lot that connected the eastern edge of the lower parking lot to what was originally a service court and is now exhibit and office space, but the parking lot itself was not impacted (MIG, 2019).

*Evaluation: Contributing*

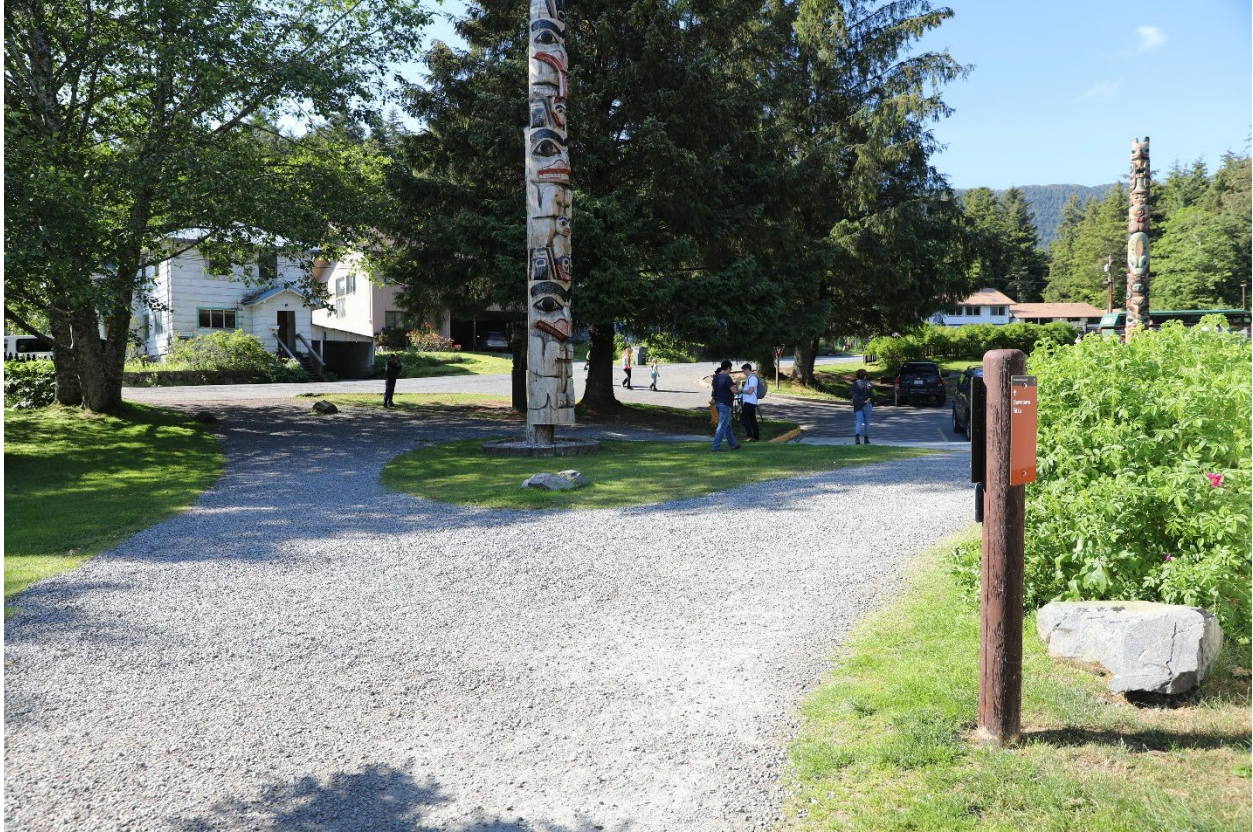
**Path Between Metlakatla Street and Shoreline Connection Trail**

This path (on the left) was not part of the 1965 landscape design but is a formalized desire trail that connects Metlakatla Street with the Shoreline Connection Trail. Though it is not clear when it was added, it does not appear in any drawings or photographs before 2000 (MIG, 2019).

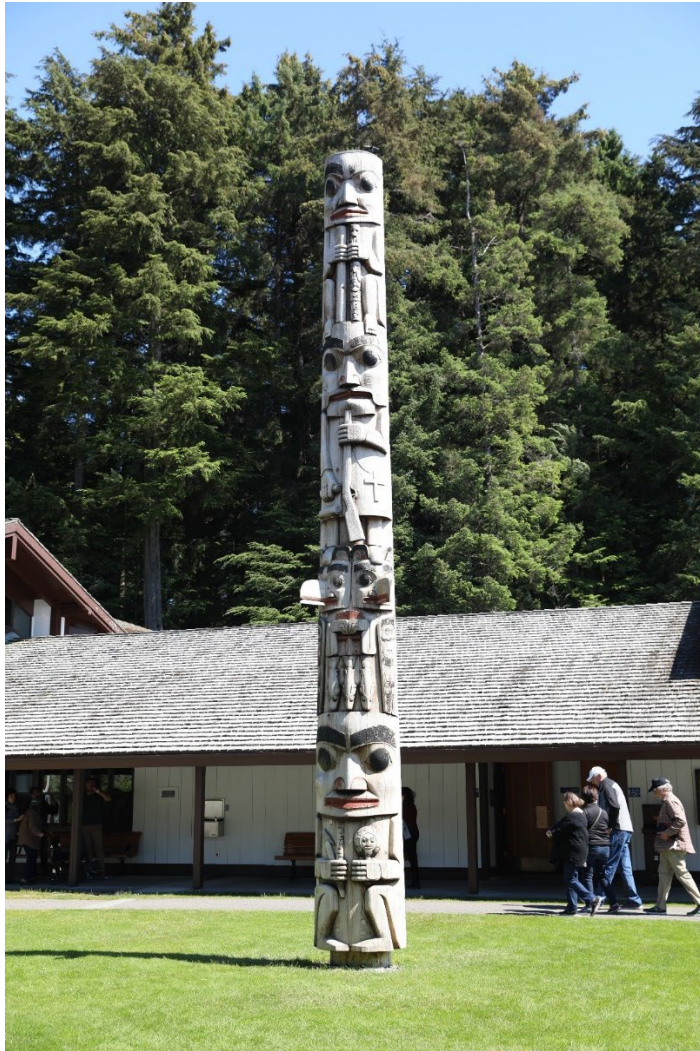
#### ***Bicentennial Pole***

Located within the Triangular Lawn, the Bicentennial Pole was carved by Duane Pasco, the winner of a design competition in 1976, this totem pole is carved in the traditional style and is meant to depict 200 years of Pacific Northwest Coast Indian history. During the period of significance there were up to three totem poles located in the Triangular Lawn. The Bicentennial Pole appears to be close to one of the original locations (MIG, 2019).

*Evaluation: Contributing*

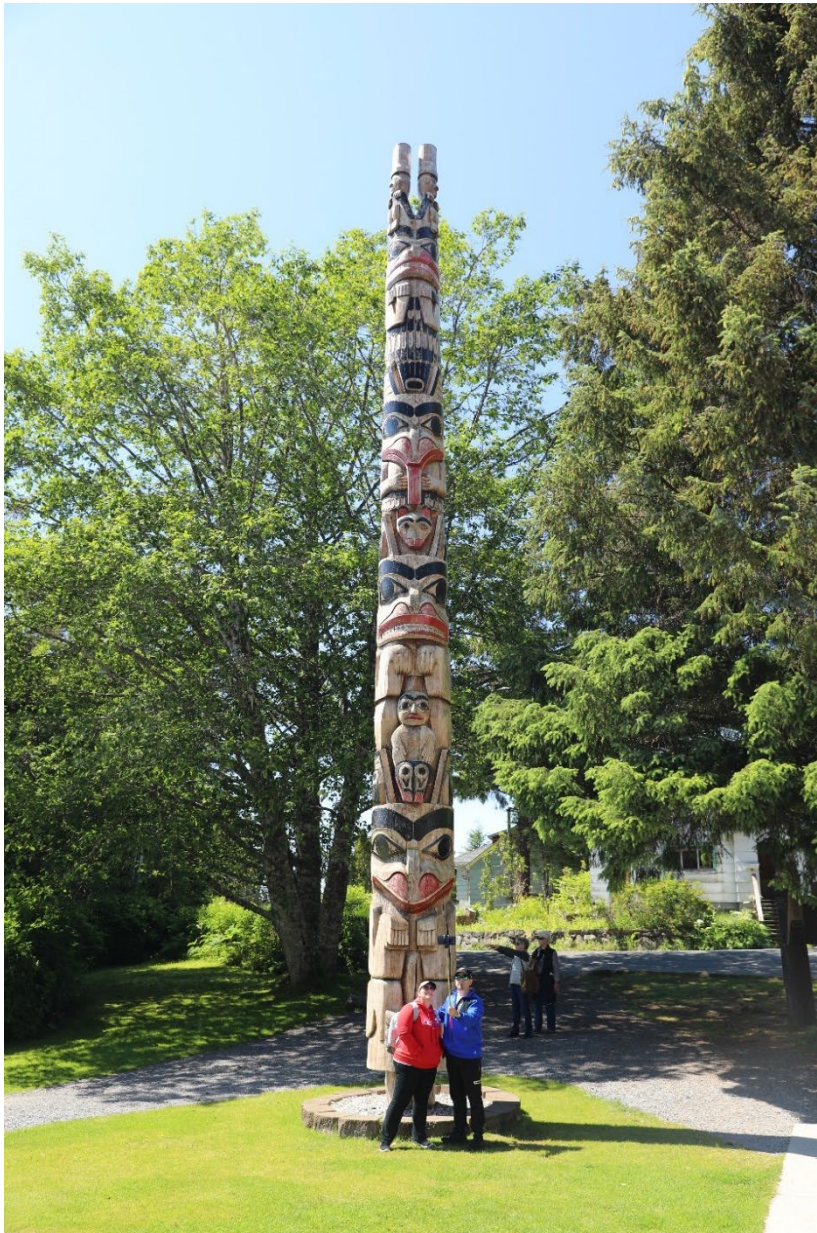
***Yaadaas Crest Pole***

The newly carved reproduction of the Yaadaas Crest totem pole was carved during the spring and summer of 2006 as a collaborative project with the Sitka Tribe of Alaska, The Kiks.ádi clan, and Haida people of Kaasaan/Haidaburg. The raising commemorated the 100th anniversary of the 1906 installation in the park of totem poles collected by Governor Brady and displayed at expositions in St. Louis (1904) and Portland (1905). It is located in a lawn area between the Path Between Metlakatla Street and Entry Sidewalk and the Path Between Metlakatla Street and Shoreline Connection Trail, where totem poles did not exist during the period of significance. The base is different than the other totem poles since it is surrounded by a circular concrete paver edge (MIG, 2019).

*Evaluation: While the totem pole itself is contributing, its location is not.*

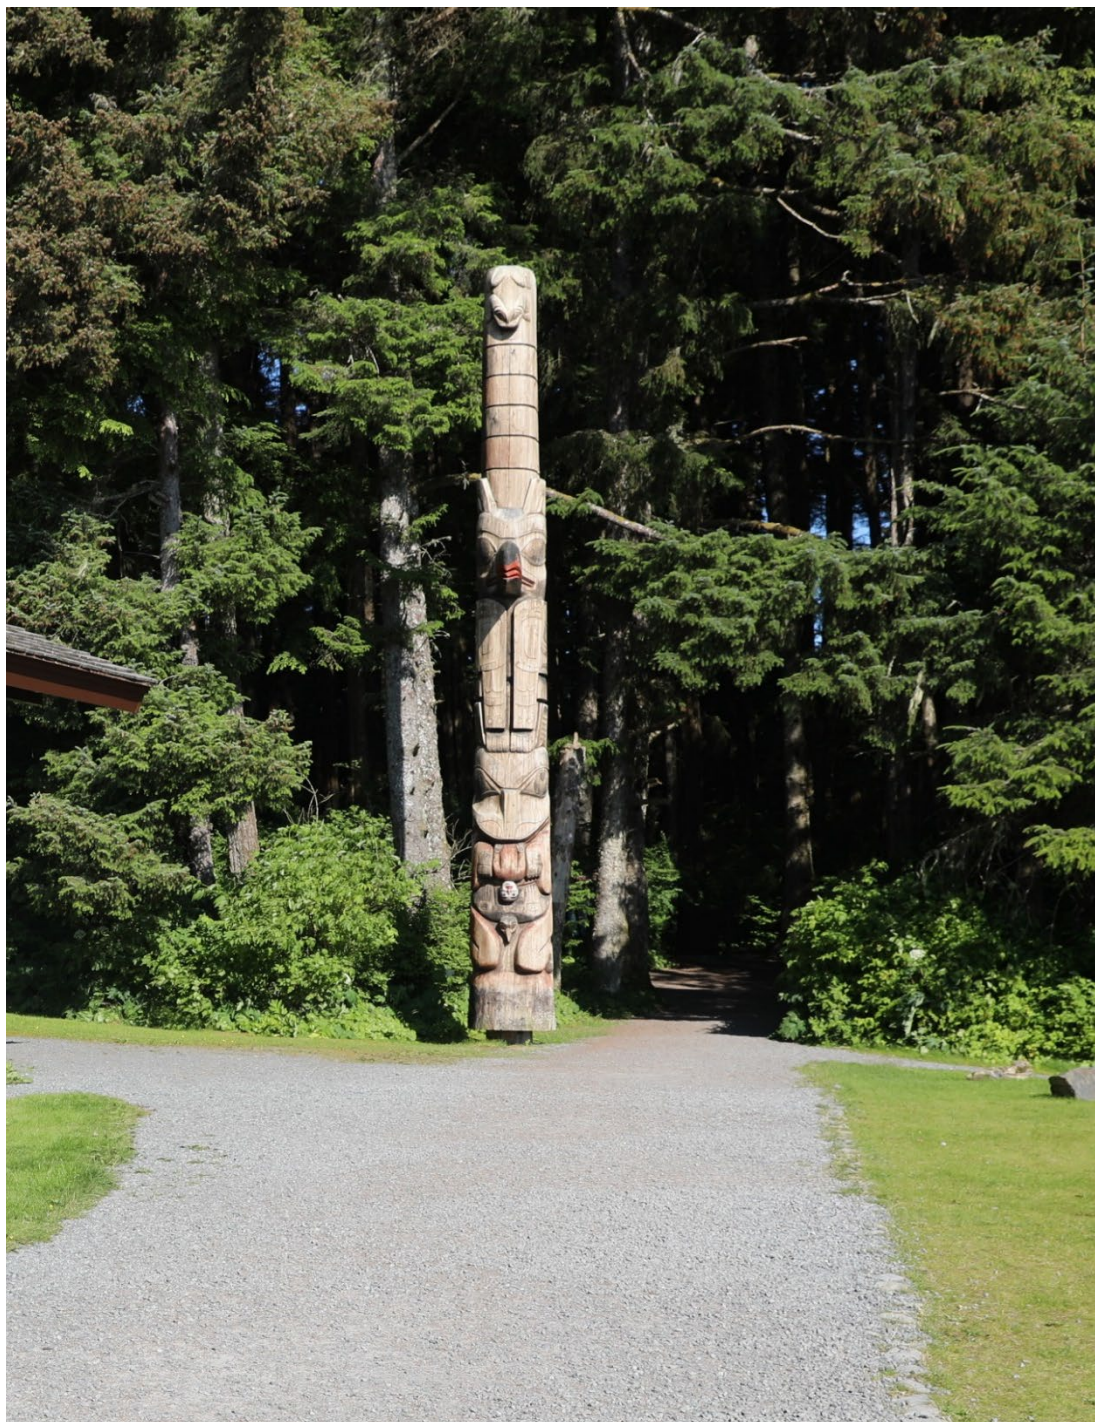
### ***Frog/Raven Pole***

At the entrance to the totem trail stands the Frog/Raven Pole which was recarved by George Benson (Lkeináa) and John Sam (Chináa) during the Civilian Conservation Corps restoration program that lasted between 1938 and 1941. It is located in or near its original location (MIG, 2019).

*Evaluation: Contributing*

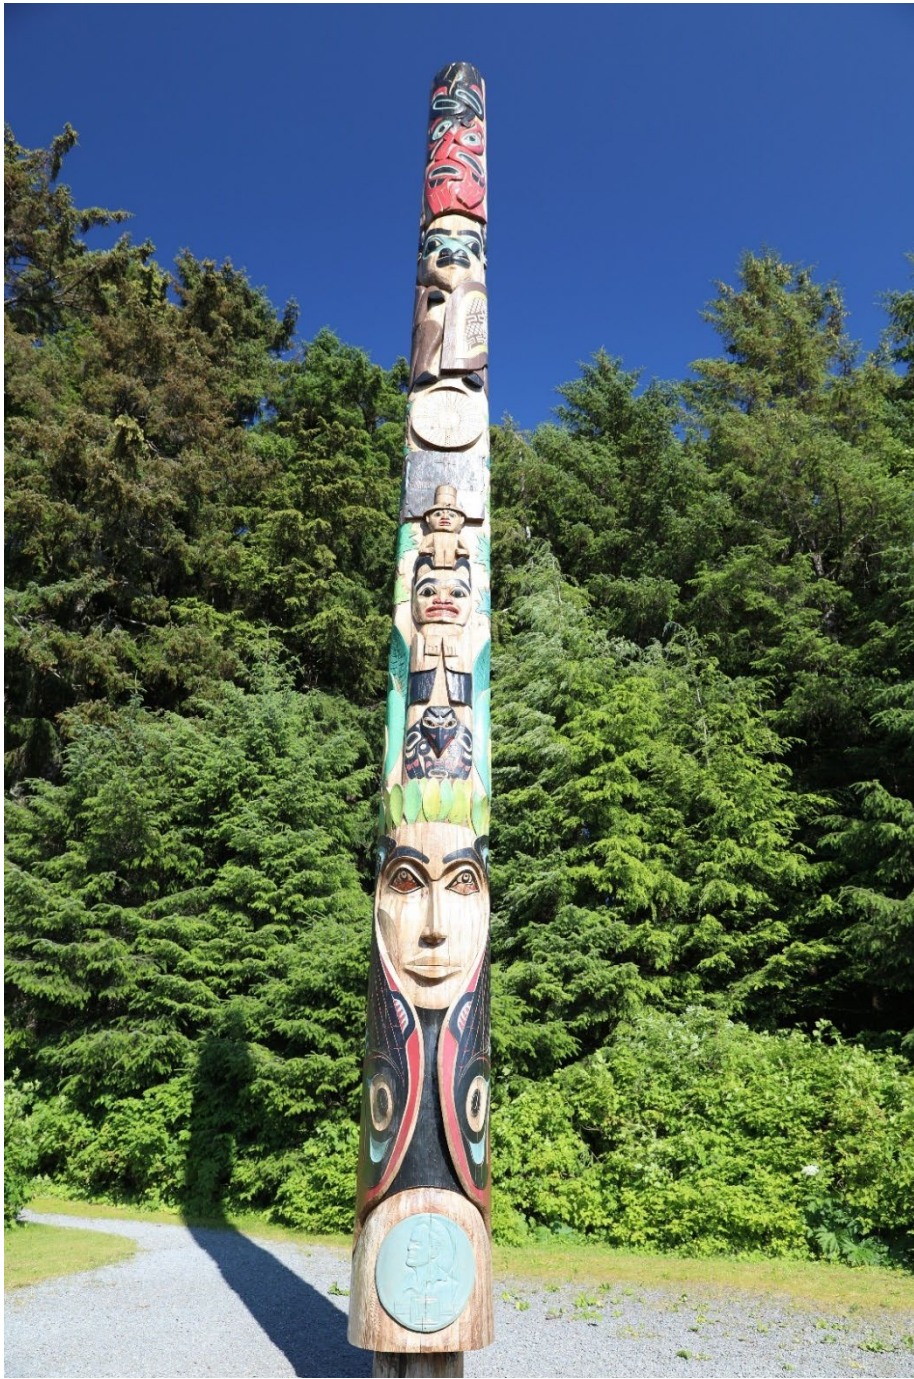
***Wooch Jin Dul Shat Kooteeya- The Holding Hands Centennial Pole***

The "Wooch Jin Dul Shat Kooteeya" or "Holding Hands Centennial" totem pole near the entrance to totem trail was commissioned to commemorate the Sitka National Historical Park's 100th anniversary. Numerous carvers shaped the totem, but the effort was led by Tommy Joseph, who supervised the project and who carved the top - a Raven/Eagle Juxtaposition. A totem pole did not exist in this area during the period of significance (MIG, 2019).

*Evaluation: While the totem pole itself is contributing, its location is not.*

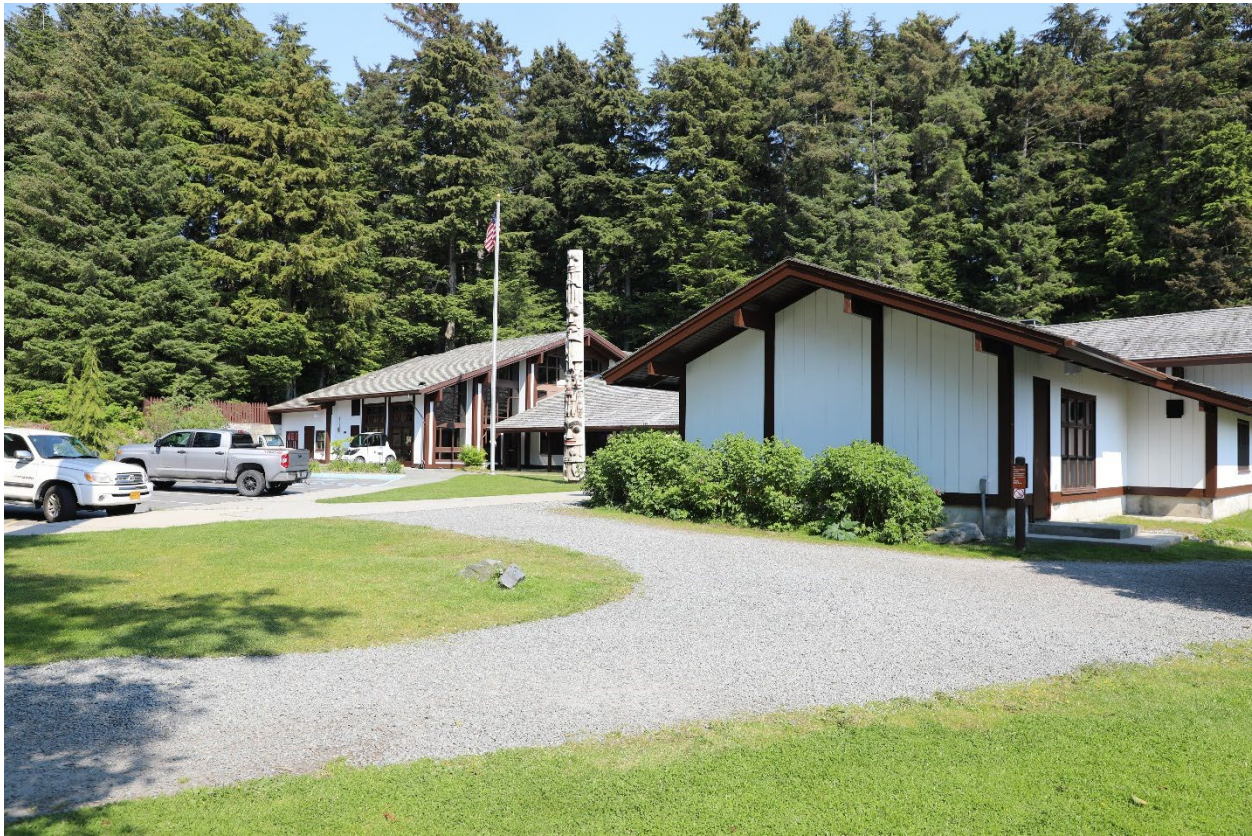
### Visitor Center

The Sitka National Historical Park Visitor Center has a primarily T-shaped plan set on a northeast southwest axis consisting of eight wings (lobby, exhibit hall, theater, cultural center, maintenance/storage addition, Totem Hall, outdoor totem storage addition, southeast addition). Four wings are original to the 1965 one-story building and a fifth, the maintenance/storage addition was designed by the original architect. The visitor center long axis is formed by the lobby (southwest portion) and the cultural center (northeast portion). The shorter axis of the T-shaped plan is formed by the theater (northwest) wing and the exhibit hall (southeast) wing. Although visitors enter the lobby via the northwest façade near the theater, the most visible façade faces Sitka Sound and is formed by the theater wing, the lobby, and the exhibit hall wing. In 1977, the fifth wing, a two-story maintenance shop and storage building, was constructed approximately 30 feet northeast of the visitor center. In 2000, the intervening space was enclosed with a sixth wing, the two-story Totem Hall. Simultaneously, a seventh wing was added to the rear (northeast) façade of the maintenance/storage building, a single-story outdoor totem shelter. A second southeast wing, located northeast of the museum wing and attached to the cultural center wing, was constructed in 2000, as the eighth and final wing (MIG, 2019).

*Evaluation: Contributing*

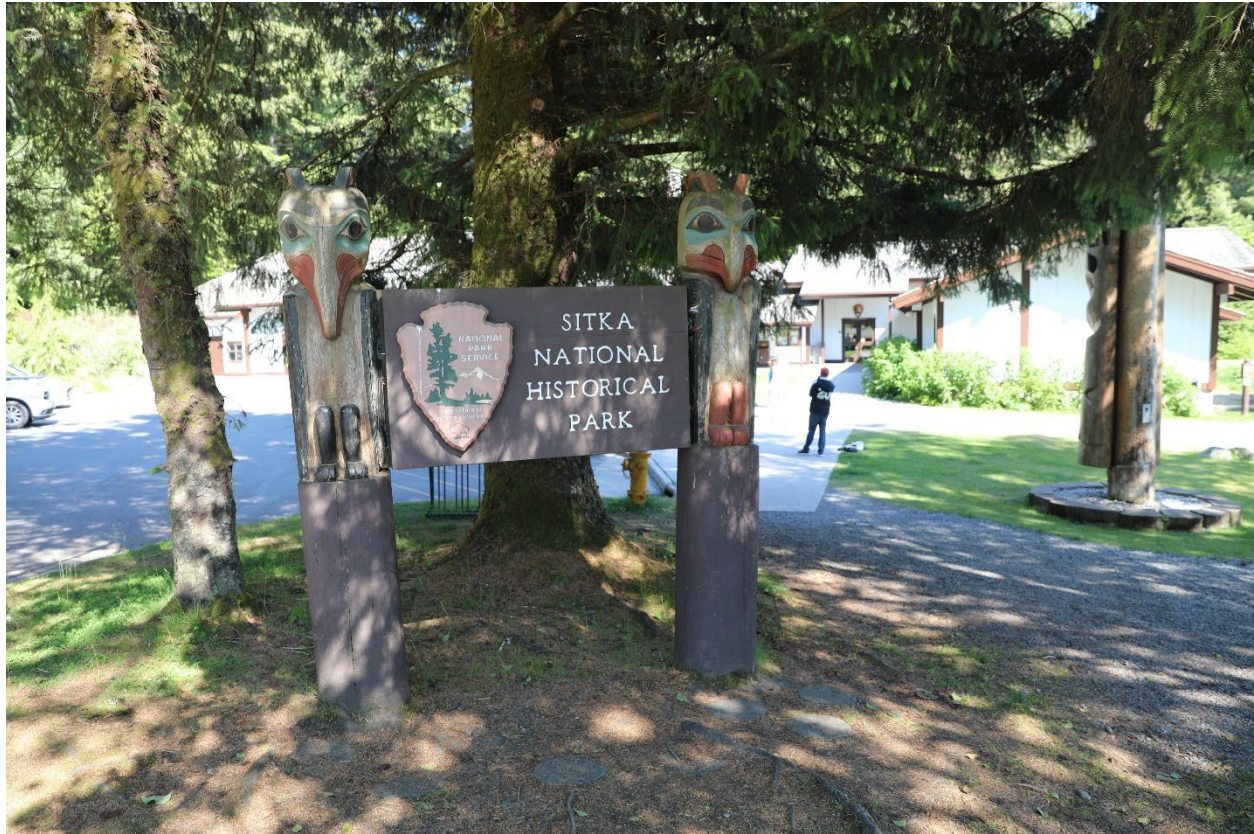
### Entrance Sign

Originally designed in the 1940s, the Entrance Sign was moved when with the construction in 1965 of the Lower Parking Lot. However, it has always been located at an angle near the entrance to the parking lot and facing towards the city center. During the 1965 construction the Entrance Sign was placed in a lawn area in between the primary vehicular and pedestrian entrance to the park where it remains. Sitka spruce were planted to the east of the sign to provide a backdrop. When the name of the park was changed in 1972 the sign was re-carved. Likely, the Raven and Eagle poles were also re-carved in the 1970s. However, the basic shape, form, and function of the sign and posts remains the same (MIG, 2019).

*Evaluation: Contributing*

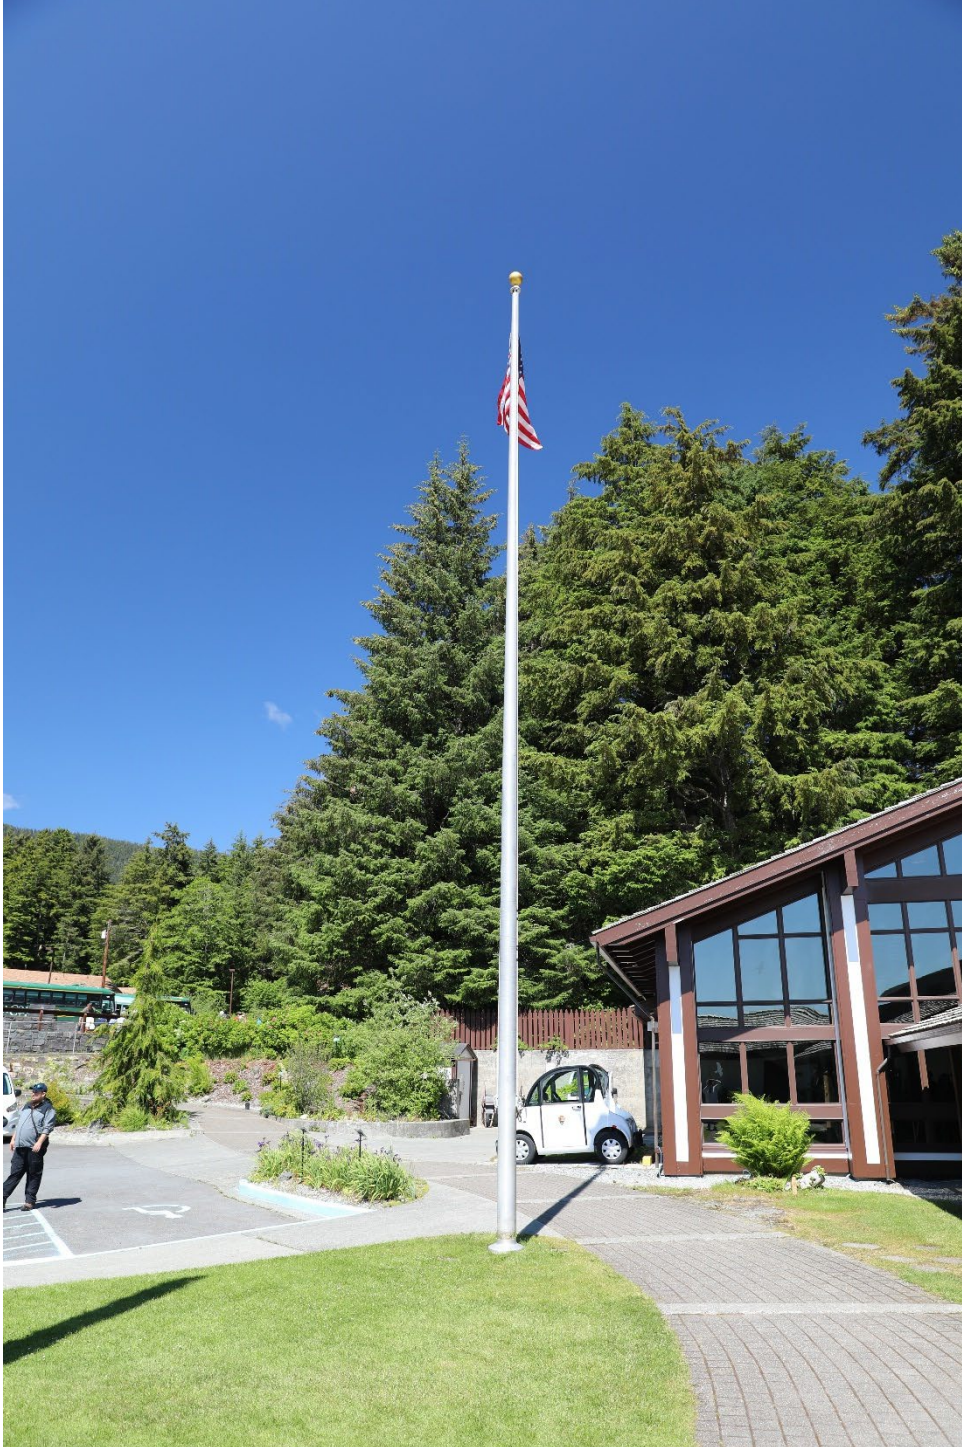
**Flagpole**

Originally installed within the northeast corner of the Entry Sidewalk, the Flagpole moved to the northern corner of the Triangular Lawn after the construction of the curvilinear walkway. Though it has been moved, it remains in the same general location in relationship to the Visitor Center and retains the same form and function (MIG, 2019).

*Evaluation: Contributing*

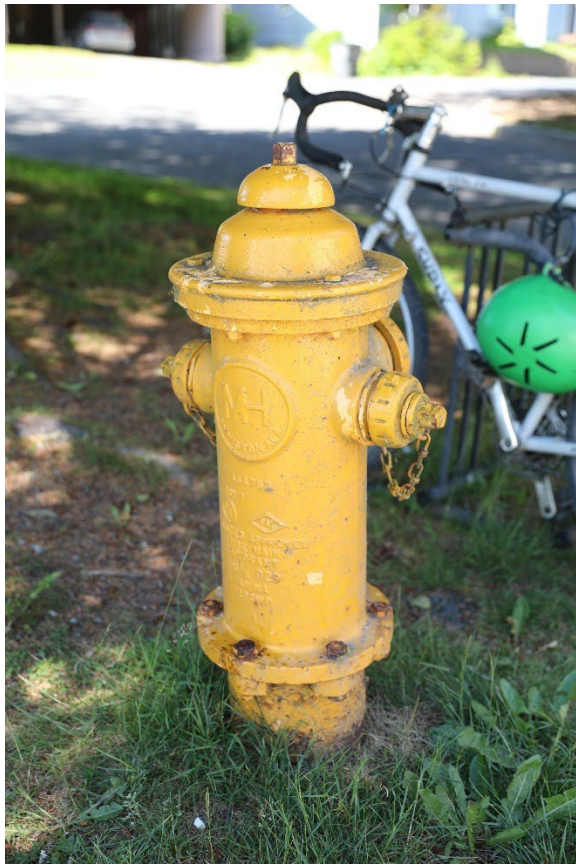
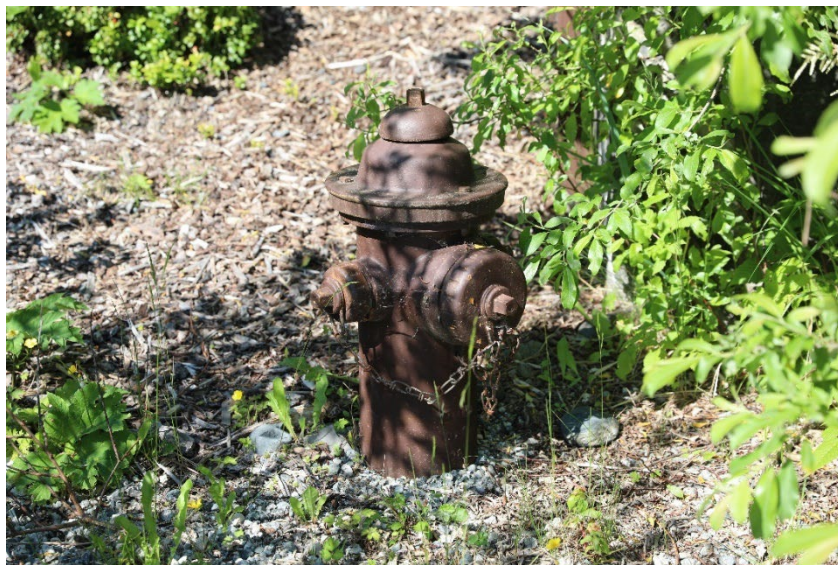
### **Fire Hydrants**

Since the initial design and construction, there have been two fire hydrants near the southwest corner and northeast corner of the Lower Parking Lot. The hydrant models have changed over the years, but the form and function remain in their original locations (MIG, 2019).

*Evaluation: Contributing*

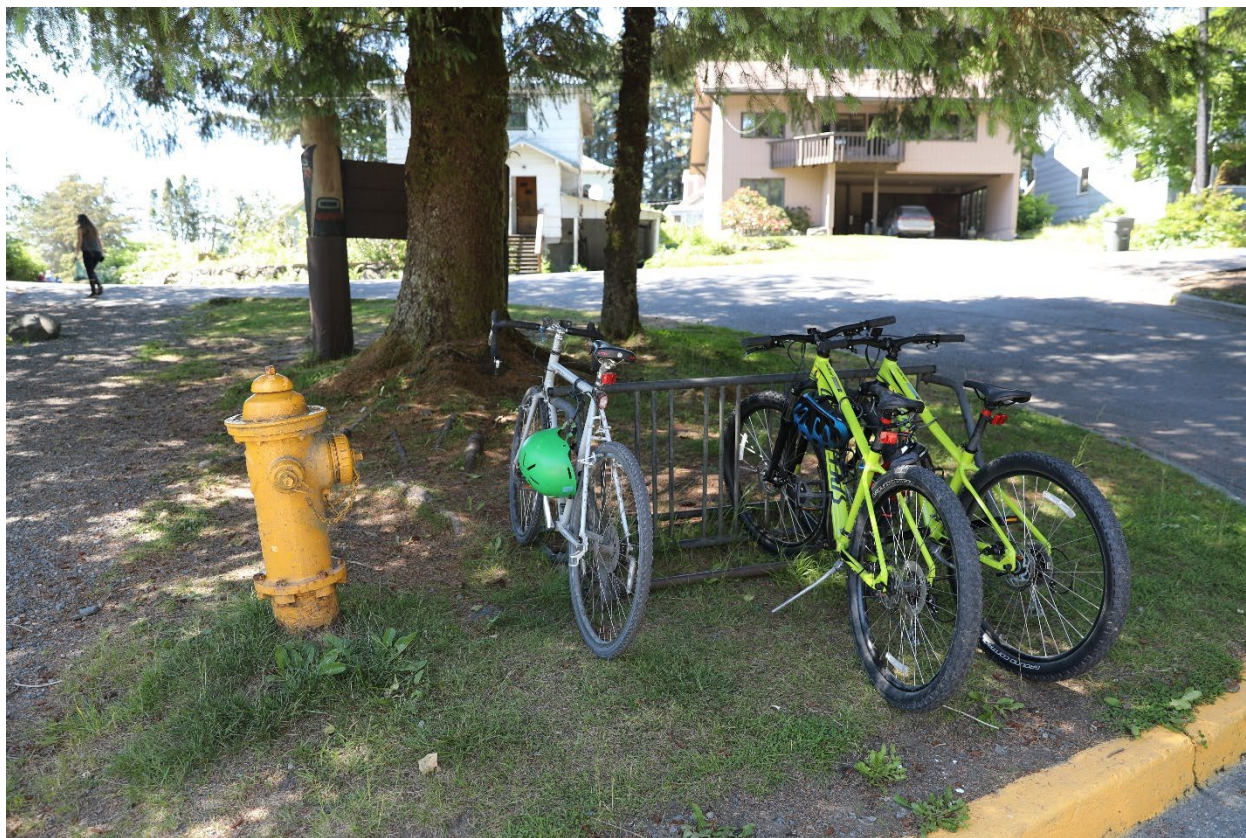
**Bike Rack**

A bike rack has been close to the southwest corner of the Lower Parking Lot since it was constructed in 1965. While the actual structure has changed, the location, form and function remain the same (MIG, 2019).

*Evaluation: Contributing*

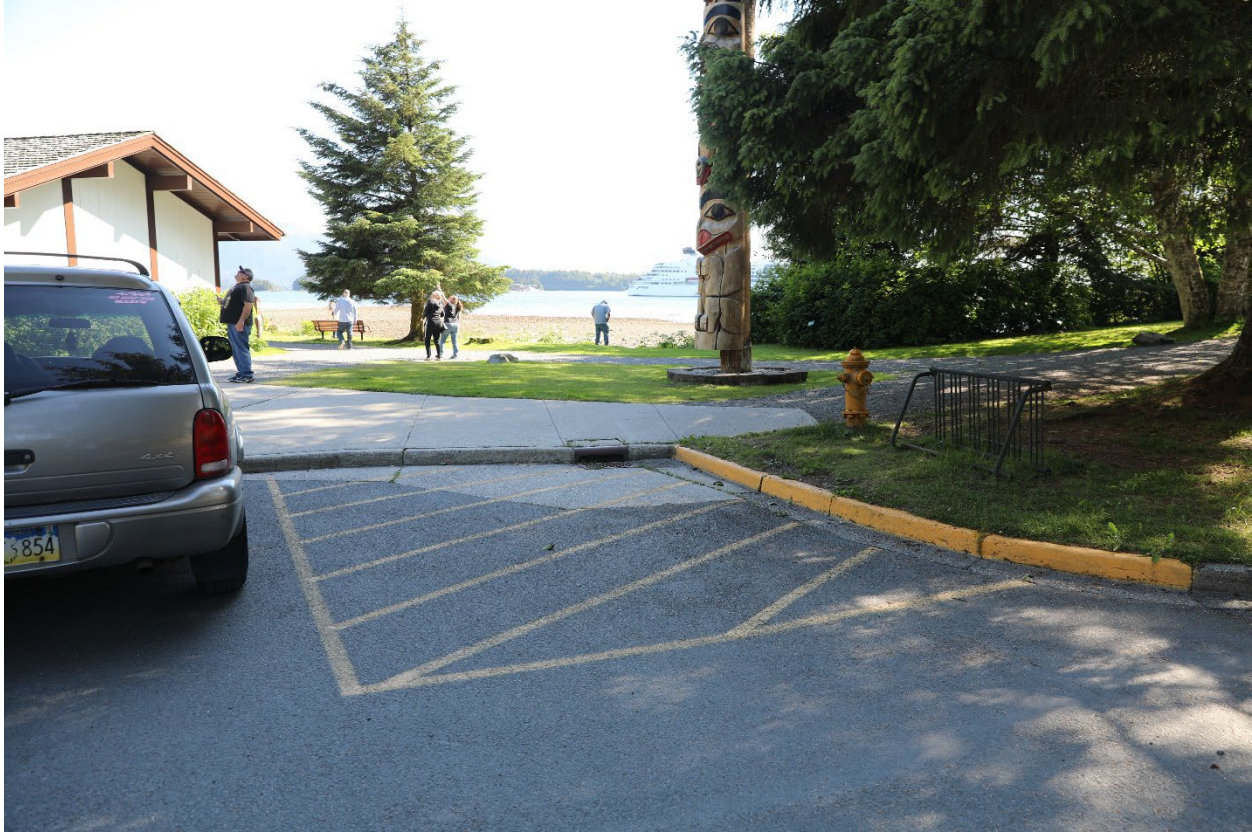
***Catch Basin***

Since the initial design and construction, there has been a catch basin in the southwest corner of the Lower Parking Lot. The catch basin has been updated since its original construction, but its location, form and function remain the same (MIG, 2019).
