National Park Service  
Cultural Landscape Inventory  
2020

Visitor Center  
Sitka National Historical Park

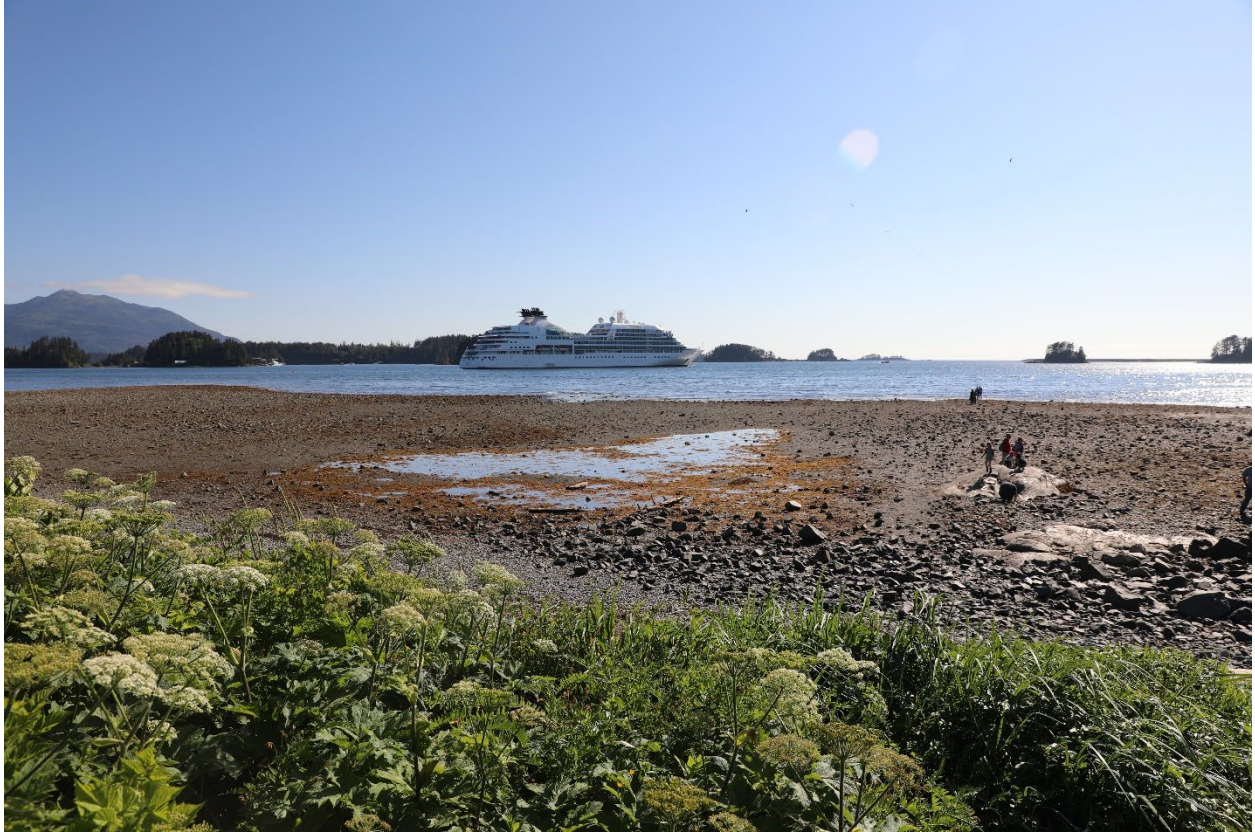
**View Towards Shoreline from Entry Sidewalk**

As visitors entered the Visitor Center site, this would be the first point they would have a more expansive view of Sitka Sound and the surrounding forests and mountains. At the beginning of the period of significance the inlet would have been in the foreground of this view, but that was filled in before the end of the period. However, several new additions to this area of the landscape are contributing to an altered viewshed. These include the Yaadaas Crest Pole, a Sitka spruce tree near the shoreline, the widened gravel paths, and site furnishings (MIG, 2019).

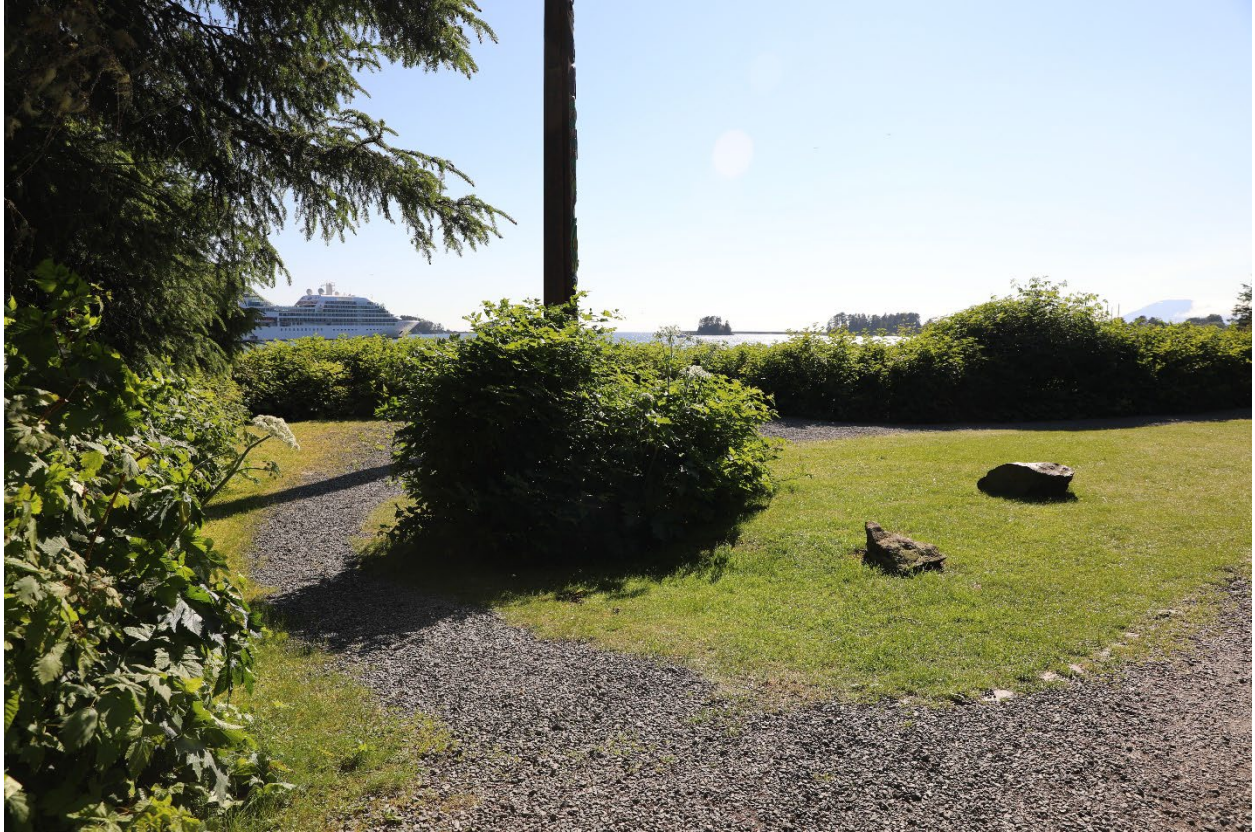
**View from Start of Totem Trail**

At the beginning of the totem trail, and surrounding lawn, visitors can view Mount Edgecumbe. Developments outside the park boundary have altered this view, as well as the clearing of vegetation for the Wooch Jin Dul Shat Kootteeya Pole, the placement of benches and picnic tables, and the widened gravel path (MIG, 2019).
