Stones River National Battlefield Cultural Landscape Report

March 2023

Cultural Landscape Report Update

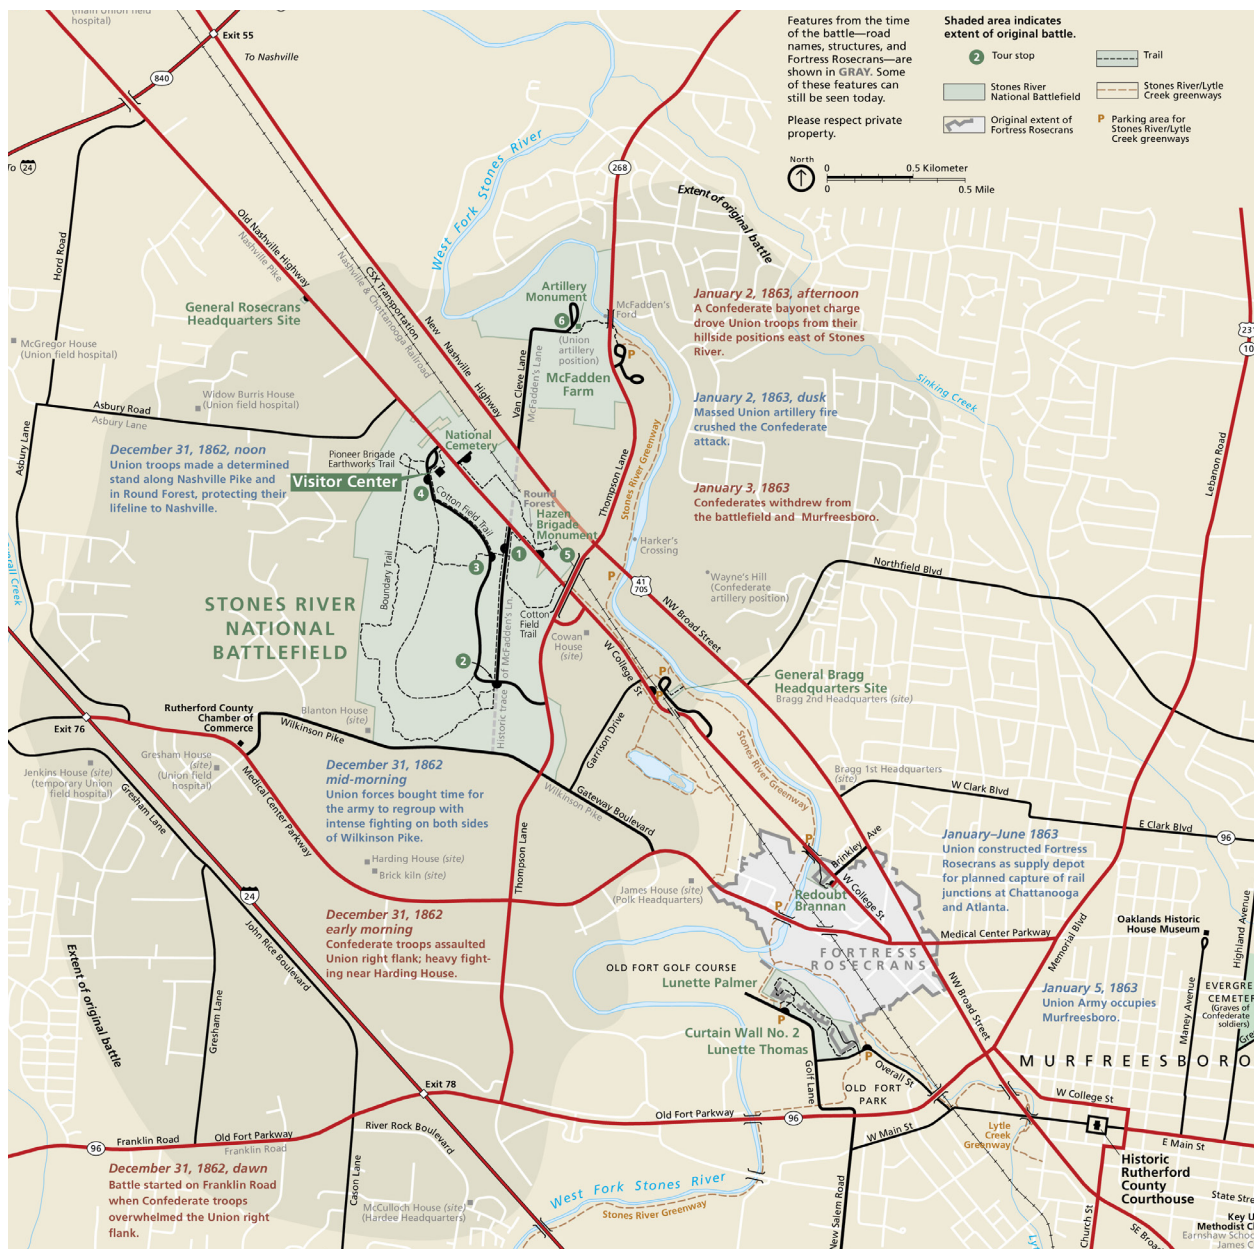
FIGURE 1–1. Stones River National Battlefield boundary and extent of historic battle ground (NPS).

For the purpose of this cultural landscape report, landscape character areas (LCA) are used to further define the landscapes within the study area (see Figure 1–1 and drawing EC-1 in Chapter 3). Landscape character areas are places that contain similar physical characteristics, qualities, attributes, and associated cultural landscape resources. Within this CLR, each unit of the park corresponds to an LCA:

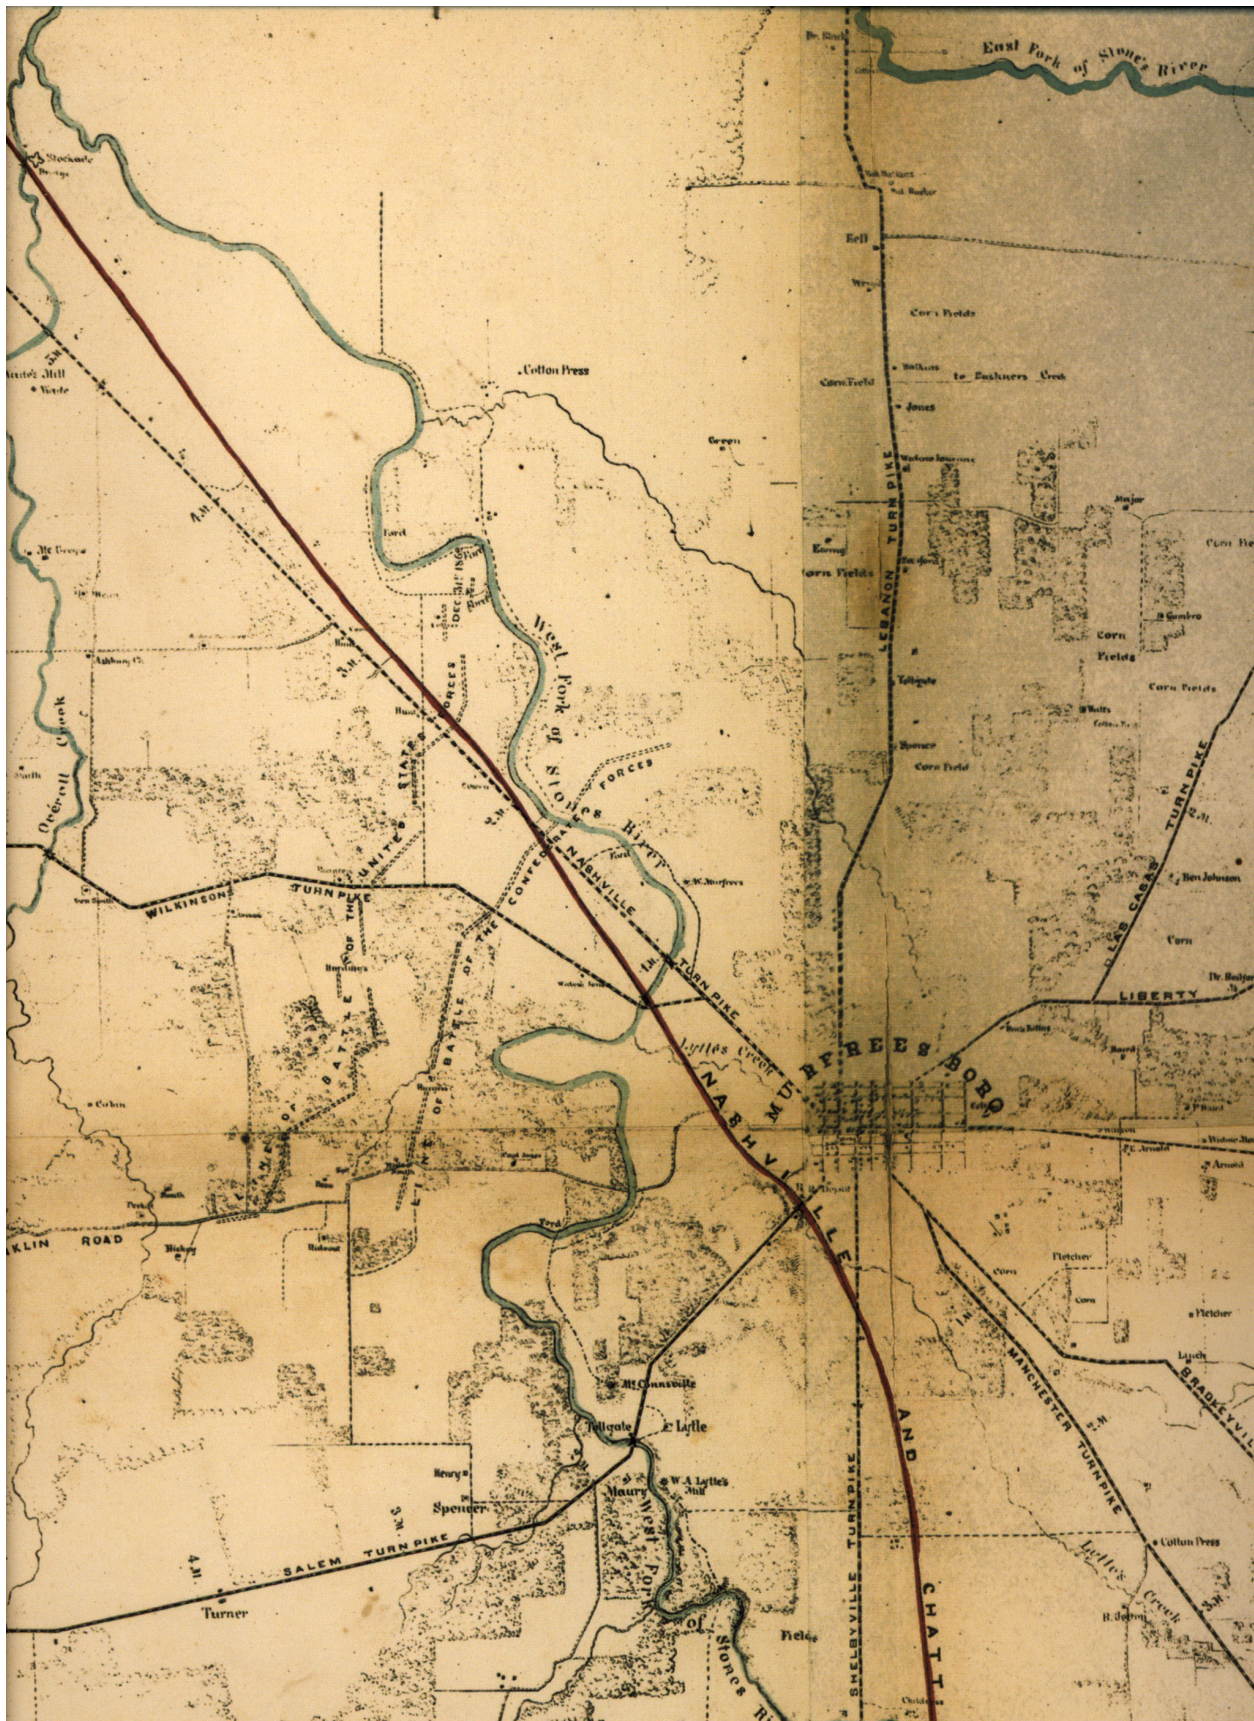
FIGURE 2-6. Detail of "Topographical sketch of the environs of Murfreesboro, Tennessee. Surveyed Jan. 1863 under the direction of Capt. N. Michler, USA, Chief Topl. Engr., Army of the Cumberland, by Maj. John E. Weyss..." (Library of Congress).

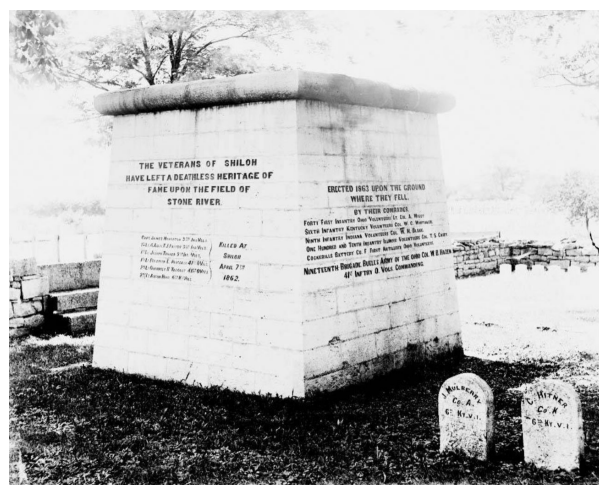
FIGURE 2-12. Hazen Brigade Monument, ca. 1900 (Kern Collection, Montgomery (Ohio) County Historical Society).

The Hazen Brigade Monument (Figure 2-12) consisted of an eleven-foot-tall, square, limestone mass. The monument and adjacent cemetery were enclosed by a four-foot-tall dry-laid stone wall, with access through three steps on the south side. In November 1863, the 115th Ohio Regiment was transferred to Murfreesboro. Two experienced stonecutters from the regiment, Sergeant Daniel C. Miller and Private Christian Bauhoff, were employed to inscribe the monument during the spring of 1864.⁴⁹ By June 1863, General Rosecrans

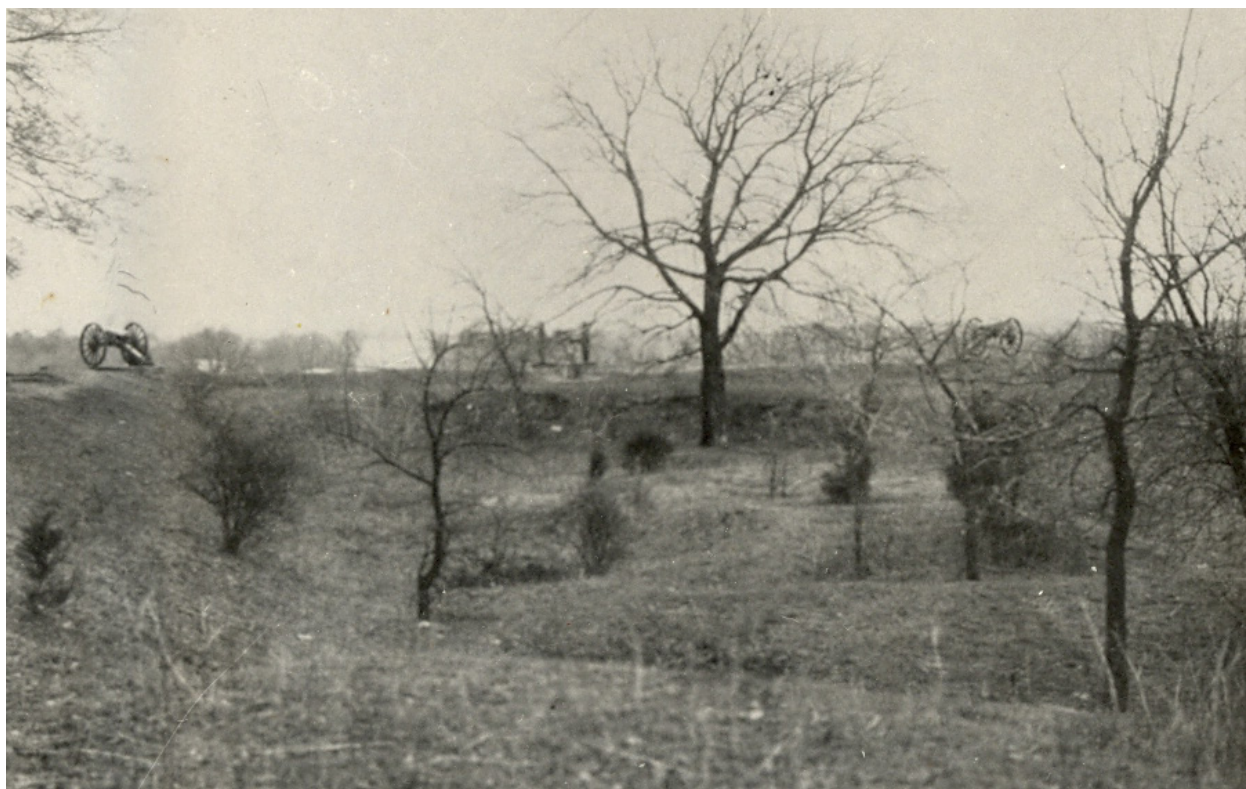
FIGURE 2–24. Gun carriages on Redoubt Brannan, 1928 (Willett “A History of Stones River National Military Park,” 1958).

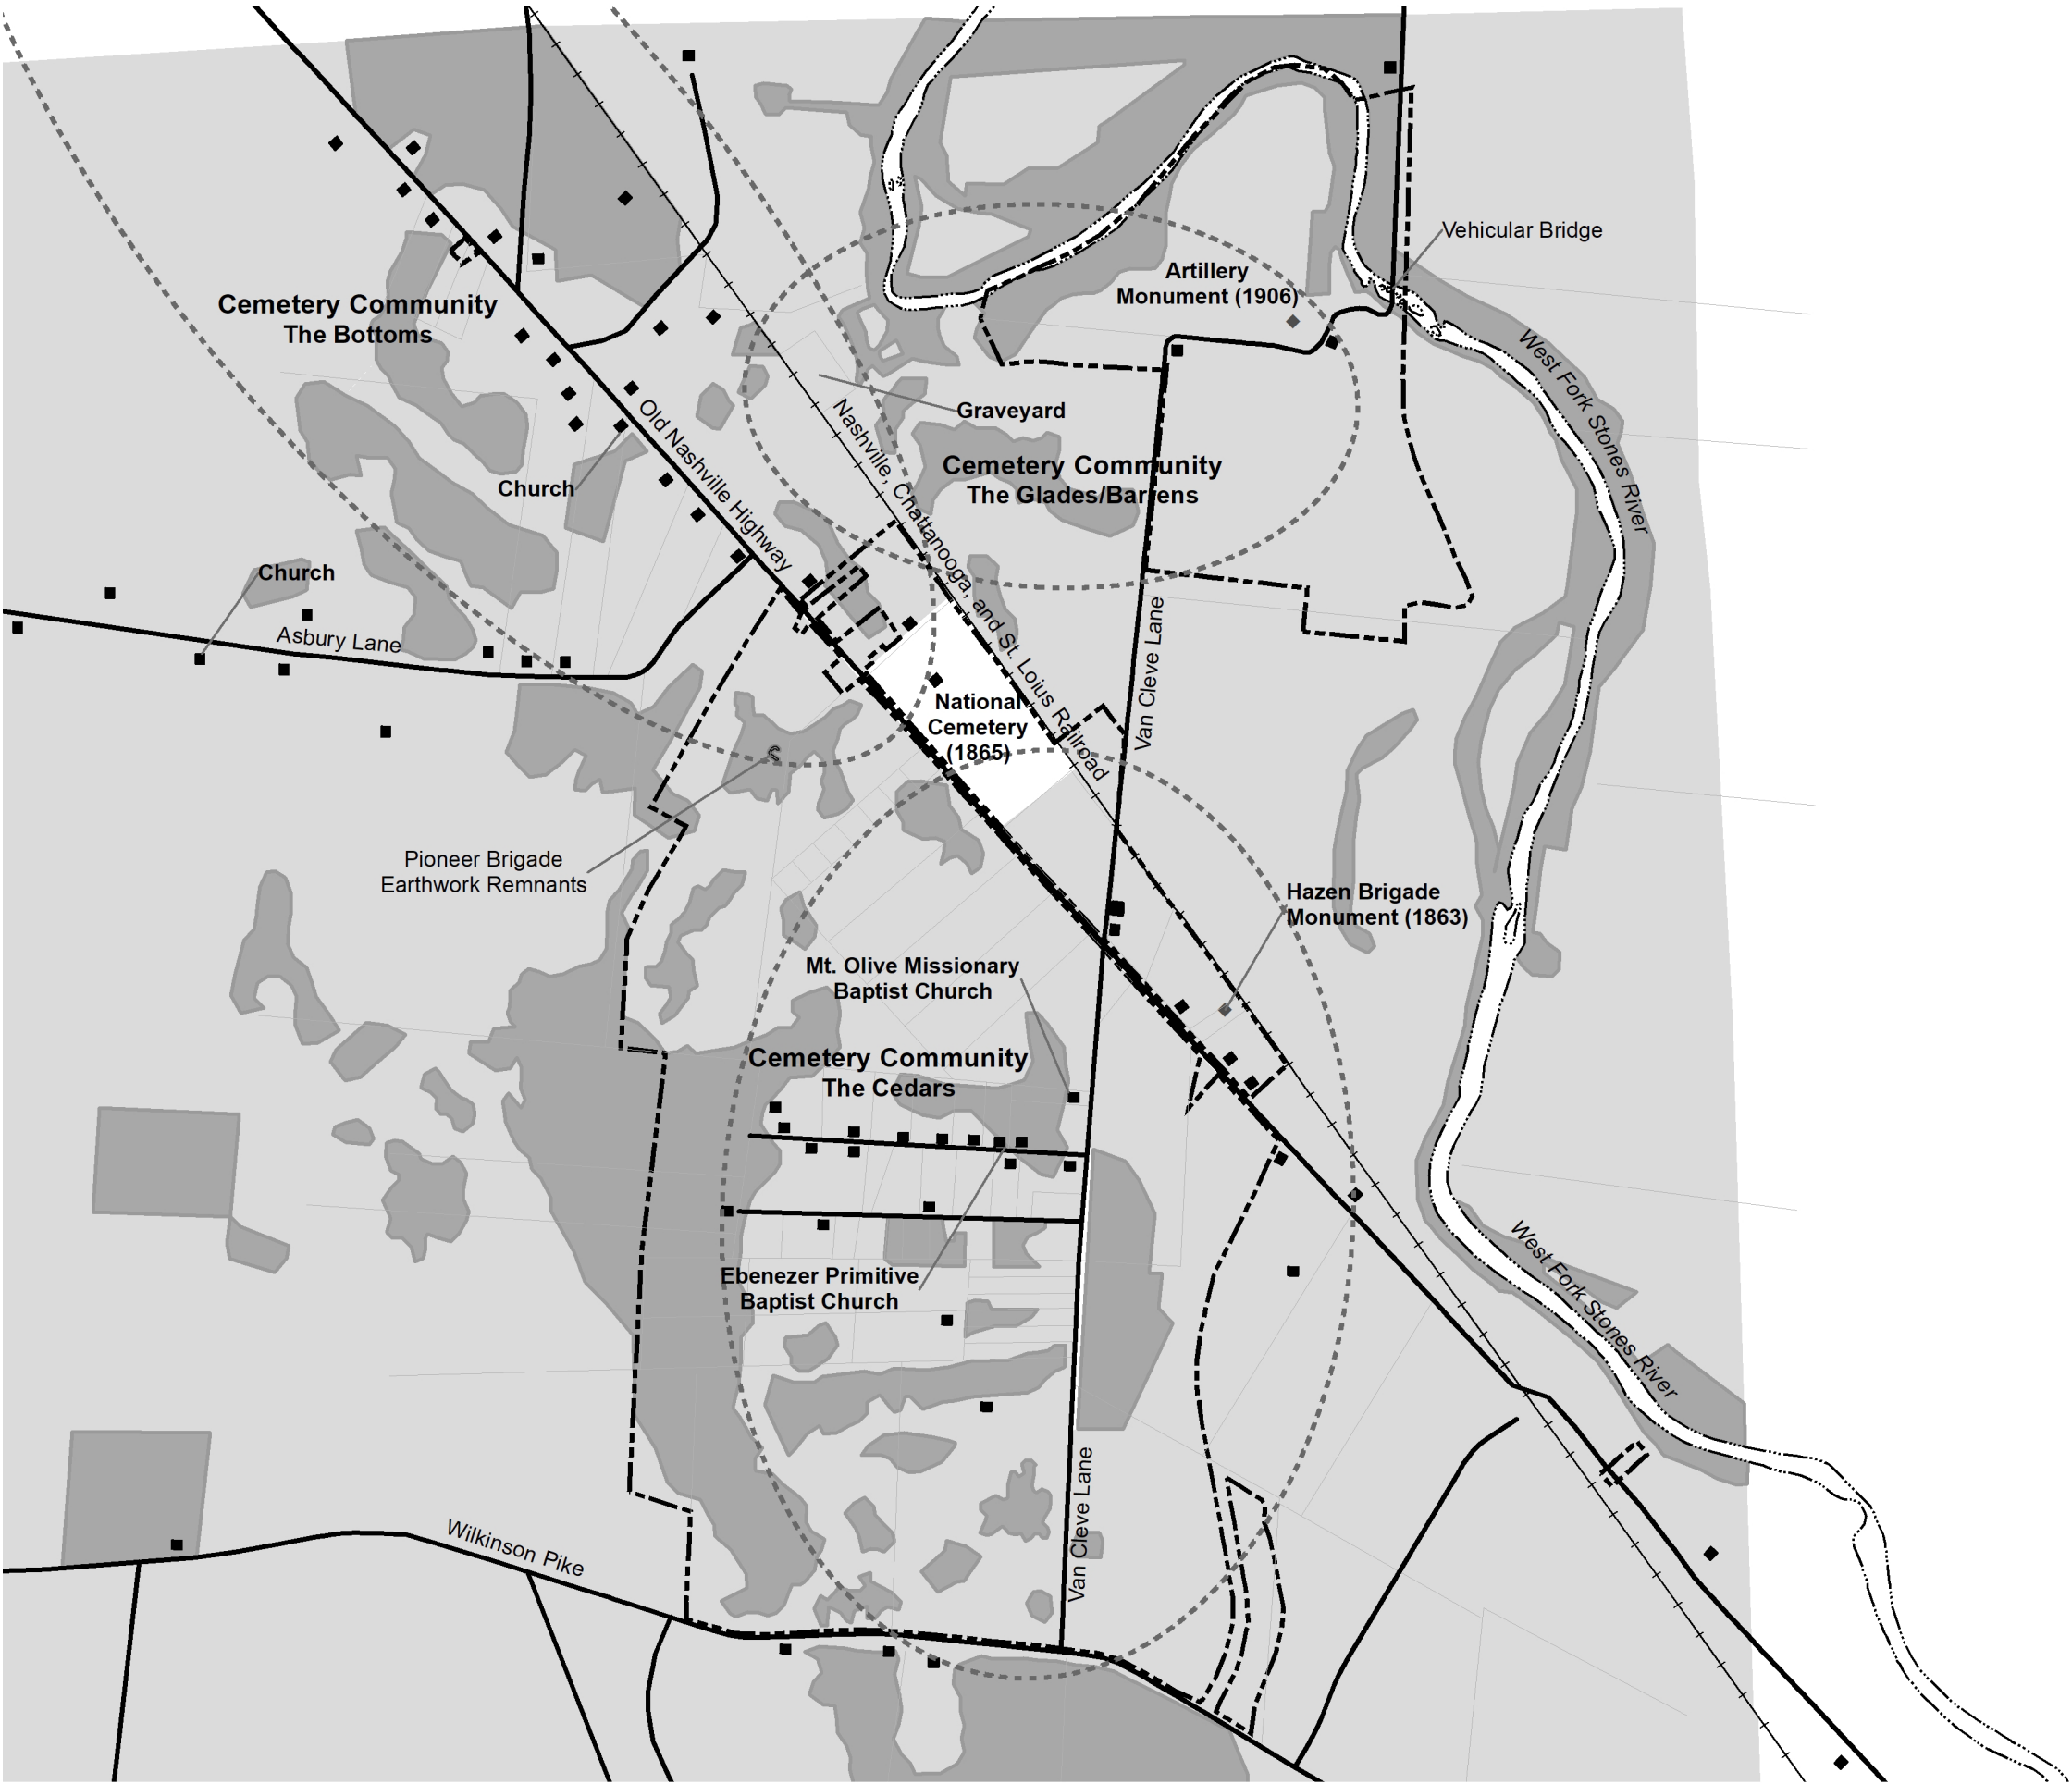
**Stones River National Battlefield
Historic Period Plan: 1863-1927**

Landscape conditions from 1863–1927 are illustrated on drawing HP-3.

Other post-battle additions to the landscape included the Hazen Brigade Monument, completed in 1863; the National Cemetery, completed in 1865; the US Regulars Monument in 1882 (within the cemetery); and the Artillery Monument, placed in 1906. Commemoration of the Battle of Stones River most likely led to an increase in visitors to the region, including veterans and the families of those buried in the cemetery.

The Nashville Pike (Old Nashville Highway) and the Nashville, Chattanooga, & St. Louis Railroad remained the primary routes of circulation during this period.

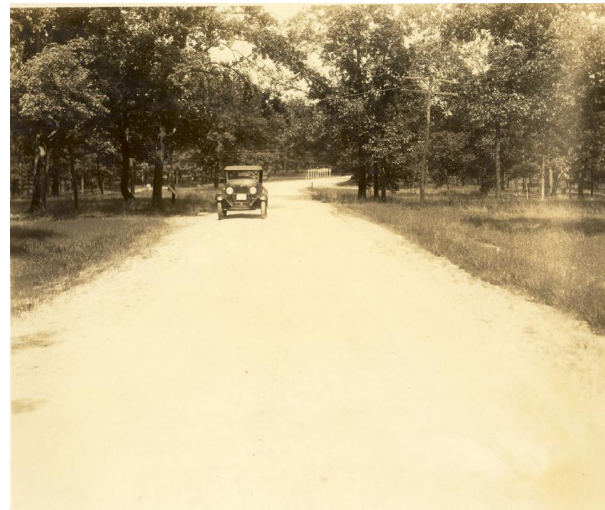
FIGURE 2–35. Widened and graveled road within the park, ca. 1930s (Stones River National Battlefield 8x10p-0031).

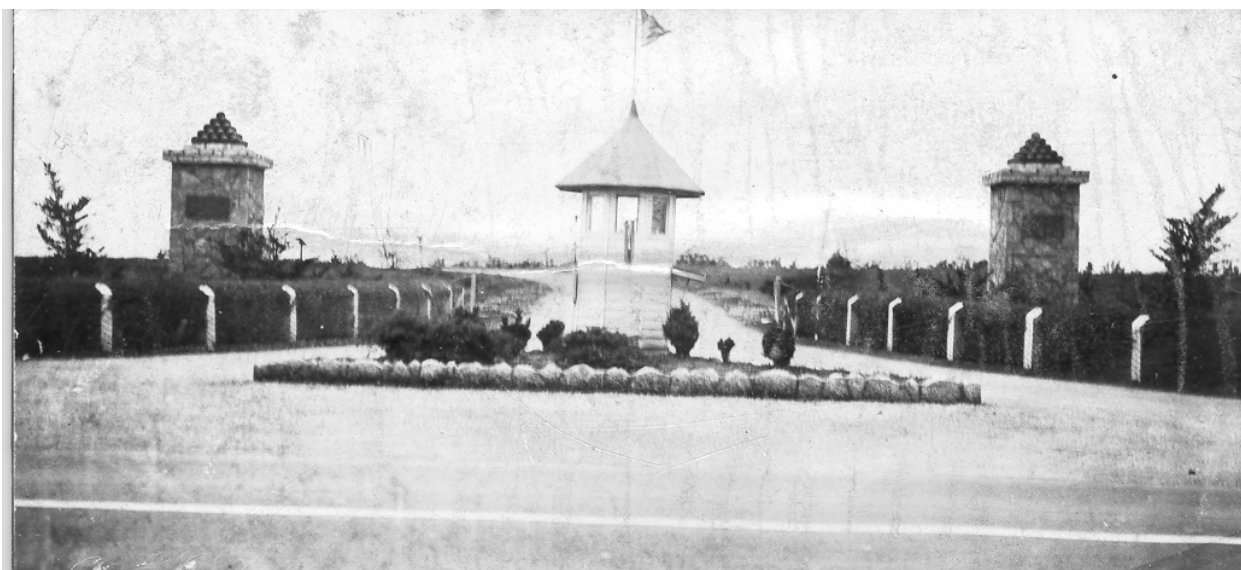
FIGURE 2–36. Main entrance gate and kiosk, ca. 1930s (Stones River National Battlefield Central Files).

Lane. Both entrances were marked with stone pillars that were built by a local Black stone mason, Herbert Smith. He was later hired to create entrances at the national parks at Fort Donelson and Shiloh.¹⁰³ The loop Tour Road had a wide curve radius at the point where it intersected with the Nashville Pike that formed a triangular apron. This was flanked by low, white-painted wood posts and evergreen hedges. Behind the hedges were planted maple trees, roses, white spirea, and tall evergreen shrubs. At the center of the apron was a triangular traffic island in which was set a wood-framed octagonal kiosk (Figure 2–36). Three cannon from Redoubt Brannan and a flagpole were placed adjacent to the west gate. The secondary entrance gates were similar but had no center island (Figure 2–37). The entrance gates were

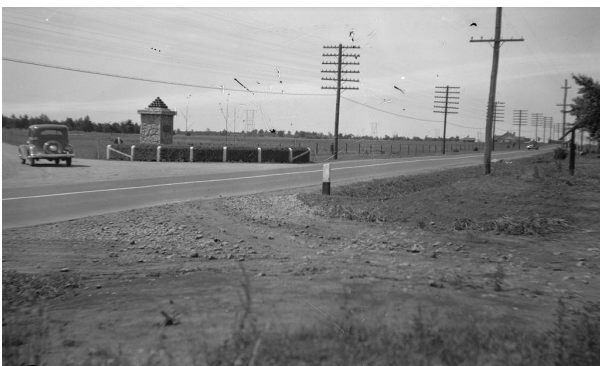
FIGURE 2–37. Secondary entrance, ca. 1930s (Stones River National Battlefield NN-0095).

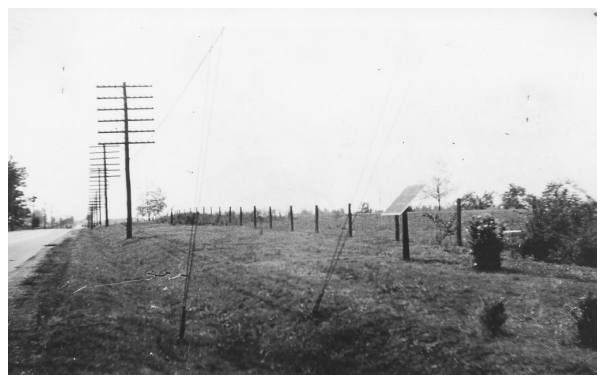
FIGURE 2–40. Nashville Pike CWA erosion control and regrading, ca. 1930s (Stones River National Battlefield Central Files 611).

eroded meadowland in the park were regraded and reseeded, and a culvert was installed at the north entrance of the cemetery (Figure 2–40). The Tour Road and Nashville Pike were also regraded.¹¹⁰

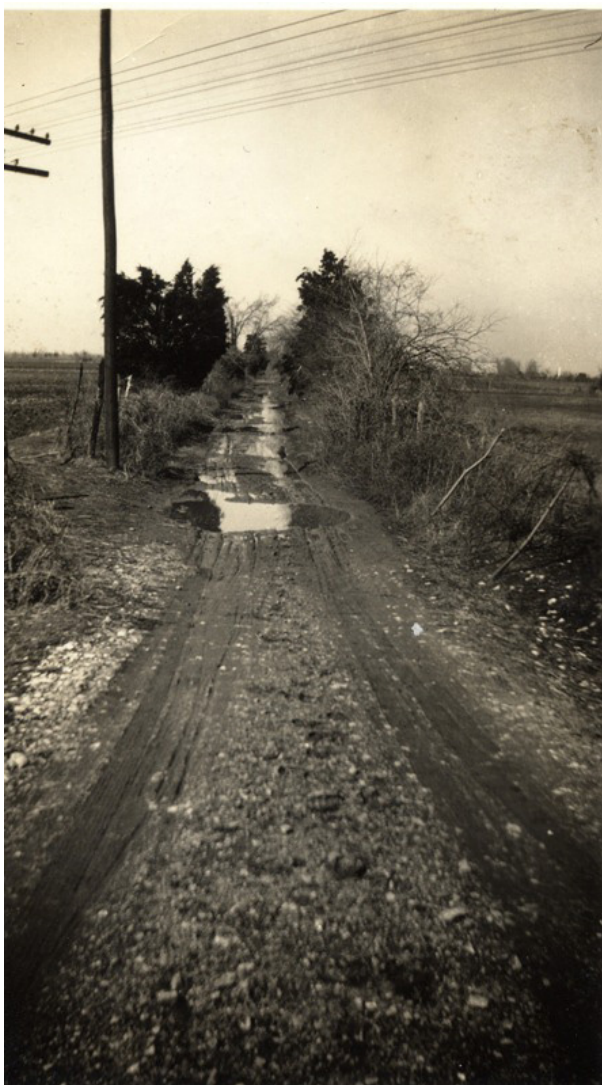
FIGURE 2-43. Condition of Van Cleve Land north of the railroad tracks prior to WPA rehabilitation, ca. 1934 (Stones River National Battlefield ICP-0464).

The last New Deal-era projects at Stones River involved the rehabilitation of the road system. A report on the condition of the roads in 1935 had noted that the park roads had not been maintained since their completion in 1931 and Van Cleve Lane, which was still dirt, was in very poor condition (Figure 2-43).¹¹⁵ The federal government appropriated \$4,250 to install a new six-inch water-bound macadam base with bituminous surface treatment over the existing roads. At the same time, Van Cleve Lane was widened to 16 feet.¹¹⁶ The same year, the NPS designed and installed four trailside interpretive markers at the Hazen Brigade Monument, the intersection of Van Cleve Lane and the park road, near the flagpole, and at a place in the National Cemetery that had a view to the Artillery Monument. The park also created a self-guided tour route of the battlefield (Figure 2-44).¹¹⁷

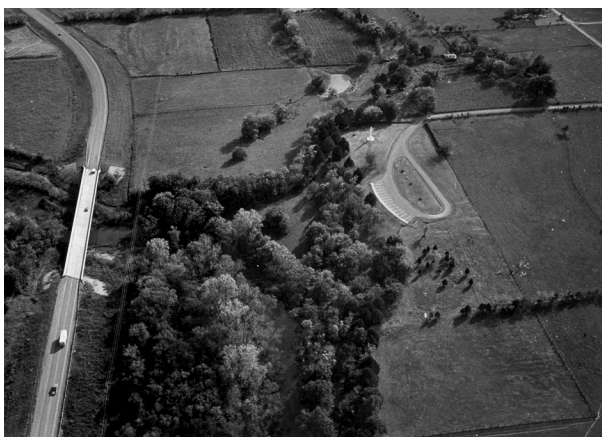
FIGURE 2-53. McFadden Farm Unit, new loop road and parking lot, ca. 1960s (Stones River National Battlefield, Central Files 008).

a fifteen-car parking lot, concrete sidewalks, and replica cannons (Figure 2-53). The site was lined by trees on the east and south sides and open fields on the west and north.¹³⁴

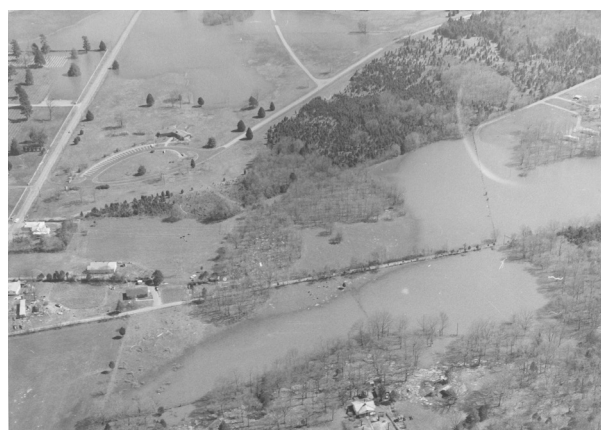
FIGURE 2–56. Aerial view of flooding at the Nashville Pike Unit (visitor center at top left), ca. 1970s (Stones River National Battlefield, Central Files 168).

Environmental issues led to several erosion control projects during the 1970s. To address flooding at the Nashville Pike Unit (Figure 2–56), in 1975 the NPS built a drainage swale two feet deep from the battlefield to the western boundary of the park (Figure 2–57). At the same time, Rutherford County constructed culverts under Old Nashville Highway and Asbury Lane to drain water to the Stones River. This did not, however, solve the issue of flooding on the battlefield and neighborhood properties. The same year at the McFadden Farm Unit, a new sewer inceptor was installed, both banks of the river were stripped of vegetation, and other vegetation was cleared to improve the historic viewshed. The following year, a native

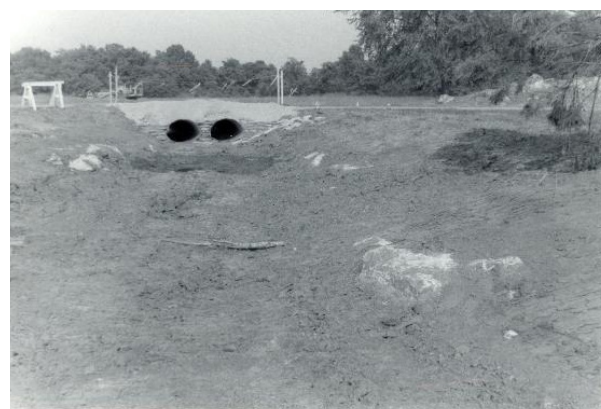
FIGURE 2–57. Drainage swale and culvert, 1975 (Stones River National Battlefield, ICP-0083).

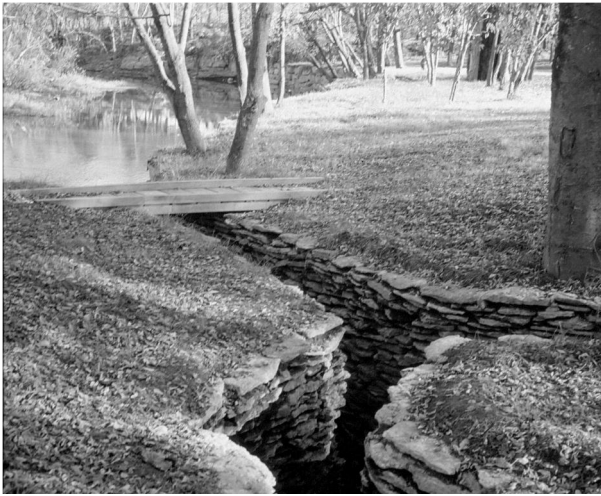
FIGURE 2-58. Limestone retaining wall at McFadden Farm Unit, ca. 1970s (Stones River National Battlefield, ICP-0083).

limestone retaining wall was constructed on the west bank of the Stones River to prevent erosion and the spring was also lined with stone (Figure 2-58).¹⁴²

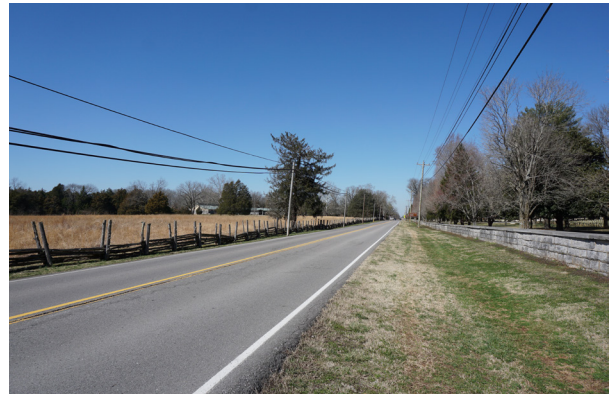
FIGURE 3-12. Old Nashville Highway (QE, 2021)

Where Old Nashville Highway passes through the Nashville Pike Unit, the pavement is approximately 21'-6" wide with a 14' right-of-way on either side (see Figure 3-12). Utility poles and overhead lines run within the right-of-way on both sides of the road, along with various wood fences associated with known historic fencelines. The width and alignment of West College Street are variable as the road shifts to intersect with the railroad, West

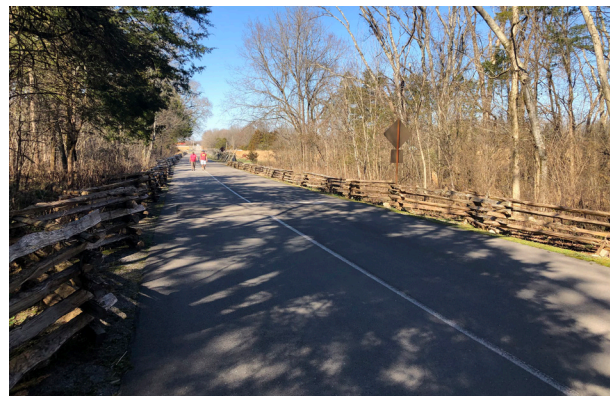
FIGURE 3-13. Van Cleve Lane looking north toward Old Nashville Highway (QE, 2021)

Within the Nashville Pike Unit, Van Cleve Lane functions as part of the one-way, single-lane Tour Road and as an asphalt-paved trail route (see Figure 3-13). The portions of Van Cleve Lane south of Old Nashville Highway are in good condition. Between Old Nashville Highway and the CSX Railroad, Van Cleve Lane is a poor-condition asphalt road functioning as a maintenance route and as part of the Round Forest Trail.

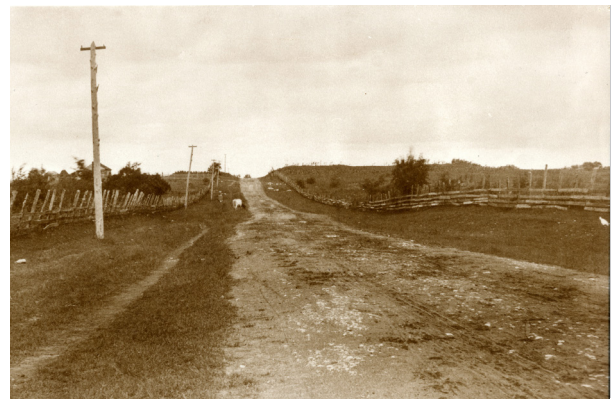
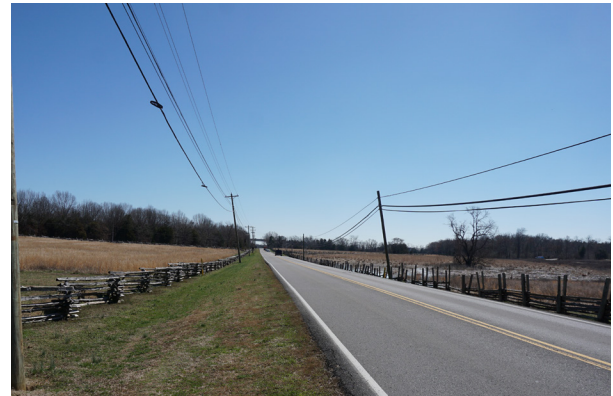
FIGURE 3–16. Where Old Nashville Highway (Nashville Pike) extends through the Nashville Pike Unit, it retains a similar alignment and much of its surrounding setting from the period of significance, despite changes to the surface material and grade. Top, Nashville Pike, 1884 (Stones River National Battlefield). Bottom, similar view, Old Nashville Highway (QE, 2021).

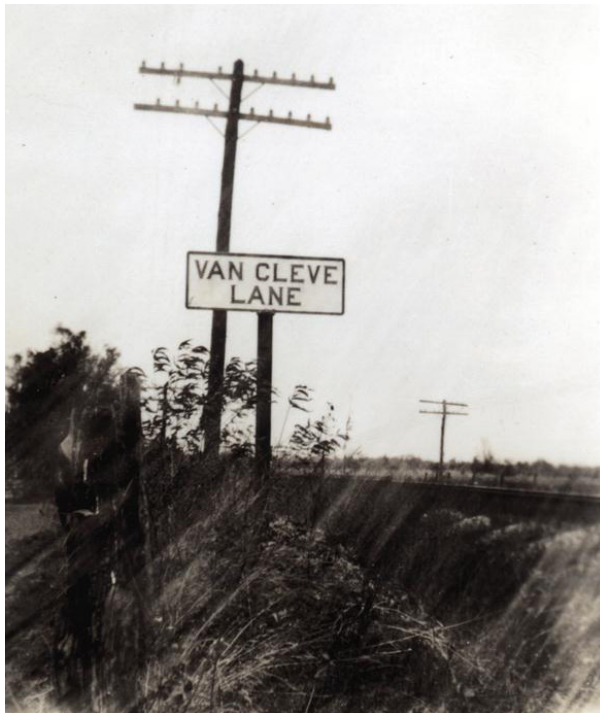
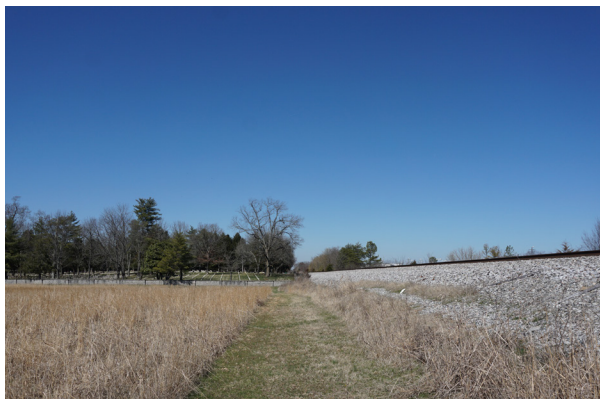
FIGURE 3–17. In the early 1900s, the Nashville, Chattanooga, and St. Louis Railway maintained signs of battlefield points of interest along the railway. While these commemorative features are no longer present, the railway follows its historic alignment through the park. Top, Van Cleve Lane sign along railroad, ca. 1920s–1930s (Stones River National Battlefield). Bottom, similar view along CSX Railroad (QE, 2021).

The existing CSX Railroad line follows the same horizontal alignment as the Nashville and Chattanooga Railroad, which opened for passengers and freight in 1851 and was targeted by both armies as a key circulation route during the Battle of Stones River. The railroad company also incorporated early commemorative and interpretive signage along the rail route (see Figure 3–17). The rail line remains in use for freight transport, but a commemorative

passenger experience is no longer implemented in the landscape. Since the end of the period of significance, the railbed has been elevated to accommodate bridge crossings and the wood ties replaced with modern materials.

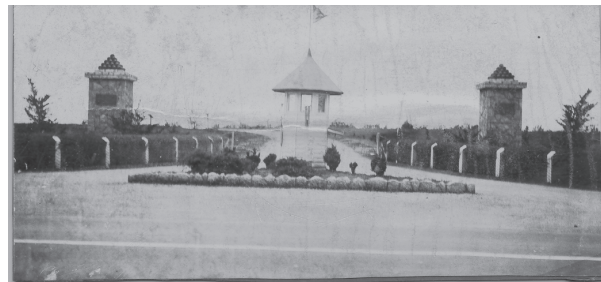
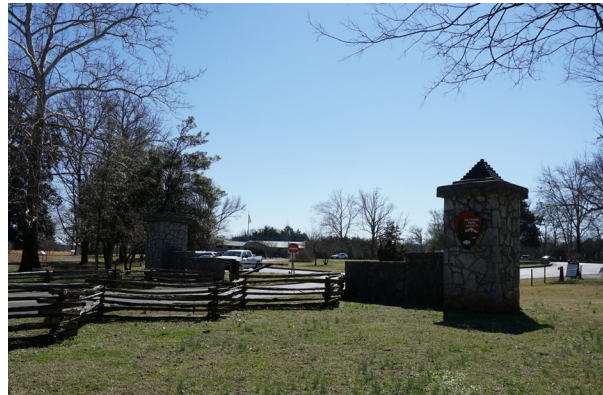
FIGURE 3–20. The Old Nashville Highway entrance gate is one of the few remaining structures from early park development. Since their original construction, the ranger contact station between the gates has been removed. Top, entrance gates and ranger station, 1930s (Stones River National Battlefield). Bottom, similar view, entrance gates (QE, 2021).

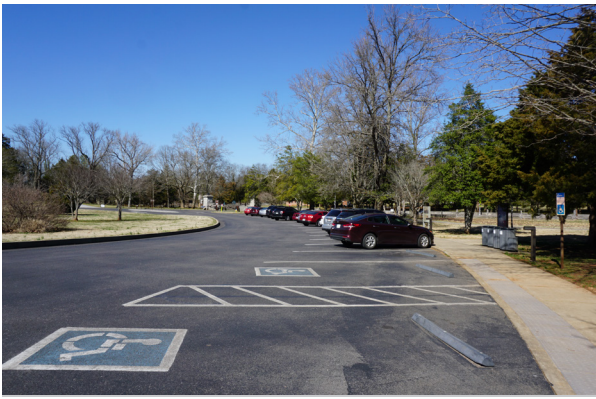
FIGURE 3-32. Visitor center parking area (QE, 2021)

Visitors access the character area via the visitor center parking area or Tour Road. The visitor center parking area is immediately south of Old Nashville Highway and consists of 35 standard and 2 handicap parking spaces spaced along the edges of a one-way loop road (see Figure 3–32). The parking area is in good condition.

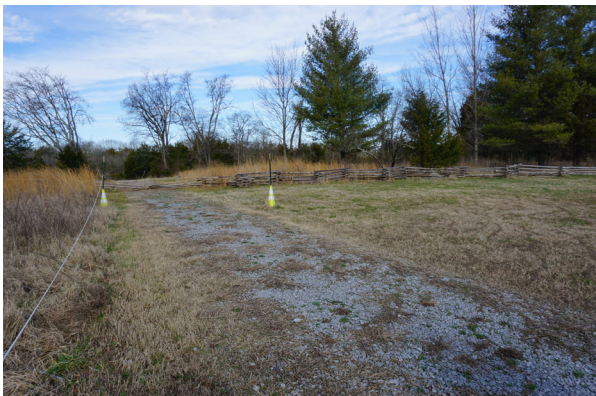
FIGURE 3-33. Overflow parking and gravel road west of the visitor center (QE, 2021)

Overflow parking is directed along an east–west gravel road connecting between the north end of the visitor center parking area and Nickens Lane (see Figure 3–33). Portions of the gravel maintenance road are overgrown with herbaceous vegetation; it is in fair to poor condition. Overflow parking is necessary to accommodate large numbers of recreational users on fair weather weekends in addition to events. When overflow parking is required, NPS directs vehicles to informal spaces within mown fields north of the Pioneer Brigade Earthworks.

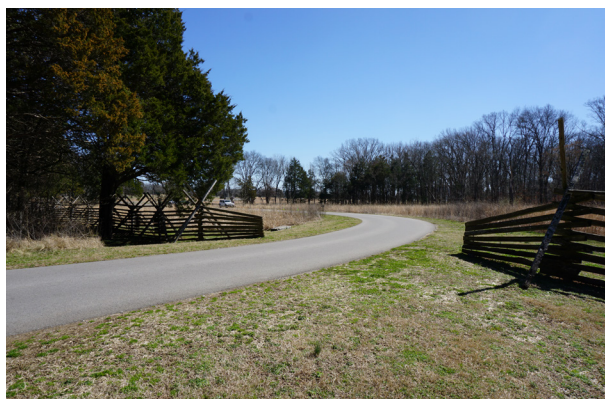
FIGURE 3–34. Tour Road (QE, 2021)

The Tour Road is a single-lane, asphalt-paved road with small parking areas to accommodate vehicles at tour stops (see Figure 3-34 and Figure 3-35). Gravel shoulders stabilize the road edge in locations where overflow parking smothered vegetation and eroded soil (see Figure 3-36). Where Van Cleve Lane is incorporated into the Tour Road, it is a one-way route with a wide shoulder for parking. Portions of the Tour Road, particularly along Van Cleve Lane, are shared with pedestrian traffic. The Tour Road is in good condition.

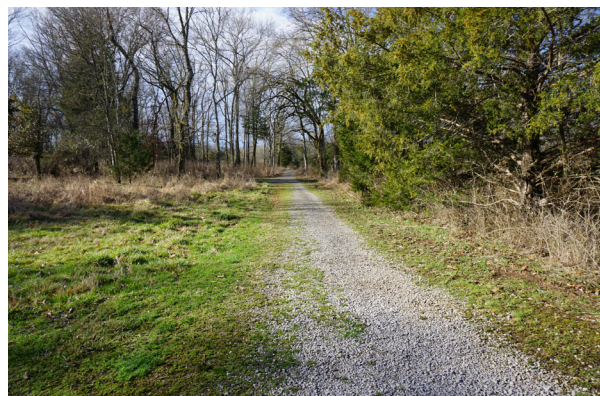
FIGURE 3–37. Nickens Lane (QE, 2021)

Nickens Lane is a northeast–southwest-oriented gravel road near the western boundary of the character area (see Figure 3-37). It is currently used as a NPS maintenance route. South of the Pioneer Earthworks, Nickens Lane curves southeast to meet the Boundary Trail. The road is in good to fair condition.

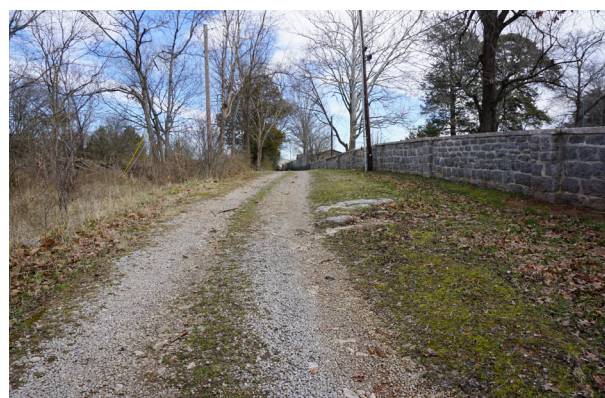
FIGURE 3–38. Maintenance road (QE, 2021)

Another gravel maintenance road extends along the western edge of the National Cemetery between Old Nashville Highway and the maintenance area (see Figure 3-38). The road is in good to fair condition.

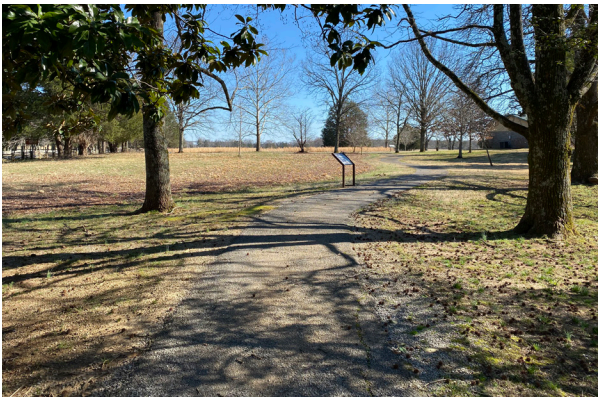
FIGURE 3-40. Interpretive trail adjacent to visitor center (QE, 2021)

Concrete sidewalks connect between the parking area and the visitor center. To the north and east of the visitor center is a short, asphalt-and-gravel interpretive trail accessing several waysides and viewpoints (see Figure 3-40). Both the sidewalks and trail are in good condition.

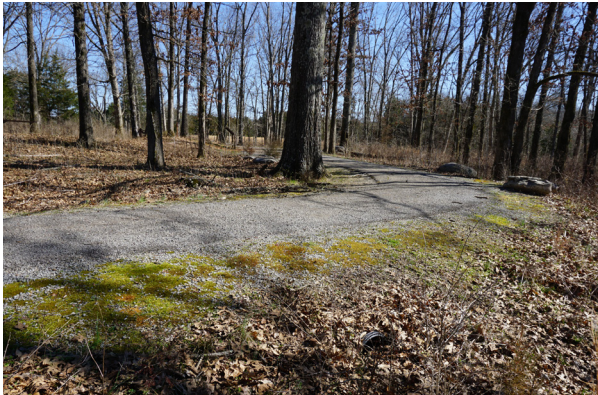
FIGURE 3-41. Pioneer Brigade Earthworks trail (QE, 2021)

A 0.25-mile asphalt and aggregate trail loops from visitor center parking area around the Pioneer Brigade Earthworks (see Figure 3-41). The trail is in good condition.

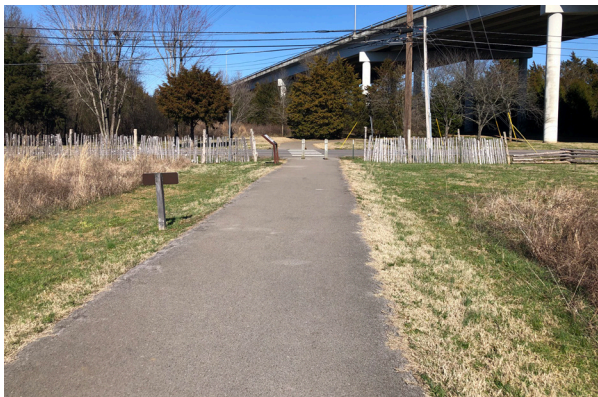
FIGURE 3-42. Cotton Field Trail (QE, 2021)

The Cotton Field Trail (1998–1999) extends from the visitor center along the north side of the Tour Road (see Figure 3-42). Near the first tour stop, the trail crosses Van Cleve Lane, then continues to the east across a broad field, connecting with the Stones River Greenway near the Thompson Lane bridge. The trail surface is asphalt and aggregate. It exhibits minor cracking and loss of surface material and is in good to fair condition.

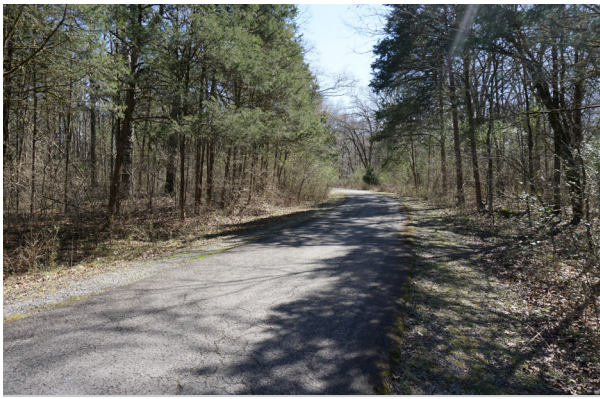
FIGURE 3-43. Old Tour Road Trail (QE, 2021)

The Old Tour Road Trail (1963) follows the western leg of the original tour road between the Slaughter Pen and the visitor center. The trail uses the original 15-foot wide asphalt road surface (see Figure 3-43). As the surface is no longer maintained as a vehicular route, it exhibits extensive cracking and spalling and is in poor condition. Along the route, three small parking areas are in place but no longer used by the public. Bikes are allowed on the Old Tour Road Trail. To accommodate multiple user types between the visitor center parking area and the existing Tour Road, bikes and pedestrians use a walkway on the west side of the Tour Road to access the Old Tour Road Trail.

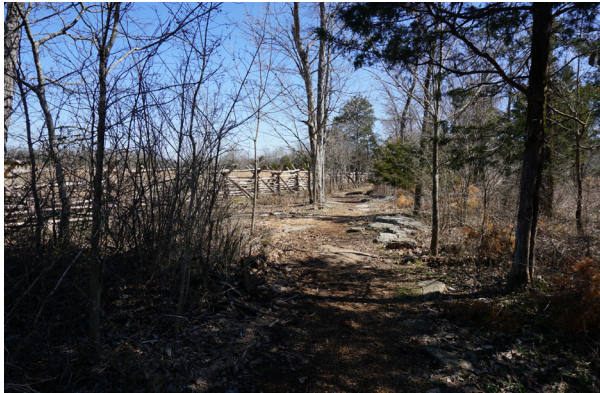
FIGURE 3-45. Cedars Trail (QE, 2021)

The Cedars Trail is a bare-earth route connecting between the eastern and western segments of the Tour Road near the center of the character area (see Figure 3-45). The trail passes through the location of the Cedars node of the Cemetery Community. Portions of the trail navigate low

limestone outcrops, and some segments are wet or eroded. The trail is in fair condition.

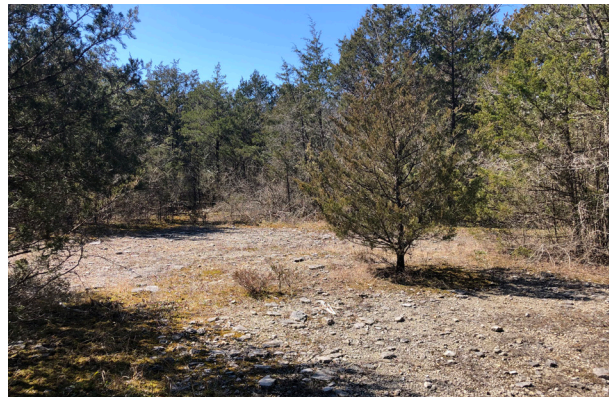
FIGURE 3–49. Nearly bare gravel glade with limestone pavement (QE, 2021)

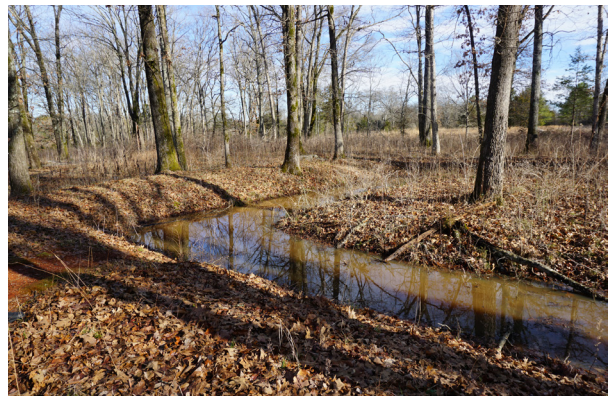
FIGURE 3-55. Pioneer Brigade Earthworks (QE, 2021)

Morton's Pioneer Brigade constructed the Pioneer Brigade earthworks in what is now a forested area west of the visitor center on January 1, 1863. The earthworks consist of a shallow lunette-shaped berm and associated dry ditch oriented northwest (see Figure 3-55). When constructed, the earthwork would also have included a timber header. The structure is now maintained under leaf litter and light woodland cover. Several large trees are growing on the earthwork tops and slopes.

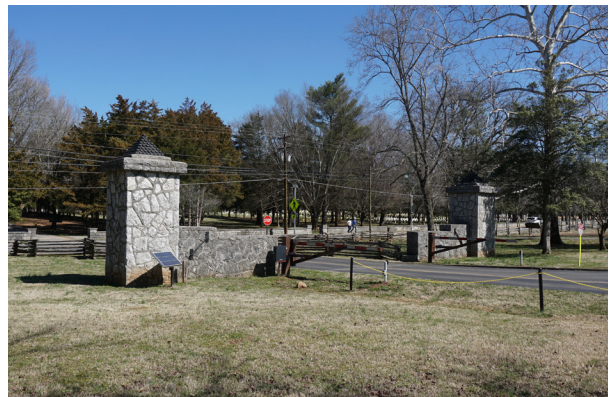
FIGURE 3-56. Old Nashville Highway entrance gate, view from south (QE, 2021)

The Old Nashville Highway entrance gate was constructed as part of NPS improvements in the early 1930s. The gate includes a pair of tall, square limestone block pillars topped with a pyramid of cannonballs. Low limestone walls extend from the interior of the pillars to frame a metal gate (see Figure 3–56).

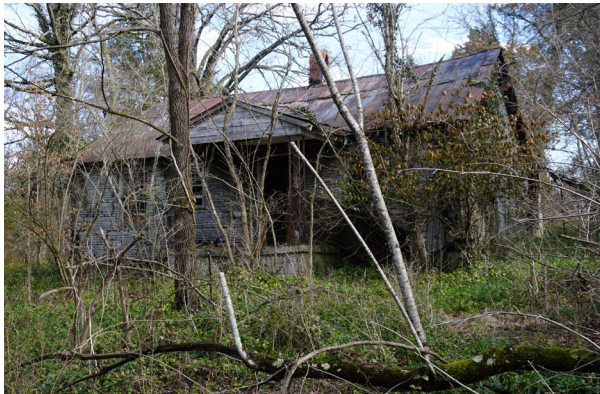
FIGURE 3–57. 3613 Old Nashville Highway (QE, 2021)

3613 Old Nashville Highway includes a house and a shed (see Figure 3–57). The house is a one-

story, three-bay by two-bay wood-frame building set on concrete block piers. The structure has a cross-gable roof and is clad in vinyl siding. A gable roof extends over the front door and porch in the center of the northeast elevation. The windows are boarded over. The shed is a square wood-frame structure with a gable roof.

Structures at all three properties are in deteriorated condition and are slated for removal.

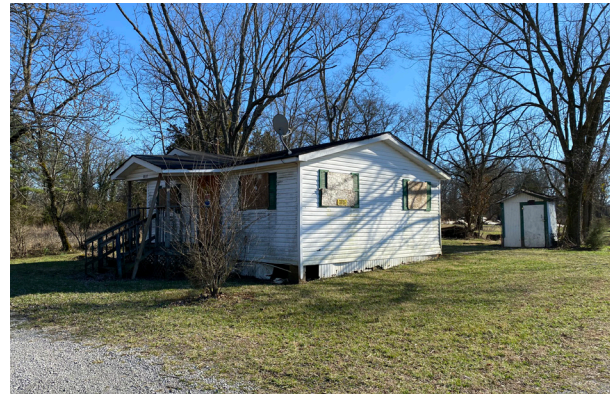
FIGURE 3–58. 3676 Old Nashville Highway (QE, 2021)

The 3676 Old Nashville Highway property contains a house and three outbuildings, all set back from the street at least 250 feet. The house is a single-story, wood-frame structure with a metal gable roof set on a concrete-block foundation (see Figure 3–58). The house is oriented toward the highway, with a gabled front porch over an entrance centered on the southwest facade. A shed roofed bay extends the northeast side of the structure. The outbuildings are northeast of the house and include a small collapsed metal structure, a rectangular wood-frame shed with a metal roof, and a small, heavily leaning wood-frame, gable-roof structure that may have functioned as a doghouse.

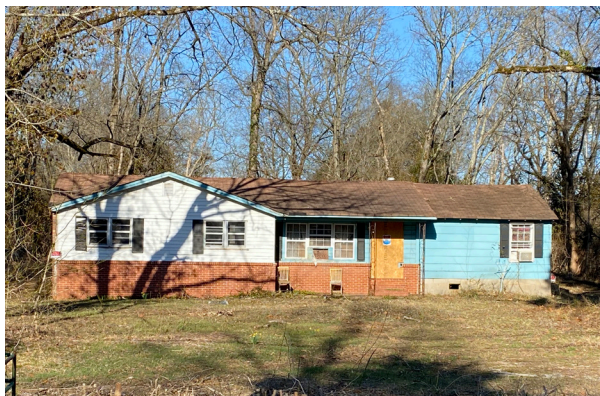
FIGURE 3–59. 3512 Old Nashville Highway (QE, 2021)

3512 Old Nashville Highway includes a single-story, five-bay by two-bay wood-frame ranch-style house clad in vinyl siding (see Figure 3–59). The structure has an asphalt-covered cross-gable roof and a brick-clad concrete foundation.

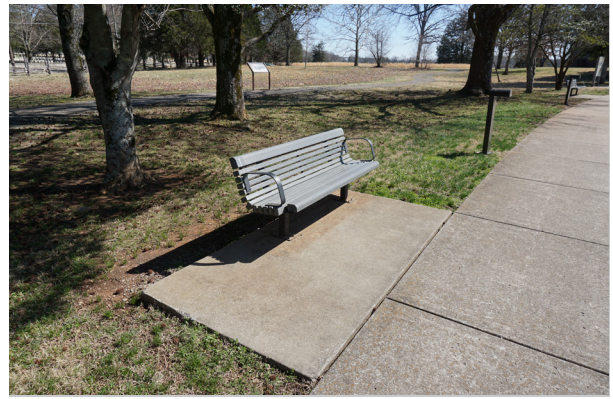
FIGURE 3–61. Composite bench at the visitor center parking area (QE, 2021)

Small-scale features are clustered at the visitor center to provide orientation, safety, interpretation, and visitor comfort. Picnic tables, bike racks, benches, and trash and recycling receptacles are situated along walkways and within mown areas immediately adjacent to the parking area (see Figure 3–61 and Figure 3–62). At the entrance to the building is an NPS standard park identifier sign and a flagpole. To the north and east of the visitor center, interpretive waysides and cannon arranged on a short trail that connects to the back (east) side of the building orient visitors to the park and support interpretation of the Trail of Tears route along Old Nashville Highway, military movements during the Battle of Stones River, and the human experience of the battle. Cannon, limber, and caisson interpret an artillery position southwest of the visitor center (see Figure 3–63). Cannon, soldier and cannon Corten steel silhouettes, and waysides extend interpretation of the battle along the Cotton Field Trail, Cedars Trail, Van Cleve Lane, and Slaughter Pen Trail. Small wood trail signs support wayfinding at trail intersections throughout the character area. Overall, interpretive materials, wayfinding signage, and site furnishings are in good condition.
