Stones River National Battlefield Cultural Landscape Report

March 2023

Cultural Landscape Report Update

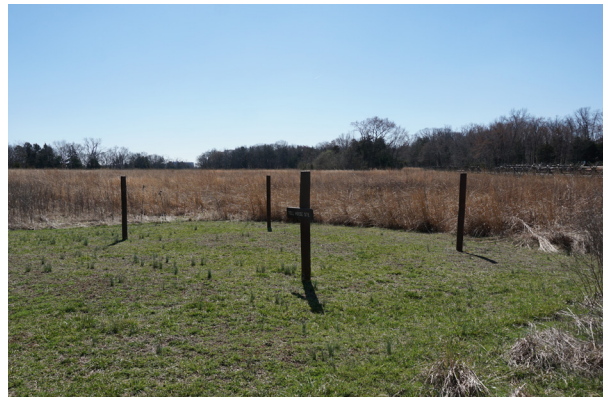
FIGURE 3–64. Tollhouse site markers (QE, 2021)

At the Tollhouse Site, four painted 4" x 4" wood posts mark the known extent of the missing tollhouse structure (see Figure 3–64). The posts exhibit some wear and are in fair condition.

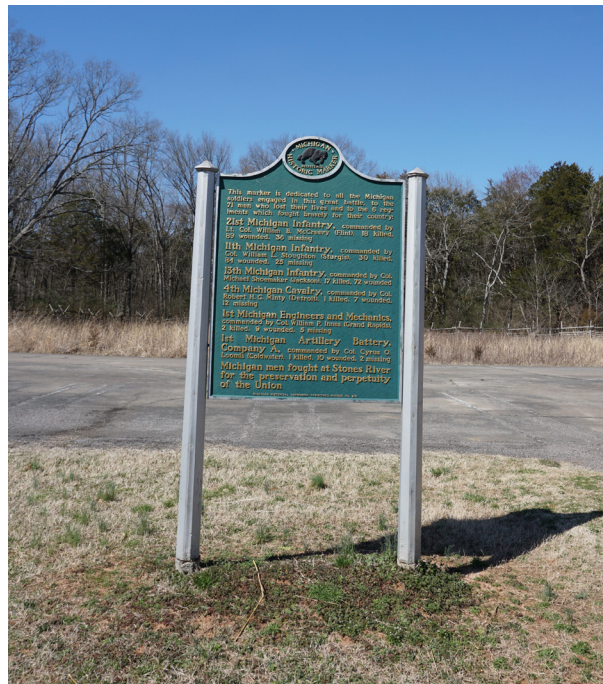
FIGURE 3–65. Michigan State Historical Commission Marker (QE, 2021)

The Michigan Civil War Centennial Observance Commission placed the Michigan State Historical Commission Marker along the Tour Road near the Slaughter Pen in 1966. The marker is a two-sided, cast-aluminum panel supported by two metal posts. “Michigan Registered Historical Marker” is cast in bas relief at the top of both sides of the panel (see Figure 3–65).

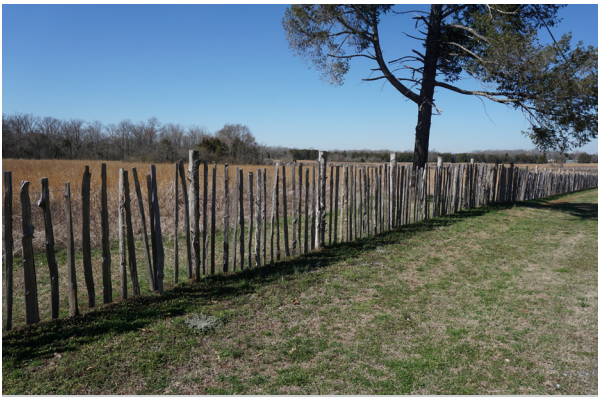
FIGURE 3–66. Wood picket fence along Old Nashville Highway (QE, 2021)

Historic fence types are maintained within the character area when known. Stacked rail fence lines the south side of Old Nashville Highway between the visitor center and Van Cleve Lane. The fence type transitions to a rough-hewn picket fence between Van Cleve Lane and Thompson Lane (see Figure 3–66). North of the Cotton Field Trail, Van Cleve Lane is lined with tall snake-rail fences with a headrail. This fence type also extends west along the Cedars Trail. NPS installs tall snake-rail fences where historic fencelines were present but the fence type is unknown, for example, along the southern end of Van Cleve Lane. NPS regularly fixes or replaces fences, and they are overall in good condition.

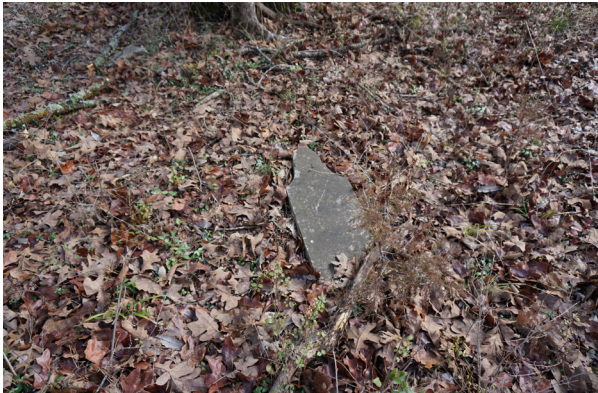
FIGURE 3–67. Norris Family Cemetery headstone (QE, 2021)

The Norris Family Cemetery includes six headstones. Four of the headstones have carved tops with pointed lancet arch projections; all are in poor condition (see Figure 3–67). Only one headstone has a decipherable inscription:

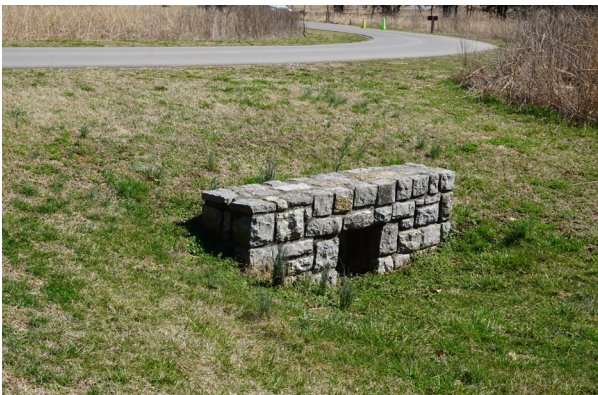
FIGURE 3–68. Stone-faced culvert along Tour Road (QE, 2021)

Culverts along the Tour Road and Old Tour Road trail typically consist of corrugated metal pipes extending under the road, capped by mortared stone headwalls on either side (see Figure 3–68). Based on the configuration of the road, some features are L-shaped or incorporate riprap to

slow the flow of water. Culverts along the original route of the Tour Road (with the exception of the four drainage structures associated with later trail development, identified above) were likely constructed as part of Mission 66-era Tour Road improvements.

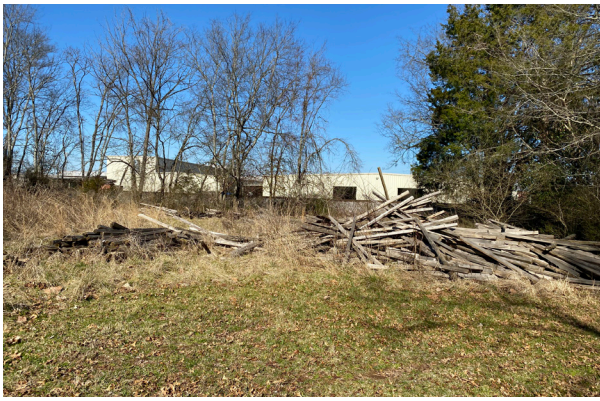
FIGURE 3-69. Maintenance storage area in northwest corner of the character area (QE, 2021)

Maintenance storage occurs in two locations within the Nashville Pike Unit. In the northwest corner of the unit (adjacent to the National Cemetery), maintenance staff store fence rails, stone, cannon carriages and wheels, mulch, and other materials (see Figure 3-69). Additional fence rails are in the field north of the Pioneer Earthworks.

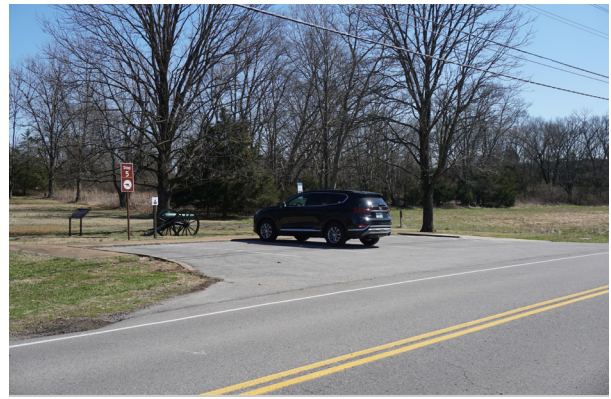
FIGURE 3–79. Hazen Brigade Monument site parking area (QE, 2021)

Visitors access the Hazen Brigade Monument from a five-car asphalt parking area on the north side of Old Nashville Highway (see Figure 3–79). From the parking area, a curvilinear concrete sidewalk extends northeast to a gate in the center of the monument's limestone perimeter wall (see Figure 3–80). Both the parking area and walkway are in good condition. Gravel is placed around the base of the Hazen Brigade monument to combat mud and erosion around the structure.

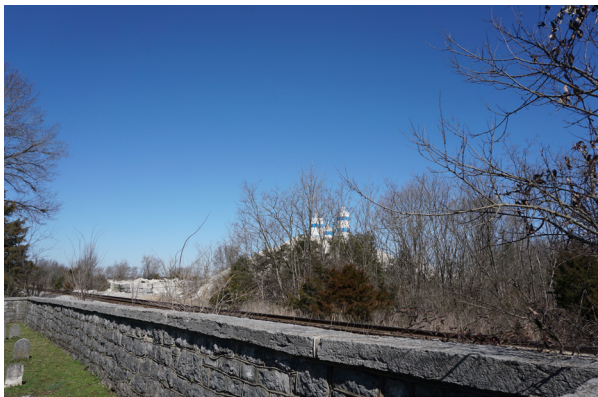
FIGURE 3-84. Although the railroad would have been prominent in views both during the battle and at the time the monument was constructed, the existing view is impacted by a concrete plant north of the railroad (QE, 2021).

opposite side of the railroad are visible to the north (see Figure 3-84).

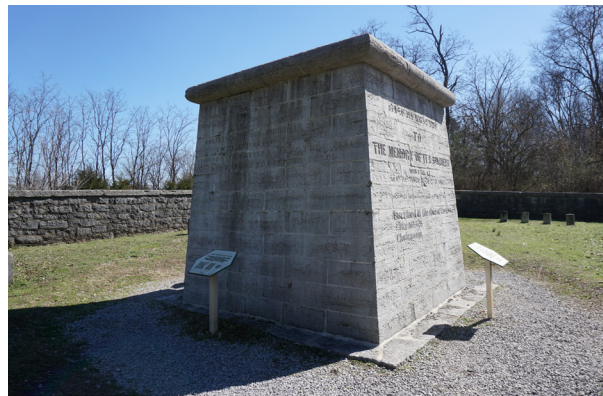
FIGURE 3–86. Hazen Brigade Monument, southwest and northwest facades (QE, 2021)

The Hazen Brigade Monument is a coursed limestone block structure with earthen fill approximately 10' square and 11' in height capped with a flat top with rounded coping (see Figure 3-85 and Figure 3-86). Members of William Hazen's 19th Union Brigade constructed the monument in 1863 to commemorate Round Forest, a position in the approximate location of the monument that was successfully held by the Brigade on December 31, 1862. In March 2021, the monument had been recently cleaned and was in good condition. However, inscriptions on each side of the monument are heavily weathered. The southwest face reads:

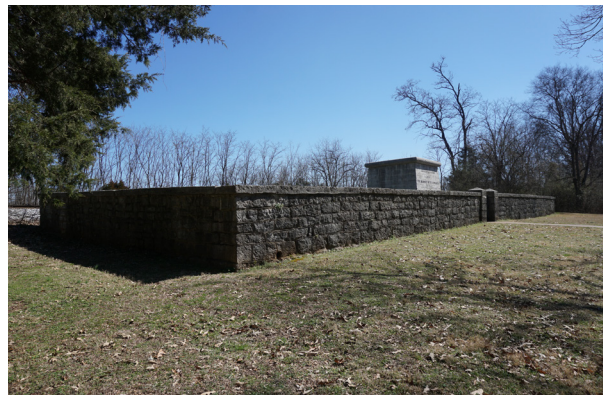
A 40' x 100' rectangular wall surrounds the Hazen Brigade Monument and associated gravestones (see Figure 3–87). The mortared ashlar limestone wall is 4' high and 2' thick. A wrought-iron gate is centered in the southwest wall on axis with the southwest face of the monument, supported by limestone stone gate posts (see Figure 3–88). The wall is in fair condition. It exhibits extensive staining and some biological growth within the mortar.

FIGURE 3–87. A mortared limestone perimeter wall surrounds the monument and associated grave sites (QE, 2021)

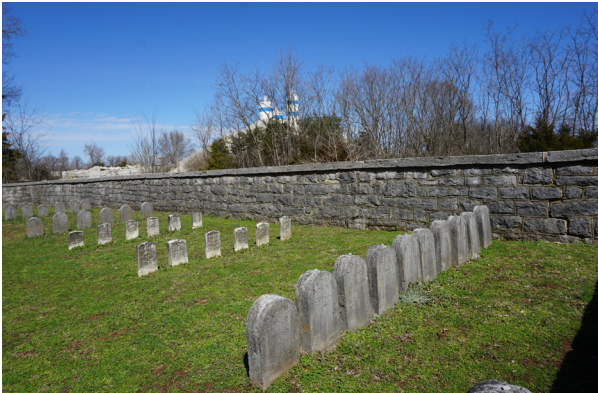
FIGURE 3-89. Limestone and marble headstones within the perimeter wall (QE, 2021)

Within the confines of the limestone perimeter wall are 55 headstones dedicated to fallen Union soldiers associated with Hazen's brigade (see Figure 3-89). 31 headstones are limestone tablets associated with brigade members buried shortly after the Battle of Stones River. The limestone tablets measure 20" tall, 12" wide, and 5" thick, with a curved top, and feature incised shields on the face with projecting letters. Twenty-four additional marble grave markers were placed in 1886 when other members of the brigade were reinterred near the monument. These tablets match the arched marble tablets used in the adjacent National Cemetery. The grave markers exhibit some biological growth, cracking, and spalling, and are in fair condition. Ground-penetrating radar investigations conducted in 2003 identified six burial trenches within the perimeter wall that do not correspond to the location of the individual headstones (see Archeological Sites section, below).⁶⁷

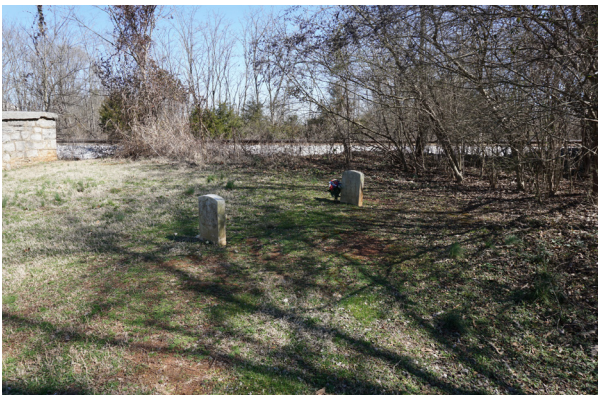
FIGURE 3-90. Holland/Harlan headstones located immediately east of the Hazen Brigade Monument wall (QE, 2021)

Immediately southeast of the perimeter wall are two additional marble headstones marking the graves of William Holland, a sergeant in the 111th Regiment USCI (1834-1909) and his descendant William Harlan, a corporal in the US Army who fought in World War I (1895-1979) (see Figure 3-90). The headstones are in good condition. The Holland marker is inscribed:

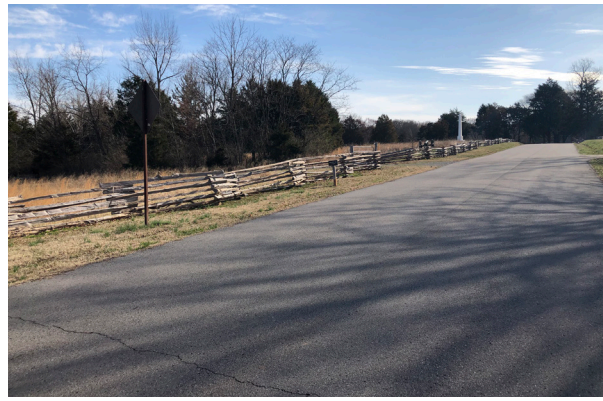
FIGURE 3–95. Van Cleve Lane looking east toward the Artillery Monument (QE, 2021)

Within the property the primary vehicular route is Van Cleve Lane, a segment of the historic road alignment that bisects the Nashville Pike Unit (see Figure 3–95). Van Cleve Lane enters the property as a two-lane north–south route and then turns to the east, ending in a turnaround loop and parking area near the center of the character area (see Figure 3–96). The parking area provides 11 standard and 2 handicap spaces. The handicap spaces are not marked with signs or pavement markings. Both the road and parking area are

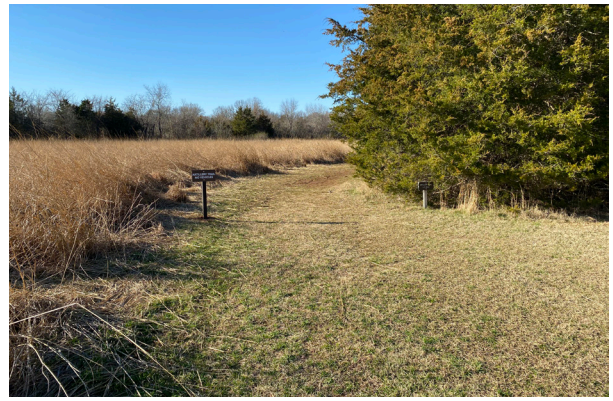
FIGURE 3-98. Artillery Trail, looking north from the parking area (QE, 2021).

The Artillery Trail is a mown grass interpretive trail providing visitor access to key Union artillery locations and viewpoints. The trail begins on the north side of the parking area and skirts the northeastern edge of a large, irregular field before following the location of the Union line south toward Van Cleve Lane (see Figure 3-98). On the south side of Van Cleve Lane, the trail forms a narrow loop along the Union line. A portion of the Artillery Trail follows a road grade extending from a former house site west of the Artillery Monument to Van Cleve Lane (see Figure 3-99). The Artillery Trail is maintained as a mown grass trail. Minor patches of erosion and bare earth are present, but the route is overall in good condition.

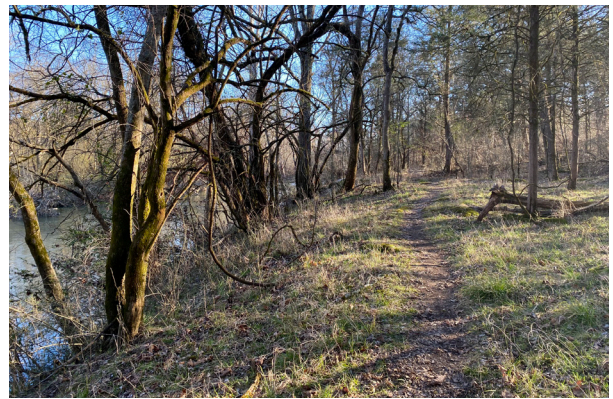
FIGURE 3-100. Social trail along West Fork Stones River (QE, 2021)

Numerous social trails traverse the woods at the McFadden Farm Unit. A well-established trail extends from McFadden Ford north along the edge of the West Fork Stones River (see Figure 3-100); additional social trails connect from this route to the parking area and Artillery Trail.

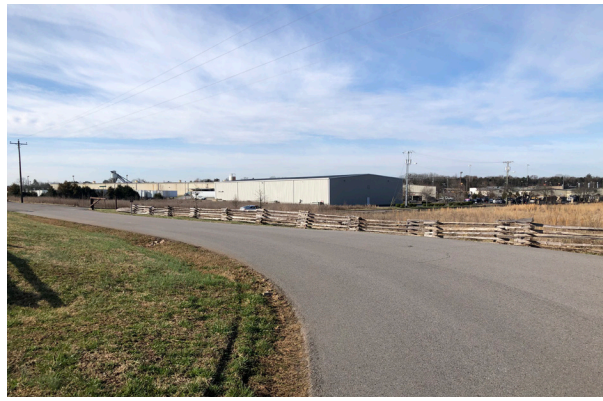
FIGURE 3–101. Industrial land use bordering character area compromises views to the south and west (QE, 2021).

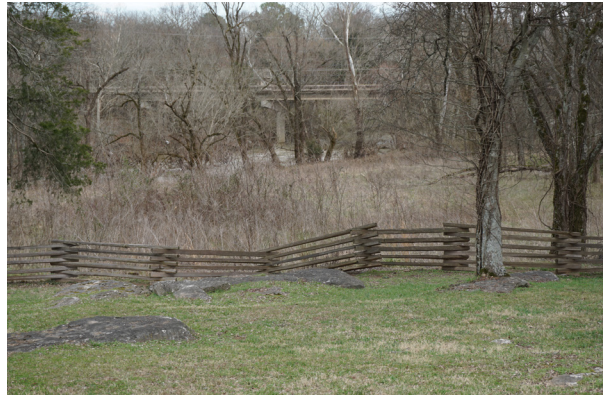
FIGURE 3–102. On January 2, 1863, Union artillery stationed on a ridge on the west side of West Fork Stones River (near the existing Artillery Monument) repulsed a Confederate advance from the east. Cleared vegetation west of the parking area affords today's visitors a partial visual connection between the ridge and the river. However, the view is impacted by the N Thompson Lane bridge, which passes over the river in the approximate location of McFadden Ford. Floodplain forest along the river is also more extensive than documented during the battle; Union artillery would likely have experienced a broader field of view against the advancing Confederates (QE, 2021).

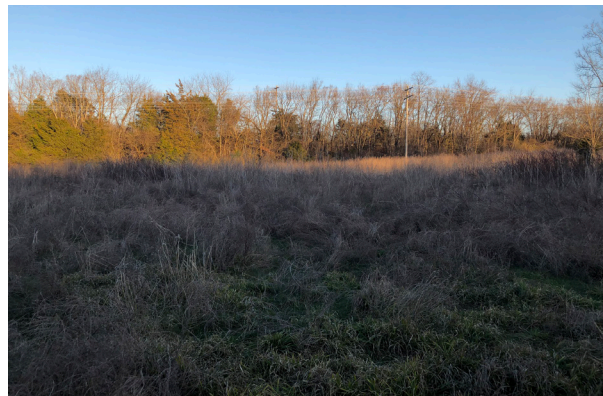
FIGURE 3–103. The existing view from the position of the Union artillery line south of McFadden Farm Lane includes a broad field and floodplain forest along West Fork Stones River. While this view helps visitors understand the physical relationship of the two opposing armies, the modern utility corridor and woody vegetation along the river are inconsistent with the historic condition of the landscape (QE, 2021).

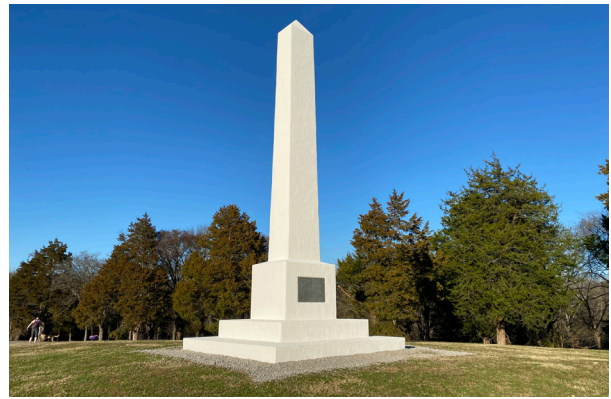
The most prominent structure in the McFadden Farm Unit is the Nashville, Chattanooga, & St. Louis Railway Artillery Monument (see Figure 3-104). The monument, designed by railroad staff engineer Hunter McDonald and constructed in 1906, is situated southeast of the parking area on a rise overlooking the West Fork Stones River. It is a 34' tall concrete obelisk on a square plinth with a 13' square two-tier Portland cement base. A bronze plaque on the east face of the plinth reads:

The obelisk was recently refinished in March 2021 and is in good condition.

FIGURE 3-104. Nashville, Chattanooga, & St. Louis Artillery Monument (QE, 2021)

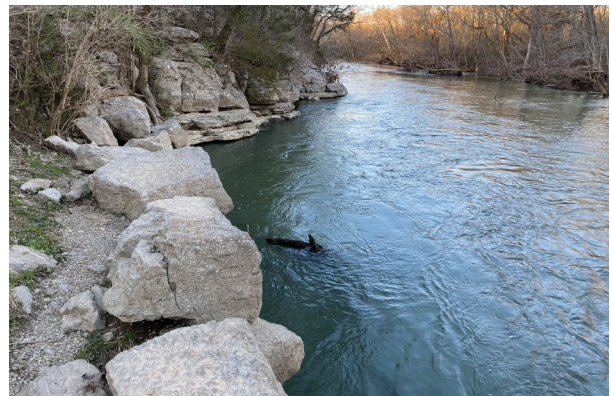
Dry-laid retaining walls were constructed from the local limestone in 1976 to protect the banks of the West Fork Stones River near the Thompson Lane Bridge (see Figure 3-105). The retaining walls blend seamlessly into the natural limestone bluffs at the turn of the river and are in good condition.

FIGURE 3-105. Stone retaining walls along West Fork Stones River (QE, 2021)

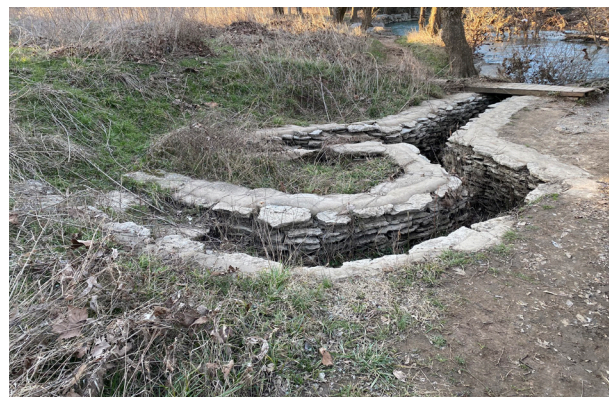
FIGURE 3-106. Mortared stone spring box and wood pedestrian bridge (QE, 2021)

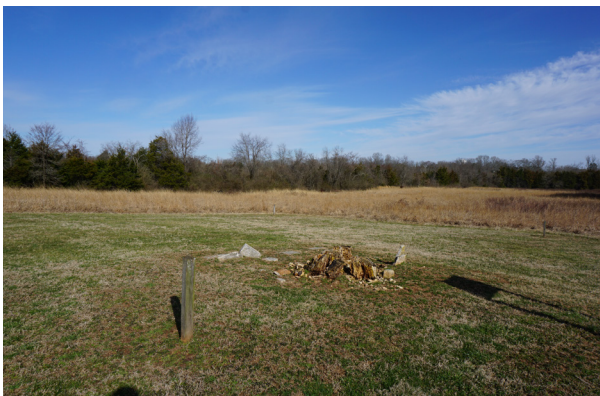
The McFadden Cemetery contains several headstones from the 1840s through early 1880s situated in the southeast corner of the site (see Figure 3–107). All headstones are in poor condition.

FIGURE 3–107. McFadden Cemetery site with remnants of large hackberry tree (QE, 2021).

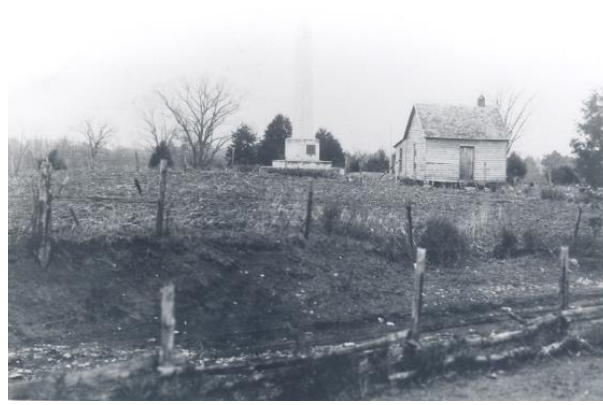
FIGURE 3–109. A 1928 image of the Artillery Monument also documents a cabin just south of the monument. During this time, land surrounding the monument was maintained as crop fields, and a stacked-rail wood fence lined Van Cleve Lane. Woodlands occupied a smaller footprint than the current vegetation community (Stones River National Battlefield, 1928).

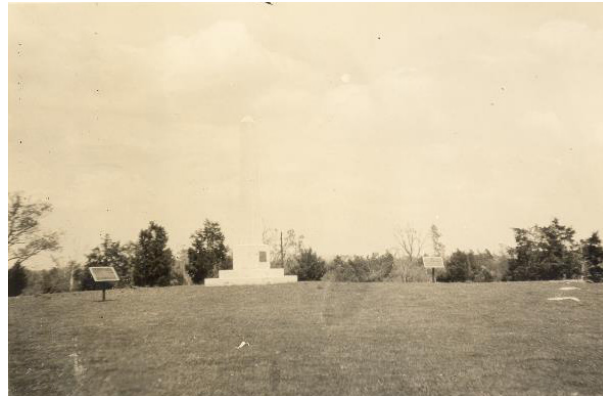
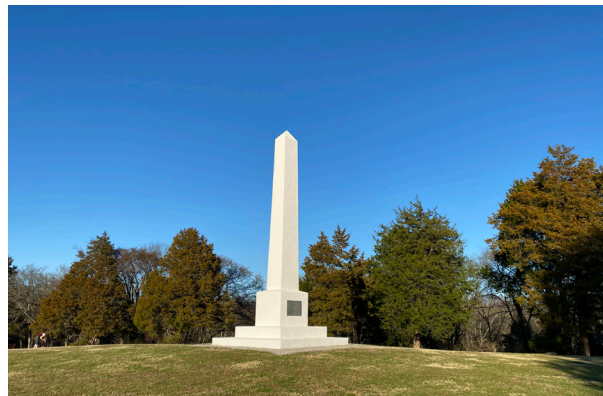
FIGURE 3–110. Artillery Monument, 1935 (Stones River National Battlefield) and similar view, 2021 (QE). Woodland cover in the vicinity of the monument has increased since the early twentieth century.

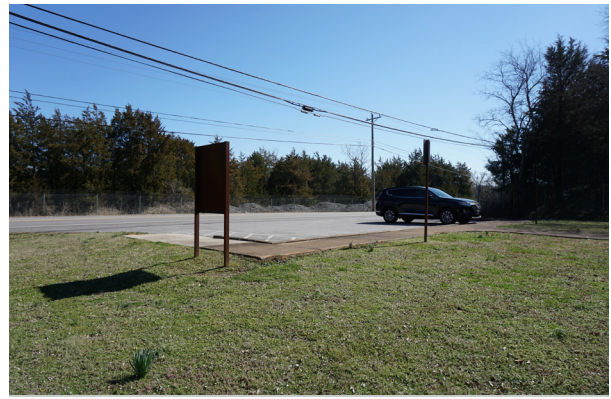
Visitors access the headquarters site via a five-car asphalt parking area situated on the south side of Old Nashville Highway (see Figure 3-112). A 5' wide concrete sidewalk edges the parking area and extends south to form a loop around the headquarters monument (see Figure 3-113). Both the parking area and sidewalk are in good condition.

FIGURE 3-112. Parking area (QE, 2021)

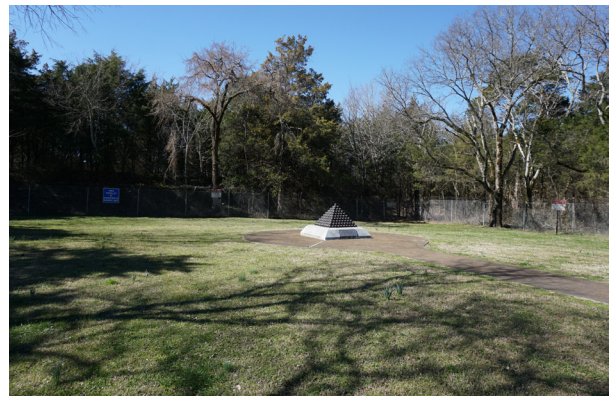
FIGURE 3-113. Concrete walkway extending from the parking area to the monument (QE, 2021)

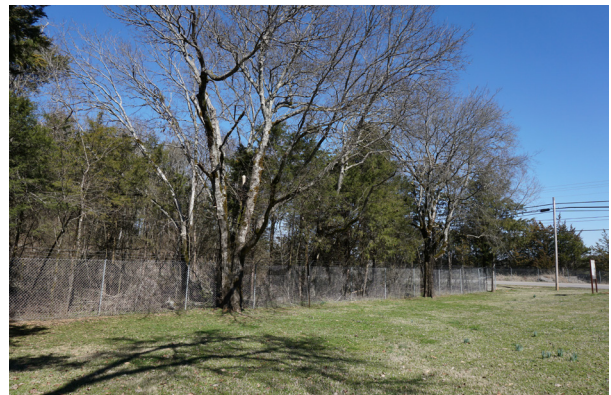
FIGURE 3-114. Hazard trees along the edge of the parcel (QE, 2021)

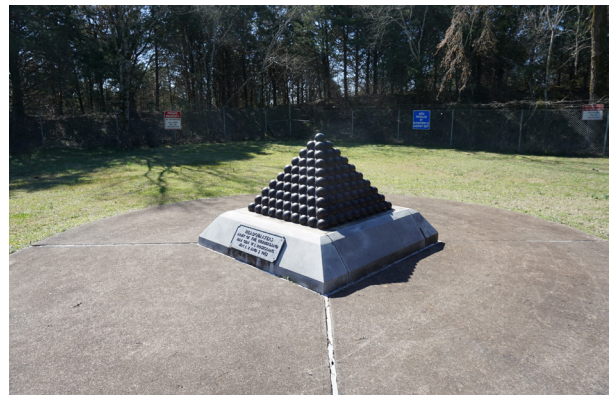
The marker is in good condition. There are minor cracks and stains on the granite base.

FIGURE 3–118. General Rosecrans’s Headquarters Marker (QE, 2021)

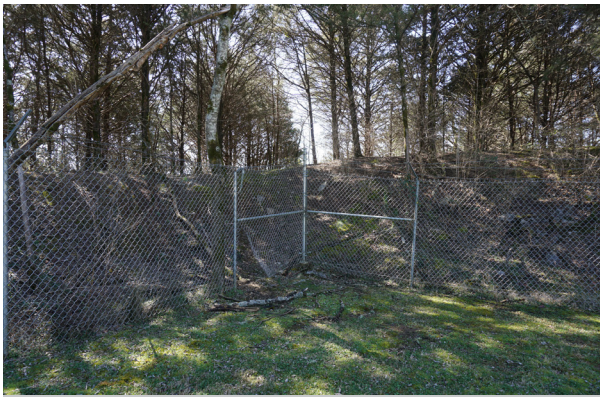
FIGURE 3-119. Damaged chain-link fence (QE, 2021)

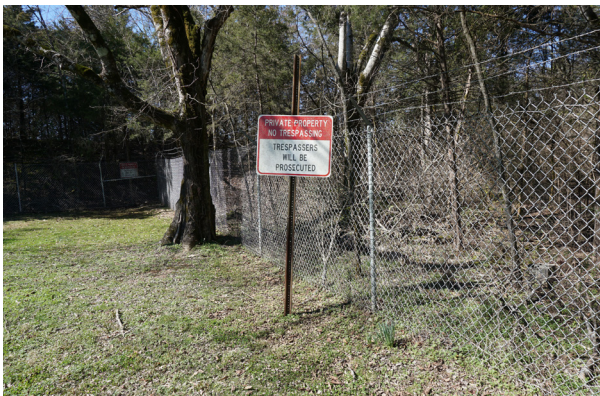
A chain-link fence topped with barbed wire marks the property line surrounding the headquarters site. At the southeast corner of the parcel, the fence has been damaged by people illegally accessing the adjacent quarry (see Figure 3–119). Four large “Private Property” signs are posted along the fenceline to discourage trespassing (see Figure 3–120).

FIGURE 3-120. Private property sign(s) (QE, 2021)

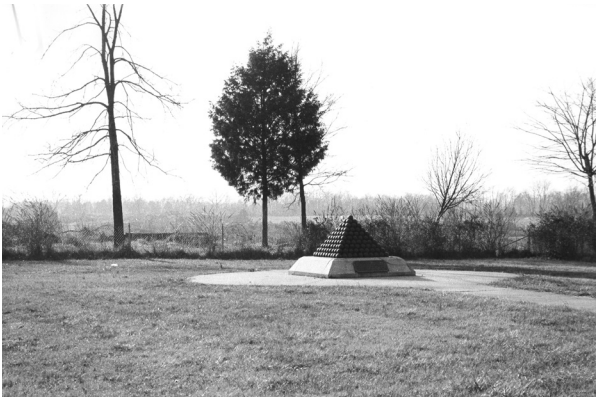
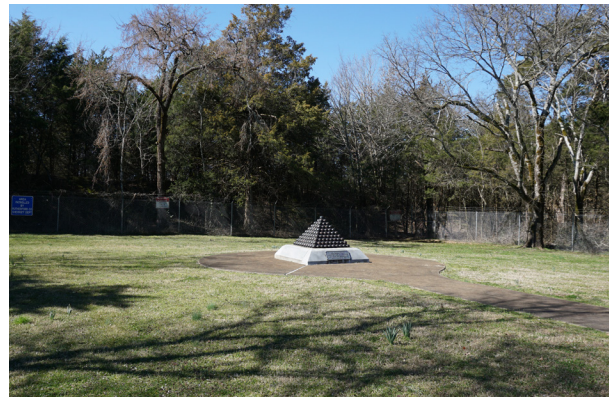
The character area retains integrity of location, design, materials, workmanship, feeling, and association for the Federal Stewardship and Conservation Period (1927–1966). The commemorative site and monument occupy their original location and retain the original design, materials, and workmanship laid out by the War Department in 1931, and together they continue to evoke the feeling of memorialization associated with early park commemorative efforts. Modern additions or alterations including the addition of the parking area, chain-link fencing, signage, and replacement of some of the original cannon shot diminish the integrity of the original design but are not substantial enough to detract from the site's overall integrity. Integrity of setting is no longer retained due to the substantial modification of the surrounding landscape since the end of the period of significance. Photographs from the mid-1970s document a level, open landscape with minimal vegetation; today, the parcel is surrounded by tailing piles and dense woodland vegetation (see Figure 3-121).

FIGURE 3-121. Through at least the mid-1970s, the headquarters site was surrounded by level, open landscape with views to the surrounding fields. Today, the site is enclosed by both quarry tailings and dense woodland. Left, monument and surrounding landscape, 1975 (Stones River National Battlefield Central Files). Right, similar view, 2021 (QE).

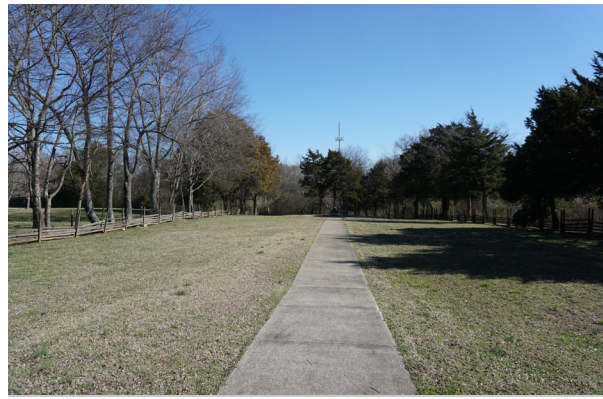
Within the parcel, a 5' wide concrete sidewalk extends through the center of the site, encircling the monument at its northeastern end (see Figure 3–122). The sidewalk continues north to connect between the monument and the Stones River Greenway, curving northwest around a large Eastern Redcedar tree (*Juniperus virginiana*) on the north side of the monument. The sidewalk is in good condition.

FIGURE 3–122. Concrete sidewalk extending to the pyramidal cannonball monument (QE, 2021)

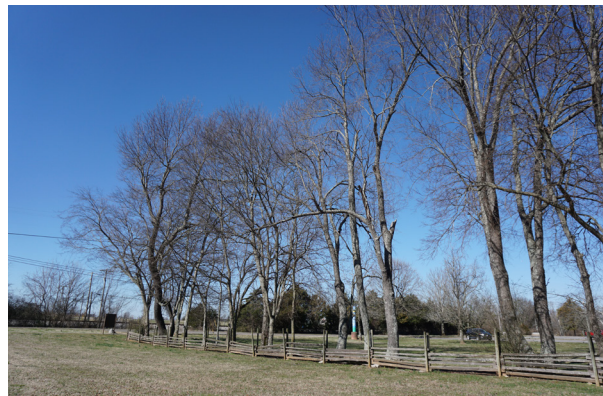
FIGURE 3–123. Row of trees along the northwest parcel boundary, including several hazard trees (QE, 2021)

Single rows of hackberry, maple, and Eastern Redcedar frame the southeast and northwest sides of the site. The trees are in fair condition. Several individual trees are missing from the rows, and many of the hackberries have standing dead branches (see Figure 3–123).

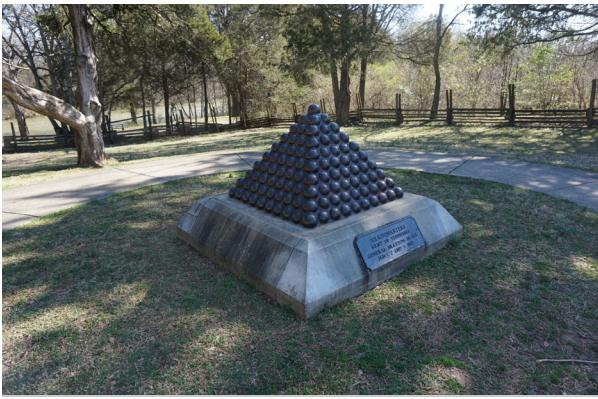
The marker is in fair condition. There are minor cracks and staining present on the base and the cannonballs require repainting.

FIGURE 3–129. General Bragg Headquarters Marker (QE, 2021)

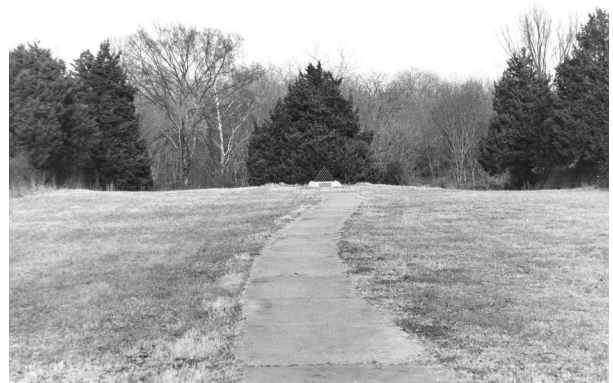
FIGURE 3–130. A 1975 image of the General Bragg's Headquarters Monument documents a curvilinear sidewalk extending through the center of the parcel (Stones River National Battlefield Park Central Files).

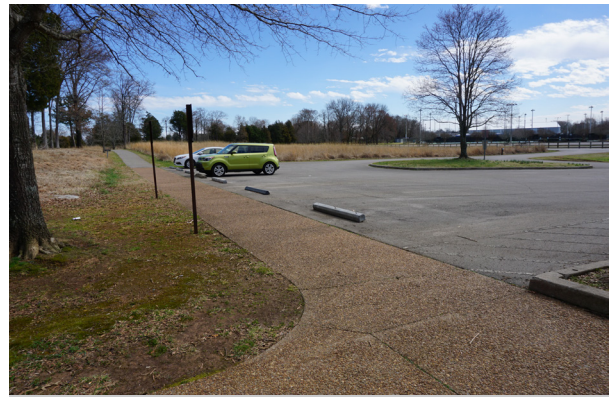
A parking area accessed from Golf Lane provides 25 standard spaces and 2 handicap spaces for both the NPS property and the Stones River Greenway trailhead (see Figure 3–131). The parking area is asphalt with concrete curbs and is in good condition. A fair-condition, exposed aggregate concrete walkway extends around the north

FIGURE 3–131. Shared NPS and Stones River Greenway parking area (QE, 2021)

and west sides of the parking area. The walkway exhibits some cracking and settling.

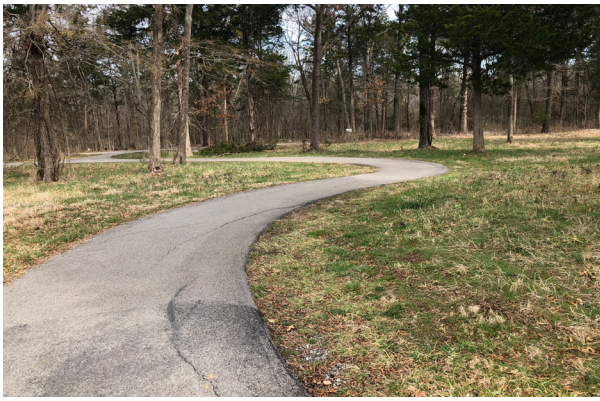
A network of asphalt walkways loops around each of the fortifications (see Figure 3–132). During field investigations in March 2021, the walkways were in fair condition; portions of the surface, particularly on slopes, exhibited cracks or eroded edges. The walkways were planned for repaving in summer 2021. Modern PVC culverts drain water under the walkways, and a short Trex trail bridge extends over a wet area near the intersection of Lunette Thomas and the unfinished earthwork (see Figure 3–133). The bridge has biological growth and some wear, and it is in fair condition.

FIGURE 3–132. Asphalt walkway adjacent to Curtain Wall No. 2 (QE, 2021)

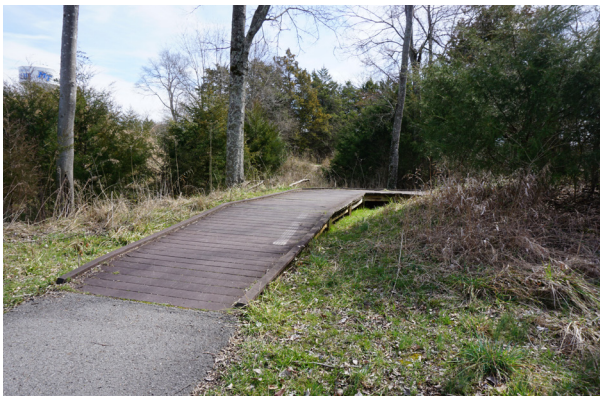
FIGURE 3–133. Trail bridge adjacent to Lunette Thomas (QE, 2021)

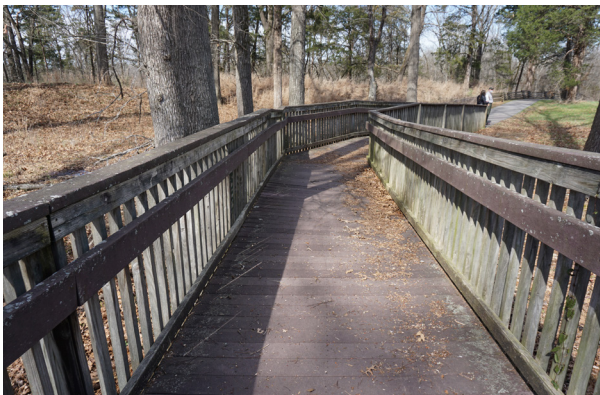
Wood and Trex boardwalks provide access to viewpoints near the tops of Lunette Palmer and Lunette Thomas (see Figure 3–134). The boardwalks were in fair to poor condition during March 2021 field investigations. Some portions of the decking and handrails are warped, rotted, or exhibit biological growth. The boardwalks were repaired in fall 2021.

FIGURE 3–134. Boardwalk at Lunette Palmer (QE, 2021)

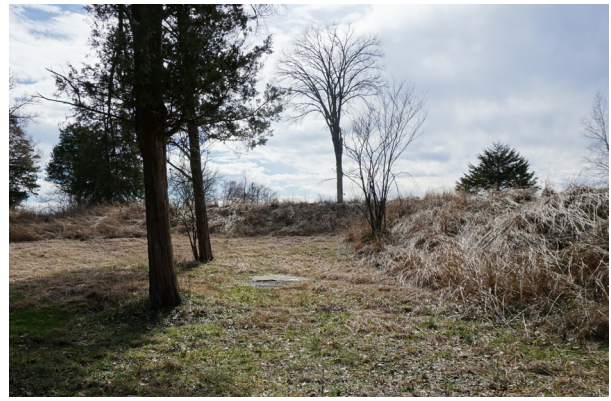
The earthworks and adjacent areas are maintained under a mix of native warm-season grasses that extend to the edges of the parking area. Flat areas are mown once to twice per year to support visibility and interpretation of the earthen structures. The lunettes, curtain wall, and unfinished earthwork are maintained according to the park's burn plan.

FIGURE 3–135. Curtain Wall No. 2 planted in native warm-season grasses (QE, 2021)

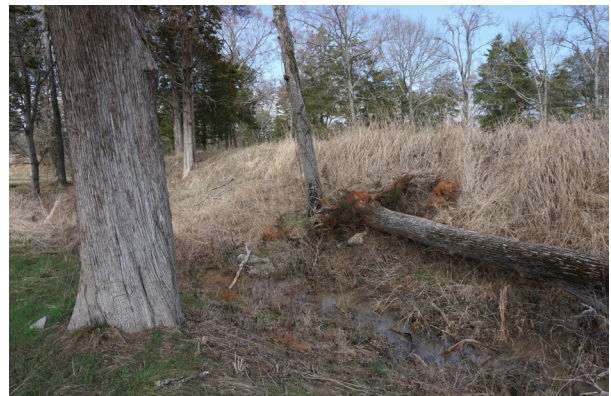
FIGURE 3–136. Hazard tree at Curtain Wall No. 2 (QE, 2021)

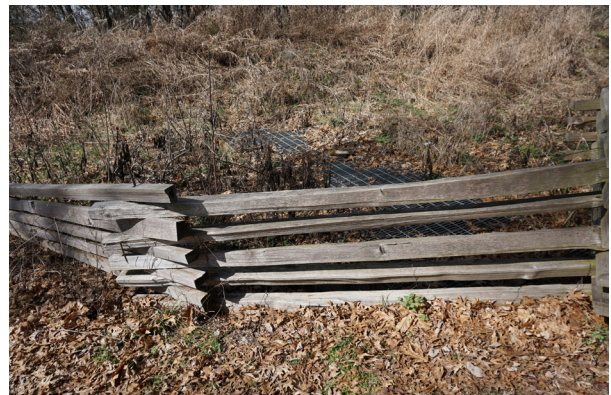
FIGURE 3–137. Sinkhole adjacent to Lunette Palmer (QE, 2021)

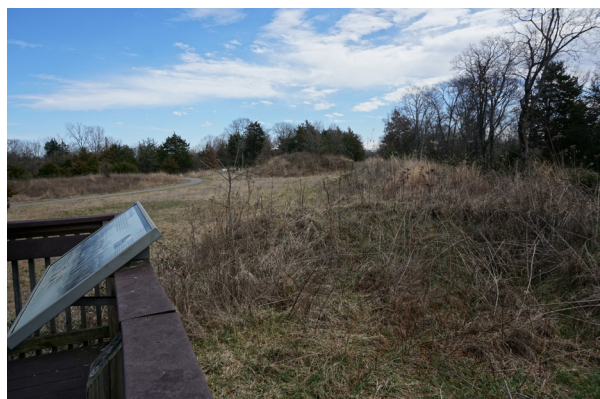
FIGURE 3-139. View of interior structure of Lunette Thomas from boardwalk (QE, 2021)

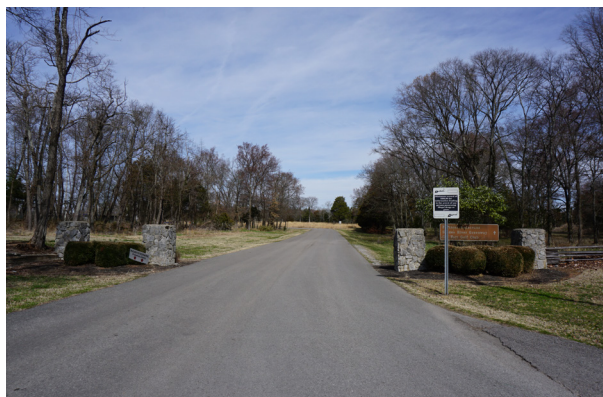
FIGURE 3-142. Small-scale features at Overall Street entrance (QE, 2021)

Small-scale features are in good to fair condition. Some signs and benches exhibit wear and biological growth. NPS staff report that waysides that experience direct sunlight require replacement on an annual or biannual basis.

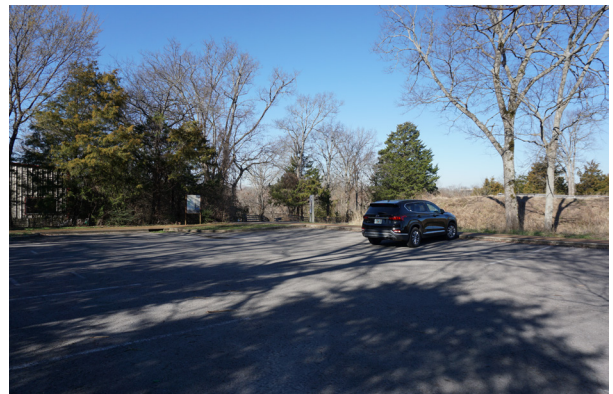
Redoubt Brannan is situated immediately south of West College Street, which follows the historic route of Old Nashville Highway. The unit is accessed via an asphalt parking lot that provides 11 standard parking spaces and 2 handicap spaces organized into 2 bays (see Figure 3–143). A 5' wide concrete sidewalk extends along the northwest and southwest sides of the parking area. The sidewalk and parking area are in good condition.

FIGURE 3–143. Redoubt Brannan parking area (QE, 2021)

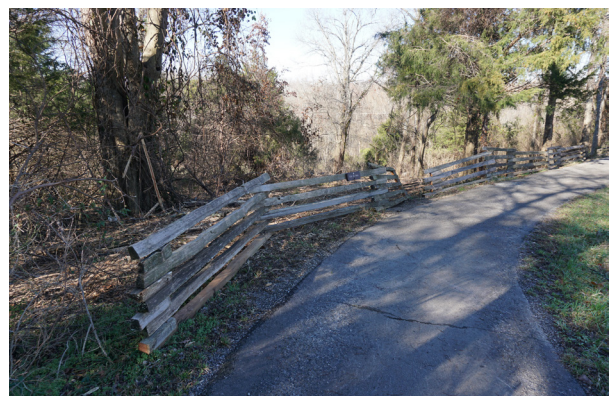
At the southwest corner of the parking area, the sidewalk connects to an asphalt and aggregate path that extends around the southwest and northwest sides of the earthworks (see Figure 3–144). From the northwest side of the redoubt, the asphalt and aggregate path continues to the northwest, connecting with the Stones River Greenway walkway at the West College Street Bridge. The path is in fair condition. It exhibits some cracking and loss of gravel surface, and portions of the walkway on the southwest side of the site are undercut by erosion.

FIGURE 3–144. Asphalt and aggregate walkway (QE, 2021)

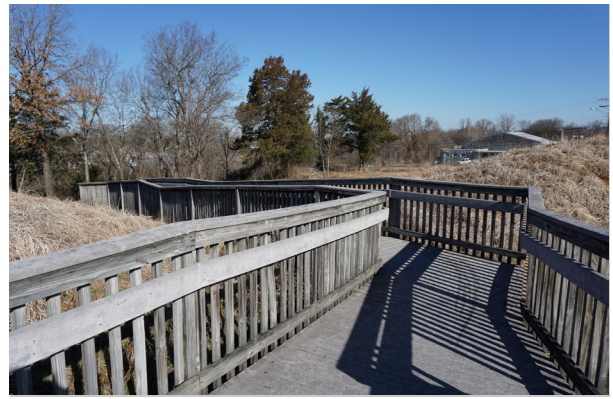
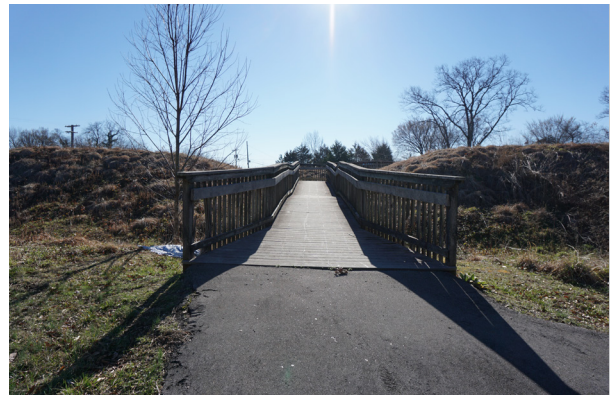
Visitors access the interior of Redoubt Brannan via a wood and composite boardwalk in the approximate location of the sallyport entrance in the center of the fortification's northwest side (see Figure 3–146 and Figure 3–147). The boardwalk forms an out-and-back path to a viewing platform at the southwest corner of the redoubt. The boardwalk was in fair condition during March 2021 field investigations; the railings exhibited staining, minor biological growth, and some missing or damaged balusters. The boardwalk was repaired fall 2021.

FIGURE 3–146. Boardwalk, looking south from within the redoubt (QE, 2021)

FIGURE 3–147. Boardwalk, looking southeast from outside the redoubt (QE, 2021)

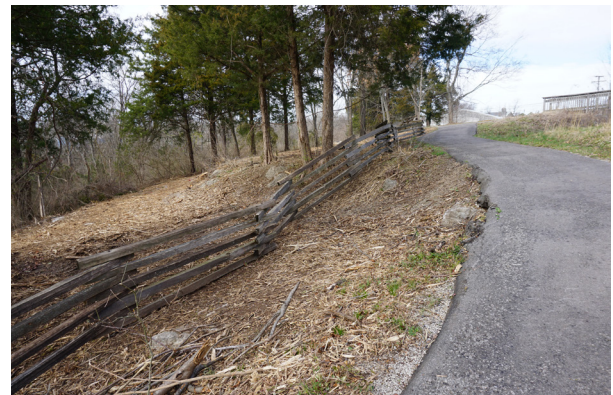
The Redoubt Brannan site is enclosed by mixed hardwood and Eastern Redcedar forest (*Juniperus virginiana*) to the southeast, southwest, and northwest. In cooperation with the City of Murfreesboro, understory vegetation was recently cleared between the asphalt trail and the edge of the slope on the southwest and northwest sides of the site in response to public safety concerns; the vegetation removal has also reopened significant views between Redoubt Brannan and the West Fork Stones River (see Figure 3–148).

FIGURE 3–148. Cleared vegetation on the slope between the walkway and West Fork Stones River (QE, 2021)

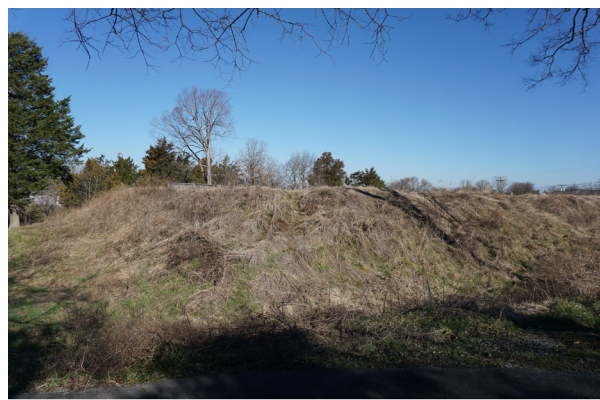
FIGURE 3-152. Redoubt Brannan exterior, southeast corner (QE, 2021)

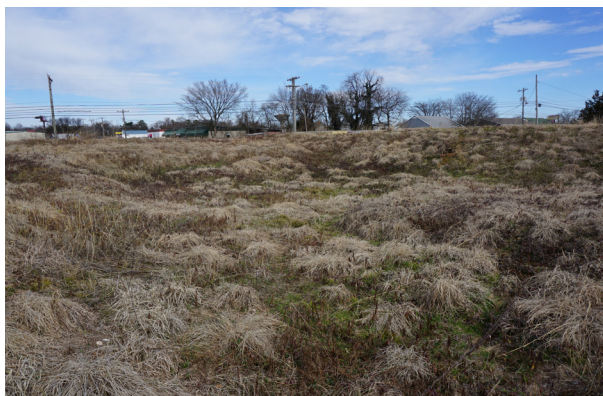
FIGURE 3-153. Redoubt Brannan interior (QE, 2021)

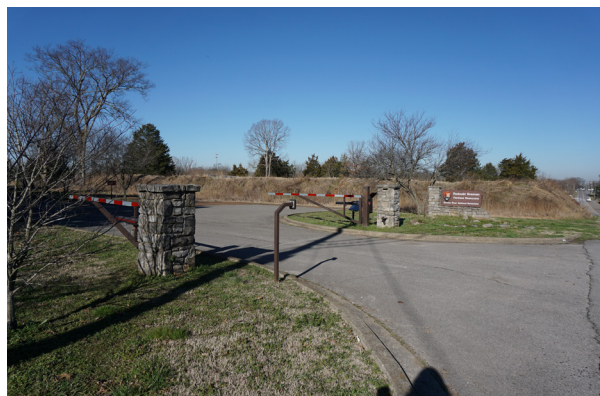
FIGURE 3-154. Park identification sign (QE, 2021)

The park identification sign base and entrance piers and gate are located at the north end of the parking area (see Figure 3–154). The features are constructed of mortared limestone consistent with other modern stone features in the park and are in good condition.

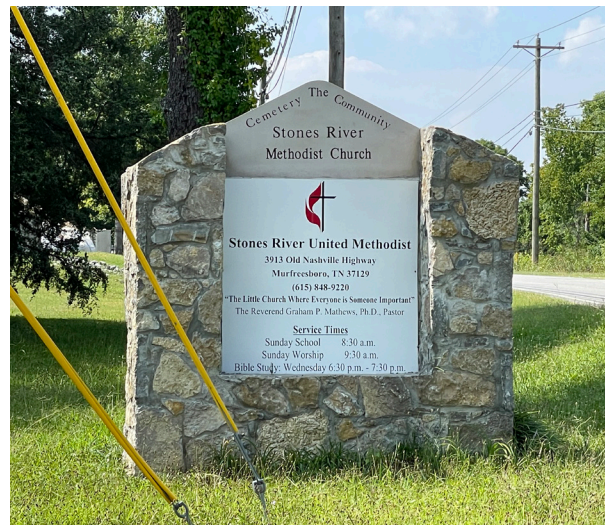
FIGURE 4-2. Existing Cemetery Community signage (QE, 2021)

- Work with the AAHSRC to identify potential collaboration on future events and educational opportunities related to the community's history.
- If deemed appropriate by the AAHSRC, consider incorporating existing Cemetery Community signage into related sites at the park (see Figure 4-2).

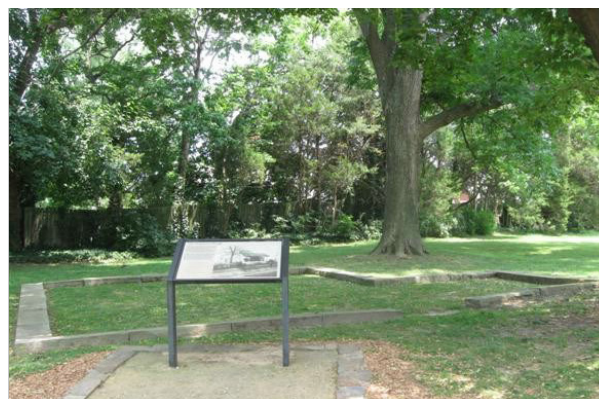
- Foundation outlines. When the dimensions and location of the footprint of a missing building or structure are known, an outline or other demarcation such as a low wall or corner markers can be placed on the ground to aid interpretation. If footings are necessary, avoid digging into the ground. Instead, add a minimal layer of fill over the site to protect any archeological resources. A foundation outline can be constructed of typical local building materials utilized during the period when the building was standing, such as stone or brick (see Figure 4-3). However, the

FIGURE 4-3. Foundation outline at Fredericksburg and Spotsylvania National Military Park (waymarking.com)

foundation outline should clearly be a product of its own time, so that it is not confused as a historic foundation or ruins. Foundation outlines may also be marked with fencing or with mowing patterns.

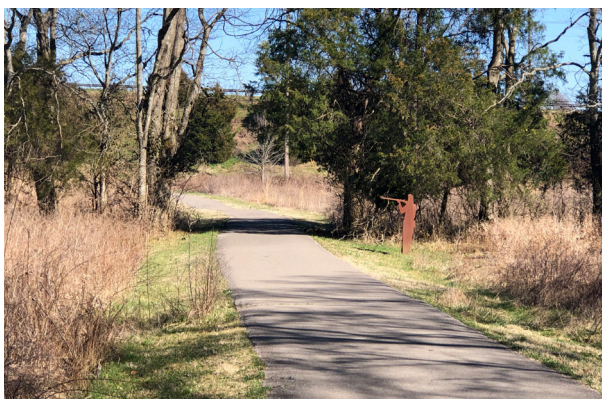
FIGURE 4-4. Asphalt walkways are currently employed to provide accessible routes within the Nashville Pike Unit and two Fortress Rosecrans units (QE, 2021).

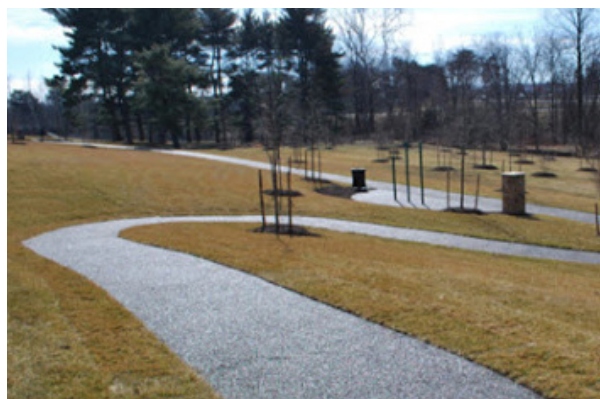
FIGURE 4-5. Flexi-pave is a heavy-duty porous pavement constructed of recycled passenger tires. It can provide an effective low-impact and accessible walking surface. Select a color that is compatible with the native soil of the cultural landscape (Capitol Flexi-Pave).

- Utilize materials, width, and edge treatment compatible with the historic character of the site and visitor use.
 - Use a material palette of asphalt, flexi-pave, or mulch for trails and walkways following non-contributing routes (see Figure 4-4 through Figure 4-8).

- With proper maintenance, asphalt, flexi-pave, concrete, crushed fines of limestone, rustic pavement, and colored chipseal can provide firm, stable surfaces compliant with ABAAS (see Figure 4-4, Figure 4-5,

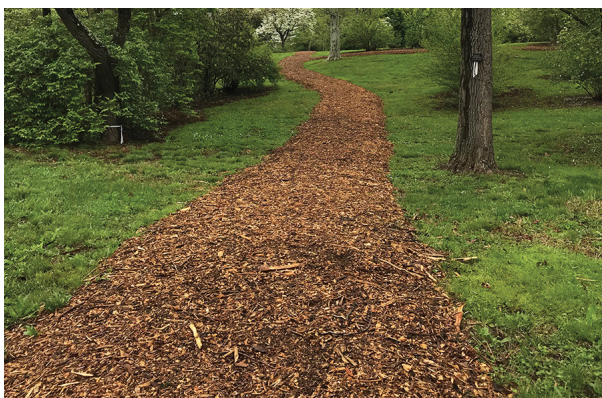
FIGURE 4-6. Mulch provides a layer of erosion protection and does not require excavation of the ground surface. However, it does not provide a firm, stable surface compliant with ABAAS (Arnold Arboretum).

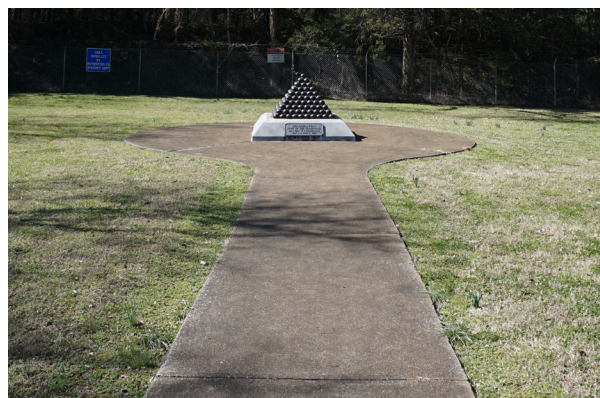
FIGURE 4-7. Concrete walkways at the Hazen Brigade Monument, General Rosecrans's Headquarters Site, and General Bragg's Headquarters Site are consistent with the historic character of early park circulation routes and also provide a firm, stable walkway surface (QE, 2021).

- Continue to use concrete walkways for routes that contribute to the Federal Stewardship and Conservation (1927–1966) Period at the Hazen Brigade Monument, General Rosecrans's Headquarters Site, and General Bragg's Headquarters Site (see Figure 4-7).

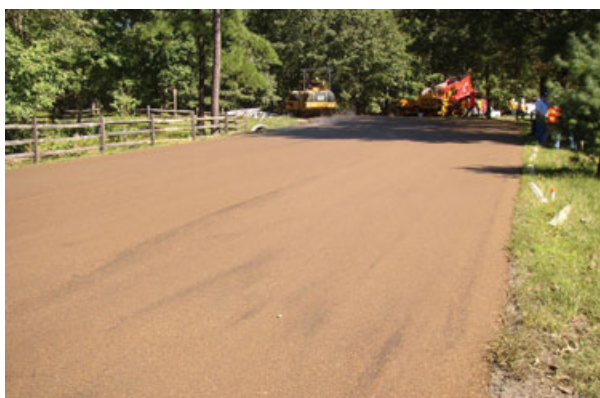
FIGURE 4-9. Rustic pavement can be used to emulate gravel or bare earth while providing a stable accessible route. The pavement utilizes a synthetic binder that allows a greater range of colors than asphalt pavement. Color variations may be achieved through a natural aggregate color with clear binder or pigmented binder (FHWA DOT).

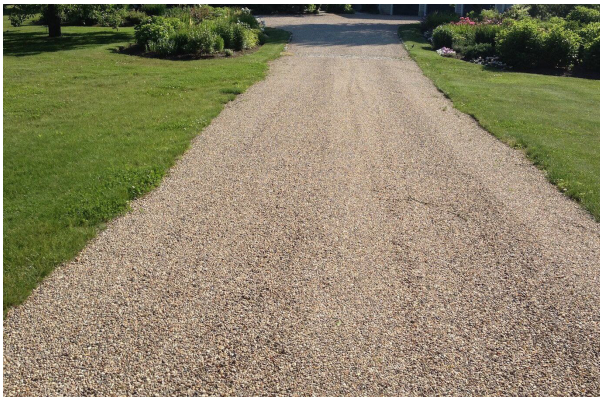
FIGURE 4-10. Colored chipseal combines asphalt pavement with a fine aggregate surface that appears similar to gravel or limestone fines pavement. Similar to flexi-pave or rustic pavement, select an aggregate color that is compatible with the character of the cultural landscape. Although properly maintained chipseal can provide a firm, stable surface, loose chips can cause the surface to be slippery. The texture of the chips may also discourage bicycle use (The Asphalt Jungle).
