# Stones River National Cemetery

## Cultural Landscape Report

# **Stones River National Battlefield Stones River National Cemetery**

November 2015

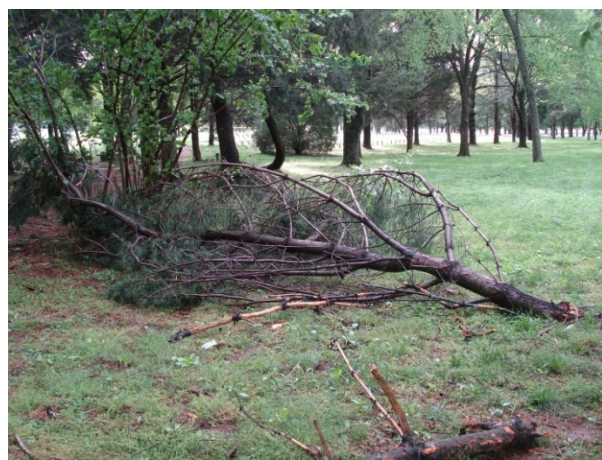
**FIGURE 48.** One of several trees and large branches that fell during storms on April 27, 2011. Source: Stones River National Battlefield, photo by park staff, 2011.

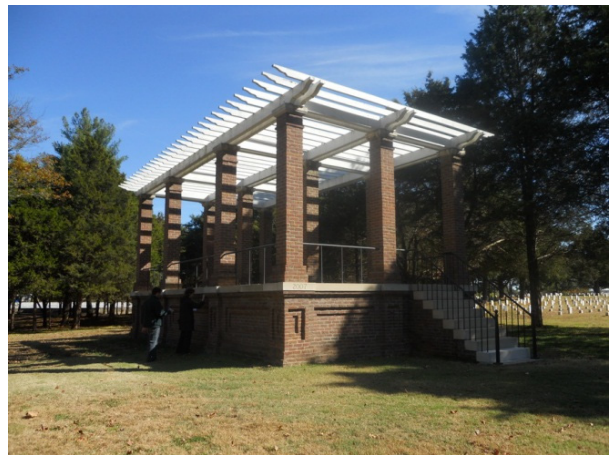
**FIGURE 97.** The original rostrum was demolished in 1941–1942 due to its poor condition. In 2007, the park reconstructed the rostrum based on original designs for the structure.

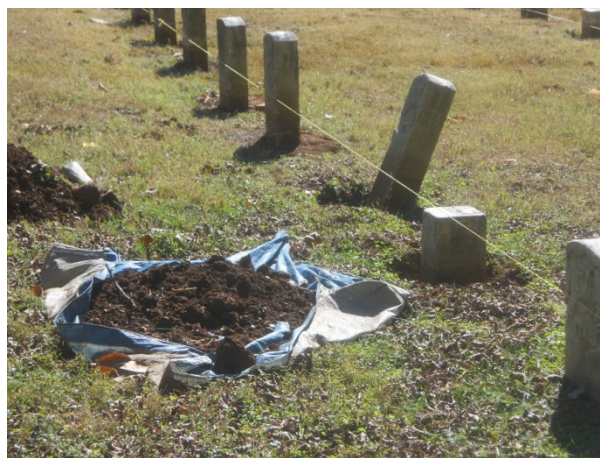
**FIGURE 127.** Grave markers are cleaned, repaired, and reset when necessary in accordance with *Director's Order No. 61: National Cemetery Operations*.

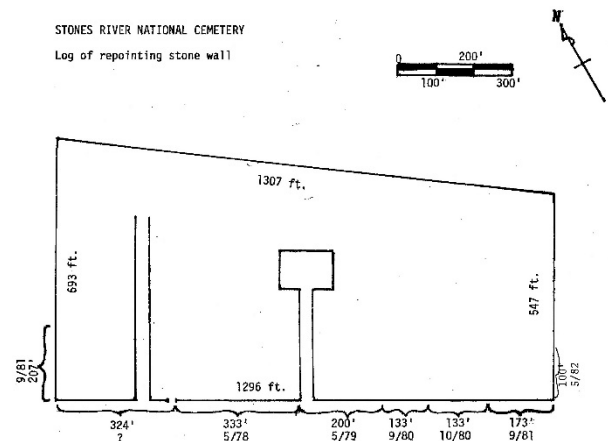
**FIGURE 176.** Key plan showing repointing work completed through May 1982. Repointing of the remainder of the wall continued into the early 1990s. Source: Stones River National Battlefield Archives, file CW1, "Log of Repointing Stone Wall," 1982.

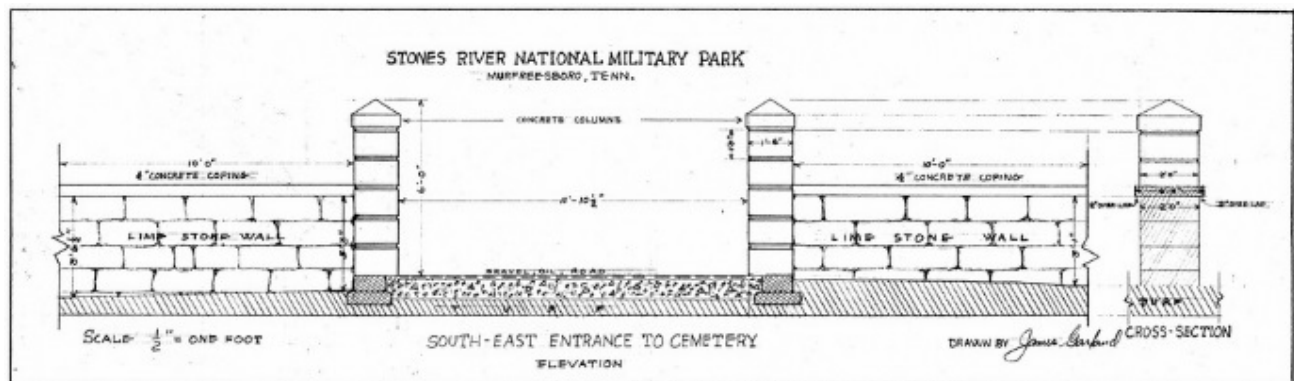
**FIGURE 186.** Drawing for the reconstruction of the cemetery entrance piers, circa 1896, showing concrete piers and stone curbs along the entrance drive. Stones River National Battlefield Archives, image STRI CEM 0025 GP 5.

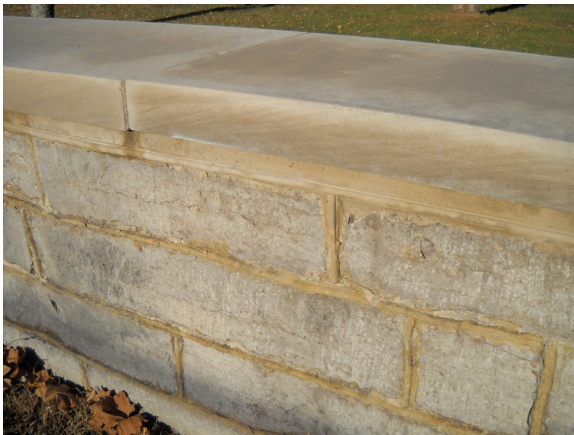
**FIGURE B-5, left.** Ashlar stone with beaded mortar joints at the street-facing portion of the site wall.

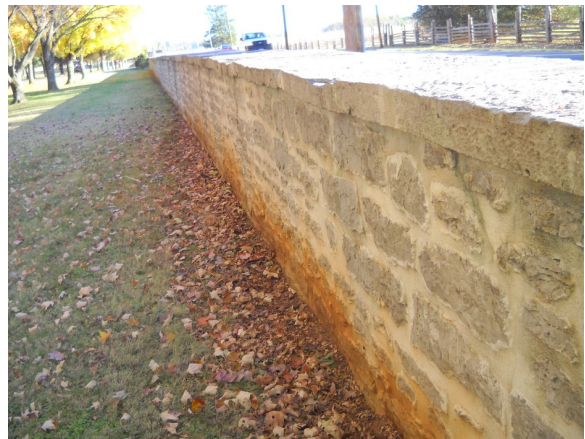
**FIGURE B-10, right.** Soiling at interior of site wall.

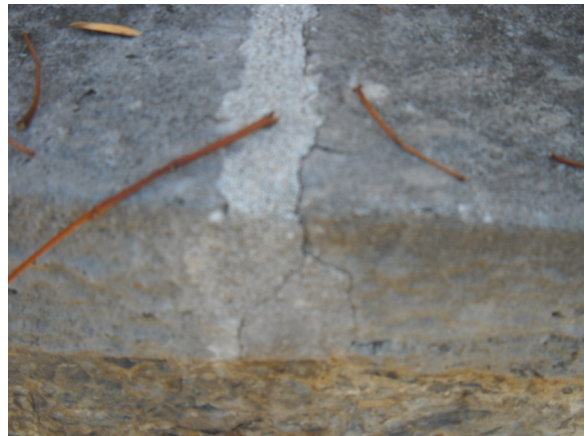
**FIGURE B-12, right.** Bond failure at sealant between coping stones.

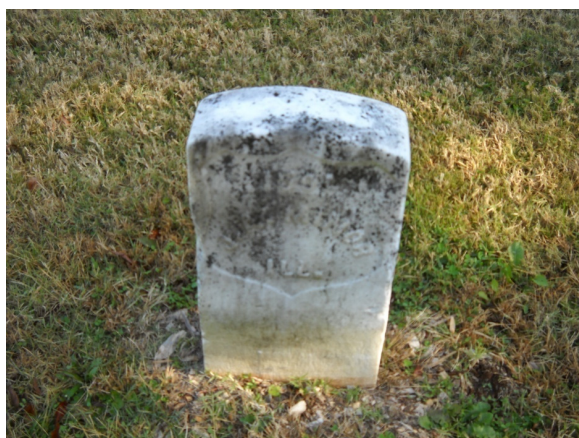
**FIGURE B-25, left.** Erosion and surface wear of inscribed shield and projecting lettering on Civil War era grave marker.

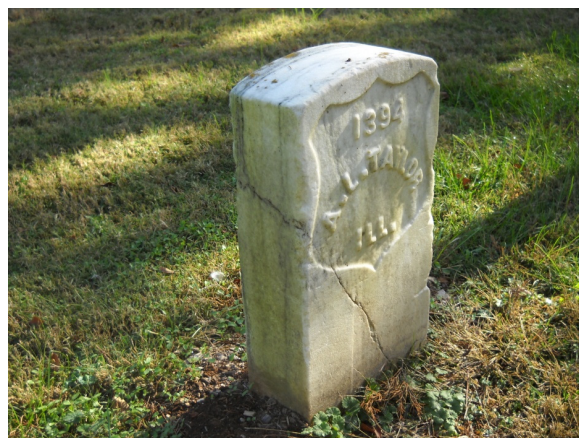
**FIGURE B-26, right.** Vertical/diagonal crack through grave marker.

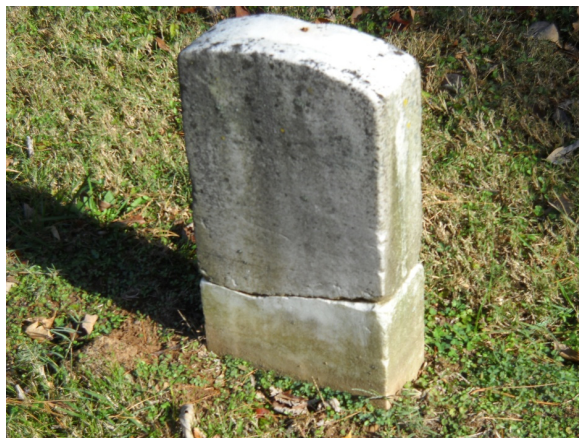
**FIGURE B-27.** Horizontal crack at base of a Civil War era grave marker.

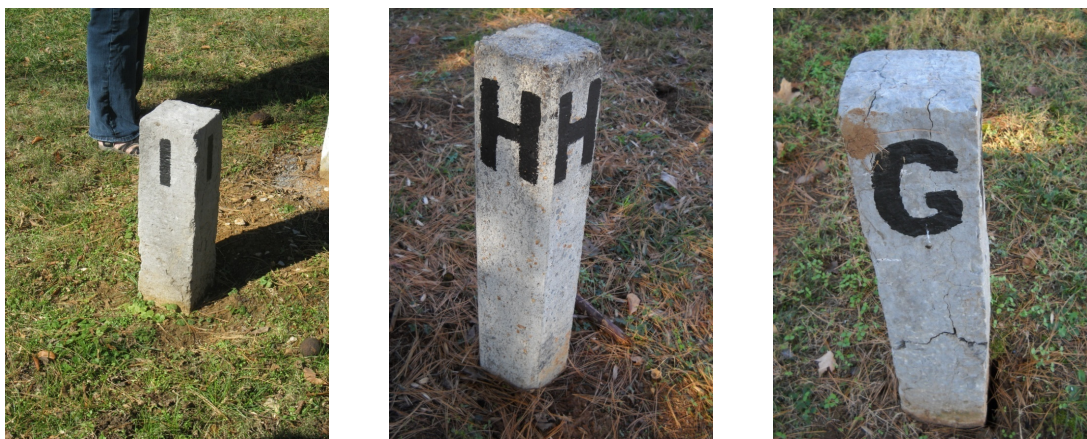
**FIGURE B-28, left.** Example of limestone section marker with chipping at the corners.
