CULTURAL LANDSCAPE REPORT - PART II
2026 UPDATE
TALLGRASS PRAIRIE NATIONAL PRESERVE

STRONG CITY, KS

| *JANUARY 2026*

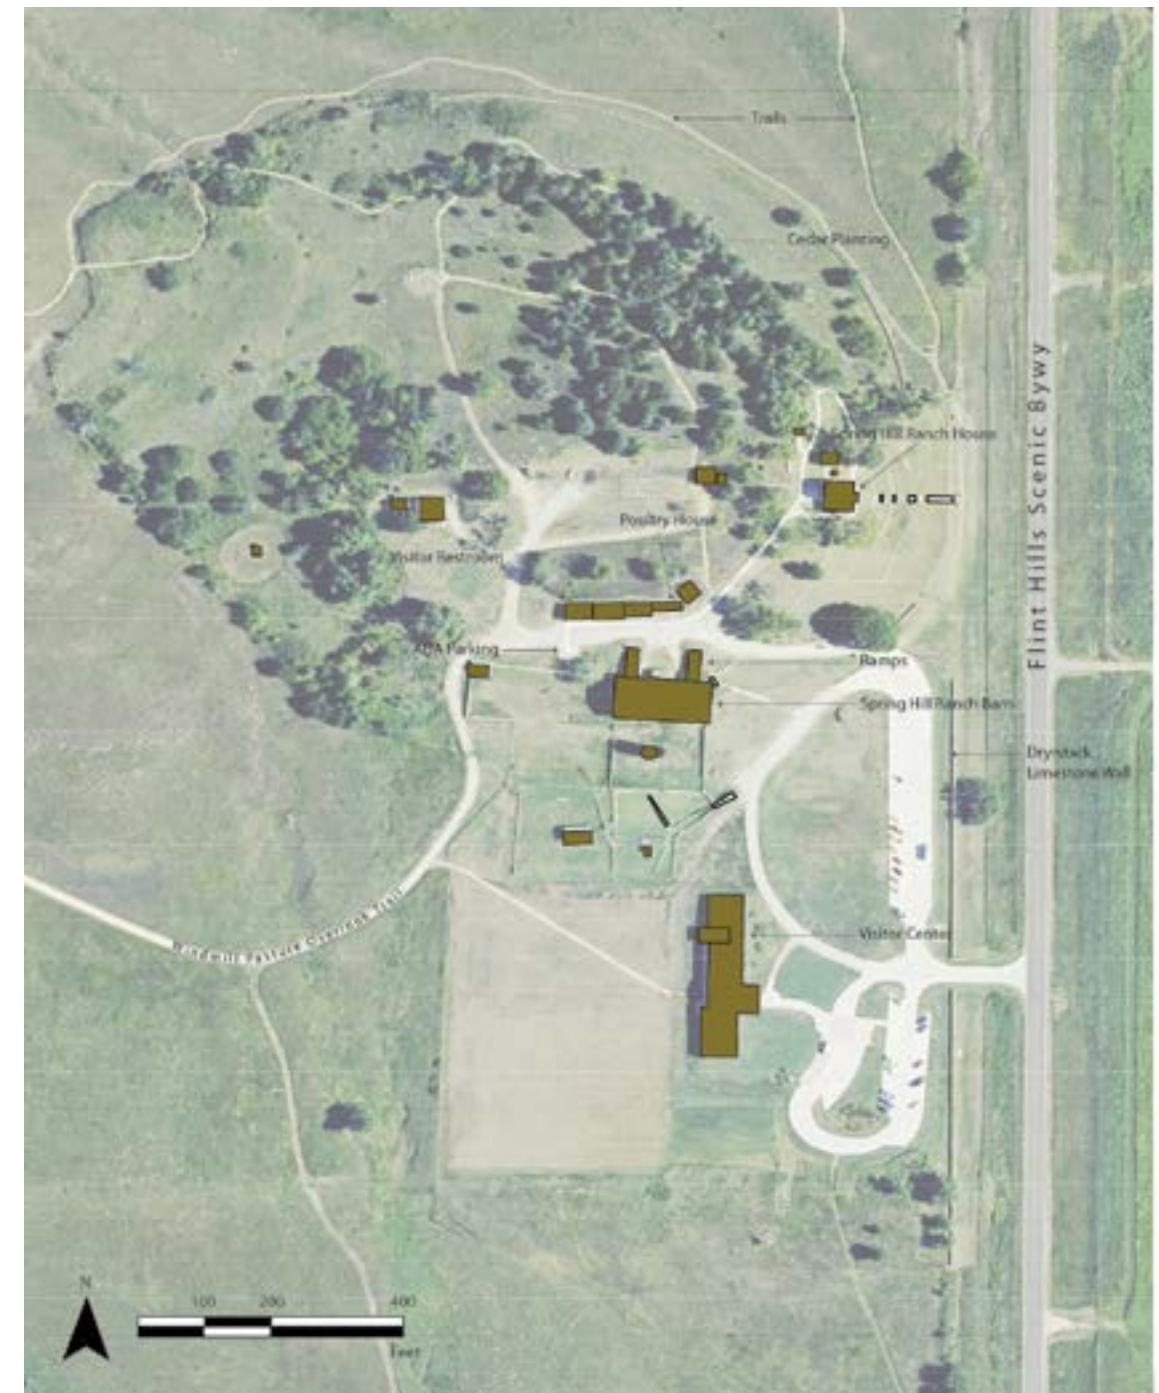
Figure 2-1. Management Zone 4 - ZBar/Spring Hill Ranch Headquarters.

Management Zone 4			
	Completed	Ongoing	Future
1. Stabilize and rehabilitate stone walls and fences	●	●	
4. Mitigate threats to spring boxes and spring houses			●
9. Expand shuttle tour route			●
10. Improve drainage in Spring Hill main house precinct and rehabilitate terraces			●
15. Protect cultural concentrations and features from prescribed burning		●	
16. Inventory, identify, control, and remove exotic invasive plants		●	
19. Establish circulation plan, including ADA access, between buildings within Z Bar/Spring Hill Ranch headquarters			●

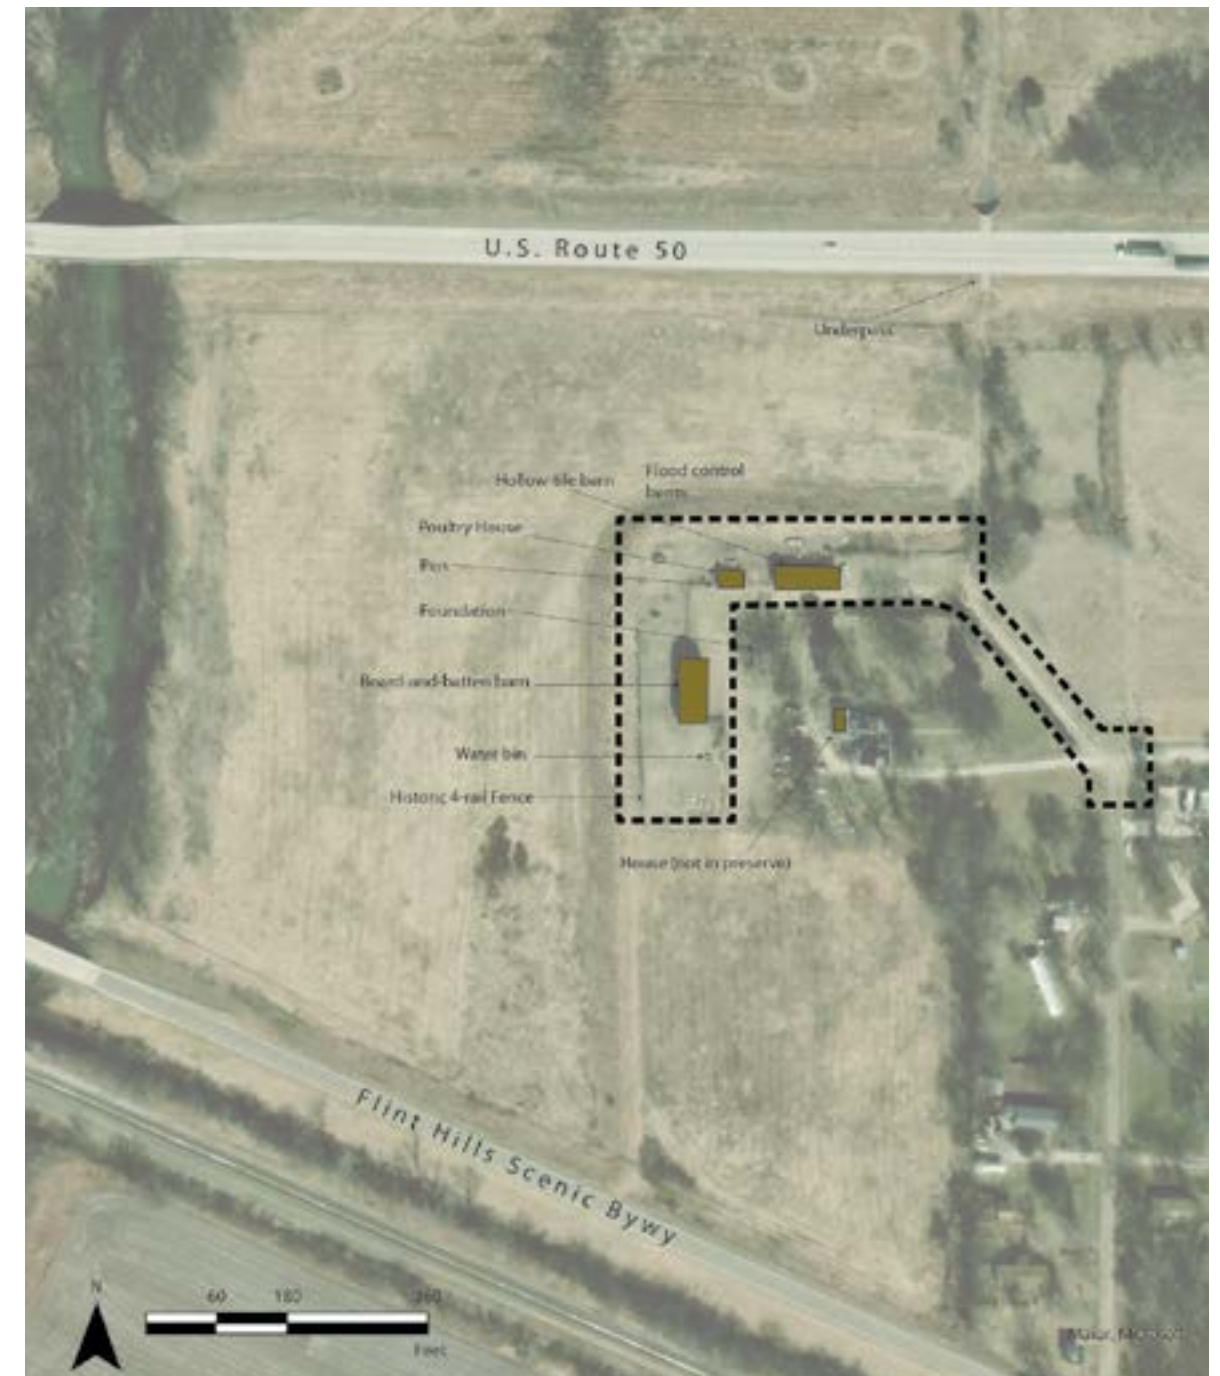
Figure 2-2. Management Zone 6- Deer Park Place.

Management Zone 6			
	Completed	Ongoing	Future
1. Stabilize and rehabilitate stone walls and fences			●
15. Protect cultural concentrations and features from prescribed burning		●	
16. Inventory, identify, control, and remove exotic invasive plants		●

As part of the design process undertaken with Project TAPR 334923, the Park expressed their desire to stabilize the Deer Park Place Barn (the largest barn on the property) in order to open portions of the lower level to visitors, provide parking and visitor access to all three structures, and rehabilitate the Urschel Tack Barn for Park use. These treatment options are discussed further in Chapters 5 and 6.

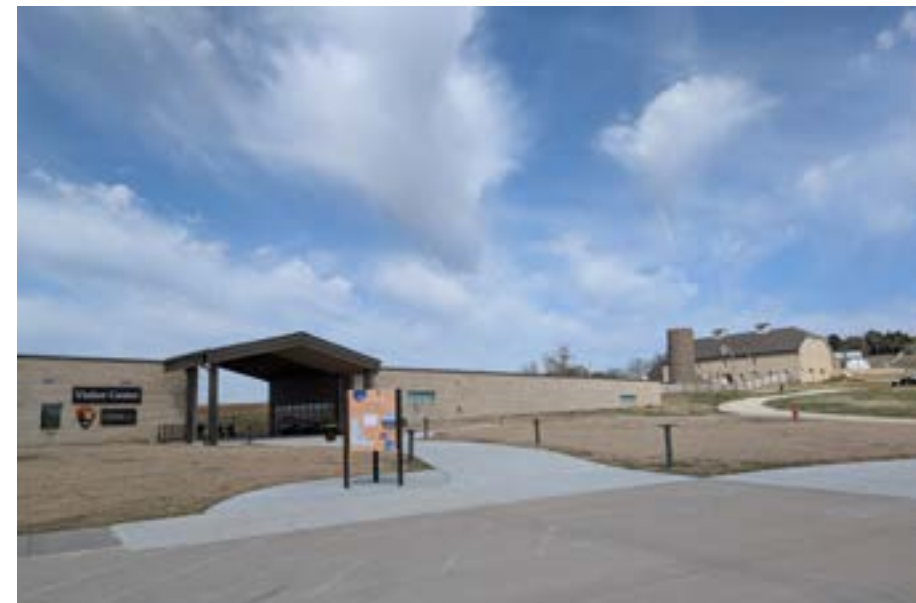
Figure 3-1. Visitor's Center and Park Headquarters, completed in 2012 (Vireo, 2025).

In 2012, a new \$6 million Visitor Center opened, including restrooms, a gift shop, and park headquarters, including staff offices and visitor contact. The center enhances interpretive experiences for visitors and acts as a gateway to the Preserve (Figure 3-1). As part of this project, a new paved visitor parking lot was constructed with accessible stalls and walkway to the Visitor's Center (Figure 3-2).

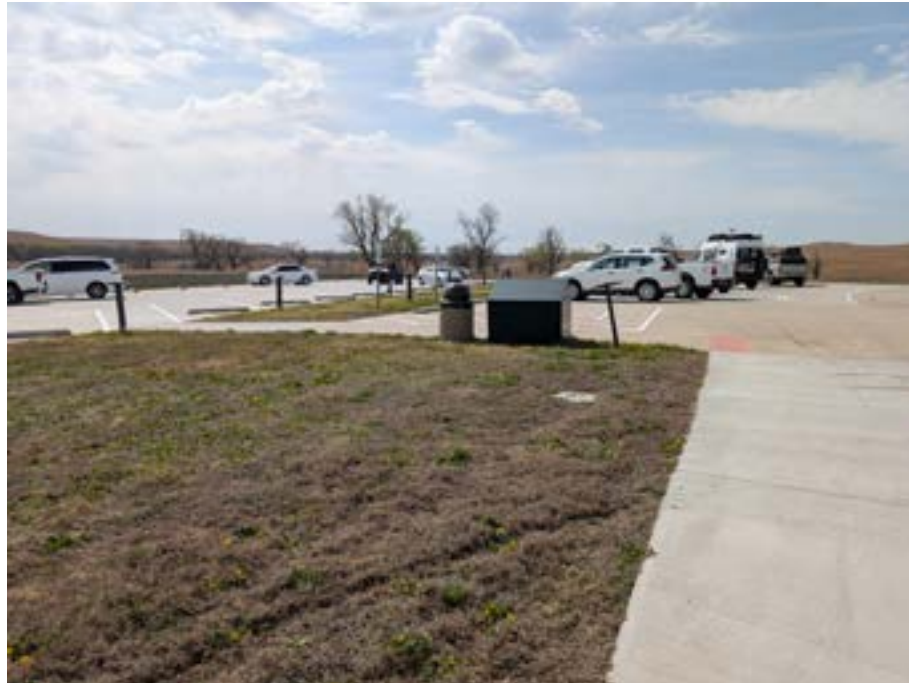
Figure 3-2. Paved Visitor's Center parking with accessible spots, completed in 2012. (Vireo, 2025).

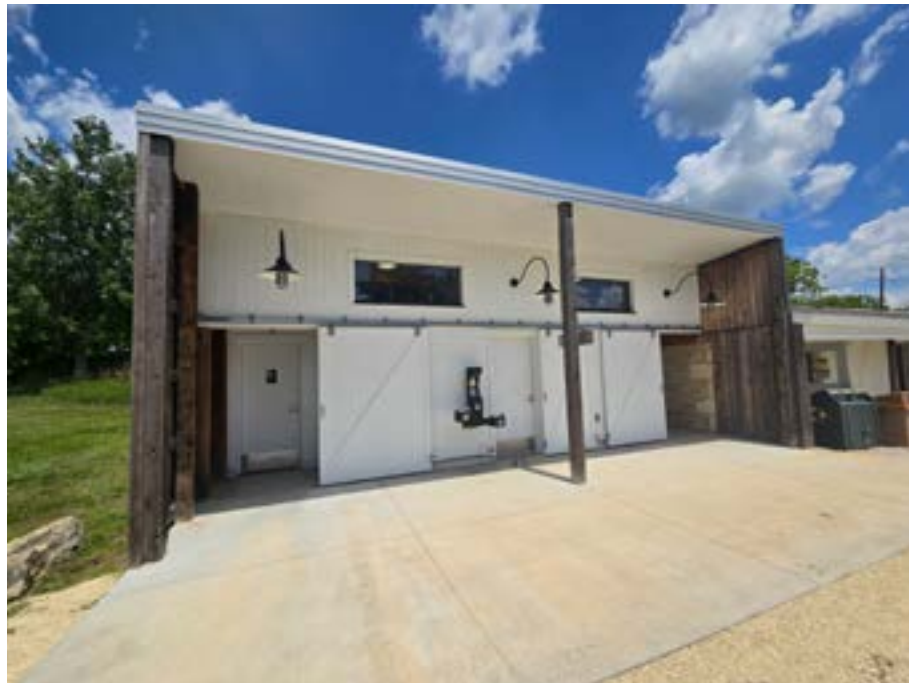
Figure 3-3. Accessible visitor restrooms, completed in 2020 (Vireo, 2024).

Other completed treatment projects included construction of a second visitor restroom building, across from the Spring Hill Barn, in 2020 (Figure 3-3), and a rehabilitation project for the Spring Hill Ranch Home completed in 2019.

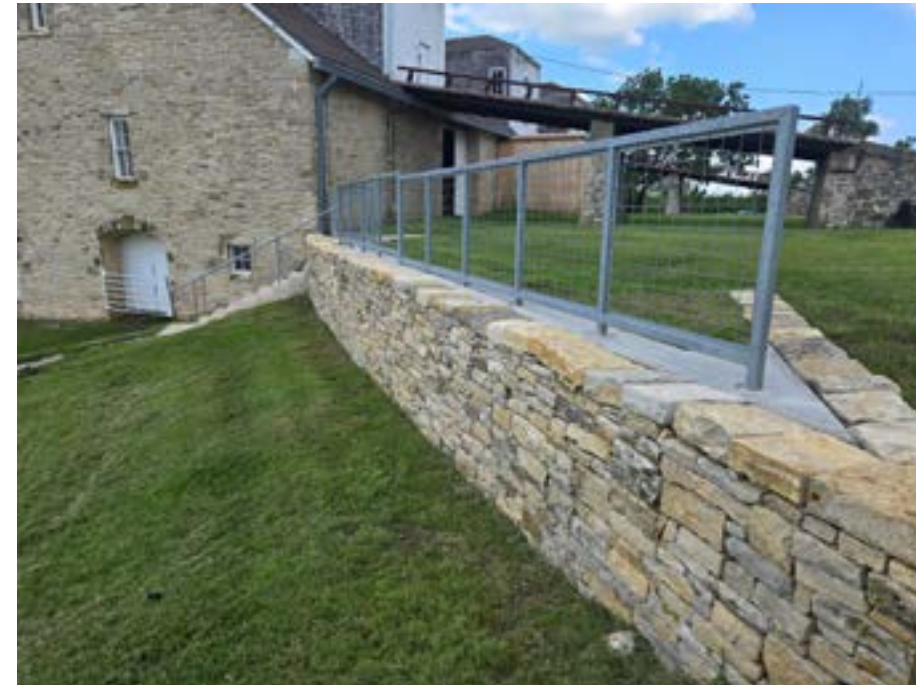
Figure 3-4. Reconstructed stone veneer retaining wall and steps, completed in 2020 (Vireo, 2024).

In 2020, a failing dry-stack retaining wall and stone steps east of the barn were rebuilt with concrete and a dry-stack stone limestone veneer, along with a new guardrail and limestone steps (Figure 3-4). New dry-stack limestone walls were added along Highway 177, and a new Park sign is located at the park entrance.

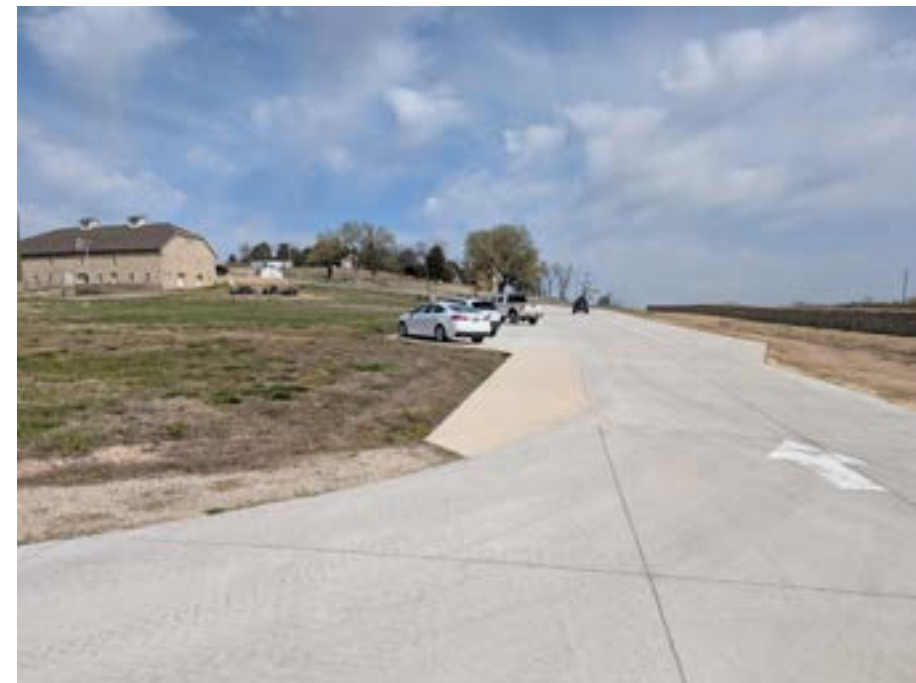
Figure 3-5. Paved parking lot, completed in 2020 (Vireo, 2024).

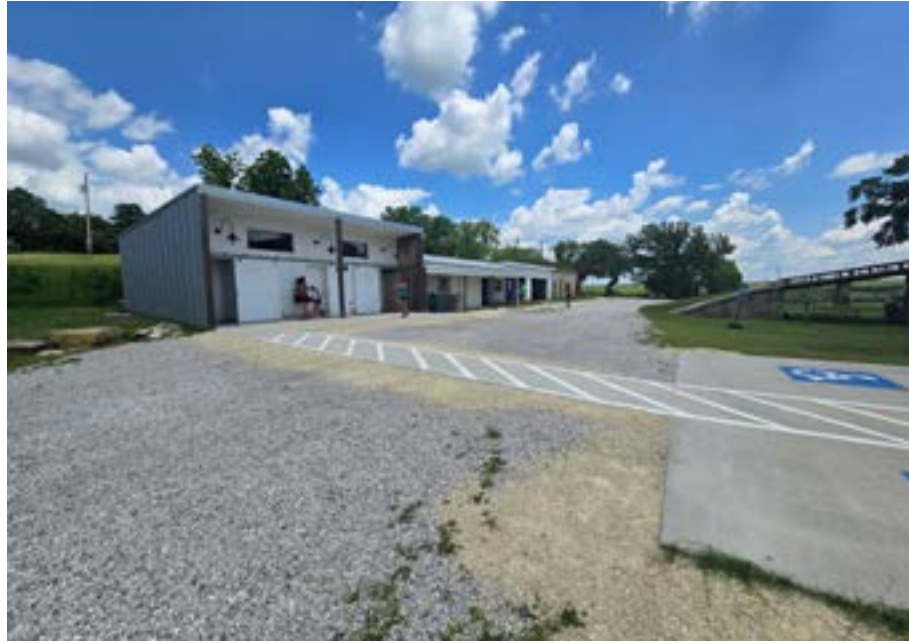
Figure 3-6. Accessible parking stalls adjacent to Spring Hill Ranch Barn, completed in 2020 (Vireo, 2024).

Northwest of the Spring Hill Barn, two new accessible parking spots (Figure 3-6) were added along with a sidewalk connecting this parking to the new restroom building and the Spring Hill Ranch Home.

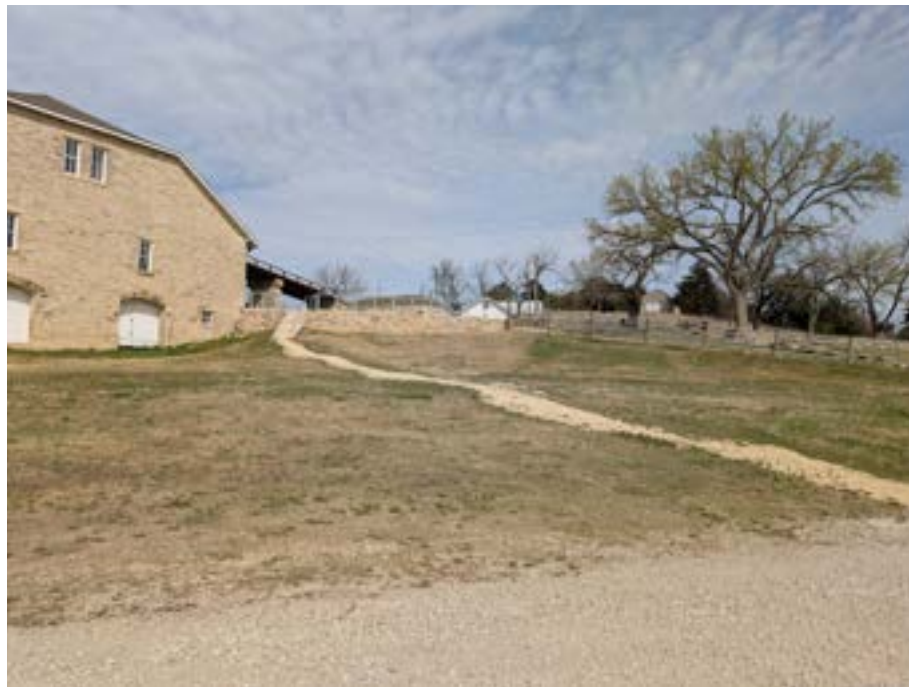
Figure 3-7. Gravel path at new steps, completed in 2020 (Vireo, 2025).

As part of the stone wall and steps construction, a new gravel path was added along the slope east of the Spring Hill Barn, connecting the upper level of the site with a gravel access road which provides connection to the new paved parking and Visitor's Center.

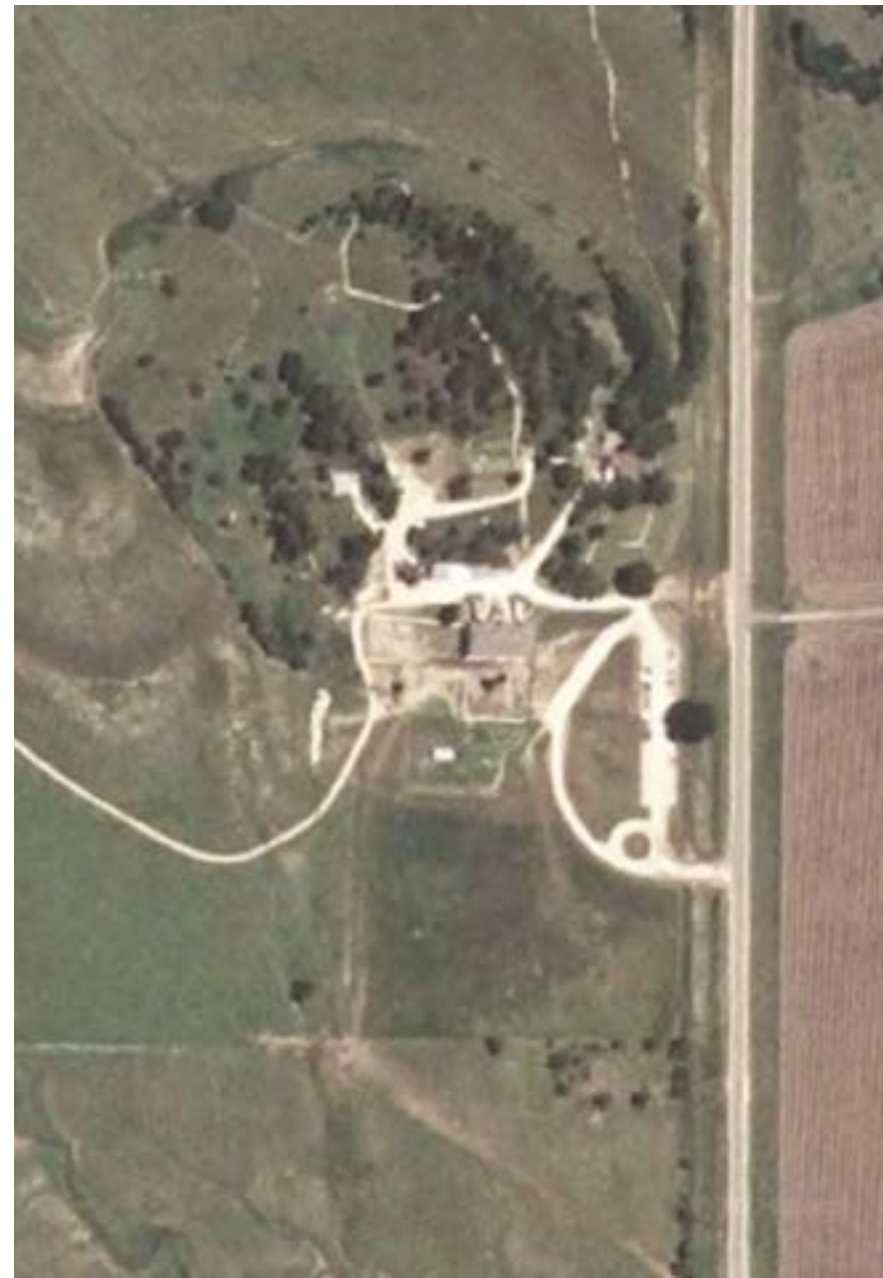
Figure 3-9. 2005 Aerial Photograph- Z Bar/Spring Hill Ranch depicting shift of Park entry and additional parking (Google Earth).

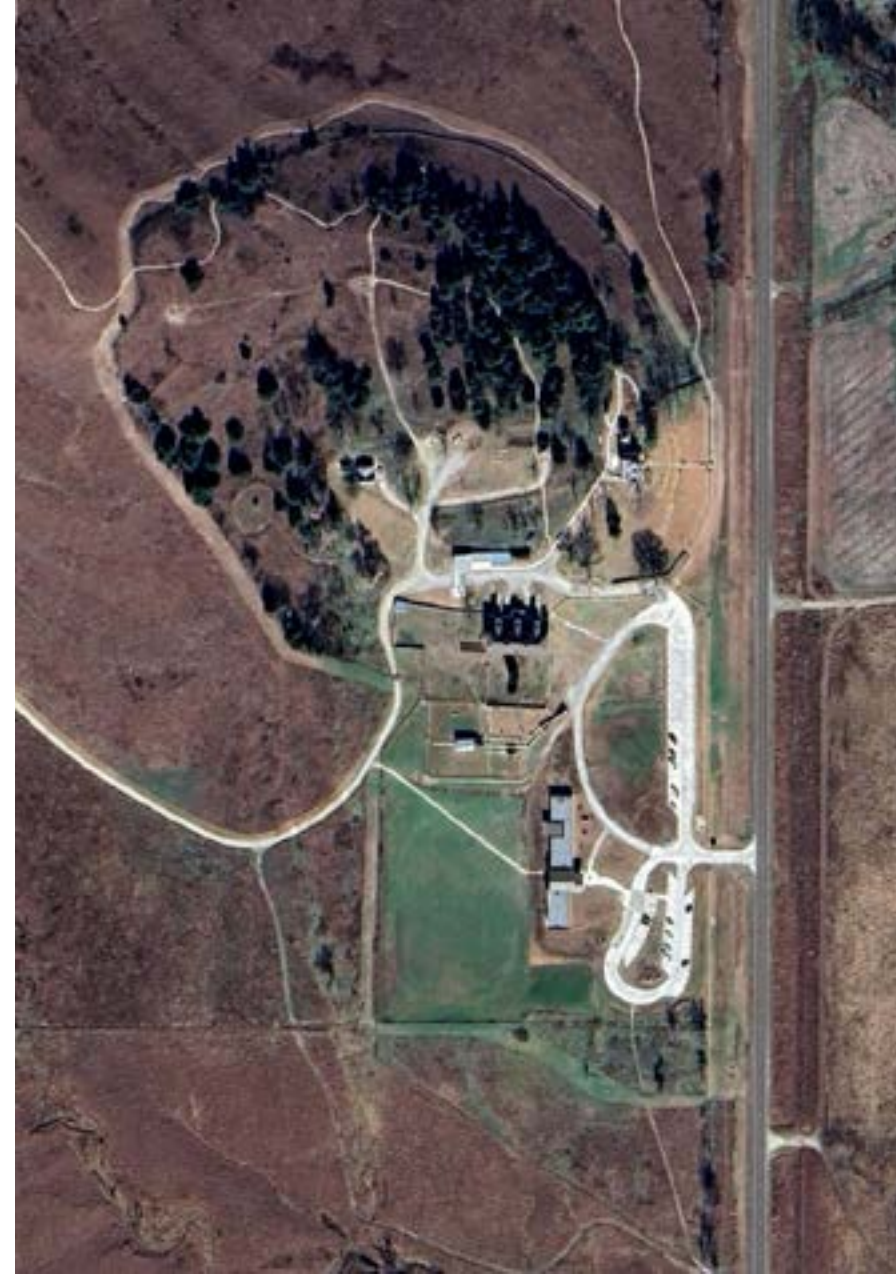
Figure 3-10. 2023 Aerial Photograph- Z Bar/Spring Hill Ranch depicting Visitor Center and additional circulation (Google Earth).

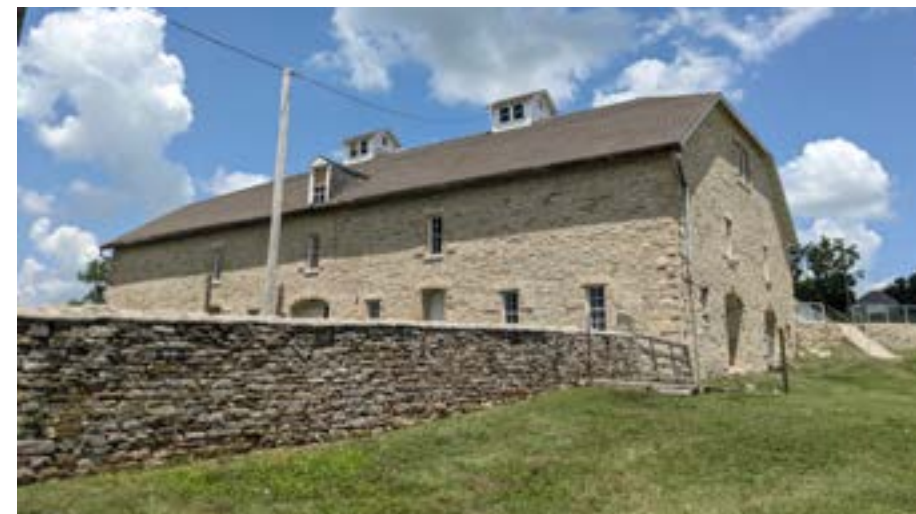
Figure 6-1. Eastern and southern facade of the Spring Hill Barn (Vireo, 2024).

The Spring Hill Ranch Barn (Figure 6-1), part of Management Zone 4, is a key historic feature at the Tallgrass Prairie National Preserve, and maintaining and repairing the structure is crucial to preserve the historic character of the ranch. The following treatment recommendations for the Barn as well as the surrounding landscape were identified in the Basis of Design Report and prioritized by the 2024 Value Methodology Workshop.

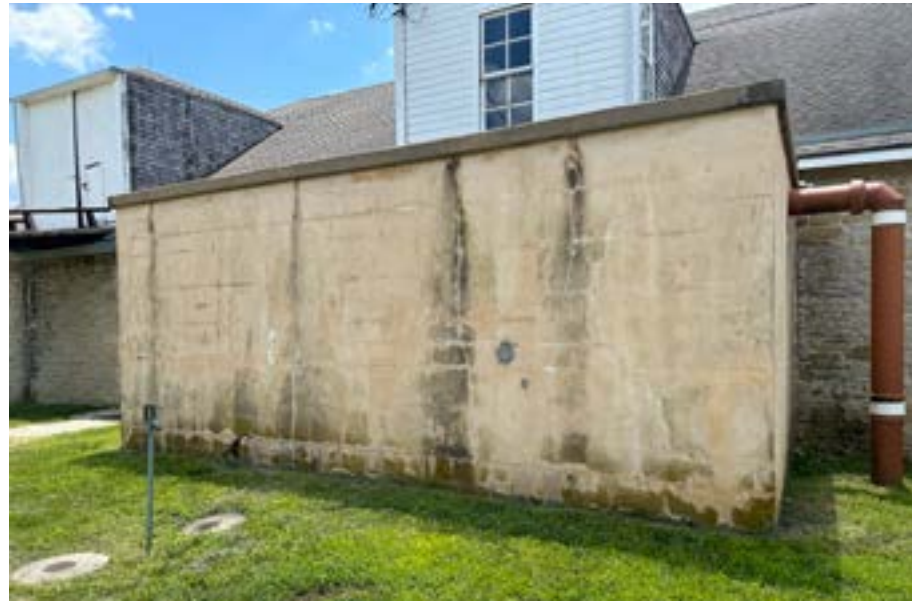
Figure 6-2. Existing cistern (Affinis, 2024).

In keeping with the treatment approach of rehabilitation identified in the 2004 CLR, the Park determined that long term stabilization of the Deer Park Place Barn was necessary to provide protection of a National Historic Landmark property. Other priorities established during the workshop included replacement of the Spring Hill Barn fire protection system, providing Architectural Barriers Act Accessibility Standard-(ABAAS) compliant site access to the 2nd floor of the Spring Hill Barn by adding a connection to the existing compliant route, and the demolition of the cistern to provide access for repairs to the historic barn.

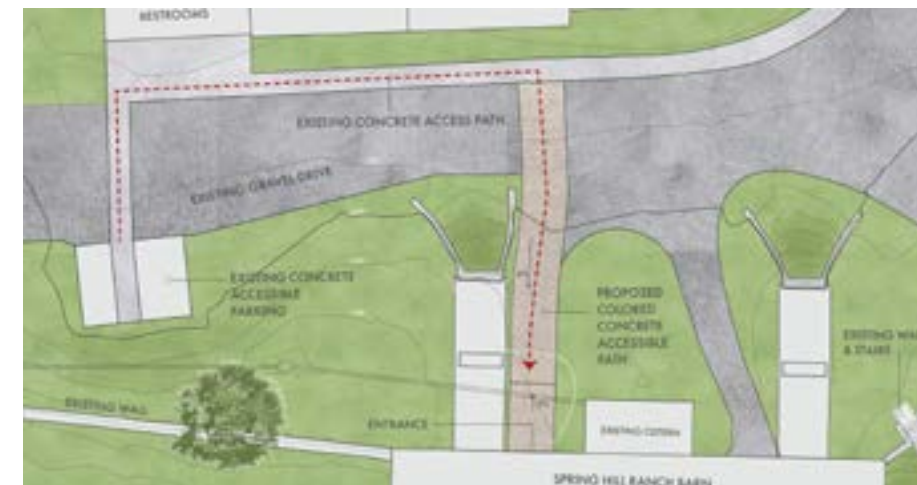
Figure 6-3. Access path to the second floor of the Spring Hill Ranch Barn (Vireo, 2024).

- Construct a new sidewalk to connect existing accessible parking to the northwest second floor entry of the barn (Figure 6-3)
- Add gravel walk along northern parking lot leading to the Visitor's Center (Figure 6-4)

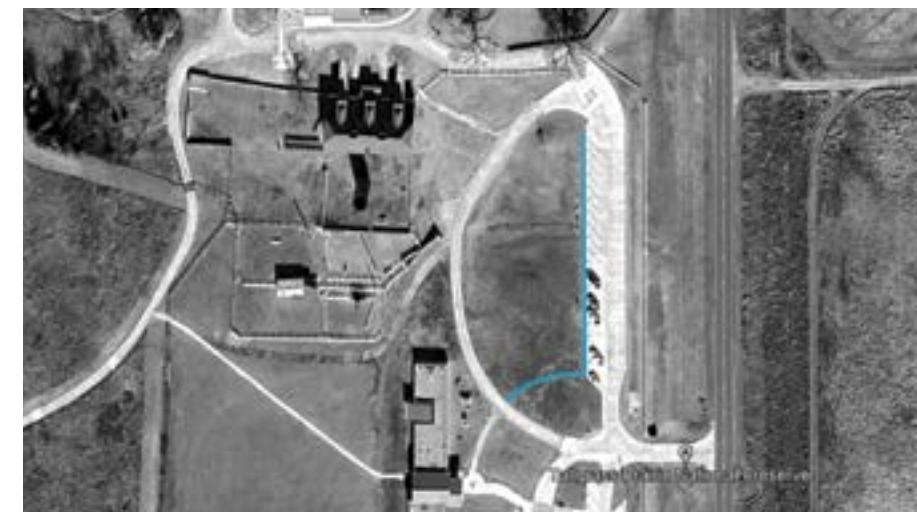
Figure 6-4. New gravel walk along northern parking lot (Vireo, 2024).

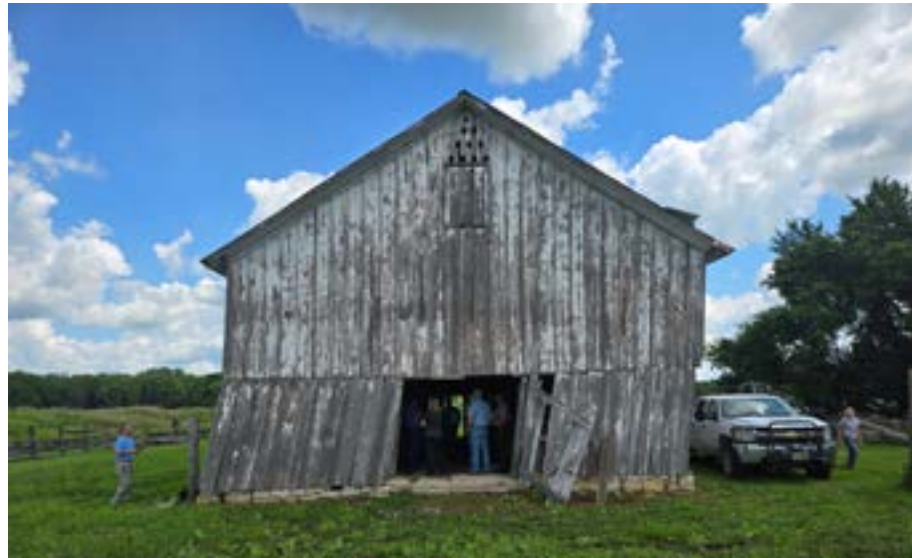
Figure 6-5. Deer Park Place Barn southern facade (Vireo, 2024).

Deer Park Place Barn is a contributing structure within the 1997 NHL nomination, and is located in Management Zone 6. The barn is in a state of accelerated degradation and is in imminent danger of collapse (Figures 6-5 and 6-6). An emergency stabilization project for the south two bays was undertaken in November 2024. Other recommended treatments include:

- Stabilize and rehabilitate the barn to offer visitor interpretation and some storage for park staff. The barn would not be fully ABAAS accessible due to elevation changes across the first floor.
- Reconstruction of Bays 5 and 6
- Repair and replacement of deteriorated wood siding
- Structural repairs to framing
- Foundation replacement
- Demolition of interior concrete
- Reconstruction of the cupolas
- Replace roof with corrugated roofing

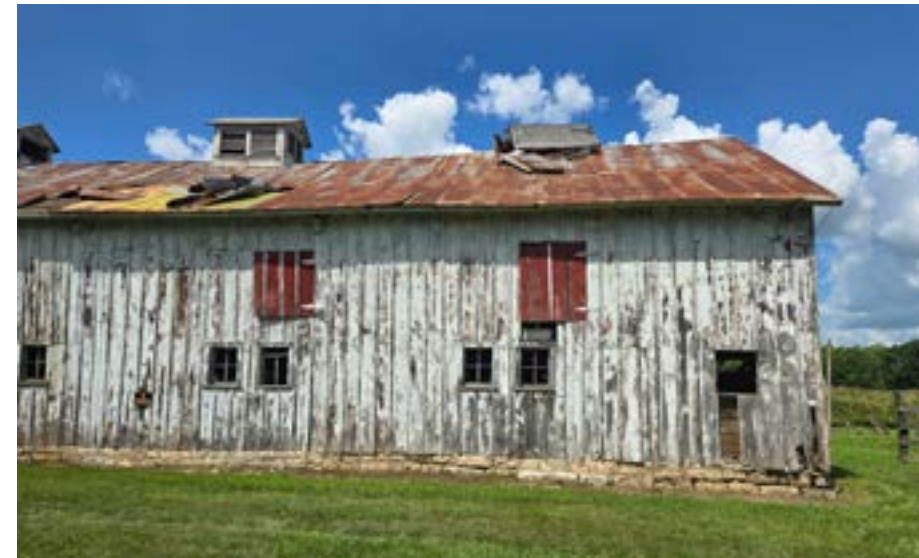
Figure 6-6. Deer Park Place Barn eastern facade (Vireo, 2024).

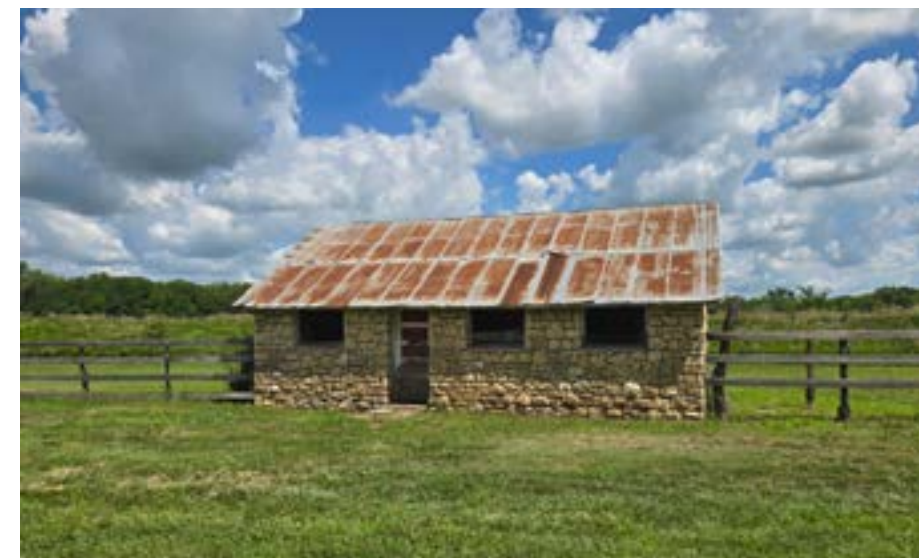
Figure 6-7. Urschel Poultry House (Vireo, 2024).

Dating from the 1920-30's, the poultry house is a contributing structure within the 1997 NHL nomination and is in generally fair condition. Recommended treatments include:

- Rehabilitation of the roof and gable structures
- Exterior masonry repairs
- Rehabilitation and replacement of windows and exterior doors
- Repair of the end gable wood-framed walls
- Restoration of the chicken doors

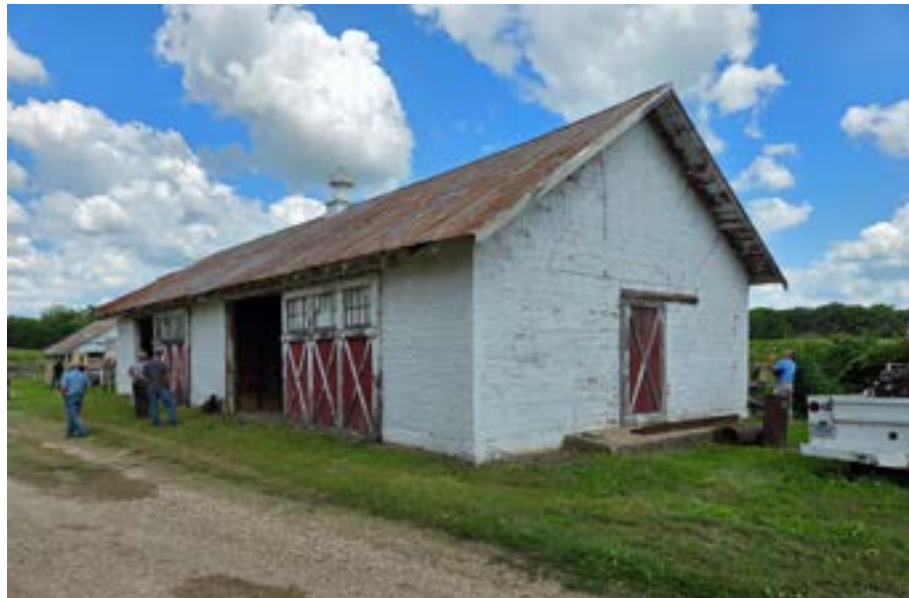
Figure 6-8. Urschel Tack Barn (Vireo, 2024).

The Tack Barn (Figure 6-8) is a contributing structure within the period of local significance for the draft 2024 National Register (NR) nomination. The structure is currently utilized by the Park for storage of equipment and materials. Treatment recommendations include:

- Foundation underpinning
- Repointing
- Repairs to the concrete floor slabs
- Roof truss and framing repairs
- Replacing seam roof with seam galvalume roof
- Restoration and replacement of windows and doors

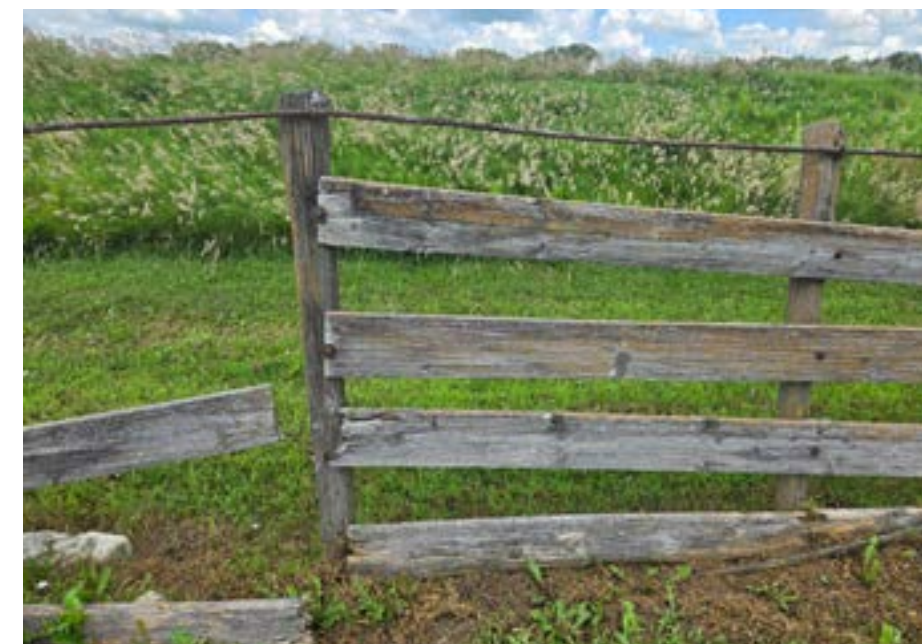
Figure 6-9. Existing four-rail fence (Vireo, 2024).

- Repair existing wooden four-rail fence
- Replace missing sections of four-rail fence in-kind with historic fence
- Fabricate and install six new custom gates inspired by historic design
- Erect a new fence to delineate boundary of private property

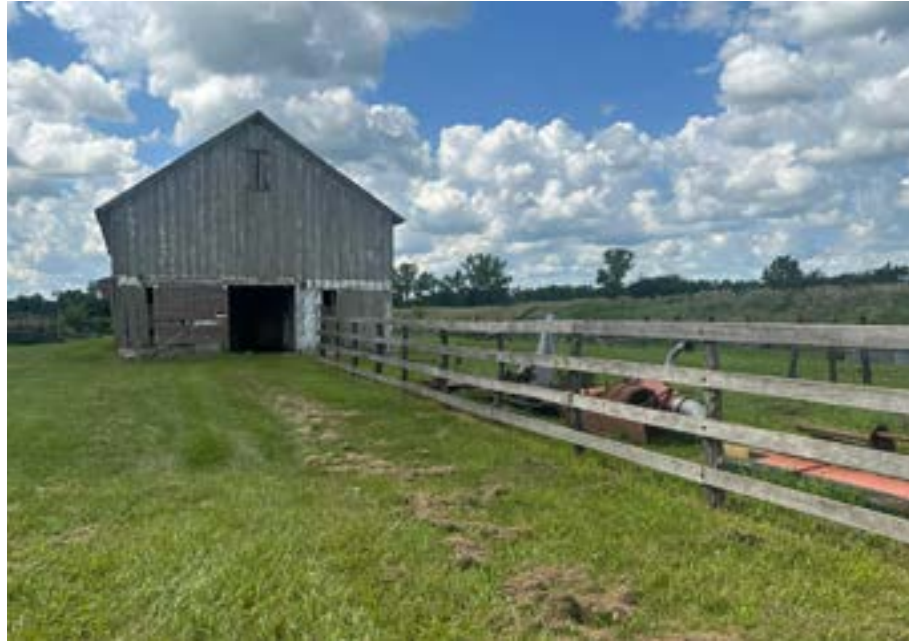
Figure 6-10. Existing four-rail fence to remain (Affinis, 2024).

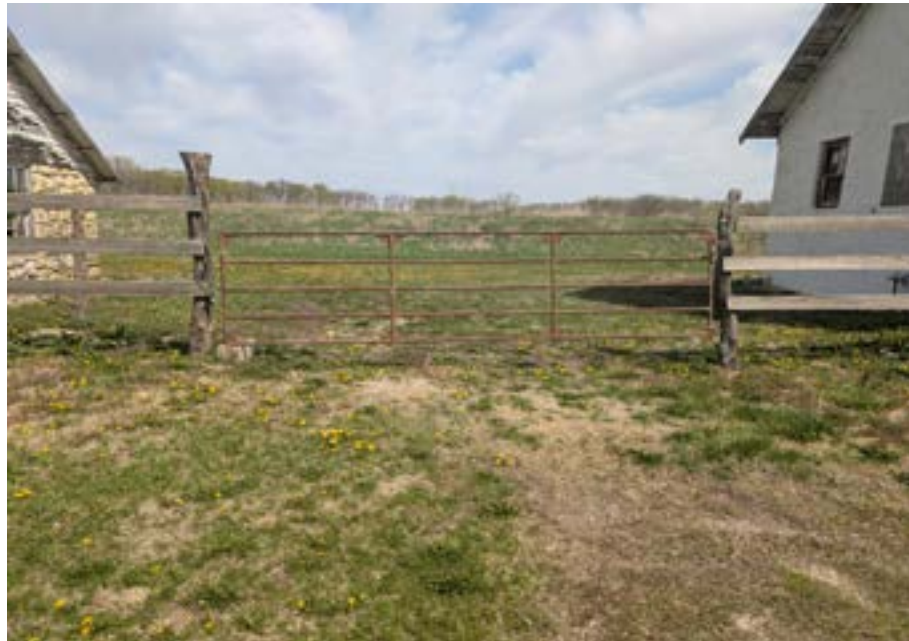
Figure 6-11. Existing steel gate to be replaced with custom swing gate (Vireo, 2025)
