*HISTORIC PROPERTY PROJECT DOCUMENTATION AND  
CLIMATE CHANGE TREATMENT PLAN*  
TALLGRASS PRAIRIE NATIONAL PRESERVE

Final | November 2024

STRATA Architecture  
Kansas City, MO

Quinn Evans  
Ann Arbor, MI

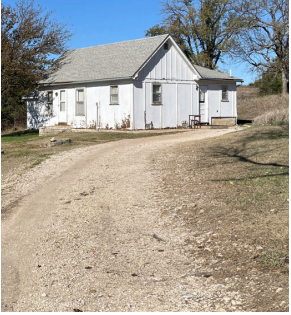
| TABLE 2: CURRENT CONDITION ASSESSMENT OF LANDSCAPE FEATURES | | | | | | | | | |
|---|---|---|---|---|---|---|---|---|---|
| Ranch hand house | 105994 | 289013 | 71693 | Contributing | Fair to Poor | The ranch hand house was moved from another ranch in the area at an unknown time. The building itself dates to ca. 1950. It is a one-and-a-half story house with a side gable roof. The building is clad in wood board-and-batten siding. There is a one-story ell addition on the north elevation. The interior is not accessible, but it is used for storage and has not been maintained as a habitable space. The building envelope and foundation show signs of deterioration. Overall the building is in fair to poor condition. | | No anticipated direct impact. Fire risk reduction will support protection of contributing buildings and structures within the study area. | Treatment of buildings and structures not included within this project scope. |

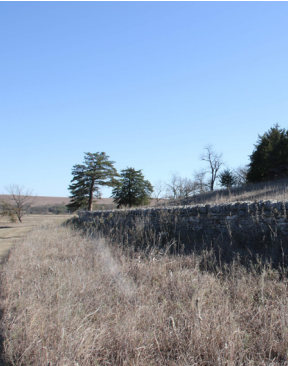
| TABLE 2: CURRENT CONDITION ASSESSMENT OF LANDSCAPE FEATURES | | | | | | | | | |
|---|---|---|---|---|---|---|---|---|---|
| Tallgrass prairie vegetation over majority of the site | 97064 | | | | Fair | <p>The tallgrass prairie vegetation within the APE was dormant during the time of field investigation. It appears to consist primarily of native warm season grasses (Indian grass, big bluestem, switchgrass, little bluestem, and sideoats grama), forbs, and some cool season grasses (fescue and smooth brome). The seedheads of several forb species were observed, including goldenrod, rough blazing star, milkweed, and asters. Several shrubs were observed within the tallgrass prairie, including the following:</p> <ul style="list-style-type: none"> <li>• Dogwood thicket along the walking trail to the west of the cedar plantation.</li> <li>• Scattered smooth sumac groupings along the stone fence line.</li> <li>• A large smooth sumac thicket to the west of the main house and outbuildings.</li> </ul> <p>Dead trees and scattered debris piles of dead tree limbs were observed throughout the prairie vegetation and enhance the risk of fire.</p> | | Treatment will improve integrity of contributing vegetation type. | <p>Remove dead trees within prairie vegetation as necessary. Snag trees (standing dead or dying trees) may remain in place to serve as habitat on a case-by-case basis, provided they are not a hazard to existing buildings or people.</p> <p>Remove all existing brush piles and debris within prairie vegetation as soon as possible. Brush piles should be hauled away and disposed of in accordance with local and state regulations. Burning of the brush piles on site is not recommended. However, burning could occur under an approved burn plan or in conjunction with prescribed burns of the prairie. Burning should be supervised by trained fire staff.</p> <p>Remove any future vegetative debris within three to six months of being created.</p> <p>Remove shrub thickets. For thickets within prairie vegetation, prescribed fire in conjunction with herbicide applications should be used as a management tool.</p> |

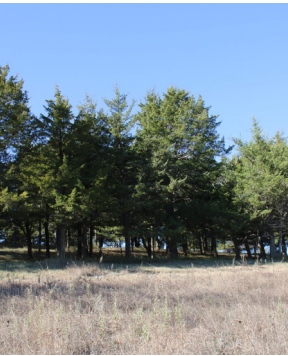
| TABLE 2: CURRENT CONDITION ASSESSMENT OF LANDSCAPE FEATURES | | | | | | | | | |
|---|---|---|---|---|---|---|---|---|---|
| Cedar plantation, Spring Hill/Z Bar Ranch headquarters | 97060 | | | | <p>Cedar tree conditions range from poor to good.</p> <p>Walnut tree conditions are consistently poor.</p> | <p>The cedar plantation is situated to the north of the main house and outbuildings. It curves around on north- and east-facing slopes with a gravel walking path cutting through the trees. The plantation is populated with eastern red cedars, which serve as the dominant overstory species. The cedar trees vary in age, size, and condition. The density of the cedars varies throughout the plantation, with areas of open space to walk between the trees while other areas have trees growing together in close proximity, almost on top of one another. The cedars’ consistent canopy coverage provides a unique, woodland-like landscape experience. Dead trees, broken and fallen limbs, and scattered limb debris were observed consistently throughout the plantation and contribute to the fire risk. Some cedar trees were observed with low branches, which could serve as ladder fuels for fire. Walnuts appear to be the most common deciduous shade tree appearing within the plantation. Many of the walnuts appear to be dead or in poor condition. The understory vegetation consists of an herbaceous layer comprised primarily of native warm season grasses with scattered forbs.</p> | | <p>Treatment will improve the condition of the contributing vegetation feature. New conifer species outlined in the Alternate Coniferous Trees for Cedar Windbreak list in General Recommendation #4 are compatible with the historic character of the cedar windbreak while also possessing drought tolerance and capacity to adapt to climate change.</p> | <p>Remove all dead walnuts and eastern red cedars within the historic context of the windbreak.</p> <p>Remove all live eastern red cedars, regardless of condition, outside of the historic context of the windbreak.</p> <p>Remove all existing brush piles and debris within the windbreak as soon as possible. Brush piles should be hauled away and disposed of in accordance with local and state regulations. Burning of the brush piles on site is not recommended.</p> <p>Remove any future vegetative debris within three to six months of being created.</p> <p>Perform selective pruning to remove dead or dying branches to improve safety, enhance appearance, and improve the trees’ overall health. Remove those cedars with extensive damage affecting their viability and replace within the historic context of the windbreak.</p> <p>Perform selective pruning to remove lower branches of the existing cedar trees to at least twice the height of surrounding grass vegetation to help reduce ladder fuels.</p> |

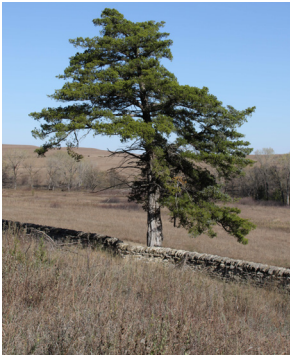
| TABLE 2: CURRENT CONDITION ASSESSMENT OF LANDSCAPE FEATURES | | | | | | | | | |
|---|---|---|---|---|---|---|---|---|---|
| Trees along fencelines | 97065 | | | | Poor to fair | Both deciduous and evergreen trees are found along the stone fence, which curves around the northern side of the main house, outbuildings, and cedar plantation. Along the section of stone fence located near the house, a mixed deciduous tree grove (walnuts, elms, and redbuds) with volunteer cedar trees was found within the fence line. The condition of these trees appears to range from poor to fair, with the walnut tree conditions consistently being poor. The remaining trees appear to be in fair condition. These tree conditions appear to range from poor to fair, with the walnut tree conditions consistently being poor. These trees appear to be in fair condition. Just beyond the tree grove, a few solitary cedar trees are growing immediately adjacent to the stone fence. The final third length of the stone fence, which appears to be loose stacked stone, has a vegetative thicket of deciduous trees and shrubs encroaching on the fence and, in some cases, growing within gaps in the stone. | | Treatment will improve the condition of contributing vegetation. | Remove existing cedar trees regardless of condition. Cedars should be mechanically removed by cutting below the bottom most branch.<br><br>Replace walnuts and other deciduous trees in grove north of house with trees from the list in Chapter 6.<br><br>Remove shrub thickets within and adjacent to stone walls by a combination of mechanical and herbicide treatments. |

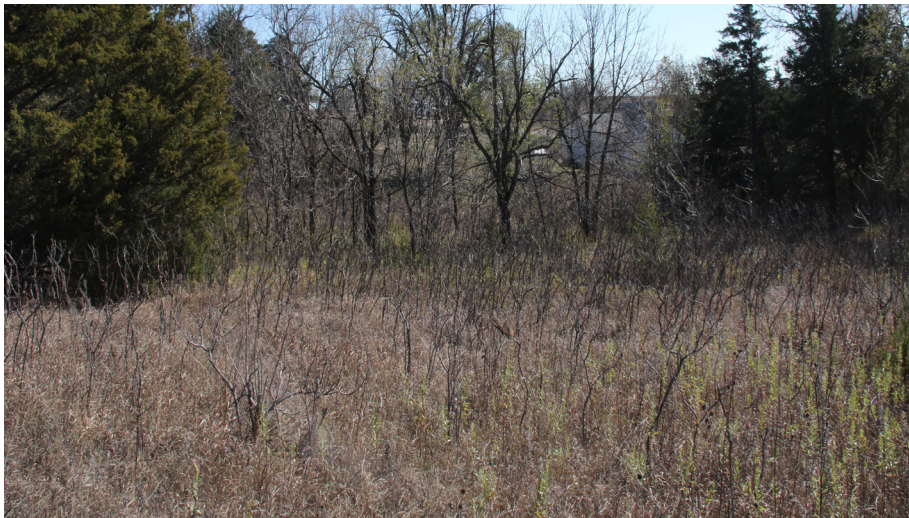
**Figure 6-7.** Eastern red cedars and shrub thicket within prairie to the west of Z Bar Ranch headquarters.

Existing trees (eastern red cedars) and shrub thickets (sumac and dogwood) within prairie vegetation (Figure 6-7 and Figure 6-8) and along fencelines enhance potential risk of fire near the Z Bar Ranch headquarters. The trees and shrub thickets also disturb the historic character and integrity of the existing stone wall.

Remove existing cedar trees regardless of condition. Cedars should be mechanically removed by cutting below the bottom most branch. Shrub thickets should be removed. For thickets within prairie vegetation, herbicide applications in conjunction with prescribed fire should be used as management tools. For thickets within and adjacent to stone walls, shrubs should be mechanically cut to the ground and the appropriate herbicide applied to the stumps.
