# Preservation/Restoration of Moton Field

Tuskegee Airmen  
National Historic Site  
Tuskegee, Alabama

*Historic Structure Report*  
Vehicle Maintenance Shed

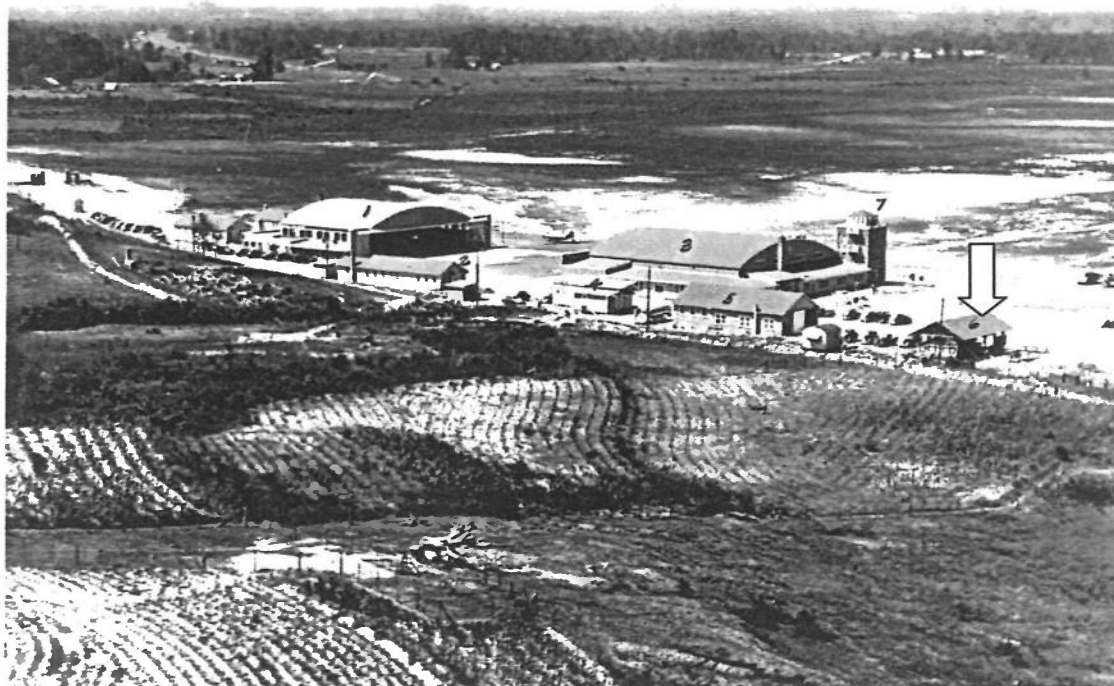
1. Hanger No. 1
2. Bathhouse
3. Hanger No. 2
4. Plant Engineer's Bldg.
5. Warehouse

6. Vehicle & Maintenance Shed
7. Control Tower

**Figure 1:** Aerial photograph of Moton Field circa Fall 1944. Vehicle Maintenance Shed is number six. Historic Photograph Collection, Howard University.

The only two historic photographs of the shed found to date are the circa 1944 and circa 1945 historic aerial photographs.<sup>28</sup> (See *Figures 1 and 2*.) In the circa 1944 photo, the shed is more clearly visible. It was a rectangular shed structure with gabled roof and open on all four sides. In the circa 1945 photo, the same gabled-roof shed can be seen. An additional shed appears to have been added at the building's rear by this time. Another shed or low-roofed building had also been constructed between the Vehicle Maintenance Shed and the Warehouse/Vehicle Storage Building. It is not known what these two additional sheds were used for, but due to their proximity to the vehicle maintenance and storage buildings, they

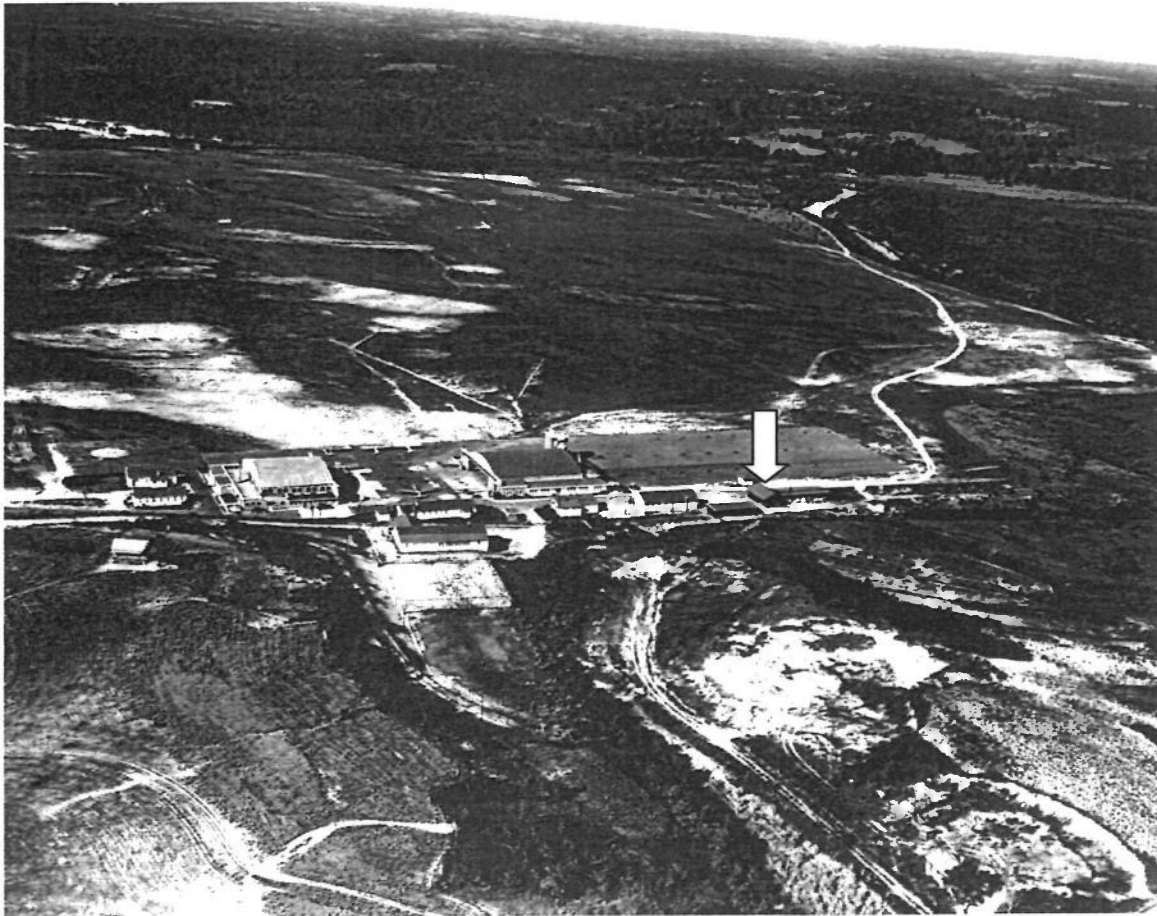
**Figure 2:** Aerial photograph circa 1945 showing Vehicle Maintenance Shed at east end of complex. Additional sheds had been constructed by this time. Historic Photograph Collection, National Park Service Curatorial Storage Facility, Tuskegee Institute NHS.
