# Precipitation impacts on earthen architecture for better implementation of cultural resource management in the US Southwest

Sharlot Hart<sup>1\*</sup>, Kara Raymond<sup>1</sup>, C. Jason Williams<sup>2</sup>, Justin Johnson<sup>3</sup>, Jacob DeGayner<sup>1</sup> and Matthew C. Guebard<sup>1\*</sup>

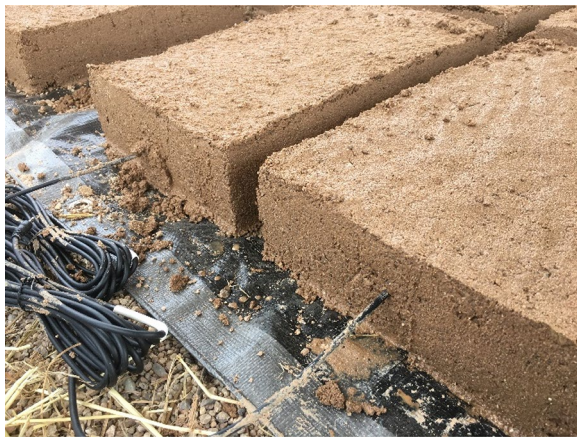
**Fig. 1** Adobe blocks drying, showing placement of sensors

southern Arizona: the head mason and a retired mason from Tumacácori NHP, and a US Forest Service historic preservation specialist. During the first training in early August 2018, participants created adobe blocks. The dimensions of each block ( $41 \text{ cm} \times 25 \text{ cm} \times 9 \text{ cm}$ ) match the size of original blocks found at the Mission Los Santos Angeles de Guevavi (part of Tumacácori NHP). Moisture sensors were placed horizontally in the blocks as they were being made to ensure the adobe was in full contact with the sensors (Fig. 1). Each sensor was placed 5 cm from a block's top and bottom faces, with the tip of each sensor 12 cm from the outside edge.

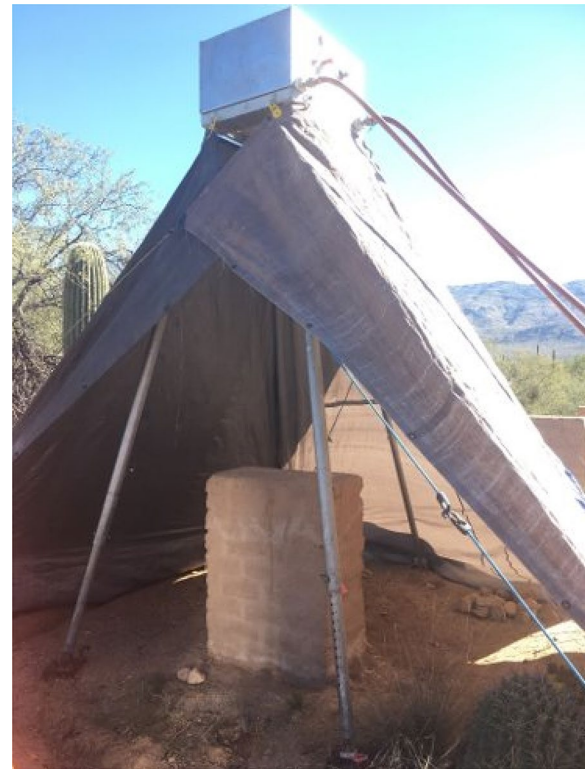
**Fig. 3** Adobe test wall with rainfall simulator and windscreen set up

All rainfall simulations were conducted by the US Department of Agriculture, Agricultural Research Service (ARS) staff, using a portable single-nozzle, Meyer and Harmon-type oscillating-arm rainfall simulator [47] raised 3 m above the ground surface (Fig. 3). The simulator design and operation were described in previous erosion studies by Pierson and others [48, 49]. To account for rainfall intensity and kinetic-energy relationships [47, 50], high-intensity simulations were conducted using a VeeJet 80–100 nozzle, while low-intensity simulations used a VeeJet 80–70 nozzle. Simulator nozzles were pressurized to  $41 \text{ N m}^{-2}$

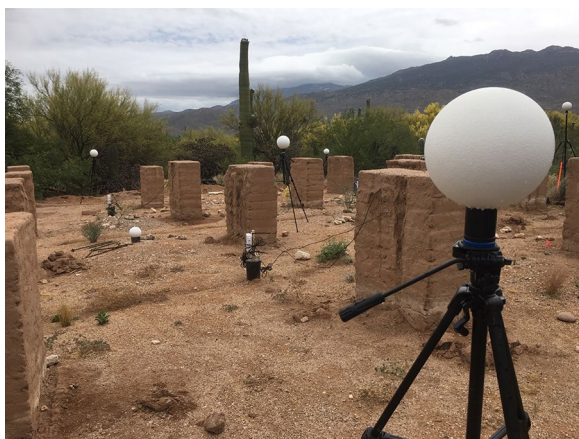
**Fig. 4** LiDAR scanning equipment and test walls during Epoch II. Photo NPS/Alice W. Biel

To improve accuracy, distances between the scanner and walls were intentionally limited to reduce the effects of beam diameter and other range-based errors. Two levels of registration were used to compute geometric differences and allow for spatial comparison of datasets. First, a mixture of 150 mm and 200 mm spherical reference targets were distributed across the study area. High densities of measured points across the surface of each sphere allowed registration software to calculate the geometric centroid of each target, resulting in common points from which to base a 3D least-squares registration solution. Second, permanent control points were used to register each scanning epoch (measurement event) to the same coordinate space. Five 150 mm target spheres were mounted on short sections of permanently installed metal pipe. The spherical geometry of the targets and the permanent metal pipe ensured targets could be identified and located in subsequent scans (Fig. 4).

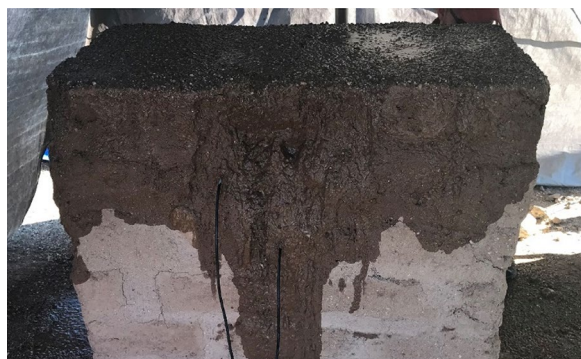
**Fig. 8** Wall S with erosion near the EC-5 sensor

3. As infiltration rates waned below the applied precipitation rate, we noted ponding on top of the walls. Runoff began to be routed along the sides of walls, creating areas more vulnerable to rain splash detachment and heightened shear stress from concentrated flow [57–59]. These vulnerable areas, typically near mortar joints, began to scour, creating incised flow paths beginning at the top of the wall or cavities immediately below the top row of blocks (Fig. 8).
