# historic structure report

**TUMACACORI**  
THE ANGLO PERIOD

HISTORIC STRUCTURE REPORT  
A HISTORY OF THE ANGLO PERIOD  
TUMACACORI NATIONAL MONUMENT  
ARIZONA

September 1977

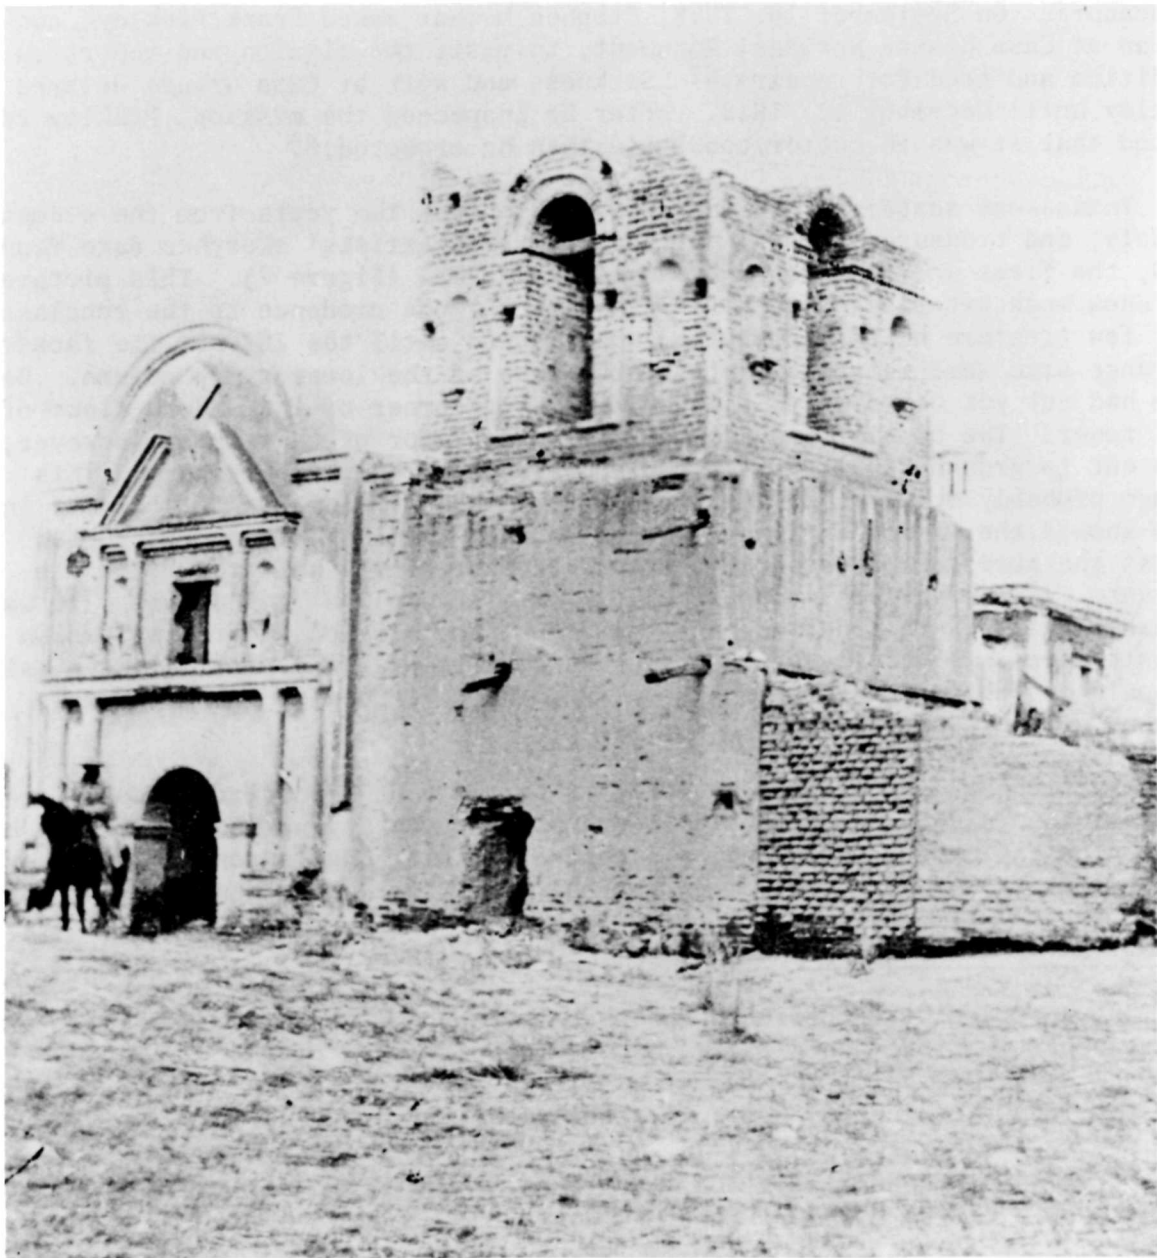
Figure 7

1883 photograph, #73-264P, Sharlot Hall Museum, Prescott, Arizona.

Tumacacori sustained considerable damage over the years from the elements, vandals, and treasure hunters. Although several artists' sketches date from 1849, the first known photograph was taken in 1883 (Figure 7). This picture did not show much exterior physical damage, which lends credence to the conclusion that few treasure hunters disturbed the mission until the 1880s. The facade and entrance arch were intact except for the base of the lower right column. Destruction had not yet occurred to the southwest top corner of the second floor of the bell tower. The baptistry window on the lower floor of that tower, however, had been cut to ground level, giving the appearance of another entrance. This damage probably occurred in the late 1850s, since J. Ross Browne's sketch in 1864 showed the window as an entrance. An adobe wall had been constructed across the corridor between the southeast corner of the bell tower and the convento. Since this wall appeared in H. M. T. Powell's 1849 drawing, it was probably built by the Indians who remained at the mission after the Spanish priests were expelled in 1828. If it had been an original part of the mission, it would undoubtedly have been plastered. The picture also showed a small portion of the convento ruins.

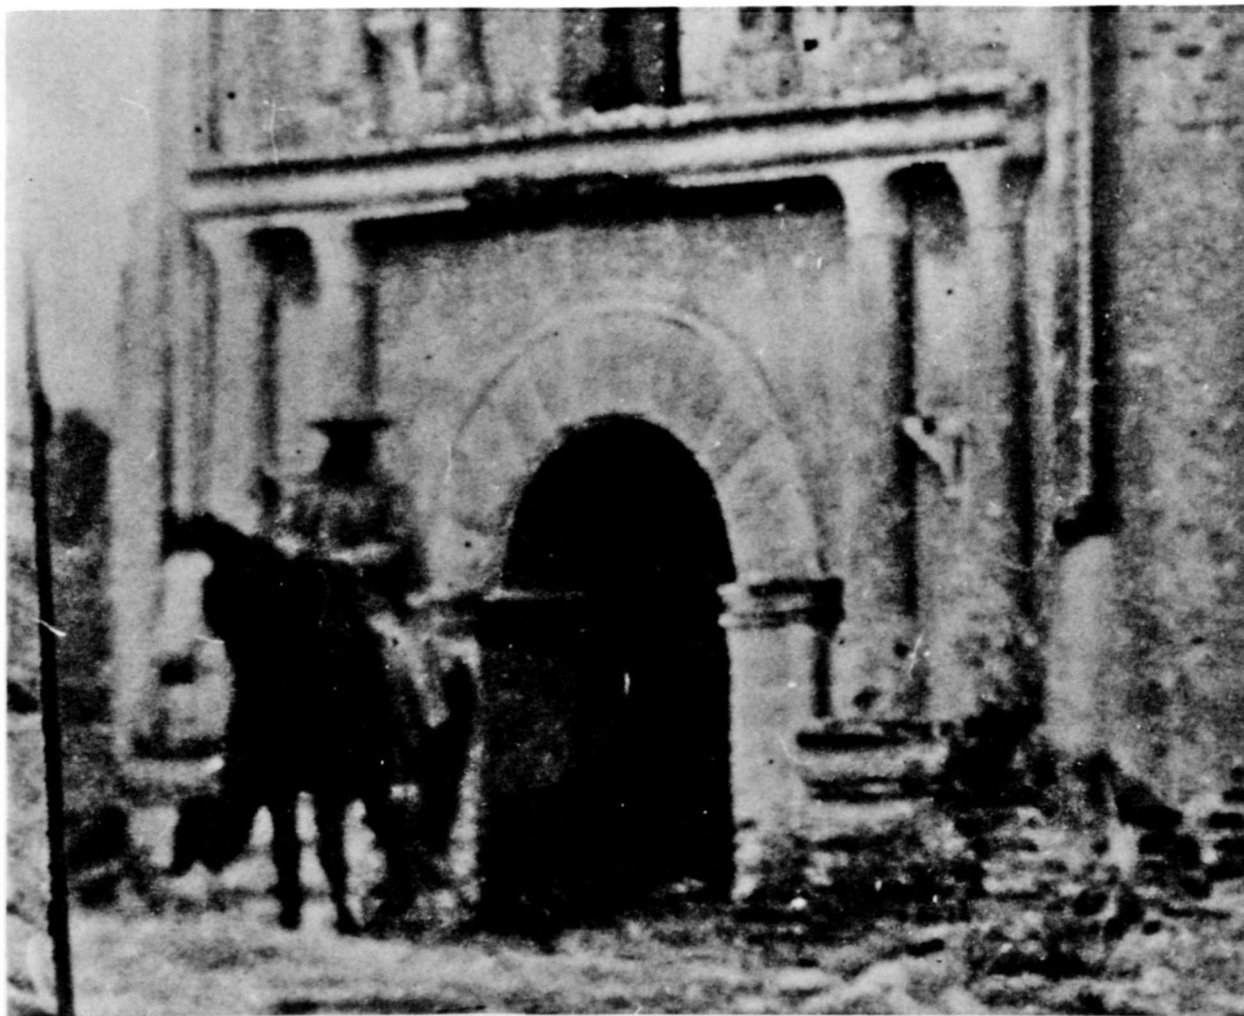
Figure 7a

Enlargement of the Lower Facade taken from the first known photograph of the mission. Sharlot Hall Museum, Prescott, Arizona.

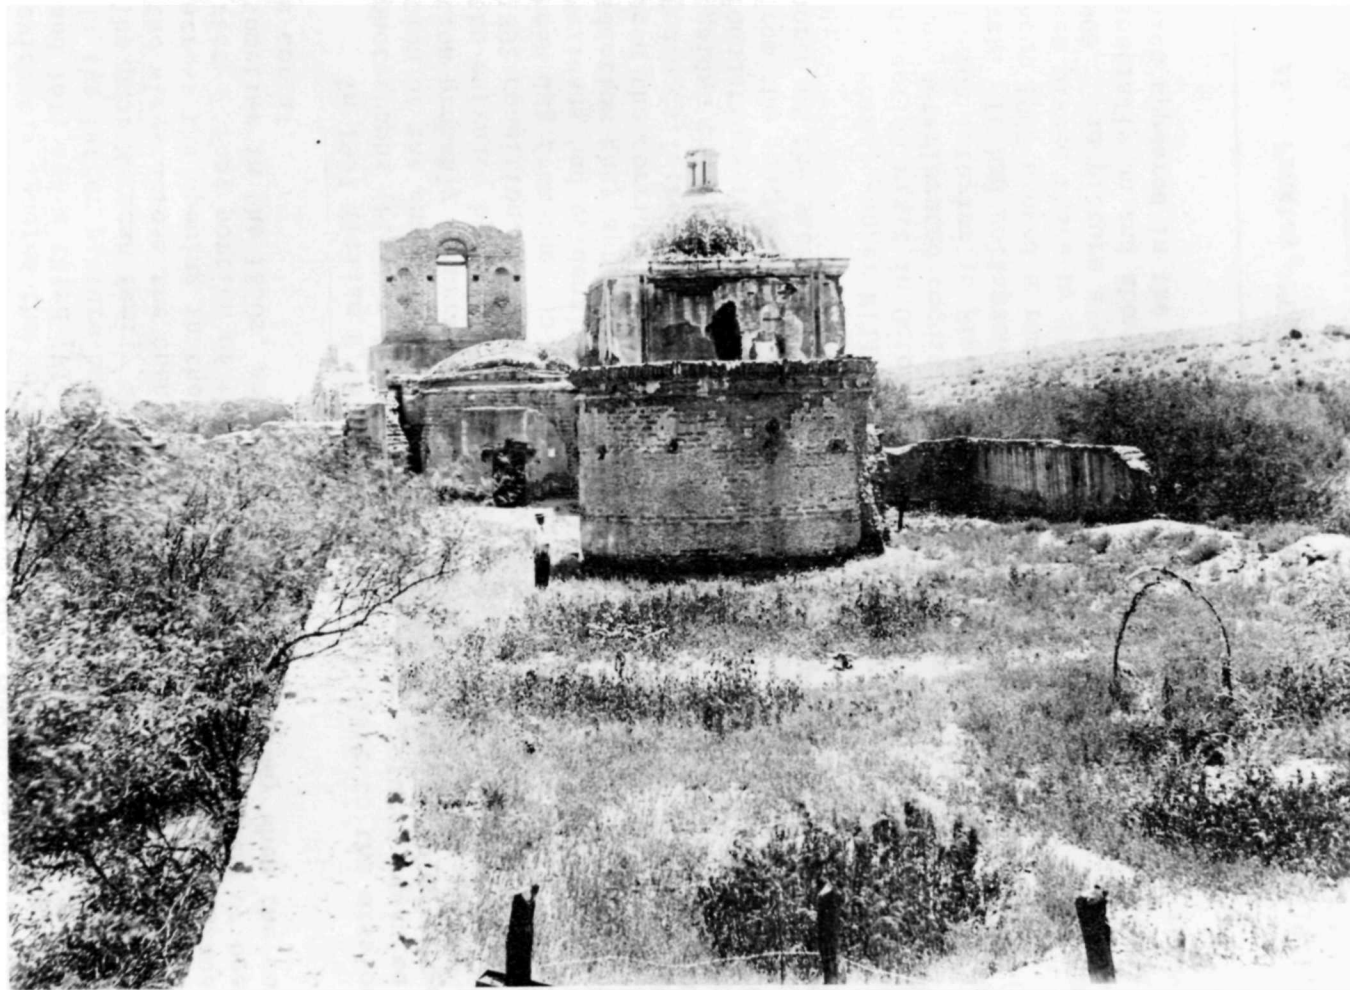
Figure 16

Ca. 1900 photograph, #44,361, Arizona Historical Society, Tucson, Arizona.

Pinkley that a statue niche had occupied the hole in the 1880s.<sup>25</sup> By 1900 this hole had been enlarged and more plaster was missing from the rear wall (Figure 16). In addition, a top of one lantern pier above the sanctuary dome had sustained damage. The 1900 photograph revealed for the first time the ruinous condition of the west cemetery wall. Some fifty feet had been destroyed after 1884.<sup>26</sup> The exposure also showed that the east wall of the sacristy had cracked and tilted away from the structure. This condition probably developed because treasure hunters had removed part of the foundation under that wall. These men evidently ignored the mortuary chapel, for in these two photographs (Figures 15 and 16), and a third (Figure 17) taken about 1906, it had few exterior changes. In the latter picture one can again see the crack in the east sacristy wall. The poor Mexican family which moved into that room in 1906 apparently placed the two wires across the opening in the north sacristy wall as well as the fence across the opening in the east cemetery wall between the granary and the sacristy. That portion of the cemetery wall had collapsed or been destroyed sometime in the 1850s, and had served as a gateway when the cemetery was used as a corral.

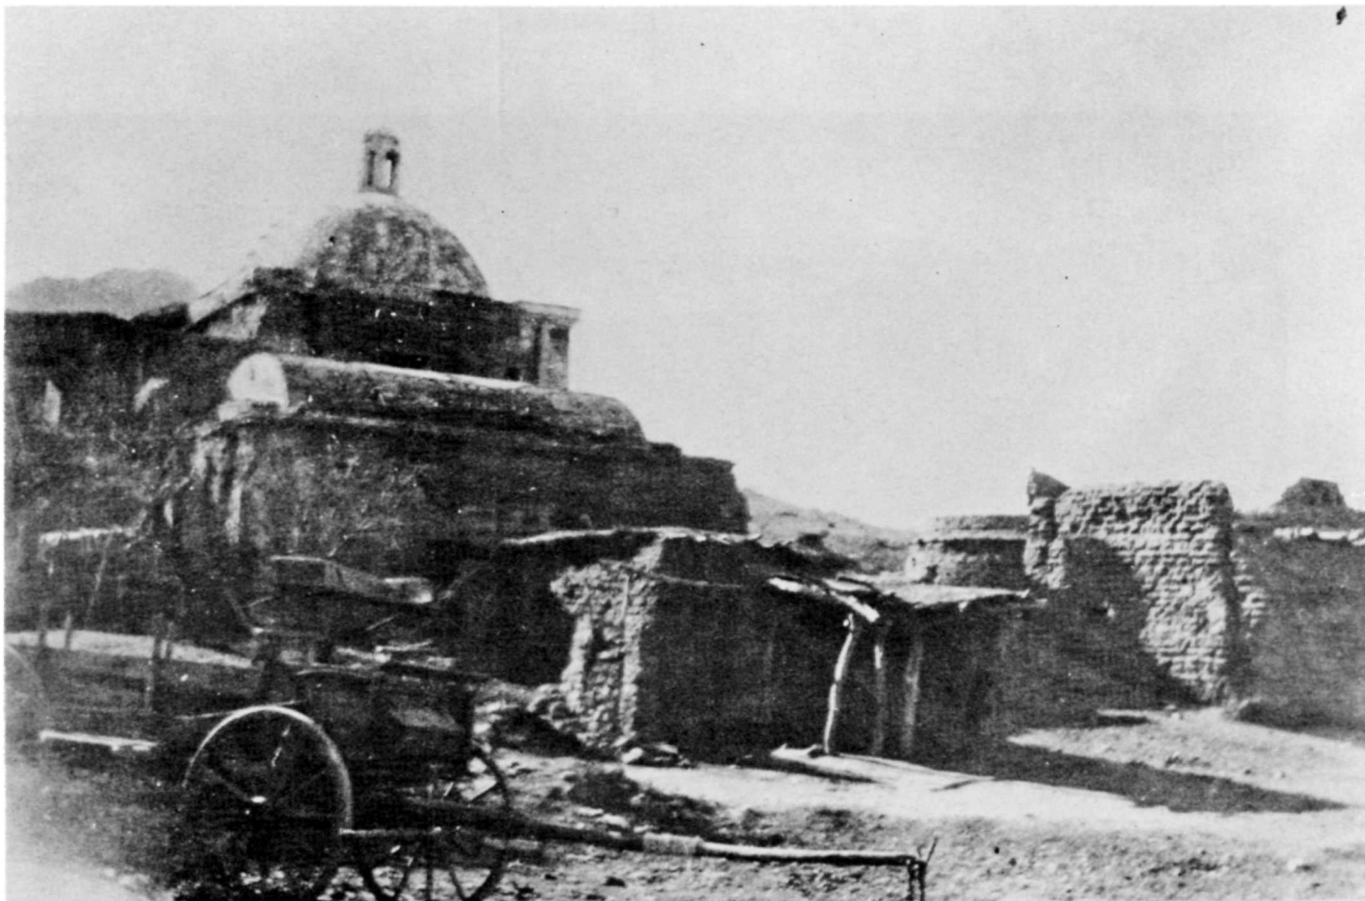
Figure 20

1907 photograph, #2121, Arizona Historical Society, Tucson, Arizona.  
Taken by William P. Blake.

In 1907 William P. Blake, on a second visit to the mission, took several photographs (Figures 18, 19, and 20). These pictures revealed continued mutilation of the church. The top of the facade was totally destroyed. This destruction probably occurred in the late 1890s. Vandals had caused further damage to the entrance by destroying the right side of the arch. When compared to their 1892 condition, the lower left columns were even shorter. More adobe brick had been dug from the top of the second story of the bell tower. The family of poor Mexicans had evidently placed the logs in front of the baptistry window. In addition they apparently fenced an area south of the sacristy. The family also used the corridor east of the sacristy (Figure 20) which had been roofed by Pedro Calistro in the 1890s. Either they or Calistro had built the ramada against the east side of that structure. No evidence of the convento arch or foundations remained and very little of the convent rooms' walls which ran east from the southeast corner of the bell tower survived. In the granary, just north of the sacristy, some of the second floor joists appeared.

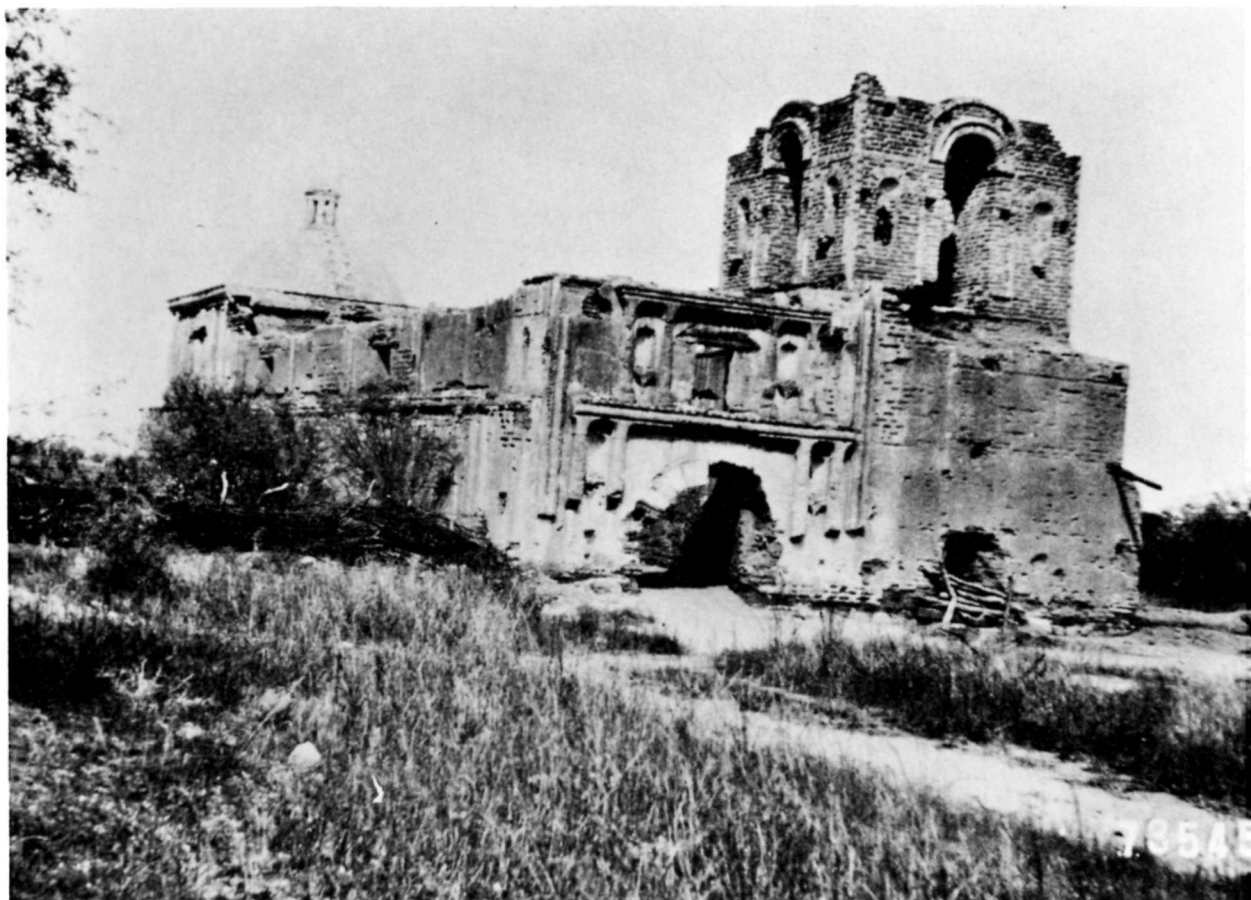
Figure 22

1907 photograph by Will C. Barnes, Records of the Forest Service,  
Regional Archives and Record Center, Denver, Colorado.

Forest Ranger Will C. Barnes also photographed the mission during his inspection visit in October 1907. His pictures (Figures 21 and 22) showed the same deteriorated condition as William P. Blake's photographs. Looking into the mission interior in Figure 21, one may note the disappearance of the choir loft arch. It had collapsed in 1906. Another interior photograph (Figure 23) taken about 1907 showed a ramada in front of the sanctuary entrance. It had evidently been placed there by the Mexican-American family which moved into the mission in 1906. The picture also revealed continued destruction of interior plaster, especially on and above the sanctuary entrance arch. In addition, the corbels which appeared in the 1889 photograph (Figure 9) had been removed.

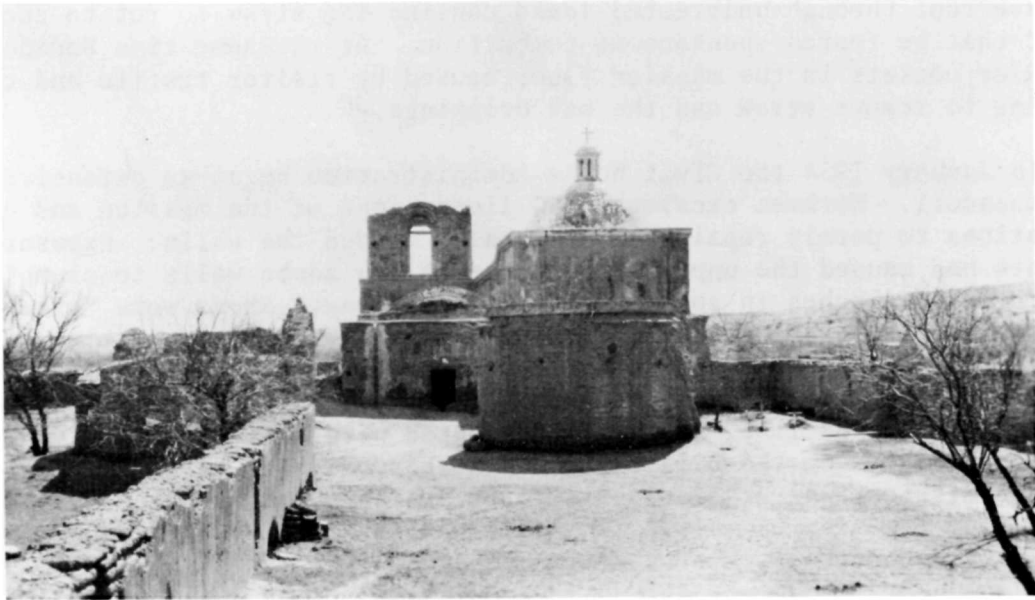
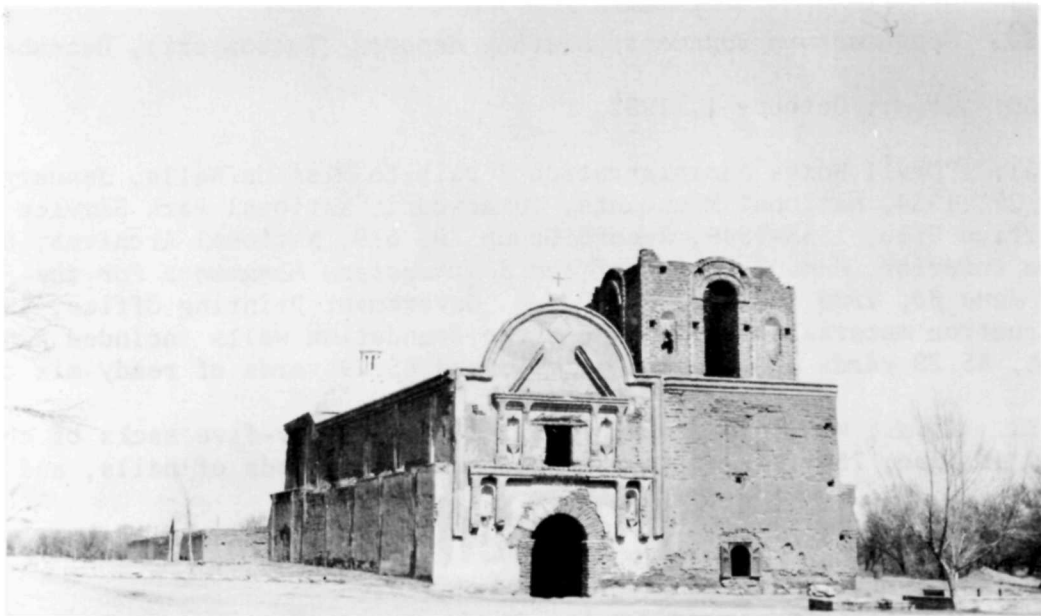
February 1928 photographs, #51,684 and 51,685, Western Archaeology Center, Tucson, Arizona. Taken by Earl Jackson.

Additional repair work was done in succeeding fiscal years during the 1920s. The Park Service report for 1925-26 merely stated some repair work was done.<sup>22</sup> In February 1928 Earl Jackson did extensive replastering on the exterior north end of the mission. During the same period he made some repairs under the cornice of the sanctuary walls. He also repaired the nave roof and gave it a coat of roof paint. In addition Jackson cleaned the cemetery and provided for better drainage of that enclosure as well as making many minor repairs.<sup>23</sup> Figure 30 shows the mission as it appeared in 1928. In the rear view one can see the uncapped east cemetery wall. From June 10 to 18, 1929, more repairs were made on the mission, including the nave roof.<sup>24</sup>

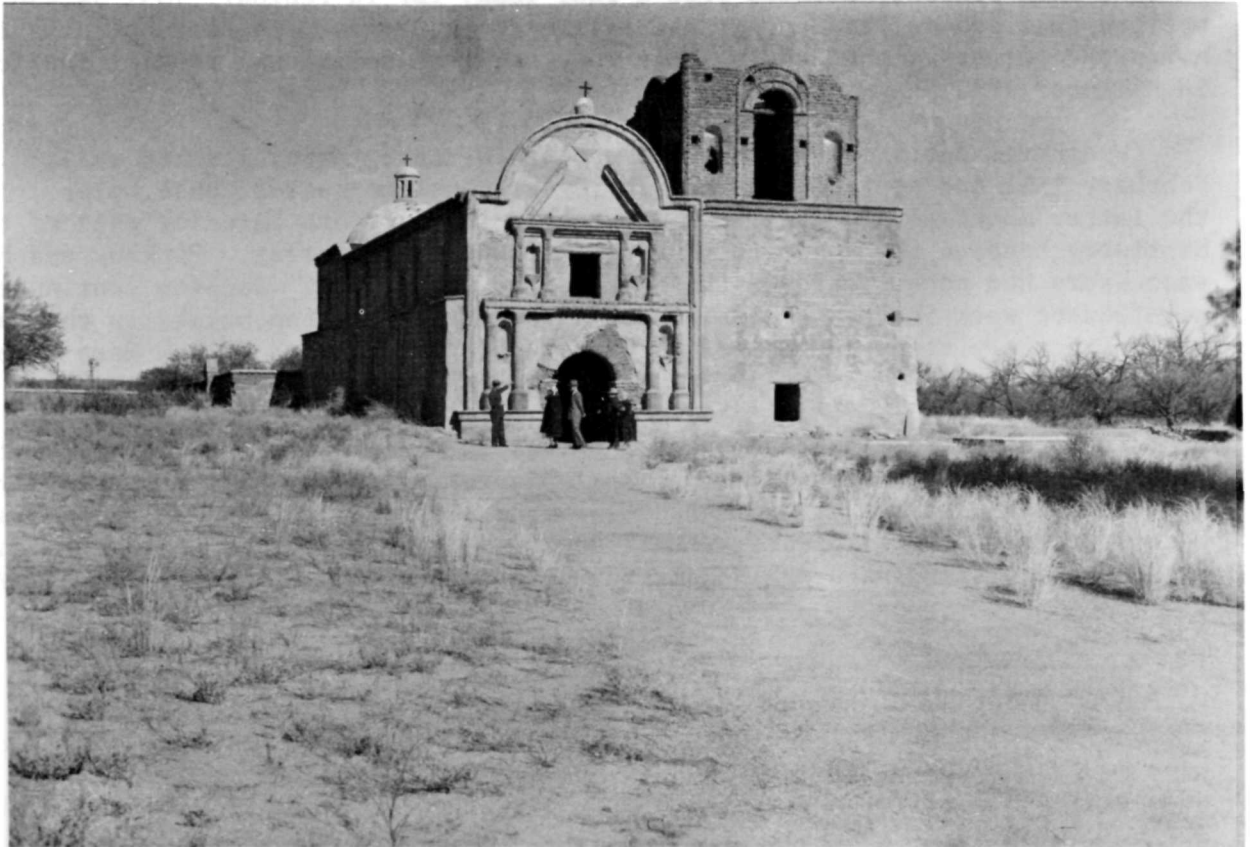
November 22, 1952, photograph, #58,119, Western Archaeology Center,  
Tucson, Arizona. Taken by Earl Jackson.

During routine maintenance on the mission's exterior walls in April 1950, Jackson found that many original plaster areas continued to become powder-soft and fall. As a result moisture could not be prevented from entering the mission's walls. Jackson concluded that patching only forestalled the disintegration of the original plaster areas. By July 1951 he decided the original plaster on the mission's west exterior wall had become so rotten that patching was impossible. He advocated replacement with his sand-lime-cement scratch coat. Meanwhile, Jackson experimented on selected areas of that wall's original plaster with two coats of a Horn Company product--Dehydratine Number 2A, colorless. This special ingredient evidently failed as a remedy, for in April 1952 workmen began to strip the plaster from the west exterior mission wall. They removed all the plaster except that placed on the upper wall area in 1947, some concrete patches which were too strong to remove, and the concrete *canales*. Some patches were made to these *canales*. By late July the workmen had replaced the stripped plaster with Jackson's scratch coat formula over galvanized metal lath. On this covering they applied Jackson's finish coat. With this work completed, all of the mission's west exterior wall had a reconstructed concrete plaster coat held by metal lath.<sup>67</sup> Figure 31 shows the mission in November 1952 after Jackson's replastering work.
