# Status of Climate and Water Resources at Tumacácori National Historical Park

*Water Year 2016*

Natural Resource Report NPS/SODN/NRR—2017/1552

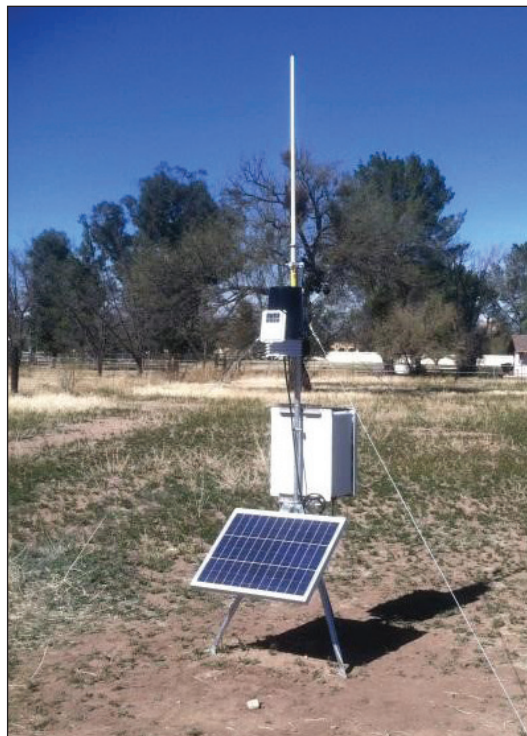
Figure 2-1. The Davis real-time weather station at Tumacácori NHP. Data are available through [www.climateanalyzer.org](http://www.climateanalyzer.org).

In 2014, the National Park Service (NPS) Sonoran Desert Network (SODN) installed a Davis weather station (Figure 2-1) at Tumacácori NHP to provide real-time weather conditions. This station is linked to the NOAA Citizen Weather Observer Program. Data from this station are accessible through [www.climateanalyzer.org](http://www.climateanalyzer.org). More detailed information about methods and data handling can be found in the Sonoran Desert Network climate monitoring protocol (Hubbard et al. in prep).
