# CULTURAL LANDSCAPE REPORT FOR ROEBLING'S DELAWARE AQUEDUCT SITE AND THE ZANE GREY PROPERTY

UPPER DELAWARE SCENIC AND RECREATIONAL RIVER

National Park Service, Boston, Massachusetts, 2023

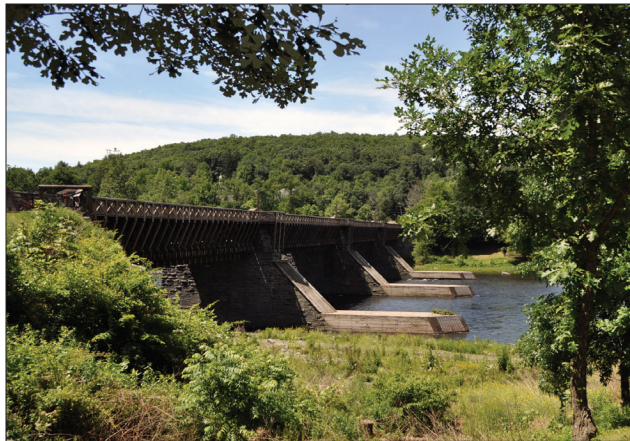
Figure 0.3. View looking southwest at Roebling's Delaware Aqueduct. (OCLP 2016, DSC\_0392)

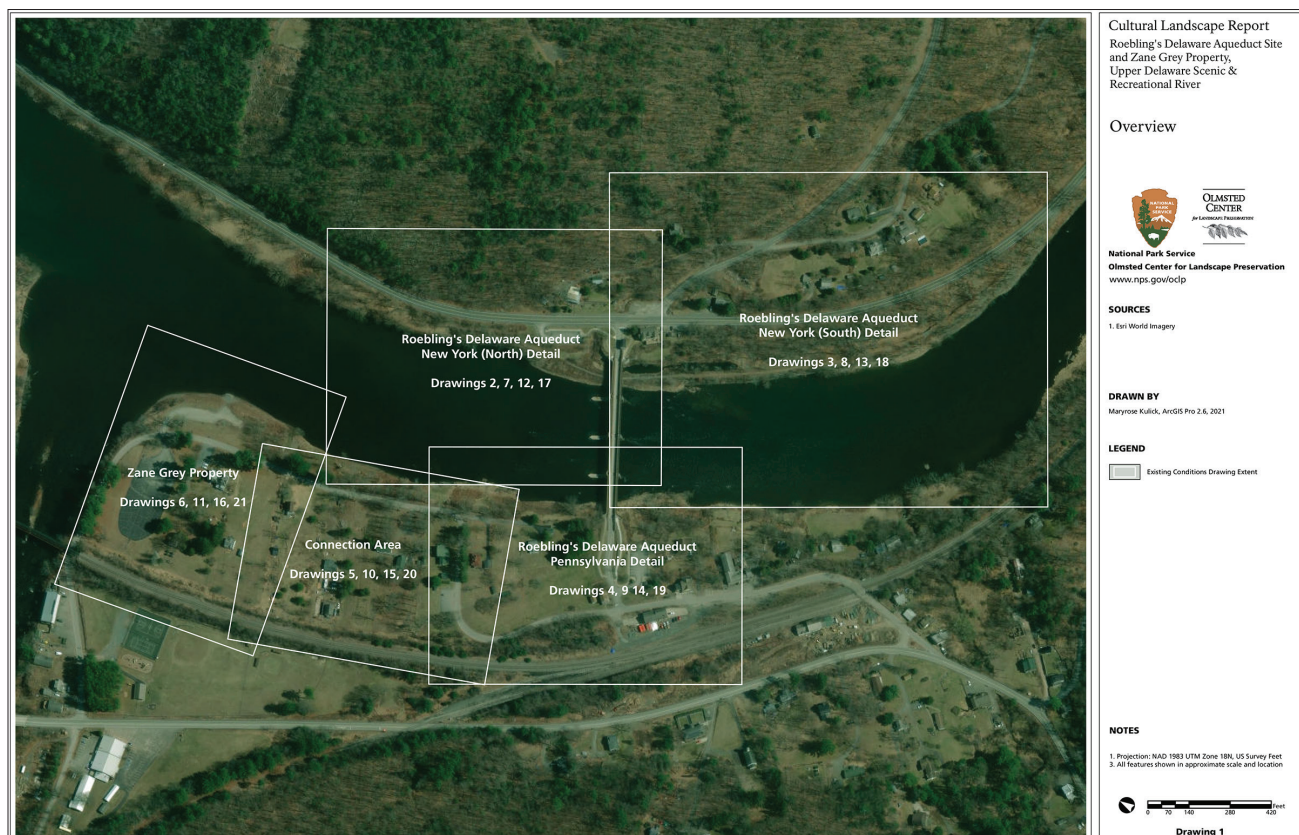
**Figure 0.6. Overview of CLR site maps. (OCLP, Drawing 1, 2023)**

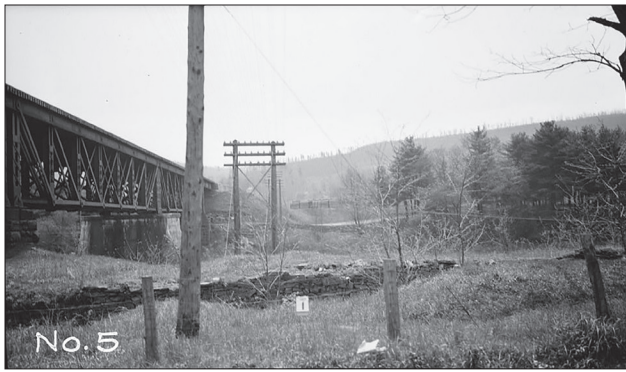
**Figure 1.5. View looking south at stone walls associated with the original canal on the north side of the Lackawaxen River, 1933. (Historic American Engineering Record, HAER PA-24, 2001, #140643pv)**

deepened from 4 to 6 feet, and widened from 28 to 48 feet at water level and from 20 to 30 feet at the bottom. As the canal sides were cut back, dry-laid stone walls were built to decrease leakage from the clay beds and prevent failure of the banks and towpaths (Figure 1.5). Locks were also increased in length, from 75 to 90 feet, and in width, from 9.5 to 15 feet. Most locks had a 10-foot lift, and all were constructed with stone and lined with wood.<sup>27</sup>

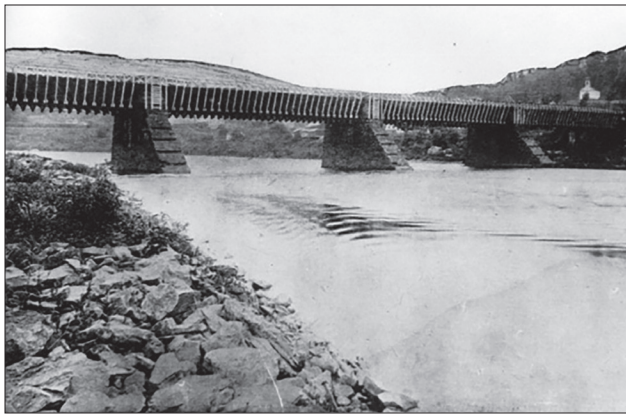
Figure 1.8. View looking southwest at the Delaware Aqueduct, 1849-1898. The west wall of the original canal on the New York side is in the foreground. (UPDE Archives, NY\_Image 4-11B)

By the end of 1848, the two aqueducts were complete and ready for the opening of the 1849 canal season in April (Figure 1.8). Great cheers went up when the first boat passed safely across the Delaware Aqueduct and through newly created Locks 72, 71, and 70, respectively, at Minisink Ford (on the New York side), which replaced Locks 1, 2, and 3 on the north side of the Lackawaxen River (on the Pennsylvania side) (Figure 1.9). At both approaches to the Delaware Aqueduct, the canal was widened to include turning basins for boats to queue up to the structure or wait their turn (Figure 1.10). The turning basin on the New York side was considerably larger because boats had to negotiate a 90-degree turn toward

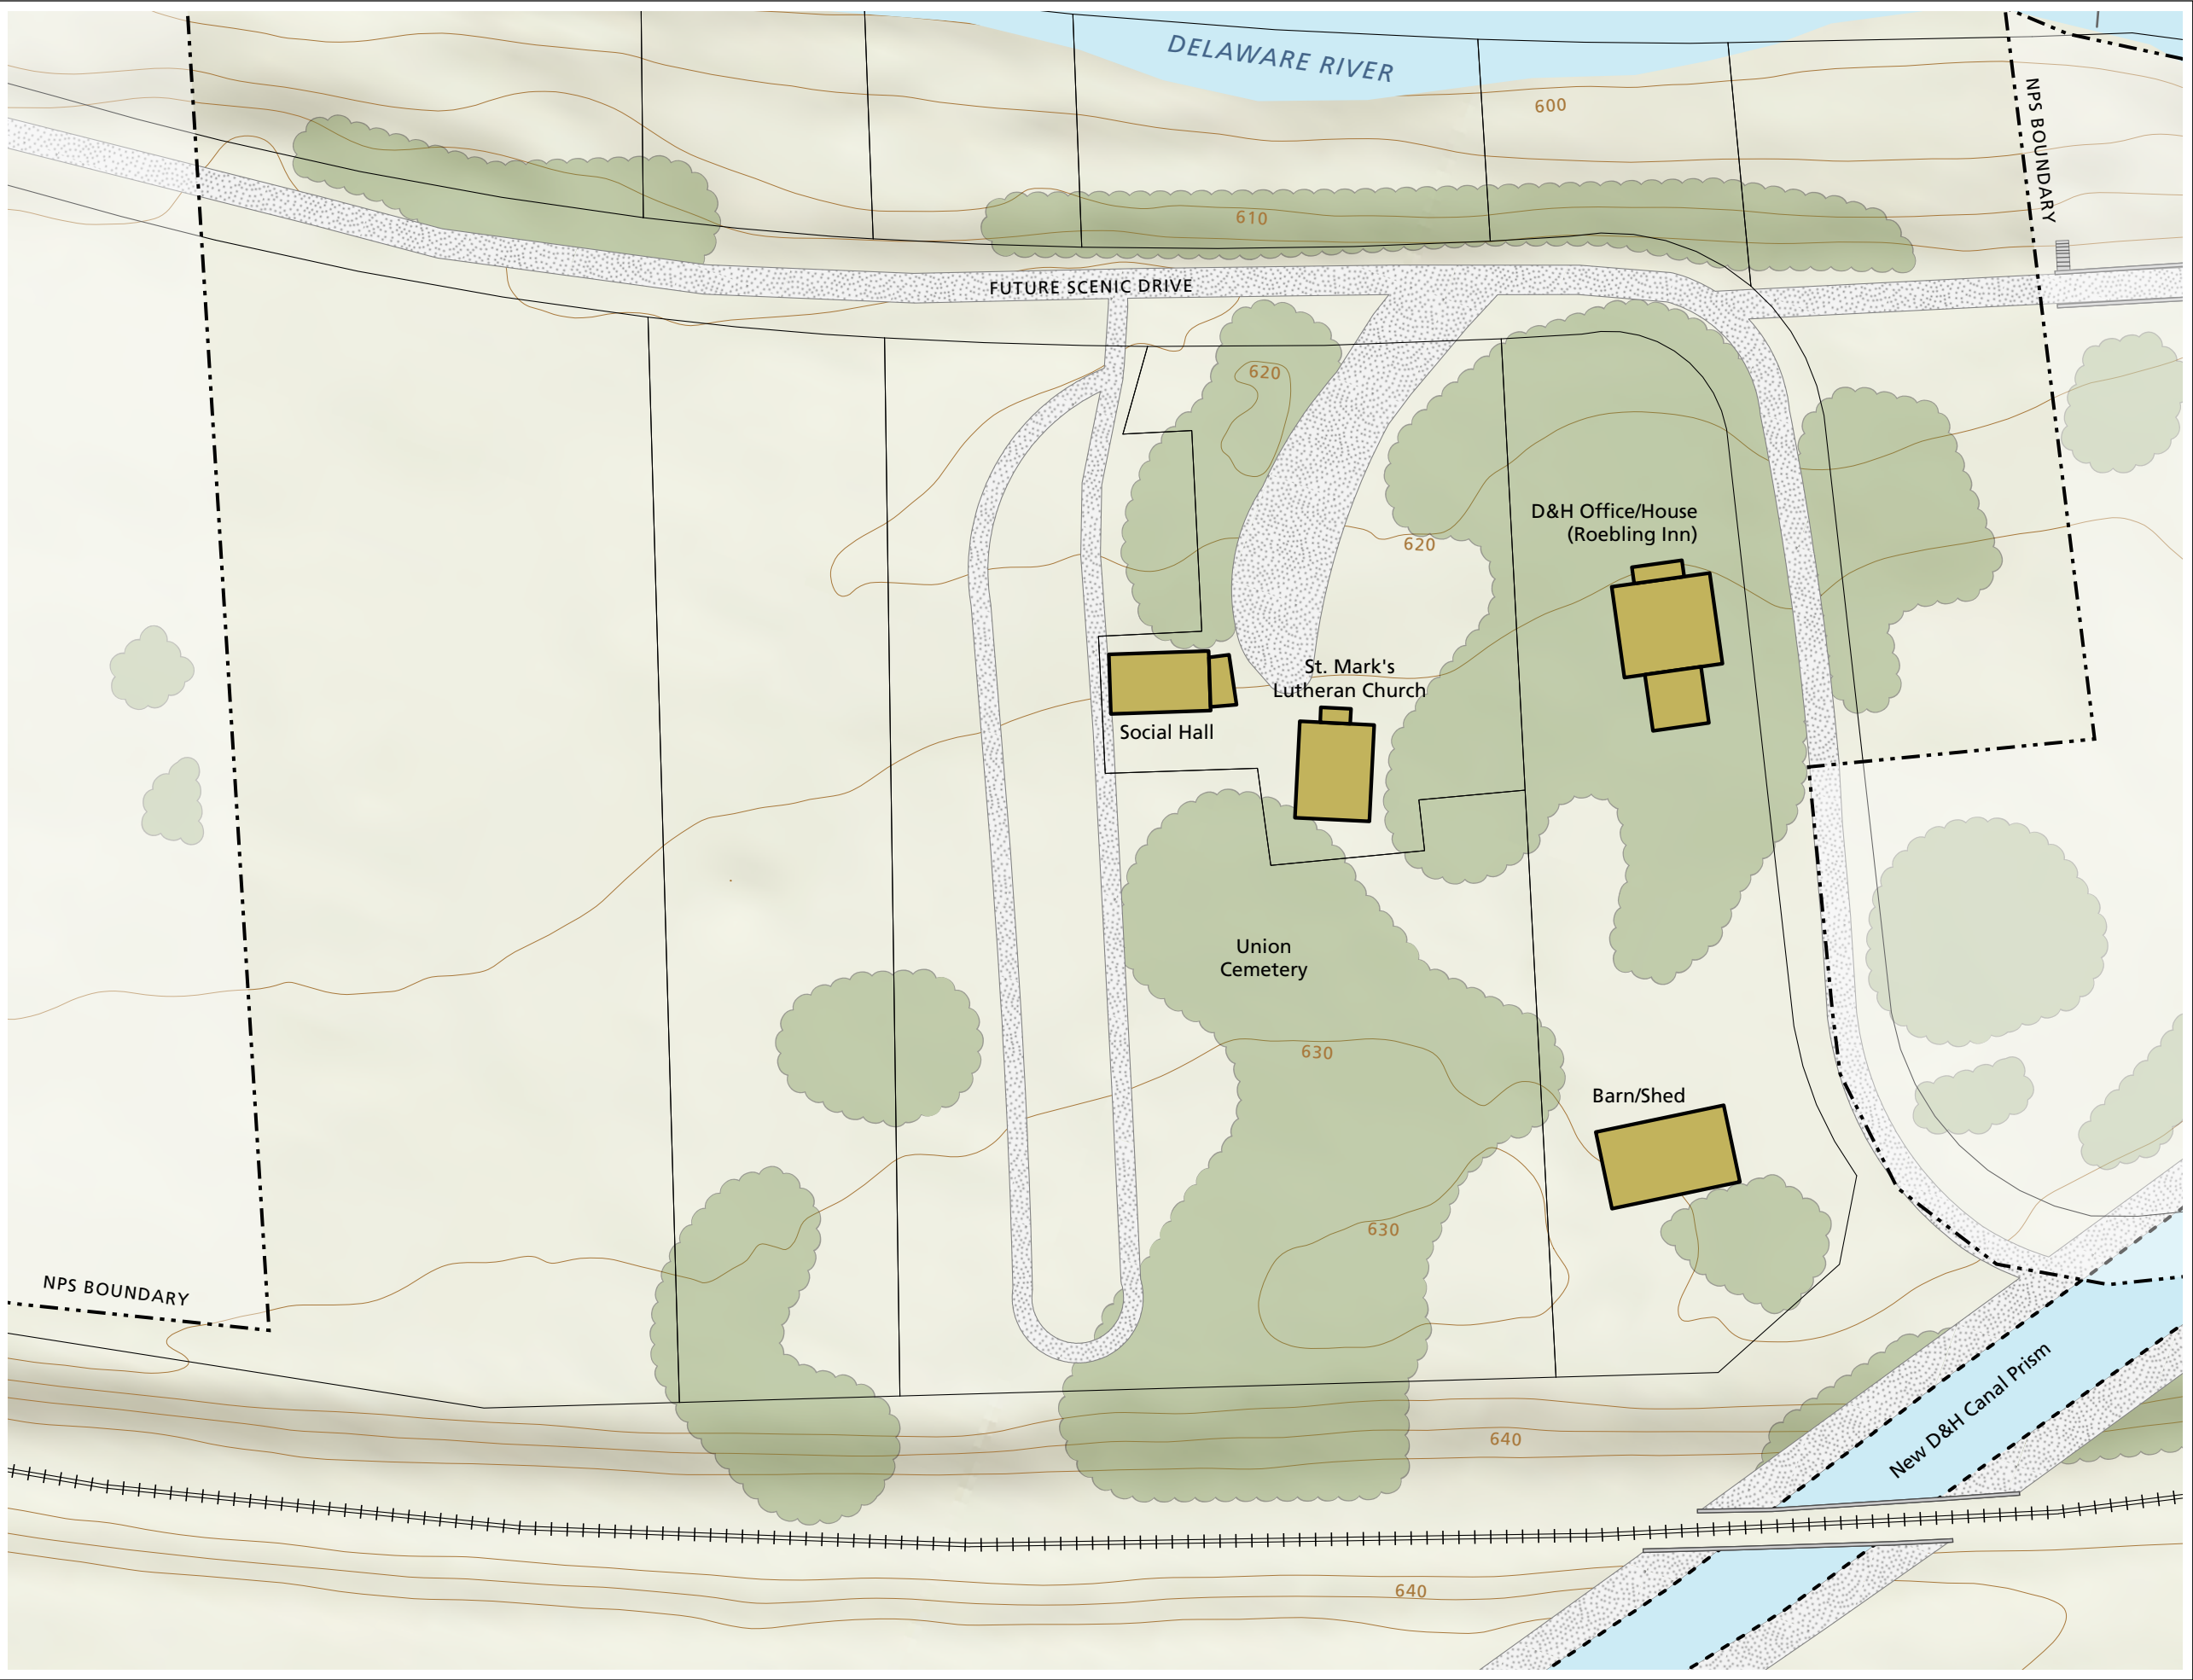
**Drawing 4**

Connection Area  
1898 Period Plan

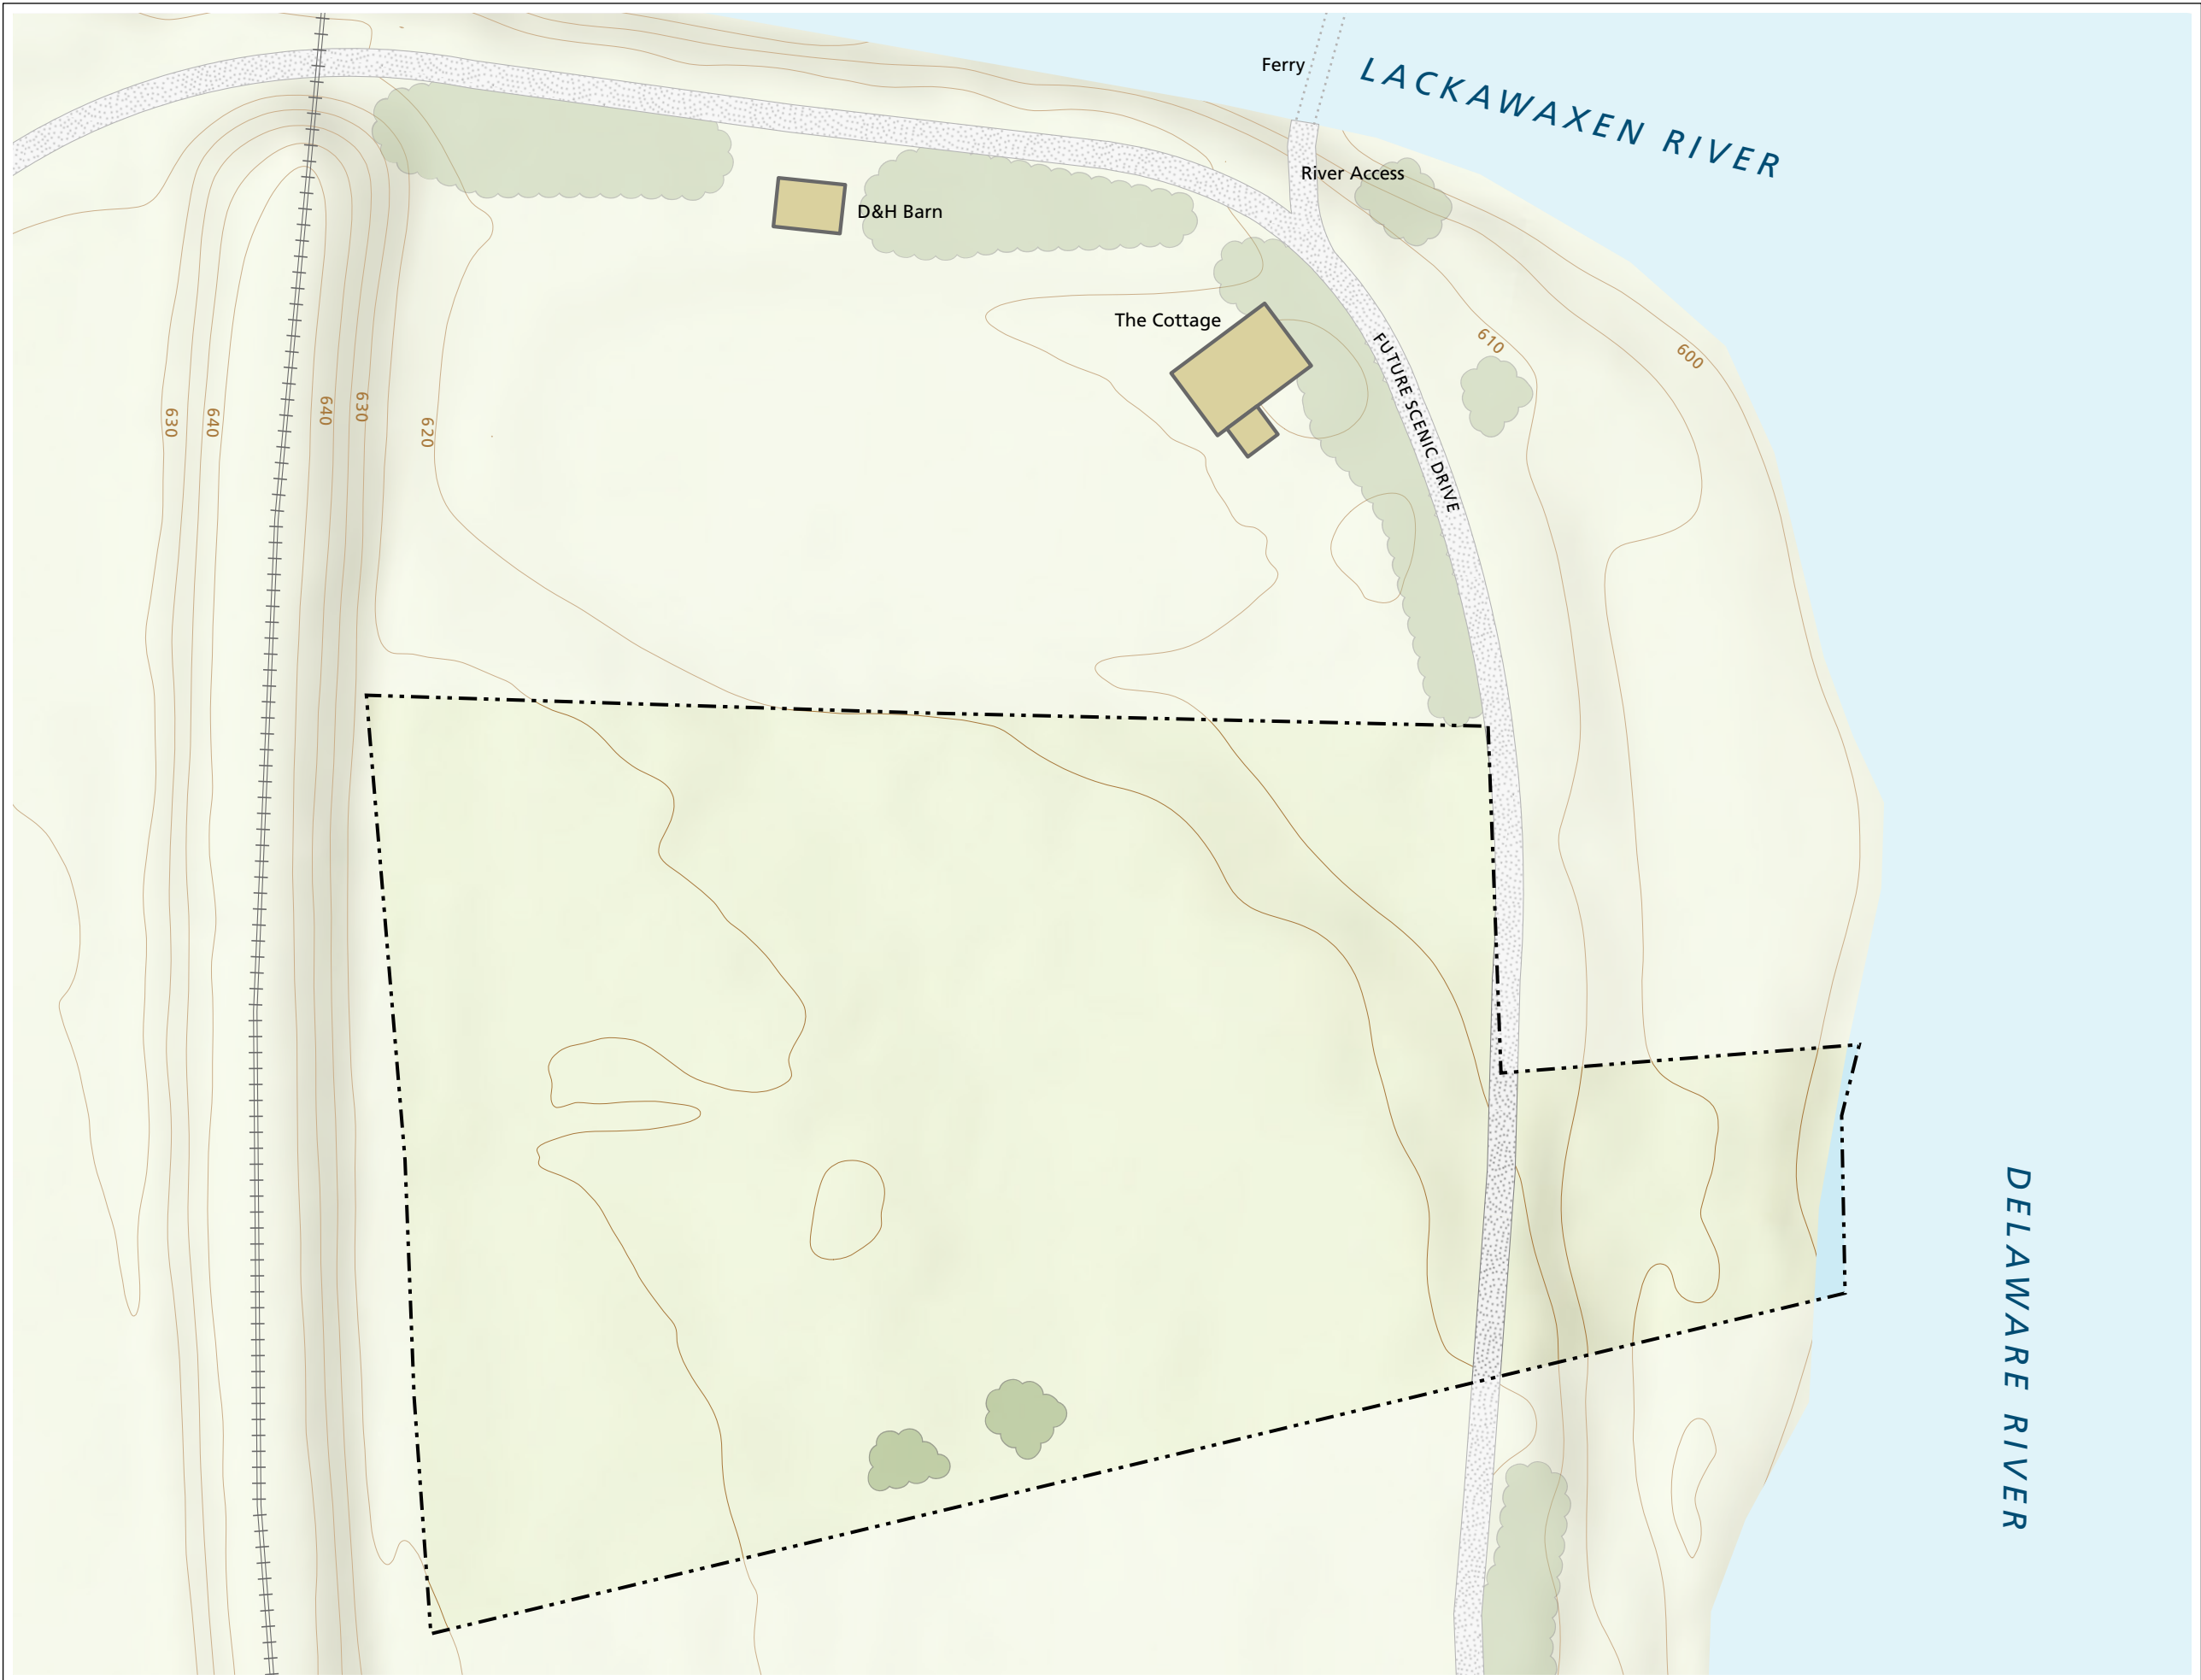
Zane Grey Property  
1898 Period Plan

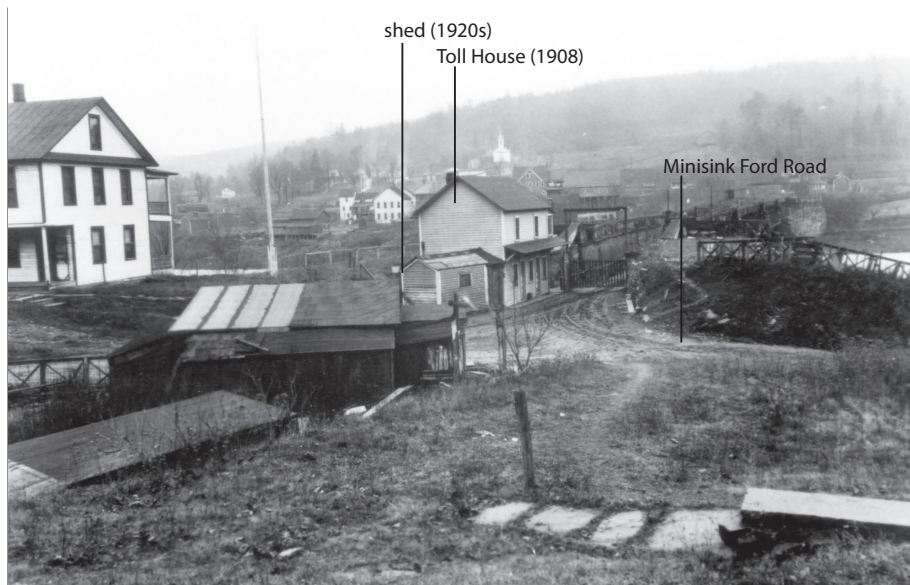
Figure 1.26. View looking southwest at the turning basin (far image left) and toll house on the New York side, 1923. The toll house was built in 1908 and a shed was added to it in the early 1920s. Note the reuse of the towpath fences at image right and left. (Delaware and Hudson Railway Company, New York State Library)

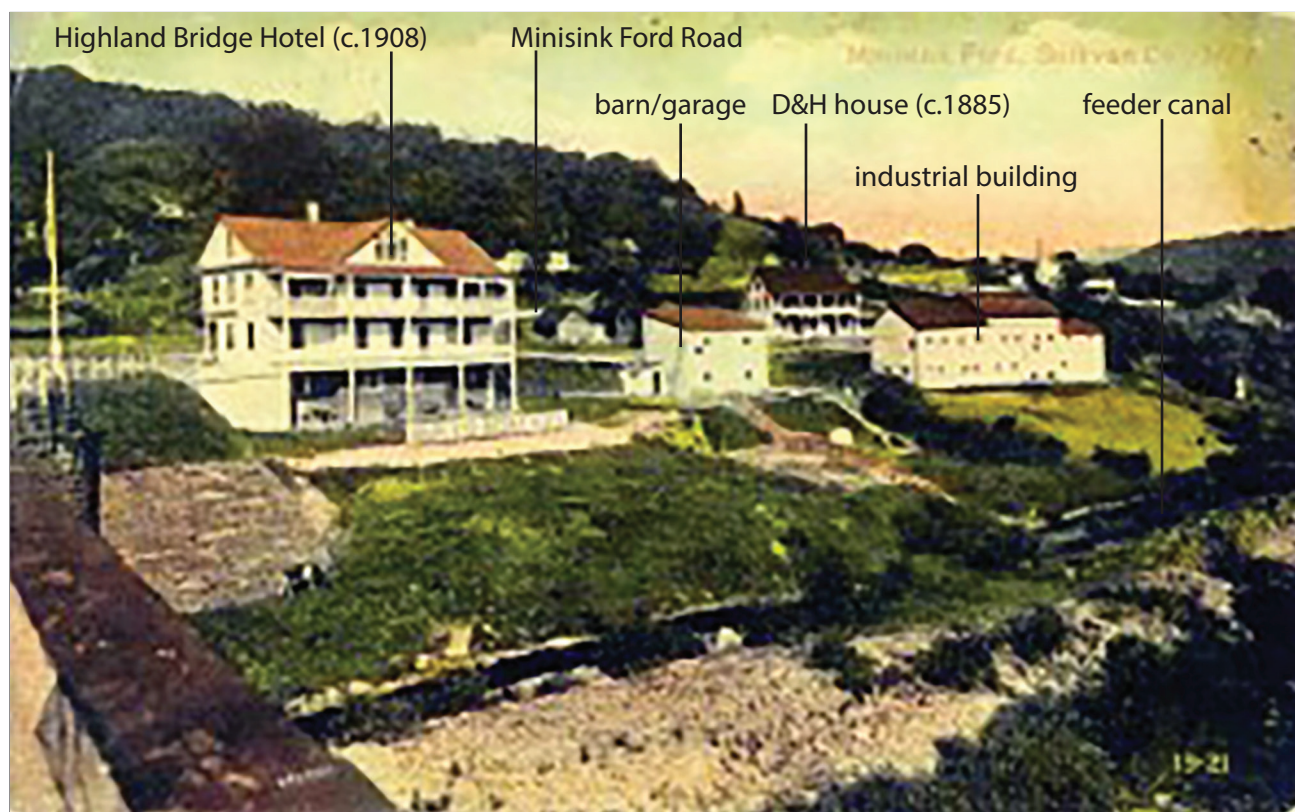
Figure 1.31. View looking southeast at lands on the New York side, south of the aqueduct, 1921. The hotel, barn/garage, and likely an industrial building crowd the hill above the old feeder canal and towpath. (UPDE Archives, 1921\_minisinkford-300x184)

routed Minisink Ford Road now passed through this area. More significant changes occurred on the lands to the south of the aqueduct/bridge, which were sold to Albert Ernst and B.J. Wood around 1903. By 1908 the three-story Highland Bridge Hotel and a detached garage/barn were built next to the toll house (see Figure 1.28). The building featured covered porches overlooking the river, and by 1921 there was a path or patio leading to the still intact feeder canal and a flagpole between it and the toll house (Figure 1.31). Just to the south in the vicinity of former Lock 72 and opposite the D&H house was a substantially larger two- to three-story building. Presumably built for industrial purposes, this building covered the lock until it was removed by 1930 (Figure 1.32). Despite the amount of new construction in this area, the stone and timber remains of the canal and Locks 71 and 70 to the south were still intact (Figure 1.33).<sup>50</sup>

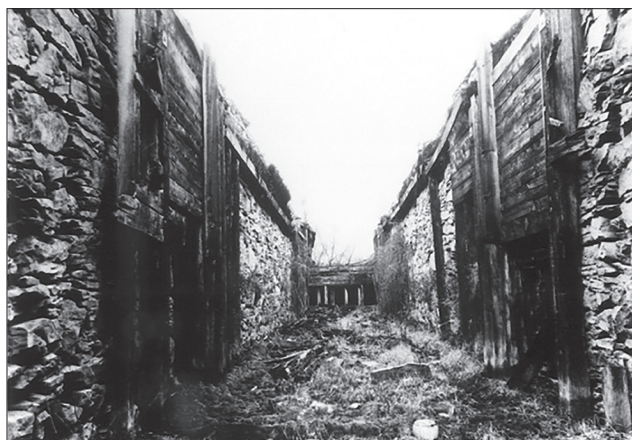
Figure 1.33. View looking northwest at Lock 71 in 1923. (Minisink Valley Historical Society, #P-82-8-6)

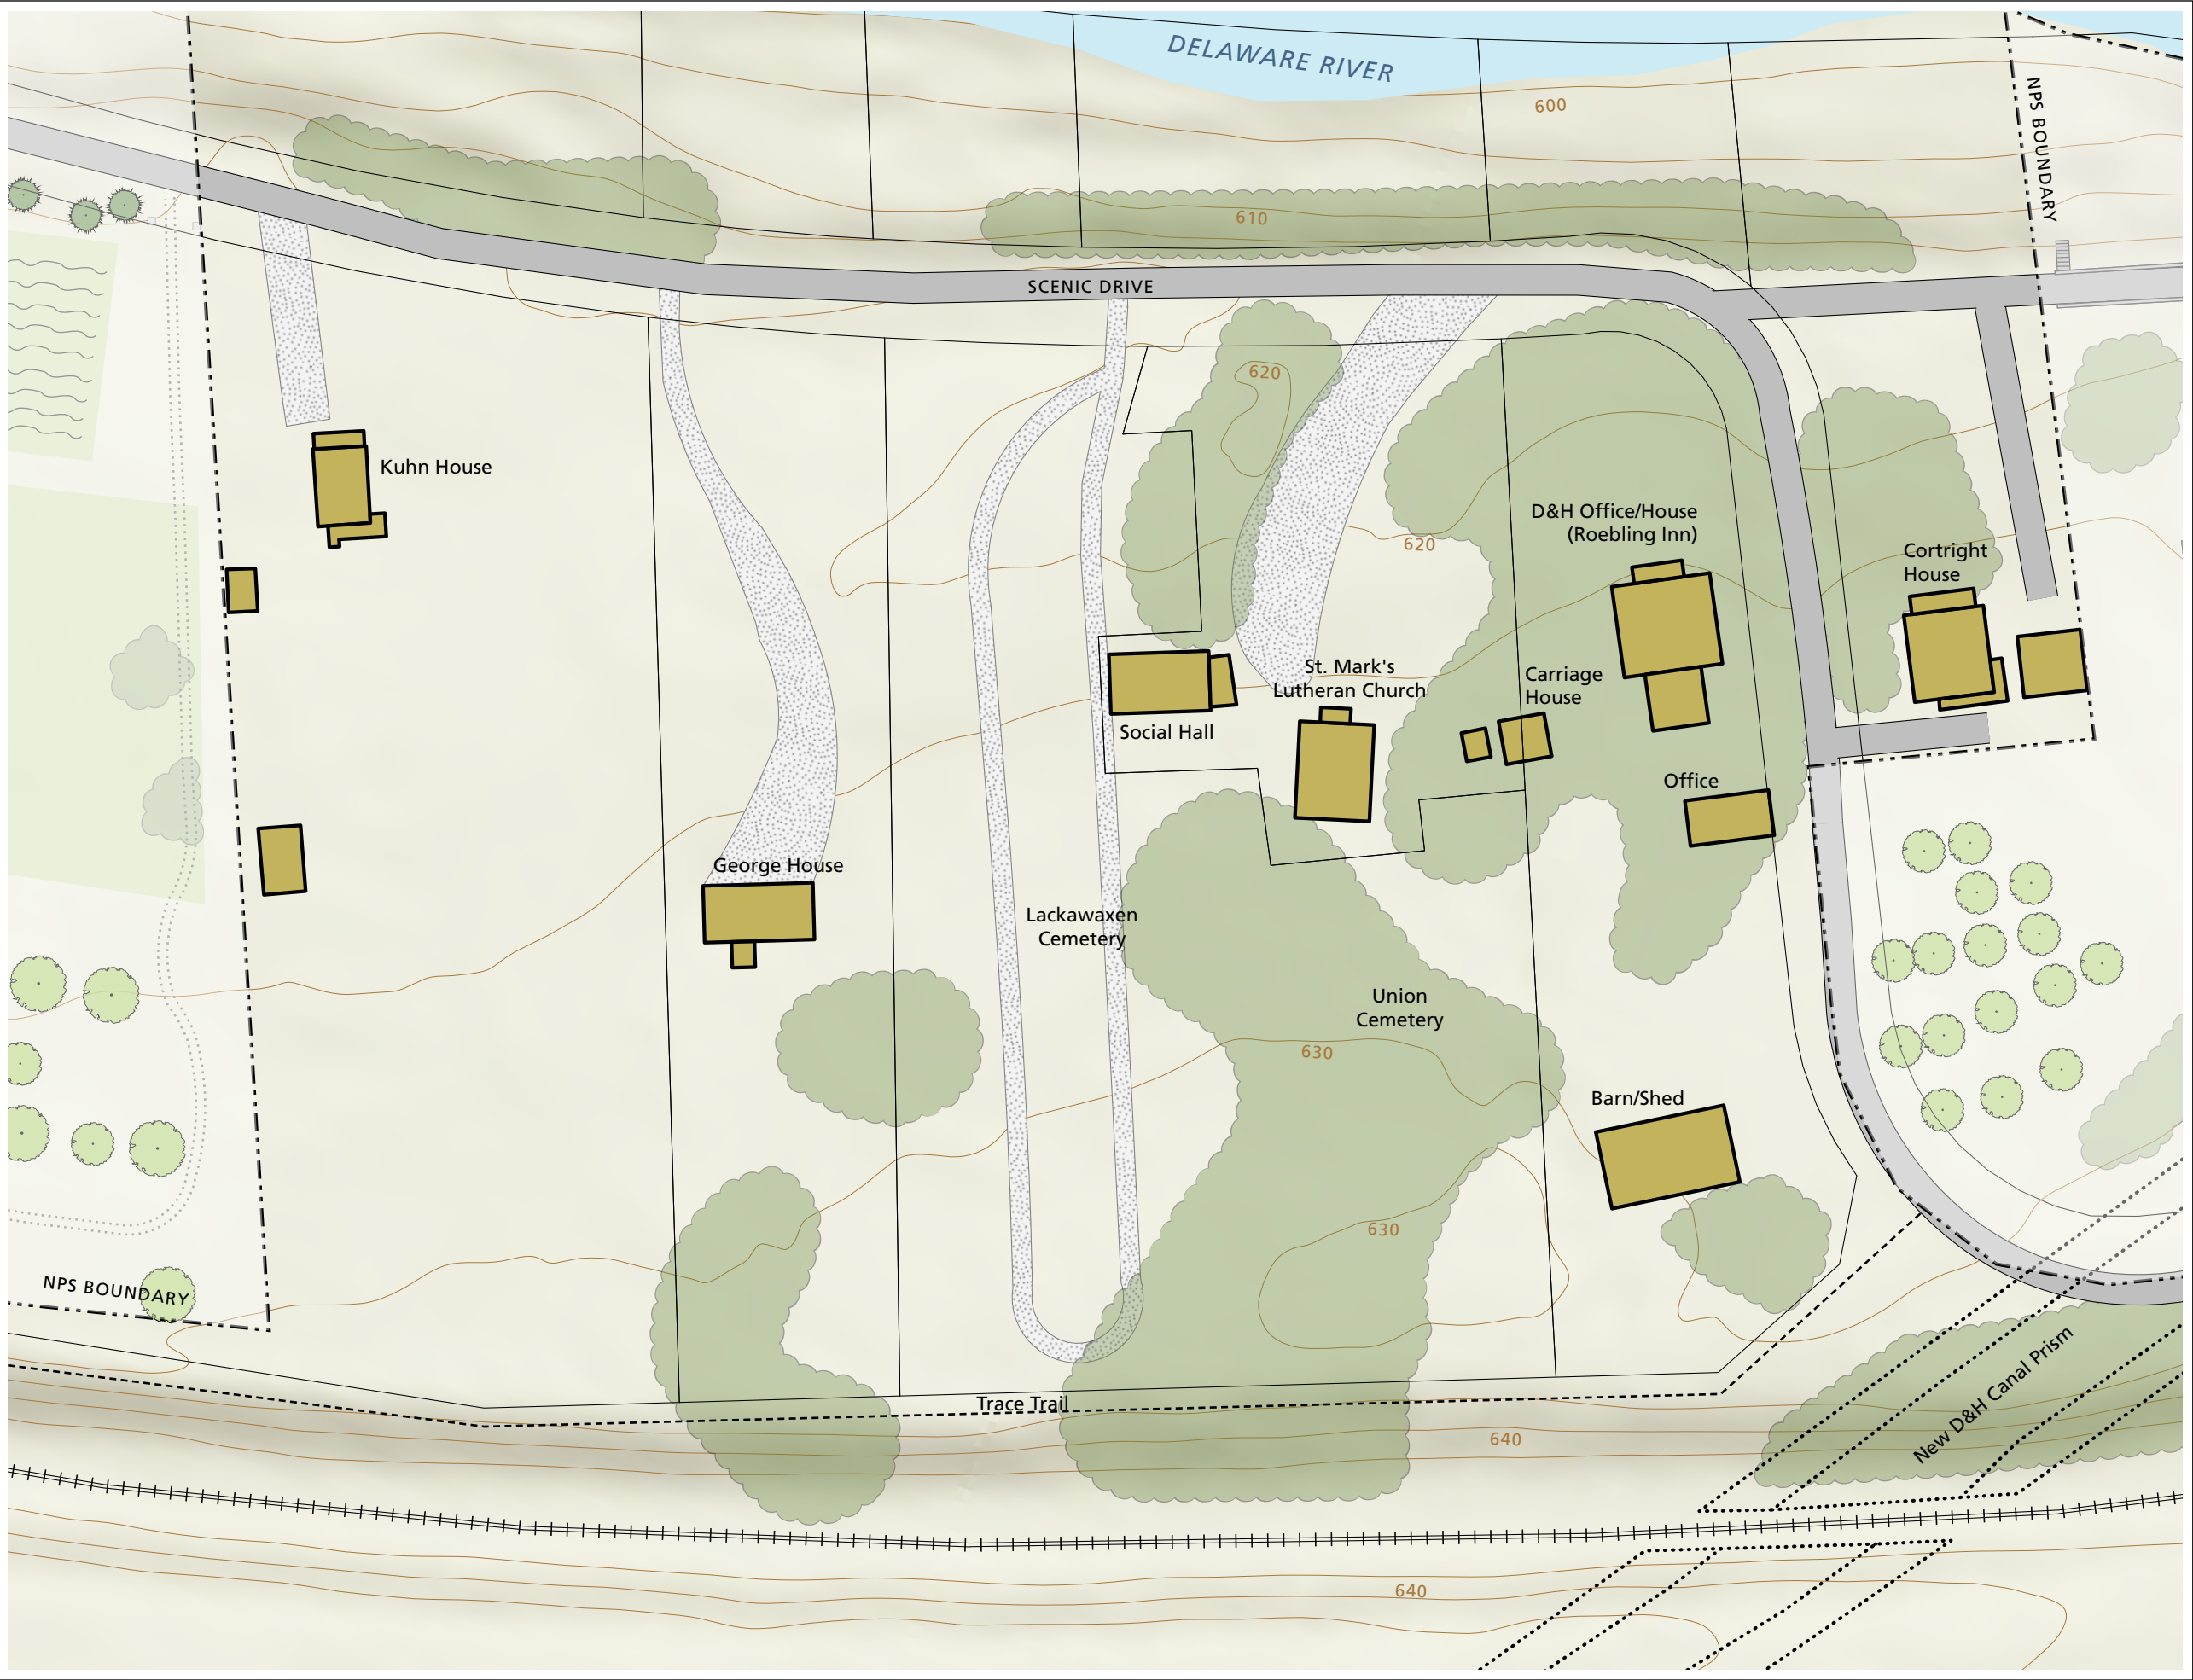
Connection Area  
1929 Period Plan

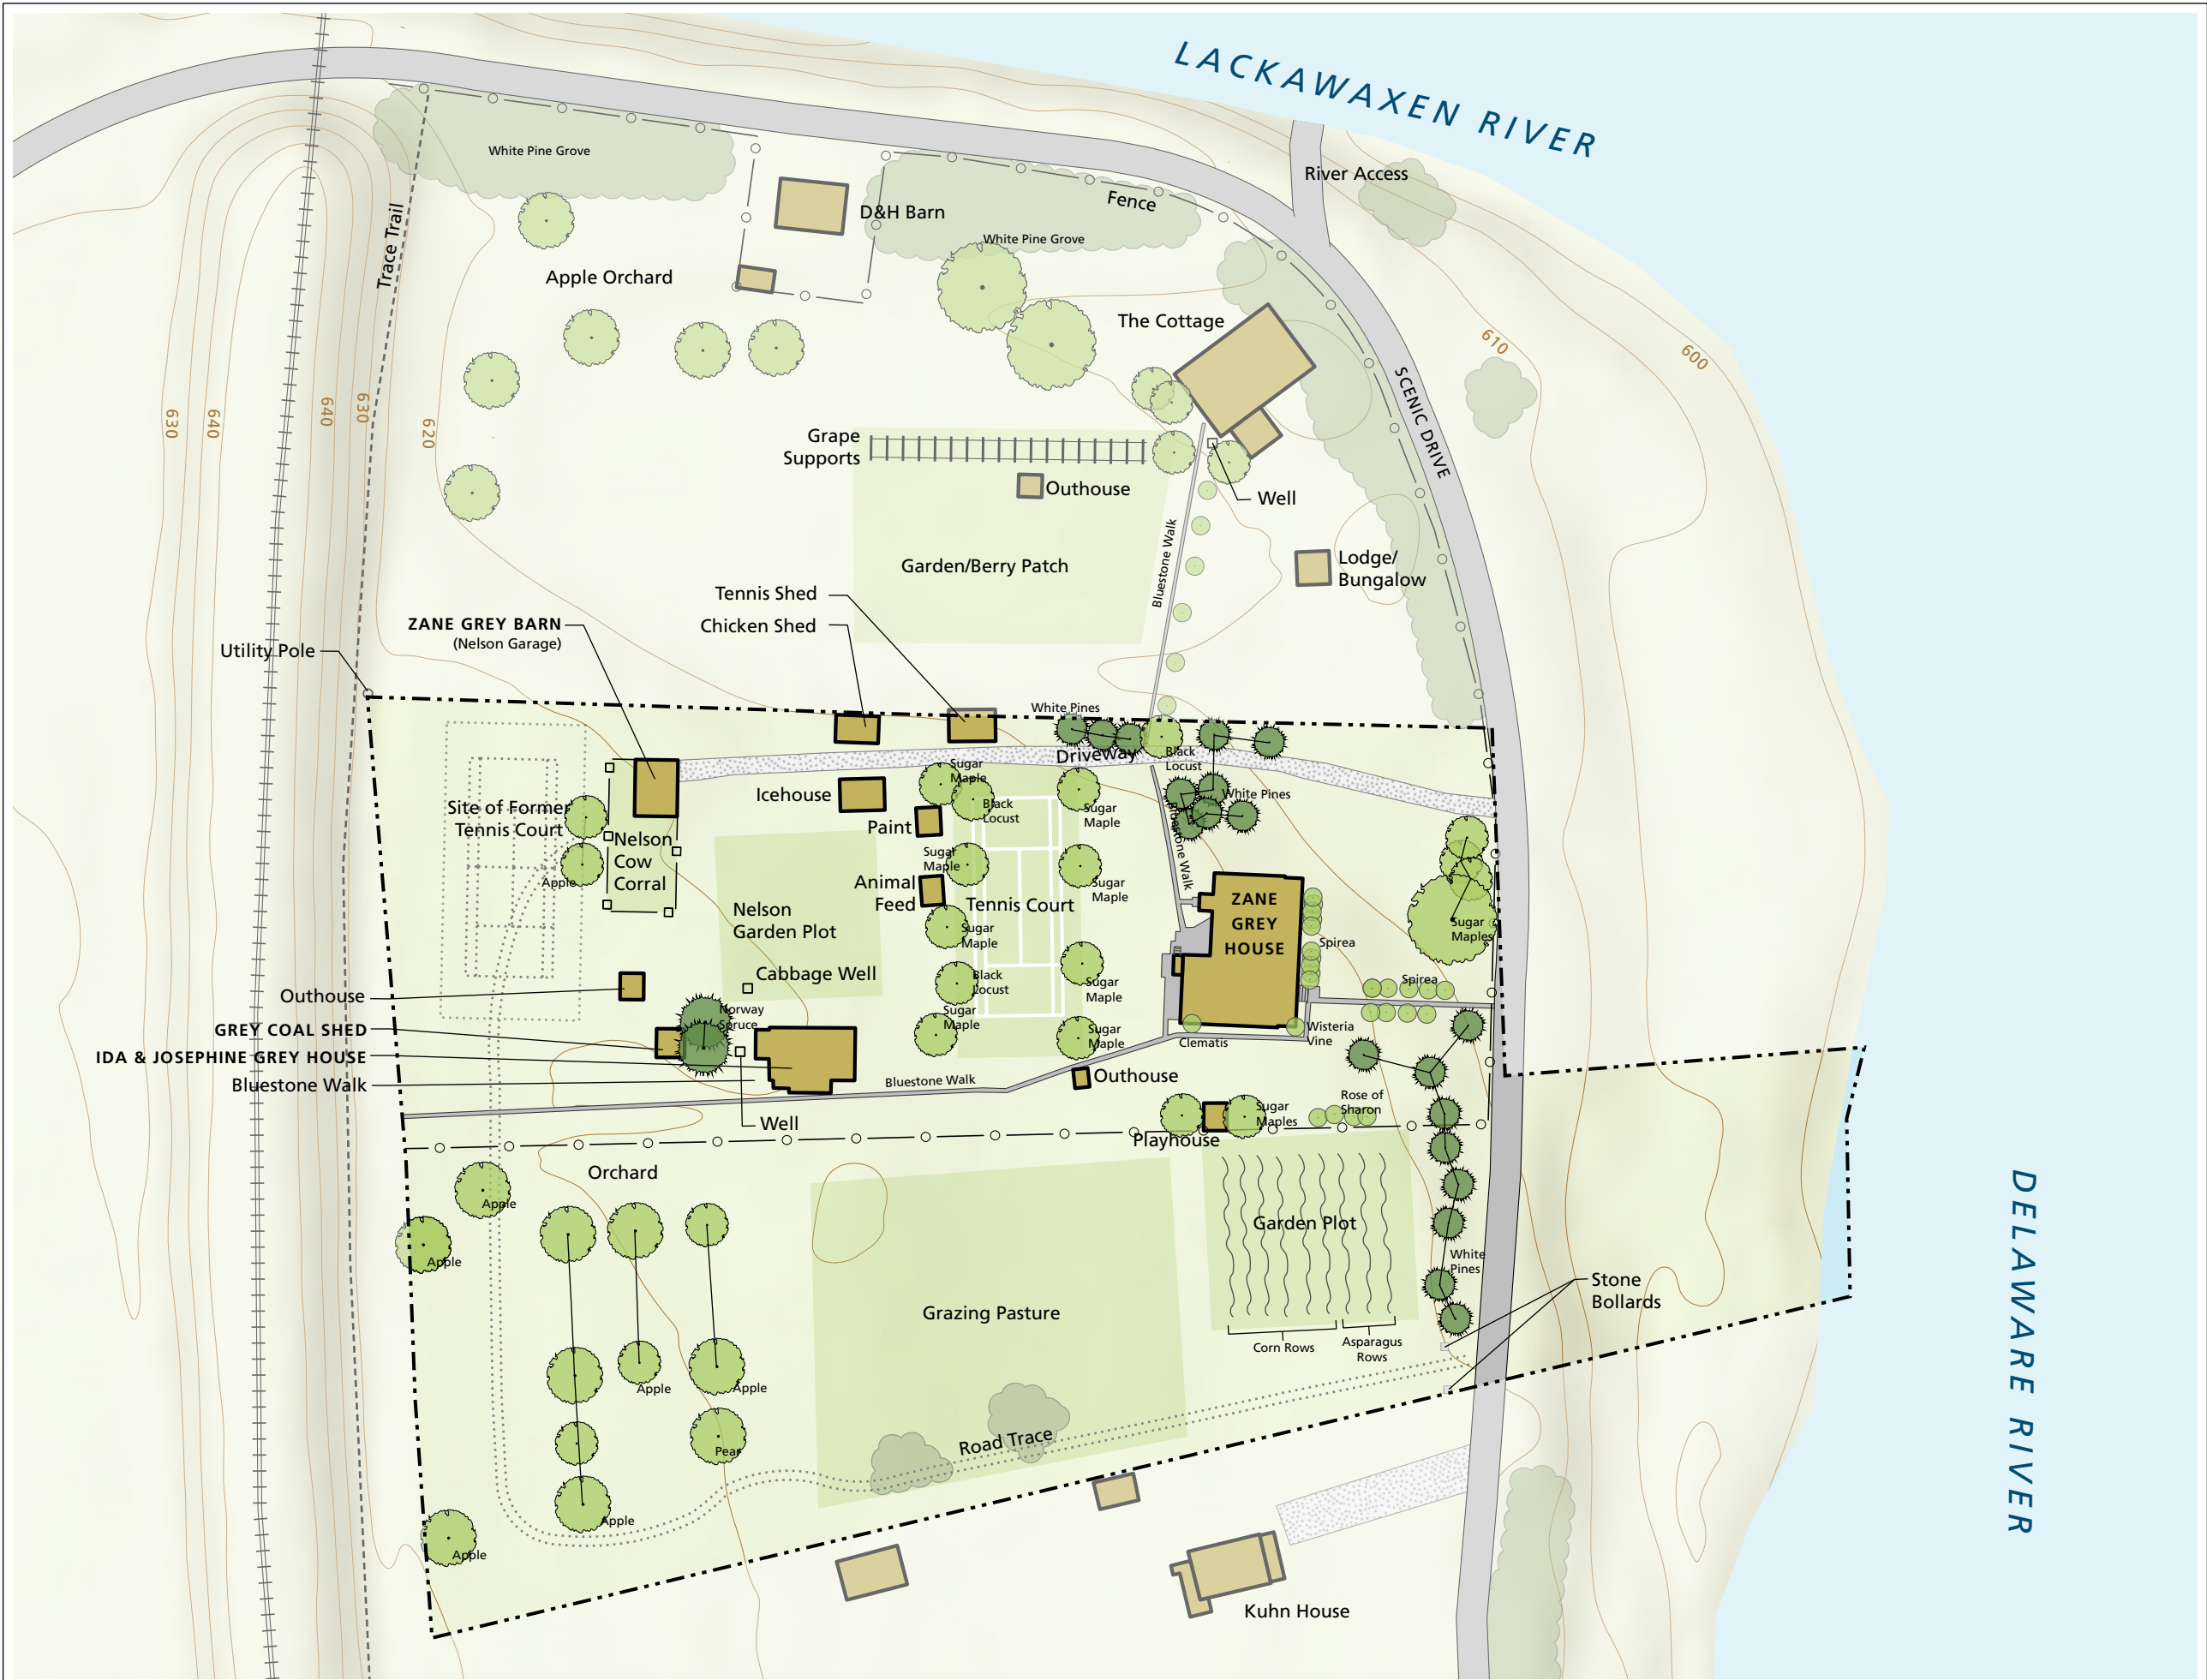
Zane Grey Property  
1929 Period Plan

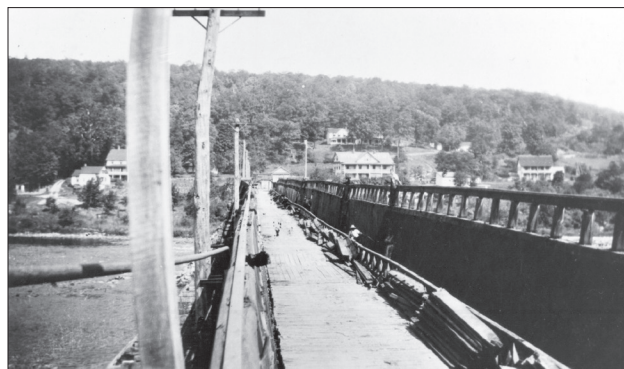
Figure 1.46. View looking east at the beginning of the project to replace the bridge deck and remove the aqueduct/bridge trunk walls, c.1931. (UPDE Archives, Scan 165)

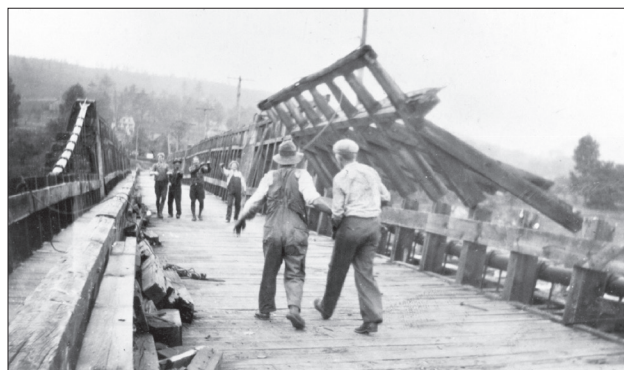
Figure 1.47. View looking west at the removal of the aqueduct/bridge trunk walls, c.1931. (UPDE Archives, Scan168)

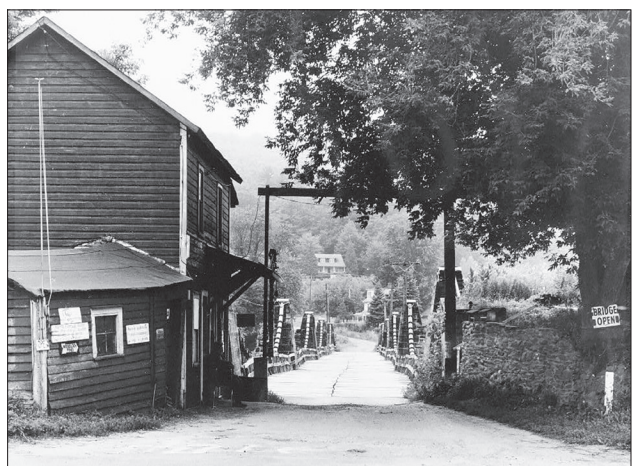
**Figure 1.52.** View looking west at the toll house and the aqueduct/bridge, c.1968. The toll gate is a simple hinged horizontal crossbar (shown here in a raised position). (Historic American Engineering Record, HAER PA-1, 1968, #140680pv)

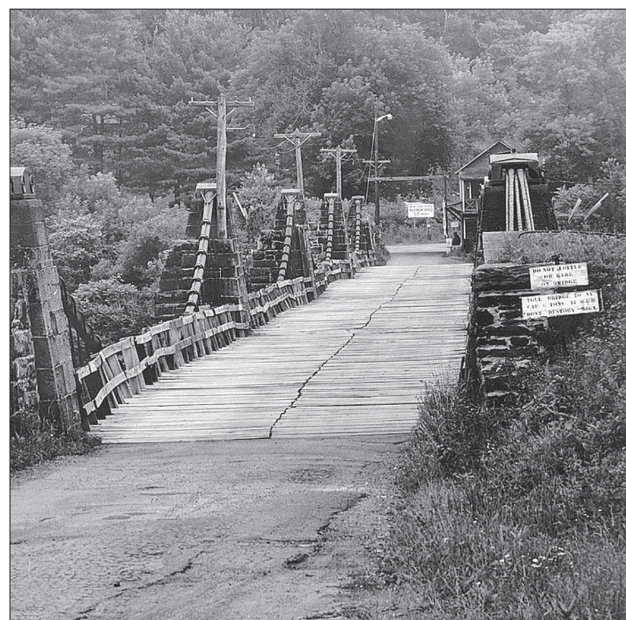
**Figure 1.53.** View looking east at the aqueduct/bridge, c.1969. The structure’s decking and railings are in poor condition. (Historic American Engineering Record, HAER PA-1, 1969, #140679pv)

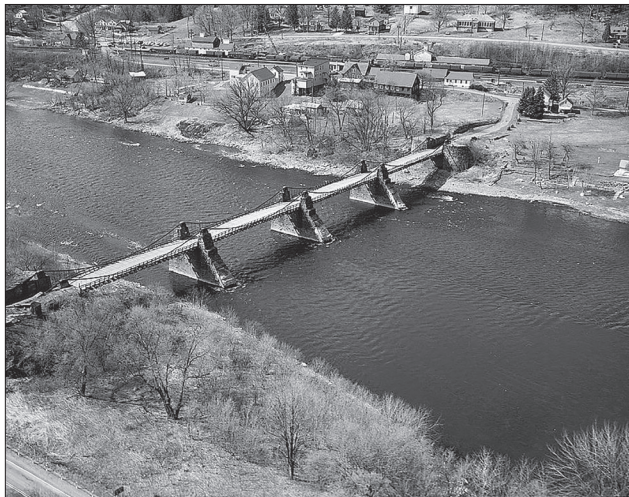
**Figure 1.54.** View looking southwest, c.1969. By this time the area north of the aqueduct/bridge on the New York side was filled with successional vegetation. On the Pennsylvania side, the partially wooded and partially graded vacant lot still stood between the aqueduct/bridge and development to the south. (Historic American Engineering Record, HAER PA-1, 1969, #140673pv)

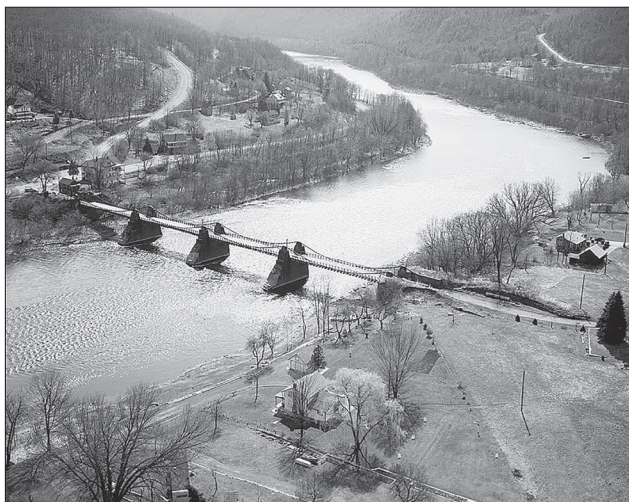
**Figure 1.55.** View looking southeast, c.1968. Note the dense vegetation on the New York side south of the aqueduct/bridge. On the Pennsylvania side north of the aqueduct/bridge, the former canal bed and towpaths (image lower right) have been leveled to the surrounding grades. A row of young trees marks the property line, which generally coincides with the outer edge of the former towpath. (Historic American Engineering Record, HAER PA-1, 1969, #140671pv)

Although Locks 72 and 70 were lost to the Route 97 project, the alignment of the new highway tracked just east of the abandoned Lock 71, leaving its stone retaining walls intact. The D&H house opposite Lock 72, and an adjacent garage, were also retained. The large industrial building south of the former hotel and garage were removed by 1931, while the garage itself was removed sometime in the 1930s and later replaced by a small shed. Much of the area between the highway and the feeder canal and river was already covered in trees at the time the highway was built. By the late 1960s the area was still cloaked in vegetation (see Figures 1.58d, 1.55, 1.56).

The 1939 aerial shows the canal bed partially filled with water and patches of vegetation, especially at the aqueduct/bridge end (see Figure 1.58a). A footbridge spanned the canal bed, connecting the Shannon house (Margold house) to the former D&H house (Brown Keller house), via a breach in the remains of the river-side towpath. Young orchards trees filled much of the open spaces north of the Brown Keller house and around the Cortright house. These conditions persisted through 1959, with the fruit trees maturing, but by 1969 most of the orchard trees were gone (see Figures 1.58c, 1.58d). The canal bed appears to have been filled in and the towpath that had been breached for a path was removed, creating a level lawn area (see Fig-

ure 1.55). A row of evergreen trees was planted along the Scenic Drive by this time, at the north end of the former canal (see Figure 1.56) (removed 2011-2015). A small shed and a driveway were present in the former orchard area by 1969 (see Figure 1.58d).

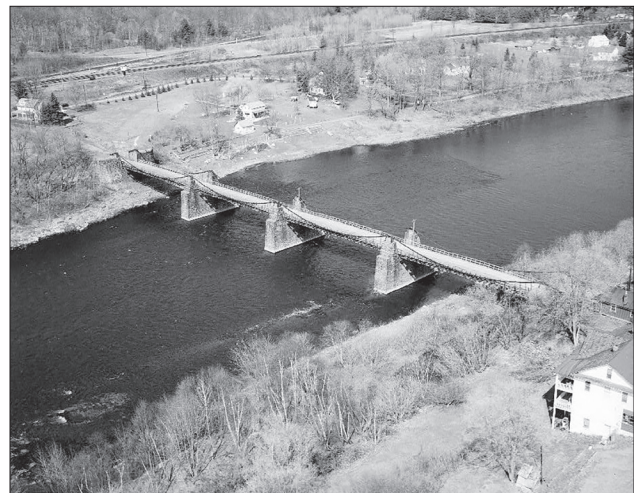
**Figure 1.56.** View looking northwest, c.1969. North of the aqueduct/bridge, a line of young pine trees lines Scenic Drive (image upper left). (Historic American Engineering Record, HAER PA-1, 1969, #140672pv)
