# CULTURAL LANDSCAPE REPORT FOR ROEBLING'S DELAWARE AQUEDUCT SITE AND THE ZANE GREY PROPERTY

UPPER DELAWARE SCENIC AND RECREATIONAL RIVER

National Park Service, Boston, Massachusetts, 2023

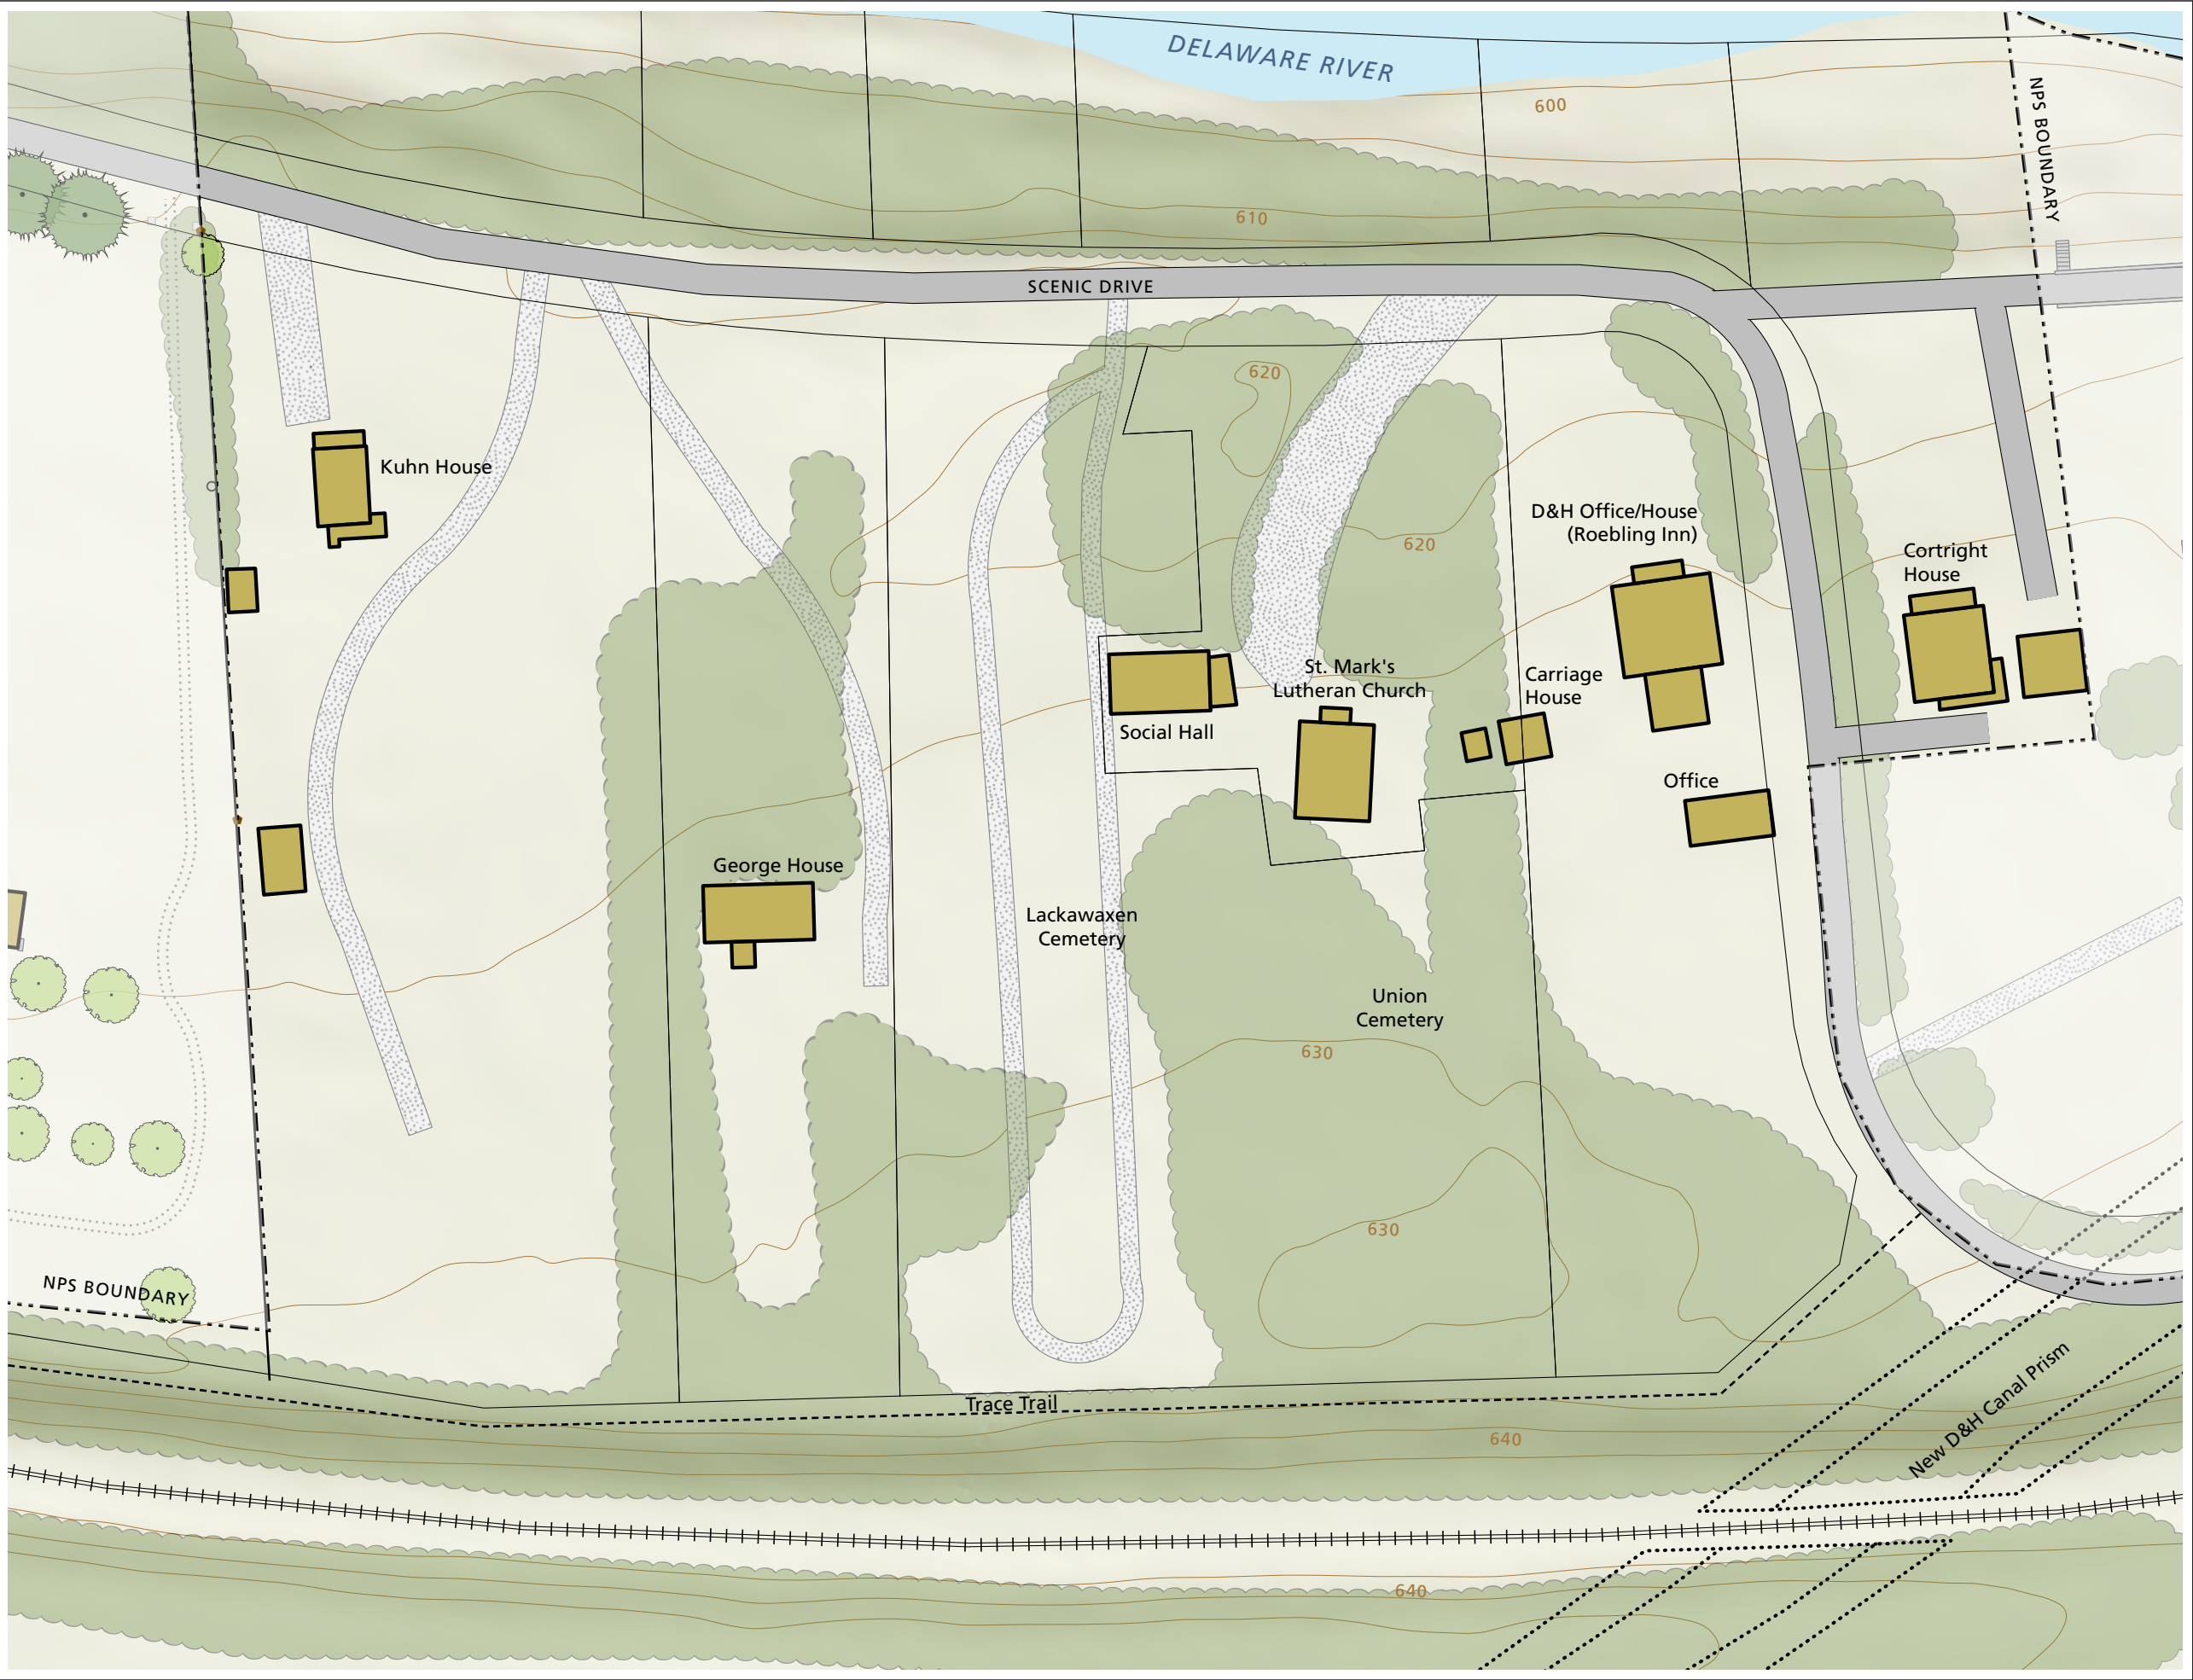
**Drawing 14**

Connection Area  
1978 Period Plan

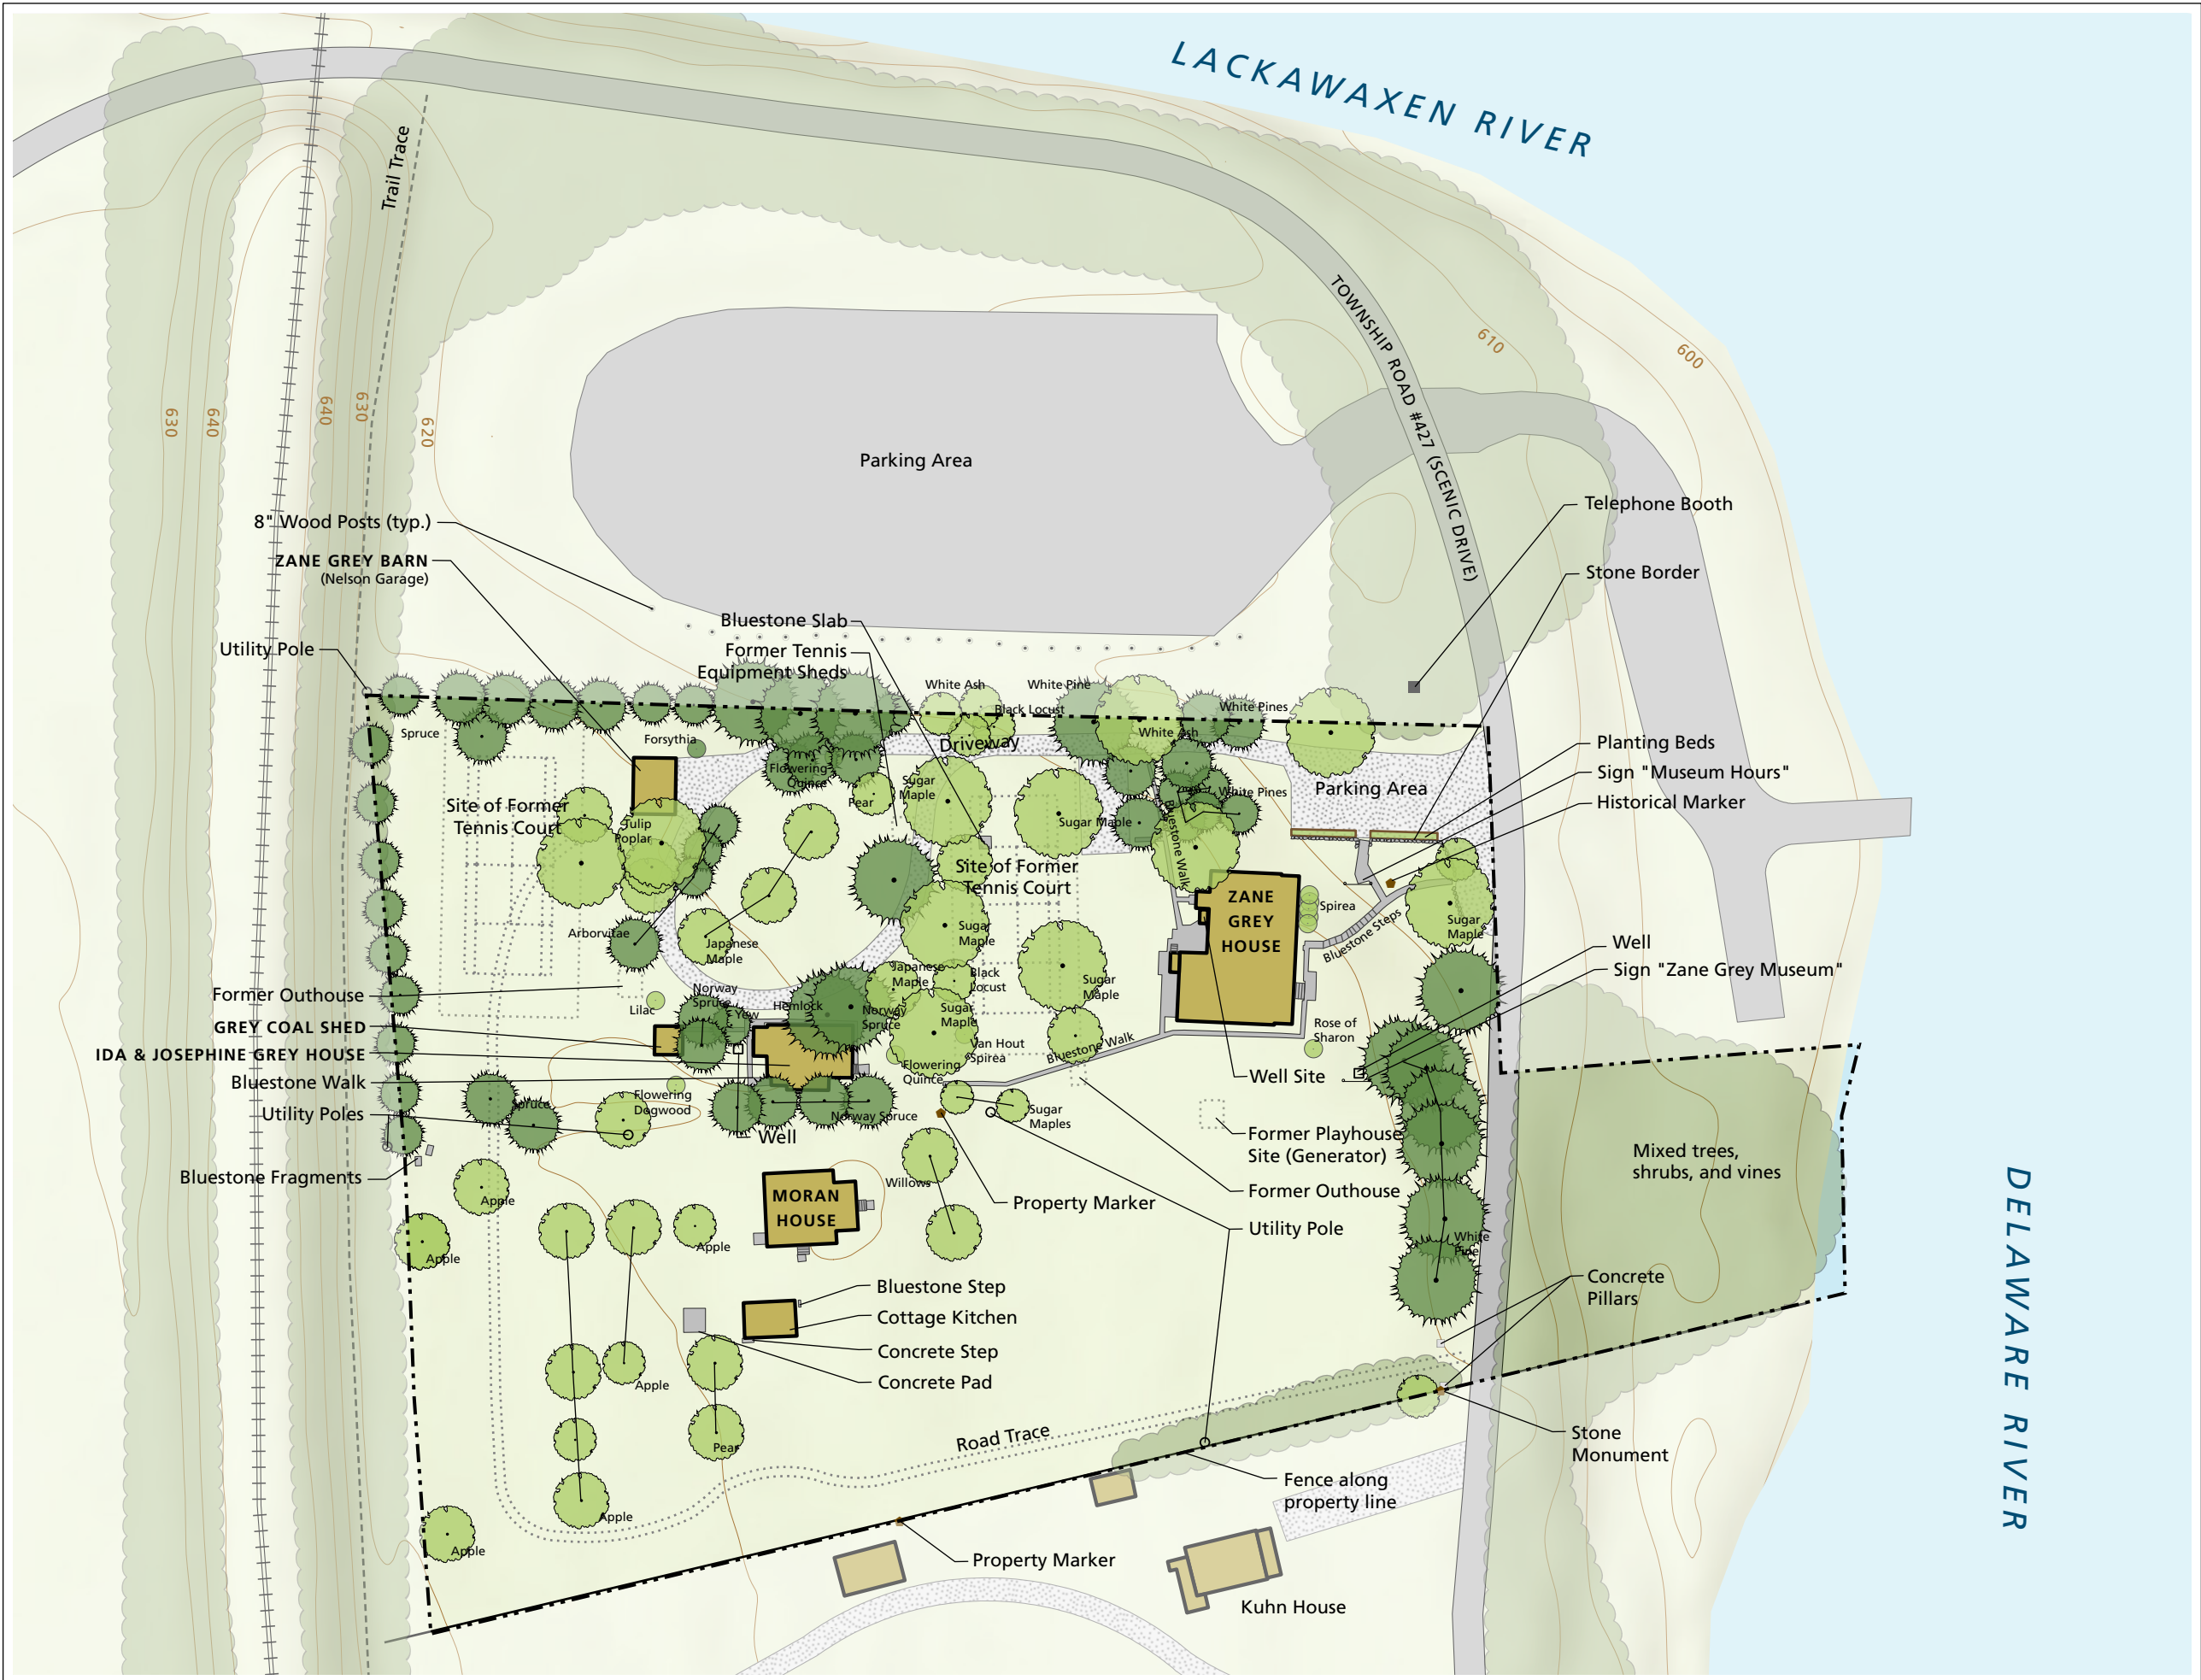
Zane Grey Property  
1978 Period Plan

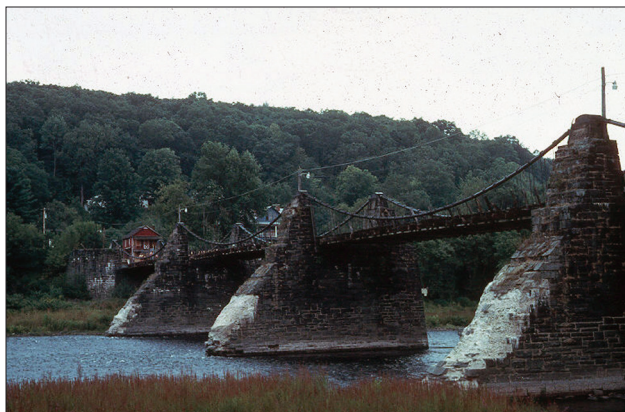
**Figure 1.62.** View looking southeast at the deteriorated aqueduct/bridge, 1980. (National Park Service, Photo Gallery, "48 Roebling Aqueduct in 1980." From <https://www.nps.gov/media/photo/gallery-item>)

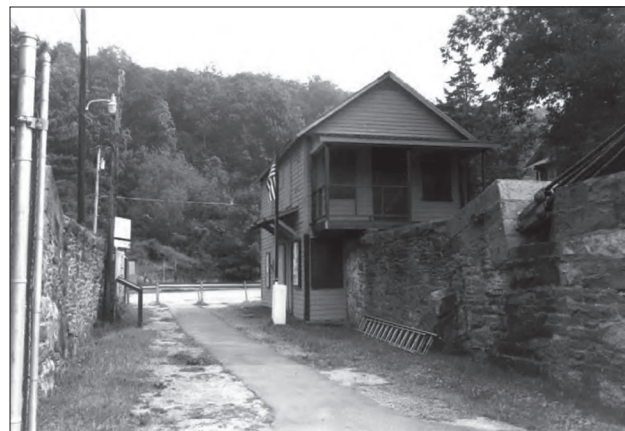
**Figure 1.63.** View looking east at the toll house, 1980s, when the aqueduct bridge was pedestrian-only. (Mary Curtis, "Toll House," Building-Structure Inventory Form, NYS Office of Parks, Recreation, and Historic Preservation, Division for Historic Preservation, 1985)

closed the structure to all traffic (Figure 1.62). Repairs were made to the deck, railings, and lights, but because of the discovery of additional major structural problems, the structure was reopened only to pedestrians in October 1980 (Figure 1.63). Local opposition to the closure of the former aqueduct to vehicles was considerable, prompting the National Park Service to reiterate their commitment to preserving the structure's historic elements and opening it to light vehicular traffic. Over the next two years, research projects were undertaken to evaluate the structure's preservation needs and the long-term effects of continued use of it by vehicles.<sup>95</sup>

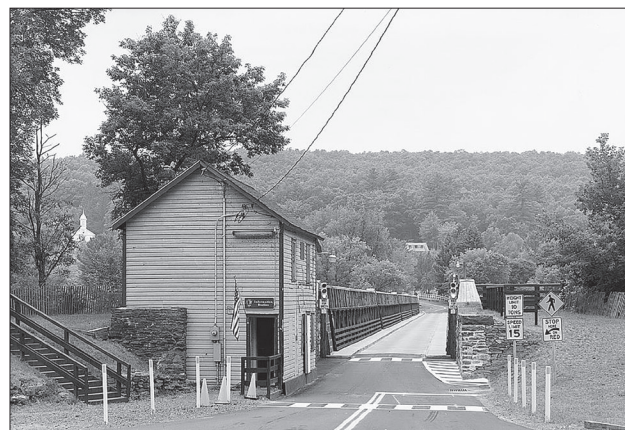
**Figure 1.65.** View looking west at the tollhouse and former aqueduct after it reopened to vehicular traffic, c.1988, before the towpaths were reconstructed in 1994. (Historic American Engineering Record, HAER Addendum PA-1, 1988, #123818pv)

opened to canal traffic in 1849. The third interpretive alternative was selected, and in 1986 a Memorandum of Agreement addressing the reconstruction was signed by representatives of the Advisory Council on Historic Preservation, the State Historic Preservation Offices of New York and Pennsylvania, and the National Park Service's Mid-Atlantic Regional Office. The multi-year project began in 1985 and included rehabilitation of the original cables and masonry, reconstruction of the icebreakers, replacement of the timber superstructure, construction of the approach roads and concrete bridge deck, placement of a steel stiffening truss system, and reconstruction of the trunk walls, towpaths, and walkways (Figures 1.64, 1.65). Roebling's Delaware Aqueduct reopened to traffic in 1987.<sup>97</sup>

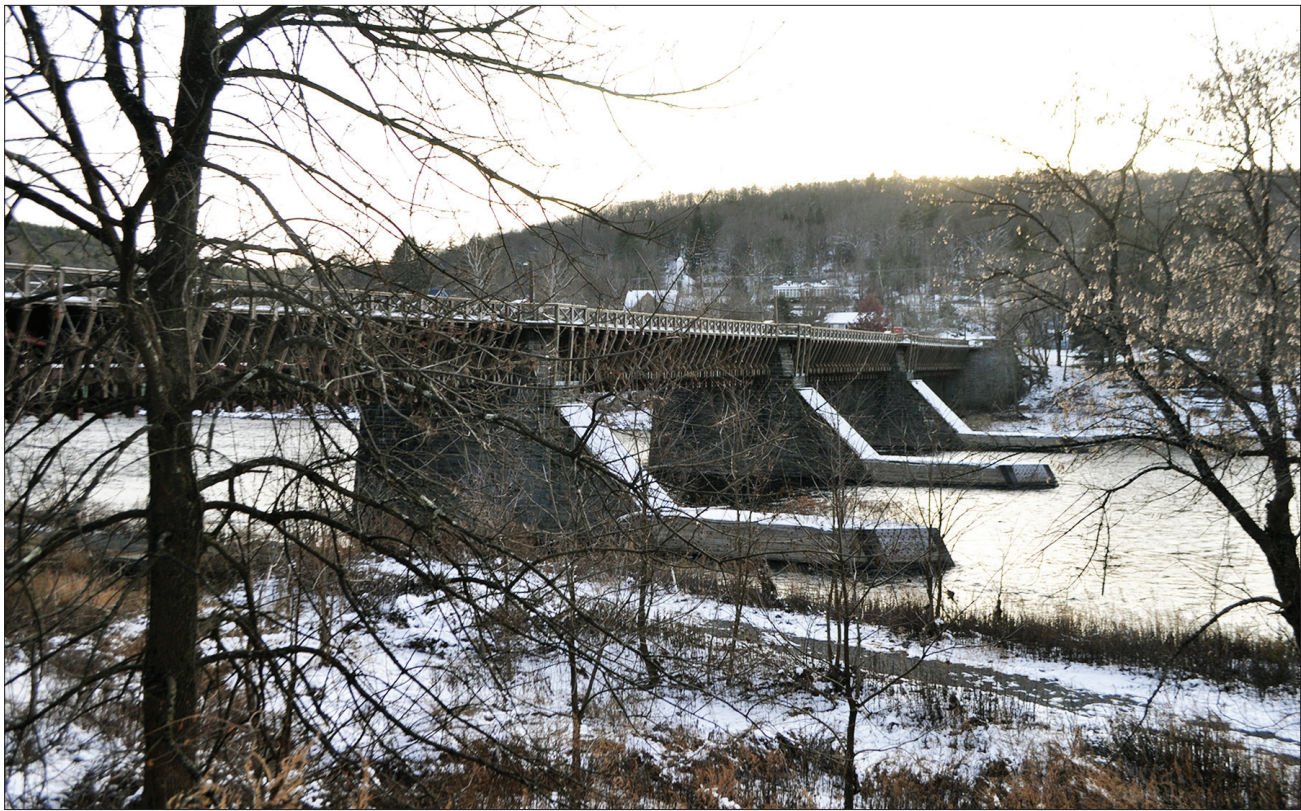
Figure 2.1. View looking south from the New York side parking lot to the upstream side of Roebling's Delaware Aqueduct. (OCLP 2022, DSC\_7492)

Roebling's Delaware Aqueduct currently accommodates one lane of traffic and pedestrians, and is in good condition (Figure 2.1). Vehicles now travel through the reconstructed aqueduct trunk, which features angled wood plank walls and a concrete and imbedded aggregate road surface. The reconstructed wood towpaths are level with the top of the trunk and offer pedestrian access across both sides of the structure. They are 6-feet wide and have wooden railings on both sides, and connect to small stone paved areas at

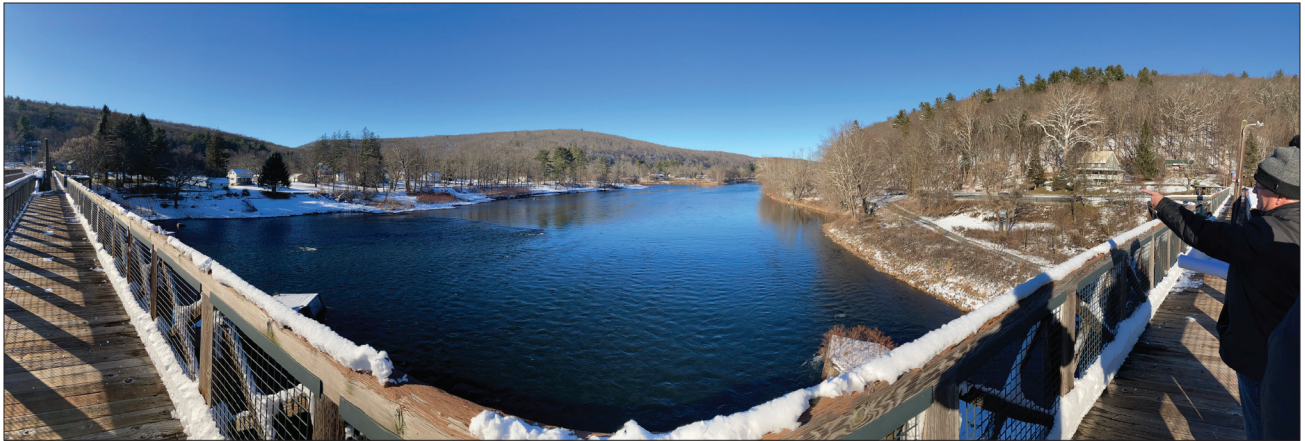
**Figure 2.2. Panoramic view from the aqueduct/bridge's upstream towpath, traces of the slackwater dam are still visible in normal river level conditions (ripples, image left). (OCLP 2022, IMG\_0740)**

each abutment that in turn connect to concrete sidewalks. From the aqueduct/bridge's upstream towpath, traces of the slackwater dam are still visible in normal river level conditions (Figure 2.2).<sup>21</sup>

did (see Figure 2.2). The towpath on the upstream side of the former aqueduct also includes projecting lookouts over each of the piers, and there are also lookouts at each abutment.<sup>23</sup>

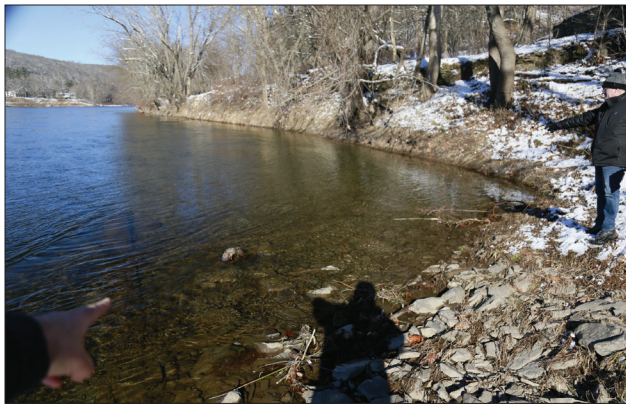
Figure 2.2a. View of parallel lengths of submerged timbers associated with a guardlock at the former entrance of the original canal. (OCLP 2022, IMG\_1877)

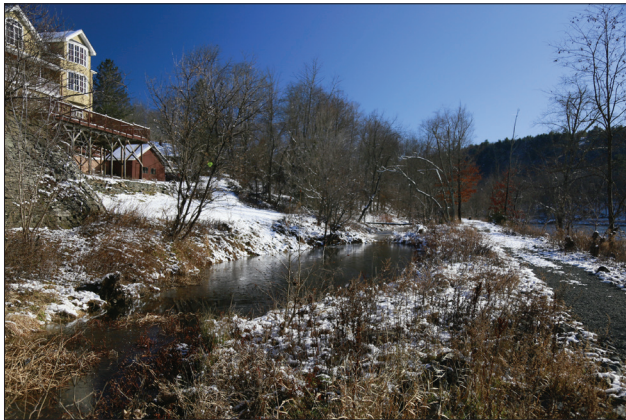
Figure 2.3. View looking southeast at the original canal prism and towpath. The river is at image right. (OCLP 2022, IMG\_1848)

Today, the original canal prism (UPDE Str #7300) is approximately 2,000 feet long and 10 feet high (Figure 2.3). It still holds water after storm and flood events, but a breach in the towpath prevents the water from getting too high. Other areas of the original canal prism have been overtaken by successional woodlands. Sections of new canal prism on either end of Lock 71 that were not buried by the highway are located on state-owned land (Figure 2.4).<sup>37</sup>

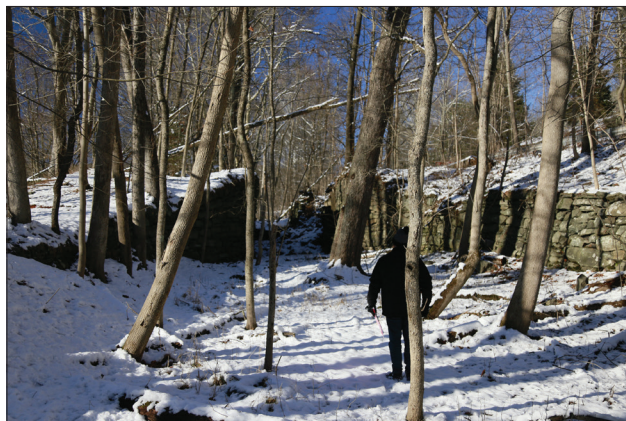
Figure 2.4. View looking northwest at the south end of Lock 71 and new canal prism and walls. (OCLP 2022, IMG\_1872)

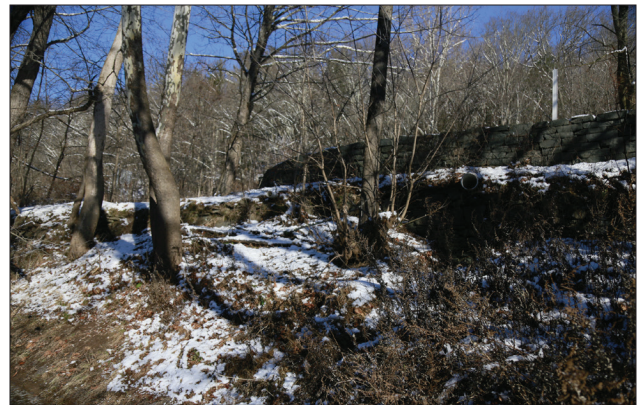
Figure 2.5. View looking west at the original towpath stone wall and a curved contemporary stone wall above it, which supports the Maintenance Access Road. (OCLP 2022, IMG\_1839)

(no#) that supported the towpath paralleling the riverbank from the rope ferry to the to the original canal remain (no Str #) (Figures 2.5, 2.6). A guardlock structure guided canal boats into the original canal and controlled the amount of water entering the canal until at least 1848, after which it was removed. Remnants of stone walls still line the original canal towpath (#7311, #7321) (Figure 2.7). By 1848 three new locks, turning basin, and towpaths were built as part of the Delaware Aqueduct. This section of new canal also featured stone wall construction, with the locks themselves armored with horizontal heavy timber planks attached to vertical boards and anchored to the walls with iron tie bars. Most of the new canal was filled in by the construction of State Route 97 in the 1930s, except for Lock 71 and its approaches, which today still features intact stone walls (#7211) (Figure 2.8, see also Figure 2.4). The park periodically removes woody vegetation from the canal walls, but soil and successional vegetation still obscure some wall segments. Various sheds, barns, and lockhouses that served as canal support structures are gone, although several canal-era houses, as well as some of the turning basin stone walls, are extant beyond the CLR project boundaries.<sup>38</sup>

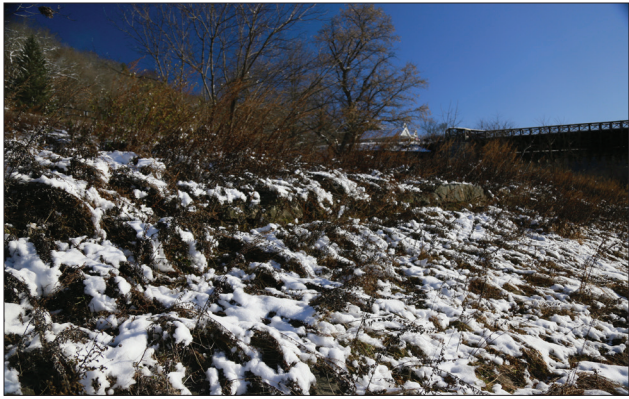
**Figure 2.6.** The top of a partially hidden section of stone wall associated with the original canal prism or towpath. (OCLP 2022, IMG 1841)

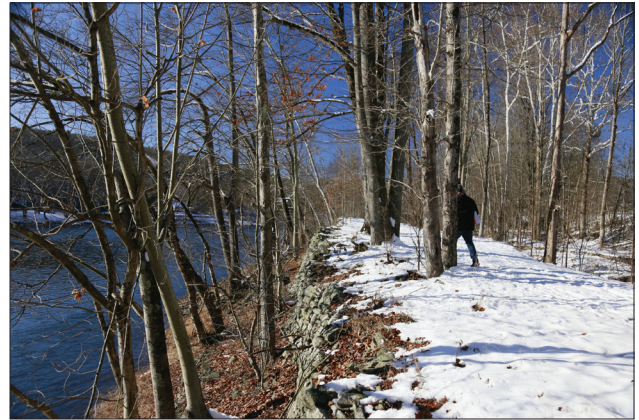
**Figure 2.7.** View northwest at a stone wall supporting the original canal towpath. (OCLP 2022, IMG\_1867)

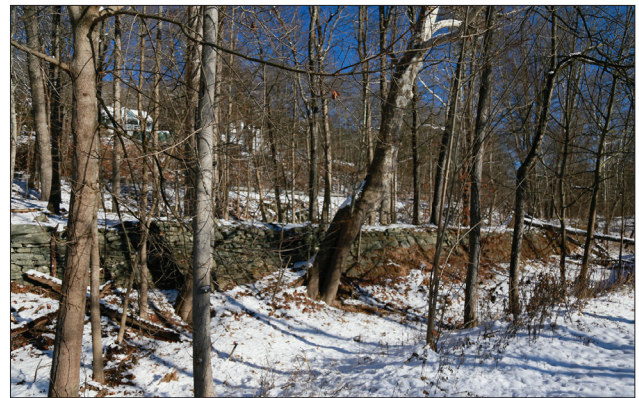
**Figure 2.8.** View looking southeast at stone walls lining along the new canal towpath, likely built atop walls associated with the original canal prism. (OCLP 2022, IMG\_1854)

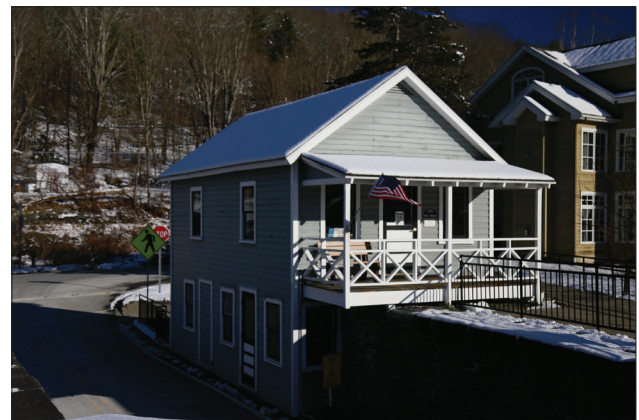
The two-story toll house (#7250) constructed in 1908 stands next to the aqueduct/bridge's east abutment, as part of that structure's conversion to a vehicular crossing (Figure 2.9). The toll house was stabilized in 1990 and houses exhibits and displays. Adjacent to the toll house is a three-story private residence built c.2000 on the site of the former Highland Bridge Hotel. The Route 97 highway project also constructed a stone diversion dam (#7323) in the original

**Figure 2.9.** View looking west at the two-story toll house, constructed in 1908 next to the aqueduct/bridge's east abutment. (OCLP 2022, IMG\_1885)

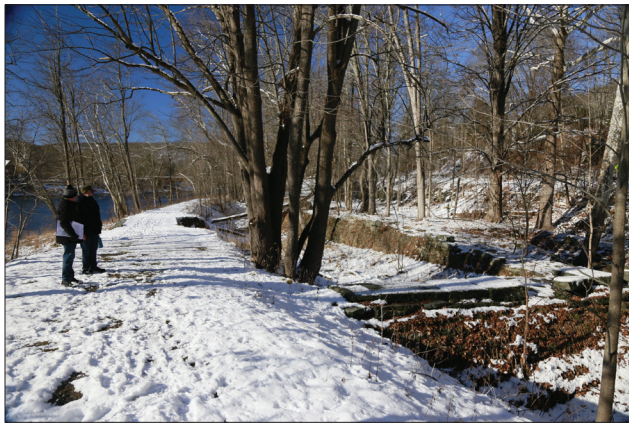
Figure 2.10. View looking northwest at the original canal prism and towpath, and the stone diversion dam. (OCLP 2022, IMG\_1860)

canal prism to prevent flood water from undermining the road's embankments (Figure 2.10). Several culvert outlets associated with the highway drain onto park-owned lands. The most prominent are double pipe and single pipe outlets north of the aqueduct, and a single pipe outlet south of the aqueduct, the outfall of which has severely damaged the stone walls in Lock 71 (Figure 2.11). More recent walls and culverts include: concrete walls and culverts at the parking lot north of the aqueduct/bridge and stone walls along sidewalk east of the tollhouse (mid-1990s), a stone wall along the Maintenance Access Road (2007), two-pipe culvert at the beginning of the Towpath Trail (2007), and a concrete box culvert/footbridge on the old towpath that spans the breach (2009) (Figures 2.12, 2.13).<sup>39</sup>

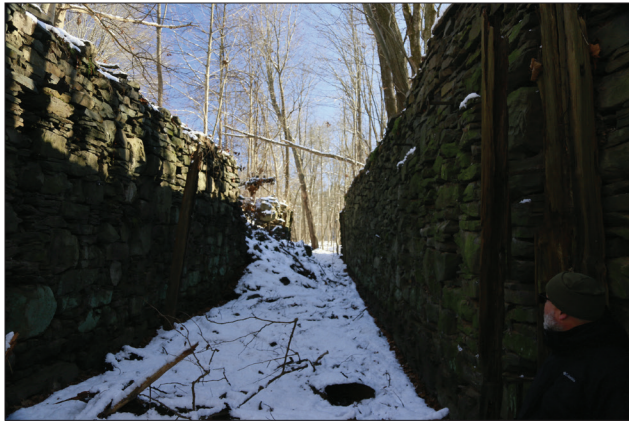
Figure 2.11. A section of Lock 71 has collapsed due to stormwater associated with a culvert on State Highway 97. (OCLP 2022, IMG\_1877)

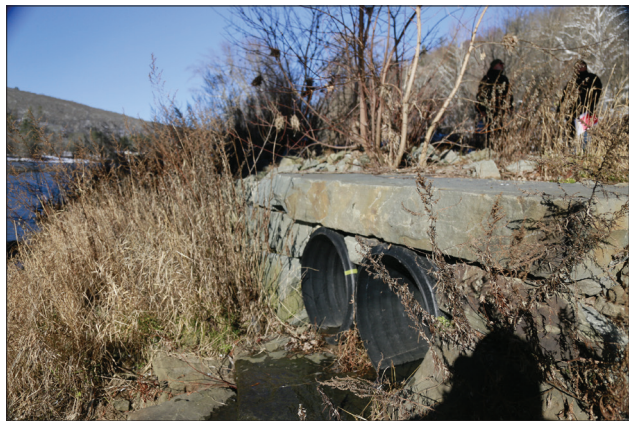
Figure 2.12. A two-pipe culvert is located under the aqueduct/bridge and empties stormwater from the original canal. (OCLP 2022, IMG\_1847)

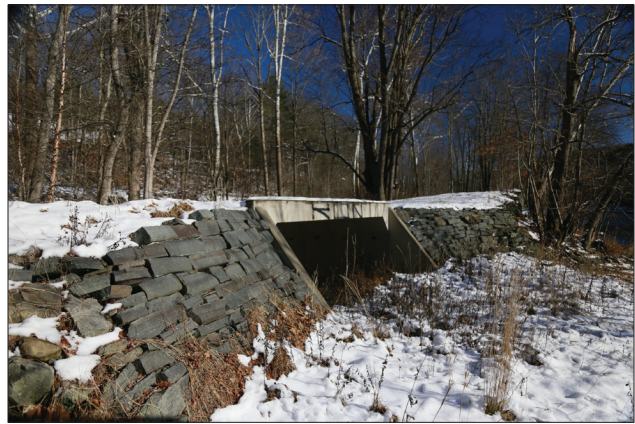
Figure 2.13. A concrete box culvert on the Towpath Trail spans the breach in the original canal and also serves as a footbridge. (OCLP 2022, IMG\_1858)

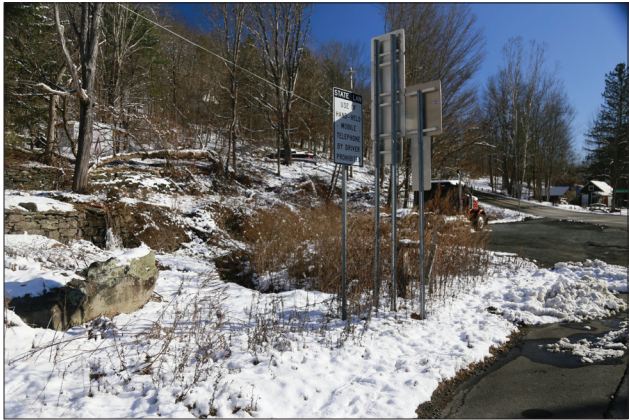
**Figure 2.14.** View looking west at the former turning basin site and remnant canal and towpath stone walls. (OCLP 2022, IMG\_1813)

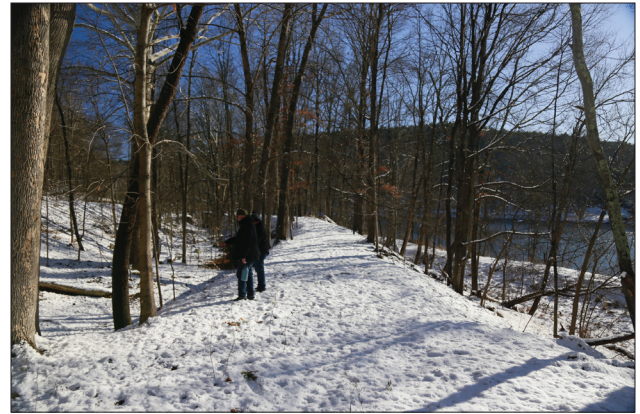
**Figure 2.15.** View looking south at the new canal towpath, located north of Lock 71. The new canal is at image left and the original canal and towpath are down the hill at image right. (OCLP 2022, IMG\_1881)

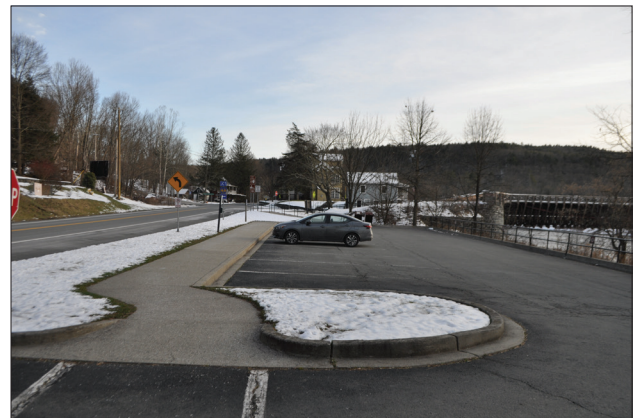
Several non-historic circulation features were constructed by the park beginning in the 1990s (Figures 2.16, 2.17, 2.18). In 1994-1997 a paved parking lot was built for 10 vehicles and included an earthen/gravel emergency access road to the riverbank. Concrete sidewalks provided visitor access to the toll house and the reconstructed aqueduct/bridge towpaths. In 2007 the park built a maintenance access road stretching from the parking lot to the north end of the Towpath Trail under the aqueduct/bridge. A planned

**Figure 2.16.** View looking southeast at the parking lot and sidewalks on the New York side of the bridge/aqueduct. (OCLP 2022, DSC\_7500)

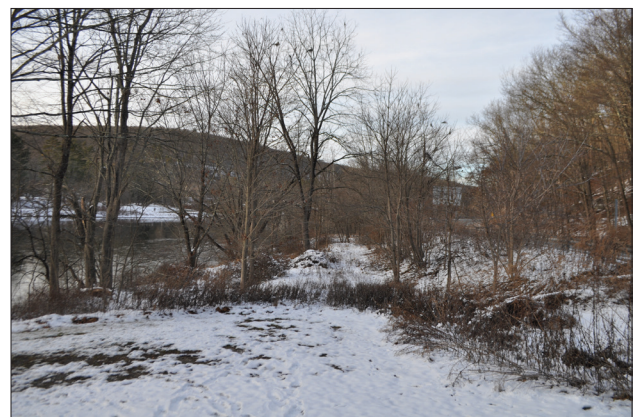
**Figure 2.17.** View looking northwest at the trace of the emergency river access road. (OCLP 2022, DSC\_7493)

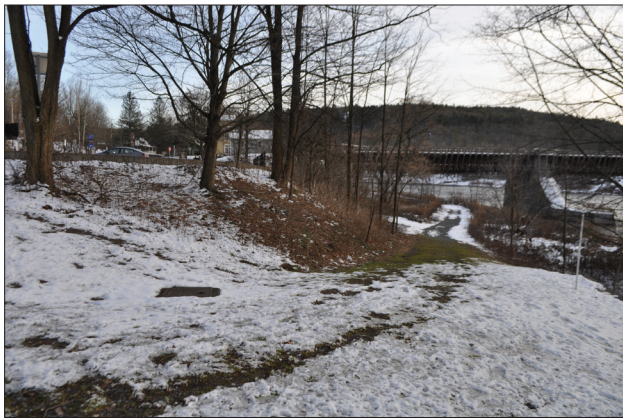
**Figure 2.18.** View looking south at the Maintenance Access Road that connects the parking lot to the Towpath Trail. (OCLP 2022, DSC\_7498)

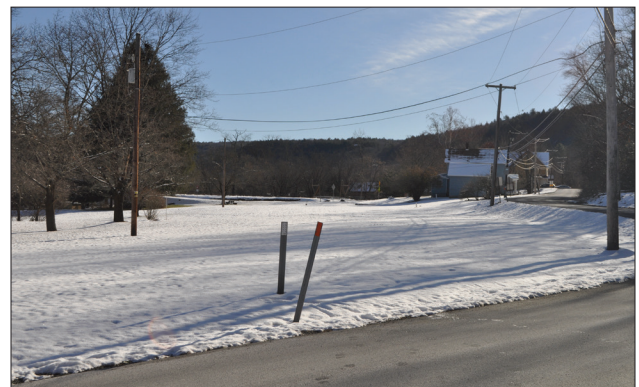
Figure 2.19. View looking east at the former location of the canal, from Scenic Drive. (OCLP 2022, DSC\_7439)

Today, this section of canal prism is around 320 feet long and is maintained as a lawn, but its former use as a canal is difficult to discern without the towpaths and stone walls (Figure 2.19). Recent geophysical research has discovered the approximate location of the canal prism and walls.<sup>60</sup>

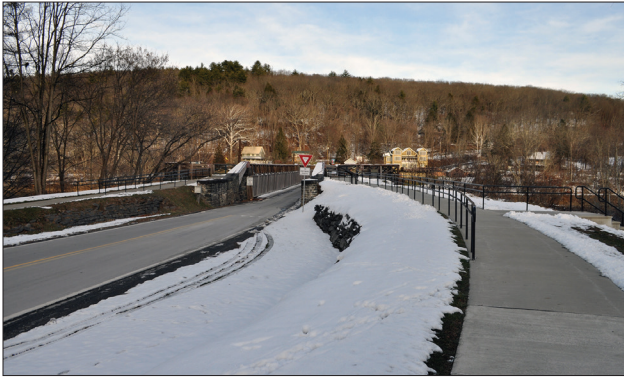
Figure 2.20. View looking east at two stone walls alongside the roadway that once lined the canal's turning basin. The sidewalk traces the location of the south towpath. (OCLP 2022, DSC\_7439)

#7006) alongside the approach road once lined the turning basin (Figure 2.20). A canal barn that once stood alongside the turning basin is no longer present. On land just east of the project boundary is a c.1855 two-story D&H canal house (Brown Keller house) that was enlarged with an addition on its west side in c.1915.<sup>61</sup>

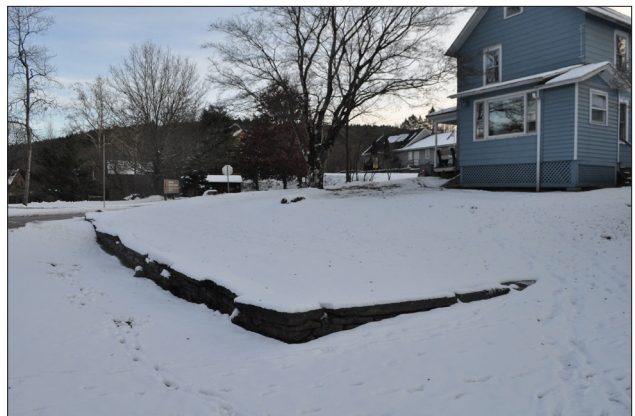
Figure 2.25. View looking south at a stone retaining wall at the Margold house. (OCLP 2022, DSC\_7447)

blend in with the surroundings, but the light color of the shed draws attention. The boathouse is built upon a stone foundation, likely dating to after 1915. A pre-fabricated 1-story restroom is located at the southwest corner of the parking lot. Built in the late 1990s, it blends in with the surroundings, with unpainted wood siding and has an entry screen on the north façade (Figure 2.23). The park plans to replace this building in the near future. On the west side of Scenic Drive is a 3-story, split level maintenance building that formerly housed the volunteer fire department (Figure 2.24). Due to its location well west of the primary historic features, it is not obtrusive in the landscape. Several non-canal related stone walls are located on the south and east sides of the Margold House, east of the boat barn and storage shed, and along the Scenic Drive extension that parallels the river (Figures 2.25, 2.26). Drainage in the parking lot is handled by a drop inlet, while a culvert, stone gutter,

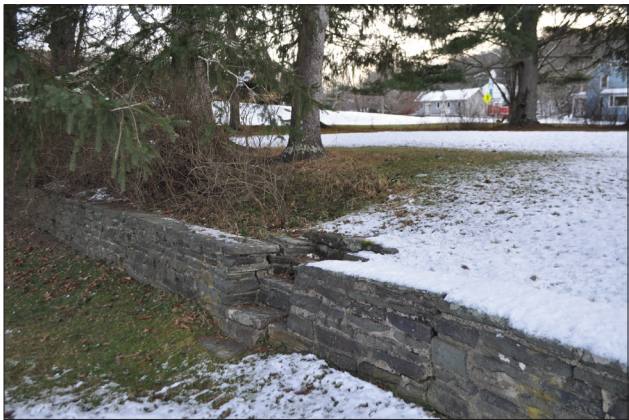
Figure 2.26. View looking south at a stone wall and steps east of the Brown Kelley garage. (OCLP 2022, IMG\_1911)

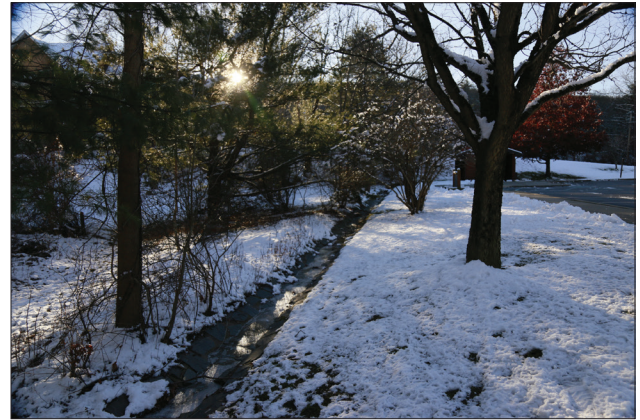
Figure 2.27. View looking southwest at the stone gutter on the east side of the parking lot.. (OCLP 2022, IMG\_1901)

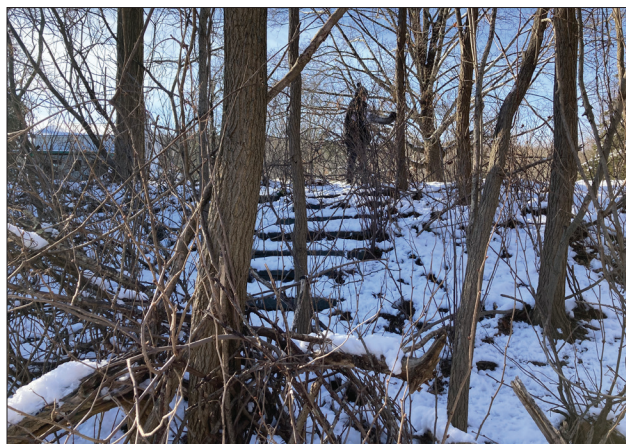
Figure 2.32. View looking southwest at remnant stone steps leading to the riverbank. (OCLP 2022, IMG\_0742)

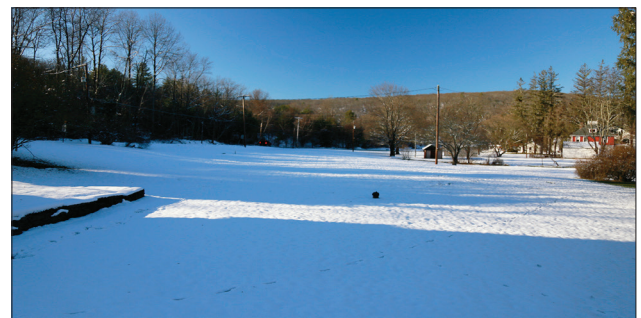
Figure 2.33. View looking west at the location of the new canal, shown here as an open, snow-covered lawn. (OCLP 2022, IMG\_1892)

from the former location of the 1847-1848 new canal that is now a lawn (see Figure 2.19). However, the park's ability to interpret this characteristic is made difficult due to the loss of the canal prism, walls, and towpaths, and the elevated position the towpaths and waterline would have provided (Figure 2.33). The overlook in the parking lot also offers a framed vista of the aqueduct/bridge (Figure 2.34).<sup>68</sup>

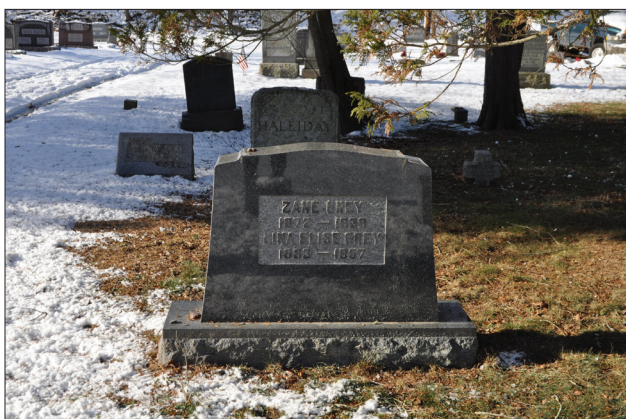
**Figure 2.45.** View looking southwest at the Zane and Lina (Dolly) Grey headstone. (OCLP 2022, DSC\_7407)

The roster of small-scale features in the Connection Area is dominated by the gravestones associated with the Union Cemetery established in c.1848 and the adjacent Lackawaxen Cemetery established c.1915. They include a headstone for Zane Grey and his wife Lina, and a modern plaque for an unknown soldier from the nearby Revolutionary Battle of Minisink (Figures 2.45, 2.46). Historic photographs show fence enclosures surrounded some of the cemetery plots (Figure 2.47).

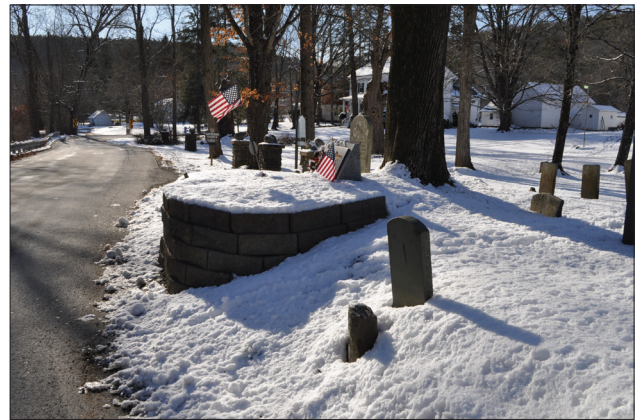
Figure 2.46. View looking south at the memorial for the Unknown Soldier. In the background five stone piers are visible. (OCLP 2022, DSC\_7404)

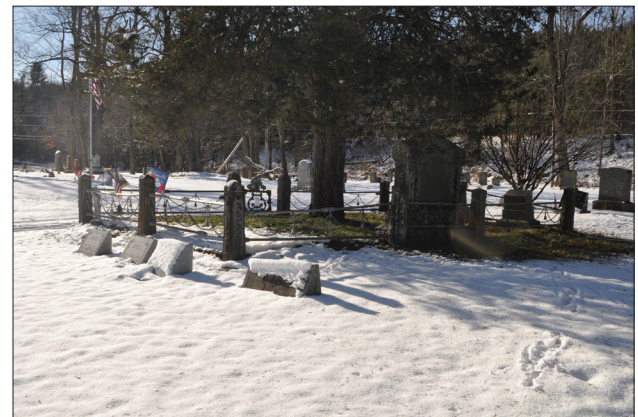
Figure 2.47. View looking south at one of the fenced cemetery plots. (OCLP 2022, DSC\_7408)

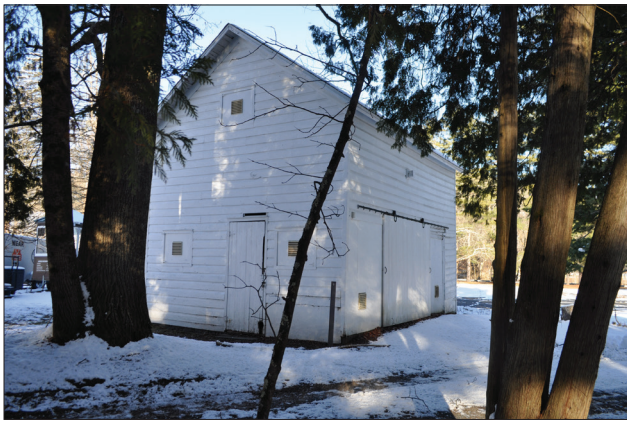
Figure 2.49. View looking northwest at the barn. (OCLP 2022, DSC\_7368)

Three historic buildings and structures associated with Zane Grey are extant. The Zane Grey house (Str #6250) was built by Romer Grey in 1906 and purchased by Zane Grey in 1914. Nicknamed the "Big House" for its location on a knoll overlooking the Delaware River, the original two-story foursquare plan featured Queen Anne and Neoclassical influences. Zane added two, two-story additions in 1915 and 1916, which resulted in the overall 30 by 65-foot footprint that exists today (Figure 2.48). The house was operated as an inn in 1948-1973 by Helen Davis, at which time the first floor was converted into a museum. The park acquired the house in 1989 and has made numerous repairs while maintaining the exhibits and using it as office space. The two-story Zane Grey barn (Str #6256) was constructed in 1915 and converted into a garage in the 1920s (Figure 2.49). It was acquired in 1998. The Grey

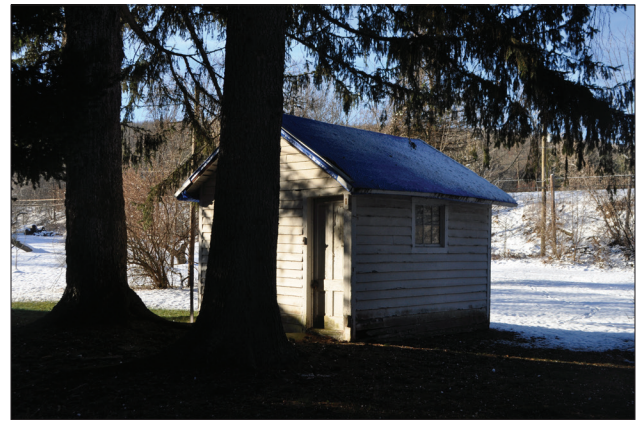
Figure 2.50. View looking southwest at the coal shed. (OCLP 2022, DSC\_7367)

coal shed (Str #6257) was built in c.1913 just west of the Ida and Josephine Grey house, and was acquired by the park in 2003 (Figure 2.50). Zane and Romer Grey also constructed the two-story Ida and Josephine Grey House (Smith-Nelson House) for their mother and sister, in 1907 (Figure 2.51). In 1913 the house was sold to friends, but additions and alterations by later owners in the late 1950s and early 1960s diminished the building's integrity. The park gained full ownership of the house in 2003 and plans to raze this non-historic building. Historic buildings and structures that have been lost include the Cottage, a D&H barn, Bungalow/Lodge, ice house, pet shelter, playhouse, and one of the outhouses.<sup>80</sup>

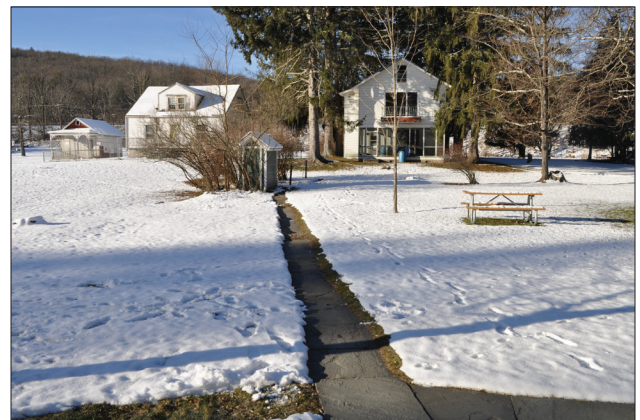
Figure 2.51. View looking southwest at the former Ida and Josephine Grey house (right), Moran house (center), and guest house (left). In the foreground is the reconstructed outhouse. (OCLP 2022, DSC\_7378)

tage, which was severely damaged during the major flood that year. The Morans also saved the Cottage's one-story kitchen ell and porch for use as a guest house, which they placed just to the south of their house. The park is planning to remove both structures (see Figure 2.51). The park reconstructed the outhouse that was located southwest of the Zane Grey house in 2007 to conceal propane tanks that fuel the property's generator (Figure 2.51).<sup>81</sup>

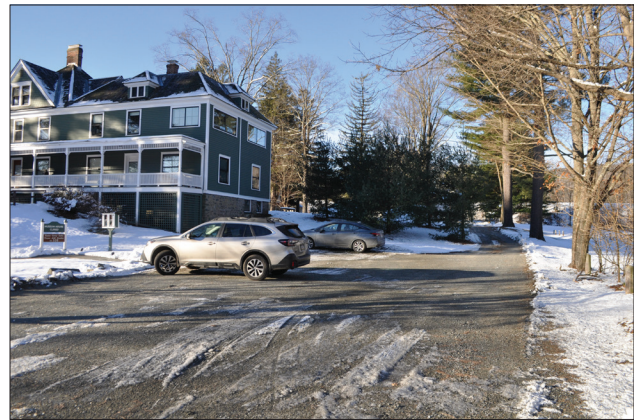
Figure 2.55. View looking southwest at the current visitor/staff parking lot. (OCLP 2022, DSC\_7356)

Non-historic features at the Zane Grey property include a gravel parking area northeast of the Big House, on the south side of the historic driveway, which was built in the 1940s to accommodate guests at the inn. The park expanded this parking area in the 1990s to accommodate eight vehicles (Figure 2.55). The trace of a smaller gravel parking area for one to two vehicles is situated near the northwest corner of the Zane Grey house, but is being allowed to grow over with grass. The former Grey property to the north, which was the location of the Cottage and other buildings and gardens, is now a paved parking lot owned by the Pennsylvania Fish and Boat Commission (PFBC). Built in the early 1970s, the facility continues across Scenic Drive to a smaller parking lot and boat ramp along the Delaware River. The parking areas accommodate large numbers of recreational boaters in the summer (Figure 2.56). The National Park Service has an agreement with the PFBC to use the parking lot, as well as a co-use/co-management agreement for river access. The other non-NPS circulation feature is Scenic Drive, an early form of which was constructed in the late 1800s and improved in the early 1900s. The two-lane drive continues to serve as the primary access route to the Zane Grey Property as well as the state parking lots.<sup>83</sup>
