# CULTURAL LANDSCAPE REPORT FOR ROEBLING'S DELAWARE AQUEDUCT SITE AND THE ZANE GREY PROPERTY

UPPER DELAWARE SCENIC AND RECREATIONAL RIVER

National Park Service, Boston, Massachusetts, 2023

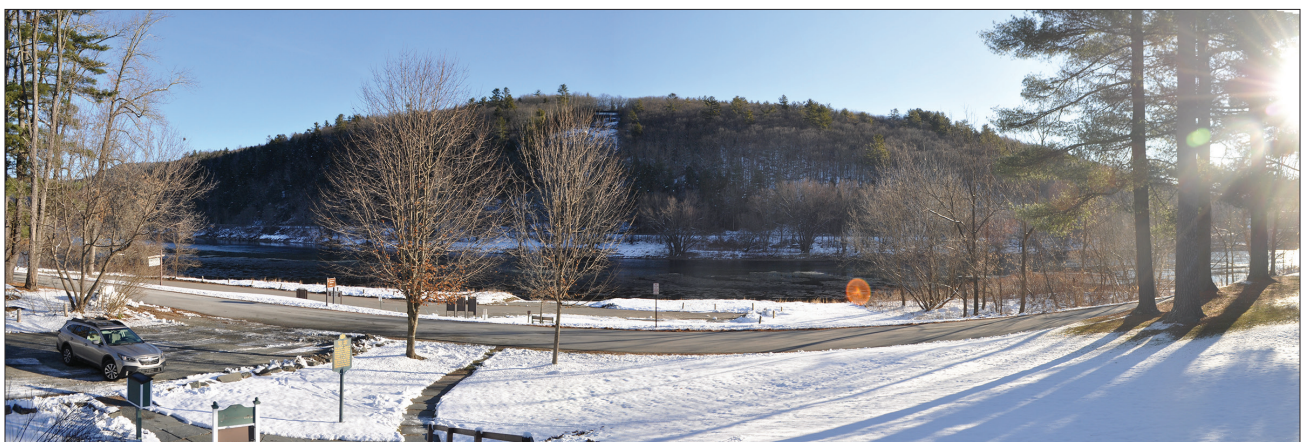
Figure 2.57. Panoramic view looking east, upstream (left side) and downstream (right side) at the Delaware River, from the front porch of the Zane Grey house. (OCLP 2022, DSC\_7361-7362)

The historic upstream view of the river valley that was present during the Zane Grey period of residence is extant, but the downstream view is partially blocked by vegetation (Figures 2.57). Zane Grey and his brother Romer pur-

After 1929 the upstream and downstream views persisted but continued to slowly narrow as vegetation matured. However, the emergence of successional riverfront vegetation to the south of the Big House (Parcel C) after the historic period has further diminished downstream views toward the Delaware Aqueduct. The bluff across the Delaware River is still mostly wooded and contributes to the background of the river views, but recent vista cutting associated with residences along Zane Grey Way threaten this condition (see Figure 2.57).<sup>88</sup>

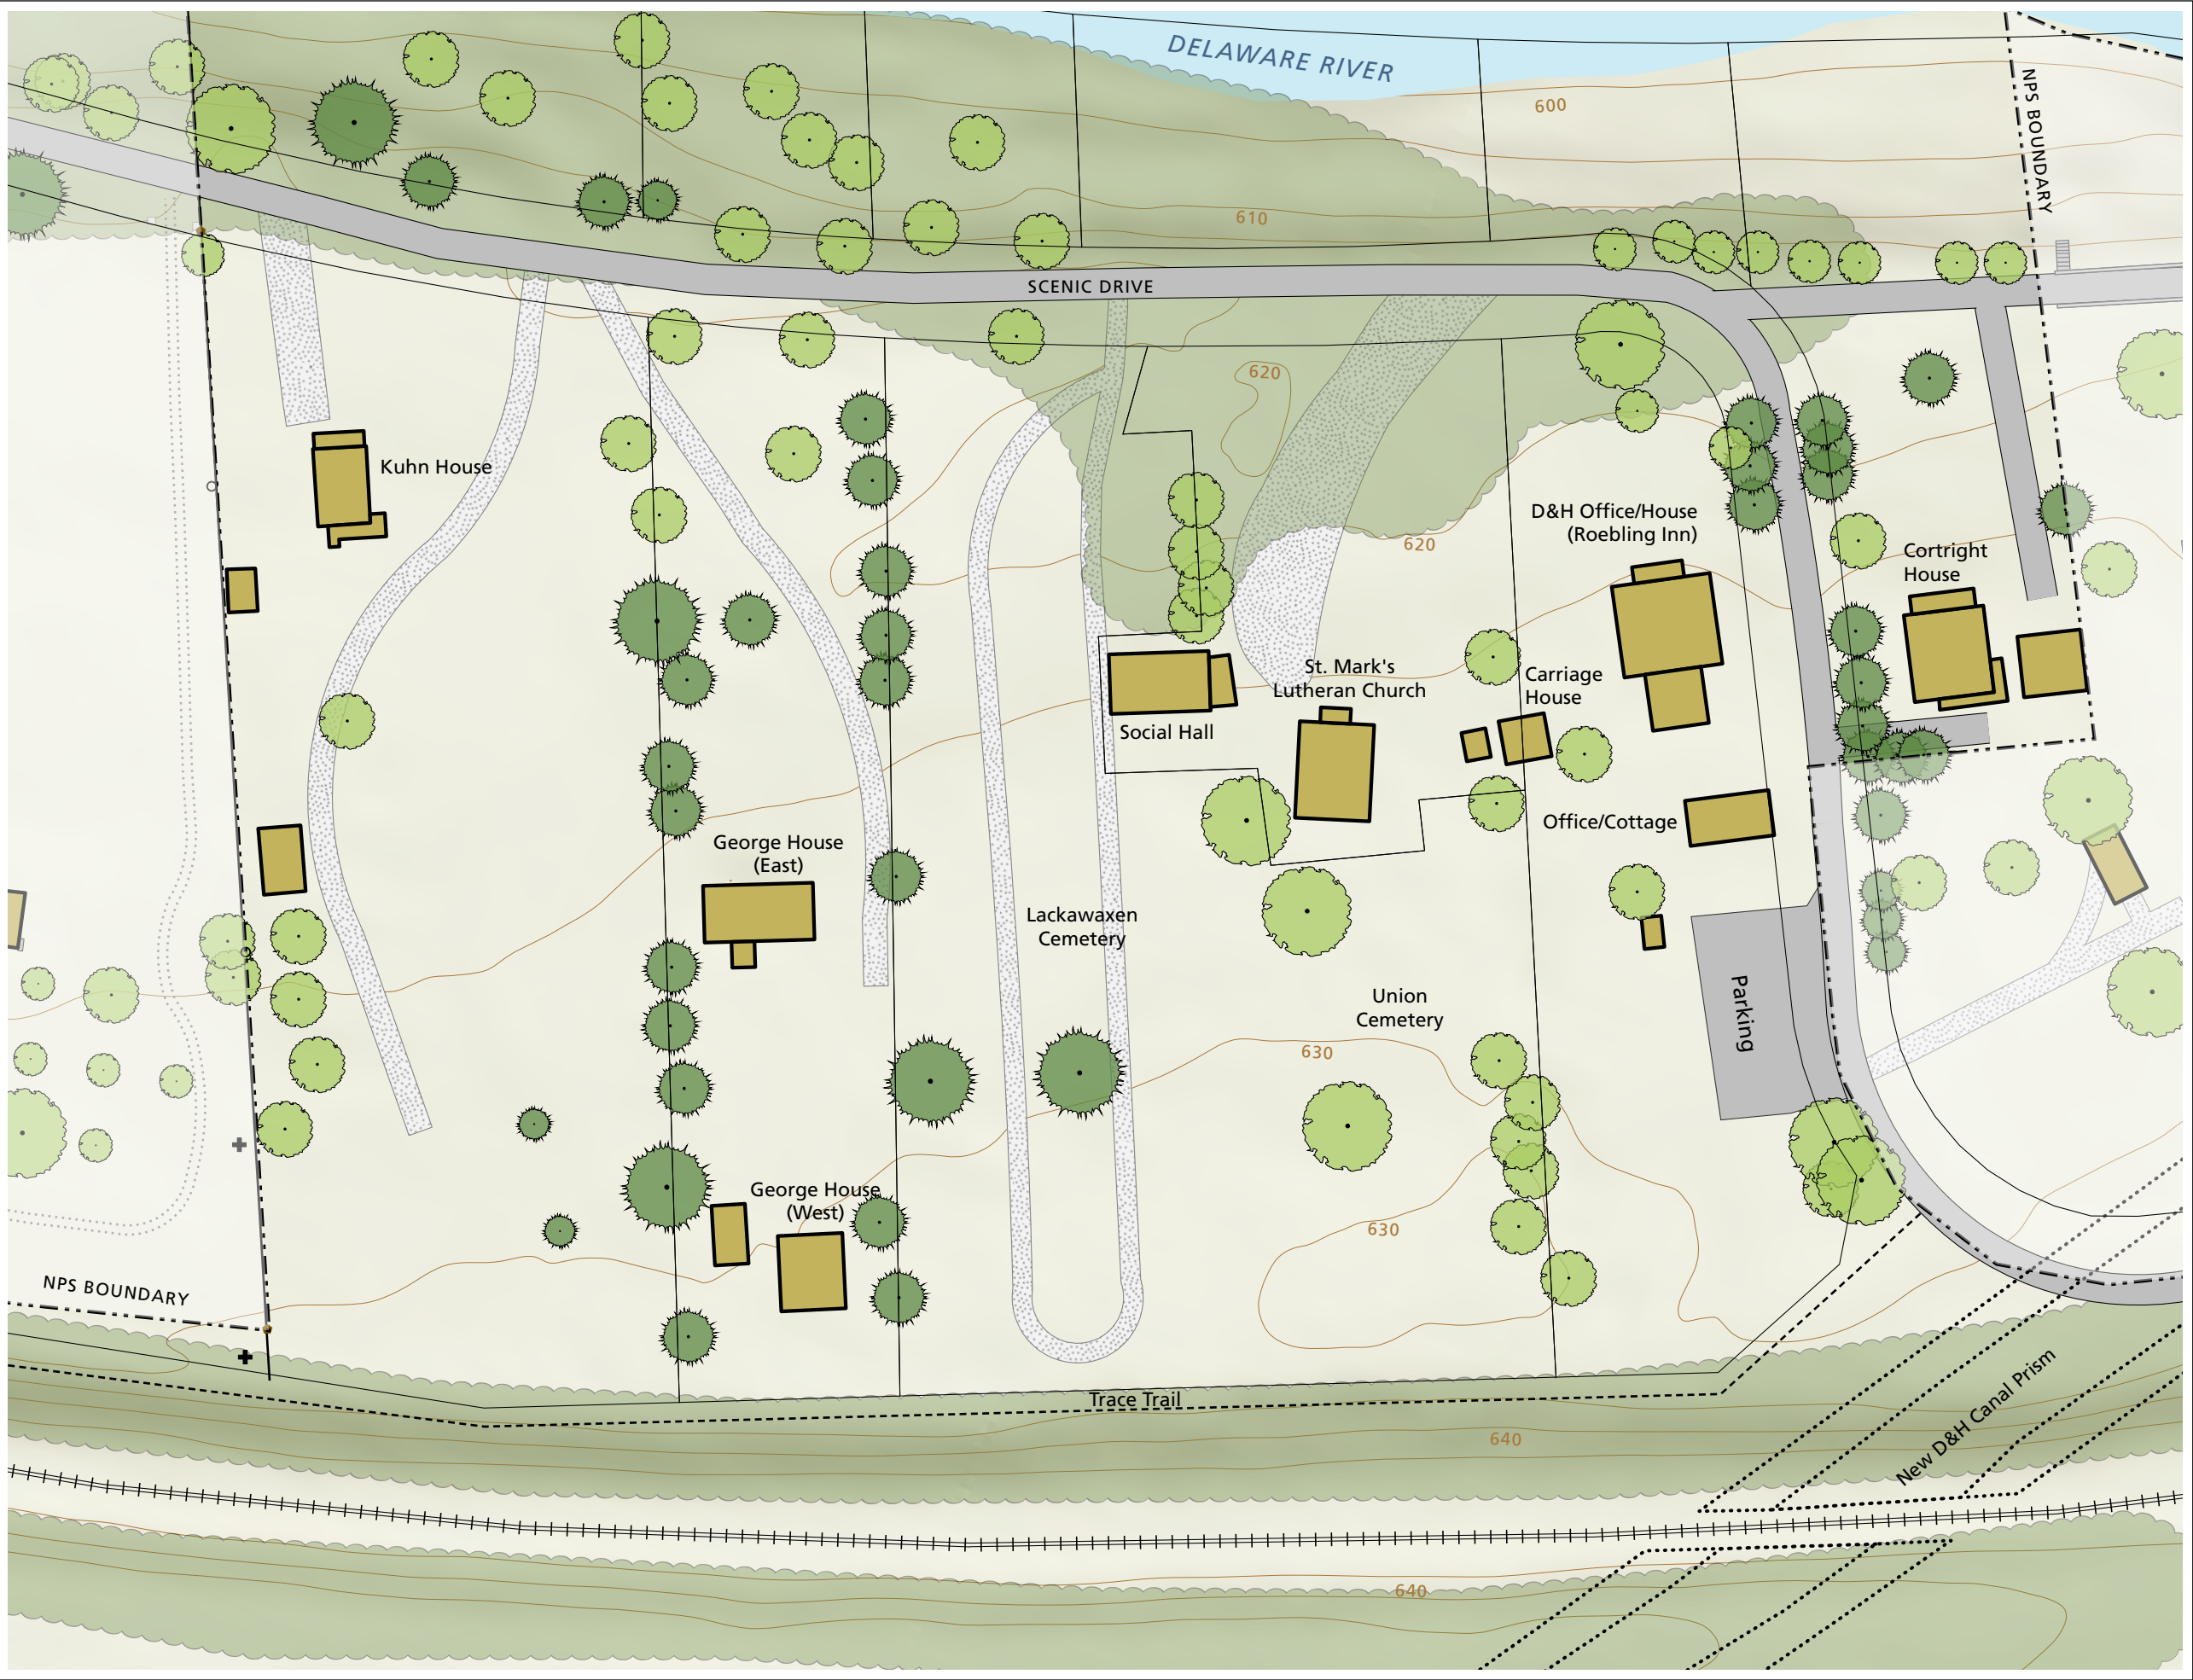
**Drawing 19**

Connection Area  
Existing Conditions 2021

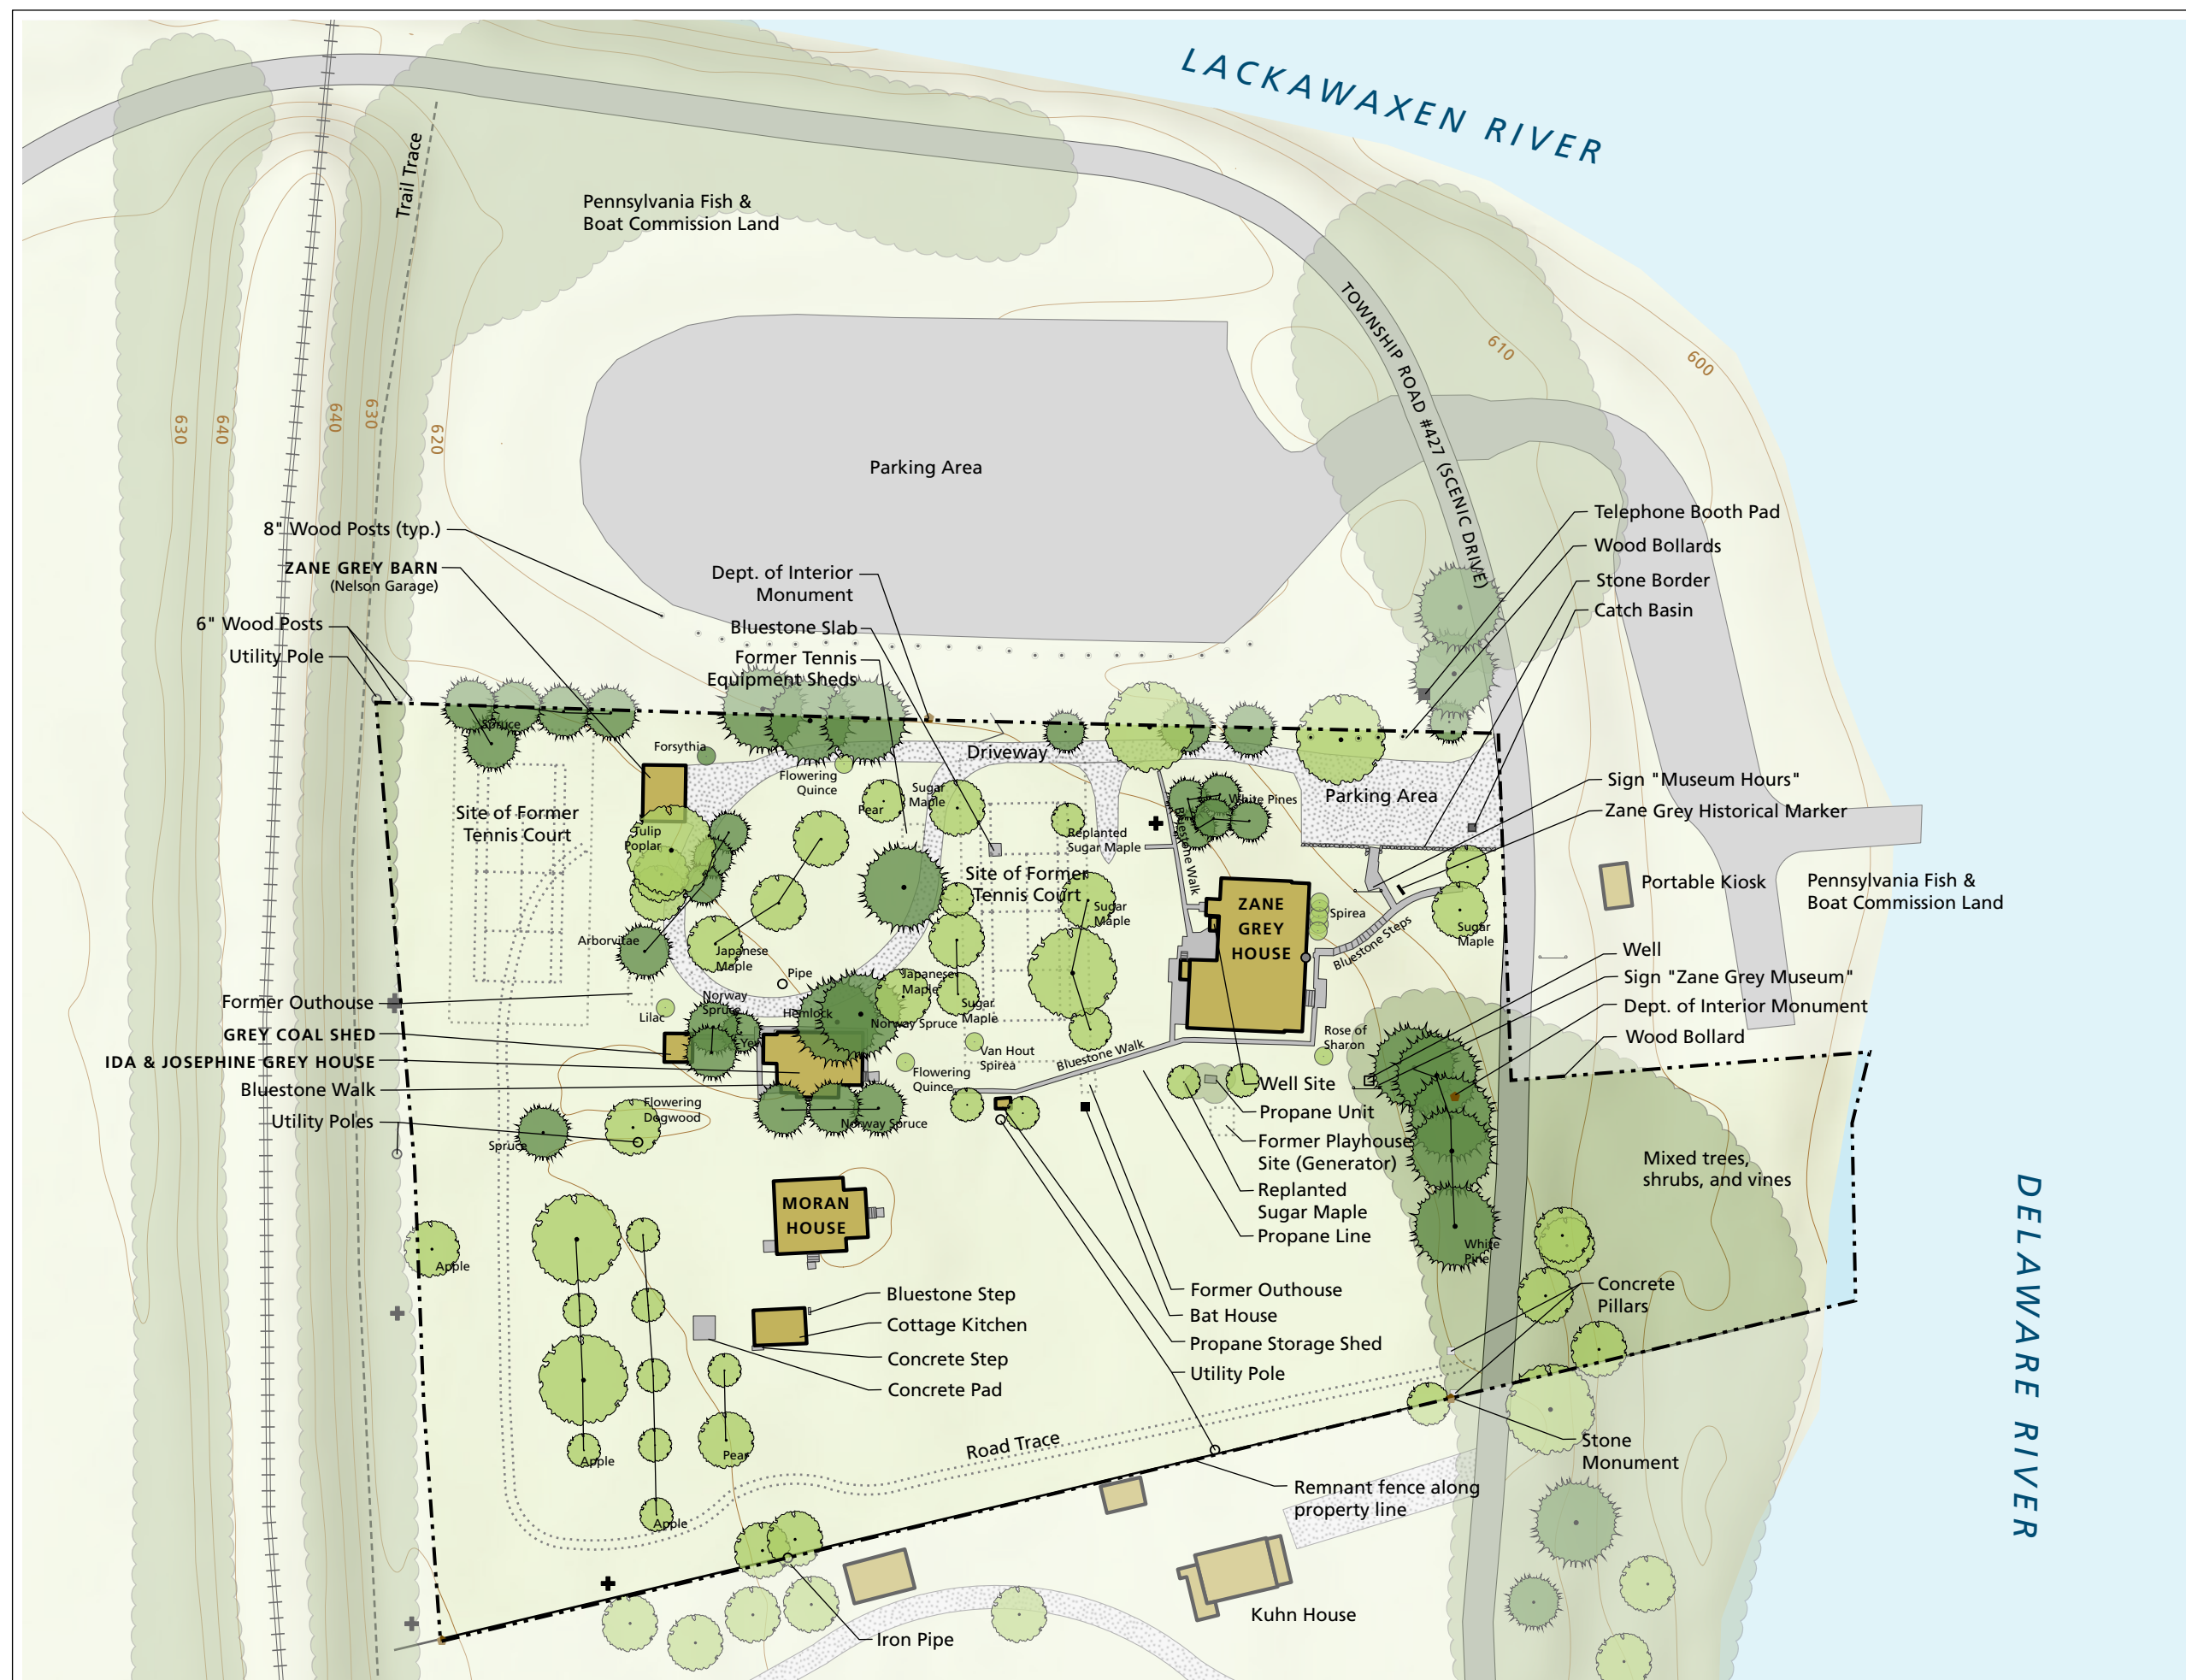
Zane Grey Property  
Existing Conditions 2021

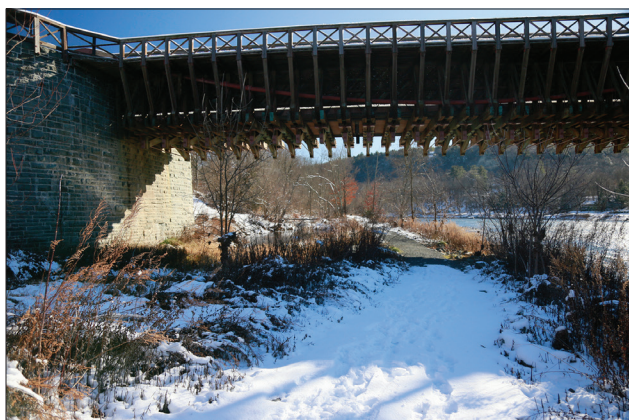
Figure 3.1b. View looking southeast at the north end of the original towpath (Towpath Trail). (OCLP 2022, IMG\_1845)

The Towpath Trail follows the route of the original section of the D&H Canal towpath on the New York side that became a feeder canal after Roebling's Delaware Aqueduct was opened (Figure 3.1a). The trail features an earthen/gravel/grass surface. Due to its location in the floodplain, floods periodically damage or destroy the trail surface. The park maintains the trail from spring to fall, but it is not maintained in the winter (Figures 3.1b-3.1h).

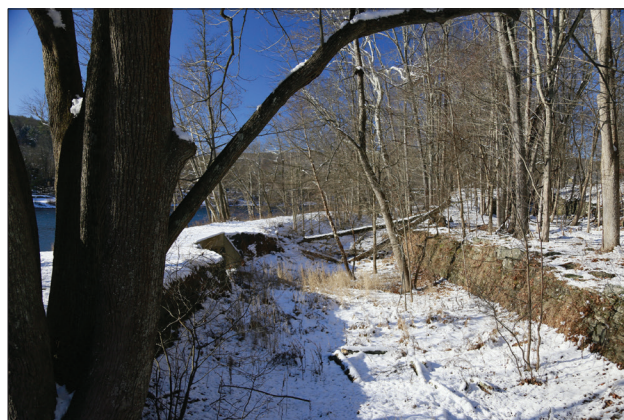
Figure 3.1e. View looking west at woody vegetation in the canal prism and on the new canal towpath (image right). (OCLP 2022, IMG\_1868)

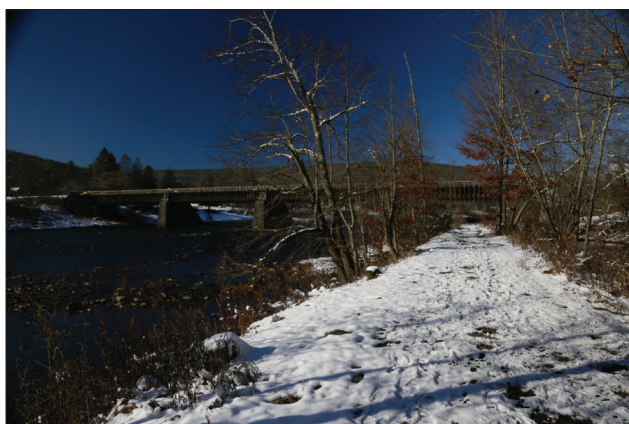
Figure 3.1c. View looking northwest at woody vegetation separating the towpath and canal prism (image right). (OCLP 2022, IMG\_1851)

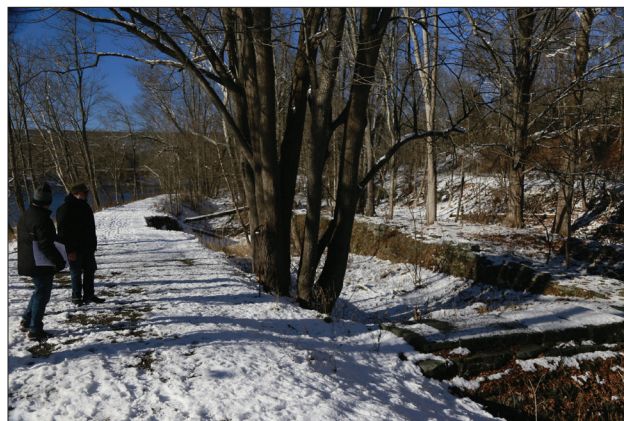
Figure 3.1f. View looking northwest at woody vegetation between the canal prism and the original towpath, from the diversion dam. (OCLP 2022, IMG\_1859)

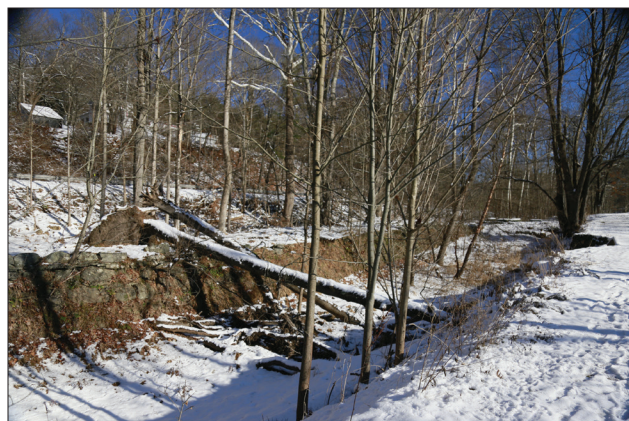
Figure 3.1d. View looking east at canal prism wall damage from a fallen tree. (OCLP 2022, IMG\_1856)

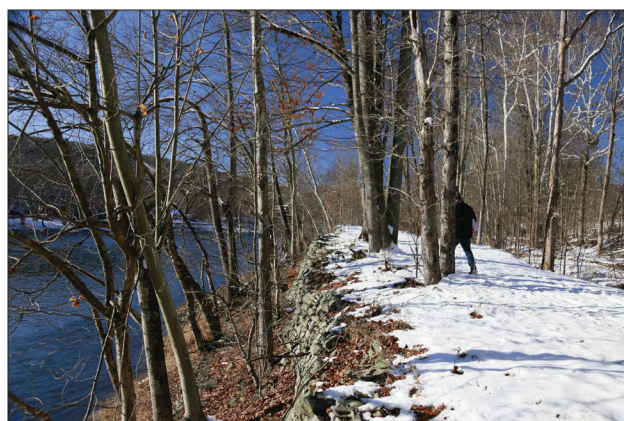
Figure 3.1g. View looking west at woody vegetation on the original towpath and abutting the towpath wall. (OCLP 2022, IMG\_1867)

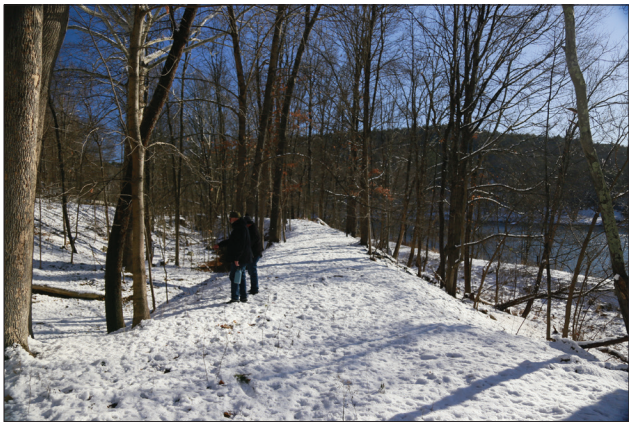
**Figure 3.1h.** View looking north at the lower portion of the Maintenance Access Road, where it meets the Towpath Trail. (OCLP 2022, IMG\_1849)

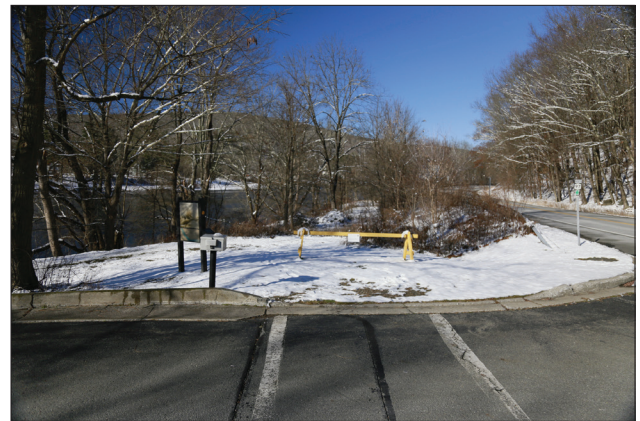
**Figure 3.2a.** View looking northwest at the upper end of the Maintenance Access Road, where it meets the parking lot on the New York side of Roebling's Delaware Aqueduct. (OCLP 2022, IMG\_1824)

Create an accessible route from the north end of the north parking lot to the north end of the Towpath Trail, via the existing gravel Maintenance Access Road (Figures 3.2a-3.2g). This option would require extending the length and lowering the grade of the upper portion of Maintenance Access Road. The unused Emergency Access Road that extends north and parallel to State Route 97 can be utilized to add the horizontal distance need achieve the correct grades. A survey will be needed to determine existing grades and the property boundary between state and federal lands.

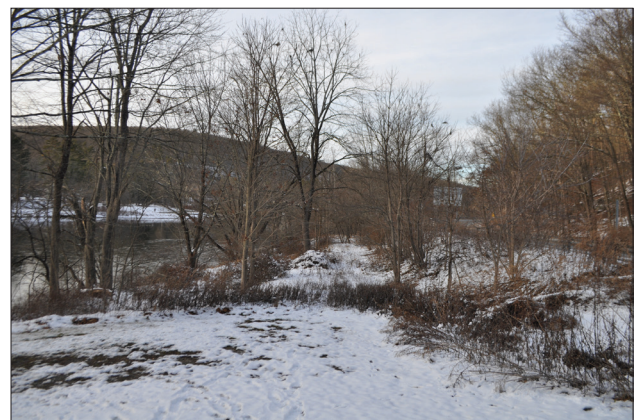
**Figure 3.2b.** View looking northwest at the former Emergency Access Road that extends north from the Maintenance Access Road. (OCLP 2022, DSC\_7493)

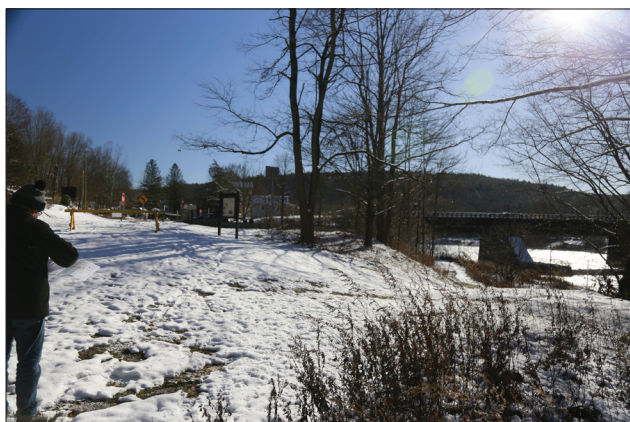
Figure 3.2c. View looking southeast at the sharp turn of Maintenance Access Road, from the former Emergency Access Road. (OCLP 2022, IMG\_1826)

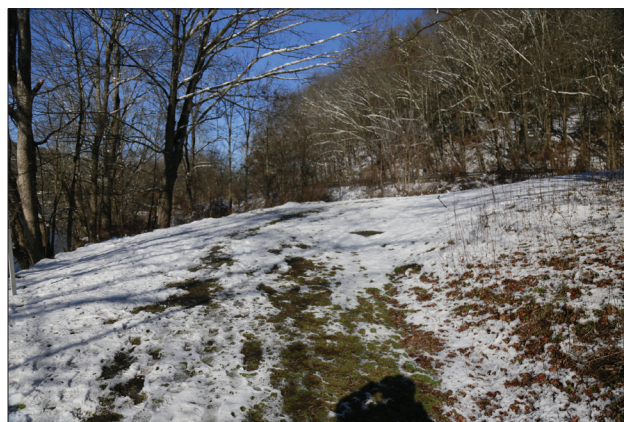
Figure 3.2f. View looking north at the steep upper portion of the Maintenance Access Road. (OCLP 2022, IMG\_1834)

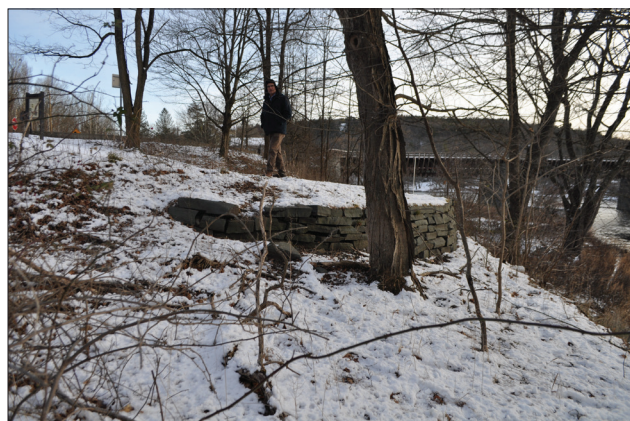
Figure 3.2d. View looking southeast at the contemporary retaining wall that supports the Maintenance Access Road. (OCLP 2022, DSC\_7495)

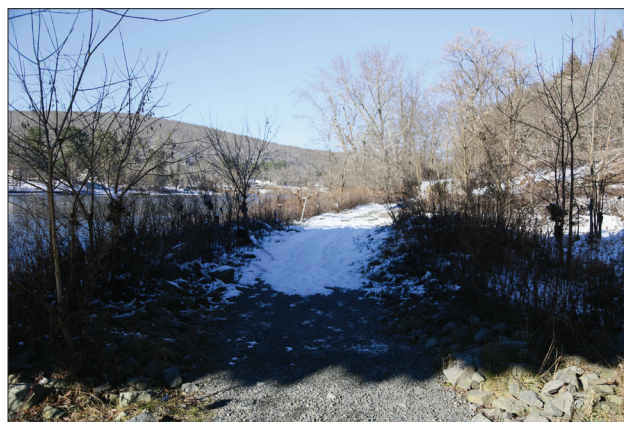
Figure 3.2g. View looking north at the lower portion of the Maintenance Access Road, where it meets the Towpath Trail. (OCLP 2022, IMG\_1849)

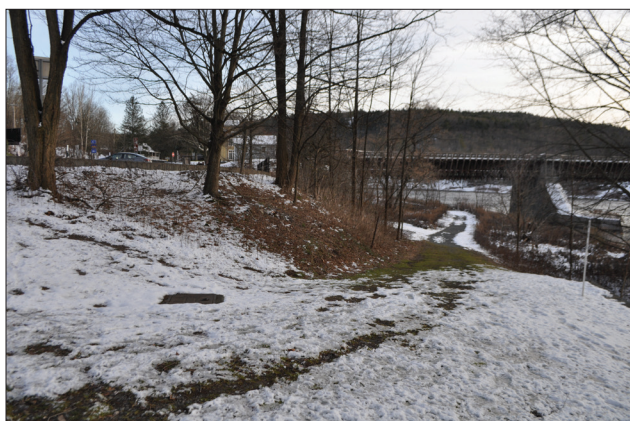
Figure 3.2e. View looking south at the Maintenance Access Road as it descends to the Towpath Trail under the aqueduct/bridge. (OCLP 2022, DSC\_7498)

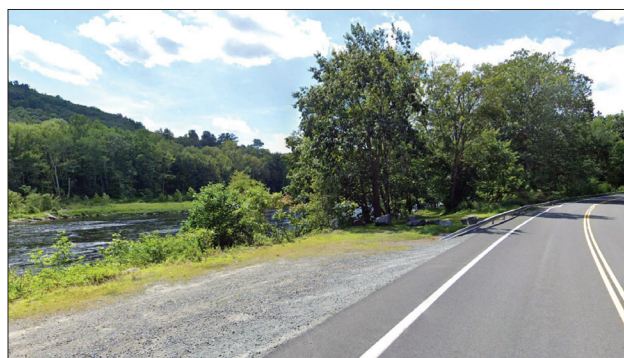
Figure 3.2h. View looking southwest at the gravel parking pull-out along State Route 97, at the south end of the Towpath Trail. This area is not on NPS property. The boulders are positioned to prevent vehicles from entering the canal prism and towpath. (OCLP 2018, DSC\_2434)

Improve the layout of an informal gravel parking pullout along State Route 97, at the south end of the Towpath Trail (Figure 3.2h). The safest layout will be parallel parking alongside the river-side edge of the pullout. Installation of a log or steel barrier along this edge, and regulatory signage, can reinforce the desired layout. An accessible parking space can be designated close to the trailhead. Head on or angle parking should be avoided in the pullout because it would require exiting drivers to back out towards or into the highway's narrow shoulder and southbound travel lane. A "no parking" sign should be placed at the boulders to prohibit parking, and warning signs should be placed along the highway to warn drivers of entering and exiting vehicles.

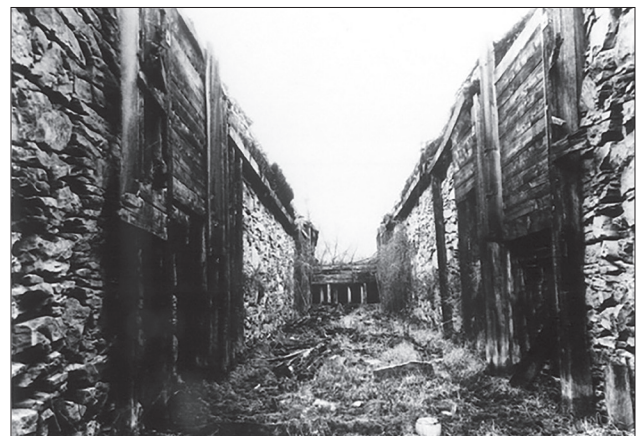
Figure 3.3b. View looking northwest at Lock 71 in 1923. (Minisink Valley Historical Society, #P-82-8-6)

Three new locks were constructed on the New York side as part of Roebling's Delaware Aqueduct. They remained after the canal closed in 1898, but in the 1930s Locks 70 and 72 were filled in or destroyed for construction of State Route 97 (Figure 3.3a, 3.3b). Lock 71 was spared and is one of only a few of the D&H Canal's locks that remain (Figures 3.3c-3.3f). Dry laid stone walls and remnants of lock doors, wood plank walls, and iron hardware tower over the leaf littered floor. Several mature trees are established within and atop the walls. Part of the east wall has collapsed into the lock due to stormwater runoff from an adjacent culvert outlet associated with State Route 97. The location of property lines and rights-of-way are not clearly marked in the field; various park drawings and descriptions

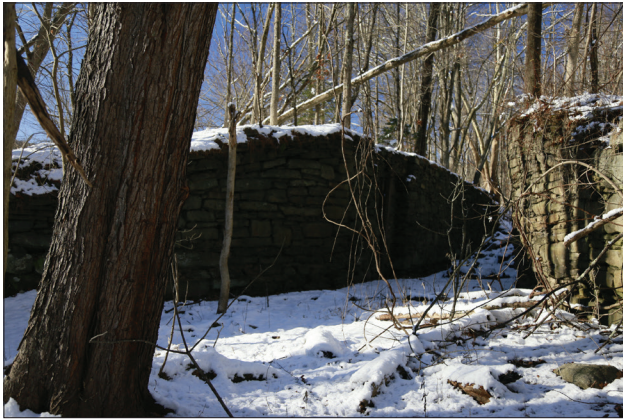
Figure 3.3c. View looking west at the new canal prism and south end of Lock 71. (OCLP 2022, IMG\_1874)

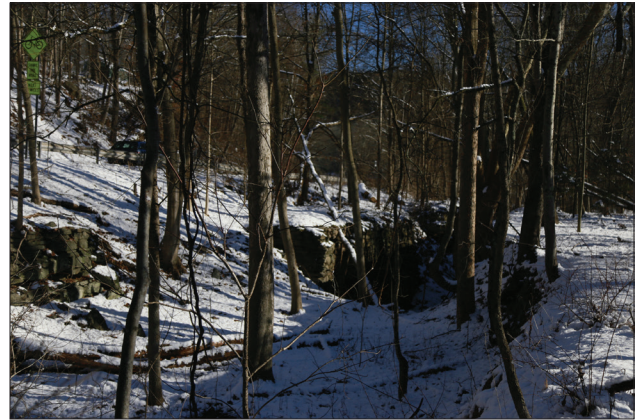
Figure 3.3f. View looking east at the new canal prism and north end of Lock 71. (OCLP 2022, IMG\_1880)

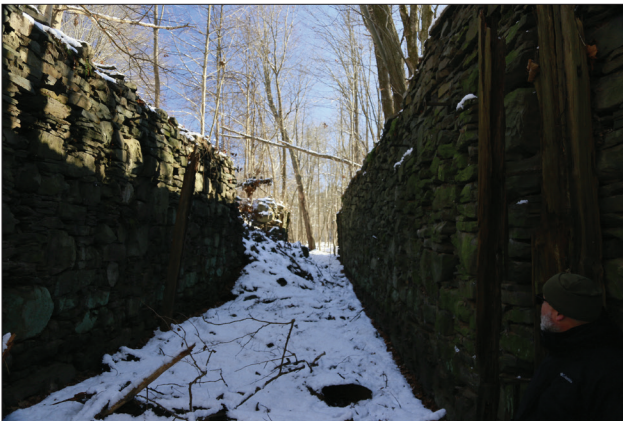
Figure 3.3d. View looking southeast from the interior of Lock 71. Note the collapsed section of the lock wall (image left). (OCLP 2022, IMG\_1877)

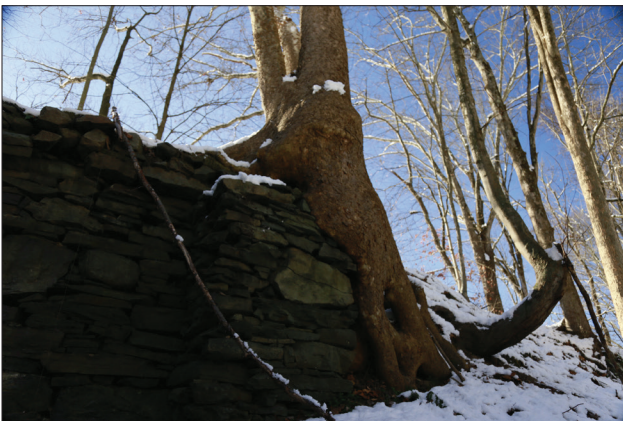
Figure 3.3e. View of a mature tree anchored in the canal wall. (OCLP 2022, IMG\_1878)

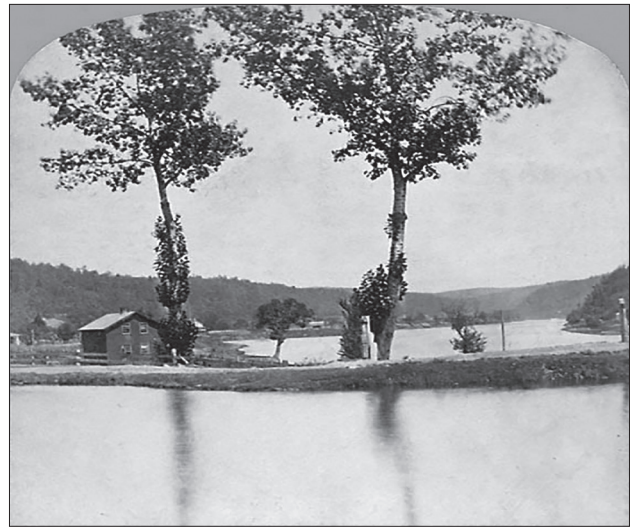
Figure 3.4a. View looking north at the Pennsylvania side turning basin and towpaths, 1855-1898. (UPDE Archives, PA\_dhCanalLack-West)

The goal of this project is to visually represent the canal's horizontal and/or vertical presence of the 1848 Delaware & Hudson Canal in the landscape between the west end of Roebling's Delaware Aqueduct to the south and Scenic Drive to the north (Figure 3.4a, 3.4b, 3.4c). Another goal is to provide pedestrian access through this area, which also links with the existing paved towpath sidewalks at the aqueduct/bridge and the proposed pedestrian route through the connector area to the north. The area is currently maintained as lawn, and except for a wayside near the approach road, provides no physical interpretation of the historic canal alignment, walls, or towpaths (Figures 3.4d, 3.4e).

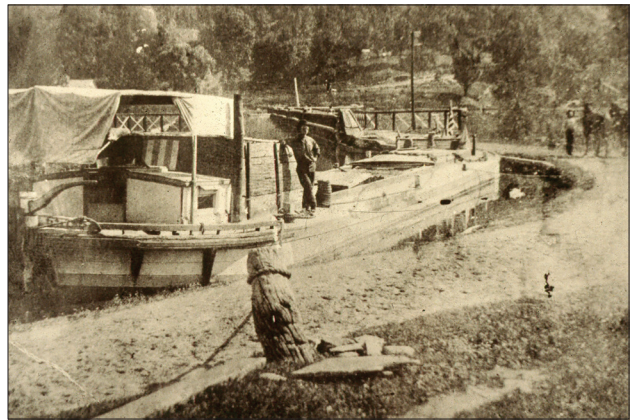
Figure 3.4b. View looking east at the turning basin on the Pennsylvania side, 1849-1898. Note the earthen tow path and the wood bollard to tie up boats. (UPDE Archives, PA\_Scan4)

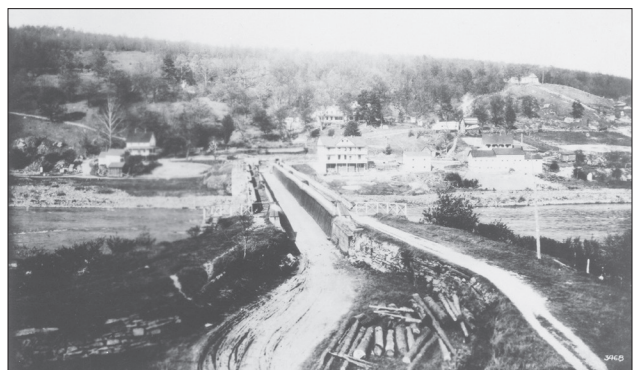
Figure 3.4c. View looking east at the former turning basin on the Pennsylvania side, after 1908. (Minisink Valley Historical Society, P-82-8-28/Delaware and Hudson Railway Company, New York State Library/Canal Society of New York State negative 10339C)

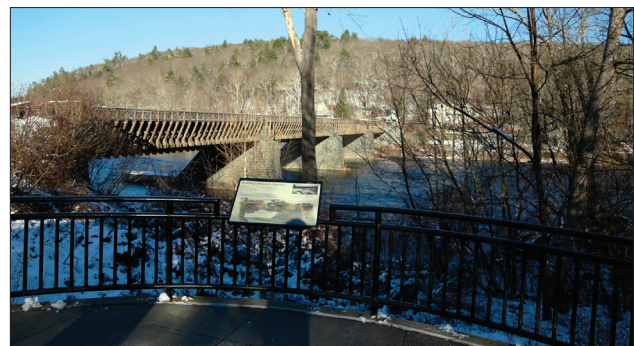
Figure 3.5a. View looking north at Roebling's Delaware Aqueduct from the overlook. (OCLP 2022, IMG\_1899)

The National Park Service constructed the pedestrian overlook at the east end of the parking lot in the late 1990s. The semi-circular concrete patio offers a framed view of Roebling's Delaware Aqueduct (Figures 3.5a, 3.5b). However, the overlook has settled and now tilts slightly toward

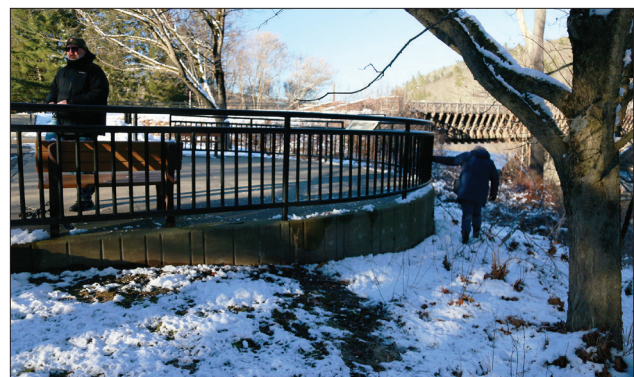
Figure 3.5b. View looking northwest at the overlook. Note the tilt of the overlook. (OCLP 2022, IMG\_1900)

the river, thereby creating drainage issues and cracked pavement surfaces on and around the overlook.

- Investigate causes of the overlook's poor condition to determine an appropriate treatment.

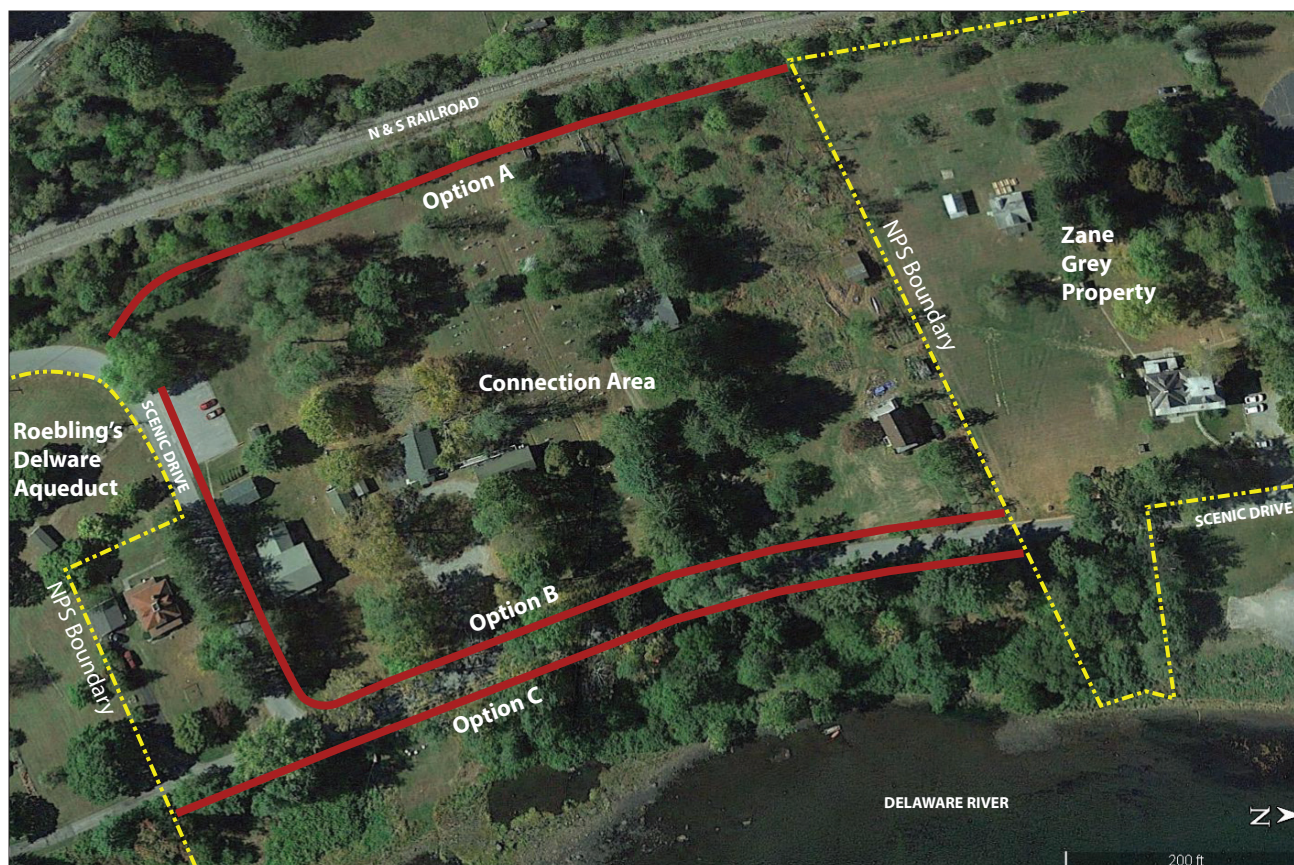
Figure 3.6a. Annotated aerial photograph showing three options for a pedestrian connection between Roebling's Delaware Aqueduct site and the Zane Grey Property. (OCLP 2023)

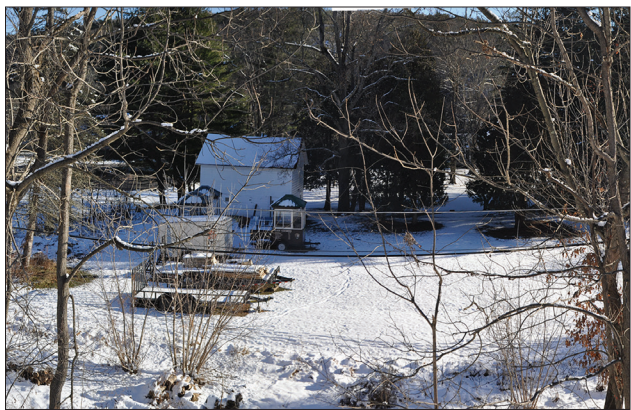
Figure 3.8b. View looking east at the proposed site of a parking lot, behind the barn (image left). An accessible path will be built (image right) to connect the lot to other paths barn. (OCLP 2022, DSC\_7389-7390)

In the plan, the west end of the driveway will be extended along the north side of the barn to access the new parking lot (Figure 3.8c). A new accessible walk will be built from the new lot to connect to other paths. Consistent with the 1999 and 2008 treatment drawings, the remainder of the historic driveway will be restored to its historic condition.

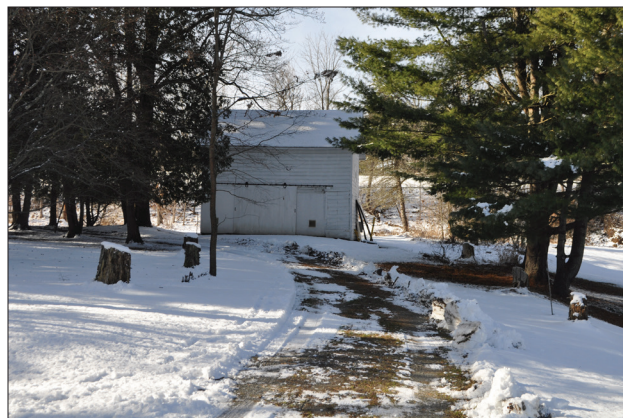
Figure 3.8c. View looking west at the barn. The historic driveway will be extended along the north side of the barn (image right) to access the new parking lot. (OCLP 2022, DSC\_7461)

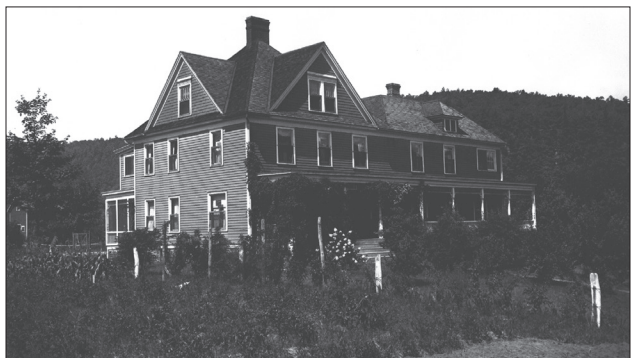
Figure 3.9a. View looking northwest, c.1916-18. In the foreground is the garden plot. In the background (image right) is a glimpse of the front bluestone walk and possible the tennis court (image left). (Courtesy Ohio Historical Society, from CLPT 1999: 21; Hawley Public Library, #1604)

During the historic period a bluestone walk extended from the front of the original portion of the Zane Grey House to Scenic Drive (Figure 3.9a). Its removal and enlargement of the driveway for parking coincides with the conversion of the Zane Grey House into a guest inn. With the proposed relocation of the visitor/staff parking lot to the rear of the property, the existing parking lot, front walk, and steps can be removed, and the original topography and lawn restored (Figures 3.9b-3.9c). The 1999 and 2008 treatment plans show the historic alignment of the front bluestone walk, from the front porch steps to Scenic Drive, and the driveway heading west to the barn (see Figures 3.7a-3.7b).

During the historic period the Greys constructed two clay tennis courts: in the back yard between the Zane Grey House and the Nelson House, and behind the barn next to the railroad embankment (Figure 3.12a, see also Figure 3.9a). Both areas are now maintained as lawns but do not reveal the extents of the playing surface (Figure 3.12b). The park will focus interpretive efforts on the tennis court closest to the Big House, as the other tennis court is the proposed site for visitor/staff parking lot (see Project #9). The 1999 and 2008 treatment plans show the approximate outlines of the tennis courts (see Figures 3.7a-3.7b).

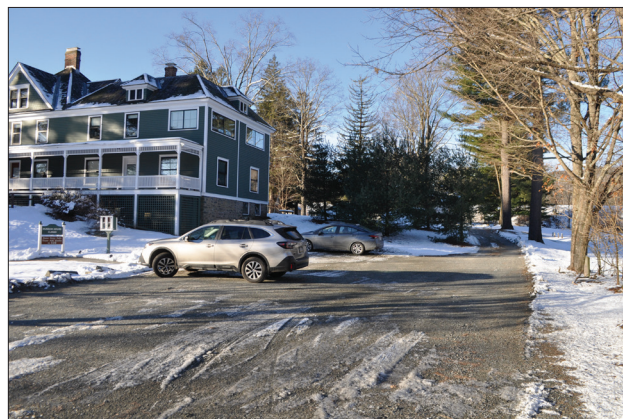
Figure 3.9b. View looking southwest at the existing parking lot. When its is relocated it can be removed so that only the original driveway portion (image right) will remain. (OCLP 2022, DSC\_7356)

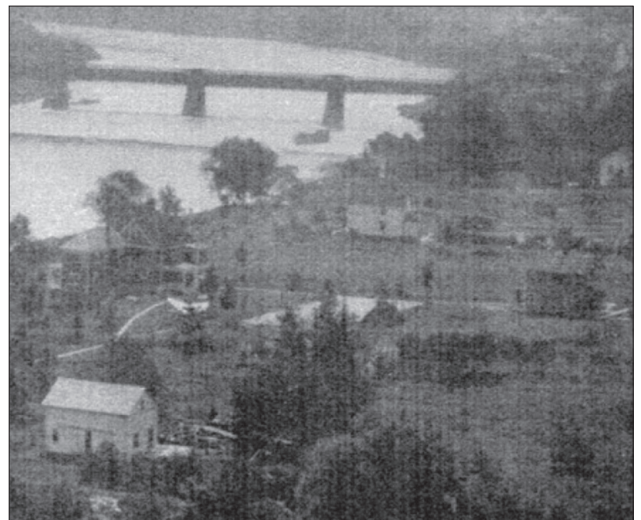
Figure 3.12a. Portion of photograph looking from Prospect Rock, c.1918. The light colored rectangular area (image center) west of the Zane Grey house may be the tennis court. (*Historic Structures Report, Alice Josephine Grey House, Barn & Accessory Buildings, Zane Grey Family Compound*, 2012: 8)
