# Administering the National Forests of Colorado

## An Assessment of the Architectural and Cultural Significance of Historical Administrative Properties

*Prepared for the U.S. Forest Service, Rocky Mountain Region by the  
National Park Service - Midwest Archeological Center*

1996

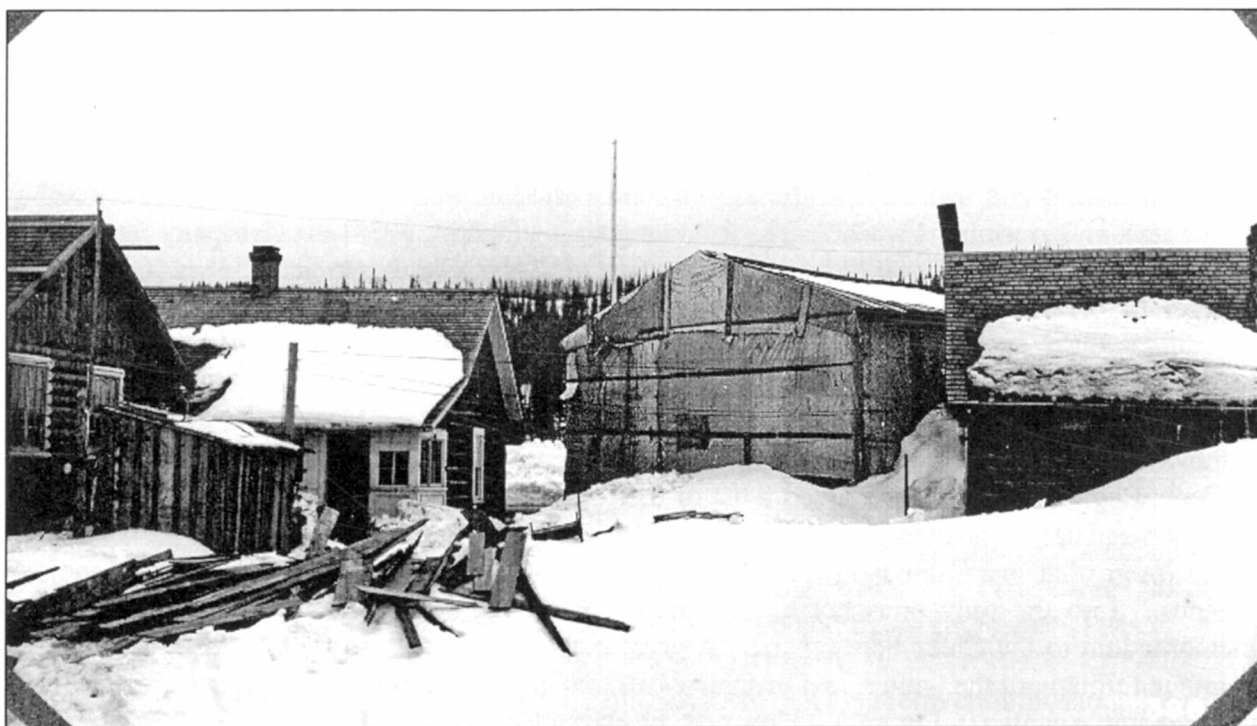
Figure 5. Construction at Mesa Lakes with Emergency Relief Administration (ERA) Camp. Photo # 398193 taken February 1940 by H.P. Gaylor. GMUG National Forests Supervisor's Office. Note garage enclosed by tent.

In consultation with the Army, the Regional Forester would determine what camps to abandon for the winter and when, usually sometime between mid-October and December 1. Some camps were occupied throughout the winter that first year. For example, in August of 1933 Allen S. Peck, Regional Forester, provided a list of the camps in Colorado to the Army in which their elevation and date of abandonment was established (Peck 1933b; Granger 1934). Of the 23 camps in the Forests that year Camp F-17-C at Land's End, F-24-C at Trout Creek, and F-30-C at Conejos-Alamosa were the only ones not to be closed for the winter. Peck (1933a:1) stated in a memorandum to the Chief Forester that "A great many men have already expressed a desire to continue throughout the winter, and in some cases this involves almost a complete camp" (winter camp example shown in Figure 5). However, he cautioned:

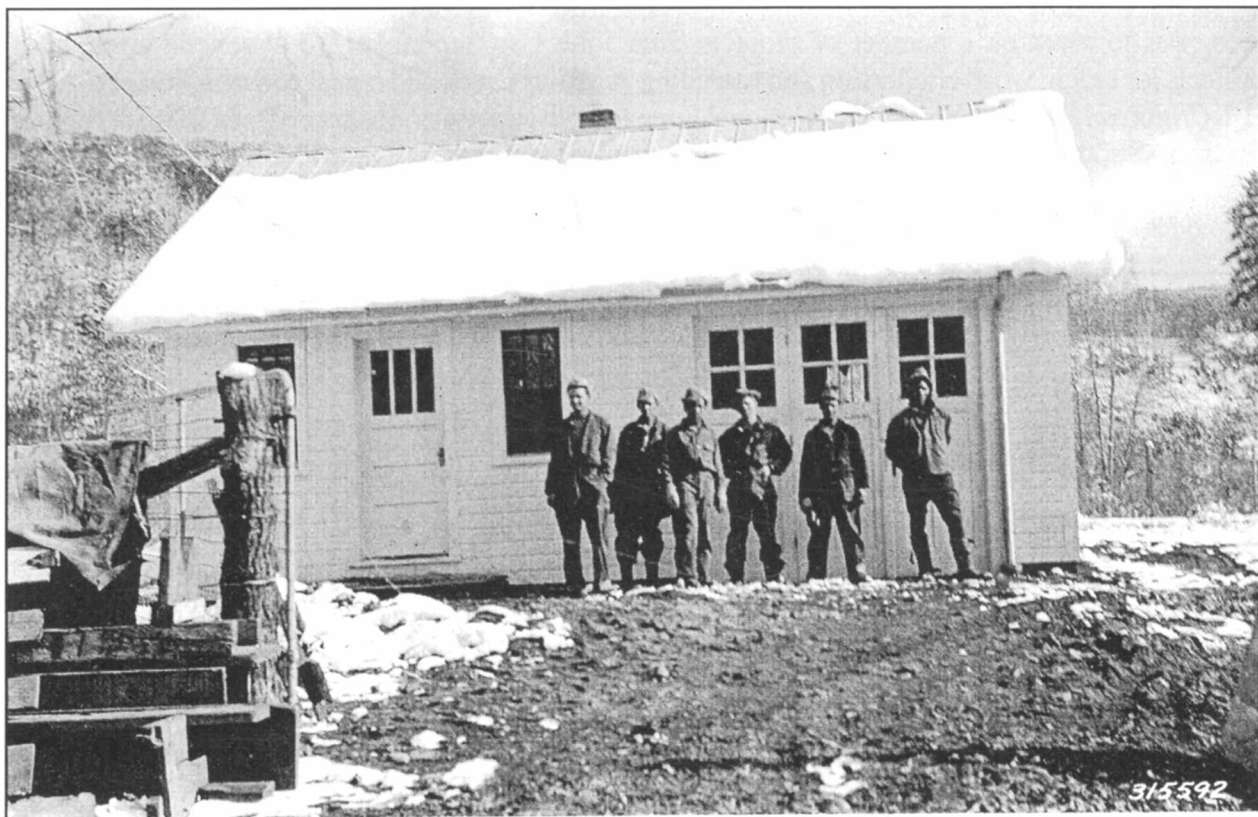
Figure 6. Square Top Guard Station. Photo # 315592 taken December 1935 by A.L. Alley. San Juan National Forest Supervisor's Office.

Other designs in the series, like that seen at Square Top Guard Station (Figure 6) differed in layout and dimension, but all had a similar exterior appearance that was influenced, as were the designs from the dwelling series, by the Bungalow Style. The informal Bungalow-style front porch was eliminated, as the buildings were "merely a temporary stopping place..." and the "necessity (for a porch) is not great" (French 1933). This belief was supported by the Washington-based USFS architects (Groben 1938:53). Despite this, the use of substantial though informal porches and stoops in Regional design became almost standard during Phase III. Designs were available with or without a chimney. At least 7 A Series designs were produced. Plans were evidently printed in the Construction and Maintenance Handbook. The functional and efficient plans were re-engineered, expanded, and constructed well into Phase III.

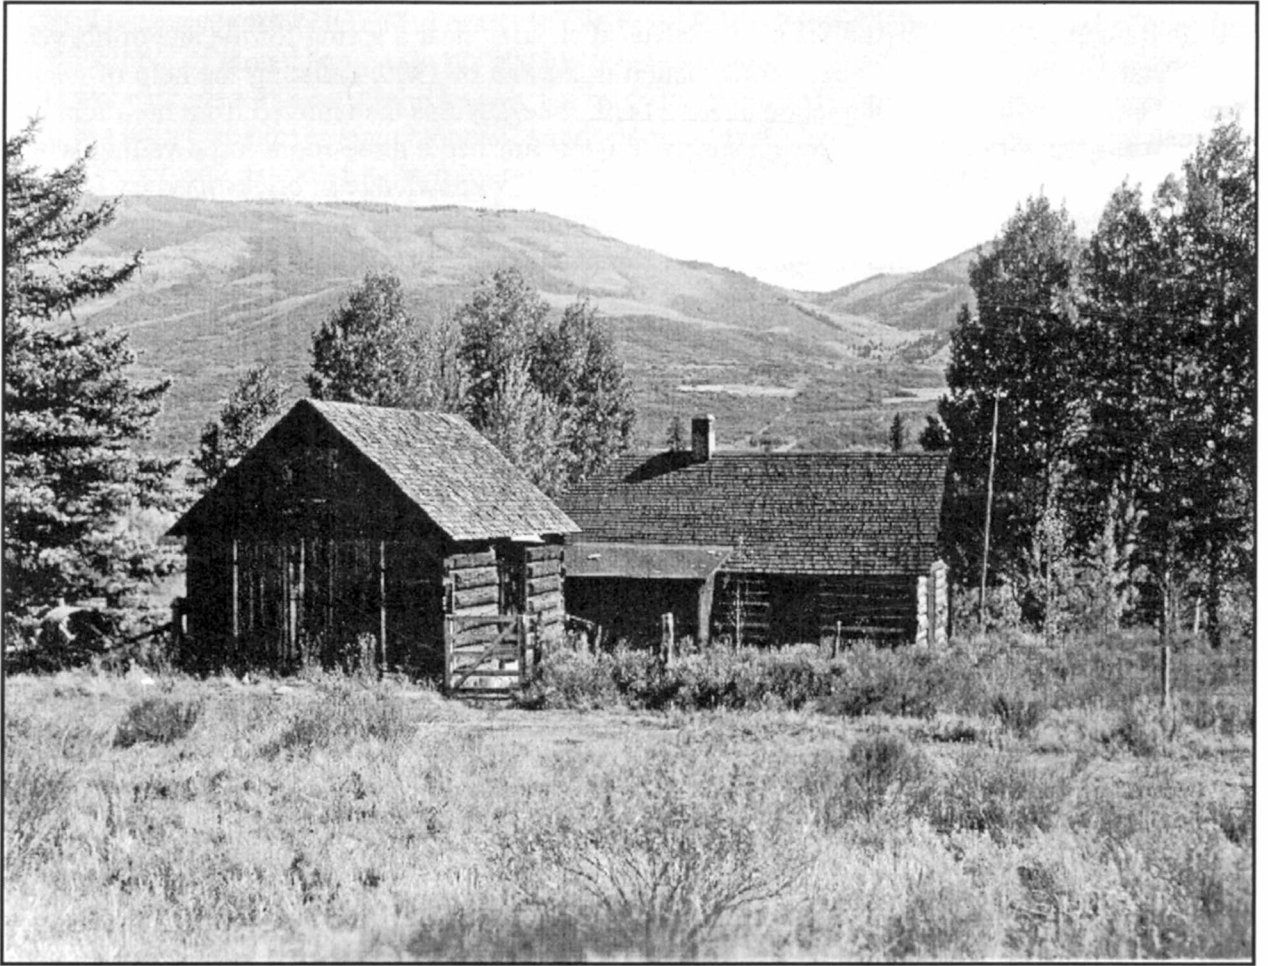
Figure 9. Cayton Guard Station. Photo # EHM2671, taken October 1960. White River National Forest Supervisor's Office. Dwelling in background, barn no longer extant.

Ranger James G. Cayton selected a secluded clearing near a spring for the site of his year-round station (Figure 9). He began construction in the fall of 1909, enlisting the help of nearby rangers and his wife in the completion of a log barn. The Caytons then moved from their tent into the barn for the winter. The following spring, Cayton finished a three-room log dwelling with a wood stove and brick chimney, despite an admitted lack of knowledge in brick-masonry (Cayton 1940). Cayton's duties included counting and examining cattle, and issuing hunting licenses and application forms and permits for grazing and construction of hay derricks.

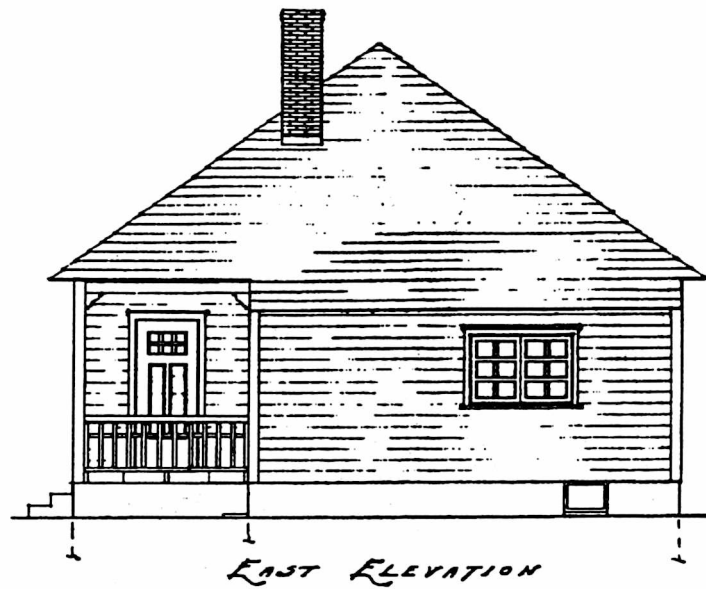
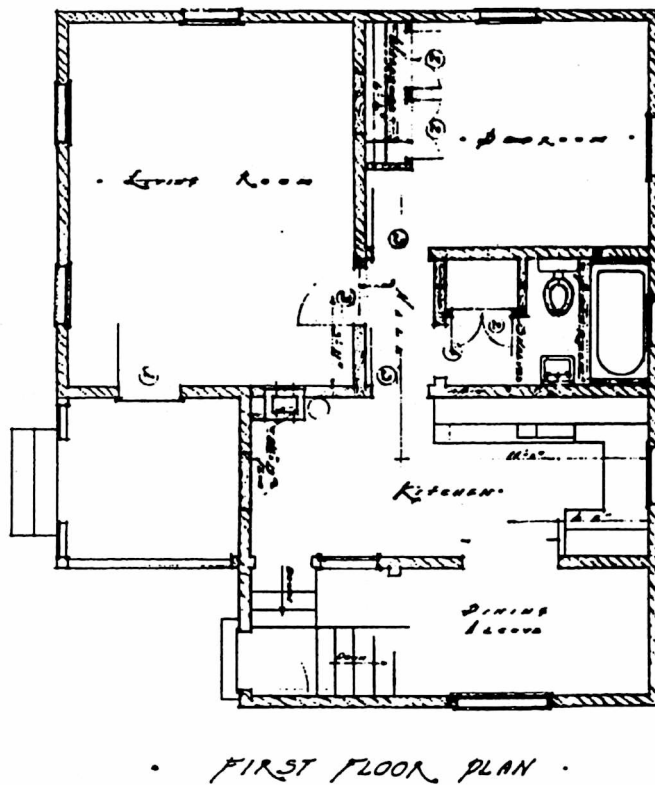
Figure 10. Building Plan and Elevation, Plan # 3, Ranger's Dwelling. Glade Ranger Station Dwelling.

Despite the presence of a Regional engineering staff, many forests developed their own standardized administrative designs and employed local builders to construct them. The Montezuma National Forest developed a series of plans, called simply Plan 1, 2, 3, 4, etc. Plan 3 was a rectangular three-room dwelling, designed on a stone foundation with a pyramidal roof. A corner porch cut into the rectangular plan. From this porch, entrances led to the kitchen and living room. A bedroom was entered off the living room (Figures 10, 11). Small scrolled wood brackets on the porch pillars are the only decorative elements.

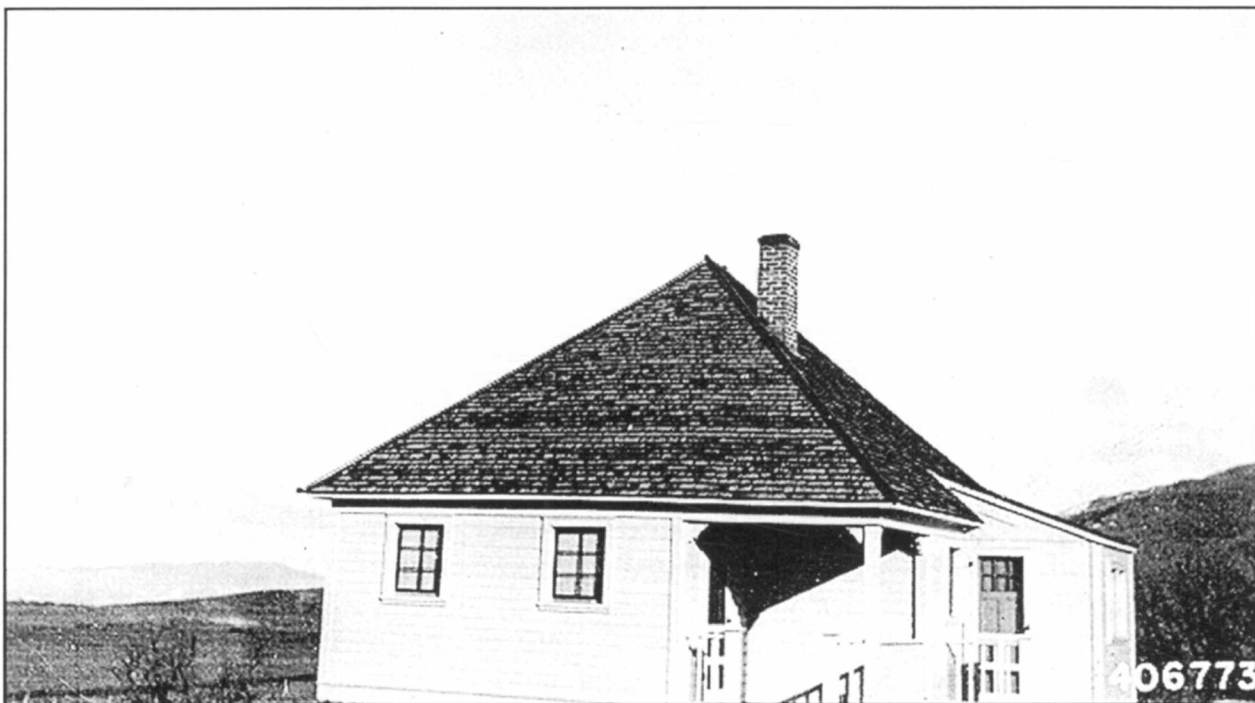
Figure 11. Glade Ranger Station Dwelling. Photo # 406773 taken November 1939 by J. Malcolm Loring. San Juan National Forest Supervisor's Office. Later addition to right.

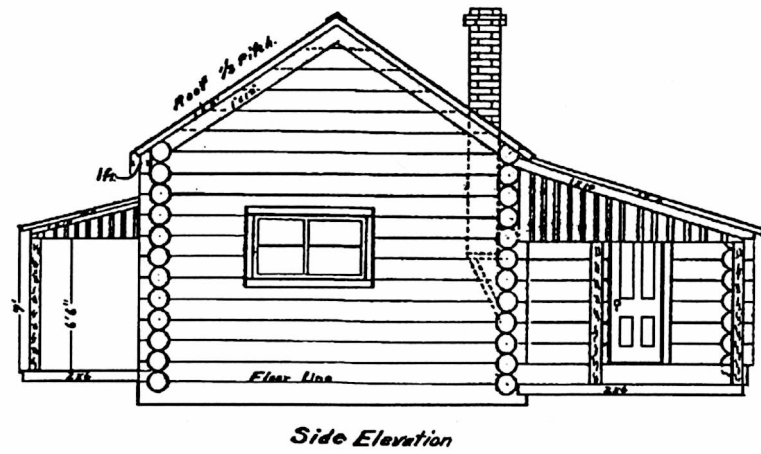
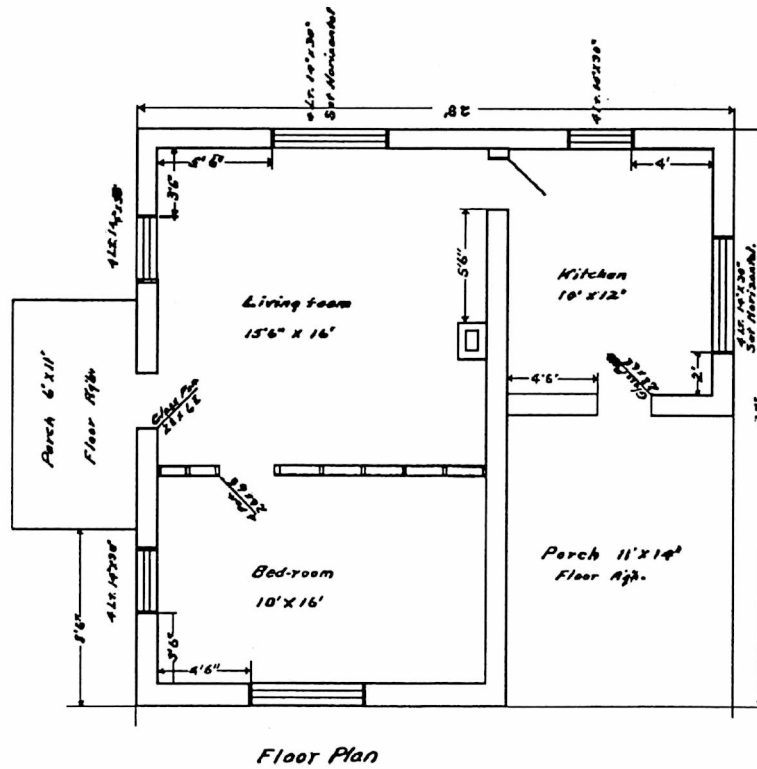
Figure 12. Building Plan and Elevation, Derby Ranger Station Dwelling.

Different forests developed distinct designs. The White River National Forest's plan for a three-room log cabin at Derby Ranger Station (Figures 12, 13) was similar in size to the Montezuma's Plan 3, but had gabled roofs. Both had a bedroom and kitchen accessible from the living room, but the kitchen of Plan 3 was almost twice the size, while the porch and bedroom were less than half the size of the White River plan.

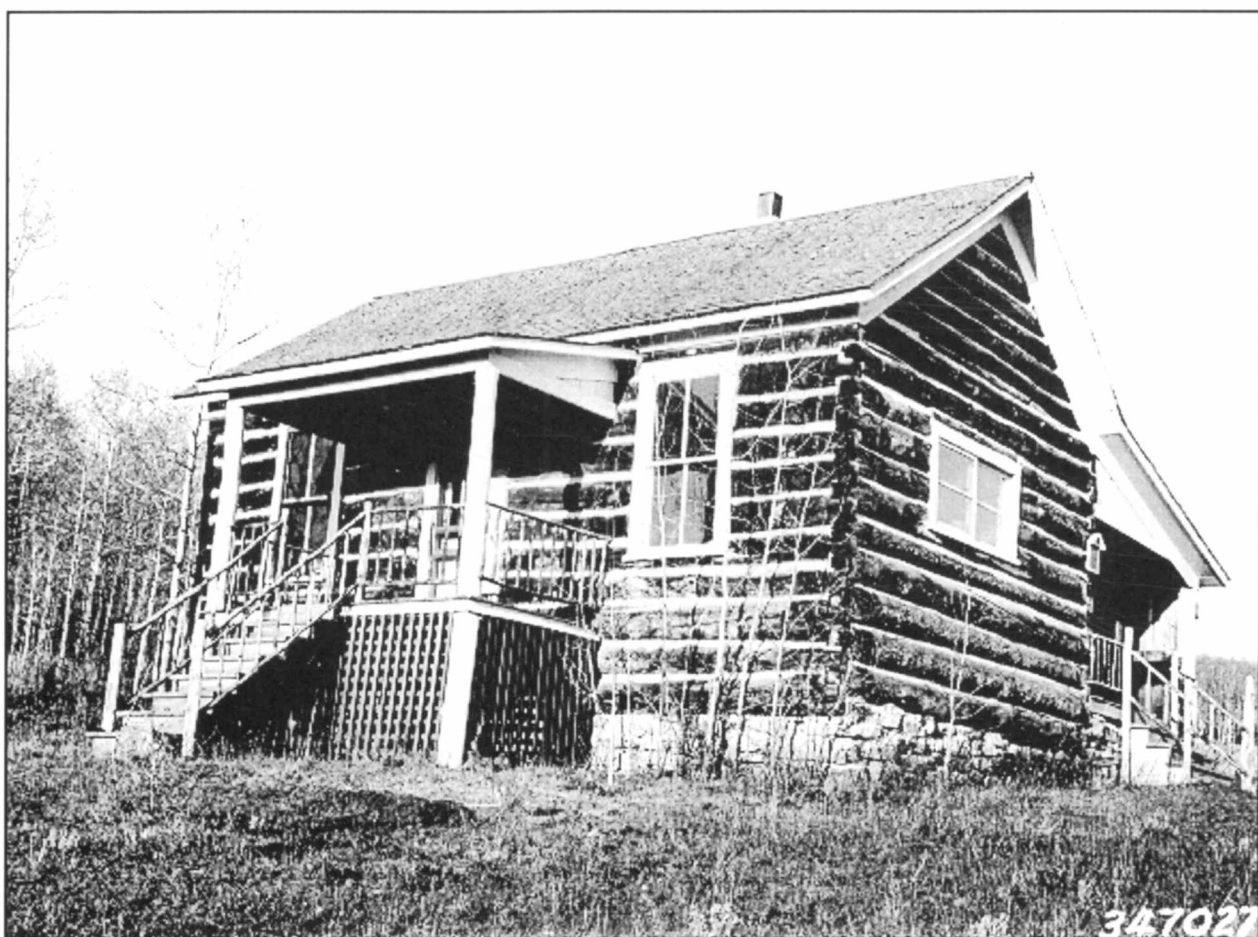
Figure 13. Derby Ranger Station Dwelling. Photo # 347027 taken May 1936 by Donald W. Shaw. White River National Forest Supervisor's Office.

Residences also evolved. The development of the Region 2 Rustic Style could be said to have begun with the White River's 1912 design for the Derby Ranger Station dwelling (Figure 13). Though designed to have notched log walls with 6" crowns, the cabin as built had square notches, with no crown. The rafters stopped at the wall, leaving a one-foot cantilever of sheathing and roofing material unsupported. The log walls, set on an uncut stone foundation, began almost at grade. The eave line (where roof and wall meet) was 11'6" from the ground, and the roof had a moderate pitch. The porch roofs were "boxed" (enclosed), thus hiding the rafters. The fenestration consisted of large 14" x 30" four-pane double-hung and sliding windows.

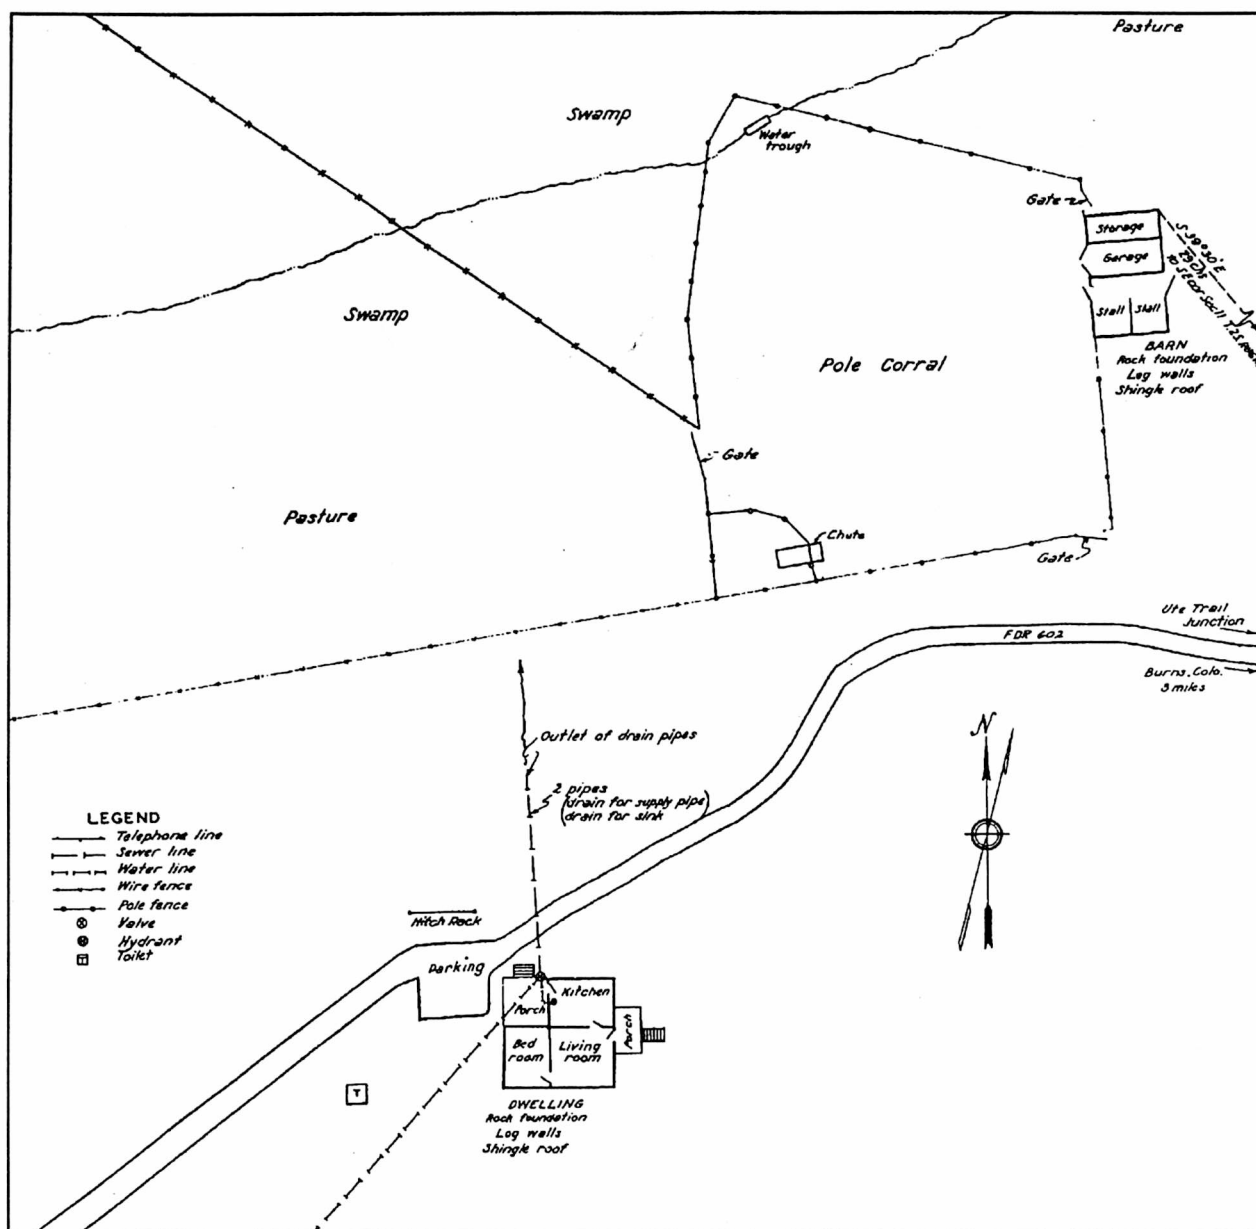
Figure 14. Site Plan, Derby Ranger Station.

The introduction of designed office space in 1931 and construction of various other buildings at administrative sites increased the need for site planning. Guard stations may have had only a single one-room cabin, but typically consisted of a two- or three-room dwelling and small barn, as seen at Derby Ranger Station (Figure 14). Ranger stations had these, and after 1930, single-car garages and combination office buildings. Other improvements could include storage or wood sheds and root cellars. Layouts followed no discernible organization, but conformed to site topography. Buildings were generally constructed close together. At Thompson Creek Ranger Station the dwelling and garage were within six feet of each other (Figure 181, White River National Forest). The Alvarado Ranger Station (Figure 87, San Isabel National Forest) barn was constructed after completion of the combination office building. It not only sat in plain view of visitors, but blocked a spectacular view of the Wet Mountain Valley below (Johnson 1935:1). Only one evaluated Phase II site, the South Fork Ranger Station, once had both office and dwelling (Figure 111, Rio Grande National Forest). The house is no longer extant, leaving no known intact examples.

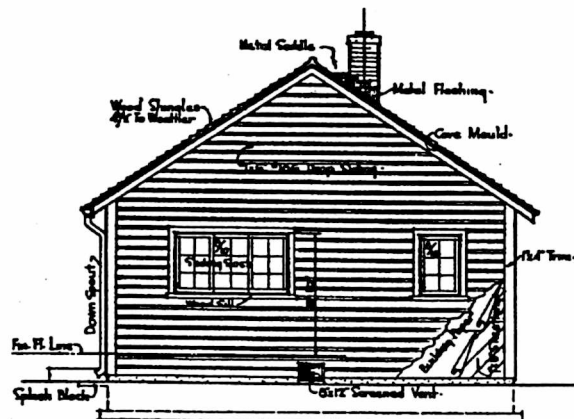
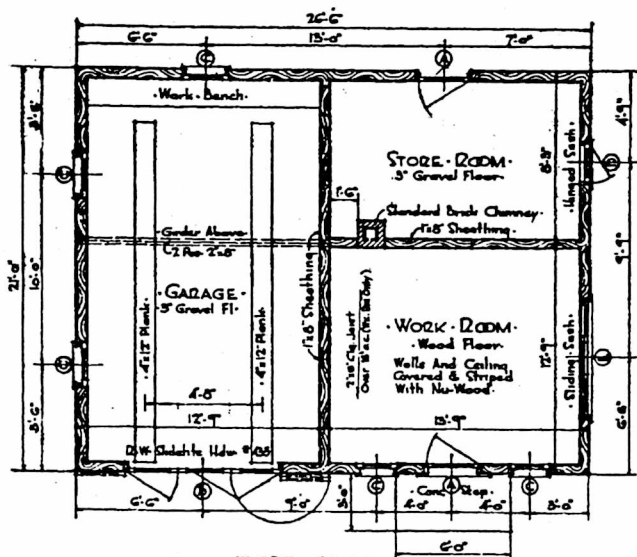
Figure 16. Building Plan, M20, Combination Office Building.

• FRONT • ELEVATION •  
• Scale 1/4" = 1'-0" •

• SIDE • ELEVATION •  
• Scale 1/4" = 1'-0" •

• FLOOR • PLAN •  
• Scale 1/4" = 1'-0" •

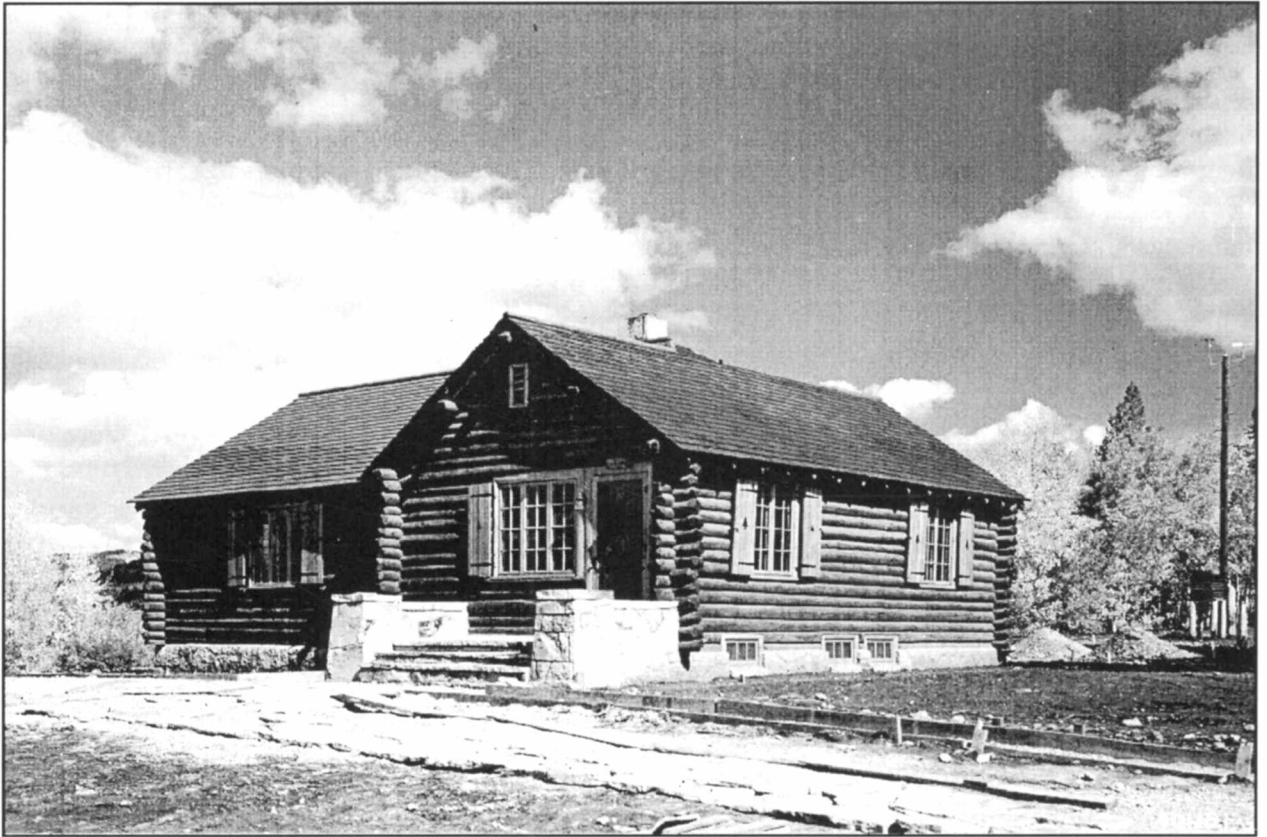
Figure 17. Brush Creek Combination Office Building. Photo # 401151. USFS Rocky Mountain Region Office. Standard (Centennial Plan) Combination Office Building.

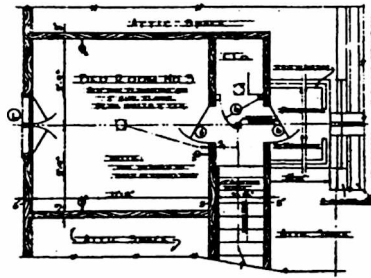
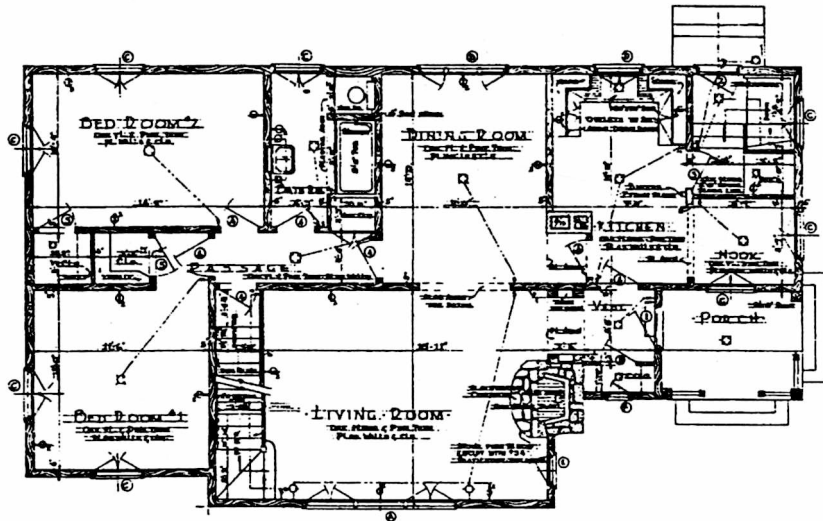
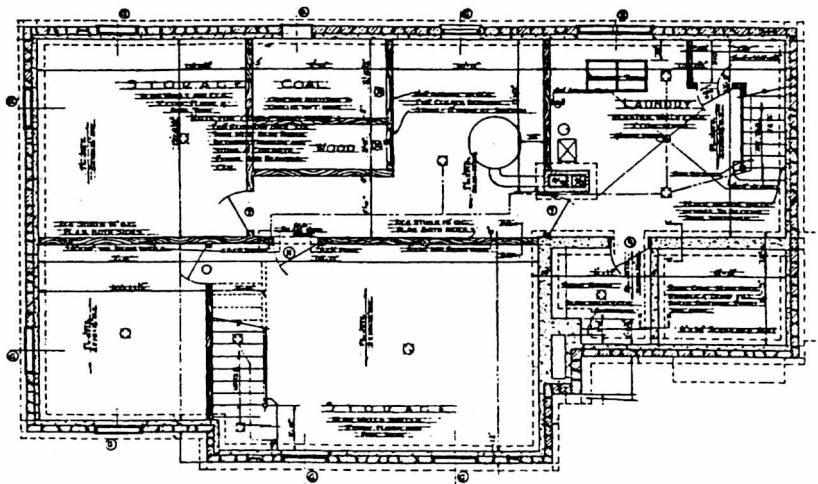
Figure 20. Building Plan, Hot Sulphur Springs Supervisor's Dwelling. Standard Rustic Style Ranger's Dwelling.

SECOND FLOOR PLAN

FIRST FLOOR PLAN

BASEMENT PLAN

Several design schemes became templates for standardization. The White River Supervisor's Warehouse at Glenwood Springs, the Centennial Ranger Station Office on the Medicine Bow (e.g., Figure 17), the Hot Sulphur Springs Supervisor's Dwelling on the Arapaho (e.g., Figure 21), and the Huerfano Ranger's Dwelling on the San Isabel National Forest (e.g., Figure 22, San Juan National Forest), were reproduced throughout the region. Several were later featured in *Acceptable Plans* (U.S. Forest Service 1938). Some designs were inspired by or borrowed directly from designs produced by other Regions within the Forest Service.

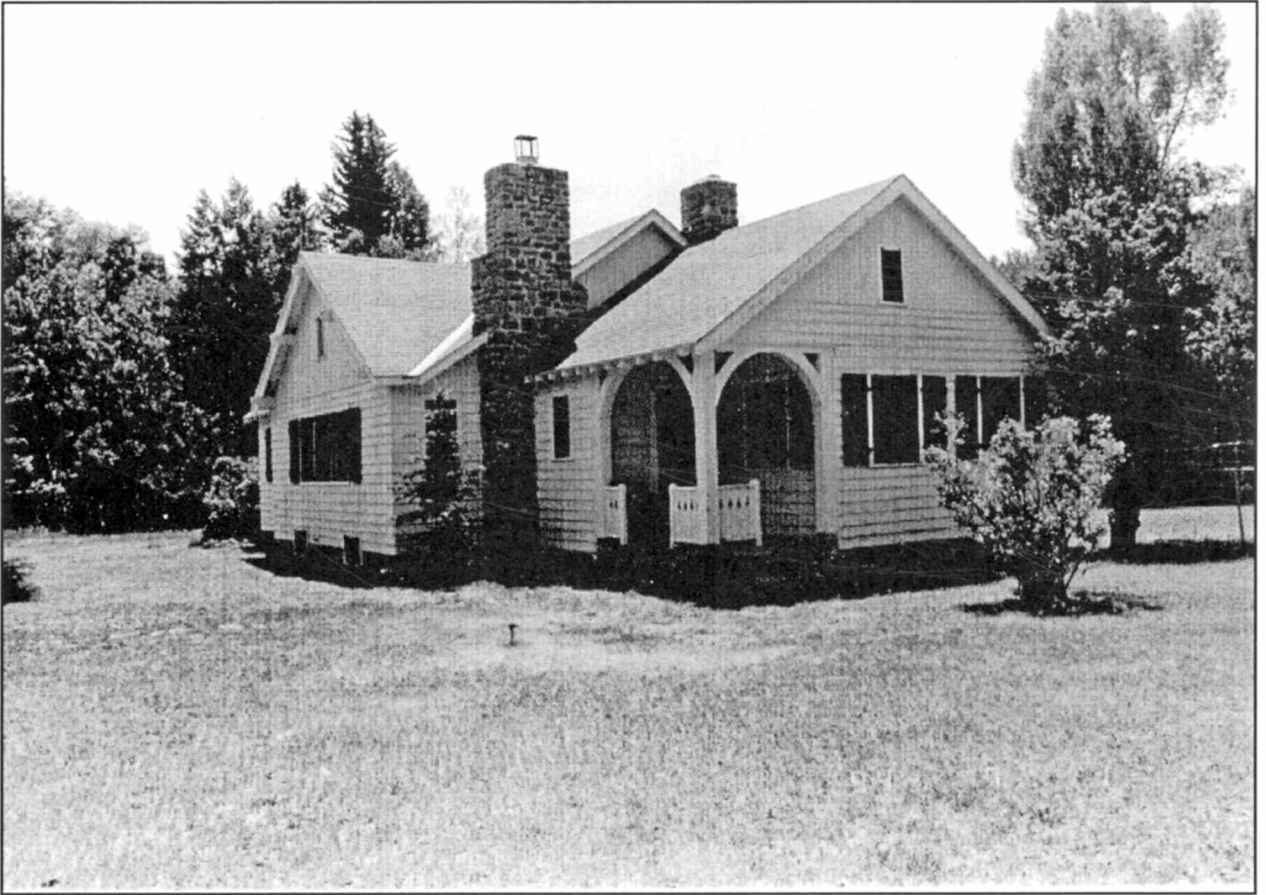
Figure 21. River Springs Ranger Station Dwelling. Photo taken July 1994, NPS. Standard (Hot Sulphur Springs) Ranger's Dwelling.

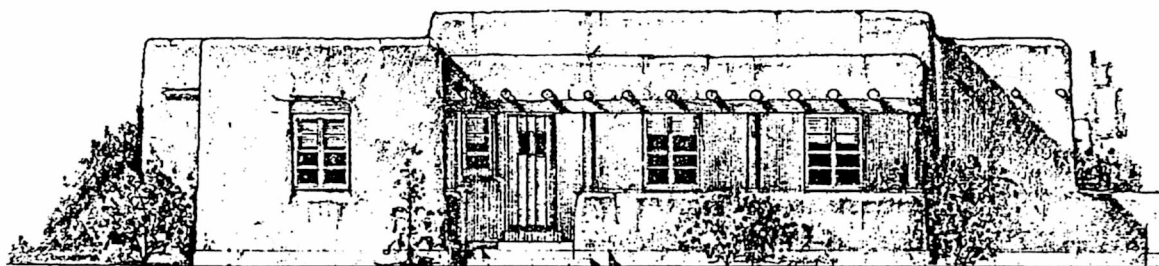
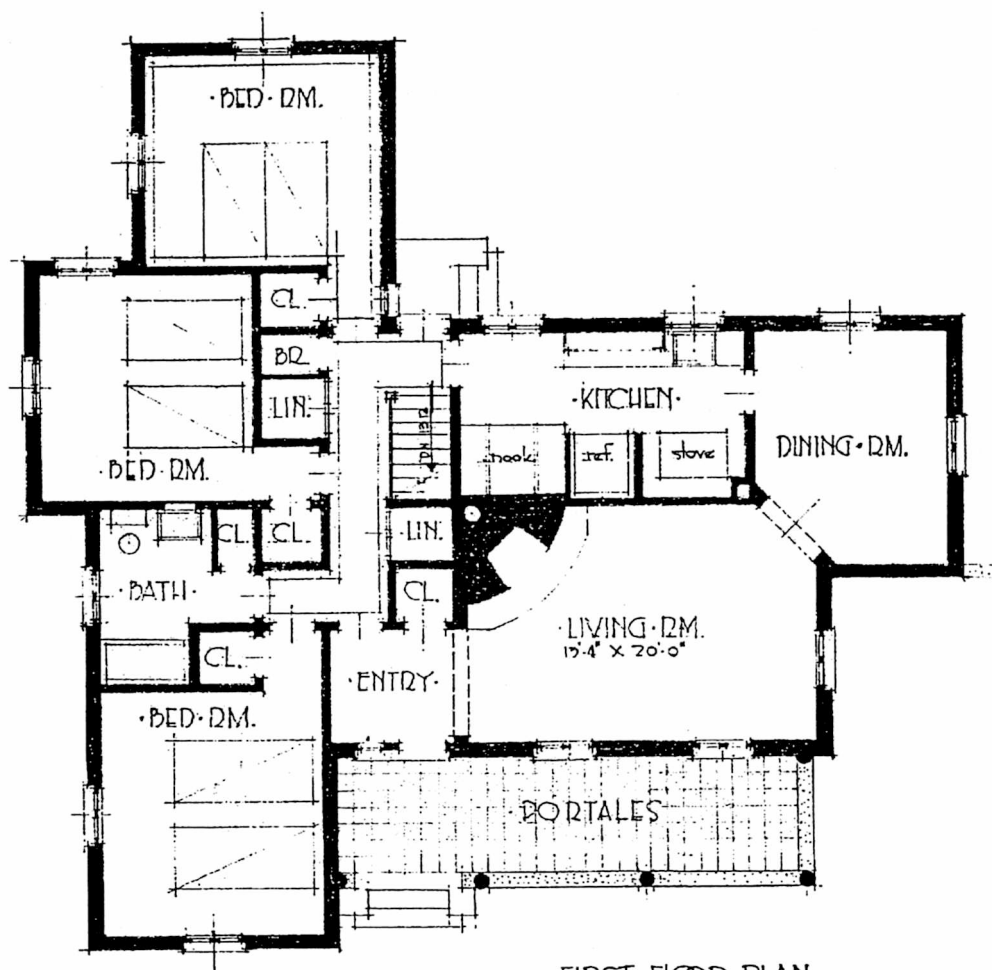
Figure 22. Building Plan and Elevation, Huerfano Ranger Station Dwelling. Standard Pueblo Style Ranger's Dwelling.

·FRONT·ELEVATION·

·FIRST·FLOOR·PLAN·

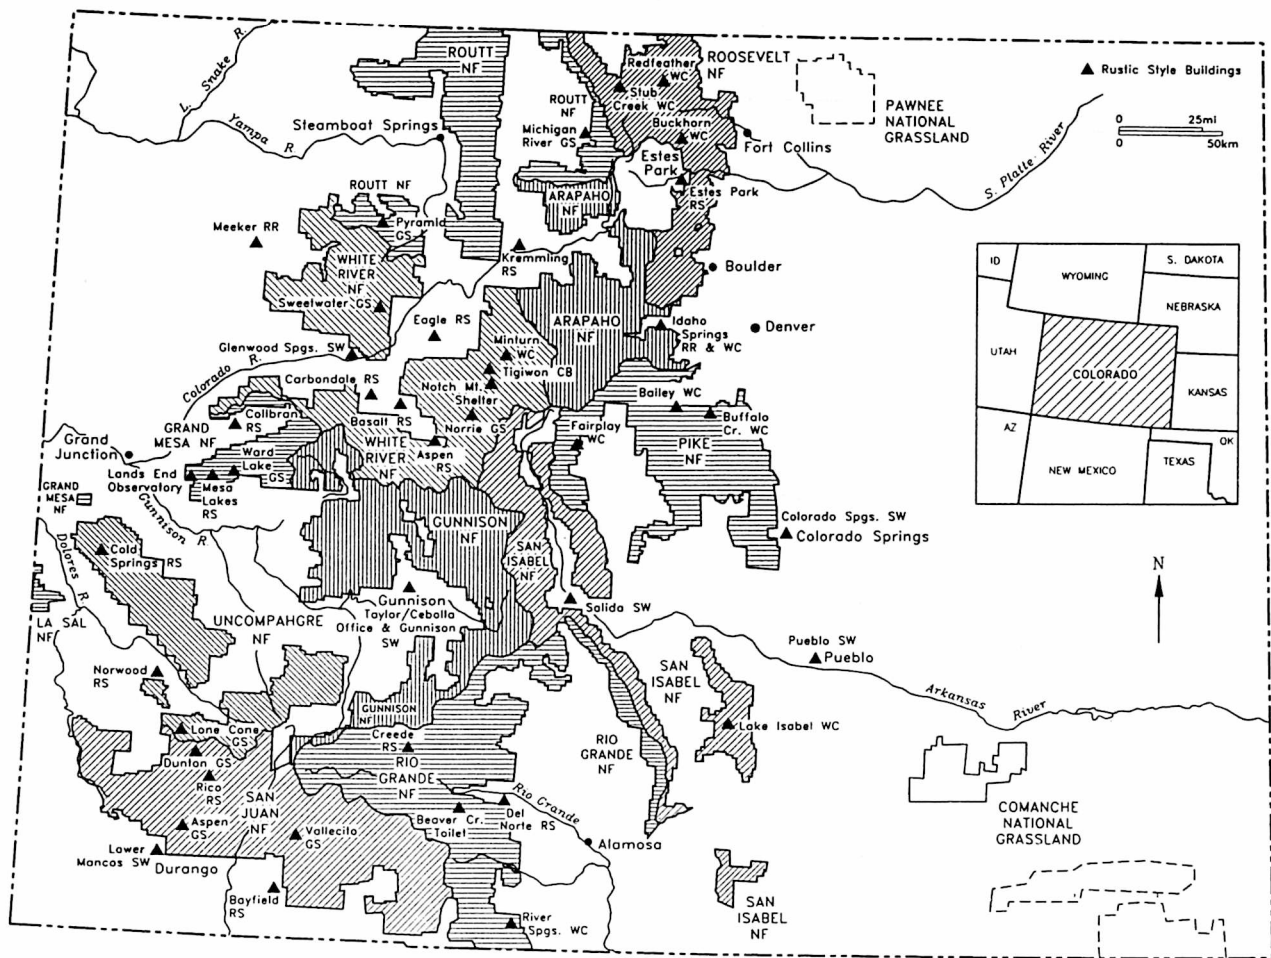
Figure 27. Phase III Rustic Style administrative construction in Colorado.

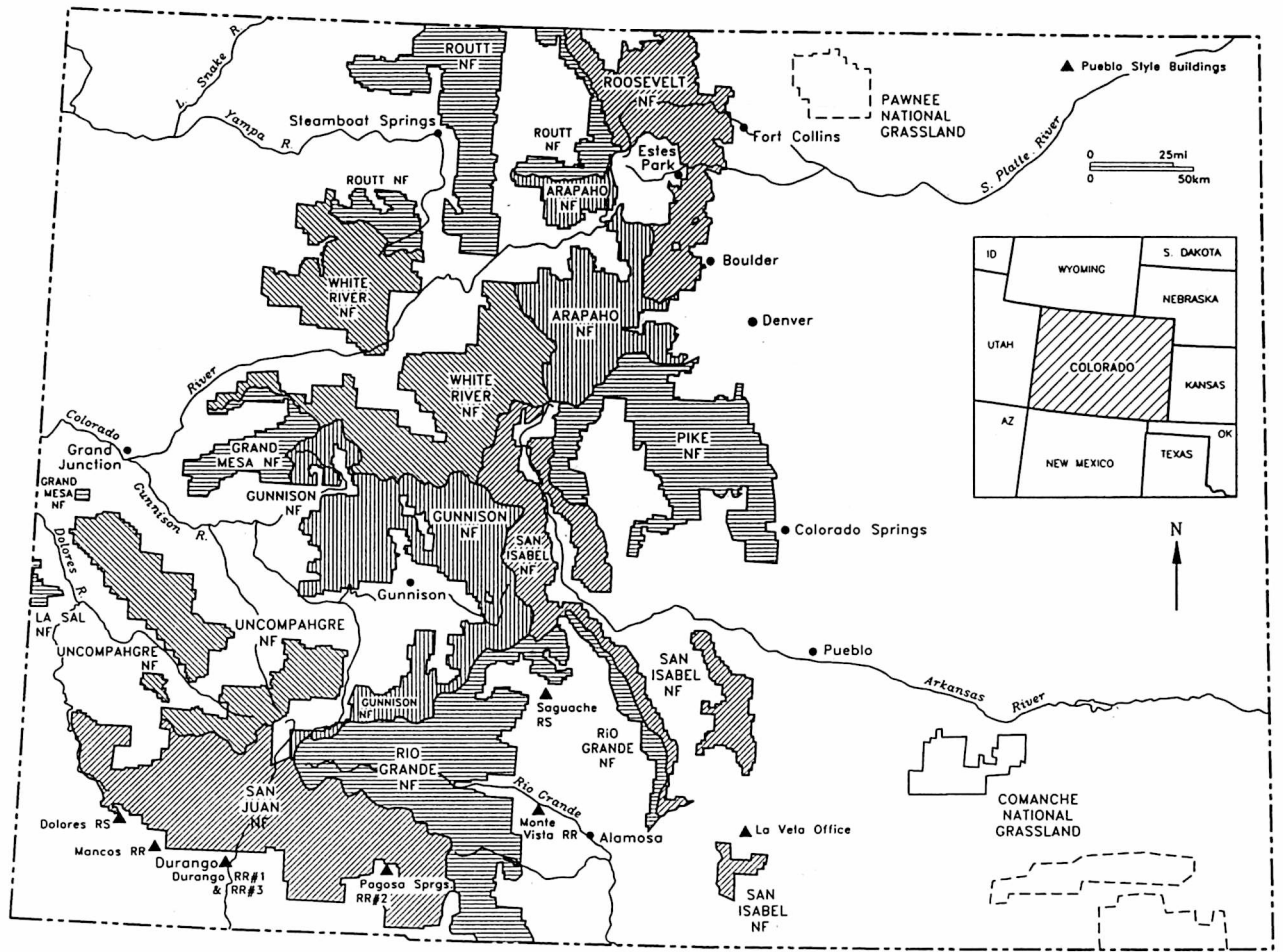
Figure 28. Phase III Pueblo Style administrative construction in Colorado.

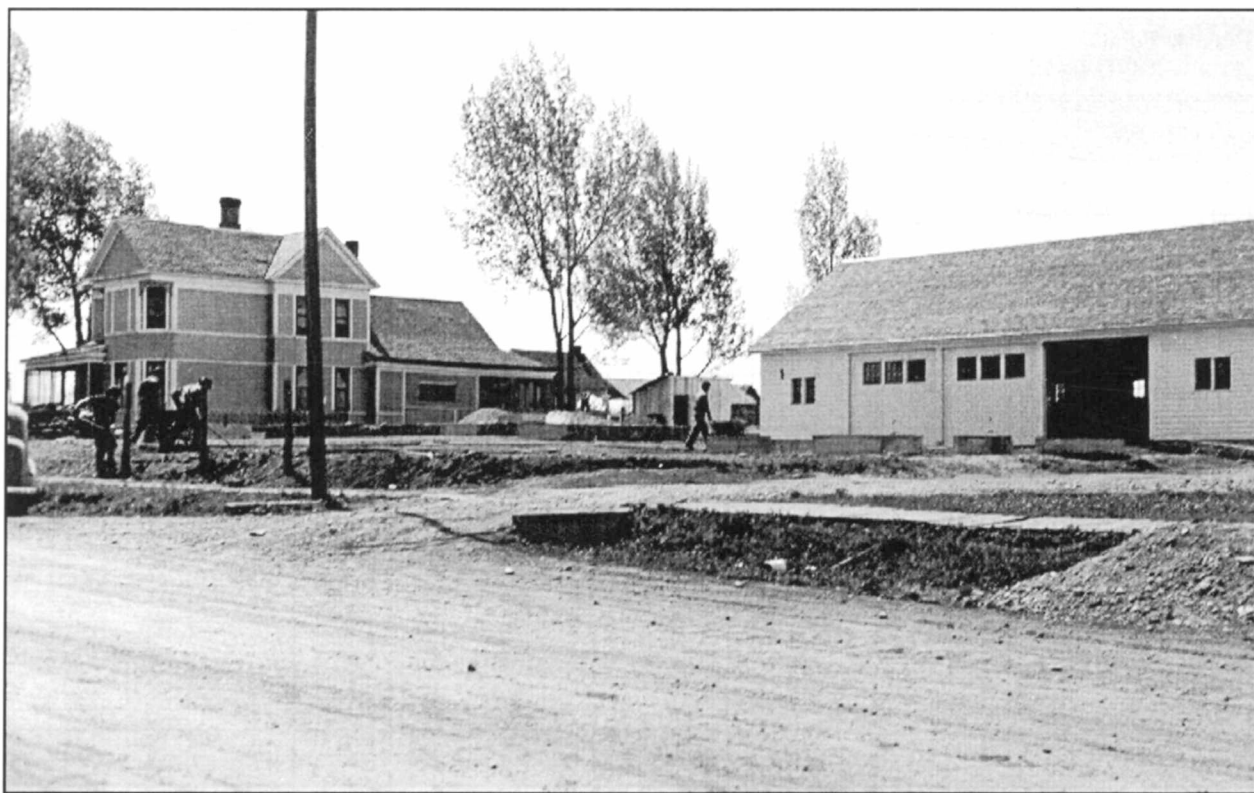
Figure 29. Norwood Ranger Station under construction. USFS Rocky Mountain Region Office. Garage to right.

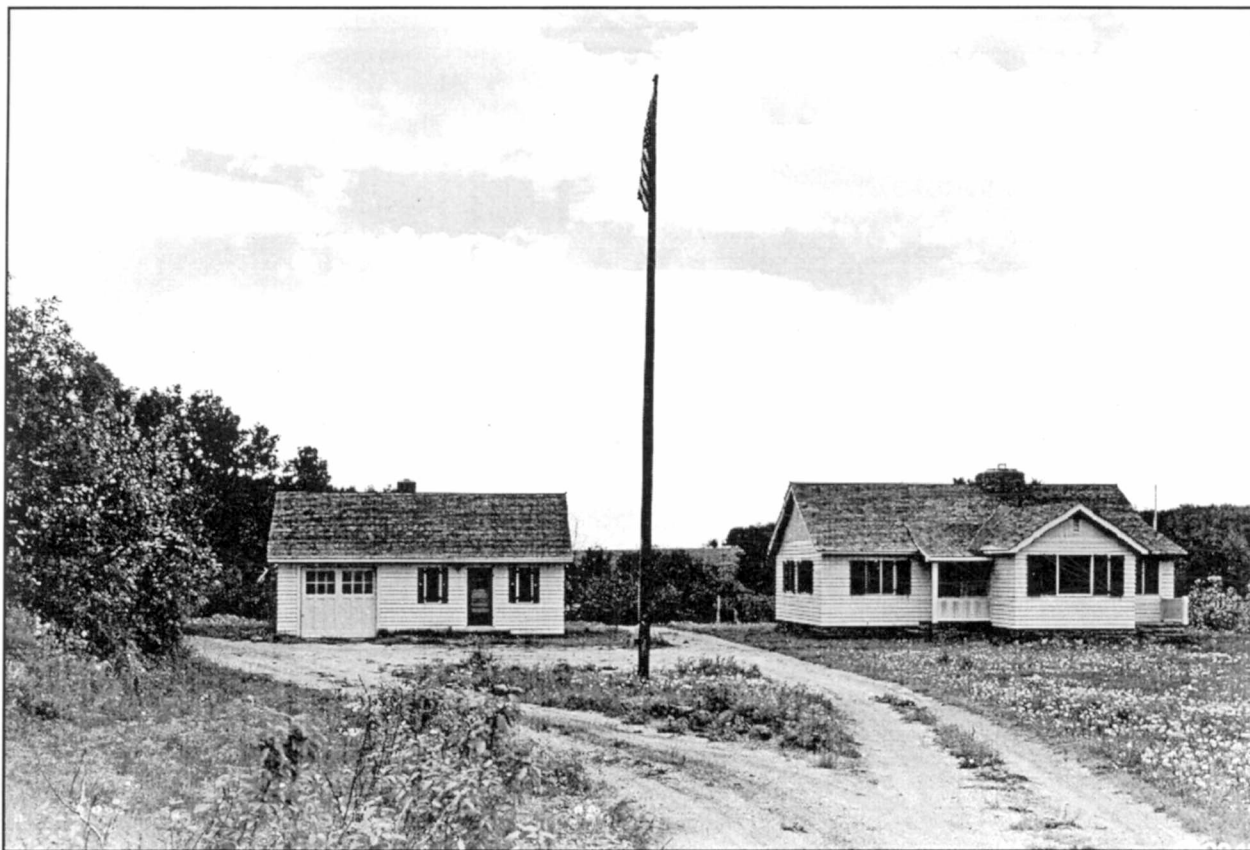
Figure 30. Cold Springs Ranger Station. Photo # 430948 taken July 1944 by Jay Higgins. USFS Rocky Mountain Region Office. Office to left, Dwelling to right.

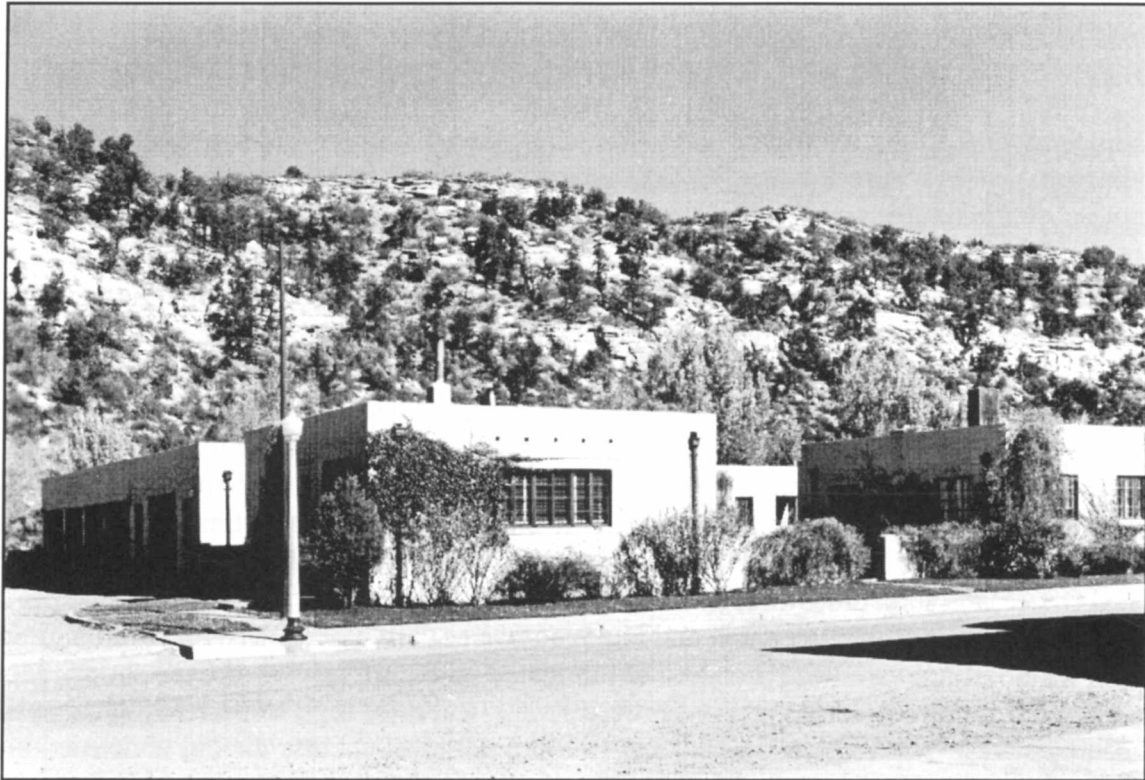
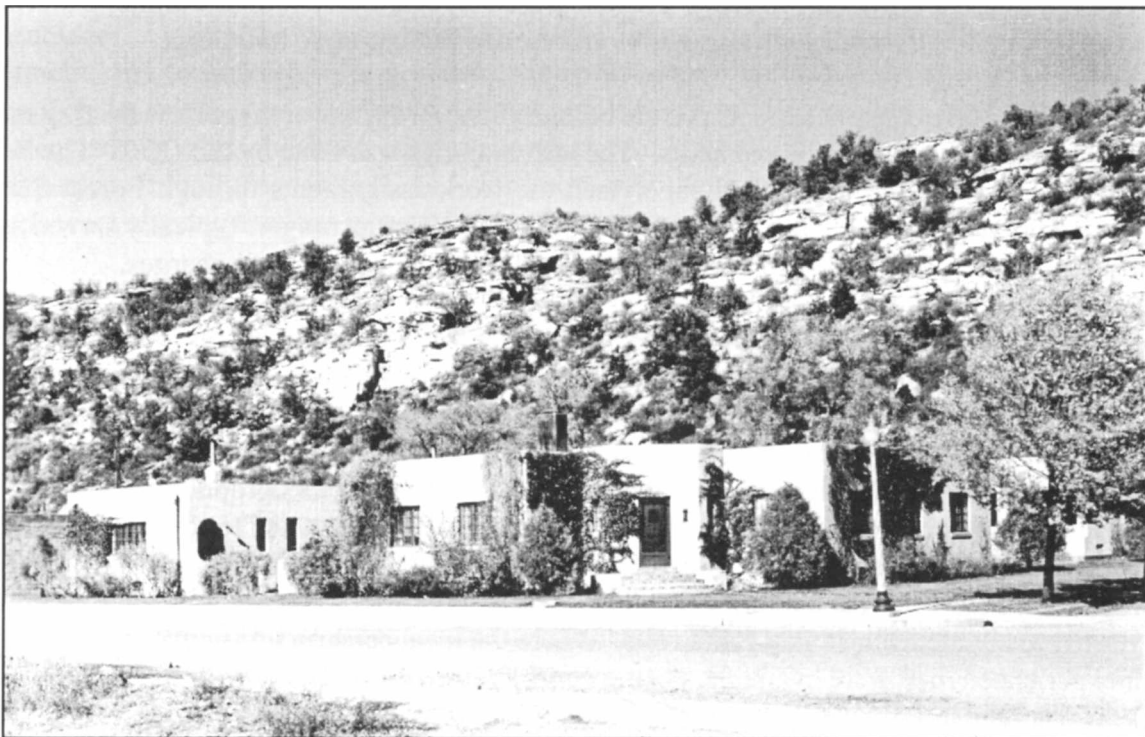
Figure 33. Dolores Ranger Station. Photo # 3016 (Top) and # 3015 (Bottom) taken October 1947. USFS Rocky Mountain Region Office. Office at center in photo # 3016 (Top), to the left in # 3015 (Bottom).
