# Administering the National Forests of Colorado

## An Assessment of the Architectural and Cultural Significance of Historical Administrative Properties

*Prepared for the U.S. Forest Service, Rocky Mountain Region by the  
National Park Service - Midwest Archeological Center*

1996

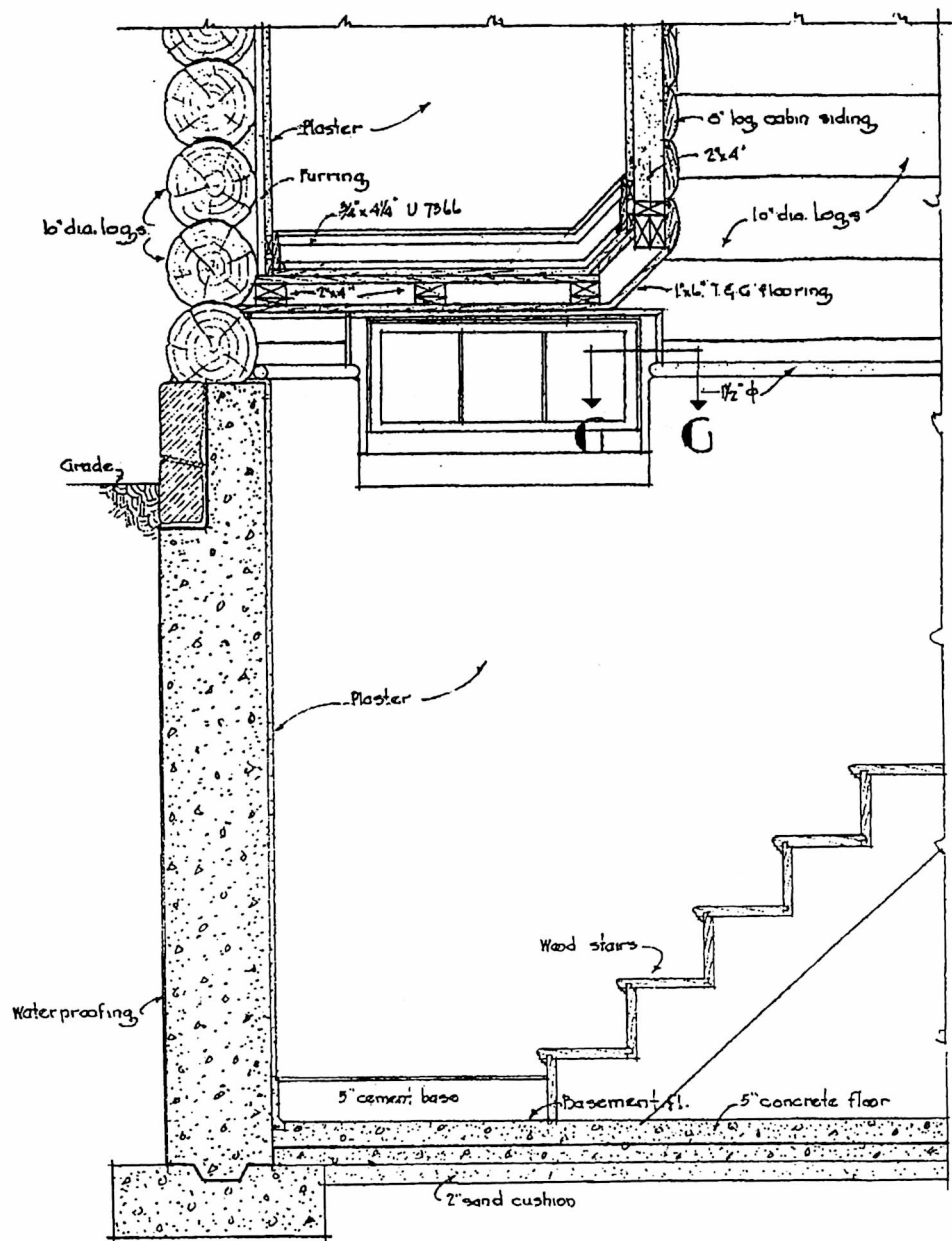
Figure 35. Construction Detail, Centennial Ranger Station Combination Office Building.

SECTION THRU STAIR  
Scale  $\frac{3}{4}" = 1'-0"$

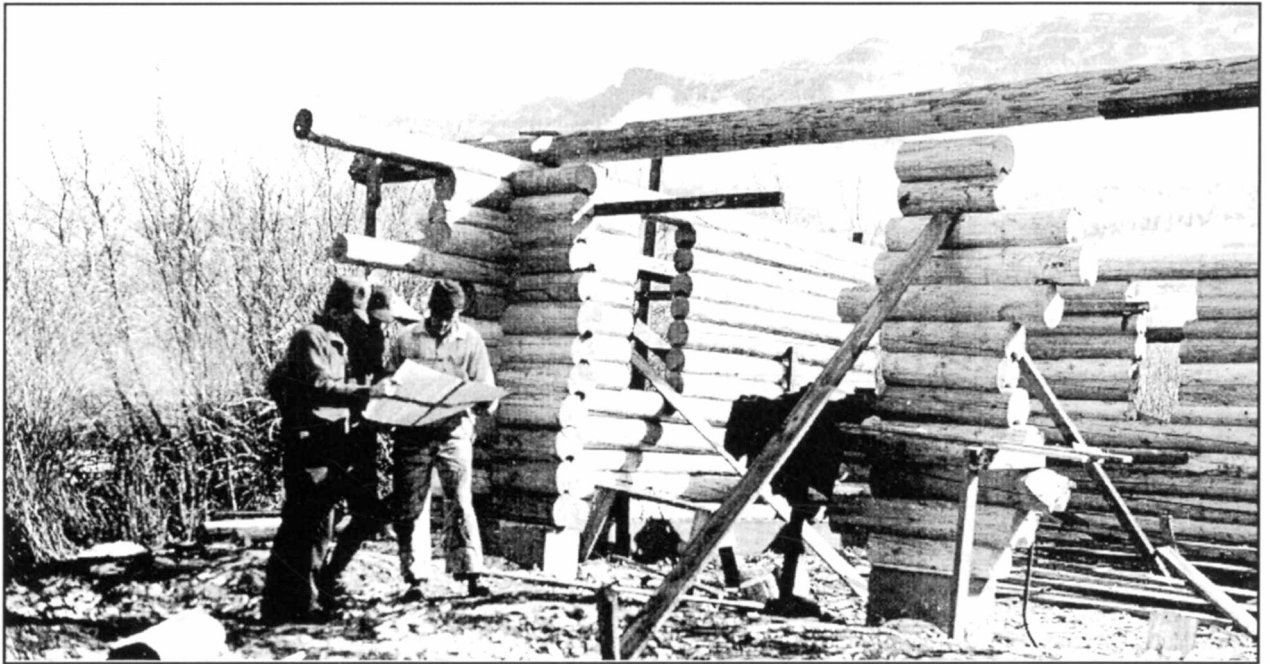
Figure 36. Construction on Shoshone National Forest. Photo # 347154 taken May 1937 by J. Sieker. USFS Rocky Mountain Region Office. Note hewn underside of logs.

Ranger Bruce Torgny proposed hewing the underside of logs, further refining the appearance of Forest Service log buildings by eliminating the need for chinking and daubing. This new system allowed a tighter fit, more permanent design, and enabled the interiors of log buildings to be left exposed, thus reducing materials costs while enhancing rusticity (Torgny 1934). This can be seen during the 1937 project on the Shoshone National Forest, (Figure 36). The practice also became a Regional standard. Figure 37 depicts the notching systems identified in the report sample.

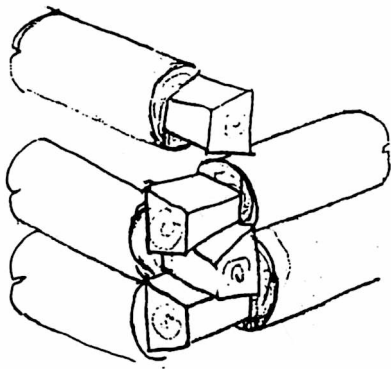
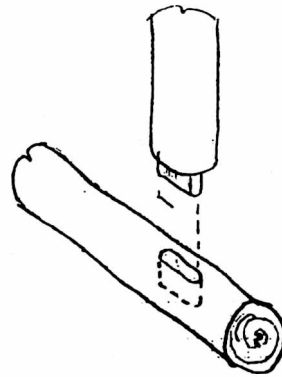
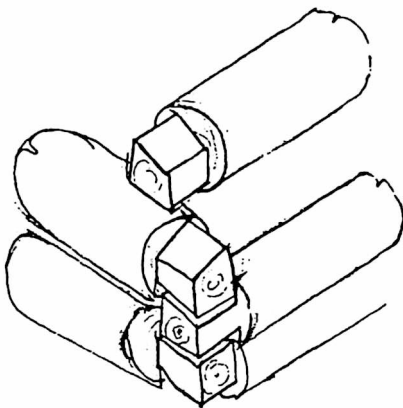
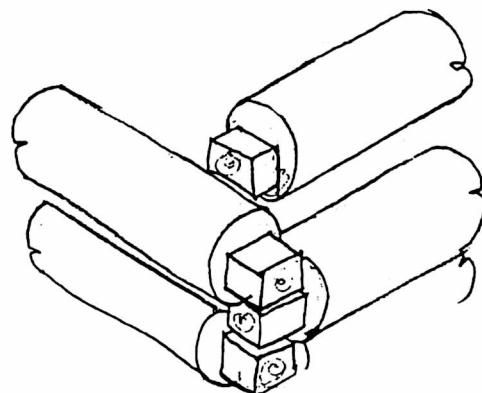
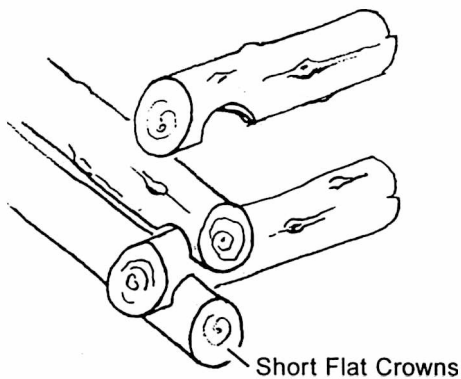
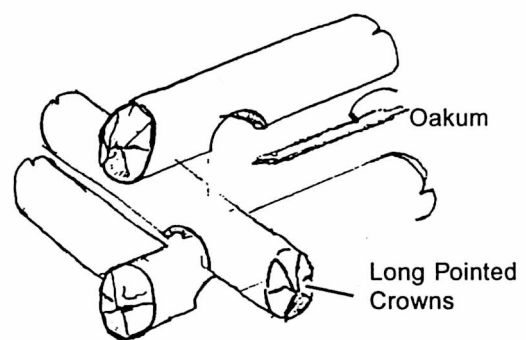
FULL DOVETAIL  
(Phase I)

MORTISE & TENON  
(Phase I)

HALF DOVETAIL  
(Phase II)

SQUARE  
(Phases I & II)

SADDLE  
(Phases I & II)

SADDLE  
(Phase III)

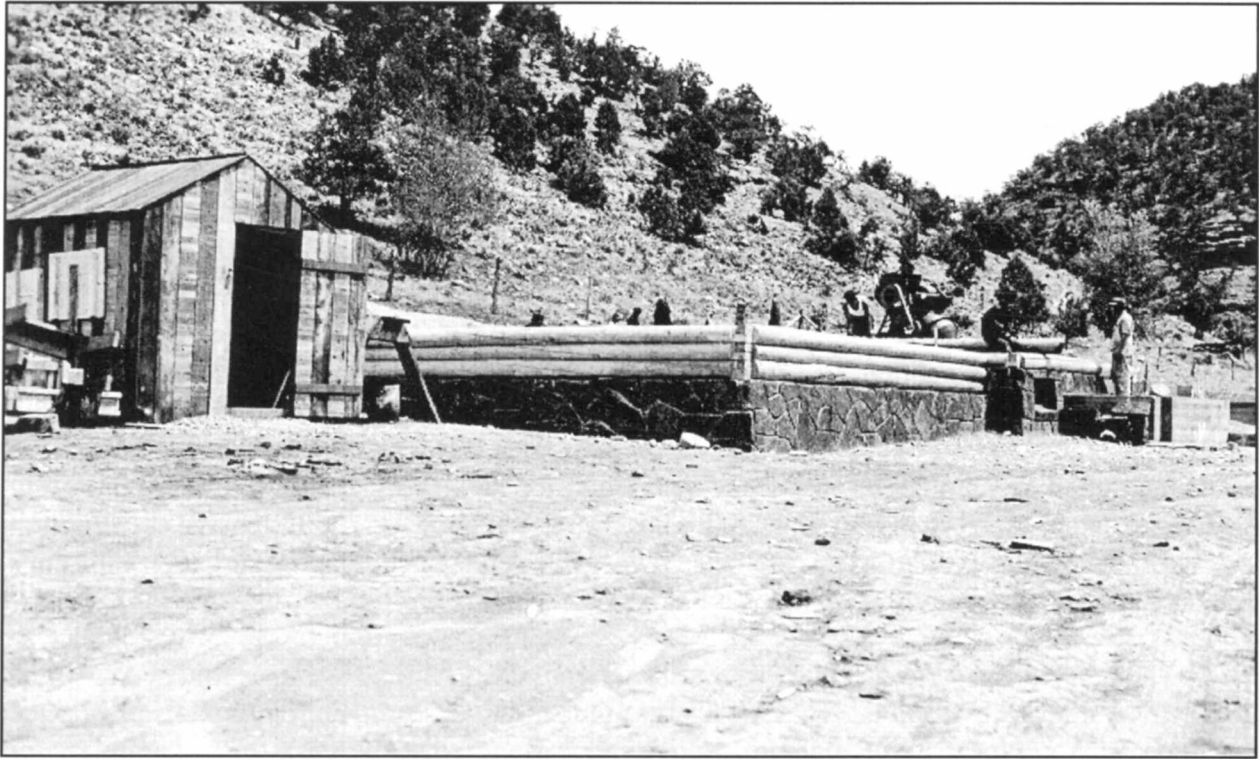
Figure 38. Construction at Basalt Ranger Station. USFS Rocky Mountain Region Office. Note square notches.

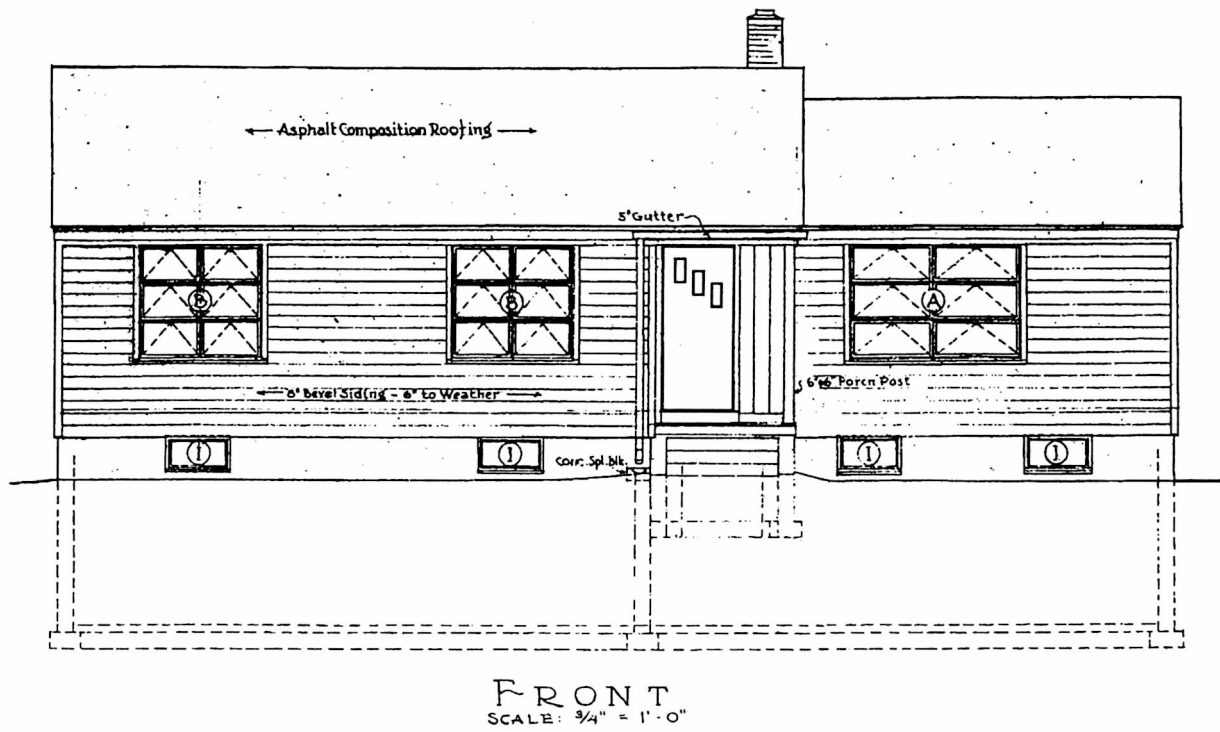
Figure 39. Building Plan, Standard Ranger's Dwelling. Three Bedroom Dwelling plan.

Other forces have impacted the original layouts of existing buildings. These include, in part, the need for computer rooms and for more staff offices. Living facilities were converted to office space when their use by Forest Service personnel dropped after the war. Consolidation of districts and forests (Hinton 1988:VII-7) has shifted administrative uses to new central facilities, prompting second conversions to bunkhouses for seasonal employees and volunteers. Noncompetitive rent structures prompted many employees to rent or purchase private market housing, resulting in additional dwelling-bunkhouse conversions (Faulk 1994). Routine maintenance has also altered appearances. The effects of Federal building efficiency mandates and requirements for handicapped accessibility are visible in the new windows, doors, siding, and ramps visible on many buildings. Re-stained or painted logs no longer have their original shade of brown. Rotted vigas and crowns have been removed. Low maintenance metal roofing has been installed over original shake shingles.

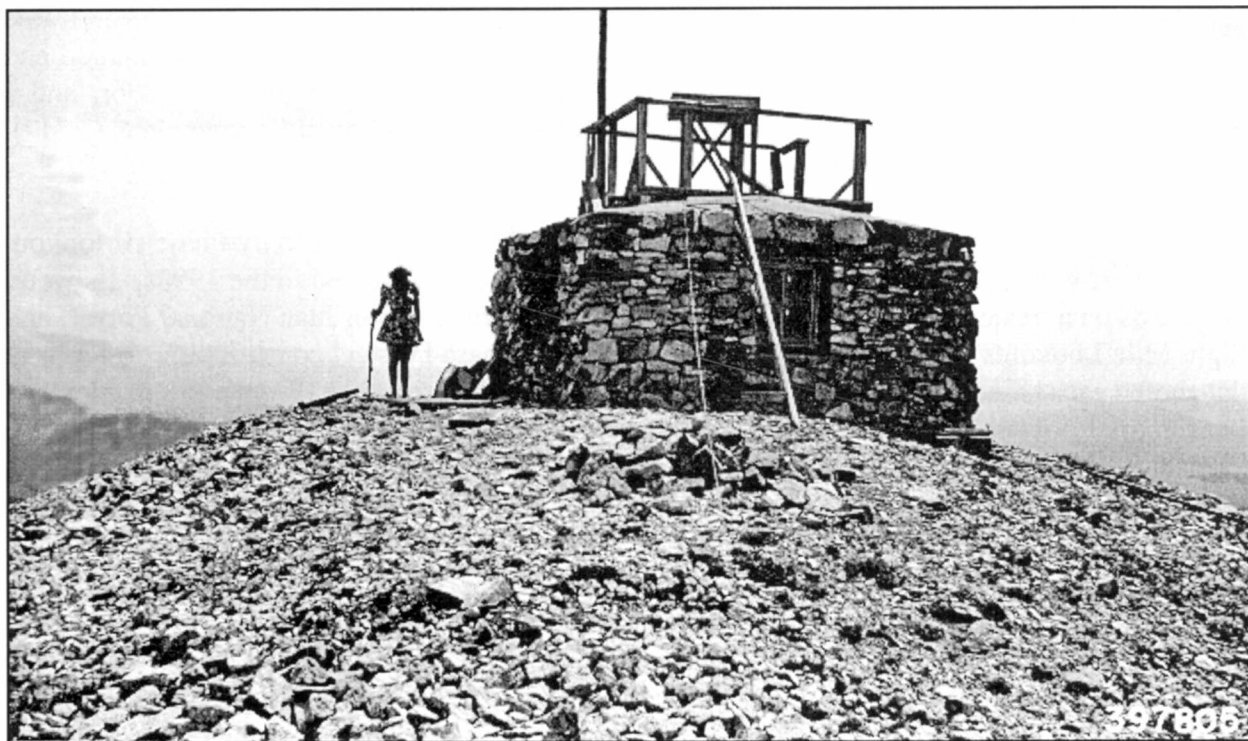
Figure 43. Hahn's Peak Lookout, pre 1940. Photo # 397805 taken August 1940 by Wm. S. Brown. Routt National Forest Supervisor's Office. Caption reads "taken before the building was enlarged and modernized."

The Hahn's Peak Lookout (Figure 42) was reconstructed in 1942 from the remains of a previous lookout (Figure 43), estimated to have been built from between Routt Forest Supervisor Harry Ratliff's estimate of 1908 or 1909 (Kay 1988) to 1912 (Stanko et al. 1979:27). Both were examples of the cupola cabin typology, which placed an observation area above a living quarters or warming room. The original structure was one of the first officially funded towers constructed in Colorado. Construction was carried out by Ratliff with the help of local rangers. The original building was functionally similar to the present one, with a stone living quarters topped by a frame lookout post. This post was surrounded by a catwalk. When the lookout post was enlarged and modernized, the open-air post atop the roof was enclosed with glass windows, a door, and a pyramidal roof. These modifications were carried out according to Forest Service plans (B247). The tower was manned until 1947.

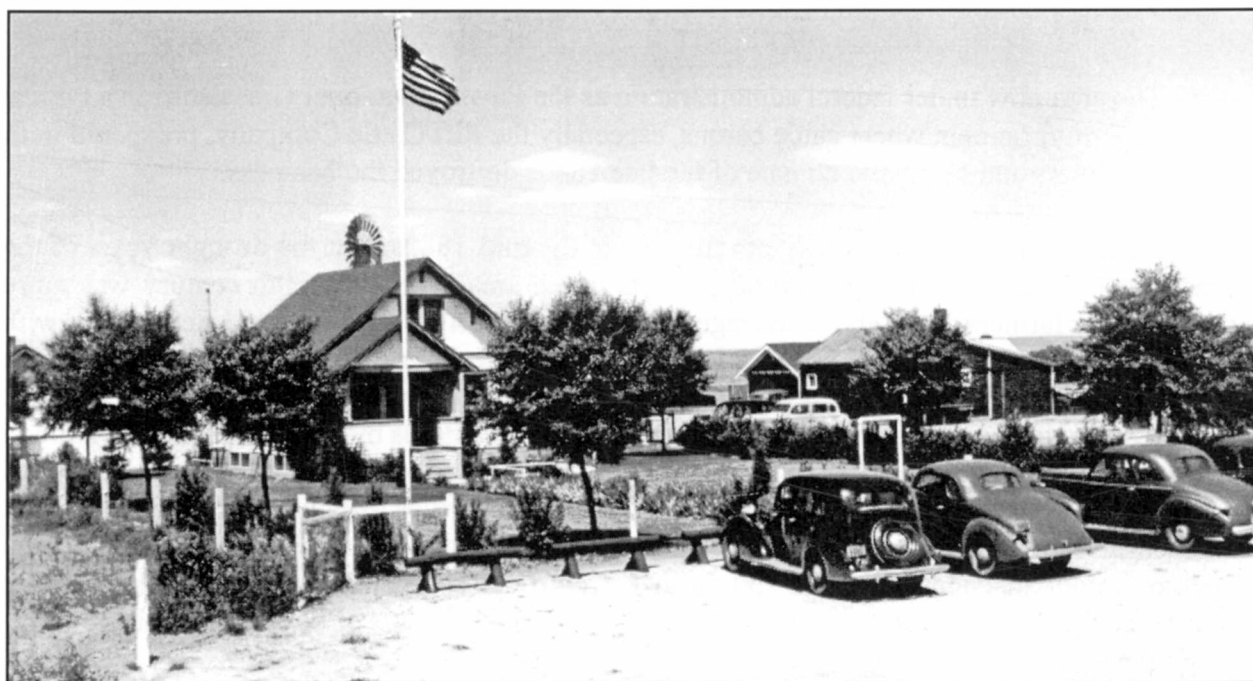
**Figure 56**  
Briggsdale Work Center  
View to the Northwest

*Statement of Significance.* More data is needed to determine if site 5WL2225 is significant under criterion A for its role in the administration of the Pawnee Grasslands. It is not recommended as significant under criterion C. The site has lost several buildings. Those remaining do not retain integrity of design.

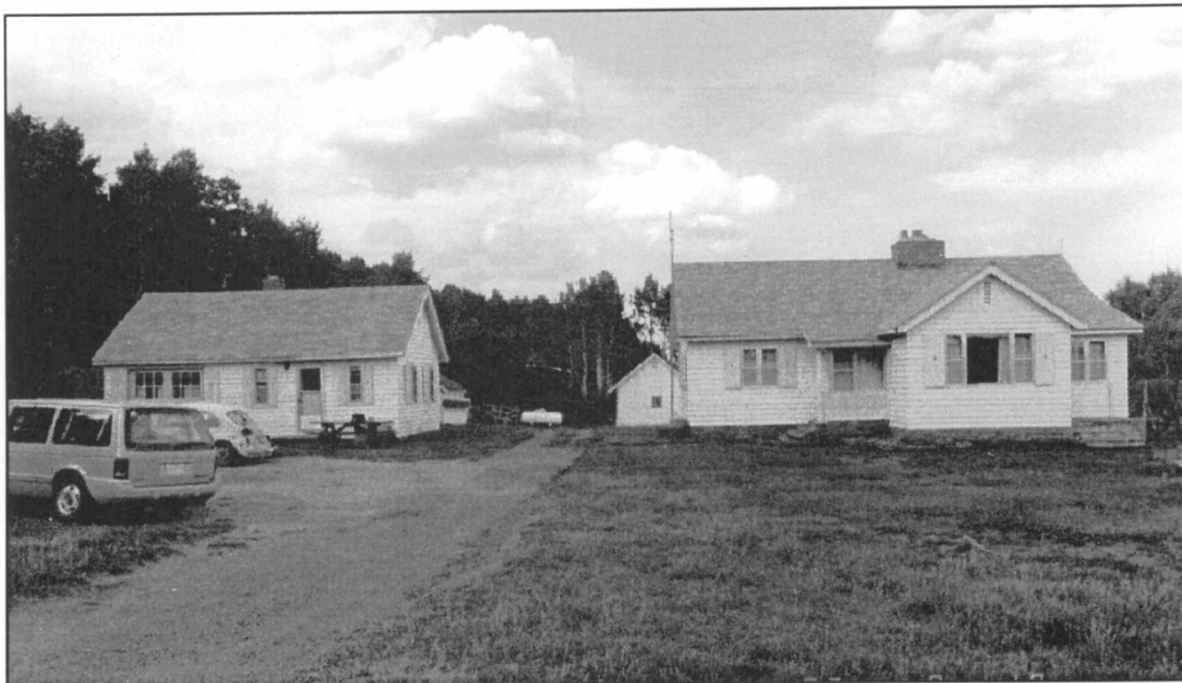
**Figure 59**

*Statement of Significance.* It is recommended that site 5ME6254 is significant under criteria A and C. The complex is associated with the development and administration of the Grand Mesa National Forest and the work of the CCC. It is one of the best preserved and most representative rural CCC era ranger stations in Colorado.

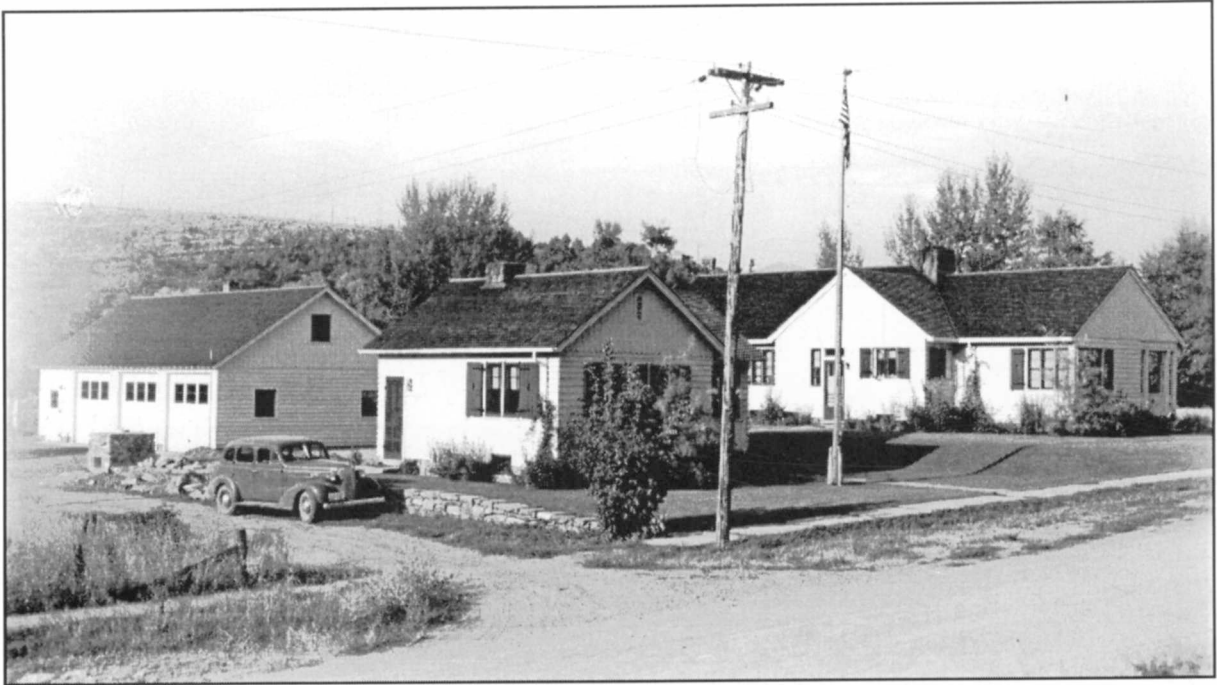
**Figure 60**  
(Collbran) Ranger Station  
and Personal Residence

*Statement of Significance.* It is recommended that site 5ME5002 is significant under criteria A and C. It is associated with the development and administration of the Grand Mesa National Forest and with the work of the New Deal. Its classic layout and well preserved buildings make it the best remaining example of a CCC-era urban ranger station in Colorado. Its construction by the ERA reflects that agency's influence upon the USFS, as well as the craftsmanship of ERA construction.

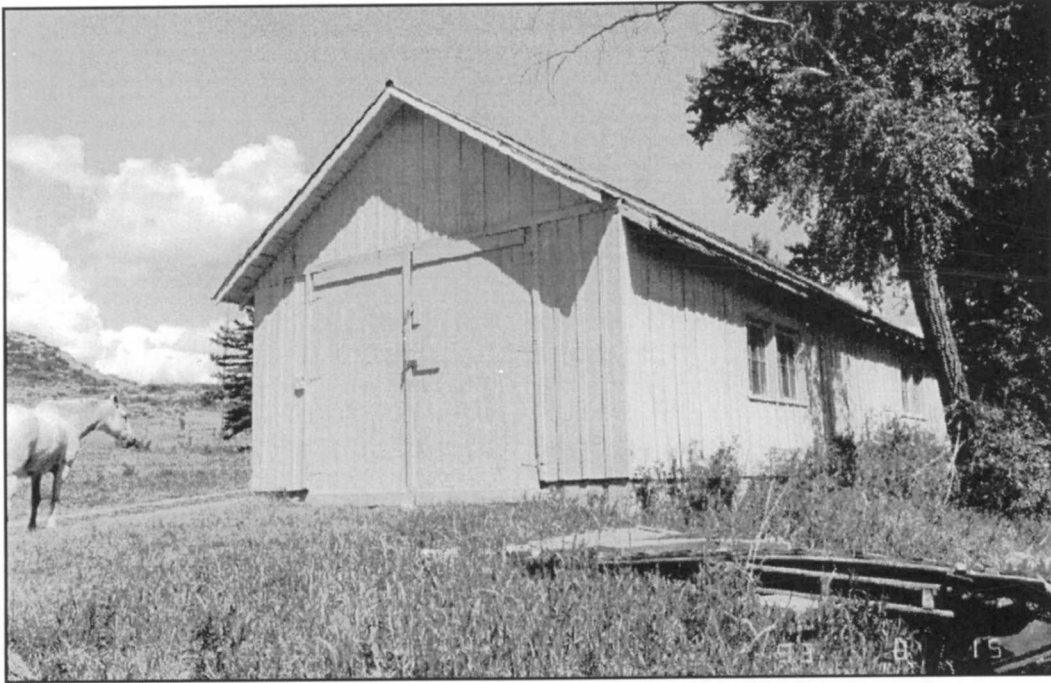
**Figure 61**

*Statement of Significance.* It is recommended that site 5ME6477 is not significant under criteria A or C. Only one building of the original five associated with this site is extant. This remaining equipment shed is not particularly representative of the Rustic-styled architecture of the USFS, nor of the administrative development of the Forest Service within Colorado.

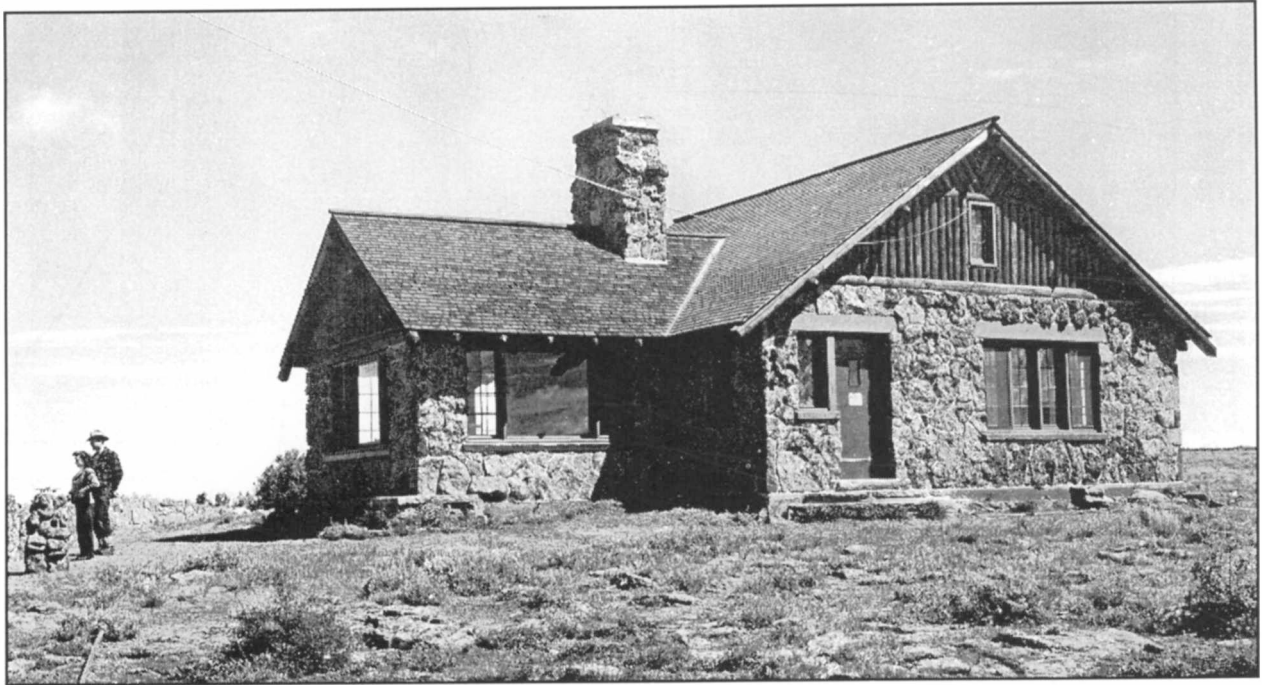
**Figure 62**  
Land's End Shelterhouse  
and Observatory

*Statement of Significance.* It is recommended that site 5ME4936 is significant under criteria A and C. The site is a very well preserved example of the USFS recreational development of the Grand Mesa National Forest. Its unique observatory and latrine are definitive representations of the USFS Rustic Style of recreational architecture developed during the Depression. Their exteriors and interiors are thoroughly detailed and remain intact. Custom Forest Service furniture designed for the observatory is preserved on site.

Construction of recreational improvements accelerated during Phase III. CCC enrollees constructed a variety of sites and buildings, including the Land's End Observatory (Figure 62, Grand Mesa National Forest), Tigiwon Community House (Figure 40), Notch Mountain Shelterhouse (Figure 176, White River National Forest) and campground toilets (e.g., Figure 98, Rio Grande

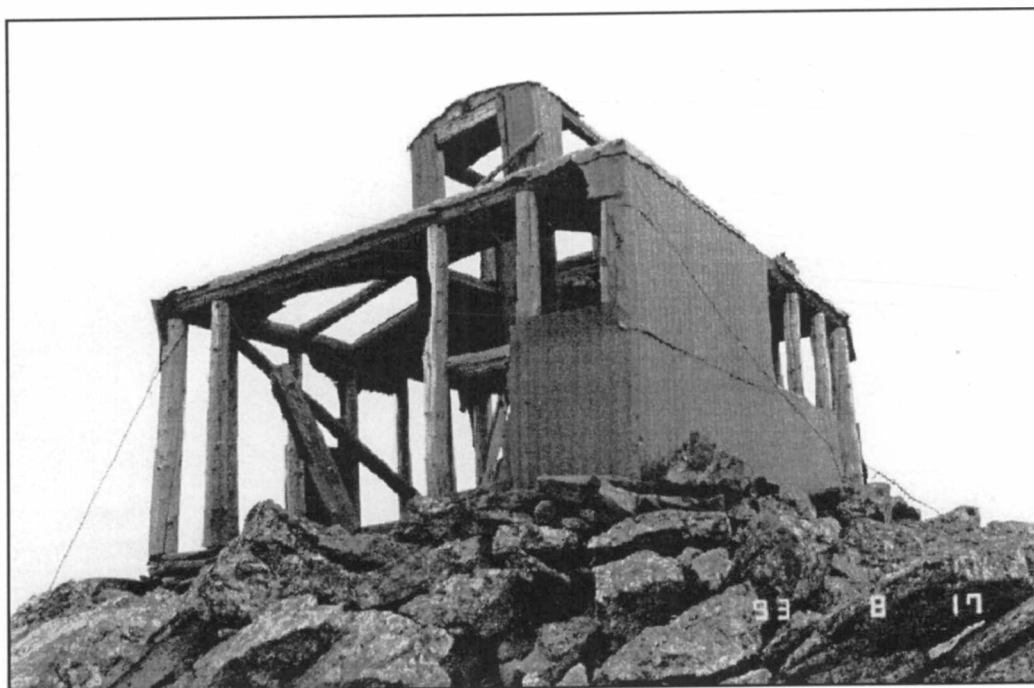
**Figure 63**

*Statement of Significance.* It is recommended that site 5ME864 is significant under criteria A and C. The lookout was utilized by the Grand Mesa National Forest for fire suppression and is representative of the USFS's early mission of protection and conservation. It is the only extant log "Cupola Cabin" type structure in Colorado, and one of the oldest in the nation. The mortise and tenon construction method is unique among the remaining USFS lookouts in Colorado. Though deteriorated, the log structure is intact, as is some of its metal siding. It was the only manned fire lookout ever built on the Grand Mesa National Forest.

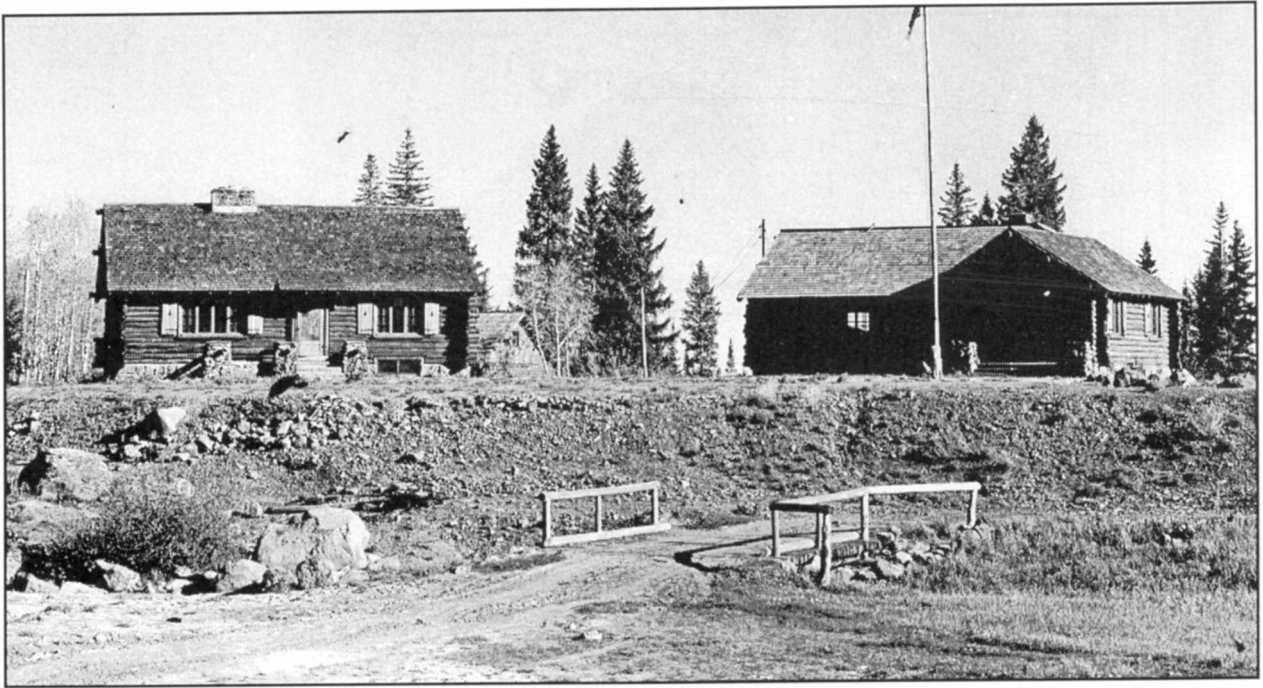
**Figure 64**  
Mesa Lakes Ranger Station  
Photo by Higgins

*Statement of Significance.* It is recommended that site 5ME7369 is significant under criteria A and C. The site is associated with the recreational and administrative development of the Grand Mesa National Forest and is a very well preserved example of CCC construction. The site displays classic USFS layout characteristics and is one of the best examples of a CCC-era rural ranger station in Colorado.

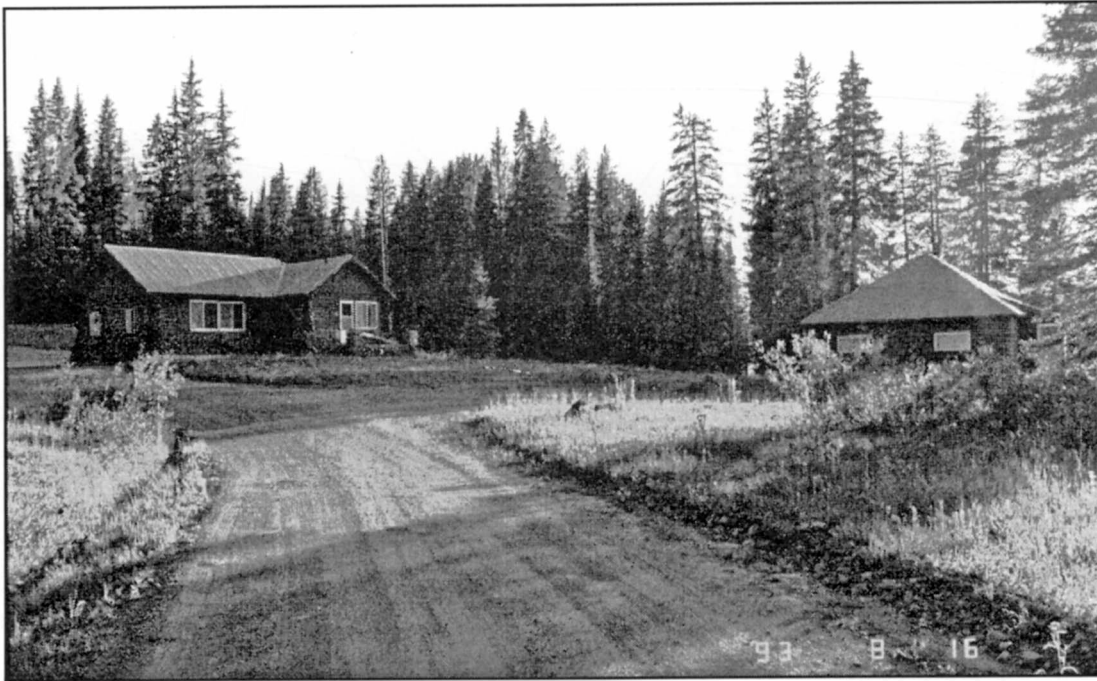
**Figure 65**

*Statement of Significance.* It is recommended that site 5DT99 is significant under criteria A and C. It is associated with the recreational and administrative development of the Grand Mesa National Forest and with the work of the CCC. Architecturally, the complex represents several eras of USFS design that reflect the evolution of the USFS Rustic Style philosophy of harmony, simplicity, and use of the land.

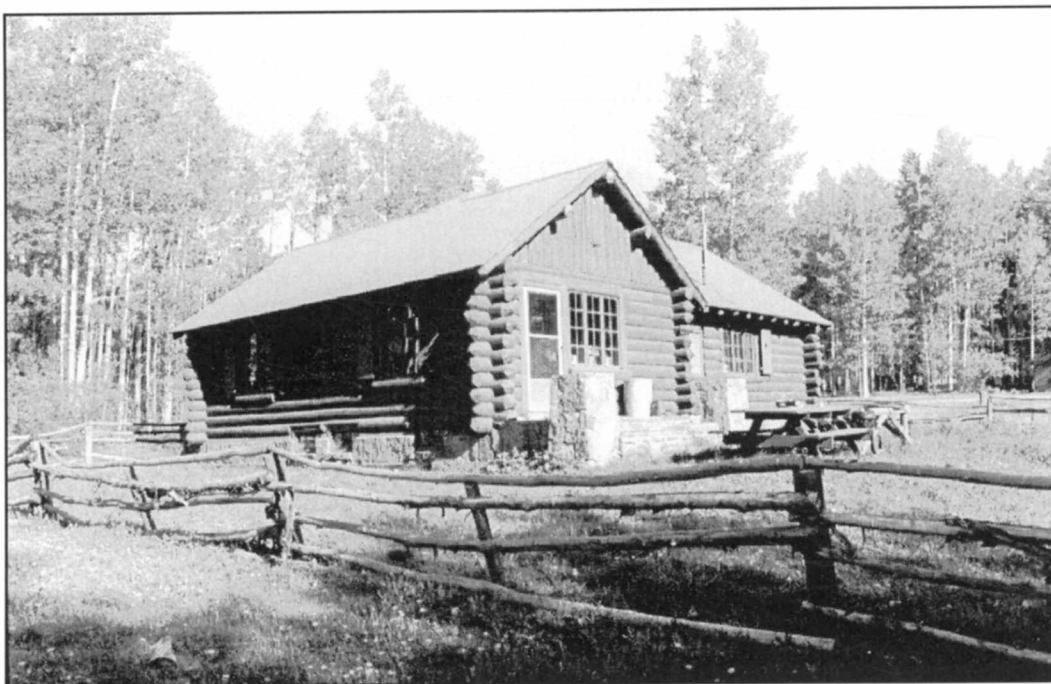
**Figure 66**

*Statement of Significance.* It is recommended that site 5SM1299 is not significant under criteria A or C. Though associated with the development and administration of the Uncompahgre National Forest, this site's buildings have been heavily modified and no longer retain their integrity of design, function, or construction.

For the administration of the grazing, a summer camp should be established on the Beaver Park Station [now Lone Cone Guard Station; see Figure 66, Uncompahgre National Forest] in Sec.26, T.42N., R.12W. This station is located in the heart of the summer grazing country and the camp will be used by the ranger of District 7. It will also be the summer headquarters of the ranger who occupies the Basin Creek Station in winter. A two room log house with a good shingle roof and a floor will cost approximately \$200.00. Good house logs can be obtained near the building sites, but the lumber must be hauled a distance of about 20 miles.

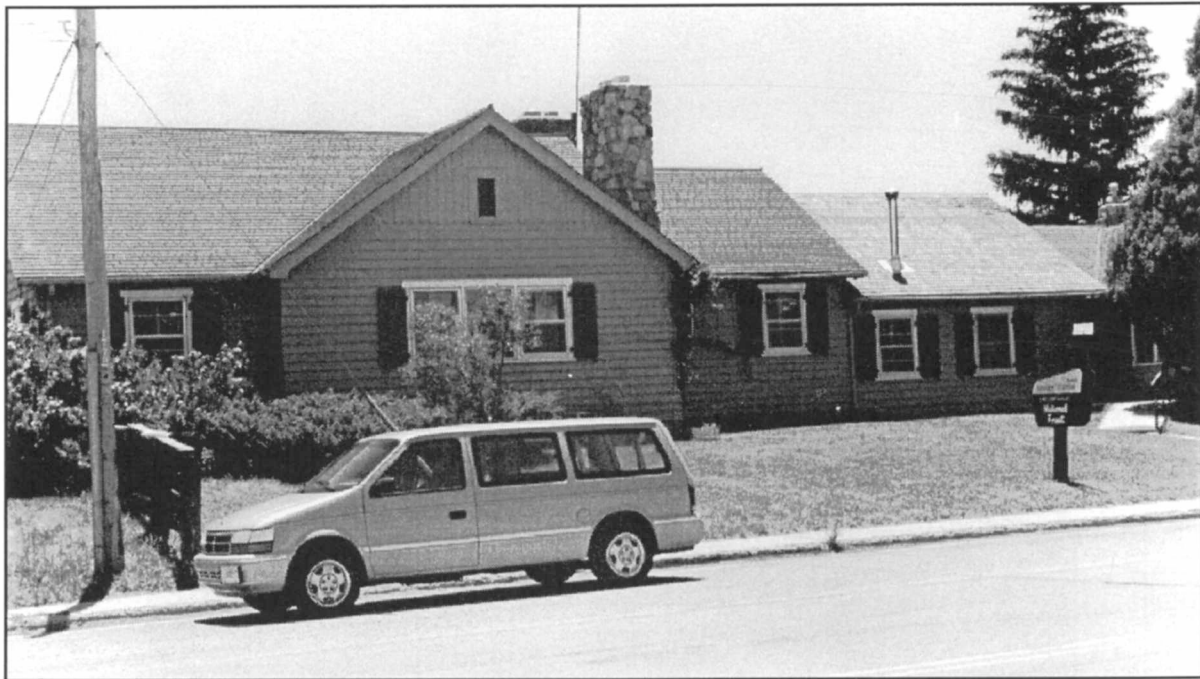
**Figure 67**

*Statement of Significance.* It is recommended that site 5SM2748 is not significant under criteria A or C. Though associated with the development and administration of the Uncompahgre National Forest, the complex is not particularly unique among CCC-era administrative sites. All buildings have been heavily modified, and the site has lost integrity of design and feeling as a complex of three buildings. Better examples of ranger stations exist in Colorado.

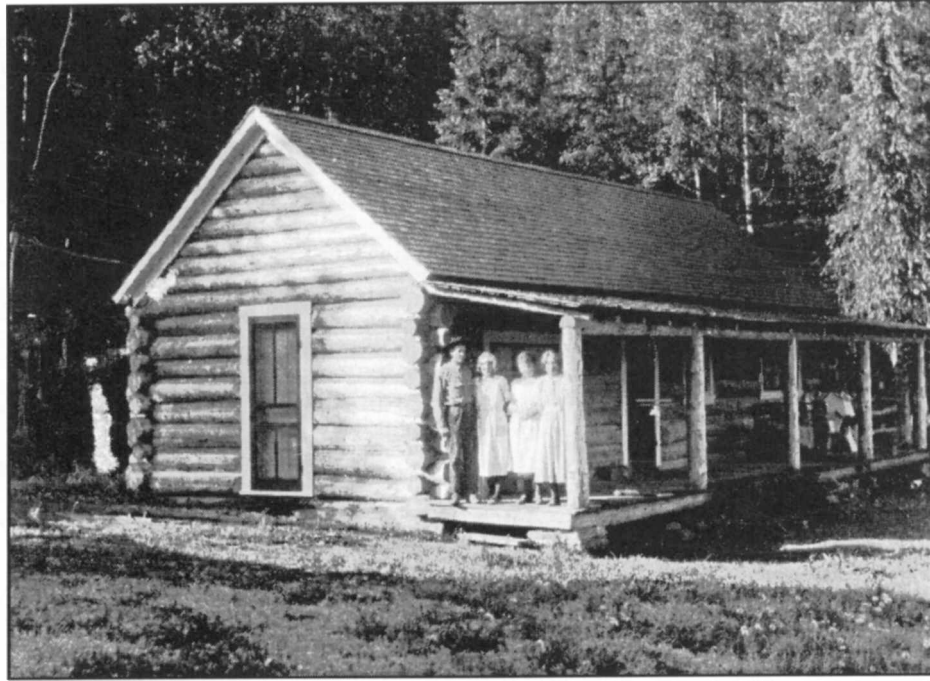
**Figure 68**

*Statement of Significance.* It is recommended that site 5GN1735 is significant under criteria A and C. The station is associated with the development and administration of the Gunnison National Forest and it has well preserved examples of pre-CCC and CCC-era construction that represent a variety of early 20th century Pioneer (pre-design) log construction techniques, using local salvaged materials. This is a good, typical example of a rural ranger station.

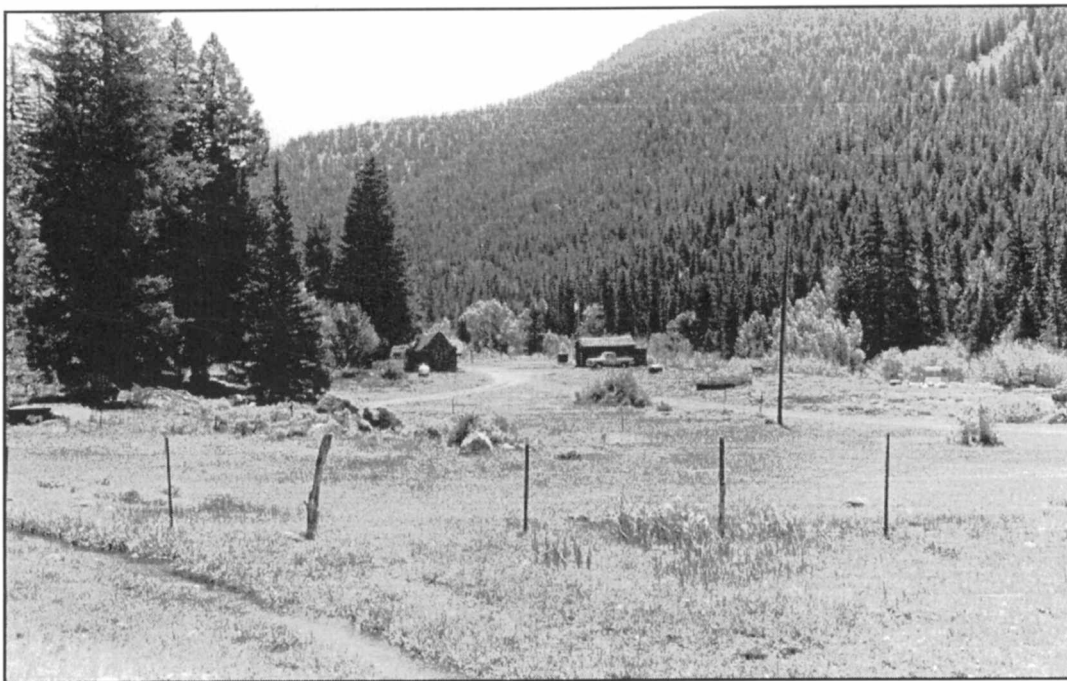
**Figure 69**

*Statement of Significance.* It is recommended that site 5GN2554 is not significant under criteria A or C. Though associated with the development and administration of the Gunnison National Forest and the work of the CCC in the area, the site has no remaining integrity as a pre-design-era ranger station. It is not particularly distinctive within the history of the Forest and is not typical of Ranger Station site layouts of any era. However, its cabin and storage building may have been former CCC Camp buildings and should be evaluated under criterion C; architecture of the CCC.

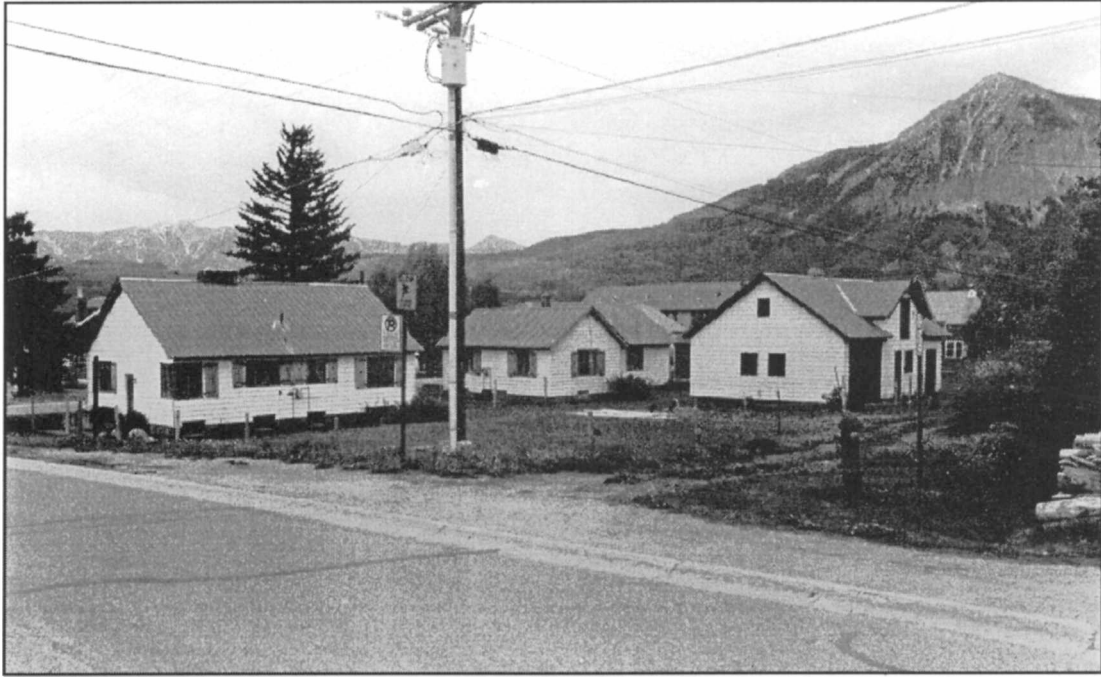
**Figure 70**  
Crested Butte Ranger Station  
View to the Northwest

*Statement of Significance.* It is recommended that site 5GN2555 is significant under criteria A and C. The site is associated with the development and administration of the Gunnison National Forest and with the craftsmanship of the CCC. Though some integrity of feeling and workmanship has been covered with siding, the original materials are most likely intact. The site retains its integrity of location, setting, design, and association as a typical USFS urban Ranger Station.

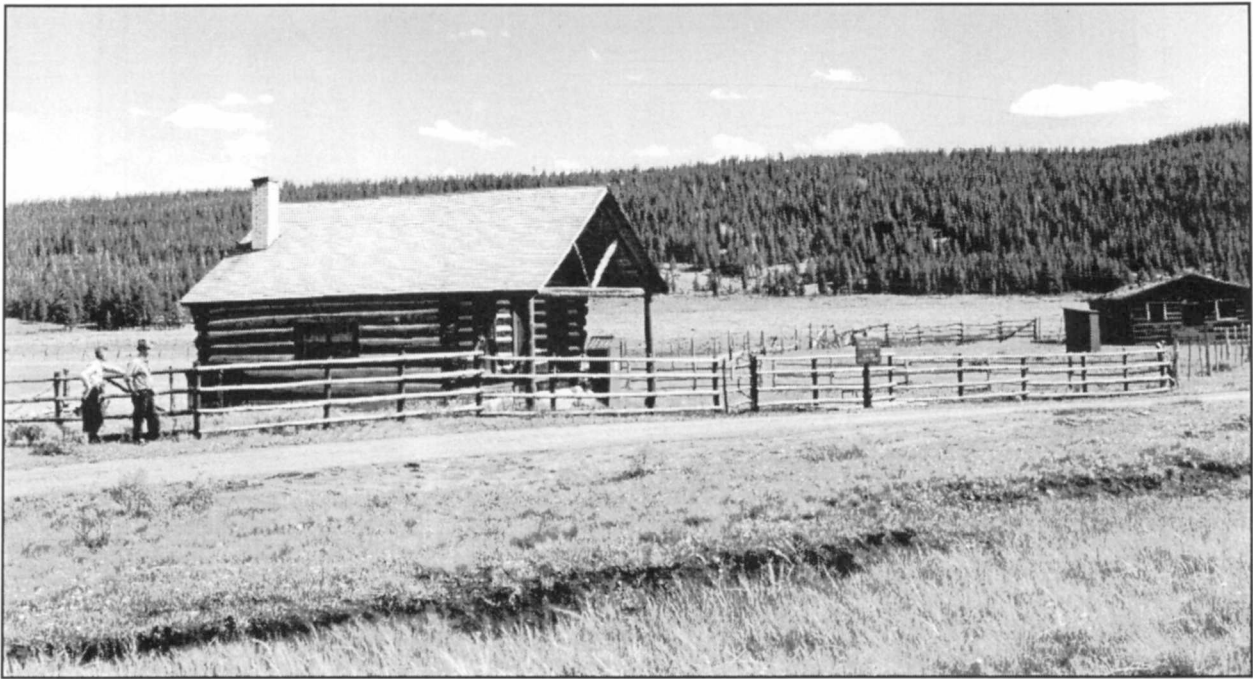
**Figure 71**  
Dorchester Guard Station

*Statement of Significance.* It is recommended that site 5GN1314 is significant under criteria A and C. Its cabin exemplifies a style associated with early mining activity and towns in Gunnison County, including the town of Dorchester. The cabin is typical of the Rocky Mountain Cabin Style with its massing, pioneer construction and porch roof. If the Ranger Station was constructed by the USFS it is also significant in its representation of the pre-design era of Forest Service administrative development.

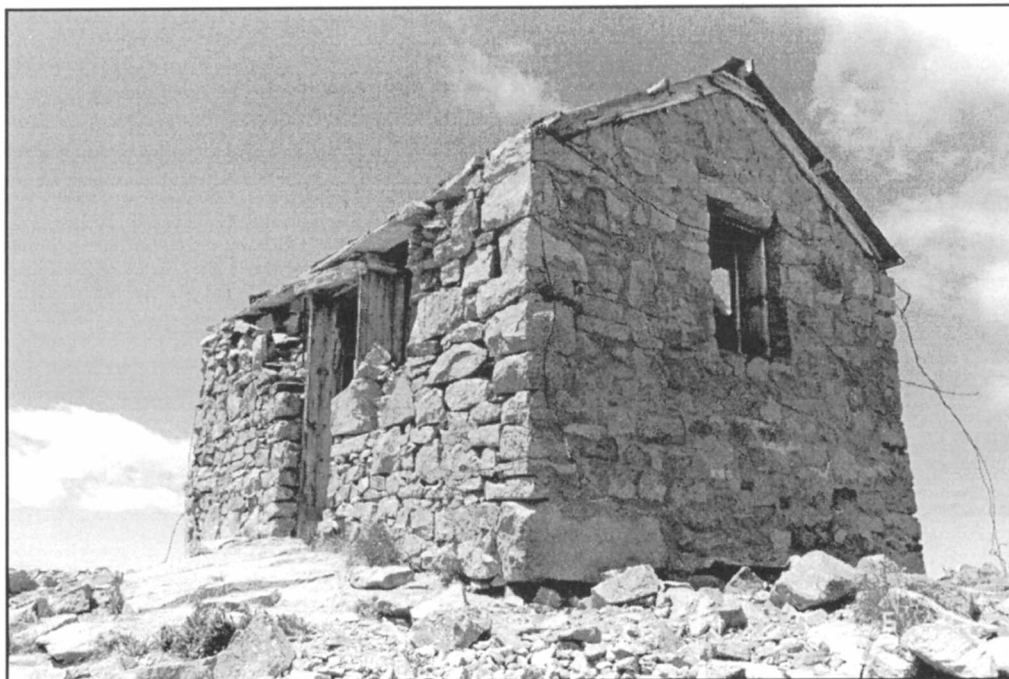
**Figure 72**

*Statement of Significance.* It is recommended that site 5GN2129 is significant under criteria A and C. The Fairview Peak Lookout was utilized by the USFS for fire suppression and is representative of the Forest Service's early mission of protection and conservation. It is architecturally representative of the pre-design era when lookouts were built primarily by rangers or citizens using locally available materials. It is one of three extant stone lookouts remaining in Colorado's National Forests, and it is the only one on the Gunnison.

Fairview Peak Lookout (Figure 72, Gunnison National Forest), a one-room cabin perched atop the rocky peak of Fairview Mountain, was built before construction of lookouts was officially funded by the Forest Service. The rectangular building likely once had a glassed-in observation cupola atop the gable roof of its one-room cabin. Its construction is of local split stone, mortared with concrete. Rough-sawn rafters support a sheet-metal roof. The rough-sawn wood framing of its windows is reinforced with metal bars anchored into the stone wall.

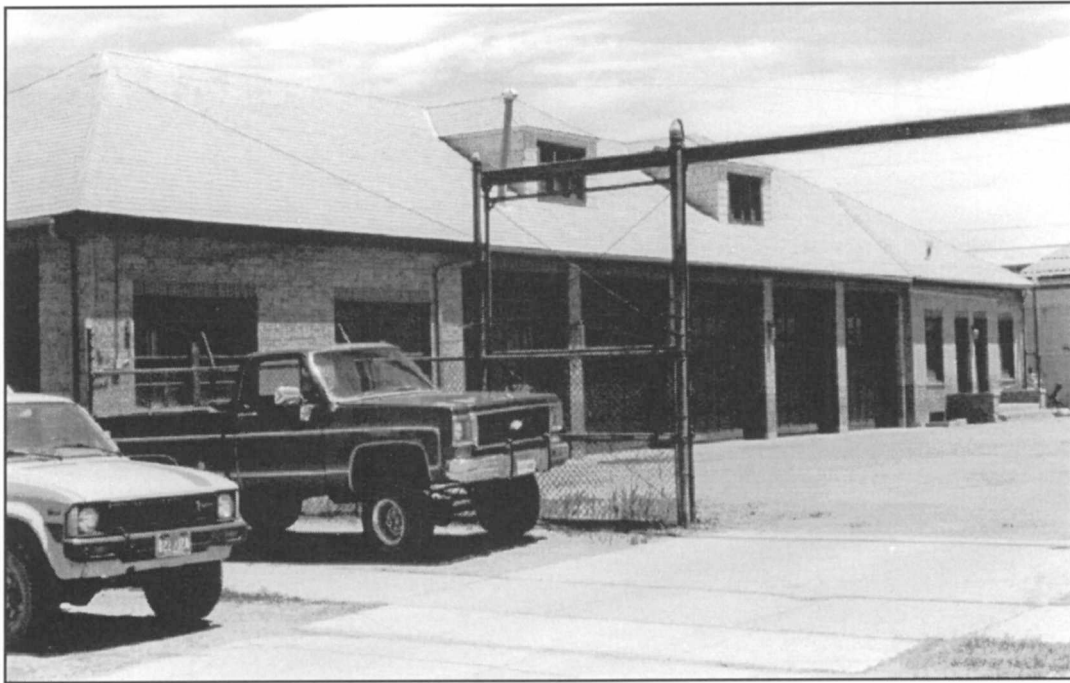
**Figure 73**  
Gunnison Garage  
View to the Northeast

*Statement of Significance.* It is recommended that site 5GN2553 is significant under criteria A and C. Though associated with the development and administration of the Gunnison National Forest the site is not the best preserved sample of its type in Colorado.

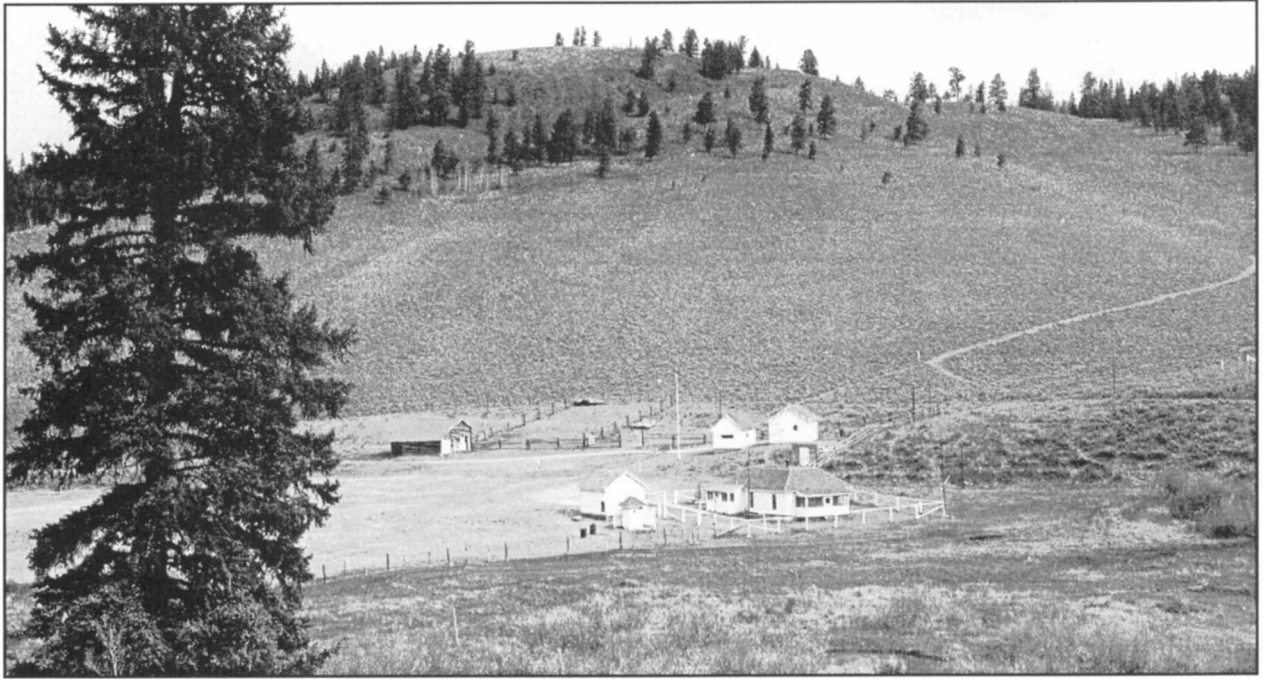
**Figure 74**  
The Long Branch Ranger Station  
Building Group Located Near Sargents, Colo.

*Statement of Significance.* It is recommended that site 5SH1471 is not significant under criteria A or C. Four of the original six buildings associated with the complex are not extant. The site has lost its integrity of feeling and design. The remaining buildings are not architecturally unique, nor do they represent the makeup of a typical Forest Service administrative site.
