# Administering the National Forests of Colorado

## An Assessment of the Architectural and Cultural Significance of Historical Administrative Properties

*Prepared for the U.S. Forest Service, Rocky Mountain Region by the  
National Park Service - Midwest Archeological Center*

1996

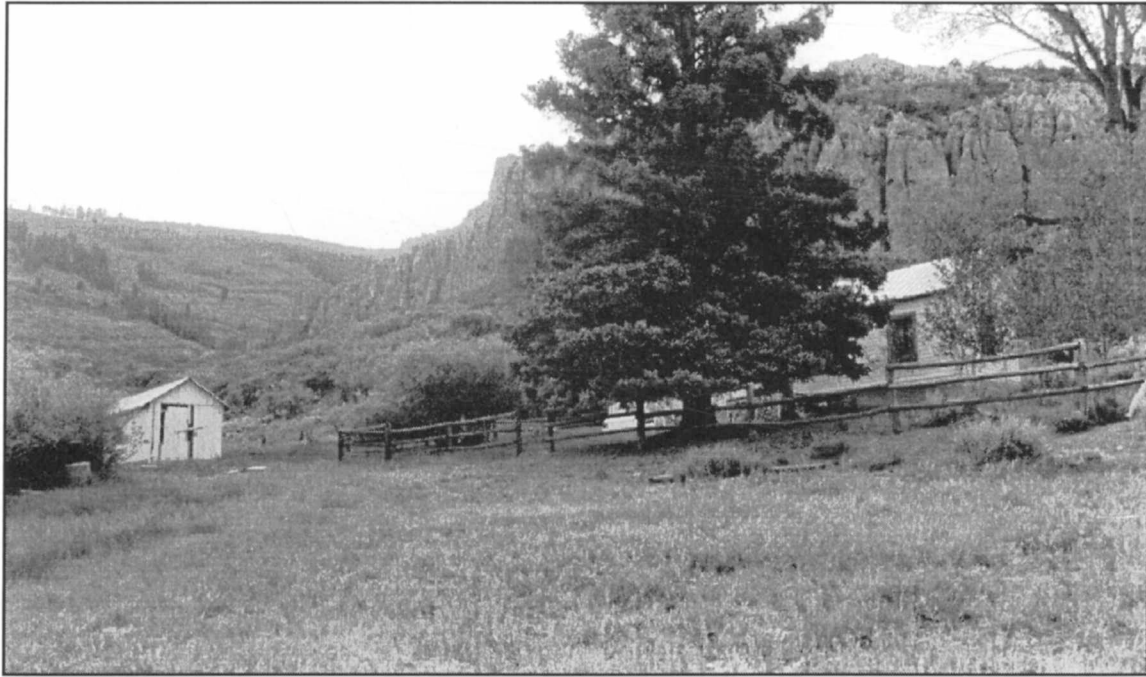
**Figure 75**  
Sapinero Ranger Station  
View to the Northwest

*Statement of Significance.* It is recommended that site 5GN2098 is not significant under criteria A or C. Both buildings have been heavily modified and are in an advanced state of deterioration. They no longer retain integrity of design, feeling, or method of construction. Better examples of ranger stations exist on the forest and in Colorado.

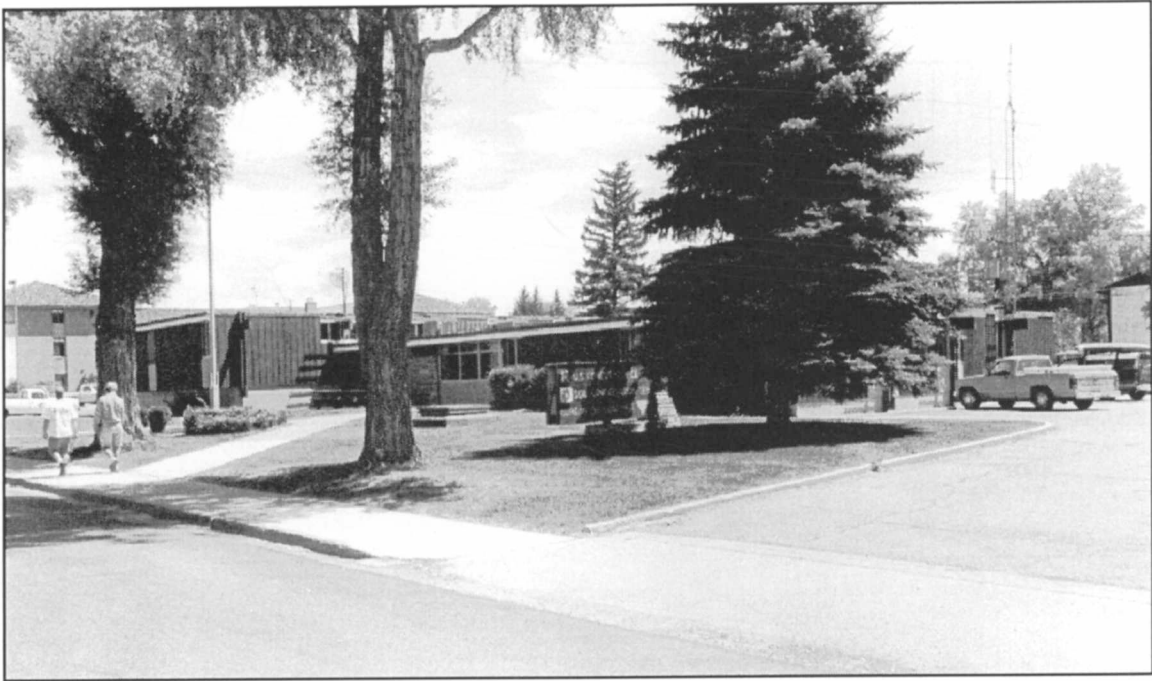
**Figure 76**  
Taylor/Cebolla Office  
View to the Northeast

*Statement of Significance.* It is recommended that site 5GN2552 is significant under criterion G. Its office building with fallout shelter is representative of how the Forest Service, as a civilian Federal agency, prepared for resource management in the event of a thermonuclear war. The building is also an excellent example of Federal architecture of the Cold War.

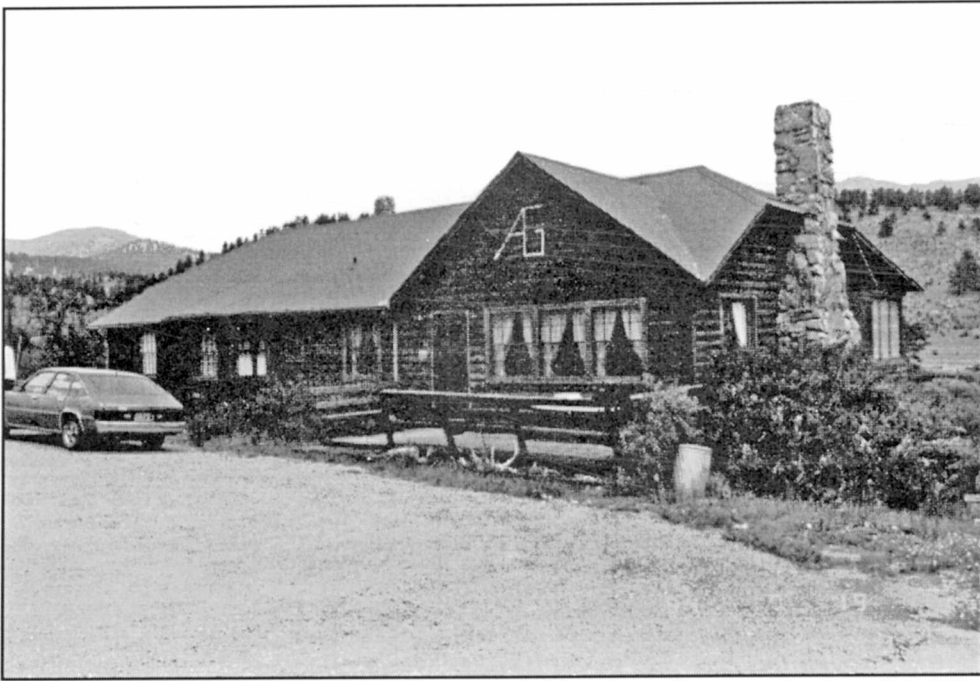
**Figure 79**

*Statement of Significance.* The log barn at site 5PA576 was officially declared individually eligible in 1980. The ranch complex was declared ineligible but has been re-evaluated under criterion G. It is recommended that the site and its buildings are significant under criterion G for their association with the Region 2 Mule Packstring, a modern symbol of the Forest Service's management of its resources, including wilderness areas.

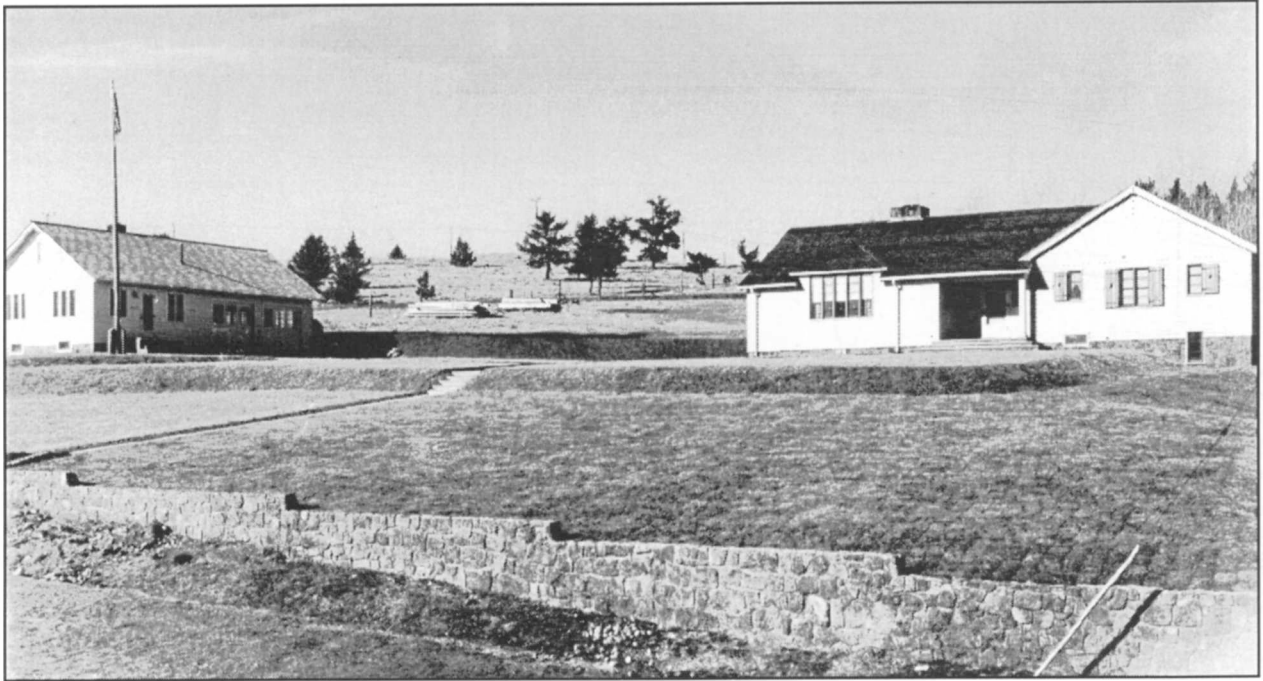
**Figure 82**  
Fairplay Ranger Station  
Residence and Administration Building

*Statement of Significance.* It is recommended that site 5PA757 is not significant under criteria A or C. It is not distinctive in its design as a rural CCC-era ranger station. The site has non-sympathetic new construction and its buildings have been significantly altered by additions, modern siding, windows and doors, resulting in a loss of integrity of design, workmanship, materials and feeling. Better examples of Rustic Style frame ranger stations exist in Colorado.

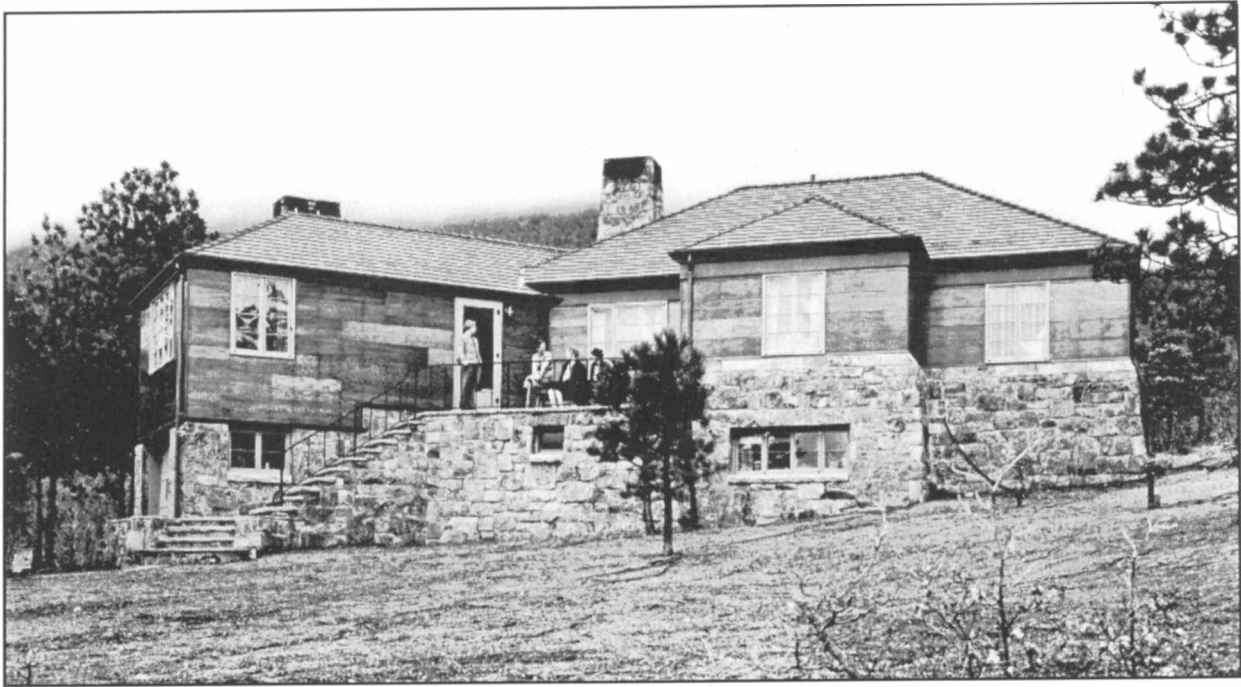
**Figure 83**  
Nurseryman's Residence  
Monument Nursery/Ranger Stations

*Statement of Significance.* It is recommended that site 5EP2214 is significant under criteria A and C. This site was used during the Depression to supply trees for the re-forestation of the Rocky Mountains and the reclamation of the windblown agricultural Midwestern plains. Its remaining buildings were constructed by the CCC. Their subsequent use by Hot Shot fire fighting crews and Environmental Education Center continues the site's association with the development and administration of the National Forests in Colorado.

Buildings were constructed in stone (e.g., Figure 176, White River National Forest), brick (e.g., Figure 130, San Juan National Forest), adobe (e.g., Figure 83, San Isabel National Forest), milled wood (e.g., Figure 48, Arapaho National Forest), or logs (e.g., Figure 159, White River National Forest). The use of wood as a construction material was perhaps the ultimate expression of Forest Service values, and designers took every opportunity to use it. Though the cost of most building materials was depressed, wood was especially cheap, easy to work with, readily available, and reflected the pioneer architectural traditions of Rocky Mountain architecture. The Rustic Style was especially appropriate in the mountains, where wood shakes, native stone, and logs were the most economical materials available. Doors, windows, shutters, porch railings, interior walls, ceilings, and floors were all wood (Groben 1938:47). The Government-sponsored New Deal programs were encouraged to use commercially available materials as a stimulus to production. Forests purchased construction materials locally, through a central purchasing arrangement with the Regional Office, and sometimes directly from a mill under Forest permit. Processed wood products like Plywood, Compo Board, Celotex, and Nu-Wood were used extensively for interior finishes. Door and window hardware was purchased or fabricated by Forest Service or CCC shops. Most of the purchased material was local, but Forests occasionally imported logs, stone, and log cabin siding from nearby states. Native pine, spruce, and fir were not ideal species for log construction, but worked well enough to use. The tall slender trees gave distinction to Regional construction in Colorado. The use of brick as a finish material was discouraged by Groben, mainly because of the skill required to use it (Groben 1938:10). Region 2 used it regardless, both as a finish material on supervisors' warehouses and as infrastructure on stuccoed Pueblo-style buildings.

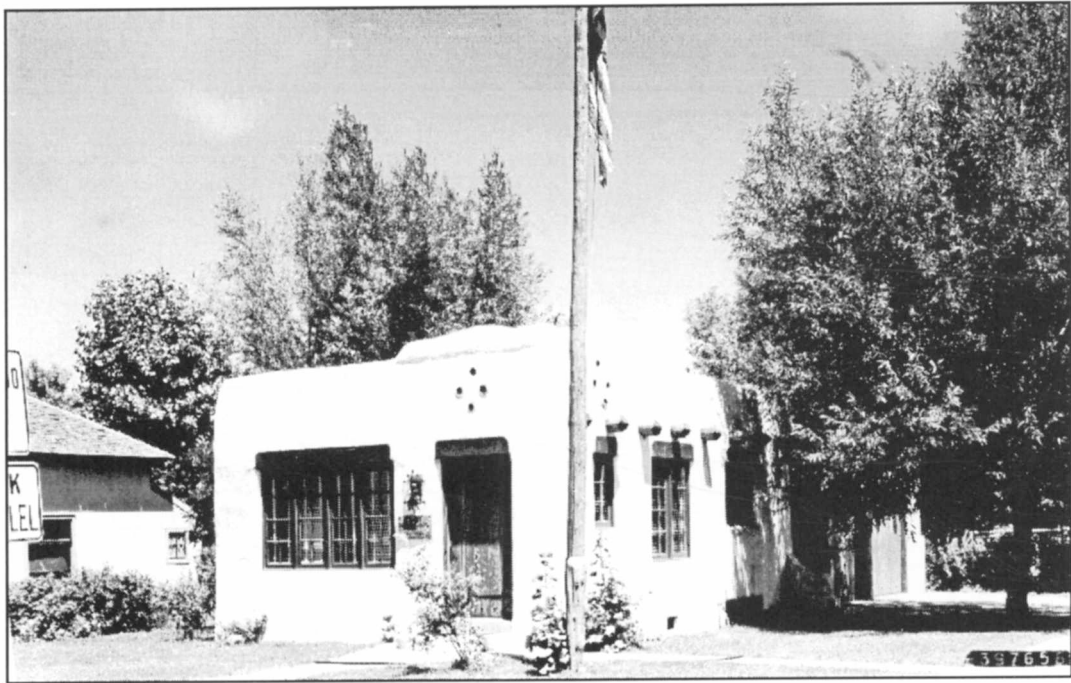
**Figure 84**  
Office, District Ranger  
San Isabel National Forest

*Statement of Significance.* Although this office building has suffered significant losses of integrity, it still remains recognizable as a CCC-era USFS Ranger District Office. It is significant for its association with the development and administration of the San Isabel National Forest, and as the only known remaining USFS-built and -owned adobe administration building in Colorado.

La Veta Ranger Station (Figure 84, San Isabel National Forest). It utilized 12"-wide adobe blocks salvaged from several area buildings, including the former Popul Vuh Ranger Station near La Veta (Stahl 1934). The blocks sat on a poured-concrete foundation which ended at ground level. Later designs produced by the Architectural Division imitated the adobe look by using hand-troweled Portland cement stucco over brick walls. Their low-slung appearance was reinforced by heavy wood window and door lintels and horizontal window panes. Buildings were painted a cream or light yellow color.

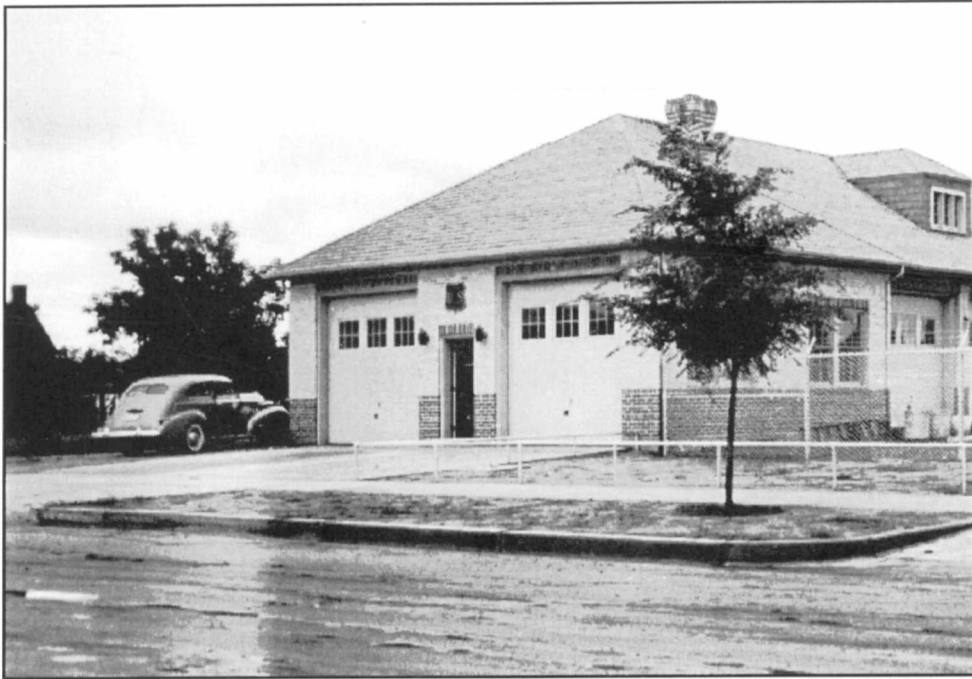
**Figure 85**  
Colorado Springs Garage  
Pike National Forest

*Statement of Significance.* It is recommended that site 5EP995 is not significant under criteria A or C. Although the garage is still recognizable as a USFS administration building, it has undergone major renovations. All vehicular doors that identify the garage/shop function have been removed, and the interior has been gutted. The structure has lost its integrity of design and materials. Three similar garages, all more intact, remain in Colorado.

Springs (Figure 85, Pike National Forest) came from lumber salvaged from several former buildings on the site. The use of salvaged materials was a practice common to every phase.

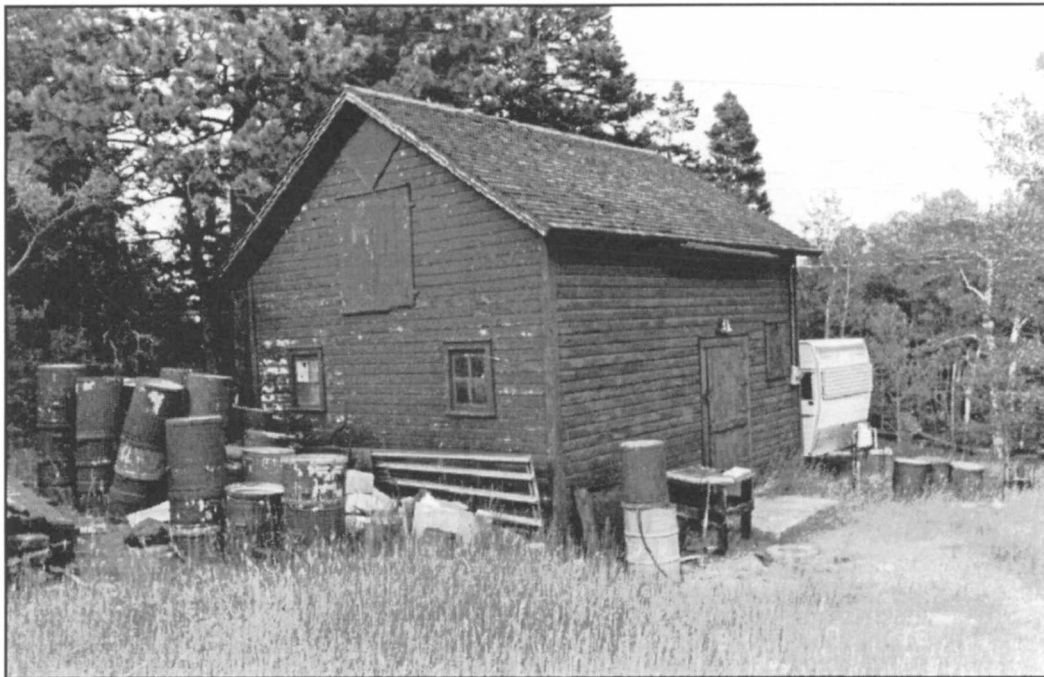
**Figure 87**

*Statement of Significance.* It is recommended that site 5HF1176 is not significant under criteria A or C. Though recently associated with the development and administration of the San Isabel National Forest, this site and barn, used as a storage and work area for Forest Service crews, is of no particular architectural or cultural distinction or significance.

Alvarado Barn  
View to the Northeast

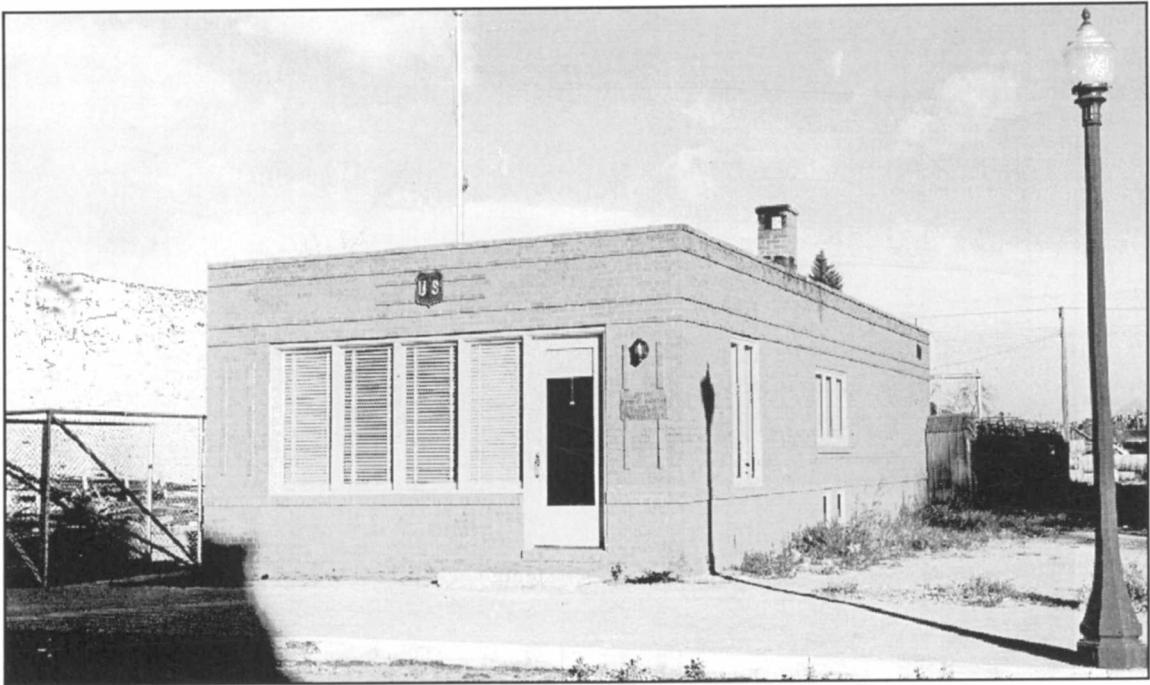
**Figure 90**  
Cochetopa National Forest  
US Forest Ranger's Office Building, Buena Vista

*Statement of Significance.* It is recommended that site 5CF828 is significant under criteria A and C. Its location makes it a prominent example of the Forest Service's presence within the community. It is unique in its Main Street site location and the commercial storefront layout of its office building. It is also one of less than six known Art Deco Style designs produced by Region 2, and the only District Office constructed on a commercial lot in Colorado.

Several supervisors' warehouses, including the Animas District Office (Figure 130, San Juan National Forest) and one combination office building at Buena Vista (Figure 90, San Isabel National Forest) were designed in the Art Deco Style. These were most likely influenced by Charles Jaka (Note 2). Their brick detailing is identical to that of Jaka's landmark Art Deco buildings at 1601 and 1611 Grape Street in Denver. Characteristic elements included fluting (small stepbacks in the brickwork) near the fenestration and doors, and strong vertical and horizontal elements. They appeared only in urban environments.

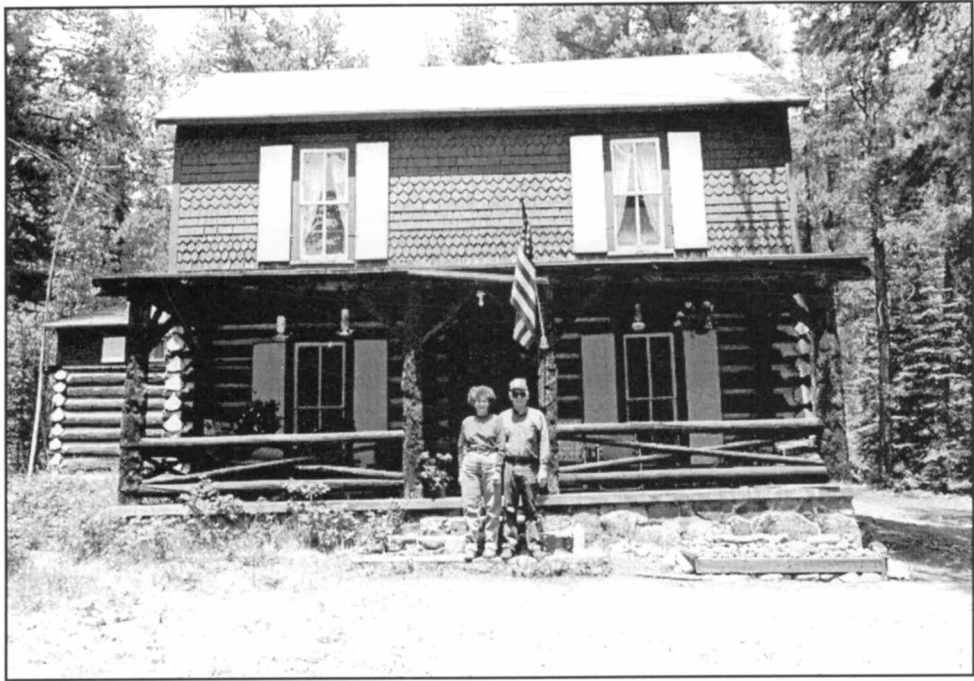
**Figure 92**  
Iron City Cabin  
View to the Northwest

*Statement of Significance.* It is recommended that site 5CF170 is significant under criteria A and C. The site has a building that is the last remaining building from the Iron City mining camp. The building is an excellent example of combination log and frame construction. The various additions are themselves historic and document a pattern of use and reuse typical in Colorado mountain architecture.

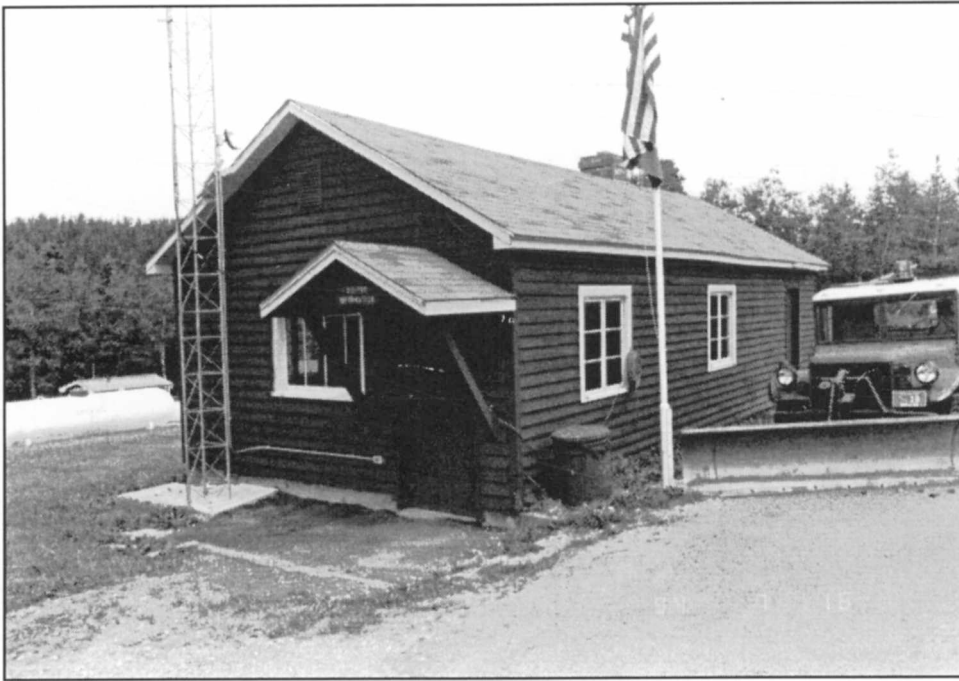
**Figure 93**  
Lake Isabel Work Center  
View to the Southwest

*Statement of Significance.* It is recommended that site 5PE1754 is not significant under criteria A or C. The office is the only building on this site old enough to be considered for eligibility. It has been moved and extensively modified and is not particularly representative of Forest Service design or construction. The office no longer retains the integrity of location, design, or materials, nor is it significant to the administrative history of the Forest Service.

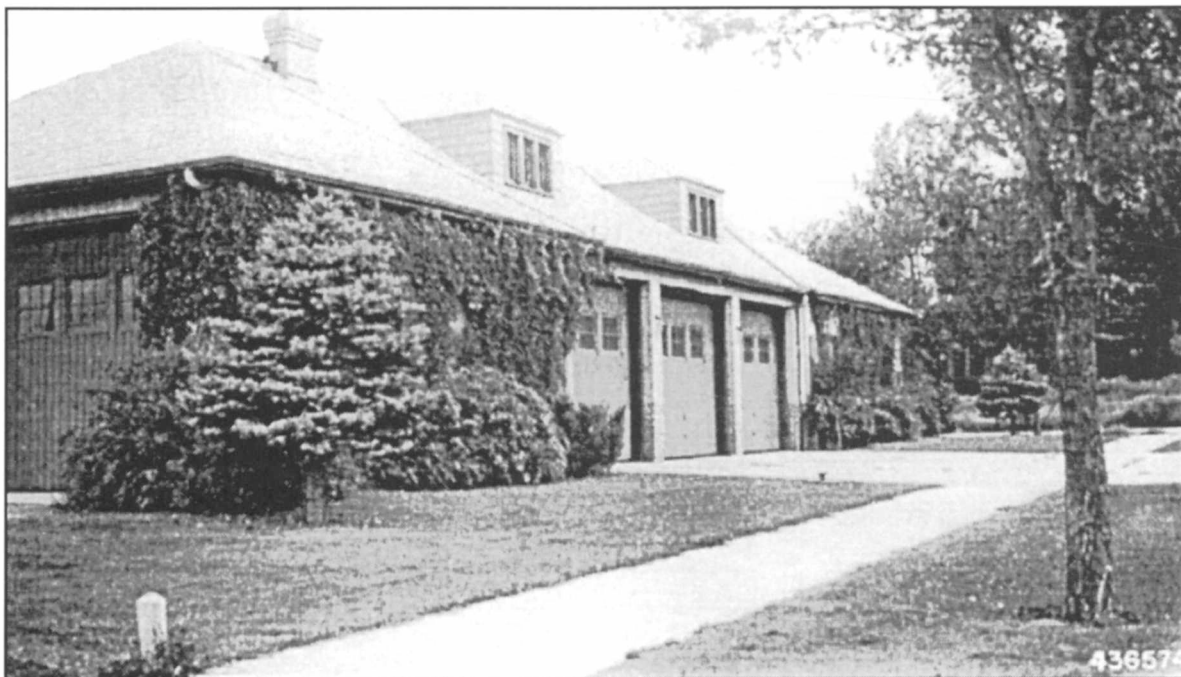
**Figure 94**  
Pueblo Warehouse  
San Isabel National Forest

*Statement of Significance.* It is recommended that site 5PE2126 is not significant under criteria A and C. Though associated with the development and administration of the San Isabel National Forest. Three similar garages on other forests are more intact and are better representative of CCC-era Rustic design and construction.

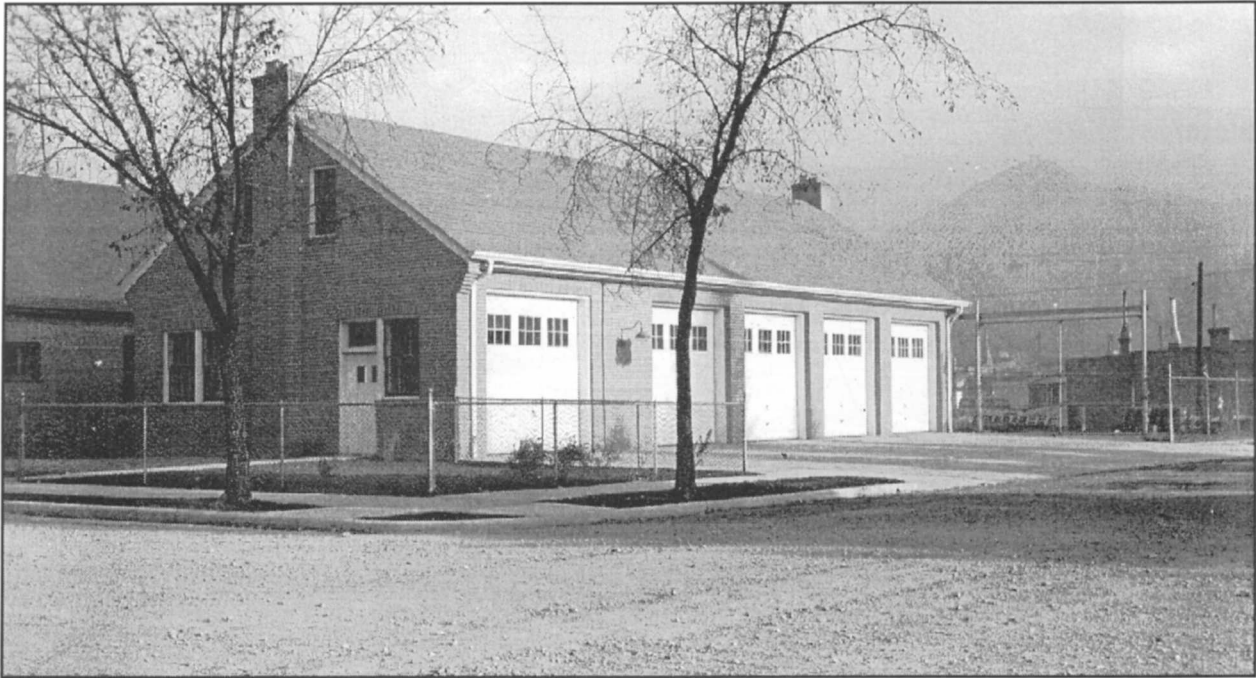
**Figure 95**

Cochetopa Warehouse and Garage  
at Salida, Colorado

*Statement of Significance.* It is recommended that site 5CF827 is not significant under Criteria A or C. Though associated with the development and administration of the San Isabel National Forest, the garage is not the most masterfully designed nor the best preserved Forest Service CCC-era brick warehouse structure in Colorado.

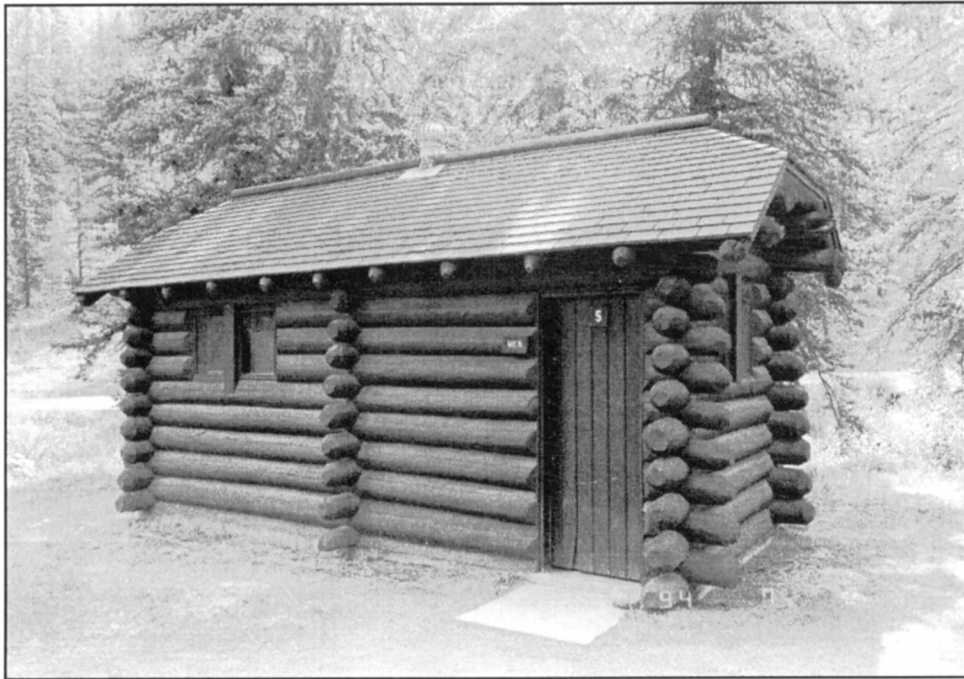
**Figure 98**

Beaver Creek Campground Toilet  
View to the Northeast

*Statement of Significance.* It is recommended that site 5RN518 is significant under criteria A and C. It is the only in situ four-hole toilet of its kind on the Rio Grande National Forest, and it is representative of the role the CCC played in the recreational development of Colorado's National Forests. It exhibits a high degree of hand craftsmanship and retains a great deal of its integrity.

Construction of recreational improvements accelerated during Phase III. CCC enrollees constructed a variety of sites and buildings, including the Land's End Observatory (Figure 62, Grand Mesa National Forest), Tigiwon Community House (Figure 40), Notch Mountain Shelterhouse (Figure 176, White River National Forest) and campground toilets (e.g., Figure 98, Rio Grande

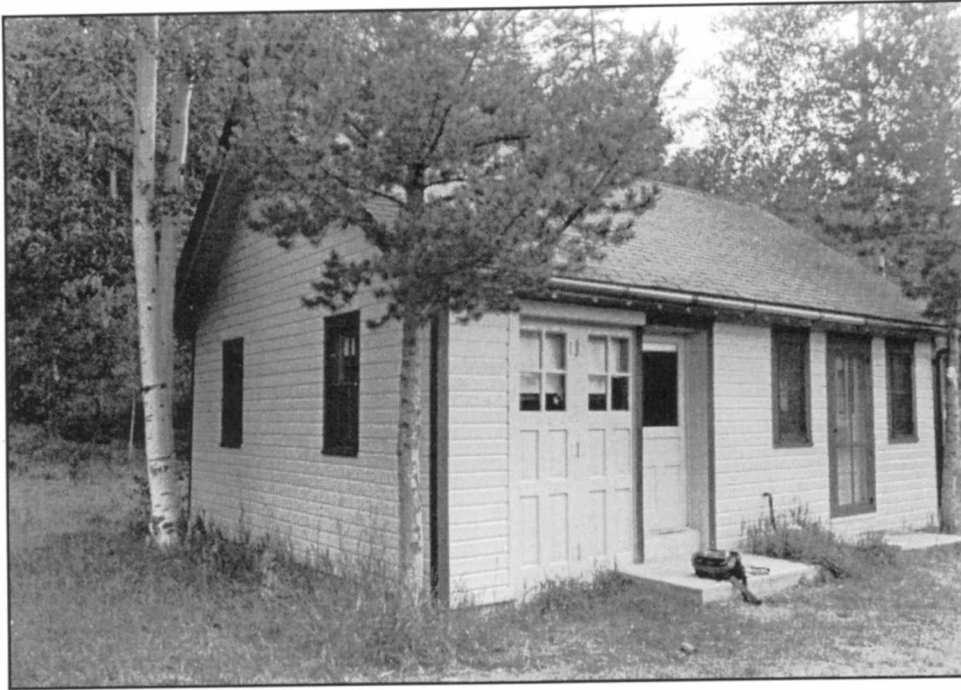
**Figure 99**

Brewery Creek Guard Station  
View to the Southwest

*Statement of Significance.* It is recommended that the combination building at site 5SH1470 is significant under criteria A and C. It is associated with the development and administration of the Rio Grande National Forest. Though modified to accommodate new use, it retains its identity as a pre-CCC-era USFS administrative building. It is the only example of an M20 type building still within Colorado Forest Service lands. Its site has lost integrity as a rural guard station, and is not significant under criteria A or C.

Construction was based upon standardized or "Series" plans produced by the Forests, Region, or National Office of Engineering. Formally designed building plans were rectangular and single storied. Guard buildings (e.g., Brewery Creek Guard Station, Figure 99, Rio Grande National Forest) had two or three principal rooms, and a single-stall garage/barn. Dwellings included one or two bedrooms, a kitchen, bathroom, and living room (e.g., Lost Creek Ranger Station, Figure 168, White River National Forest). Some had basements or cellars, often used for the furnace or storage. Single-stall garages (e.g., Thompson Creek Ranger Station, Figure 181, White River National Forest) were never attached to dwellings. Barns (e.g., River Springs Work Center Barn, Figure 108, Rio Grande National Forest) were rectangular, sometimes with lofts.

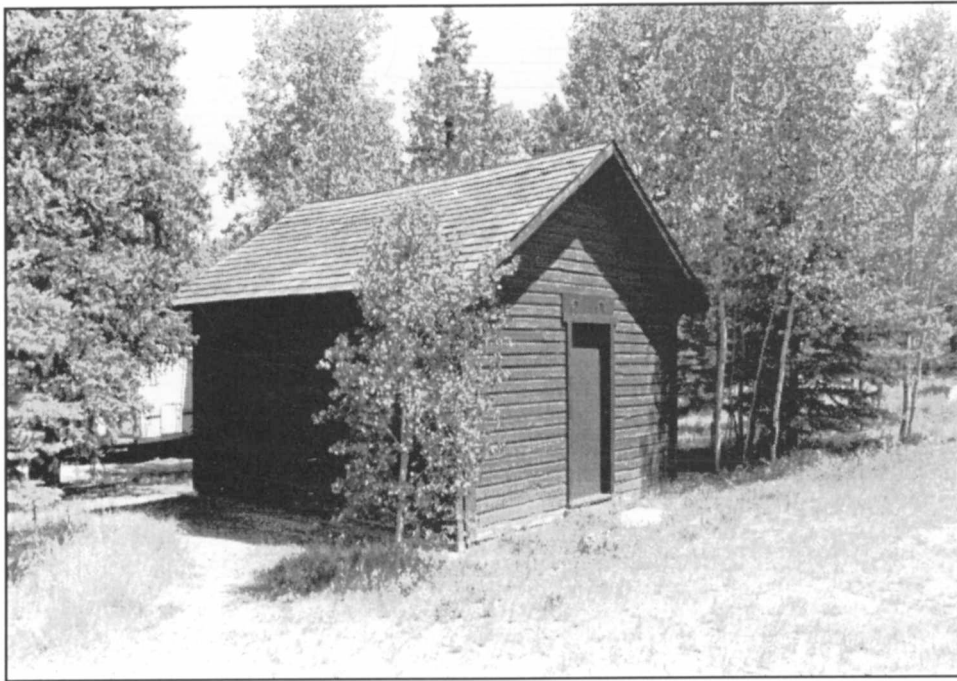
**Figure 100**

Bristol View Work Center  
View to the Southwest

*Statement of Significance.* It is recommended that site 5HN280 is not significant under criteria A or C. The site has lost its integrity as a Ranger Station due to the removal or deterioration of its buildings. The site was determined ineligible by the Colorado State Historic Preservation Office in 1988.

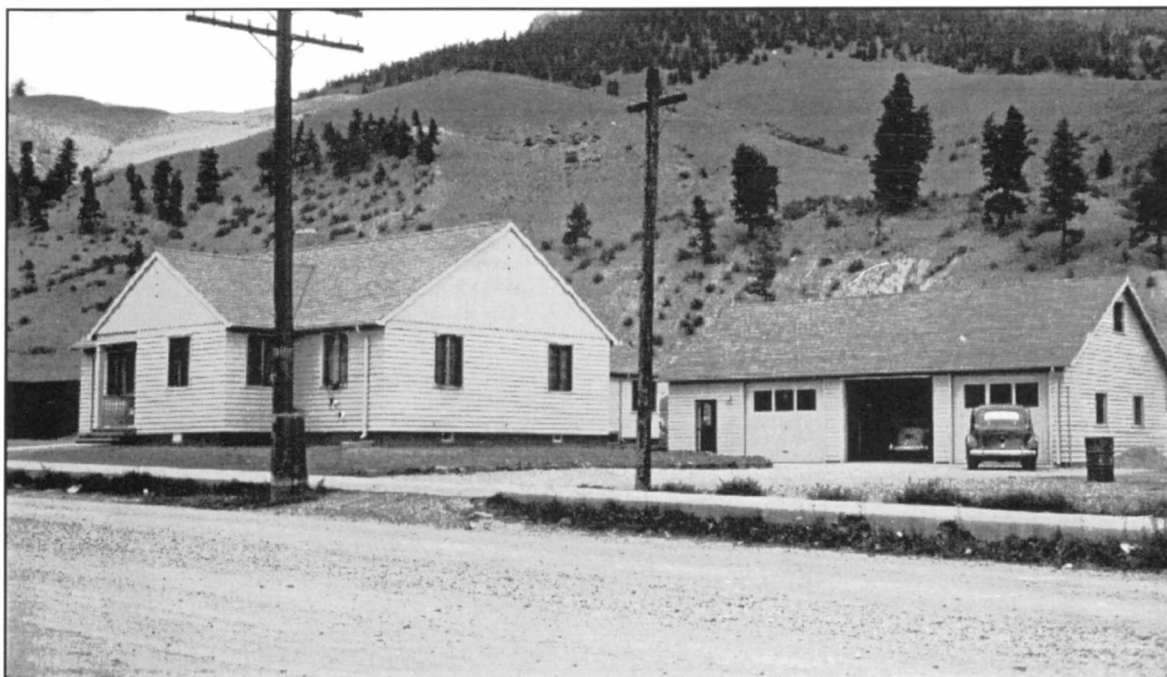
**Figure 101**

Creede Ranger Station  
View to the Northwest

*Statement of Significance.* It is recommended that site 5ML284 is not significant under criteria A or C. Only two of three original buildings remain. These have been heavily modified, and are no longer recognizable as two distinct CCC-era USFS administrative buildings. Determined ineligible by the Colorado State Historic Preservation Office in 1992.

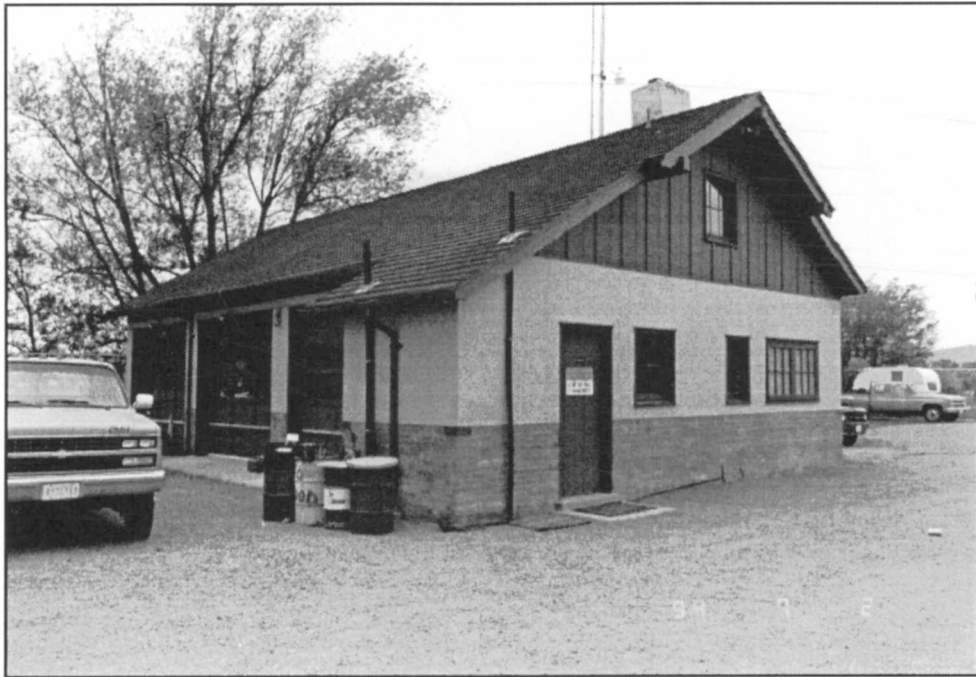
**Figure 102**

Del Norte District Office  
View to the West Northwest

*Statement of Significance.* It is recommended that site 5RN472 is not significant under criteria A or C. The site has lost integrity as a Ranger Station due to the removal of several buildings. The remaining buildings are not typical of R2 design, nor are they unique within the Rocky Mountain Region. Both buildings have suffered some loss of integrity of materials and design.

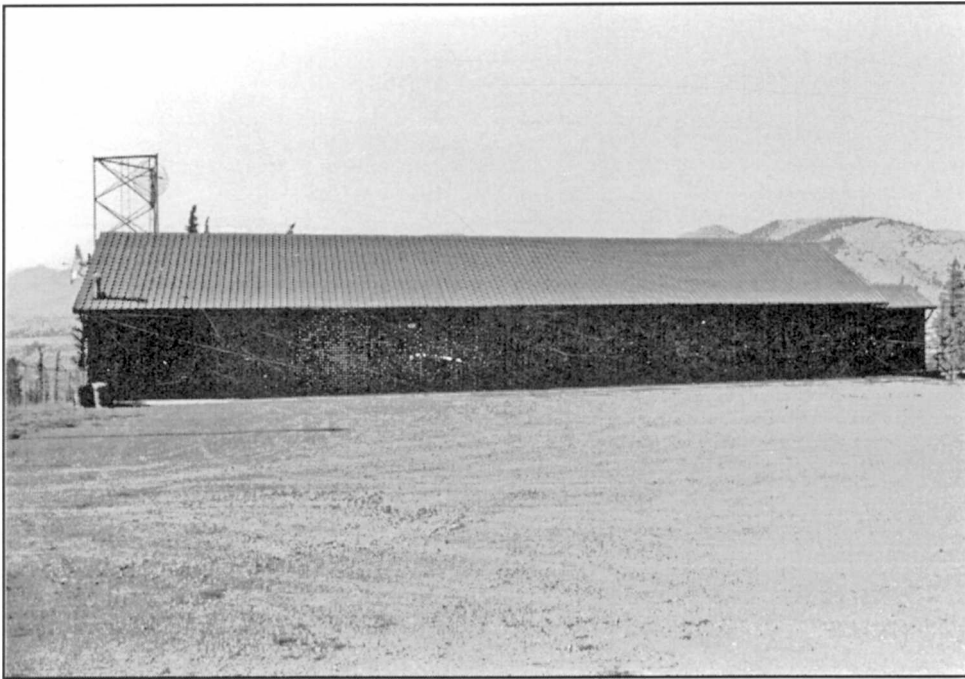
**Figure 103**

East Bench Administrative Site  
View to the North and Northeast

*Statement of Significance.* It is recommended that site 5ML285 is not significant under criteria A or C. The only part of the site currently old enough to be considered for the National Register is the garage, which was moved onto the site in 1982 from the nearby Creede Ranger Station. This garage has been heavily modified and has lost all integrity of style as a three-stall CCC-era USFS garage.

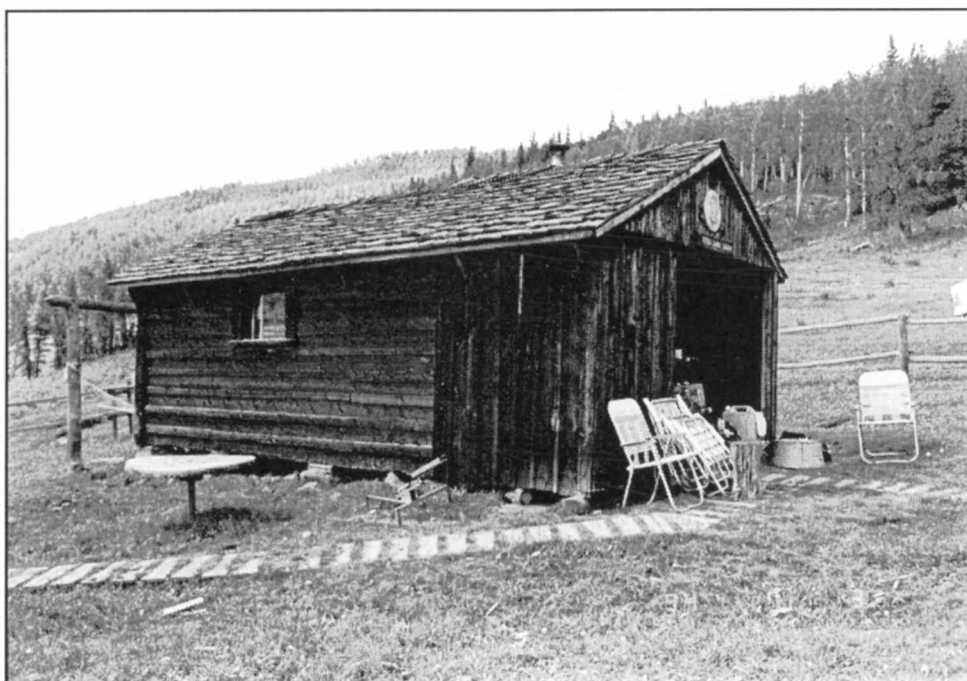
**Figure 104**

Fitton Guard Station Cabin  
View to the Northwest

*Statement of Significance.* It is recommended that site 5RN314 is significant under criteria A and C. The site overall is representative of a pre-design era Region 2 USFS guard station, and is the oldest administrative site on the Rio Grande National Forest. The cabin exhibits many characteristics of, and is a well preserved example of, the Rocky Mountain Cabin Style.

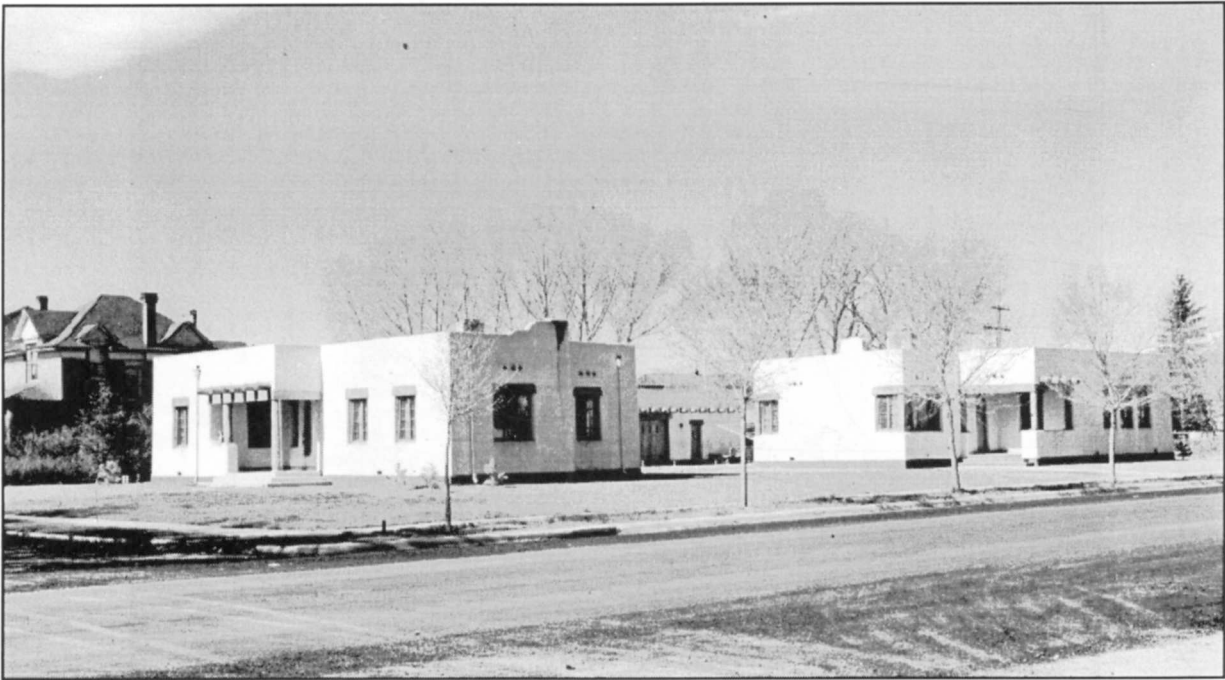
**Figure 105**

Monte Vista Supervisor's Residence  
View to the Southwest

*Statement of Significance.* It is recommended that site 5RN516 is significant under criteria A and C. This site is among the most intact Pueblo Style Forest Service complexes within Colorado, and it is the most representative Supervisor's Residence in the state. Its buildings were built by the CCC and are still highly representative of the Forest Service's interpretation of local architectural tradition. This site is a significant element within the Monte Vista Downtown Historic District.

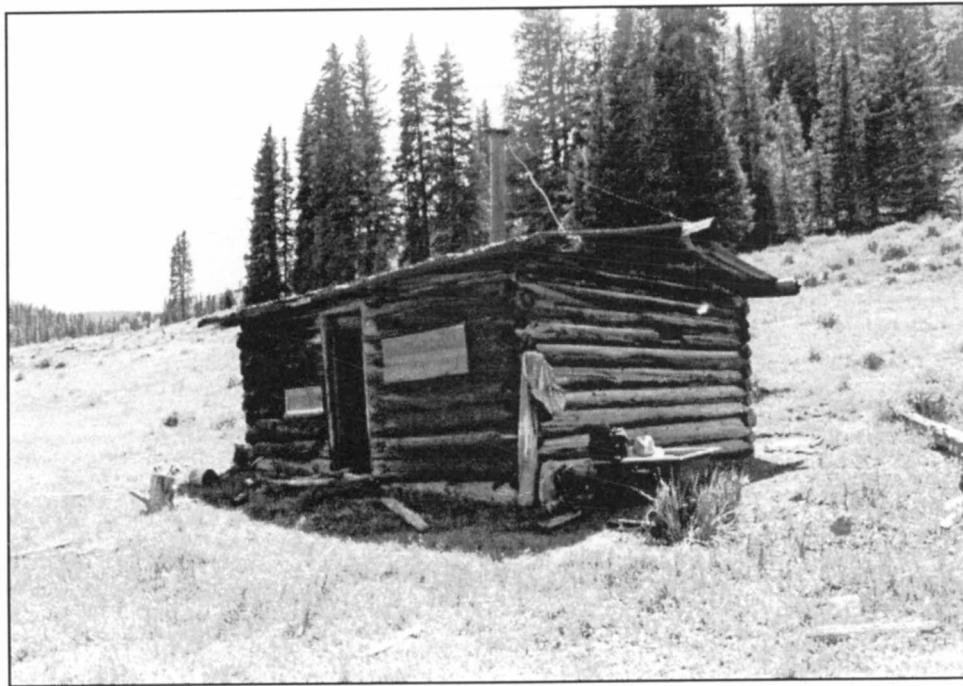
**Figure 106**

Off Cow Camp  
View to the North Northwest

*Statement of Significance.* It is recommended that site is significant under criteria A and C. The Off Cow Camp site has several elements common to a high altitude seasonal cow camp. Its buildings are in fair condition and are good examples of pioneer construction. The site was previously recommended as being eligible (Spero 1982).

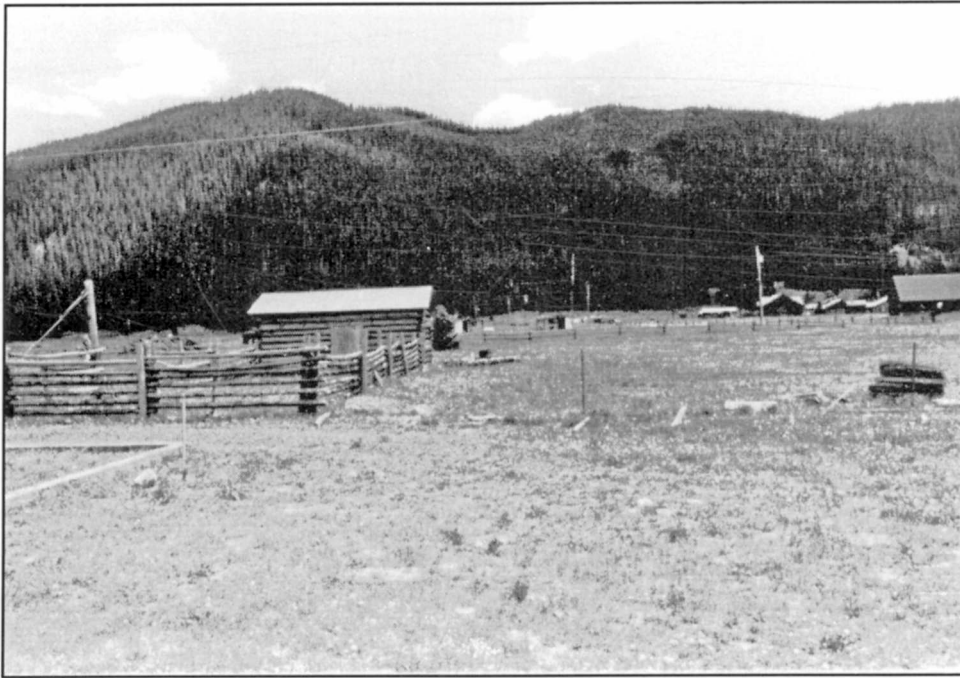
**Figure 107**

Platoro Work Center  
View to the South

*Statement of Significance.* It is recommended that site 5CN796 is not significant under criteria A or C. This barn is not uniquely or particularly representative of either pre-design era USFS construction or Pioneer construction in Colorado. It is not typical of a Region 2 administrative site since it contains no other potentially historic buildings or structures.

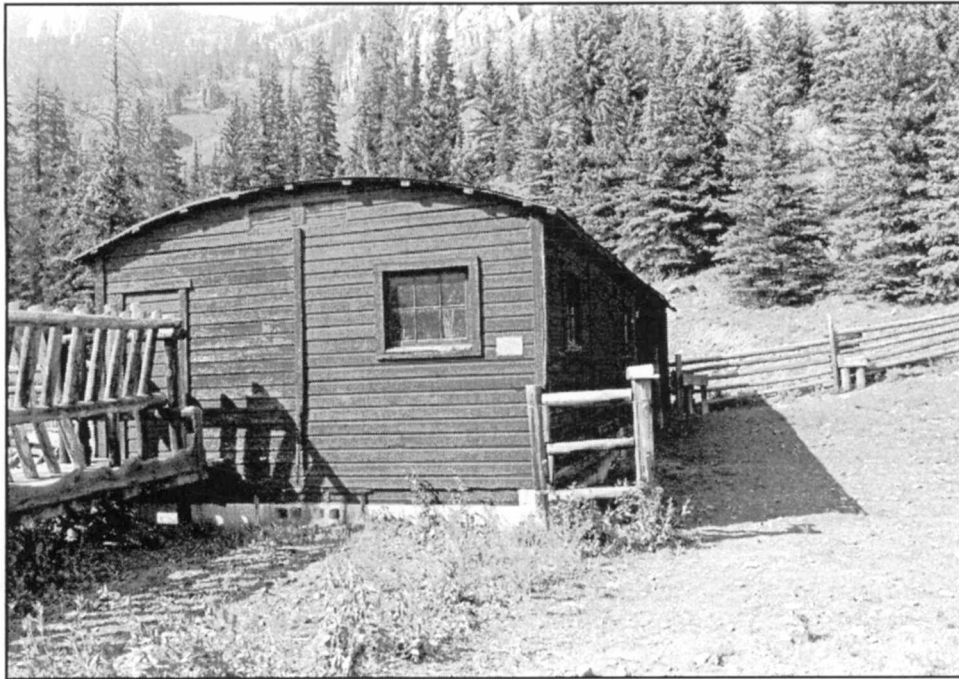
**Figure 110**  
Seepage Creek Site  
View to the Southwest

*Statement of Significance.* It is recommended that site 5ML286 is not significant under criteria A or C. The site has few of the characteristics of a Region 2 administrative site, and the barn does not retain integrity of location, materials, design, or association as a CCC temporary building.
