# Administering the National Forests of Colorado

## An Assessment of the Architectural and Cultural Significance of Historical Administrative Properties

*Prepared for the U.S. Forest Service, Rocky Mountain Region by the  
National Park Service - Midwest Archeological Center*

1996

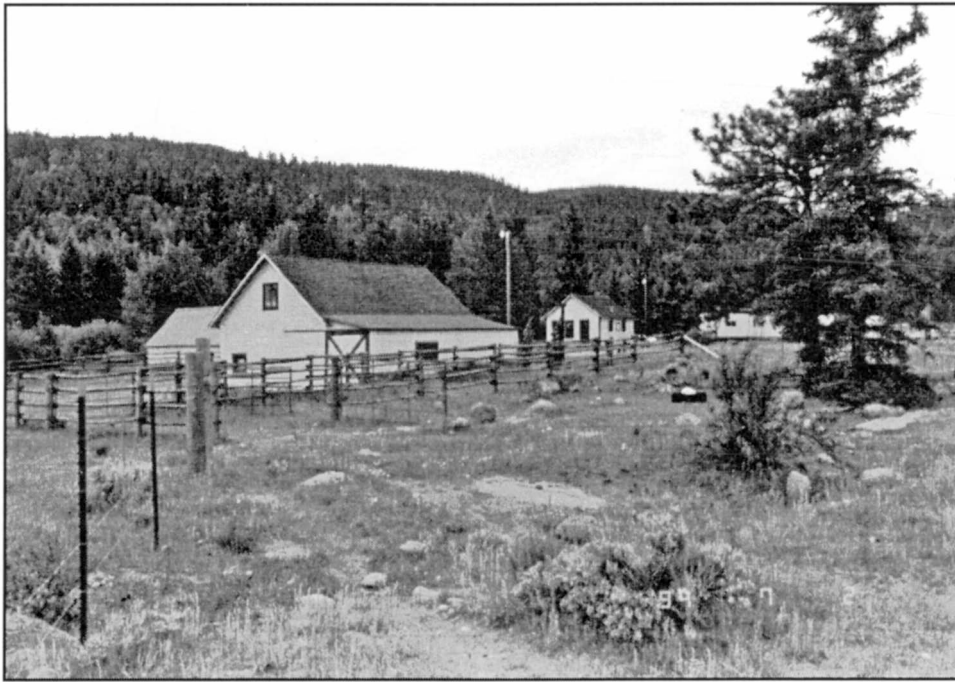
**Figure 111**

South Fork Guard Station  
View to the South and Southeast

*Statement of Significance.* It is recommended that site 5RN517 is not significant under criteria A or C. Though associated with the administration and development of the Rio Grande National Forest, this site is not typical of pre-CCC-era ranger station designs. It has been altered through the removal or addition of several buildings, significantly diminishing the integrity of the site. The two remaining historical buildings do not retain the integrity of design of a CCC-era Region 2 ranger station.

The introduction of designed office space in 1931 and construction of various other buildings at administrative sites increased the need for site planning. Guard stations may have had only a single one-room cabin, but typically consisted of a two- or three-room dwelling and small barn, as seen at Derby Ranger Station (Figure 14). Ranger stations had these, and after 1930, single-car garages and combination office buildings. Other improvements could include storage or wood sheds and root cellars. Layouts followed no discernible organization, but conformed to site topography. Buildings were generally constructed close together. At Thompson Creek Ranger Station the dwelling and garage were within six feet of each other (Figure 181, White River National Forest). The Alvarado Ranger Station (Figure 87, San Isabel National Forest) barn was constructed after completion of the combination office building. It not only sat in plain view of visitors, but blocked a spectacular view of the Wet Mountain Valley below (Johnson 1935:1). Only one evaluated Phase II site, the South Fork Ranger Station, once had both office and dwelling (Figure 111, Rio Grande National Forest). The house is no longer extant, leaving no known intact examples.

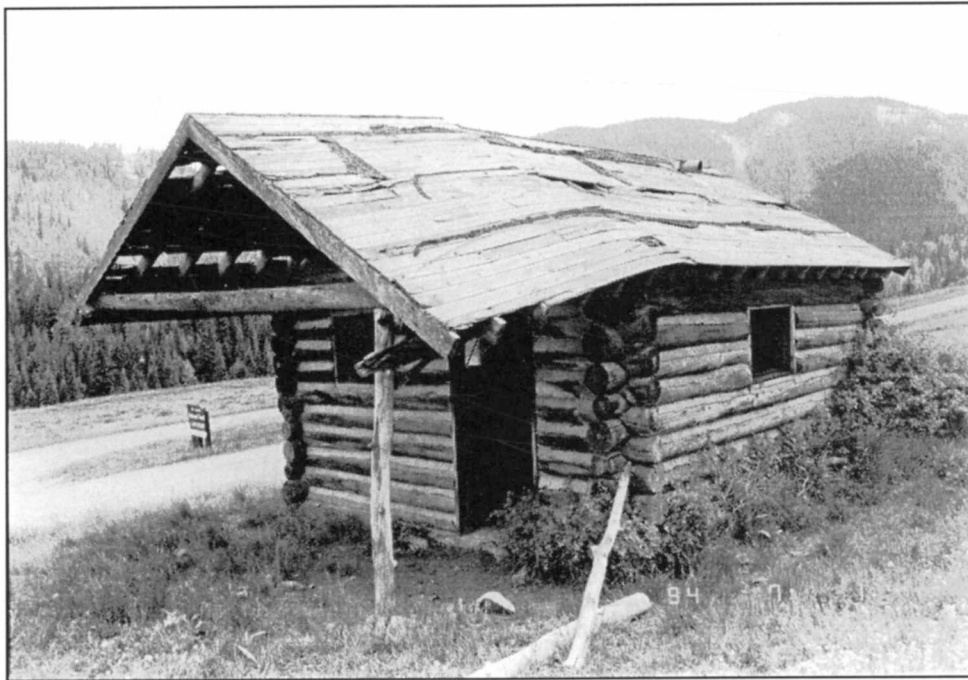
**Figure 112**  
Stunner Line Cabin  
View to the Southeast

*Statement of Significance.* It is recommended that site 5CN795 is significant under criteria C. The cabin exhibits many characteristics of the Rocky Mountain Cabin Style. The site is associated with the development of telephone communications in Colorado and may also be significant under criteria A as representative of the socio-cultural development of the state.

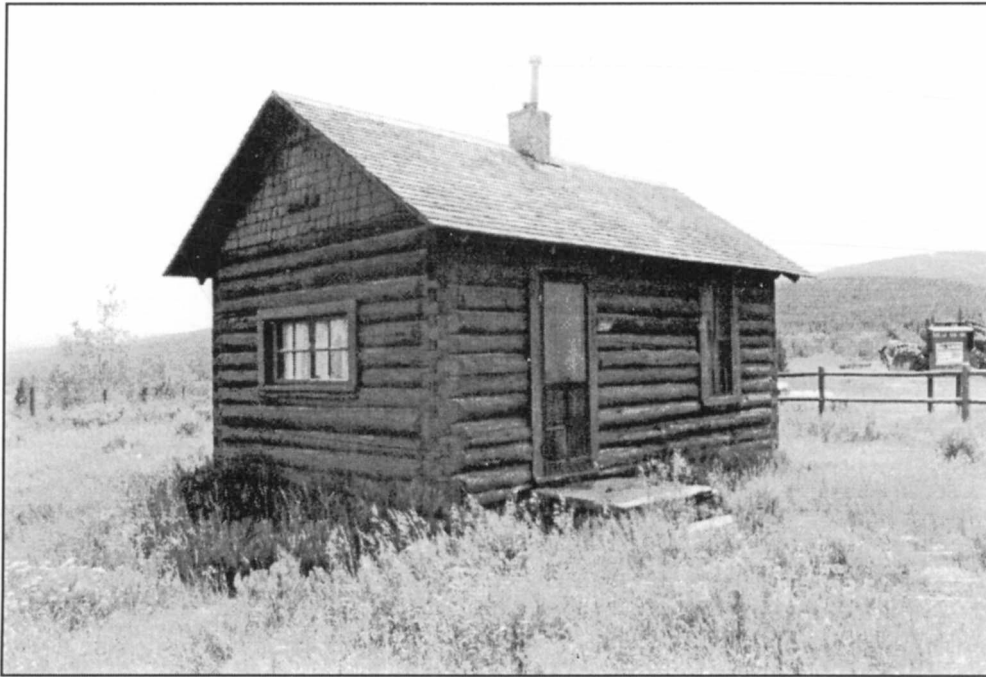
**Figure 116**  
Grizzley Creek Guard Station  
View to the Southwest

*Statement of Significance.* Site 5JA544 was officially determined significant under Criterion A in 1983. It is recommended that the dwelling at site 5JA544 is also significant under Criterion C. The building, with rare full dovetail notching, is a well-preserved and highly crafted example of ranger-built, pre-design-era Forest Service architecture, which was highly reflective of the pioneer construction techniques of its builders. The site, however, has lost its log barn, which is essential to a ranger station's integrity. A more intact pre-design-era site can be seen at Hog Park (5JA561).

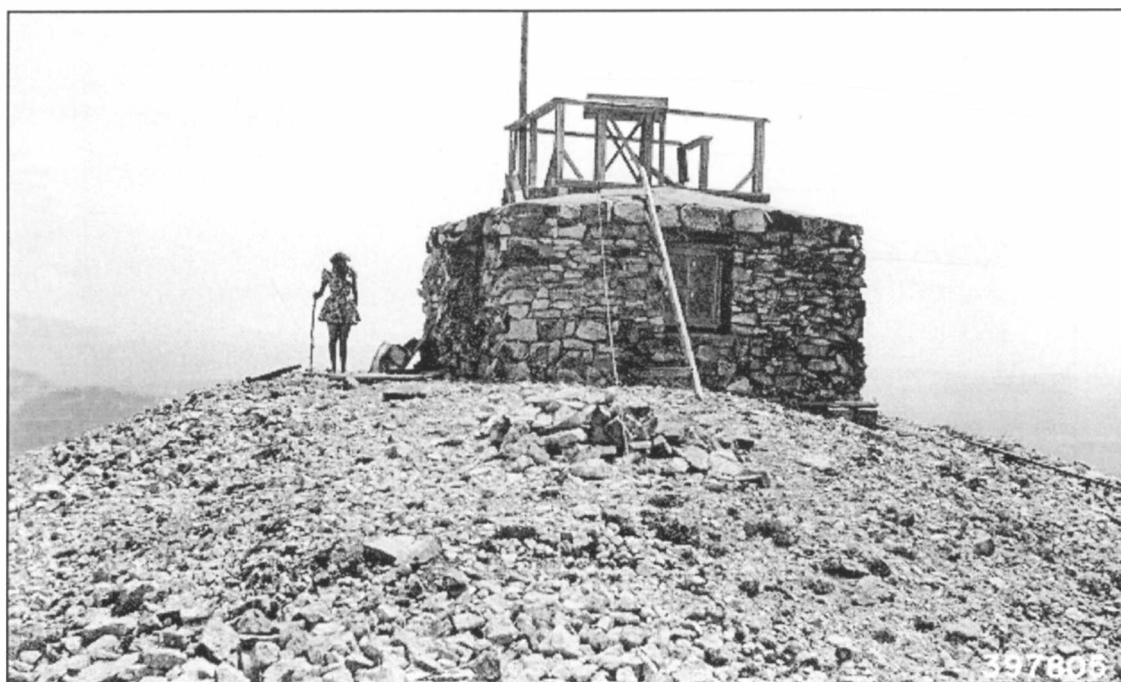
**Figure 117**  
Hahn's Peak Fire Lookout  
View to the Northwest

*Statement of Significance.* It is recommended that site 5RT1179 is significant under Criteria A and C. The Lookout was utilized by the USFS for fire suppression and is representative of the Forest Service's early mission of protection and conservation. It is architecturally representative of the era when many lookouts like Hahn's Peak were rebuilt by the CCC. It is the best of two known extant cupola/cabin type lookouts remaining in Colorado's National Forests, and the only one on the Routt.

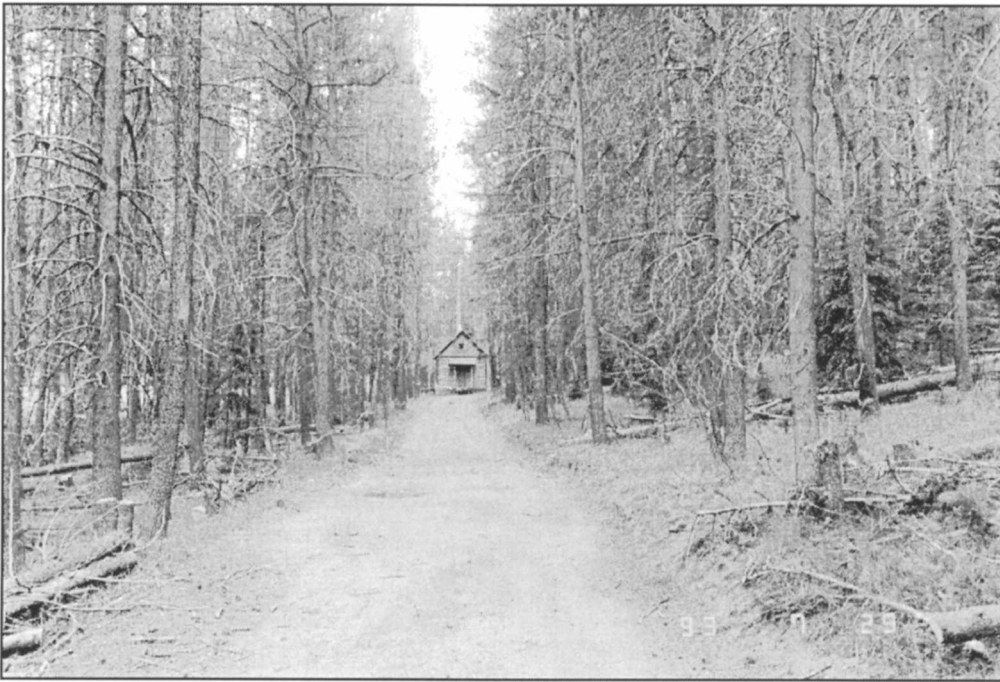
**Figure 118**  
Hog Park Guard Station  
View to the South

*Statement of Significance.* It is recommended that site 5JA561 is significant under Criteria A and C. It is the oldest standing station on the Routt National Forest. The site is intact and highly representative of a pre-design era ranger station. Its buildings are well preserved and reflective of the pioneer construction techniques of its builders.

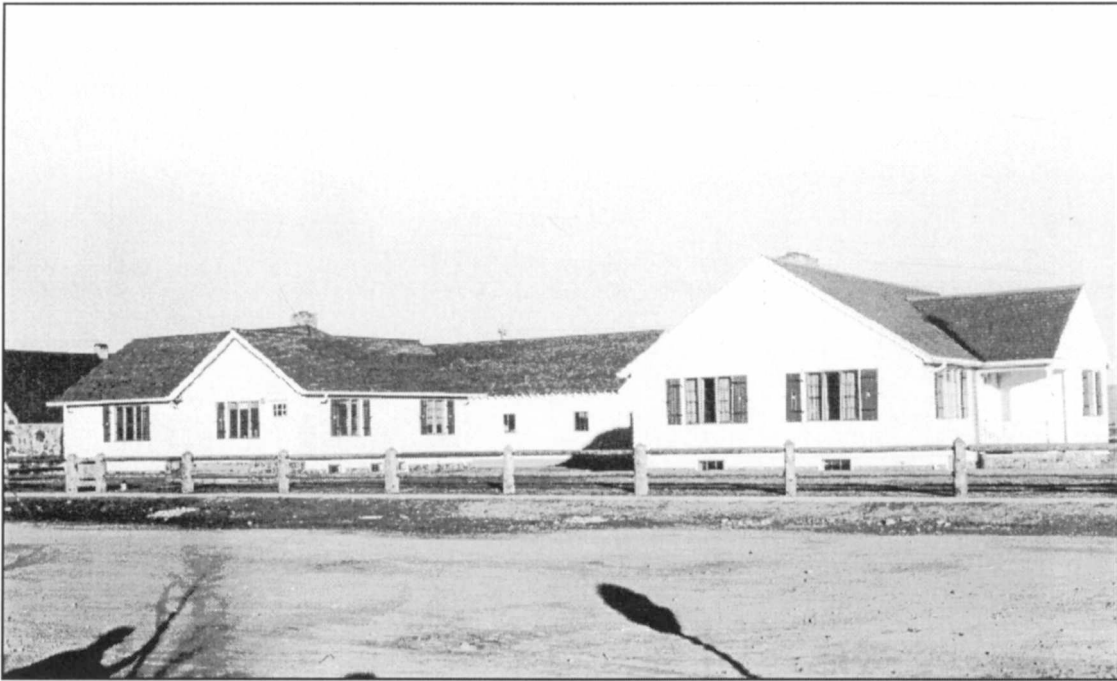
**Figure 121**  
Kremmling Ranger Station  
From the Southwest Side

*Statement of Significance.* It is recommended that site 5GA1891 is not significant under Criteria A or C. Though associated with the development of the Arapaho and Routt National Forests extensive new construction has significantly altered the integrity of design, feeling, and materials of both site and buildings. The site is no longer representative of a CCC-era ranger station. Better examples exist in Colorado.

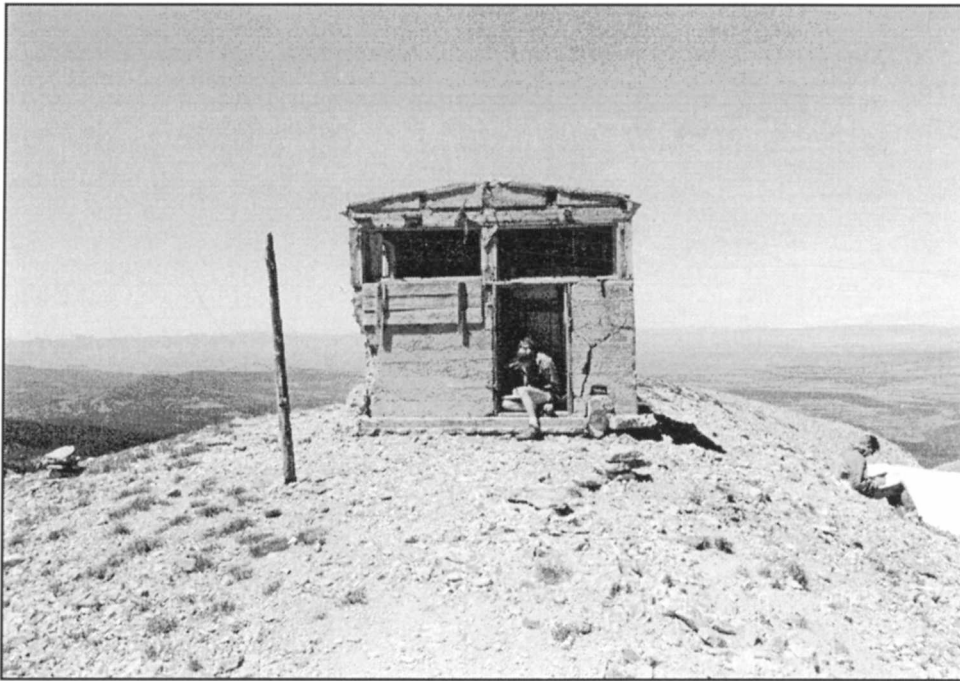
**Figure 122**  
Parkview Fire Lookout  
View to the North

Parkview Lookout (Figure 122, Routt National Forest) was representative of the type best utilized above tree line. It was a single-story, one-room, stone and concrete cabin with observation windows on each wall. Built in 1915-16, it was one of the first fire towers constructed in Colorado with official funds. Its walls consisted of poured concrete mixed with local stone. Rough-milled rafters supported a low gable concrete roof. The lookout sits at an elevation of 12,296 feet, making it one of the few that violated the conventional wisdom of placing lookouts near the timber line. It overlooked portions of the heavily timbered regions of the present North Park, Middle Park, and Sulphur Ranger Districts of the Routt and Arapaho National Forests. Personnel probably quartered at the Gilsonite Guard Station (not extant) at the base of the mountain (Sullivan 1994). Although legend held that a man with a good telescope could identify individuals on the streets of nearby Rand, 10 miles to the north of the cabin, it "overscanned vital stretches of timber, and the station was eventually abandoned" (Black 1969:310).

*Statement of Significance.* It is recommended that site 5GA1353 is significant under Criteria A and C. The Lookout was utilized by the USFS for fire suppression and is representative of the Forest Service's early mission of protection and conservation. It is architecturally representative of the era when construction of lookouts was executed primarily by rangers without standardized designs, and built predominantly of materials available on site. It is only known extant observation cabin type lookout remaining in Colorado's National Forests.

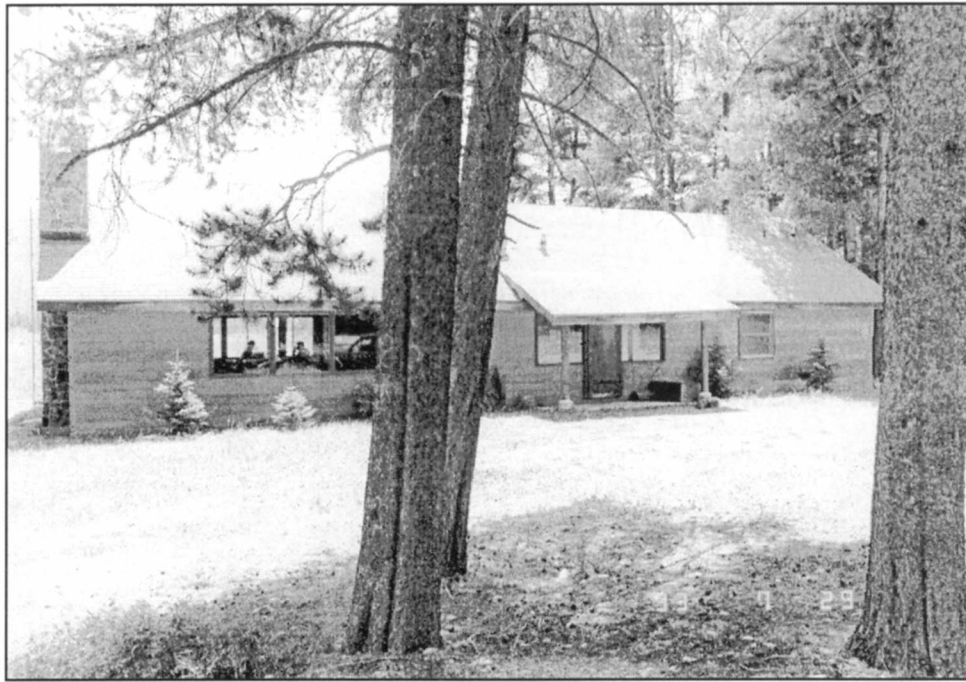
**Figure 123**  
Ptarmigan Ranch Lodge  
View to the Southwest

*Statement of Significance.* It is recommended that site 5GA1892 is not significant under Criteria A or C. The site was acquired by the Forest Service in 1978. Forest Service use of the site as a crew quarters and animal pasture is not significant to the development and administration of the Routt National Forest. The vernacular buildings are not distinctive in their type, period, or method of construction; they have lost integrity of association.

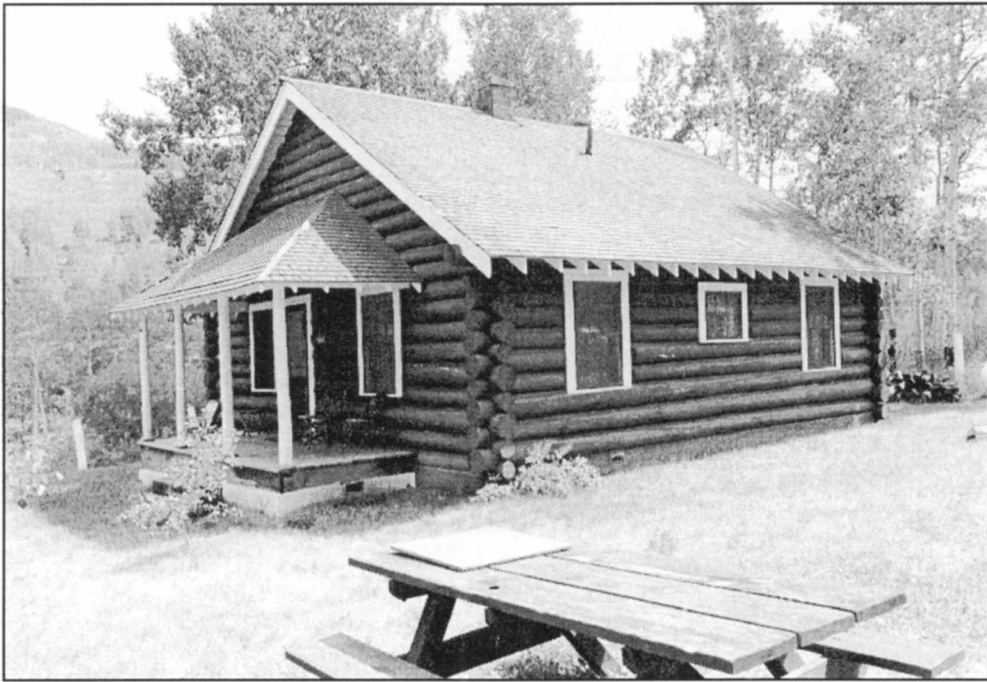
**Figure 124**  
Pyramid Guard Station Dwelling  
View to the South

*Statement of Significance.* Site 5RB2882 was officially determined eligible under Criteria A and C in 1992. The site is associated with the development and administration of the White River and Routt National Forests, and with the CCC. The station's buildings represent the evolution of Forest Service architectural design and evolution from a Bungalow Style to a Rustic Style. The buildings have some of the best CCC construction seen in Colorado's Forest Service administrative design.

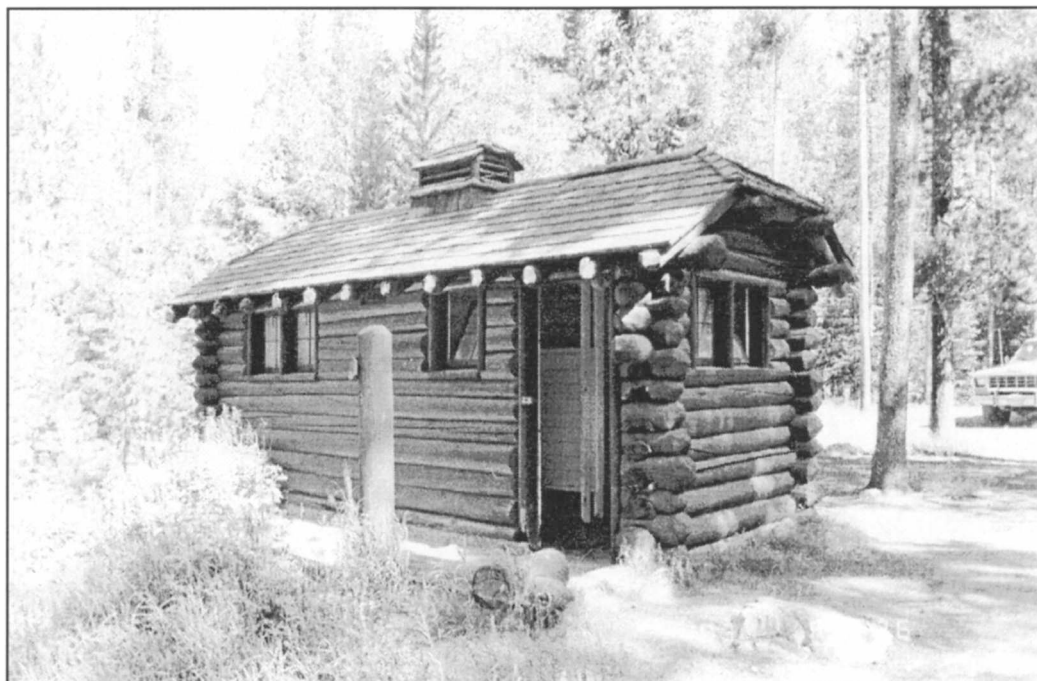
**Figure 125**

Seedhouse Campground Toilet  
View to the Northeast

*Statement of Significance.* It is recommended that site 5RN462 is significant under Criteria A and C. It is the last known four-hole log toilet of its kind of the Routt National Forest, and is representative of the role the CCC played in the recreational development of Colorado's National Forests. It retains its integrity despite replacement of some logs.

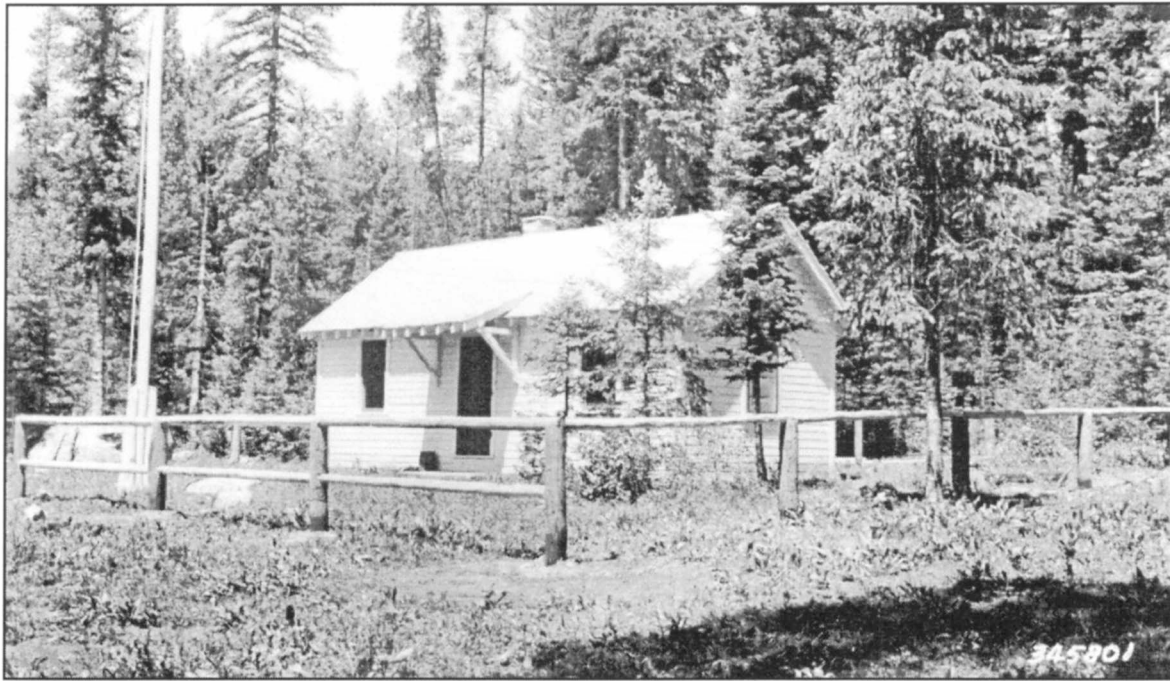
**Figure 126**  
Seedhouse Ranger Station  
used for summer quarters

*Statement of Significance.* It is recommended that site 5RT1178 is not significant under Criteria A or C. Though the site contains enough elements to be recognizable as a pre-CCC or early CCC-era administrative site, many better examples exist in Colorado.

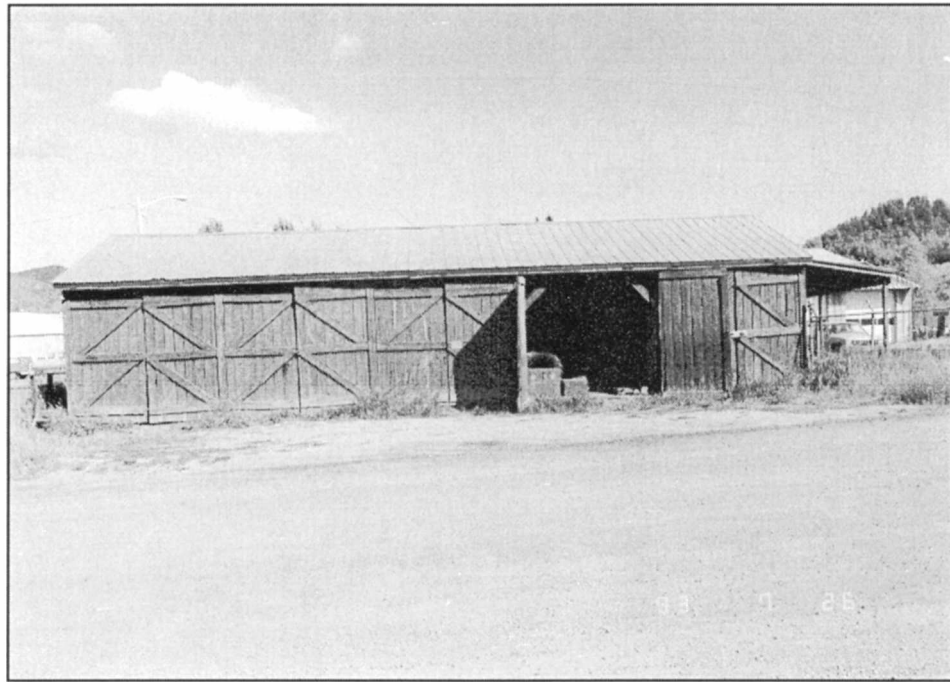
**Figure 127**

Storage Garage 3509  
View to the Southeast

*Statement of Significance.* It is recommended that site 5RT1180 is not significant under Criteria A or C. The site has few of the characteristics of a Region 2 administrative site, and the storage garage does not retain integrity of location, design or association as a CCC temporary building.

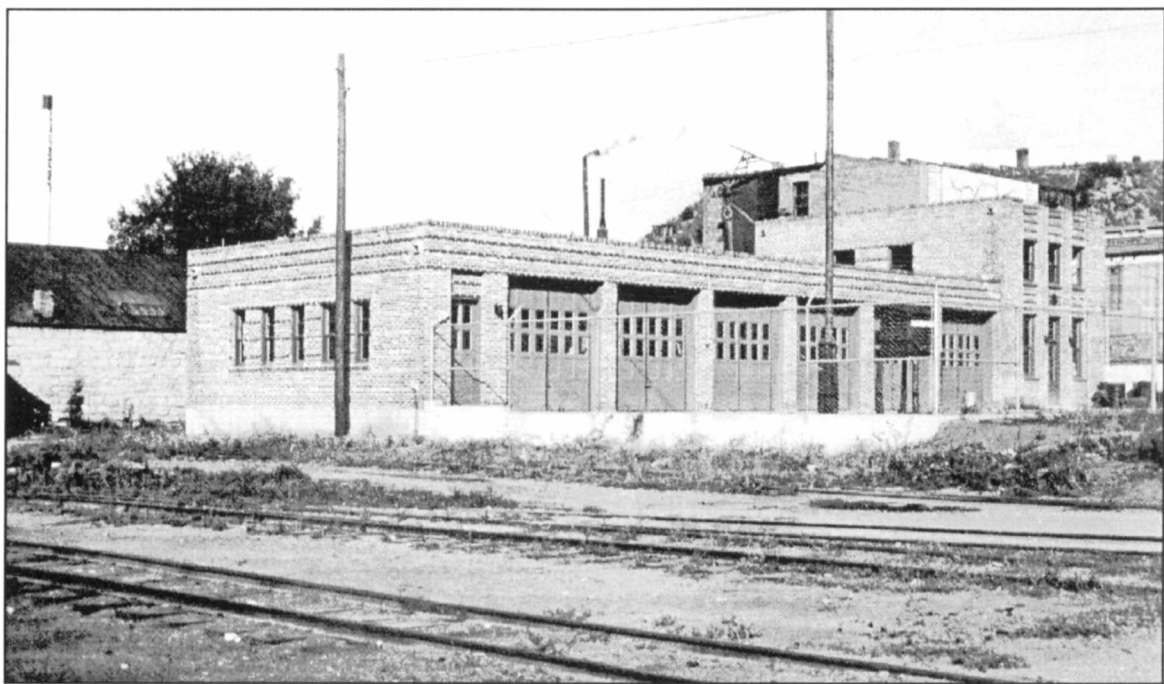
**Figure 130**  
Animas Supervisor's Warehouse  
San Juan National Forest

Several supervisors' warehouses, including the Animas District Office (Figure 130, San Juan National Forest) and one combination office building at Buena Vista (Figure 90, San Isabel National Forest) were designed in the Art Deco Style. These were most likely influenced by Charles Jaka (Note 2). Their brick detailing is identical to that of Jaka's landmark Art Deco buildings at 1601 and 1611 Grape Street in Denver. Characteristic elements included fluting (small stepbacks in the brickwork) near the fenestration and doors, and strong vertical and horizontal elements. They appeared only in urban environments.

Buildings were constructed in stone (e.g., Figure 176, White River National Forest), brick (e.g., Figure 130, San Juan National Forest), adobe (e.g., Figure 83, San Isabel National Forest), milled wood (e.g., Figure 48, Arapaho National Forest), or logs (e.g., Figure 159, White River National Forest). The use of wood as a construction material was perhaps the ultimate expression of Forest Service values, and designers took every opportunity to use it. Though the cost of most building materials was depressed, wood was especially cheap, easy to work with, readily available, and reflected the pioneer architectural traditions of Rocky Mountain architecture. The Rustic Style was especially appropriate in the mountains, where wood shakes, native stone, and logs were the most economical materials available. Doors, windows, shutters, porch railings, interior walls, ceilings, and floors were all wood (Groben 1938:47). The Government-sponsored New Deal programs were encouraged to use commercially available materials as a stimulus to production. Forests purchased construction materials locally, through a central purchasing arrangement with the Regional Office, and sometimes directly from a mill under Forest permit. Processed wood products like Plywood, Compo Board, Celotex, and Nu-Wood were used extensively for interior finishes. Door and window hardware was purchased or fabricated by Forest Service or CCC shops. Most of the purchased material was local, but Forests occasionally imported logs, stone, and log cabin siding from nearby states. Native pine, spruce, and fir were not ideal species for log construction, but worked well enough to use. The tall slender trees gave distinction to Regional construction in Colorado. The use of brick as a finish material was discouraged by Groben, mainly because of the skill required to use it (Groben 1938:10). Region 2 used it regardless, both as a finish material on supervisors' warehouses and as infrastructure on stuccoed Pueblo-style buildings.

*Statement of Significance.* It is recommended that site 5LP3867 is not significant under Criteria A or C. Though associated with the development and administration of the San Juan National Forest, better examples of USFS art deco design and brick supervisor's warehouse construction remain in Colorado.

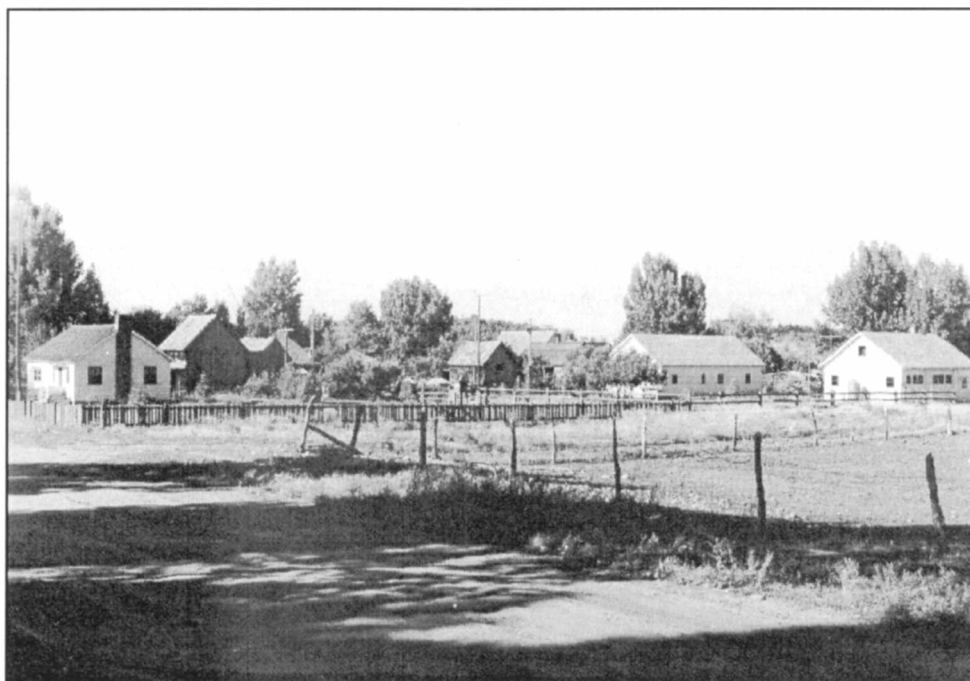
**Figure 132**  
Bayfield Ranger Station  
Site in Bayfield

*Statement of Significance.* It is recommended that site 5LP3869 is not significant under Criteria A or C. Though associated with the development and administration of the San Juan National Forest, each of its historical buildings have been modified, some heavily. One building has been moved and the site has several intrusive new buildings that have altered the original design. Though still recognizable as a CCC-era ranger station, more intact examples exist on the Forest.

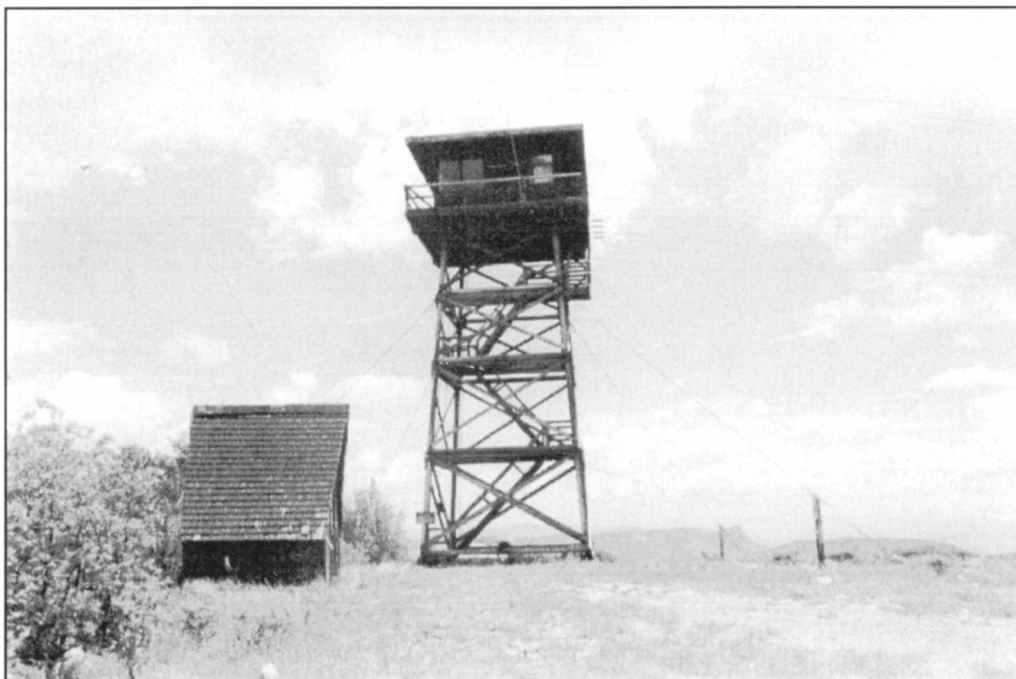
**Figure 133**  
Benchmark Lookout Tower  
View to the East

*Statement of Significance.* It is recommended that site 5DL1793 is not significant under Criteria A or C. The tower is not old enough to be considered eligible. Better examples of post-CCC-era lookout design and construction exist in Colorado.

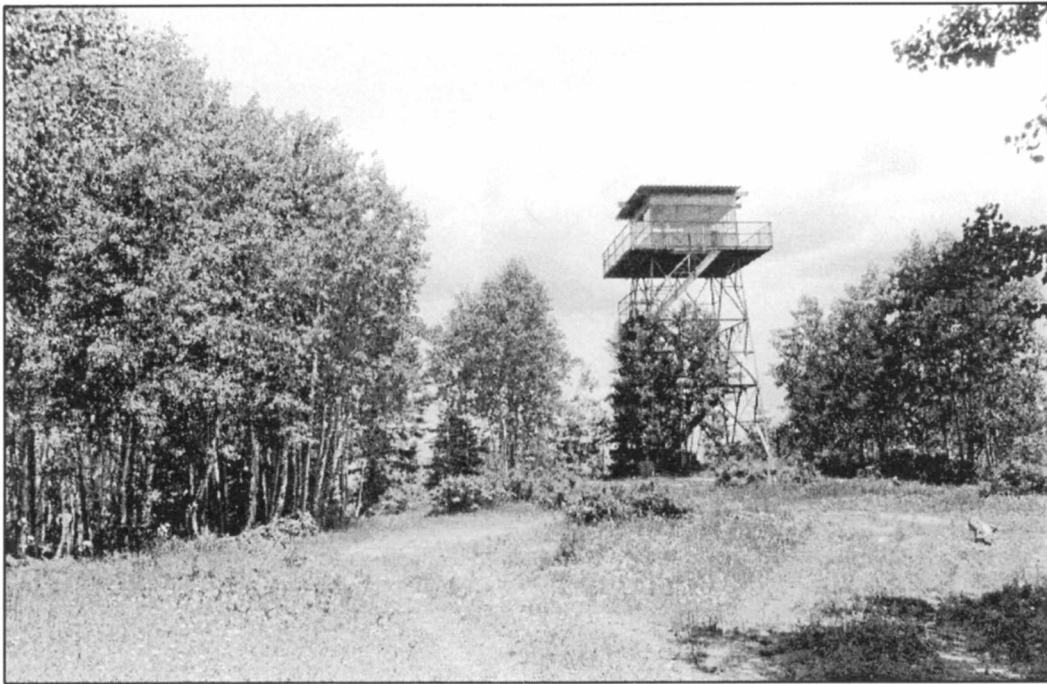
**Figure 134**  
Devil Mountain Lookout Tower  
View to the Northeast

Jersey Jim Lookout (Figure 142, San Juan National Forest) was the only Phase III lookout surveyed. It was probably originally built in 1940, but was reconstructed in the 1990s. Its wood cab stands on a treated timber tower. Devil Mountain (Figure 134, San Juan National Forest) and Eight Mile Lookouts (Figure 44) are typical examples of Phase IV steel construction. Both have flat-roofed cabs based upon the USFS CL-100 Series Aermotor steel cabs (Figure 45), and towers. Benchmark Lookout (Figure 133, San Juan National Forest), constructed in 1969, is based upon a CL-100 Series standard plan known as the R-6 flat. It consists of a treated timber tower with a plywood cab. It represents one of the last of a dying breed of manned lookouts.

*Statement of Significance.* It is recommended that site 5AA1859 is significant under Criterion G. The Lookout was utilized by the USFS for fire suppression and is representative of the Service's historic mission of protection and conservation. The tower and its site, though not old enough to be considered eligible, is the best of the remaining examples of post-CCC-era lookout design and construction known to exist on the National Forests of Colorado.

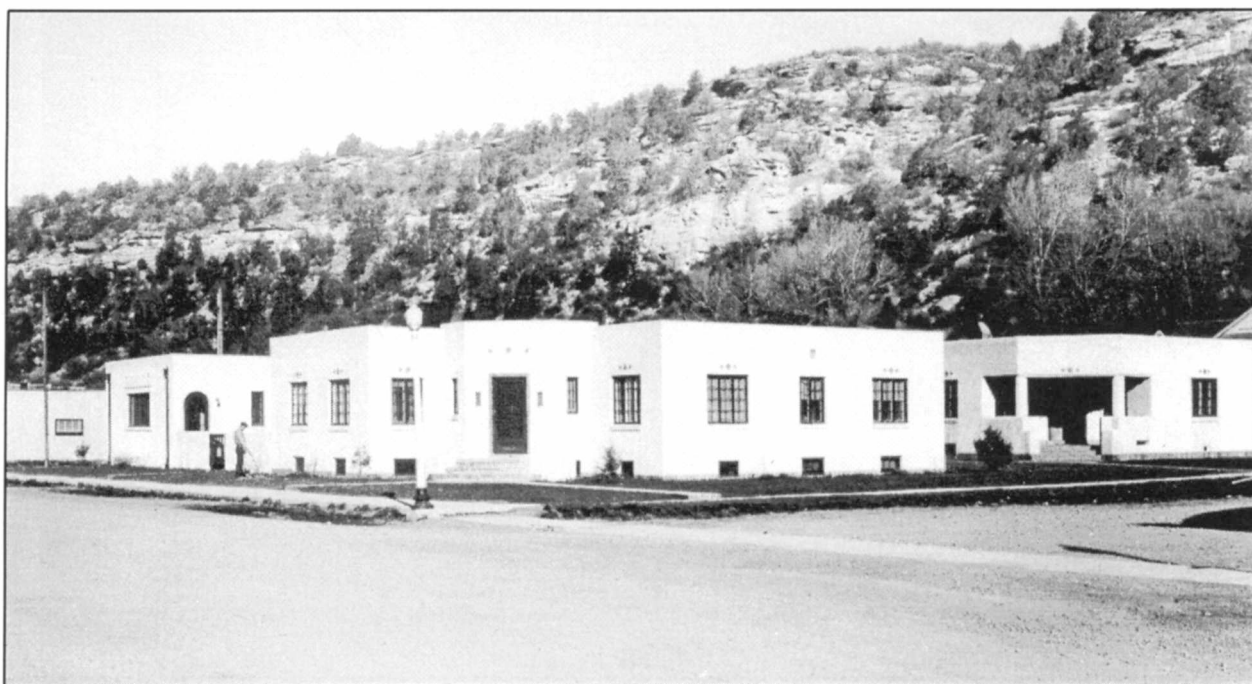
**Figure 135**

The Forest Service group of  
buildings at Dolores, Colorado

*Statement of Significance.* It is recommended that site 5MT12041 is significant under Criteria A and C. The complex contains four Pueblo Style administration buildings designed by the Region's first architect, S.A. Axtens, and was built by the CCC. It is one of the largest and most intact Pueblo Style Ranger Stations in Colorado. Its buildings are associated with the development and administration of the San Juan National Forest, contain unique detailing, and represent a mastery of Pueblo Style design.

Forest Service designers were heavily influenced by regional styles. The Pueblo Style (e.g., Dolores Ranger Station, Figure 135, San Juan National Forest) emulated the Native American architecture of southwest Colorado. Most designs had stucco-covered brick walls, though at least two were constructed with stuccoed adobe blocks. The Portland concrete stucco was hand troweled and painted to achieve the look of adobe. Some rectilinear Rustic layouts were constructed with Pueblo-style facades. True Pueblo-style layouts were single-story with irregular footprints, battered walls, and flat roofs. Foundation lines were sometimes accentuated by a small ledge or a change in materials, but were often stuccoed over for a seamless finish. The low-slung appearance of the buildings was reinforced by heavy wood window and door lintels constructed of both surfaced and unsurfaced lumber. The roofs drained through interior gutters, canals, or metal scuppers with drain pipes.

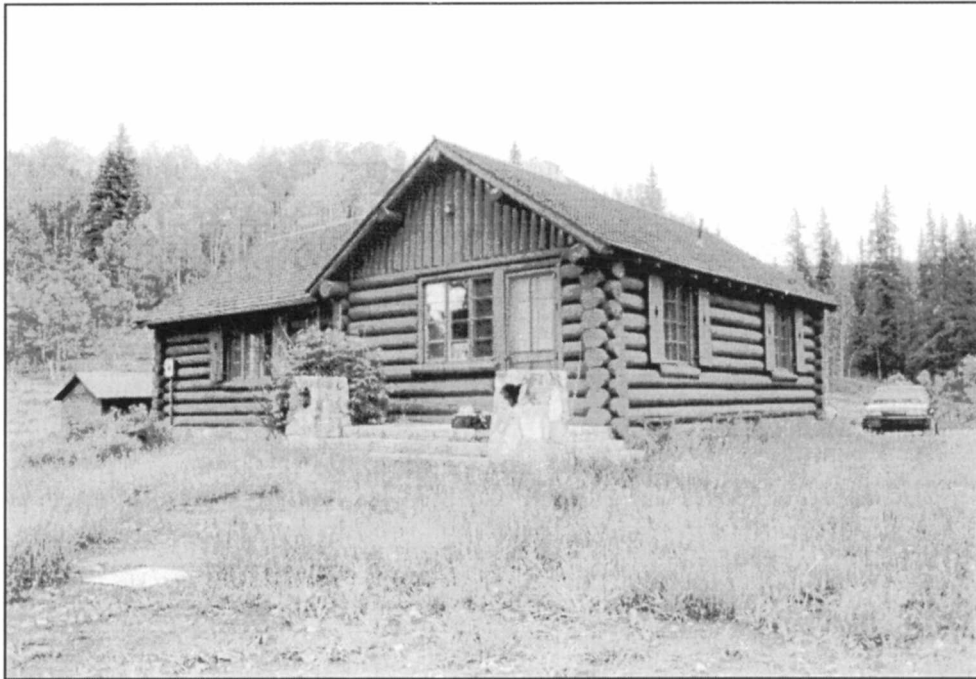
**Figure 136**  
Dunton Guard Station  
View to the Northwest

*Statement of Significance.* It is recommended that site 5DL1790 is not significant under Criteria A or C. Though associated with the development and administration of the San Juan National Forest, the office building on this typical rural guard station has suffered heavy losses of integrity of design and construction. Several better examples of both rural guard stations and this building plan exist in the Forest and throughout Colorado.

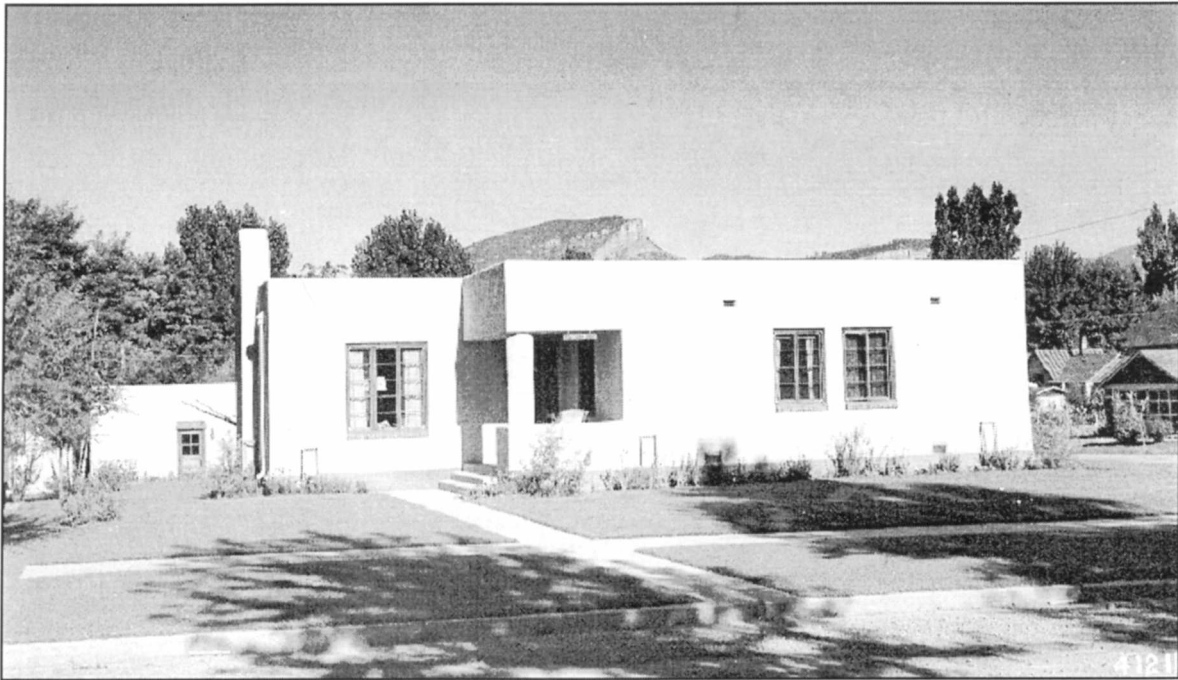
**Figure 137**  
Forest Service Residence No. 2  
located in Durango, Colorado

*Statement of Significance.* It is recommended that site 5LP3872 is not significant under Criteria A or C. Though associated with the development and administration of the San Juan National Forest, the complex is not the most representative nor the most intact example of a USFS Ranger's Residence. The dwelling has suffered heavy losses of integrity of design and construction. Better examples of exist in the Forest and in Colorado.

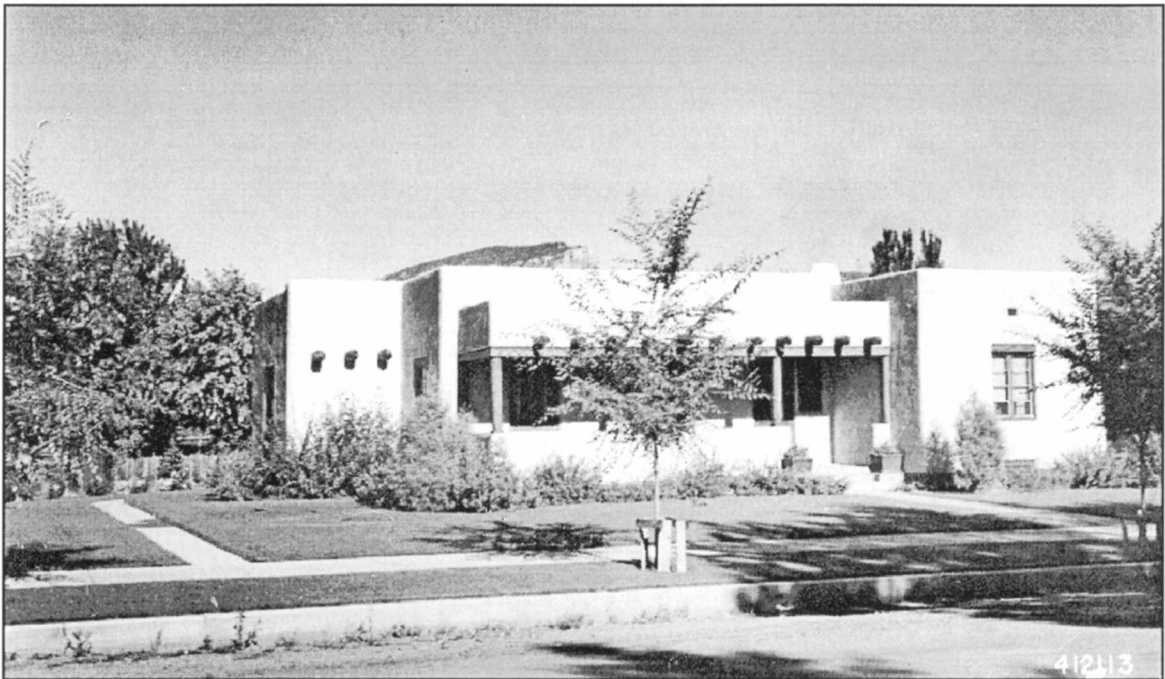
**Figure 138**

Supervisor's Residence provided  
by the FS in Durango

*Statement of Significance.* It is recommended that site 5LP3871 is not significant under Criteria A or C. Though associated with the development and administration of the San Juan National Forest, the complex is not the most representative or most intact example of a USFS Supervisor's Residence. The dwelling has suffered heavy losses of integrity of design and construction. Better examples of exist in Colorado.

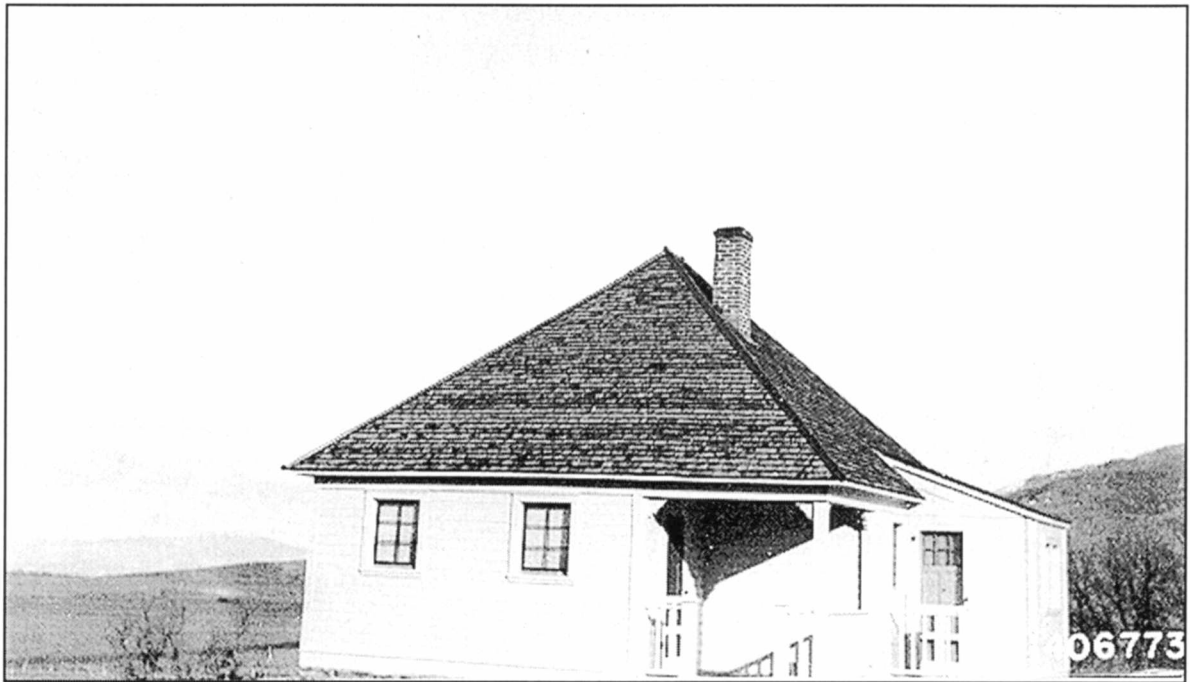
**Figure 140**  
Glade Ranger Station  
Dwelling

*Statement of Significance.* It is recommended that site 5DL1792 is significant under Criteria A and C. It is associated with the development and administration of the San Juan National Forest. It was one of the oldest administrative sites remaining on the San Juan. Its buildings represent several era's of Region 2 design and construction, as well as the craftsmanship of the CCC.

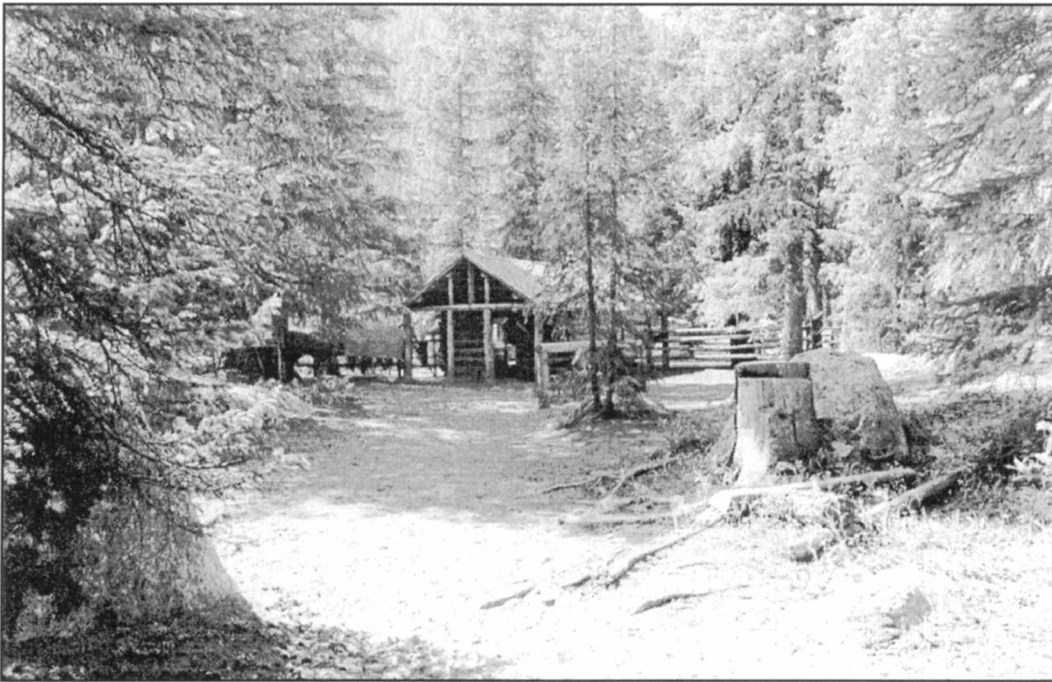
**Figure 141**  
Granite Peak Guard Station  
View to the Southeast

*Statement of Significance.* It is recommended that site 5HN508 is significant under Criteria A and C. It is associated with the development and administration of the San Juan National Forest. Its cabin exemplifies a method of construction associated with early high country settlement, that of the Rocky Mountain Cabin Style. The cabin is also significant in its representation of the pre-design era of Forest Service administrative development.

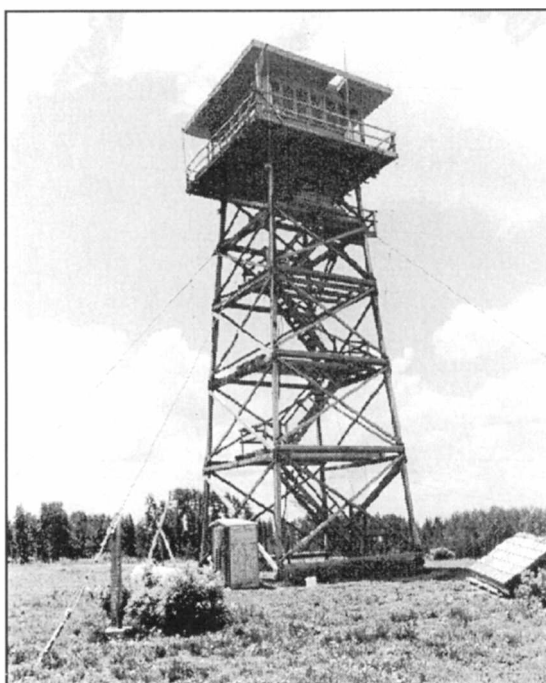
**Figure 142**  
Jersey Jim Lookout Tower  
View to the Southwest

*Statement of Significance.* It is recommended that site 5MT12555 is not significant under Criteria A or C. Though the site does represent the Forest Service's mission of protection and conservation, the current fire tower and cab have been completely rebuilt, and retain no integrity of materials.

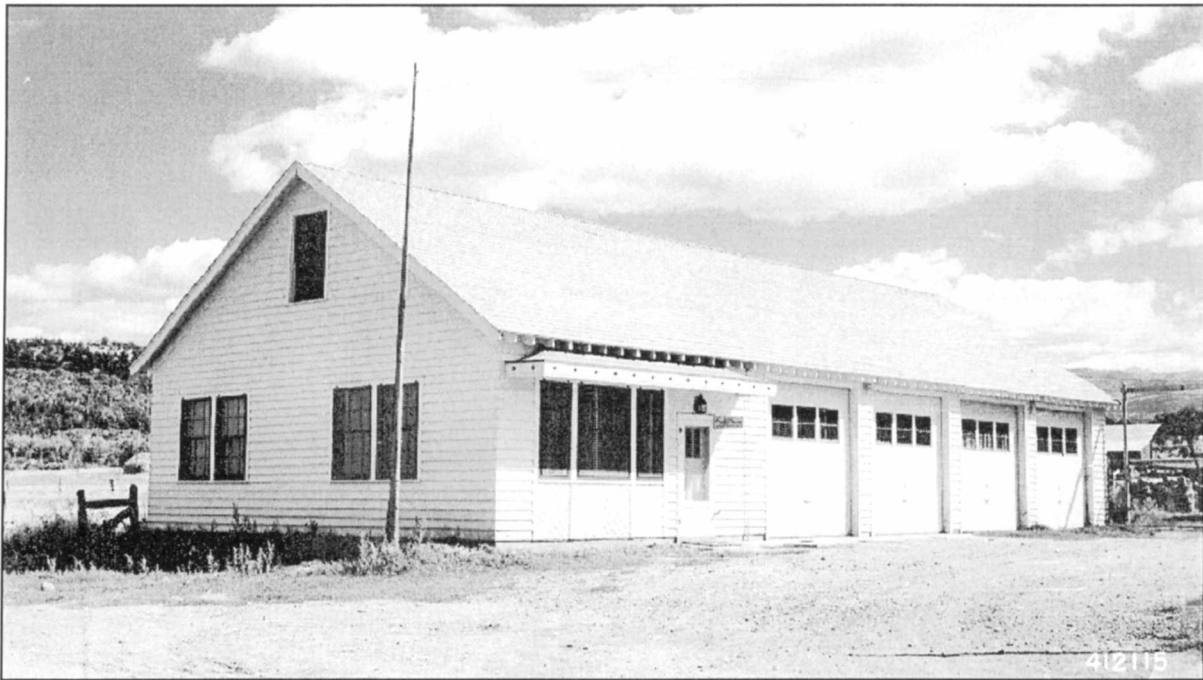
**Figure 143**  
Ranger's Office and Garage Building  
Located in Mancos, Colorado.

*Statement of Significance.* It is recommended that site 5MT12552 is not significant under Criteria A or C. Though associated with the development and administration of the San Juan National Forest, this site and its warehouse building have lost integrity of design, feeling, materials, and craftsmanship as a Forest Service administrative site. The garage has been gutted and converted for use as a local visitor center. Better examples of supervisors' warehouses exist within the Forest.
