# Administering the National Forests of Colorado

## An Assessment of the Architectural and Cultural Significance of Historical Administrative Properties

*Prepared for the U.S. Forest Service, Rocky Mountain Region by the  
National Park Service - Midwest Archeological Center*

1996

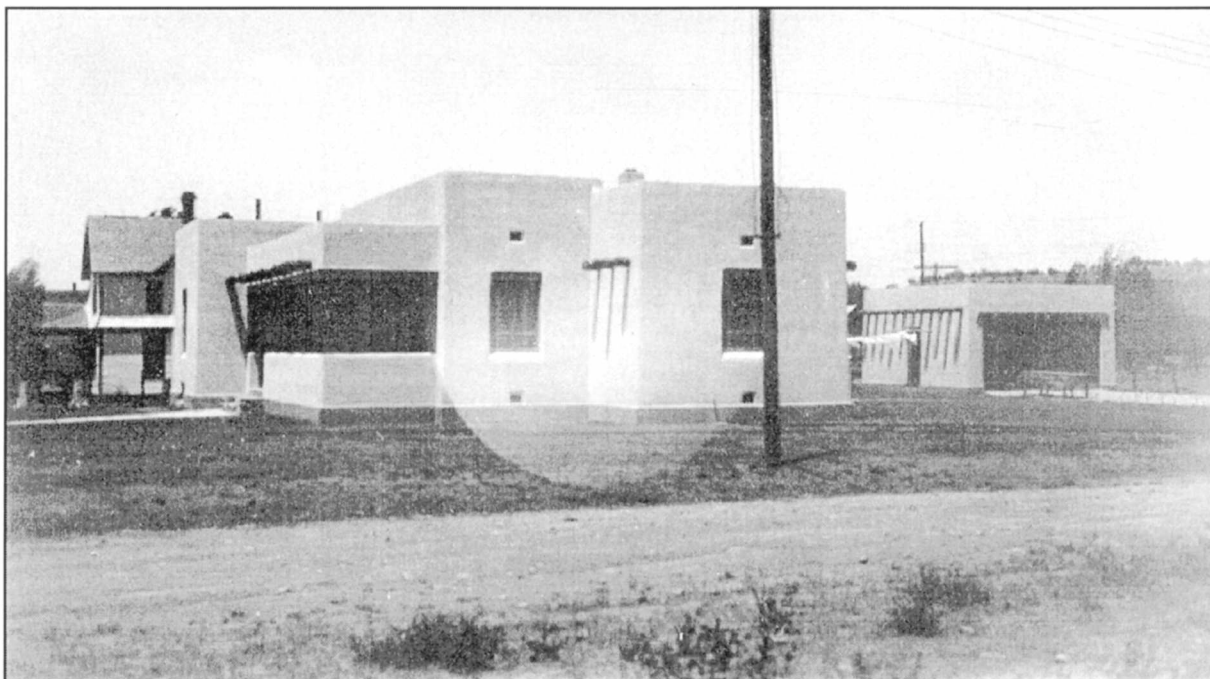
**Figure 144**

Mancos Ranger's Residence  
Mancos, Colorado

*Statement of Significance.* It is recommended that site 5MT12553 is not significant under Criteria A or C. Though associated with the development and administration of the San Juan National Forest, the buildings on this typical urban rangers residence have suffered moderate losses of integrity of design and materials. Several better examples of both urban ranger stations and this building plan exist in the Forest and throughout Colorado.

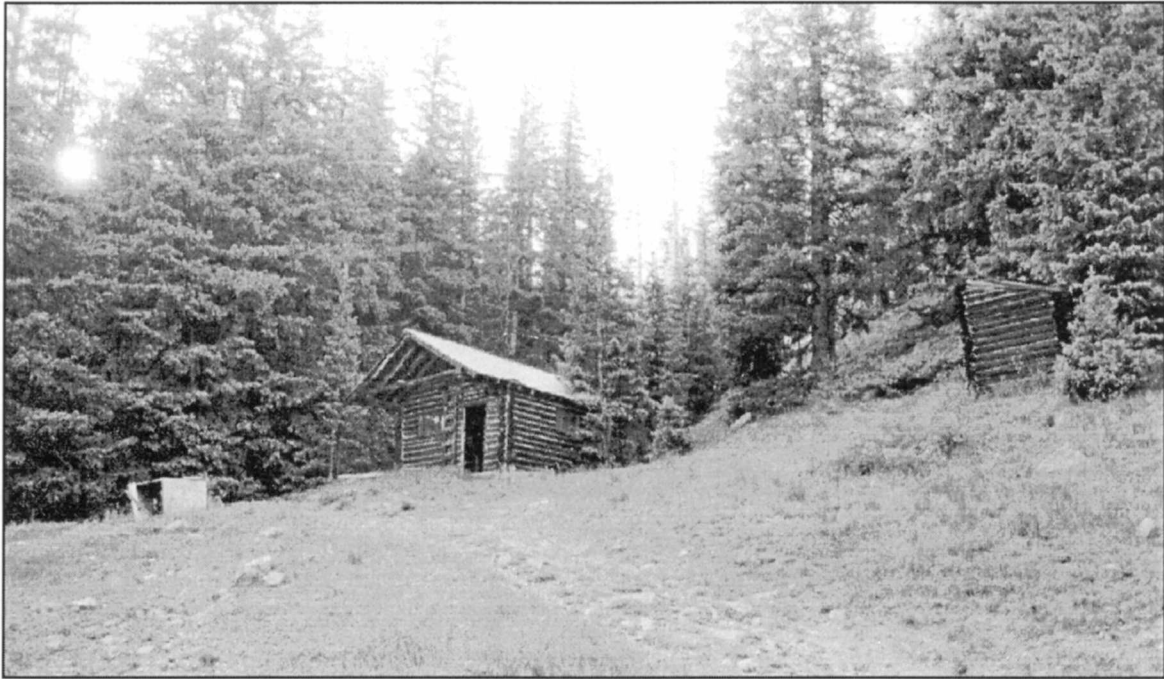
**Figure 145**  
McCormick Cabin  
View to the Northwest. Outhouse to the right.

*Statement of Significance.* It is recommended that site 5ML287 is significant under Criteria A and C. It is associated with the development and administration of the San Juan National Forest, and also with the establishment of the Colorado Telephone Company phone line that ran in the valley. Its very well preserved Rocky Mountain Cabin Style cabin and associated toilet exemplify high altitude pioneer construction methods.

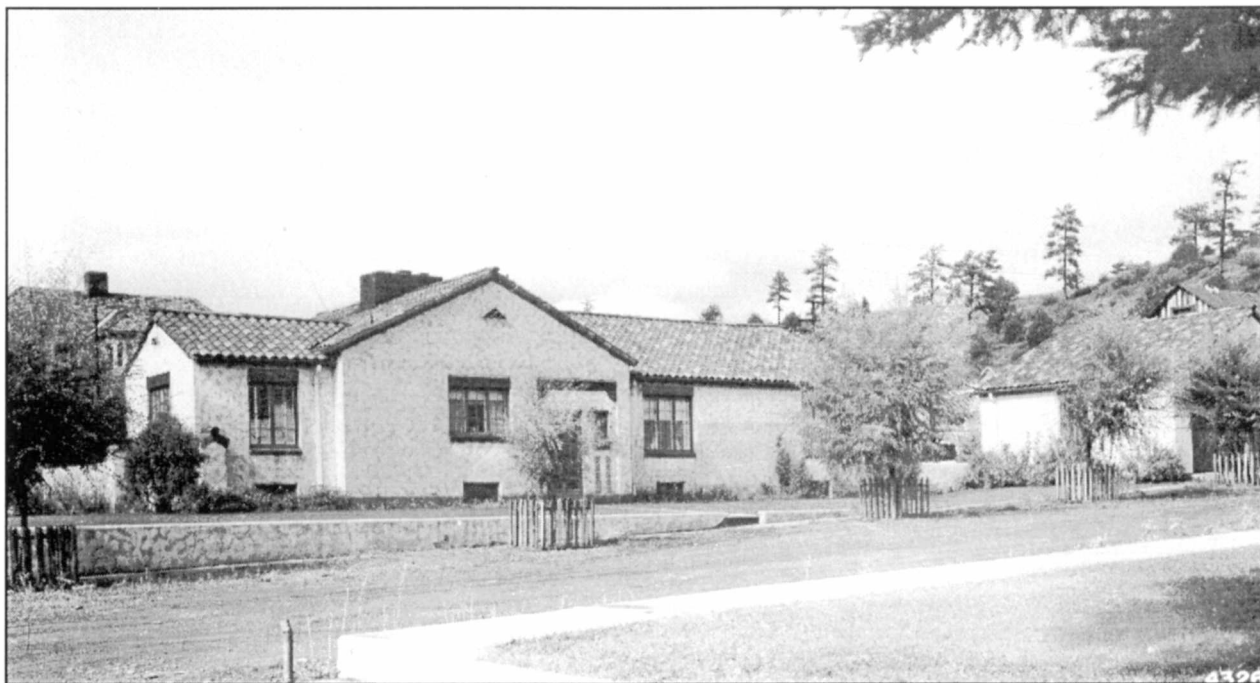
**Figure 146**

Exceptions to the practice of contextual continuity exist. One example occurred at the proposed San Juan National Forest Ranger's Residence No. 1 at Pagosa Springs (Figure 23; Figure 146, San Juan National Forest). An incongruous group of neighboring architectural styles prompted the regional office to erect a distinctively different Spanish Colonial-style dwelling, the only example of the style built in the Region. See Appendix B for a complete description of the architectural characteristics of Phase III.

Architect Arthur G. Longfellow produced several designs during his short stint with the Regional Architectural Division in 1937. His known works include the Spanish Colonial Style Ranger's Dwelling No. 1 on the San Juan National Forest (see Figure 146) and a Colonial Revival dwelling on the Uncompahgre National Forest. He was also adept at the Rustic Style, modifying plans from the Sunlight Ranger Station dwelling for the new Redfeather Ranger Station dwelling (see Figure 53, Roosevelt National Forest), one of the Region's most articulate Rustic Style examples. Longfellow may have come from Region 5 where a Colonial Revival building very similar to the one later built on the Uncompahgre appeared in 1936, strangely out of context even on the West Coast and designed by an "A.G.L." (Supernowicz 1989:17).

East Side of Ranger's Dwelling &  
Garage. Pagosa Springs, Colorado

*Statement of Significance.* It is recommended that site 5AA1855 is significant under Criteria A and C. The complex is associated with the development and administration of the San Juan National Forest. It contains the only Spanish Colonial Style USFS administration buildings known to exist within Colorado. The site's location and layout are typical of CCC-era ranger's residences.

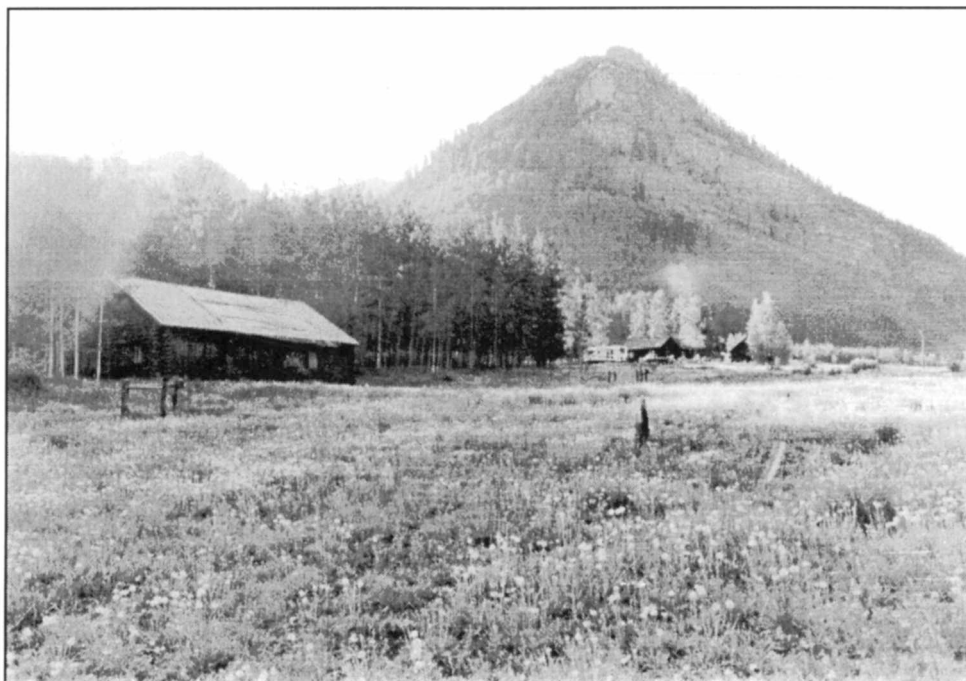
**Figure 149**  
Rico Guard Station  
View to the Northwest

| Building Name | Bldg. No. | Date | Builder | Style |
|---|---|---|---|---|
| Dwelling | N/A | 1939-41 | CCC F-53-C | Rustic |
| Office | N/A | 1939-41 | CCC F-53-C | Rustic |
| Barn | N/A | 1939-41 | CCC F-53-C | Rustic |

*Statement of Significance.* It is recommended that site 5DL1791 is not significant under Criteria A or C. Though associated with the development and administration of the San Juan National Forest, the three remaining utility buildings do not convey the character of a ranger station. Several better examples of rural ranger stations exist in the Forest and throughout Colorado.

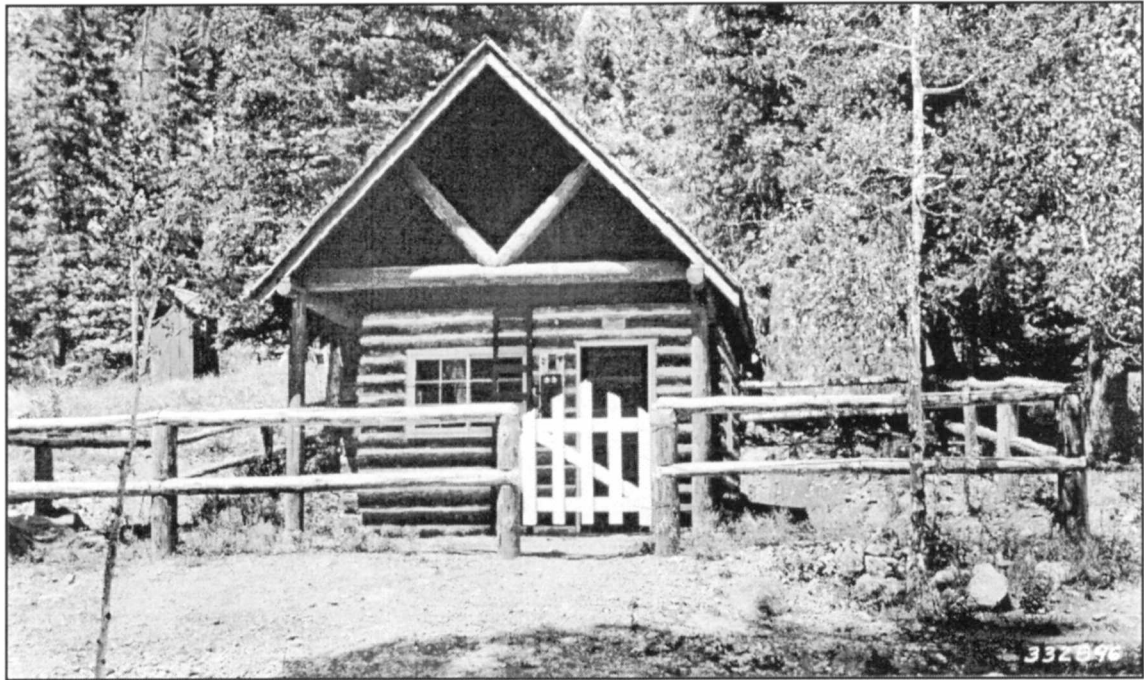
**Figure 150**  
Front View of Silver Falls  
Ranger Station

*Statement of Significance.* It is recommended that site 5HN507 is significant under Criteria A and C. It is associated with the development and administration of the San Juan National Forest. Its very well preserved Rocky Mountain Cabin Style cabin and associated buildings exemplify pioneer construction methods and early USFS administrative design and site layout. It is the only ranger constructed log building of this plan remaining on the Forest.

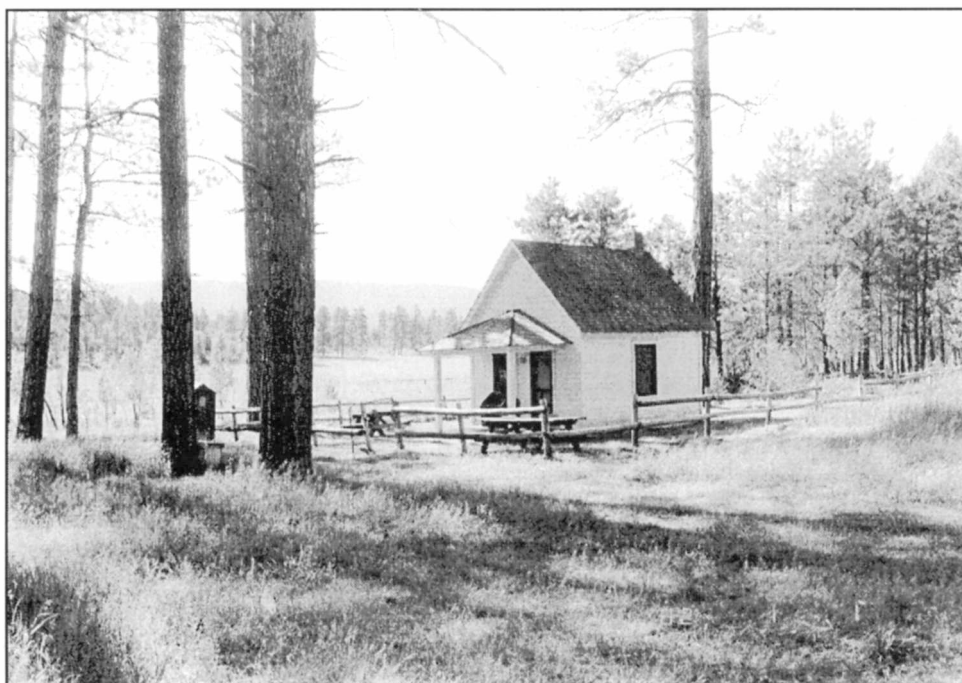
**Figure 154**  
Turkey Springs Guard Station  
View to the Northwest

*Statement of Significance.* It is recommended that site 5AA1755 is significant under Criteria A and C. It is associated with the development and administration of the San Juan National Forest. It has a well preserved example of pre-CCC-era ranger-built guard building. The site retains all the elements associated with guard stations.

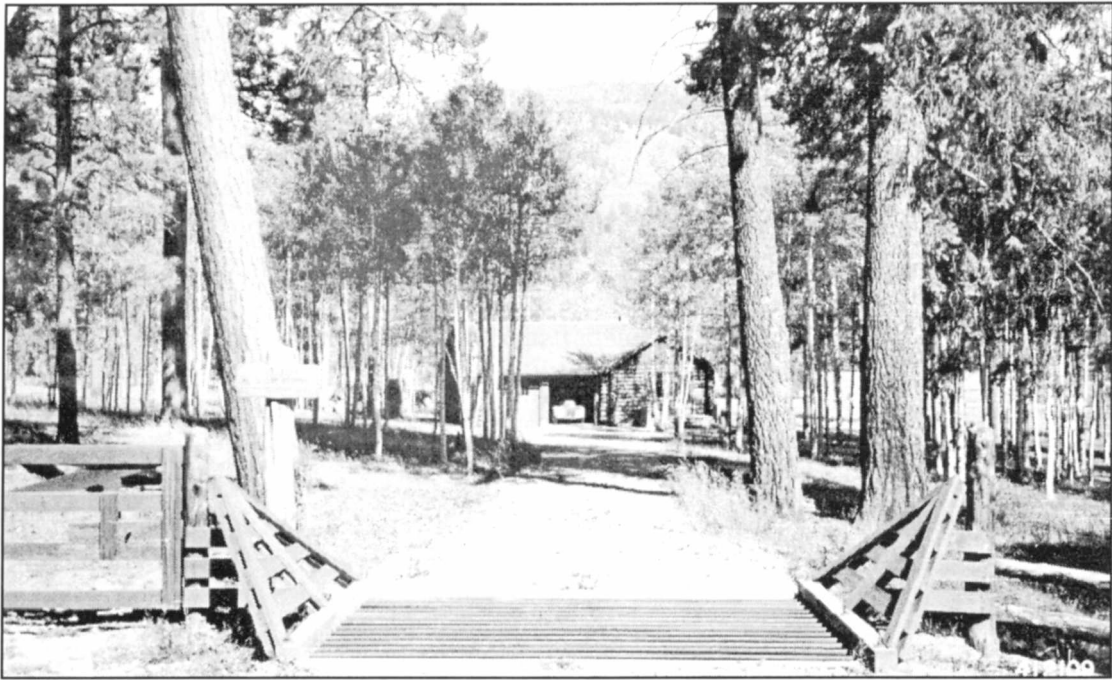
**Figure 155**  
Vallecito Guard Station  
From the Road Passing this Station.

| Building Name | Bldg. No. | Date | Builder | Style |
|---|---|---|---|---|
| Office | N/A | 1940-41 | CCC F-74-C | Rustic |
| Oil House | N/A | 1940-41 | CCC F-74-C | Rustic |

*Statement of Significance.* It is recommended that site 5LP3870 is not significant under Criteria A or C. Though associated with the development and administration of the San Juan National Forests, the site is not the best preserved guard station in Colorado. Better examples of rural stations, and the office's design, remain within the state.

and contained two stalls. Many combination office buildings also had two garage stalls (e.g., Figure 155, San Juan National Forest). Many barns, such as that seen at River Springs Ranger Station, also had one or more garage stalls.

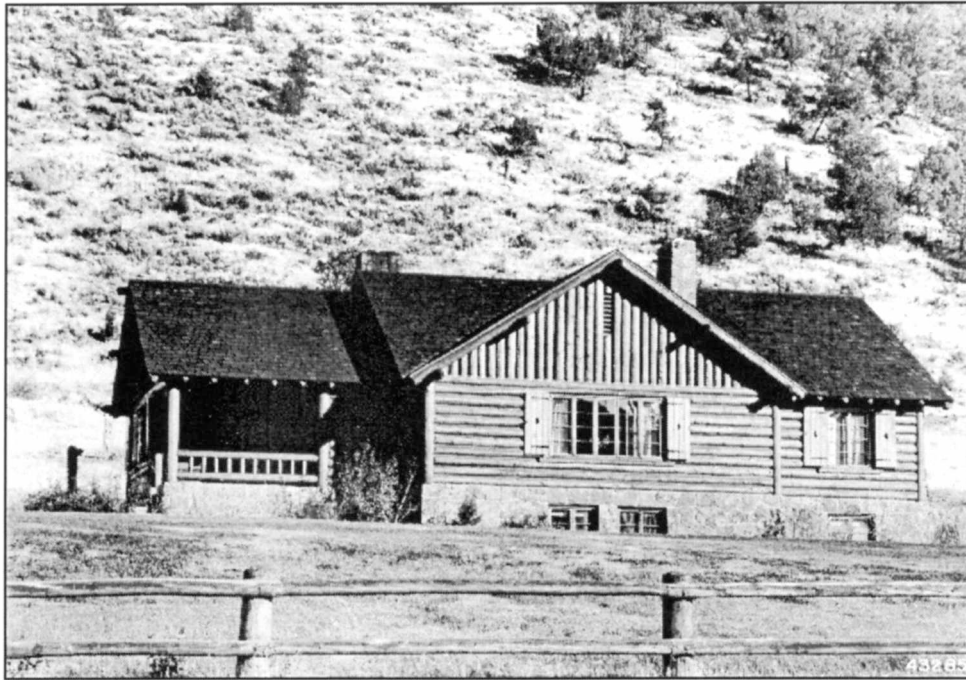
**Figure 159**  
Basalt Ranger  
Station Residence

| Building Name | Bldg. No. | Date | Builder | Style |
|---|---|---|---|---|
| Dwelling | WR311 | 1936-41 | CCC F-65,68,51-C | Rustic |
| Barracks | WR312 | 1936-41 | CCC F-65,68,51-C | Rustic |
| Garage/Shop | WR313 | 1936-41 | CCC F-65,68,51-C | Rustic |

*Statement of Significance.* It is recommended that site 5EA892 is significant under Criteria A and C. The site is associated with the development and administration of the White River National Forest. It is a very well preserved and masterful example of CCC construction. The site is laid out in classic USFS form and has several of the best examples of CCC-era Rustic ranger station design and construction in Colorado.

Buildings were constructed in stone (e.g., Figure 176, White River National Forest), brick (e.g., Figure 130, San Juan National Forest), adobe (e.g., Figure 83, San Isabel National Forest), milled wood (e.g., Figure 48, Arapaho National Forest), or logs (e.g., Figure 159, White River National Forest). The use of wood as a construction material was perhaps the ultimate expression of Forest Service values, and designers took every opportunity to use it. Though the cost of most building materials was depressed, wood was especially cheap, easy to work with, readily available, and reflected the pioneer architectural traditions of Rocky Mountain architecture. The Rustic Style was especially appropriate in the mountains, where wood shakes, native stone, and logs were the most economical materials available. Doors, windows, shutters, porch railings, interior walls, ceilings, and floors were all wood (Groben 1938:47). The Government-sponsored New Deal programs were encouraged to use commercially available materials as a stimulus to production. Forests purchased construction materials locally, through a central purchasing arrangement with the Regional Office, and sometimes directly from a mill under Forest permit. Processed wood products like Plywood, Compo Board, Celotex, and Nu-Wood were used extensively for interior finishes. Door and window hardware was purchased or fabricated by Forest Service or CCC shops. Most of the purchased material was local, but Forests occasionally imported logs, stone, and log cabin siding from nearby states. Native pine, spruce, and fir were not ideal species for log construction, but worked well enough to use. The tall slender trees gave distinction to Regional construction in Colorado. The use of brick as a finish material was discouraged by Groben, mainly because of the skill required to use it (Groben 1938:10). Region 2 used it regardless, both as a finish material on supervisors' warehouses and as infrastructure on stuccoed Pueblo-style buildings.

Rustic designs during this era had frame (e.g., Carbondale Ranger Station, Figure 161, White River National Forest) or log (e.g., Basalt Ranger Station, Figure 159, White River National Forest) construction. Log Rustic design used both native and imported stone and timber. Building footprints were simple, though often irregular. Foundations for all CCC-era design were constructed of 6"- to 12"-thick non-reinforced poured concrete on footings. Rustic designs were usually veneered with between 12" and 24" of locally cut stone. Wall logs were sometimes just peeled, but were typically shaved to a uniform diameter and saddle notched. Overhung crowns were usually about 12" long at the foundation line but several inches shorter at the eave line. Some designs varied the length of each crown, creating an irregular vertical edge. Log ends were sometimes cut flat, but most often came to a sawn or axe-cut blunt point. Logs were hewn on their bottom side, and oakum was laid between courses. Joints were sometimes caulked and reinforced with metal anchor bolts.

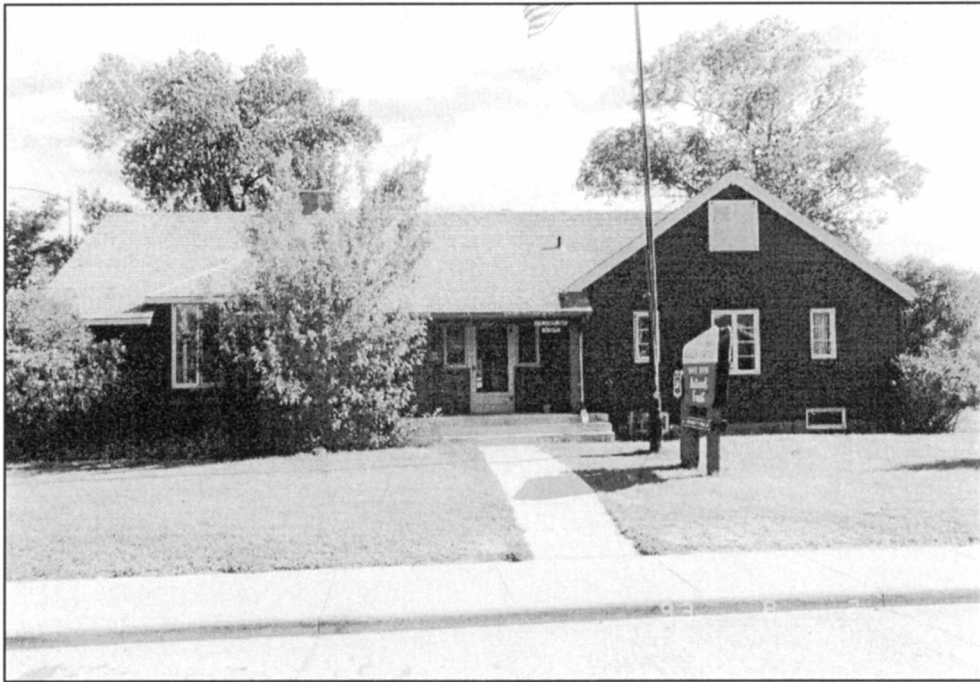
**Figure 161**  
Carbondale Ranger Station Dwelling  
View to the South

| Building Name | Bldg. No. | Date | Builder | Style |
|---|---|---|---|---|
| District Office | WR301 | 1940 | CCC F-65-C | Rustic |
| Zone Office | WR302 | 1937 | CCC F-65-C | Rustic |
| Garage | WR303 | 1938 | CCC F-65-C | Rustic |

*Statement of Significance.* It is recommended that site 5GF1483 is not significant under Criteria A or C. Though associated with the development and administration of the White River National Forest and the work of the CCC, this site and its buildings have lost much of their integrity of design, setting, and craftsmanship. Better examples of urban CCC-era ranger stations remain within Colorado.

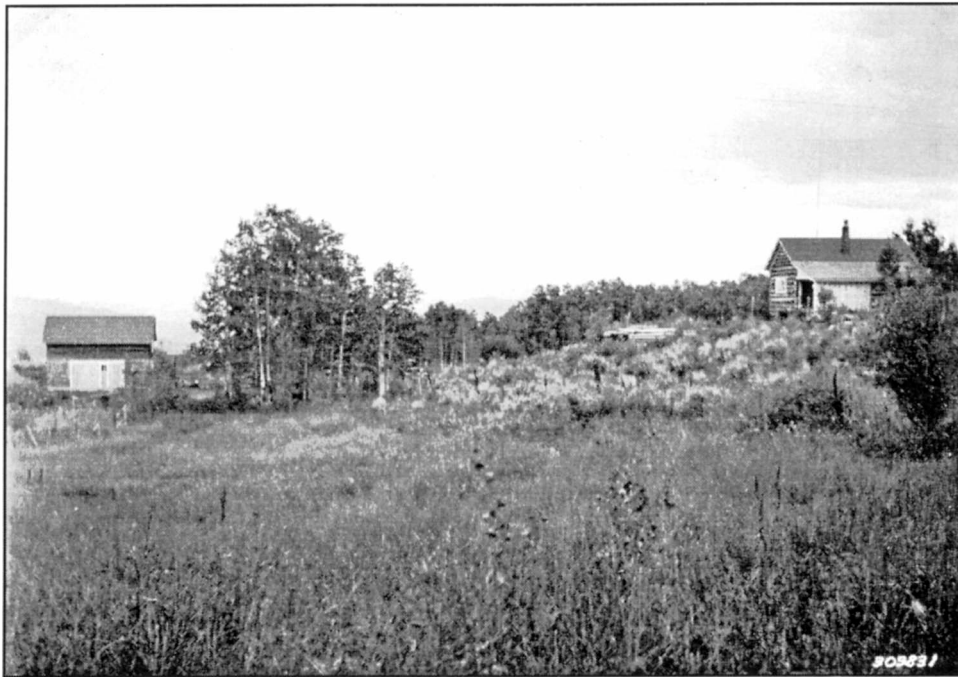
**Figure 164**

General View of Improvements at  
Derby Mesa Ranger Station

*Statement of Significance.* It is recommended that site 5EA889 is significant under criteria A and C. It is associated with the development and administration of the White River National Forest. Its formally designed but pioneer constructed buildings are well preserved and are architecturally significant as representative of the evolution of Forest Service Rustic design and construction. The dwelling is among the earliest USFS designed log cabins in Colorado. The site exhibits classic early ranger station layout characteristics.

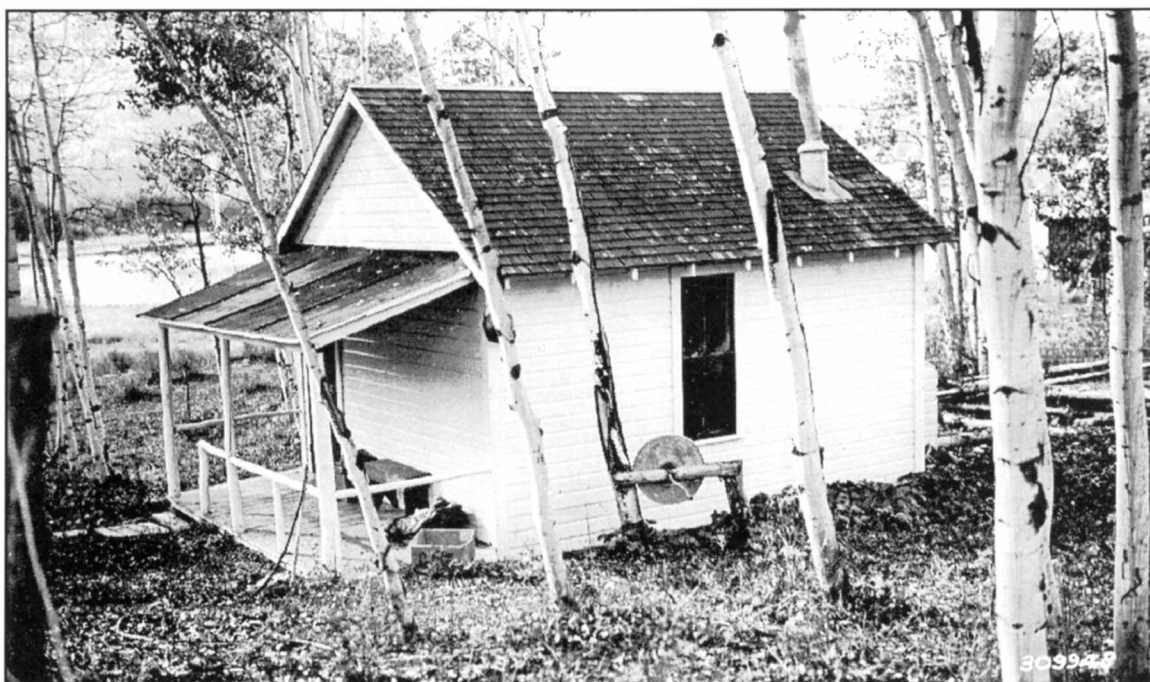
**Figure 167**  
Lily Lake Ranger Station  
Dwelling, Side View

*Statement of Significance.* It is recommended that site 5GN2551 is significant under criteria A and C. The site is associated with the development and administration of the White River National Forest. Though neglected, the site retains all of the characteristic elements of typical pre-CCC-era administrative design. The site is typical in its layout and contains several examples of standard 1920s USFS designed buildings. It is the best remaining guard complex of its era in Colorado.

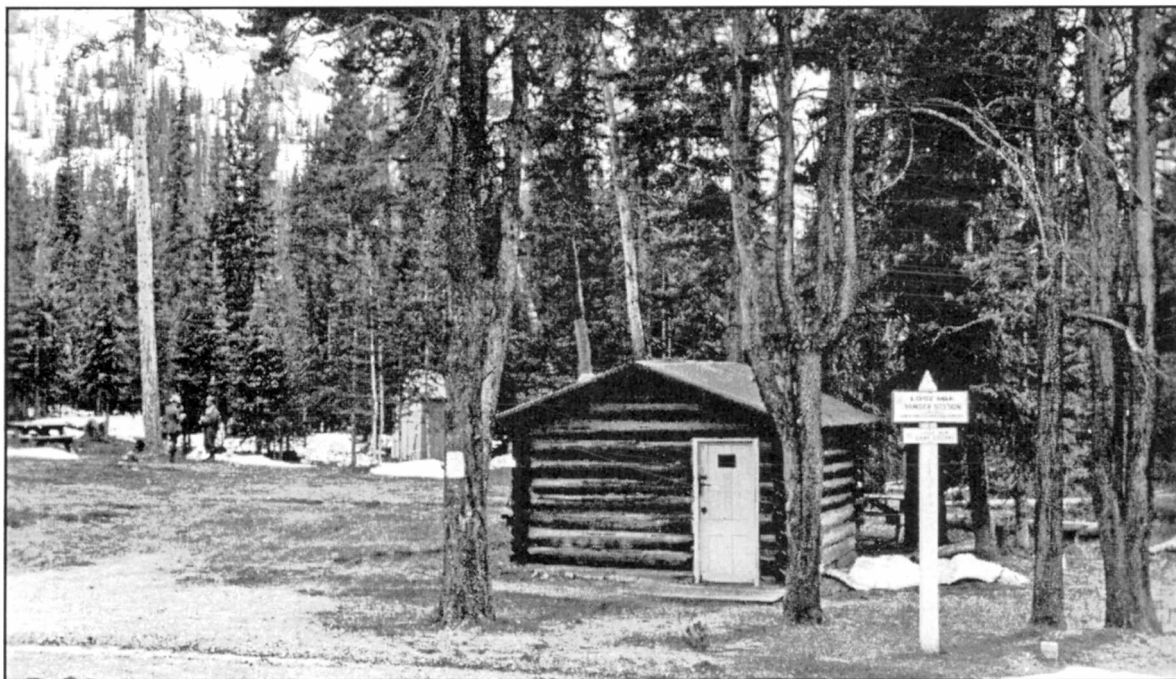
**Figure 169**

Lost Man Ranger Station Used  
Only as a Temporary Stopping  
Place

*Statement of Significance.* It is recommended that site 5PT547 is significant under Criteria A and C. The site, built by the USFS and the Mountain States Telephone Company, is associated with the development and administration of the White River National Forest and with the technological and cultural development of the state. It is a well kept example of a line cabin/guard station and pioneer construction.

Important considerations for site placement included the availability of water, protection from the elements, and accessibility to mail delivery and existing or potential access to telephone lines (Philips 1909), though established phone systems were rare. The District prioritized improvements that would most benefit area residents. As part of the Region's effort to link all stations (U.S. Forest Service 1916), many roads and phone lines in Colorado were originally established by the Service for administrative use. Several cabins constructed along line routes originally housed line crews but were later used for Forest Service administration. At Lost Man Guard Station (Figure 169, White River National Forest), the Forest Service cooperated with a local telephone company in the joint construction and use of a line/guard cabin.

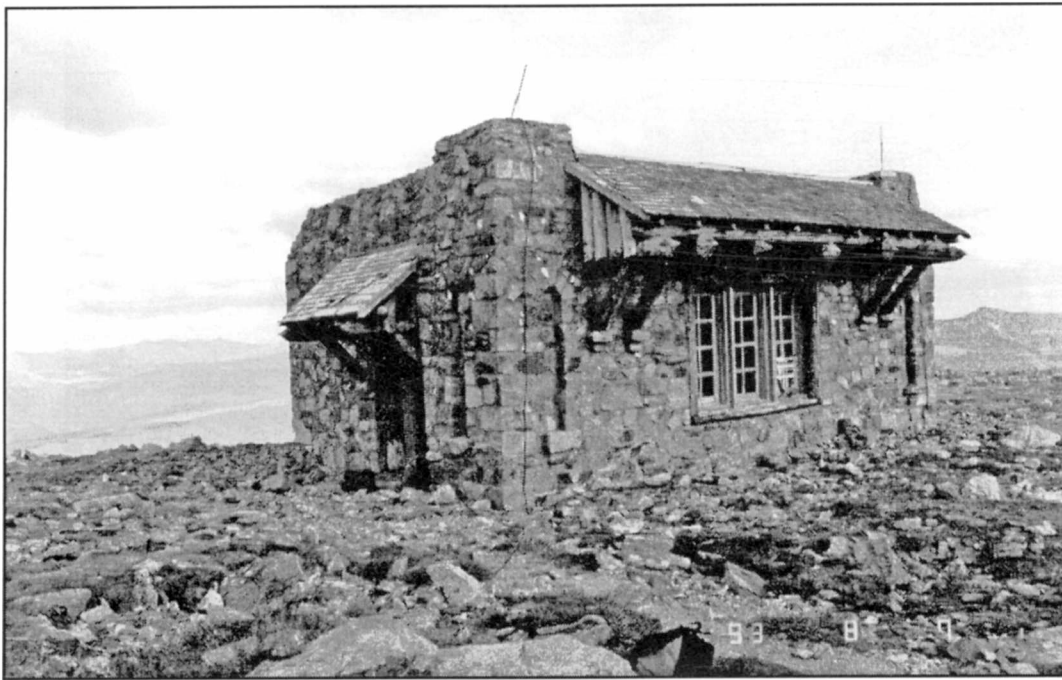
**Figure 176**

Notch Mountain Shelter  
View to the Northeast

*Statement of Significance.* It is recommended that site 5EA906 is significant under criteria A and C. It is representative of the role the CCC played in the recreational development of Colorado's National Forests. It is closely associated with the development of the Holy Cross National Monument. It exhibits a high degree of hand craftsmanship, retains a great deal of its integrity, and is a well established landmark within the region.

Construction of recreational improvements accelerated during Phase III. CCC enrollees constructed a variety of sites and buildings, including the Land's End Observatory (Figure 62, Grand Mesa National Forest), Tigiwon Community House (Figure 40), Notch Mountain Shelterhouse (Figure 176, White River National Forest) and campground toilets (e.g., Figure 98, Rio Grande

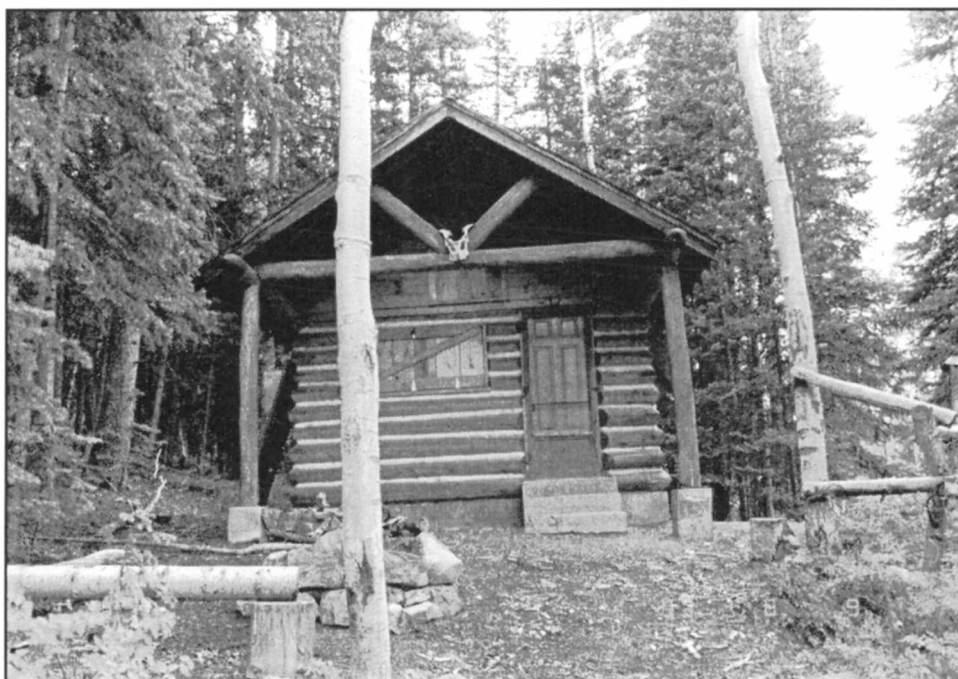
**Figure 177**  
Piney Guard Station  
View to the Southwest

*Statement of Significance.* It is recommended that site 5EA905 is significant under criteria A and C. It is associated with the development and administration of the White River National Forest. Its cabin is a well preserved and uniquely constructed example of a pre-CCC-era standardized design. The highly finished log walls and distinct notching are representative of the evolution of Forest Service Rustic design and construction.

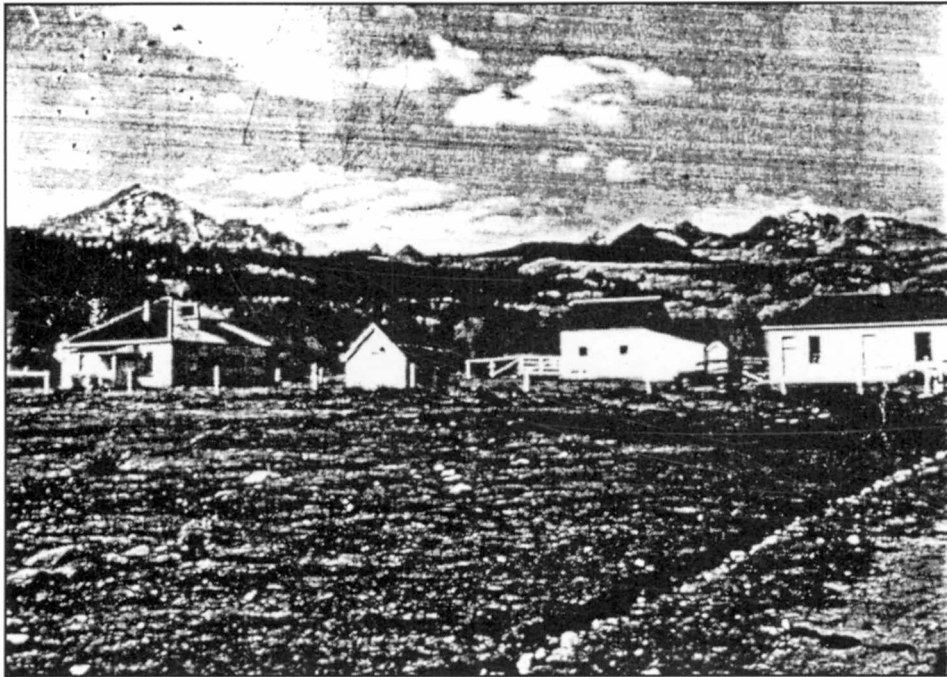
**Figure 178**  
Slate Creek Ranger Station  
Barn and shed in background

*Statement of Significance.* It is recommended that site 5ST622 is not significant under criteria A or C. Though associated with the development and administration of the Arapaho and White River National Forests, this site's two remaining buildings are not distinctive within Forest history, are not architecturally distinctive, and do not retain enough integrity to convey the feel and character of a ranger station. Better examples of ranger stations remain within the forest.

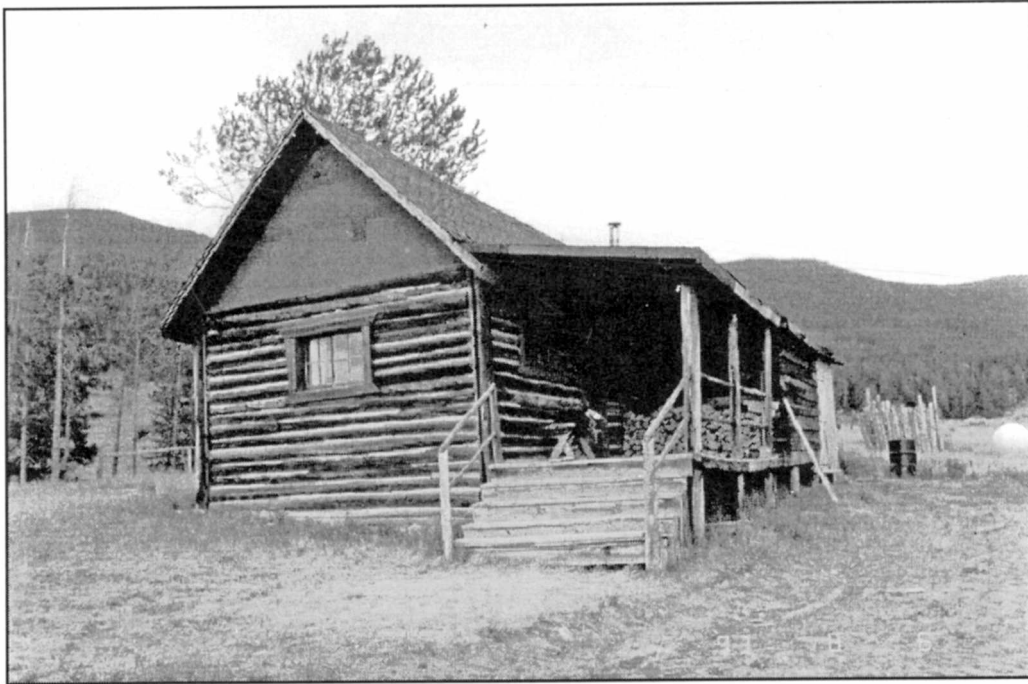
**Figure 179**  
Soda Creek Homestead  
View of Reynolds Cabin

*Statement of Significance.* It is recommended that site 5ST366 is not significant under criteria A or C. Its recent acquisition and use by the Forest Service is not significant to Forest history. The buildings are not distinctive in their design, materials, or method of construction. The site has been determined eligible for its association with ranching and recreation in Colorado.

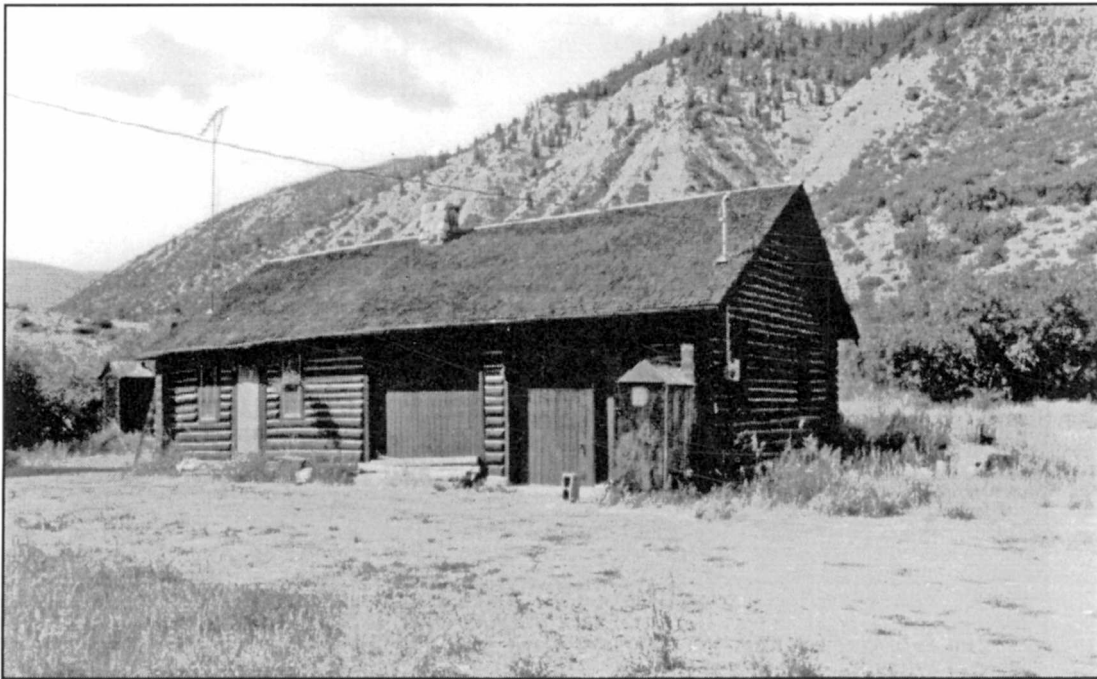
**Figure 180**

Sweetwater Guard Station  
View to the North

*Statement of Significance.* It is recommended that site 5GF1484 is not significant under criteria A or C. Though associated with the development and administration of the White River National Forest, this site is not distinctive or particularly representative of a CCC-era Guard Station. The dwelling has been modified and has lost integrity of design and function. Better examples of Guard Stations and Rustic architecture remain within Colorado.

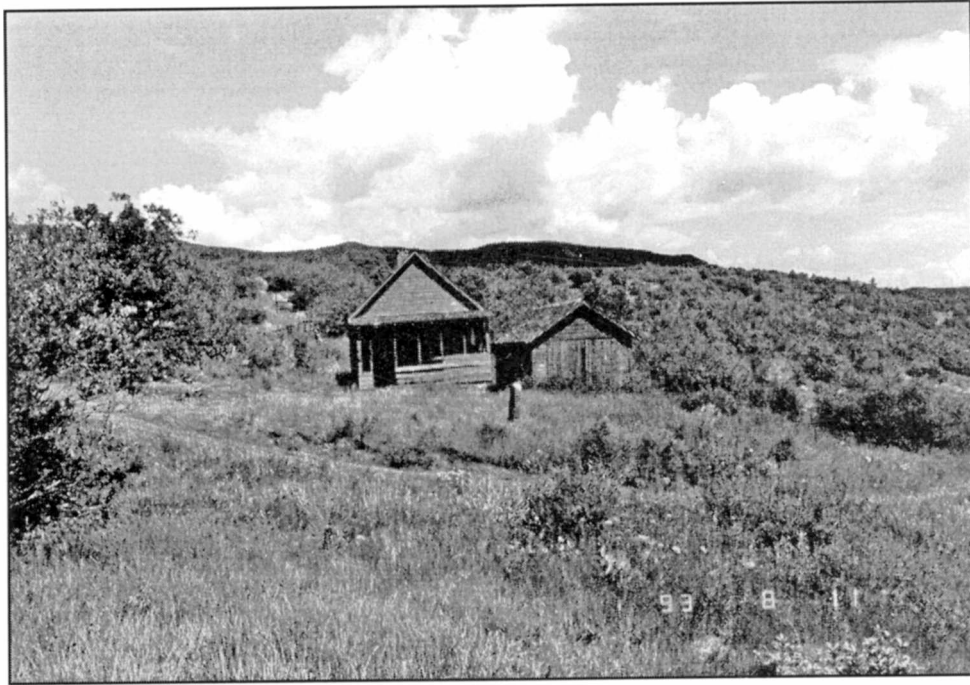
**Figure 181**  
Thompson Creek Ranger Station  
View to the Northwest

*Statement of Significance.* It is recommended that site 5PT554 is not significant under criteria A or C. Though associated with the development and administration of the White River National Forest, this sites buildings are indistinct as USFS pre-CCC-era design and construction. The site is deteriorated and not typical of administrative site layout of its era. Better examples of stations from this era exist on the Forest.

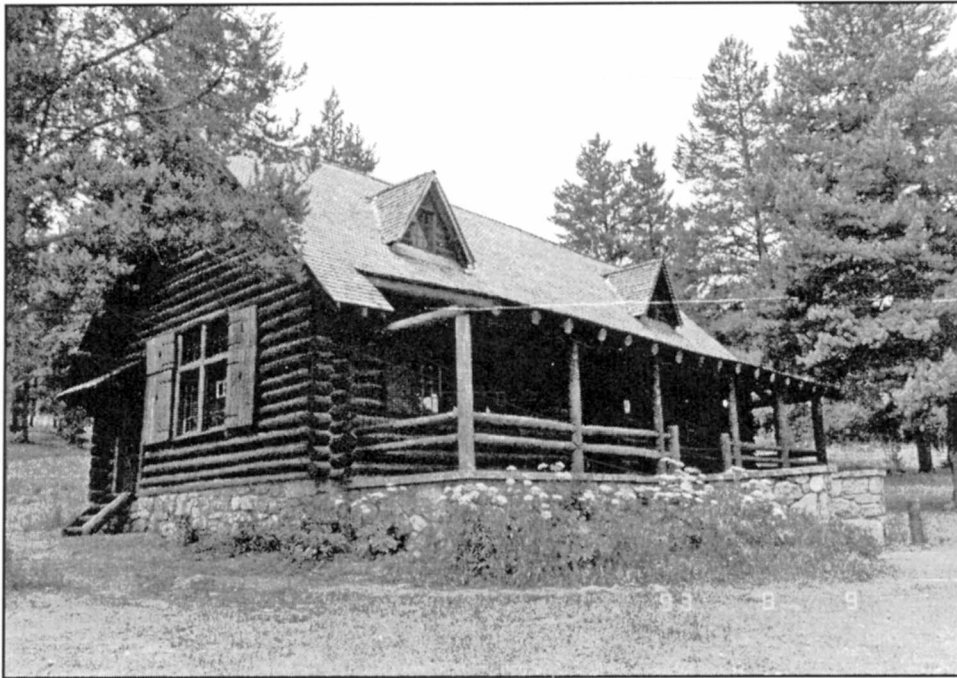
**Figure 182**

Tigiwon Community Building  
View to the South

*Statement of Significance.* It is recommended that site 5EA795 is significant under criteria A and C. It is representative of the role the CCC played in the recreational development of Colorado's National Forests. It is closely associated with the development of the Holy Cross National Monument. It exhibits a high degree of hand craftsmanship, retains a great deal of its integrity, and is a well established landmark within the region.

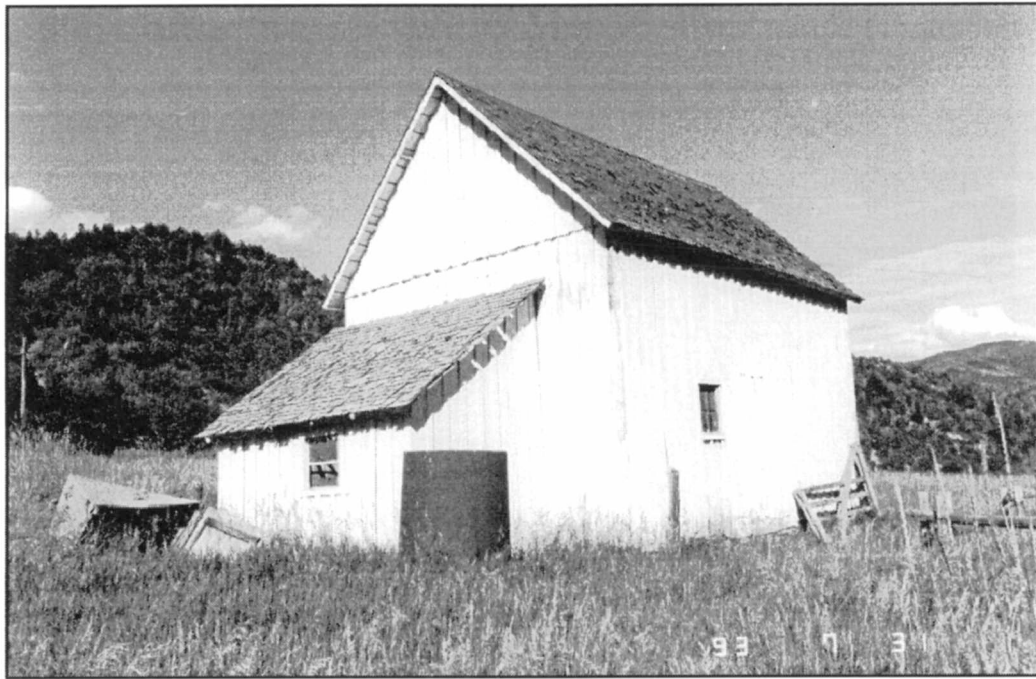
**Figure 183**  
West Elk Creek Barn  
View to the Northeast

*Statement of Significance.* It is recommended that site 5GF1486 is not significant under criteria A or C. Though associated with the development and administration of the White River National Forest, this site has only one remaining building that is not distinct within Forest history, is not architecturally distinct, and does not retain enough integrity to convey the feel and character of a ranger station. Better examples of ranger stations remain within the forest.

Sites were often located on flat areas near springs or streams. All evaluated Phase I sites were in rural areas. Sites could include a log dwelling (e.g., Derby Ranger Station, Figure 13), bunkhouse, a wood frame (e.g., West Elk Creek Barn, Figure 183, White River National Forest) or log barn (e.g., Platoro Work Center (Guard Station), Figure 107, Rio Grande National Forest), and a wood frame or log toilet. Associated features included spring developments, hitching posts, flag poles, corrals, pasture fences and an identifying sign, sometimes posted on the building or on a nearby tree.
