Vanderbilt Mansion National Historic Site  
Hyde Park, New York

## **Vanderbilt Mansion National Historic Site Historic Structure Report**

Volume II: Introduction to Physical Investigation; Exterior, Sub-Basement, Basement  
October 2018

**JOHN G. WAITE ASSOCIATES, ARCHITECTS**

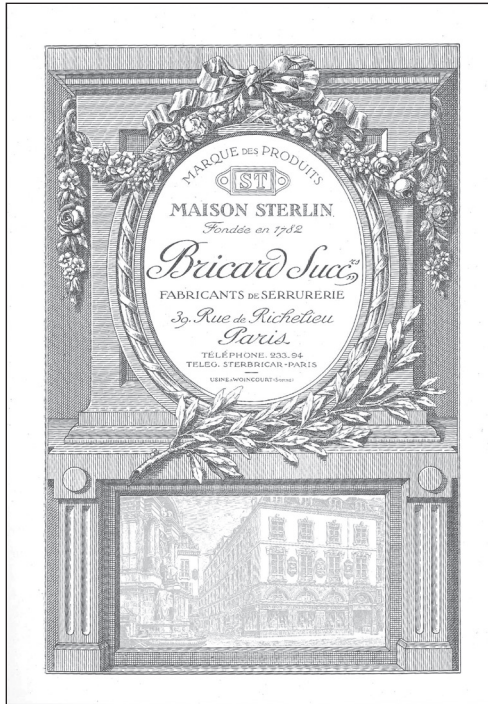
Figure 2. The frontispiece from the circa 1900 Bricard catalog.

The finest hardware used in the mansion was imported from France. The ornate Louis XV style ormolu bronze locks, knobs, levers, and hinges were supplied by the Parisian firm of Bricard, Fabricants de Serrurerie, 39 Rue de Richelieu. This firm was the successor to Maison Sterlin, founded in Paris in 1782. The hardware in the mansion is stamped "ST" for Maison Sterlin on the knobs, levers, and hinges. The circa 1900 Bricard catalog illustrates several of the hardware pieces found in the mansion (see Figure 2).<sup>2</sup>

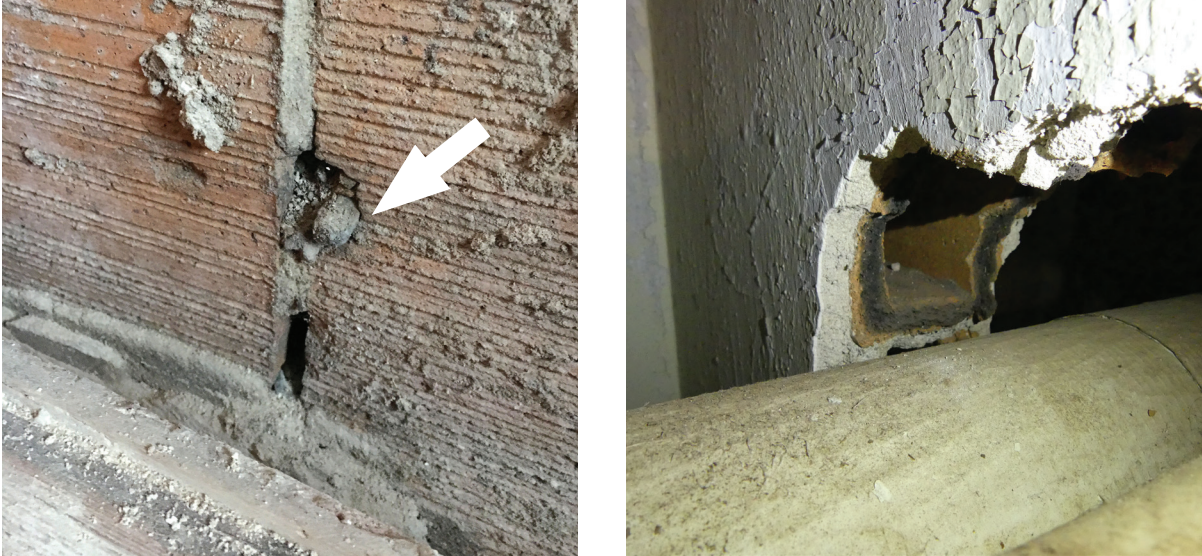
Figure 3. Wood trim was fastened to wood plugs set into the terra cotta tiles, such as this one in the Butler's Room (B13) (left). In the sub-basement stair hall (SB01), a hole cut through the wall reveals the cross-section of the terra cotta building tiles (right). JGWA, 2018.

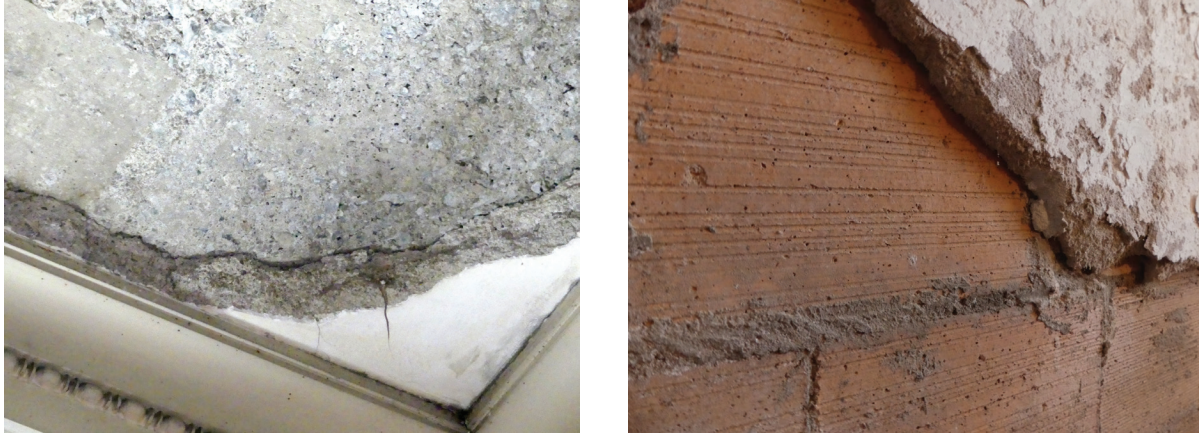
Figure 4. Areas of plaster damage reveal show the plaster layers applied directly to the masonry substrate: in the Empire Room (304) (left), the plaster is applied to the concrete roof slab; and in the Butler's Room (B13) (right), it is applied to the fireproof terra cotta tiles. JGWA, 2018.

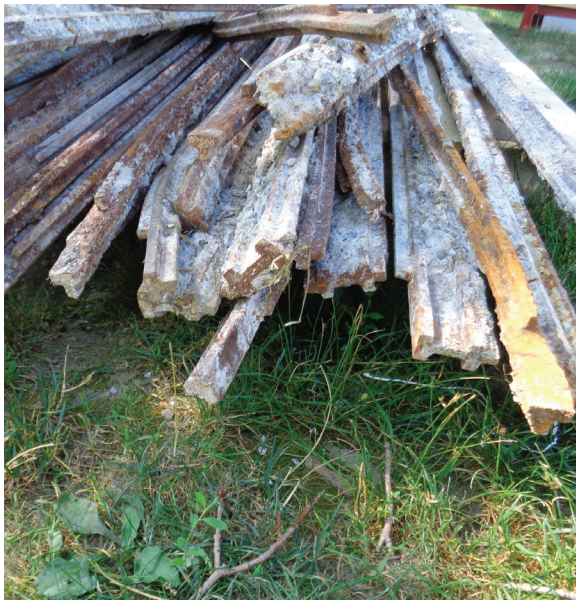
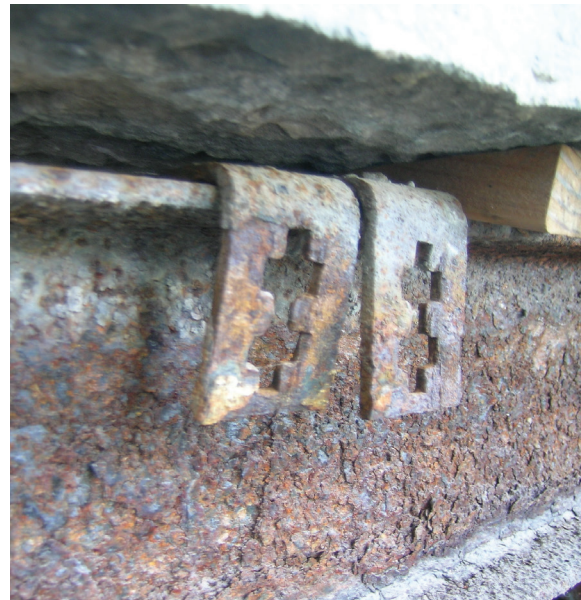
Figure 6. The mansion's framing included Columbian Fireproofing Company Reinforcing Bars. The two lower photographs show the double-T connecting bars and stirrups taken from the framing for the west porch floor. The upper drawing shows the system from the 1906 Sweets Catalog. The Architectural Record Company, "Sweet's" *Indexed Catalogue of Building Construction for the Year 1906*, 105.

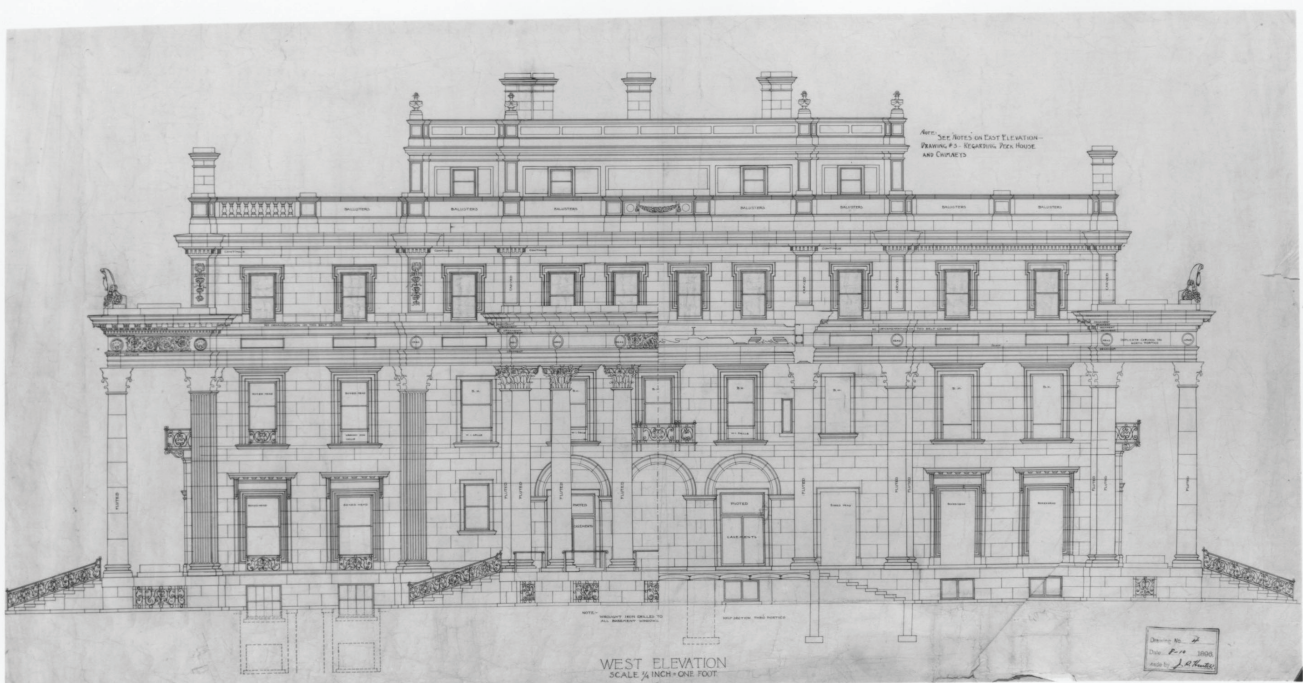
Figure 7. McKim, Mead & White drawings for the east elevation (upper image) and west elevation (lower image), August 10, 1896. Note the roof deck house. McKim, Mead & White Architectural Record Collection, PR 42, #3 and #4, Department of Prints, Photographs, and Architectural Collections, The New-York Historical Society, photographic copy in park archives.

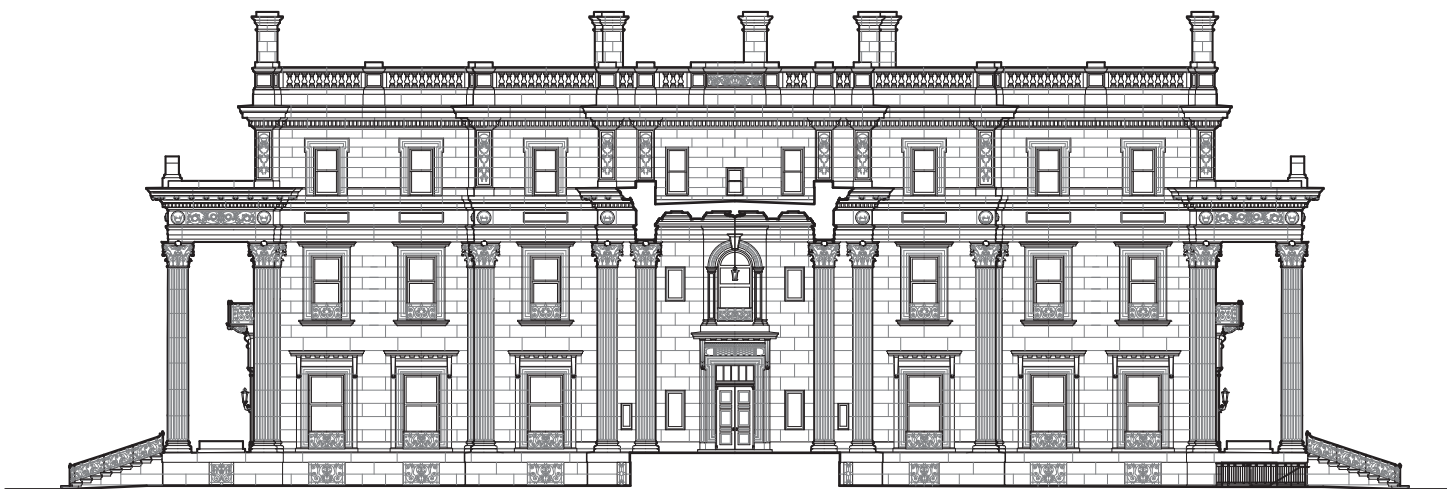
Figure 8. East elevation (upper image) and section through east portico (lower image). JGWA.

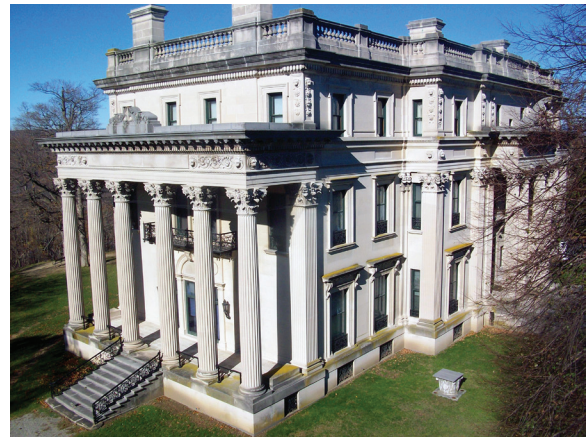
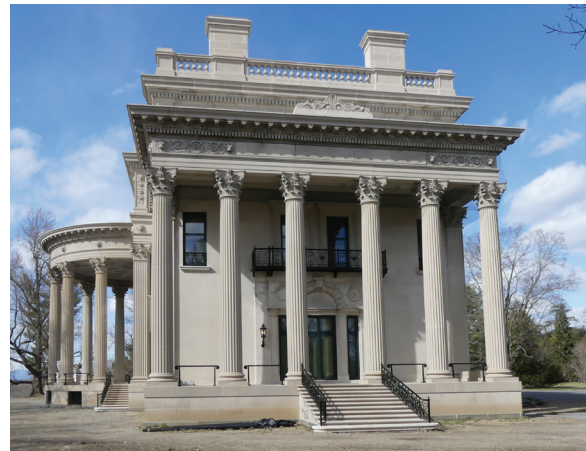
Figure 13. The mansion from the southwest, showing the south portico before the recent restoration (upper image); the south portico after restoration (lower image). JGWA, 2011, 2018.

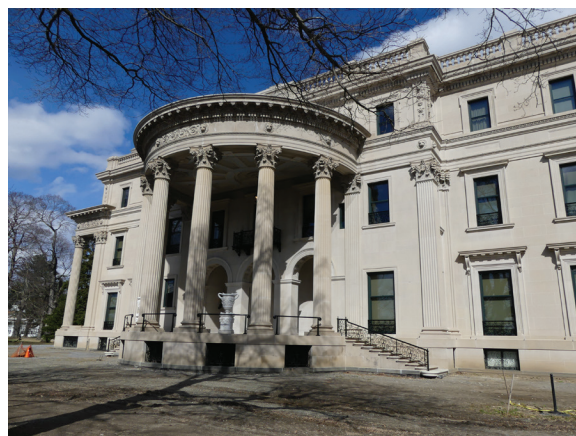
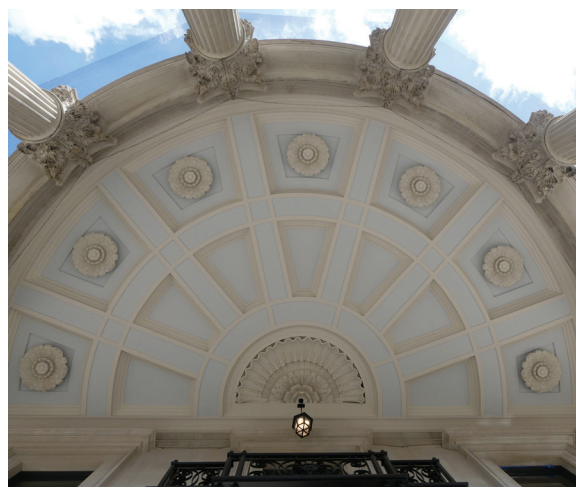
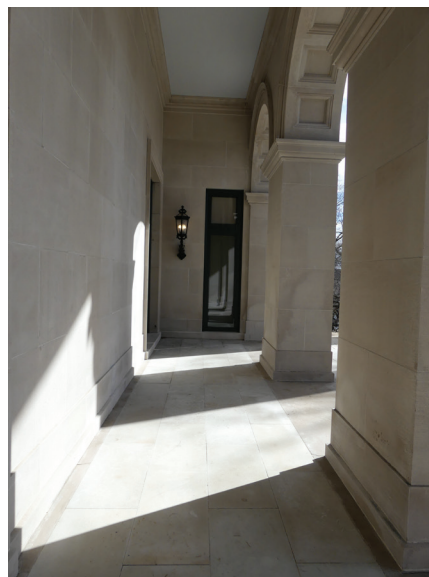
Figure 14. View from the southwest (upper image); the west portico ceiling (center image); and the loggia, looking south (bottom image). JGWA, 2018.

The stucco ceiling of the portico is divided into seven coffered bays, radiating out from a large semi-circular coffer embellished with a central rosette set in a shell and scallop medallion. The outer bays include plaster rosettes.

At center of the west façade, behind the portico, is a three-bay-wide arcade that opens to a one-story loggia. Each of the four piers supporting the arcade begins with a two-fasciae base, and continues up with a plain shaft trimmed with an abacus to a simple capital (ovolo, fascia, cyma reversa and fillet). Three-

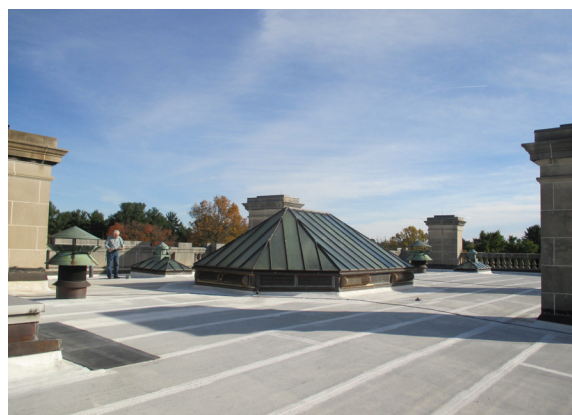
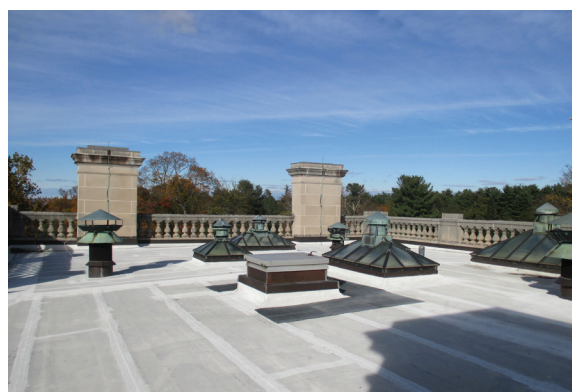
Figure 18. The mansion roof, looking southeast (upper image); northeast (center image); and towards the southeast chimney (bottom image). JGWA, 2017.

**SYSTEMS:** Large cast-iron plumbing vents to the north and south of the octagonal skylight, at the west side of the north wing, and between the service room skylights, have cone-shaped caps and ring-shaped baffles. Smaller tube-shape ventilators penetrate through the roof surface.

Copper lightning rods on the chimneys connect via copper cable conductors to the roof drain piping.

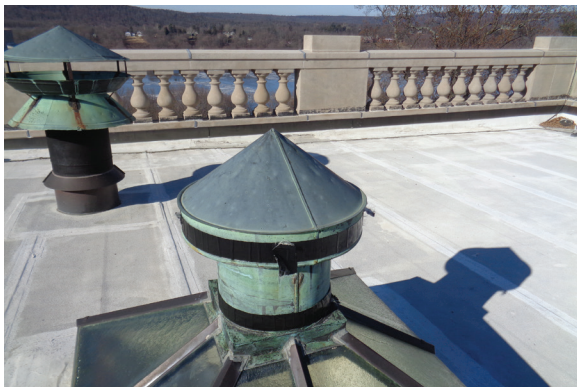
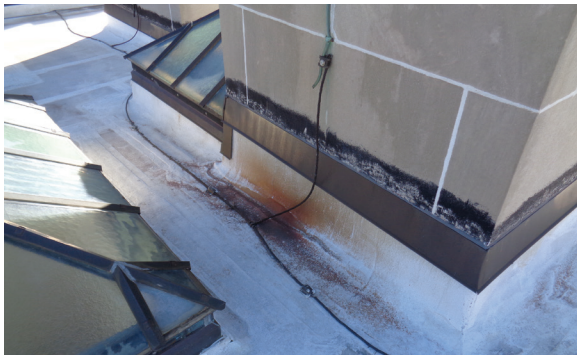
Figure 19. Given the recent extensive exterior restoration, most of the remaining problem conditions are at the roof, and in particular are related to the various roof penetrations such as skylights and vents (upper image). In the lower image, there is tar residue on the chimney stone. JGWA, 2018.

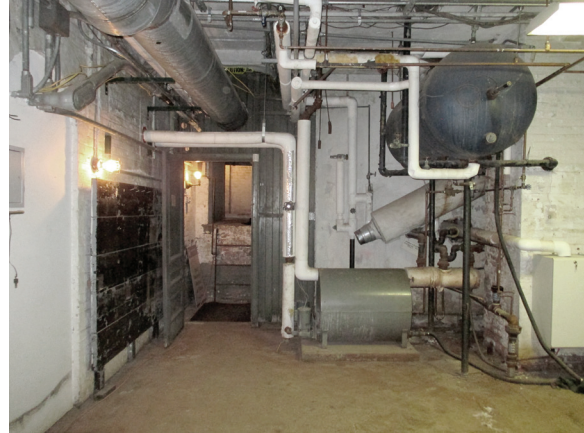
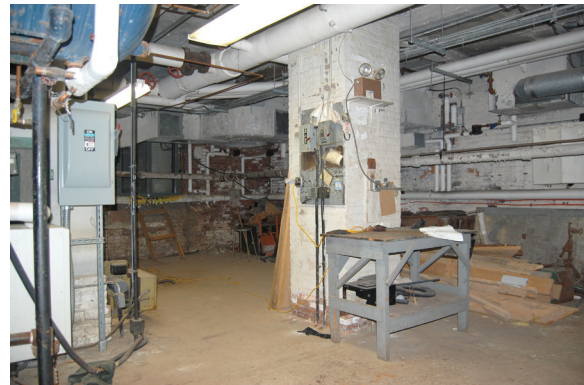
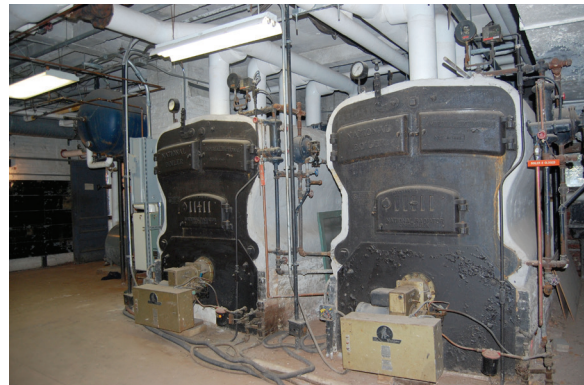
Figure 23. Old Boiler Room (SB02), looking south (upper image) and northwest (center image). The 1940s boilers (bottom image) are positioned in the same location in SB02 as the original boilers. JGWA, 2017.

The original, nearly square (32' x 32'-1") boiler room for the mansion fills the northwest area of the sub-basement. Many of the existing features in the L-shaped room are shown on the McKim, Mead & White floor plan: brick platforms for the two massive boilers next to the south wall; a sink to the west of the boilers; brick piers supporting the floor above; and two windows in the west wall (see Figure 20).<sup>24</sup> Two arched openings in the east wall are still in place, although they have been filled in with a door (in the northeast arch) and gypsum board. The plan shows this room open to the Stair Hall, but instead, a terra-cotta tile partition covered in plaster and a vertical beaded board partition incorporating a doorway enclose the hall. Originally, partitions enclosed the northeast end of the room for coal storage; there is no evidence for these partitions now.

**FLOOR:** The floor is original poured concrete. North of the boilers, the floor slopes gently down to a drain. The boilers are supported on brick platforms. Both of these features are shown on the McKim, Mead &

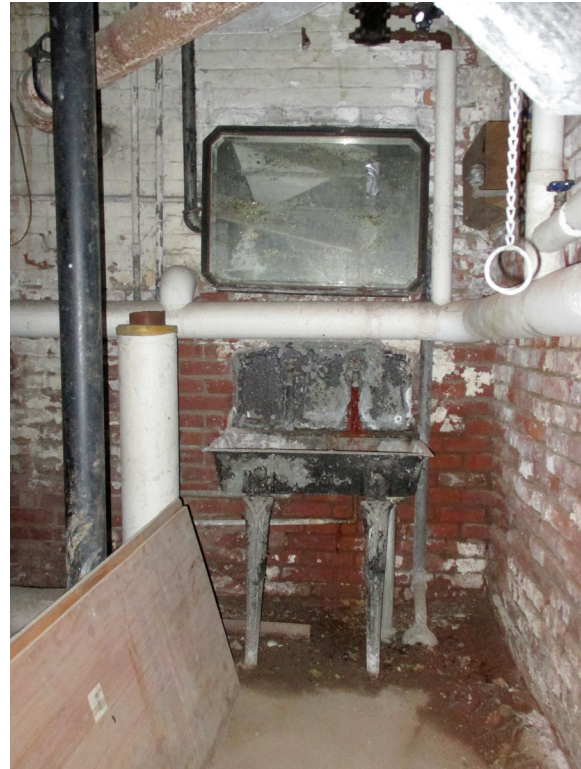
Figure 24. A Vanderbilt-era sink remains in its original location in the southwest corner of the space. JGWA, 2017.

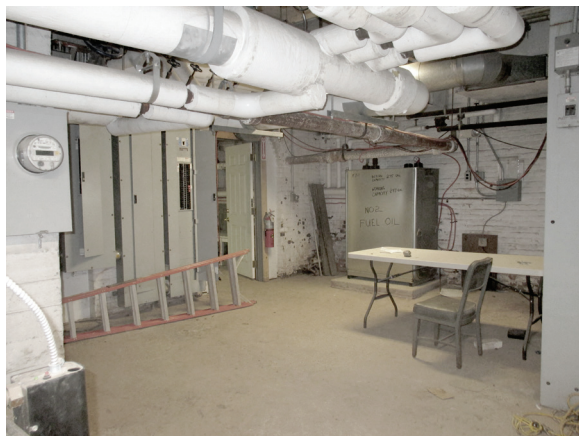
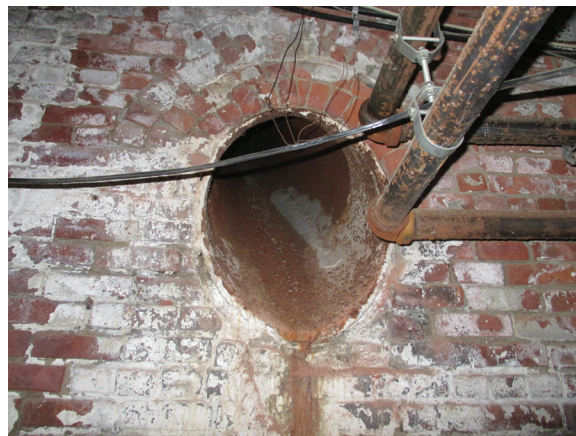
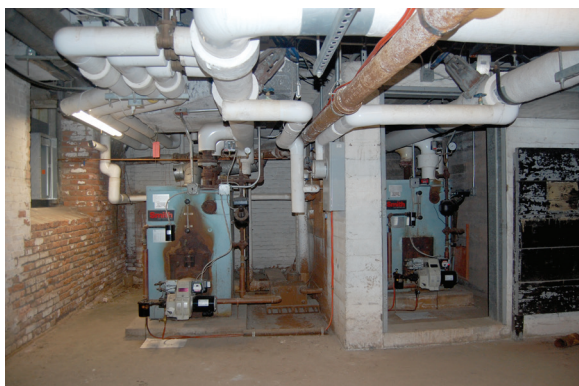
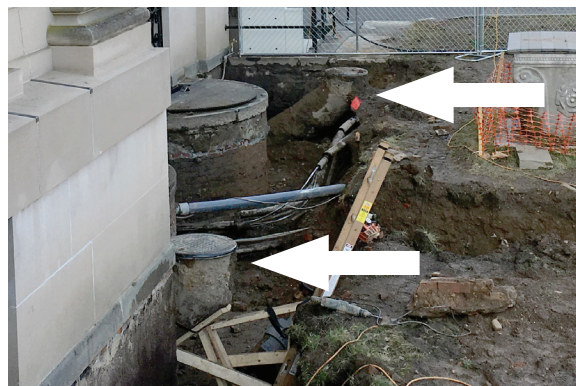
Figure 25. The space that stored the coal and wood (SB03), looking northwest (upper image) and south towards the current boilers (lower image). JGWA, 2017.

Figure 26. The original two coal chutes are still intact in the east wall of SB03 (upper image). Recent excavation work around the foundation revealed the exterior outlets (lower image). JGWA, 2017.

Wood trim at the townhouse was attached to porous terra-cotta, which needed to contain "50% of saw dust before burning and shall be able to receive and hold a nail without splintering or fracture..." The Florham specifications expected that the contractor would build in the blocking needed to "receive nailings for the carpenter's work." That type of blocking can be seen in the Vanderbilt's Chef's Room (B13), where part of the chair rail has fallen away from the wall, revealing small round holes in the edges of some of the tiles for round nailer pegs (see Figure 26).

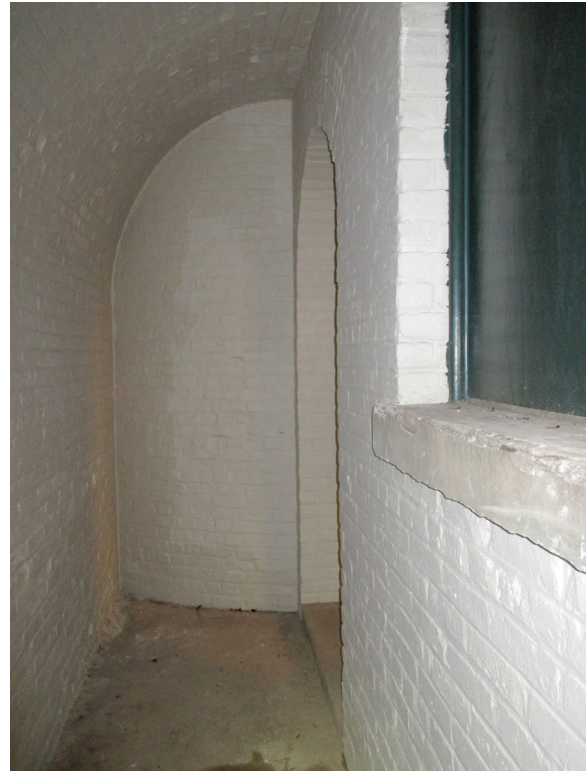
Figure 27. The Passage/Window Well (SB04), looking south. JGWA, 2015.

This tall, narrow areaway (3'-5" wide x 15'-5 3/4" long) is positioned beyond the east foundation wall of the sub-basement. It includes a doorway and a

window opening in the foundation wall. The existing conditions match those shown on the McKim, Mead & White floor plan (see Figure 20).<sup>27</sup>

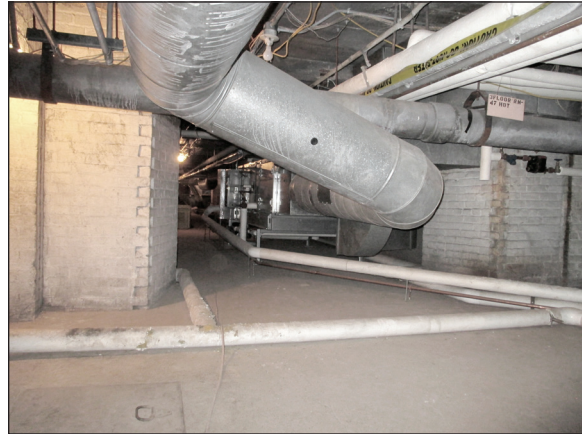
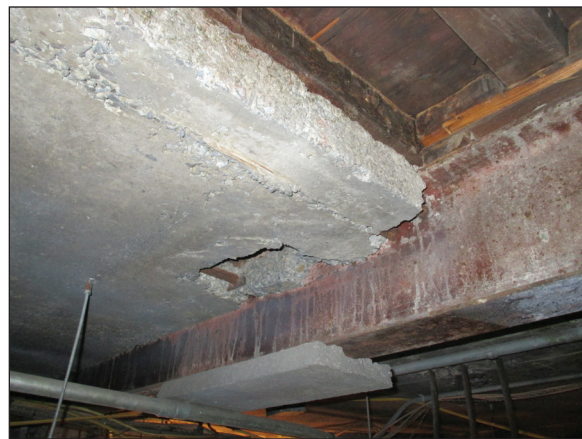
**CEILING:** A 9" deep steel I-beam extends east-west, supporting the structure of the 4-1/2" thick concrete ceiling (6'-2 1/2" above the floor). The beam was encased in concrete, but much of the concrete is missing. In the northwest corner of the ceiling is the wood-framed access hatch to the north Hall.

Figure 28. SB05 (the north end of the raised sub-basement) looking south (upper image) into SB06; the ceiling structure of the sub-basement, as revealed at the wood hatch up to the basement North Hall (lower image). JGWA, 2017.

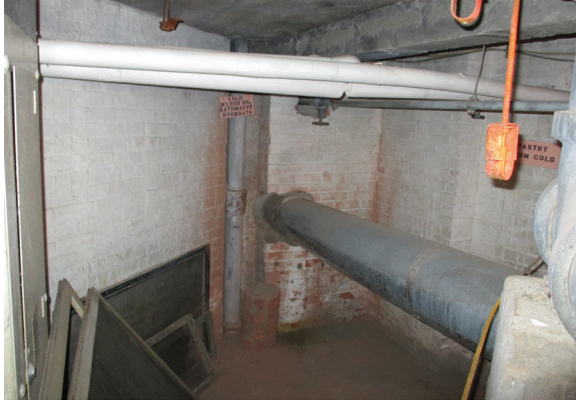
Figure 29. SB07, looking north (upper image); and SB08, looking southwest (lower image). SB08 retains a Vanderbilt-era light bracket and shelf, seen in this image to the left of the doorway. JGWA, 2017.

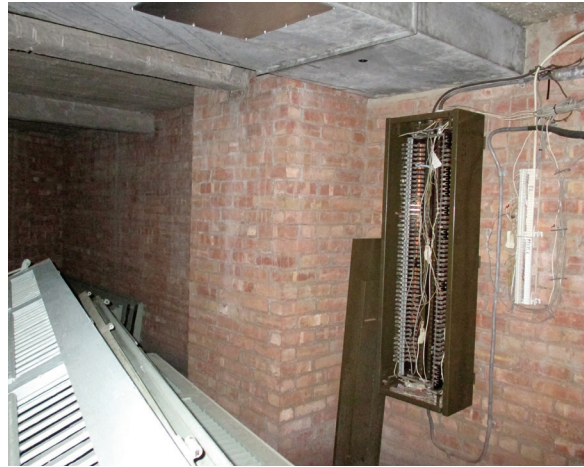
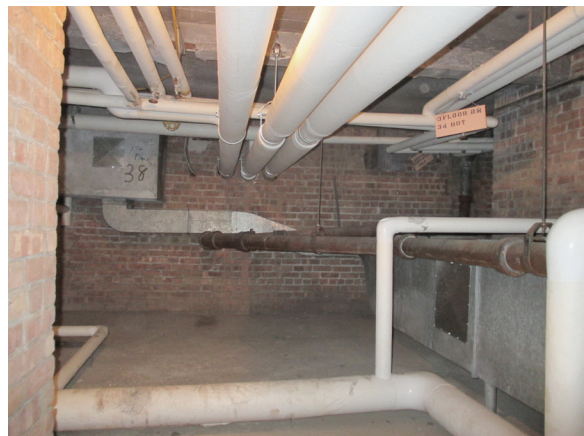
Figure 30. In SB10 (upper image), the east area of the elliptical section, the telephone panel for Franklin D. Roosevelt's World War II switchboard remains on the west wall; view of SB11, looking south (lower image). JGWA, 2017.

A significant feature found in this room is the steel telephone switch box on the west wall. This apparatus was installed in the early 1940s to service Franklin Roosevelt's third floor switchboard.

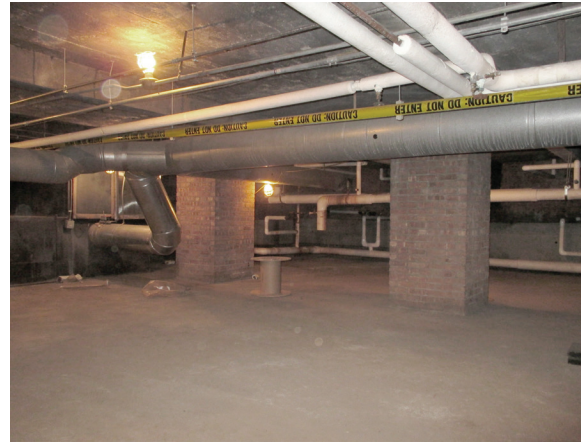
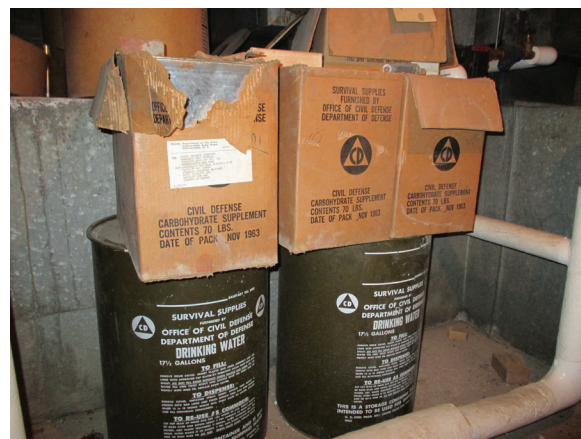
Figure 32. The south end of the sub-basement (SB14), looking southeast (upper image); and the bomb shelter supplies in SB15 (lower image). JGWA, 2017.

This room was used to store fallout shelter food supplies distributed by the United States Office of Civil Defense in the 1960s (see Figure 32).

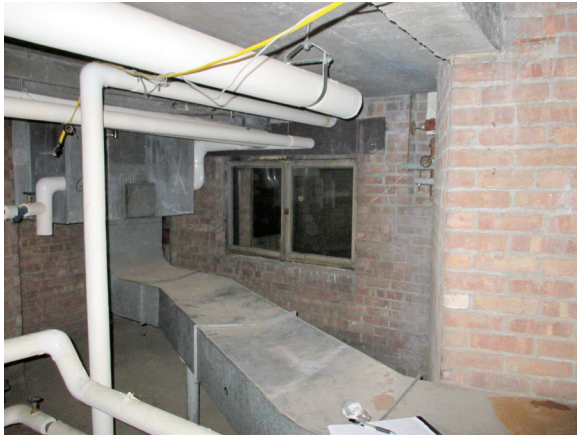
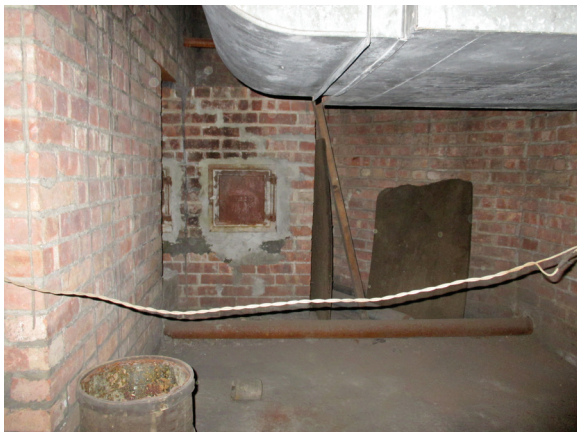
Figure 33. The area west of the elliptical section (SB16), looking towards the southwest window (upper image); and the original boiler-flue cleanout doors in the north wall of SB17 (lower image). JGWA, 2017.

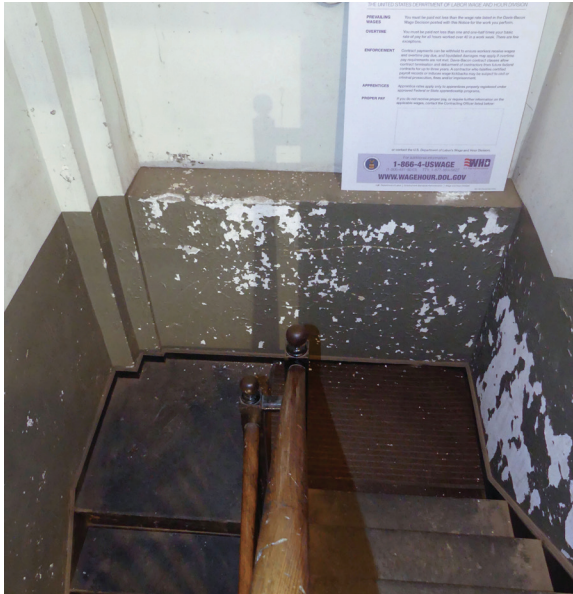
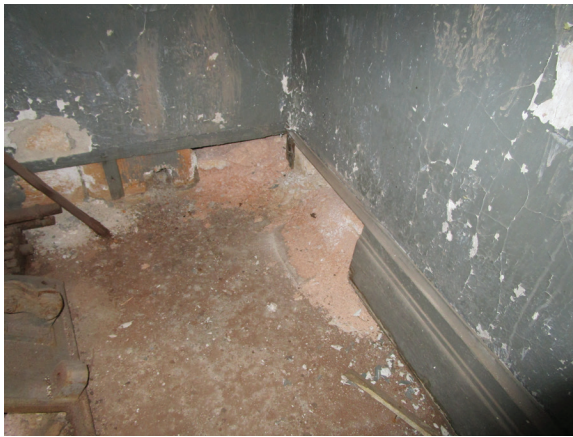
**Figure 34.** In the upper image, rising damp has severely compromised the terra cotta block wall surrounding the stair to the subbasement. This underlying condition has also adversely effected the paint at the landing level of the stairs, and surface rust covers much of the metal components of the stairs. In the lower image, the terra cotta block wall to the south of Room SB02 is severely compromised by rising damp, and the adjacent wood trim is also deteriorated. JGWA, 2018.

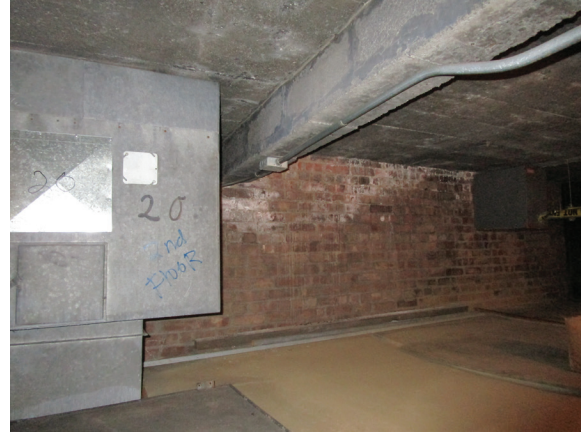
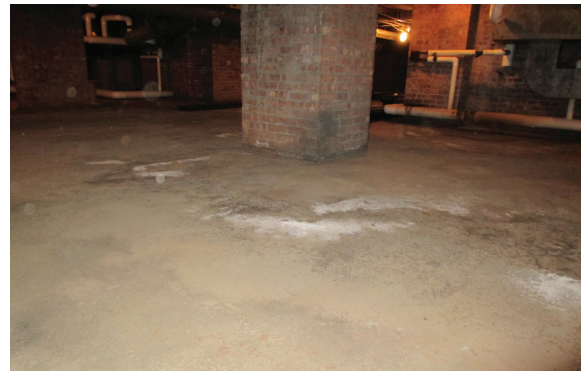
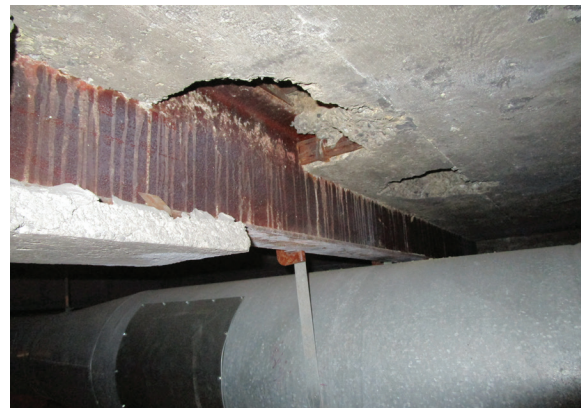
- Moisture staining and efflorescence are visible at the low areas of the floor on the east side of the space and around the opening into room SB15 to the west.

Figure 35. (Upper image) Evidence of moisture in the sub-basement can be seen on perimeter walls, where efflorescence and related mortar and brick deterioration are present, and in the center of the floors in some rooms. Evidence of standing water at low points in the floor (center image) are often accompanied by salt deposits around their perimeter. Rising damp can be seen at the base of some of the central piers.

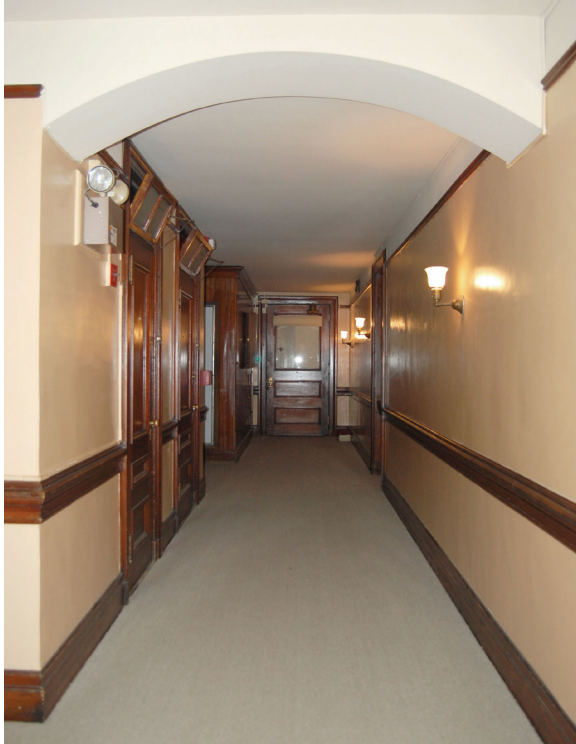
Figure 39. The North Hall, looking north. JGWA, 2017.

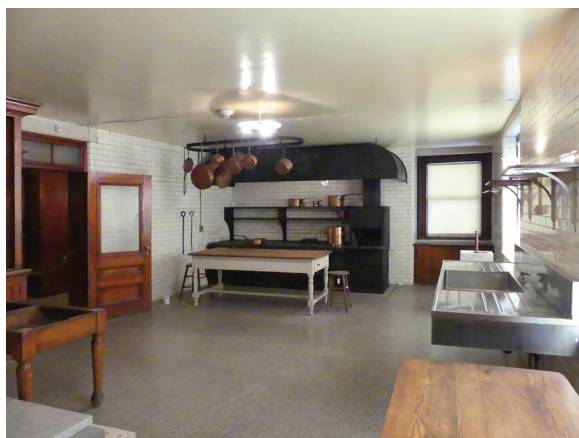
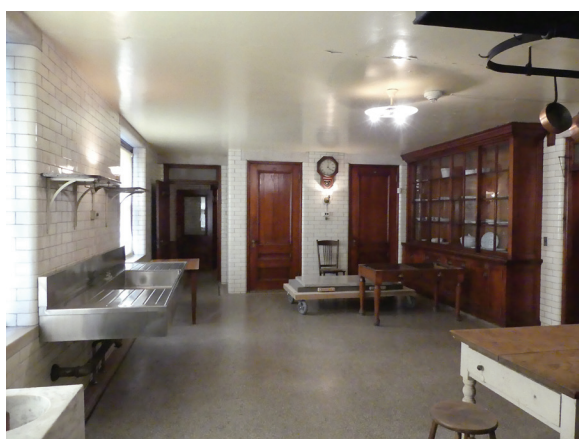
Figure 41. Kitchen, looking north (upper image) and south (lower image). JGWA, 2018.

**HEATING:** A decorative cast-iron ventilation grille is placed in the north wall, above the stove. There is no evidence for a radiator, as heat was provided by the range. The grate, painted light cream, is a different pattern than found elsewhere in the house, more of an arabesque design, with geometric shapes around the edge and stylized quatrefoils at the center.

**PLUMBING:** McKim, Mead & White’s floor plan shows a sink with integral drainboards, similar to the one in the Scullery, but larger. According to Tom Morgan, the houseman, the original sink was of white porcelain.<sup>56</sup> A Monel metal sink (VAMA 7020) is now mounted to the east wall, between the windows. The Monel sink is of a type and size available beginning in the 1920s, and it may well have been installed before Mr. Vanderbilt’s death. The faucets were replaced in 1942.<sup>57</sup> The tub in the center is flanked by integral drain boards.

**COMMUNICATIONS:** The mouthpiece for a speaking tube remains in the wall between the south closet doorways; speaking tubes are also found in the Vanderbilts’ bedrooms and in the Butler’s Pantry. A small wood plaque at the top of the west wall, between the hall doorway and the built-in cupboard, held a Vanderbilt-era electric bell (now removed). Similar bells can be found throughout the service areas.

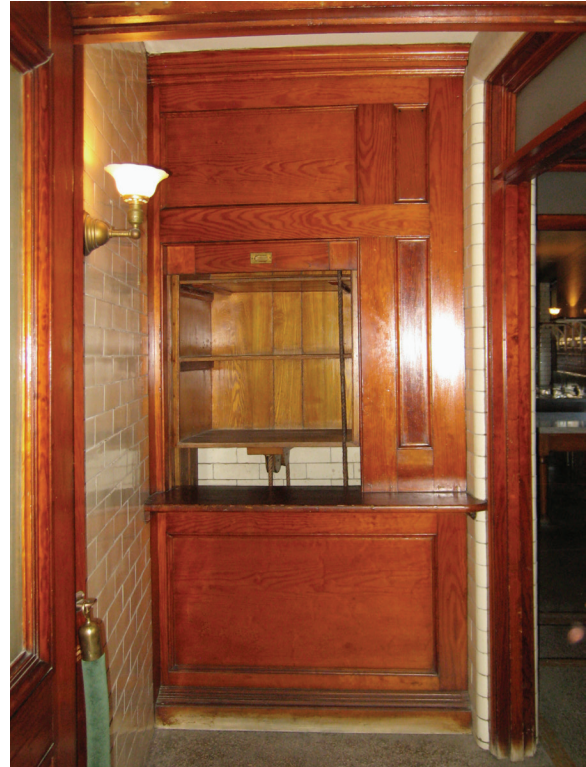
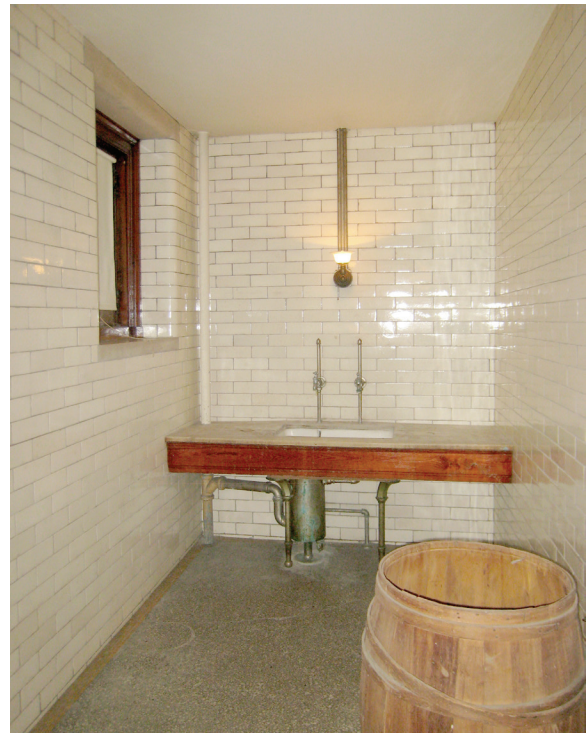
Figure 43. The Dumbwaiter, looking north (upper image); the Scullery (B02), looking east (lower image). JGWA, 2013.

**LIGHTING/ELECTRICAL:** An original brass electric wall bracket on the east wall of the Scullery has an opal-glass shade and a pull chain. Three pipes, closely set together, rise from the mounting box up to the ceiling. The center pipe is used for electrical wiring; the function of the two flanking pipes and the caps on the side of the box has not been determined.

**PLUMBING:** The white enameled ceramic sink is set in a worn, unfinished wood counter with integral drain boards on either side of the sink (VAMA 7026). Two ornamental bronze legs support the sink and counter. Pipes extending up from the hot and cold faucets are capped with acorn finials marked “Em-Ess Meyer Sniffen.” The large “Tucker” grease trap beneath the sink was also manufactured by Meyer Sniffen. The firm’s catalog promised that

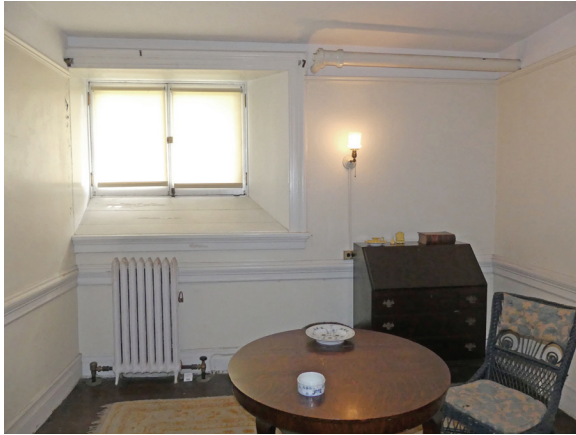
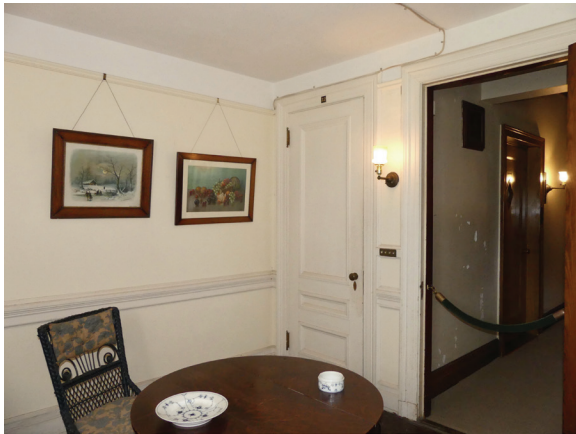
Figure 45. The Housekeeper's Office (B03), looking east (upper image) and southwest (lower image). JGWA, 2018.

plastered canted reveal at the south end; the jamb is straight at the north end. The architrave framing the opening matches the door trim. The opening sits above a molded sill with a plain apron and holds a pair of two-light casement sash. The sash are painted off-white. Hardware includes pairs of bronze hinges with ball finials (five knuckles each), a bronze casement fastener with a T-handle, and a slide bolt at the bottom of the south sash.

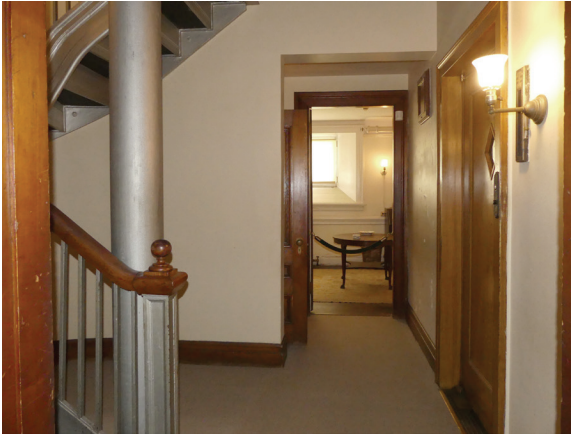
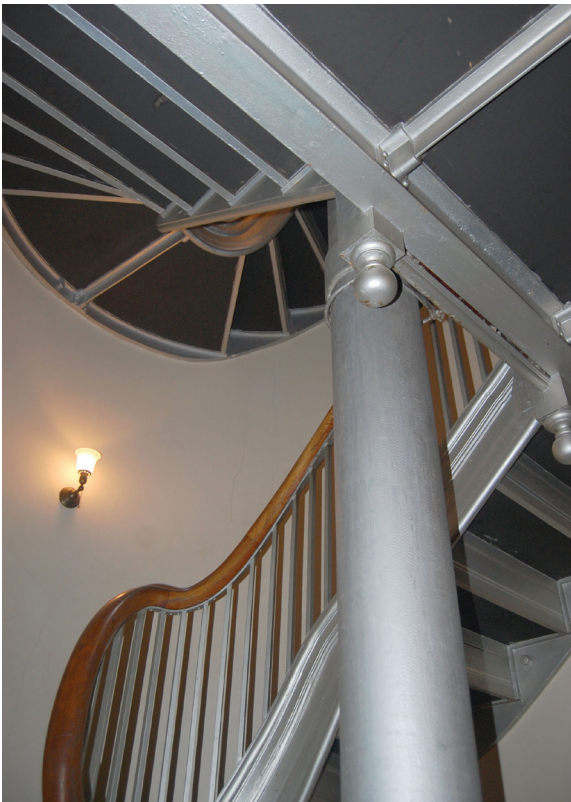
Figure 47. Service Stair at the basement level (upper image); and view of the stair as it ascends from the basement to the first floor (lower image). JGWA, 2018.

**Elevators:** Each of the 3'-0" x 7'-0" exterior elevator metal doors has a single recessed panel with a cyma recta molded panel edge and a small diamond-shaped window centered at eye-level, with chicken wire imbedded in the glass. Like the trim, the doors are faux-grained to resemble oak. **Hardware:** Each door has a bronze knob on the exterior face and a bronze plate with a recessed pull on the interior space. At each level, the door is mounted with heavy duty bronze spring hinges to the east jamb to open into the Service Stair hall.

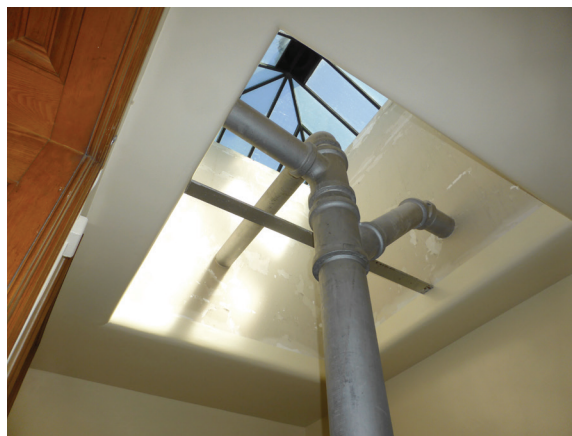
A metal bar that extends east/west across the bottom of the light shaft supported a pulley mechanism for a small, open dumbwaiter caddy that moved up through the open well of the stair; the caddy is still in the collection. The ropes extended down through holes that remain in the basement level floor, next to the later roof drain pipe; there is no evidence in the sub-basement for the pulley mechanism.

Figure 48. The Service Stair: skylight shaft above the stair (upper image); and looking down from the third floor (lower image). JGWA, 2017.

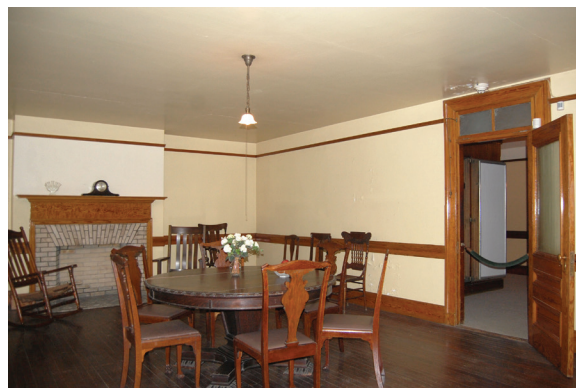
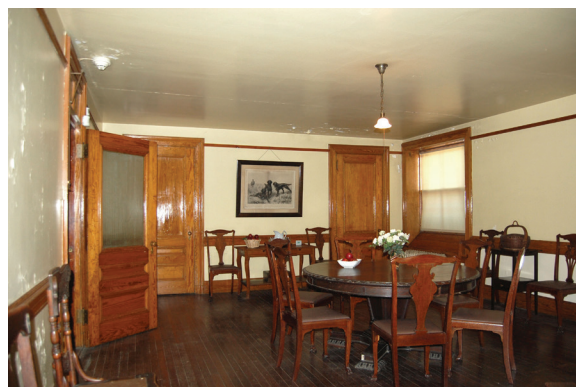
**FIREPLACE:** The decorative fireplace in the north chimney foundation has no flue. The hearth is of beige brick laid in a herringbone pattern. The firebox is also

Figure 50. Servants' Hall (B14), looking northeast (upper image) and south (center image). An annunciator in the collection (lower image) may have been used in the Servants' Hall. JGWA, 2017.

of beige brick, but has been patched with a buff-color brick.

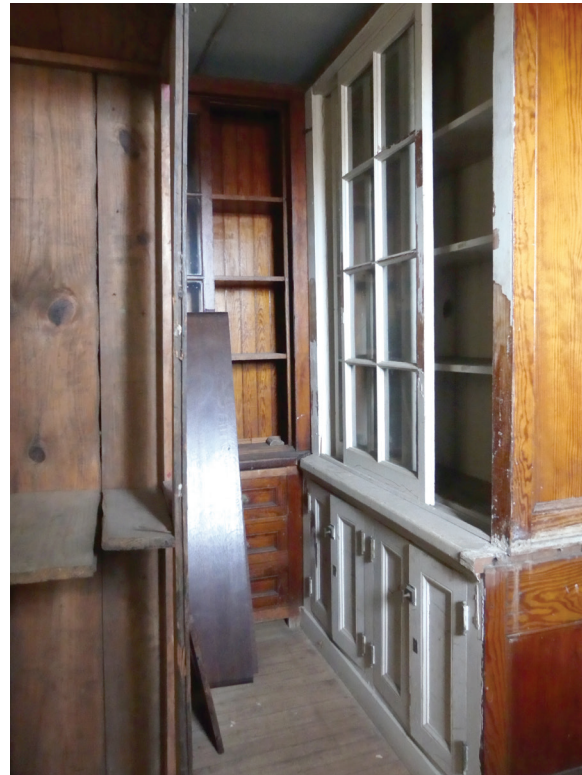
Figure 51. The Pantry off of the Servants' Hall. JGWA, 2018.

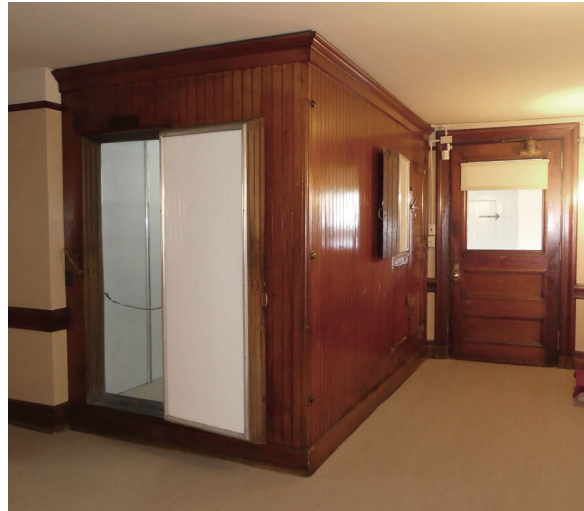
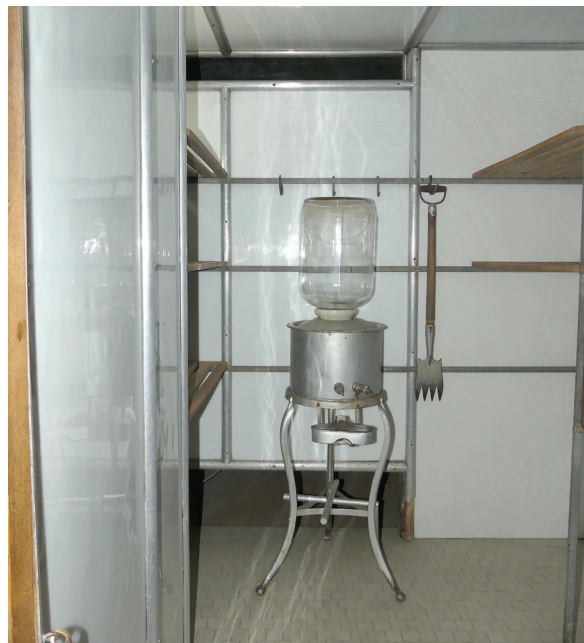
Figure 52. The Refrigerator/Ice Box (B21). JGWA, 2017.

Second. It is insulated with hair felt, cross sheathings of tongued and grooved spruce, and sheathings of specially made water-proof paper, passing all joints. This method, combined with the thorough assembling of the parts, absolutely prevents any loss of cold air—economy in ice.

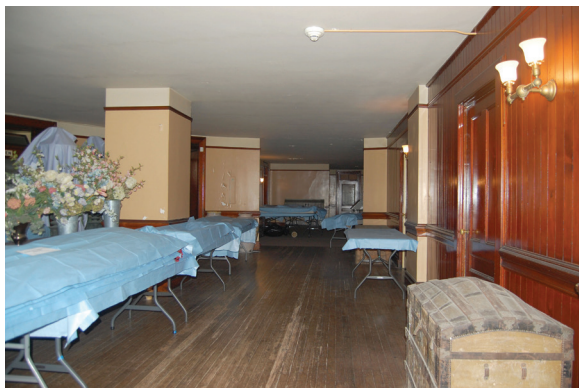
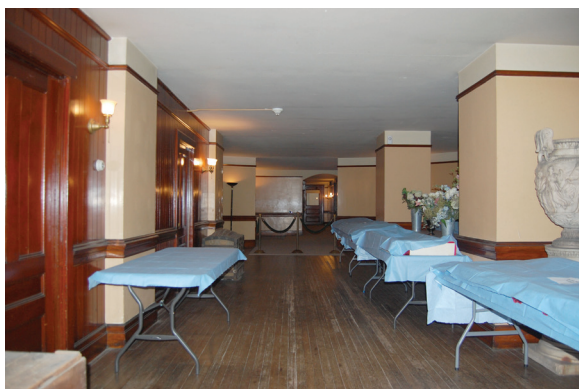
The 2018 paint analysis revealed that the earliest retained finish found on the upper walls and ceiling of the Central Hall was a complex finish consisting of a grayish yellow (Munsell 2.5Y 8/4) base coat matching Pittsburgh Paint's PPG 12-29 "Ivory Beauty," topped with a thin moderate yellow (Munsell 2.5Y 8/8)

Figure 54. The central Hall, looking south (upper image) and north (lower image). JGWA, 2017.

translucent glaze similar to Benjamin Moore's HC-7 "Bryant Gold." The upper wall of the hall and the ceiling retained six painting campaigns with variations of the original finish repeated for the next three campaigns.

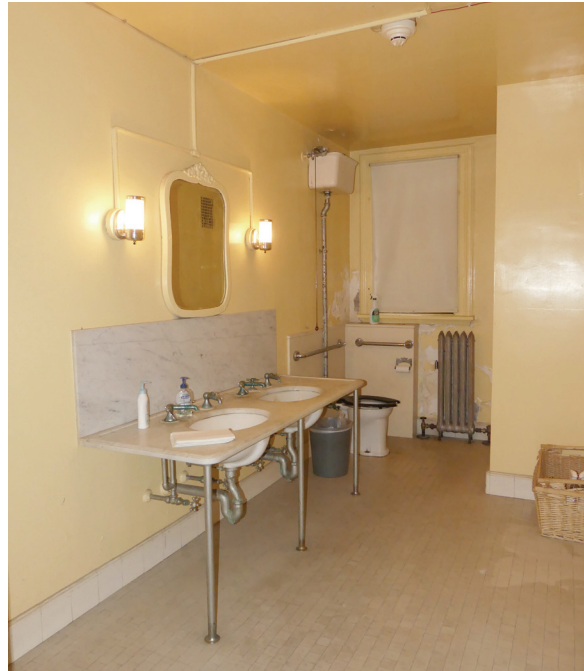
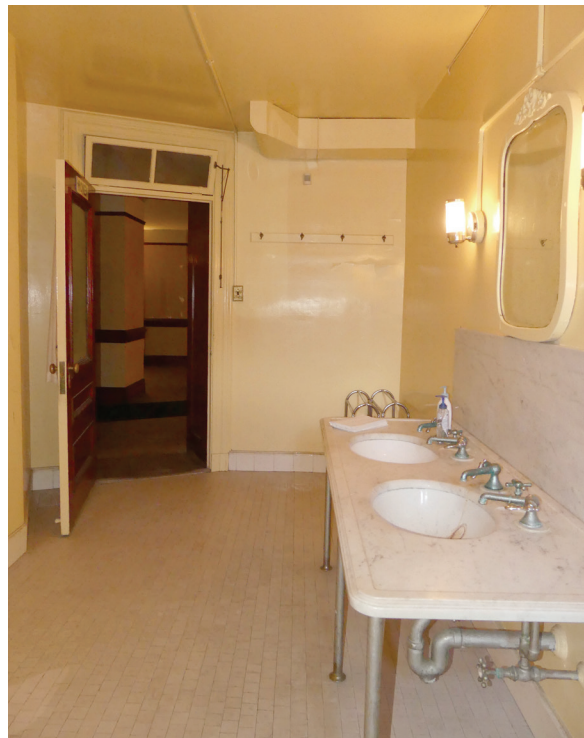
A framed mirror hangs on the north wall, above the lavatory. A similar mirror is used in the third floor bathroom 312. Both appear to have been originally attached to chests of a type used in the servants' bedrooms.

Figure 55. The basement North Lavatory (B20), looking east (upper image) and west (lower image). JGWA, 2018.
