Vanderbilt Mansion National Historic Site  
Hyde Park, New York

## **Vanderbilt Mansion National Historic Site Historic Structure Report**

Volume II: Introduction to Physical Investigation; Exterior, Sub-Basement, Basement  
October 2018

**JOHN G. WAITE ASSOCIATES, ARCHITECTS**

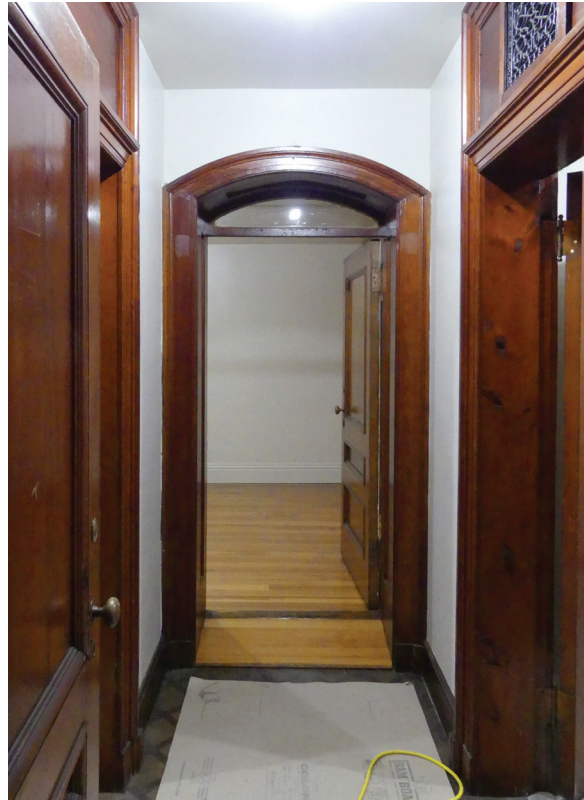
**Door (to vestibule):** A 2017-2018 door replaced the missing door in this opening. The design duplicates the door to the South Storage Room. Hardware: The 2017-2018 hardware includes a pair of 5" high bronze butt hinges and a 4-1/2" high bronze mortise lockset with knobs and oval keyhole escutcheons.

Figure 57. The Wine Storage (B04) vestibule after restoration (upper image); linoleum on vestibule floor (lower image). JGWA, 2018.

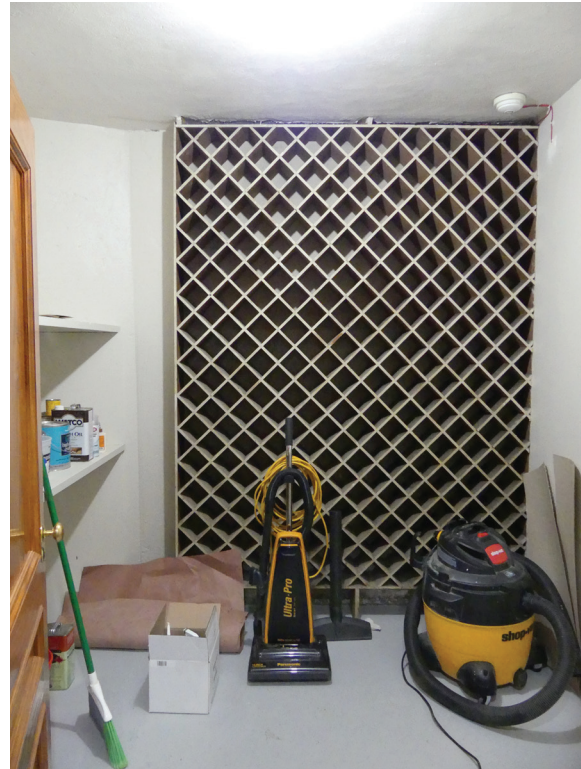
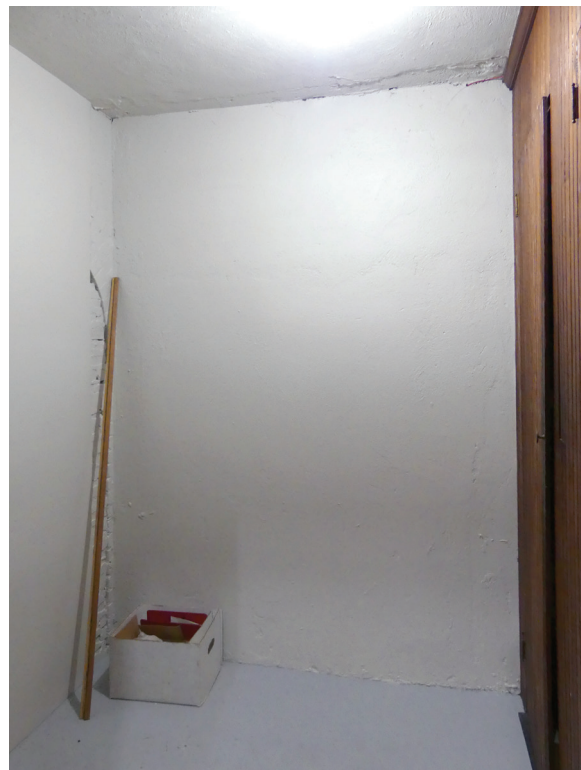
Closet: The closet on the west wall, a later Vanderbilt addition, is constructed with 3-1/4 inch vertical beaded boards with beaded edges and center reeds. Each of the two vertical beaded board doors is hung with small five-knuckle hinges, and has an oval knob and a separate keyed box lock. The north side of the closet has four shelves and the south side has two shelves. A filleted-cyma reversa molding runs along the top of the closet.

Figure 58. The Wine Storage (B04) North Room (upper image) and South Room (lower image). JGWA, 2018.

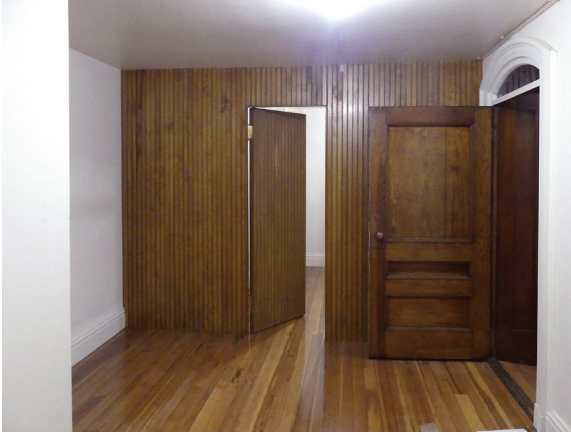
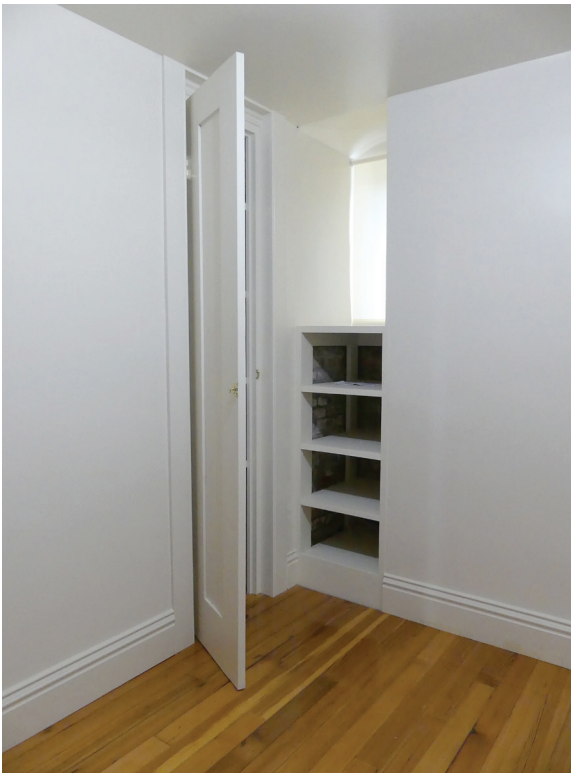
Figure 59. Wine Storage (B04) east room after restoration (upper image); south area of east room, looking southeast (lower image). JGWA, 2018.

Paint evidence on the north, west, and south walls inside the cabinet reveals the position of an earlier cabinet (probably a bottle rack) in the same location.

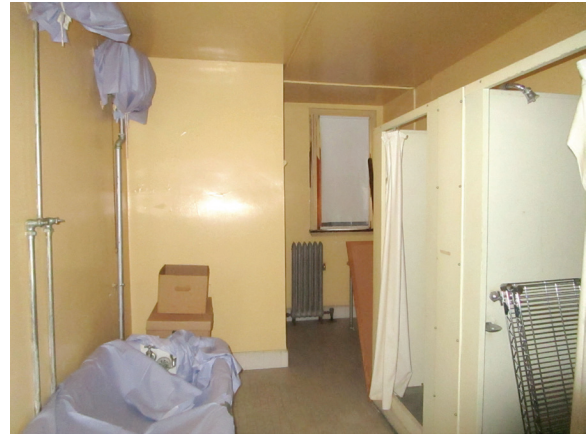
**PLUMBING:** The original lavatory on the north wall has a Meyer-Sniffen "Alpha" porcelain basin set in a 3' wide by 2' deep marble counter with a 3' wide by 1'-6" high marble splash; the counter is supported by two metal legs. The faucets were replaced in 1942.<sup>92</sup>

At the east end of the north wall is a J.L. Mott "Descendo" toilet with a wood lid and high enameled

Figure 60. Men's Bath (B19), looking east. JGWA, 2017.

cast-iron water tank. The linked brass rods from the tank end in a ring pull.

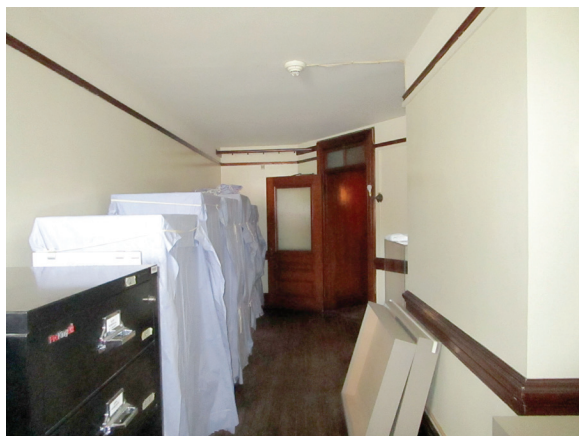
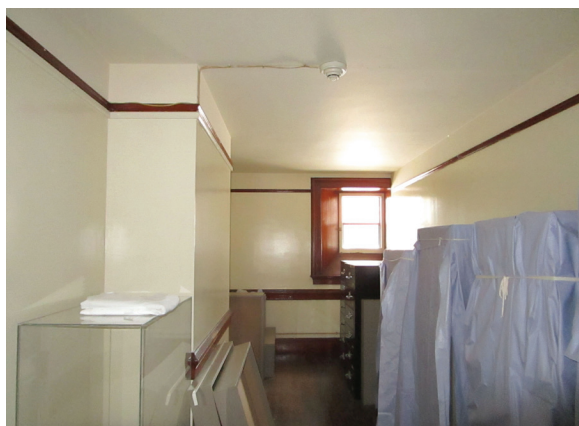
Figure 61. Boot Room/Servant's Room (B05), looking west (upper image) and east (lower image). JGWA, 2017.

plan, a closet is sketched in to the west of the chimney foundation on the north wall. The key from the housekeeper's key closet for this room is labeled "Boot Room," and the clothes rod with five pulleys on the west wall, similar to the clothes rod in Mrs. Vanderbilt's closet, indicates that the room was used to care for clothing. In the original McKim, Mead & White plan, the "Boots & Lamps Room" was in what is now known as the Chef's Room (B13). By the 1920s, one of the assistant butlers, "the third man" (Alfred Martin [1909-1938] or his successor) stayed in this room.<sup>94</sup>

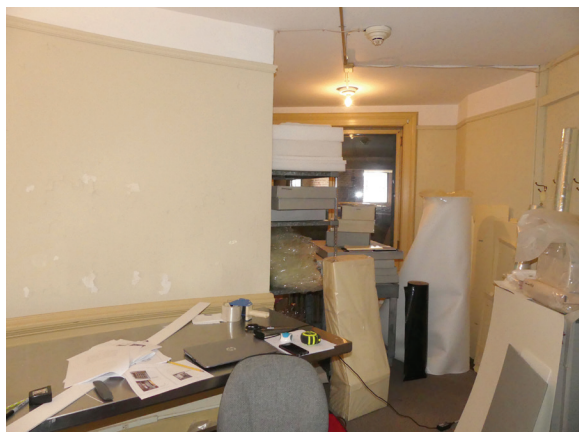
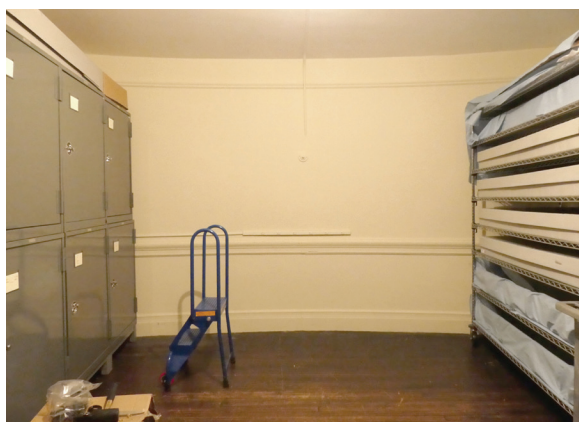
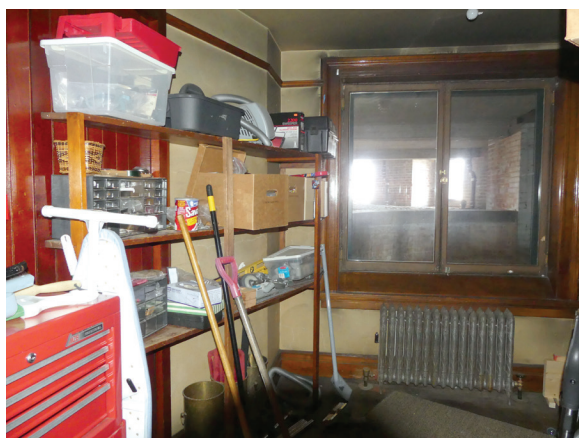
Figure 62. The storage rooms added onto the west side of the elliptical Hall, looking west: the Southwest Storage Room (B17) (upper image); Central Storage Room (B15) (center image); and Northwest Storage Room (B18) (bottom image). JGWA, 2018.

**WINDOW:** The window opening is deeply set into the west wall with plain, straight reveals and a canted sill. A two-fasciae architrave and molded sill frame the opening; both are painted an ochre color to match the other trim. The opening holds a pair of single-light casement sash, hinged to open into the room, and secured with a bronze T-handle latch on the meeting rails.

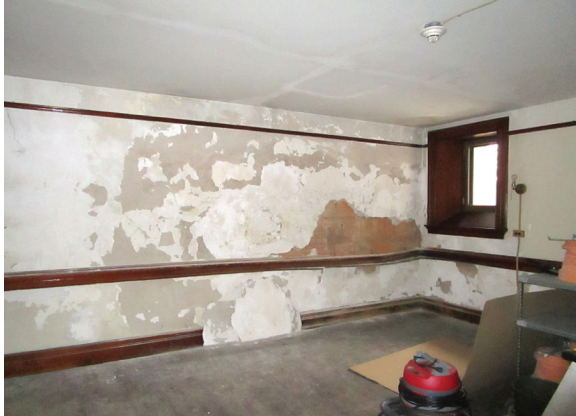
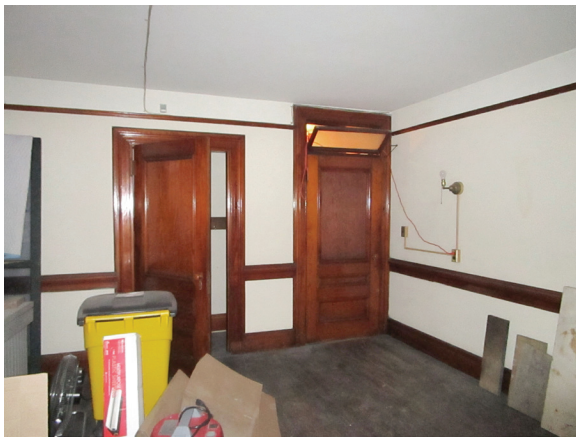
Figure 64. Chef's Room (B13), looking northwest (upper image) and southeast (lower image). JGWA, 2017.

**BASEBOARD:** The typical 8" high baseboard includes three fasciae and a filleted cyma cap. The cap molding continues up along the door architraves to miter with the bottom molding on the chair rail. The baseboard is painted white.

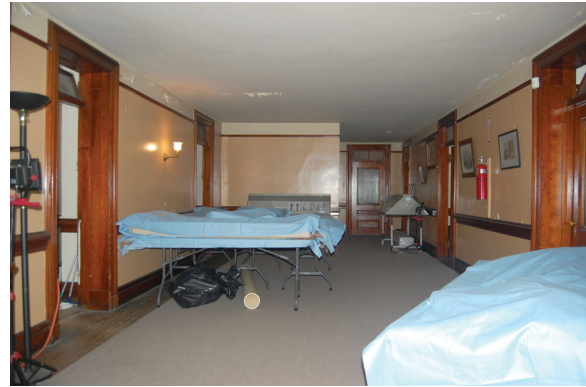
Figure 65. The South Hall, looking south. JGWA, 2017.

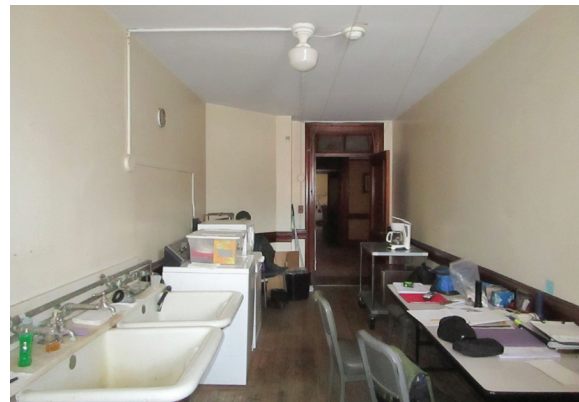
Figure 66. (Upper image) Detail of the servants’ laundry on the McKim, Mead & White basement plan. McKim, Mead & White Architectural Record Collection, PR 42, #8, Department of Prints, Photographs, and Architectural Collections, The New-York Historical Society, photographic copy in park archives. (Lower image), B06 looking west. JGWA, 2017.

This vestibule and the walk-in closet were inserted in a large space originally designed for a Boots and Lamps room. The McKim, Mead & White plan shows both areas in pencil (see Figure 66). The creation of these spaces added privacy for the occupant (eventually the chef) of the room to the west, as well as valuable storage space in the walk-in closet.

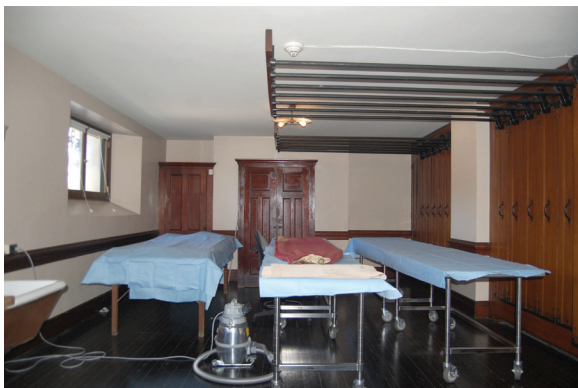
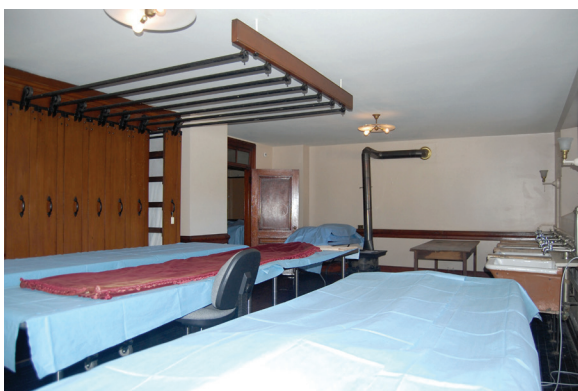
Figure 68. The Laundry (B07), looking south (upper image) and north (lower image). JGWA, 2017.

The McKim, Mead & White basement plan labels this room "Room No. 1" (see Figure 68).<sup>93</sup> On that

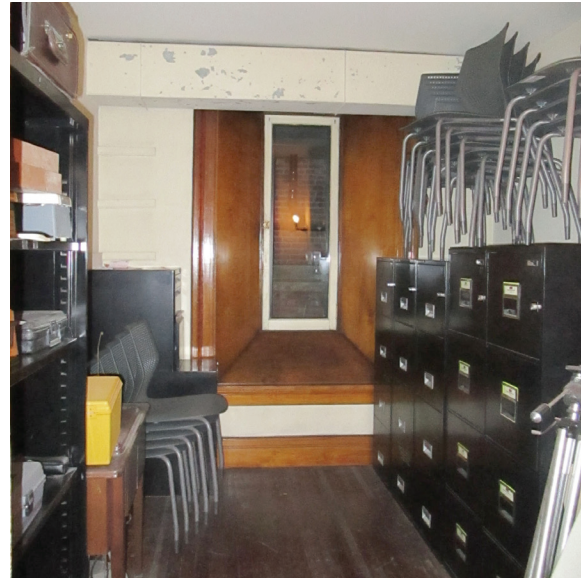
Figure 69. The Servants' Store Room/Service Trunk Room (B16), looking south. JGWA, 2017.

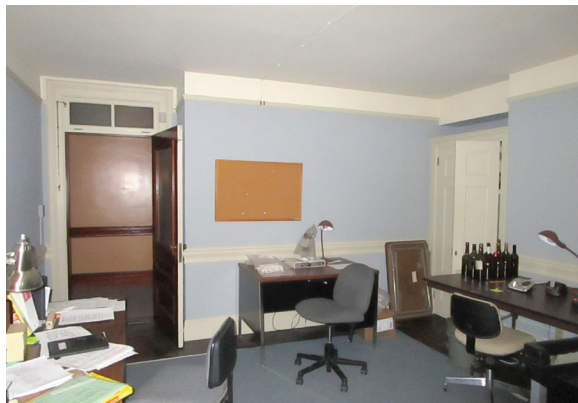
Figure 70. Detail of Room No. 5 from the McKim, Mead & White basement plan (upper image); and the Butler's Room (B09), looking east (lower image). McKim, Mead & White Architectural Record Collection, PR 42, #8, Department of Prints, Photographs, and Architectural Collections, The New-York Historical Society, photographic copy in park archives. JGWA, 2017.

The 15' x 15'-6" room in the southwest corner of the basement is one of the larger servant's bedrooms at that level. It includes a doorway in the east wall and a window in the west wall. The chimney foundation for the southwest Living Room fireplace projects from the south wall. A structural pier is incorporated into the east wall to create an entrance alcove in the northeast corner of the room. This layout matches the McKim, Mead, & White floor plan of room "No. 5", including a closet penciled into the area west of the chimney breast (see Figure 70).<sup>114</sup>

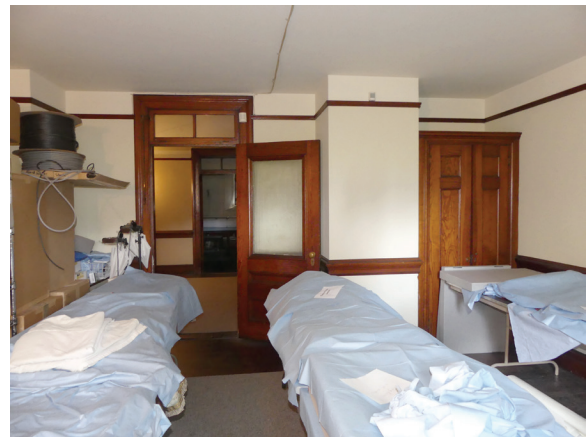
Figure 71. Detail of Room No. 4 from the McKim, Mead & White basement plan. (upper image); and the Valet/Second Man's Room (B10), looking east (lower image). McKim, Mead & White Architectural Record Collection, PR 42, #8, Department of Prints, Photographs, and Architectural Collections, The New-York Historical Society, photographic copy in park archives. JGWA, 2018.

It appears as room "No. 4" on the McKim, Mead & White plan (see Figure 71).<sup>116</sup> A closet, penciled into the space south of the east wall pier, was added as part of the original construction.

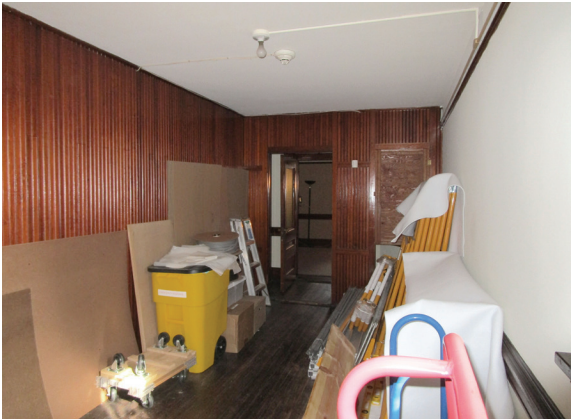
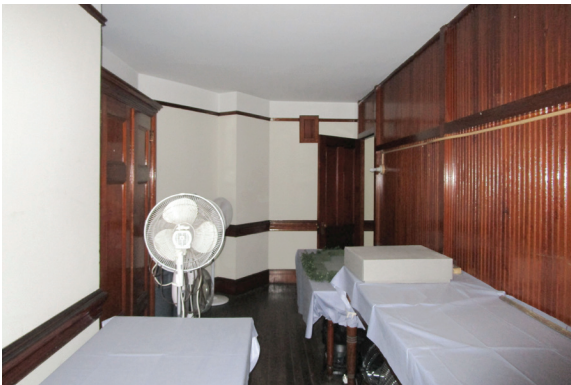
Figure 72. Detail of Room No. 3 from the McKim, Mead & White basement plan (upper image); and Houseman's Room (B11), looking east (center image) and the adjoining Store Room (B12), looking east (lower image). McKim, Mead & White Architectural Record Collection, PR 42, #8, Department of Prints, Photographs, and Architectural Collections, The New-York Historical Society, photographic copy in park archives. JGWA, 2017.

On the McKim, Mead & White basement floor plan, this room is part of one large room southwest of the elliptical central hall (see Figure 72).<sup>118</sup> At an undetermined date, the Vanderbilts divided "Room No. 3" into two rooms with a vestibule and closet

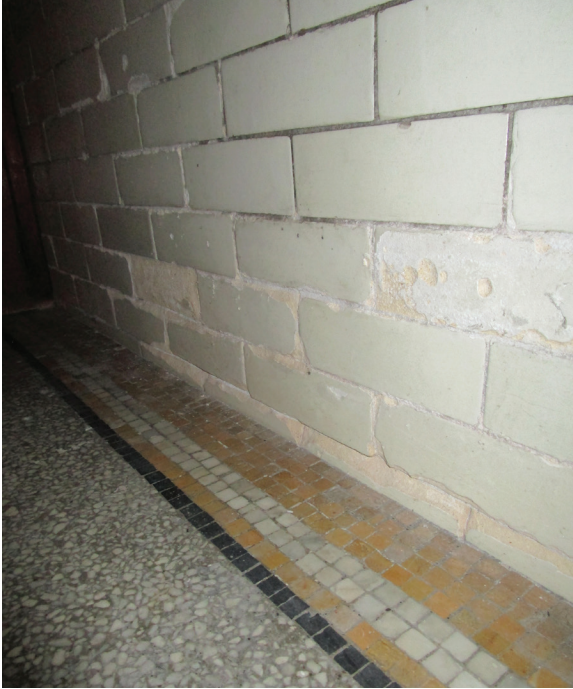
**Figure 73.** The glazed wall brick at the northeast corner of the Kitchen (B01) is substantially deteriorated as a result of rising damp, which is likely related to heavy salt use on the adjacent paved surface and stairs. JGWA, 2018.

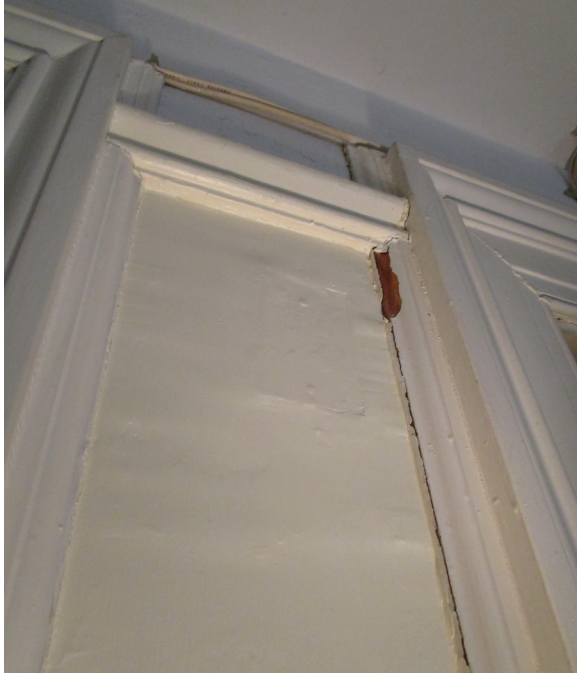
**Figure 74.** An electrical junction box in the Housekeeper's Office (B03) has been left in place but covered with a rudimentary plaster patch. The electrical box can still be seen beneath the uneven surface; it is not known if the box still houses live wiring. JGWA, 2018.

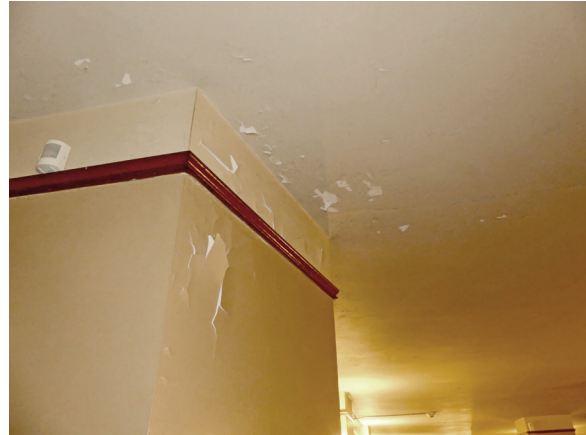
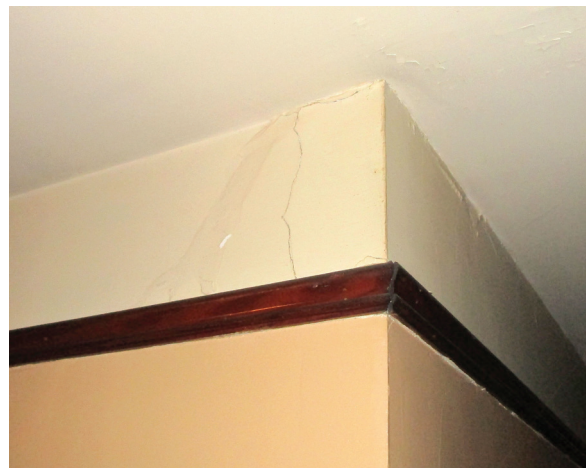
**Figure 75.** Paint and plaster deterioration can be seen on the perimeter of the basement level where site water has soaked through the foundation in some locations, but paint and plaster problems can also be seen on the walls of the interior corridor (B08). The paint and finish coat of plaster deterioration seen in the upper image are prevalent problems at the basement level. A substantial offset crack in the South Hall, adjacent to the northwest corner of the laundry room drying racks, was successfully patched at some point in the past (lower image). JGWA, 2018.

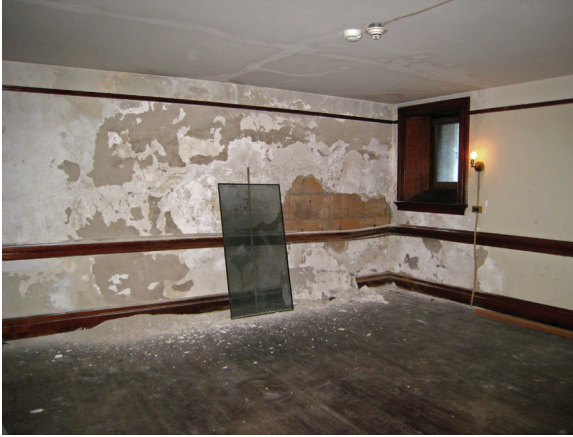
**Figure 76.** Extensive plaster damage extends along the east and north walls of the Chef's Room. The chair rail on the west wall is buckling, and the baseboard is pulling off of the wall. The recent exterior restoration eliminated the water infiltration that caused the damage. JGWA, 2017.

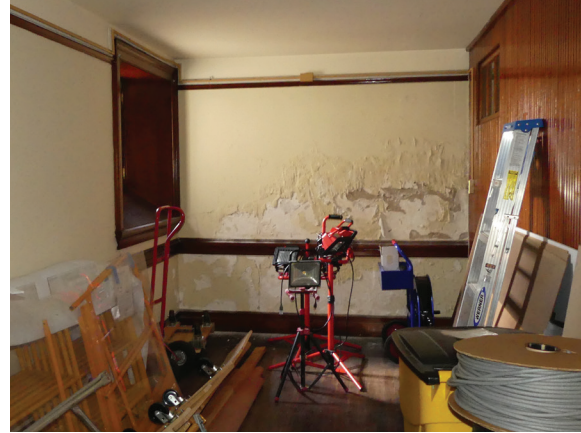
**Figure 77.** Plaster failure covers the entire lower half of the west wall of room B11. This extensive moisture-based deterioration is immediately adjacent to the south stair of the west portico. The recent repairs to this stair, and elimination of open mortar joint, has corrected the moisture ingress problem. JGWA, 2018.

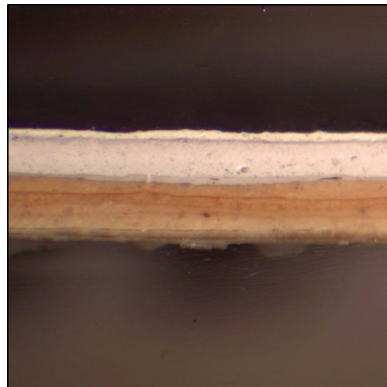
Figure 91. Photomicrographs of selected paint samples from the Butler's Room, shown in simulated daylight on the left, and in ultraviolet light on the right. The earliest paint layer is at the bottom of each photograph. JBC, 2018.

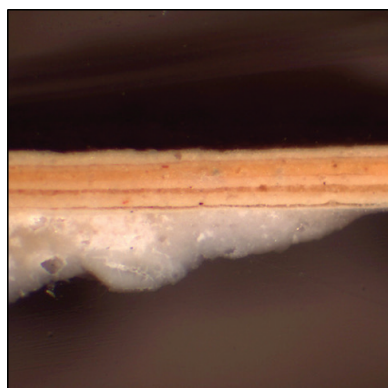
Figure 95. Photomicrographs of selected paint samples from the Servants' Hall and Pantry, shown in simulated daylight on the left, and in ultraviolet light on the right. The earliest paint layer is at the bottom of each photograph. JBC, 2018.

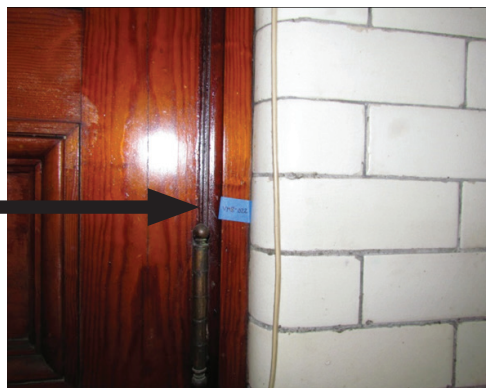
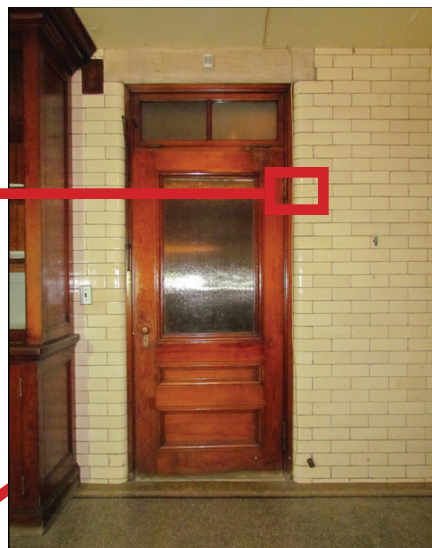
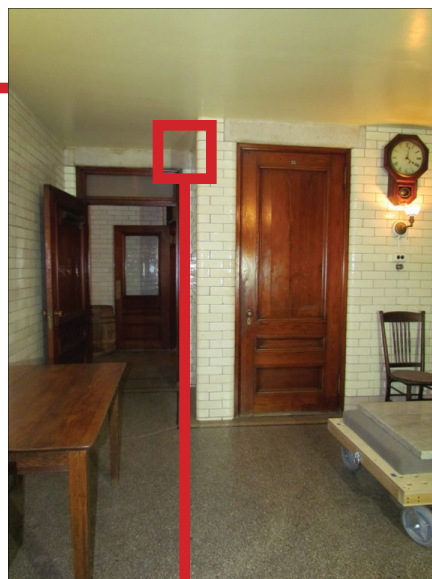
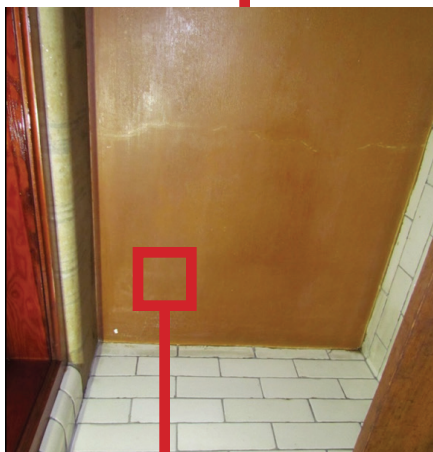
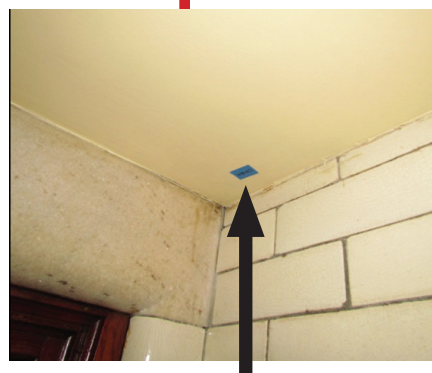
Figure 96. Paint samples taken from the Kitchen. JBC, 2018.

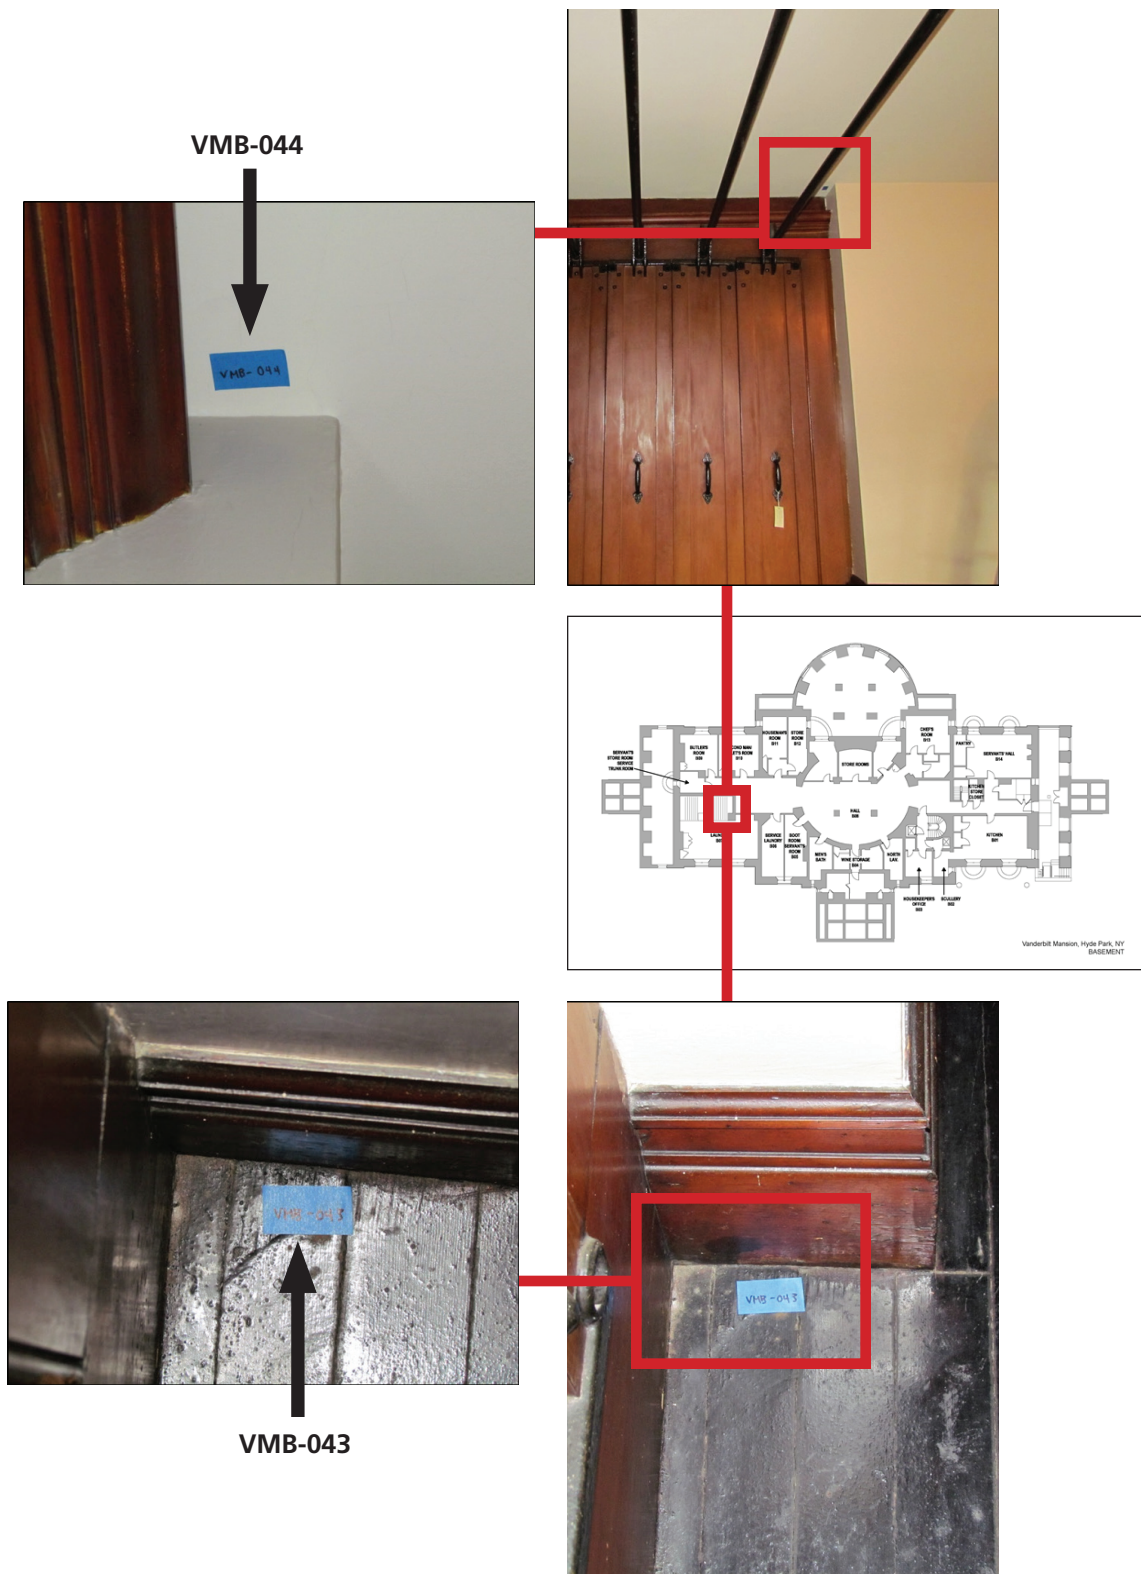
Figure 108. Paint samples taken from the Laundry. JBC, 2018.
