Vanderbilt Mansion National Historic Site  
Hyde Park, New York

## Vanderbilt Mansion National Historic Site Historic Structure Report

Volume III: First Floor  
October 2018

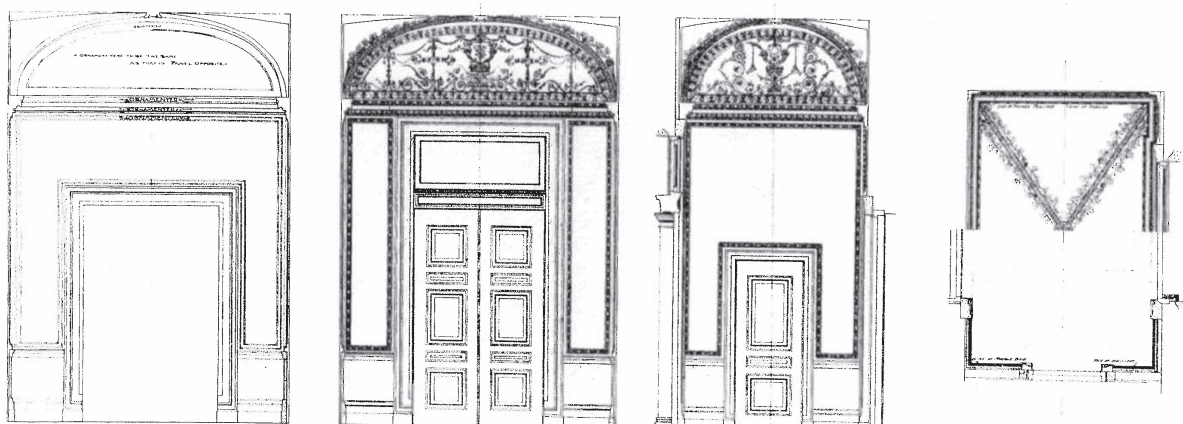
THREE-QUARTER INCH SCALE DETAILS OF VESTIBULE -  
HOUSE FOR F.W. VANDERBILT, ESQ.  
AT HYDE PARK ON THE HUDSON, N.Y.  
NOTED: THESE DRAWINGS WERE MADE  
FOR THE ARCHT. FIRM OF MCKIM, MEAD & WHITE  
160. 5TH AVE., NEW YORK, N.Y.

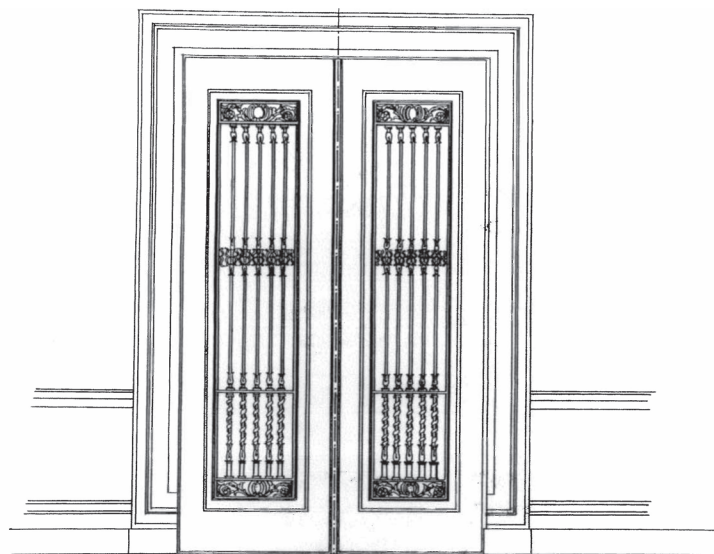
1/4" INCH SCALE DETAIL OF BRONZE GRILLE FOR VESTIBULE DOOR -  
HOUSE FOR F.W. VANDERBILT, ESQ.  
AT HYDE PARK ON THE HUDSON, N.Y.  
BOTH SIDES OF GRILLE  
TO BE THE SAME -  
MCKIM, MEAD AND WHITE ARCHT.  
160. 5TH AVE., NEW YORK, N.Y.

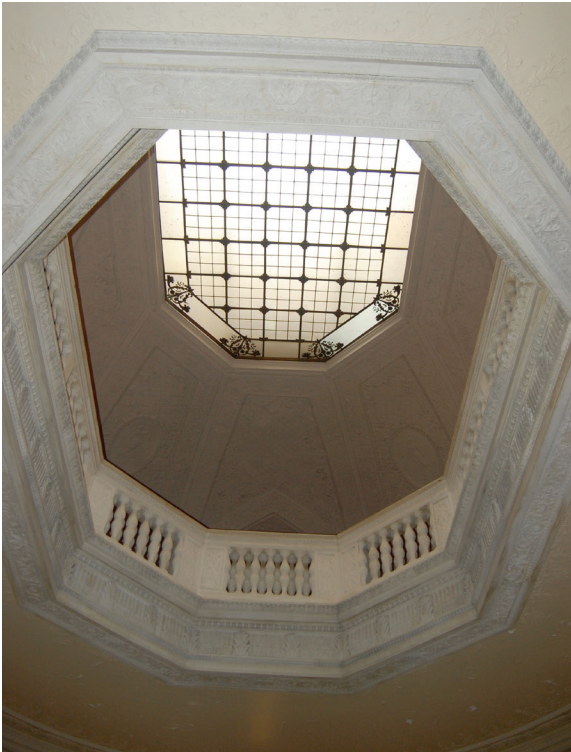
(Left) Looking up through the Whitney Warren ceiling opening towards the second floor skylight. JGWA, 2017.

double balustrade (see Figure 8). At the same time, the second floor Hall received a classically-inspired coved plaster ceiling with a new flat laylight. This ceiling is visible from the Hall, increasing the drama of the first floor space.

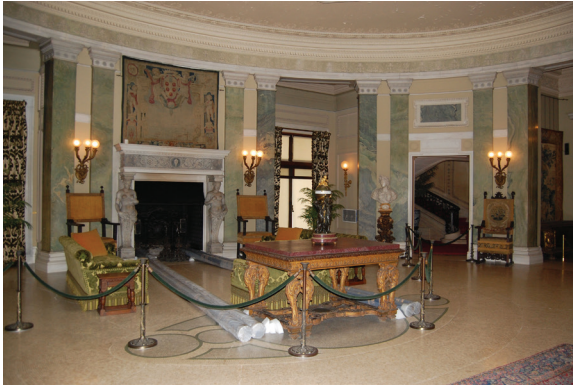
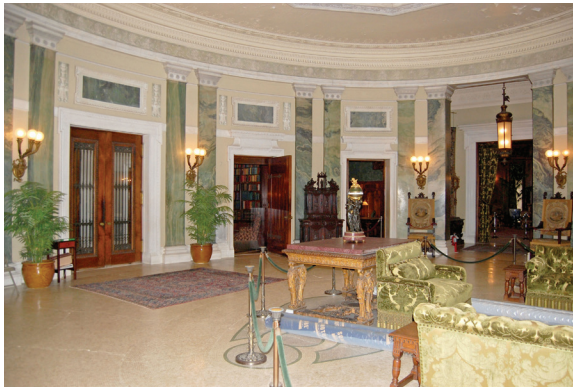
**Figure 10. The first floor elliptical Hall, looking northwest (upper image) and southeast (lower image). JGWA, 2017.**

**CEILING:** The painted plaster ceiling is 17'-10 3/8" above the floor. The predominant feature of the ceiling is Whitney Warren's long, octagonal opening.

tobacco and a subtle relief of the same anthemion details (I) found in the entablature frieze. The full border profile includes, from the outside edge: a dropped bead-and-reel, relief banding of sheathed tobacco, another dropped bead-and-reel, and the anthemion relief

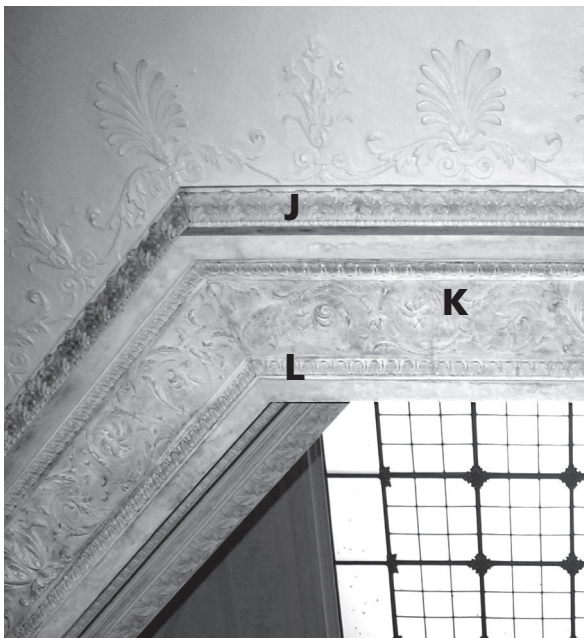
**R.** White marble two-fasciae shouldered **architraves frame the doorways** to the adjoining rooms.

**S.** An ornate **overlintel** surmounts each of the openings to the Office, Den, Reception Room, and Lavatory/Cloaks Room. The hood is the same height as, and aligns with, the horizontal decorative paneled band on the walls.

another fillet, and a cyma reversa header), crowned by a hood composed of a bottom flat fascia with modified triglyphs, a fillet, and a cyma reversa egg-and-dart molding topped by a plain fascia.

A 3-3/4" wide architrave, composed of (from the outside) a fascia, fillet, fillet, and congé, trims the opening to the Main Stair. Above the opening is a horizontal white marble panel that fits between the architrave and the horizontal paneled band. Plaster paterae are applied to the spaces flanking the panel.

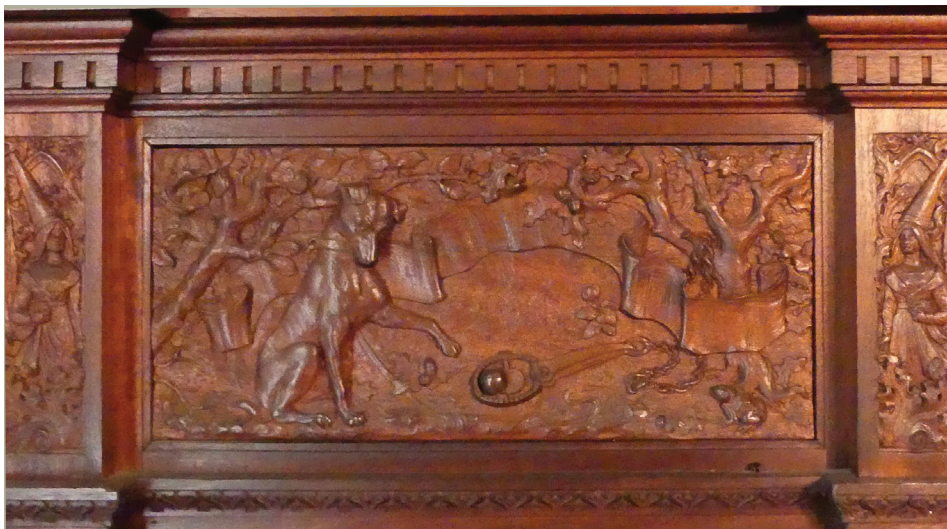
**C.** The intricately carved **frieze panels** above the arch panels—each unique—depict a fanciful array of animals, putti, and scenes (see lower image).

**D.** A denticulated **crown molding** caps the wainscot.

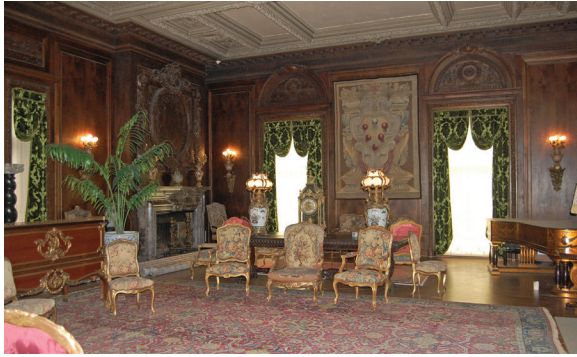
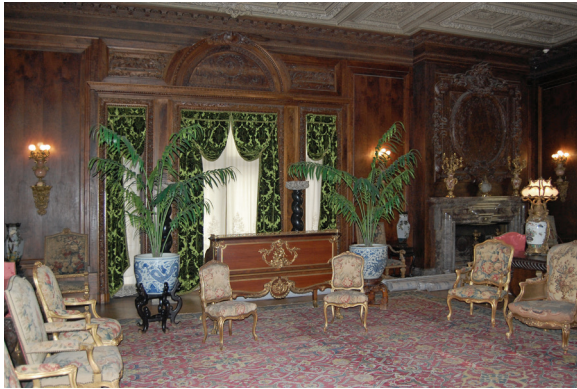
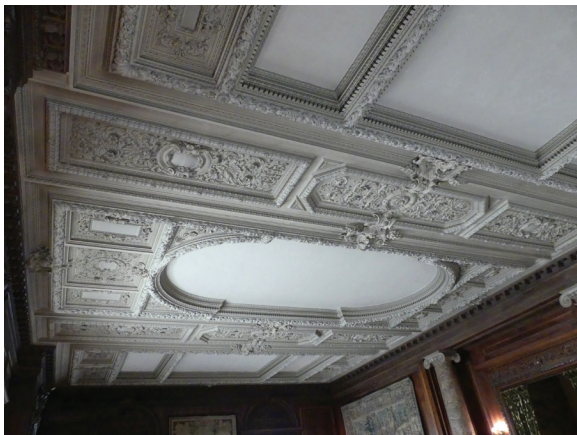
Figure 32. The Living Room, looking southwest (upper image) and south (center image); and the ceiling (bottom image). JGWA, 2017.

**CORNICE:** The plaster cornice was faux-grained in 1906. The cornice includes a two-fasciae architrave (A), trimmed with a bead-and-reel between the fasciae and with an anthemion molding at the top; a plain frieze (B); a filleted egg-and-dart molding (C); and brackets alternating with rosettes on the ceiling (D).

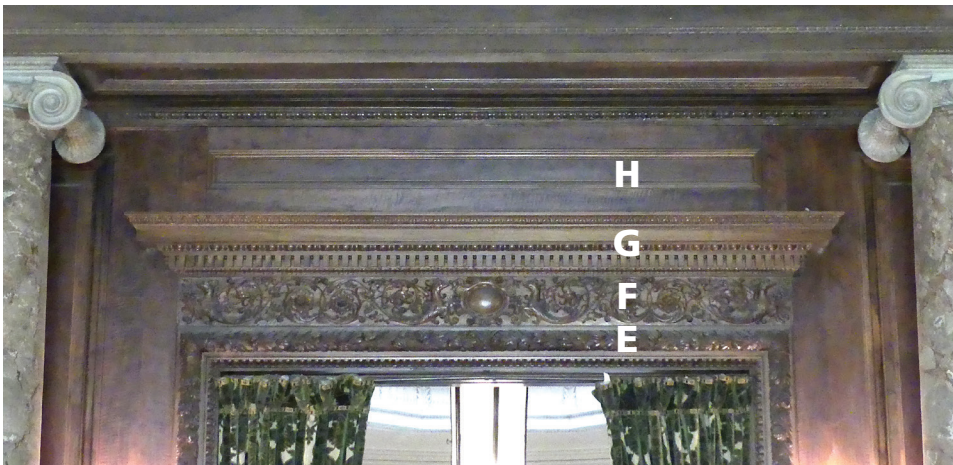
**WINDOWS AND NORTH DOORWAY**

- E.** Carved molding: **laurel rope** of intertwined fruit and foliation
- F.** **Frieze of molded rinceau**, flanking a centered cartouche.
- G.** **Corona**.
- H.** Plain wood **panel** installed in 1906 by Whitney Warren.
- I.** Carved arched **tympanum**
- J.** Carved **architrave** that arches up to a **cartouche**.

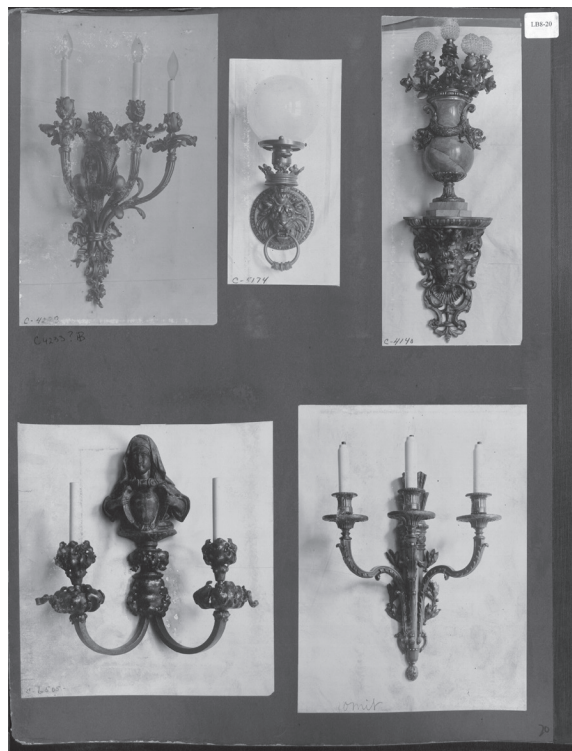
**Figure 34.** Page from one of the E.F. Caldwell & Co. binders. The upper right photograph shows the Vanderbilt mansion's Living Room light bracket. <http://library.si.edu/digital-library/collection/caldwell/browse/LB008?page=19>.

**LIGHTING/ELECTRICAL:** Eight Vanderbilt-era pink marble and bronze urns with bronze foliated branches hold bulbs with glass bead shades (VAMA 4651-4658). The fixtures, supplied by E.F. Caldwell & Co. (see Figure 120),<sup>45</sup> are supported by bronze consoles mounted to the walls. There are two on each wall: one pair flanking the north entrance; one pair flanking the south glazed doors; and two pairs on the east and west walls. A single electrical outlet is positioned behind the base of each of the urns, providing the receptacle for each light's plug. All are installed approximately six-and-a-half feet from the floor.

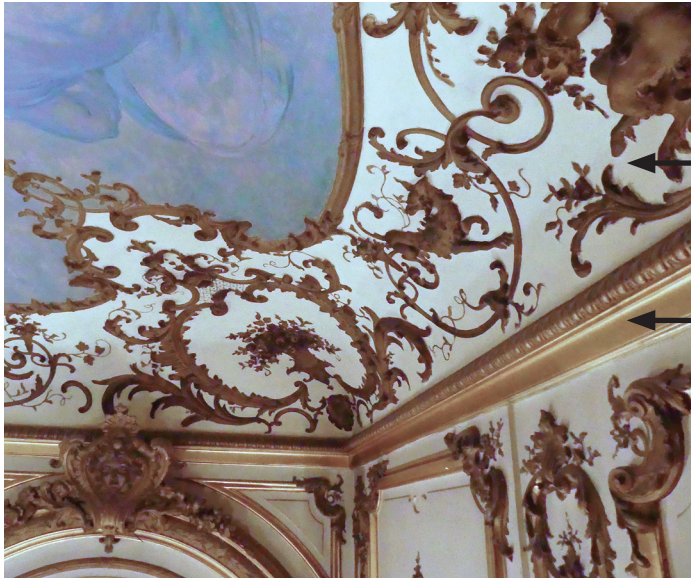
#### RECEPTION ROOM (105): *BOISERIE*

- A.** Inner, slightly raised **panels**.
- B.** Foliated plaster **appliques** at the corner and center edges of the panels.
- C.** Semi-circular **tympanum** ornamented with a bronzed **medallion** featuring musical instruments.
- D.** Rococo compo **cartouche** with a central mask motif.
- E.** Fascia and egg-and-dart **corona**.
- F.** Coved edge of the ceiling filled with bronzed plaster figures and foliated scroll plaster trim.

**CORNICE:** A fascia and egg-and-dart corona caps the top of the *boiserie* (E). The coved edge of the ceiling is painted in a bright white background and filled with bronzed figures (F), including satyrs and other allegorical figures, and foliated scroll trim, all in plaster.

**DOORS:** The doorway in the northeast curve of the wall provides access from the Hall. This opening appears rectangular from the Hall, but the Reception Room paneling and ornate gilded trim frame an arched doorway with a recessed tympanum. The tympanum is ornamented with a bronzed medallion

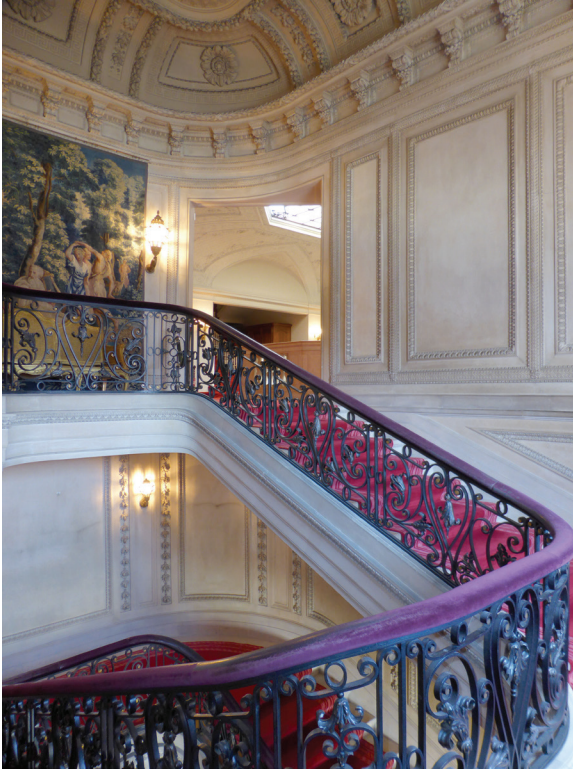
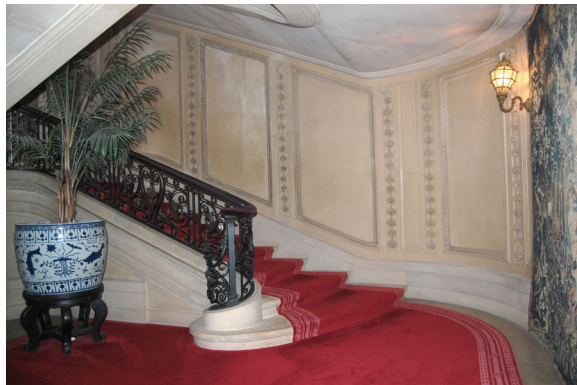
Figure 42. The Main Stair (219). JGWA, 2017.

**WINDOWS:** The window openings in the west wall, at the first and third landings, are fitted with 1/1 chain-hung sash. At the first landing, a three-fasciae architrave frames the opening. The third landing window trim is integrated into the wall paneling. Each sash has a bronze sash lock, and two plain bronze sash lifts (recessed ovals within plain rectangular plates)

mounted on the bottom rail of the lower sash. At the first landing, the two sash are of equal size; while at the third landing, the upper sash is shorter than the lower sash. Small recessed bronze sockets (for sash poles) are set in the top rails of both sash at the upper landing and in the bottom sash only at the lower landing. The bottom sash of the lower landing includes a wood-framed screen with metal hand grips on the lower rail. The wood in each opening is painted a light cream color.

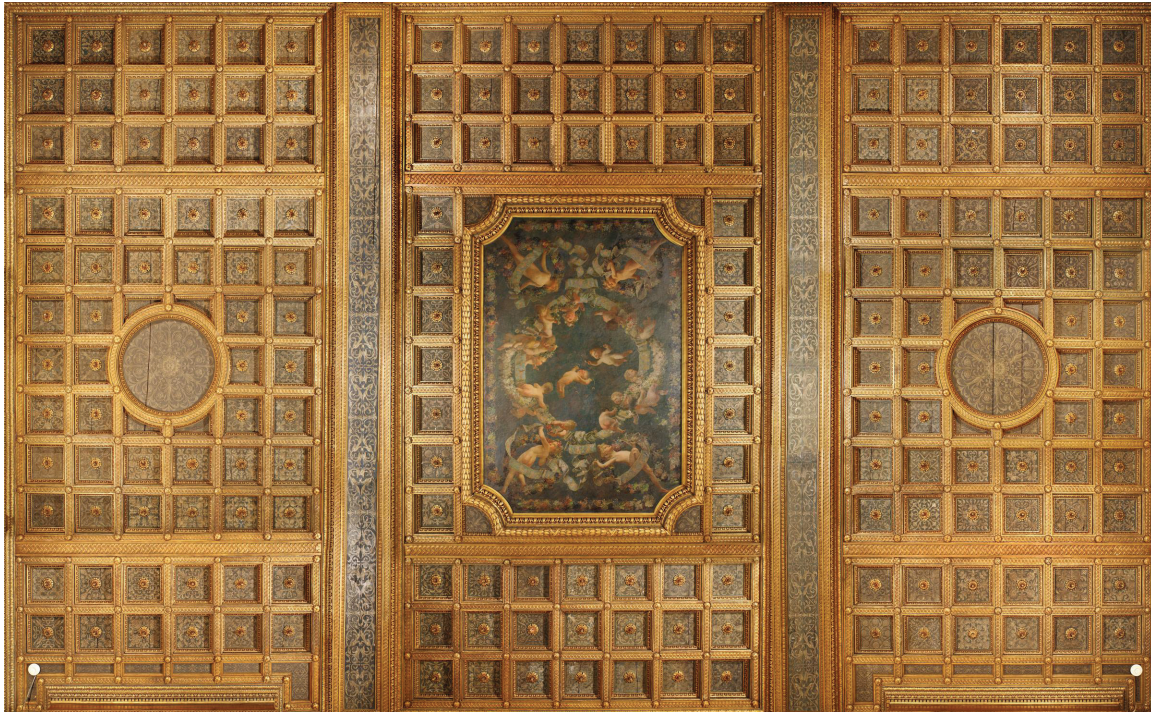
Figure 48. Photograph of the Dining Room ceiling, and a diagram showing the sections (in blue) added by Herter Brothers. Building Conservation Associates, Inc., "Vanderbilt Mansion National Historic Site, Dining Room Ceiling Conservation Condition Survey and Treatment Proposal," January 2009.

| Figure 48. Photograph of the Dining Room ceiling, and a diagram showing the sections (in blue) added by Herter Brothers. Building Conservation Associates, Inc., “Vanderbilt Mansion National Historic Site, Dining Room Ceiling Conservation Condition Survey and Treatment Proposal,” January 2009. .... | 60 |

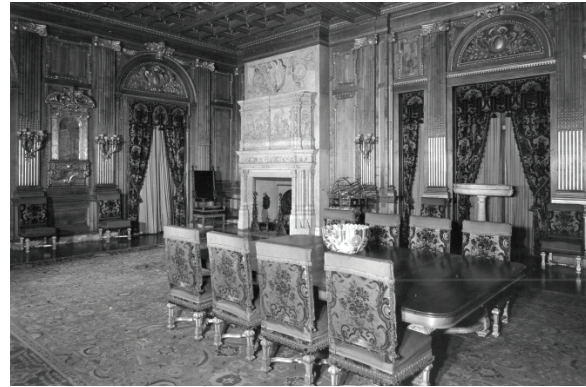
**Figure 51. Dining Room, 1938 (upper image).**  
Photographs of Hyde Park Property, Residence of Frederick W. Vanderbilt, Hyde Park, NY, by Rodney McKay Morgan for Margaret Louise Van Alen, ROVA Archives.

**CEILING:** The ceiling is largely an antique artifact that Stanford White purchased in Italy.<sup>86</sup> Two encased beams that align with the marble columns at the south entrance extend north/south, dividing the ceiling into three bays. Within each bay are deep square coffers.

The flanking bays include small round center panels. All of the coffers are ornamented with gilded pendants, except for the large rectangular panel in the center bay; it holds a mural on canvas, by Edward Simmons. The mural is 17'-10" above the floor. The 2008-2009 study by Building Conservation Associates found that Herter Brothers provided the edging of the encased beams, the trim around the mural, non-square coffers around the fireplace chimneys and their moldings, and most of the east-west molding.<sup>87</sup>

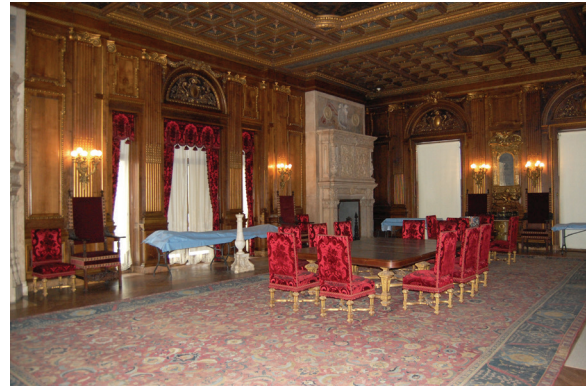
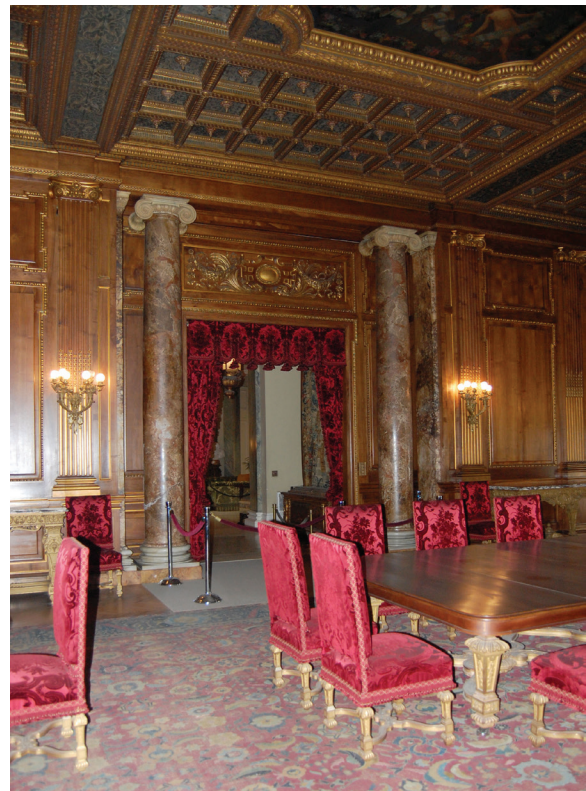
**Figure 53. Dining Room, looking northeast (upper image) and south (lower image). JGWA, 2017.**

**North door (center) (to North Porch):** The center of the south openings holds two stile-and-rail glazed doors, each approximately 2'-9" wide x 7'-10" high and each with a single glazed panel. The doors are faux-grained. Hardware: On the west leaf is an ornately-cast bronze Cremone bolt with an ornamental oval knob. Each of the doors is hung on three 2-1/2" high bronze butt hinges to swing out to the south portico.

**North flanking doors (to North Porch):** The doors flanking the center south opening are similar to that door. Each is a 1'-8" wide x 7'-10" high faux-

grained door with a single glazed panel. Hardware: Each door has three 2-1/2" high bronze butt hinges and a cast-bronze Cremone bolt with an ornamental oval knob (matching the center door).

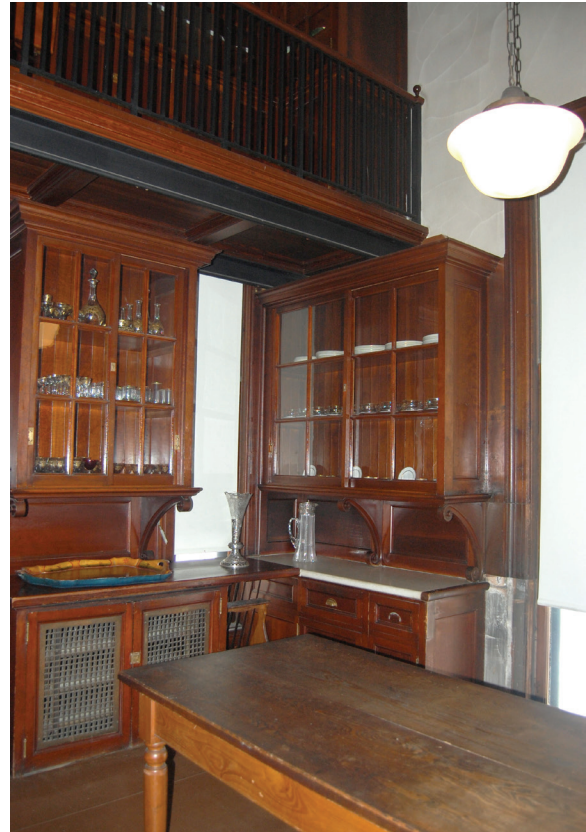
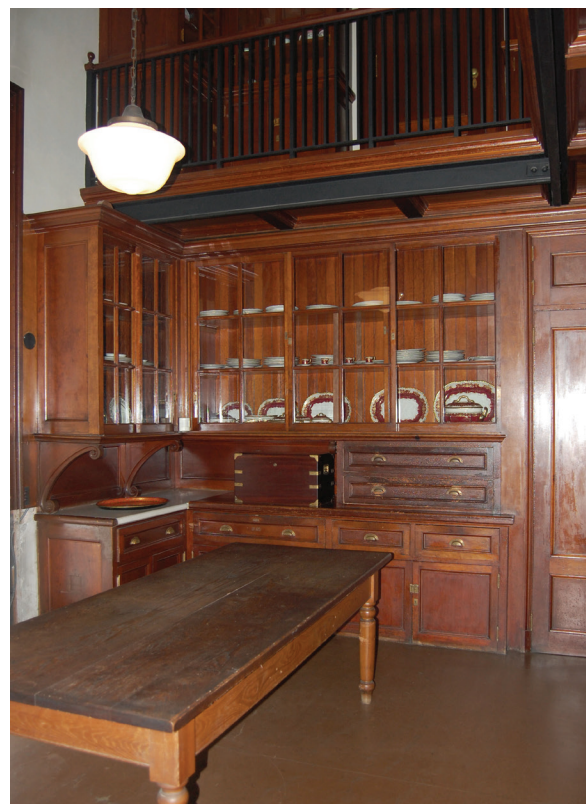
Figure 55. The Butler's Pantry, looking northeast (upper image) and southeast (lower image). JGWA, 2017.

**COMMUNICATIONS:** On the north face of the southwest cabinet, there is a DeVau intercom with a mouthpiece, earpiece, and bells. Below the intercom are three round holes, the locations for the missing mouthpieces of three speaking tubes, labeled “Kitchen,” “Mrs. Vanderbilt,” and “Mr. Vanderbilt”; the awkward positioning of these tubes directly below the intercom suggest that the tubes were in use prior to the installation of the electric intercom. A plate beneath the holes has three switches, one of which retains its original porcelain label marked “Butlers Pantry.” A call button is positioned in the wood surface beneath those switches.

A wood and glass annunciator box, like one in the third floor north passage and one formerly in the basement Servant’s Hall, is mounted to the cabinet above the intercom. The room labels are missing from the individual tabs in the box.

Above the southwest cabinet is a jumble of cloth-covered bell wire. The wire extends down into the upper portions of the cabinet. A small switch device

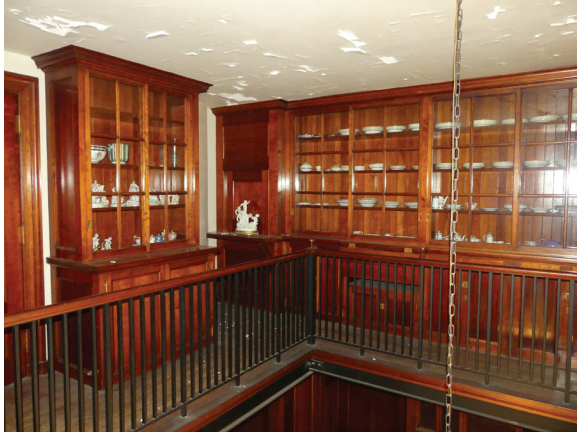
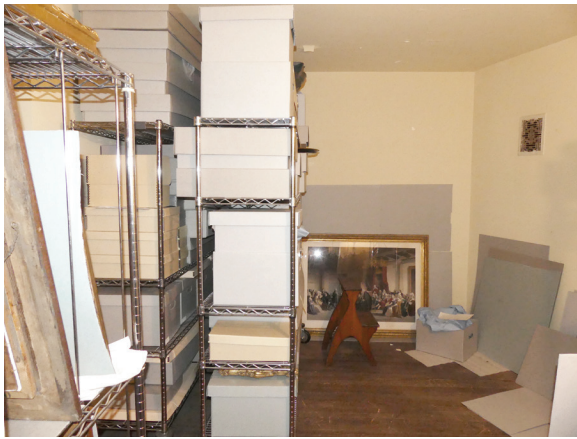
**Figure 57. The Butler's Pantry Mezzanine (upper image) and Office (lower image). JGWA, 2018.**

West door (to Service Stair): The 2'-11 3/4 wide x 7'-0" high x 2-1/2" thick stile-and-rail door has three recessed panels. On the Service Stair side, the panels are framed with a quirked ogee molding; on the Pantry side, there is a small ogee panel molding. The door is hinged on the north jamb to open into the Mezzanine. Hardware: The 7-1/4" high bronze mortise lockset (stamped with a mark for the Mallory, Wheeler Company) includes bronze knobs and long oval keyhole escutcheons. The three 5" high bronze butt hinges have ball finials, five knuckles per hinge, and five screws per plate.

South door (to store room): This 2'-8" wide x 7'-0" high x 2-1/2" thick stile-and-rail door is similar to the west door but has small ogee panel moldings on both sides of the door. Hardware: The 7-1/4" high bronze mortise lockset (stamped "61" and "U72") includes bronze knobs and one long oval keyhole escutcheon on the Mezzanine face. The three 5" high bronze butt hinges have ball finials, five knuckles per hinge, and five screws per plate.

**LIGHTING/ELECTRICAL:** Except for the ceiling fixture and equipment related to the modern intrusion system, no electrical fixtures are located in the balcony space.

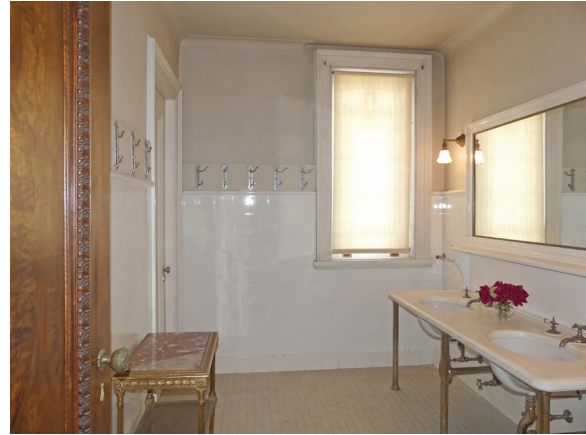
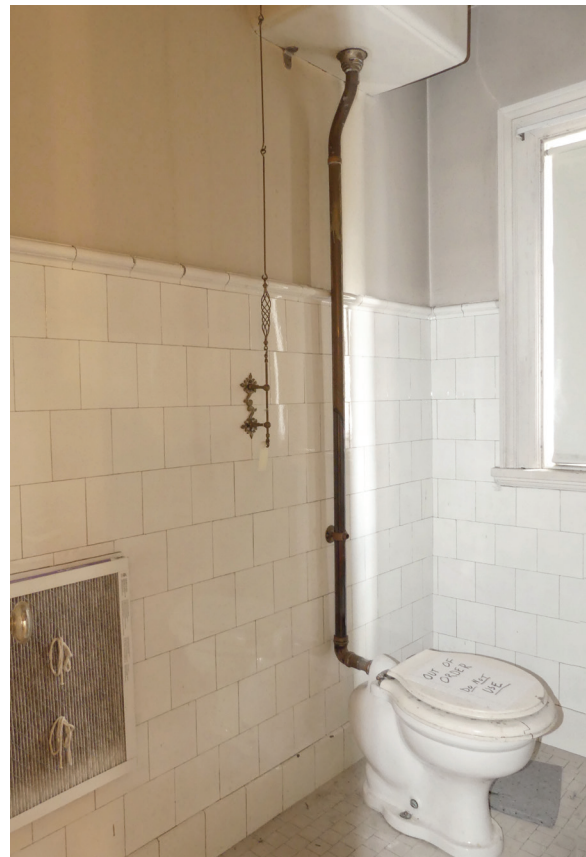
Figure 58. The Lavatory/Coat Room, looking west in the lavatory area (upper image) and in the toilet room (lower image). JGWA, 2018.

**WINDOWS:** The window openings in the east walls of both spaces are framed by architraves that match the trim at the door to the Toilet, and sit above 3"

high molded sills. The opening in the east wall of the lavatory space is fitted with a single sash, painted off-white, that slides up into a wall cavity. The sash is filled with leaded glass in an Art nouveau pattern, with three bulls-eye glass rondels incorporated into the design near the top. The sash hardware includes two flush rectangular bronze sash lifts in the bottom rail, and two slide bolts surface-mounted to the bottom rail to secure the sash.

**LIGHTING/ELECTRICAL:** Two Vanderbilt-era brass electric wall brackets flank the sink on the south wall. The fixtures have plain, bell-shaped backplates and single plain arms with frosted, fluted shades that face down. There is a similar fixture (without a shade) on the south wall of the toilet room. These fixtures match the bracket in the toilet room adjacent to Mr. Vanderbilt's Office.

The toilet (VAMA 7017) and high water tank on the north wall of the north room have no markings (unlike the other guest room toilets, consistently marked J.L. Mott "Primo." The pull of interlocked brass rods from the water tank, and the decorative guide, are similar to the ones in the other guest rooms; the pendant drop handle is missing.

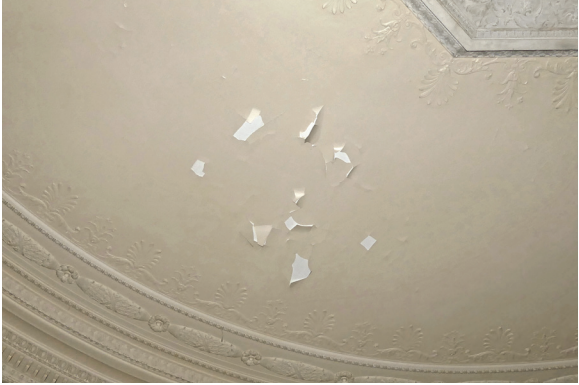
**Figure 59.** There are only a few layers of paint on the decorative plaster ceiling in the entrance Hall, but extensive paint failure is present across much of the ceiling. In most areas this failure extends to bare plaster. JGWA, 2018.

| Figure 59. There are only a few layers of paint on the decorative plaster ceiling in the entrance Hall, but extensive paint failure is present across much of the ceiling. In most areas this failure extends to bare plaster. JGWA, 2018. .... | 81 |

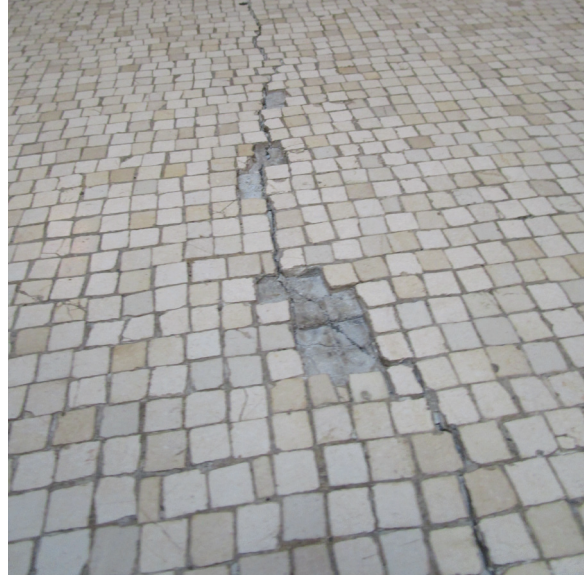
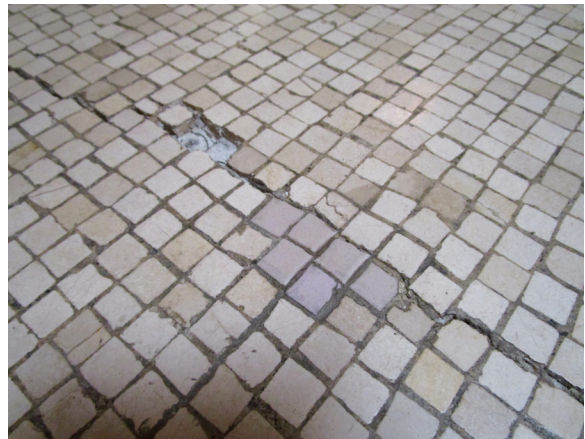
**Figure 60.** The mosaic floor in the entrance Hall (101) has a network of cracks that extend in a pattern radiating from the center of the room to its perimeter. Loss of original mosaic tiles extends along the largest of these cracks. Replacement materials do not match the original mosaic and are not set flush with the original surface. JGWA, 2018.

| Figure 60. The mosaic floor in the entrance Hall (101) has a network of cracks that extend in a pattern radiating from the center of the room to its perimeter. Loss of original mosaic tiles extends along the largest of these cracks. Replacement materials do not match the original mosaic and are not set flush with the original surface. JGWA, 2018. .... | 81 |

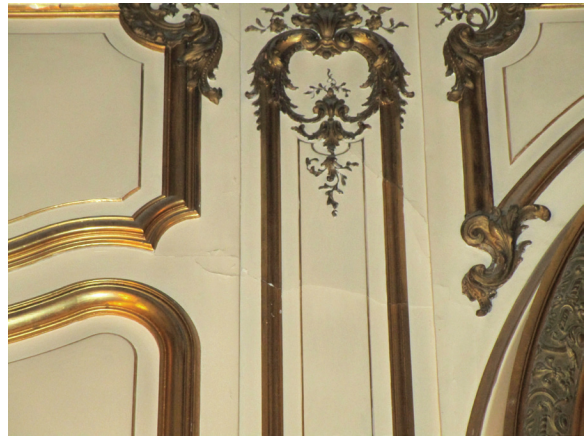
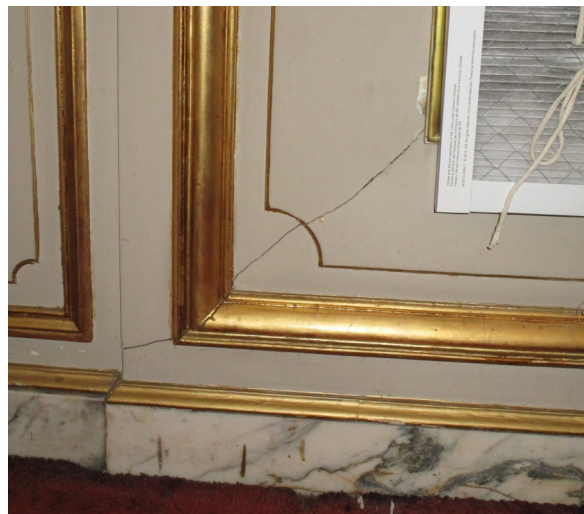
**Figure 61. The decorative plaster in the Reception Room (105) was produced off site and installed in panels. In some areas plaster cracking appears at the junction of panels (lower image), while in others a network of apparently random cracking extends through panels (upper image). Conditions like this are common on both the first and second floor levels, and in most locations are little more than hairline cracks. JGWA, 2018.**

| Figure 61. The decorative plaster in the Reception Room (105) was produced off site and installed in panels. In some areas plaster cracking appears at the junction of panels (lower image), while in others a network of apparently random cracking extends through panels (upper image). Conditions like this are common on both the first and second floor levels, and in most locations are little more than hairline cracks. JGWA, 2018. .... | 83 |

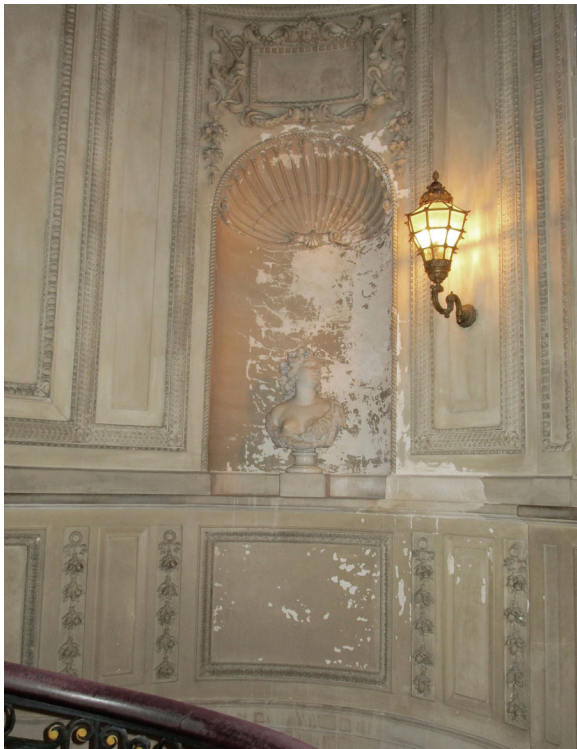
**Figure 62. Moisture ingress at the west portico roof level has led to damage around the niche on an intermediate landing of the main staircase. The stone stringers at both of the intermediate landings of the main staircase have cracks through mortar joints or a combination of the joints and adjacent masonry units. JGWA, 2018.**

| Figure 62. Moisture ingress at the west portico roof level has led to damage around the niche on an intermediate landing of the main staircase. The stone stringers at both of the intermediate landings of the main staircase have cracks through mortar joints or a combination of the joints and adjacent masonry units. JGWA, 2018. .... | 84 |

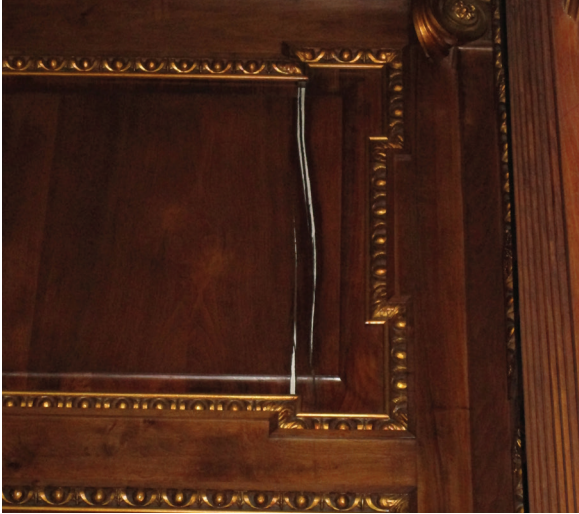
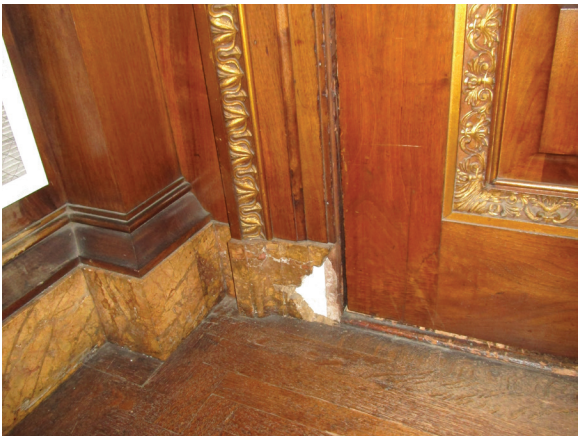
Figure 63. In some of the most formal rooms in the house, marble baseboards exist in conjunction with wood or plaster paneling or trim. Loss of sections of this baseboard can be seen in the Dining Room (lower image), where the underlying plaster can be seen. White plaster can also be seen behind several of the cracked wood panels at the upper level of the Dining Room walls (upper image), and paneled wood ceiling. JGWA, 2018.

| Figure 63. In some of the most formal rooms in the house, marble baseboards exist in conjunction with wood or plaster paneling or trim. Loss of sections of this baseboard can be seen in the Dining Room (lower image), where the underlying plaster can be seen. White plaster can also be seen behind several of the cracked wood panels at the upper level of the Dining Room walls (upper image), and paneled wood ceiling. JGWA, 2018..... | 85 |

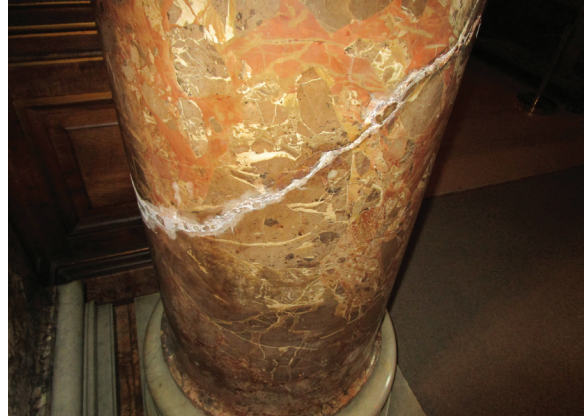
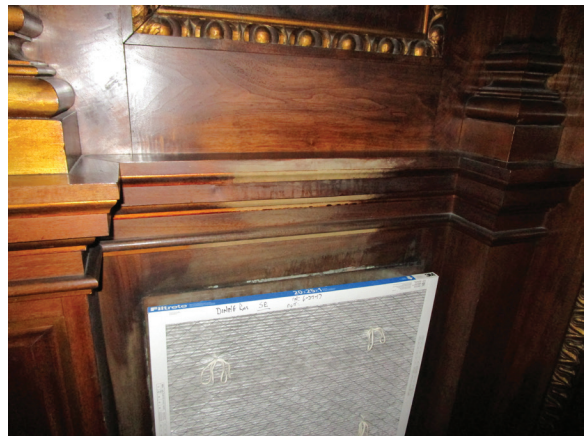
Figure 64. The shafts of the polished stone free-standing columns in the Living Room (104) and Dining Room (106) are made of conglomerate stone that is prone to developing fissures within the matrix of the stone. In the case of the east column in the Dining Room, this condition has led to the loss of some material and an offset diagonal crack through the shaft (upper image). Elsewhere in the Dining Room, the wood paneling is deteriorated immediately adjacent to a wall vent (lower image). Similar surface deterioration, adjacent to vents, can be seen in several locations throughout the house's interior. JGWA, 2018.

| Figure 64. The shafts of the polished stone free-standing columns in the Living Room (104) and Dining Room (106) are made of conglomerate stone that is prone to developing fissures within the matrix of the stone. In the case of the east column in the Dining Room, this condition has led to the loss of some material and an offset diagonal crack through the shaft (upper image). Elsewhere in the Dining Room, the wood paneling is deteriorated immediately adjacent to a wall vent (lower image). Similar surface deterioration, adjacent to vents, can be seen in several locations throughout the house's interior. JGWA, 2018. .... | 85 |

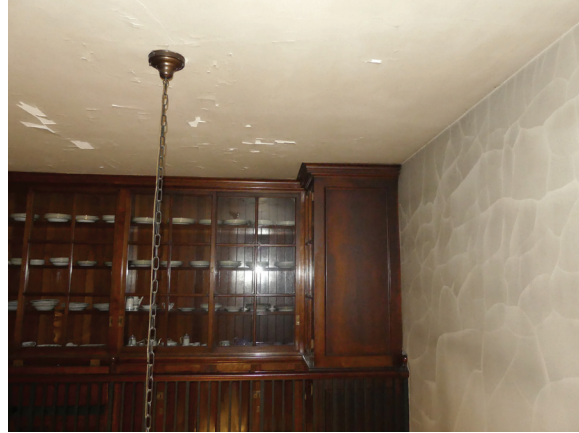
**Figure 65.** The upper mezzanine level of the Butler's Pantry exhibits several problems that are common to the interior. The soot staining on the east wall of the room serves to highlight the extensive network of hairline cracks through the wall plaster. The ceiling exhibits signs of extensive paint failure. JGWA, 2018.

| Figure 65. The upper mezzanine level of the Butler's Pantry exhibits several problems that are common to the interior. The soot staining on the east wall of the room serves to highlight the extensive network of hairline cracks through the wall plaster. The ceiling exhibits signs of extensive paint failure. JGWA, 2018..... | 86 |
