Vanderbilt Mansion National Historic Site  
Hyde Park, New York

## **Vanderbilt Mansion National Historic Site Historic Structure Report**

Volume V: Third Floor and Attic  
October 2018

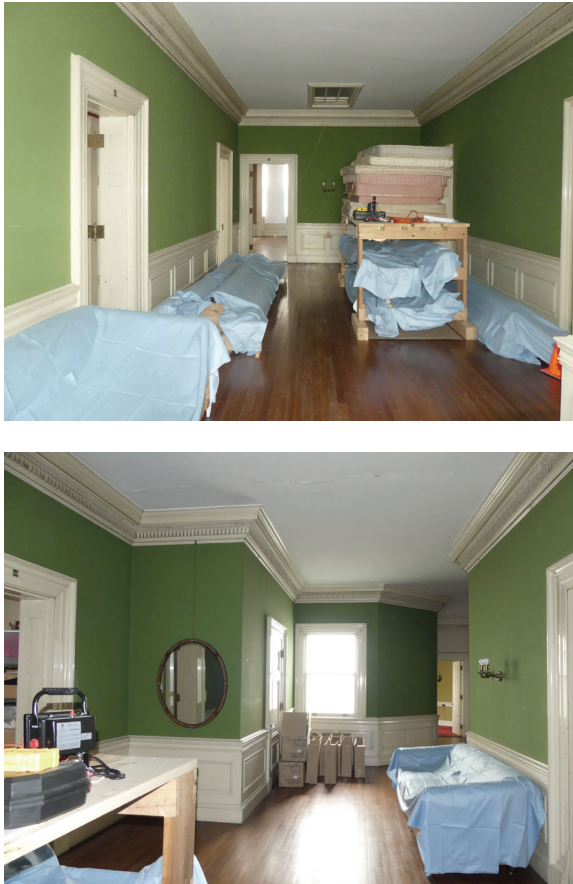
Figure 4. The Guest Hall (301), looking south (upper image) and north (lower image). JGWA, 2018.

**FLOOR:** The 2-3/8" wide tongue-and-groove floorboards are laid north/south. The stain and finish of the flooring has aged to a honey-red color. Brass sockets along the perimeter of the wall held the fixing nails that fastened the Vanderbilt-era carpet (now in storage), which was a rose ground, wall-to-wall carpet with a bold floral trellis pattern and a rope border matching that on the Main Stair.

**LIGHTING/ELECTRICAL:** There are three Vanderbilt-era electric bronze wall brackets: one on the west wall, across from the stair landing; one on the east wall, north of the doorway to the Pink Bedroom, and one centered on the south wall. Each fixture features two single scrolled arms. The brackets have a wreath of bound reeds with leaves imprinted in the backplate, rounded S-shaped fluted arms with minimal foliage at the origin of the arm at the backplate, and an egg-and-dart detail imprinted on the edge of the cup that holds the bulb. The upright, tulip-form frosted glass shades are each composed of six scallops with etched medallions, separated by narrow ridges.

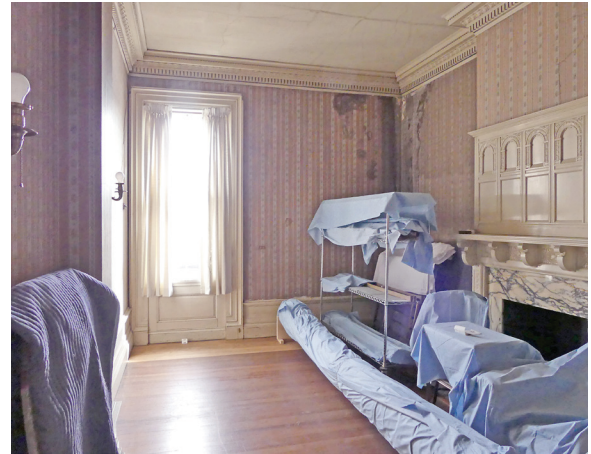
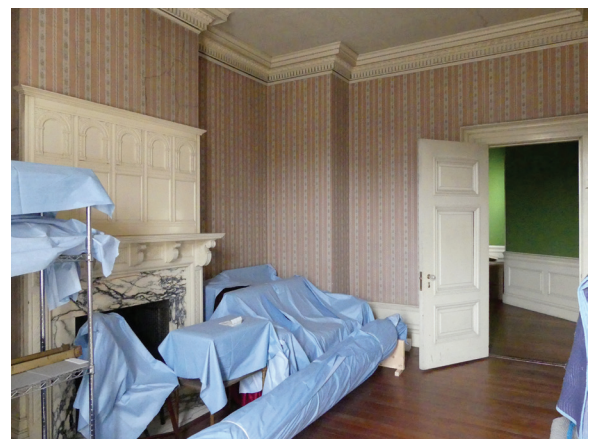
Figure 6. The Small Pink Bedroom (325), looking east (upper image) and southwest (lower image). JGWA, 2018.

**LIGHTING/ELECTRICAL:** There are four Vanderbilt-era bronze electrical wall brackets in this room. The west fixture, immediately south of the doorway, is capped, possibly removed because the door opens against the wall; the remaining backplate is cast with the typical wreath and foliation. The other fixtures, mounted on the north wall, are single brass fixtures with unfluted S-shaped arms with minimal foliation where the arm anchors to the backplate, and an undecorated bobesh. The frosted glass tulip-form shades are open to the ceiling and differ from the hall shades in that they are divided with alternating narrow pointed and wide rounded ridges. The glass shades are not etched.

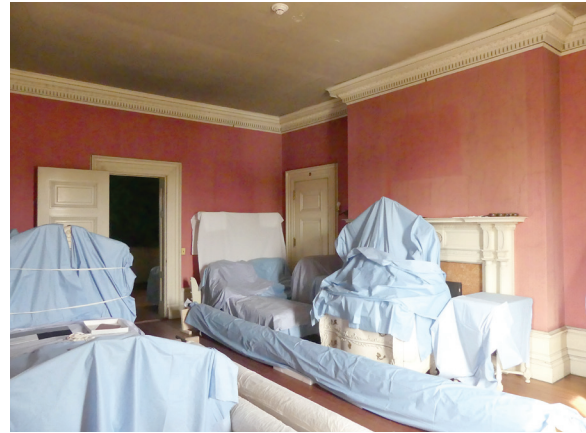
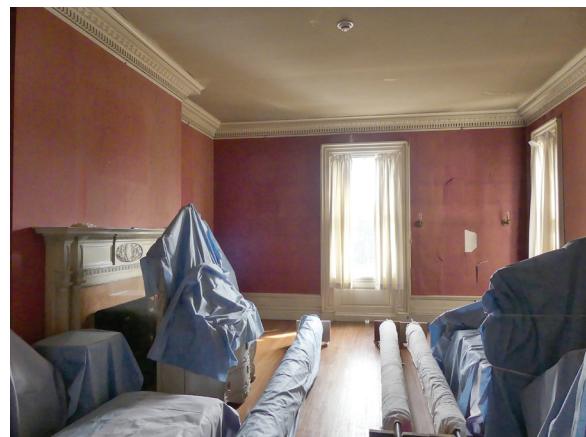
Figure 8. The Pink Bedroom (326), looking northwest (upper image) and east (lower image). JGWA, 2018.

**FIREPLACE:** The primary architectural feature in the Pink Room is the fireplace centered on the north wall. The firebox has a floor of brick laid in a herringbone pattern, and is lined with a fluted cast-iron fireback and sides; the back includes a decorative casting of an arch, a sun motif, and five torches. The hearth and fireplace surround are a mottled, pinkish, rust-colored marble.

**LIGHTING/ELECTRICAL:** There are four Vanderbilt-era bronze electric wall brackets (two on the east wall, one on the south wall, and one on the north wall near the doorway to the closet). The decorative brass fixtures have no fluting on the arm and minimal decoration (similar to the type found in the Small Pink Room (325). Each has a single S-shaped arm and an upright frosted glass shade that includes alternating large scallops and narrow ridges, with etched medallions in the large scalloped sections. Other electrical fittings include a duplex outlet flush-mounted in the south dado, to the east of the doorway, and a single switch plate flush-mounted in the west wall immediately to the north of the doorway.

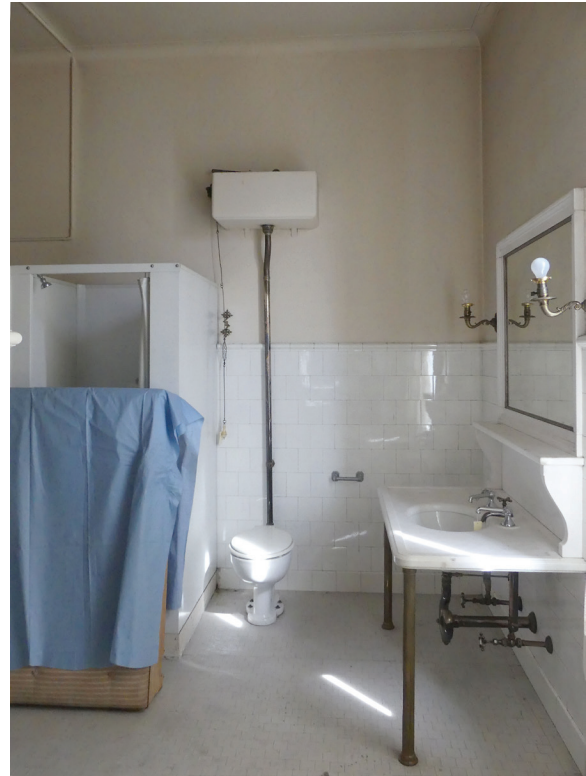
Figure 10. The Pink Room/Lavender Room Bathroom (302), looking north. JGWA, 2018.

**PLUMBING:** A Vanderbilt-era lavatory with a Meyer-Sniffen “Alpha” porcelain basin set in a white marble slab (VAMA 7006) is positioned against the east wall. The marble splash includes curved supports for a marble shelf; a marble-framed mirror is positioned immediately above the shelf.

The Vanderbilt-era J.L. Mott “Primo” toilet on the south wall (VAMA 7007) has an original high water tank and a later seat and lid (marked “Beneke”). The

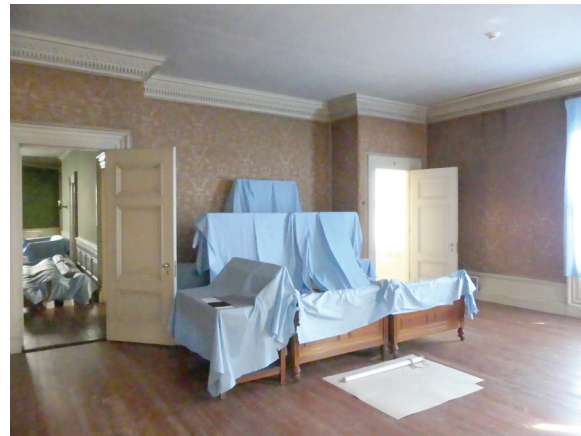
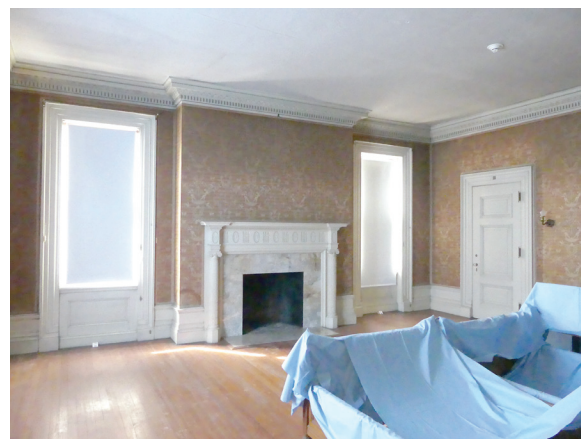
Figure 12. The Lavender Room (303), looking northeast (upper image) and southwest (lower image). JGWA, 2018.

**LIGHTING/ELECTRICAL:** Two Vanderbilt-era bronze electric wall brackets on the west wall, and a matching fixture on the east wall, have S-shaped fluted arms, typical oak-leafed wreathed backplates, plain bulb cups, and upright frosted shades. Two Vanderbilt-era electrical outlets with parallel blade terminals are set in backplates on the ends of the north wall, flanking the bed alcove. A single-switch plate is flush-mounted in the north wall at the west corner, immediately to the west of the doorway.

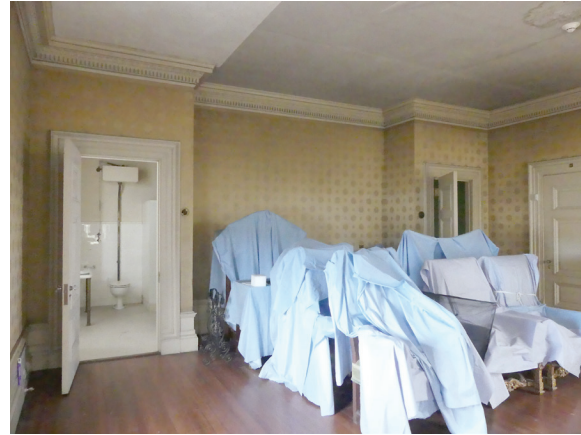
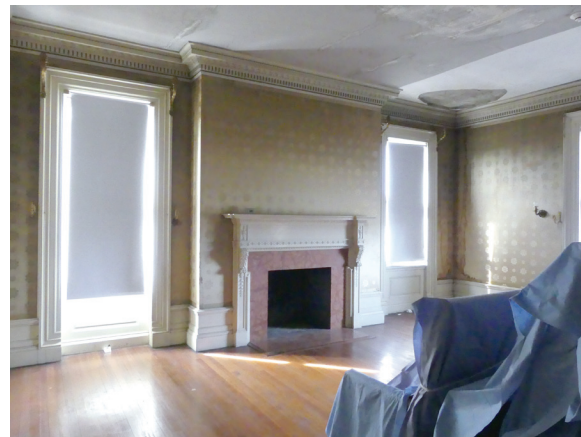
Figure 14. The Empire Room (304), looking northeast (upper image) and southwest (lower image). JGWA, 2018.

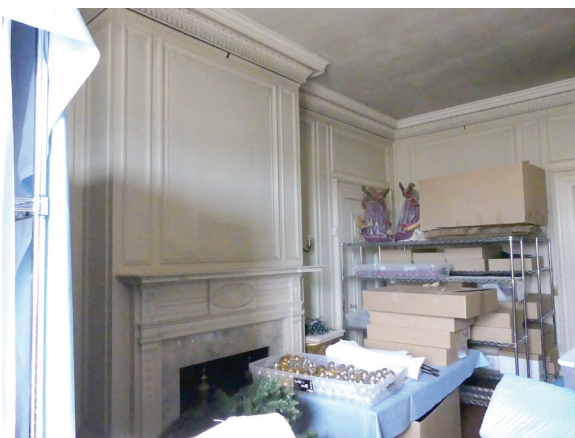
Figure 17. The Green Bedroom (322), looking northeast. JGWA, 2018.

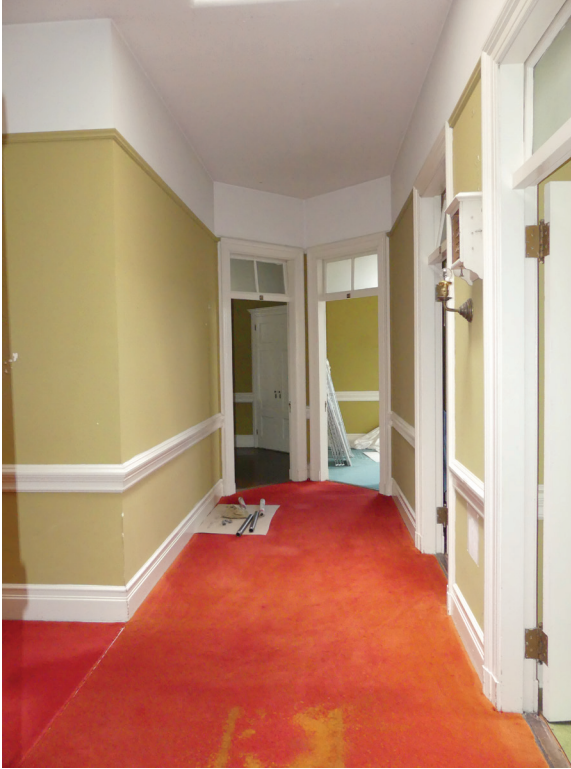
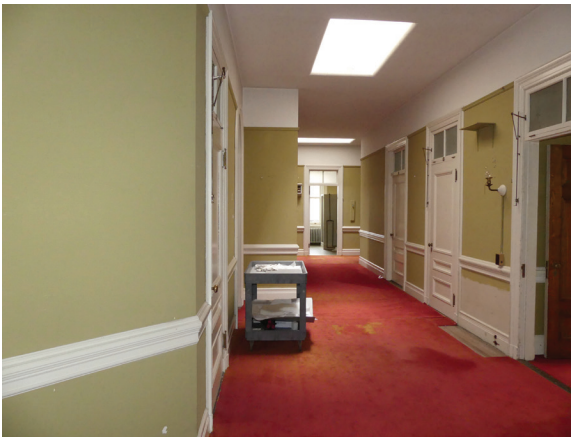
Figure 19. The north area of the Service Hall (329), looking west (upper image); and the central section of the Hall, looking north (lower image). JGWA, 2018.

latches on the trim of the door to the Housekeeper's Hall and on the door to the north Bathroom (317) secured the cords that operated the skylight vents.

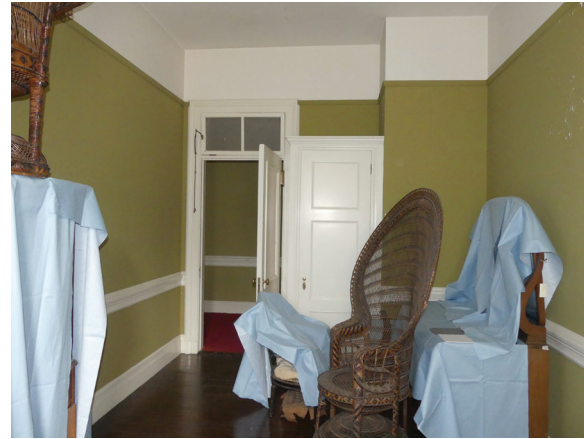
Figure 20. Room 307, looking east. JGWA, 2018.

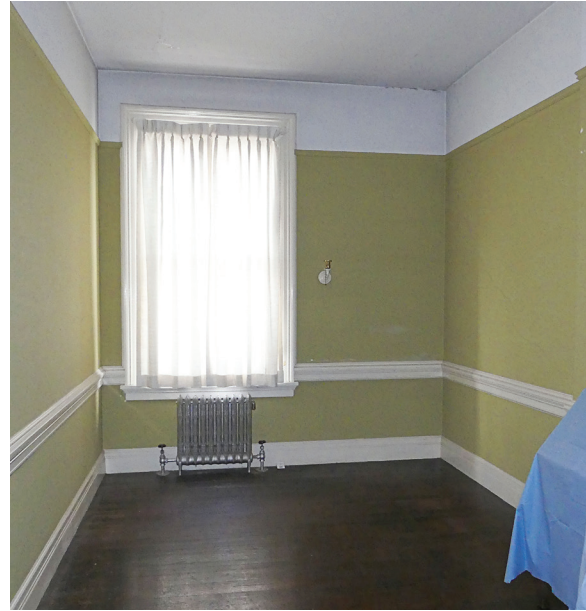
Figure 21. Room 308, looking west. JGWA, 2018.

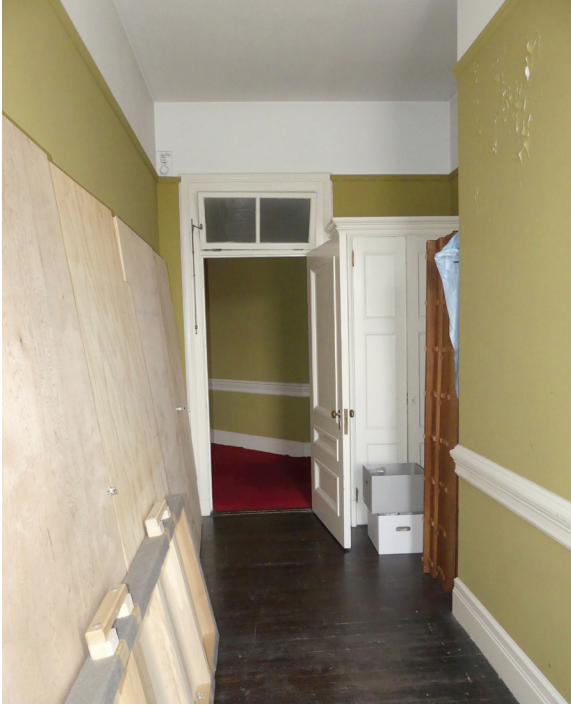
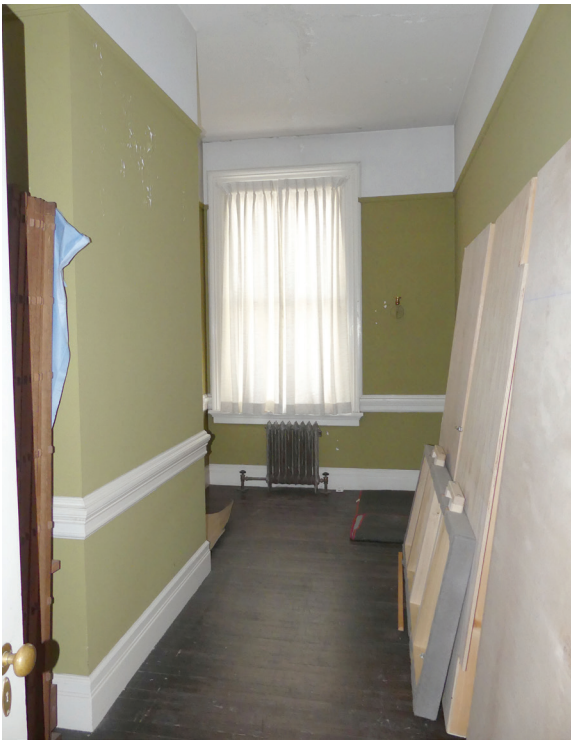
Figure 22. Room 309 looking west (upper image) and east (lower image). JGWA, 2018.

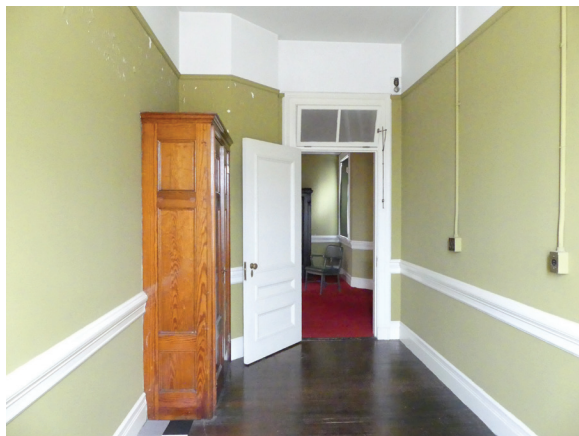
Figure 23. Room 310, looking east. JGWA, 2018.

As described in the section for room 309, this room ("No. IX" on the McKim, Mead & White plan) was nearly part of a larger room that included the bedroom to the south.<sup>22</sup> Instead, it was built according to the original plan: a 17'-9" x 7'-9" room with a doorway in the east wall, a window in the west wall,

and a structural pier projecting into the northeast corner of the room. A closet was built on the north wall after the initial construction.

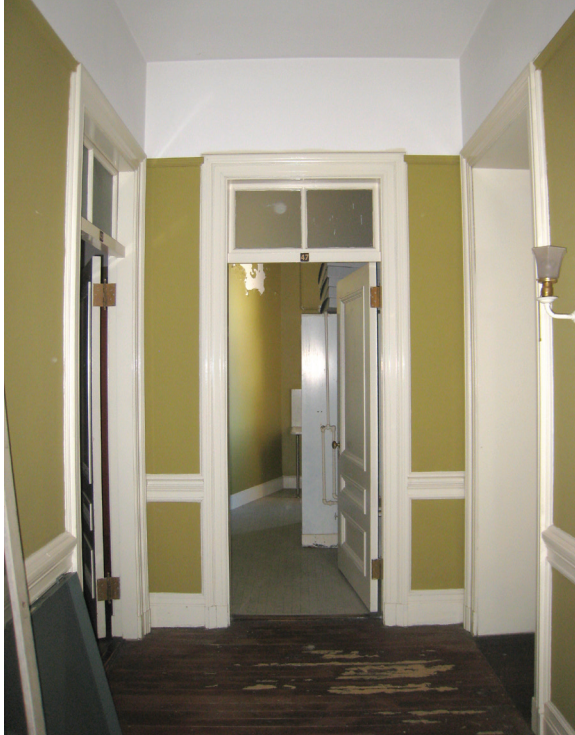
Figure 24. Foyer, looking towards 311/312. JGWA, 2014.

This 10'-3" x 6'-2" passage includes original doorways in the east and south walls, and a later doorway in the north wall. As originally constructed, the foyer established the privacy of a bedroom (311) and bathroom (312) to the west. The arched east opening,

noted on the McKim, Mead & White floor plan,<sup>23</sup> visually set the entrance and its suite apart from the other rooms off of the third floor Service Hall. Sometime after the completion of the mansion, the arched opening was modified by the insertion of a transom and door, providing more separation from the Service Hall. At an unknown date, a doorway was inserted in the north wall, giving the bedroom to the north access to the private bathroom.

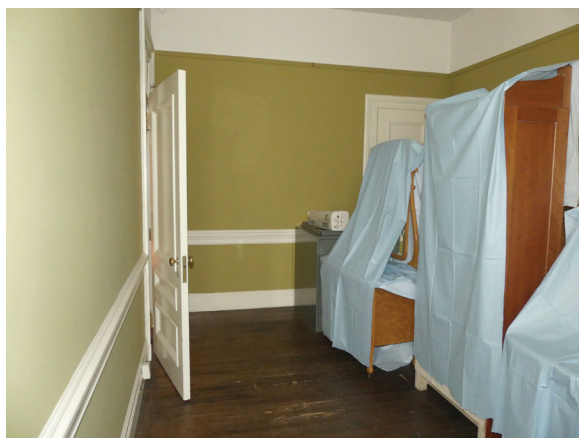
Figure 25. The Sewing room/Lady's Maid's Room (311), looking east. JGWA, 2018.

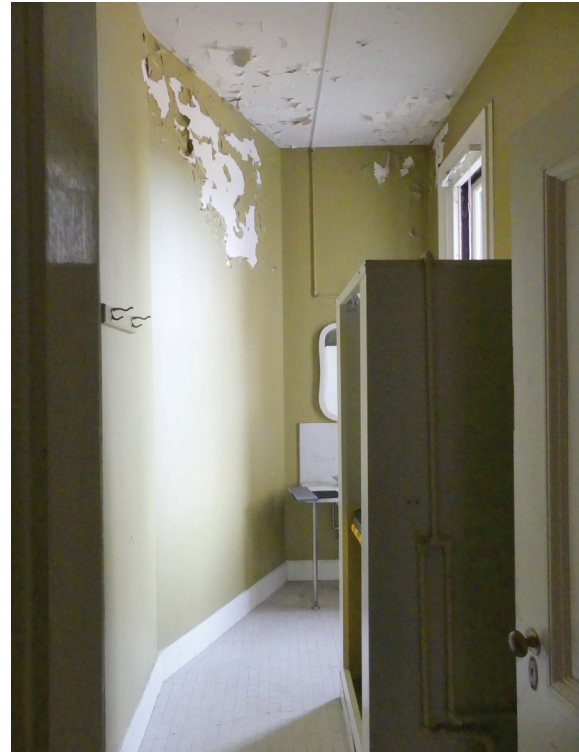
Figure 26. The Bathroom (312) in the semi-private suite, looking west. JGWA, 2018.

As built, the narrow room is just 6' wide with the angled wall extending across the southwest corner. A doorway opens to a vestibule to the east. There is a narrow window opening in the north wall.

The bathtub was removed, one shower stall installed, and the tank mechanism, toilet seat, and lavatory faucets were replaced for the Secret Service in 1942.<sup>27</sup> A ceiling fixture, switch, electrical outlet, and a wood rail with clothes hooks date to that same period.

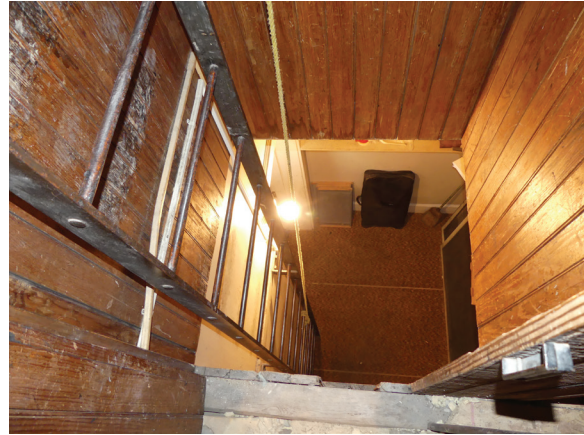
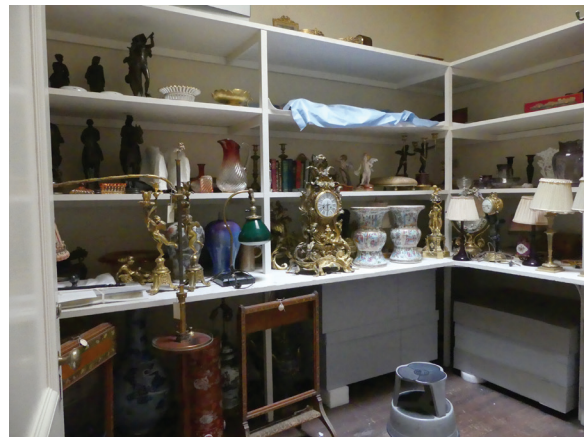
Figure 27. (Upper image) Looking down into room 313 from the attic access; (lower image), Room 316, looking northwest. JGWA, 2018.

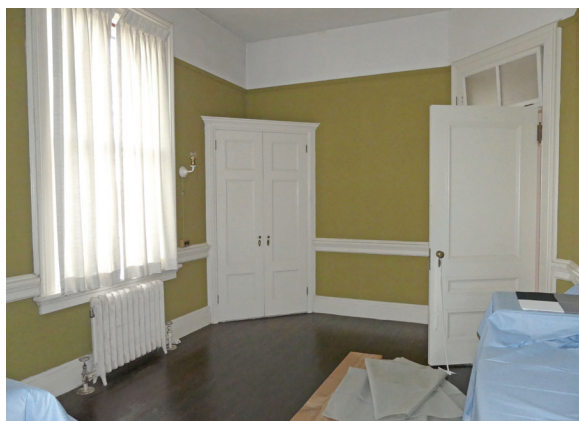
Figure 28. Room 314, looking north. JGWA, 2018.

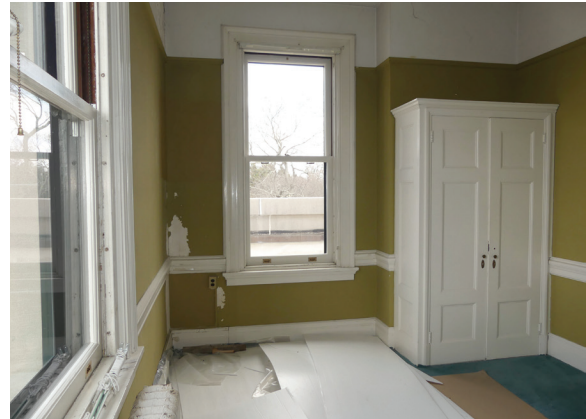
Figure 29. Room 315, looking north. JGWA, 2018.

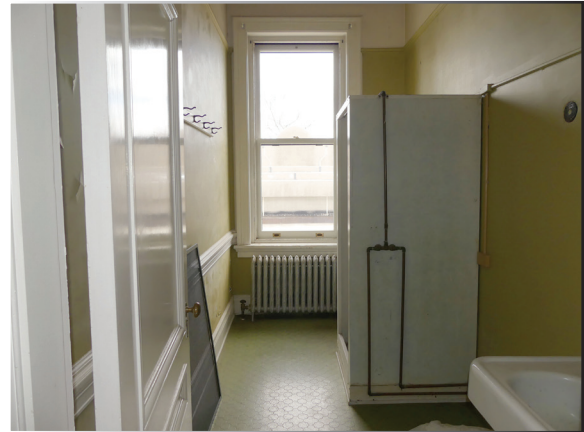
Figure 31. Bathroom 317, looking north. JGWA, 2018.

**FLOOR:** The floor is covered in modern linoleum above a plywood subfloor. The 1943 report notes that this room had new linoleum. The current flooring probably covers a wood floor surface. The typical ceramic tile flooring found in the other bathrooms was never installed here; perhaps there was linoleum on the floor during the Vanderbilt era.

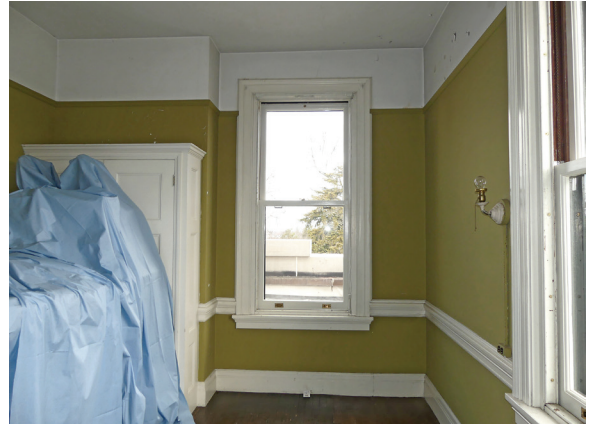
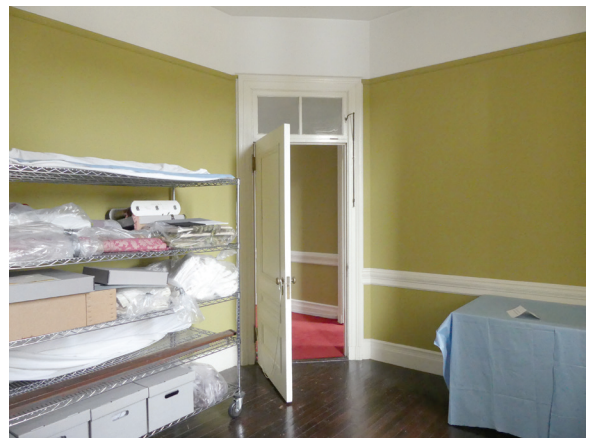
Figure 33. Room 319 (upper image) and Room 320 (lower image), looking north. JGWA, 2018.

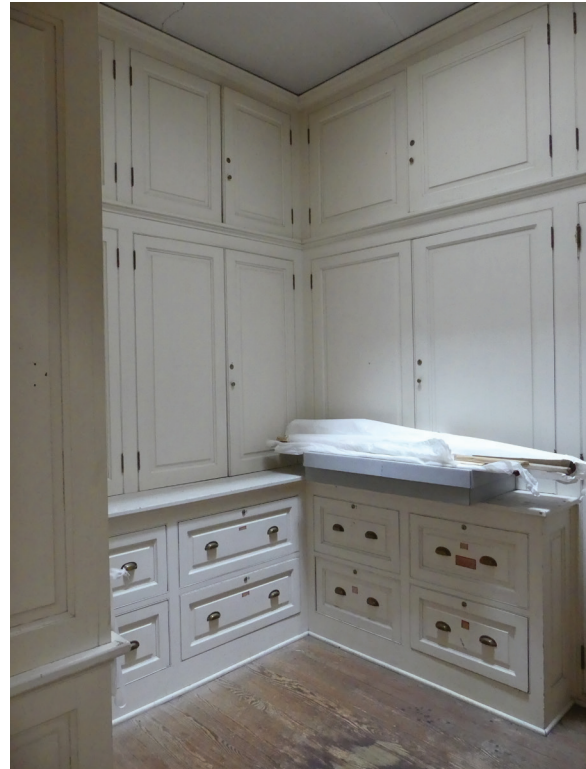
Figure 34. The Trunk Room/Storage Room (321), looking northeast. JGWA, 2018.

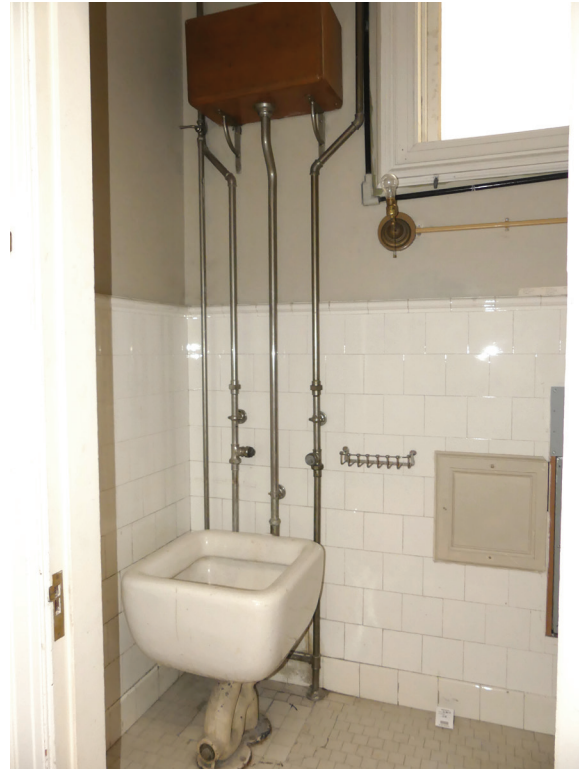
Figure 35. The Maids' Closet (331), looking northeast. JGWA, 2018.

**WINDOW:** The window opening in the east wall receives natural light from the Service Stair. It is

framed by a two-fasciae surround. The opening holds a frosted glass single-light sash. The architrave and sash are painted white.

**PLUMBING:** The original slop sink (VAMA 6889) is positioned against the east wall. It retains its original high wood water tank. The original hot and cold water faucets have been removed, and their locations capped off. They matched the faucets still in place in the second floor Maids' Closet. The chain is missing from the water tank, which provided a second source of water to flush out the sink.

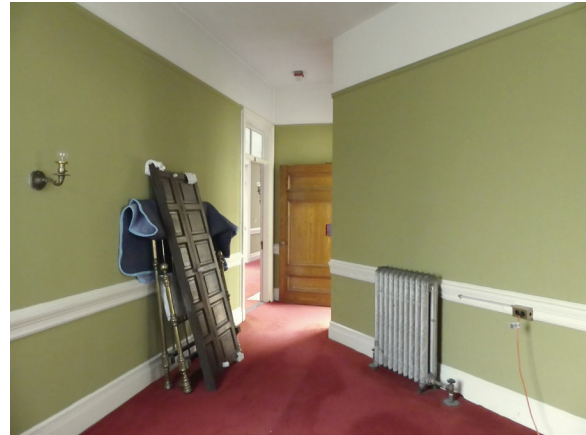
Figure 36. Housekeeper's Hall (330), looking north (upper image) and south (lower image). JGWA, 2018.

**DOOR:** The four doorways—one in the south wall, one in the east wall, one at the north end of the west wall, and a mirroring doorway at the north end of the east wall—are framed by 6-1/4" wide door two-fasciae architraves. The two openings at the north end of the hall include two-light transoms; the sash operator is missing from the northeast doorway.

Northeast door (to Service Stair): The 3'-5 7/8" wide x 6'-11" high x 1-3/4" thick stile-and-rail door has three recessed panels framed by large quirked cyma reversa panel moldings, typical of the service area doors. The door is painted off-white on the Hall side, and is stained and varnished on the Service Stair side. Hardware: The typical 7" high bronze mortise lockset (stamped "36 FLOOR 3" and "U36") includes round bronze knobs and oval bronze keyhole escutcheons. The door is hung on the north jamb to open to the Housekeeper's Hall with two 5" high bronze butt hinges with ball finials. A door closer is mounted at the top of the door on the Service Stair side.

**WINDOW:** The window in the angled southwest wall, looking into the lightwell, is framed by an architrave that matches the door trim, and sits above a square-edged sill that overlaps the chair rail. A 1/1 chain-hung sash, glazed with frosted glass, fills the opening. The window hardware includes a pair of recessed bronze

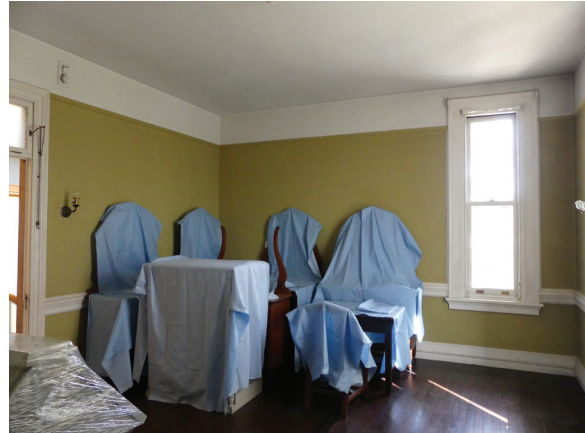
Figure 37. The Housekeeper's Sitting Room (322), looking northwest (upper image) and southwest (lower image). JGWA, 2018.

**WALLS:** The walls are finished in plaster, painted olive green below the picture rail and white above the picture rail. Apparently, the room was wallpapered during the Vanderbilts' occupancy. The fragments of blue wallpaper that NPS staff found in the 1950s-60s can still be seen behind the radiator.<sup>50</sup>

**DOOR:** The west doorway and two-light transom are framed by a typical 5" wide two-fasciae architrave. The rod transom operator is mounted to the north architrave.

West door (to Service Stair): The 2'-11 3/4" wide x 6'-11" high x 1-3/4" thick stile-and-rail door has three recessed panels framed by large quirked cyma reversa panel moldings. The door is stained and varnished on the Service Stair side and painted white on the other side. Hardware: The typical 7" high bronze mortise lockset (stamped "35 FLOOR 3" and "U35") includes round bronze knobs and oval bronze keyhole escutcheons. The door is hung on the south jamb to open into this room with two 5" high bronze butt hinges with ball finials.

**LIGHTING/ELECTRICAL:** Vanderbilt-era brass electric wall brackets on the east and west walls have simple upright arms and frosted glass shades. Both have concentric circles embossed in their backplates. In 1942, the east bracket was remounted to accommodate wire mold that extends to a surface-mounted duplex outlet above the chair rail, and continues to the baseboard and east to a duplex receptacle on the north baseboard

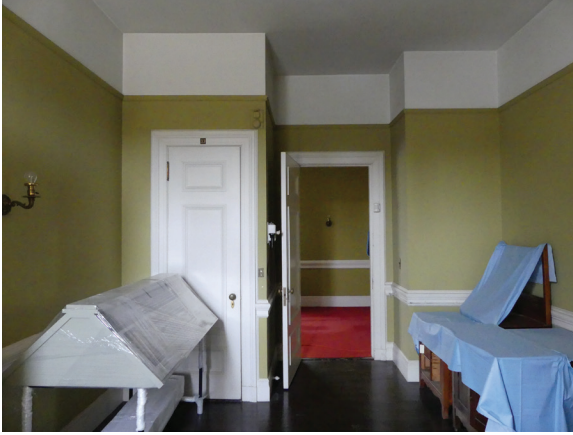
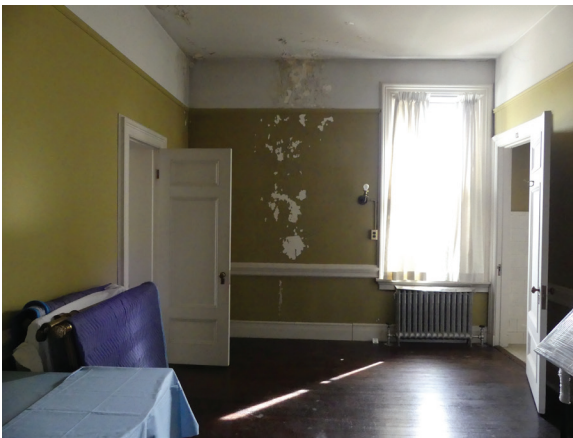
Figure 38. The Housekeeper's Bedroom (323), looking west (upper image) and east (lower image). JGWA, 2018.

**LIGHTING/ELECTRICAL:** Vanderbilt-era bronze electric wall brackets on the east and south walls have single floriated scrolled arms and upright frosted glass shades; these fixtures match the ones used in the third floor guest rooms, each with a round backplate with cast oak-leaf wreath, a foliated S-shaped bracket, and the plain bulb cup.

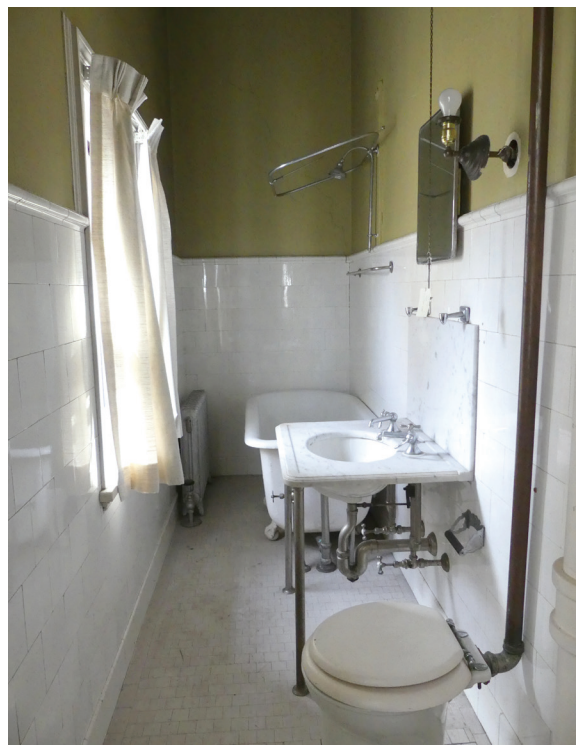
Figure 39. The Housekeeper’s Bath (324), looking south. JGWA, 2018.

**FLOOR:** The floor is composed of two-inch square white ceramic tiles, surrounded by an elongated tile border.

**WALLS:** The 5’-1 1/2” high tiled wainscot is composed of 6” square glazed white ceramic tiles, with a course of rounded tiles at the base, and capped by a course of bullnosed tiles. The plaster walls above the wainscot are painted an olive color.

**LIGHTING/ELECTRICAL:** A Vanderbilt-era brass electric wall bracket on the west wall has a straight arm and an upright frosted glass shade. Concentric rings are embossed onto the backplate.

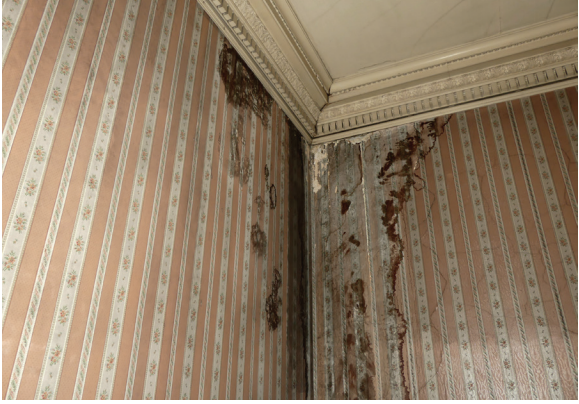
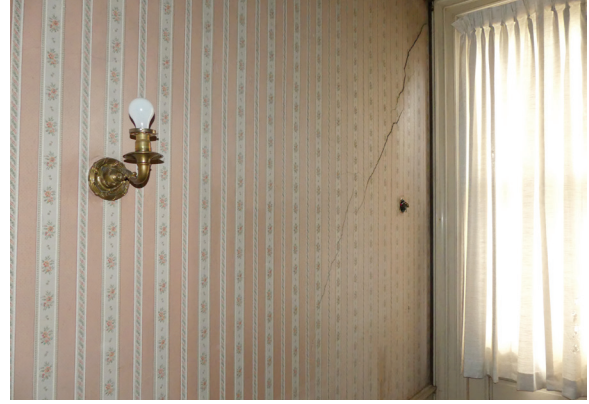
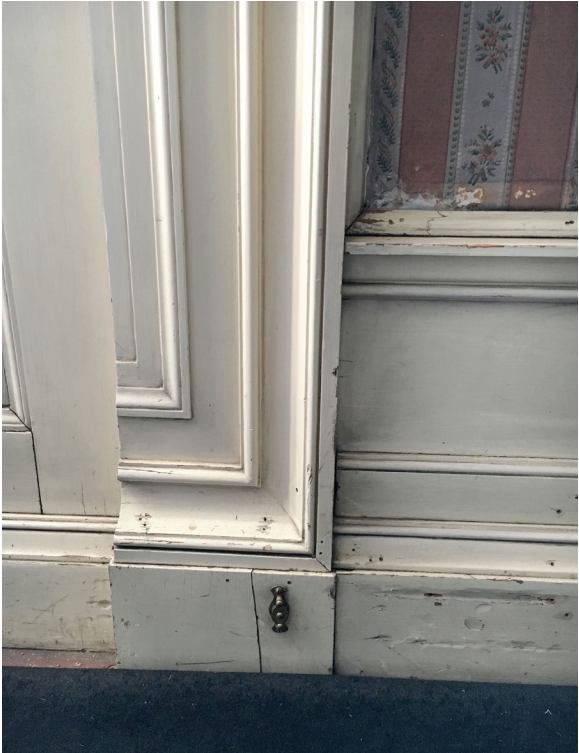
**Figure 40.** (Upper image) This section of wallpaper in the Small Pink Room is another example of damage from moisture infiltration. (Lower image) As is the case with many surfaces in the mansion, this section of baseboard near the east window retains its original painted finish. Although the early finish is still in sound condition it has been compromised by impact damage and holes from removed anchors. (Upper right) A large offset crack can be seen on the north wall. JGWA, 2018.

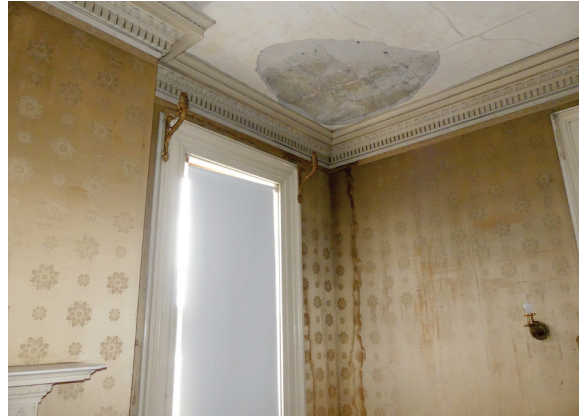
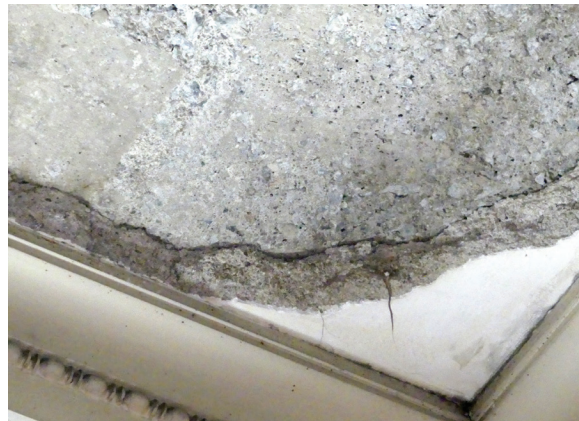
**Figure 41.** The guest quarters at the third floor level have suffered moisture damage. Fabric wall coverings have deteriorated in several rooms at the south end of the third floor, such as the silk in the Empire Room; and a large section of finish plaster recently became dislodged from the southwest corner of the room. JGWA, 2018.

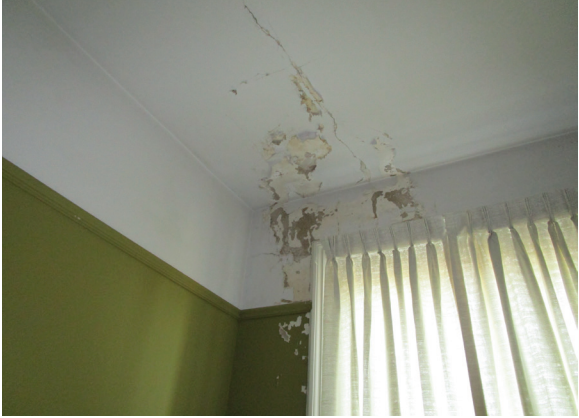
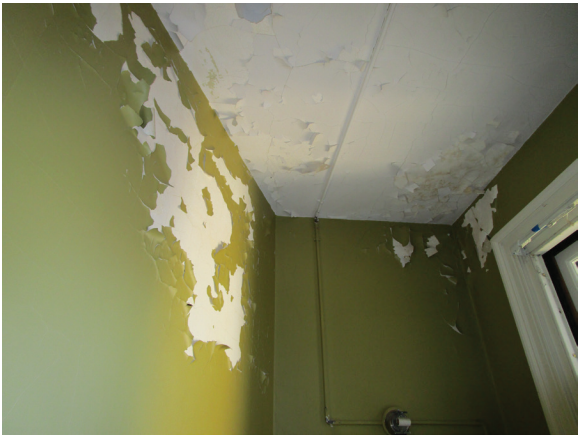
Figure 42. Numerous areas of plaster and paint deterioration exist at the third floor level. These areas are concentrated near, but are not limited to, the exterior walls. A second common condition at the third floor level is cracking across the plaster ceilings. The upper image shows a location where water has migrated along the course of a crack. These are largely unrelated issues, but the course of water through cracks has worsened the deterioration of the plaster in numerous locations. JGWA, 2018.

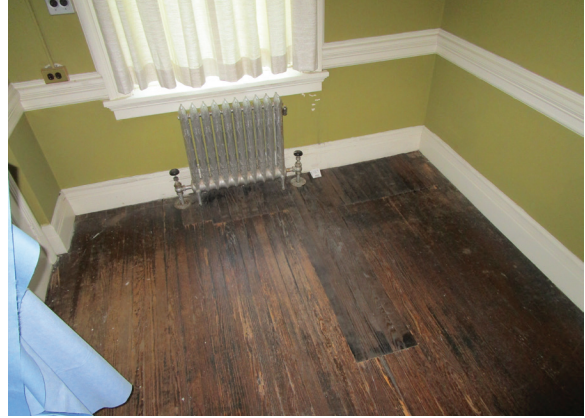
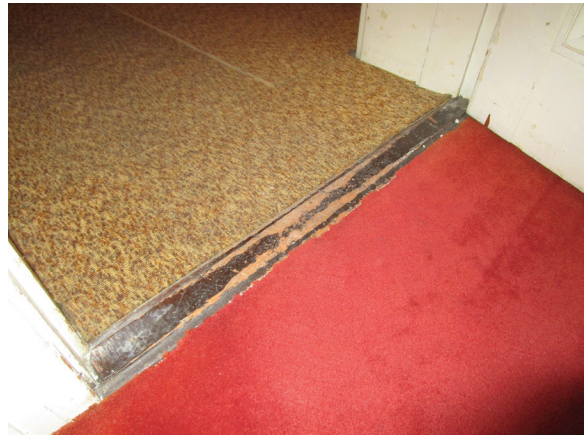
Figure 43. The floors on the third floor have suffered from water and sun-related deterioration, but other conditions have had an impact. Wear and cracking of the floorboards can be seen in several areas, as can patches that were likely necessitated by water damage. The lower image shows a threshold worn to bare wood. This condition will only worsen without a protective coating on the wood. JGWA, 2018.

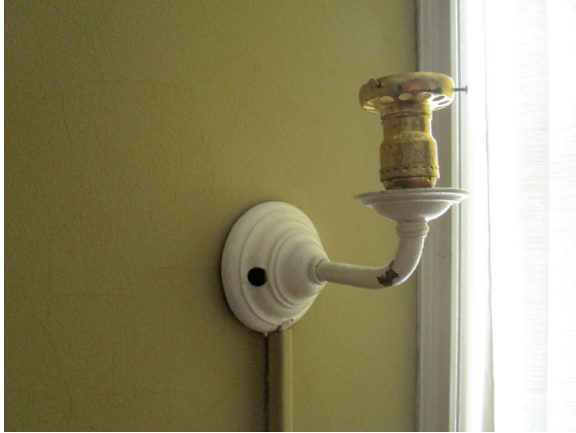
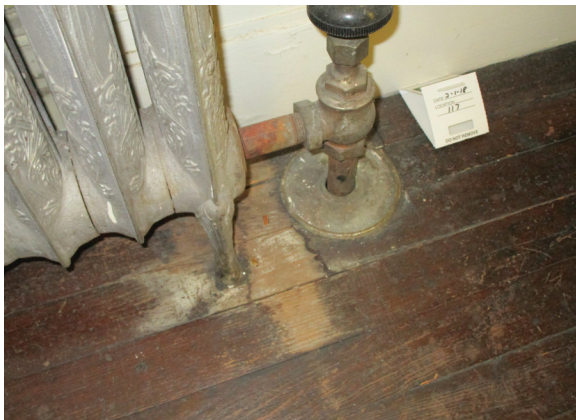
**Figure 44. (Upper image)** Many of the historic light fixtures were damaged in an effort to retrofit them to work with a modern system of exposed wire conduit. This is particularly prevalent at the third floor. **(Lower image)** In several locations steam radiators have leaked as a result of deteriorated steam release valves. This image shows surface rust and floor damage that resulted from such a leak. JGWA, 2018.

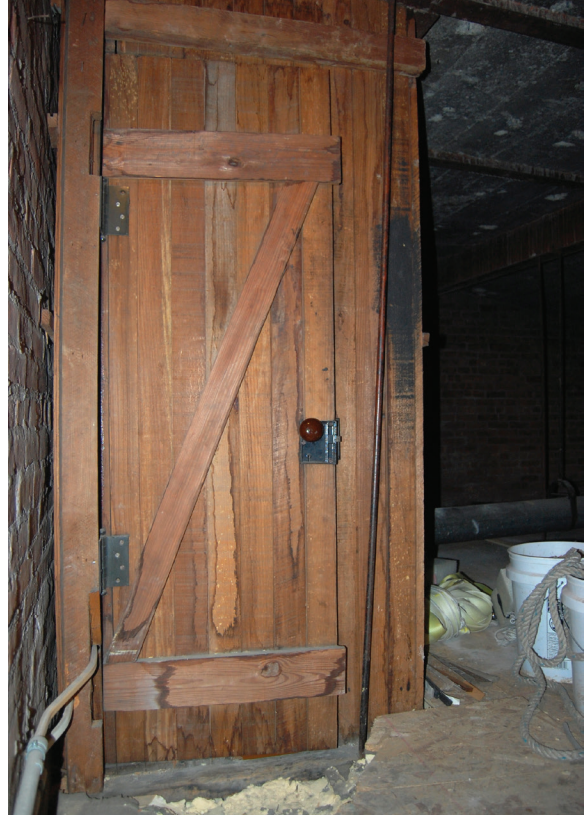
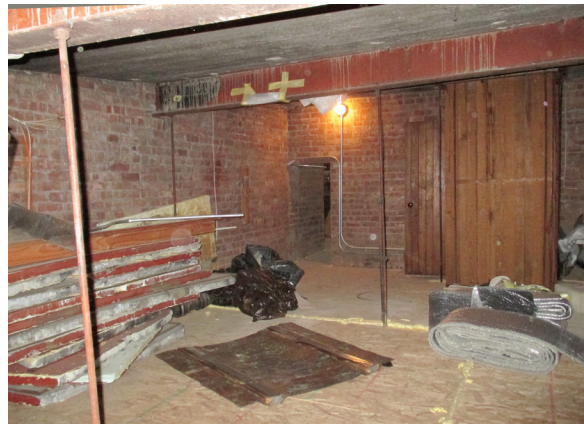
Figure 53. Attic access in room 401 (upper image), and 401, looking southwest (lower image). JGWA, 2017.

**LIGHTING/ELECTRICAL:** An incandescent porcelain utility fixture is mounted to the east wall. Metal conduit extends from the fixture through the east opening; additional conduit extends from the fixture along the east wall, into the ladder well, and continues into the south section of the attic.

**PLUMBING:** An iron pipe from a roof drain in the southwest corner of the room connects to a drain

extending through the south wall, then continues through the west wall towards the vertical drain in the Service Stair.

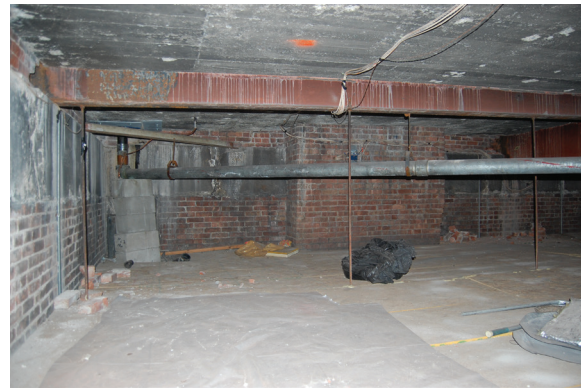
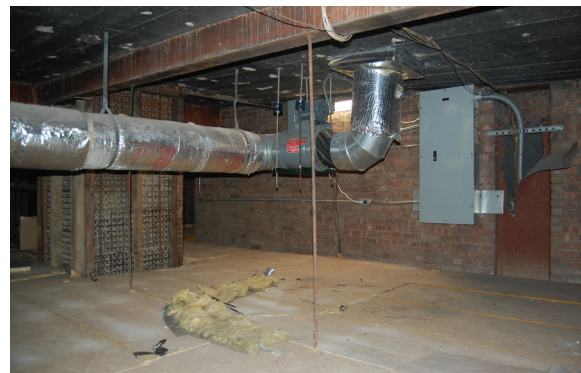
Figure 54. North attic (402), looking northwest (upper image) and looking towards the west end of the north wall (lower image). JGWA, 2017.

Other electrical elements include a panel and duplex receptacle on the south wall. A corrugated metal trough with cables extends down through a vertical trough in the south wall.

**PLUMBING:** Iron pipes from roof drains in the northeast and northwest corners of the roof angle towards the south wall, where they connect and continue through the south wall towards the vertical drain in the Service Stair. Another drain near the

center of the north wall bends towards the north wall where it continues down through a brick niche.

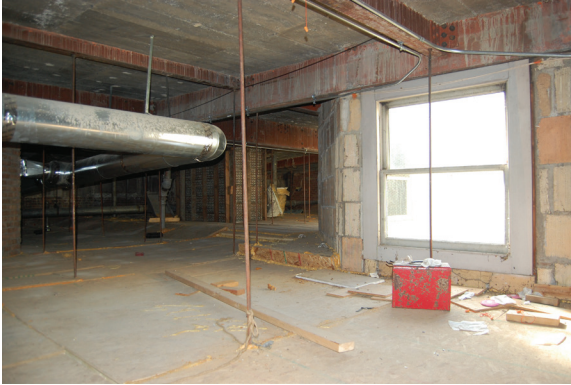
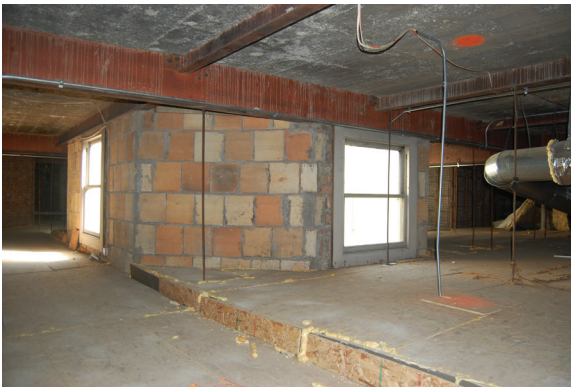
Figure 55. Center attic (403), looking southeast towards the octagonal light shaft (upper image) and looking northeast from south of the light shaft (lower image). JGWA, 2017.

**FLOOR:** The concrete floor is covered in insulation and plywood. To the south of the octagonal light shaft, the floor steps up 5-1/2" to accommodate the higher ceiling in the third floor guest rooms. Small sections of

the floor also step up at the northeast and northwest corners of the shaft.

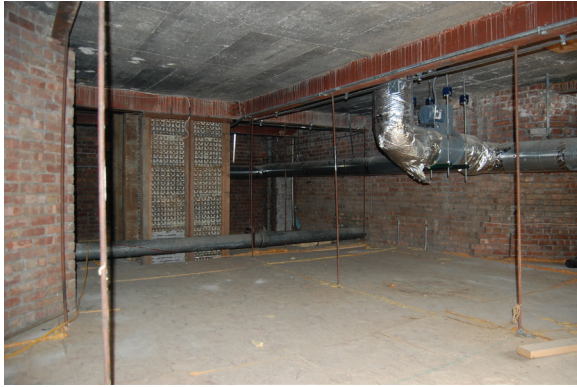
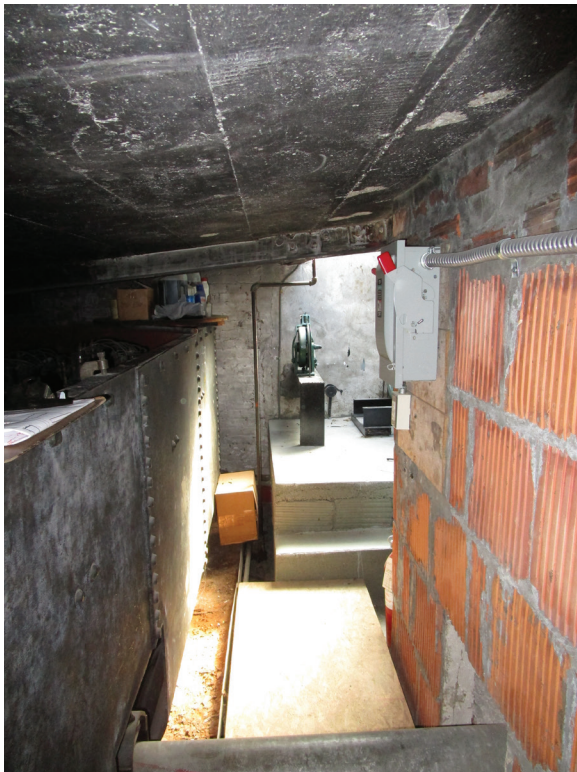
Figure 57. (Upper image) Area north of the central light shaft, looking northeast towards the opening to 404. (Lower image) 404, looking south, with the water tank on the left, the skylight shaft on the right, and the elevator equipment straight ahead. JGWA, 2017.

**WALLS:** The outer brick walls are laid in common bond, with one header course every five to six stretcher courses, painted white. Unfinished, exposed hollow terra-cotta fireproof tiles enclose the east and west sides of the skylight shaft. The actual shaft is formed of corrugated metal lath and plaster supported on wood framing.

The elevator equipment is set below a skylight, and the walls to the south and west of the equipment are finished in plaster on brick.

**CEILING:** The poured concrete roof deck that slopes towards the east is supported by a large I-beam extending north/south near the center of the space. Smaller I-beams at the south end of the space are used to frame around the hipped skylight for the elevator equipment. Insulation foam covers a hipped skylight centered over the water tank.

**DOOR:** A low doorway, north of the northeast corner of the skylight shaft, encloses the space with the cistern and elevator equipment. The opening has a 2-1/2" wide molded steel frame.

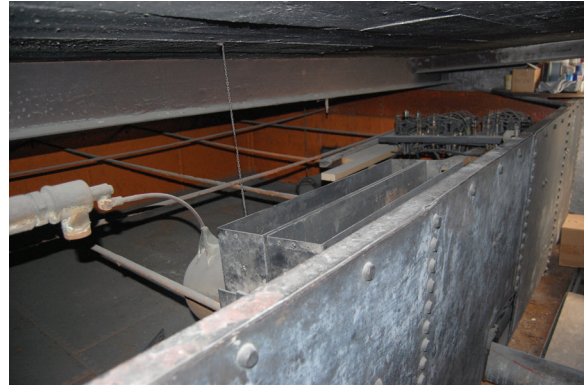
Figure 56. Water tank (upper image) and elevator equipment (lower image) in 404. JGWA, 2017.

**DOOR:** The 1'-11 1/2" wide x 4'-10" high x 1-3/4" thick steel door has a single recessed panel on each face. Hardware: Door hardware includes 5" high mortise lockset with bronze-finished iron rectangular plates and round knobs. The door is hung on the south jamb to open to the west passage with two bronze-finished iron 4-1/2" high butts with ball finials.

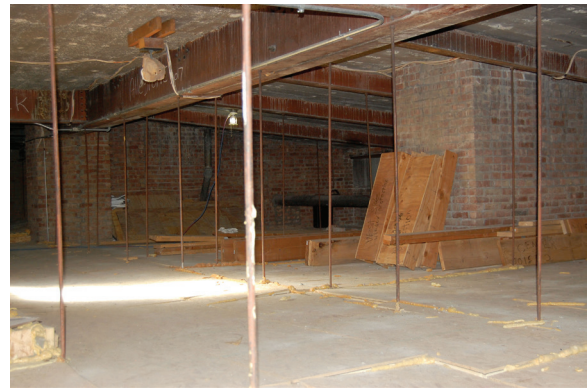
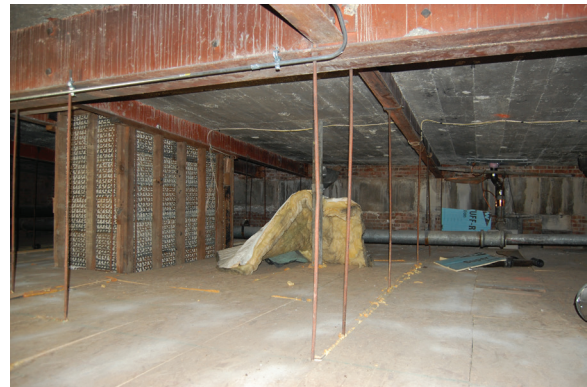
Figure 58. Central west attic (405) (upper image), looking southwest. Central east attic (406), looking east (enter image) and south (bottom image). JGWA, 2017.

**LIGHTING/ELECTRICAL:** The space is lit by a porcelain utility fixture on the ceiling. Rigid conduit stretches across the ceiling to feed the fixture.

**PLUMBING:** An iron pipe collecting water from the roof drains extends through the north and south walls. A drain pipe from the roof bends down towards the south wall

At the north end of the stone course in the west wall, a small copper trough was installed to collect rainwater leaking through the edges of the roof.

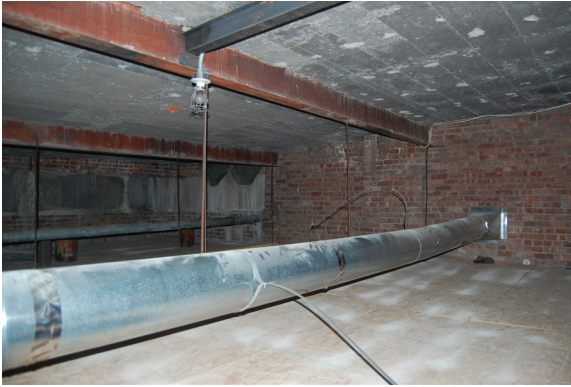
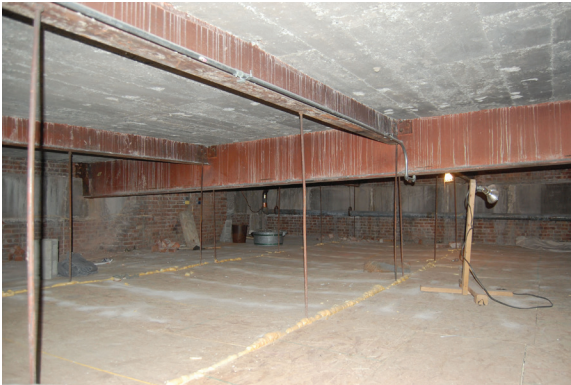
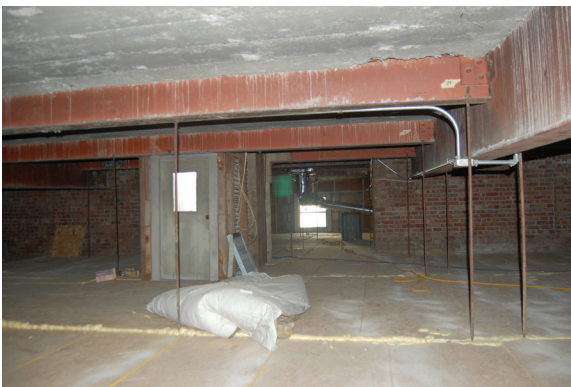
Figure 59. Southeast attic (408), looking southeast (upper image); and south attic (409), looking southwest (center image) and north (bottom image). JGWA, 2017.
