Vanderbilt Mansion National Historic Site  
Hyde Park, New York

## **Vanderbilt Mansion National Historic Site Historic Structure Report**

Volume V: Third Floor and Attic  
October 2018

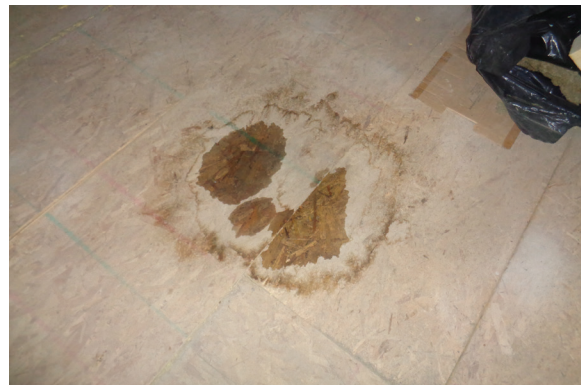
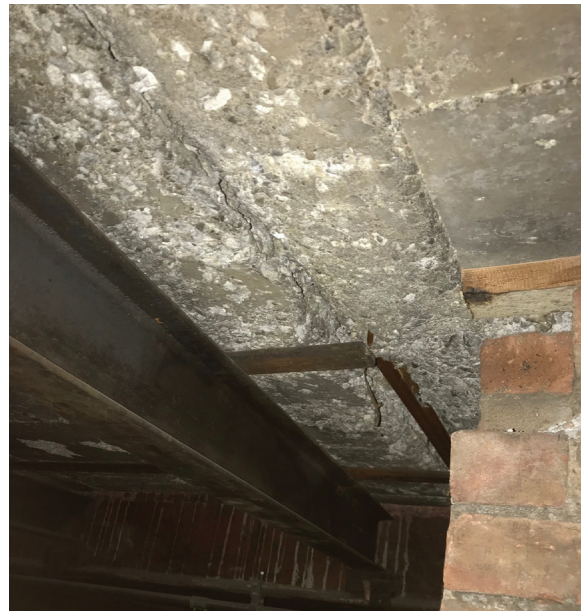
Figure 60. (Upper image) Evidence of leaks, or water pooling as a result of condensation, can be seen on the plywood flooring under several roof vents. (Lower image) A large offset crack exists through the roof deck to the south of the central skylight. This damage to the roof deck appears to have occurred a long time ago. JGWA, 2018.
