## **Vanderbilt Mansion National Historic Site Historic Structure Report Volume VI: Appendices A-E**

Appendix A - Measured Drawings (John G. Waite Associates, Architects)  
Appendix B - Mechanical, Electrical, and Plumbing Systems Report (Kohler Ronan)  
Appendix C - Limited Interior Finish Color Investigation (Jablonski Building Conservation)  
Appendix D - Interior Paint Samples (Albee)  
Appendix E - McKim, Mead & White Drawings

# VANDERBILT MANSION NATIONAL HISTORIC SITE HISTORIC STRUCTURE REPORT

## VOLUME VI APPENDICES

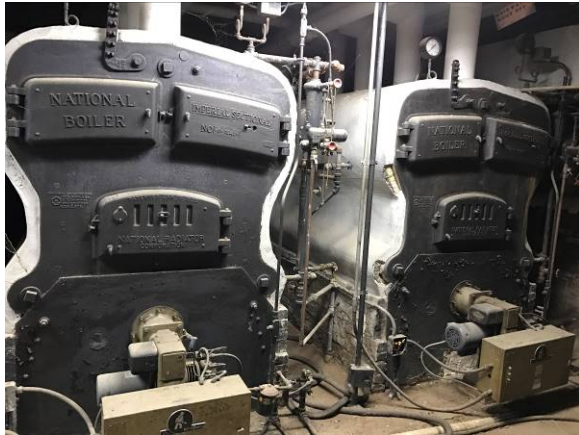
*Abandoned boilers and oil burners in room SB02.  
[KR, 2017]*

Two abandoned steam boilers, installed in the 1940s, remain in room SB02 along with the abandoned steam distribution. The boilers are manufactured by National Radiator Corporation, model National Boiler Imperial Sectional S-1242. The boilers were oil fired via burners manufactured by Dunham-Bush Inc., model C120-1-GM, serial number C64298 and model C120-0-SM for boiler #1, serial number C64453, respectively. Both burners are rated for 15 gph.

The boilers are oil fired via burners manufactured by P.W. Becket Corp., model CF-1400, and serial numbers of 031112-91808 and 031112-91860 respectively. Fuel oil is supplied to the burners from a 275-gallon fuel oil day tank located in the same room. The day tank is double wall with a containment capacity of 110%, manufactured by Roth Industries Inc., model Eco DWT Plus 3, and serial number 0851405366563, Manufactured in 2014, along with a transfer pump. The 1/4 hp transfer pump maintains the day tank oil level by drawing oil from a buried, fiberglass, 2500-gallon #2 fuel oil tank approximately 20 years old.

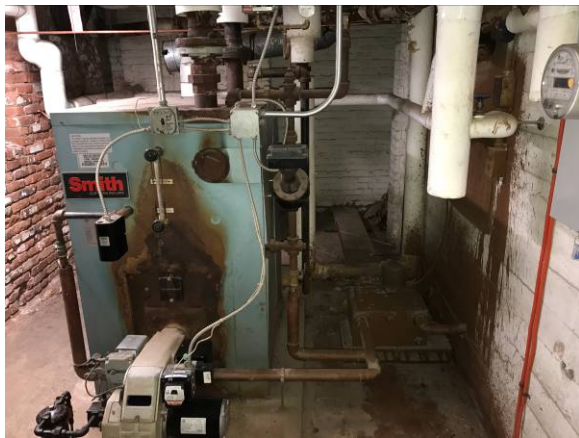
*Oil fired boiler; Boiler #1; and condensate receiver in room  
SB03.  
[KR, 2017]*

Steel piping carries the steam and condensate to and from several heating systems types; including cast iron radiators, gravity convectors, and an air handling unit. Most of the steam and condensate piping is insulated except for valves, unions, and the boiler trim. Manual isolation valves are gate type; the existing gate valves; Jenkins with wood hand wheels, have been cut out and replaced. The condensate is returned to a duplex condensate receiver and pumped back to the boilers; the receiver is manufactured by ITT Bell & Gossett, Model Hoffman M20 100HBF-D, serial number 161056 0497415, rated for 20 gpm.

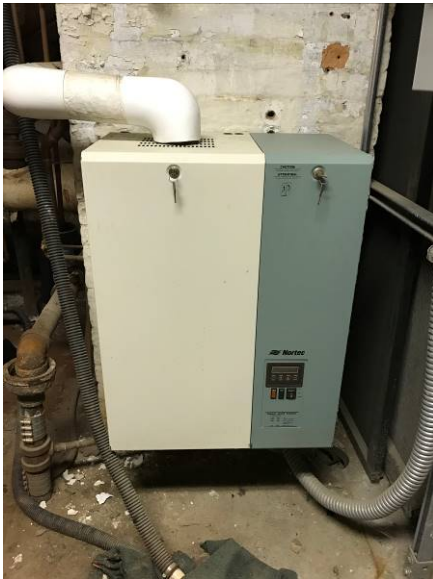
*Electric humidifier located in room SB02.  
[KR, 2017]*

The duct mounted humidifier dispersion grid is supplied by an electric steam generating humidifier located in room SB02. The unit is manufactured by Nortec, model NHMC 100, and serial number 641963621001.
