# White House Stone Carving

BUILDERS AND RESTORERS

1992

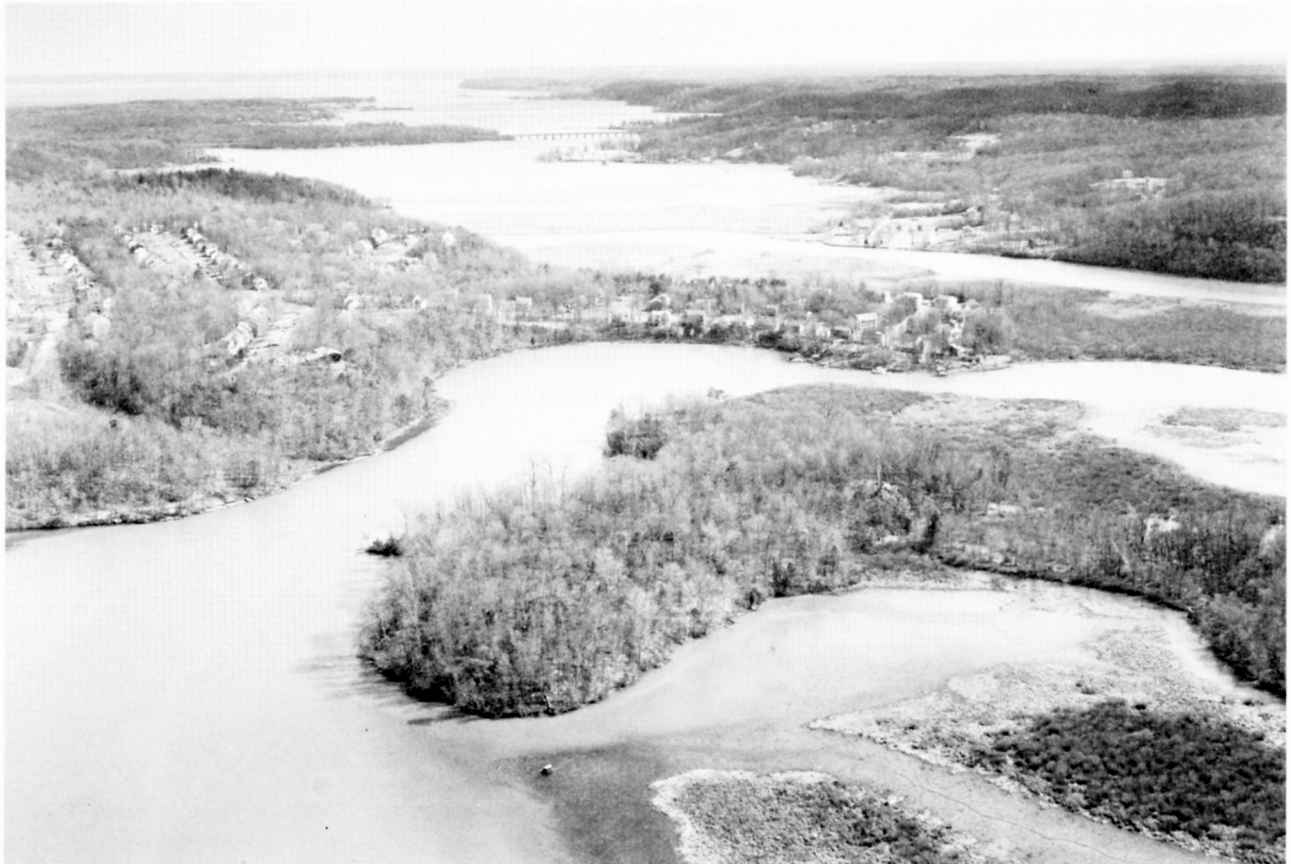
Fig. 1 Aerial view of Government Island, site of several quarries that furnished stone for the White House. Located along Aquia Creek in Stafford County, Virginia, about forty miles south of Washington, D.C., this tidal island is connected to the mainland by marshy bogs and a man-made causeway. The present overgrowth conceals what was a rather extensive quarrying operation in the 1790s. After quarrying, the blocks of stone were hauled to a dock, seen here jutting out on the left edge of the island, where they were loaded onto boats, then floated down Aquia Creek to the Potomac River and shipped upriver to Washington. Thousands of tons of stone were quarried and shipped from this island for the White House in the early 1790s. photo: Jack Boucher, NPS Historic American Buildings Survey (HABS).

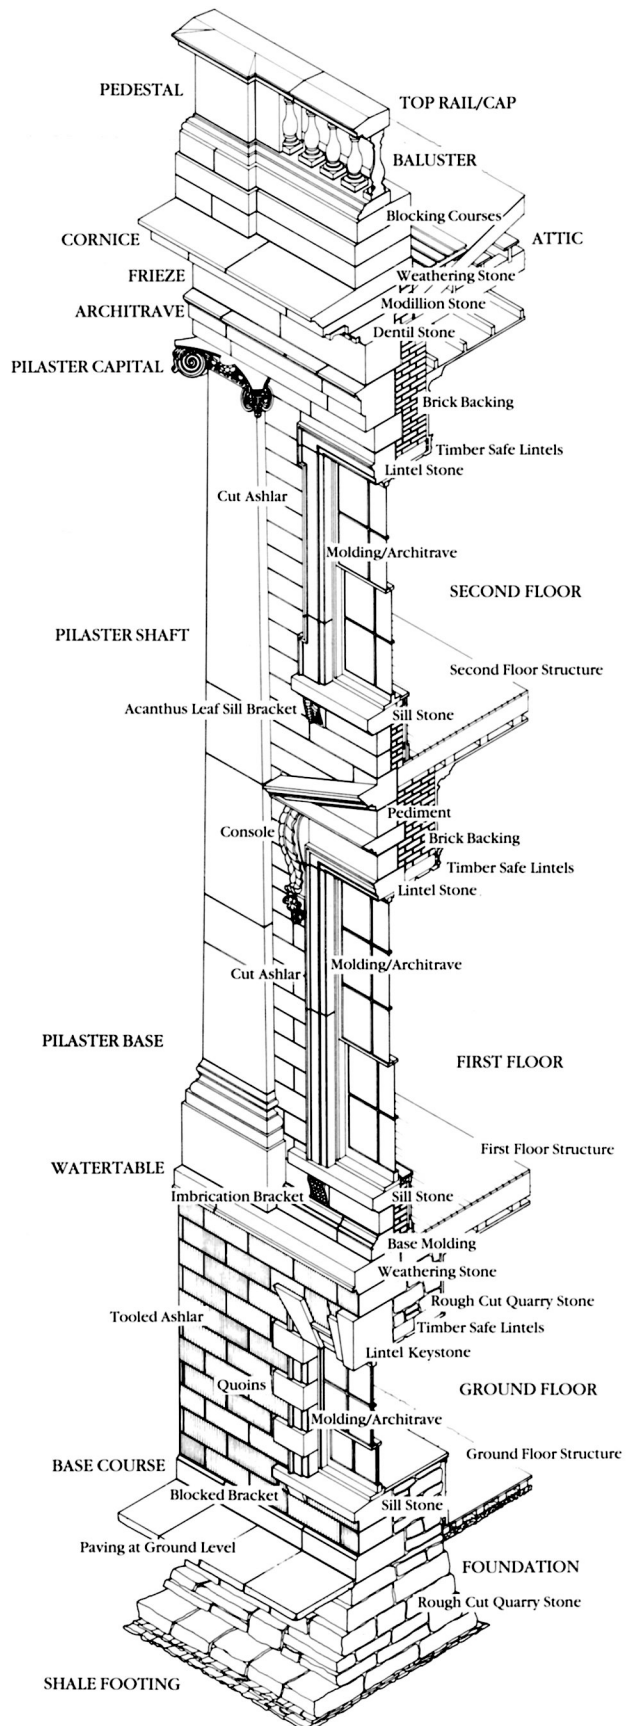
Fig. 3 Partial section through the south wall of the White House showing the original stepped foundations and the solid stone walls for the ground floor. In an attempt to cut costs and expedite work after the project began, the upper walls were built of brick with a stone facing. Most of the dressed stone coursing is 12 inches in height and extends roughly a foot or more into the wall. Also seen are some of the carved stone embellishments, including the molded window architraves, several types of brackets under the window sills, the carved pediments and their supporting consoles, the pilaster capitals, the entablature with the projecting cornice and the roof balustrade. illustration: Tim Buebner, NPS.

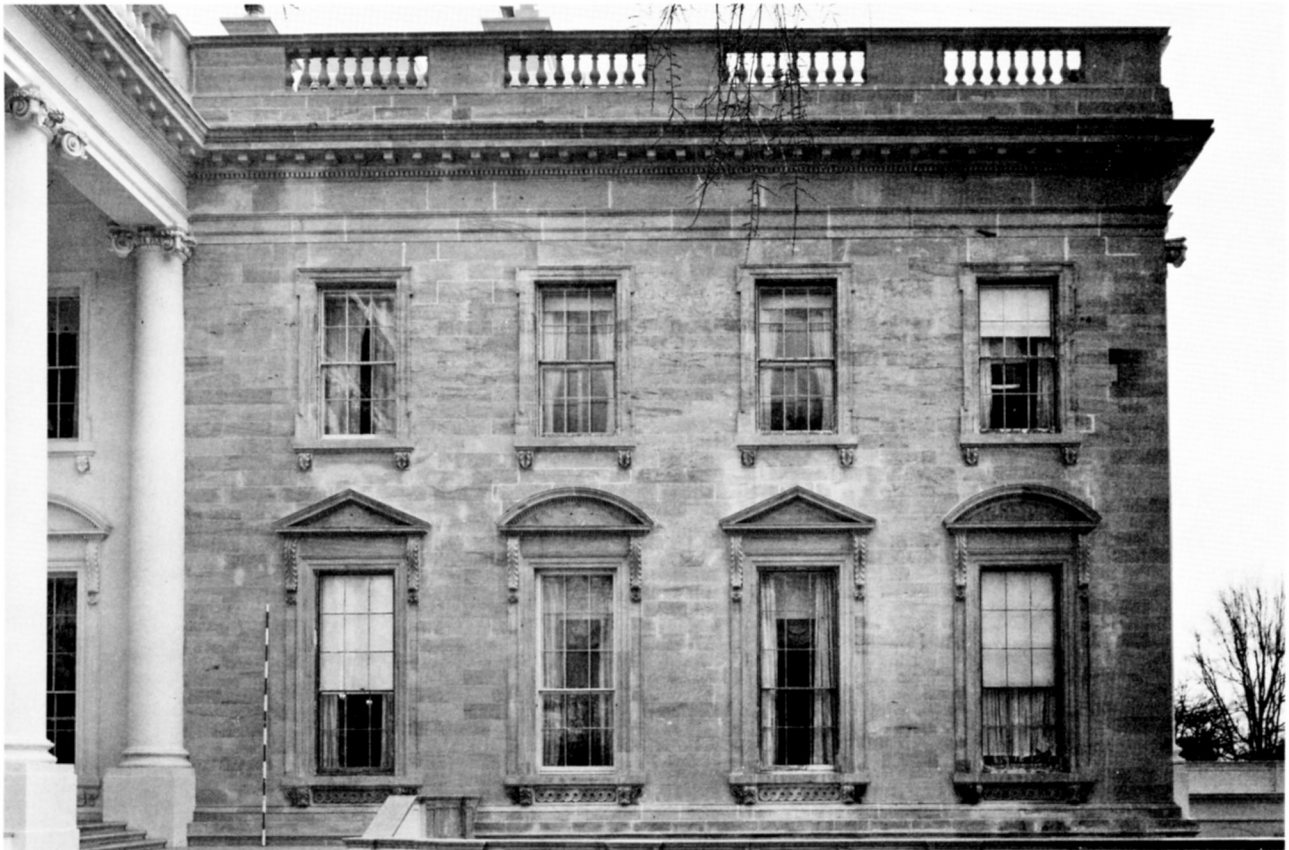
Fig. 4 The windows on the first floor of the White House have alternating triangular and arched pediments supported by large consoles. The second floor windows have kneed architraves (moldings) and acanthus leaf brackets supporting the sills. photo: Jack Boucher, HABS.

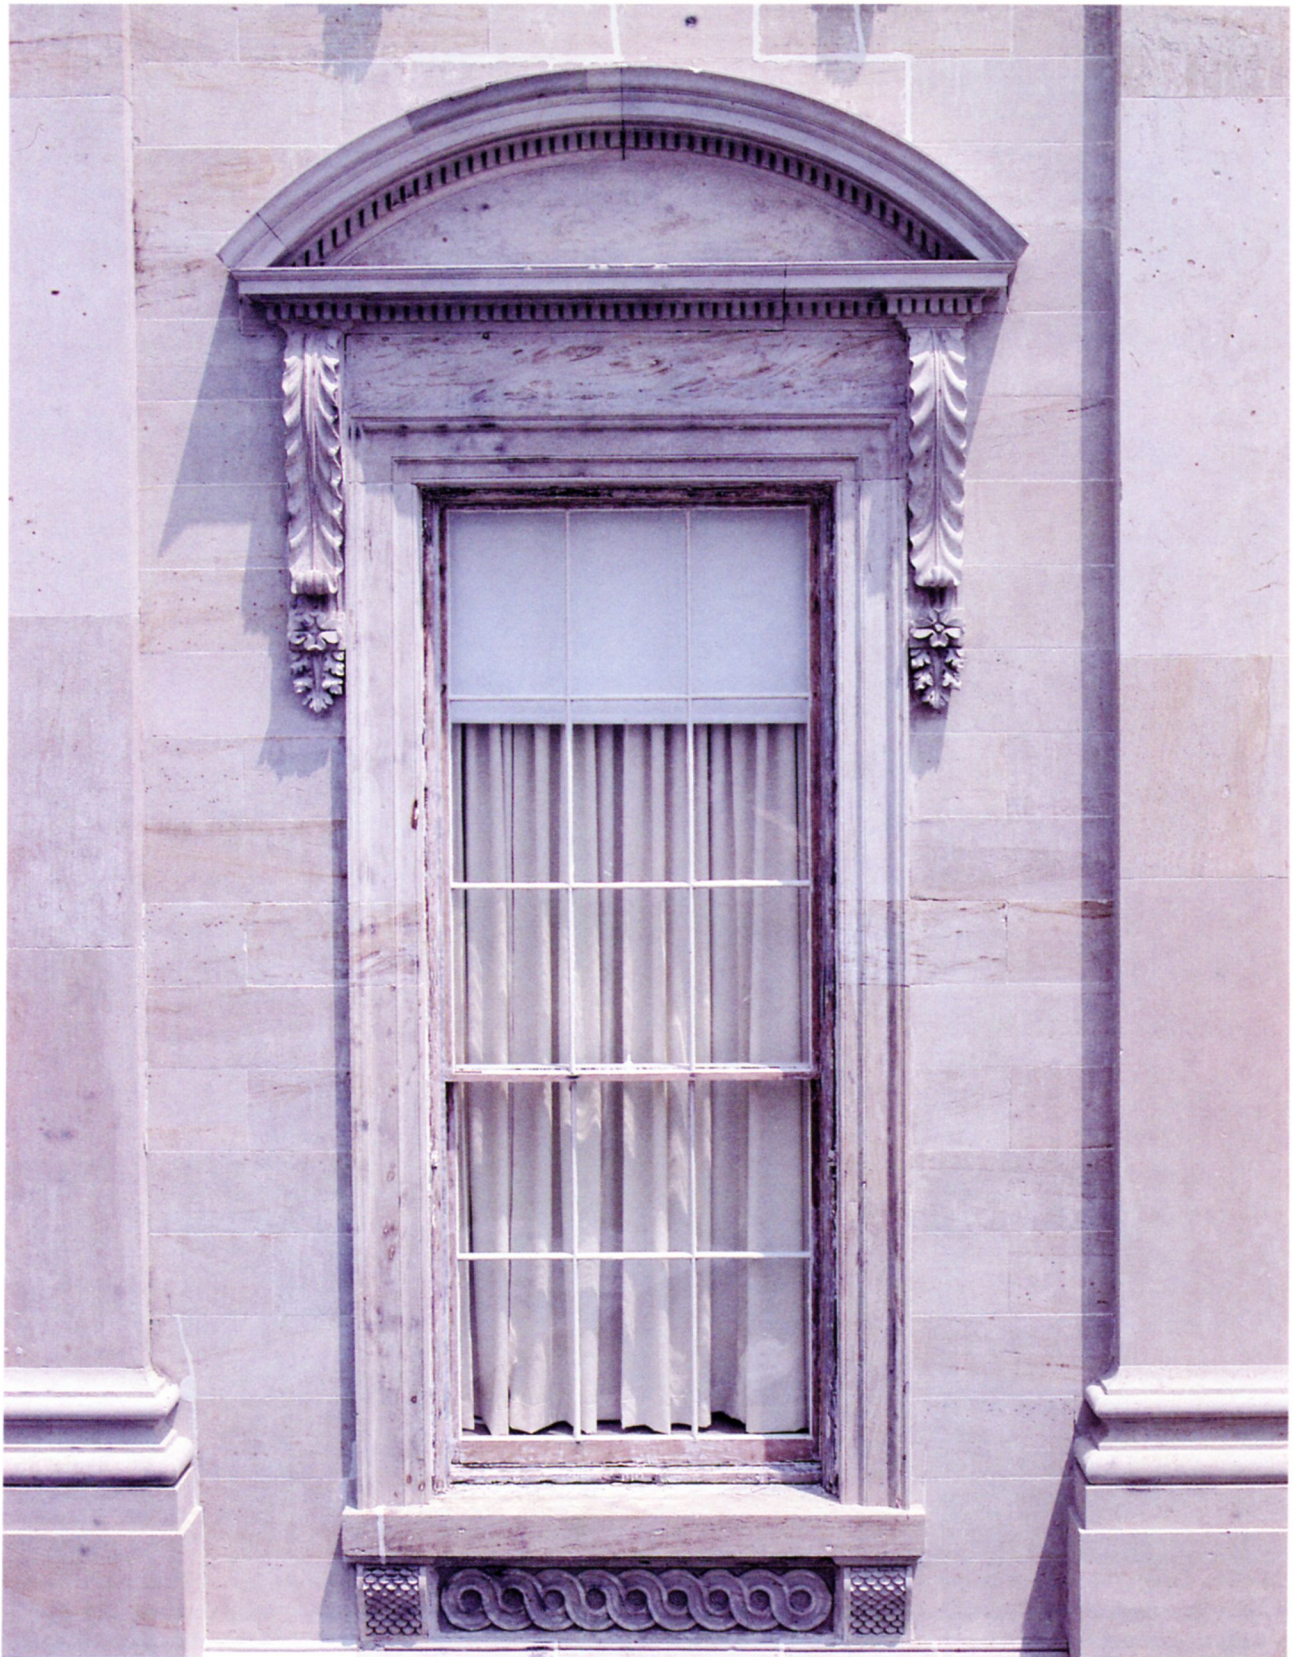
Fig. 5 The first floor windows on the north, east and west side walls have the band of interlocking circles (guilloche) beneath the sills, but only the windows on the east and west walls have imbrication brackets supporting them. photo: Tim Buehner, NPS.

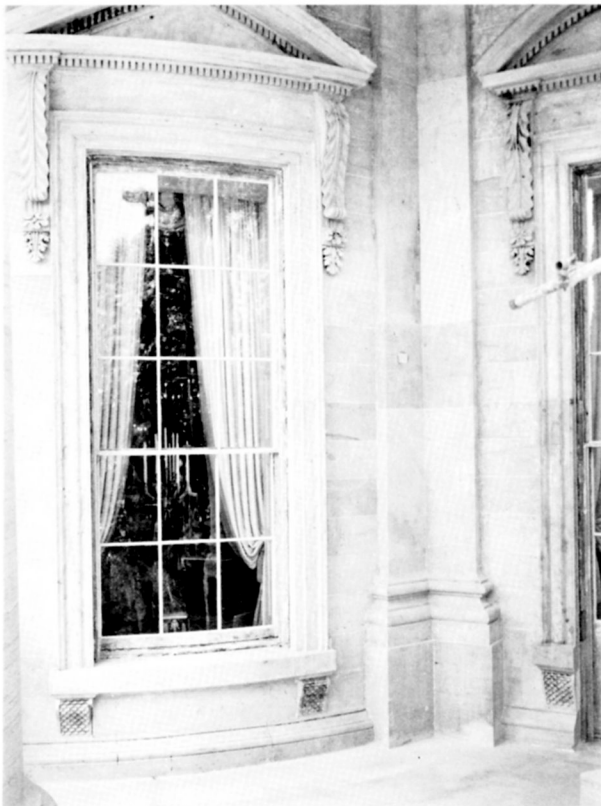
Fig. 6 This view under the Truman Balcony on the south portico shows craftsmanship not found in any other windows on the building. The pediments, the architraves, the sills, and the base moldings are all curved to conform with the surface of the wall. These must have required a multiple set of wooden templates since each curved surface had a different radius that the stone carver had to follow. photo: Jack Boucher, HABS..

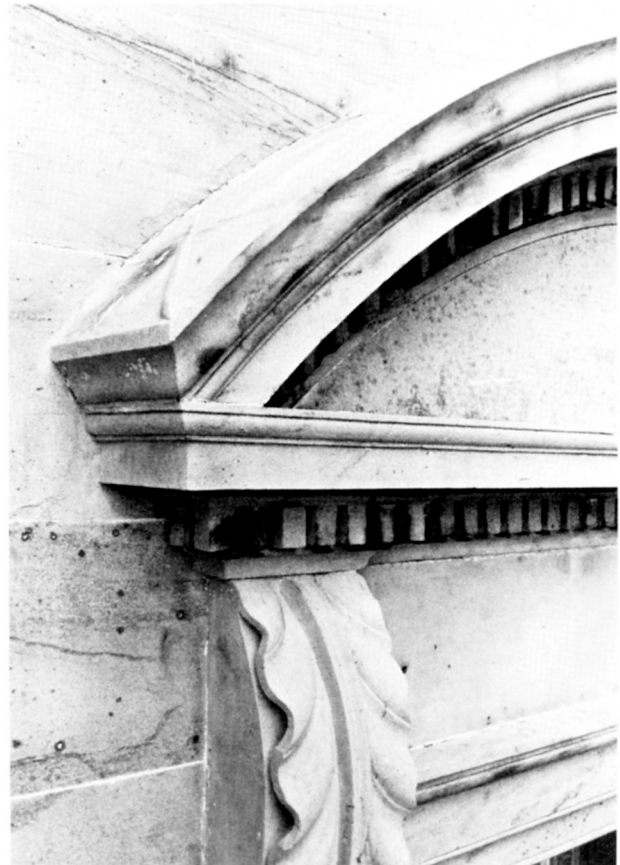
Fig. 7 A built-in drip ledge on the top surface of a window pediment. The ledge is an integral part of the stone. This detail, not seen from the ground, diverts the rainwater washing down the top of the pediment away from the wall surface, thus reducing staining on the wall. photo: Jack Boucher, HABS.

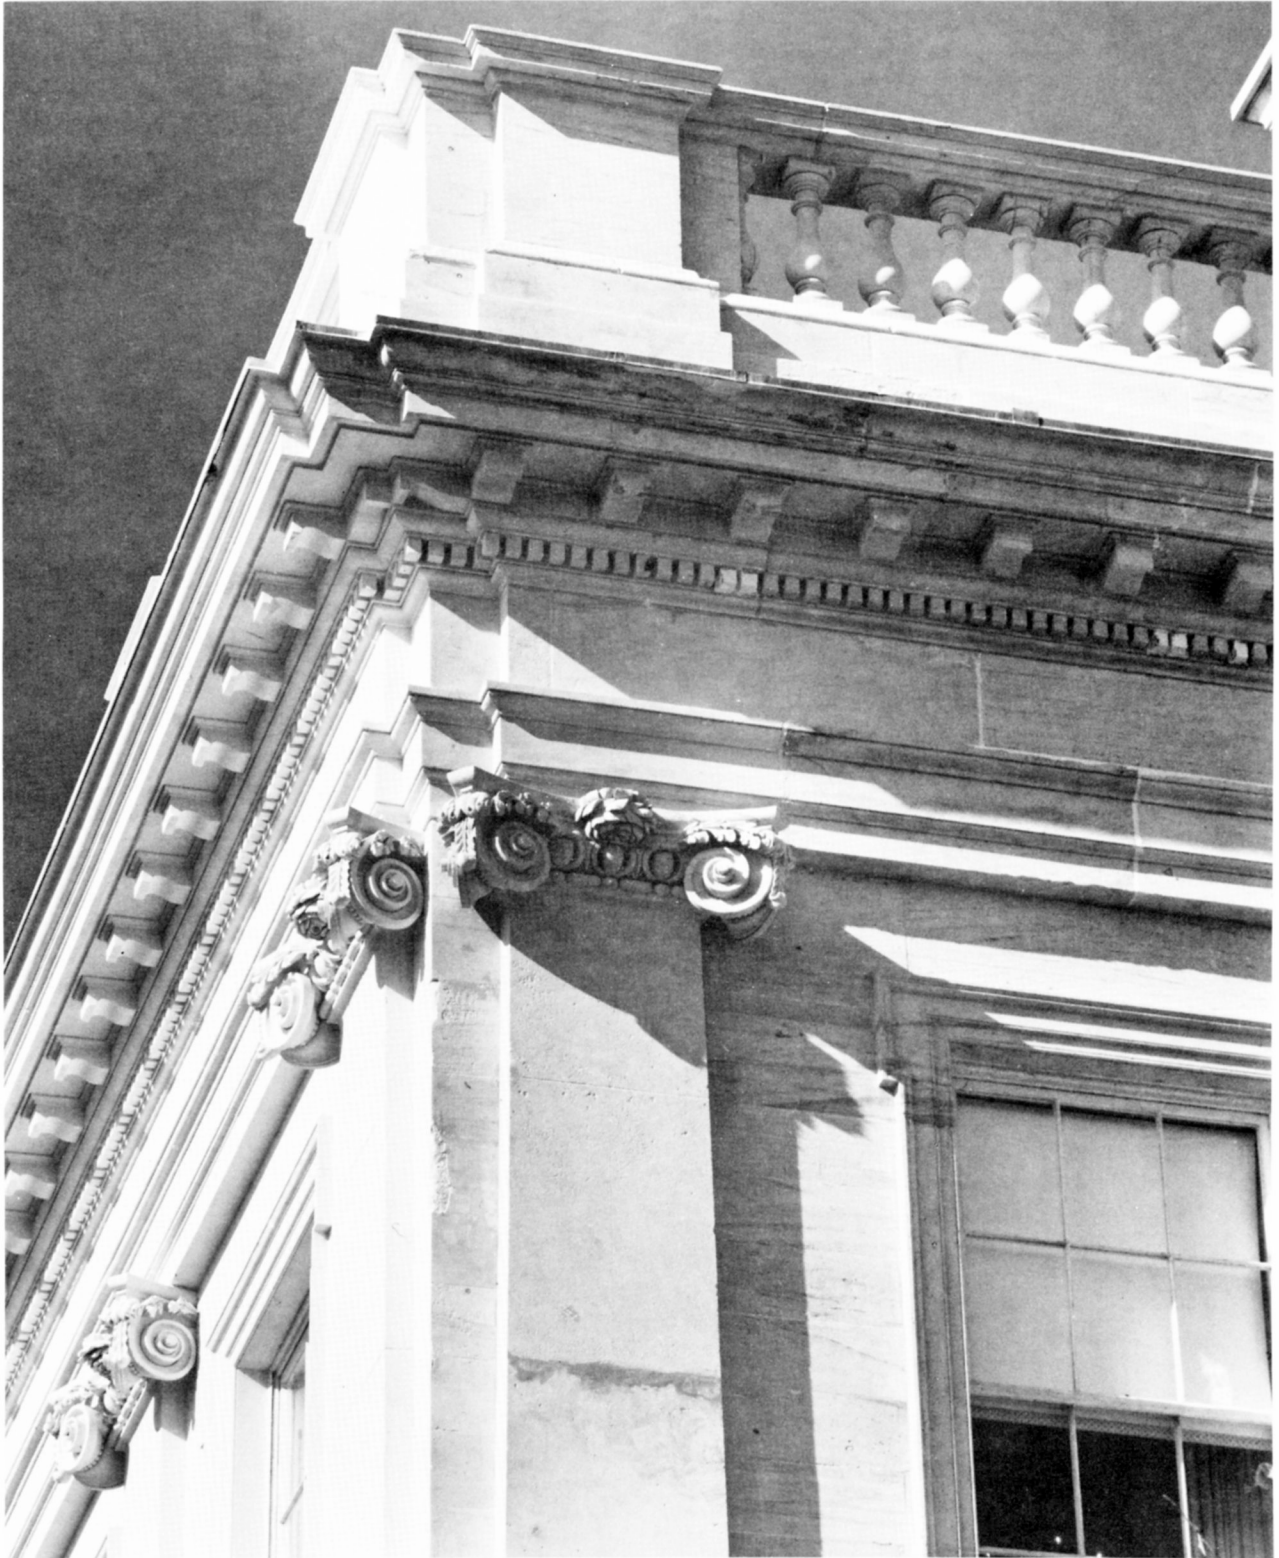
Fig. 8 General view of the upper reaches of the White House at the southeast corner, showing the most concentrated array of stone carving on the building. It encompasses the pilaster capitals and the entire entablature with its architrave, dentils, modillions and overhanging cornice. All of this is topped with the stone balustrade composed of piers, round balusters, and top rail. Some of the individual pieces in the cornice weigh over 3000 pounds and rest over 50 feet above the ground. photo: Jack Boucher, HABS.

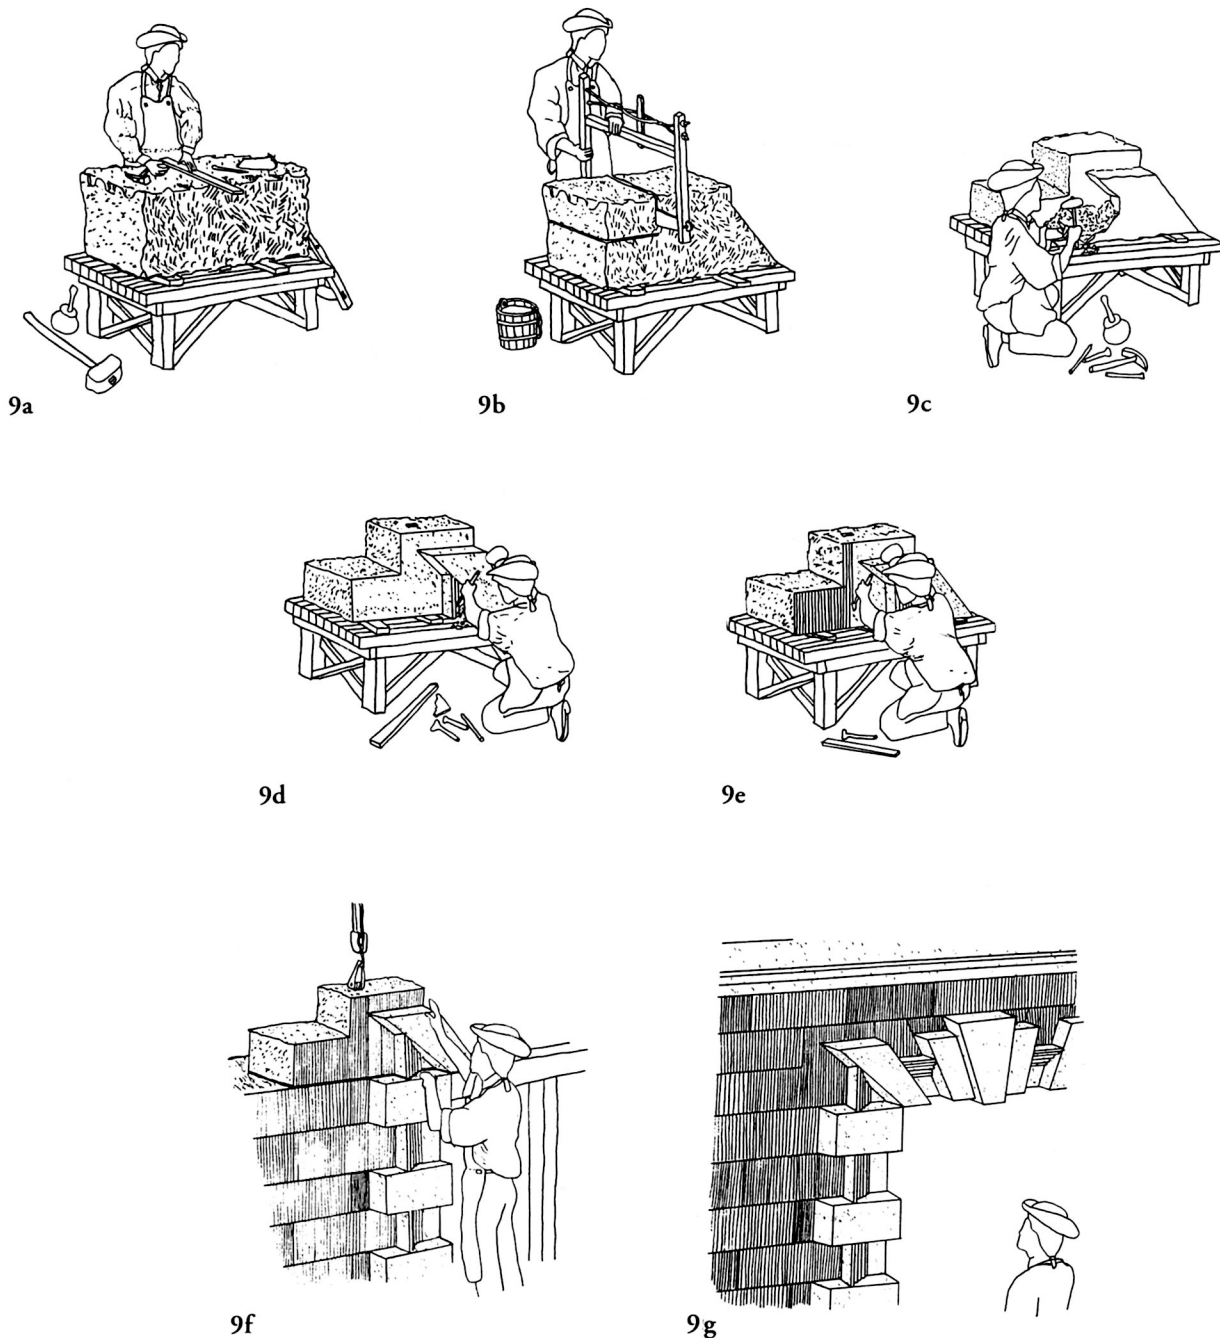
Fig. 9 Steps in cutting and carving one stone, a typical lintel stone for a ground floor window of the White House. illustrations: Tim Buebner, NPS.

- f) The finished stone is hoisted into place using a lewis, iron wedges inserted into a fitted hole in the top surface of the stone.
- g) The stone is in place at the top left corner of a typical ground floor window. See Fig. 10 for a photo of a complete window.

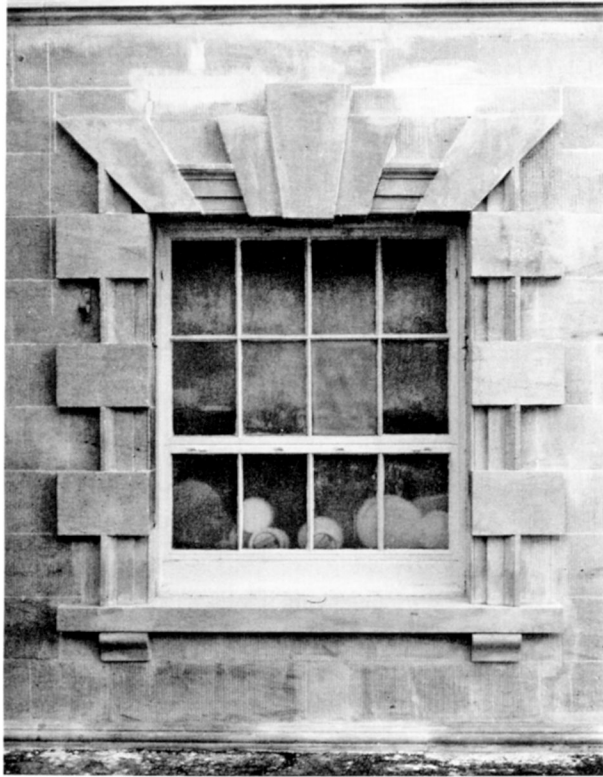
Fig. 10 A typical window on the ground floor of the north wall. The complexities of carving one of the projecting voussoir stones around the windows are illustrated in Fig. 9. Note the tooled surface of the wall stones used on the ground floor, but not on the upper walls. The ground floor wall cannot be seen from Pennsylvania Avenue, but is visible on the south side because of the sloping ground. photo: Jack Boucher, HABS.

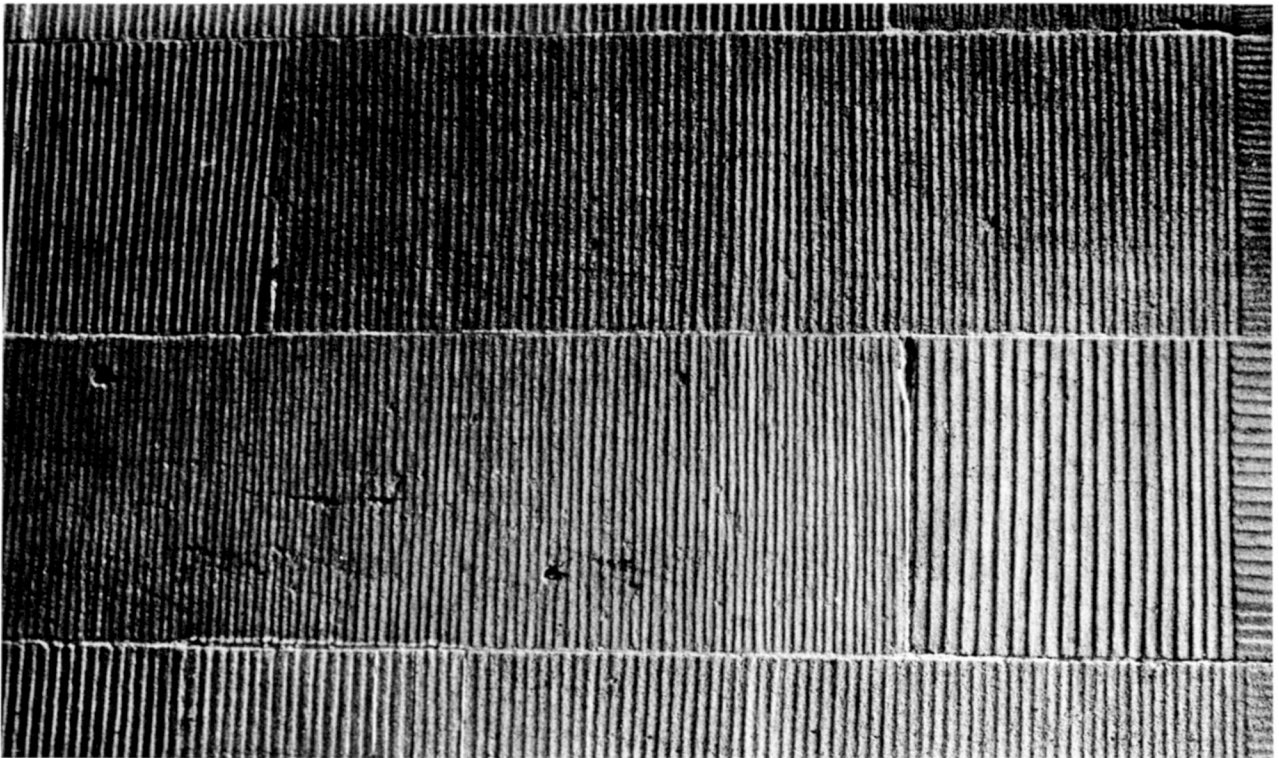
Fig. 11 Close-up of the tooled surface on the ground floor wall. Each stone was tooled by a craftsman before the stone was placed in the wall. Variations in the spacing of both the vertical and horizontal tooling indicate that different craftsmen worked on the stones. photo: Jack Boucher, HABS.

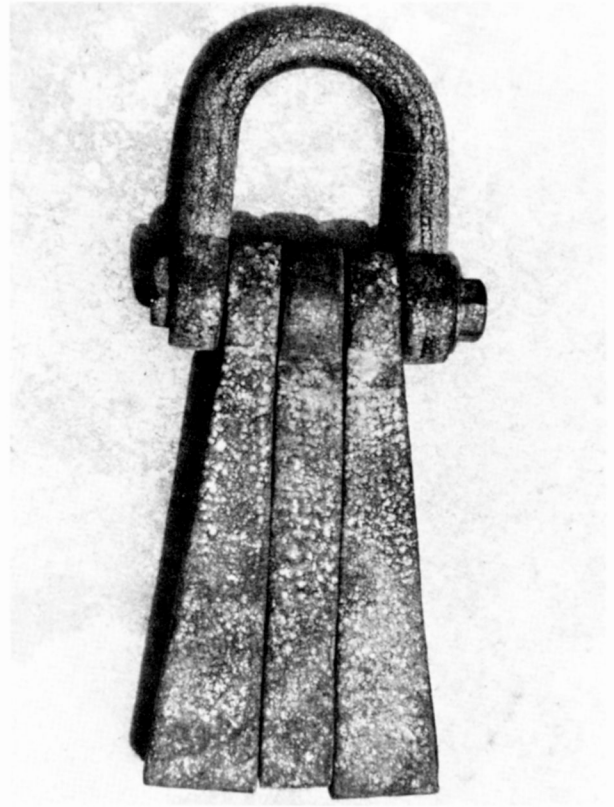
Fig. 13 Alewis, a device used for lifting heavy blocks of stone. Though this one is modern, it is basically the same as those used throughout history. Stones had to be lifted onto the walls from the top so that rigging ropes would not get in the way when lowering the stone into place. To accomplish this, a three inch deep slot was chiseled into the top surface of the stone. The hole needed to be chiseled like a dovetail, that is, wider at the bottom than at the top. To install the lewis, the two outer wedge shaped irons were first put into the hole; the middle spacer was inserted; and then the bolt or iron pin was reinstalled, locking it in place. Once the lewis was secured, a rope could be attached for hoisting. The pressure of the iron wedges against the tapered hole kept the lewis from coming out. photo: Tim Buehner, NPS.

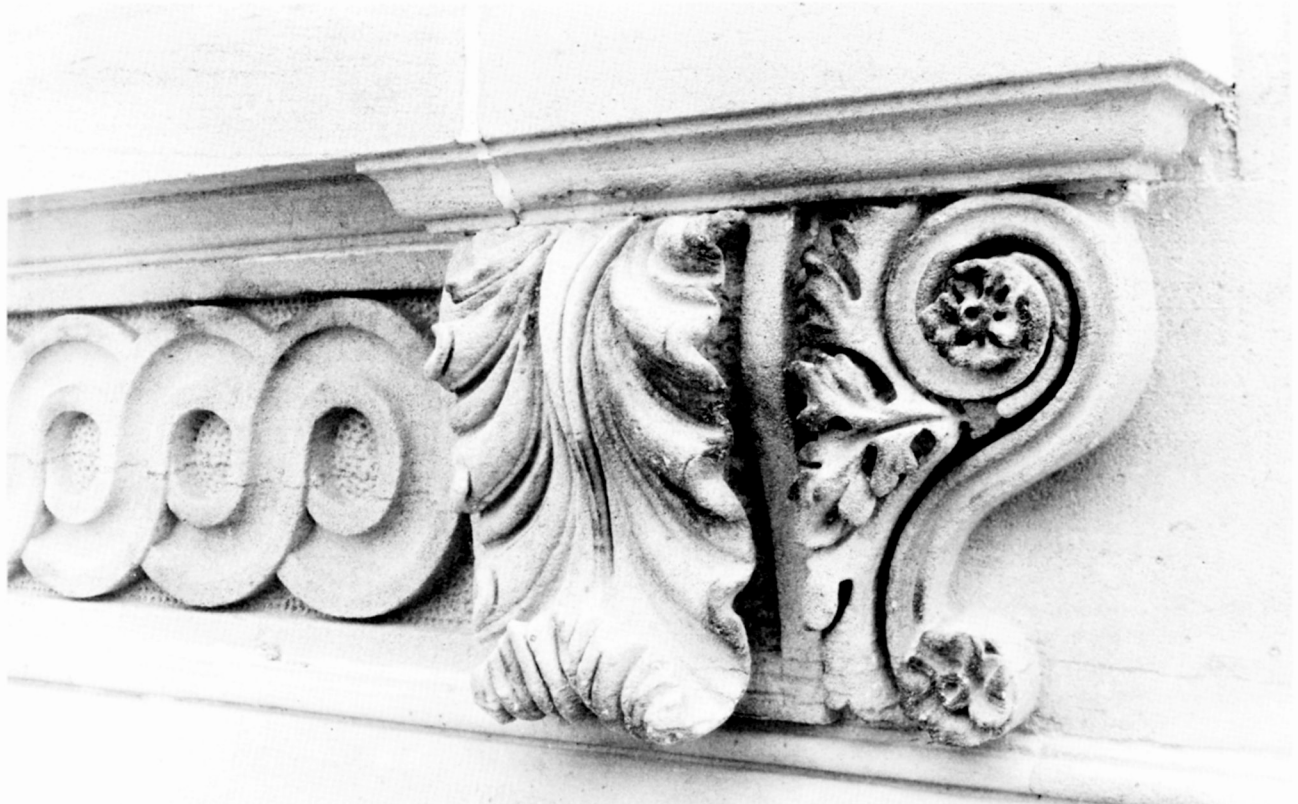
Fig. 14 Brackets and guilloche (the chain of interlaced curves and circles) under the first floor window sills on the north wall. photo: Jack Boucher, HABS.

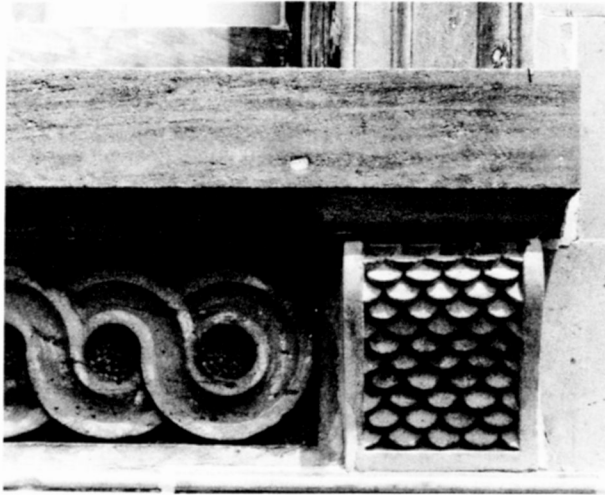
Fig. 15 Detail in the stone brackets supporting the first floor window sills on the south, east and west sides. The pattern, known as imbrication, resembles overlapping scales. photo: Tim Buehner, NPS.

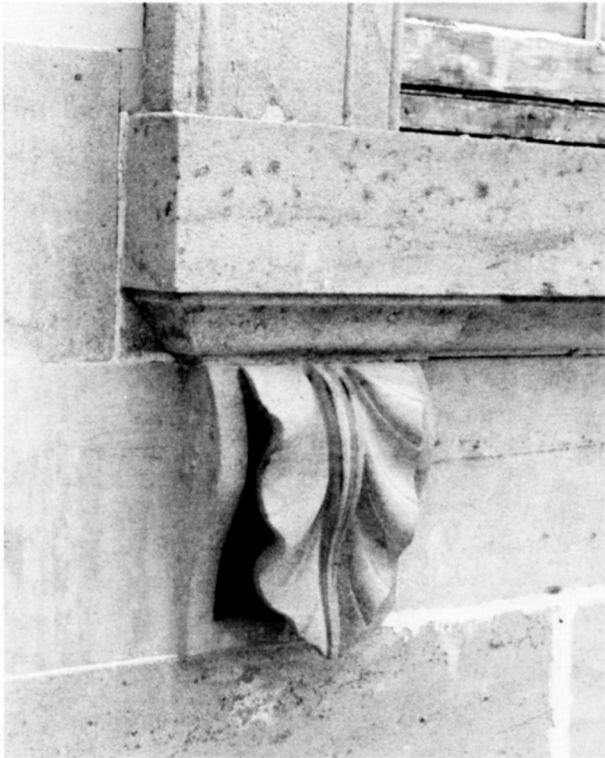
Fig. 16 A carved bracket under one of the second floor window sills. There are 64 brackets of this design on the White House, and while it might be assumed that they are all identical, each is slightly different, individually carved by hand and inserted into the wall. Since the bracket and the wall stone are one unit, a large amount of stone had to be carved away to make the flat surface behind the projecting bracket. photo: Tim Buehner, NPS.

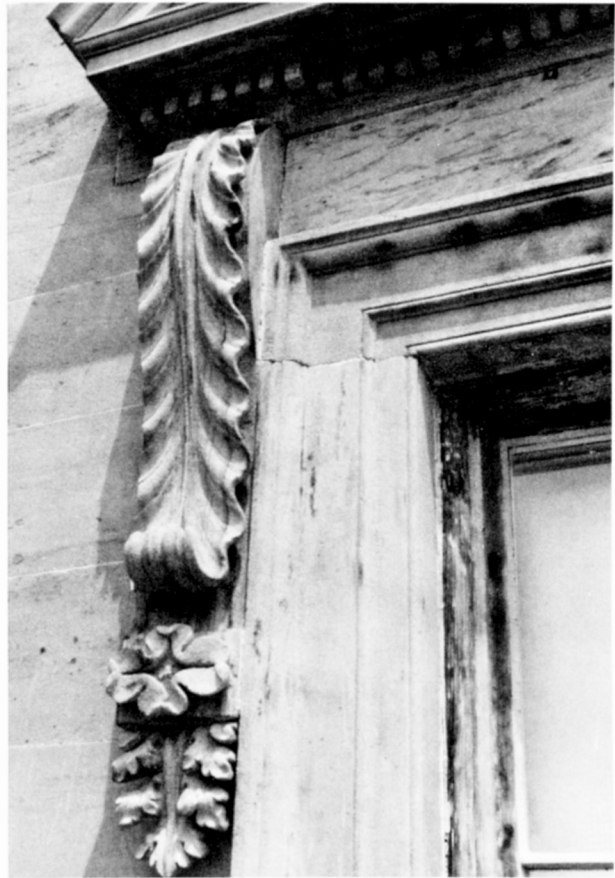
Fig. 17 A typical carved console supporting the first floor window pediments. Note the carved stone moldings that are part of the architraves enframing the windows. photo: Tim Buehner, NPS.

**Console:** a long carved bracket supporting the pediments of the first floor windows. The consoles are adorned with a long rolling acanthus leaf and a flowered quatrefoil supported by a label corbel or label stop of small acanthus leaves.

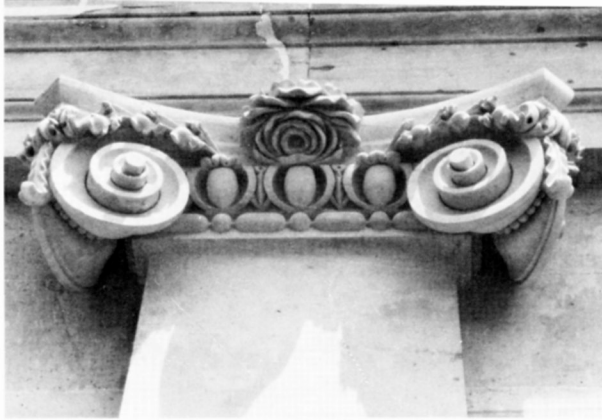
Fig. 18 Ionic capital for one of the pilasters, typical of those on the south, east and west walls of the White House. These capitals cannot be fully appreciated from the ground, but they exhibit delicately turned volutes, acanthus leaves, egg and dart moldings and finely detailed cabbage roses, canted downward toward the viewer on the ground. Compare these wavy rose petals with the plainly carved petals in the capitals of the later columns on the 1820s north portico (fig. 19). photo: Tim Buebner, NPS.

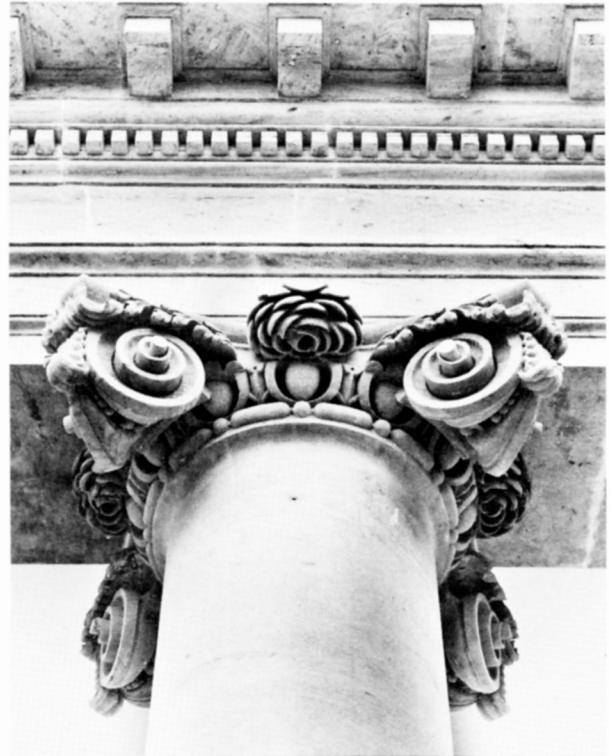
Fig. 19 Ionic capitals on the columns of the north portico, an addition constructed in 1829-30. Compare how the rose petals are arrayed in smooth concentric curves, as opposed to the more naturalistic petals on the original pilaster capitals carved in the 1790s (fig. 18). photo: Richard Cheek.

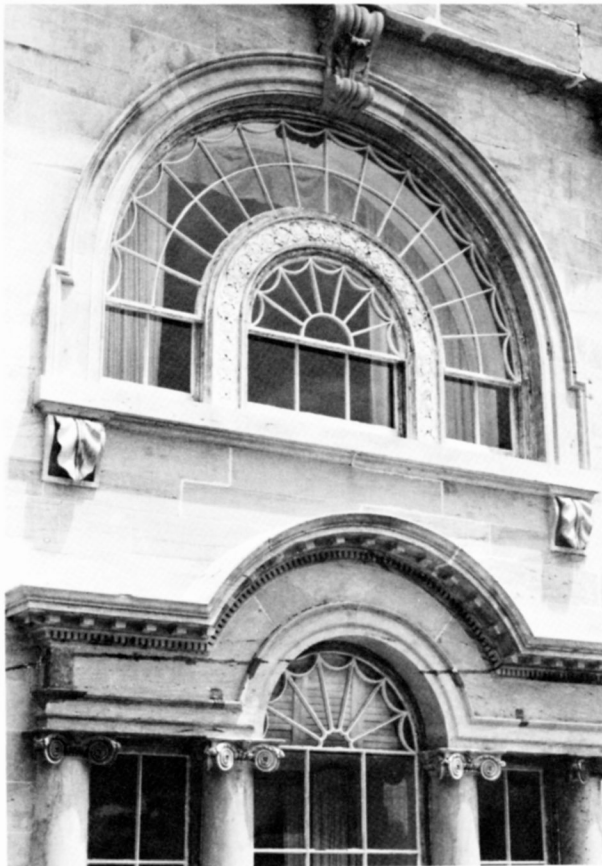
Fig. 20 General view of the large lunette window and Palladian entry centered on the west wall. The central portions of the east and west walls were damaged beyond repair during the burning of the White House by the British in 1814, and were rebuilt in 1816 under the direction of the original architect, James Hoban. The stone details in these sections are believed to match the original construction. The lunette window is framed in stone with a kneed molding, a large scrolled keystone with a projecting acanthus leaf, and large acanthus leaf brackets supporting the window sill. The band of small rosettes around the inner window were originally carved in wood, but were later replaced with cast lead replicas. photos: Tim Buebner, NPS.

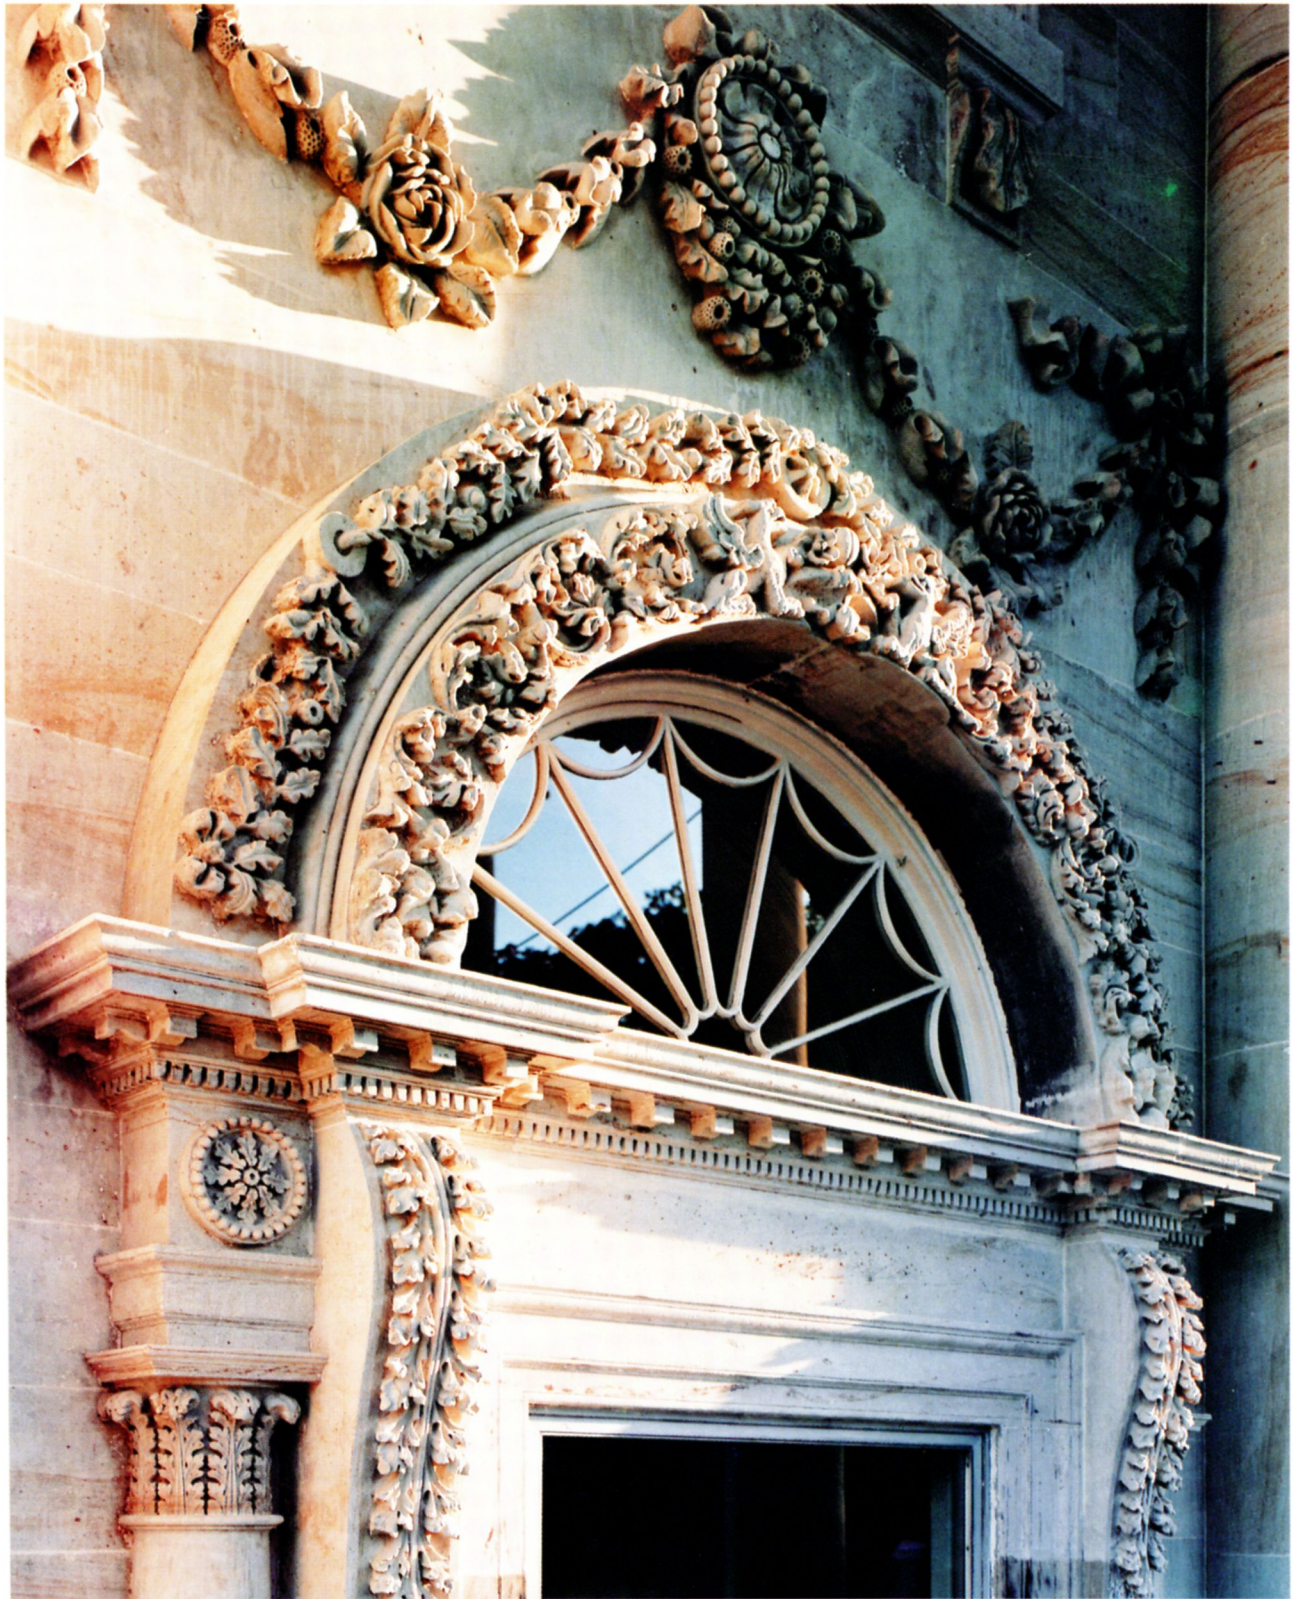
Fig. 21 Nowhere on the White House is the richness of the stone carving more evident than over the north (front) doorway. The enframing includes consoles, engaged columns, and arches ornamented with a mixture of oak leaves, acanthus leaves, medallions, and griffins. Above the entrance are high relief carvings of ribbons, bows, and swags of oak leaves and acorns accented with roses. photo: Jack Boucher, HABS.

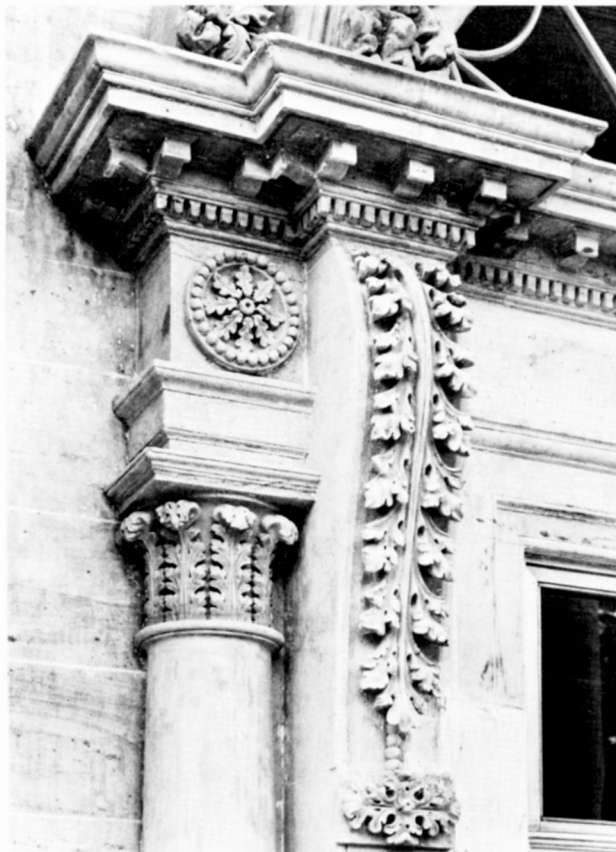
Fig. 22 Many layers of paint had obscured the quality of the carvings around the north doorway until this area was stripped of its paint in 1984. photo: Richard Cheek.

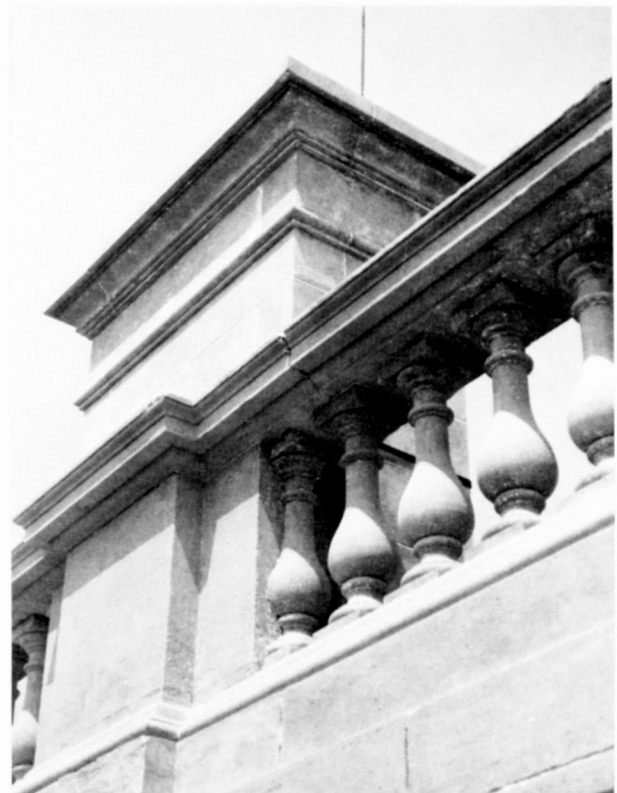
Fig. 23 Typical carved stone balustrade of the White House. Many of the original sandstone balusters have been replaced over the years (mainly with Indiana limestone), as their extreme exposure makes them susceptible to damage. photo: Tim Buebner, NPS.

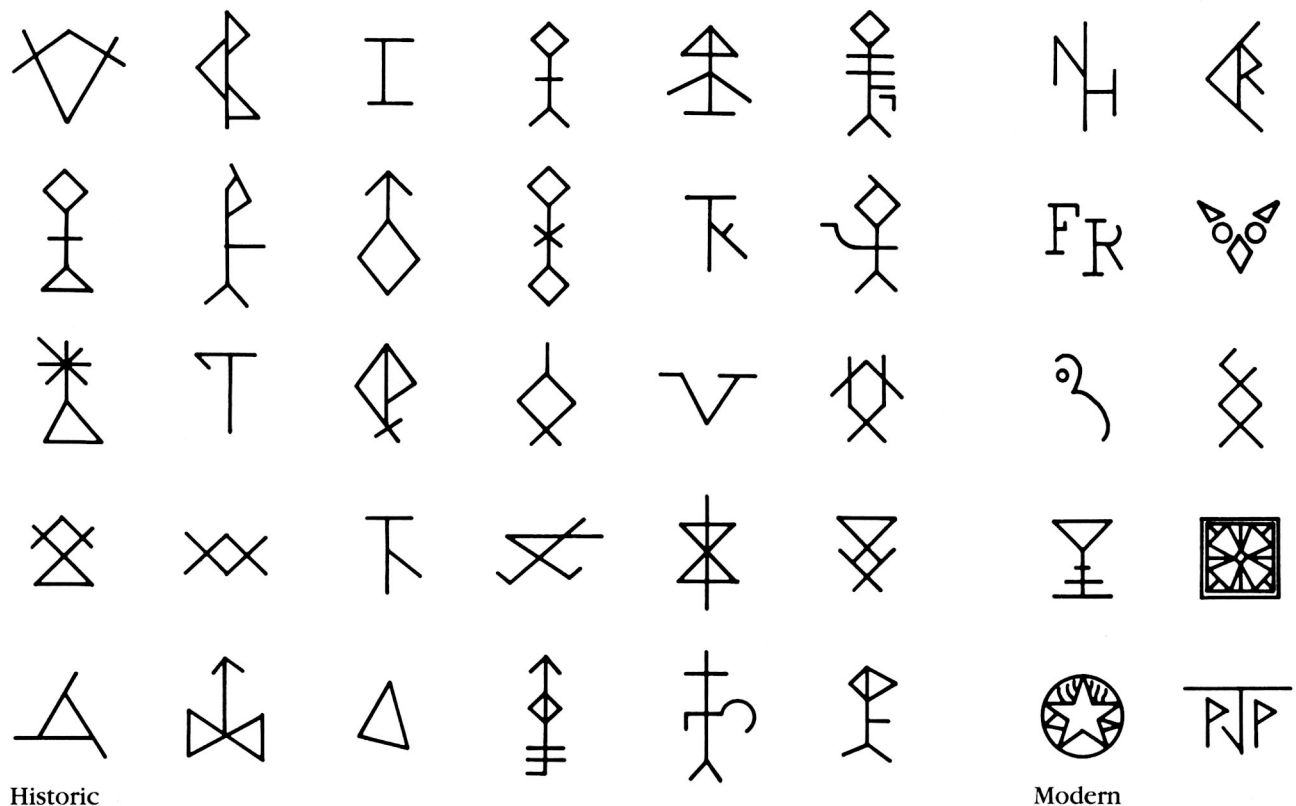
Fig. 24 Examples of the mason's marks found upon the various stones at the White House during the renovation and restoration work. Over 40 marks have been found. It has not been possible to date or link any of these marks with stonecarvers known to have worked on the building in the 1790s. Carvers working on recent restoration have left their own marks. illustration: Tim Buehner, NPS.

Over 40 characters have been found and recorded during periods of renovation and alteration at the White House. These marks are the signatures of stone

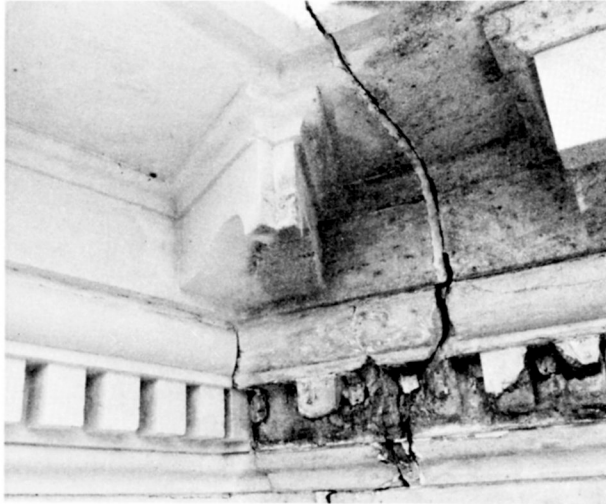
Fig. 25 One of the major cracks in the entablature of the south wall. This view also shows the results of environmental damage where the protected stone dentils absorbed airborne pollutants that could not be washed off by rainwater. Over the past 200 years, many of the dentils have been destroyed or damaged in this way. photo: Bill Allman, Office of the Curator, The White House.
