# White House Stone Carving

BUILDERS AND RESTORERS

1992

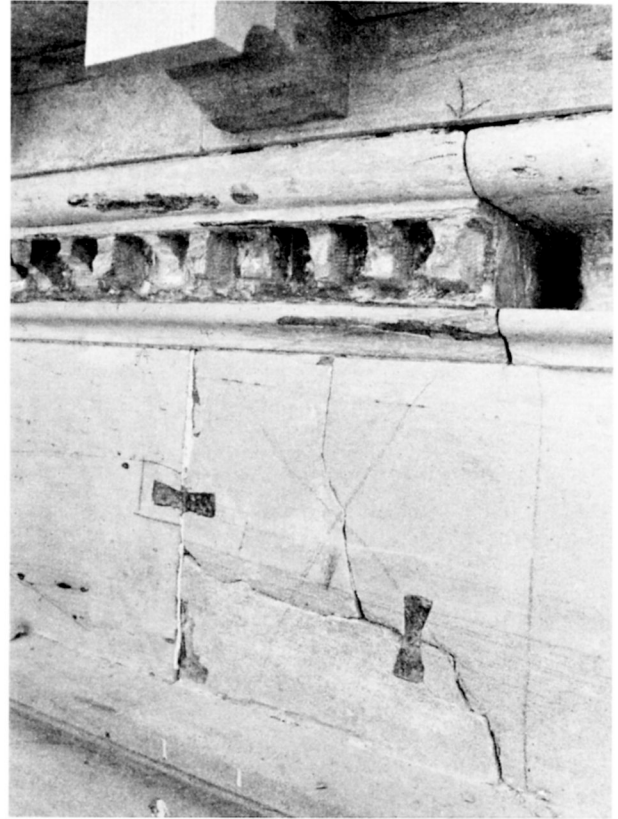
Fig. 26 Close-up of the entablature, just below the cornice. In the frieze area, a pair of cracks were repaired (probably at an early date) with iron cramps. The iron cramps extend into the face of the stone at each end to hold the stones together and keep the loose pieces from falling out. Also note the extensive erosion of the dentils. photo: Bill Allman, Office of the Curator, The White House.

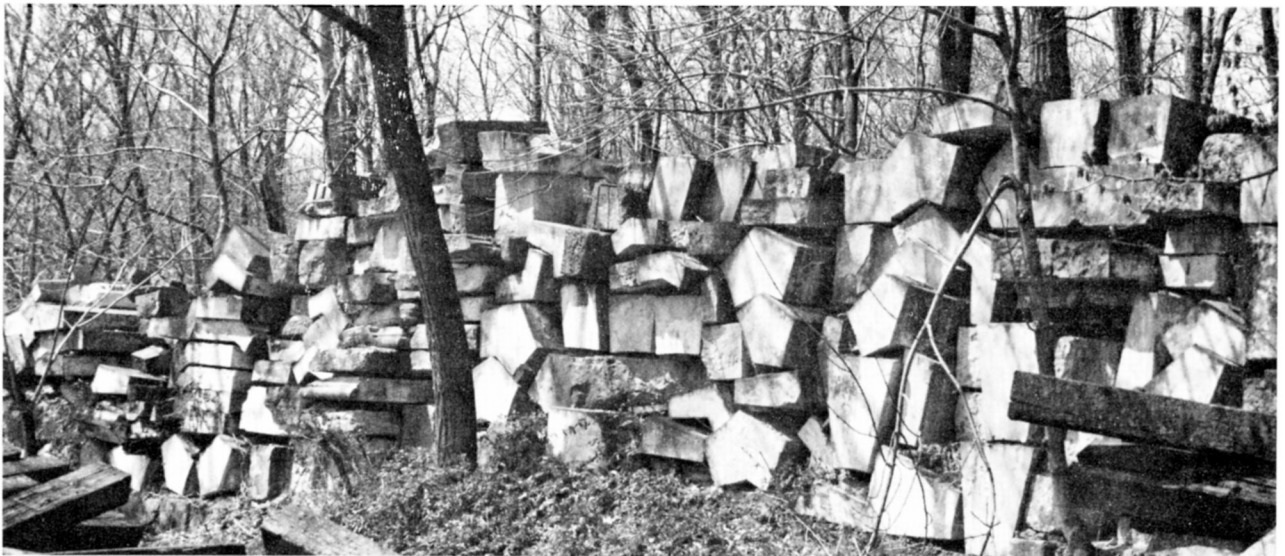
Fig. 27 Aquia stone that was removed from the U.S. Capitol during the extension of the East front in the 1950s and put into government storage. Some of this stone is now being used for the restoration of the exterior stonework on the White House. photo: Tim Buebner, NPS.

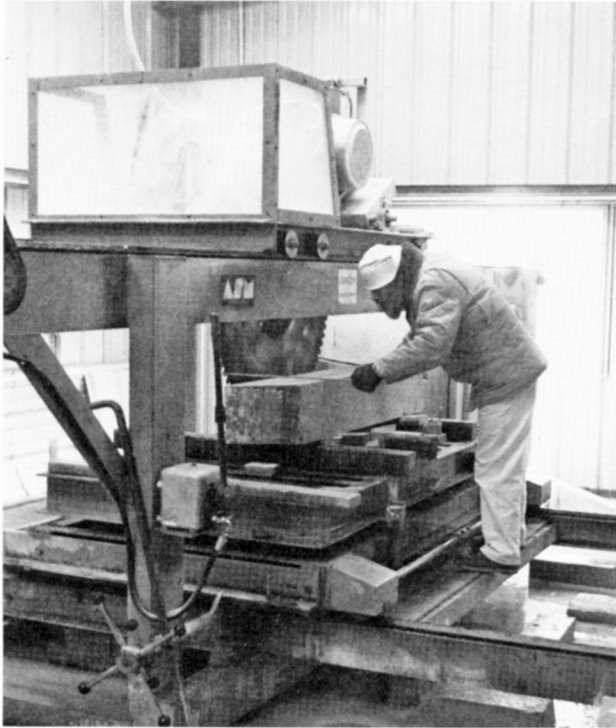
Fig. 28 Patrick Plunkett, stone superintendent working on the White House restoration, is shown operating the large circular saw used for rough cutting the old stone blocks salvaged from the Capitol. photo: Tim Buebner, NPS.

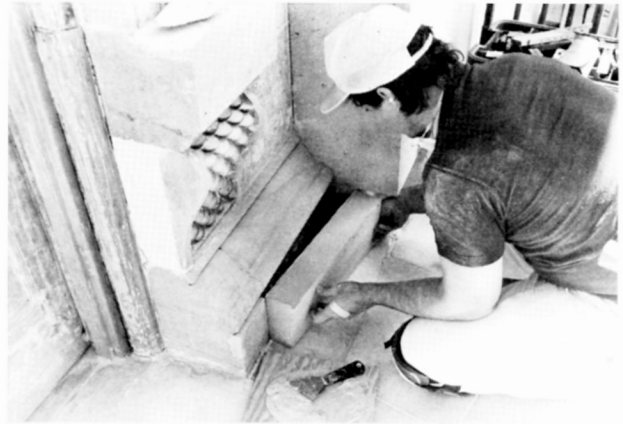
Fig. 29 While most of the restoration involved repairs due to poor original stones or environmental damage, some of the work was to correct damage from previous alterations. This restoration stone cutter is seen fitting in a new piece of stone to correct damage below the base molding on the south portico. Such work is done with very tight tolerances, and often will be unnoticed when the work is through. photo: Jack Boucher, HABS.

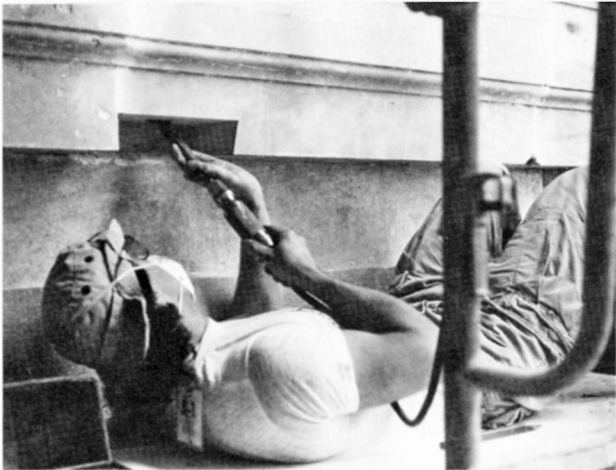
Fig. 30 Most of the stone repairs were small and made in place. Working from scaffolding, the stone cutters employed air-powered chisels to cut away the damaged portions. Replacements were then made slightly oversized on the outer face so that it could be trimmed to make a flush fit with the adjacent stonework after it had been set in place. photo: Tim Buebner, NPS.

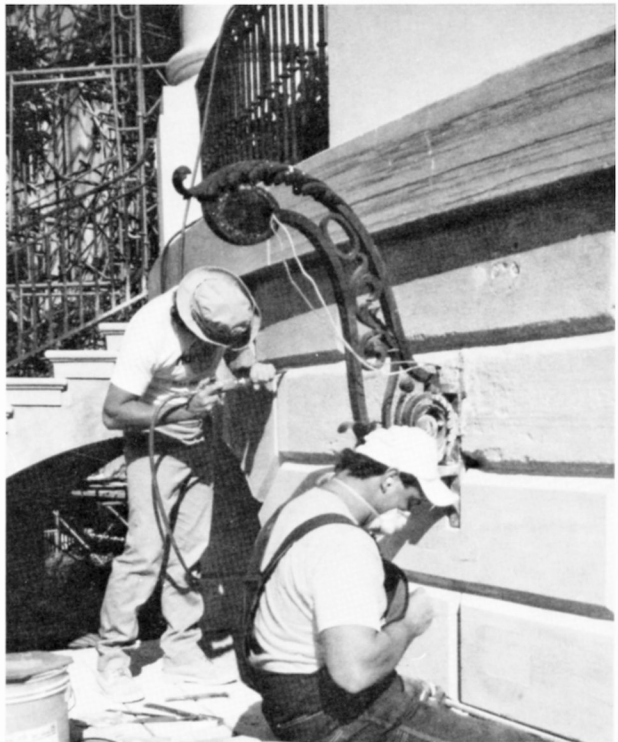
Fig. 31 Many of the repairs to the old stonework were necessitated by the damage from earlier metal attachments for lighting, railings, shutters, and electrical devices. Often the removal of such attachments left unsightly holes and in some cases the rusting metal cracked the stonework. The stonecutters are inserting new pieces of stone at the points of damage. photo: Lee Nelson.

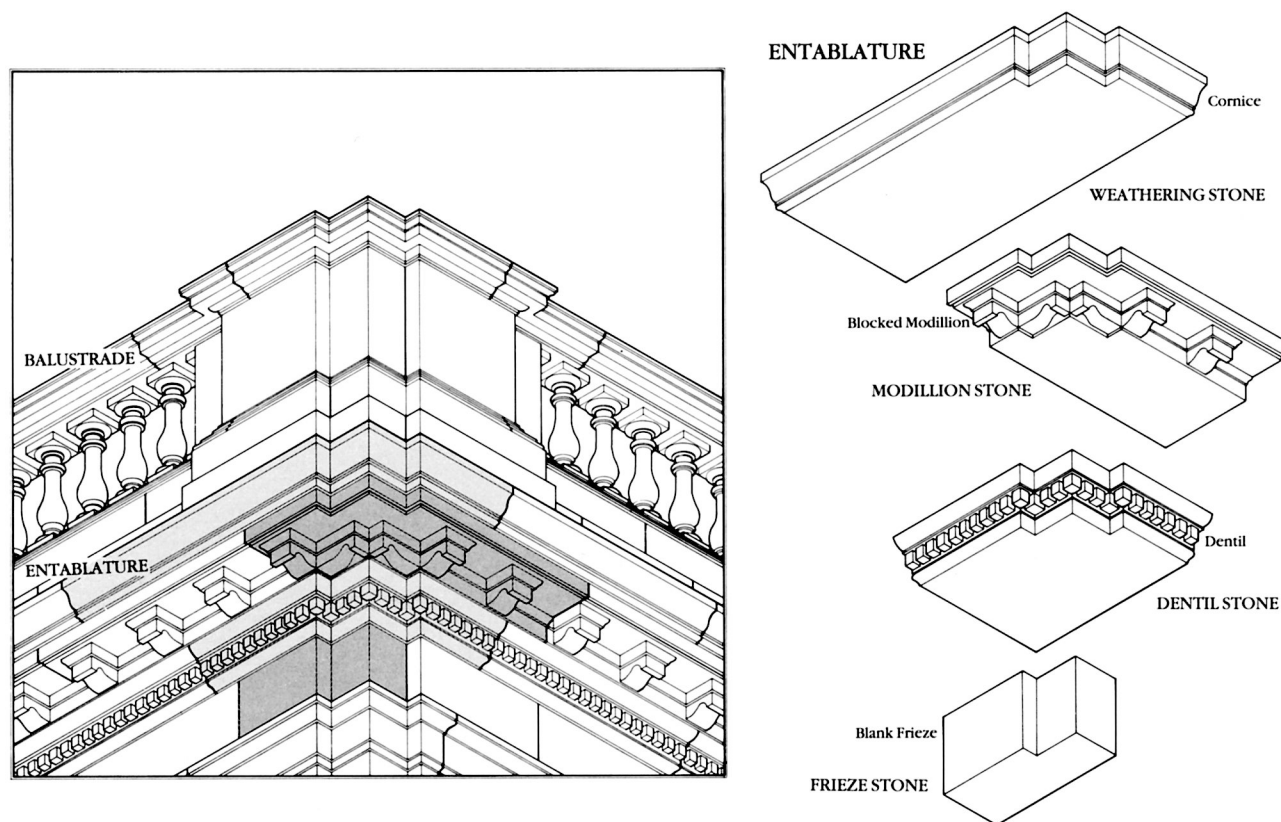
Fig. 32 Isometric drawing looking up at the entablature and roof balustrade of the southwest corner of the White House. A serious crack extending through several layers of stone in the entablature was discovered during the present restoration. While this situation required analysis and repair, it also provided the opportunity to study some of the original construction details. This area is complicated, partly because the stones at the corner have architectural features on both faces of the building, and partly because there are five layers of large stones that comprise the entablature: the weathering stone creating the cornice, the modillion stone, the dentil stone, the blank frieze, and the architrave. The details of four of these stones are drawn off to the side, and show how the original stone carvers planned and executed the overlapping stones to carry the projecting weight. The weathering stone, the upper stone, weighs over 3000 pounds. illustration: Tim Buebner, NPS.

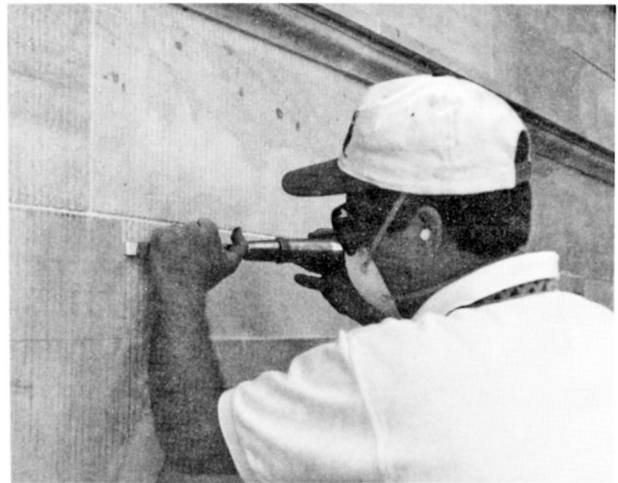
Fig. 33 A stonecutter is chiseling furrows, called tooling, into the new stonework. Only the ground floor walls of the White House have tooled surfaces as opposed to the smooth upper walls which have dressed stone faces. During the repair work, the new tooling is made to match the texture of the adjacent original stonework. photo: Patrick Plunkett.

Different techniques are used depending on the type of stonework involved. On the ground or lowest floor the original stones had a tooled or furrowed surface, achieved by cutting a series of very narrow grooves into the surface of the stone. Today when making repairs, the damaged portion of the stone block is first cut away. Then the replacement piece is

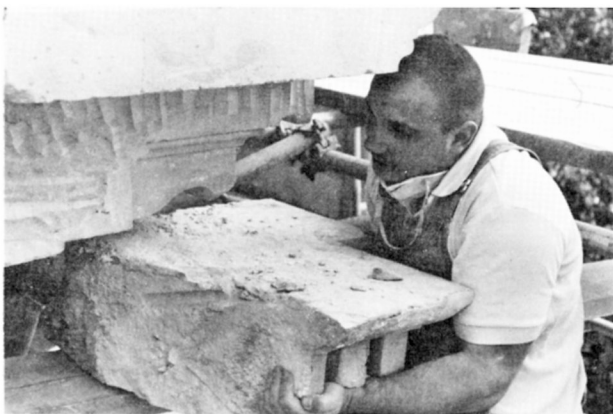
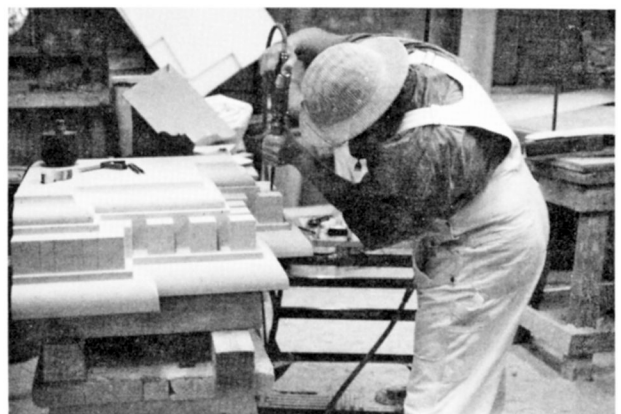
Fig. 34 (a, b) The most serious damage to the original stonework was at the upper southwest corner of the White House where four very large stones had broken early in the history of the building and had been repaired with large iron bolts. The iron bolts rusted over time causing secondary damage. It was necessary to remove the damaged portions of the stone and replace them with new stones. These two views show one of the broken stones being removed and its replacement being carved in the shop on the White House grounds. (See fig. 32 for a detail of the four stones that were replaced.) photo: Tim Buebner, NPS.

Since preserving historic fabric is the guiding principle in this project, only the damaged portions of the original stone are being cut away and replaced. Thus, the cracked portions of the stones are cut away and filled with new pieces of old Aquia stone selected to match the original in texture and bedding planes.

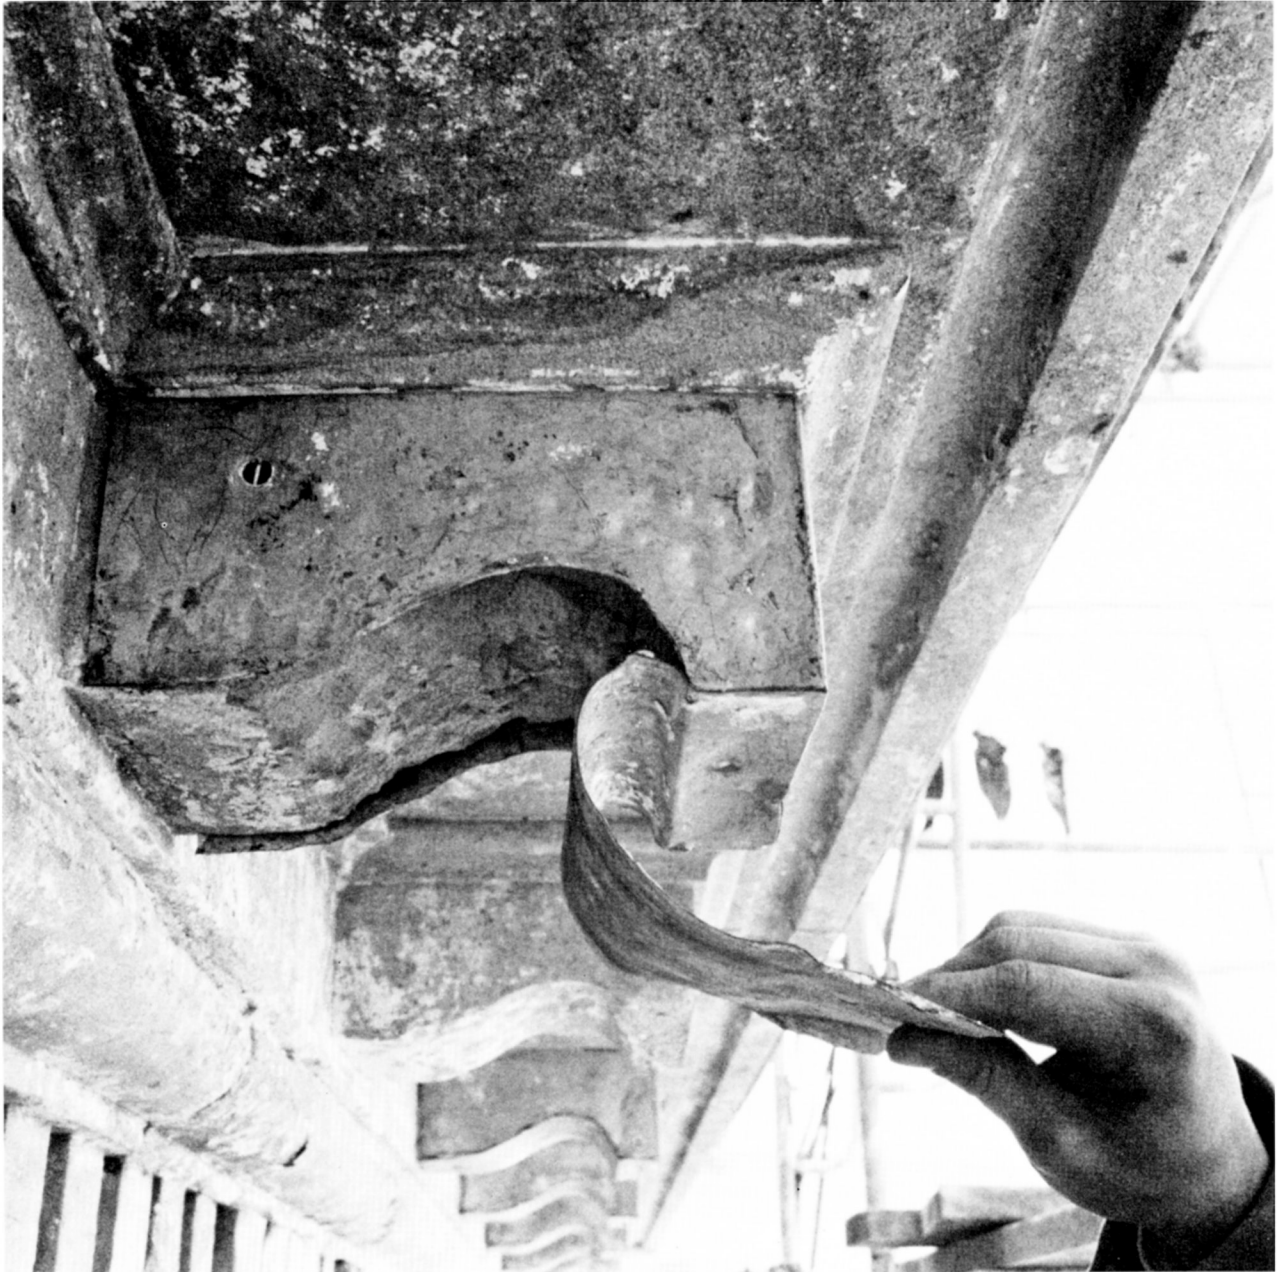
*Fig. 35 During the present restoration, many modillions (and dentils) were found to have sheet metal covers screwed to the stone. These later covers concealed the underlying deterioration. Subsequent layers of paint had hidden these makeshift repairs. photo: Bill Allman, Office of the Curator, The White House.*

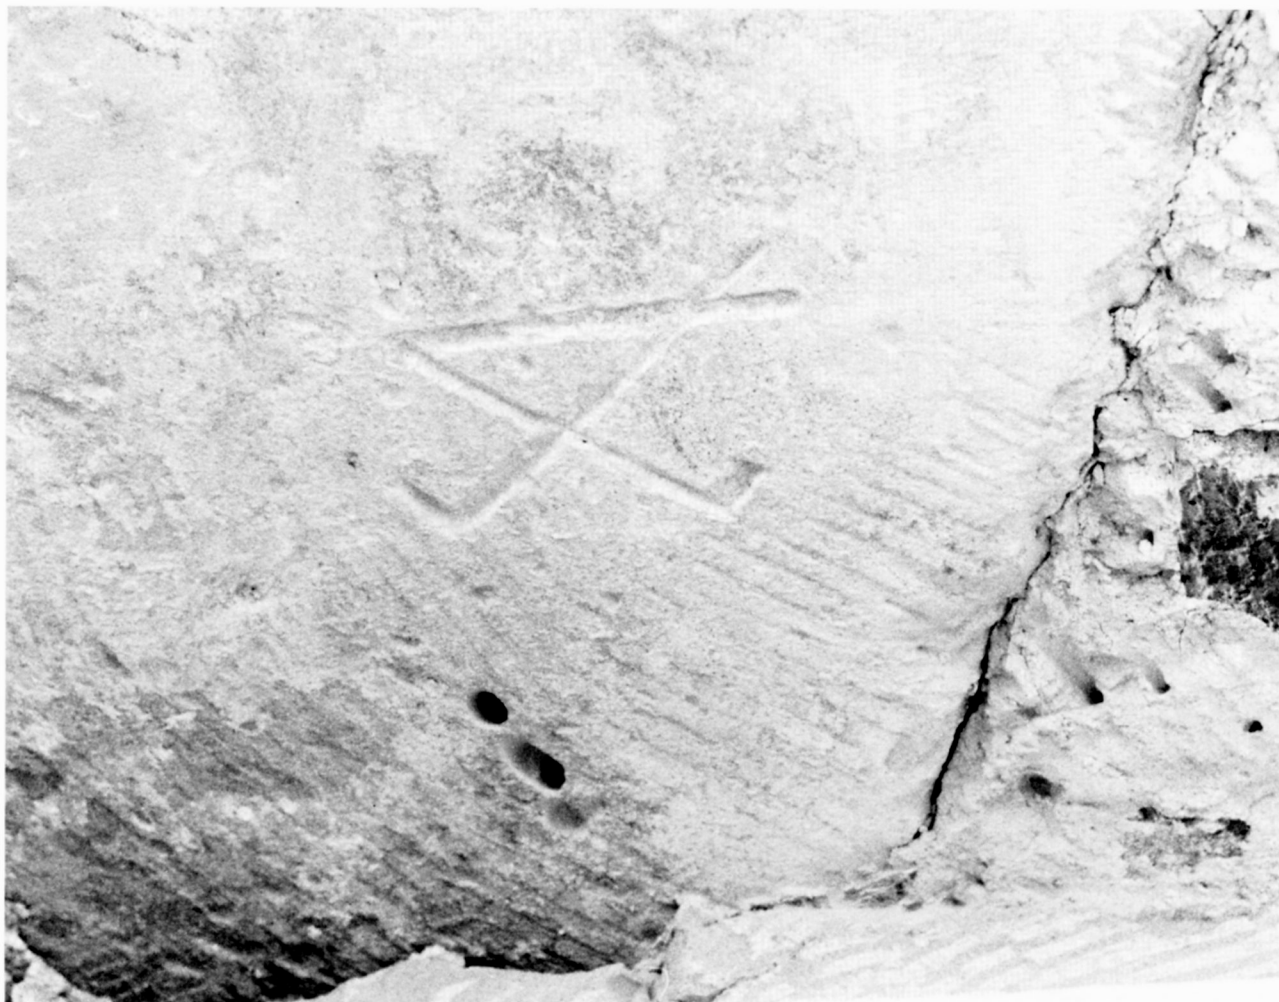
Fig. 36 A typical mason's mark on a White House stone. Such marks were usually chiseled into an unexposed face of the stone to identify the mason's work. Sometimes there are several such marks on a stone, thus indicating that two carvers worked on it—perhaps a master stone carver and an apprentice. Traditionally, a mark was given to a carver upon completion of his apprenticeship, but some of the apprentices at the White House may have taken on their own identifying marks. photo: Bill Allman, Office of the Curator, the White House.

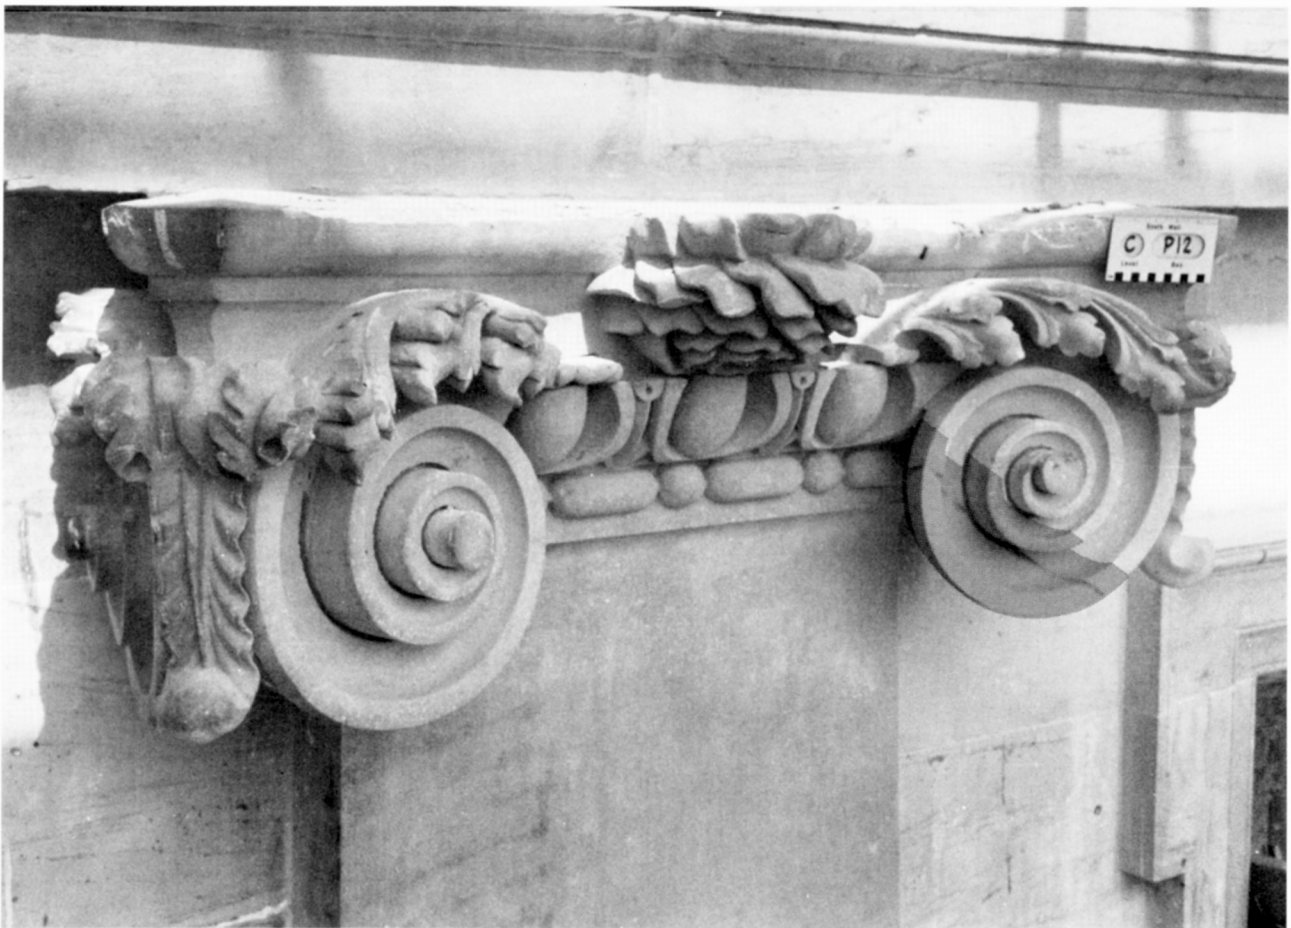
Fig. 37 This view of one of the pilaster capitals on the south wall (with paint removed) shows that the stone carving has weathered rather well. However, there are a number of flaws in the stone, such as small cracks and holes, which have allowed water penetration, thus causing pieces of stone to fall or erode away. This capital required restoration of the right volute. The shaded area shows the portion of the damaged capital that was replaced in 1990. photo: Lee Nelson.
