**National Park Service  
Cultural Landscapes Inventory  
2025**

**Whiskeytown Visitor Center Historic District  
Whiskeytown National Recreation Area**

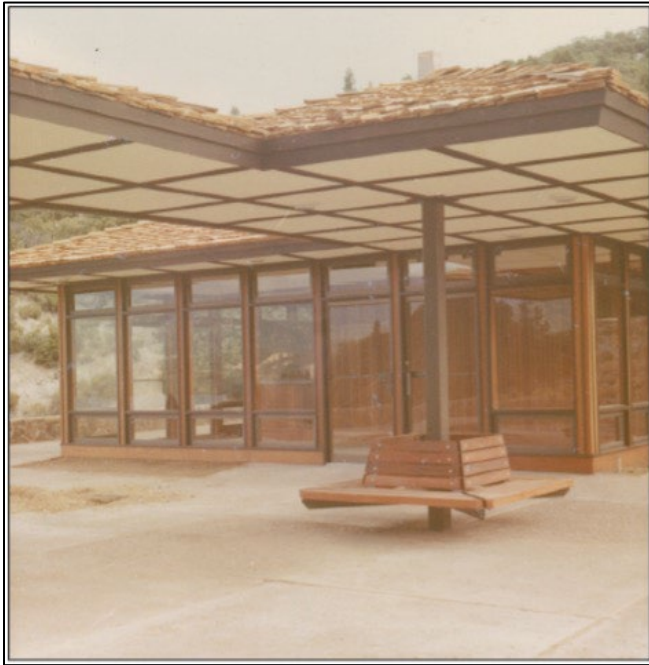
*Figure 11. Visitor center and shade canopies, ca. 1966. Note the presence of the double doors and the window wall on the south façade. The bench underneath the shade canopy has since been removed (NPS Whiskeytown Archive).*

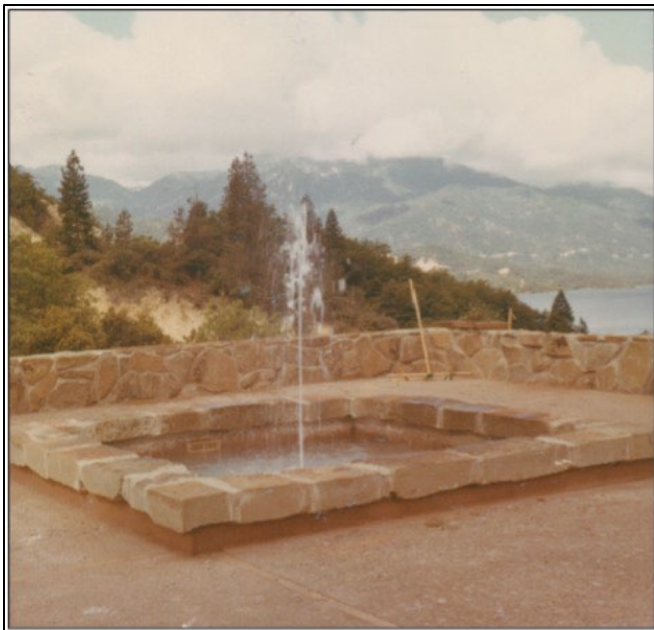
*Figure 12. The fountain in the visitor center promenade, ca. 1966. The fountain was converted into a planter in 1998 (NPS Whiskeytown Archive).*

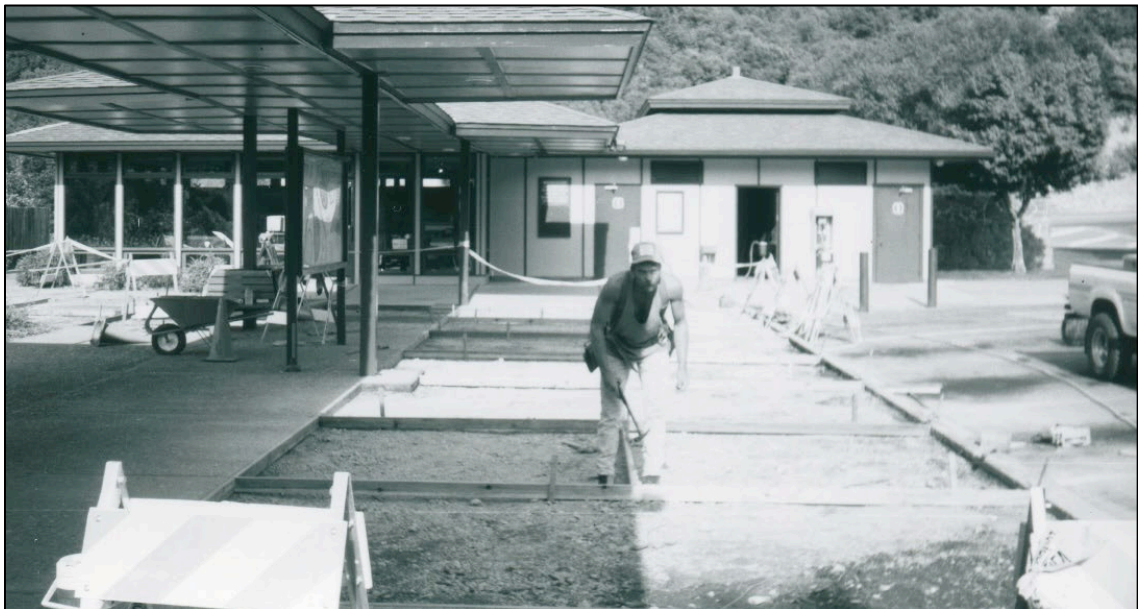
*Figure 16. Installation of new paving and planters in 1998 (NPS Whiskeytown Archive).*

Further alterations were made to the shelter canopy area and promenade paving in 1998. Some planter boxes were refurbished or replaced. Several exposed aggregate pavers in the areas south and north of the canopies were replaced with poured concrete pavers. The planter boxes north of the canopies were rebuilt with new concrete edging. The original fountain and pool were filled and is now used as a planter (Seigel & Strain Architects and architecture + history, llc 2022, P1.B.10).

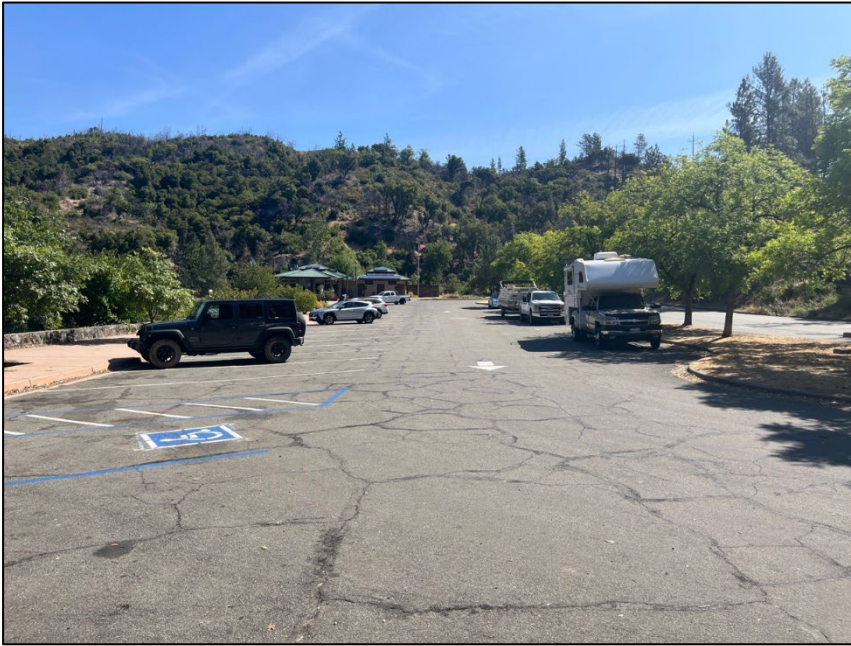
*Figure 26. Parking lot, camera facing northeast (NPS 2025).*

The overall layout of the parking lot is nearly identical as it was designed and constructed during the period of significance. The parking lot has likely been repaved since its original construction in from 1965-1967, and various cracks have been filled with asphalt. The parking lot is still an open area that allows views of the Whiskeytown Visitor Center Historic District from John F. Kennedy Memorial Drive, it reflects the same materials and serves its historic purpose as the main parking area for visitors.

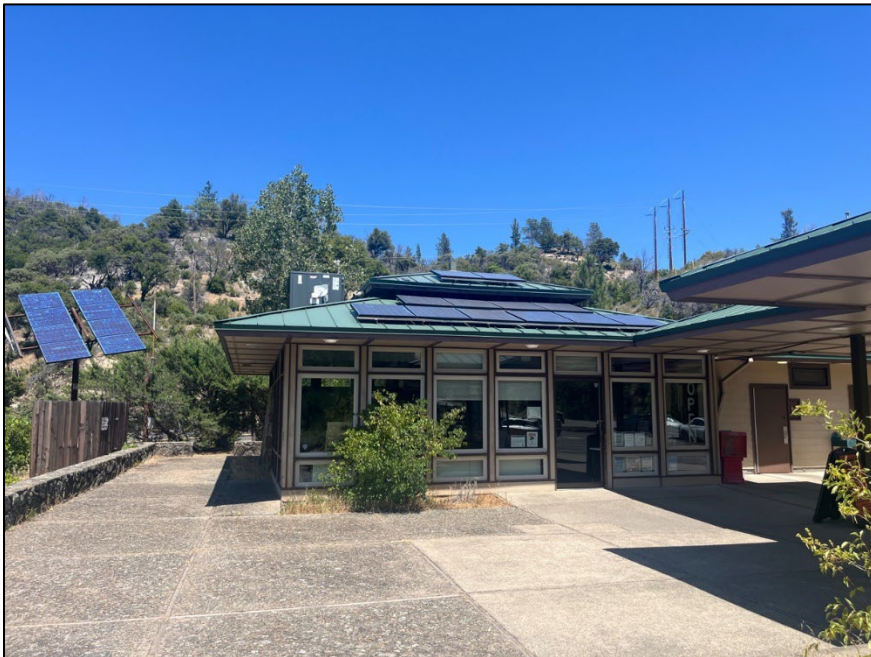
*Figure 33. Photovoltaic panels and HVAC unit atop the visitor center (NPS 2025). Note the replacement vinyl windows. Camera facing northeast.*

The visitor center had further alterations in the 2000s. In 2005, photovoltaic panels were added to the southern roof slope of the main building and restroom wing. In 2006, a green, standing seam metal roof replaced the asphalt shingles from 1984. All the remaining windows at the original visitor center were replaced with light tan vinyl windows in 2009, further diminishing the Modern aesthetic of the visitor center. Finally, in 2021, a new HVAC unit was placed on the visitor center's western roof slope.

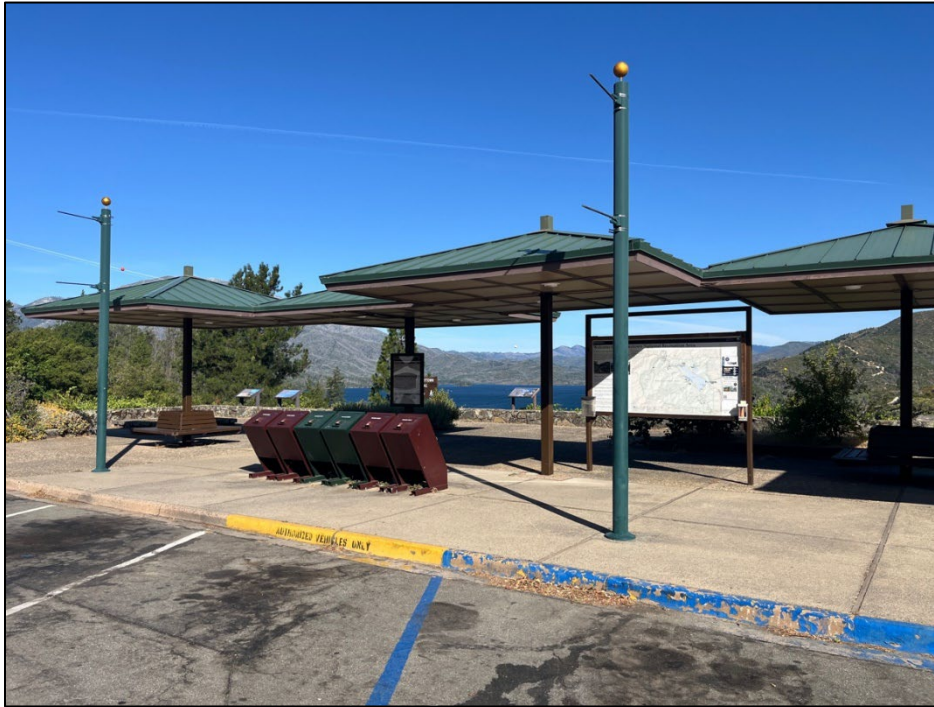
*Figure 34. View of shade canopy from the north portion of the parking lot, camera facing northwest (NPS 2025).*

A series of five interconnected shade canopies extend southward from the visitor center building. The shade canopies consist of five pyramidal hipped roofs each supported with a central post that mirror the pyramidal hipped roof shape of the visitor center building. The wood shake roof on the shade canopy was replaced with asphalt shingles in 1984. In 2006, a green standing seam metal roof was added.

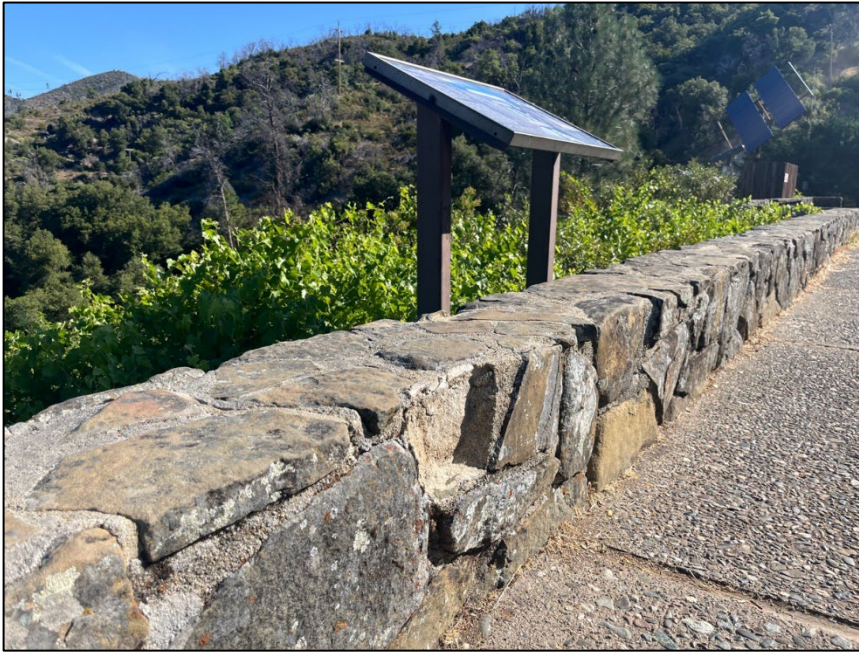
*Figure 37. Missing masonry on the perimeter rubble masonry wall, camera facing north (NPS 2025).*

The rubble masonry stone wall along the overlook consists of an 18” tall wall that is comprised of rubble stone. The wall follows the edge of the hillside from northeast to southwest in an undulating pattern and acts as the northern boundary of the district. The rubble masonry wall is comprised of both original and replacement mortar and stones. Some repaired areas contain mortar and stones that do not match the original wall. In 2007, a small portion of the wall to the north of the visitor center building was removed to allow for access to the native plant garden.

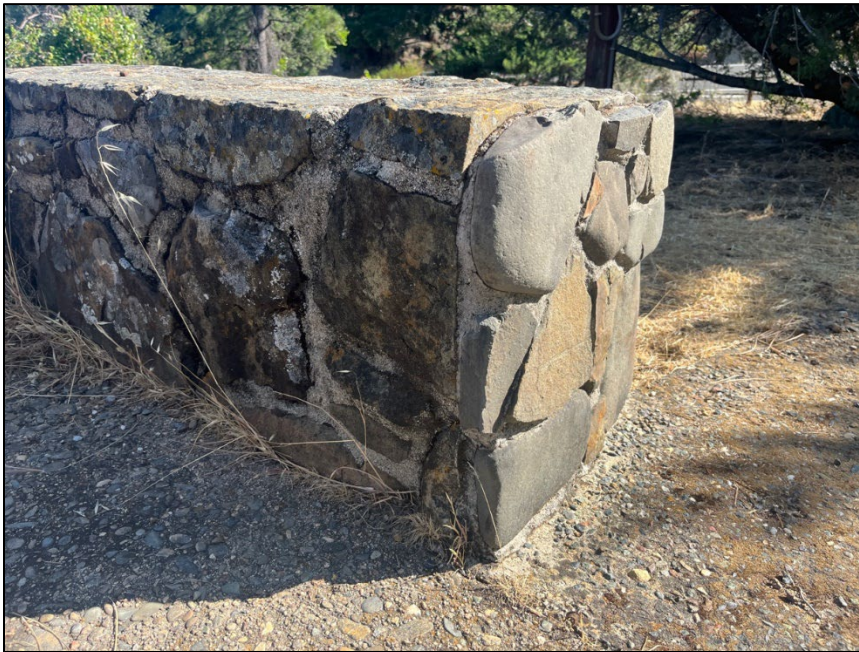
*Figure 38. Replacement rubble masonry on wall where the wall was cut to allow access to the native plant garden, camera facing north (NPS 2025).*

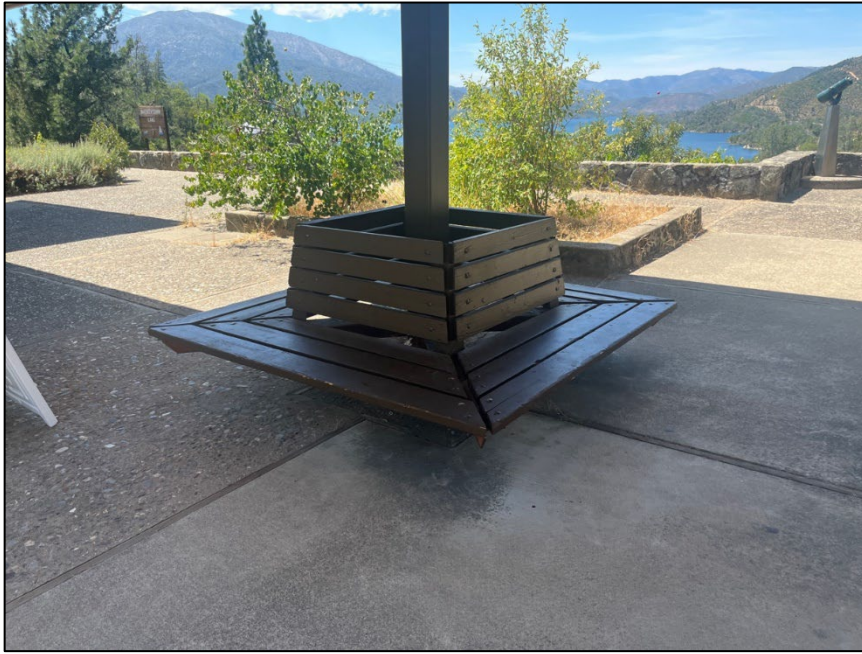
*Figure 39. Redwood bench under shade canopy (NPS 2025). Note the varying pavers with redwood dividers. The rubble masonry wall is in the background. Camera facing west.*

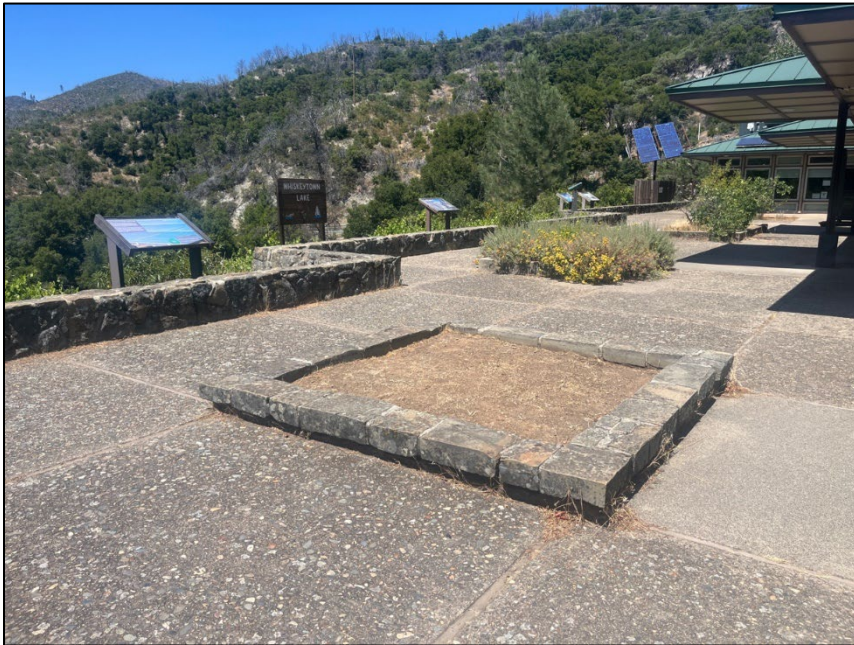
*Figure 40. Fountain planter, camera facing northeast (NPS 2025).*

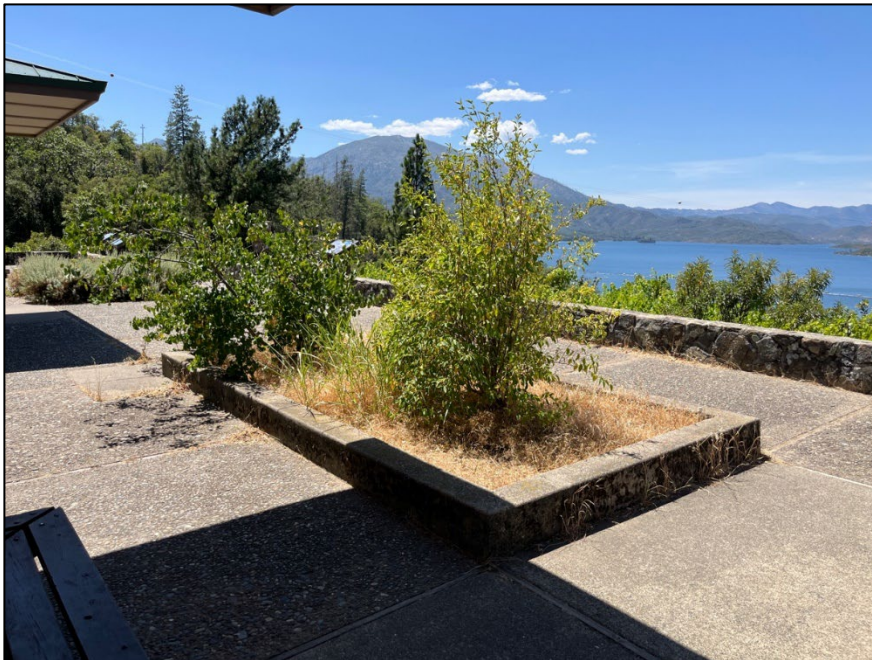
*Figure 50. Example of replacement concrete planter, located on the promenade near the shade canopies, camera facing west (NPS 2025).*

All the planters (except for the one that previously contained the fountain) have been replaced or changed in some manner since the visitor center's construction in the 1960s. The planters are either 8'x8' or 8'x16'. The original redwood edging around the promenade planters were replaced with concrete curbs when most of the planters were replaced in 1998. In 2014, several tree planters located at equal intervals on axis with the shade canopy were installed.

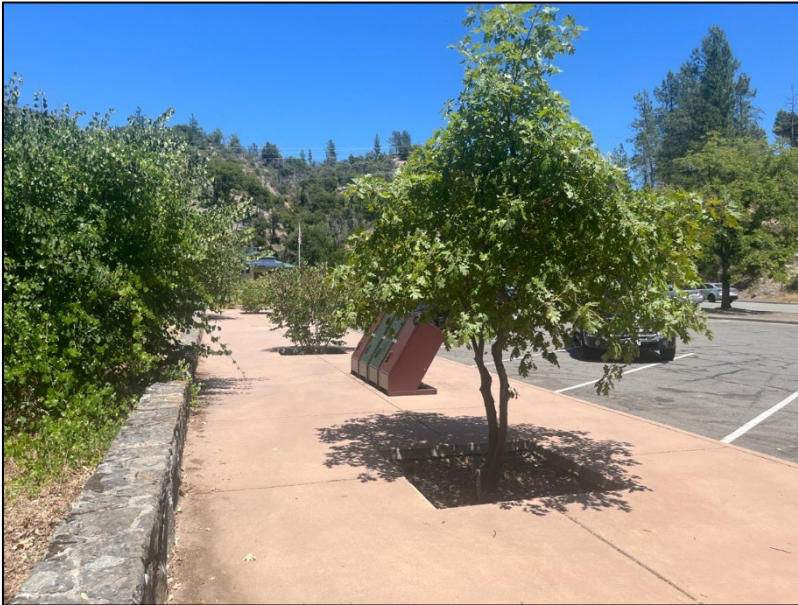
*Figure 51. Example of planters added in 2014 along the south portion of the promenade, camera facing east (NPS 2025).*
