National Park Service  
U.S. Department of the Interior- Whiskeytown National Recreation Area  
Regions 8, 9, 10 and 12

# WHISKEYTOWN ENVIRONMENTAL SCHOOL REBUILD

## *Environmental Assessment*

January 2026

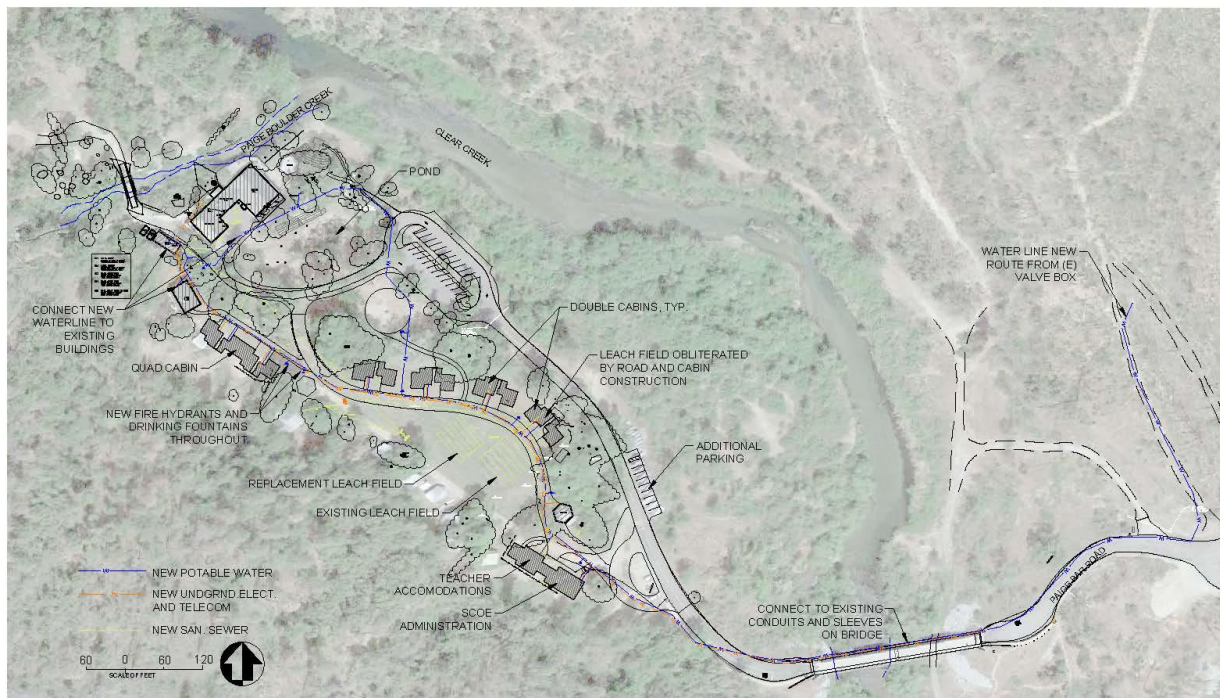
**FIGURE 5. UTILITY DEVELOPMENT CONCEPT SITE PLAN FOR WES.**

**Water** - The WES site underground water main would be replaced from its connection point at Hatcher Hall to the Clear Creek Water District main line on the opposite side of Clear Creek. The new line would be approximately 3,500 feet and it would cross Clear Creek beneath the existing bridge over Clear Creek on conduits installed on the bridge for this purpose. Lateral underground water supply lines for portable water and fire suppression would be installed to each building.

**Septic** - The existing leach field is being evaluated and in planned to remain in situ with potential expansion of the system in the same general area as part of the existing system will be impacted by building and fire road construction. New underground lateral lines would be installed to connect the septic system to the new buildings.

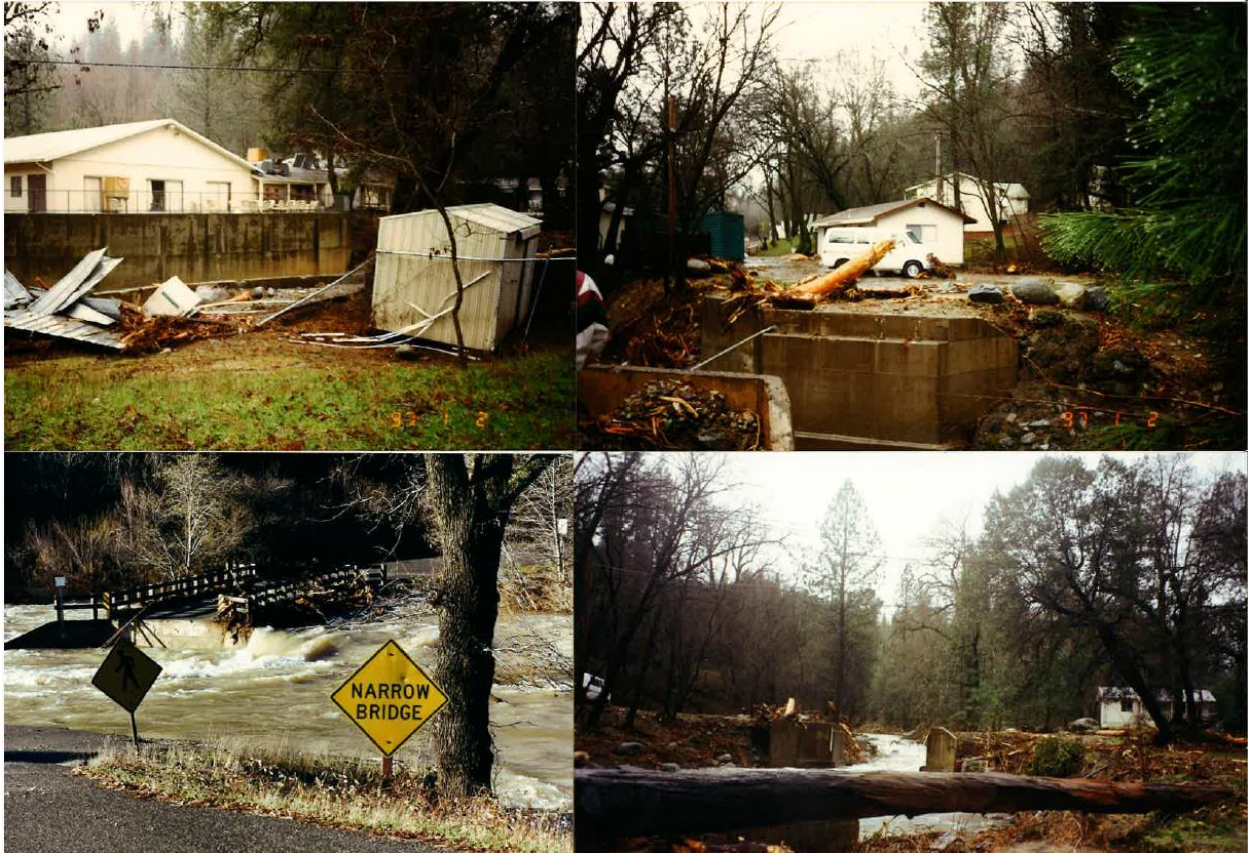
**FIGURE 7. PHOTO DOCUMENTATION OF STORM AND DEBRIS FLOW DAMAGE CAUSED BY THE 1997 NEW YEAR'S STORM. PHOTOS SHOW BRIDGE DESTRUCTION BY CREEK, HIGH WATER, AND DESTROYED BUILDING.**

On New Year's Eve 1997 a storm delivered 19 inches of rain in a 48-hour period to watersheds that were already saturated within WHIS (NPS 1997). Rapid snowmelt in areas above 4500' elevation exacerbated the effects of the storm, contributing to the excessive streamflow. Heightening the effects of flooding, debris flows originated in headwater regions and caused extensive damage to park facilities. Much of the upper Paige Boulder watershed is underlain by Shasta Bally granodiorite, which is rich in the mineral biotite that weathers relatively quickly and deeply and causes hillslope instability (Bilderback, 2020). The erosive soils combined with the storm led to a debris flow in Paige Boulder Creek. It began as a small-scale failure originating in locations disturbed by prior logging operations and progressed into a much larger "debris torrent" in the downslope basin and mainstem of the creek. The "debris torrent" removed one bridge and cut access to another bridge at WES (Figure 7). The three buildings closest to Paige Boulder Creek (Hatcher Hall, Buildings 717 and 723) during this storm experienced water damage or very narrowly avoided water damage (Bilderback, 2020).
