**Consensus Determination of Eligibility for  
Wupatki National Monument Visitor Center Complex Historic District  
National Park Service, Flagstaff Area National Monuments  
Coconino County Arizona**

Wupatki National Monument Visitor Center Complex

The NPS Rustic and Modern architectural styles and Mission 66 Developments throughout the National Park Service, 1933-1972

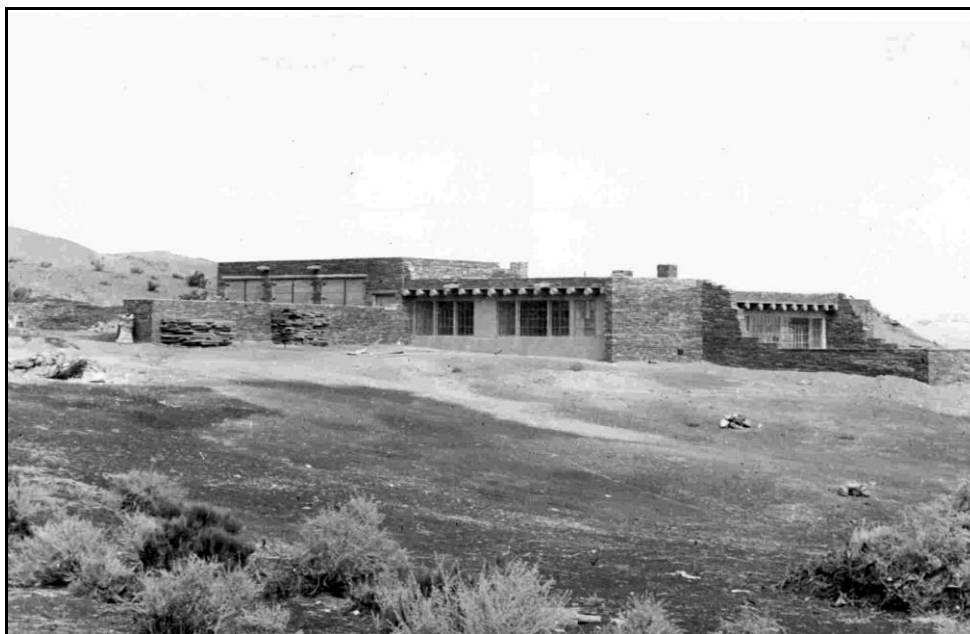
**Figure 4. Custodian's Residence south elevation (NPS 1940).**

The custodian's residence (Figures 2-6) is variously referred to as the Rock House, Building 1, House 1, Residence 1, and Historic Building 1. It was designed by NPS architect Cecil Doty and embodies the rustic design style popular in the first half of the Twentieth Century. Except

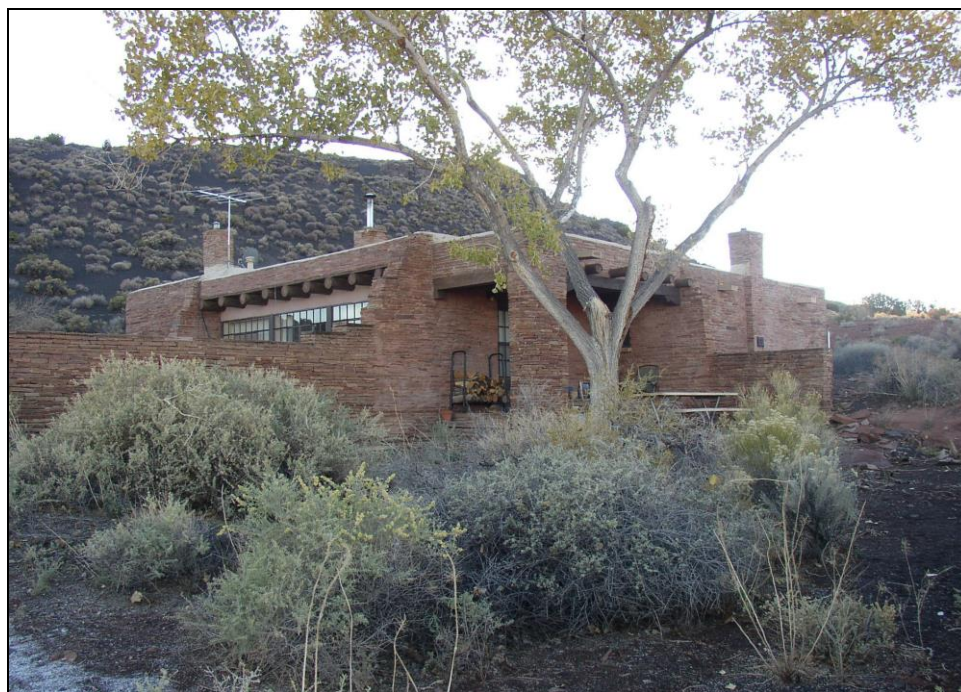
**Figure 5. Custodian's Residence north and east elevations (NPS 2004).**

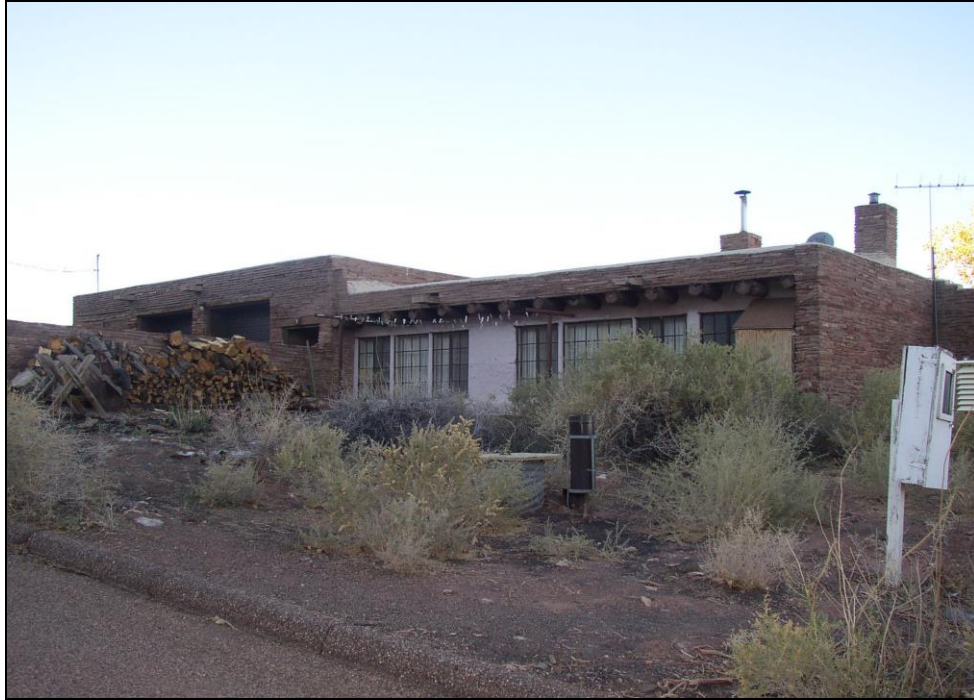
**Figure 6. Custodian's Residence south elevation (NPS 2004).**

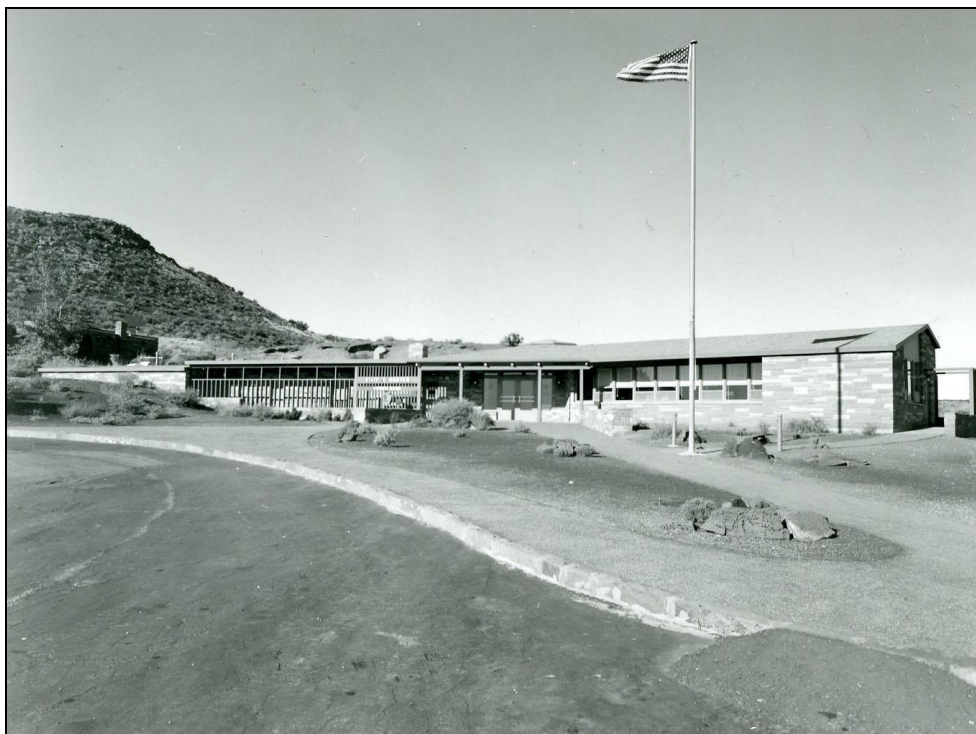
**Figure 10. Mission 66 visitor center east elevation. Custodian's residence is at far left of visitor center. The administration building basement is the below ground structure (left) attached to visitor center by covered walkway (NPS 1966).**

Designed by NPS architect Cecil Doty, the Wupatki National Monument visitor center (Building 16) blends modern materials in the International style with natural materials that harmonize the building with the surrounding landscape and earlier constructed rustic style buildings. With its octagonal shape and stone veneer walls the visitor center is reminiscent of the shape of a Navajo Hogan, the walls of Wupatki Pueblo and colors of the Painted Desert that surround it. The building's exhibits highlight the prehistoric landscape. Educational and interpretive experiences available at the visitor center include hands-on displays, and exhibits featuring the culture history and geology of the area (Figures 8-11).

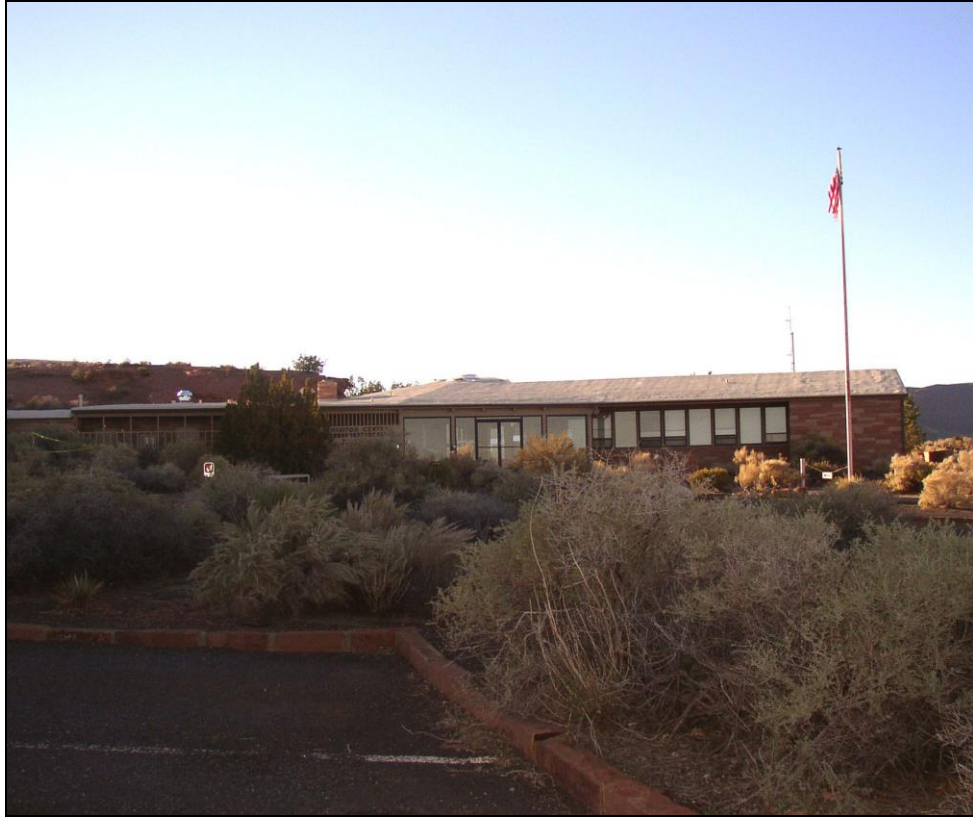
**Figure 11. Mission 66 visitor center east elevation (NPS 2004).**

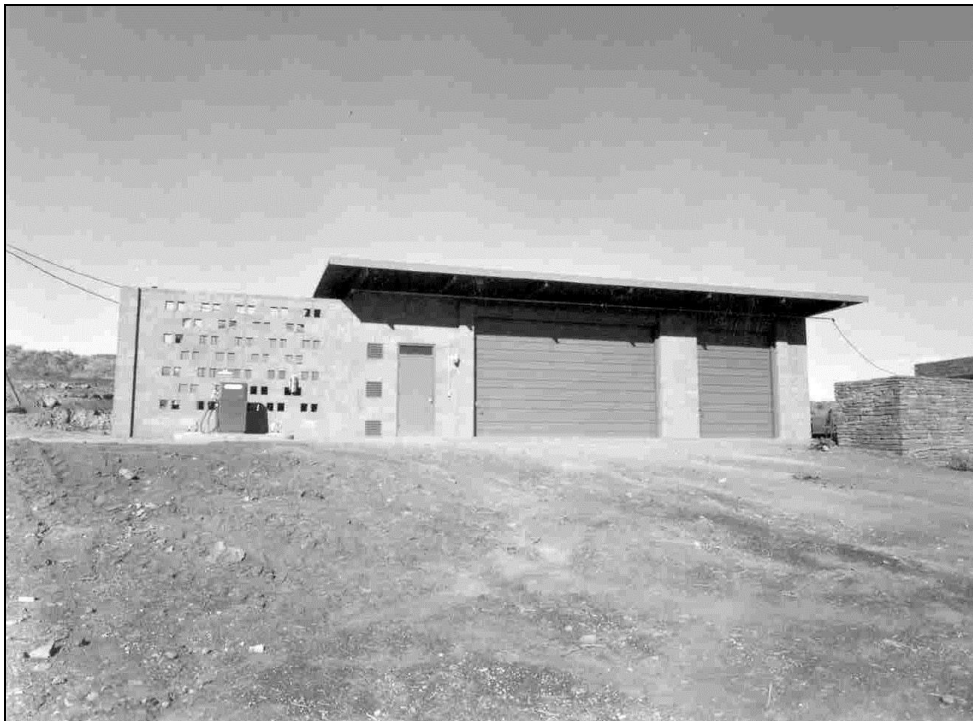
**Figure 12. Mission 66 Maintenance Building east elevation (NPS 1966).**

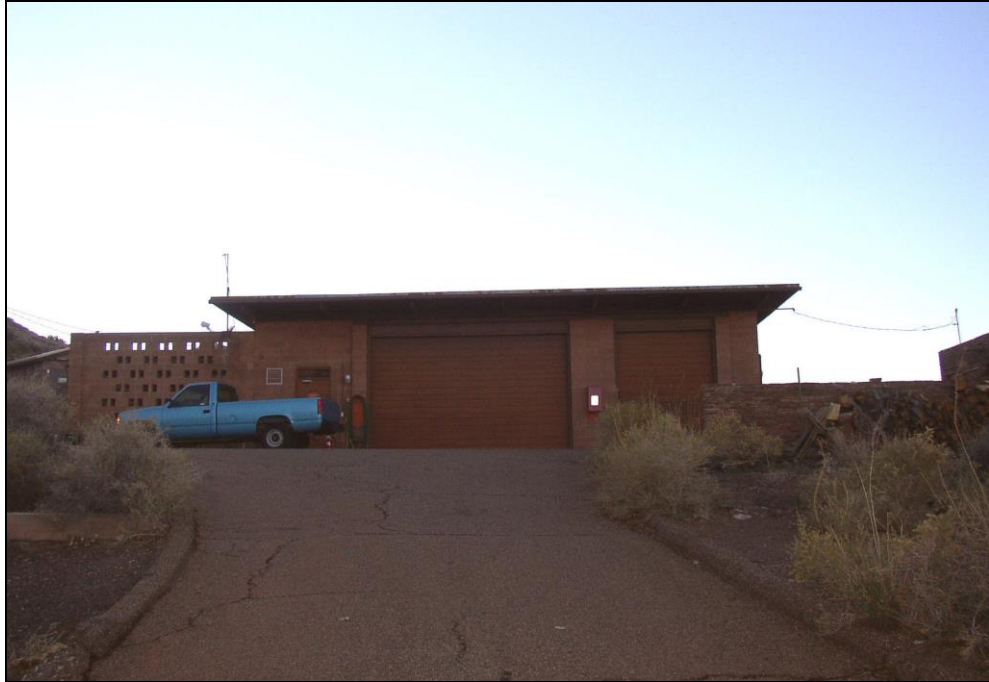
**Figure 13. Mission 66 Maintenance Building east elevation (NPS 2004).**

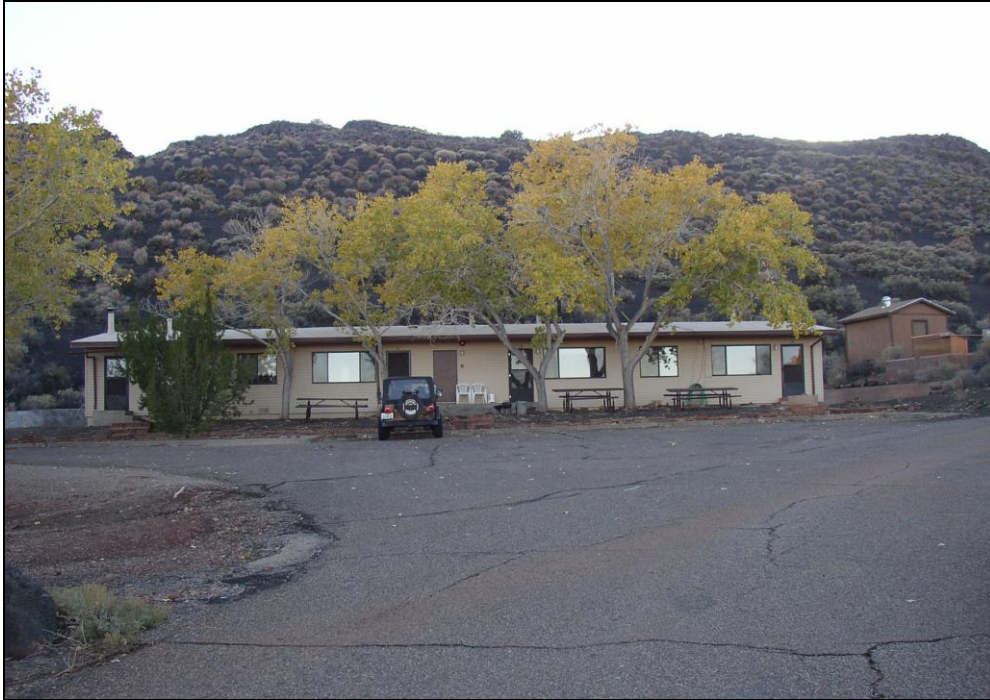
**Figure 15. Mission 66 apartment building north elevation (NPS 2004).**

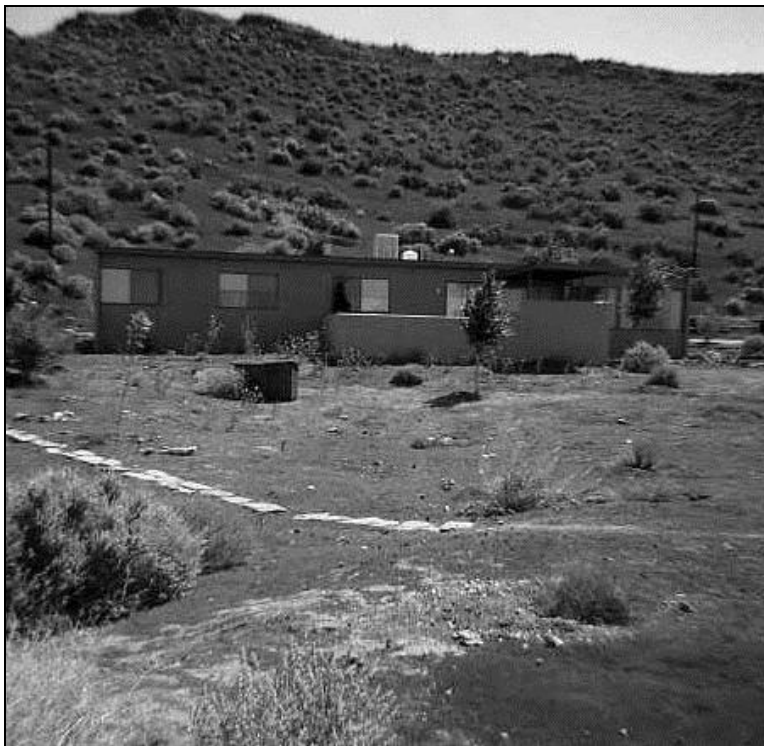
**Figure 16. Mission 66 Residence 10 north elevation (NPS 1963).**

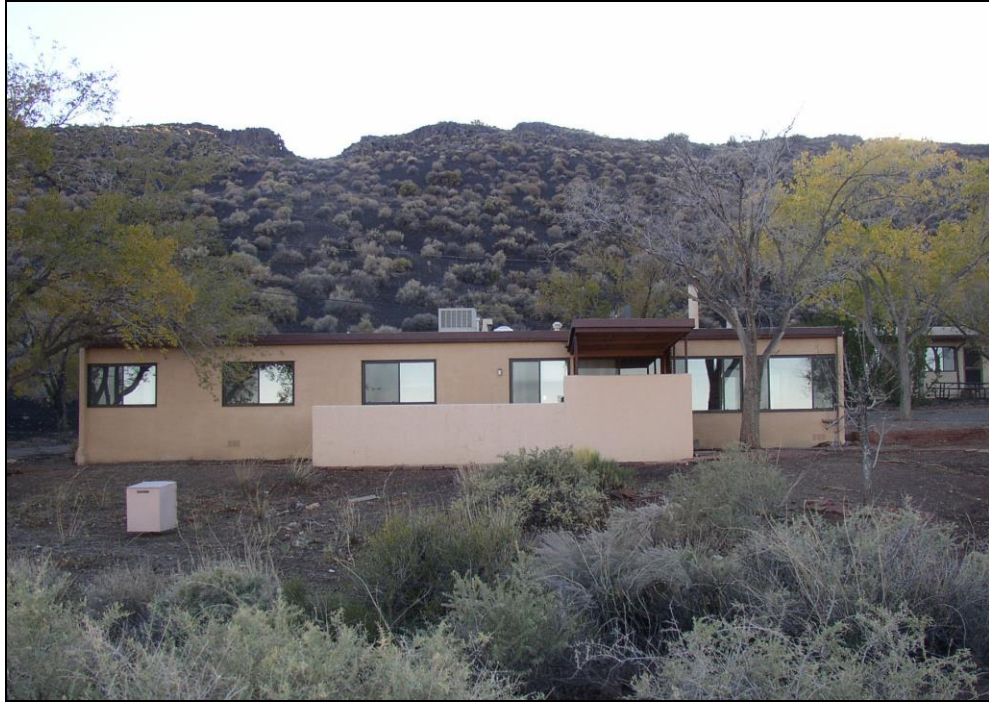
**Figure 17. Mission 66 Residence 10 north elevation (NPS 2004).**

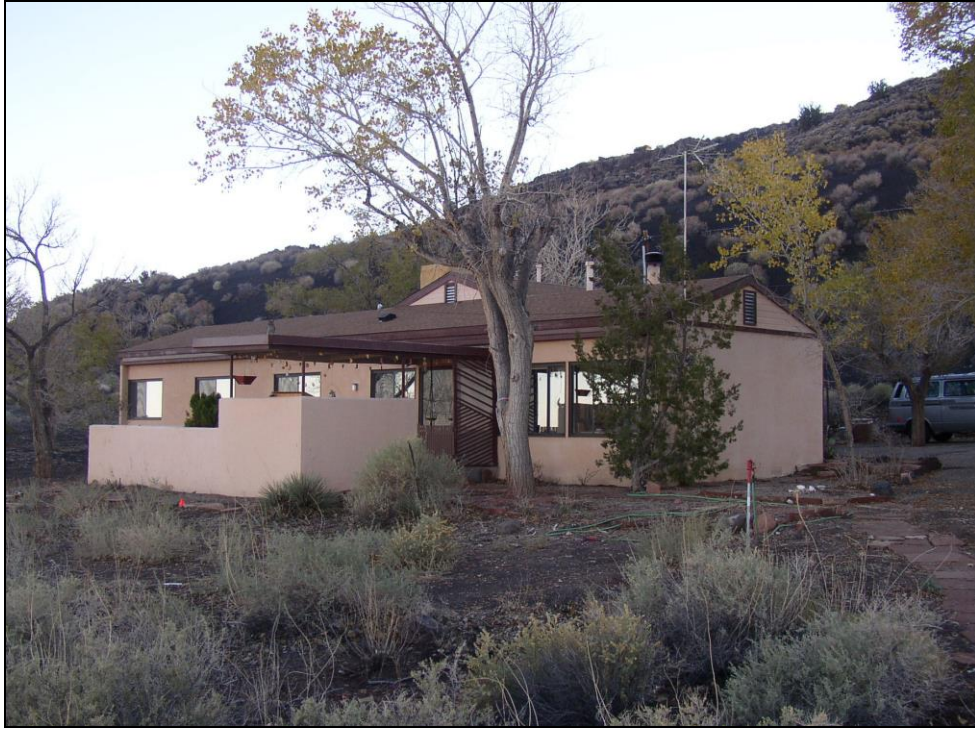
**Figure 19. Mission 66 Residence 12 north elevation (NPS 2004).**

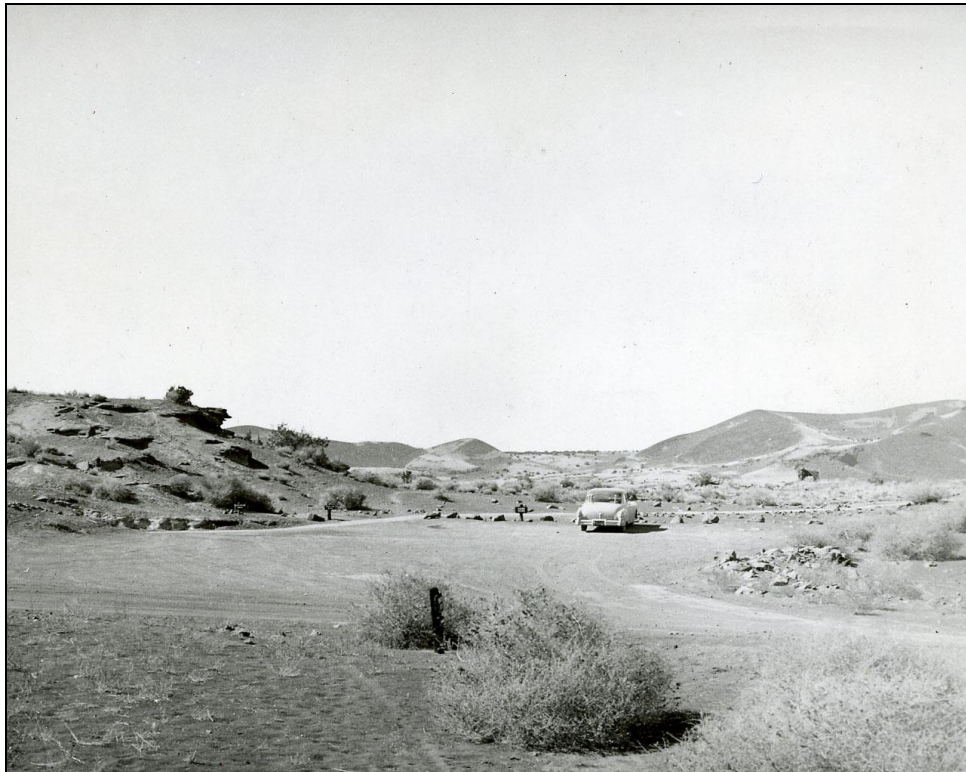
**Figure 20. Parking for Wupatki Pueblo prior to construction of Mission 66 parking lot and curbing (NPS 1952).**

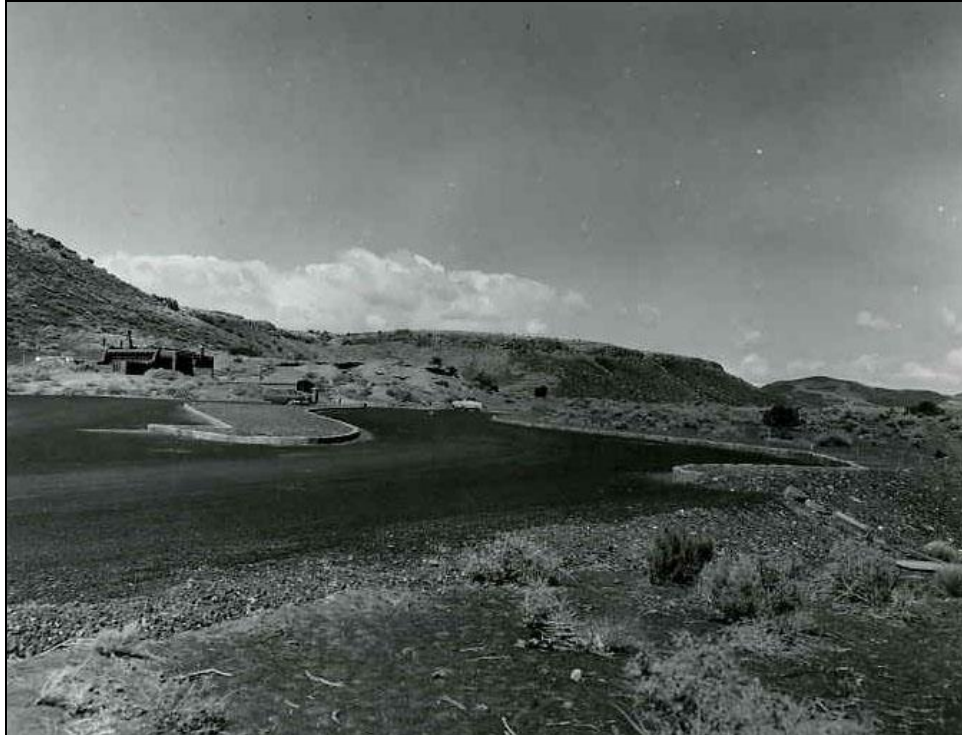
**Figure 21. Mission 66 parking lot and curbing before construction of visitor center (NPS 1957).**

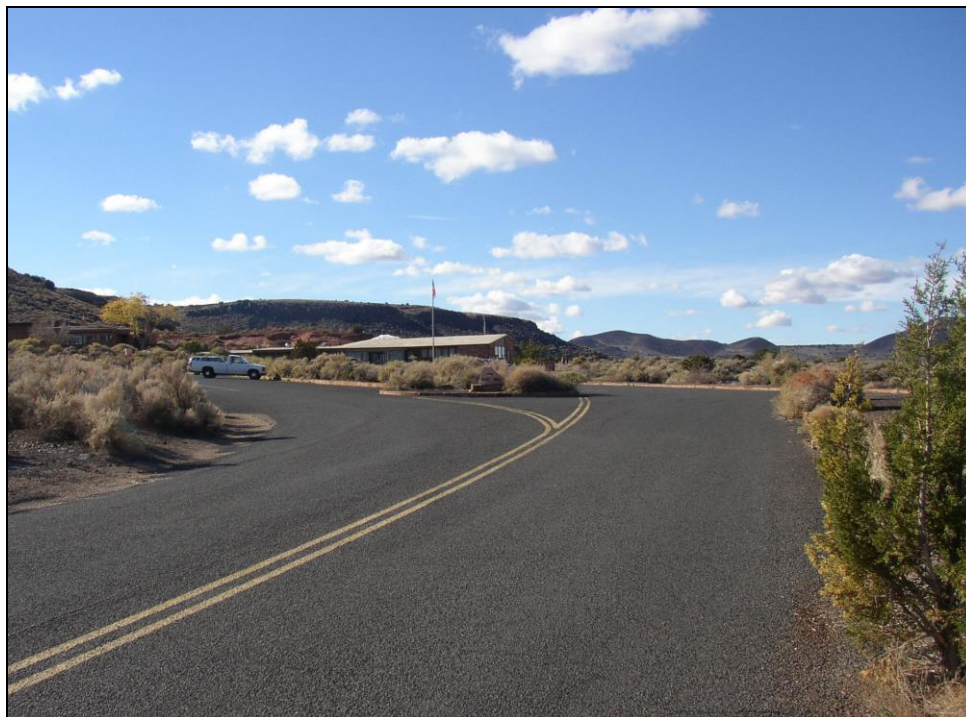
**Figure 22. Mission 66 parking lot. Visitor Center and Custodian's Residence in background (NPS 2004).**

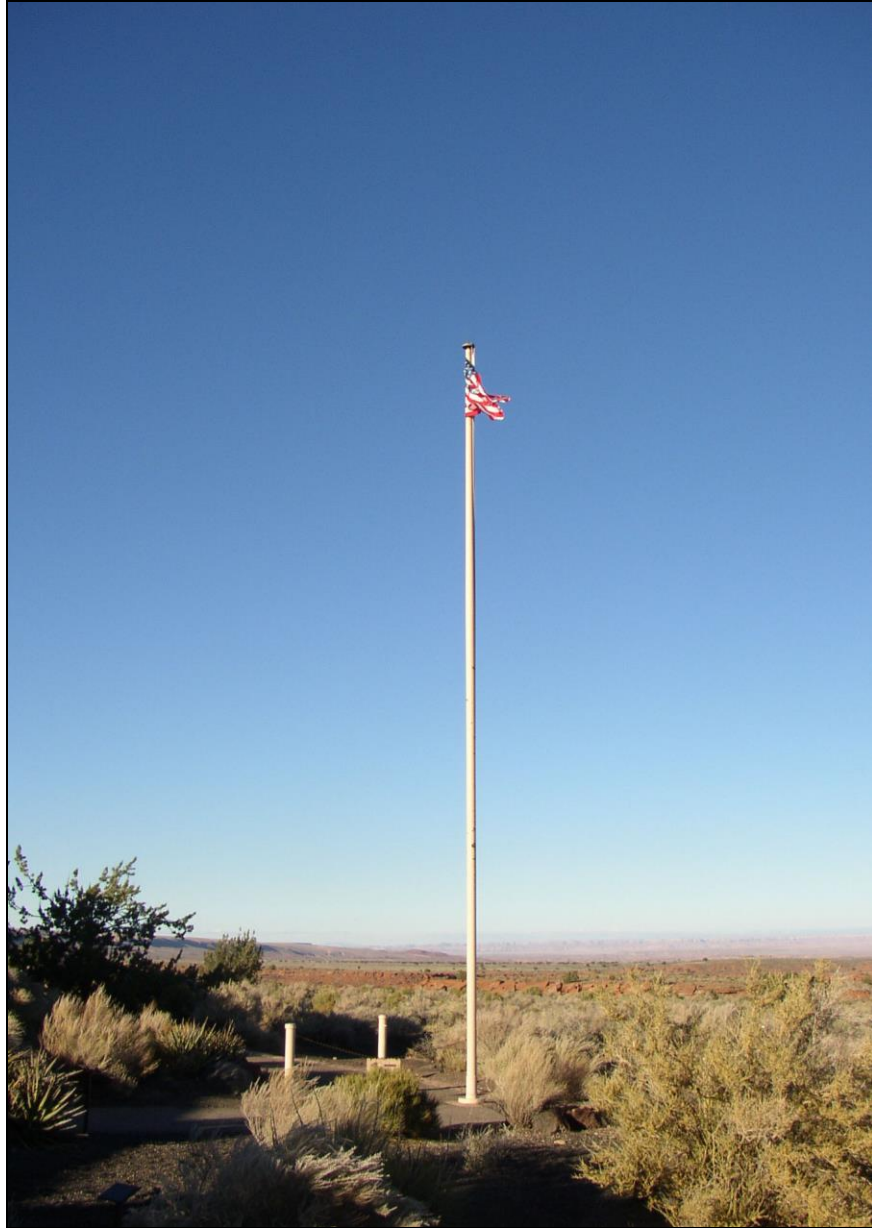
**Figure 23. Mission 66 flagpole looking north (NPS 2004).**

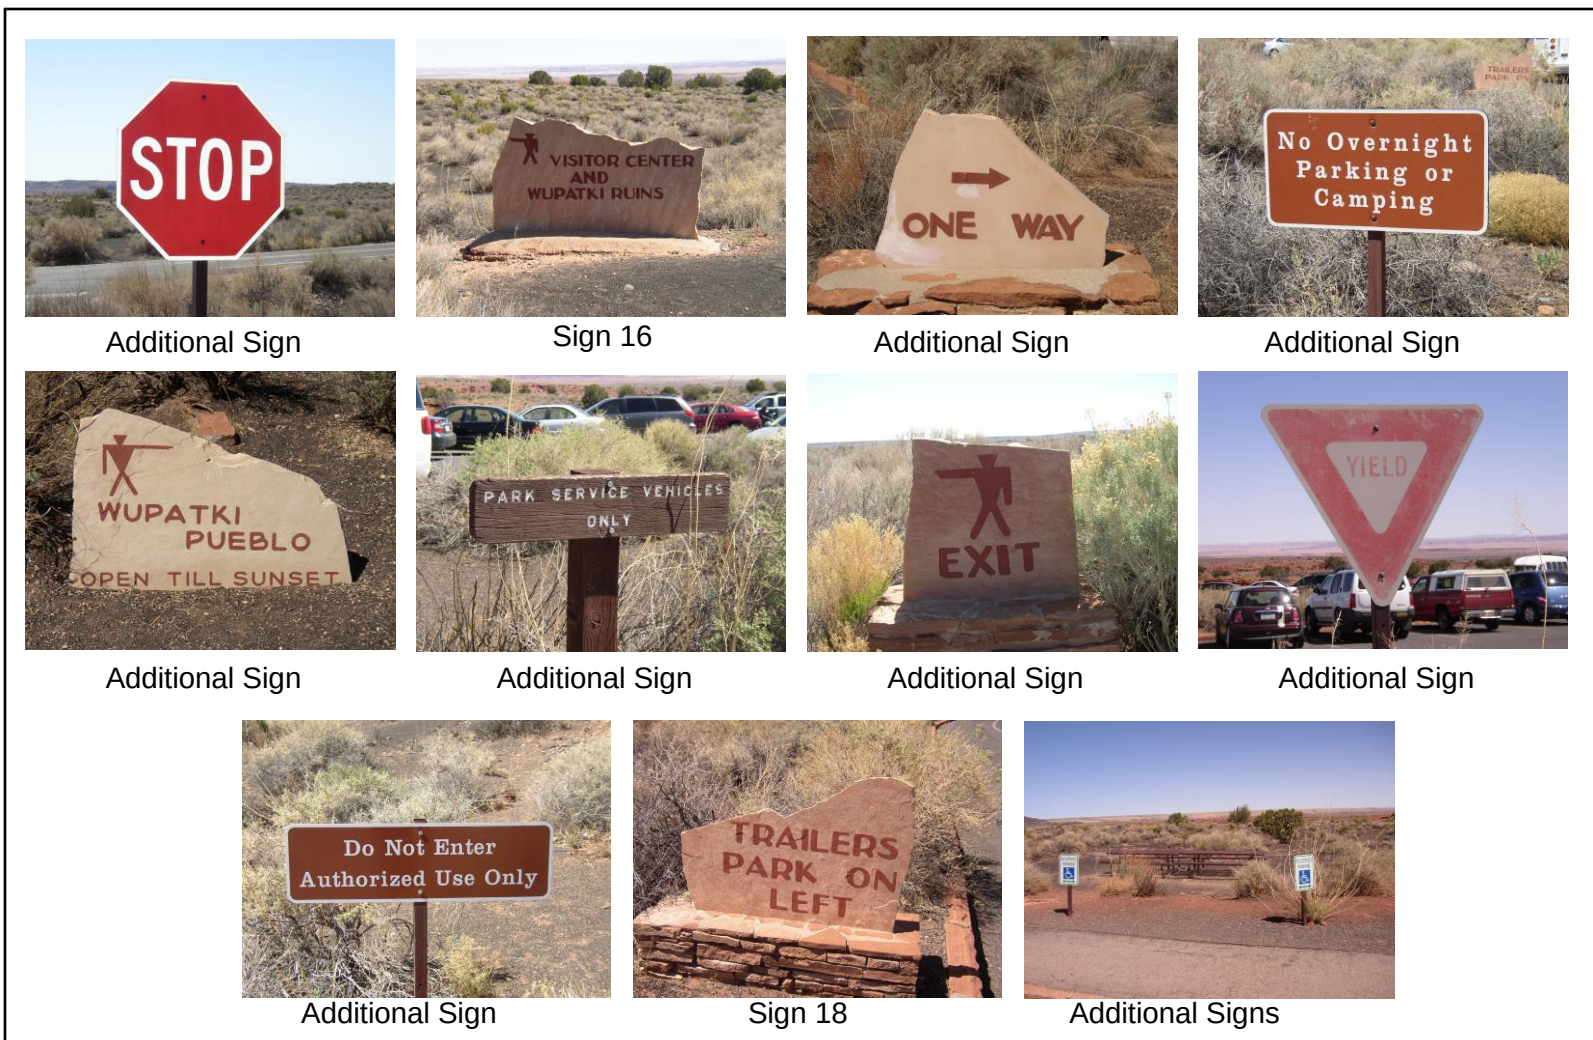
**Figure 24. Parking area and administrative road system signs (NPS 2006).**
