Artist Point Overlook Cultural Landscape Inventory Summary

Historical Chronology

Historic Integrity

Character Defining Features

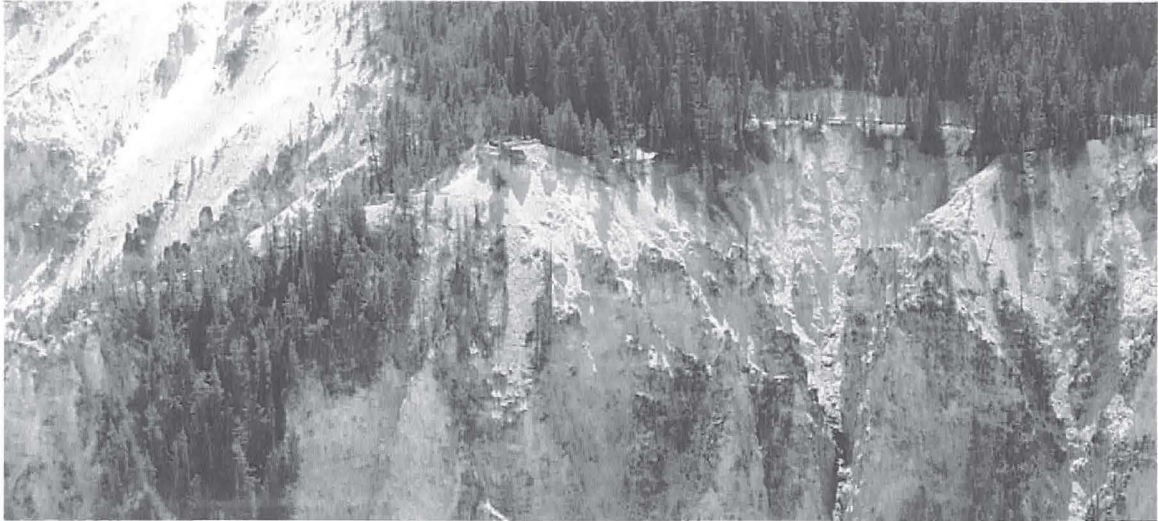
Artist Point Overlook as seen from the North Rim (2002)

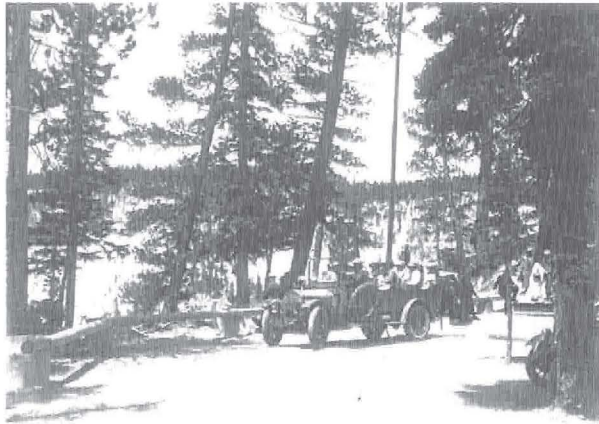
1903 Artist Point Road (now known as South Rim Drive) is constructed. The road extends from the Chittenden Bridge and terminates in a looped cul-de-sac at the base of the Artist Point Overlook.

1906 Artist Point Road terminus is widened to 18 ft. to allow horse-drawn coaches to turn around and park at the base of the elevated overlook.

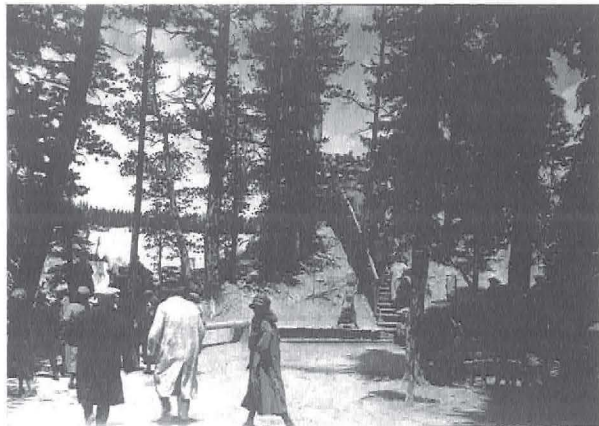
1907 A wooden overlook platform is constructed at Artist Point.

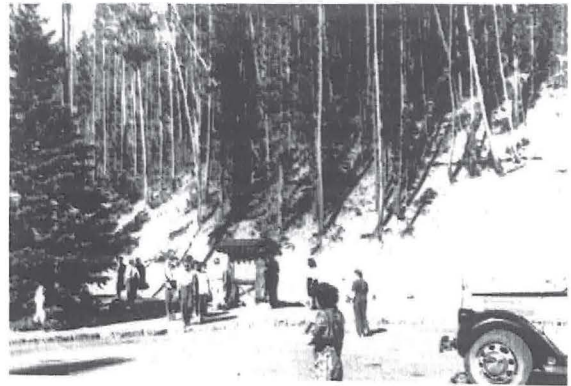
- 1931 Topographic survey completed for Artist Point Overlook. Shows trail at the location of the steps. Shows a very wide cul-de-sac where cars formerly drove and parked before they were prohibited in 1930.

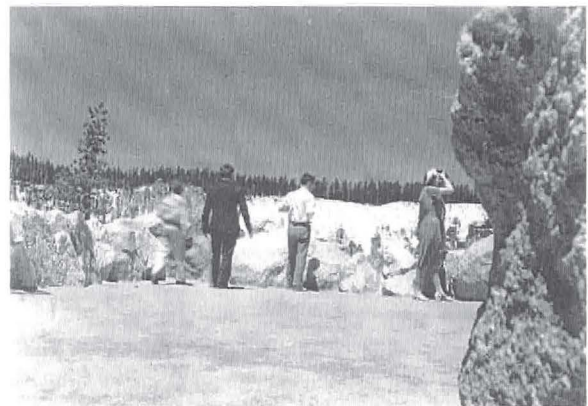
- 1938 The extant overlook platform encircled by a stone parapet wall replaces the unstable wooden platform. A sister-set of stairs, split-log benches and boulder edging along the promenade and lower platform area are also installed during this two-year period of construction.

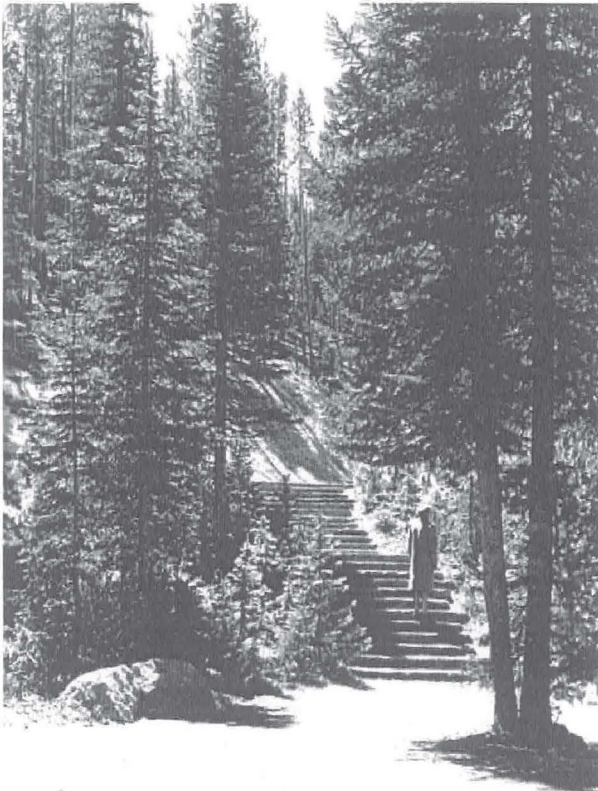
1940

"I Believe it would be well to refrain from holding a definite six-foot width of the stairs, allowing enough variation to break the straight line. Sufficient boulders should be used on the side of the stairs to avoid the lined boulder effect along the sides."

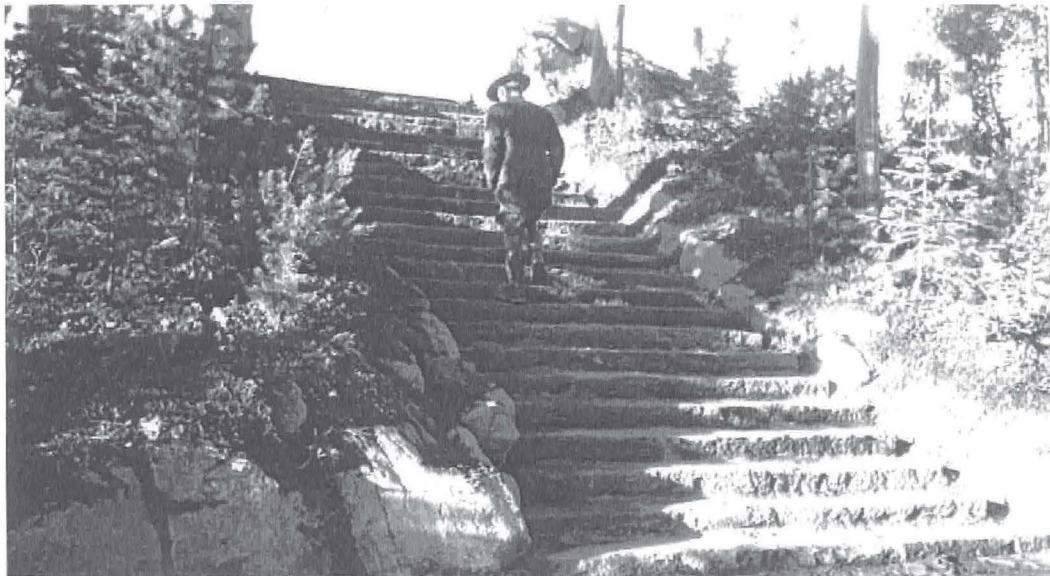
In constructing the new stairs, care is taken to let vegetation blend the development into the landscape, a trademark of Rustic style.

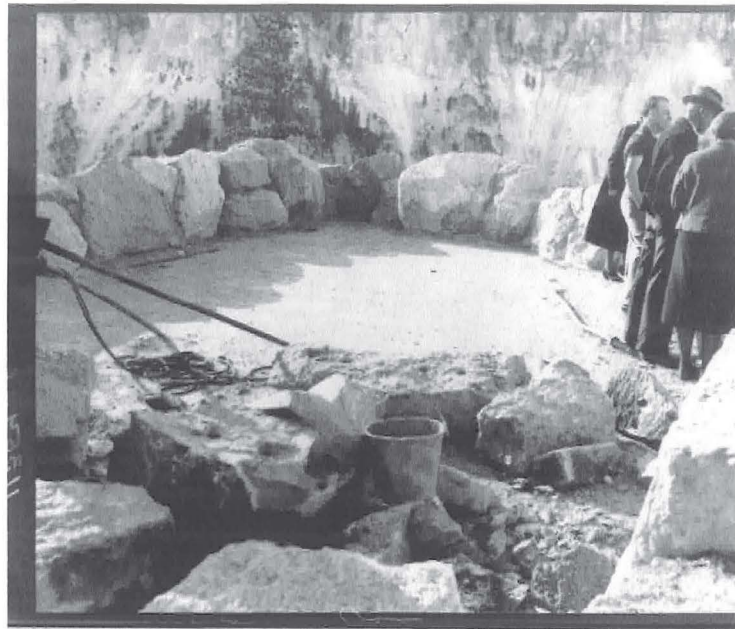
Large rhyolite boulders were placed vertically or are stacked in no more than two courses. The overall height is not uniform and the top and base of the wall forms an irregular line.

1938 Overlook during construction.

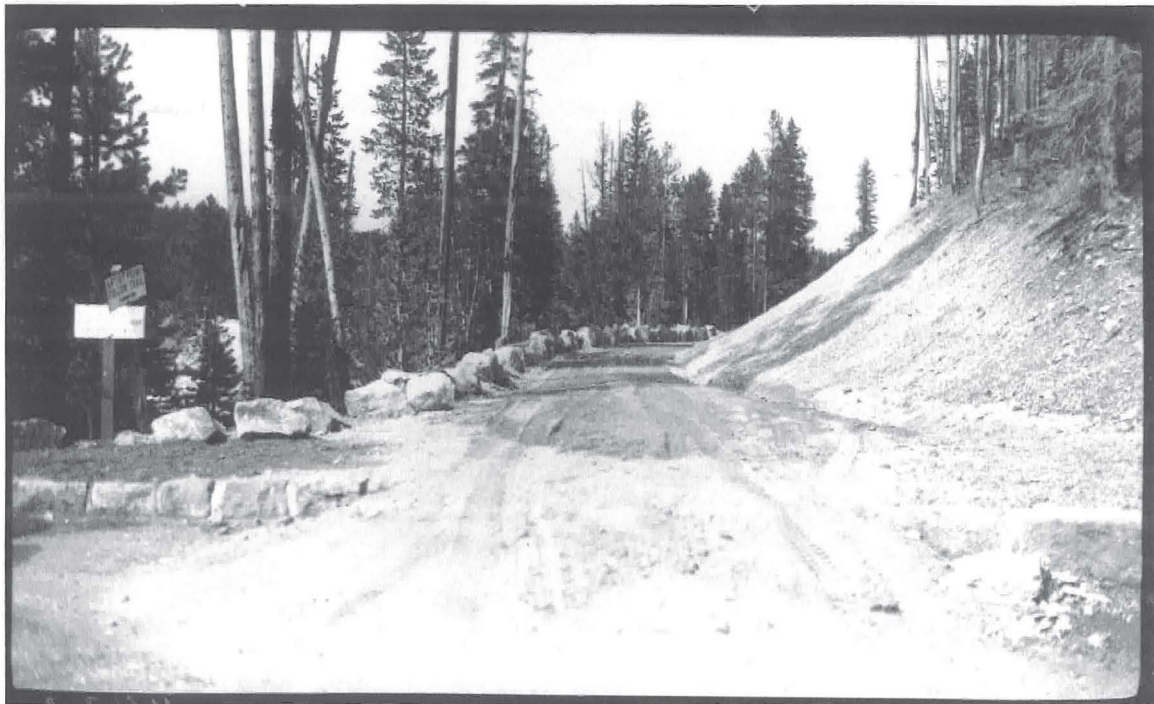
1939 Promenade during construction.
