National Park Service
Cultural Landscapes Inventory
2008

Roosevelt Lodge Historic District
Yellowstone National Park

Inventory Summary

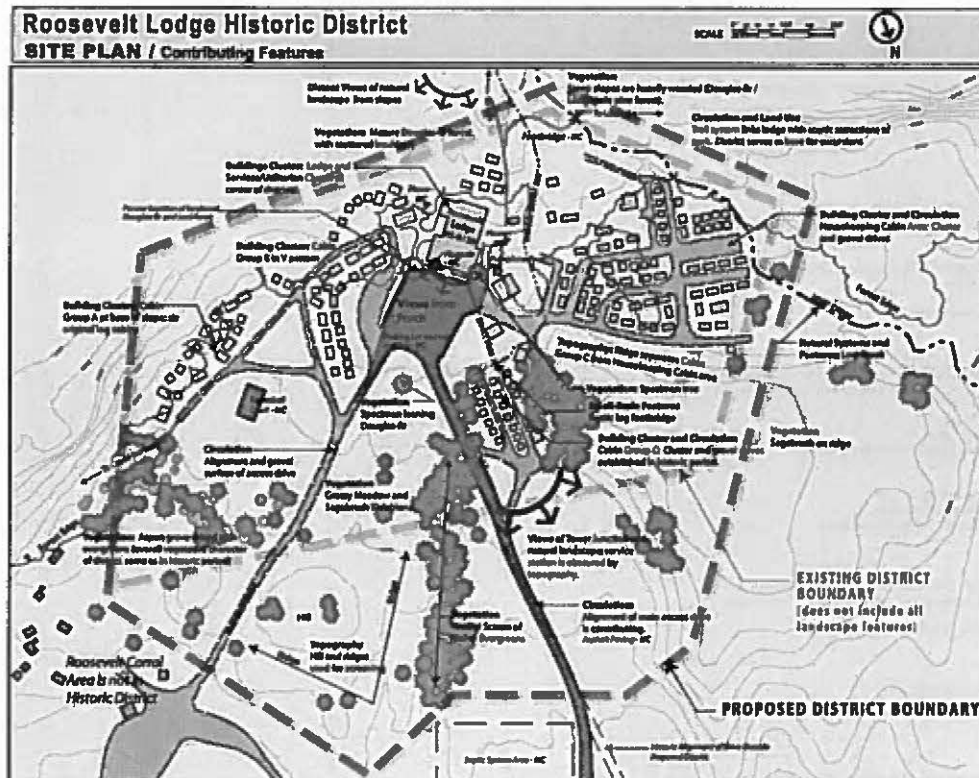
Site Plan

Site plan of Roosevelt Lodge with contributing features, April 2007. Source: Shapins Associates.

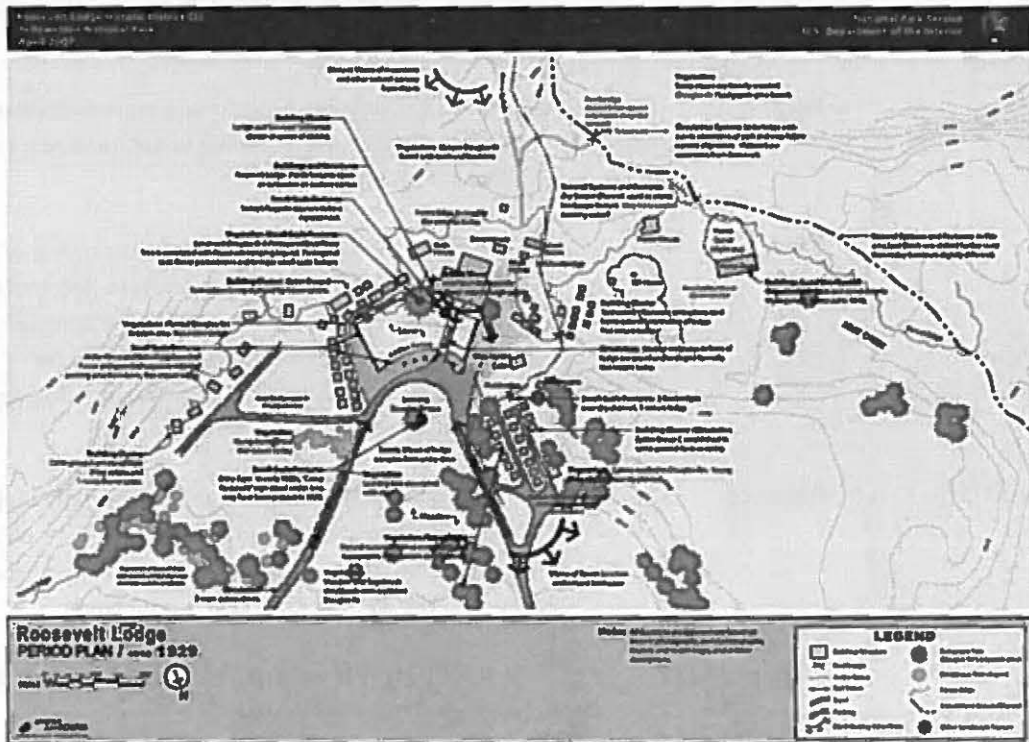
1929

Roosevelt Lodge period plan, circa 1929. Source: Shapins Associates.

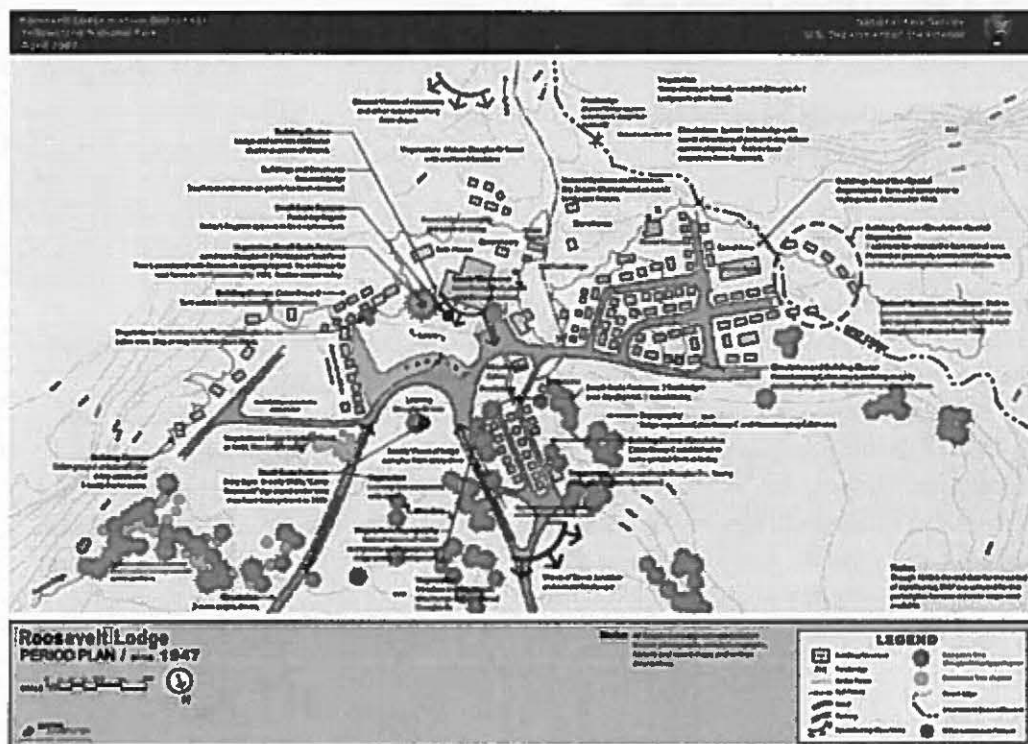
1947

Roosevelt Lodge period plan, circa 1947. Source: Shapins Associates.

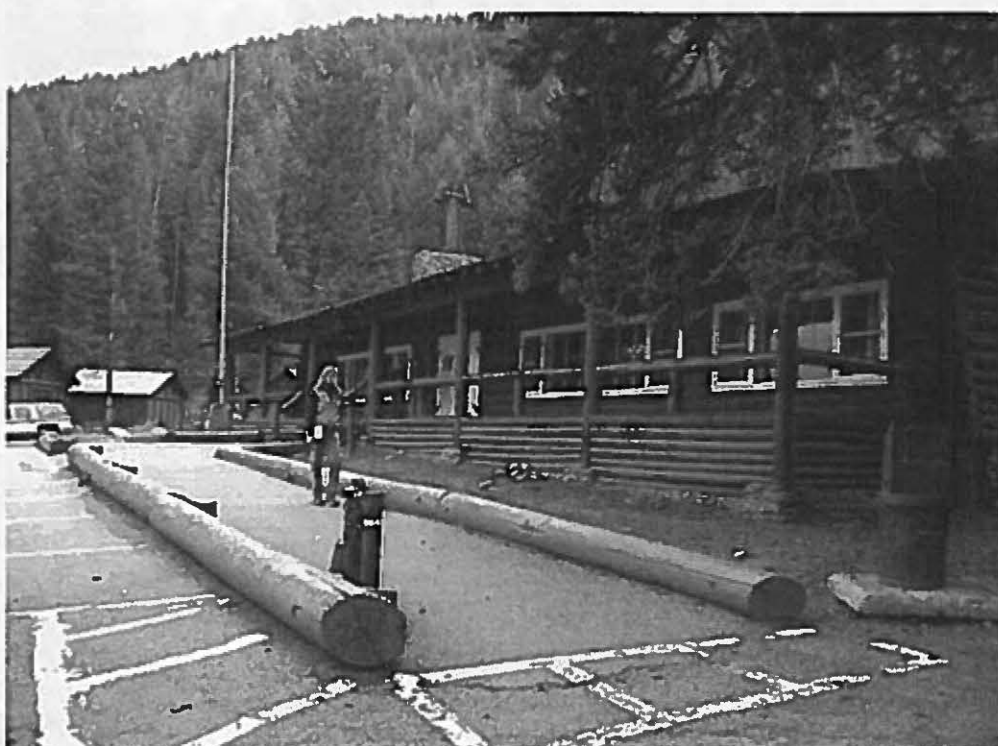
Built in 1919-1920, the Roosevelt Lodge remains the central building in the district. The walk and log curbing in this view are non-contributing. Source: Shapins Associates, 2004.

The Yellowstone Park Company built the lodge in 1919-1920. Ultimately, Roosevelt Lodge was the smaller of the lodges built in Yellowstone National Park (Culpin 1982). Executed in the Rustic Style, the lodge is of horizontal log construction, and features large stone chimneys and a deep porch. In October 1919 the Superintendent's Monthly Report proposed to make the area "something of the order of the 'dude ranch' of the West" (Culpin 1982). The lodge was to be the center of this complex, surrounded by Rustic structures for accommodations. Strictly speaking, the buildings and landscape at Roosevelt Lodge constitute a lodge complex rather than a dude ranch. (The lodge is primarily a form of tourist accommodations, while a dude ranch is a ranch that caters to tourists on a reservation basis.) Yet the general arrangement of buildings and their rustic character is evocative of a dude ranch, even to this day.

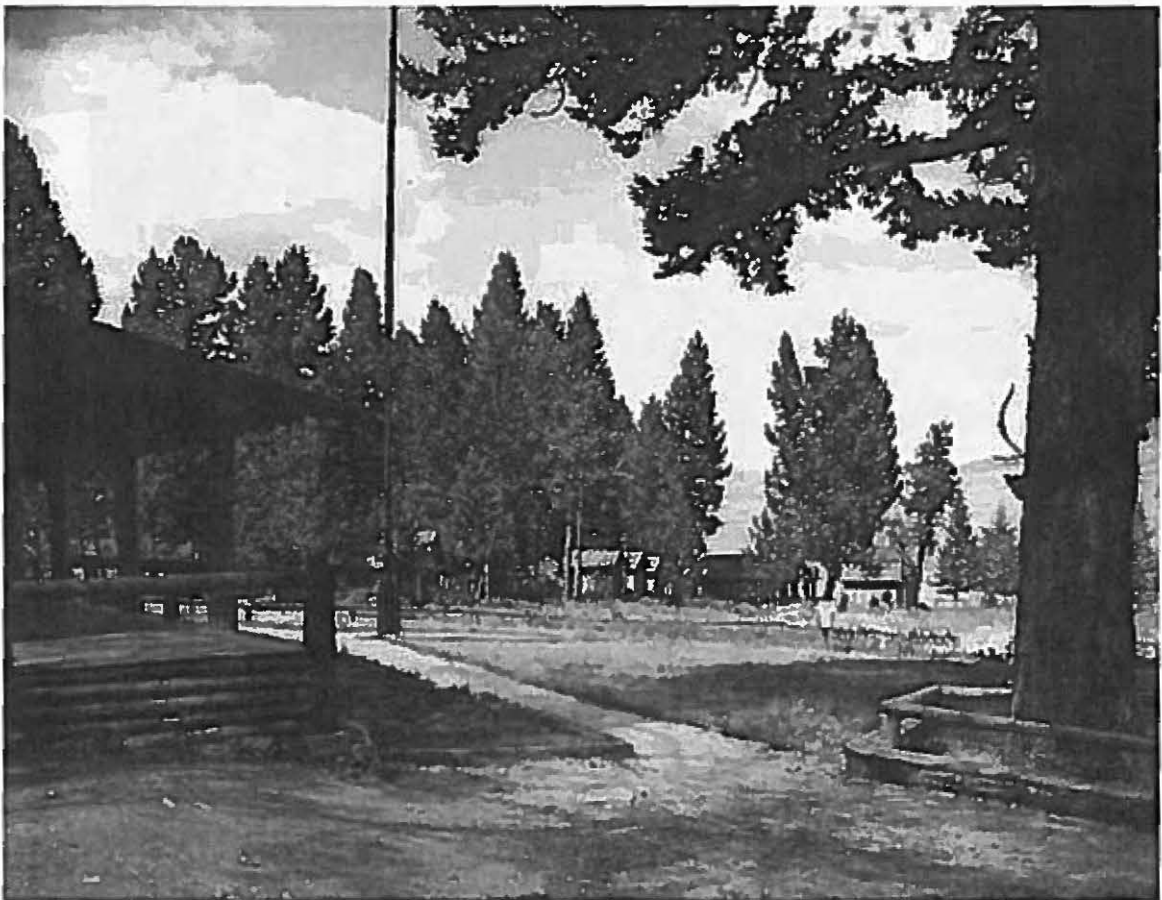
View to the cabins north of the lodge. Note porch extension and Douglas-fir with seat/fence (not extant today). Source: Montana State University Library, Merrill G. Burlingame Special Collection, circa 1924-1929, photo 220.

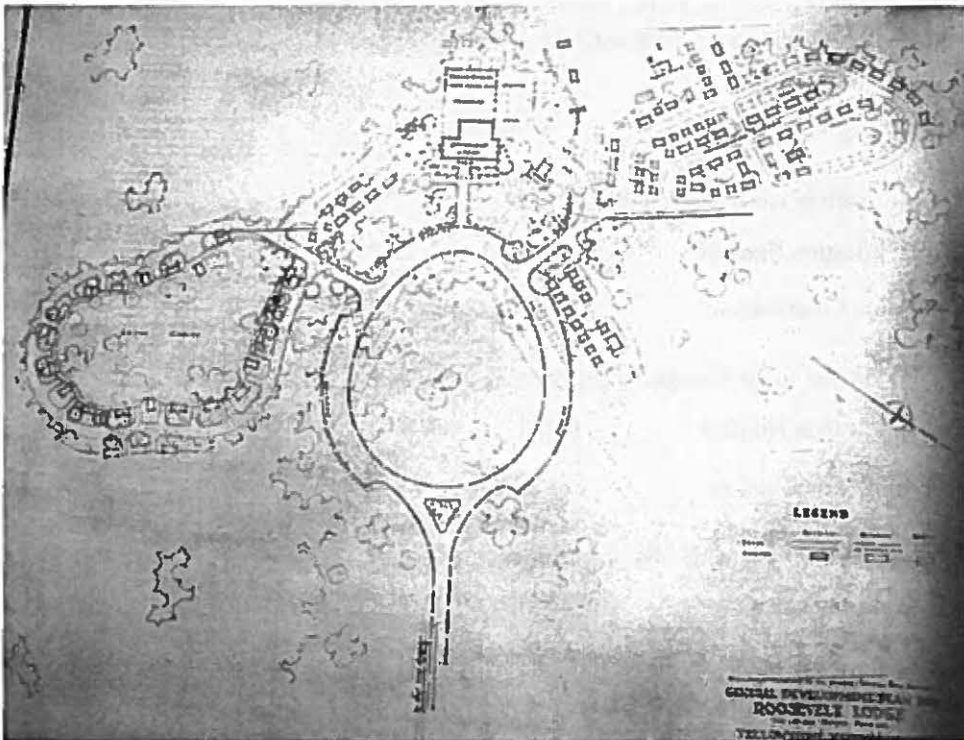
General Development Plan, part of the Master Plan for Yellowstone National Park, 1939, proposes reconfiguration of circulation systems to preserve views; removal of existing drives; and removal of several cabins/tent-cabins in the proposed loop drive.

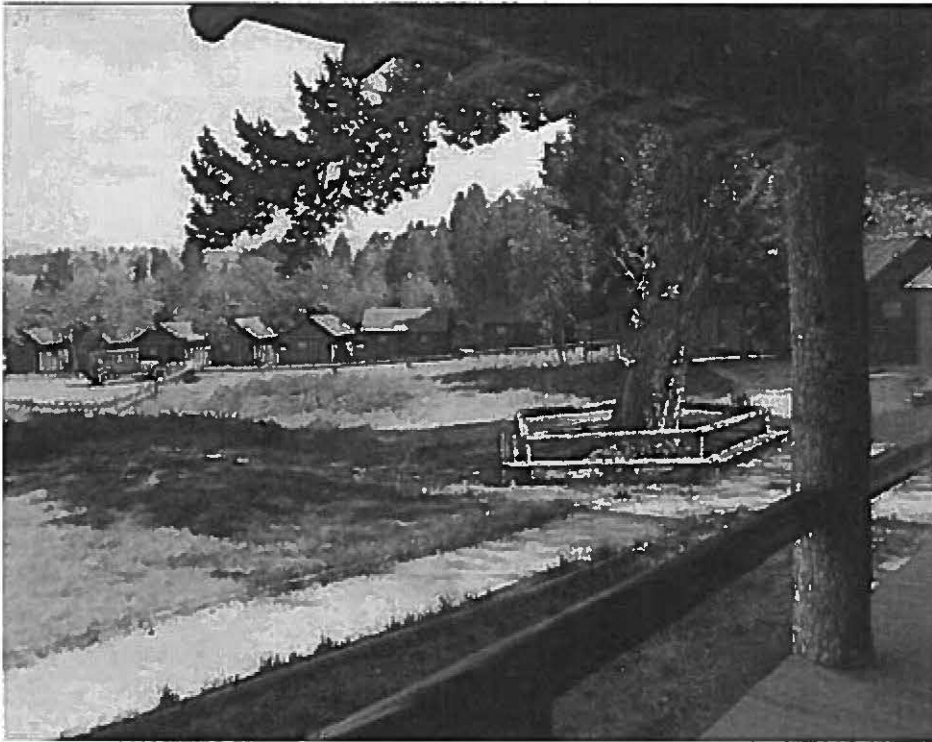
Historic view of walkways and raised log curbing, which appears to meet the antler fence and defines a parking area. Source: Montana State University Library, Merrill G. Burlingame Special Collection, circa 1924-1929, photo 219.

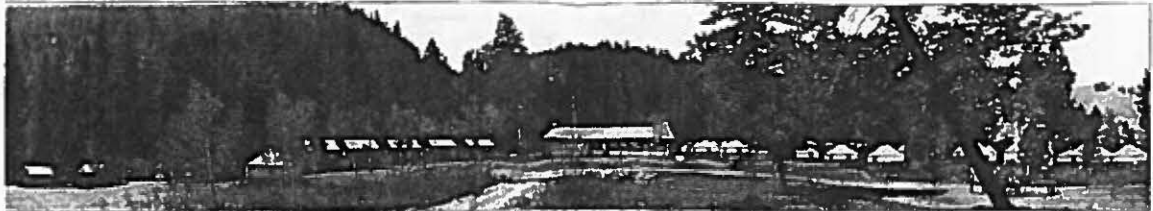
View of Camp Roosevelt from YPCC promotional pamphlet, 1923 season. Log cabins at base of slope are established, while other cabin areas are occupied by tents and other type cabins. Source: YELL archives.

Of all the building clusters, Cabin Group C is the farthest north, located at the base of a ridge that divides it from the housekeeping area. In the 1922-23 photograph from the YPCC brochure a group of tent-cabins appears in the general vicinity of Cabin Group C. About 1927 the tent-cabins were converted to permanent cabins, as 13 rustic-frame "logs-out" cabins, one log duplex, and four frame cabins were erected on the site (McDonald Architects 1993, 25). These buildings were aligned in three orderly rows along two drives that are parallel to the main lodge entry drive. Over time some of the buildings in this cluster have been replaced, but the overall arrangement today very closely approximates that during the period of significance. Cabin Group C is still used for guest accommodations.

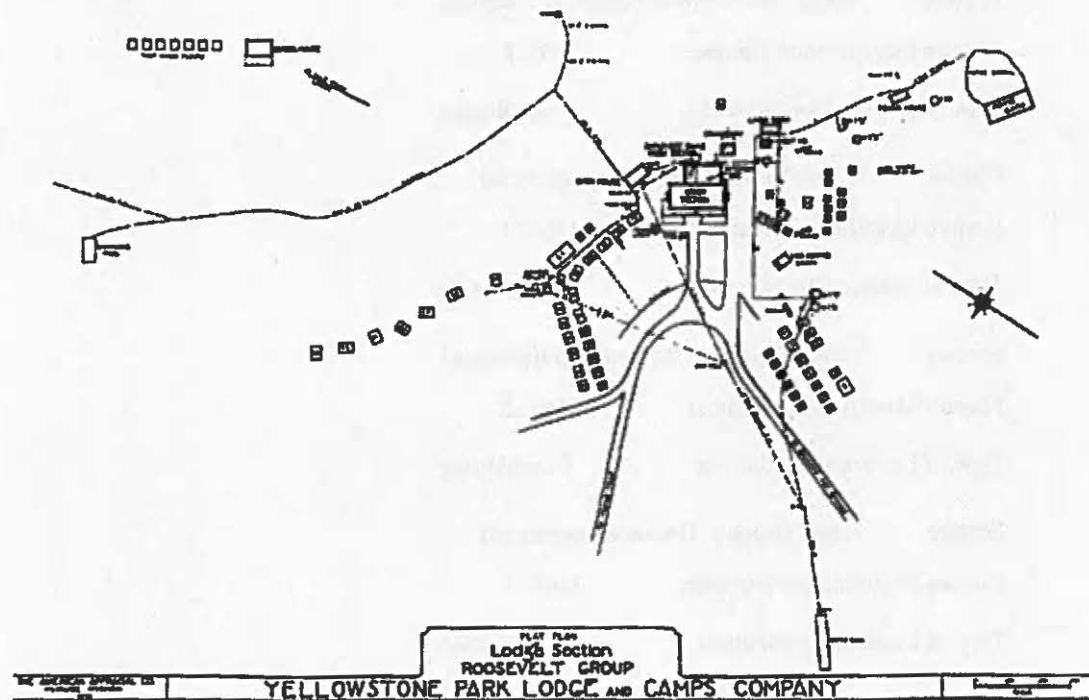
Plat Plan of Lodge Section, Roosevelt Group, Yellowstone Park Lodge and Camps Company, American Appraisal Co., 1929. Source: YELL archives.

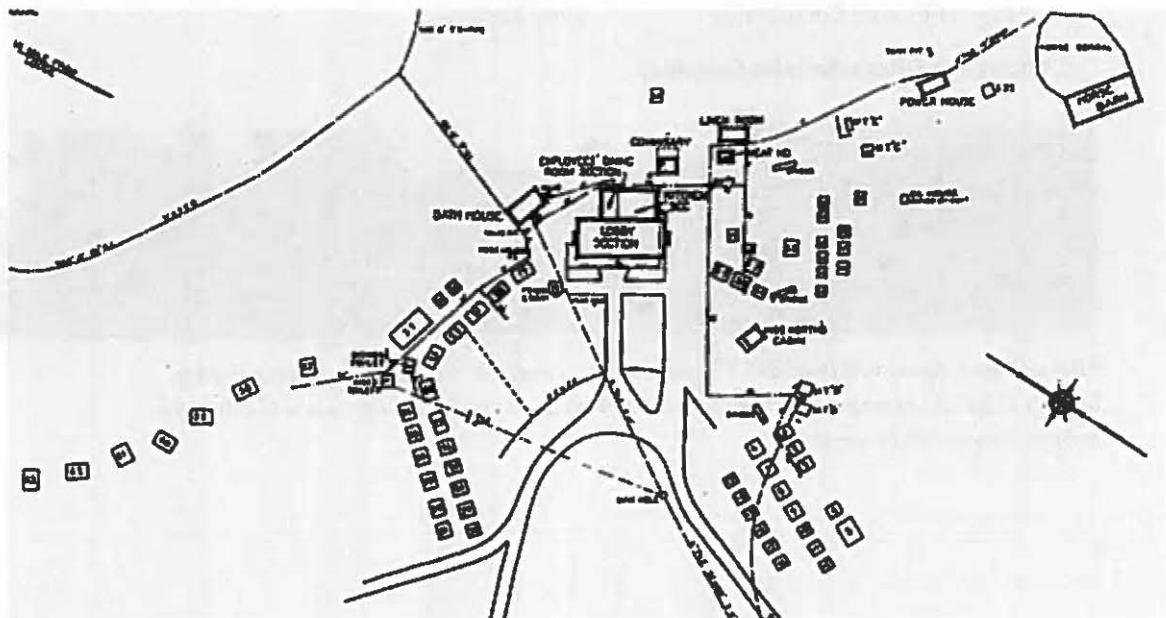
Detailed view of the American Appraisal Co. plan from 1929. Antler fence, pentagonal seat/fence surrounding Douglas-fir, and porch extension are visible, along with three footbridges that cross the (now) dry channel. Source: YELL archives.

One extant small-scale feature in the cabin areas is a small footbridge spanning the former stream channel near the caretaker's cabin. This is a log bridge of rustic design. Two historic maps (reproduced later in this report) show that three footbridges once crossed this channel, but only one such footbridge survives. A number of small water spigots for visitor use are also conspicuous features of the cabin area. These spigots do not appear to be historic but they have been designed to fit in the natural landscape. By design, they resemble small tree stumps burnt by fire.

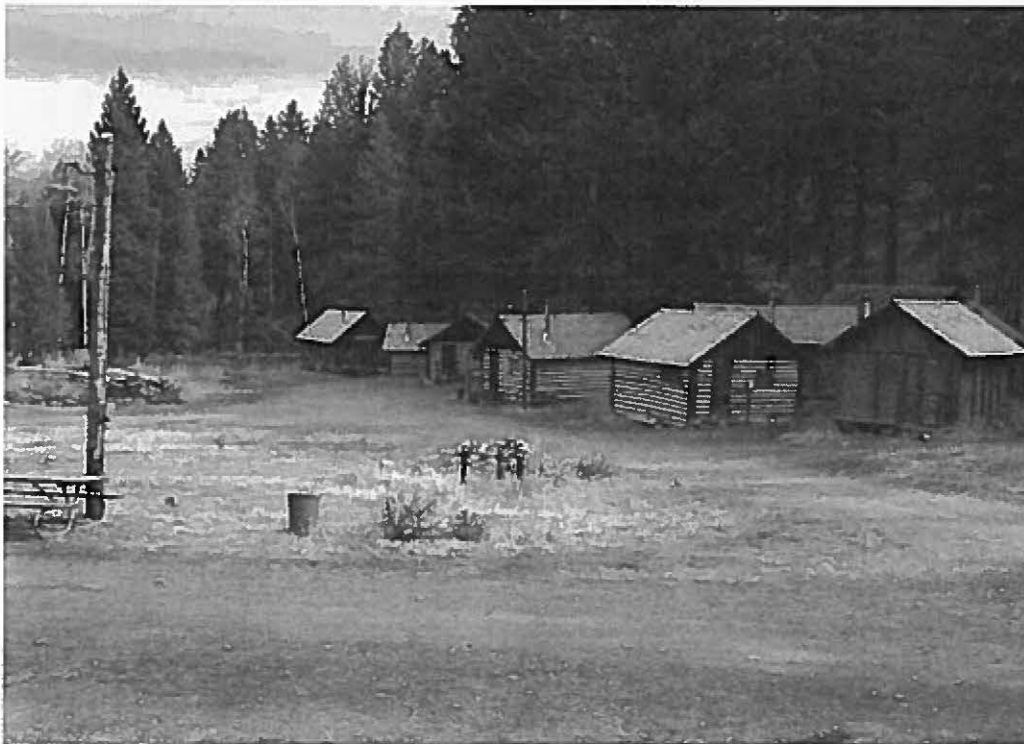
The cluster of log cabins in Cabin Group A were some of the first buildings erected at Roosevelt Lodge. Over time, many frame cabins were brought to this area from other sections of the park. Source: Shapins Associates, 2004.

Cabin Group A is composed of a number of Rustic cabins that form a very irregular line at the base of a steep slope. The organization of this cluster is very loose: the size and orientation of the buildings vary. One rustic-frame "logs-out" cabin in this group was constructed as early as 1924. Other such cabins have been added over time (McDonald Architects 1993, 24). The most conspicuous members of the group are six original log cabins, which were built about 1922. Featuring horizontal logs and white chinking, these cabins were the first cabins constructed specifically for the new lodge system at Yellowstone. Within the park, this type of cabin is unique to Camp Roosevelt (McDonald Architects 1993, 23). Cabin group A is now used for employee residential purposes.

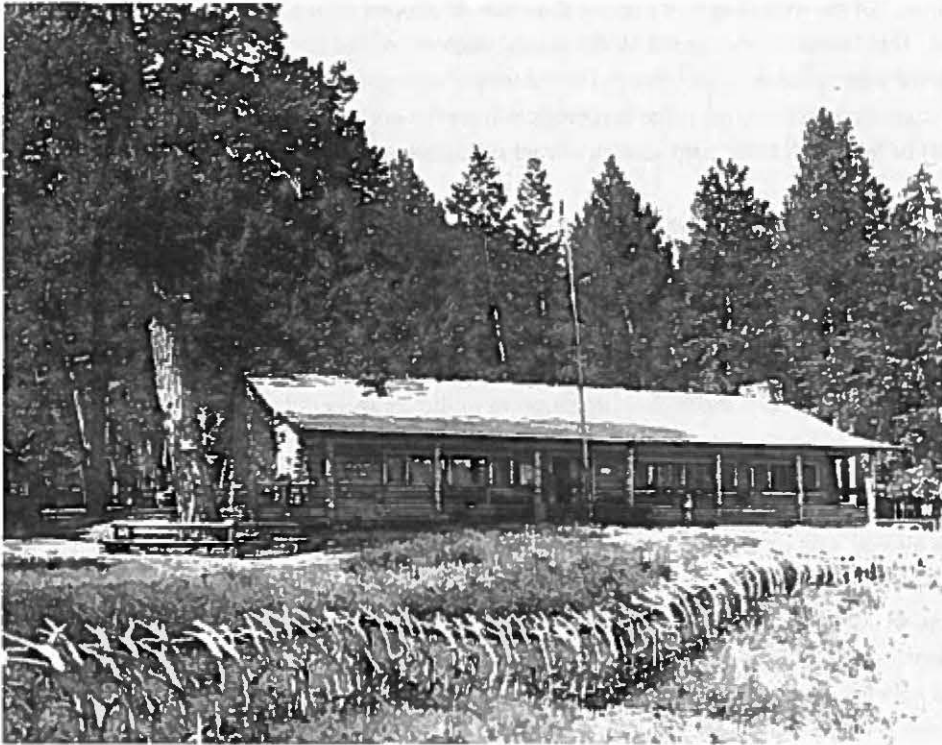
Small-scale features include an elkhorn fence, peeled-log flagpole, and the large pentagonal seat/fence protecting the landmark Douglas-fir. Source: Montana State University Library, Merrill G. Burlingame Special Collection, circa 1924-29.

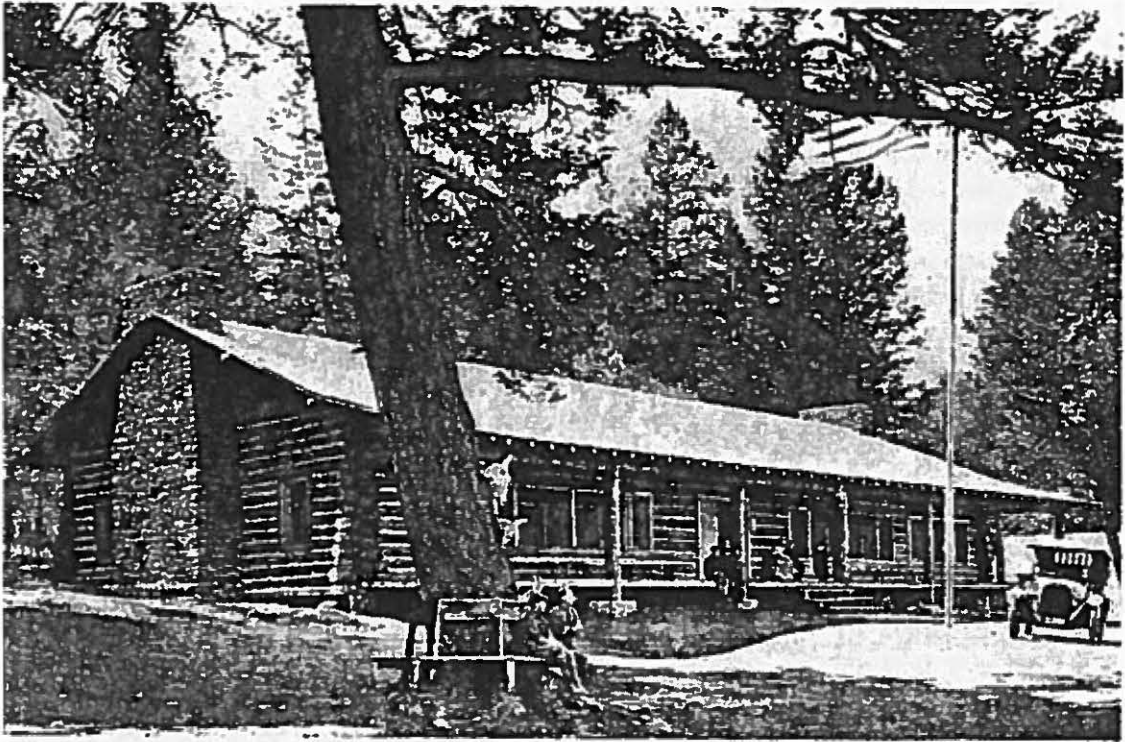
Roosevelt Lodge soon after completion with landmark Douglas-fir and early, primitive version of seat encircling it. Source: YELL archives, pamphlet for Yellowstone Park Forest and Trail Camp for 1921 season.

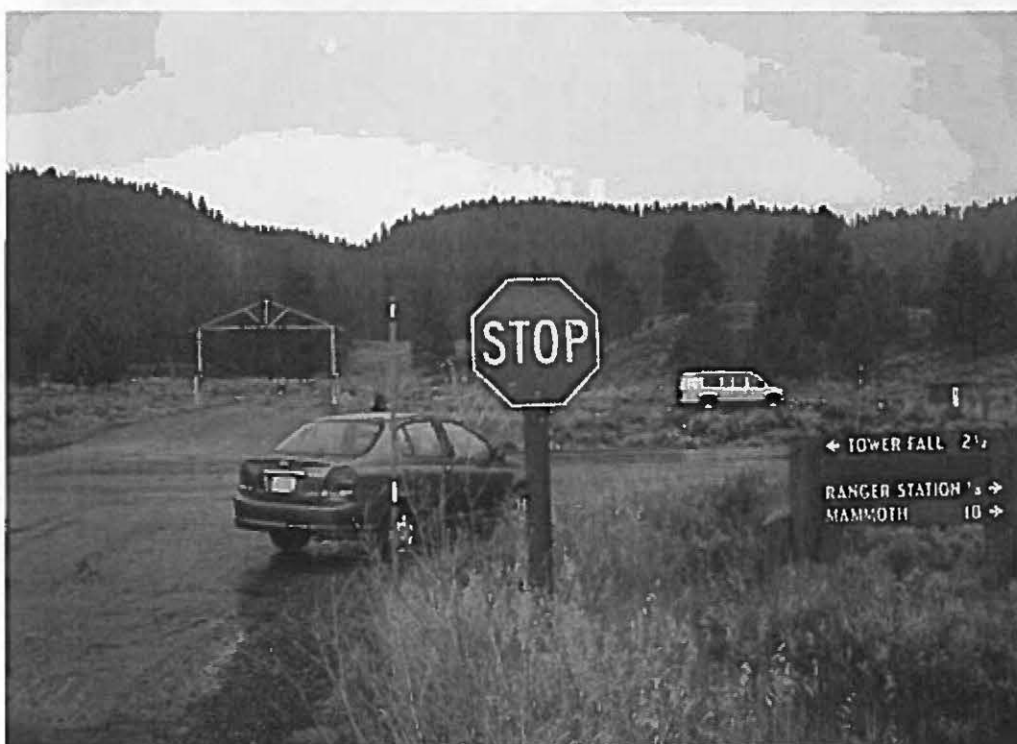
At the junction, the lodge is obscured from view, but a log gateway erected in 1961-1962 (outside the district) now announces its presence. Source: Shapins Associates, 2004.

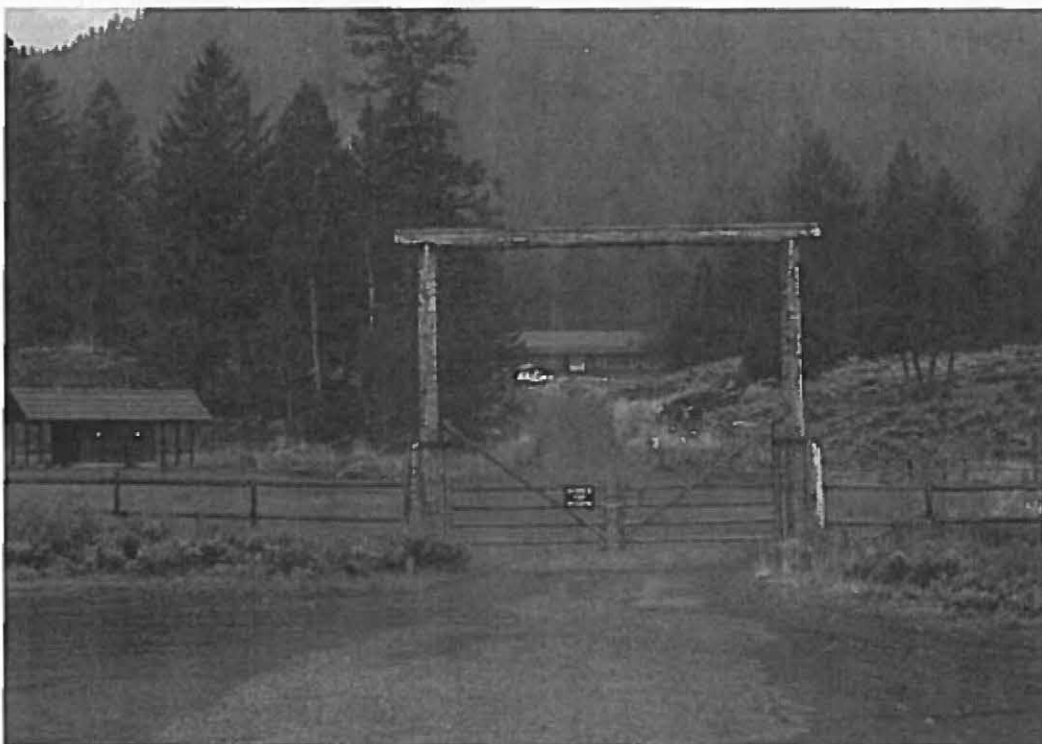
The lodge is set back from the road, located behind a natural vegetative screen. This second log gateway frames a direct vista of the lodge from the corral area, but it was erected after the period of significance. Source: Shapins Associates, 2004.

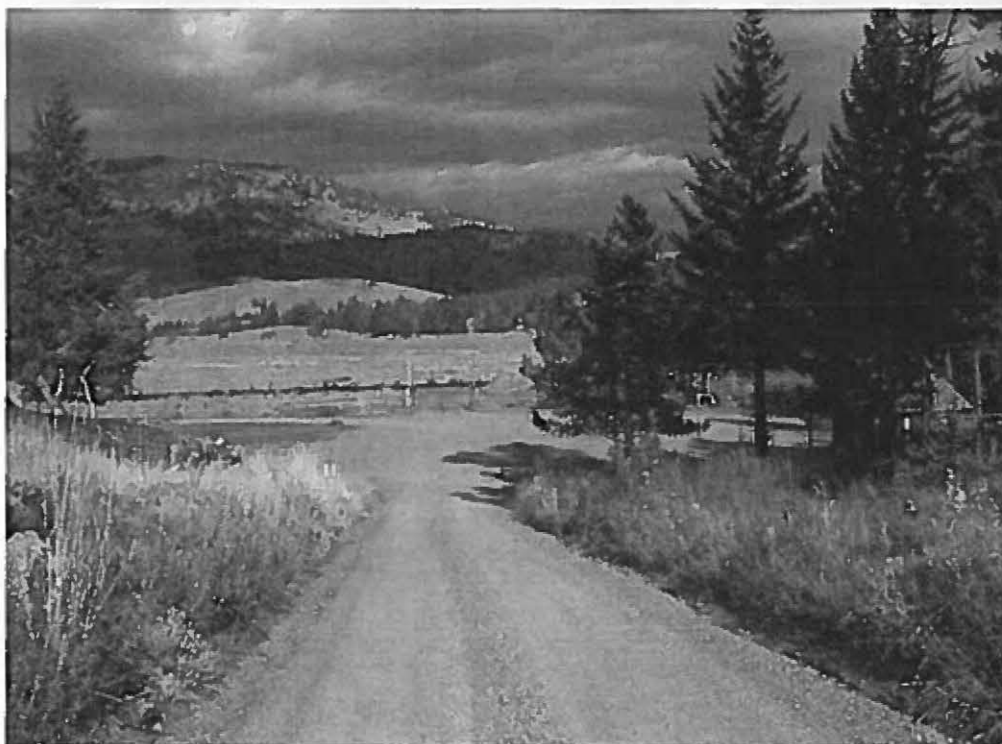
The corral operations and staging area remain obscured from lodge views and do not interfere with distant views to the valley. Source: Shapins Associates, 2004.

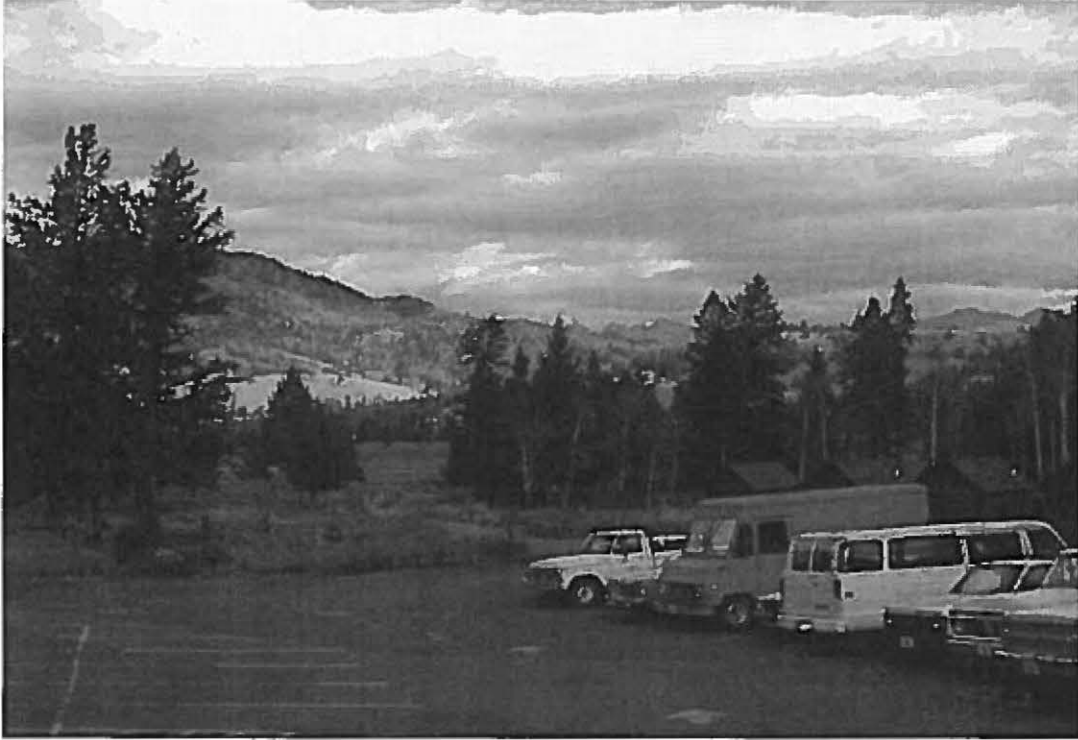
Views from the lodge porch have been compromised by the asphalt parking area. Source: Shapins Associates, 2004.

Today, the asphalt parking lot is a large and conspicuous feature that does not reflect the historic circulation system. In places, very large, peeled log curbs define its edges. The lot extends quite close to the lodge building, and wraps around its side to the service area. A wide asphalt walk runs the length of the building façade, only separated from the asphalt lot by one of the log curbs. Other walkways that lead to important buildings are also asphalt and lined with (smaller) peeled logs. Near the lodge building itself, the walk system does not reflect historic conditions. Gravel roads service the cabin areas. Just northwest of the main lodge, a curved informal gravel lot serves many employee cabins. This gravel lot is separated from the main lot by only a thin grassy strip. Combined with the asphalt parking lot and the wide asphalt path, the inescapable impression of the area in front of the lodge is of a broad expanse of paved surface.

The gently sloping area in front of the lodge is now occupied by a parking lot, but historic photos and plans show that this space was once maintained as an informal lawn, at least as late as 1951 (YELL 31809). At one time, this space was further defined by a decorative antler (or elkhorn) fence erected along its edges, as were many such informal lawns in Yellowstone National Park. The replacement of this lawn area with a large parking area is the most significant alteration to the historic spatial organization of the component landscape.
