National Park Service
Cultural Landscape Inventory Level I
2004

South Entrance Developed Area
Cultural Landscape
Yellowstone National Park

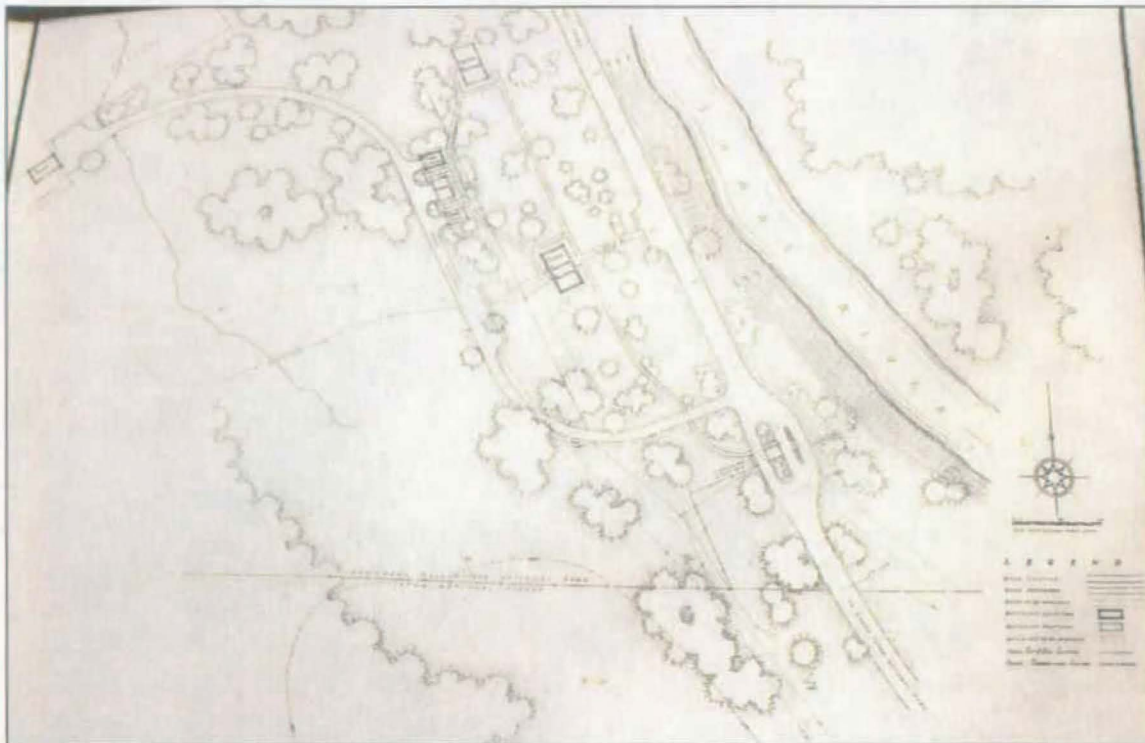
Figure 7: Photo image of 1939 Master Plan of South Entrance

Existing Conditions 1939 Master Plan

Dotted and solid lines indicate that the curvilinear (S-shaped) road leading from the entrance station to the barn is "existing," as is the duplex, fire cache and barn/pasture.

Note indication of trees vs. meadow (assumed existing conditions) where all development is placed amongst trees. The Ranger duplex (HS-0215) is shown as visible and accessible from the main road.

Considerable reconstruction took place in 1940 after the fire. South Entrance Ranger Station, (2) 5 room apartment buildings, Ranger Station wood storage building.

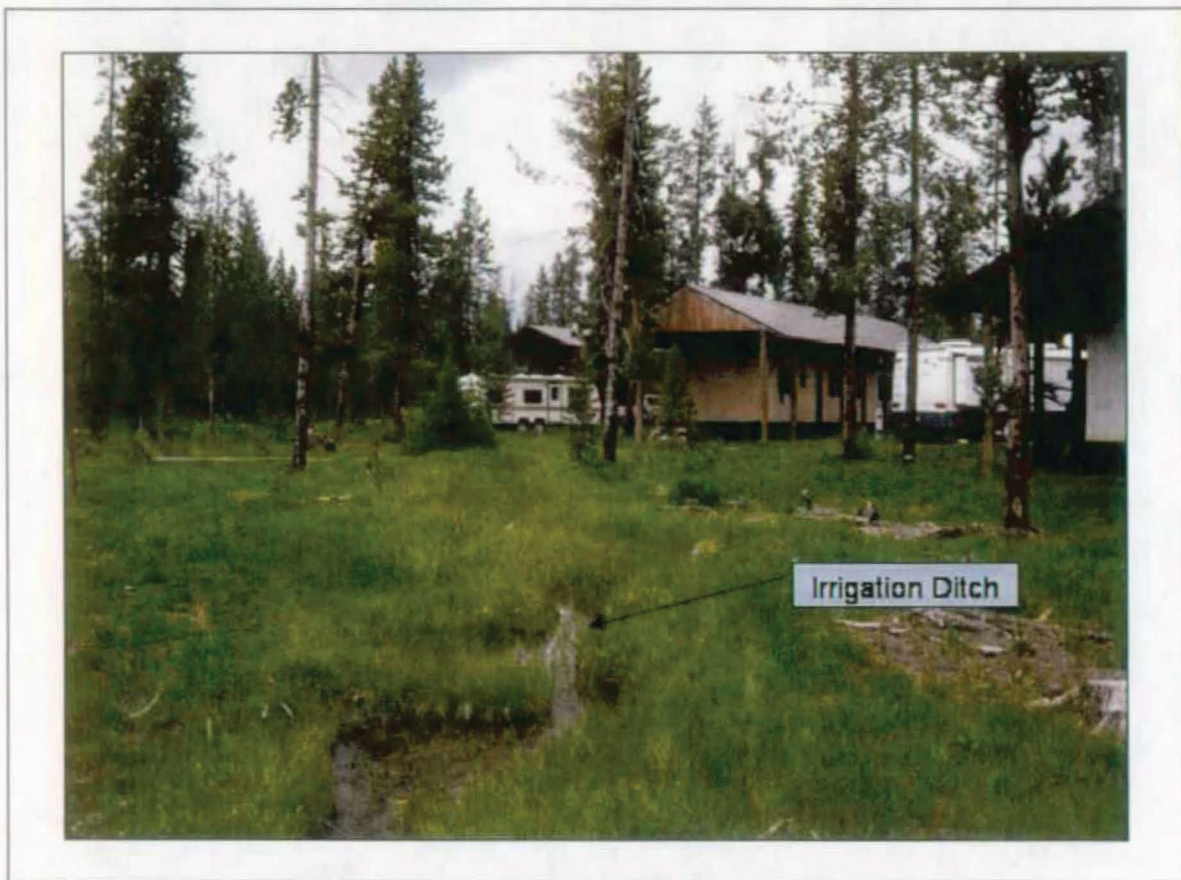
Figure 12; Irrigation Ditch

Irrigation Ditch "Johnson Creek," constructed pre-1933; water was obtained from a small ditch which diverted the flow from springs half a mile away. This water was pumped into a sump and used throughout the development. The irrigation ditch was constructed by digging a ditch and piling the spoils along the banks. In 1934 a more permanent system was installed running 4,500 feet of line to the springs.

Presently the irrigation ditch referred to locally as "Johnson Creek," continues to divert water through the development. The water is used for horses and a small amount of irrigation. The National Park Service has constructed a horse corral over a portion of the ditch which is used as a water source for the horses. Also a metal culvert was installed for vehicle access to the horse barn and corral. The ditch and run out have the characteristics of a natural wetland.

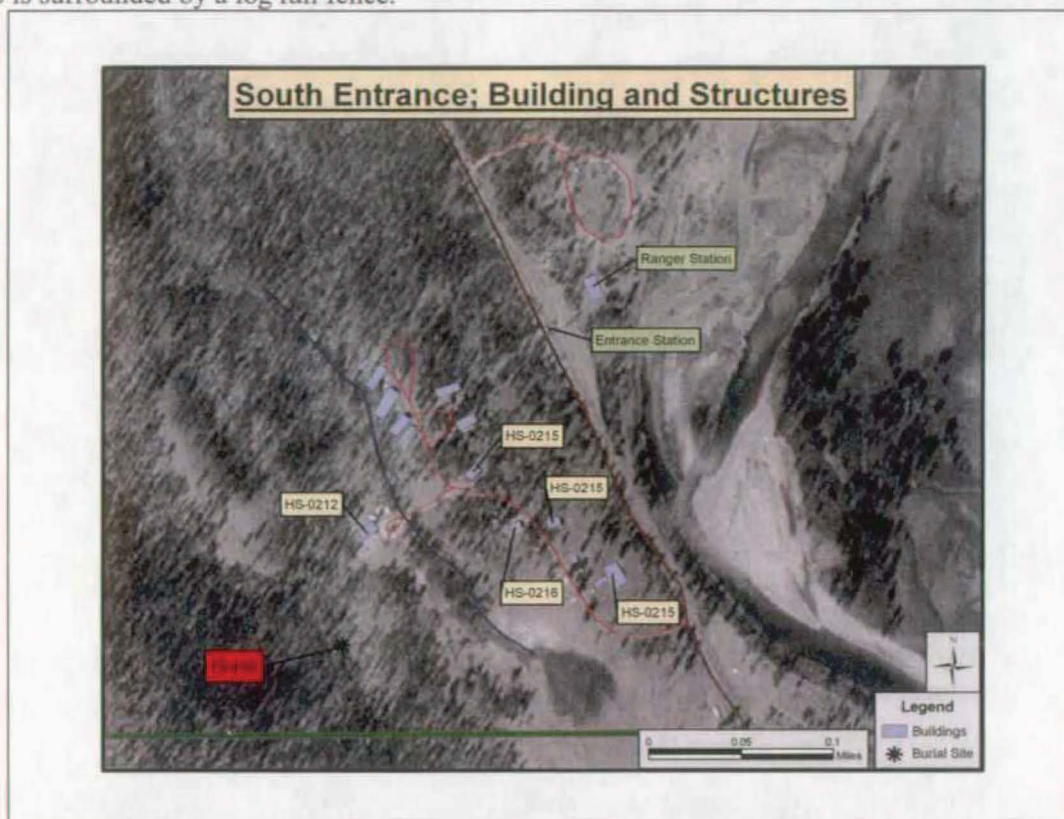
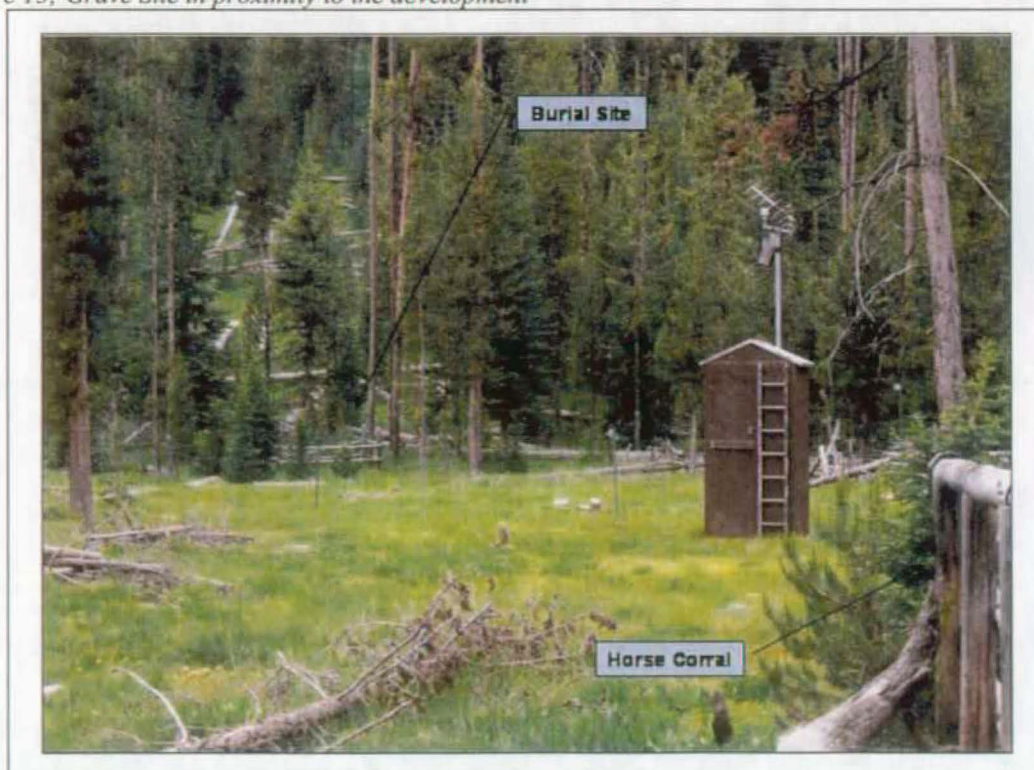
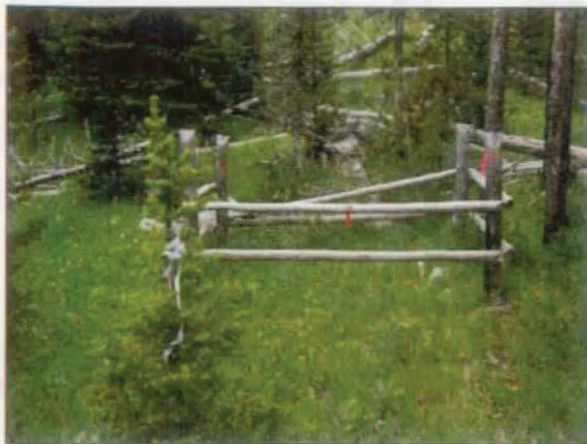
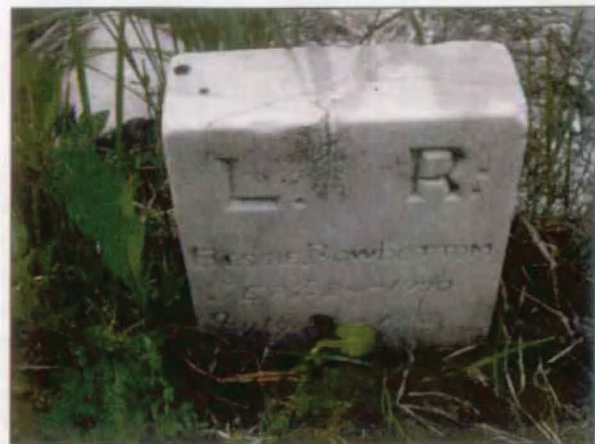
Grave site; L.R. Bessie Rowbottom, Sept.24, 1900 – July 8, 1903

The site is surrounded by a log rail fence.

Figure 13; Grave Site in proximity to the development

Figure 14; View of Grave Site looking Southwest from Horse Corral

Figure 15; Grave Site, South Entrance

Figure 16; Headstone, South Entrance
