National Park Service  
Cultural Landscapes Inventory  
2002

Stephens Creek  
Yellowstone National Park

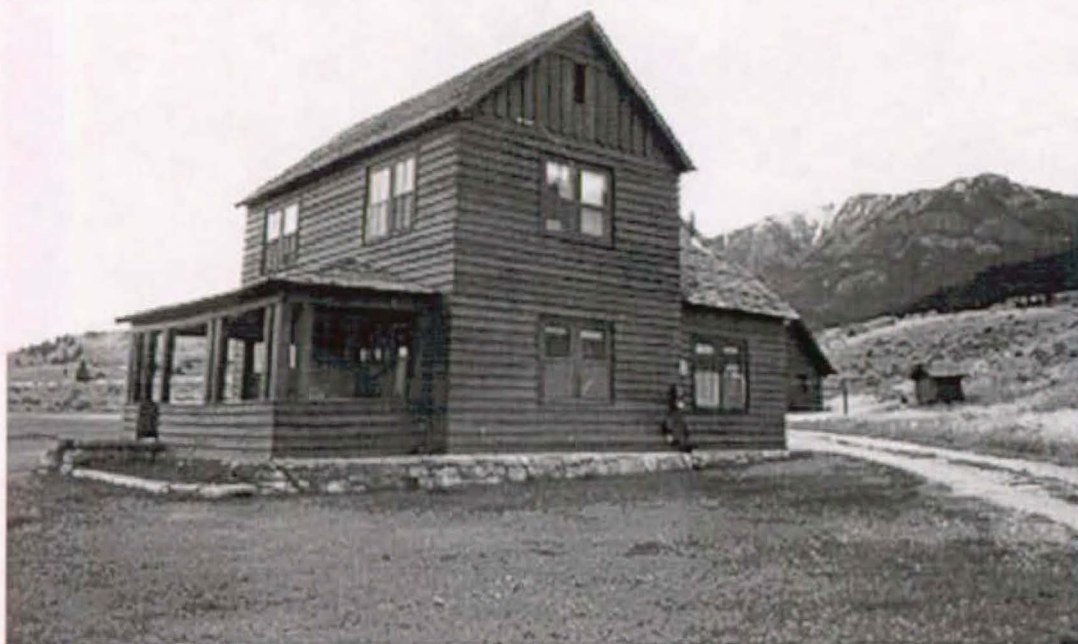
Modern view of the residence that was constructed in 1917, and moved to Stephens Creek in 1935 (1996)

The majority of the park service improvements currently present at the Stephens Creek property were completed between 1934 and 1935. Development of park service infrastructure was initiated during the winter of 1933-1934, when the building known as the "Rife house" was moved onto the Game Ranch, to serve as a residence and office for the new administrative group. The Rife house came from an adjacent ranch on the east side of the railroad tracks. By the spring of 1934, Junior Landscape Architect Frank Mattson, of the Branch of Plans and Design in San Francisco, California, was drafting plans for "revising and remodeling the structure." (Frank E. Mattson, "Report to the Chief Architect through the Superintendent of Yellowstone National Park, Period - March 1 to 9, Inclusive", File: 1934 Reports (2), Box No. D-37, Landscape Architects & Engineers Reports & Misc., Yellowstone National Park Archives, Mammoth Hot Springs, Wyoming [hereafter YNPA]). The moving of the building was done

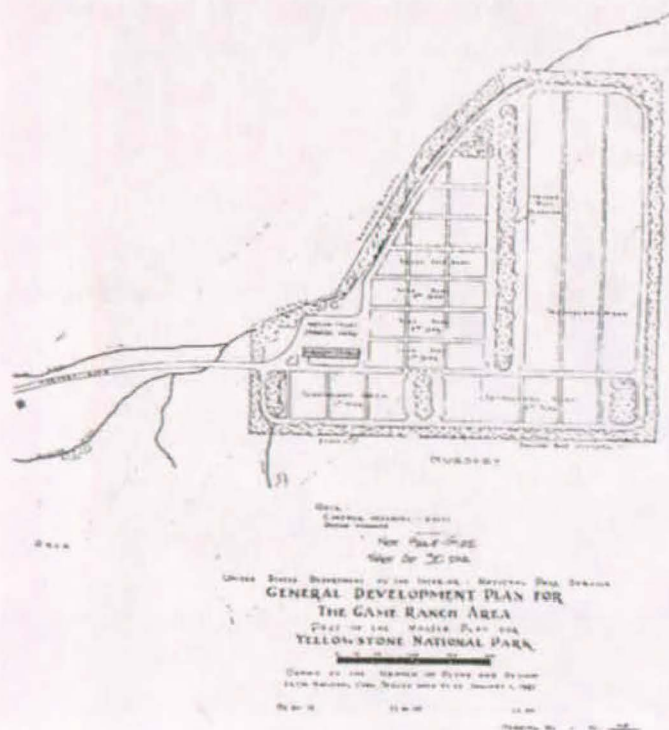
January 1941 plan of the Nursery at Stephens Creek drawn by the Branch of Plans and Designs, National Park Service

Early written accounts describing the selection of the Game Ranch site for development as the park nursery mention the recommended relocation and use of both willow and aspen as shelter belt plantings surrounding the nursery. The design drawing for the Nursery dated May 1935 shows an existing shelter belt area labeled "willows and aspen" along the west southwest edge of the Nursery. The remaining shelter belt areas shown surrounding the perimeter of the Nursery are labeled "proposed" and no particular species are noted. Later, a 1941 drawing shows shelter belt plantings around the entire perimeter of the Nursery, within the boundary fence.

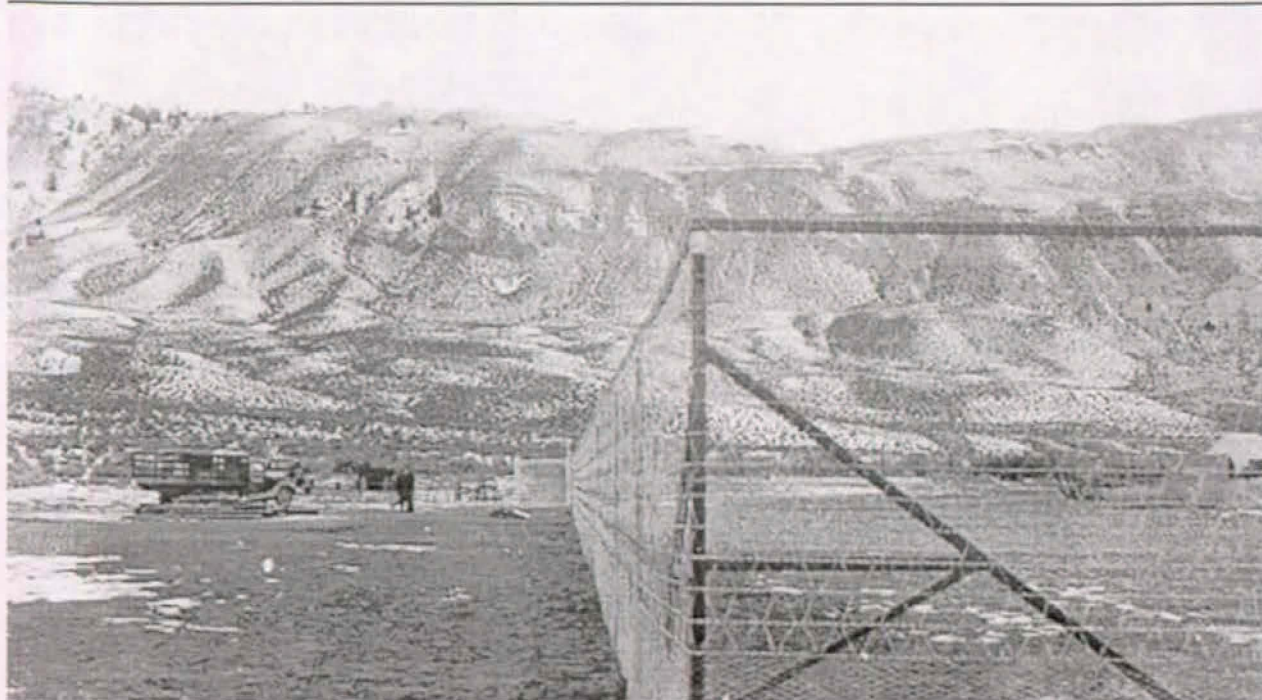
*Completed rodent and game-proof fence (2 Dec 1935)*

The establishment of the nursery proceeded quickly. In October of 1935, Hill reported that construction of the nursery fence (ECW project #105), was 50 percent complete. "All posts and post braces have been set, some of the posts have been set in concrete and part of the small wire mesh has been installed at the ground line." (Sanford Hill, E.C.W. Report to the Chief Architect, October 1935, File: 1935 Reports (2) Box D-37, YNPA.) Other E.C.W. projects included preparation of the beds and transplantings (Project #106); collecting tree seeds for the nursery (Project #107); and, moving and planting trees for the nursery's shelter belt (Project #108).

The single remaining historic structure currently in the Nursery Area is the perimeter fence. Constructed with iron posts, hog wire and chicken wire at the bottom, it remains substantially intact, except for the segment along the southwest end of the enclosure where the barn and associated corral are now located.

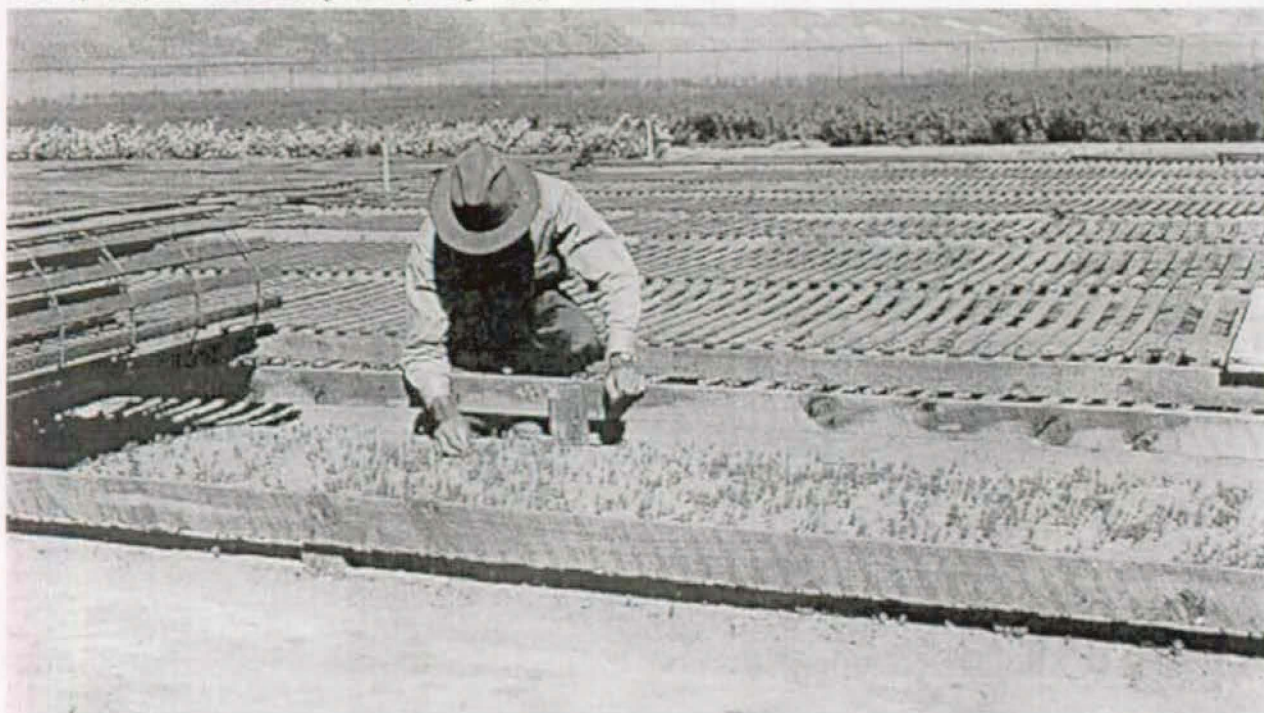
*Inspecting seedling for diseases under shade-screen lathing (7 Aug 1936)*

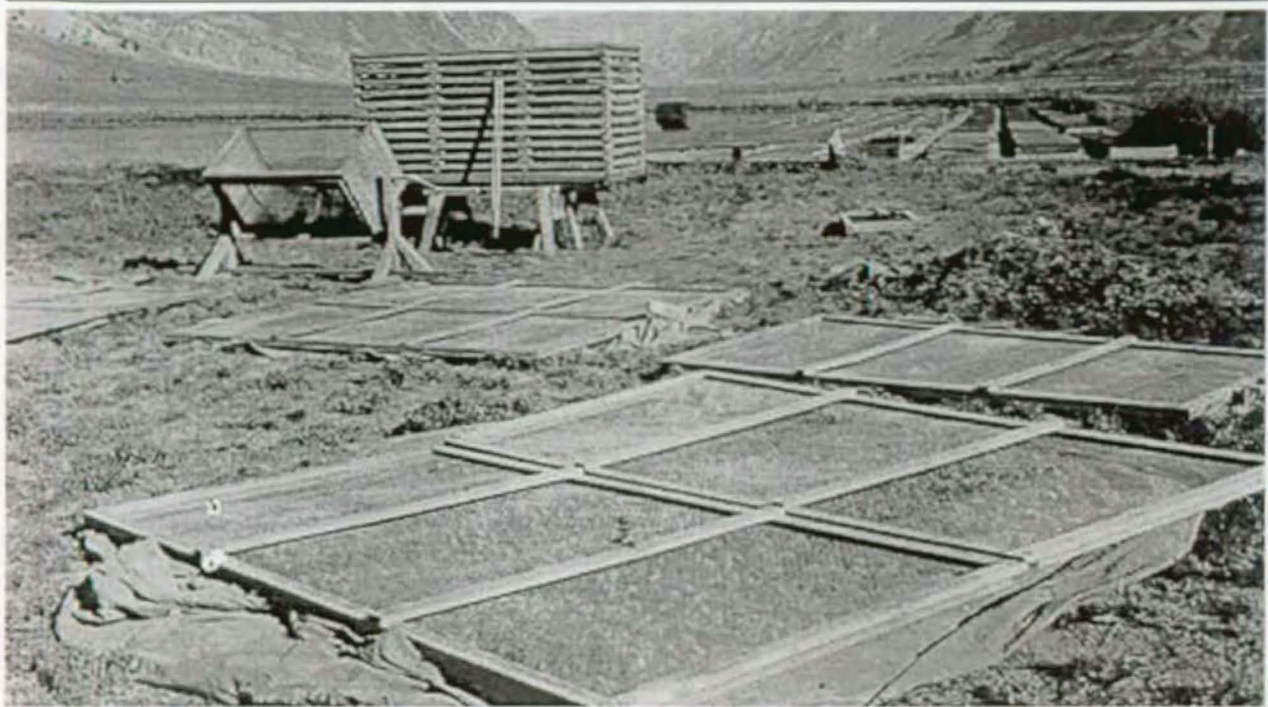
*Pine cones drying under screens (22 Sept 1936)*

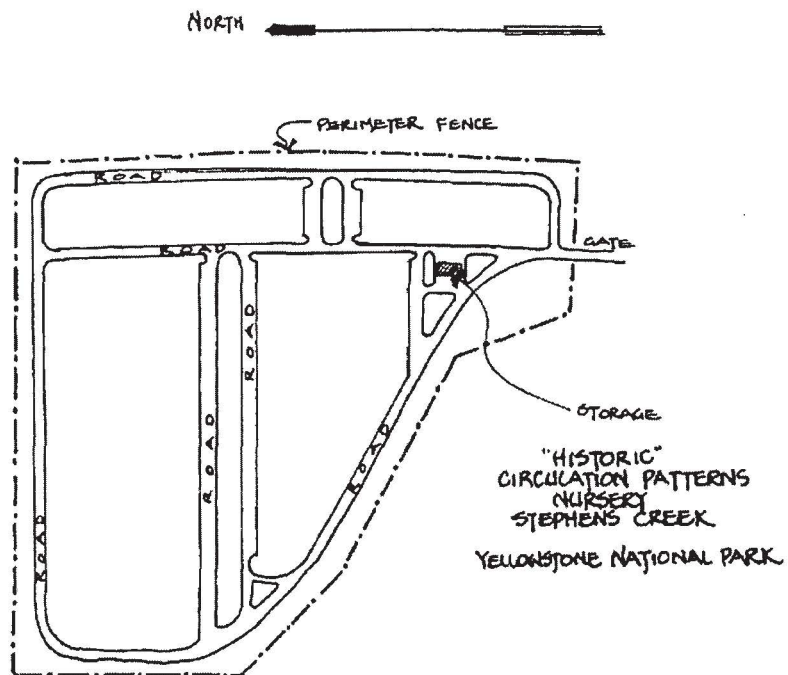
*Historic Nursery circulation patterns*

**Summary:** The vehicular access road into the site has not been modified since the historical period. However, the internal access roads have been changed. After the historical period, the access road to the rear of the residence was extended to the west, making it a through road. Also, the spur road into the horse barn and corral complex was eliminated when the barn was removed. But, there are two pedestrian paths that remain in place. Around the Nursery area, the abandonment and rehabilitation of the site for new, noncontributing land uses has destroyed the internal circulation of the nursery. Neither the parking area nor the roads remain apparent; the landscape characteristic of circulation lacks integrity.

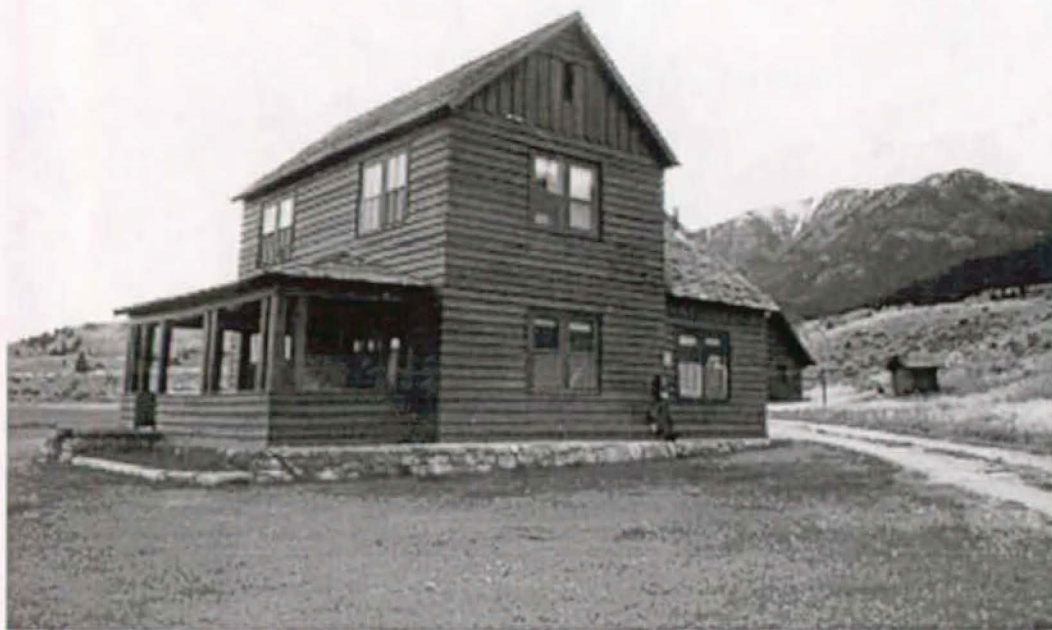
*View of Ranger Residence, the main structure of the Stephens Creek landscape (1996)*

Historically, there were three buildings within the Administrative Area landscape: the residence, the garage, and the barn. Contributing structures used to included the corral, the hose house, and the water storage tank. The three primary buildings were all constructed in the "rustic style" typically promoted by the park service during the 1930s. Although the residence was originally constructed as a private residence, after being moved to the site, new materials were applied to the building to make it compatible with the garage and the barn, both of which were constructed according to park service standard plans. These "rustic" materials include the wide weatherboard siding on the exterior walls, the stone veneer on the concrete foundation; and sawn wood shingles doubled every 6th row on the roof.

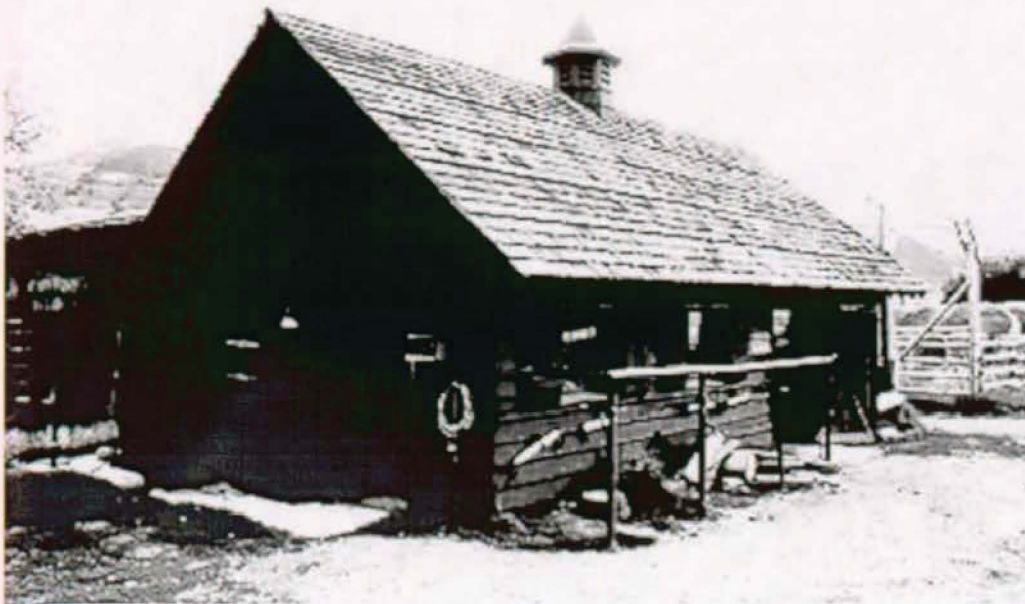
*View of park horse barn in old Nursery Area (1996)*

The horse barn is removed from its original location and placed in the vicinity of the abandoned nursery.

The barn was completed in April of 1935. Hill notes in his monthly report that the barn "has been stained the regular Park Service brown. The shade of green for the roof, however, has been changed from the regular blue green to a Bronze green which blends well with the surrounding hillsides." (Sanford Hill, "Monthly Report for April 1935", File: 1935 Reports (2), Box D-37, YNPA.)

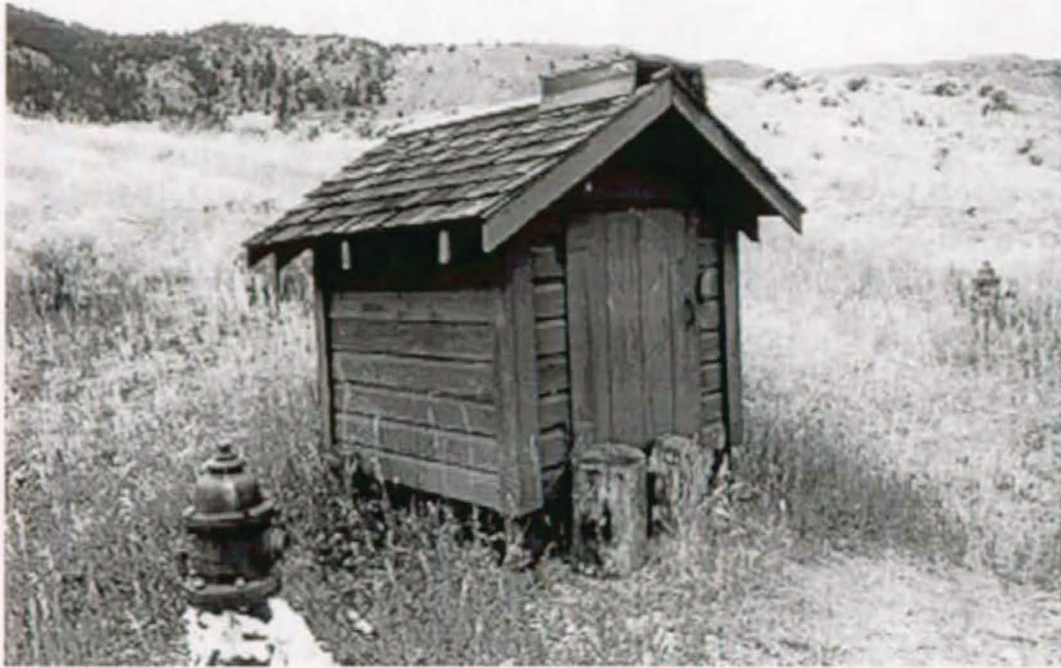
*The hosehouse, one of the last remaining small scale structures in Stephens Creek (1996)*

Historically, the Stephen Creek Administrative Area contained a few small-scale features, including the two fire hydrants located near the fire hose shelter. These features continue to exist within the landscape today. The Nursery contained many small-scale features including a variety of drying and sorting screens for cones and seeds, irrigation features (sprinkler heads, head gates along irrigation ditch, etc.), and shade laths. However, these features were removed when the Nursery was abandoned in 1942. Therefore, while the Nursery possess no small scale features with integrity, the hydrants and hose shelter near the Administrative Area could be considered as contributing features to the historic landscape.
