CORKSCREW BRIDGE  
(Loop Bridge  
Under-Pass Bridge  
Spiral Bridge)  
Yellowstone National Park  
Yellowstone National Park Roads and Bridges  
Old East Entrance Road, Sylvan Pass  
Yellowstone National Park  
Park County  
Wyoming

HAER No. WY-86

## CORKSCREW BRIDGE

# CORKSCREW BRIDGE

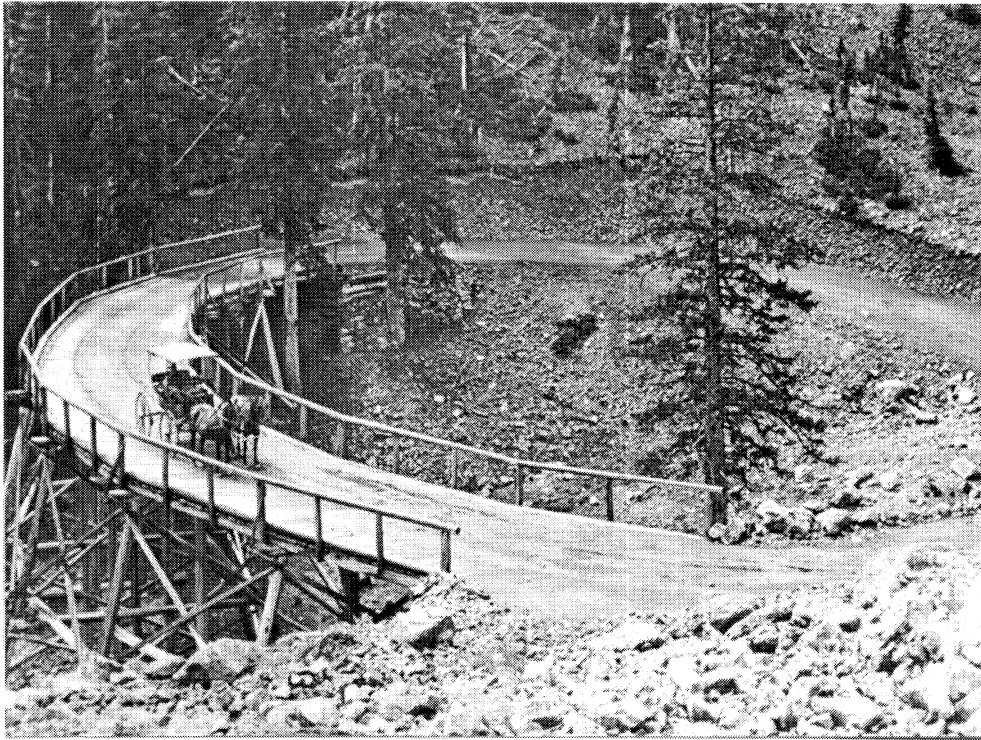
Figure 1: Original wooden trestle Corkscrew Bridge. Photo number YELL 30078, courtesy Yellowstone National Park Photo Archives.

<sup>10</sup> See Figure 1, Appendix A.

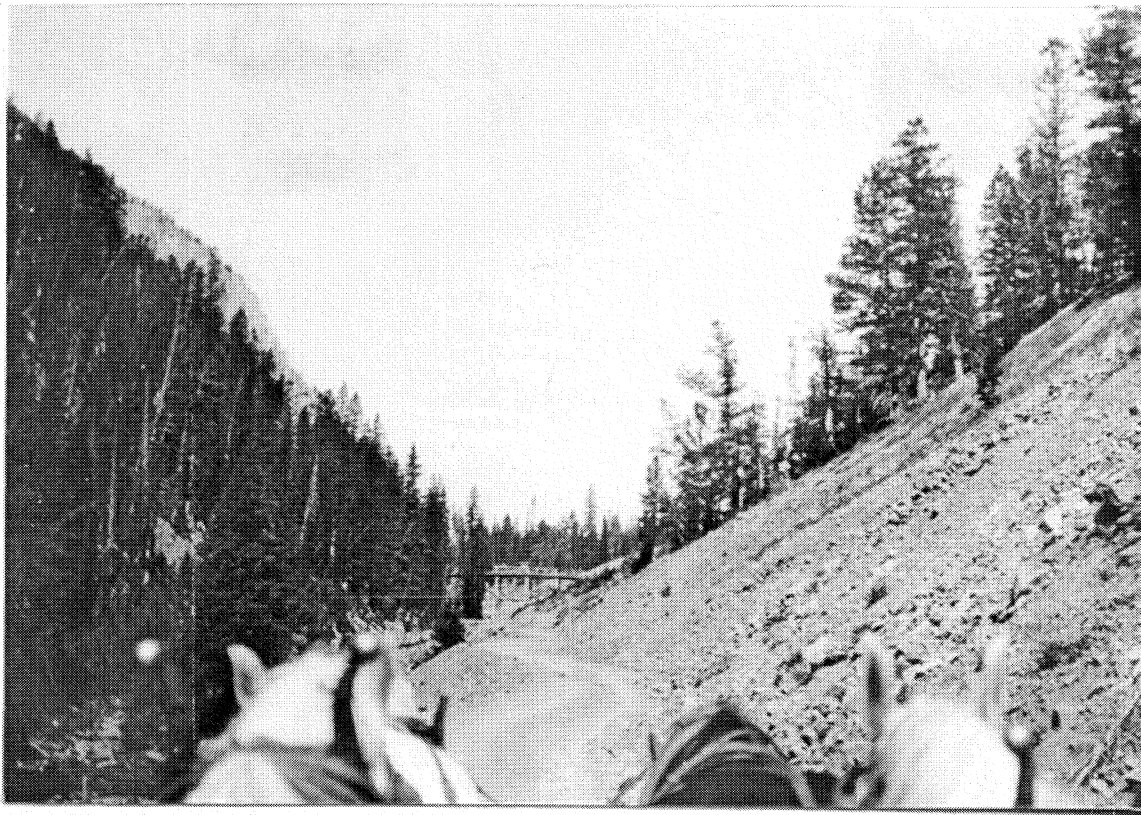
Figure 2: Road approaching Corkscrew Bridge as seen from a stagecoach. From C. C. Kreska scrapbook, "The Wonders of Geyserland." Catalog number YELL-1809, courtesy Yellowstone National Park Museum Collection.

<sup>11</sup> See Figures 2 and 3, Appendix A.

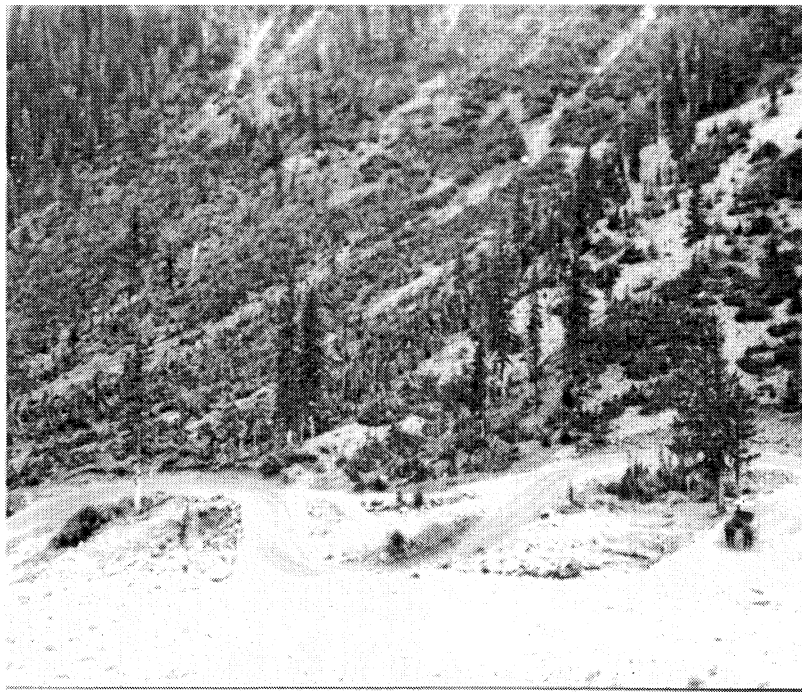
Figure 3: S-curves between summit of Sylvan Pass and the Corkscrew Bridge, showing measures necessary to reduce the grade on the steep descent. Photo number YELL 39697, courtesy Yellowstone National Park Photo Archives.

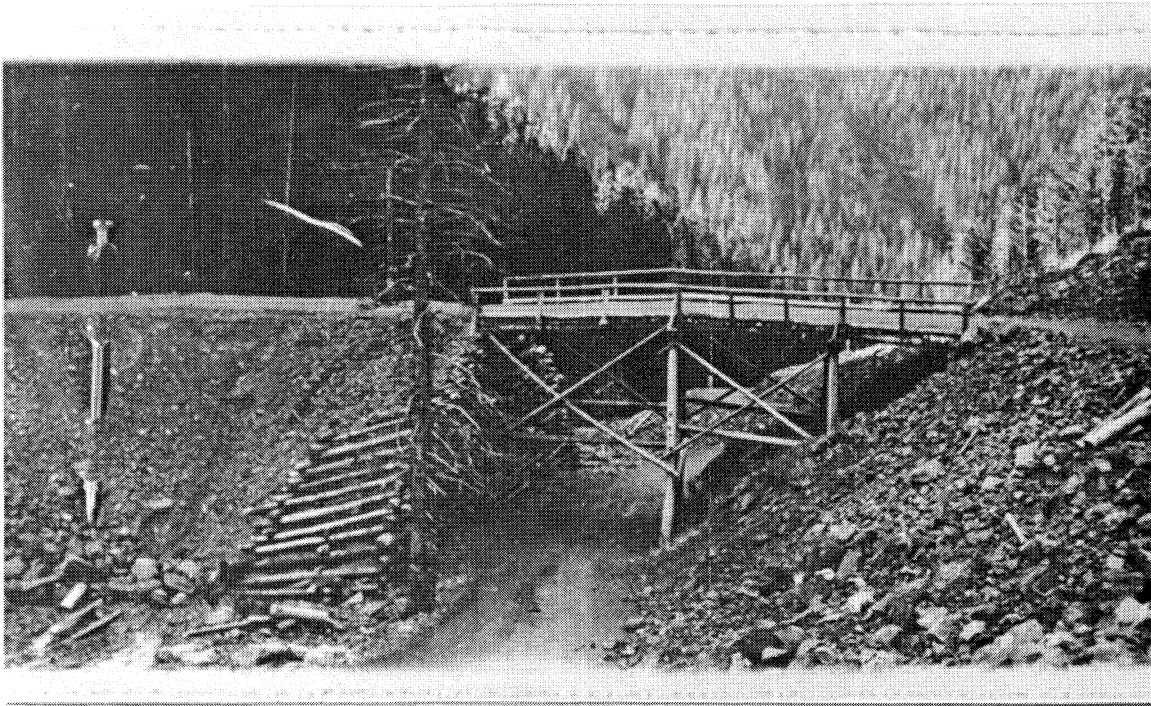
Figure 4: 1916 version of the Corkscrew Bridge, looking east of downslope. Photo courtesy Yellowstone National Park Archives, from "Proposal and Specifications for Construction of a Reinforced Concrete Under-pass Bridge Near Sylvan Pass."

The planned replacement called for a short, 25'-span bridge with a rock fill at the west abutment. When completed in late 1916, the new loop bridge instead consisted of a 60' trestle with only two distinct bays and one layer of cross bracing. Earth-filled rock and log cribs buttressed the earthen causeway constructed to reduce the span on the north end of the bridge. The significantly shorter 1916 version of the loop bridge lacked the symmetry and rustic appeal of the earlier wooden trestle.<sup>13</sup>

<sup>13</sup> *Superintendent's Annual Report*, 1916, 24, "Improvement," *ARCE*, 1916, 1840; 1917, 1947, 3752. See Figure 4, Appendix A.

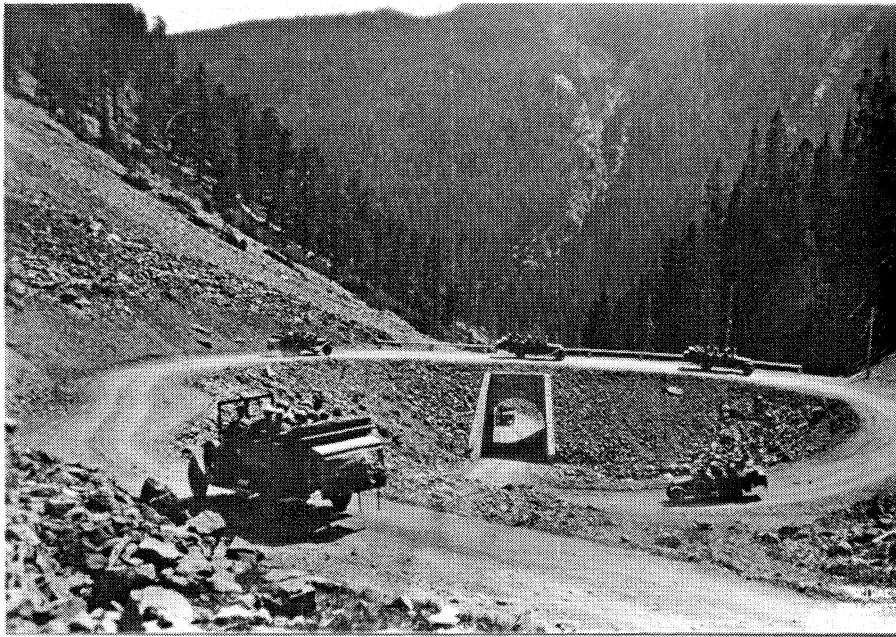
Figure 5: Cars on 1919 version of the Corkscrew Bridge. Photo number 8020, courtesy Pioneer Museum/Gallatin County Historical Society Photo Archives, Bozeman, Montana.

<sup>18</sup> For completed bridge, see Figure 5, Appendix A.

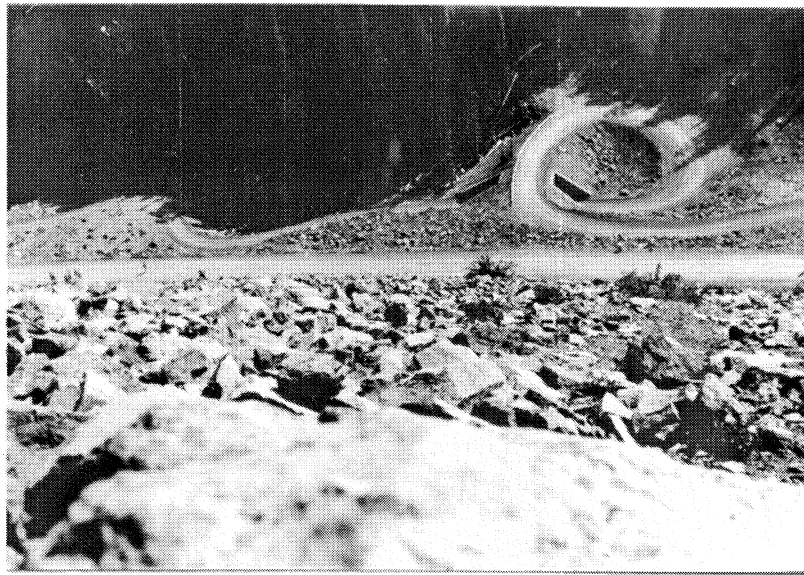
Figure 6: Looking down on Corkscrew Bridge in the valley and the newly rerouted East Entrance Road, 1935. Photo courtesy Yellowstone National Park Archives, from C. F. Capes, "Progress report on Bureau of Public Roads Activities on Yellowstone National Park Highway System."

As work proceeded, the road was cut into the side of the mountain along a relatively gentle grade, rendering the old S-curves and loop bridge unnecessary.<sup>26</sup> Although the new alignment was considered more economical and practical than the old road through the valley, construction proved difficult due to the steep incline and the presence of the old road just below. The park had to implement traffic controls, closing the road completely between 7:00 p.m. and 7:00 a.m. Construction also had to be shut down periodically during the day to allow passage of tourist traffic. Work was further frustrated by tourists who simply broke through the barriers and proceeded on when the road was closed.<sup>27</sup>

<sup>26</sup> Figure 6, Appendix A shows the new road in relation to the old.

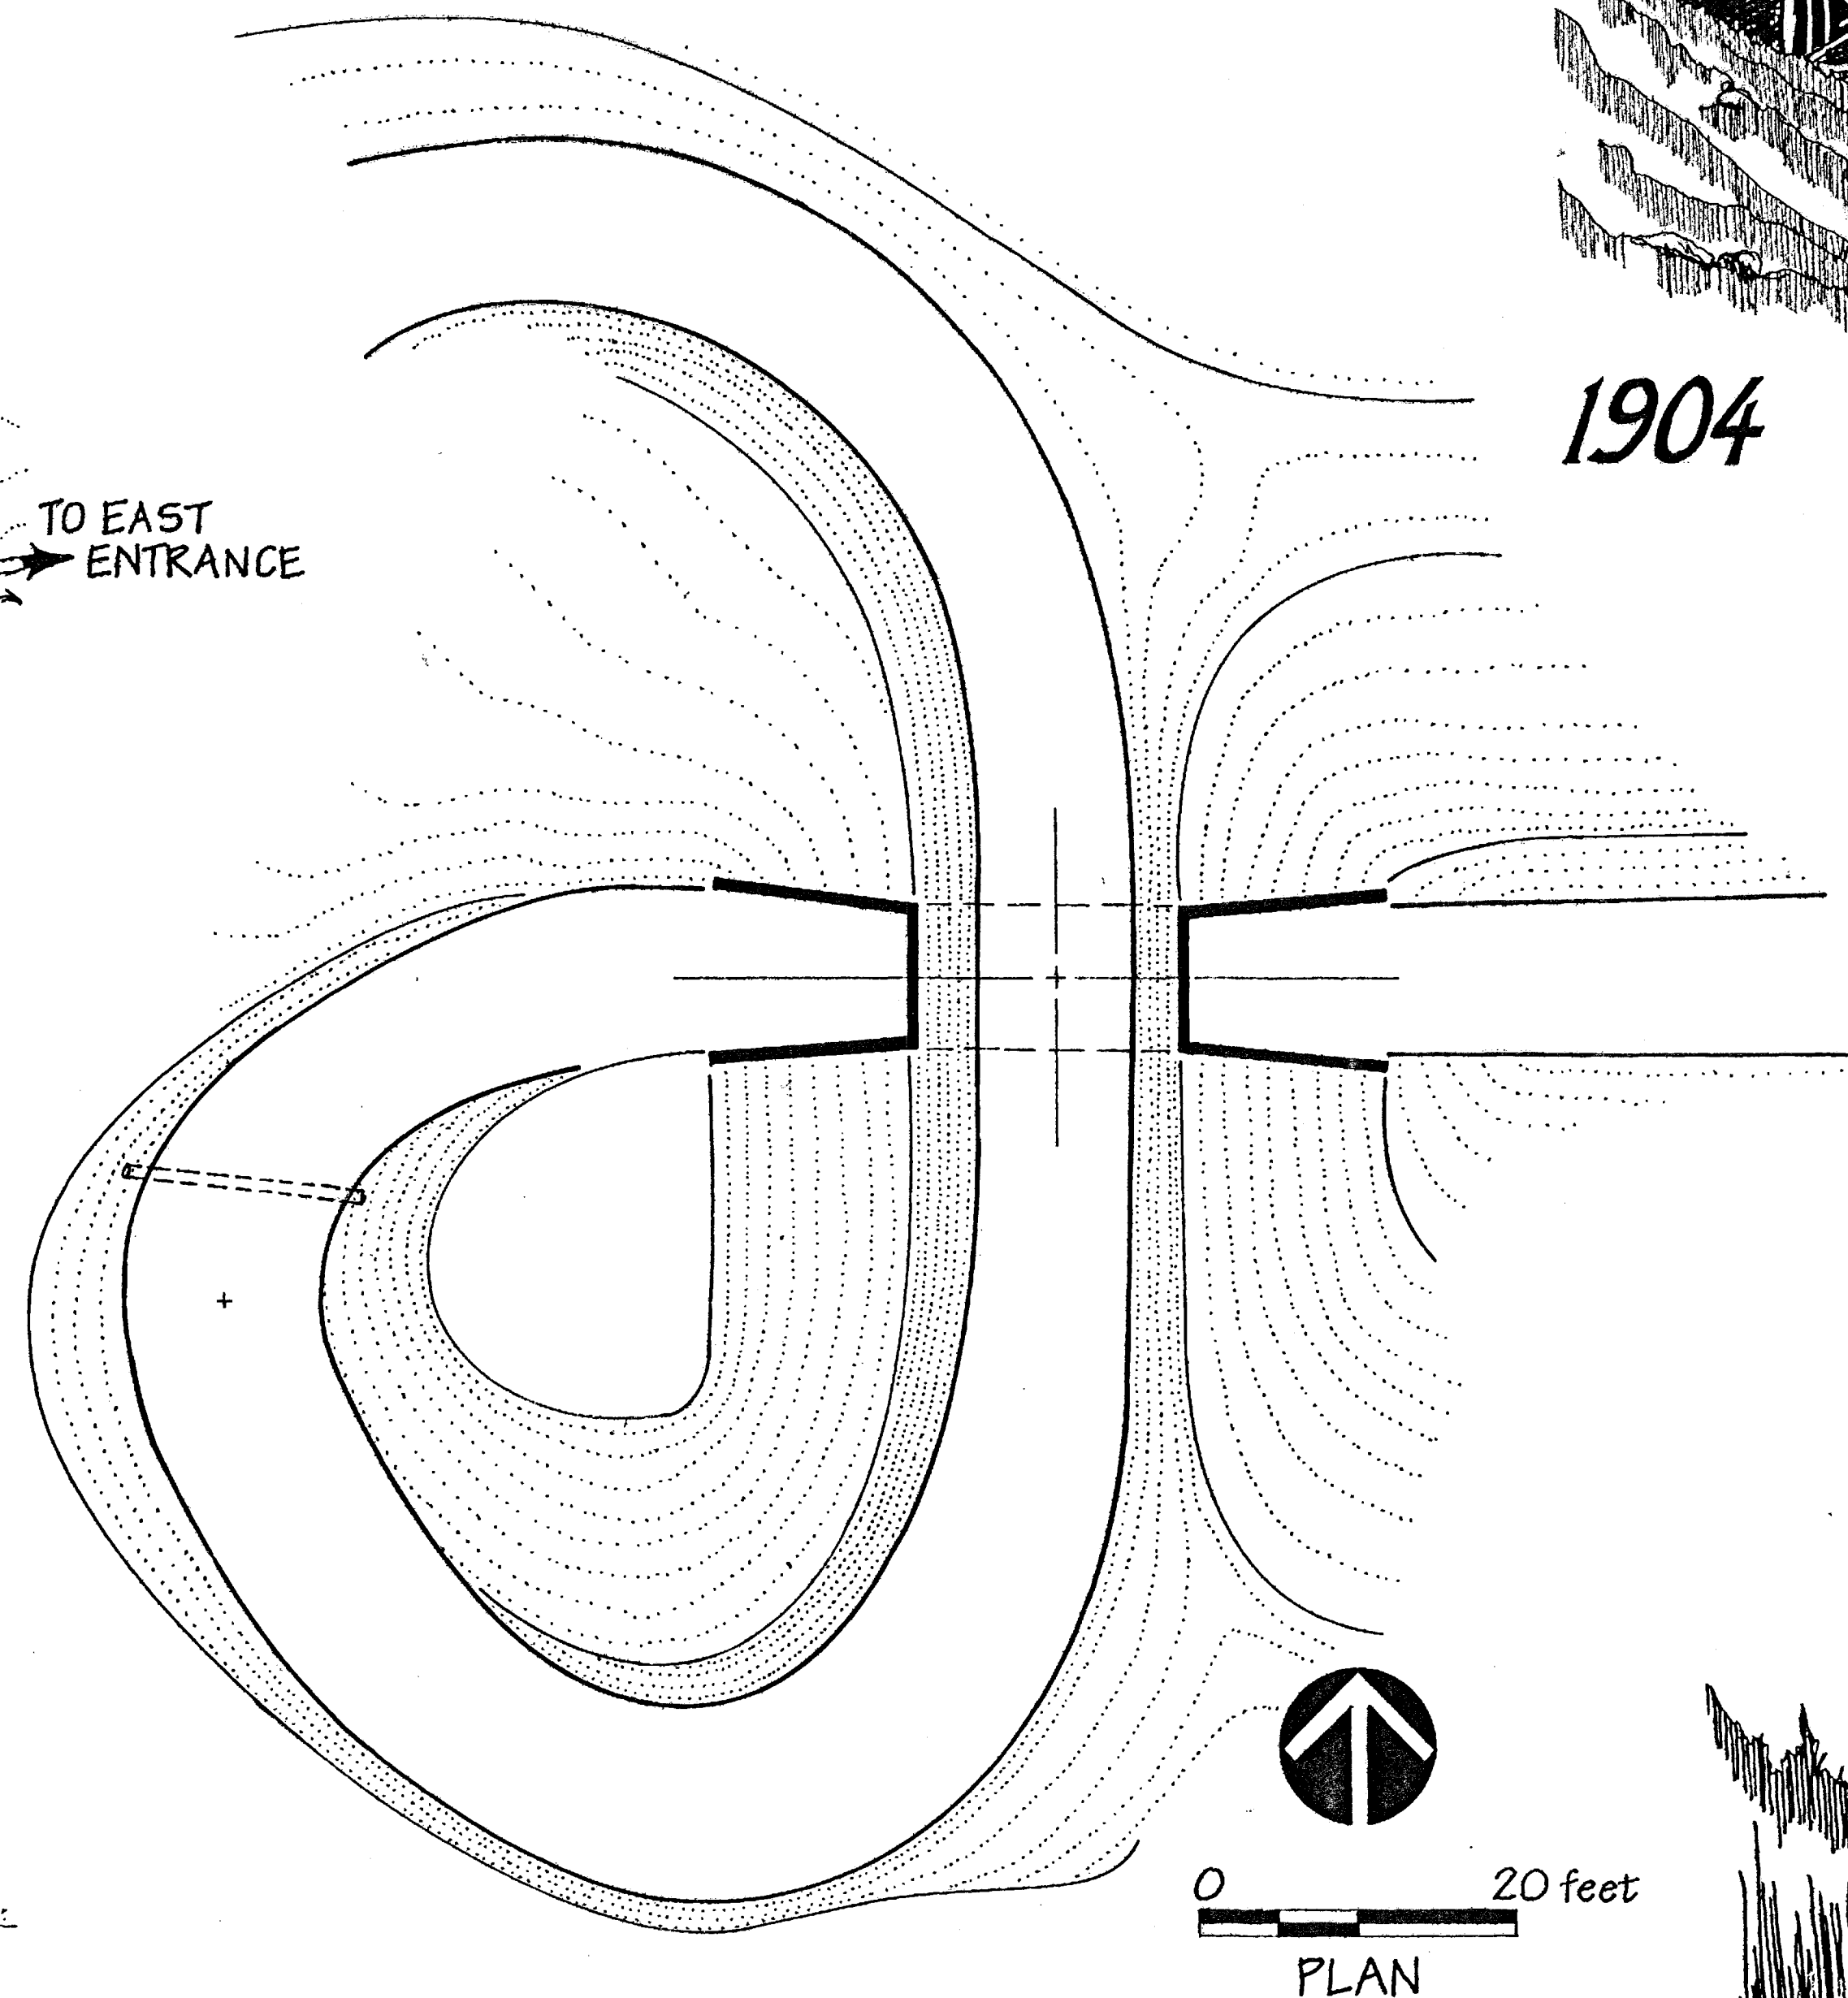
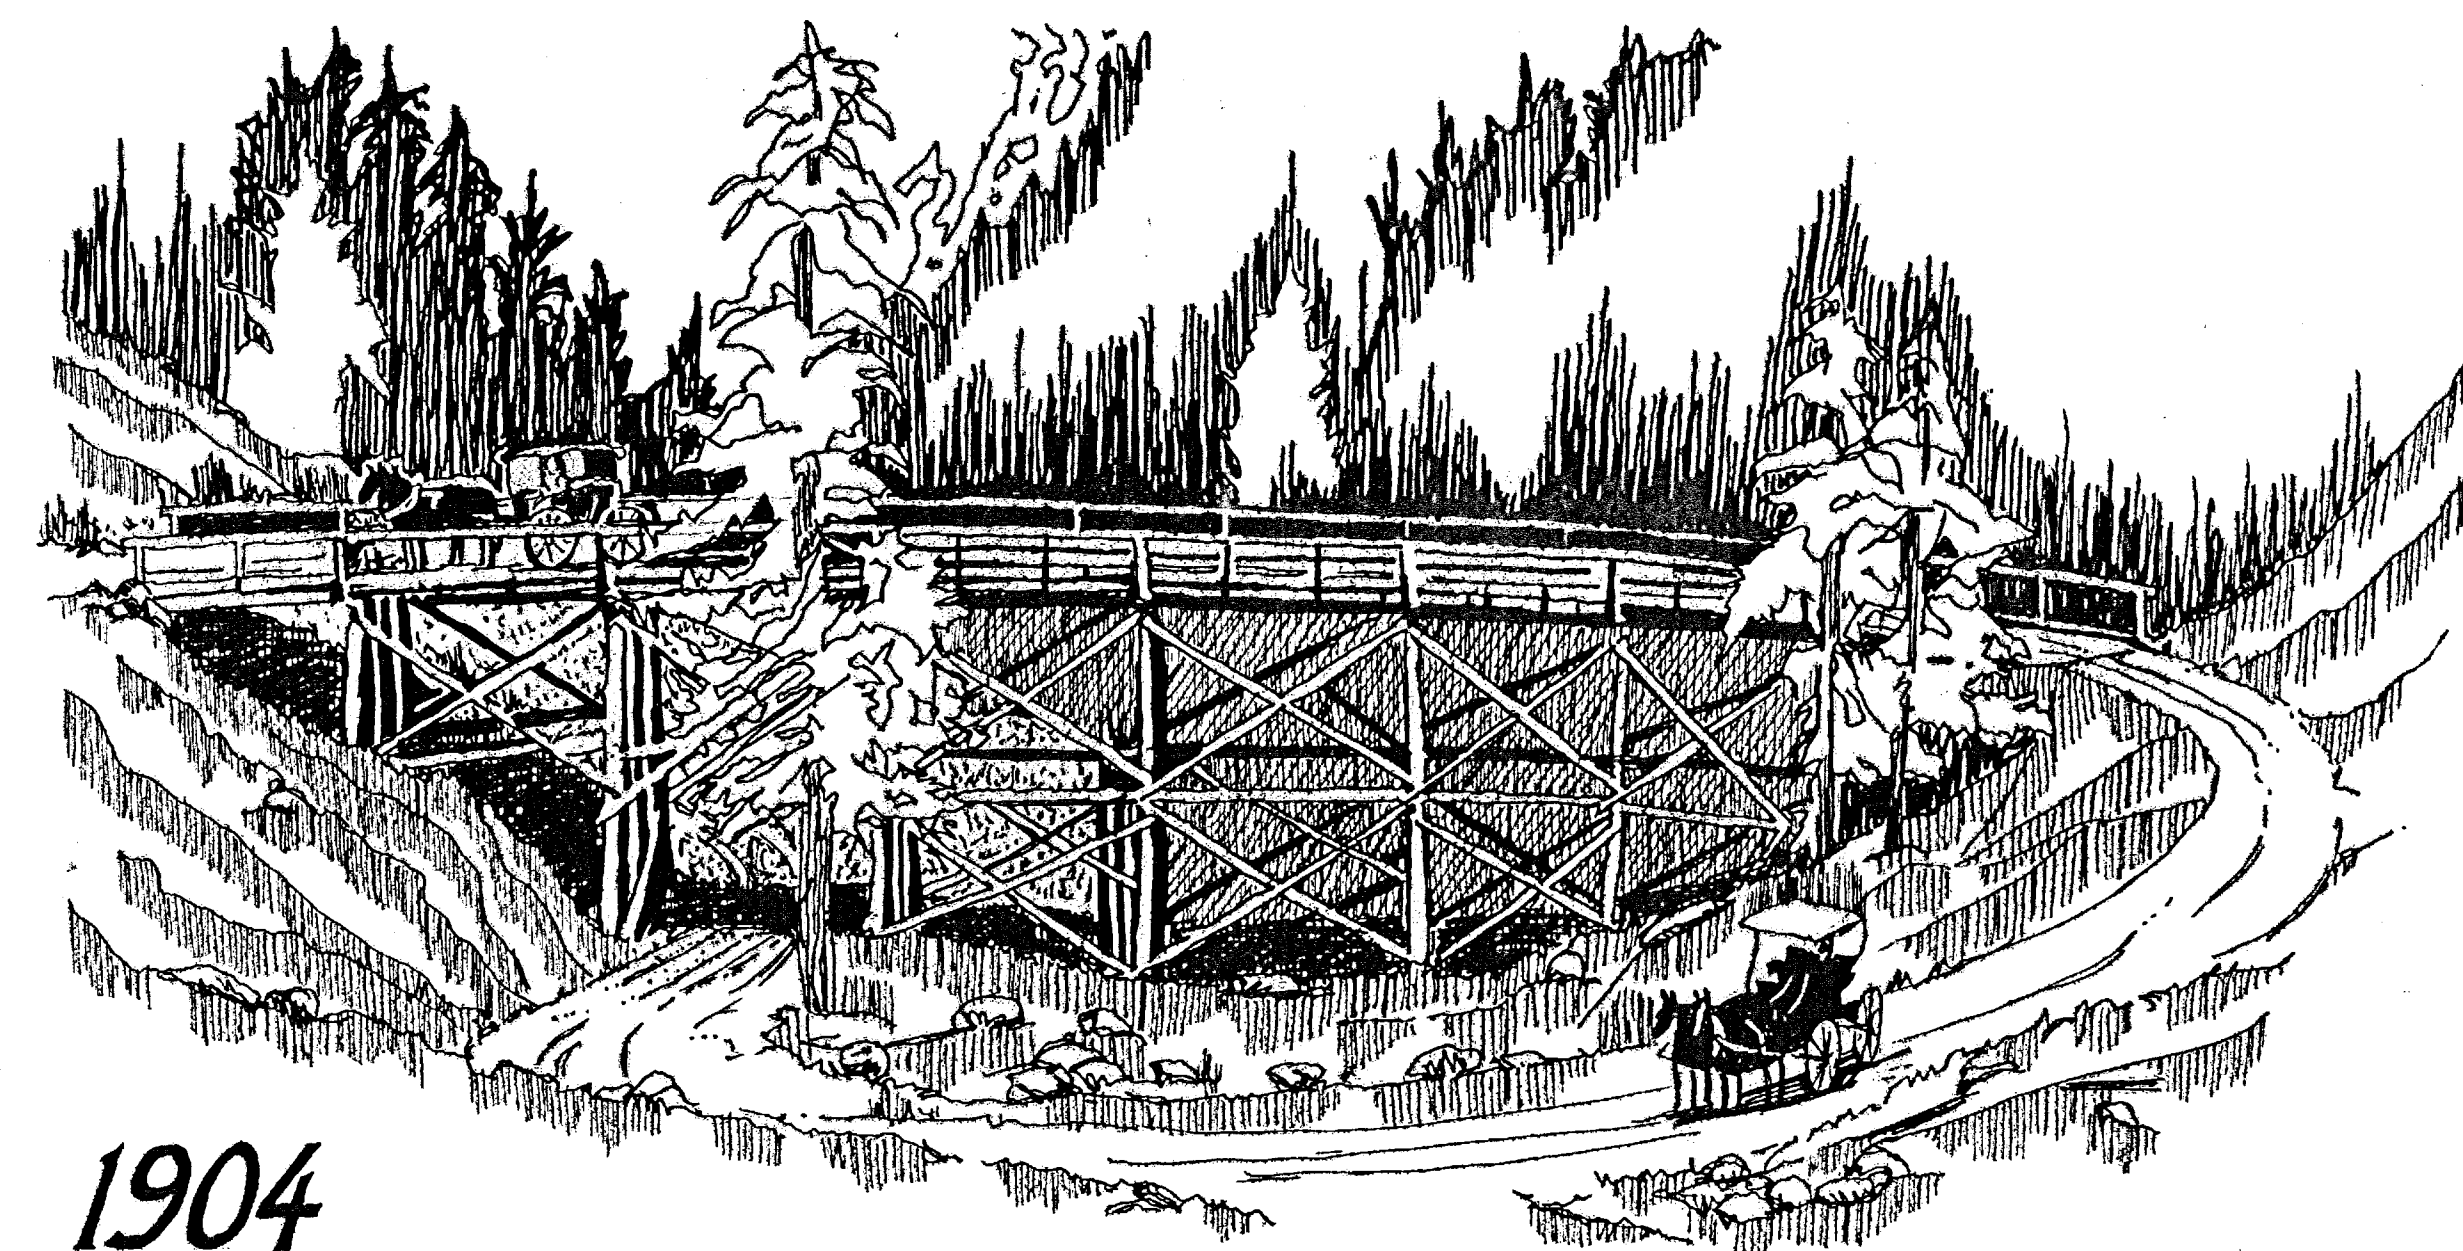
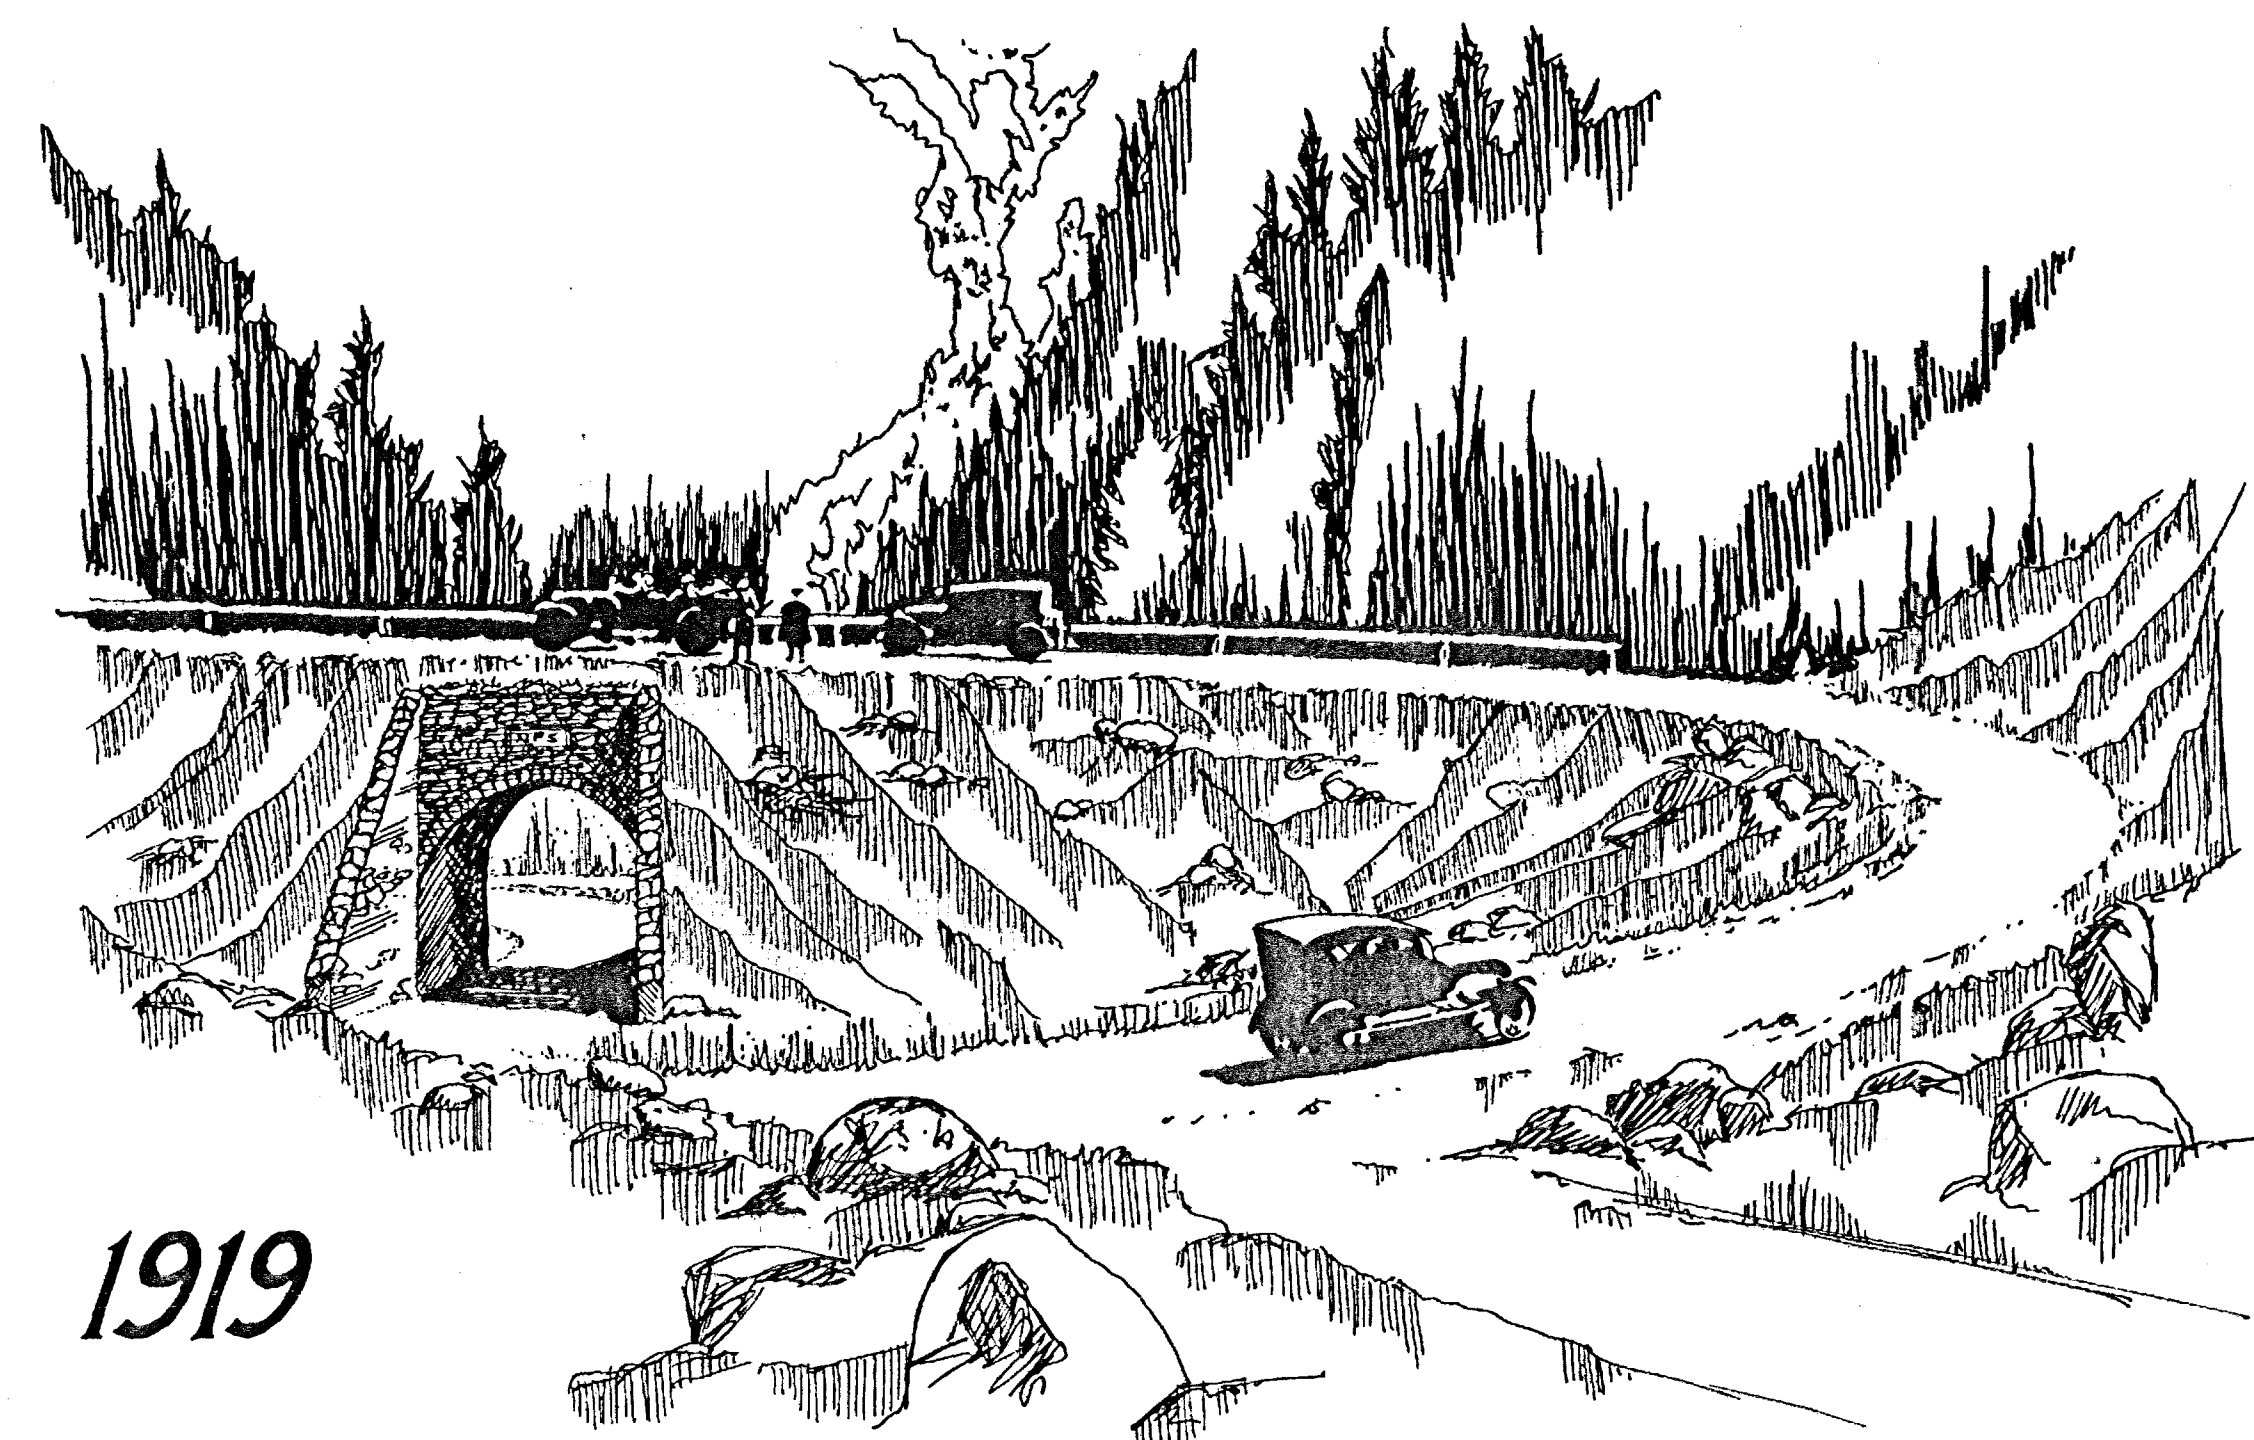
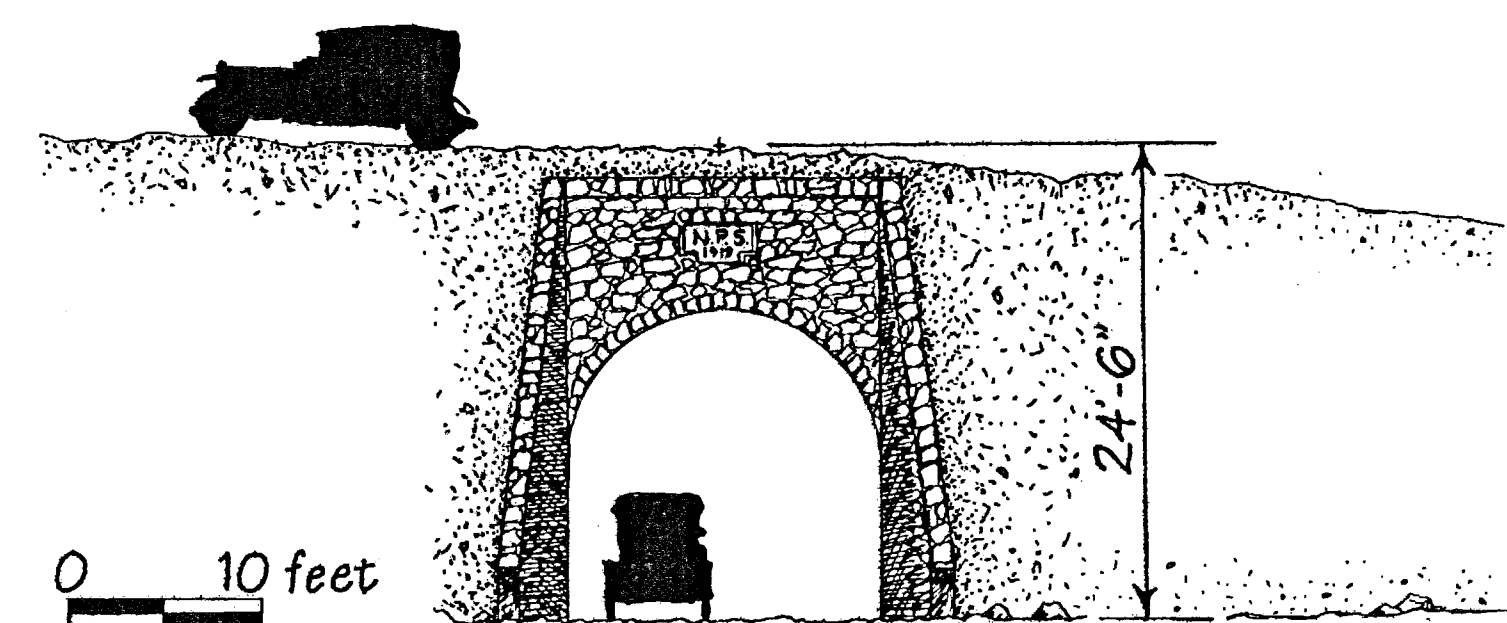
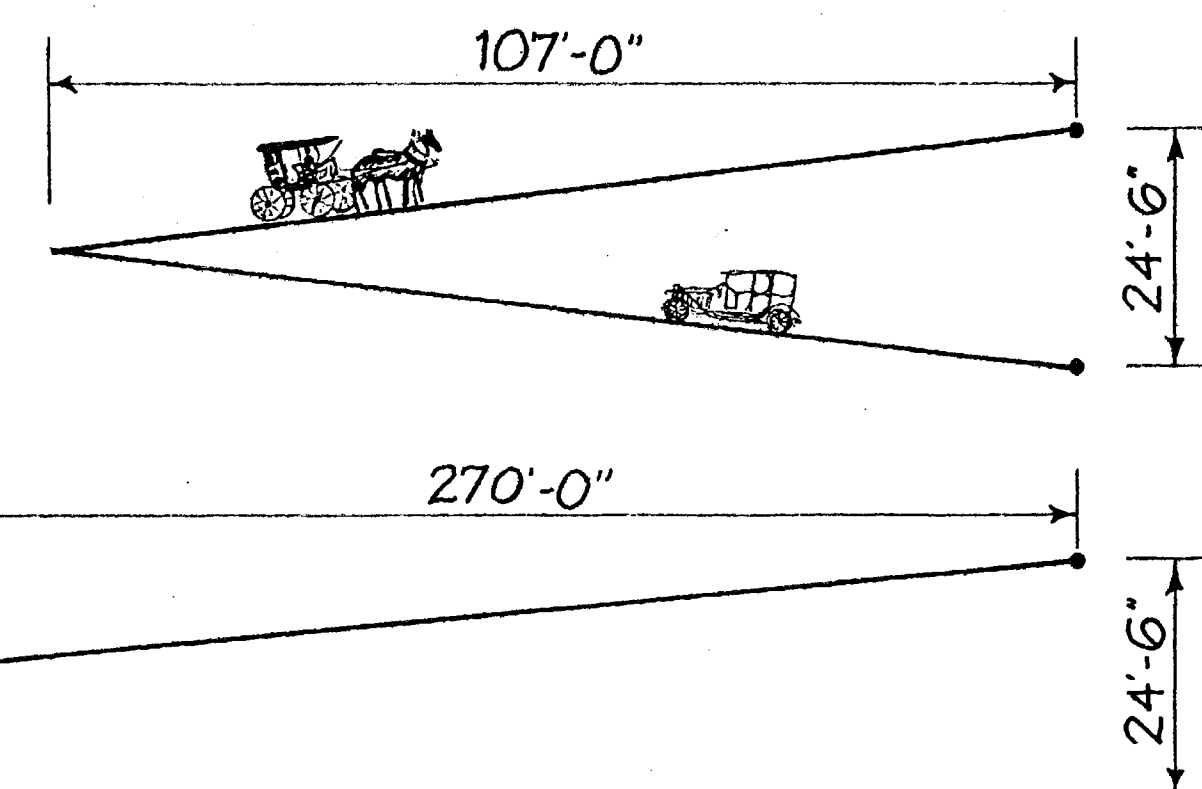
Building a road through Sylvan Pass presented a formidable challenge. The steep descent on the east side of the Absaroka Range delayed the construction of the East Entrance Road until after the turn of the twentieth century. To carry the road safely down the slope at a maximum grade of 10 percent, U.S. Army Corps of Engineers Captain Hiram M. Chittenden introduced a spiral to quickly change elevation in a short distance. Completed in 1904, the timber trestle supported the road that then looped around to pass beneath it. The trestle was replaced by a shorter span in 1916. In 1919 Superintendent Horace M. Albright approved specifications for a reinforced concrete "underpass" bridge in the same location. By 1929, advances in road construction technology and the demands of automobile traffic rendered the narrow bridge obsolete. A new road cut into the hillside above gradually made the descent from Sylvan Pass over eight miles, and the Corkscrew Bridge was bypassed. To observant motorists, it is still visible in the valley below.

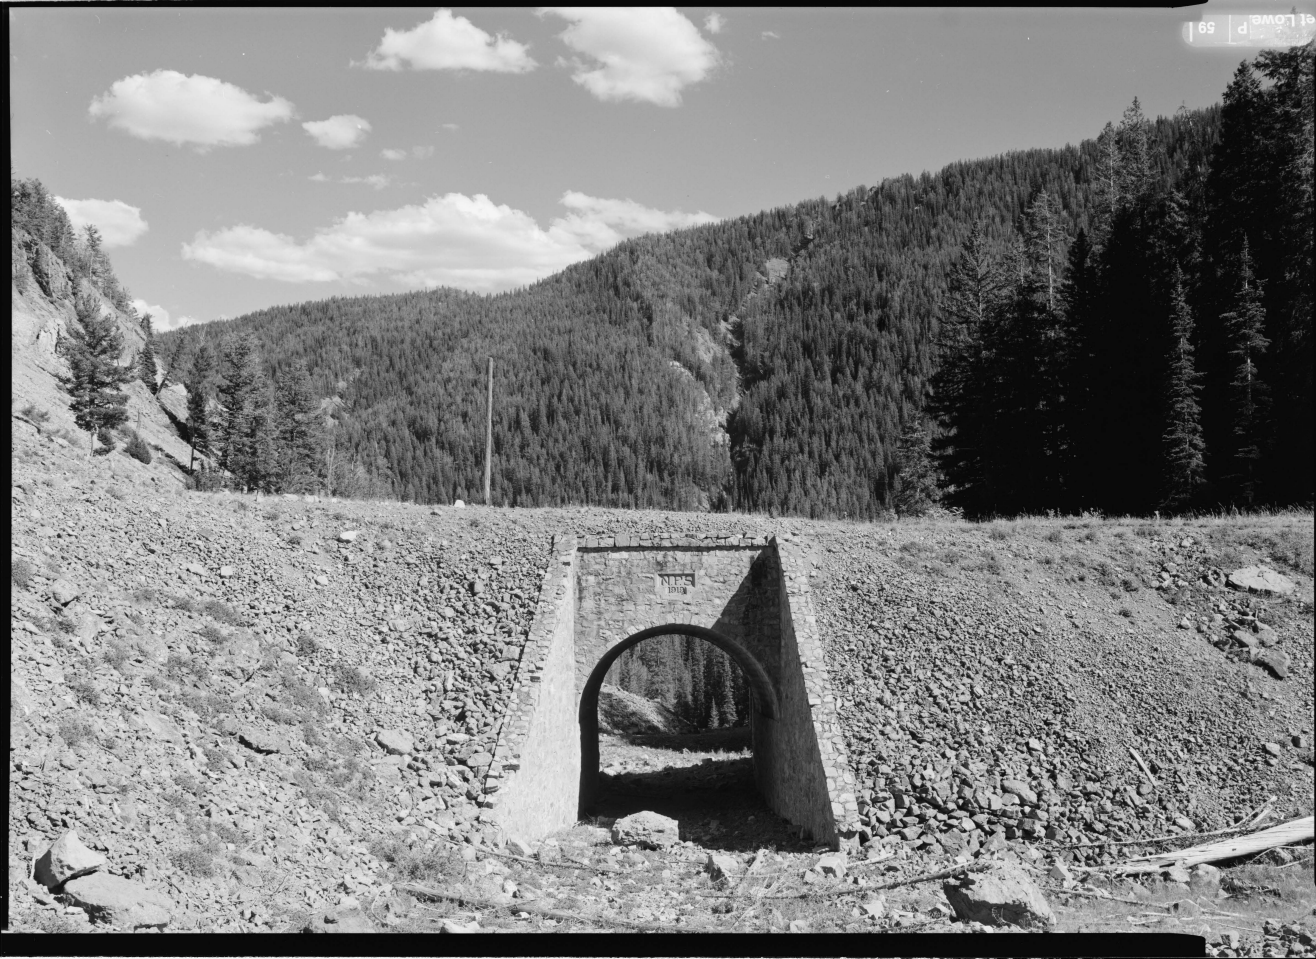
HAER NO WY-86-2

- WY-86-1      REMAINS OF CORKSCREW BRIDGE. LOOKING EAST.
- WY-86-2      WEST ELEVATION OF CORKSCREW BRIDGE, WITH 1919 TUNNEL AND ARCH.
- WY-86-3      STONework DETAIL OF WEST FACE OF CORKSCREW BRIDGE.
- WY-86-4      VIEW WEST ALONG ROADWAY TOWARD EAST FACE OF CORKSCREW BRIDGE.
