UNITED STATES DEPARTMENT OF THE INTERIOR  
NATIONAL PARK SERVICE**NATIONAL REGISTER OF HISTORIC PLACES  
INVENTORY -- NOMINATION FORM**

SEE INSTRUCTIONS IN *HOW TO COMPLETE NATIONAL REGISTER FORMS*  
TYPE ALL ENTRIES -- COMPLETE APPLICABLE SECTIONS**1 NAME**HISTORIC ~~Historic Resources of (Yellowstone National Park: (Partial Inventory.~~  
Roosevelt Lodge Historic District)

The Roosevelt Lodge Historic District is a part of the Multiple Resource nomination for Yellowstone National Park. The Roosevelt Lodge Historic District is located on Lost Creek, 18 miles east of the Mammoth Hot Springs Headquarters area. Lost Creek meanders down the slope of Prospect Peak through Lodge Pole Pines, Douglas Fir forest and sagebrush flats toward the Yellowstone River. The district stands where Lost Creek reaches the sagebrush flats. The district's boundary follows the configuration of the cabin layout with the west boundary being Lost Creek. This boundary only includes the lodge, cabins, comfort stations, and service buildings. Unpaved roads lead into and around the lodge and cabin area.

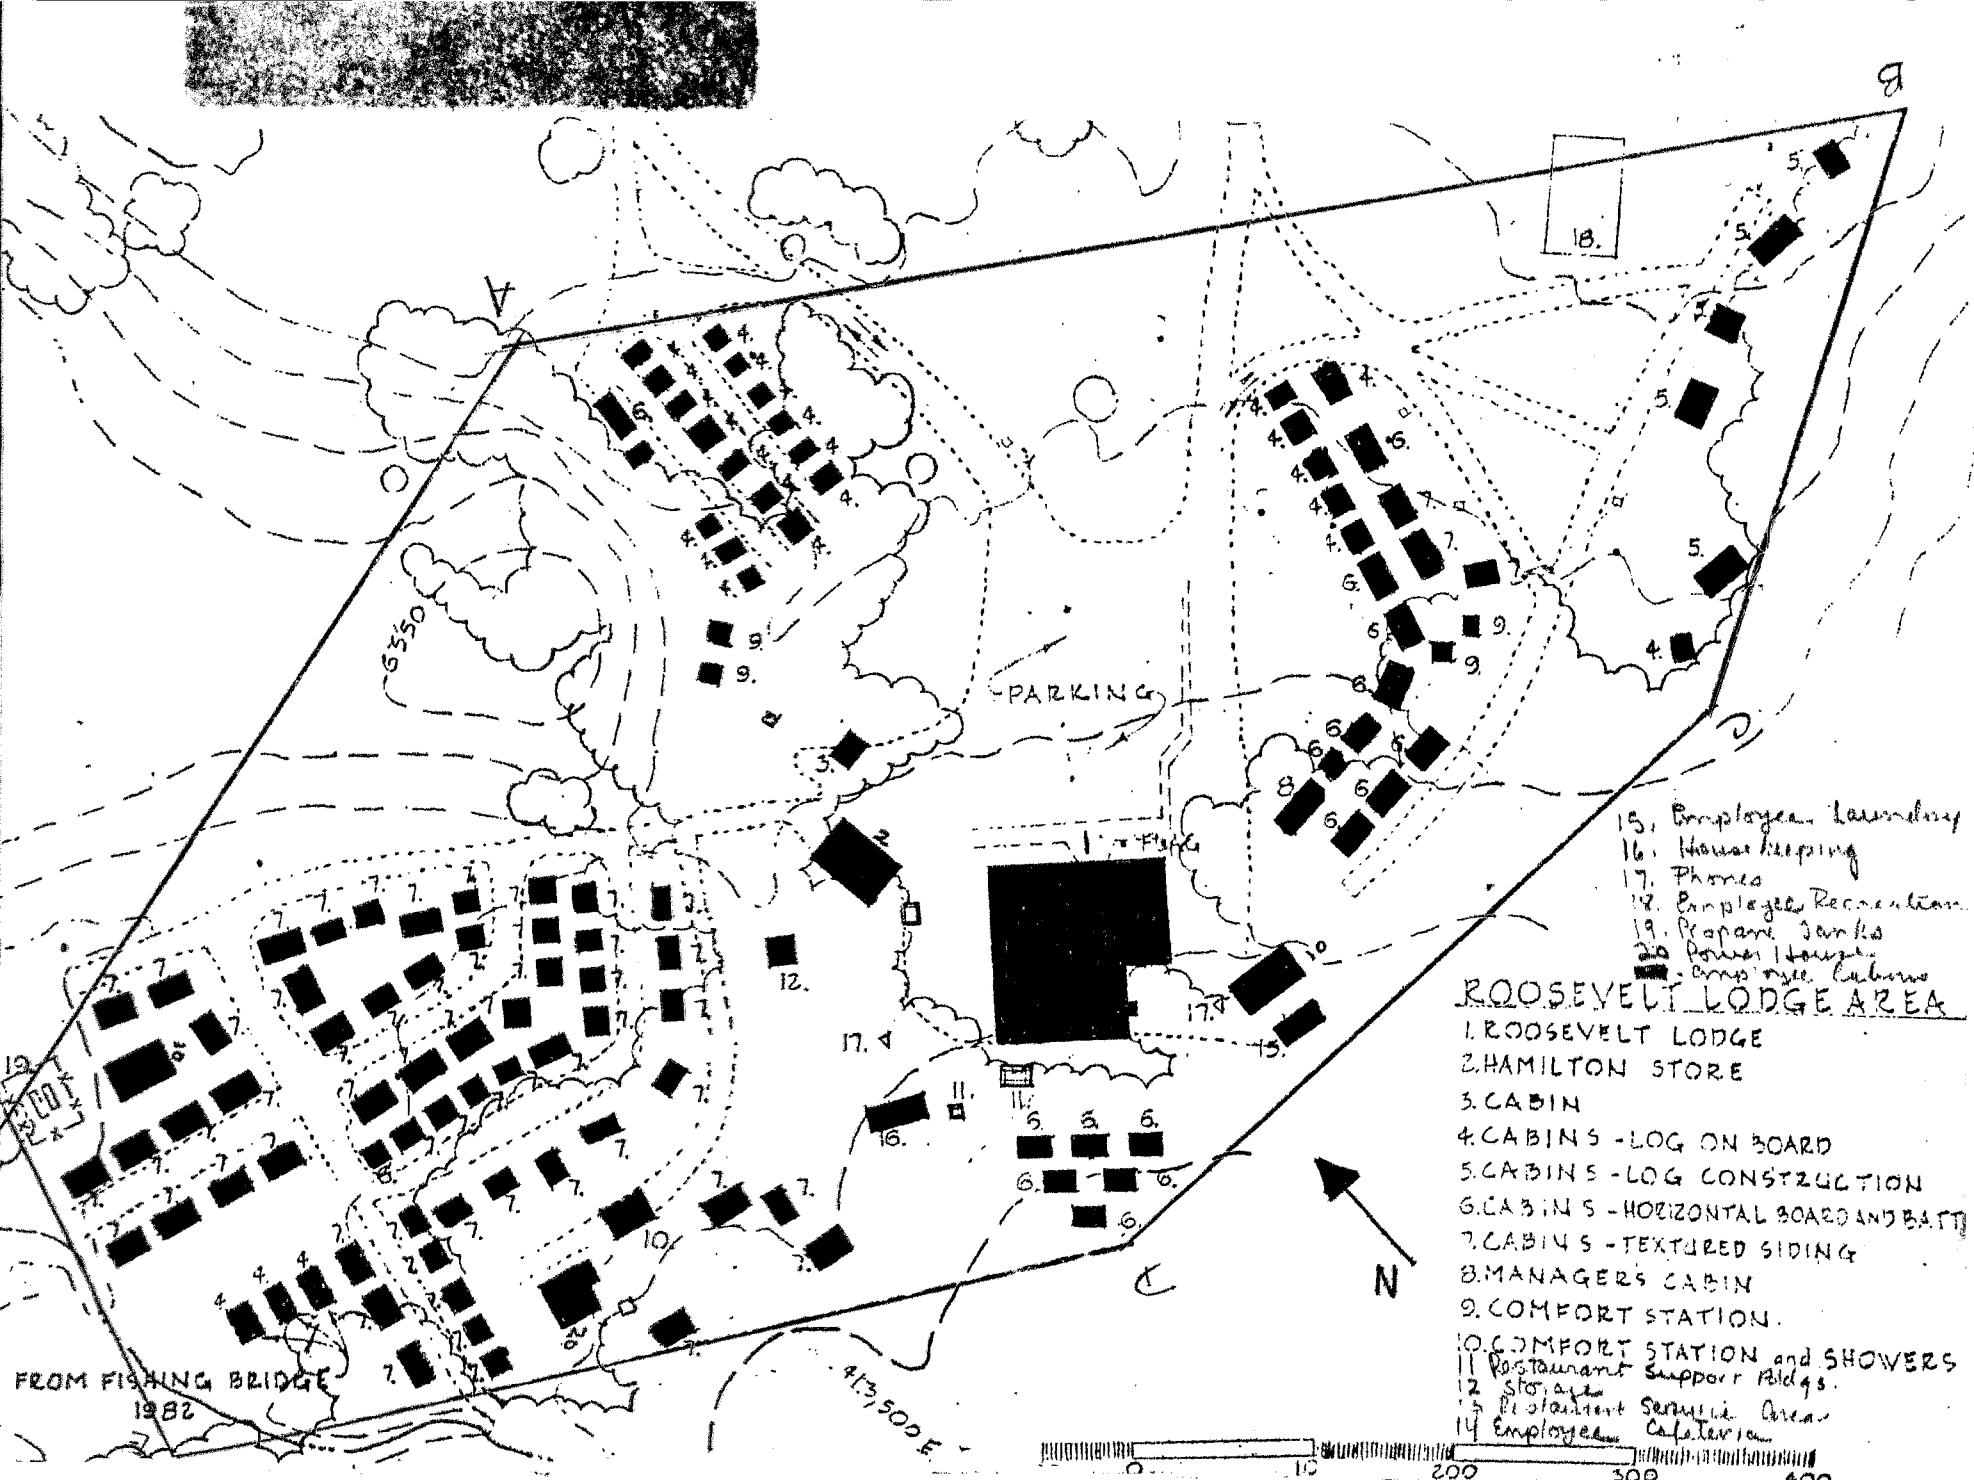
# ROOSEVELT LODGE AREA

Three site plans dated 1929, 1947, and 1982 are enclosed to aid in understanding the development of the historic district. Some of the obvious changes in the site are the following:

1. 1929 plan-----note horse barn northwest of the powerhouse  
1947 plan-----barn has been removed
2. 1947 plan-----proposed relocation of 7 cabins (change in river course) and 2 areas for proposed siting of cabins  
1982 plan-----shows cabins located in roughly the same configuration as the proposed "K", "L", "M", and "N" sites on the 1947 plan with cabin no. 31 remaining from the original group (1929)
3. 1947 plan-----shows 6 cabins have been sited behind the lodge. They were possibly relocated from Mammoth Hot Springs area in 1934.
4. 1982 plan-----shows that cabin 43 (to the left of lodge) has been removed
5. 1982 plan-----shows 3 cabins ("stud's out") that were relocated from the Fishing Bridge Historic District in 1981

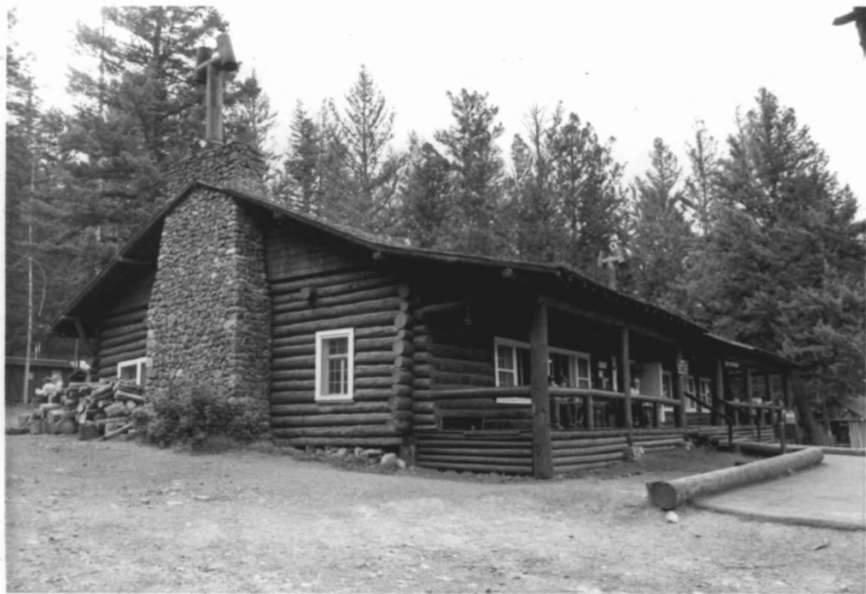
PHOTO NUMBER: 1

NAME OF PROPERTY: Roosevelt Lodge

The Lodge--Begun in 1919 and completed in 1920 by the Yellowstone Park Company, the modified L-plan, 1 story building is approximately 90' x 50' with the L extension being 29' x 59'. The original log constructed building is on a masonry foundation. The exterior horizontal log walls are saddlenotched and the logs still retain their bark. The building has a wood shingled gable roof, with an extended bell cast roof covering the porch which extends across the front of the building. A large stone masonry chimney is on each end of the building. Metal extensions were placed on the chimneys in the 1920's. The raised portion of the front porch has horizontal log members resting on a stone masonry foundation. The columns and rails are log. The windows are single and double multi-light wood casement with 6 light wooden transoms. The windows on either side of the front door are plate glass with wood casement sidelights. All of the windows except for the plate windows on the front have beveled glass. Originally the porch extended and wrapped around the southeast corner of the building. This extension was removed in 1948. In 1926, an employee's dining room, 16' x 30', was added to the rear of the building. In 1948, the kitchen wing was enlarged on the three exterior walls. The "logs out" addition has a tar and gravel shed roof.

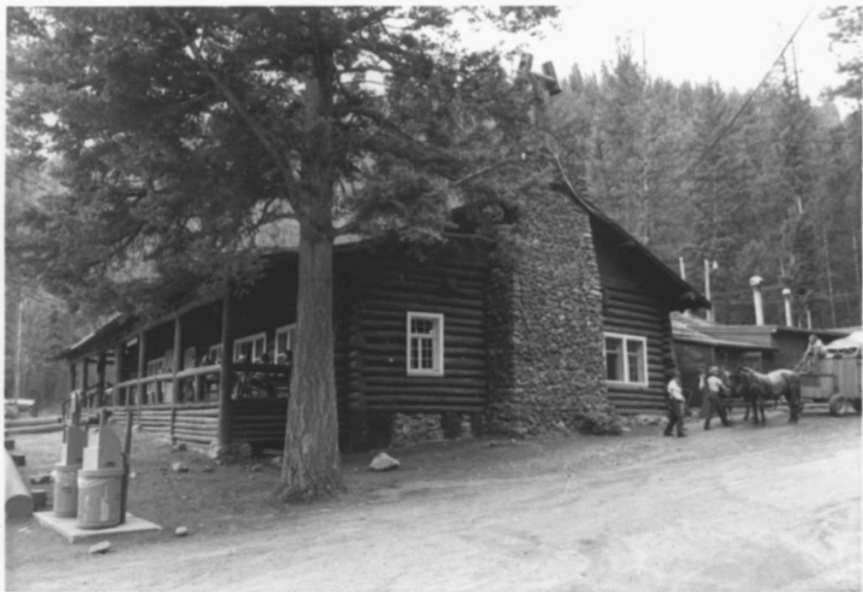
PHOTO NUMBER: 2

NAME OF PROPERTY: Lodge

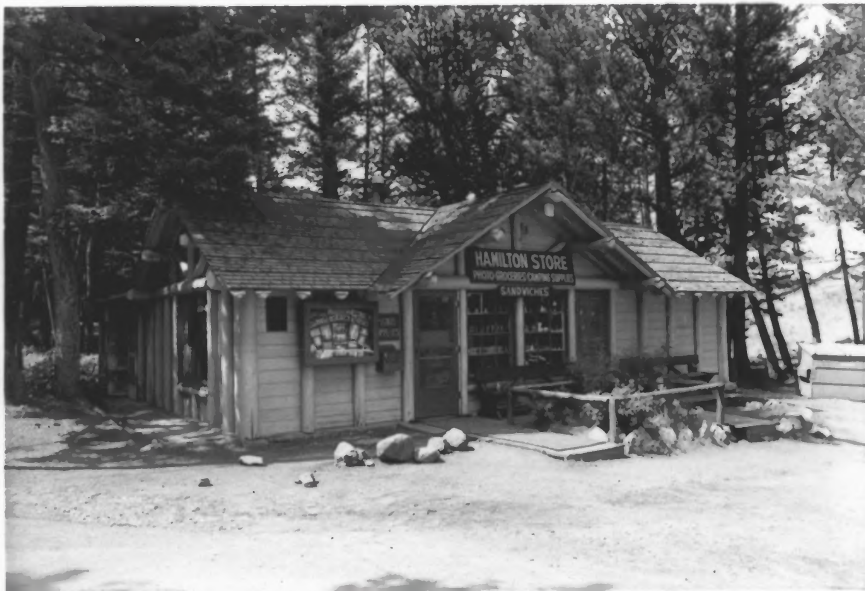
PHOTO NUMBER: 5

NAME OF PROPERTY: Hamilton Store

CONTINUATION SHEET	DESCRIPTION	ITEM NUMBER	PAGE
		7	2
No. 6151.	Store--Built in 1936 by Haynes, Incorporated, the 1 story, frame constructed building was originally T-shape, but after the 1954 addition, it became L-shape. The building is on a concrete foundation; the exterior walls are shiplap siding with "logs out" detail. The wood shingled gable roof has exposed log rafters and purlins. The logs are used as detailing in the gable ends. The building is approximately 36' x 16' with the L extension being 20' x 28'. 6' x 5' plate windows are on either end of the retail area. The front elevation has double multi-light sash store windows flanked by single doors. The building is in good condition. The building retains its architectural and historical integrity.		
No. 6140.	Caretaker's Cabin--Built in 1924 by the Yellowstone Park Company, the log constructed, 1 story, 2 room rectangle plan building is approximately 18' x 27'. The wood shingled gable roof extends over the front elevation creating a covered porch. The rafters, King post, tie beams, porch columns and rails are log. The exterior walls are horizontal logs with log corner posts. The windows are wooden casement sash. The building is in fair condition. It retains its architectural and historical integrity.

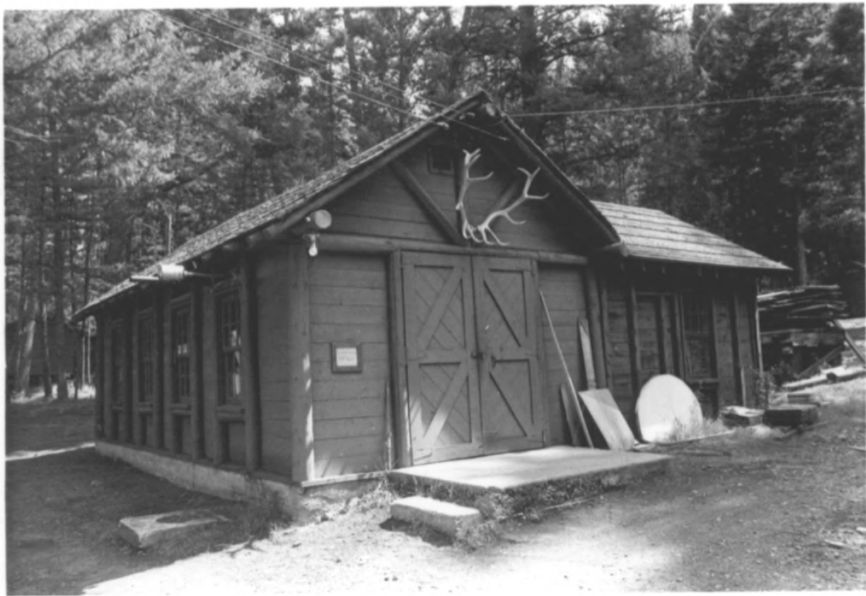
PHOTO NUMBER: 7

NAME OF PROPERTY: Powerhouse

- No. 6134. Powerhouse--Built ca. 1927, by the Yellowstone Park Company, the 1 story building is approximately 14' x 28'. The "studs out" frame constructed building is on a concrete foundation. The wood shingled gable roof building has double-hung 6/6 light wooden windows. The building has 2 double garage type openings. The building was altered in 1966, by a 11' x 12' addition. However, the building retains its architectural and historical integrity and is in good condition.

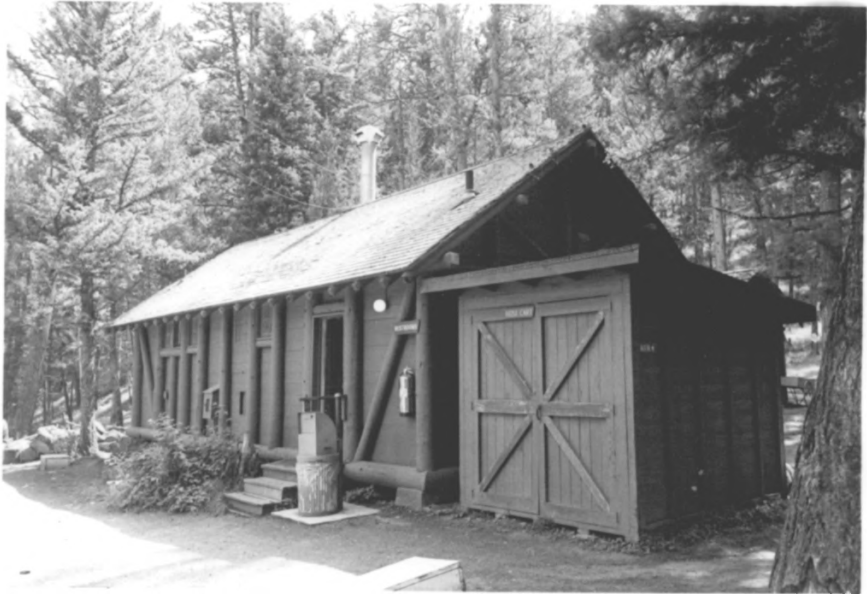
NAME OF PROPERTY: Double Comfort Station/Hose  
LOCATION: Roosevelt Lodge Historic District,<sup>House</sup>  
Yellowstone National Park, Wyoming  
PHOTOGRAPHER: Rodd L. Wheaton  
DATE OF PHOTO: September 1982  
LOCATION OF NEGATIVE: National Park Service,  
Rocky Mountain Regional Office--Denver, CO  
PHOTO NUMBER: 11

No. 6131.	Double Comfort--Built in 1926 by the Yellowstone Park Company, the Station 1 story, rectangular plan building is approximately 27' x 19'. The frame constructed building has horizontal board siding with vertical and diagonal log moulding detail. Awning type windows encircle the building at eave level. The building, on a concrete foundation, has exposed log rafters and purlins. The building has been slightly altered, the bark stripped from the logs and an interior brick chimney was removed. A small frame constructed "studs out" hose cart house is adjacent to the Comfort Station. The building has a built up shed roof, double doors on the front and it is on a masonry foundation. The building retains its architectural and historical integrity and is in good condition.		
No. 6132.	Comfort Station--Built in 1938 by the Yellowstone Park Company, the 1 story, 2 room building is approximately 17' x 31'. The frame constructed building, on a concrete foundation, has horizontal wood siding with log moulding detail. The wood shingled gable roof has exposed log rafters,

purlins, and ridge pole. The building retains its architectural and historical integrity. The building is in good condition.

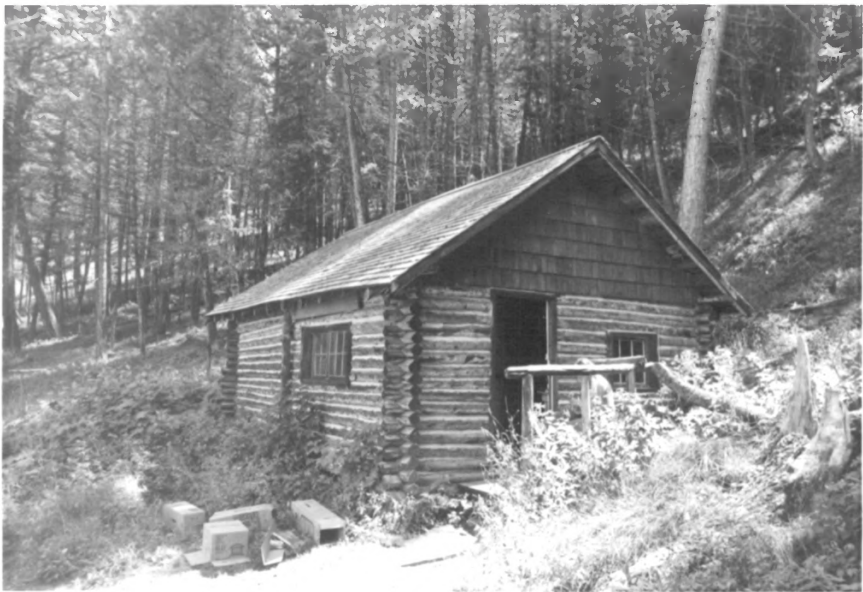
PHOTO NUMBER: 13

NAME OF PROPERTY: Cabin No. 38

- No. 38.      Cabin--Built in 1922, the rectangular plan log constructed cabin has horizontal saddlenotched walls. The wood shingled gable roof with gable ends is sheathed in exterior wood shingles. The cabin has 4 light sliding wooden sash windows, single front door and raised stoop. The roof has exposed log rafter ends. The building retains its architectural and historical integrity and is in fair condition.

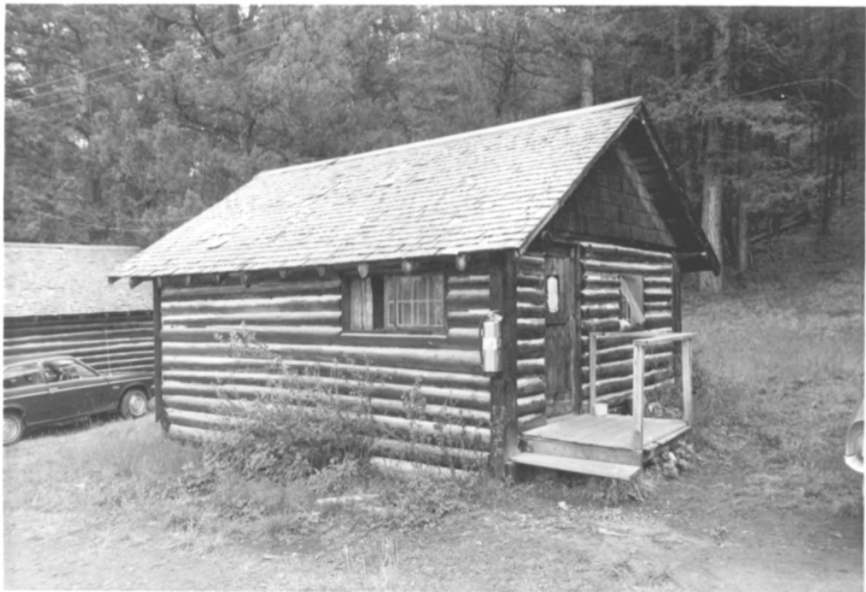
PHOTO NUMBER: 14

NAME OF PROPERTY: Cabin No. 39

- No. 39.      Cabin--Built in 1922, the rectangular plan log constructed cabin has horizontal log walls with corner boards. The wood shingled gable roof has exposed log rafter ends and the gable end is sheathed in exterior wood shingles. The windows are 4 light sliding wooden sash. The cabin has a stoop on the front. The cabin is on a concrete block foundation. The building retains its architectural and historical integrity and is in fair condition.

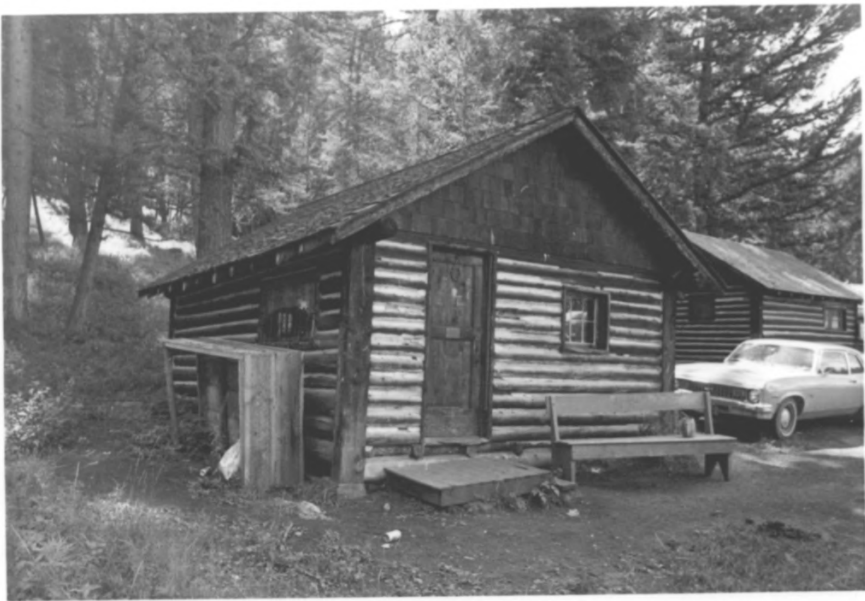
PHOTO NUMBER: 15

NAME OF PROPERTY: Cabin No. 42--No. 41  
in background

- No. 41.                      Cabin--Built in 1922, the rectangular plan log constructed cabin has horizontal log walls with corner boards. The wood shingled gable roof has exposed log rafter ends and the gable end is sheathed in exterior wood shingles. The windows are 4 light sliding wooden sash. The cabin has a stoop on the front. The cabin is on a concrete block foundation. The building retains its architectural and historical integrity and is in fair condition.

- No. 42.                      Cabin--Built in 1922, the rectangular plan log constructed cabin has horizontal log walls with corner boards. The wood shingled gable roof has exposed log rafter ends and the gable end is sheathed in exterior wood shingles. The windows are 4 light sliding wooden sash. The cabin has a stoop on the front. The cabin is on a concrete block foundation. The building retains its architectural and historical integrity and is in fair condition.

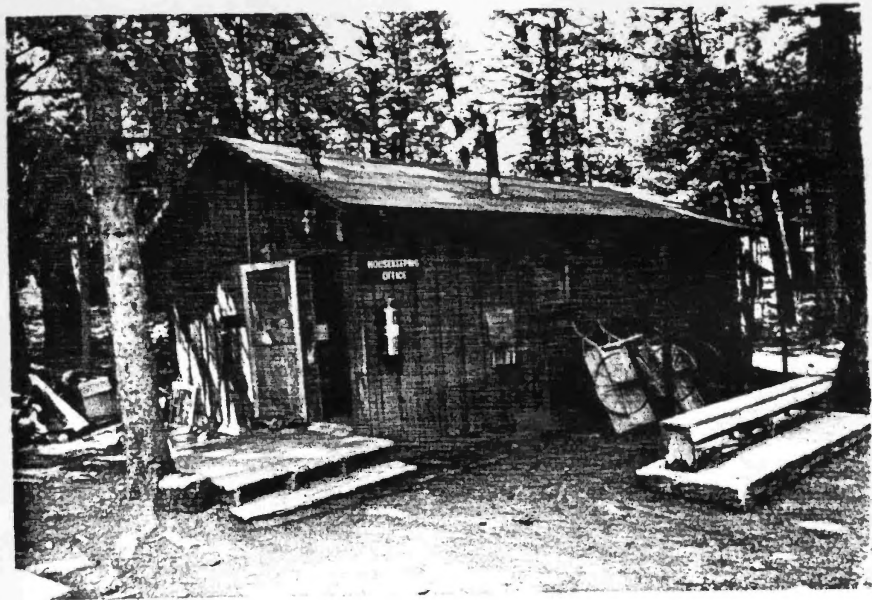
NAME OF PROPERTY: Housekeeping Office  
LOCATION: Roosevelt Lodge Historic District,  
Yellowstone National Park, Wyoming  
PHOTOGRAPHER: Rodd L. Wheaton  
DATE OF PHOTO: September 1982  
LOCATION OF NEGATIVE: National Park Service,  
Rocky Mountain Regional Office--Denver, CO  
PHOTO NUMBER: 9

- No. 6138. Housekeeping Office--Built at an unknown date by the Yellowstone Park Company, the 1 story, 1 room, frame constructed rectangular plan building is approximately 29' x 14'6". The exterior walls are vertical board and batten; it is on a concrete foundation. The building has small awning type windows and the roof is covered with rolled roofing. The building retains its architectural and historical integrity and is in fair condition.

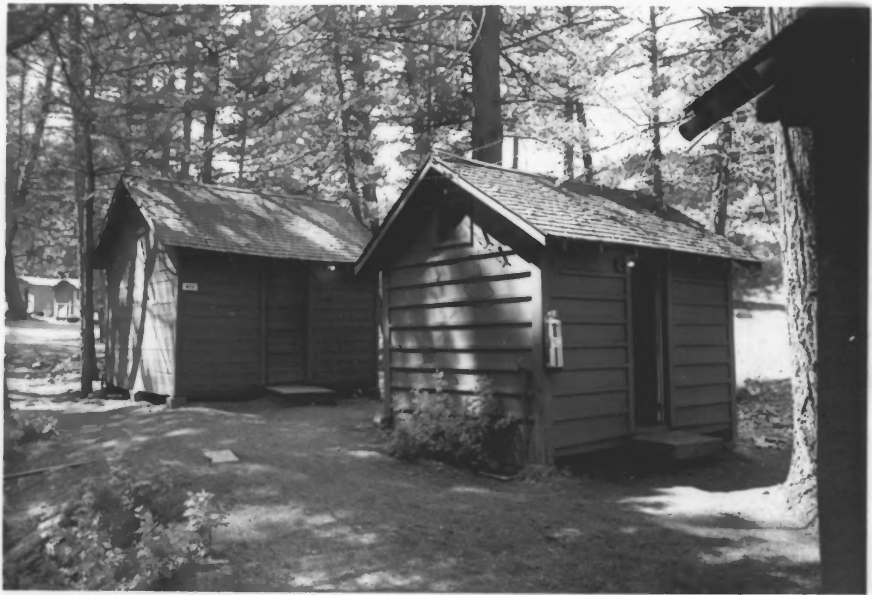
PHOTO NUMBER: 25

NAME OF PROPERTY: Comfort Stations

- Comfort Stations (4)--Built in the 1920's, the rectangular plan frame constructed comfort stations have wood shingled gable roofs and they are on concrete block foundations. Three of the comfort stations have flush horizontal siding and one has board and batten siding. Some have stoops and some have steps. A window is set high on the gable end of each building. One group of two (men and women) is located in the cabin group to the left of the lodge. The other two (men and women) are located between the caretaker's cabin and the group of cabins northeast of the lodge.

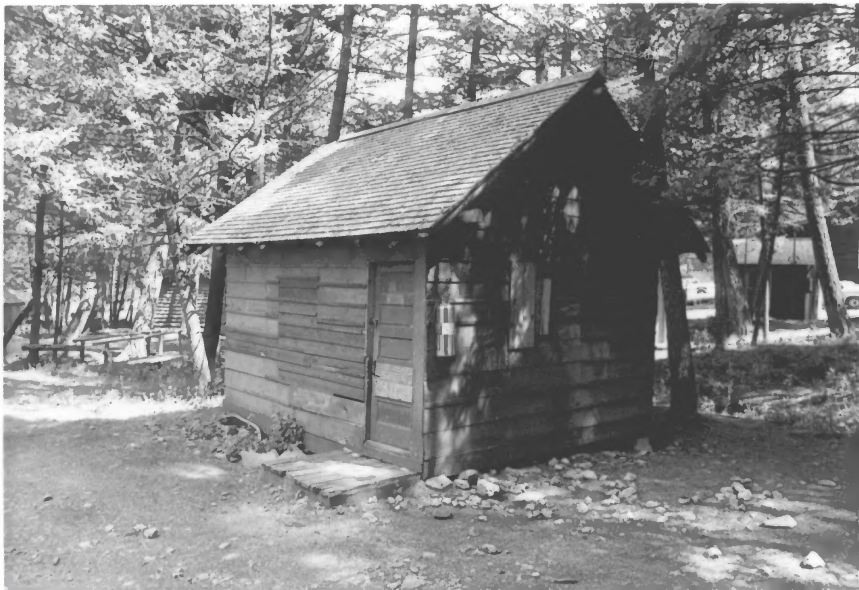
PHOTO NUMBER: 44

NAME OF PROPERTY: Shed

- Shed--Built at an unknown date, the rectangular plan building has horizontal board and batten siding, a wood shingle roof with exposed log rafters and purlins. The windows have been boarded. The shed is on a concrete block foundation. The building retains its architectural and historical integrity and it is in poor condition.
