# **THE PHYSICAL HISTORY OF THE MOORE HOUSE**

**1930-1934**

**CHARLES E. PETERSON**

**1935**

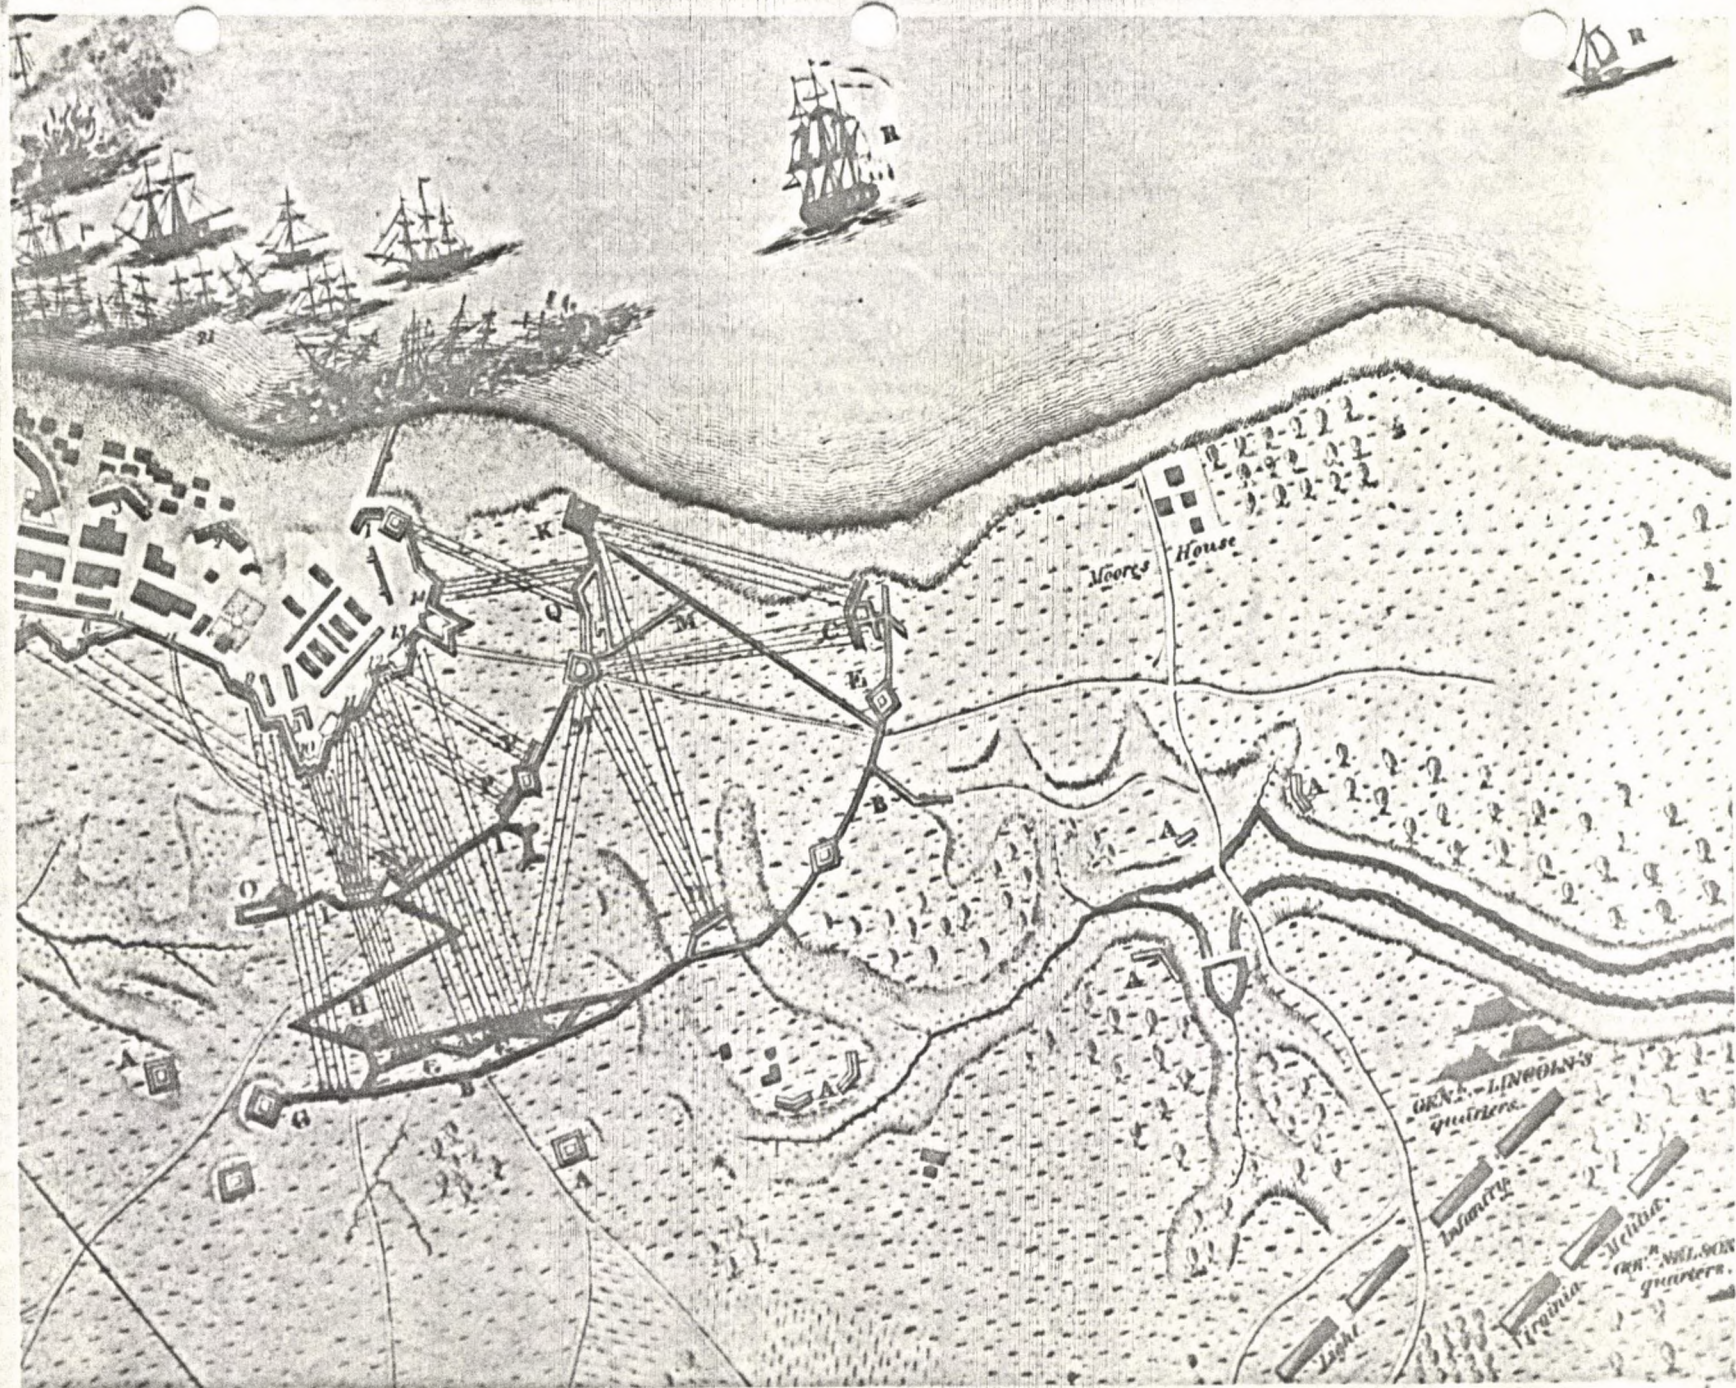
PLATE NO. 1

Portion of the "PLAN OF YORKTOWN IN VIRGINIA AND ADJACENT COUNTRY, Exhibiting the operations of the American, French, and English armies during the Siege of that place in October 1781. Surveyed from the 22nd to the 28th Octr....Drawn by Jn. F. Renault with a Crow-pen and presented to the MARQUIS DE LA FAYETTE."

This map is one of a considerable number prepared about this time. All of them vary in details such as the number and grouping of the buildings at the Moore House.

The Revolutionary maps carry the first graphic representations of the Moore House.

(1) See Plate No. 1.

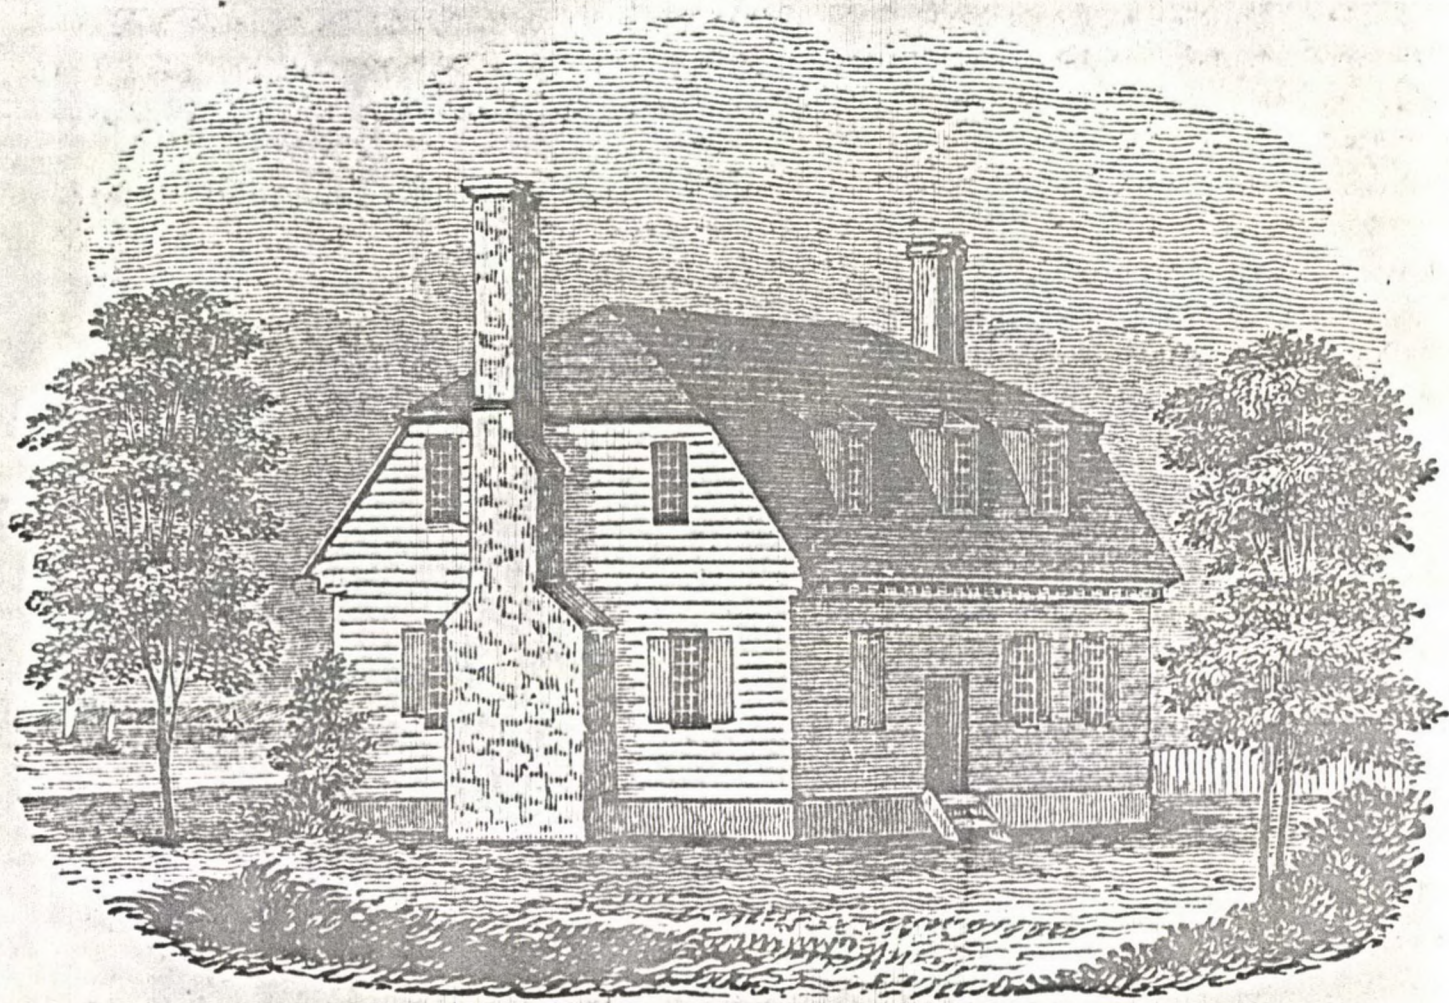
PLATE NO. 2

A photostat (enlarged) of the illustration (V 2 p. 530) in Henry Howe's "Historical Collections of Virginia," (1849).

This is the earliest published view of the Moore House, brought to our attention by a loan of the volume from Mrs. A.Y. Burcher of Newport News, Virginia.

This is the only information we have on the step arrangement at the rear door.

(3) See Plate No. 2.

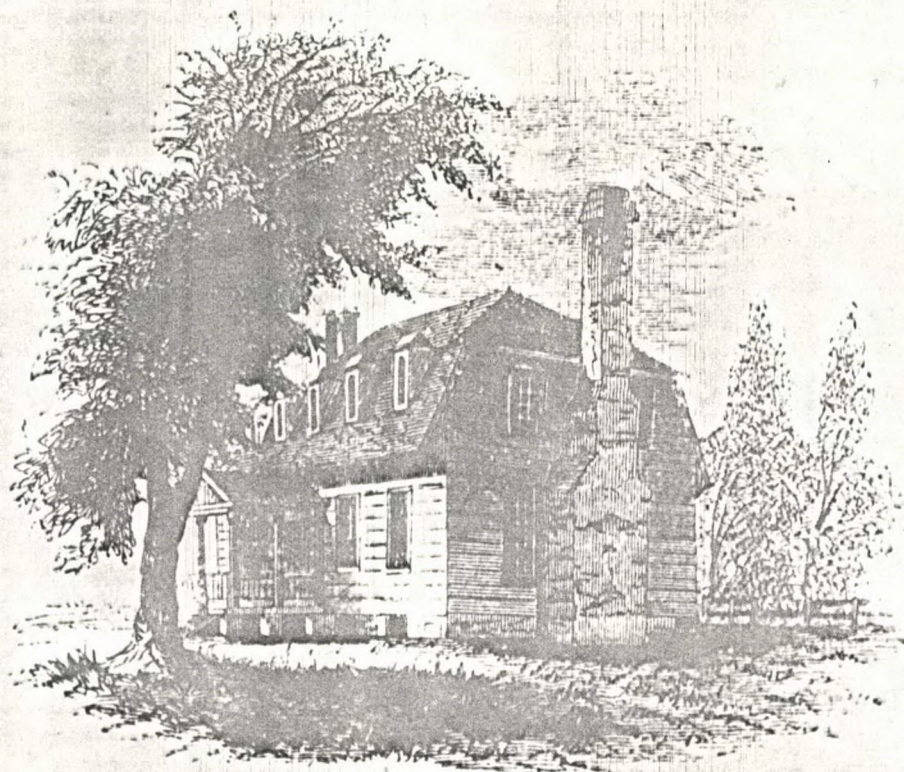
PLATE NO. 3

A photostat (enlarged) of the illustration in Vol. II, (p. 324) Benson Lossing's "Pictorial Field Book of the Revolution," (1850). Lossing made a tour of the places associated with the Revolutionary War, visiting Yorktown in 1848.

This is the second earliest known pictorial representation of the Moore House. Brought to our attention by Mr. Thomas T. Waterman, then of the Williamsburg Restoration.

(4) See Plate No. 3.

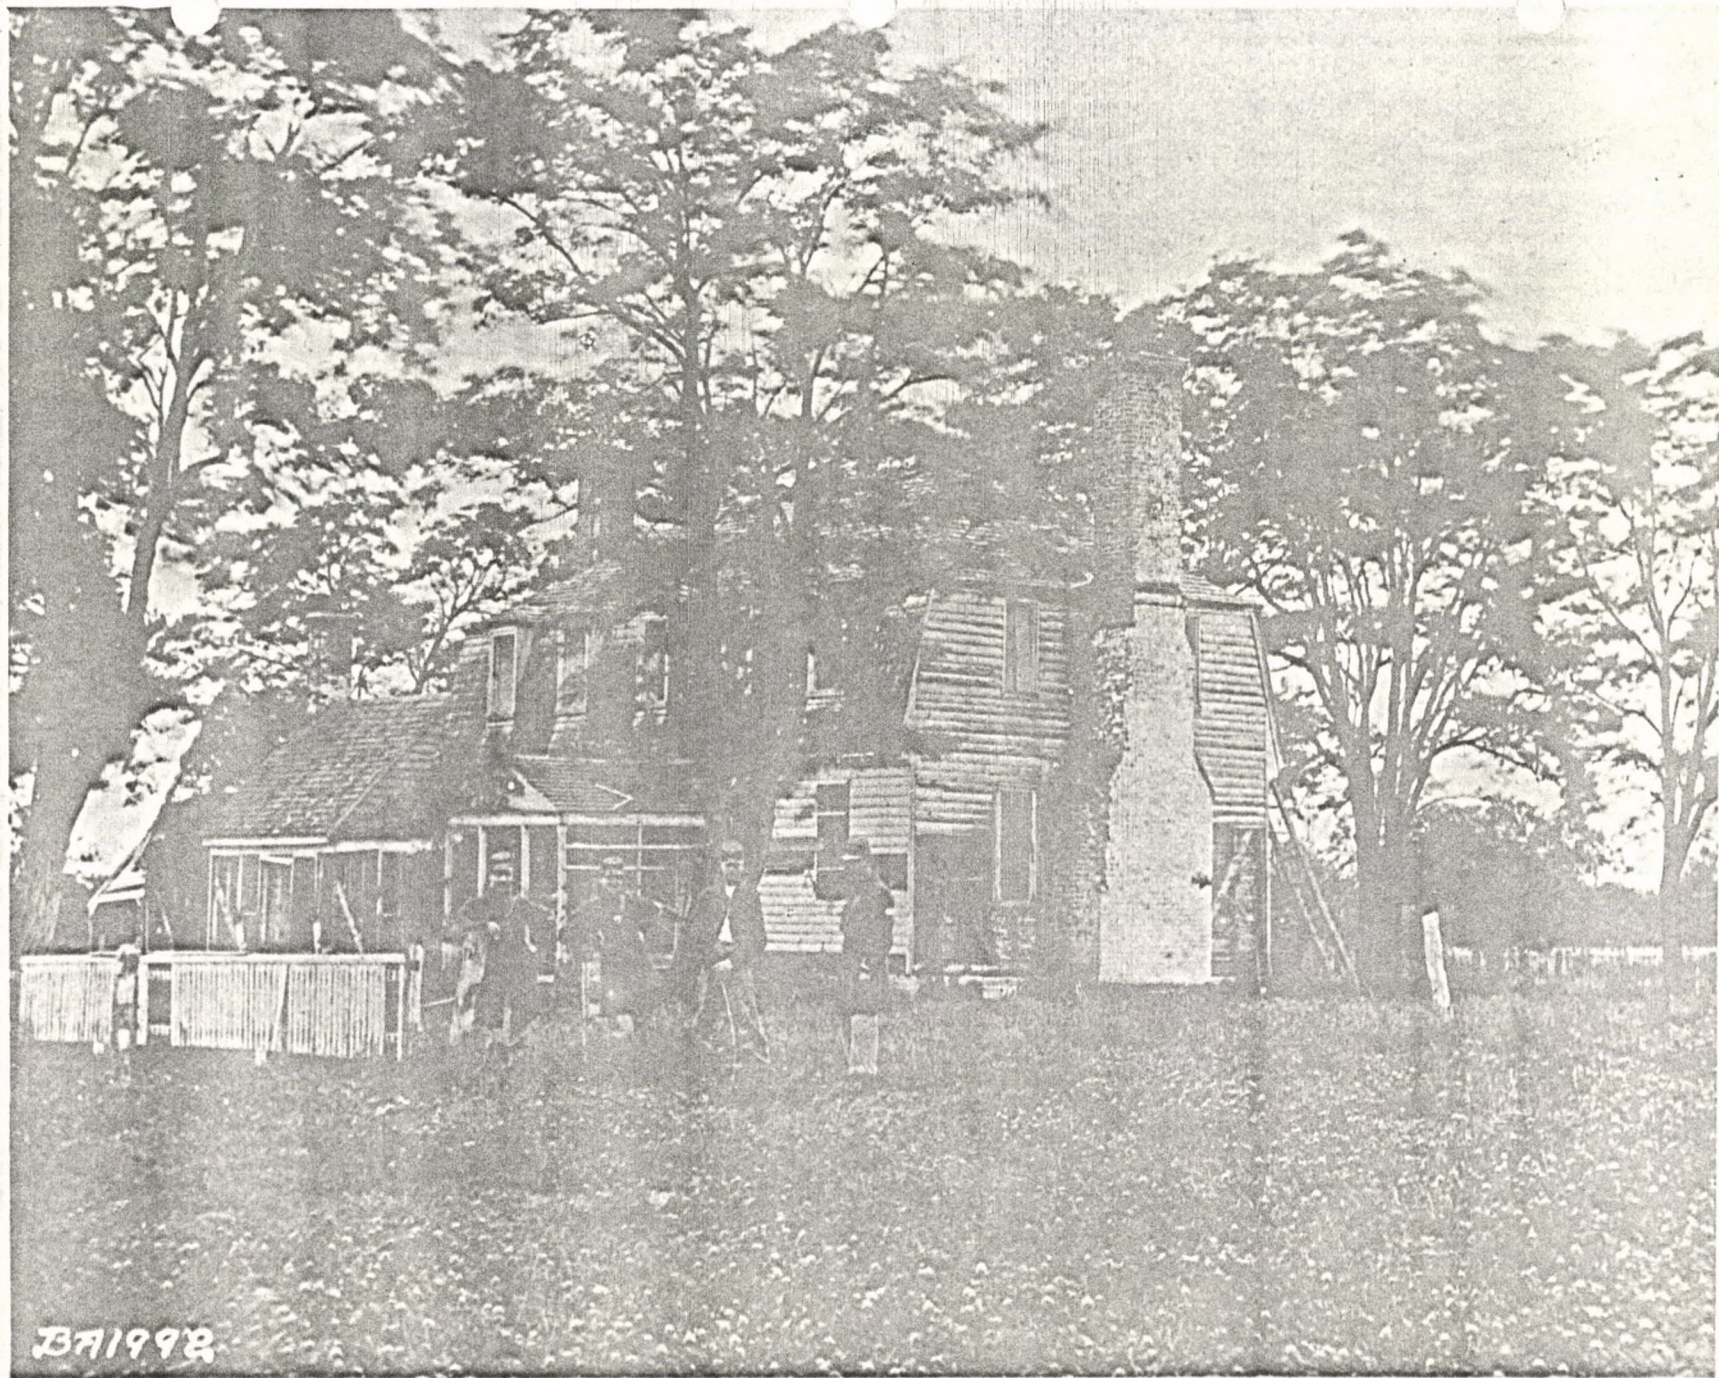
PLATE NO. 4

Enlargement of the photograph taken by Matthew Brady in 1862, located by the writer in the Library of Congress.

The decision to restore a front porch was based on a study of this photograph. There have been at least four front porches on the House, (1) an 8' by 8' porch from which the brick pier bases survive; (2) the porch shown in this photograph; (3) the porch removed in 1931 which was built probably in 1881; (4) the present porch which is a conjectural restoration of (1).

This view shows the chaos of the grounds during the War which may account for the disappearance of the outbuildings. The Civil War photographs show the East Wing for the first time.

(2) See Plate No. 4.

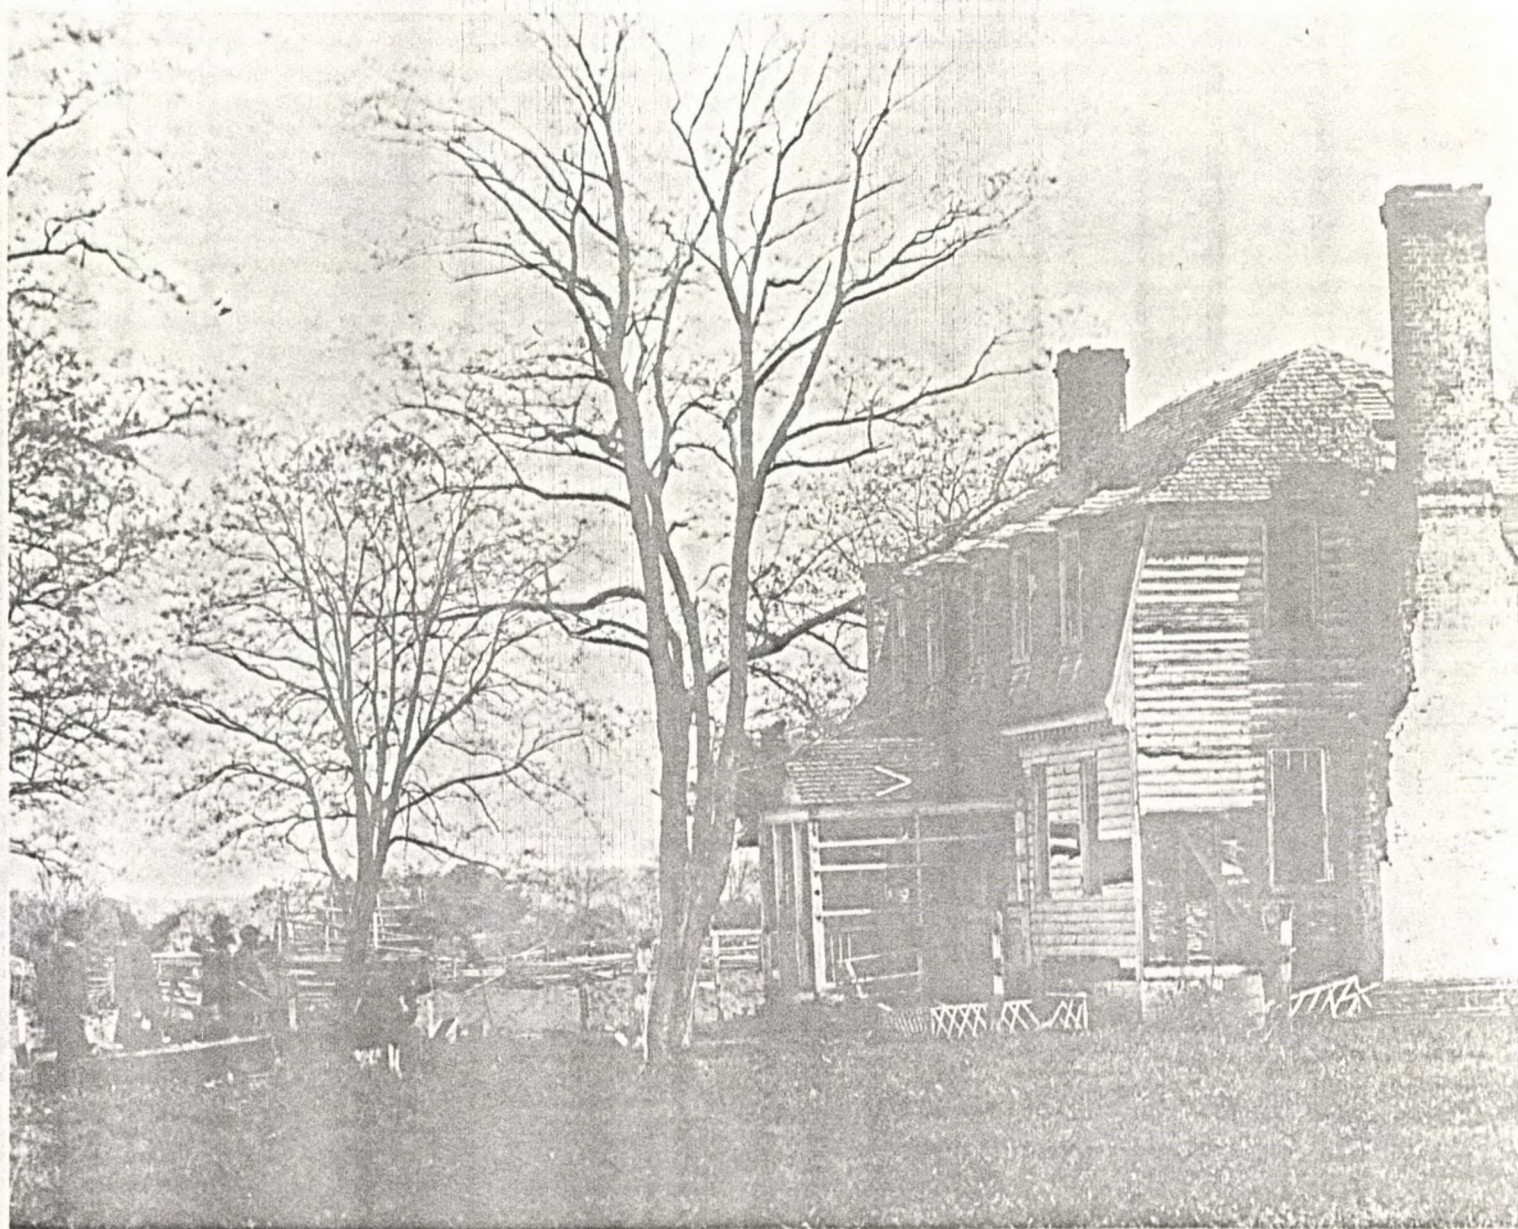
PLATE NO. 5

The Gardner print from a negative by Wood and Gibson, May 1862. Brought to our attention by Mr. Louis R. Fiske of Upper Darby, Pennsylvania, who sold it to the writer.

This view shows beyond a doubt that the building was whitewashed at the time. It also shows the interesting "swirl" of the shingles on the hips of the roof and the dormers. The size and shape of the shutter hinges is clearly indicated.

Unfortunately this hitherto unknown photograph did not show up until October 8, 1931, after the roof had been reshingled according to our plans. The first opportunity to correct the effect came with the Public Works program.

(3) See Plate No. 5.

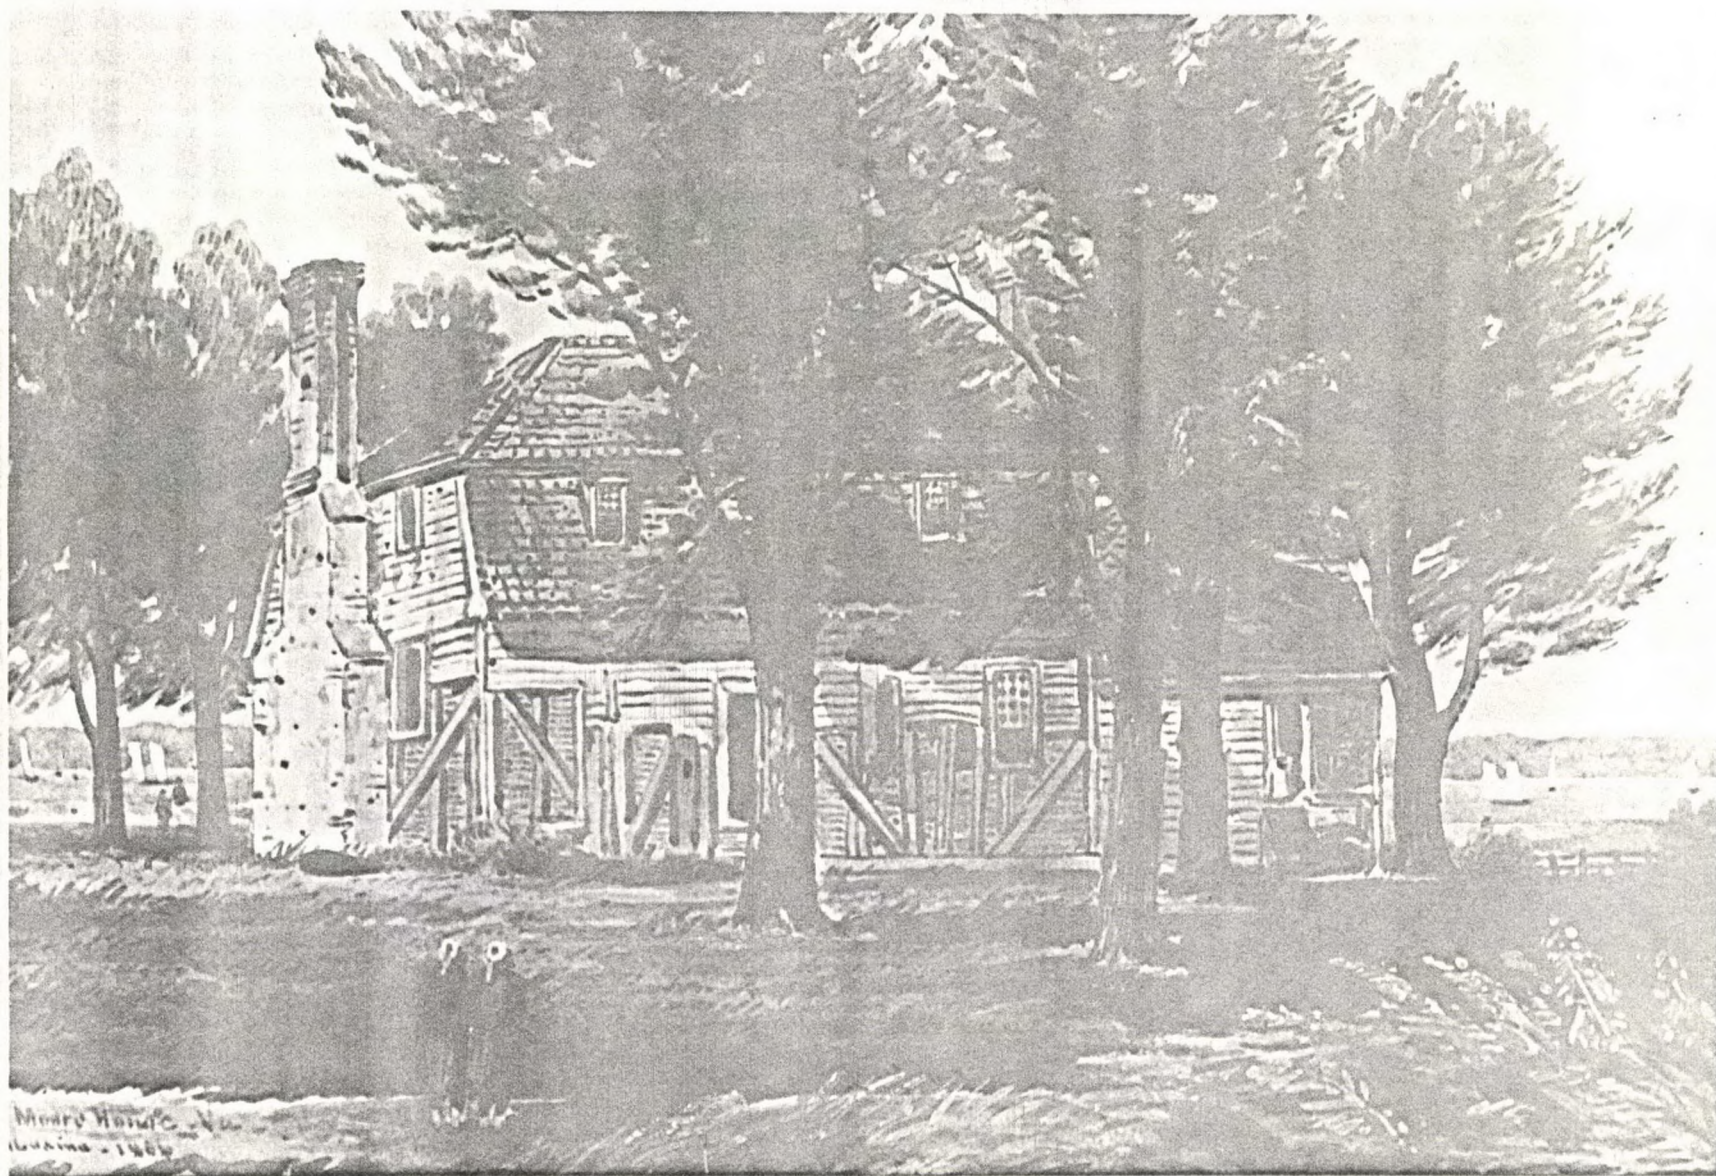
PLATE NO. 7

The second Hellwaine water color shows the rear of the House. A first glance at the original suggested red brick nogging between the framing members. Since the examination of the structure revealed no evidences of this it seems more likely to assume that it is just lath and plaster.

(5) See Plate No. 7.

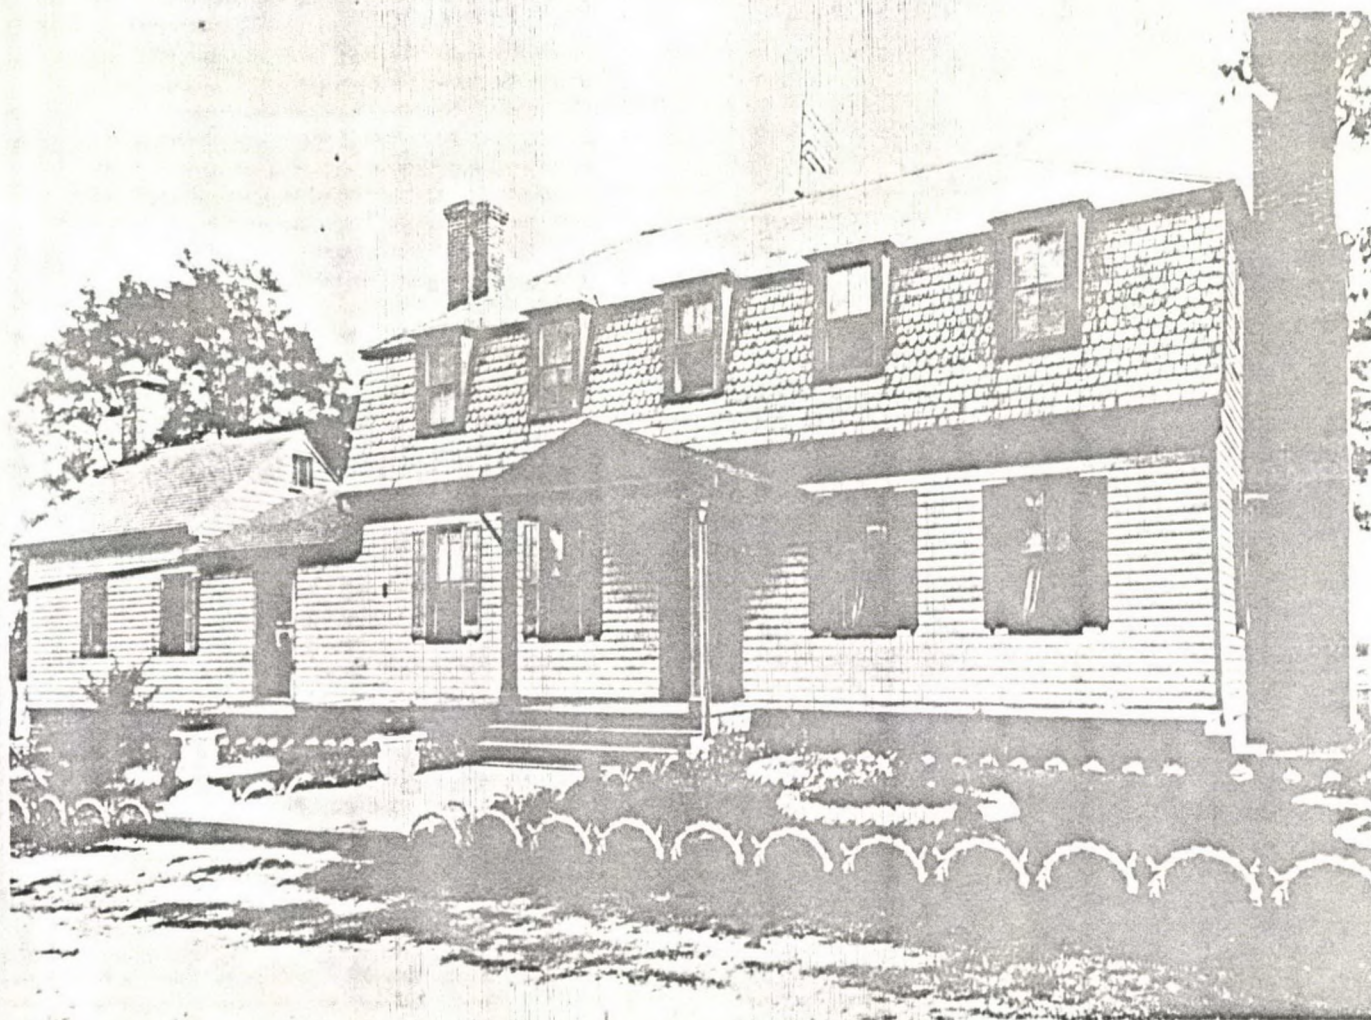
PLATE NO. 10

A photostat of a photograph inlaid between pages 22 and 23 in "A History of the Monument at Yorktown, erected by the United States Government to commemorate the close of the Revolutionary War, at Yorktown, October 19, 1781", Philadelphia, 1890.

This was taken probably on the occasion of the Centennial in 1881.

(1) See Plate No. 10.

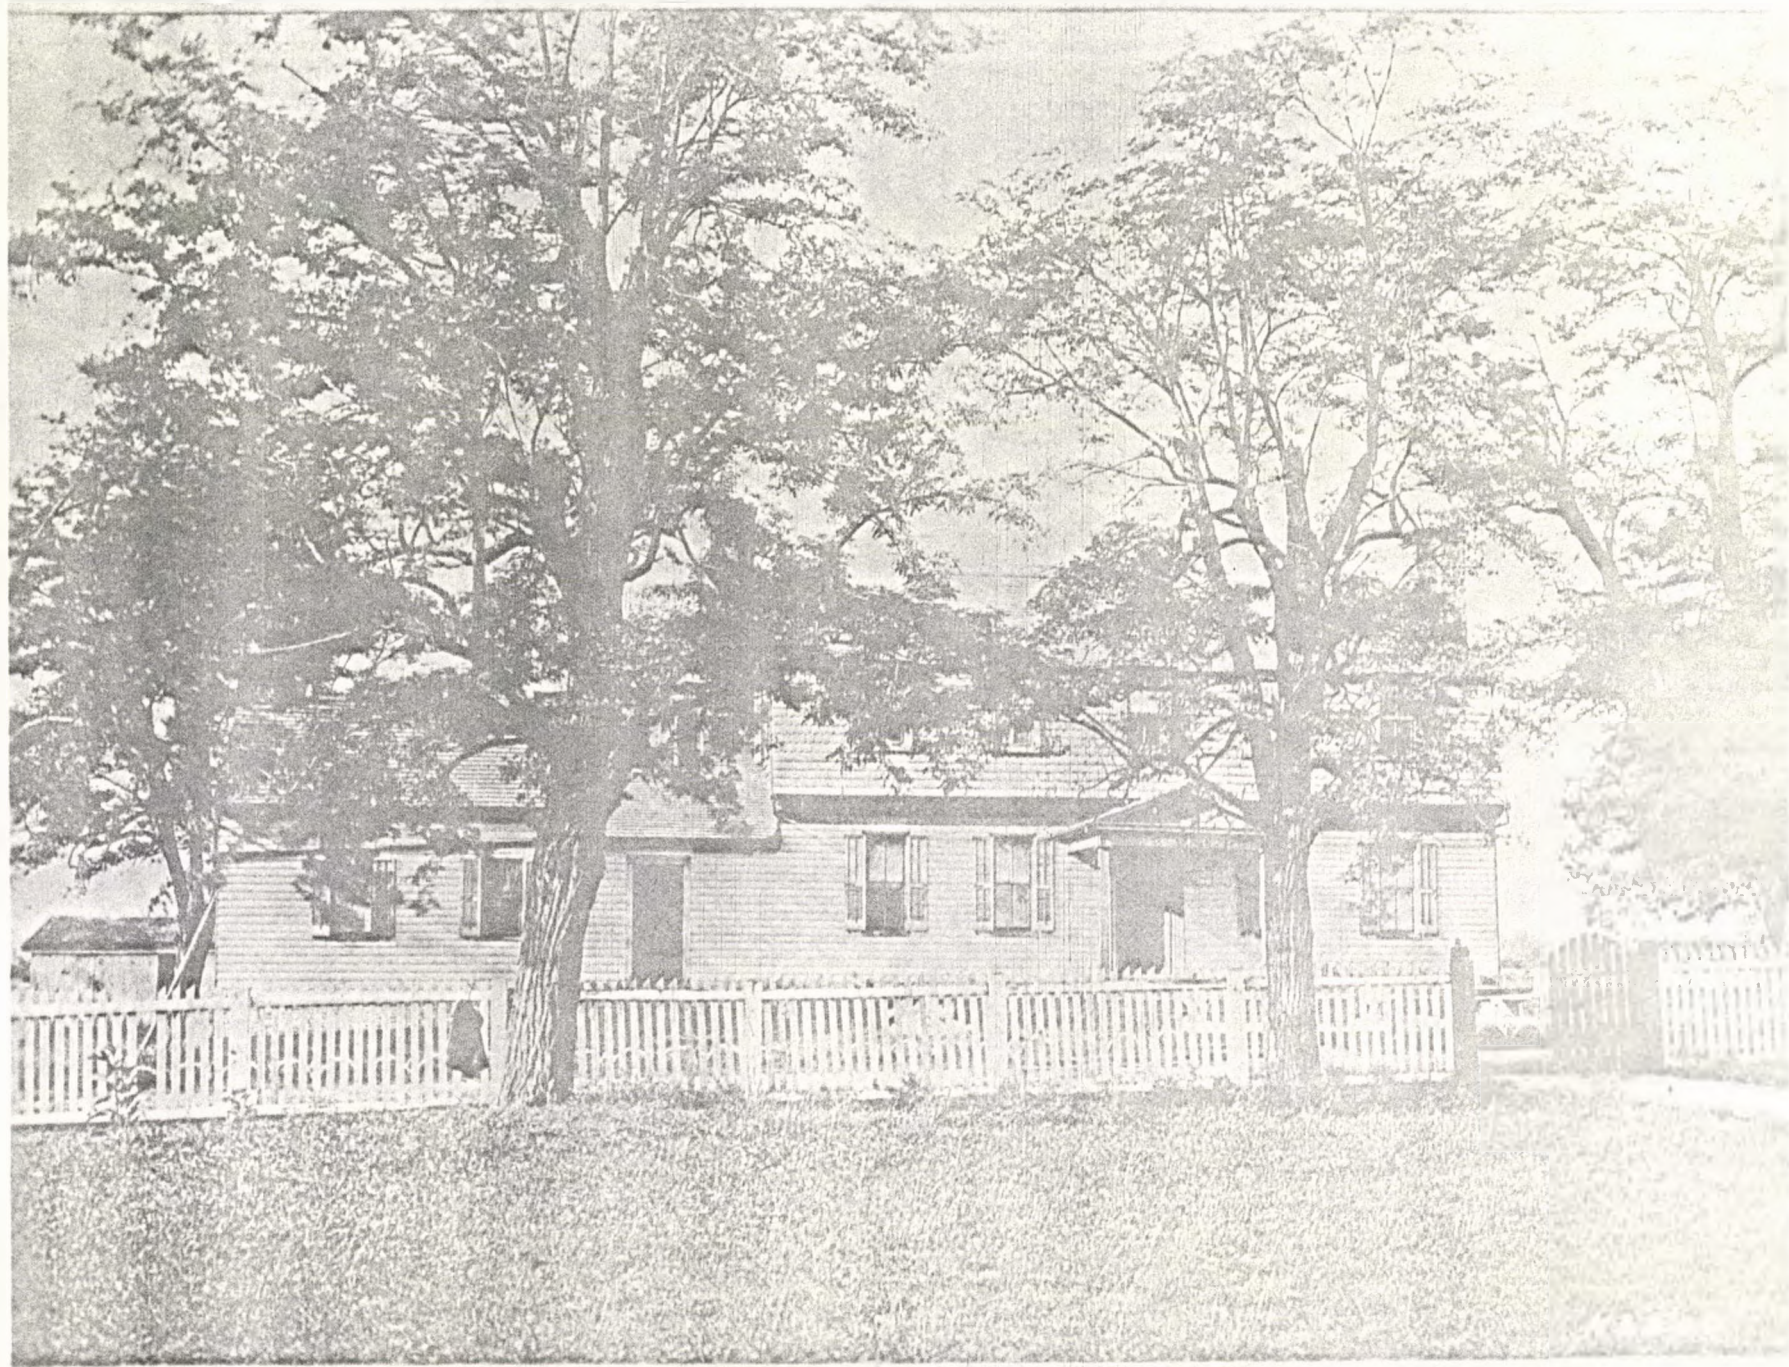
PLATE NO. 11

Photograph of the House (date unknown)  
some time after the Centennial, contributed  
to us by Mr. Walter Maconber of the Williams-  
burg Restoration.

The cornices seem to be painted dark and  
it is believed that this is the olive green  
color found on the rear cornice when it was  
opened up in 1931.

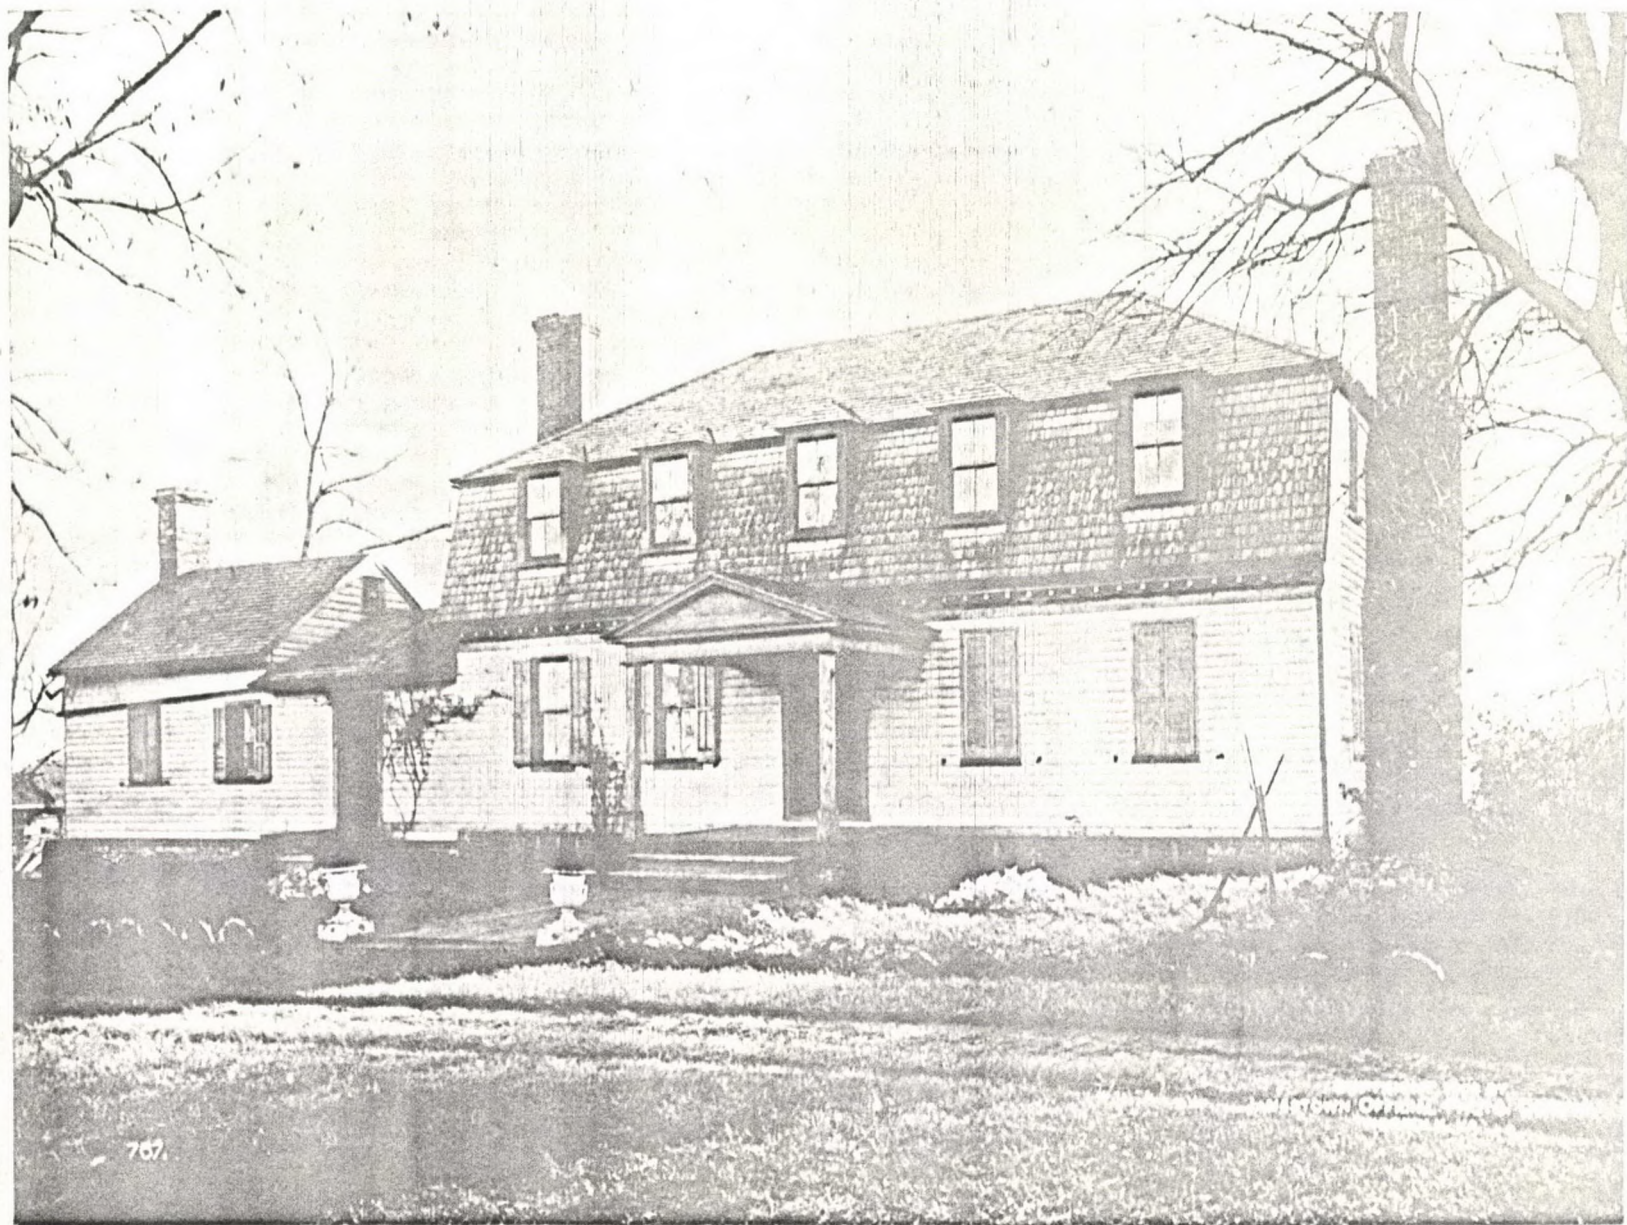
PLATE NO. 11-B

Photograph, somewhat enlarged, of a photographic print in the possession of Mr. Fayton Nelson of Williamsburg. Kindly loaned for reproduction by the owner.

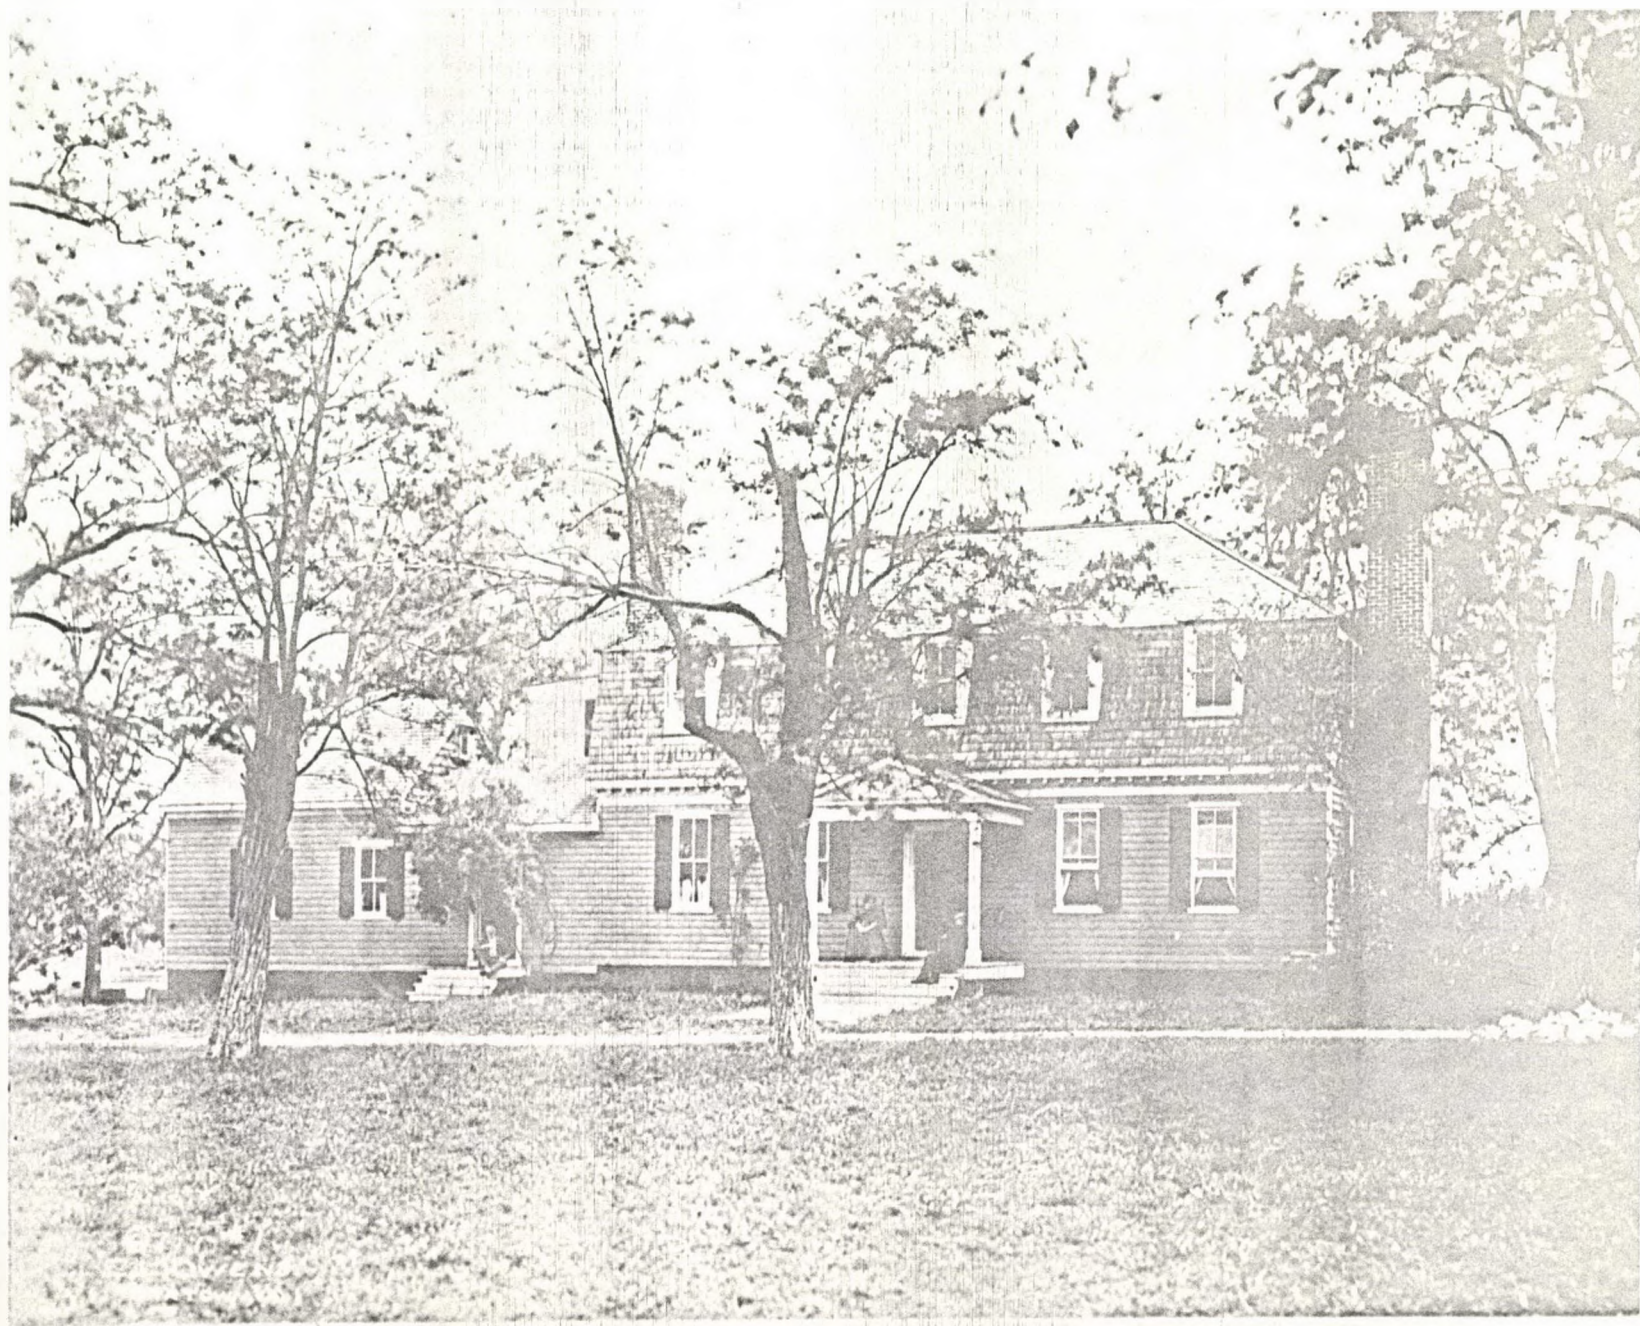
PLATE NO. 11-C

Photograph copyright 1911 by E. L. Owens,  
reproduced from print in the Library of Congress.

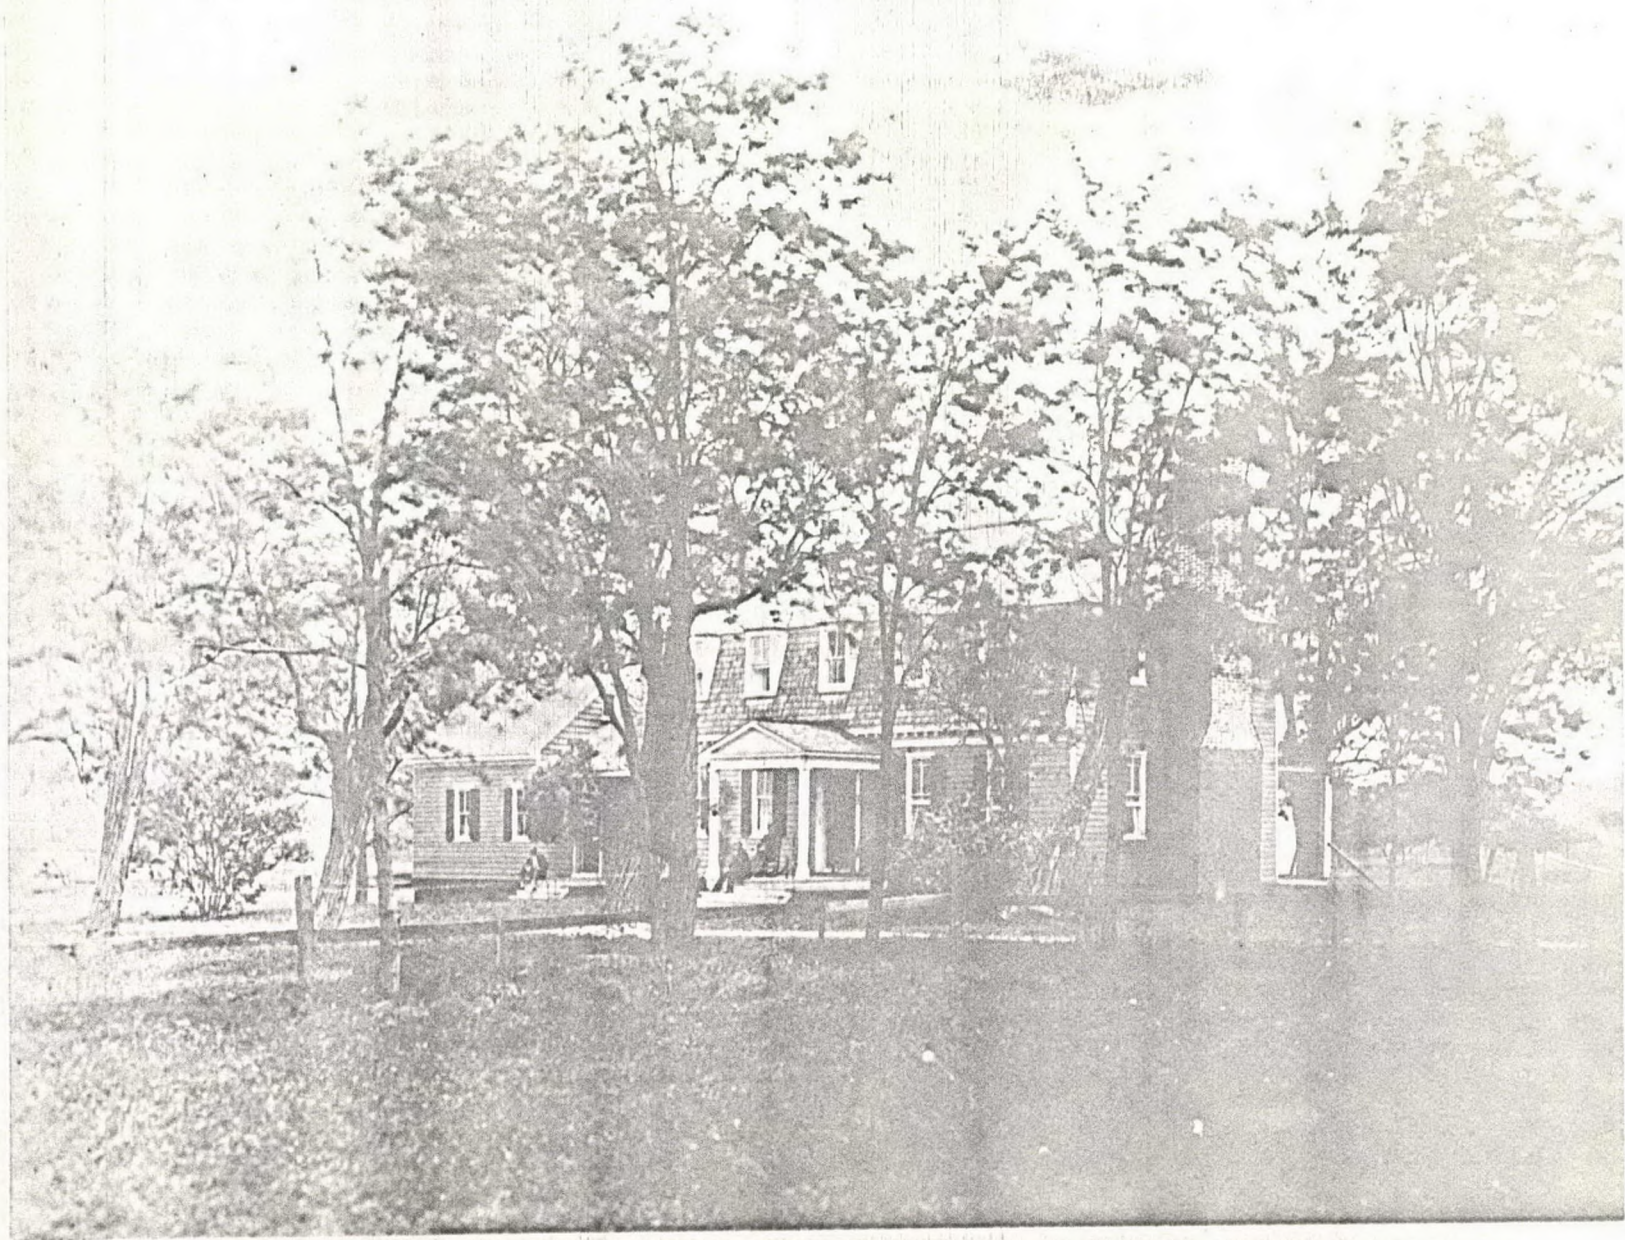
PLATE NO. 11-D

Apparently taken same day as No. 11-C (note seated figures). Reproduced from print in the Library of Congress.
