# **THE PHYSICAL HISTORY OF THE MOORE HOUSE**

**1930-1934**

**CHARLES E. PETERSON**

**1935**

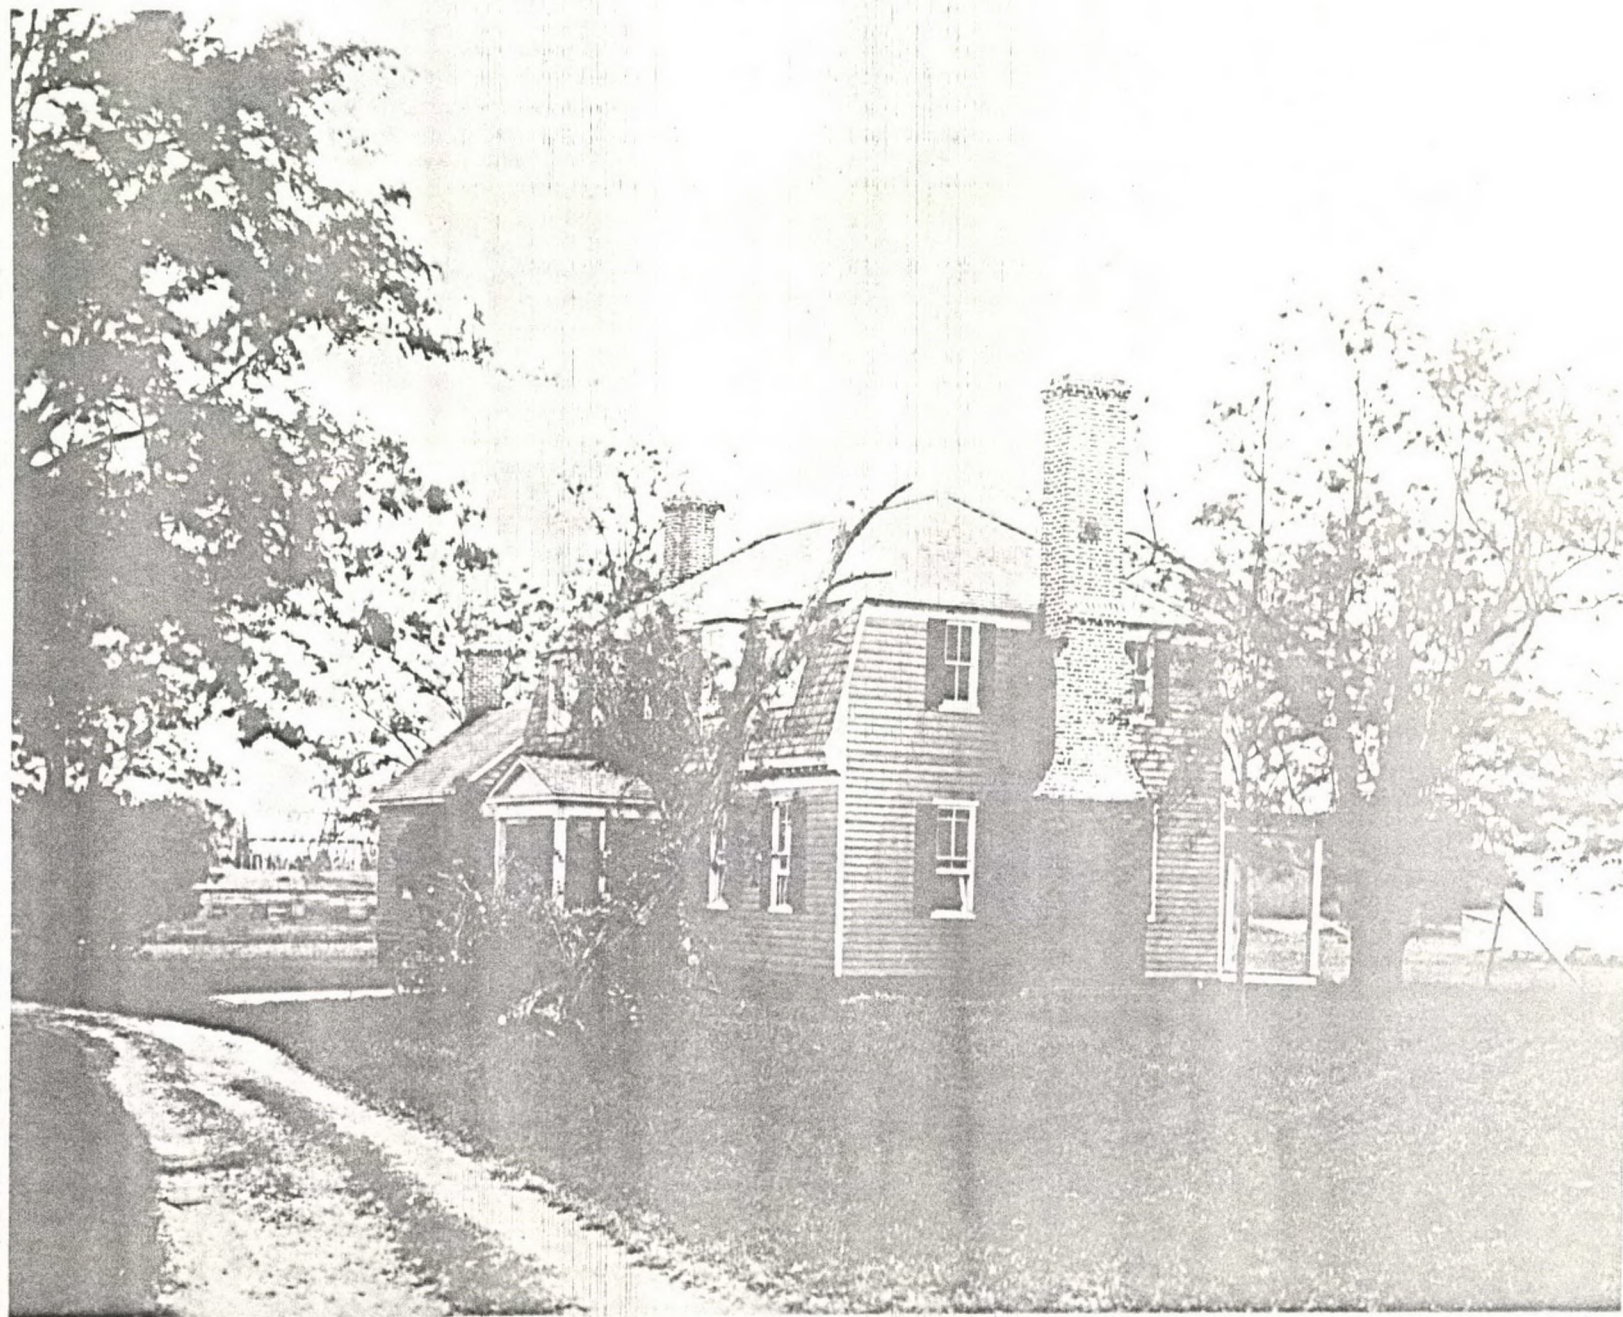
PLATE NO. 11-3

This view seems to belong to the 1911 copyright group (note paint tones) represented in 11-C and D. Reproduced from print in the Library of Congress.

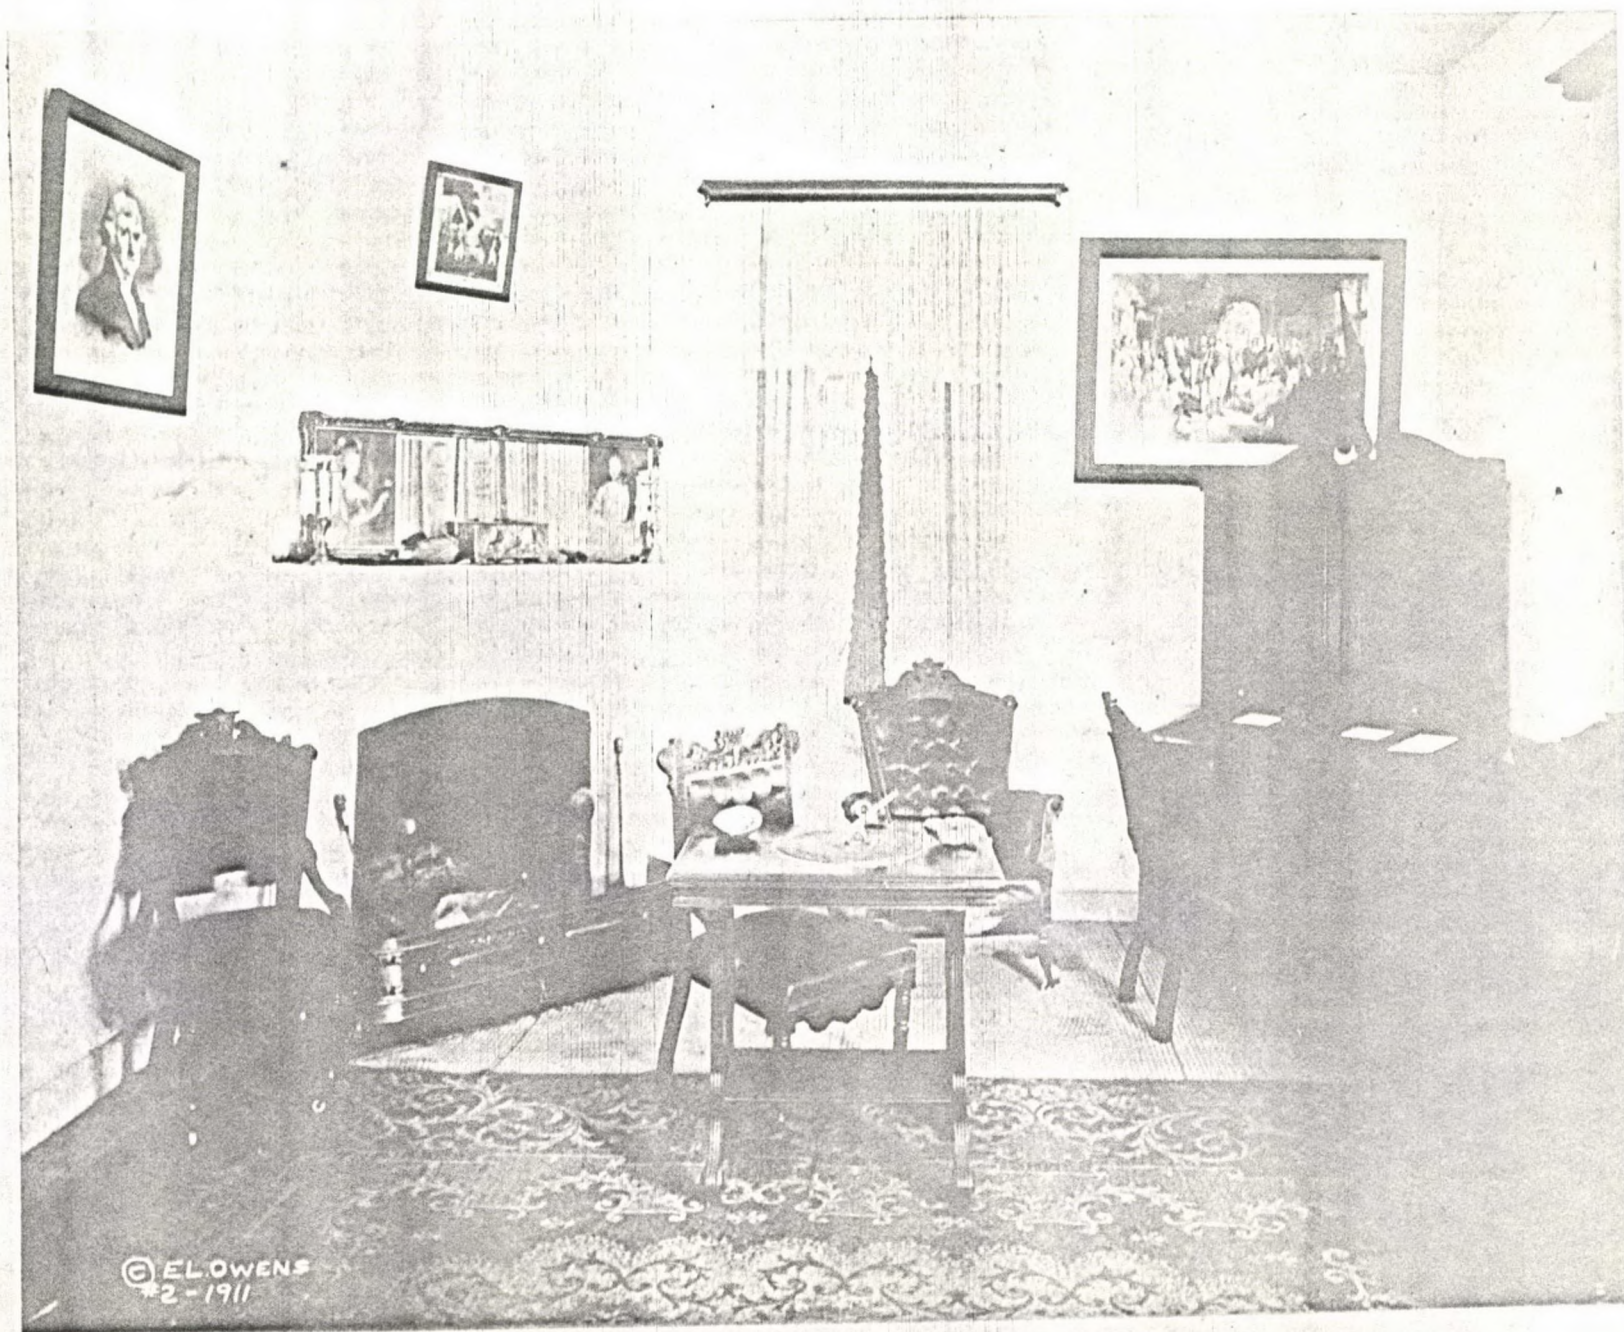
PLATE NO. 11-F

View of the interior of the "Surrender Room."  
Copyright 1911 by E. L. Owens. Reproduced from  
print in the Library of Congress.

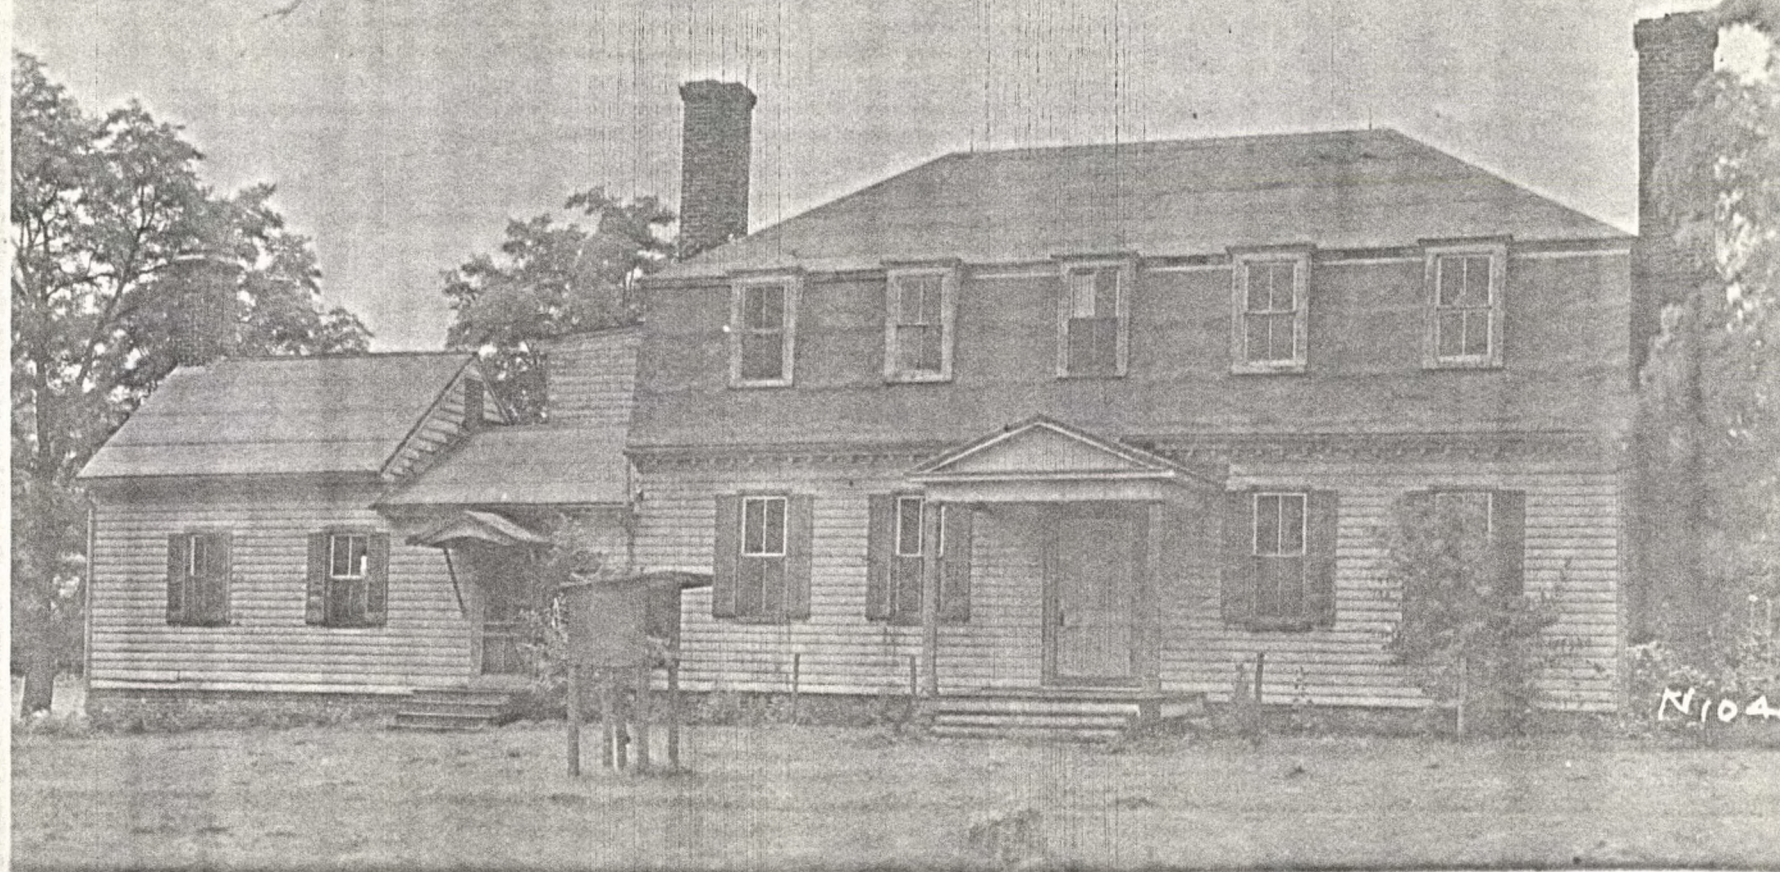
**PLATE NO. 12**

**Front view of the House, July 1931, before the 1931 restoration work. Note the Victorian window sash, shutters, door and porch. The roll roofing was a protective measure supplied by the Williamsburg Holding Corporation. The hose connection, provided by some thoughtful agency, was connected with the Navy Mine Depot water supply.**

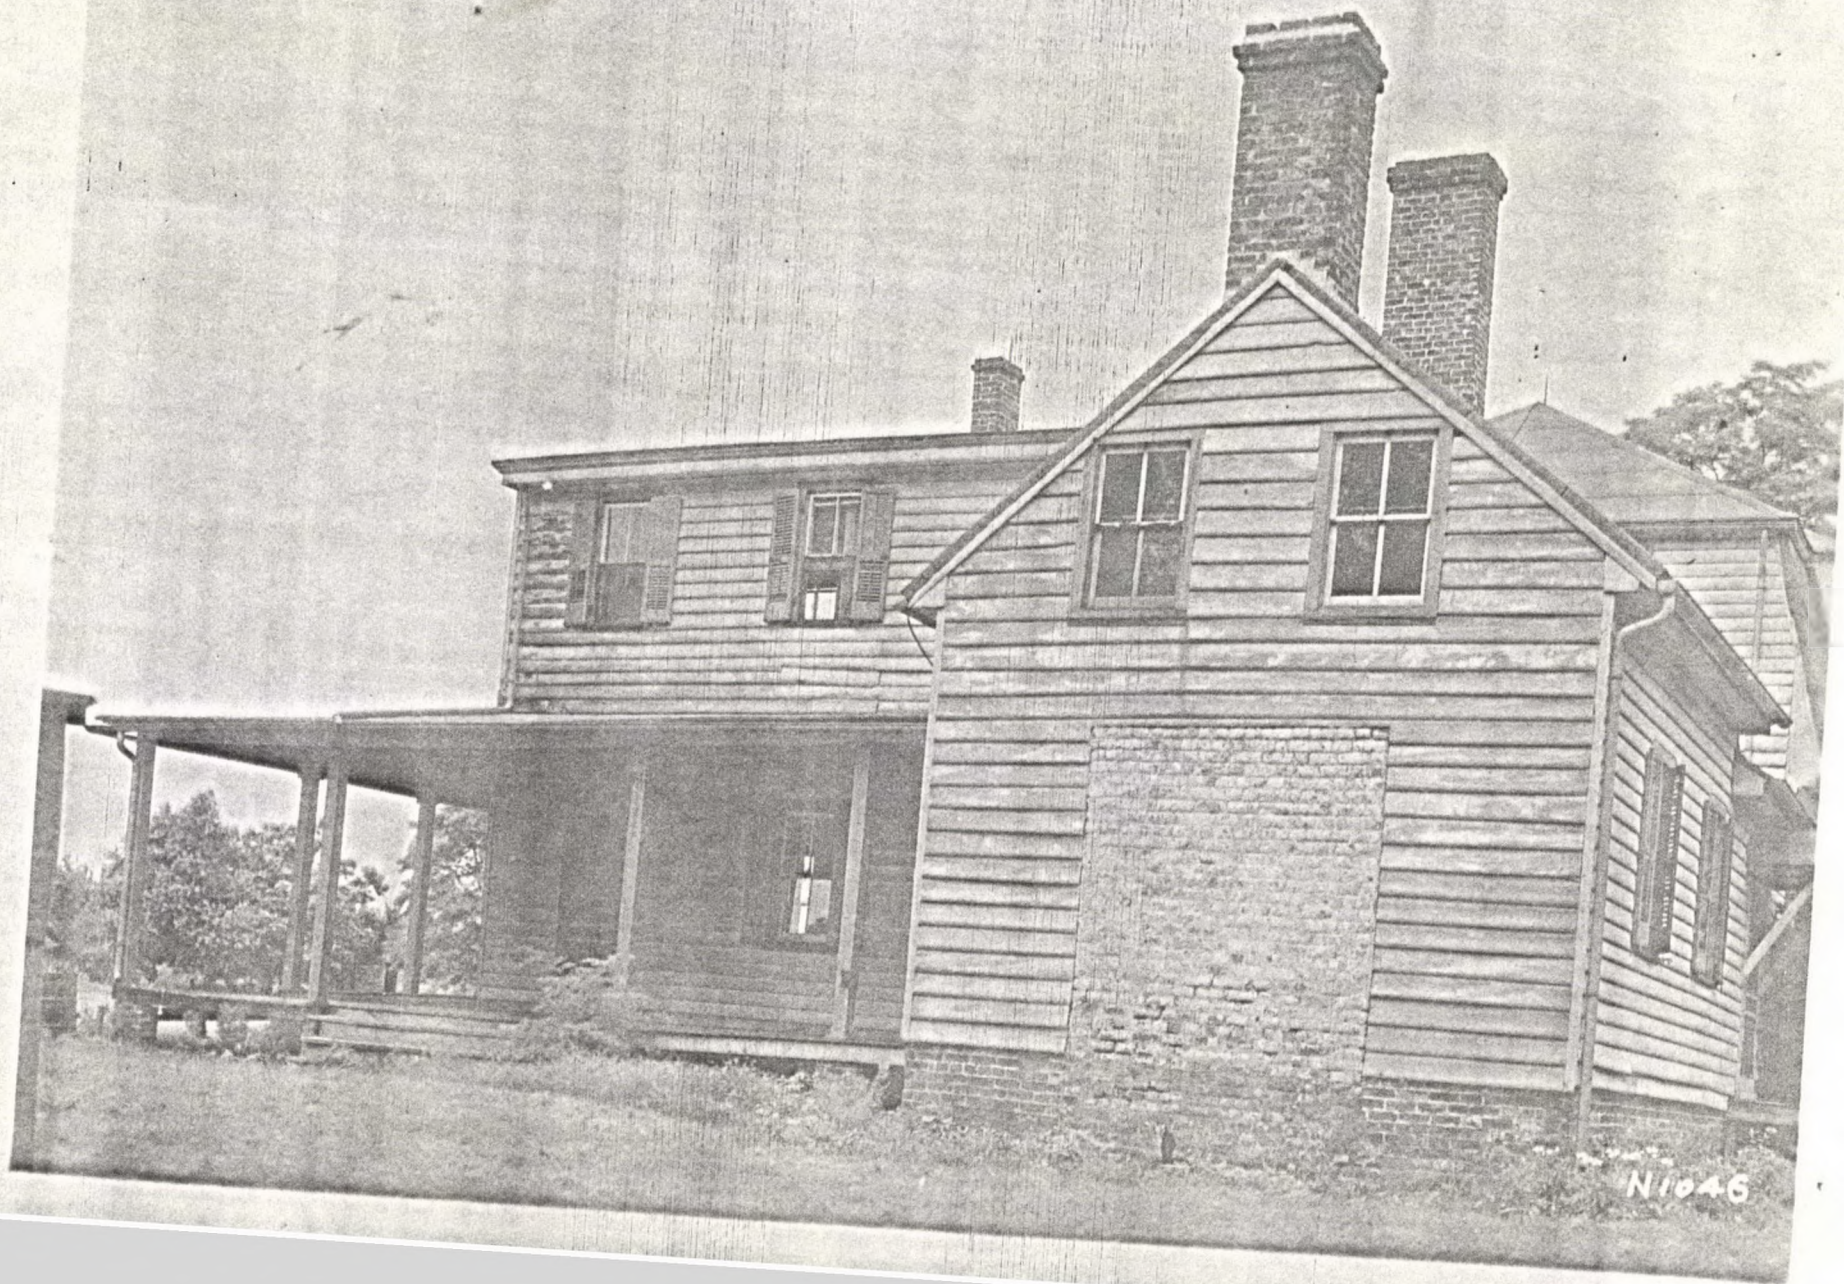
PLATE NO. 14

East wing detail, July 1931. This wing is thought to have been added somewhere between 1800 and the Civil War. Its foundations are of common bond, whereas those of the main structure are of Flemish.

(1) See Plates Nos. 14 and 15.

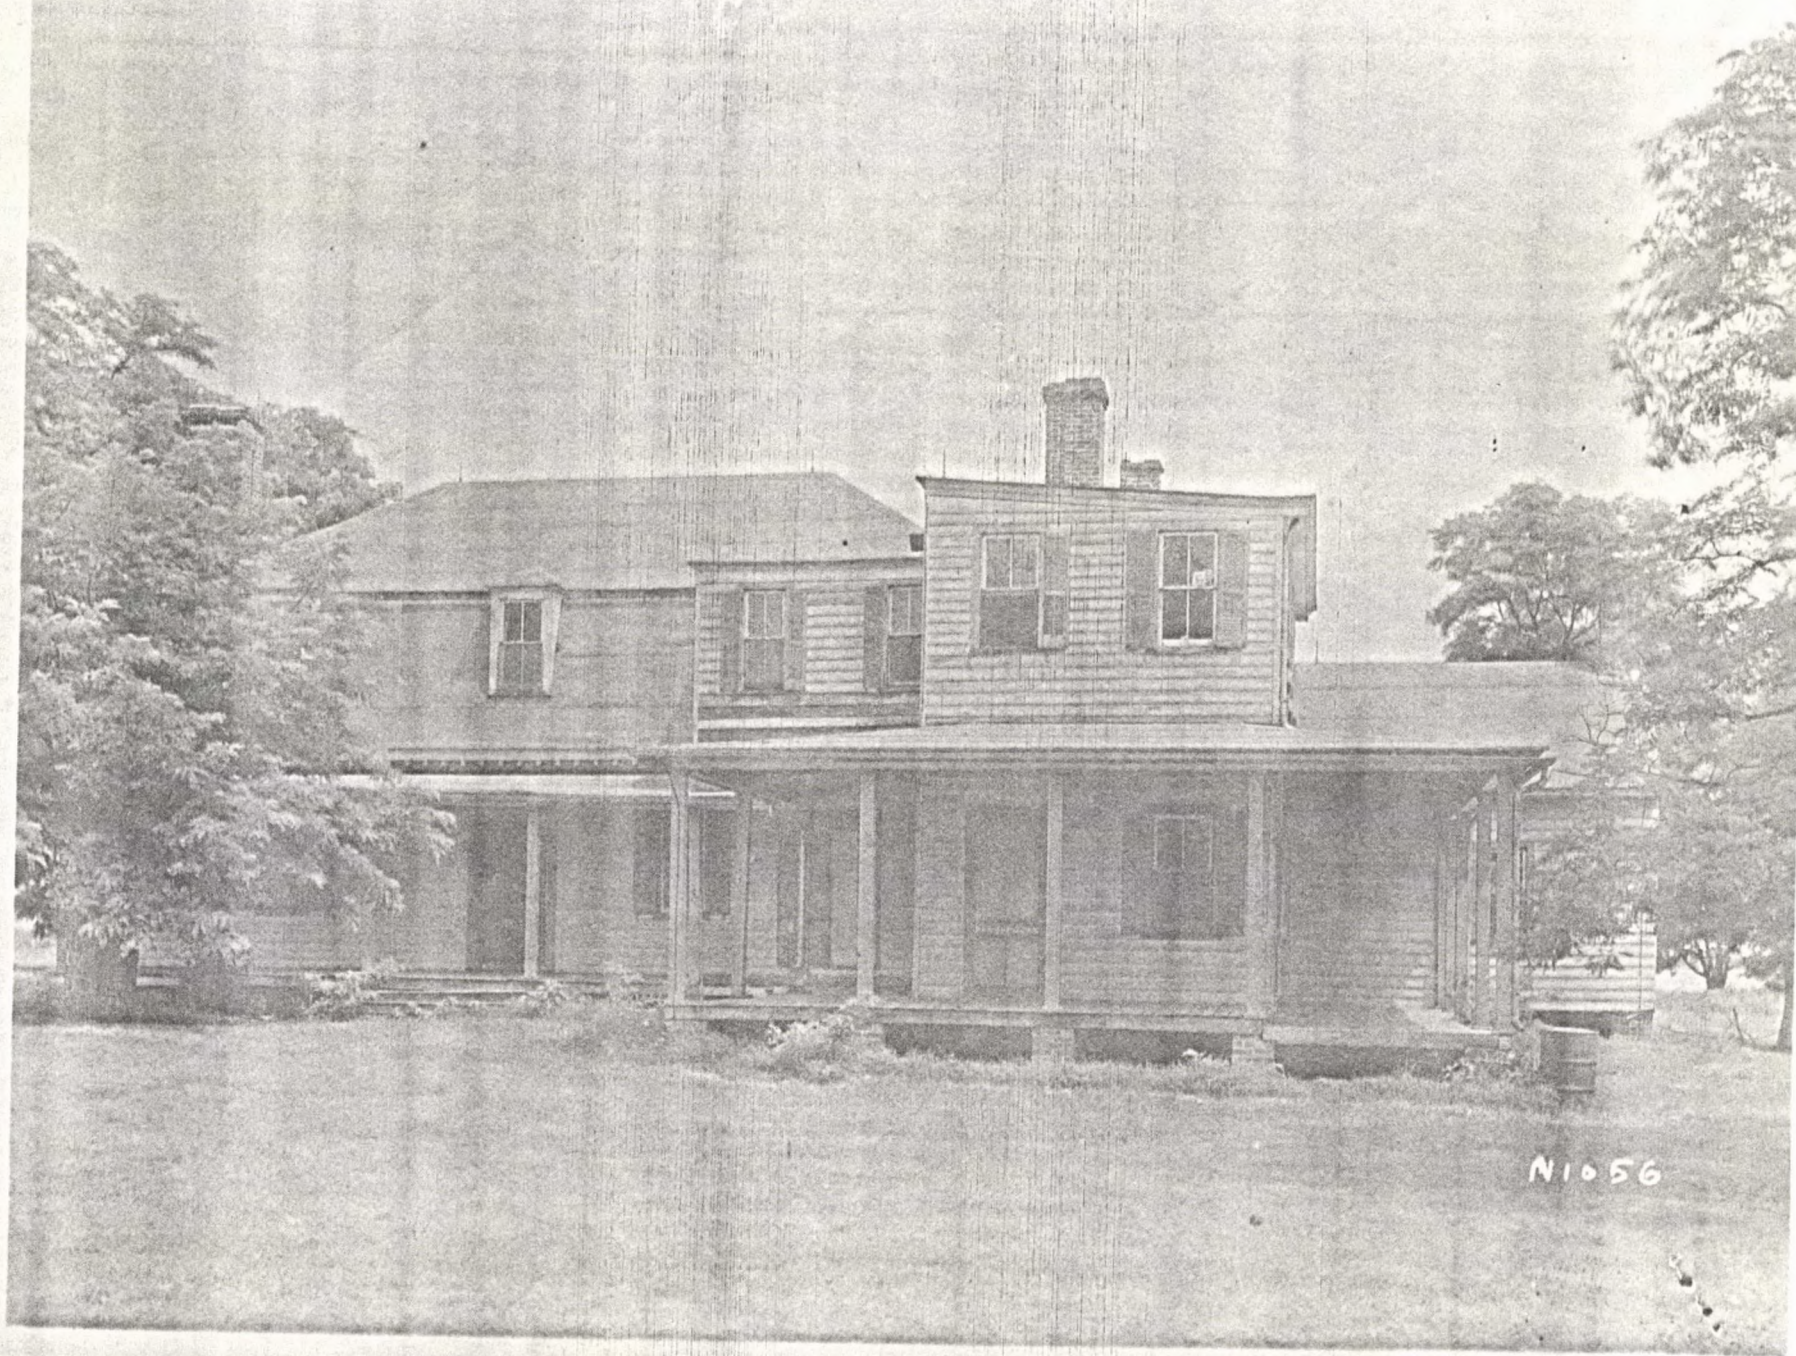
PLATE NO. 16

Rear View, July 1931. The rear wing was built at two different times: the lower floor was added for "the entertainment of distinguished visitors" in 1881, and the upper floor by John Cruikshank about 1886.

A third dormer was torn away during the Cruikshank additions, but part of the framing remained in the walls.

(1) See Plate No. 16.

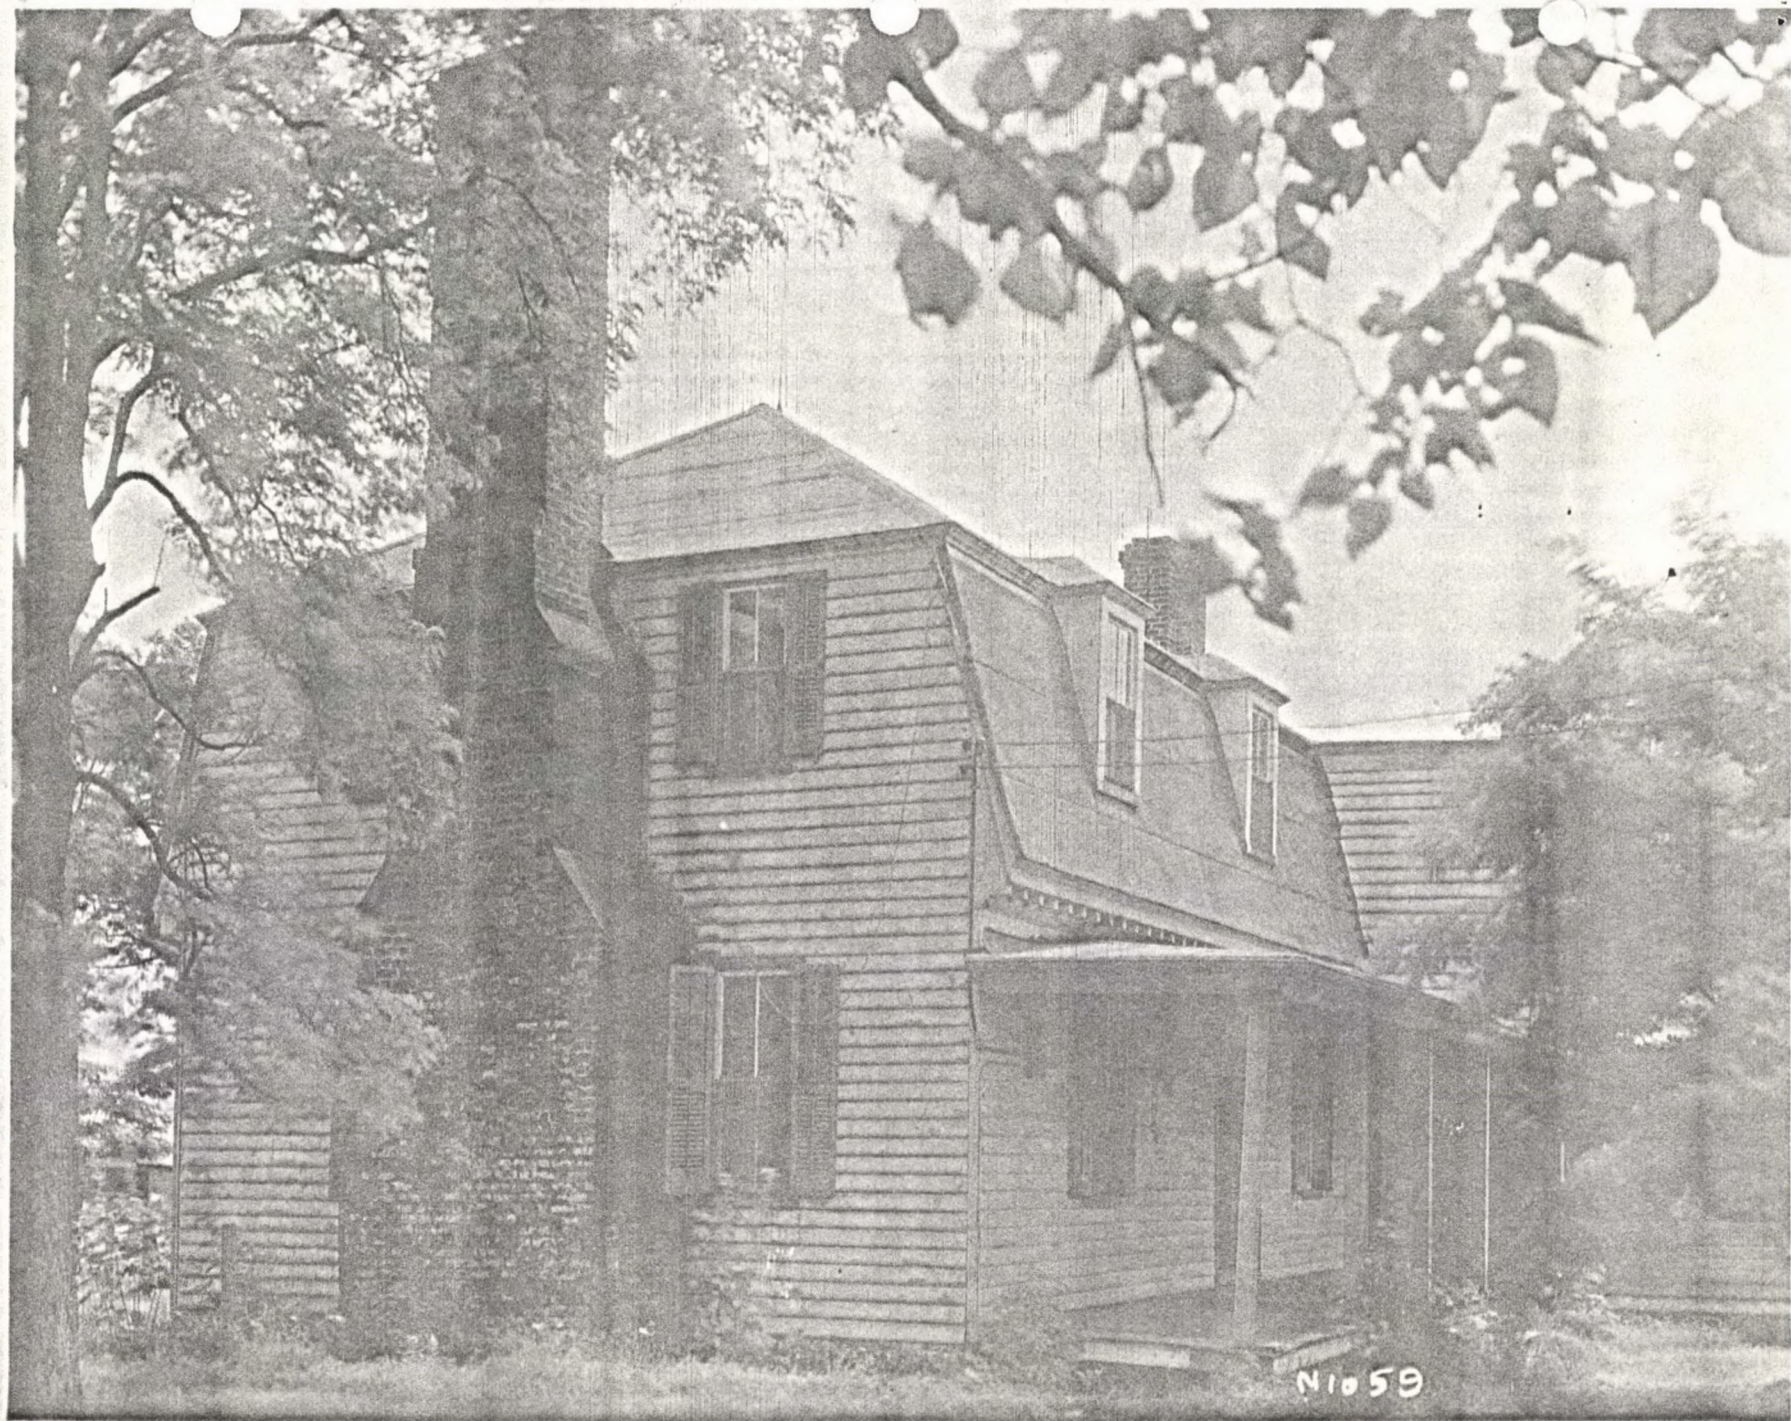
PLATE NO. 17

Southwest corner detail, July 1931.

The rear cornice was largely buried under the Victorian porch roof. Original modillion blocks, when removed were found to be of poplar fixed in place with wrought nails.

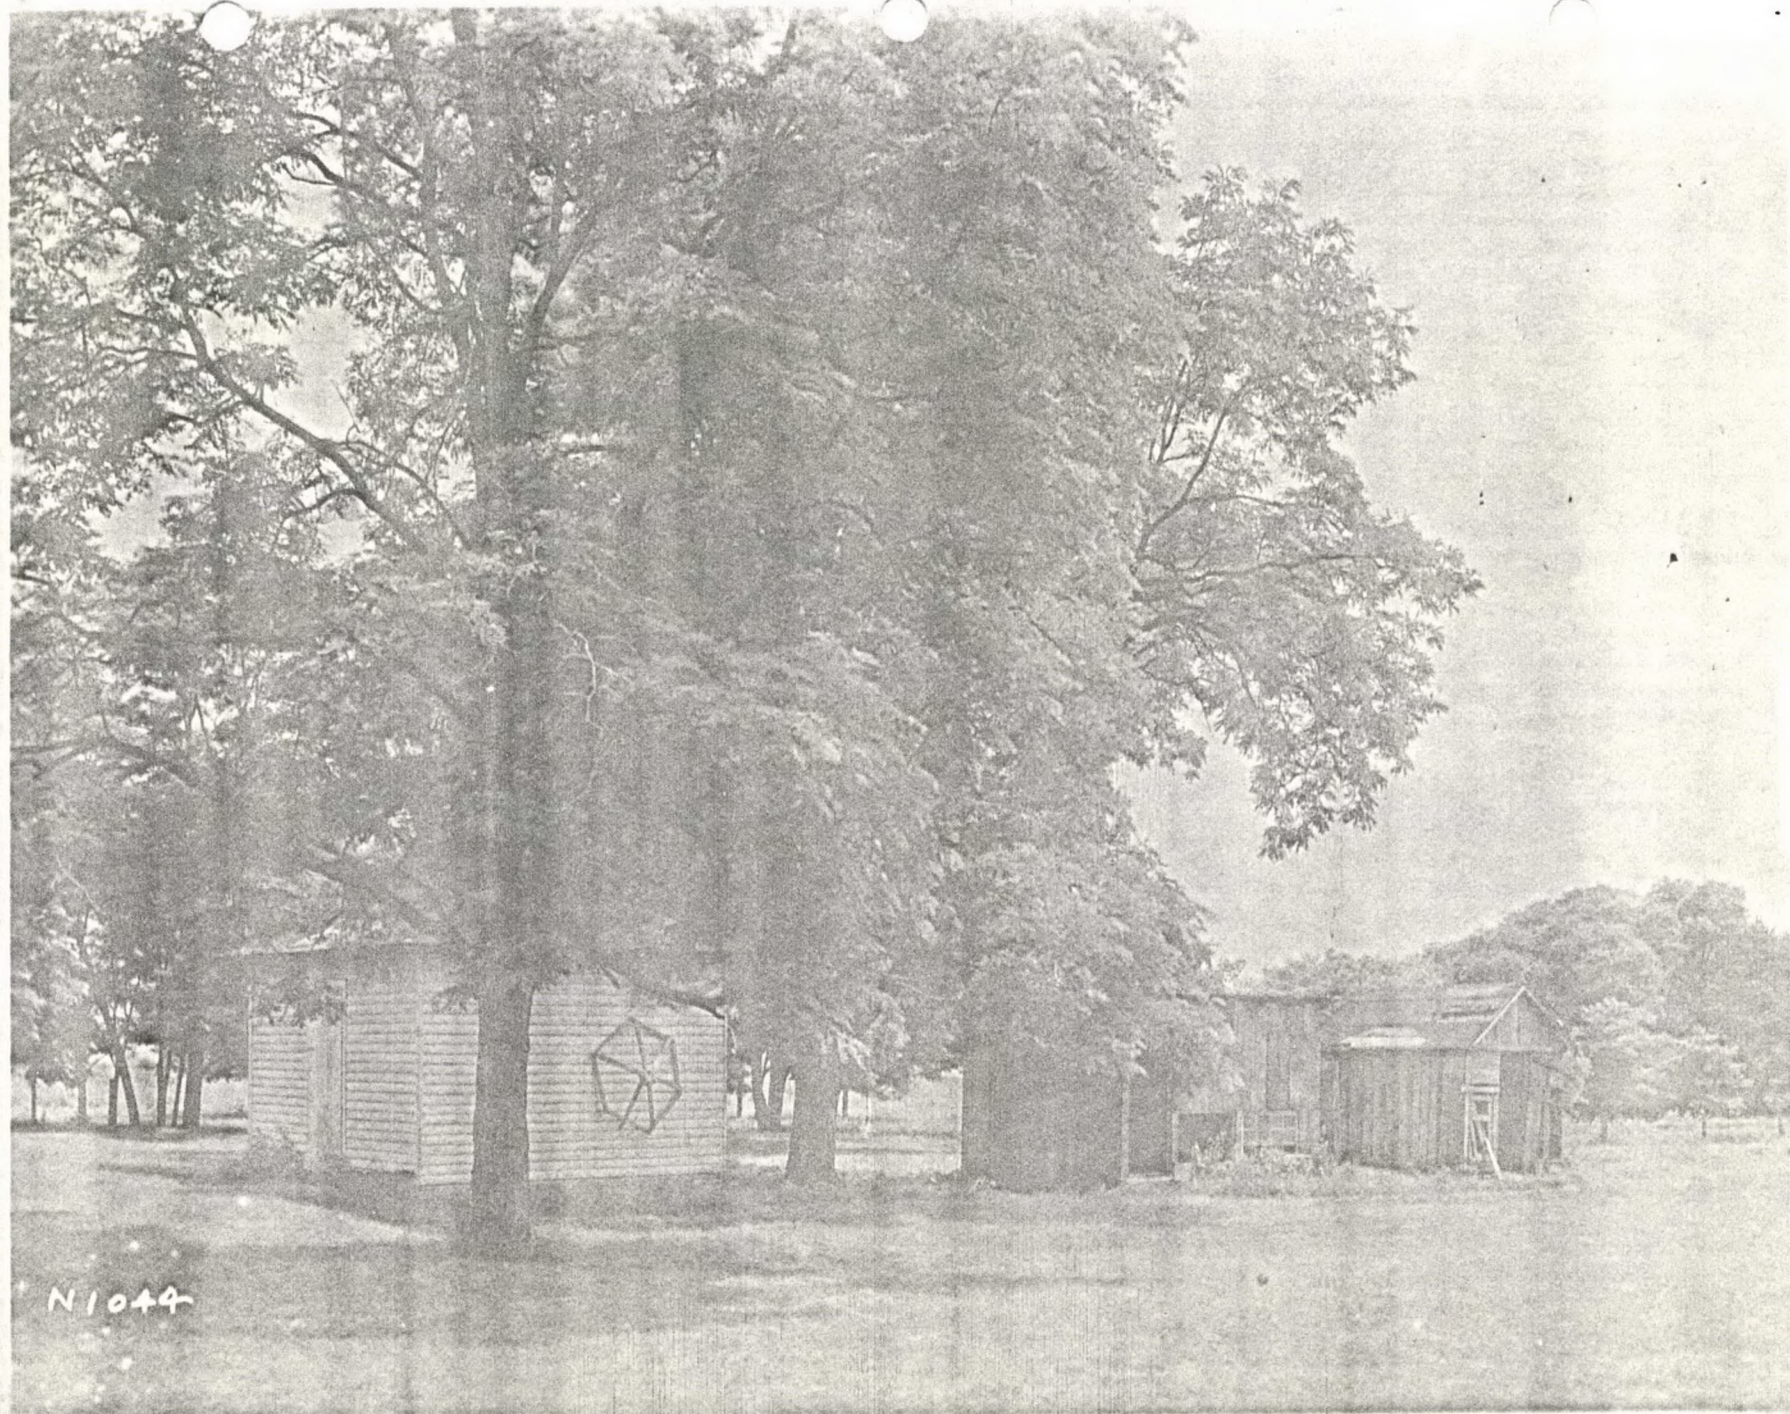
PLATE NO. 20

More outbuildings, July 1931. One not  
shown in these plates was a double maple  
bowling alley in the orchard.

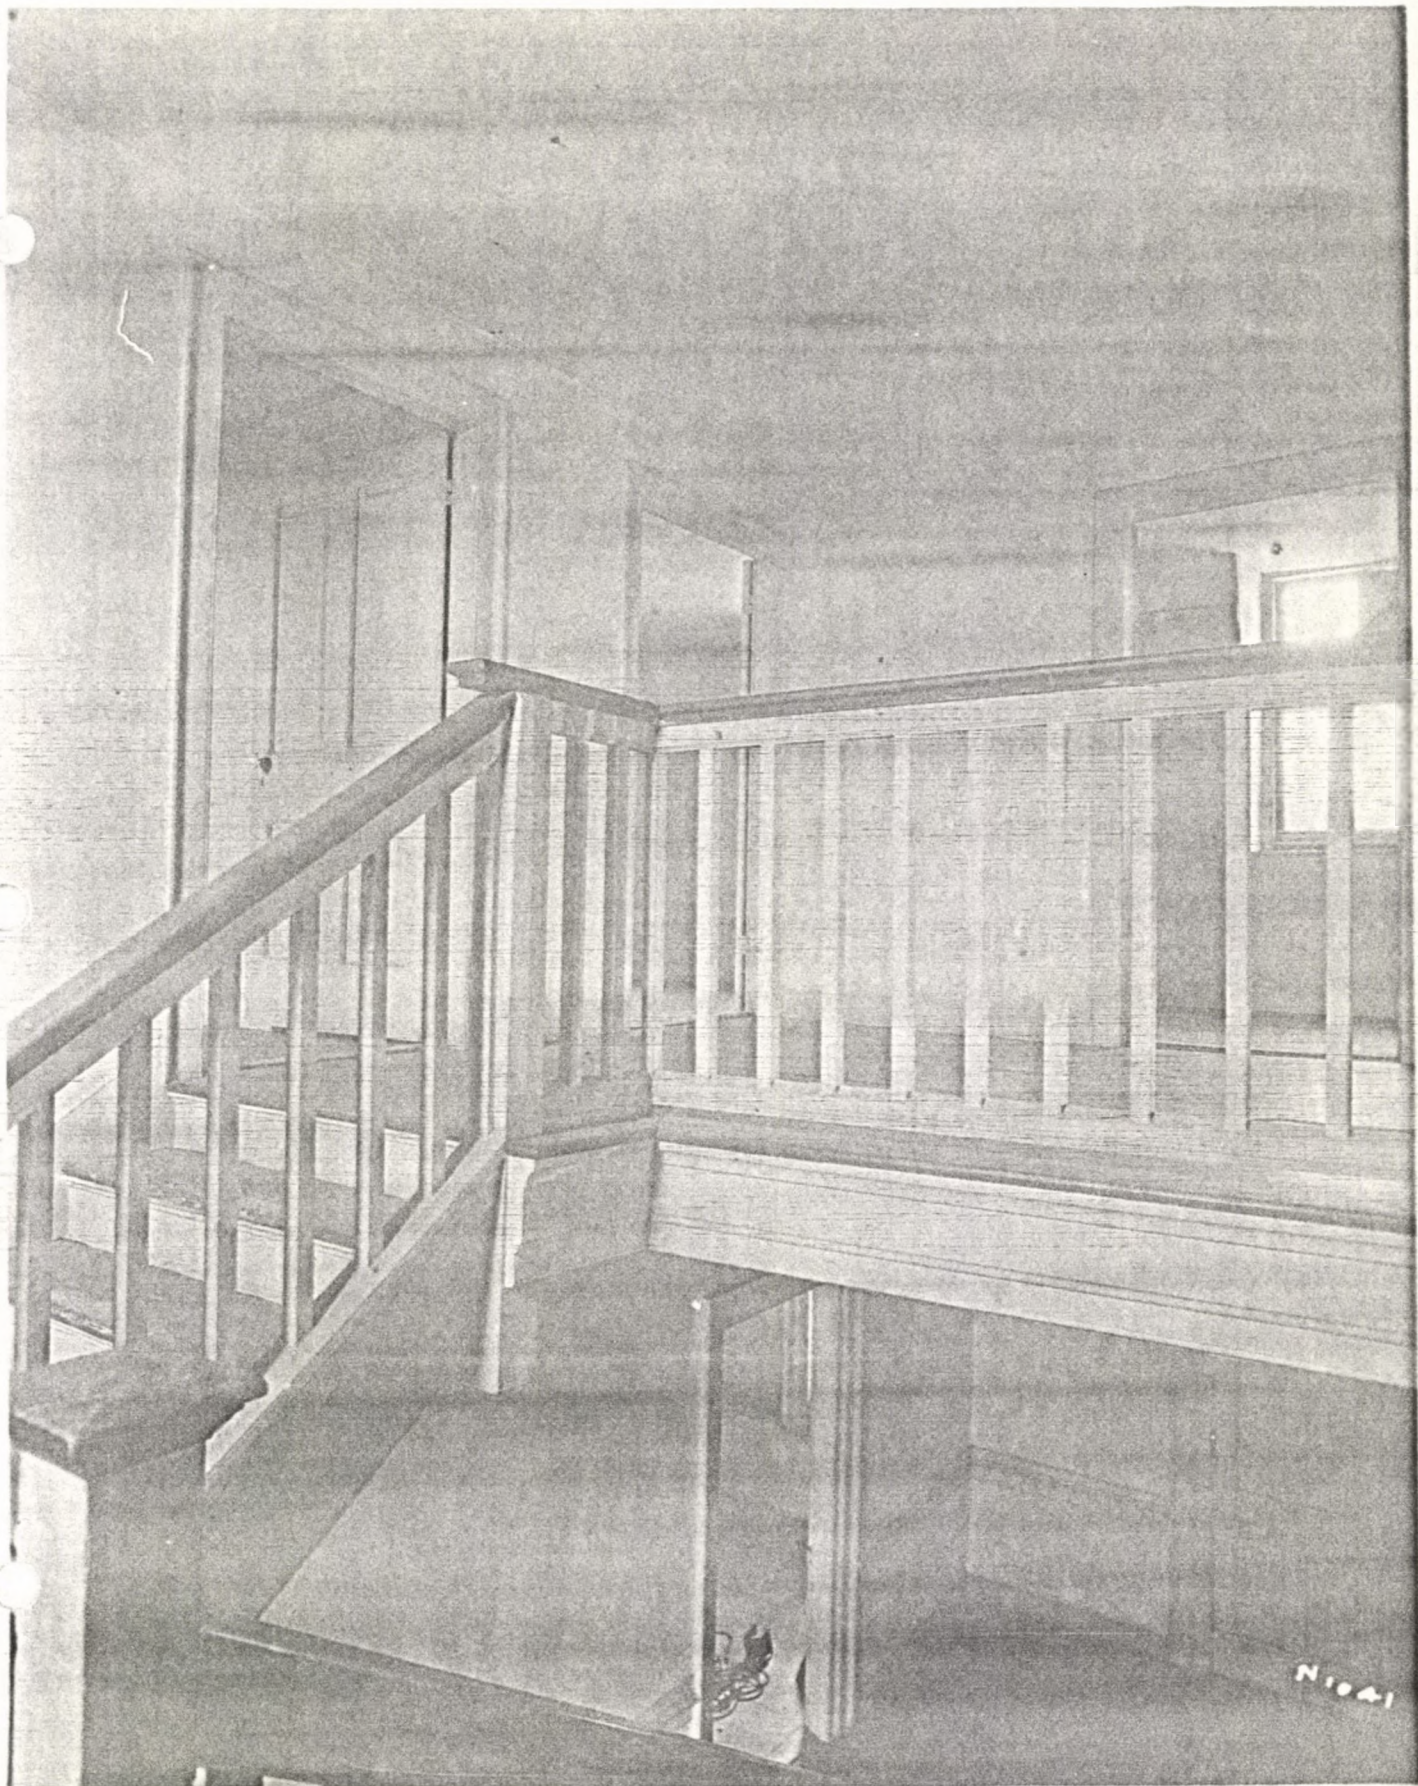
PLATE NO. 25

Stairway detail, July 1931. The modern stringer, rail, and balusters continued across the well. They were thought to have been 1881 construction.

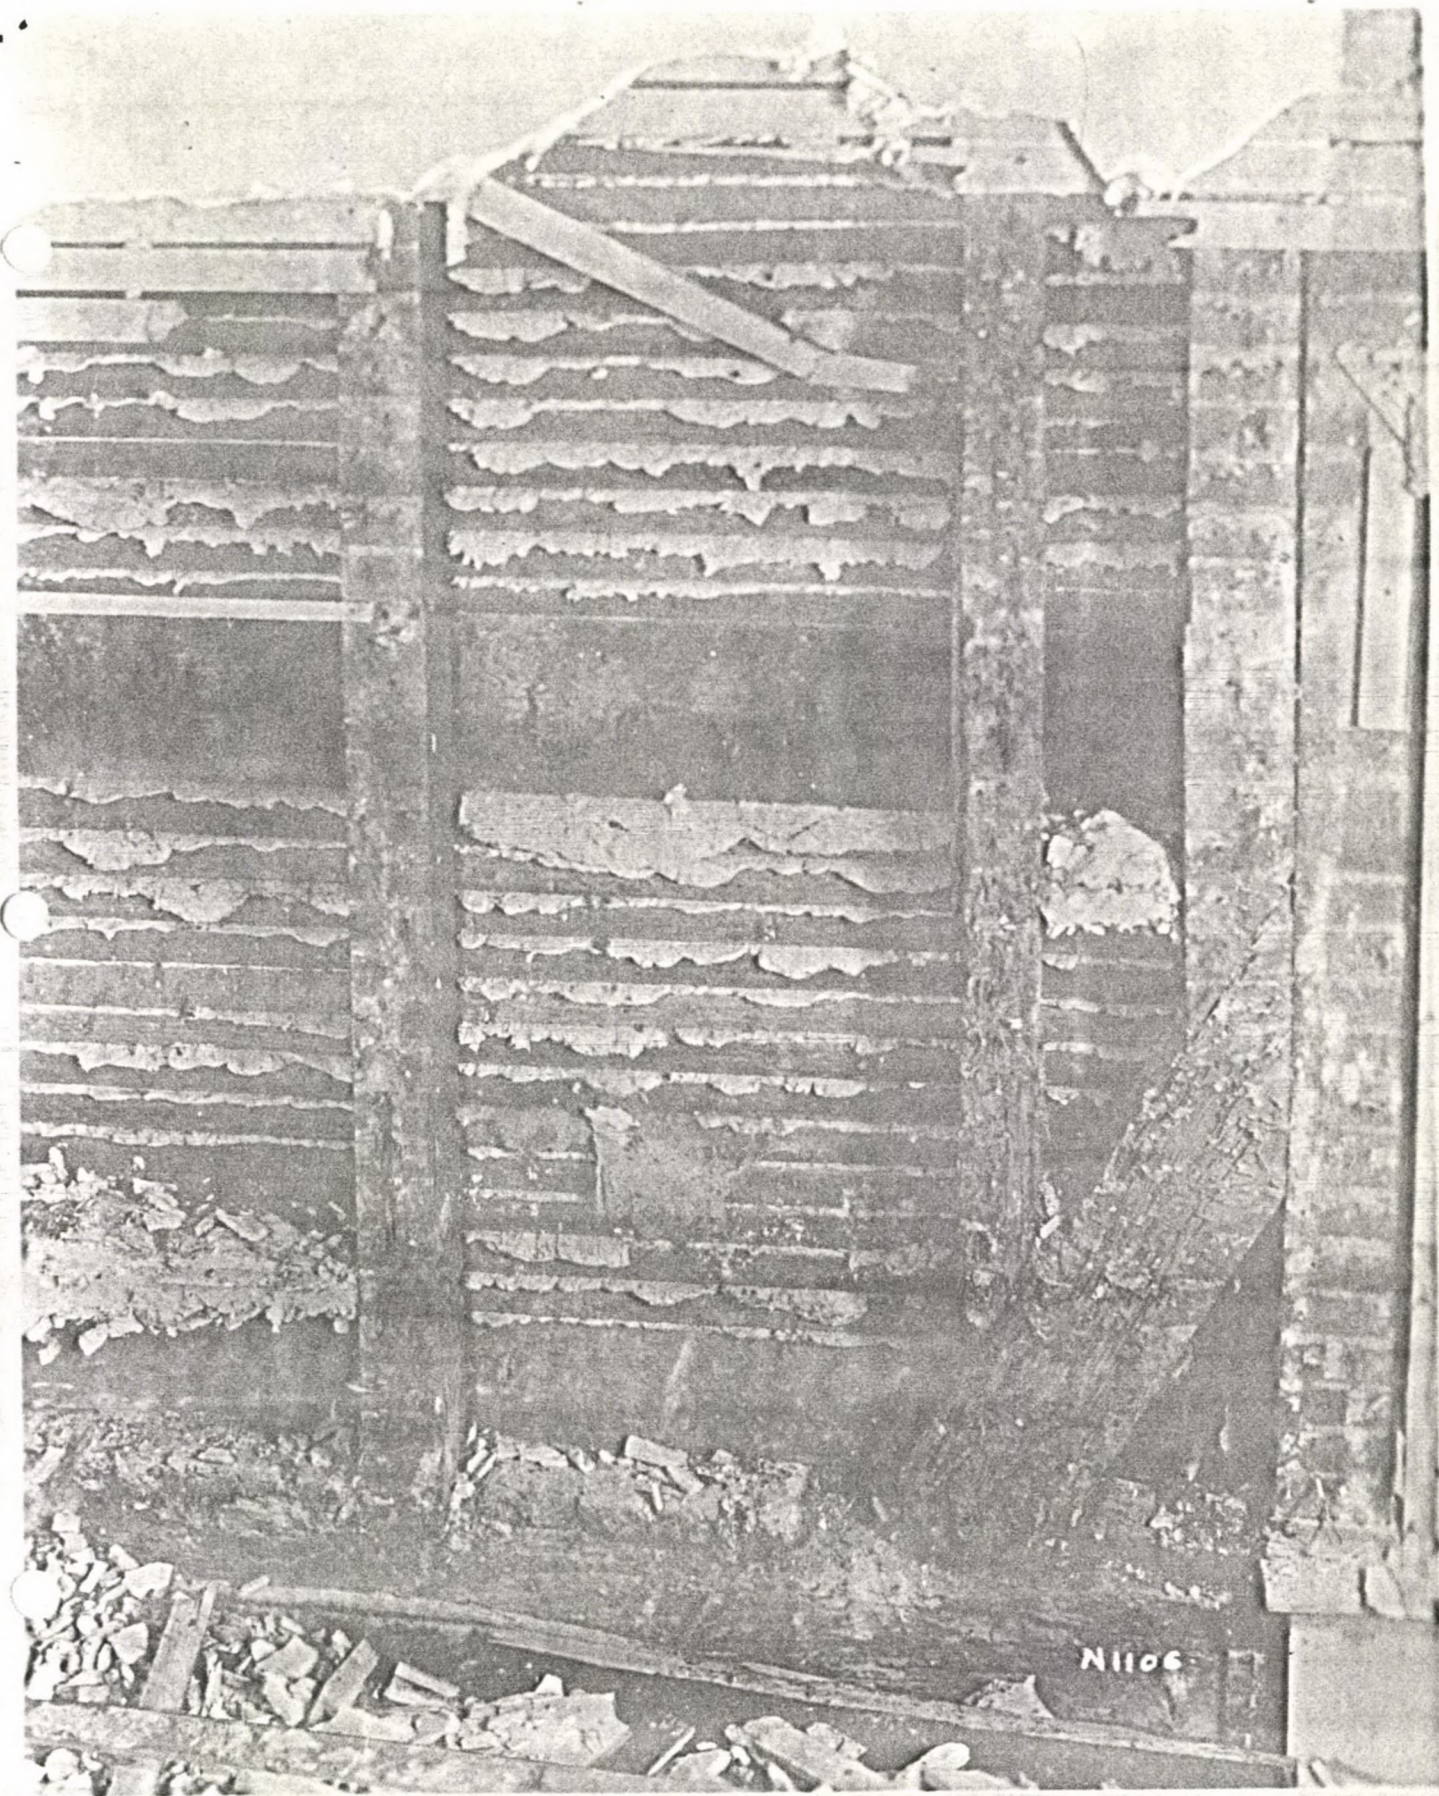
PLATE NO. 39

Detail of framing, southeast corner of the first floor, July 1931. The corner post and cross-brace were badly rotted and had been patched.
