National Park Service  
Cultural Landscapes Inventory  
2010

Badger Pass Ski Area  
Yosemite National Park

## **Badger Pass Ski Area**

### **Yosemite National Park**

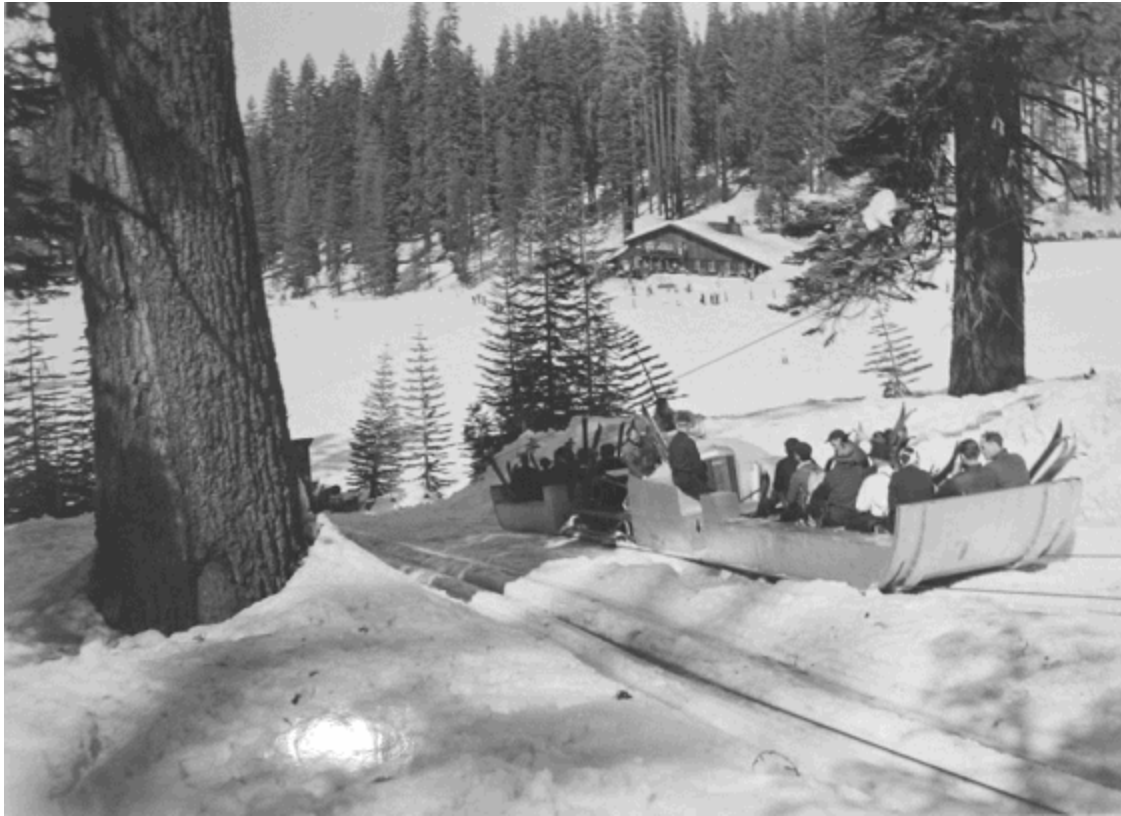
*Up-ski, Queen Mary sled, looking northwest towards Badger Pass Ski Lodge, 1937.  
Source: Yosemite Research Library.*

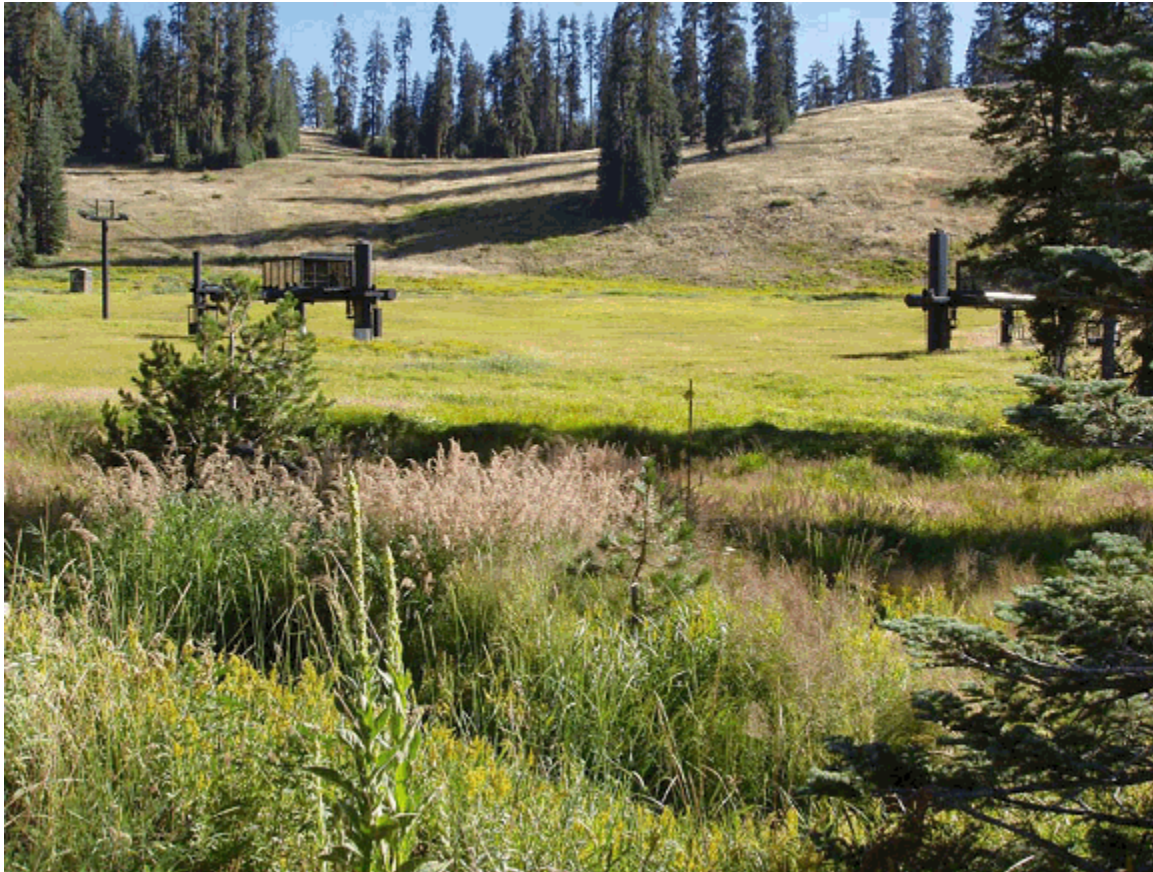
*Grouse Creek and wetland. Source: PGADesign, 2008*

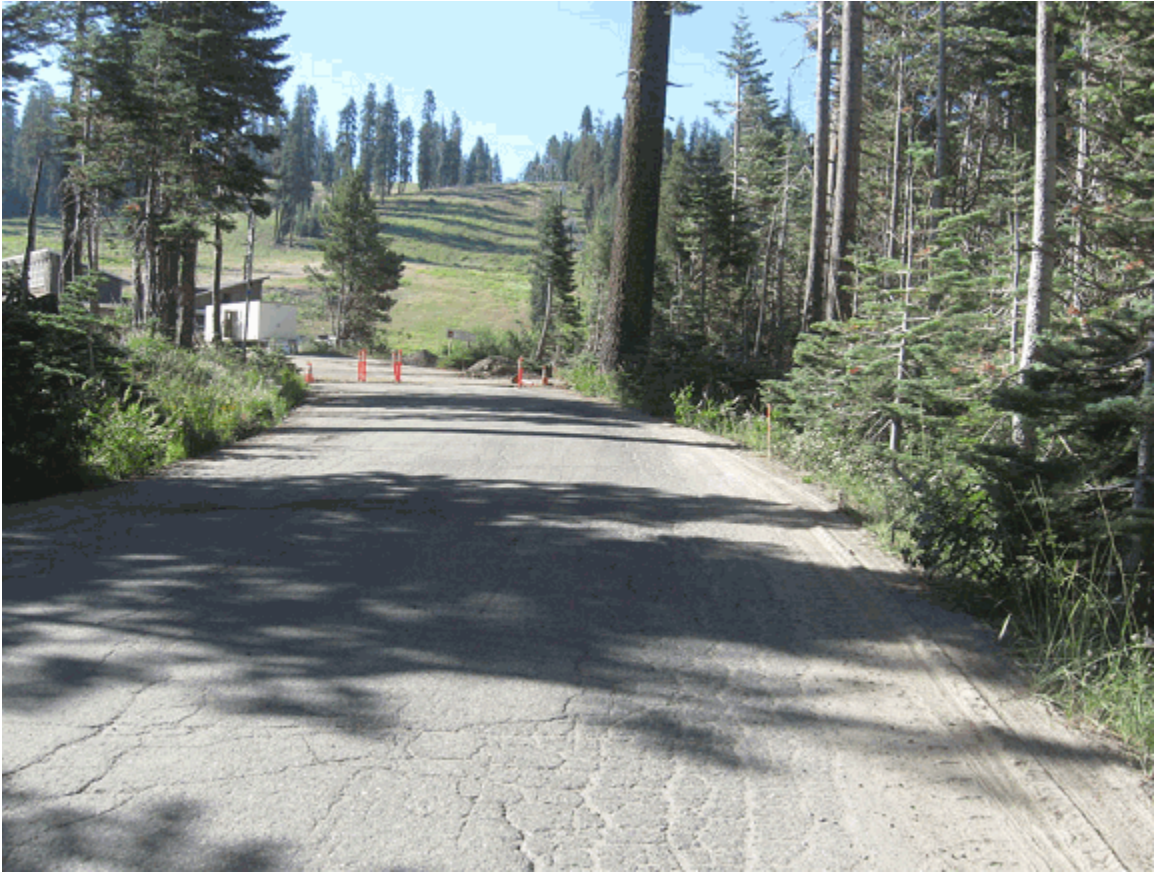
The paved asphalt road measures approximately 22'-0" wide and is severely cracked and unevenly patched. Currently the road is in fair condition and is in the process of undergoing repairs. The road does not have curbs, and is instead defined by a 2'-0" to 4'-0" sandy embankment on either side. The character of the road is defined by its slightly curved shape, width, cross slope and pitch at the curves, as well as its slightly upward slope towards the Badger Pass Ski Lodge. The Badger Pass Access Road contributes to the site as the major circulation route providing vehicular access to the Badger Pass Ski Area.

*Badger Pass Access Road, looking south. Source: NPS, 2009.*

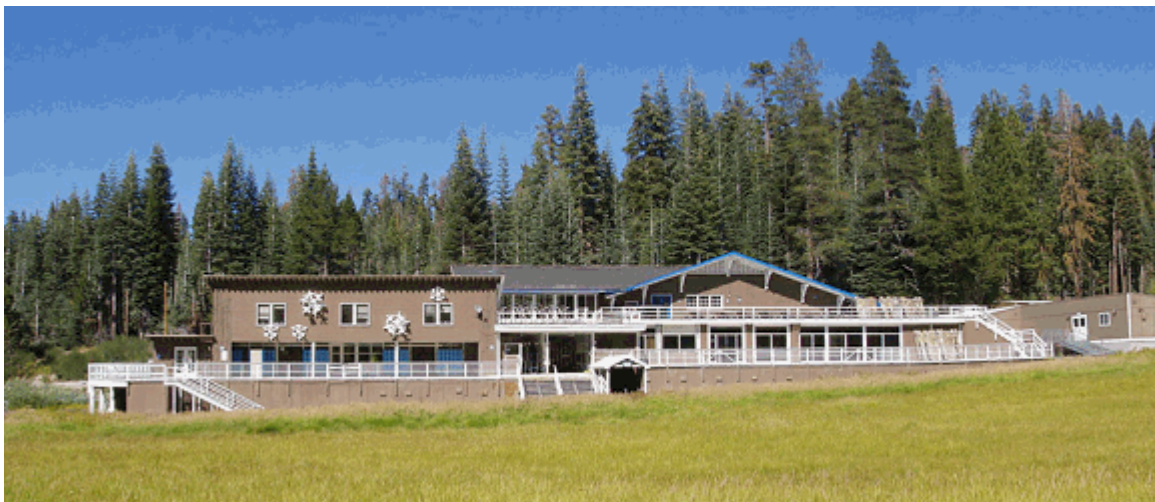
The Badger Pass Ski Lodge was constructed in 1935 to provide permanent facilities for downhill skiing operations at Badger Pass. Located at the base of Monroe Meadow, the original building was designed in the Park Service Rustic style with Swiss Chalet style influences by Eldridge T. Spencer. The two-story, wood frame building featured cubic massing, a dramatic gable roof, and rustic wood finishes. The main (north) façade faced the parking area while the rear (south) façade faced the meadow and the ski slopes above.

Almost immediately upon completion of the lodge, plans were made to expand its facilities and the building underwent a series of alterations over time. These alterations began as early as 1936 and included minor alterations in 1938, major alterations completed between 1954 and 1956, when a shed-roof addition was constructed to the west of the original lodge. Additional alterations were made between 1957 and 1968, the building was stabilized in 1996, and emergency deck repairs were made in 2005 and 2007.

*Badger Pass Ski Lodge, looking north. Source: Page & Turnbull, 2008.*

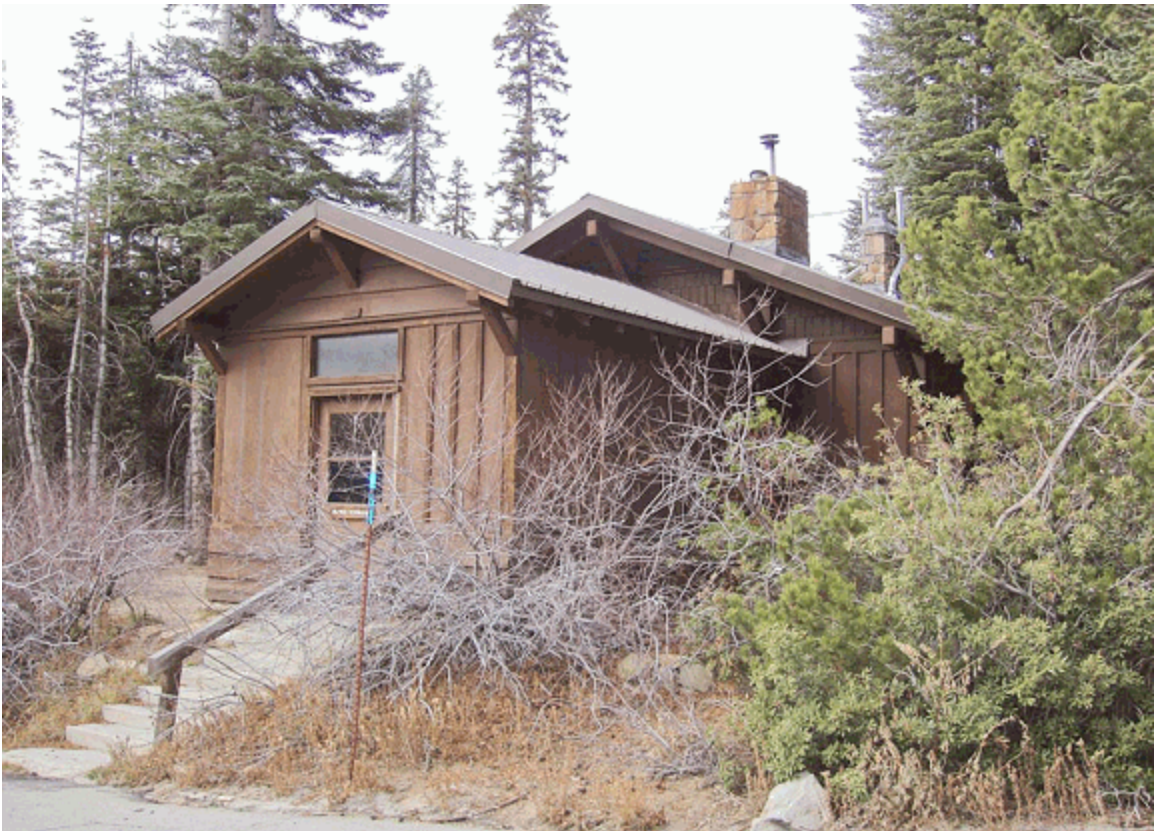
*NPS Ranger Residence, looking west. Source: Page & Turnbull, 2008.*

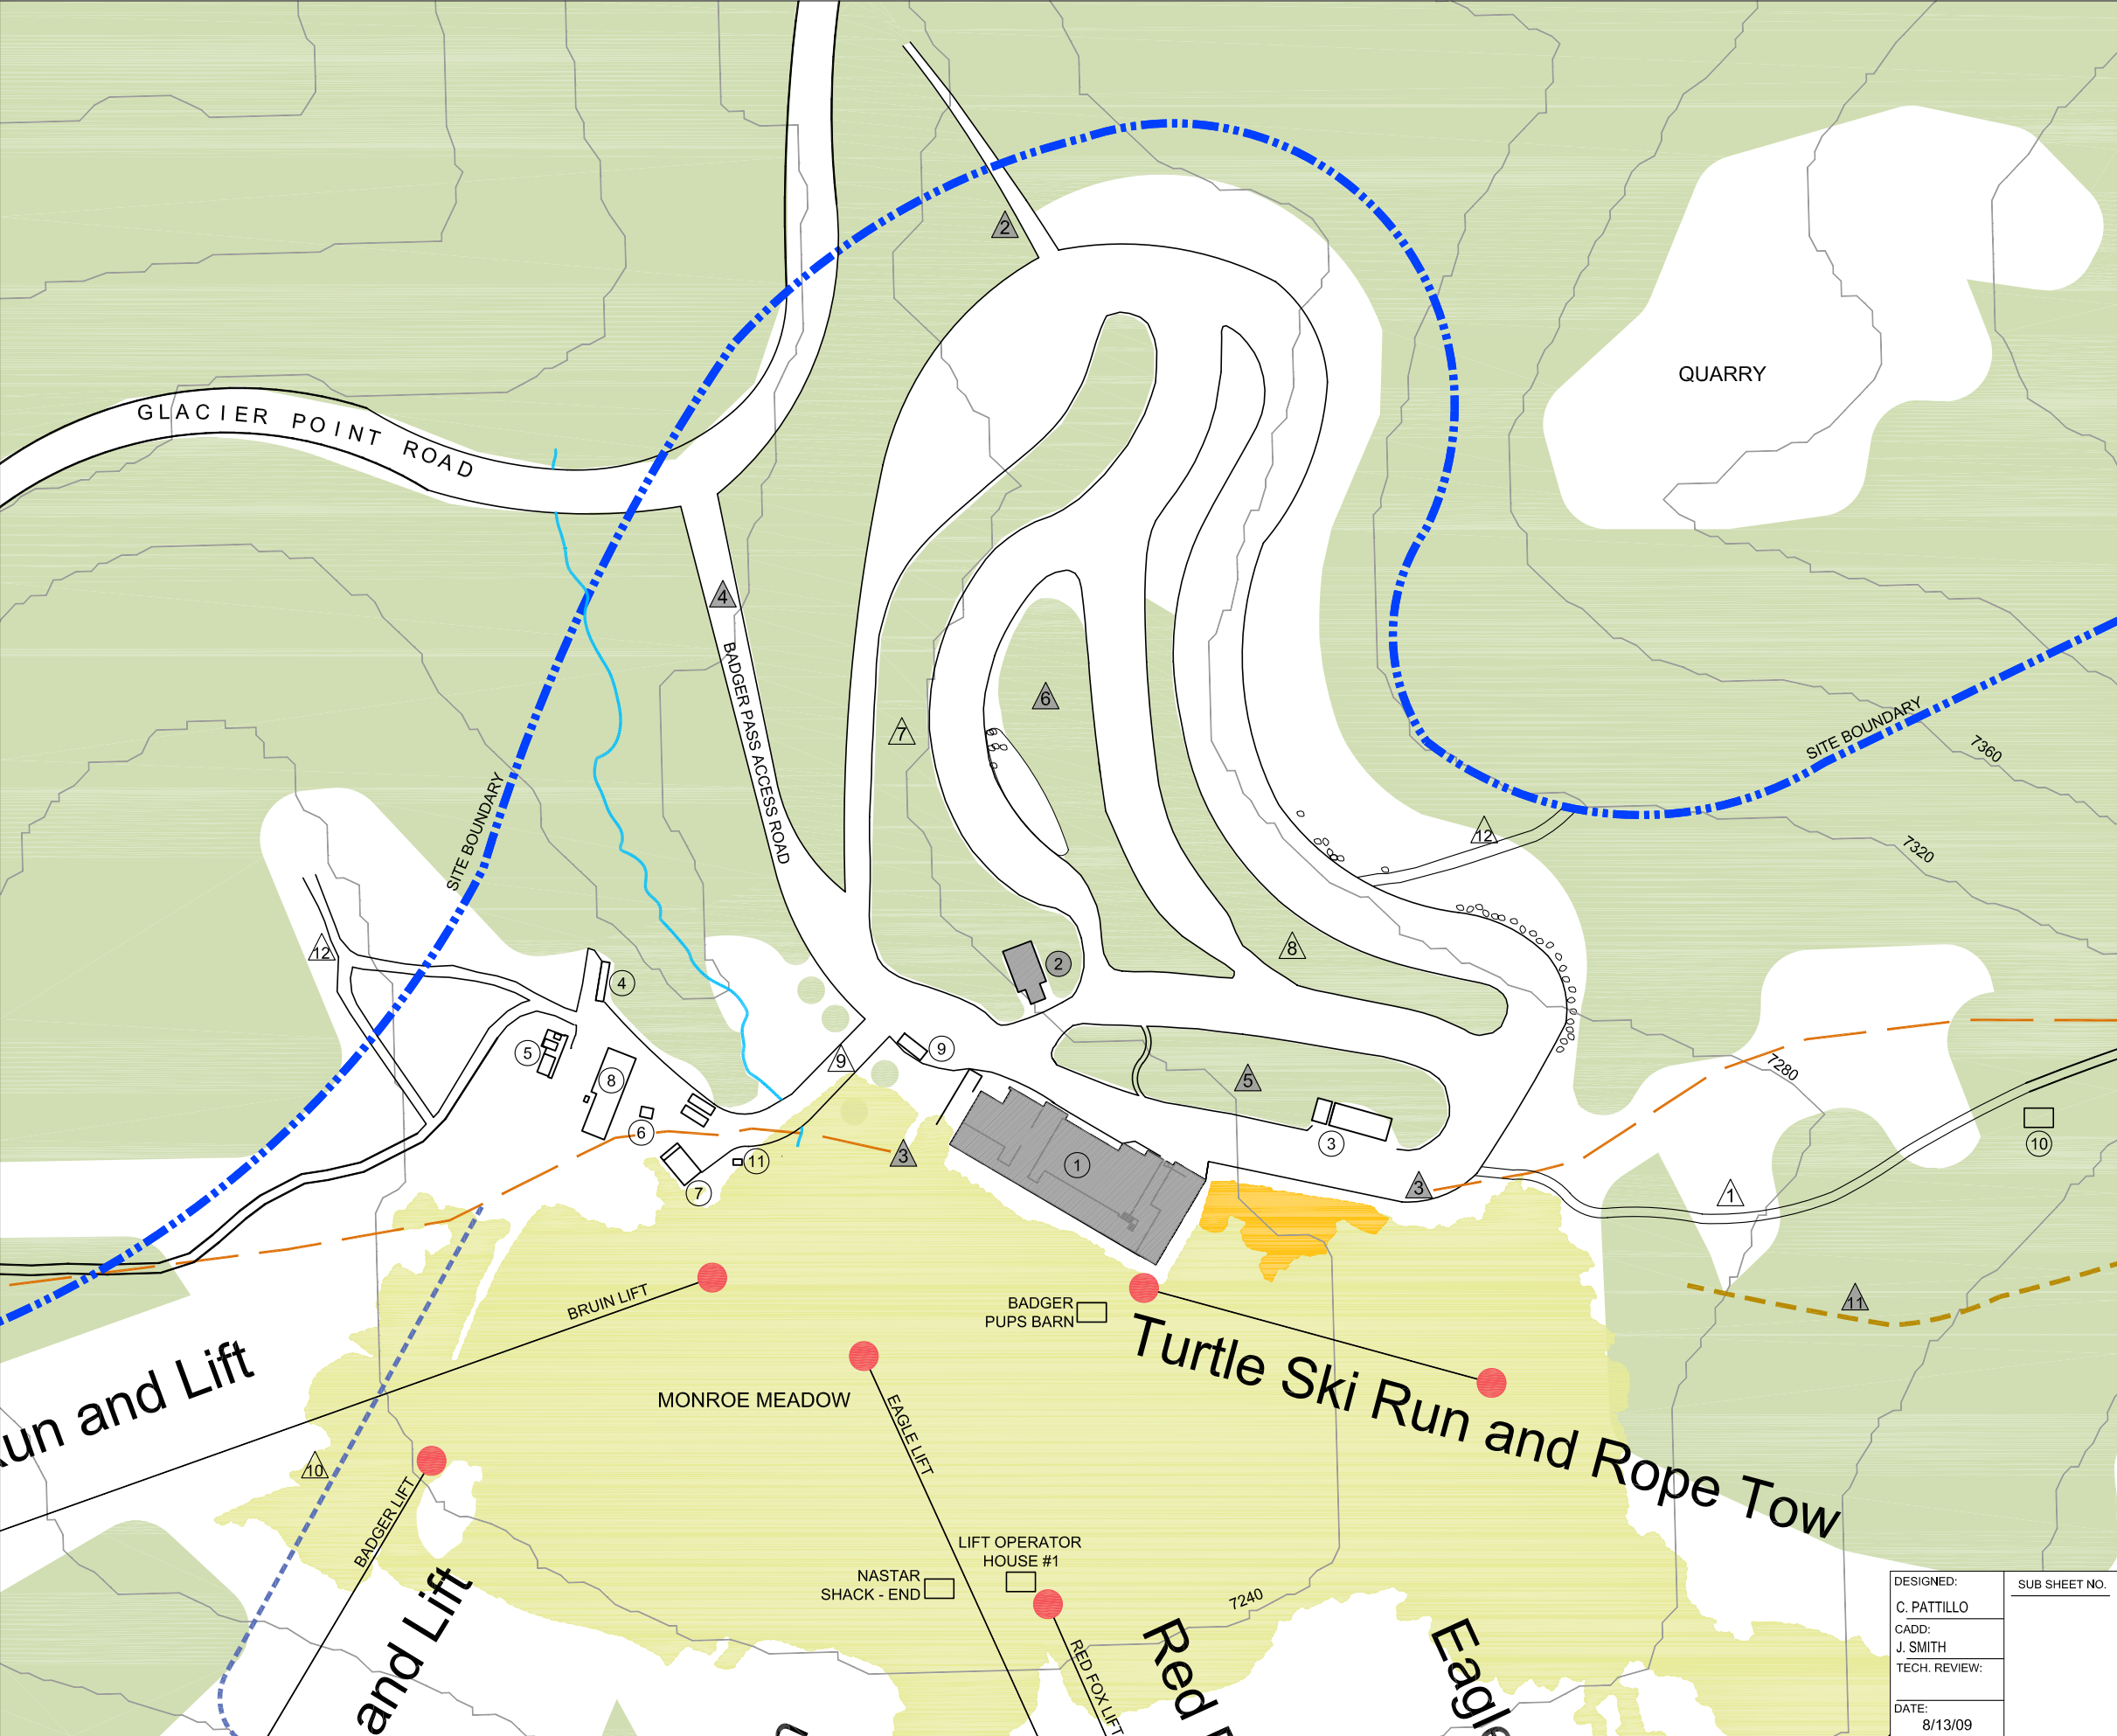
- KEY
- 1 BADGER PASS SKI LODGE
  - 2 RANGER RESIDENCE
  - 3 CROSS COUNTRY SKI RENTAL
  - 4 STORAGE CONTAINER
  - 5 MAINTENANCE / FUEL STORAGE
  - 6 MAINTENANCE SHED
  - 7 RANGER STATION
  - 8 MAINTENANCE GARAGE
  - 9 OFF SEASON PORTABLE
  - 10 WATER TOWER
  - 11 WEATHER STATION
  - 12 CROSS COUNTRY TRAIL
  - 13 TRAILHEAD TO GLACIER POINT ROAD XC TRAIL
  - 14 OLD GLACIER POINT ROAD XC TRAIL
  - 15 BADGER PASS ACCESS ROAD
  - 16 ORIGINAL PARKING LOOP (1936)
  - 17 1941 PARKING LOOP
  - 18 1958 PARKING LOOP
  - 19 CA. 1987 PARKING LOOP
  - 20 ROAD TO MAINTENANCE YARD
  - 21 MAINTENANCE TRAIL
  - 22 SNOW SHOE TRAIL
  - 23 MAINTENANCE ROAD
  - 24 SITE BOUNDARY
  - 25 OLD GLACIER POINT ROAD
  - 26 ROCK OUTCROP
  - 27 SKI LIFT
  - 28 RED FIR FOREST
  - 29 WILLOW THICKET
  - 30 HERBACEOUS WETLAND
  - 31 GROUSE CREEK
  - 32 CONTRIBUTING FEATURES
  - 33 NON-CONTRIBUTING FEATURES
