National Park Service
Cultural Landscapes Inventory
2004

Mariposa Grove
Yosemite National Park

CULTURAL LANDSCAPES INVENTORY (CLI) PROGRAM
2009 Condition Assessment Update for:

Cultural Landscape Inventory Level II:
Mariposa Grove
Yosemite National Park

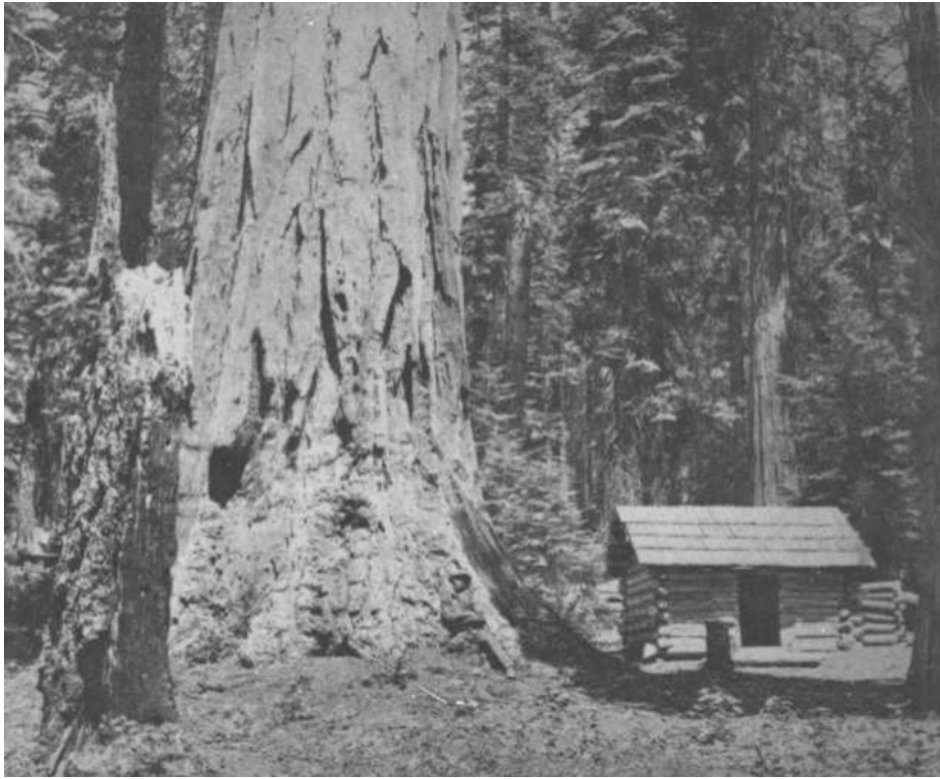
Figure 1. Clark's cabin ("hospice") in the upper portion of the Mariposa Grove. Photograph by John. P. Soule, 1870. YRL Photo No. RL-16483.

Clark conveyed his fascination with the big trees and publicized its existence by leading tourists to the grove. Sometime between 1858 and 1864, he constructed a small, windowless cabin in the upper grove to accommodate and shelter visitors (Figure 1). One early visitor, Reverend Henry Bellows of New York, probably gave the cabin its name of "Clark's Hospice" after taking shelter there in June of 1864. Another early tourist stopped there three years later, referring to it as "Clark's Hospice" and noting that the cabin stood near "a spring of ice cold water," where the group had eaten lunch and rested (Greene 1987:236-237; Hull 1989:10). By the early 1860s, Milton Mann had built a trail from Clark's Station at the Wawona Meadow into the grove as far as the site of this cabin, initiating a long and vital association between Wawona and the grove (Barbee 1968:Appendix A).

Some ten years earlier, in 1885, Clark's Hospice in the grove had undergone a renovation at the state's direction. The renovated cabin was an extension of Clark's original structure: the open triangle that had been previously used as a kitchen at one end was demolished and replaced with an enclosed area with a chimney (Greene 1987:236) (see Figure 2). One of Clark's successors as guardian, W. E. Dennison, visited the remodeled cabin in September of 1885 and described it as "a most substantial, roomy, old-fashioned structure with [a] good stone chimney, a crane in the fire place, two doors and two windows and an even floor of tongue & groove yellow-pine boards." He characterized the cabin as "entirely in keeping with its massive surroundings" (W. E. Dennison, Guardian, to William B. May, Secretary and Treasurer, Yosemite Commission, Sept. 24, 1885, 979.447 Y-5a, Vertical Files, YRL).

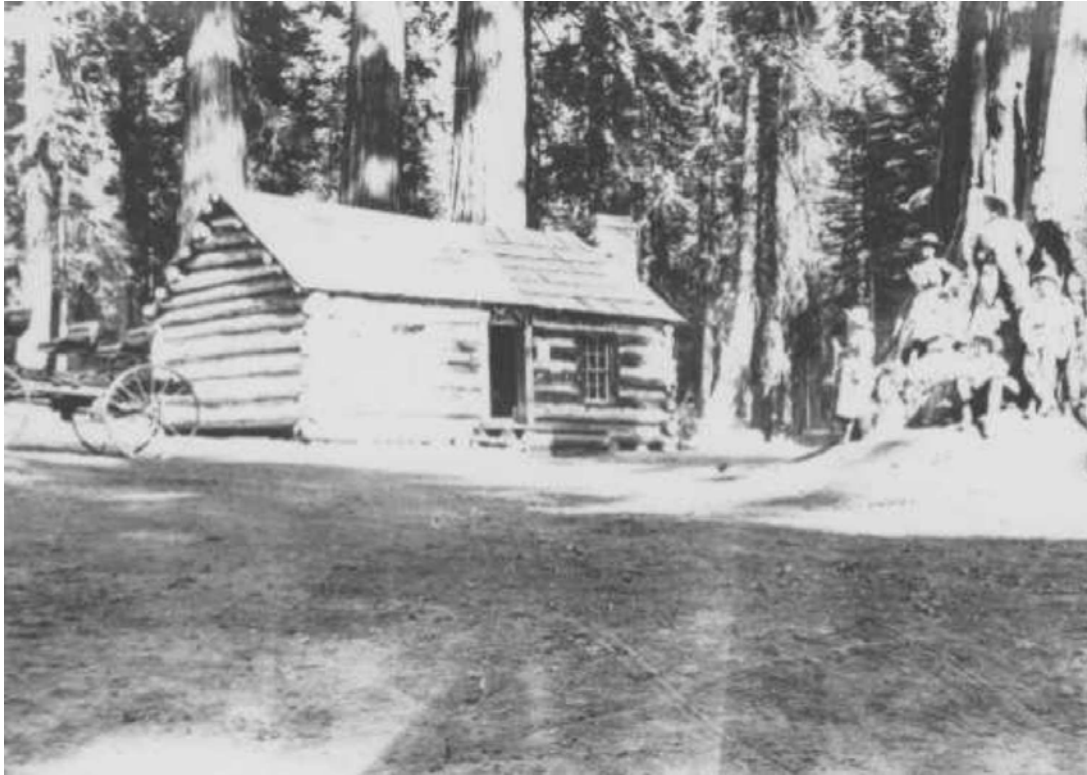
Figure 2. Clark's cabin after renovation by the state. YRL Photo No. RL-17479.

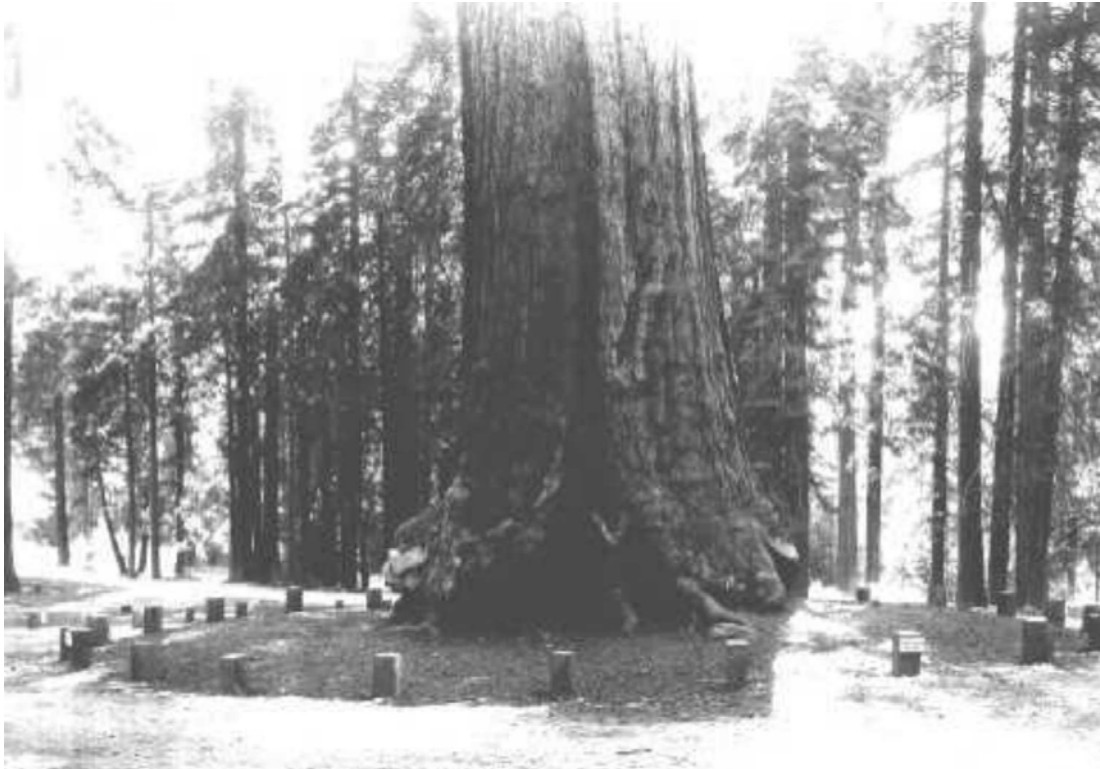
Figure 3. Photograph of the Grizzly Giant in 1926, showing the sequoia wood stubs around the base of the tree. YRL Photo No. RL-979447-9.

The purpose of these enclosures was two-fold: to prevent tourists from climbing on the bases of trees and to deter them from taking pieces of sequoia bark as souvenirs. By 1926, the wire fence around the Grizzly Giant had been removed, at the behest of Park Superintendent W. B. Lewis. As an alternative, National Park Service Director Stephen Mather had suggested setting posts around it and erecting signs to warn visitors to stay out of the enclosure. Superintendent Lewis, on the other hand, favored a barrier of unpeeled cedar logs around the base of the tree to deter climbing and the chipping of bark as souvenirs (O. G. Taylor, Resident Engineer, to Dan Hull, Landscape Engineer, July 22, 1926, Mariposa Grove of Big Trees, 1910-1939, File: 701-01.42, Separate Files, YRL). Director Mather’s suggestion was implemented between 1926 and 1929. Sequoia wood posts were set around the base of the Grizzly Giant in 1926. Signs warning “Do not enter this circle” were attached to several of these posts (Figure 3). Within three years, a chain was hung between the posts (Ralph Anderson, A Photographic Study of the Grizzly Giant, ca. 1938, 979.447 Y-35a, Vertical Files, YRL). The search for an effective enclosure, however, would continue into the 1930s.

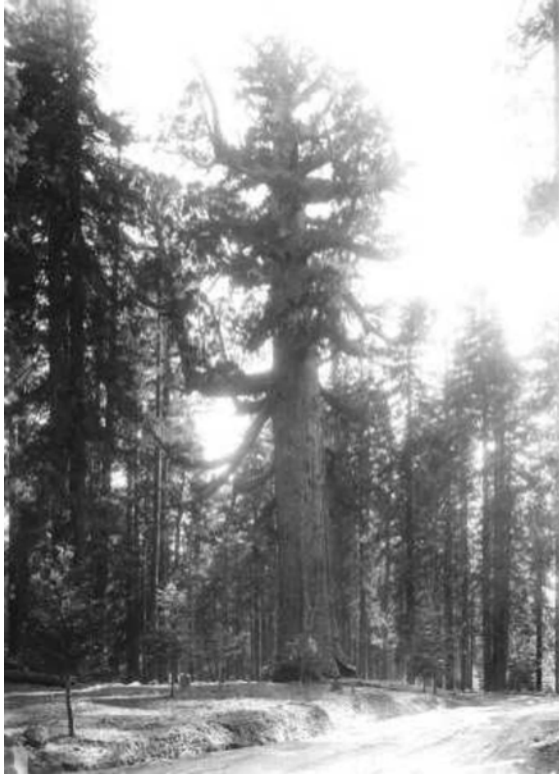
Figure 6. Photograph of the Grizzly Giant showing road and drainage ditches on north side of tree. YRL Photo No. RL-979447-7.

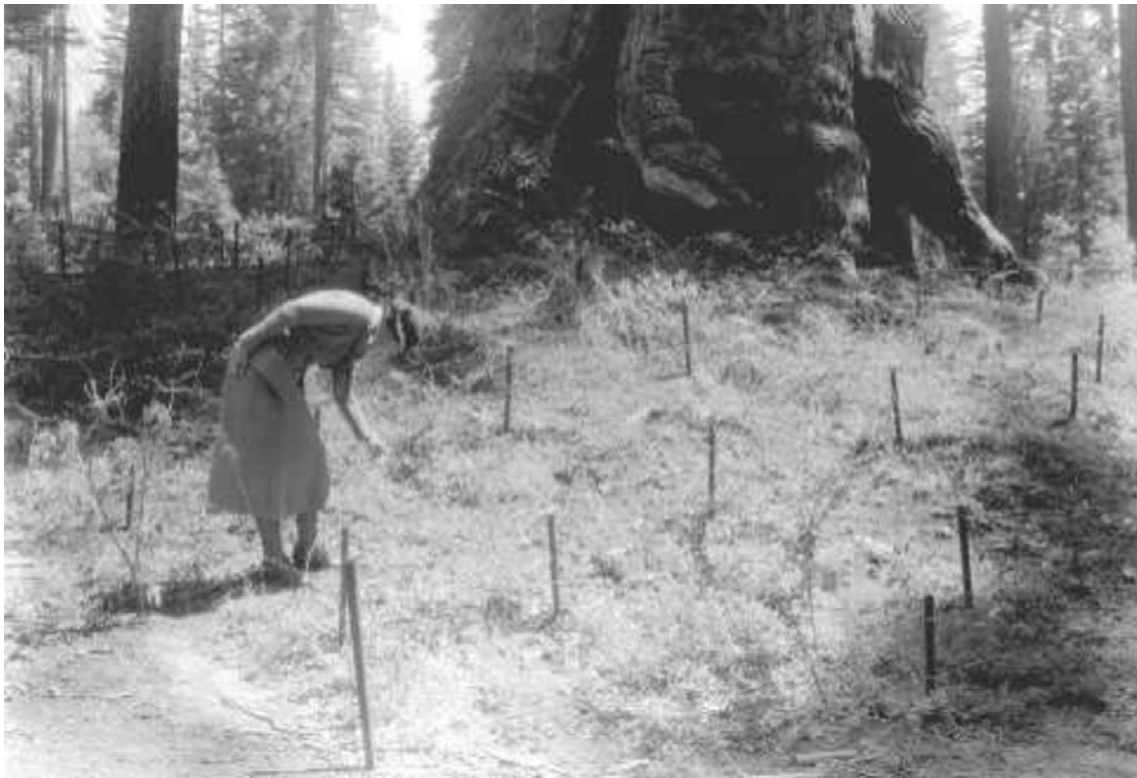
Figure 7. Photograph of the base of the Grizzly Giant with barbed wire entanglement and newly planted shrubs. Approximately 1931. YRL Photo No. 979447-14

Trying to protect the sequoias from the impact of heavy visitation continued to produce new ideas for enclosures around them, especially around the Grizzly Giant. In late 1930, Superintendent Thomson "hit upon" a new device, inspired from his years as a soldier in France during World War I. As a result of Thomson's flash, a "low parapet wire entanglement" of the "low German type with long triple-barbed wire strung crisscross between steel posts standing at a maximum of a foot from the ground" some 20 feet from the tree's base now encircled the Grizzly Giant. To soften the effect, the project also included the planting of ferns, azaleas and snow bushes. To Thomson's eye, the effect was "simply splendid as now the Grizzly Giant rears its great bulk out of an area of lush vegetation (Figure 7). A narrow trail encircles the tree at a reasonable distance, reducing the hazard to its root system to the absolute minimum possible" (Thomson to National Park Service Director, Nov. 11, 1930, Mariposa Grove of Big Trees, 1910-1939, File: 701-01.42, Separate Files, YRL).

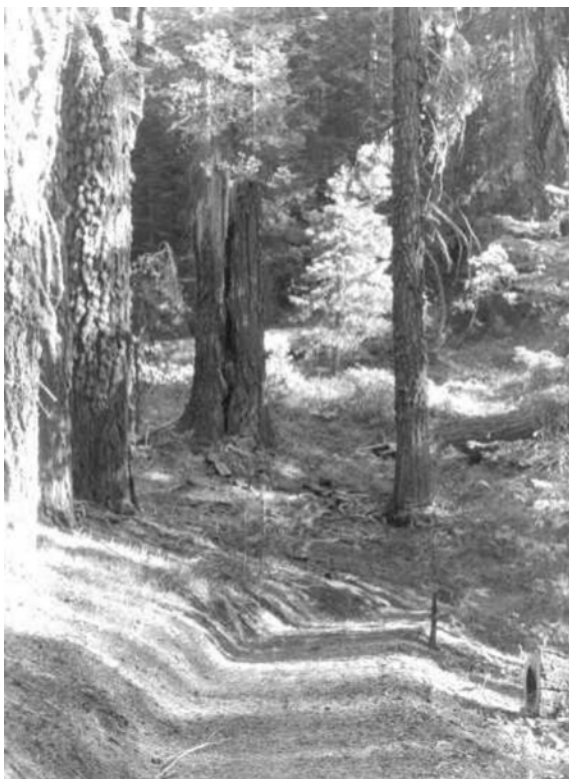
Figure 16. Photograph of newly completed bridle trail in upper portion of the grove. YRL Photo No. RL-7564.

6-foot-wide bridle paths within the grove (Figure 16) as well as a path from the grove to Wawona that replaced the steep Lightning Trail. At a junction near Sunset Point, the bridle path from Wawona joined the outer loop path that circled the upper grove (General Management Plan 1942; Grizzly Giant Report, 1935, 979.447 Y-35b, Vertical Files, YRL; Superintendent's Monthly Report, Sept. 1933; Nov. 1933). Smaller projects in 1934 included placing overhead telephone wires underground (also funded by PWA) and building ten wooden platforms in the 1.3-acre campground near the ranger station. The platform flooring was surrounded by pipe to which tent ropes could be attached. In this way, campers would put up their tents on the platforms rather than on the sloping ground, thereby preventing damage to the roots of nearby trees (General Management Plan 1942; Grizzly Giant Report, 1935, 979.447 Y-35b, Vertical Files, YRL).

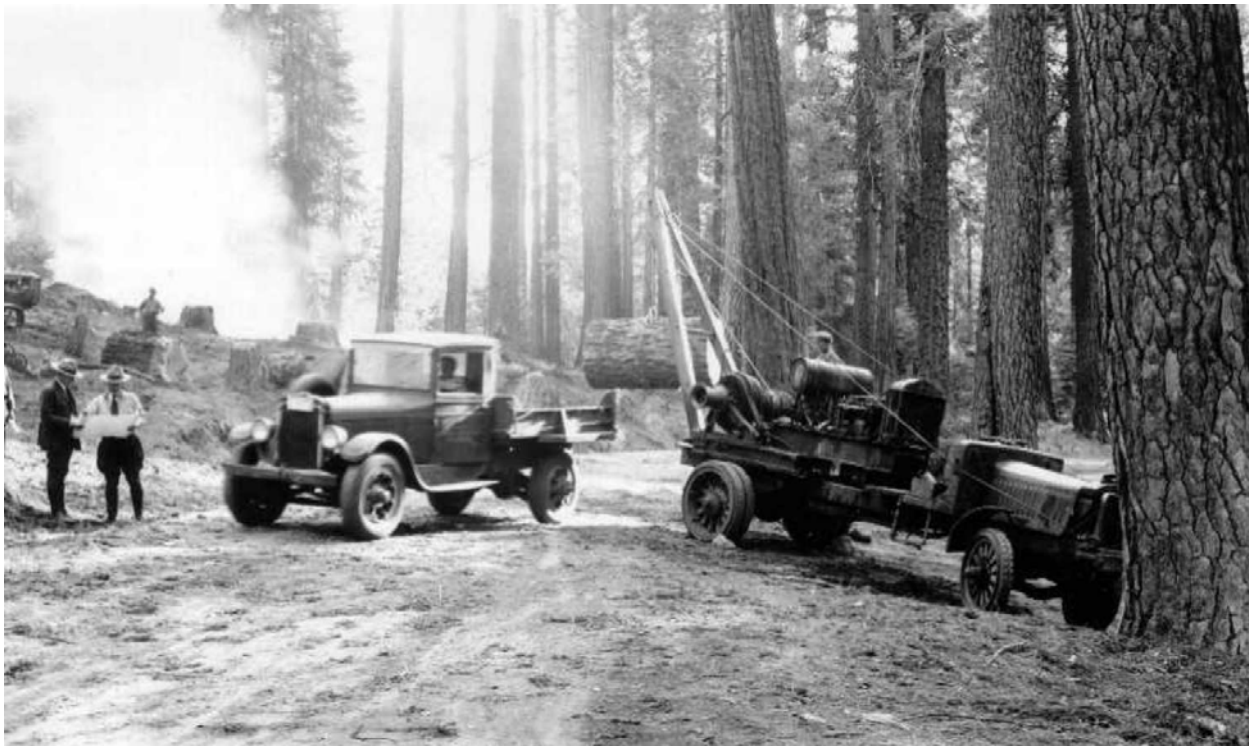
Figure 8. Rerouting the road around the Grizzly Giant. [Photo scanned from Thomson 1932 "Final Report, Grizzly Giant Road", Office of the Chief of Maintenance, El Portal, CA.]

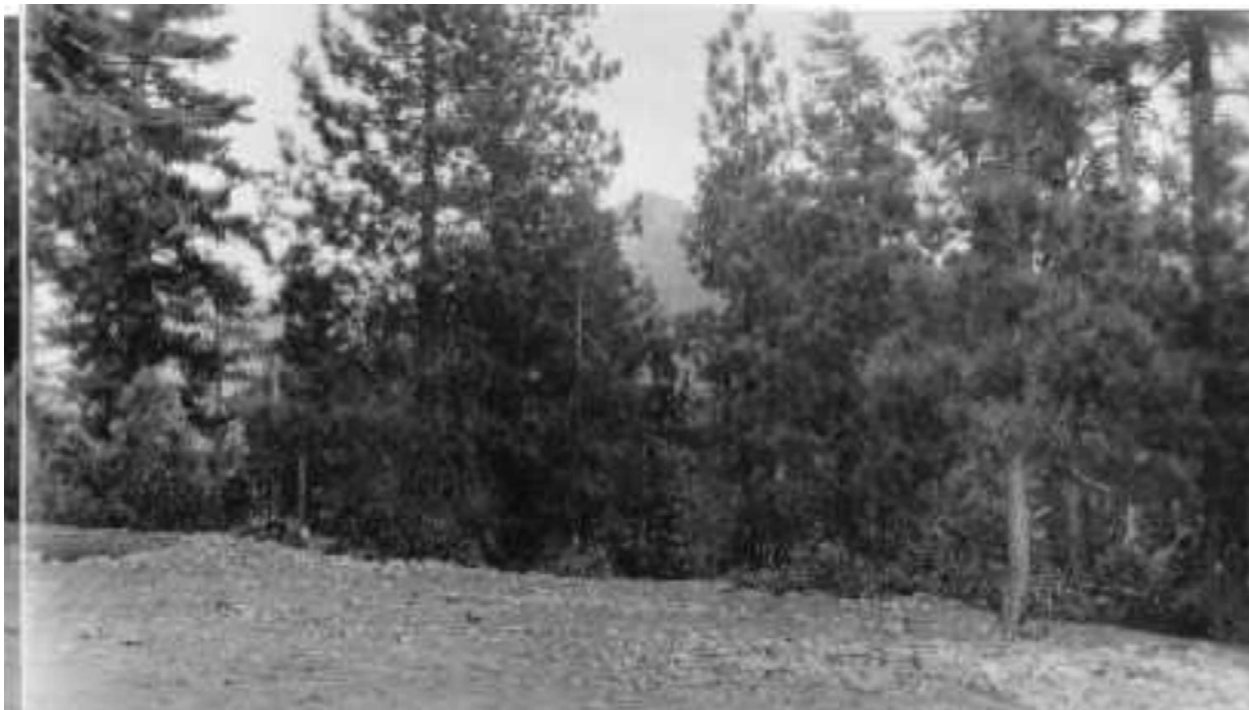
Figure 9. Mt. Raymond vista prior to clearing. [Photo scanned from Thomson 1932 "Final Report, Account 504.2, Development Wawona Point", Office of the Chief of Maintenance, El Portal, CA].

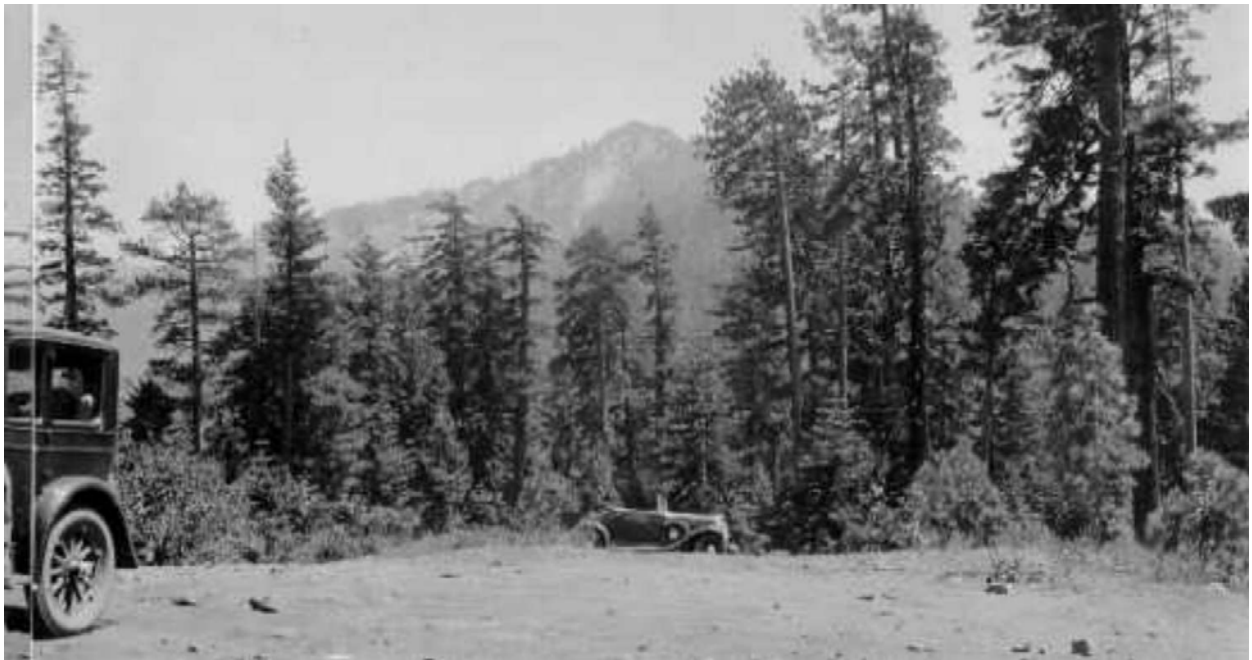
Figure 10. Mt. Raymond vista after clearing. [Photo scanned from Thomson 1932 "Final Report, Account 504.2, Development Wawona Point", Office of the Chief of Maintenance, El Portal, CA.]

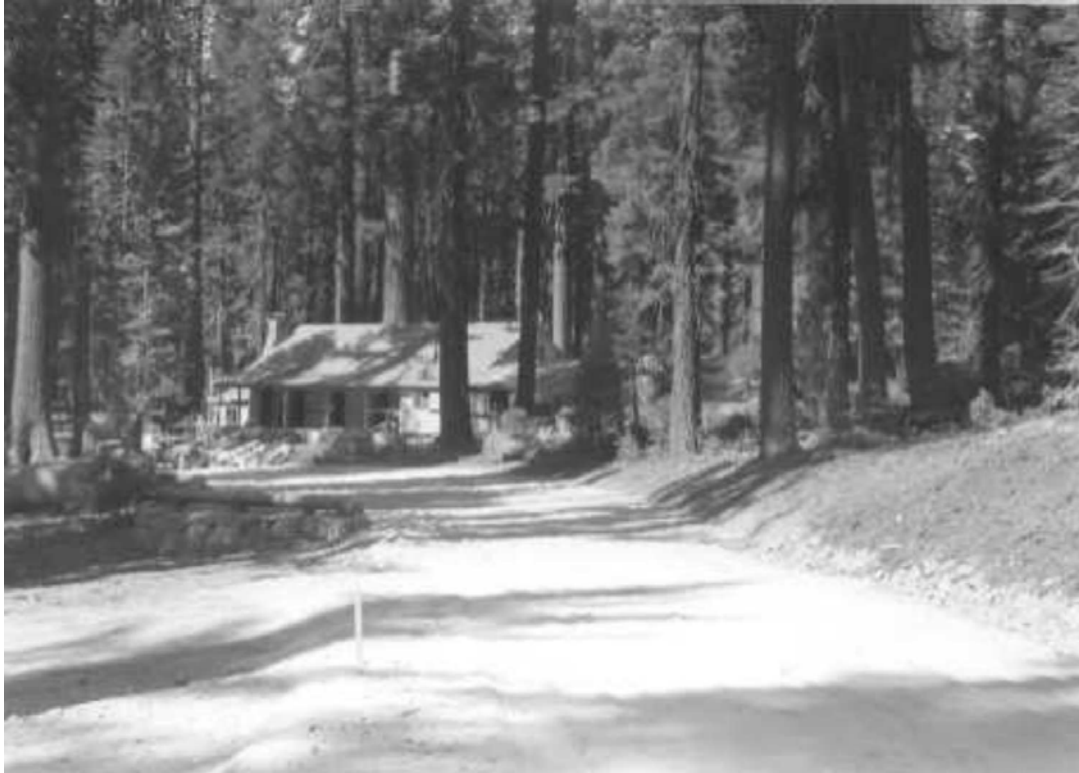
Figure 12. Overview of the new Big Trees Lodge and access road. [Scanned from Thomson 1933 "Final Report, Mariposa Grove Lodge Road & Parking Area", Office of the Chief of Maintenance, YOSE El Portal, CA.]

Under the heavy snow pack of the winter of 1931-1932, the old Big Trees Lodge and cabins collapsed. By 1932, the Yosemite Park and Curry Company had built a new Big Trees Lodge in the upper grove, just west of the Elephant's Foot. In conjunction with its construction, the Park Service built 700 feet of new road at a distance of 40 feet from the lodge. The 18-foot-wide road segment passed through the fallen trunk of the Elephant's Foot. Also constructed were two parking areas (Figure 12). One area could accommodate 26 cars with right-angle parking, was located parallel to the road, and consisted of an 18-foot widening of the road's downslope side that extended for a distance of 210 feet opposite the new lodge. The other could accommodate 24 cars, was a rectangular area 55 feet by 100 feet, and was located downhill from the lodge (Thomson 1933 [Final Report, Mariposa Grove Lodge Road & Parking Area]:1).

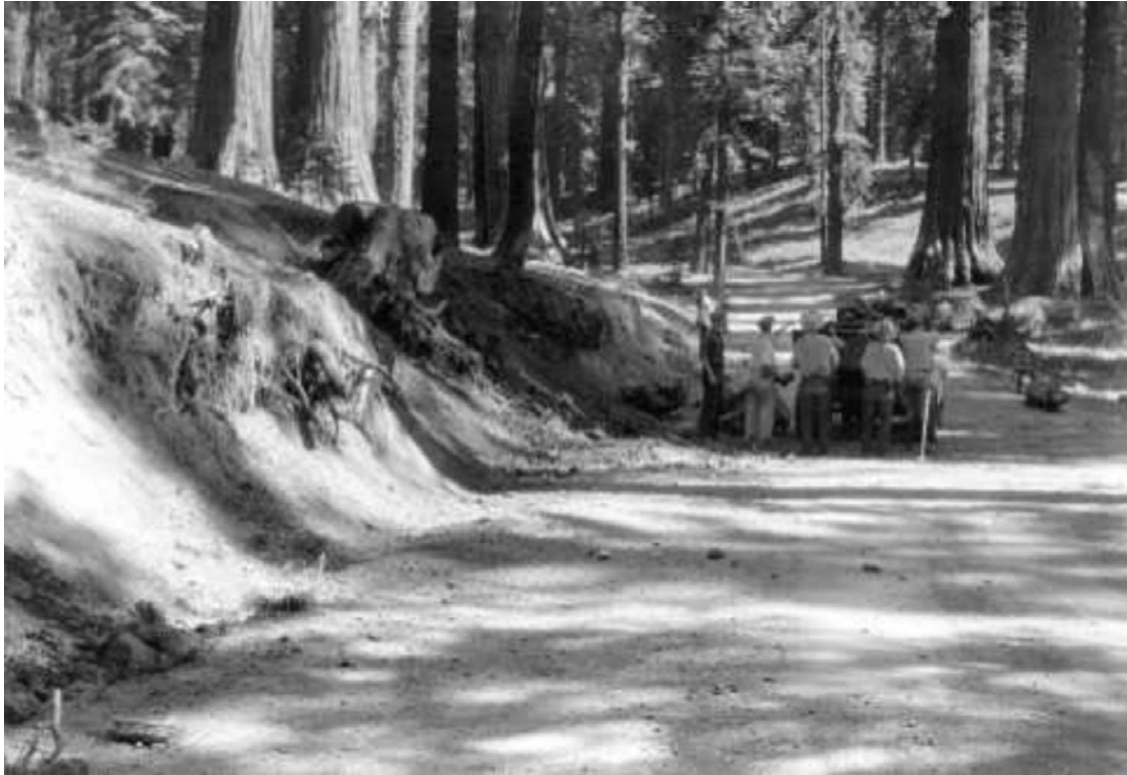
Figure 13. "Landscaping an unsightly slope near Mariposa Grove Big Trees Museum." [Scanned from Thomson 1934 "Preliminary Report – Armor Coat Paving Mariposa Grove Road F.P.#238.8 Account No. 521", Office of the Chief of Maintenance, YOSE, El Portal, CA.]

The landscaping accomplished along the road corridor during the 1934 construction project contributes to the current character of the road. There are no overhanging banks, no protruding root systems or stumps, and the slopes adjacent to the road have been reshaped to “conform to the surrounding scenery” (Thomson 1934 [Preliminary Report-Armor Coat Paving, Mariposa Grove Road]). Similarly, the differences in the width of the road between the two-way and one-way segments, reflects the historical pattern of development during the 1930s.

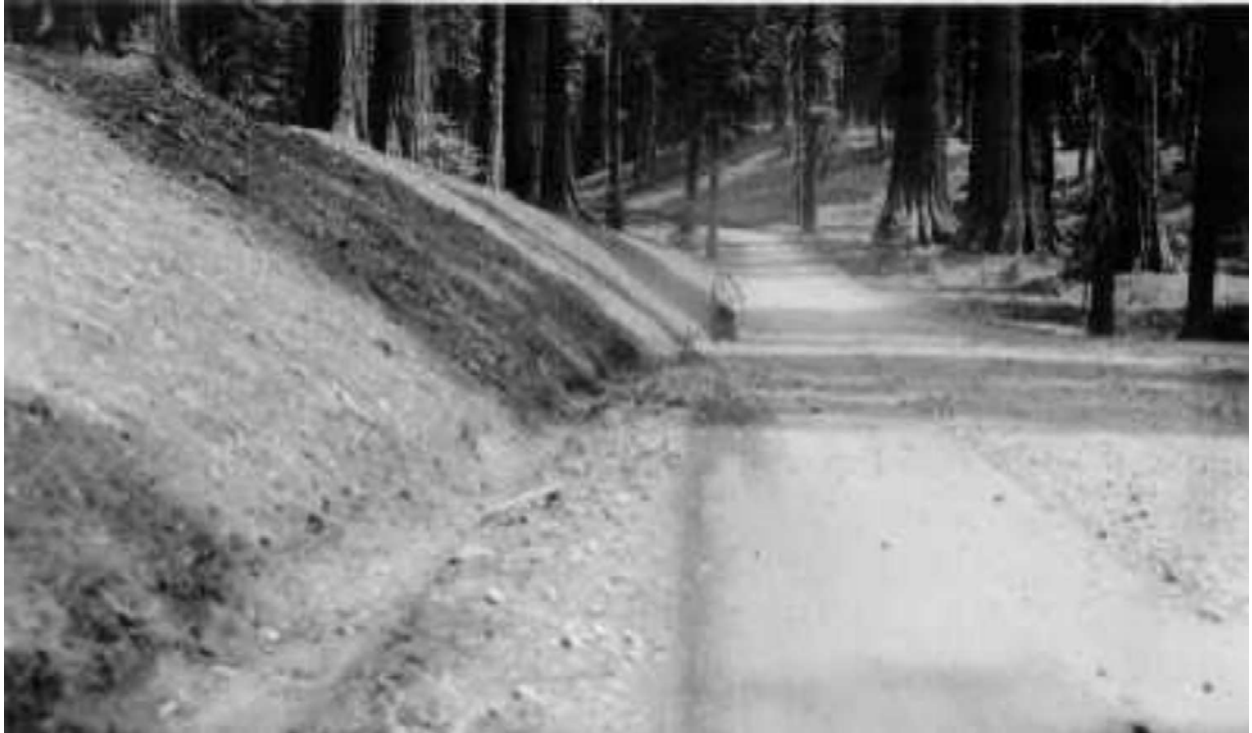
Figure 14. "...All evidence of stumps and overhanging bank removed" [Scanned from Thomson 1934 "Preliminary Report – Armor Coat Paving Mariposa Grove Road F.P.#238.8 Account No. 521", Office of the Chief of Maintenance, YOSE, El Portal, CA.]

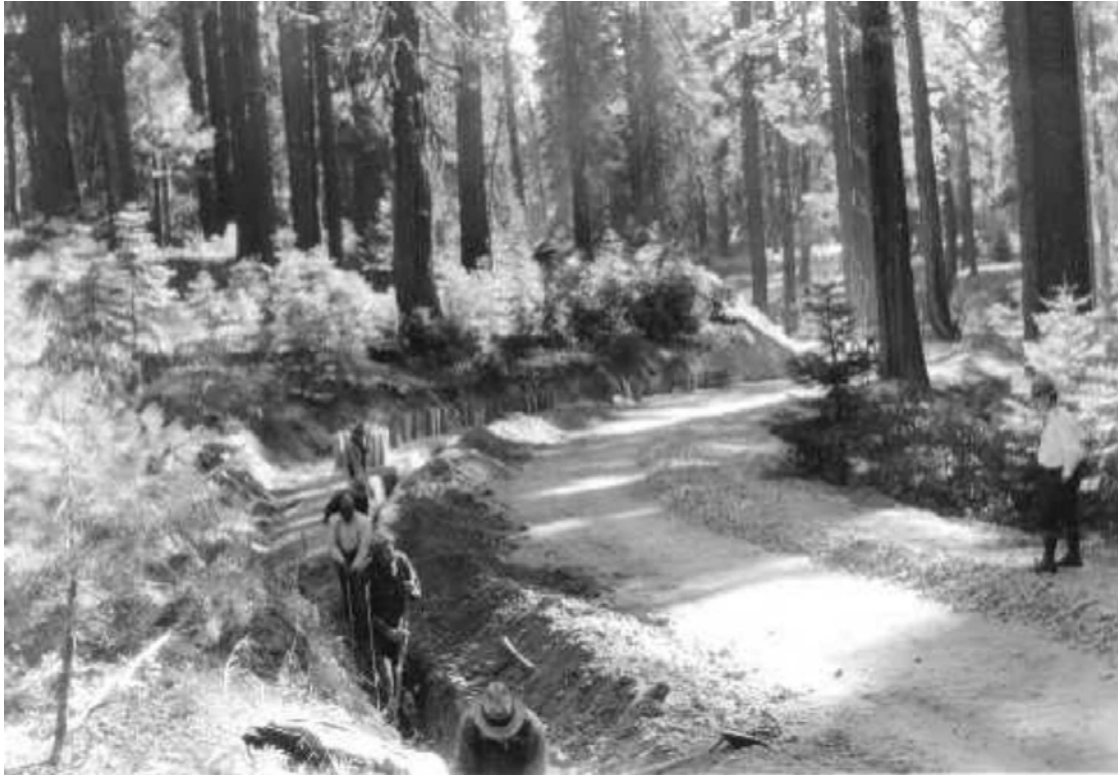
Figure 15. "Installing 6-inch drain tile..." [Scanned from Thomson 1934 "Preliminary Report – Armor Coat Paving Mariposa Grove Road F.P.#238.8 Account No. 521", Office of the Chief of Maintenance, YOSE, El Portal, CA.]

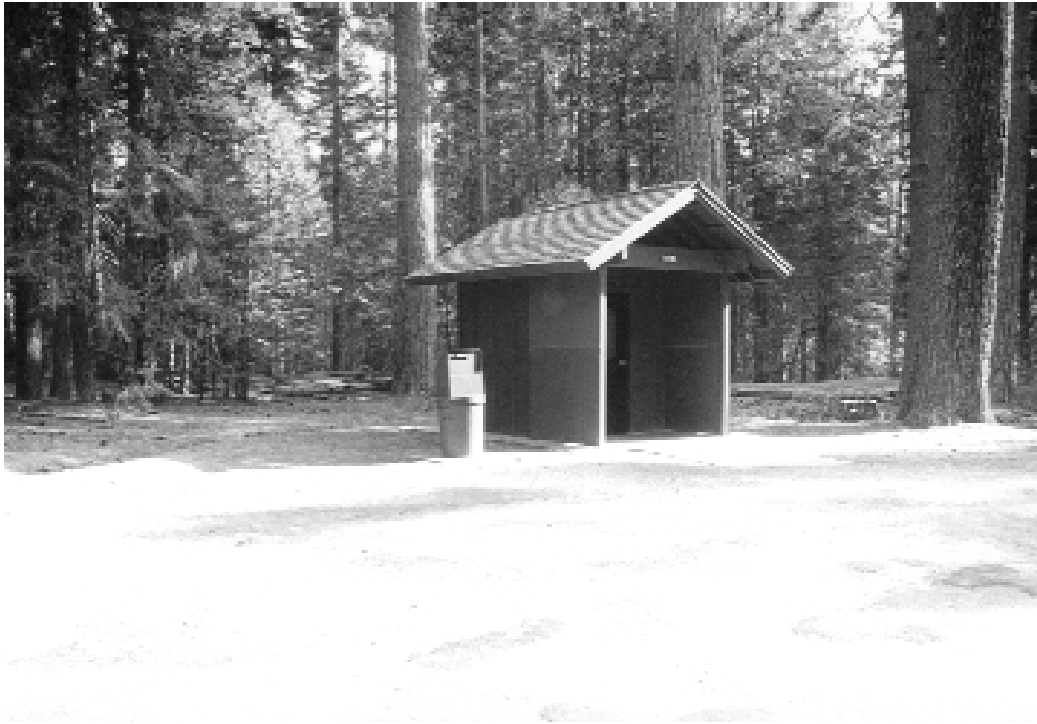
Modern, non-contributing comfort station near the tram stop at the Grizzly Giant. 11/1999, HRA

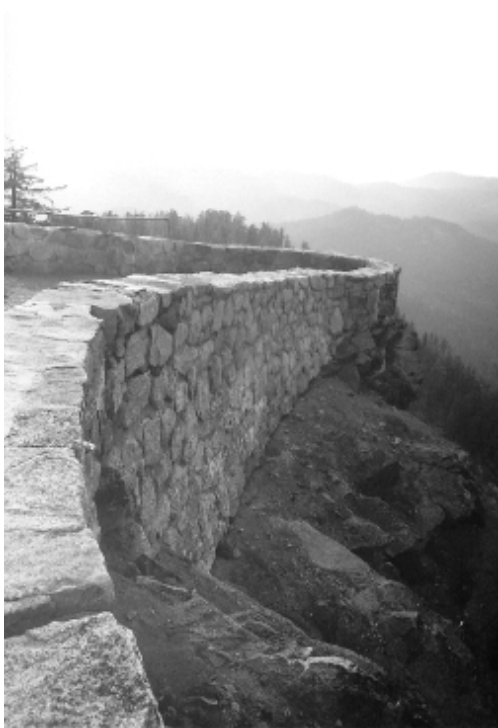
Overview of mortared stone retaining wall at Wawona Point Lookout. 11/1999, HRA

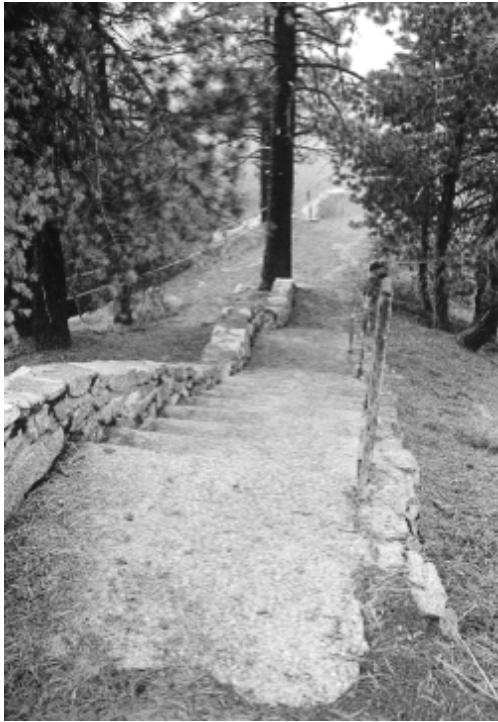
Sairway to north lookout platform at Wawona Point Lookout. Note that original stone stairs have been replaced with concrete. HRA, 11/1999.

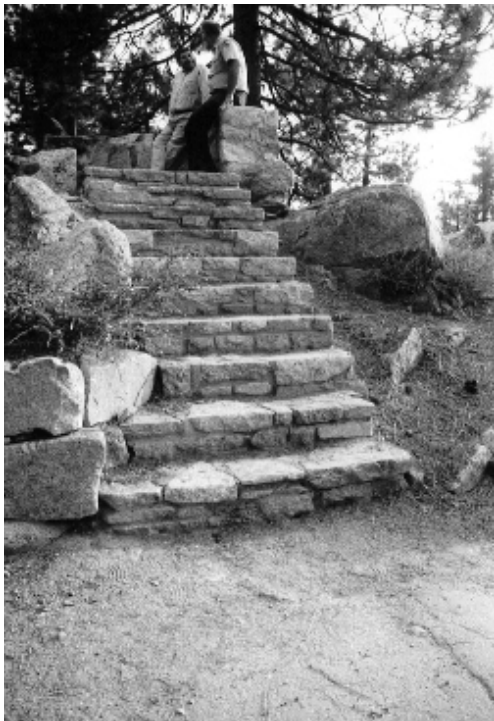
Stone stair to south lookout platform. Note original stone steps. HRA, 11/1999.

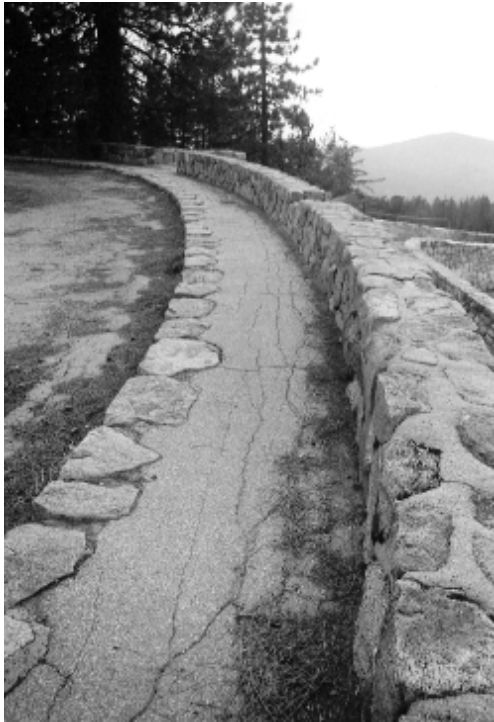
Parapet guardrail and stone-lined walk at Wawona Point. HRA, 11/1999

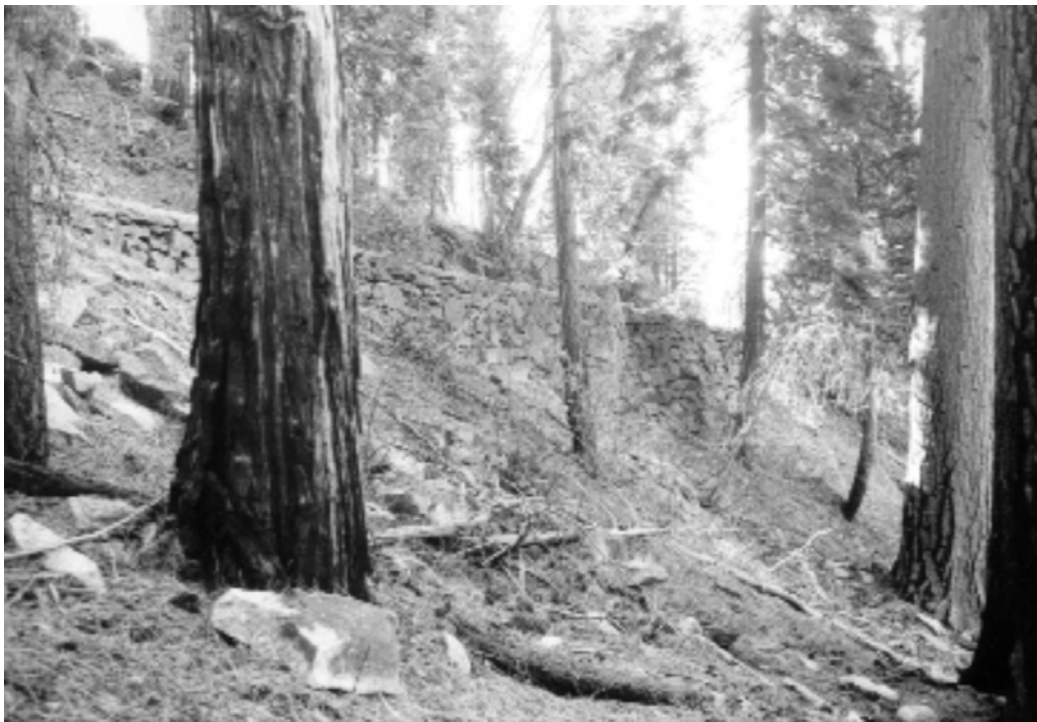
Dry-laid stone retaining wall stabilizing fill section in main vehicular road. HRA, 11/1999

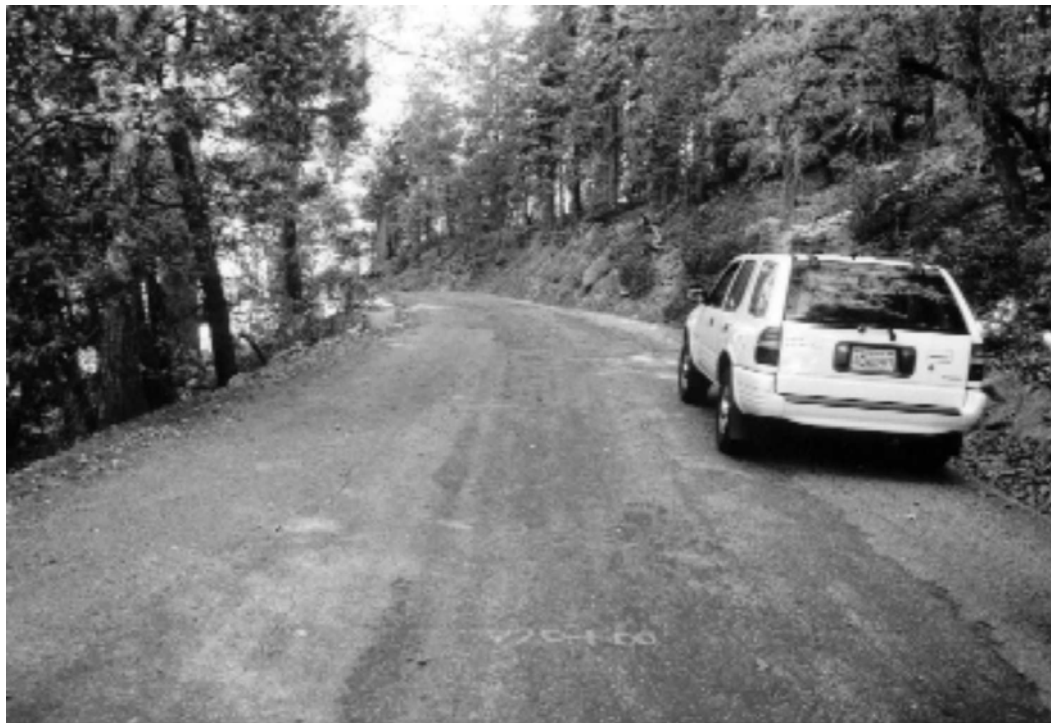
Looking northwest along two-way segment of the Mariposa Grove Road. HRA, 11/1999.

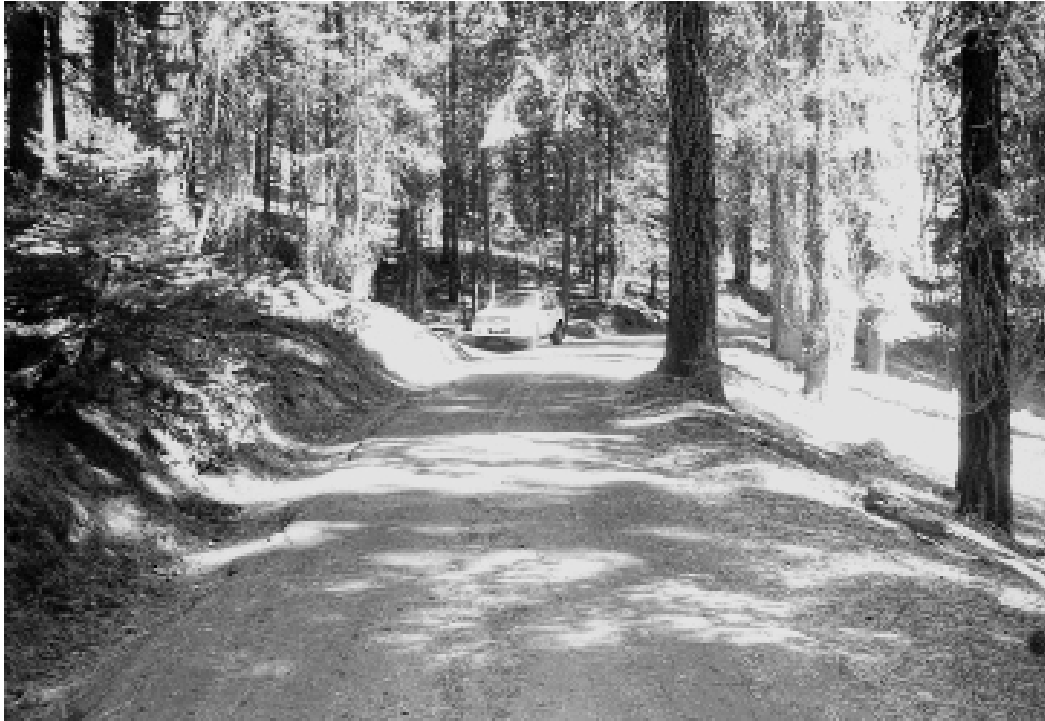
Looking northeast along the one-way loop within the upper portion of the grove. Borrow pit to left of road in center of photo. HRA, 11/1999.

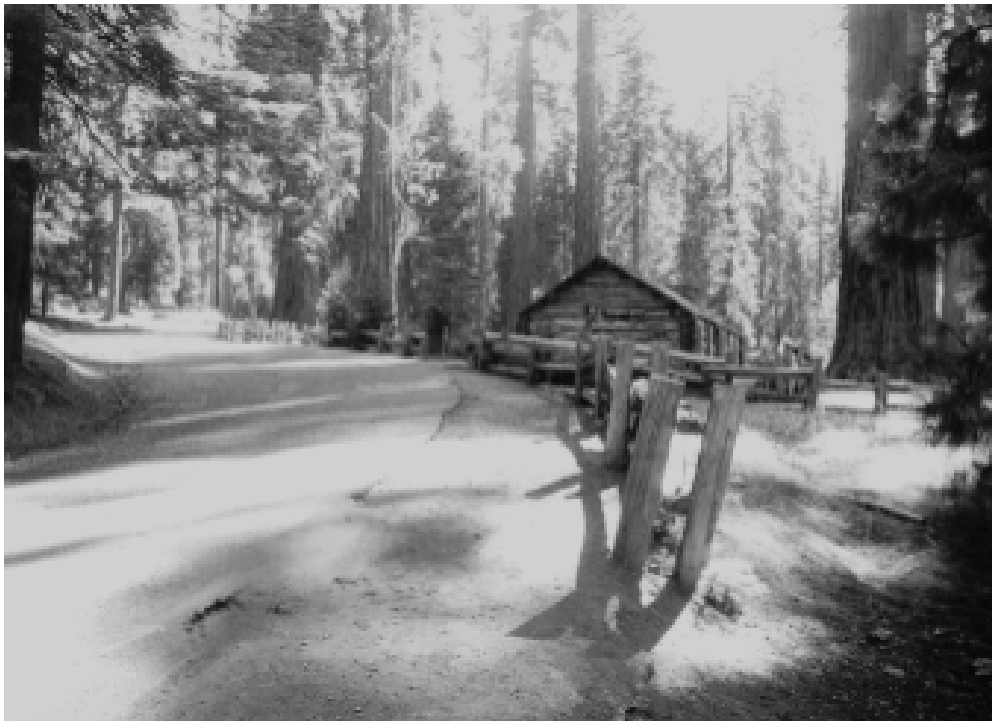
Looking southeast along road to museum. Note the raised grade in this vicinity, designed to cushion sequoia roots. Fencing is modern. HRA, 11/1999.

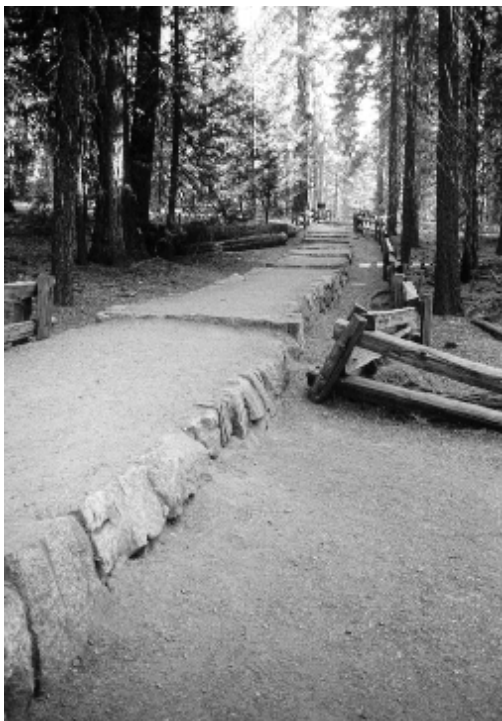
Looking northeast along the 1986 raised grade trail to the California Tree. These modern trails are noncontributing features. HRA, 11/ 1999

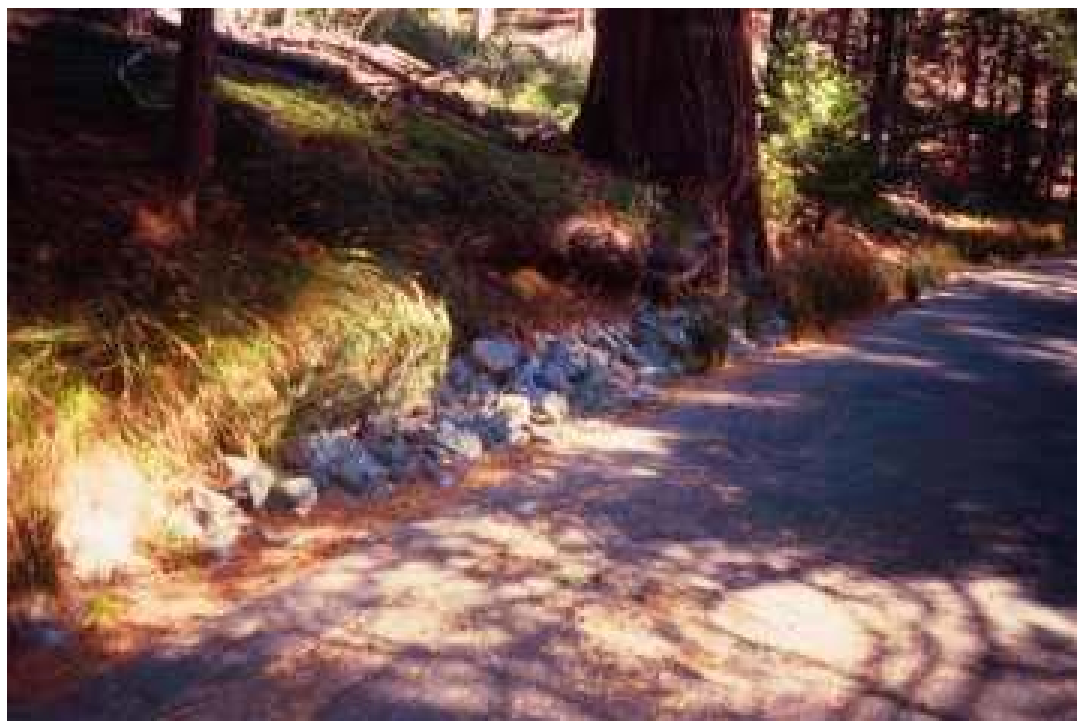
Drainage along the Mariposa Grove road continues to be a problem, especially during flood events. In some instances, attempts to halt erosion in road-side ditches have resulted in the application of inappropriate materials, which detract from the appearance of the road. An example of this is the light colored rip-rap laid in the road-side ditches during the 1997 flood.

Example of riprap applied to ditches to prevent erosion during 1997 flood. HRA, 11/1999.

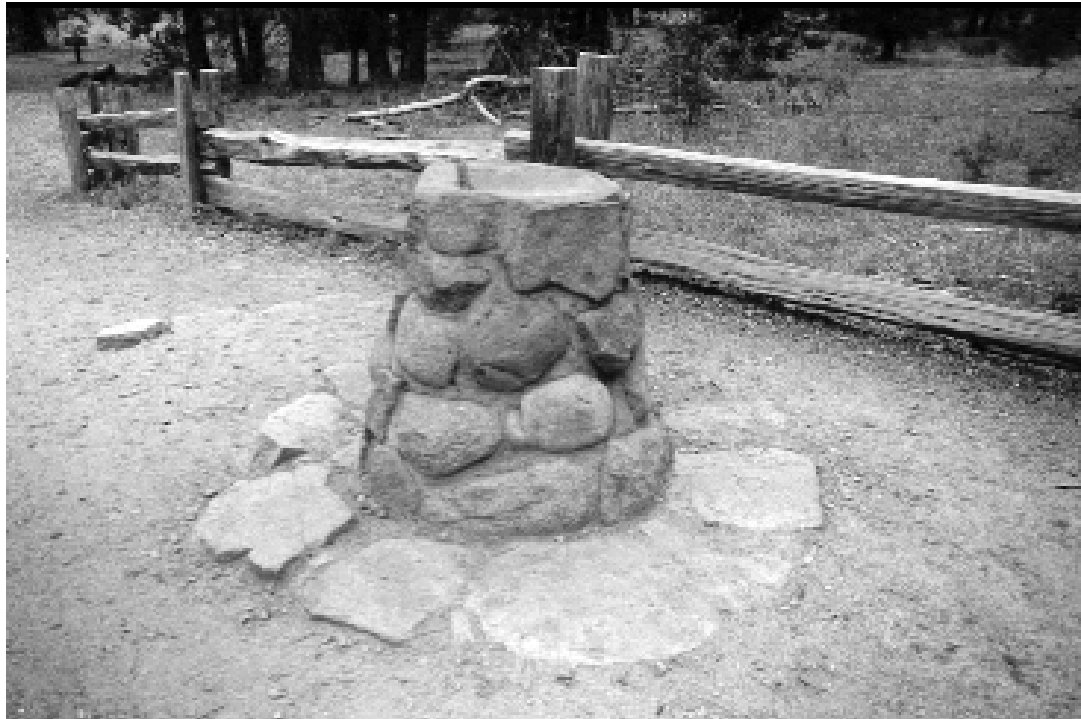
Drinking fountain in upper portion of grove, near museum. HRA, 11/1999.

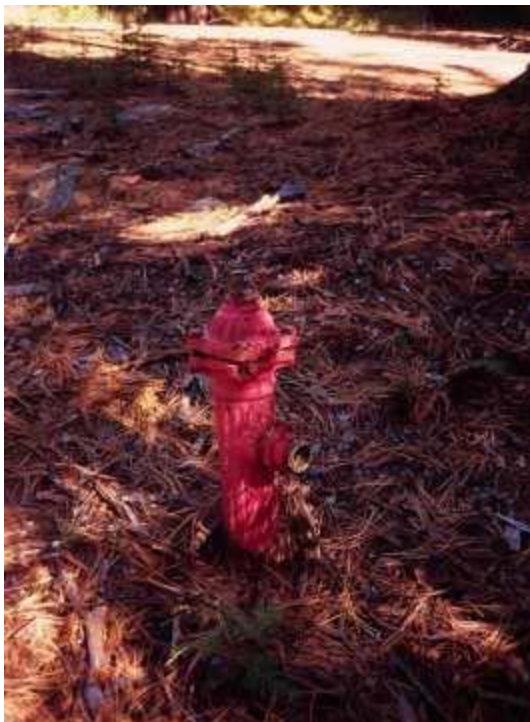
Fire hydrant located in upper portion of grove near site of Big Trees Lodge. HRA, 11/1999
