**National Register of Historic Places  
Inventory—Nomination Form**

NAME: Woodchopper Roadhouse

LOCATION: Left bank of the Yukon, approximately 1 mile  
upriver of Woodchopper Creek

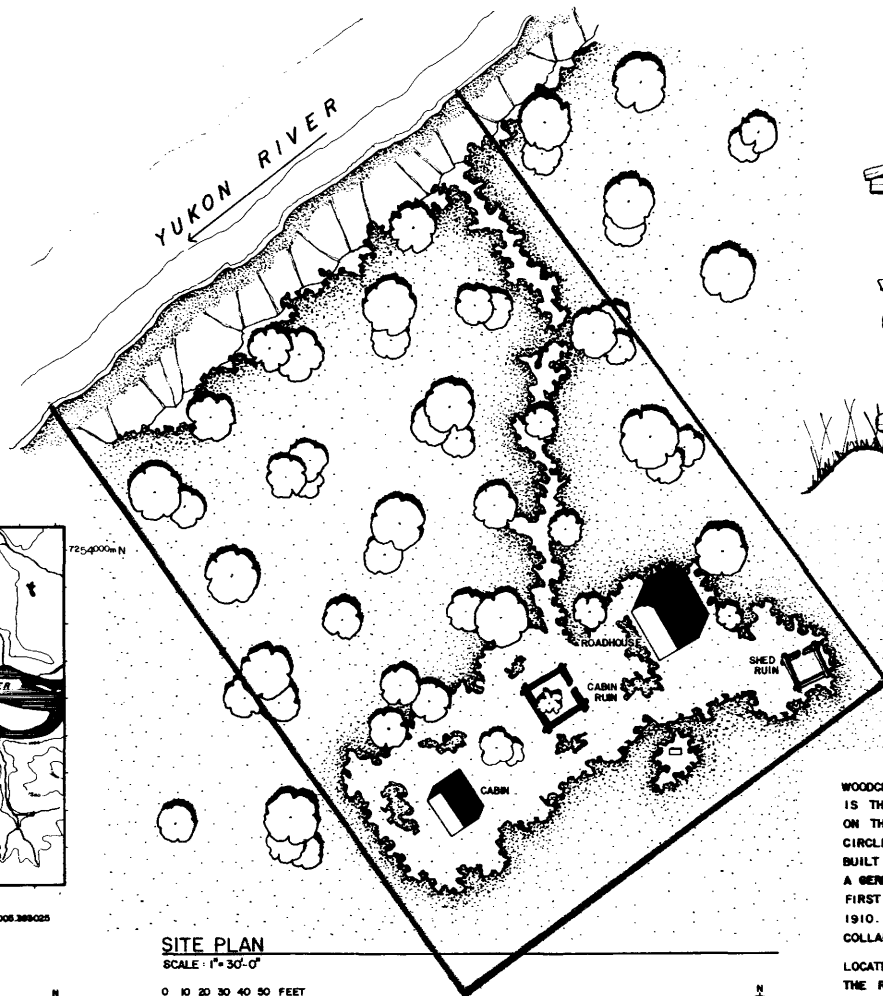
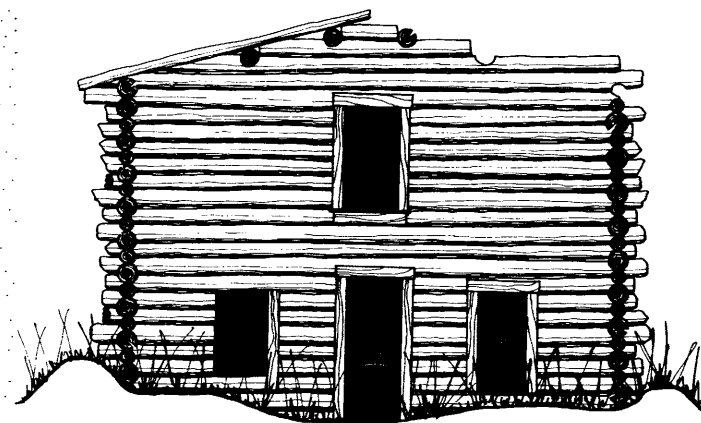
ILLUSTRATION 3

WOODCHOPPER ROADHOUSE, BUILT ca. 1910, IS THE LARGEST AND OLDEST LOG STRUCTURE ON THE YUKON RIVER BETWEEN EAGLE AND CIRCLE. THE BUILDING MAY HAVE BEEN BUILT BY VALENTINE "WOODCHOPPER" SMITH, A GERMAN IMMIGRANT MINER WHO STAKED HIS FIRST CLAIM ON WOODCHOPPER CREEK IN 1910. THE TWO-STORY BUILDING'S ROOF HAS COLLAPSED.

Woodchopper Roadhouse, site plan, with  
boundary

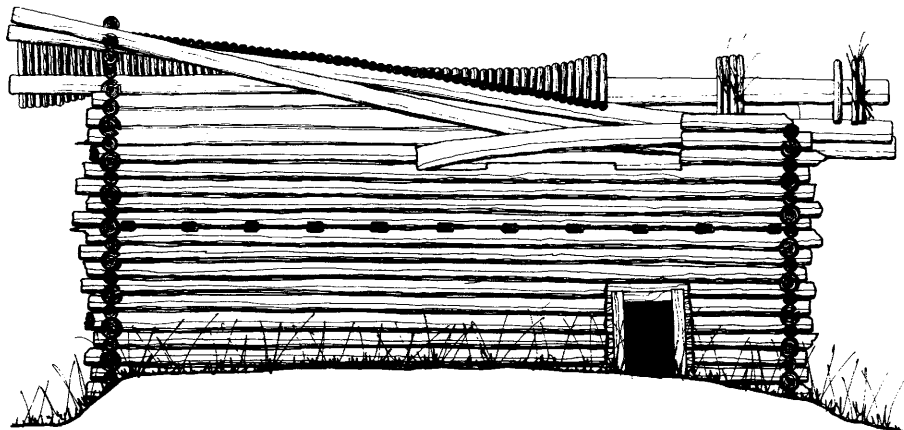
SOUTHWEST ELEVATION  
SCALE: 3/8"=1'-0"

the second floor. The southeast gable end was built with a first floor door with one window above on the second floor. The southwest wall was built with one first floor window and two second floor windows. The northeast wall was built with one first floor window and three above on the second floor. The gable roof deck was made of 5" (average diameter) rough poles supporting a sod roof, which was covered at some time with corrugated metal. The exterior walls were covered on the inside with fabric, either canvas, linen, cheesecloth, or muslin. Interior walls were faced with rough sawn 1"X4" vertical planks, some covered with wall paper. Window and door frames were built of dimensional lumber. The floor was constructed of 8" (average diameter) log stringers at 3'-0" on center, which supported a plank floor covered with linoleum. The second floor was partitioned into four rooms which as late as 1976 contained bedframes and wardrobes.

- WALLS:** WALL LOGS ARE 10" AVG. DIAMETER, PEELED BUT NOT HEWN AND JOINED AT THE CORNERS WITH SADDLE-NOTCHES. JOINTS WERE FIRST CHINKED WITH MOSS THEN COVERED WITH MORTAR. EXTERIOR WALLS ARE COVERED INSIDE WITH CHEESECLOTH OR MUSLIN. INTERIOR WALLS WERE FACED WITH ROUGH SAWN 1" x 4" VERTICAL PLANKS, SOME COVERED WITH WALL PAPER. WINDOW AND DOOR FRAMES ARE OF DIMENSIONAL LUMBER.
- FLOOR:** 8" AVG. DIAMETER LOG STRINGERS AT 3'-0" ON CENTER, SUPPORTED A 1" x 5" PLANK FLOOR COVERED WITH LINOLEUM, MOST OF WHICH HAS BEEN DESTROYED BY SEASONAL FLOODING. THE CELLAR HAS COLLAPSED IN ON ITSELF.
- ROOF:** THE ROOF DECK IS MADE OF 5" AVG. DIAMETER ROUGH POLES SUPPORTING A SOD ROOF NOW COVERED WITH CORRUGATED METAL.
- NOTE:** INTERIOR IS NOW INACCESSIBLE BECAUSE OF ADVANCED DETERIORATION.

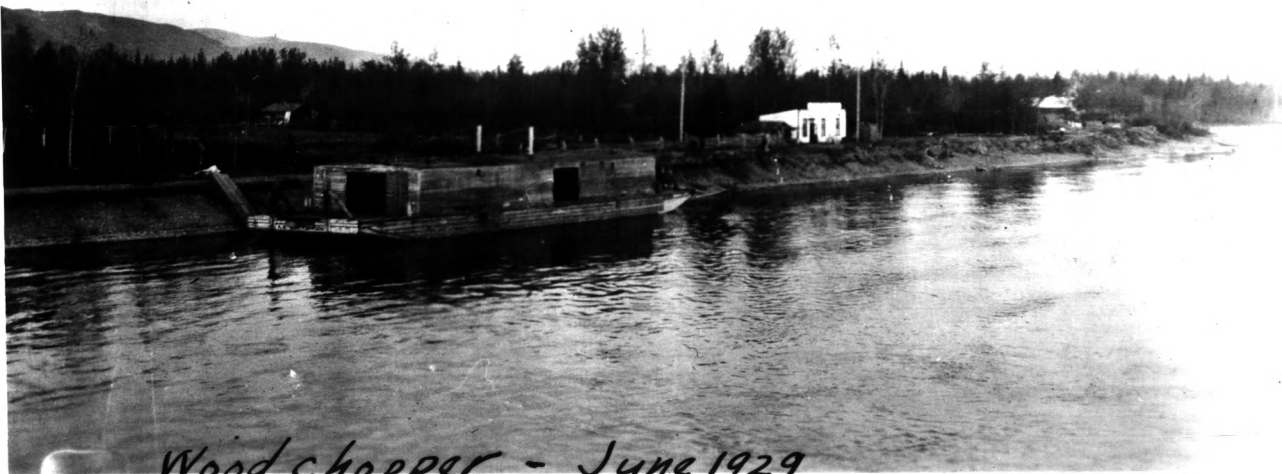
1. WOODCHOPPER; YUKON RIVER LIFEWAYS
2. Eagle vicinity, Alaska
3. 4. 1929
5. Alaska Historical Library, Alaska  
Road Commission
6. looking south 7. P11; I3

Steamboats tied up at a gangplank at the cut bank in the river. The bank rises fifteen or twenty feet above the river beach with a path leading up to the roadhouse. The site was cleared, the white spruce used for construction. It was readily visible from the river, an impressive combination of buildings and activities associated with the maintenance of a large complex in the wilderness along the Yukon. (P10,11)

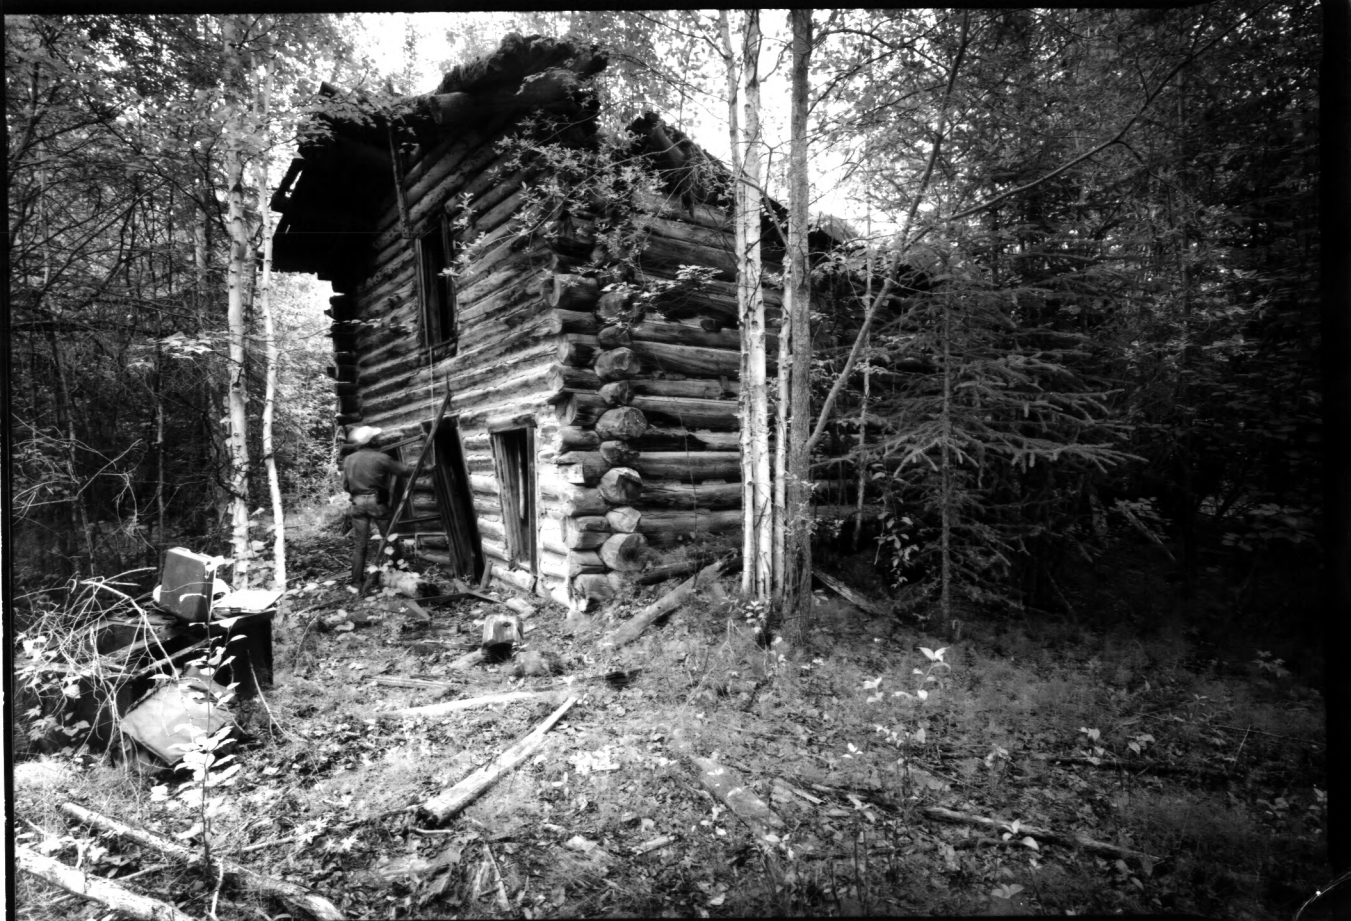
1. WOODCHOPPER ROADHOUSE; YUKON RIVER  
LIFEWAYS
2. Eagle vicinity, Alaska
3. Jet Lowe                      4. August 1984
5. Library of Congress, HABS collection
6. from the northwest
7. P13; I3, 4

The roadhouse still appears massive although the roof has collapsed, as well as all of the southeast section and part of the southwest section of the second floor. The walls are caving inward. The cellar collapsed in on itself. Most of the first level flooring has been destroyed by flooding. Windows and doors are missing. The interior is now inaccessible because of advanced deterioration. The building has a visual impact because of its size and almost ghostly appearance in the wilderness. The feeling of the historic

period is well conveyed by this site. Although the wilderness has reclaimed much over the years, the site retains historic integrity. (P13,14;I4)

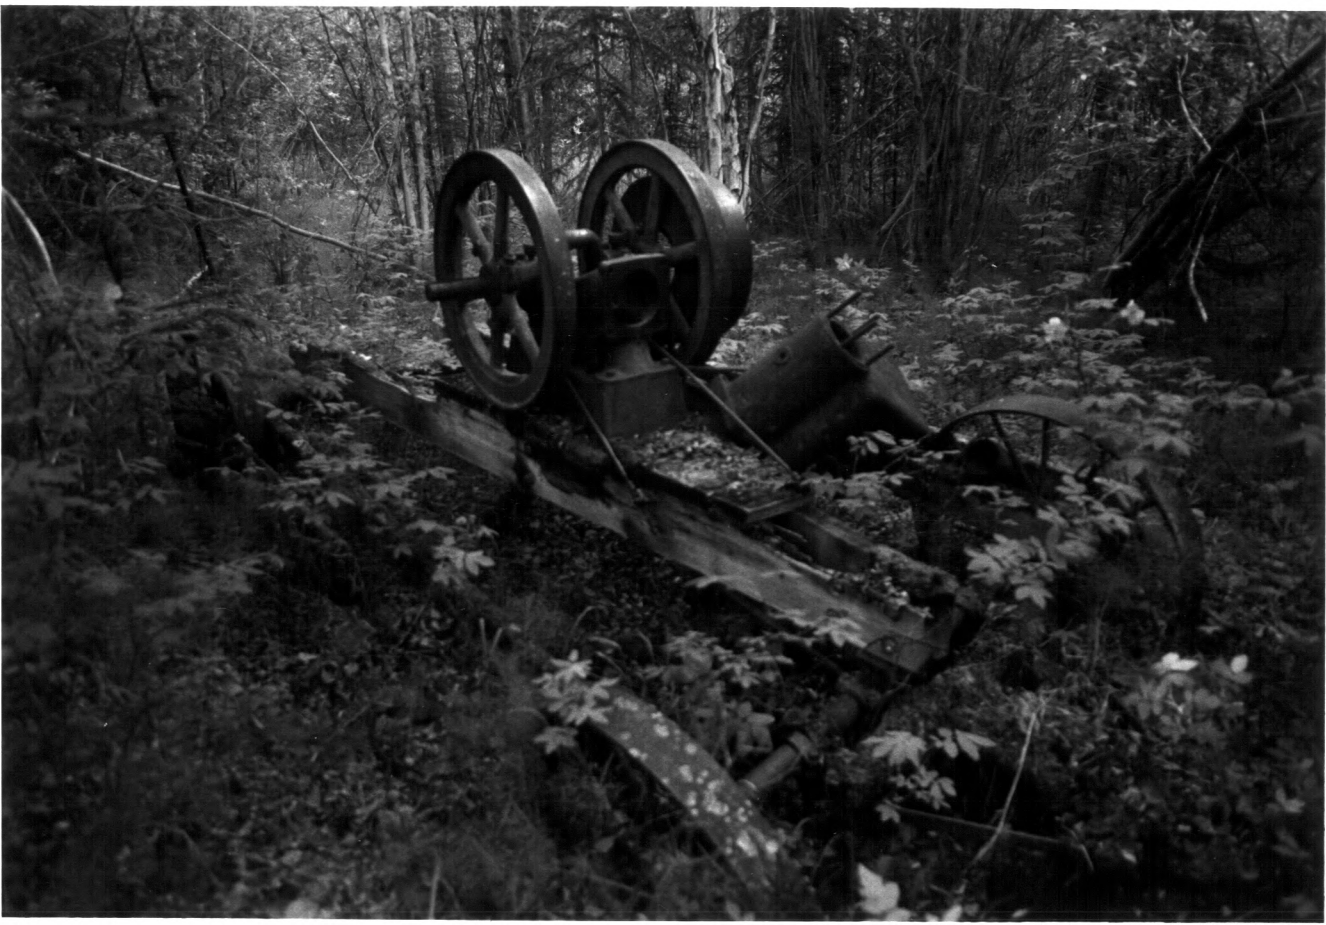
1. WOODCHOPPER ROADHOUSE, MACHINERY;  
YUKON RIVER LIFEWAYS
2. Eagle vicinity
3. Bill Vandeventer 4. June 1985
5. NPS-ARO
6. looking south 7. P15; I3

The old metal gangplank still sits at the steamer landing. Woodchopper Roadhouse, once in a clearing visible for miles along the river, now an alder thicket masks it from view. (I.3) The brush has grown up around a complex of buildings. Many of these cannot be found; for others there is just a depression or moss covered sill logs. The site now is comprised of a residential cabin with some furnishings intact, four or five courses of logs extant from a shed west of the roadhouse, and a shed northeast of the roadhouse with lapjointed corners which is now missing its roof. There is a large amount of heavy equipment, such as boilers and winches, strewn about the brush. (P15)

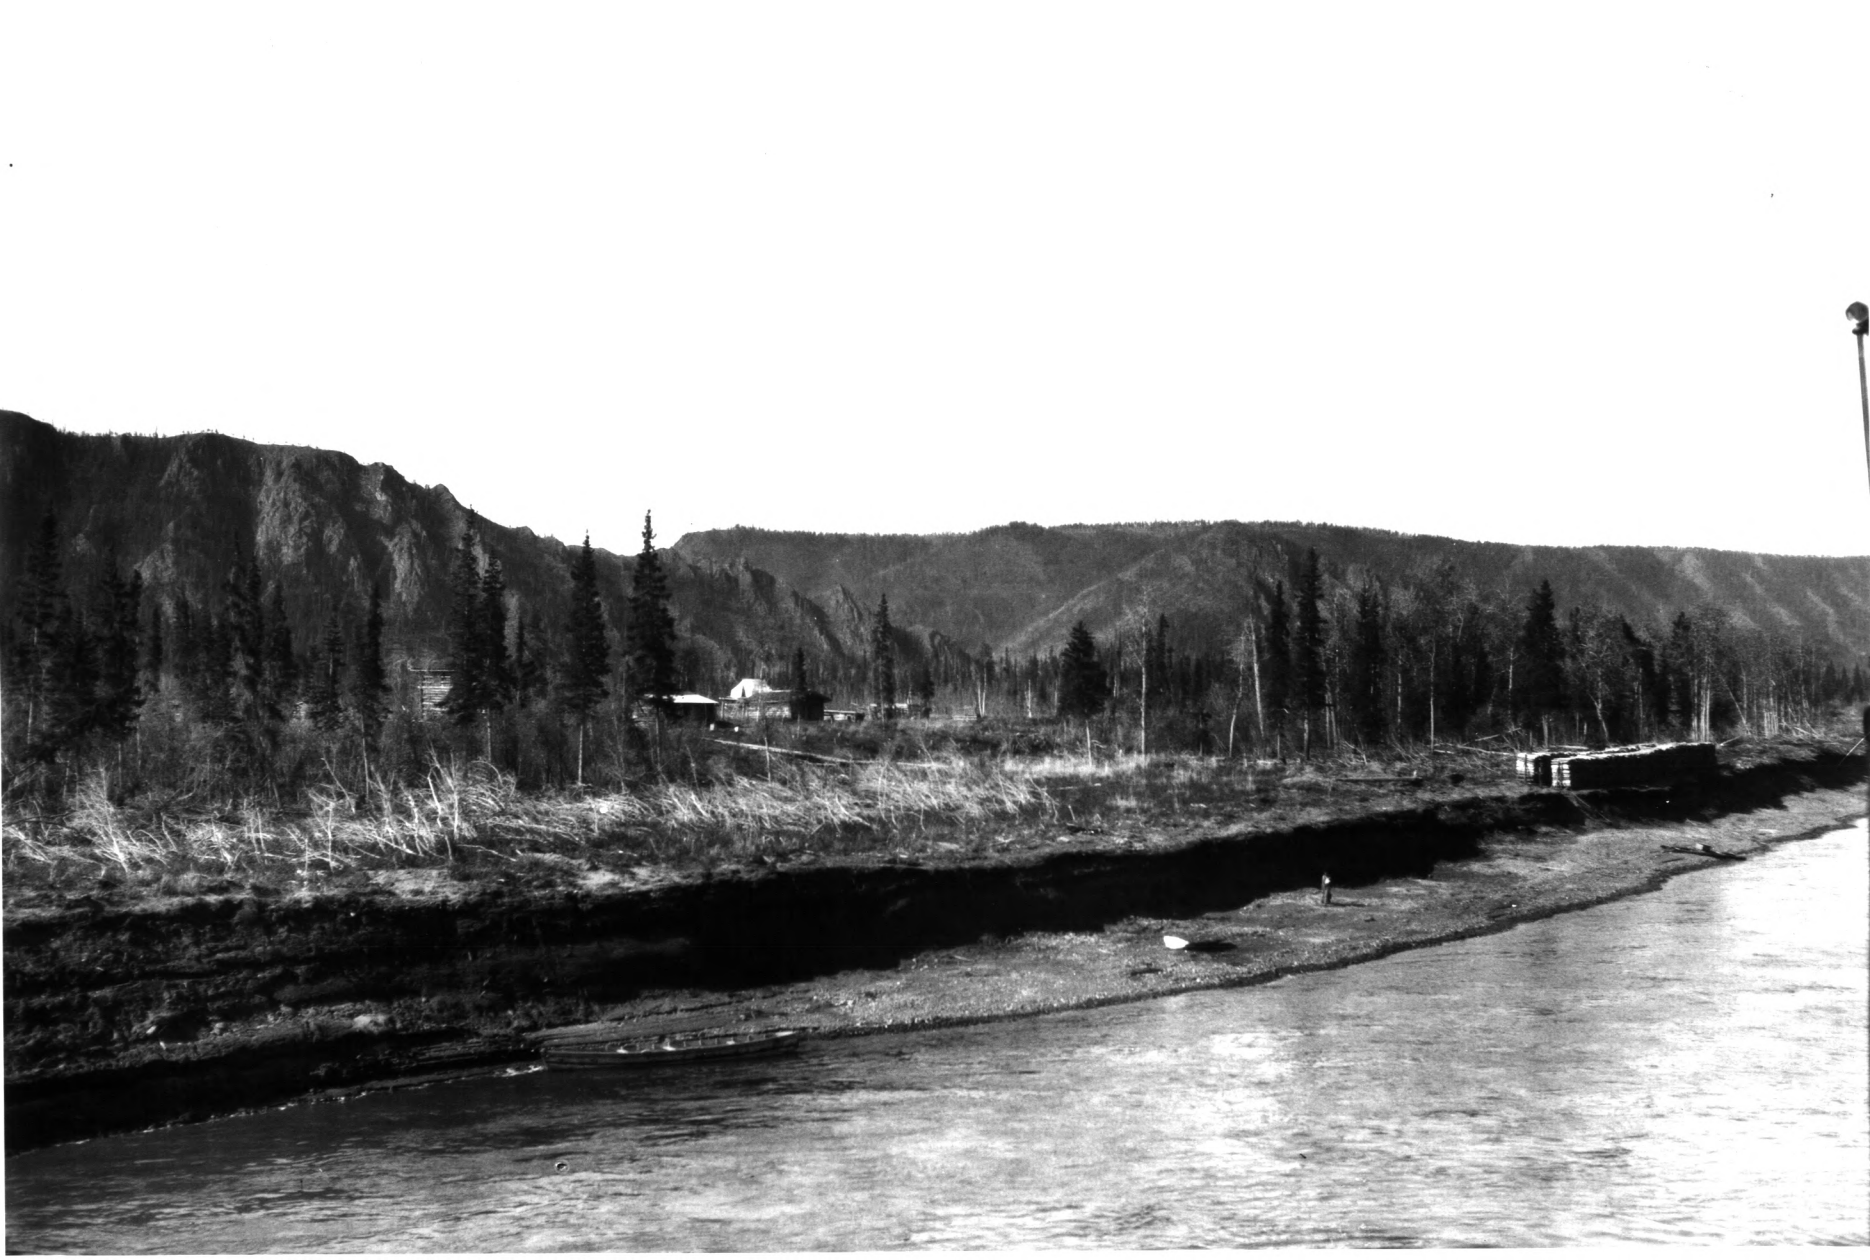
1. TOWN OF WOODCHOPPER; YUKON RIVER  
LIFEWAYS
2. Eagle vicinity, Alaska
3. J.B. Mertie                      4. 1926
5. US Geological Survey, Denver #1277
6. looking south              7. P10; I3

Woodchopper Roadhouse was a major establishment that developed out of the Woodchopper Creek mining camp. It was located among fifteen or twenty buildings about 100 yards back from the river. In order to create more dry land for cabins, builders dug drainage ditches around the site. According to a 1926 photograph, outbuildings near the roadhouse included: a gable roof shed; a residential cabin; dog barns; and a shed.
