# Hydrology and Geochemistry of Yucca House National Monument and Surrounding Area, Southwestern Colorado

By Winfield G. Wright  
*Certified Professional Hydrologist*

## *Hydrological Studies Report 2006-1*

*Prepared in Cooperation with the National Park Service,  
Mesa Verde National Park*

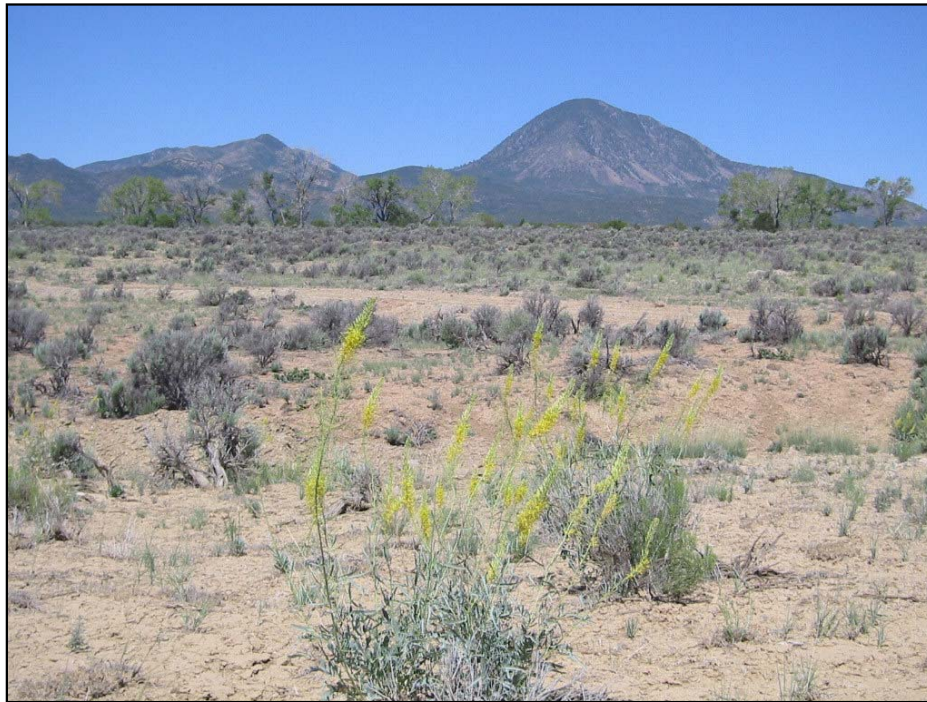
Figure 5. Photograph showing bare soil, sage, and prince's plume which is a primary indicator of high selenium concentrations in soil.

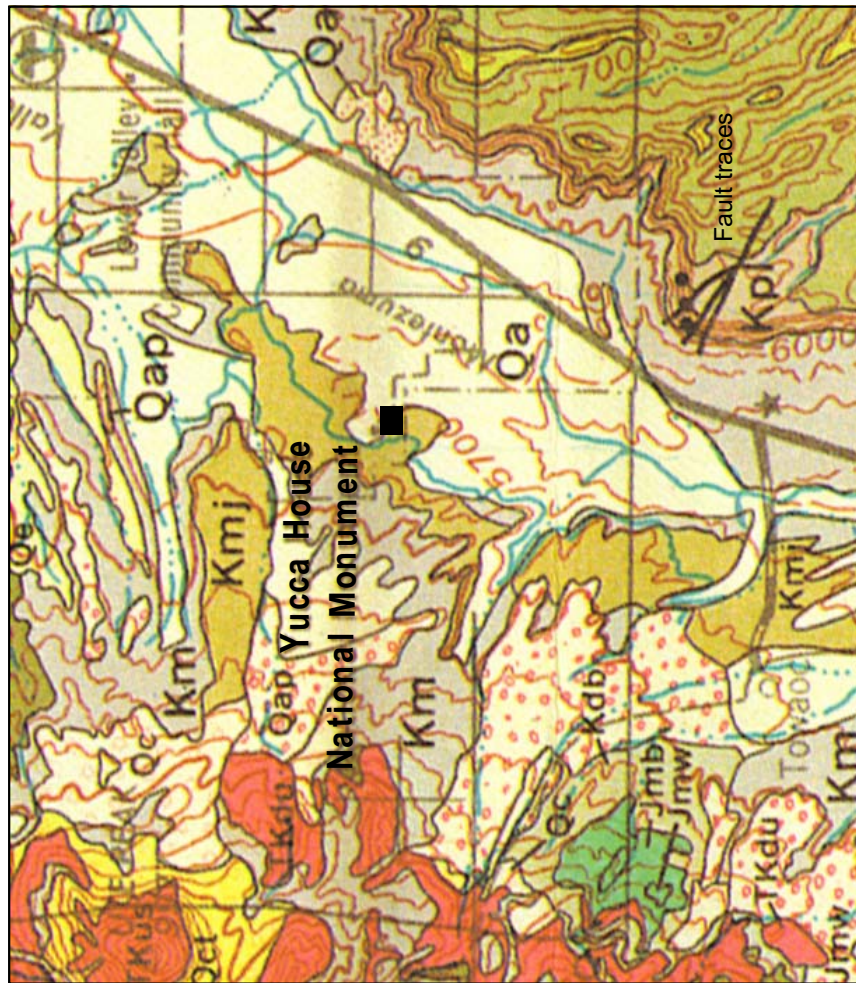
Figure 6. Geologic map of Yucca House National Monument and surrounding area (from Haynes and others, 1972).

There are no faults known in the Yucca House area; however, there are indications of faults across Montezuma Valley, southeast of Yucca House (Figure 6). Fracturing of the bedrock has likely occurred because of the uplift of the rocks caused by the intrusive Sleeping Ute Mountains. Fractures can act as conduits for the movement of ground water.
