Archeological Investigation
of the Carriage House
James A. Garfield National Historic Site,
Mentor, Ohio

Midwest Archeological Center
Technical Report No. 62

United States Department of Interior
National Park Service
Midwest Archeological Center
Lincoln, Nebraska

1999

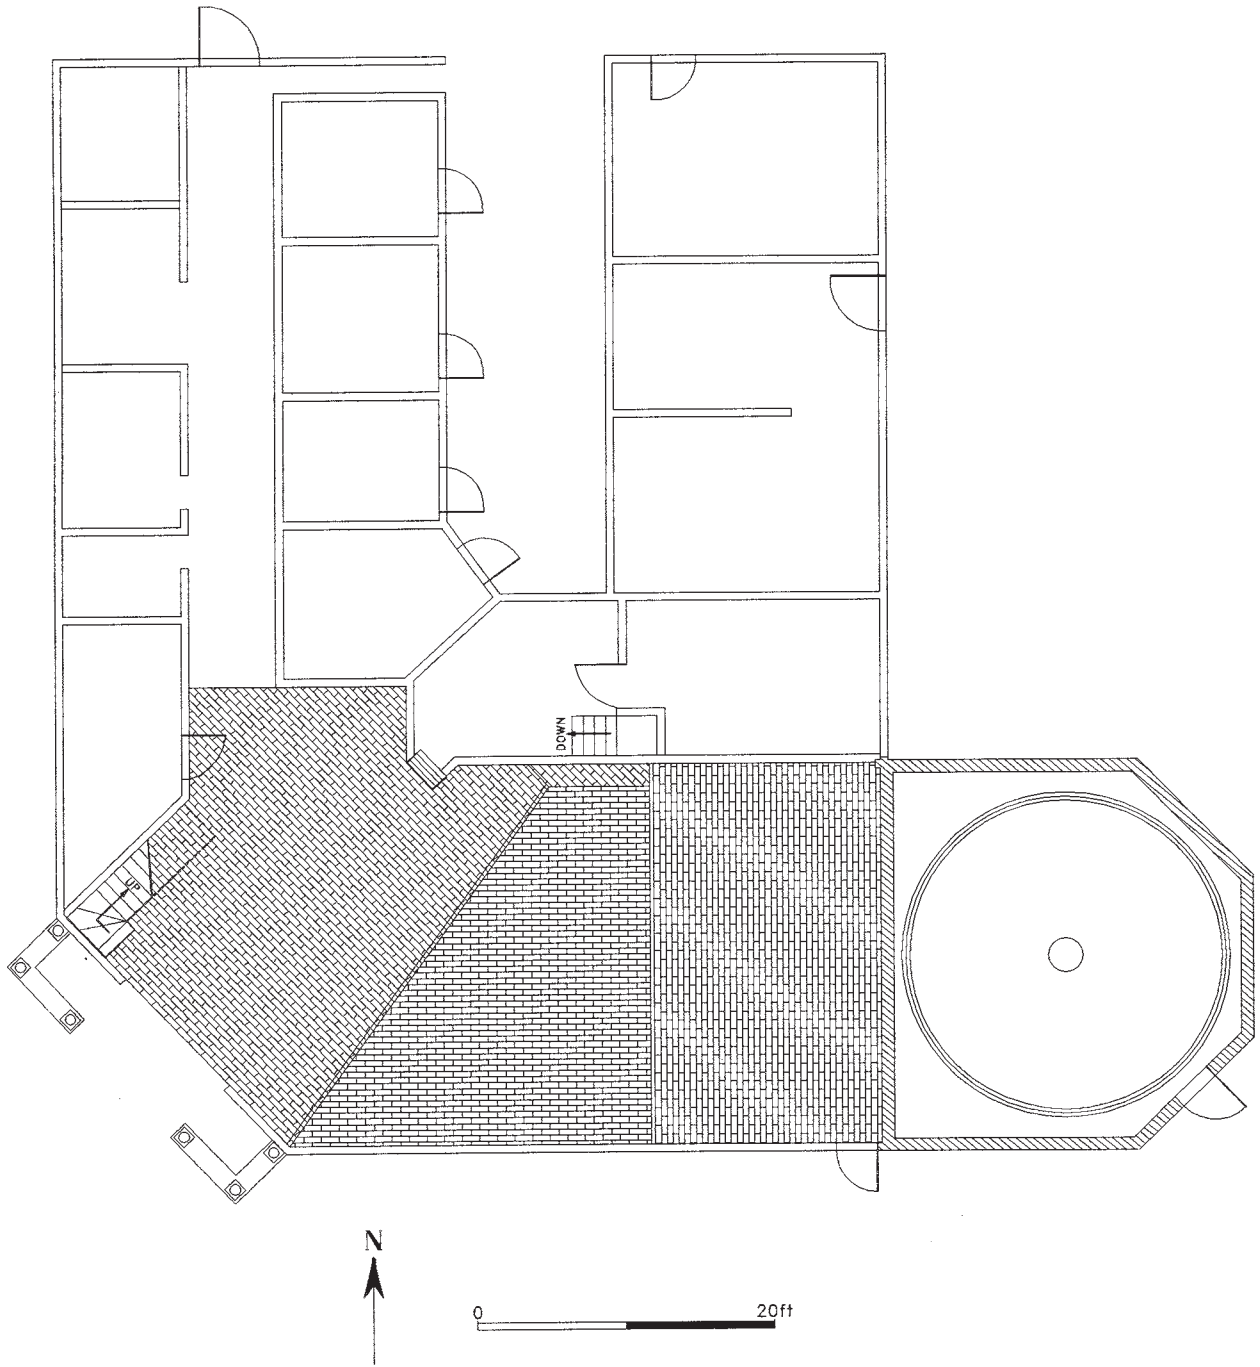
Figure 4. Carriage House/Gas Holder first-floor plan.

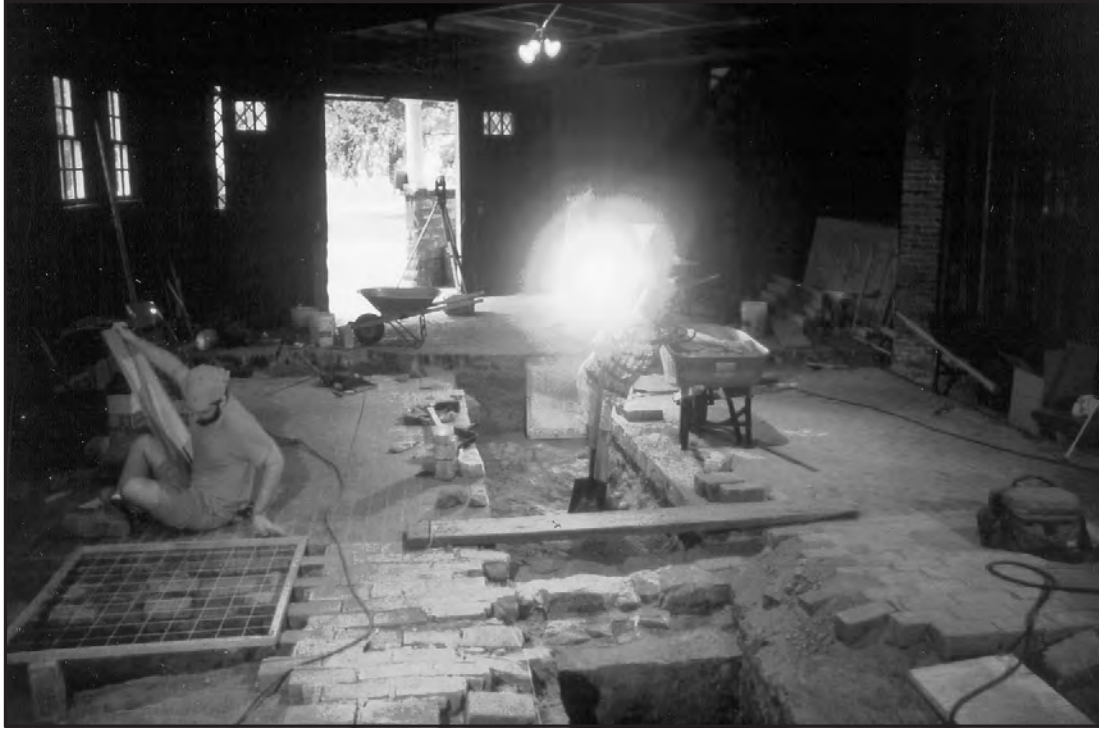
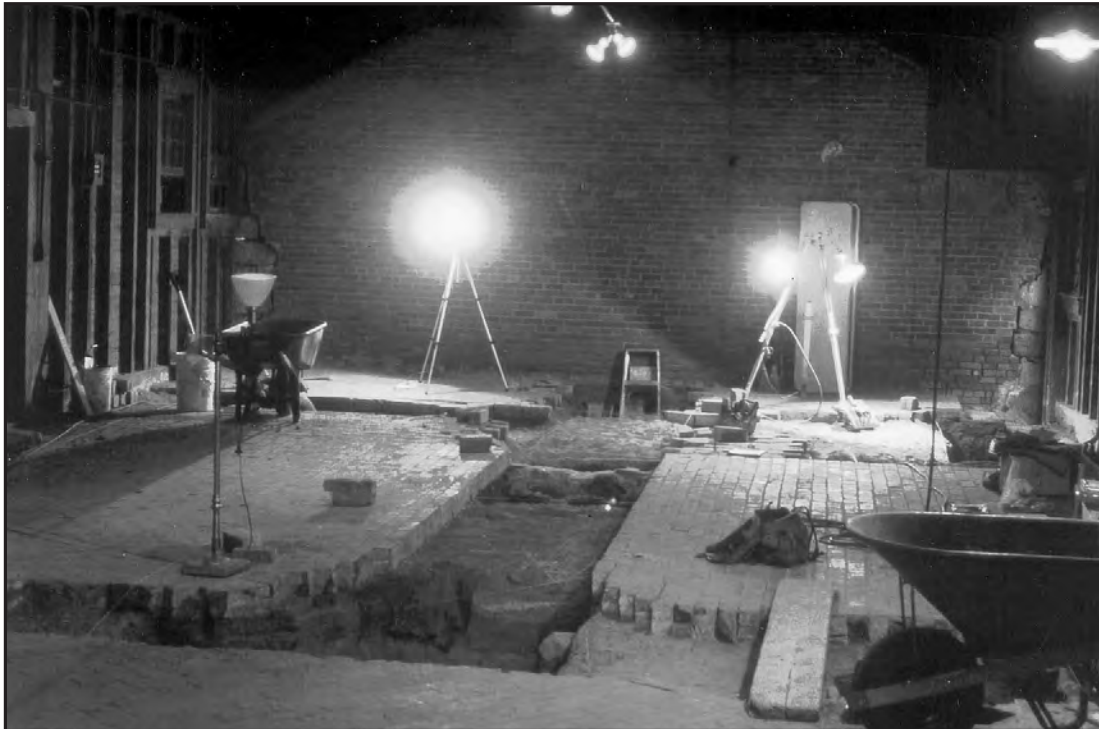
Figure 6. South Room excavations; view to east from near the South (Carriage) Room door (top), and view to west from near the common wall with the Gas Holder (bottom).

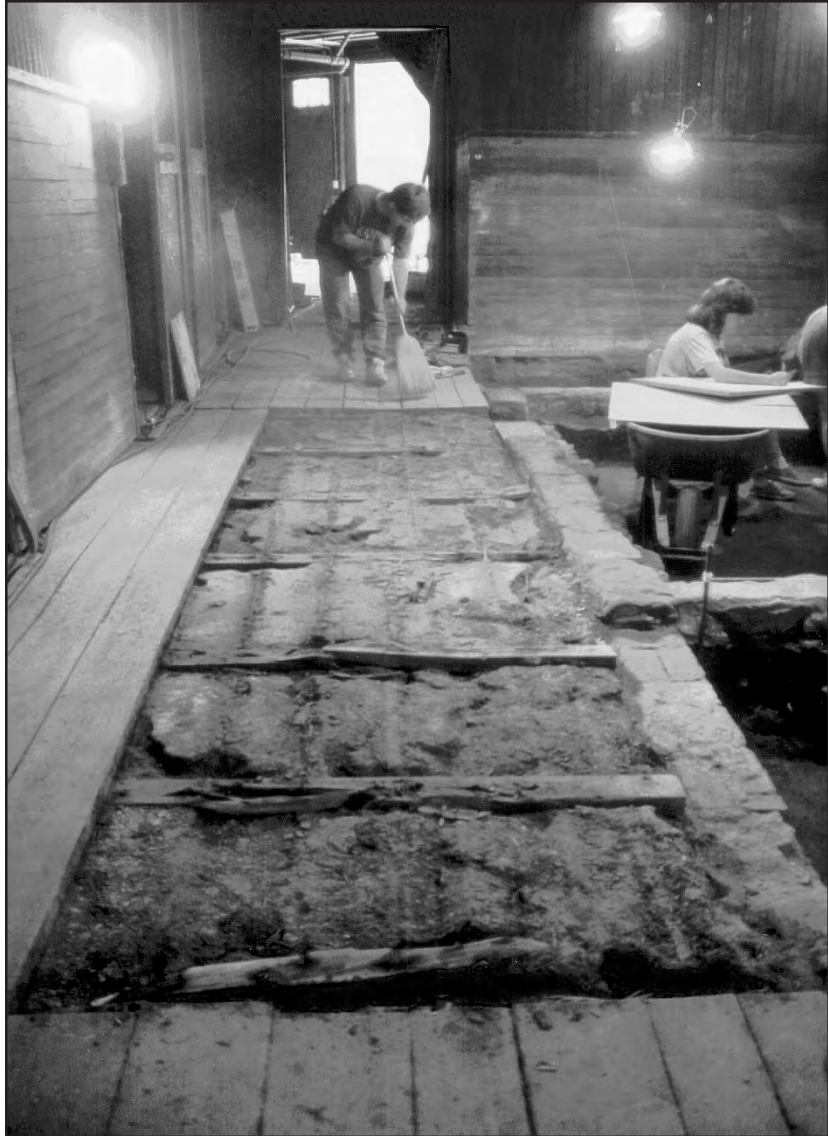
Figure 7. Excavated areas within the North (Stable) Room looking south across the floor openings. Enclosures A-C are to the right.

The North Room differed physically from the South Room in that it was broken up into distinct units of space by visible architectural features. These included a series of foundations on the west side of the room, a plank floor at its center, and a number of horse stalls on the east side. Knowing that the structure had a relatively brief history, it was decided to use these architecturally bound spaces as investigative units (Figure 5). The spaces enclosed by foundations were tackled first, as their dirt floors were most accessible to excavators. Once the foundation-enclosed areas were completed, sections of planks were taken up at the middle of the floor, with spaces between the floor joists defined as excavation units. The stables on the east side were never investigated other than by some subsurface probing in the southernmost stall. This was the only stall with a dirt floor. The remaining stalls had concrete or plank flooring that prevented easy access, and by the time the investigation of other areas in the North Room were completed, no time remained for testing these locations.

Enclosures A–D. The west side of the North Room was divided into four spaces by foundations of various construction. Three of these were virtually of the same size, with the southernmost space being about half the size of the others. The remaining portions of the latter space appeared to lie under the concrete floor of a storage room built between the stairwell and the North Room. For convenience, these four foundation-bound spaces were termed “Enclosures” and designated A to D from south to north (Figure 5). Each was further divided into quarters labeled NE, NW, SE, and SW, with each quarter excavated separately from the others. Enclosure A, being about half the size of the other enclosures, was divided into north and south units.¹ The southeast and northwest quarters of each enclosure were removed in arbitrary 10-cm units. This allowed continuous north–south and east–west stratigraphic cross sections of each enclosure to be drawn. As vertical stratigraphic profiles were visible on two faces of the southwest and northeast quarters, they were removed using SUs.

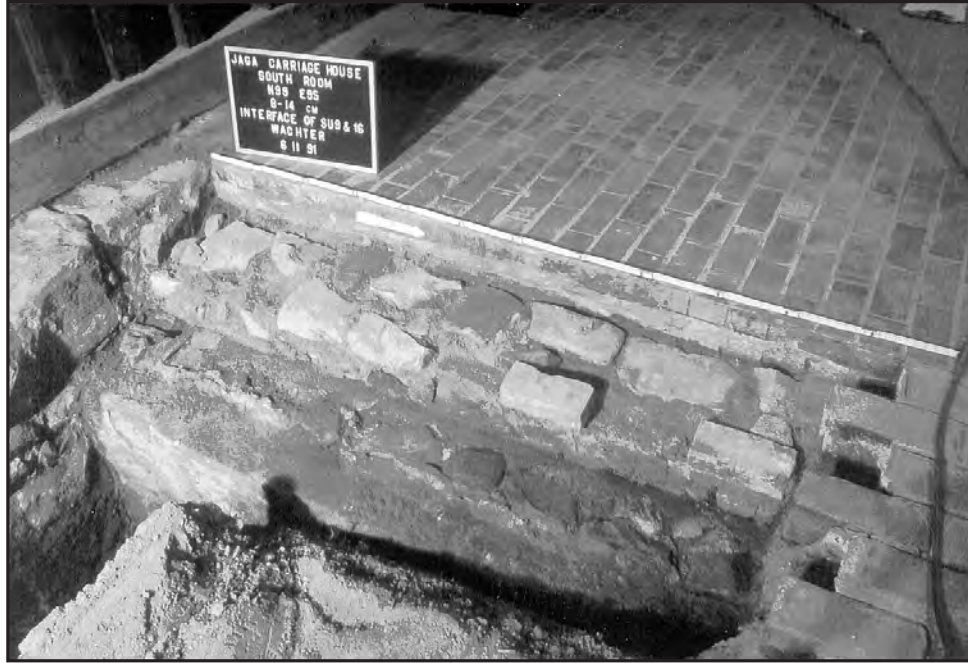
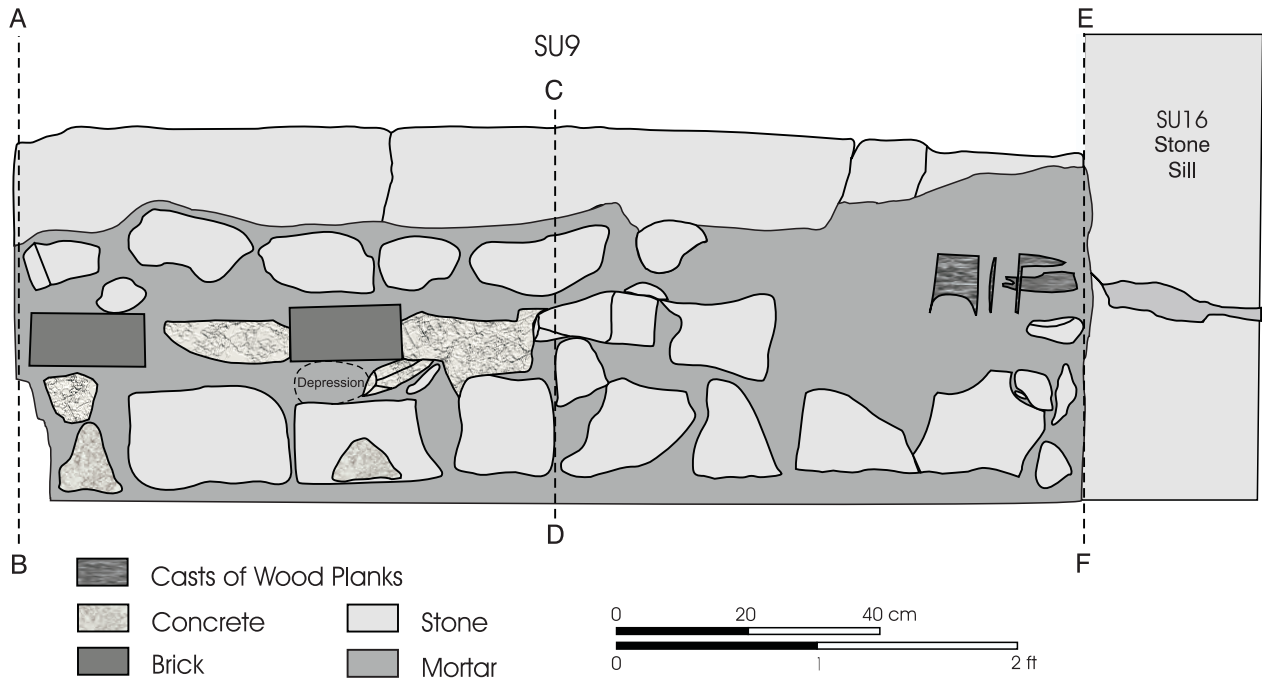
Figure 11. Upper margins of the Gas Holder basement's west foundation; view of exposed segment at juncture with south wall (top), and plan view showing construction materials (bottom).

In cross section, the upper surface of the foundation appears as a series of four “ledges” (Figure 11). The lowest ledge (A) is composed of neatly mortared sandstone block and actually represents the upper, unmodified element of the foundation. It lies 15–23 cm (9.0 in) below the inside corner of the top of the foundation and is about 18 cm (7.1 in) wide. Lying immediately on top of this is Ledge B, a thin (4 cm/1.6 in) layer of mortar and thin, flat stones. The upper margins of this ledge are 20 cm (7.9 in) wide and retain fragments of wood. The north–south orientation of the fragments’ grain suggests that an 8-in-wide wooden sill once rested here. Ledge C, lying immediately west of B, is composed of plaster. It has a squared, 7 cm (2.76 in) high face and a flat, 16–18 cm (6.3–7.1 in) wide upper surface. The vertical face of the plaster retains wood fragments and impressions of wood, reinforcing the belief that a wooden sill had been placed against it. It also suggests that the upper walls of the Gas Holder building’s west room may have been plastered. The uppermost portion of the foundation (Ledge D) rises 4–5 cm (1.5–2.0 in) above the plaster. Here, the foundation is composed of irregularly shaped sandstone and a hard mortar, with small, flat stones placed across the top to level its upper surface. The builder’s trench on the exterior face was filled with cobbles, mortar chunks, and shaped fragments of stone. This portion of the wall is crude in appearance but would not have been observed by a visitor to the Gas Holder, as it lay underground.

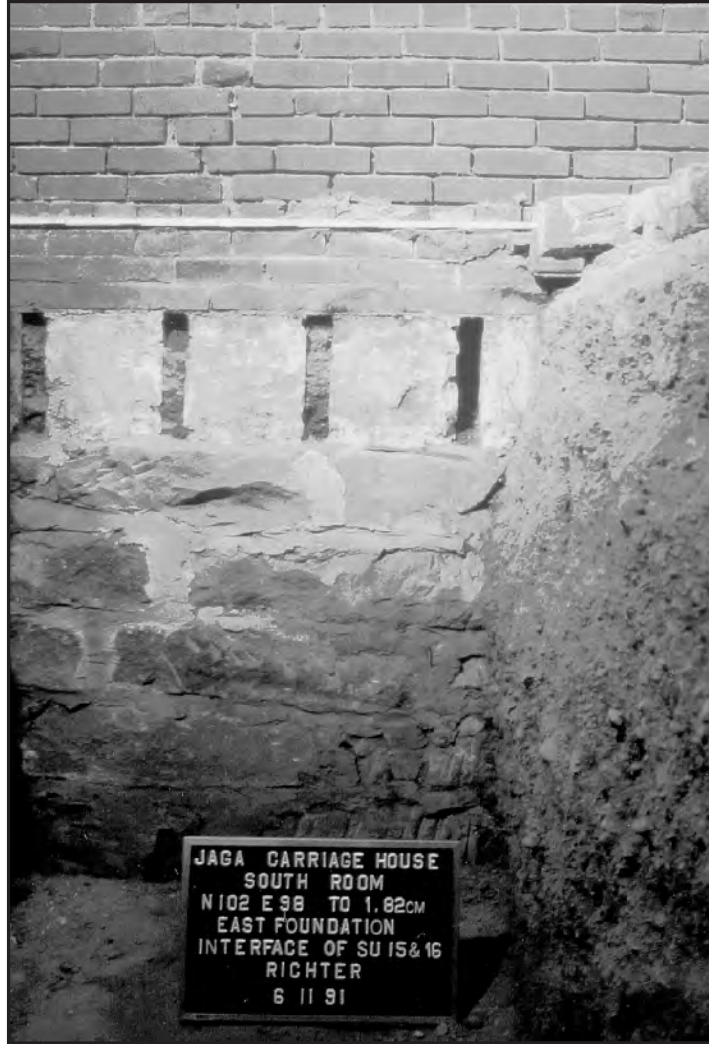
Figure 12. Juncture of basement foundation and brick wall separating Carriage House from the Gas Holder.

East Foundation (SU 9E). The east foundation (Figure 12) was exposed in only one excavation unit (N102-E98), which was dug to a depth of 1.28 m (4.2 ft) below the upper surfaces of the brick floor (SU 7). The Historic Structure Report (HSR) for the Carriage House states that “the foundation to the wall separating the Gas Holder from the Carriage Area is brick” (Mack 1991:12). However, excavations revealed that the foundation here is actually composed of courses of large, rectangular-shaped sandstone block surmounted by a short segment (about 4 courses) of plastered-over brick. Both brick and stone are bound with a concrete mortar. The top of this brick segment is parallel with the base of the brick floor. Above this segment is the brick wall dividing the South Room from the Gas Holder.

Five courses of the stone foundation were exposed. Each block incorporated into this structure is of a unique size, individual specimens varying in width from 12 to 16 cm (4.7–6.3 in) and in length from 8 to 65 cm (3.15–25.6 in). Foundation stones are bound together with thick layers of hard mortar which was somewhat carelessly applied during its application, with significant portions of the individual stone faces obscured.

The HSR suggests that the ground level of this area of the Gas Holder building had a wooden floor (Mack 1991:13), and this hypothesis was confirmed archeologically. The plastered brick segment immediately above the stone foundations at the east side of the room was a short (29 cm/11.4 in) wall (SU 100) containing a series of 6 cm (2.36 in) wide by 29 cm (11.41 in) long vertical slots spaced 25 to 26.5 cm (about 10 in) apart.³ These are interpreted as evidence for flooring above the basement, each slot having held

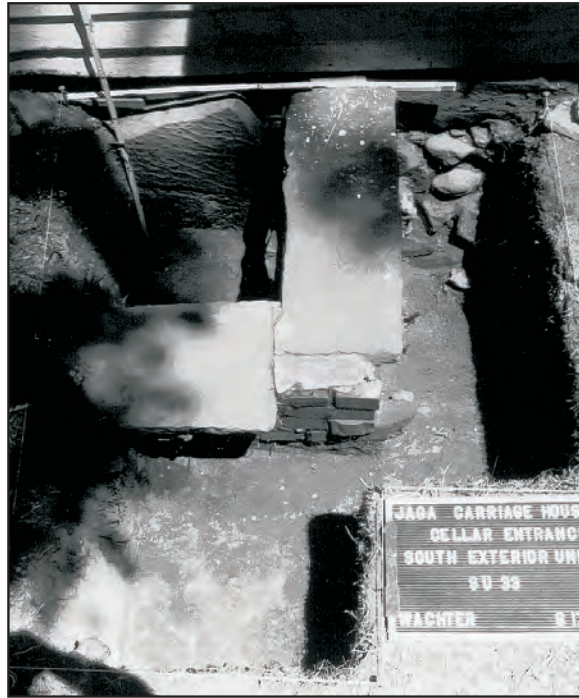
Figure 13. Stairwell or window well in Gas Holder basement's south wall. Note stone slab sealing the opening photograph.

Access to the basement may have been through an opening in the foundation (SU 33A) near the southeast corner of the building (Figure 13). A groundhog burrow through the upper portion was visible on the outside of the building prior to excavation, a situation which may have led to its identification as a crawl space in the HSR (Mack 1991:13). The east margin of the opening is situated at N99-E98.3 about 1.7 m (10.5 ft) west of the South Room’s east wall. It is rectangular in shape, about 75 cm (30 in) high by 94 cm (37 in) wide. The east and west margins of the opening are of stone, with roughly squared faces. The lower sill is manufactured of a sandstone slab shaped with a stone mason’s chisel. The upper surface of this stone slants downward toward the basement floor. The size and shape of the opening suggest a stairway at this location, with the stair’s stringers supported by the sloping stone sill.

The exterior elements of this entry were exposed in Exterior Unit 2 (Figure 13). The outside of the entry had been blocked with a large slab of sandstone, brick, and cobbles. It is enclosed by a small rectangular foundation (SU 33B) or entry well of brick and sandstone slab construction. A narrow builder’s trench (SU 34) of loose, root-filled, dark fill was noted in conjunction with this structure. The outside dimension of the well foundation, from front (south side) to back (north side), is 91 cm (3 ft). Though only the east half of this foundation was excavated, it is estimated to have an overall width of about 1.7 m (5 1/2 ft). It encloses a rectangular space 59 cm (23.2 in) deep and estimated to be about 1.12 m (3.7 ft) wide. Its various elements have been put together so that its upper surfaces demonstrate a 15-degree tilt from front to back (Figure 14).

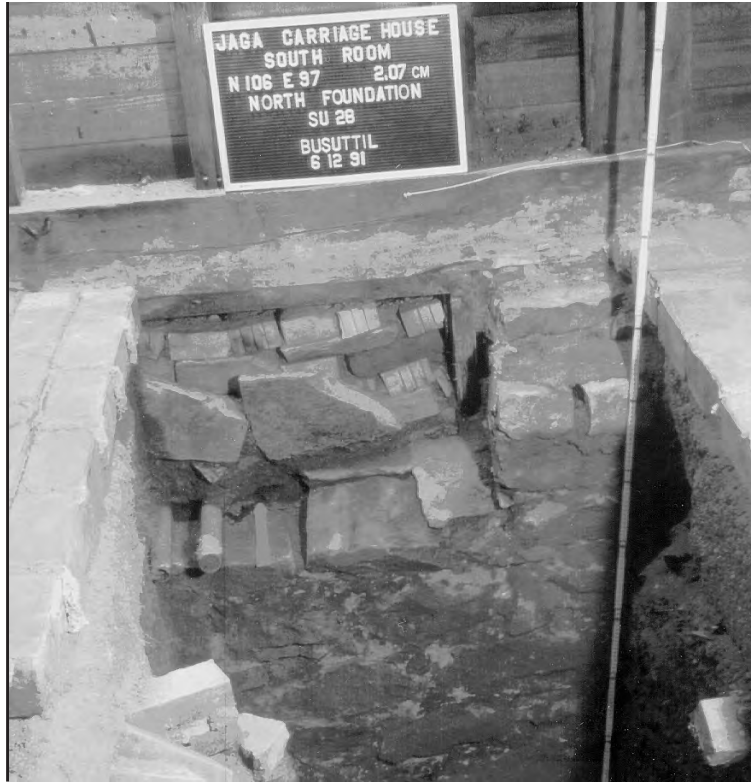
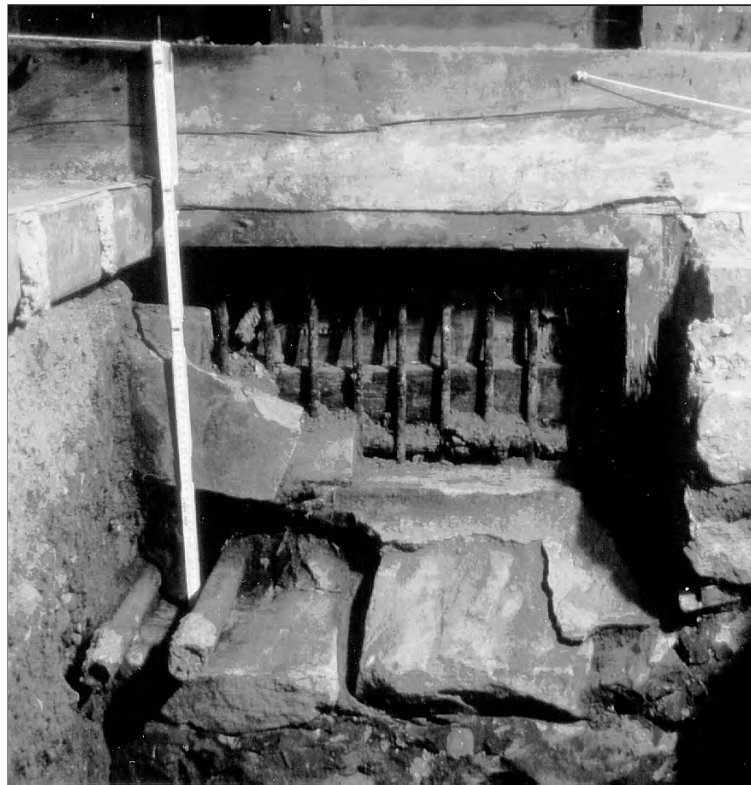
Figure 15. Window in Gas Holder basement's north wall with blockage in place (top) and after blockage was cleared (bottom).

North Foundation (SU 9N). A 1-m (3.3-ft) wide section of this foundation was exposed at N106-E96 (Figure 15). Its construction appeared to be generally the same as that described for the other foundation elements, with the exception that this portion is pierced with a barred opening (SU 28A). The opening is partially visible in the south wall of the sloped access (Room 109 in the HSR) to the boiler pit and is illustrated in the HSR with the caption "Ventilator to Area Below Room 102 [Carriage Storage]. This vent indicates that the east portion of the carriage storage area had some type of open area below the east end of the floor, perhaps related to the Gas Holder" (Mack 1991:82).

Several pipes from the steam room protrude from between the bars. The intrusive presence of these pipes and the opening's partial obstruction by the concrete wall of the boiler pit suggest that it was in place before construction of the boiler pit and its sloped access (sometime after the Carriage House construction in 1893). At the time the basement was abandoned and filled, the opening was blocked up with flat slabs, brick, and cobbles similar to that previously noted for the entry in the south foundation.

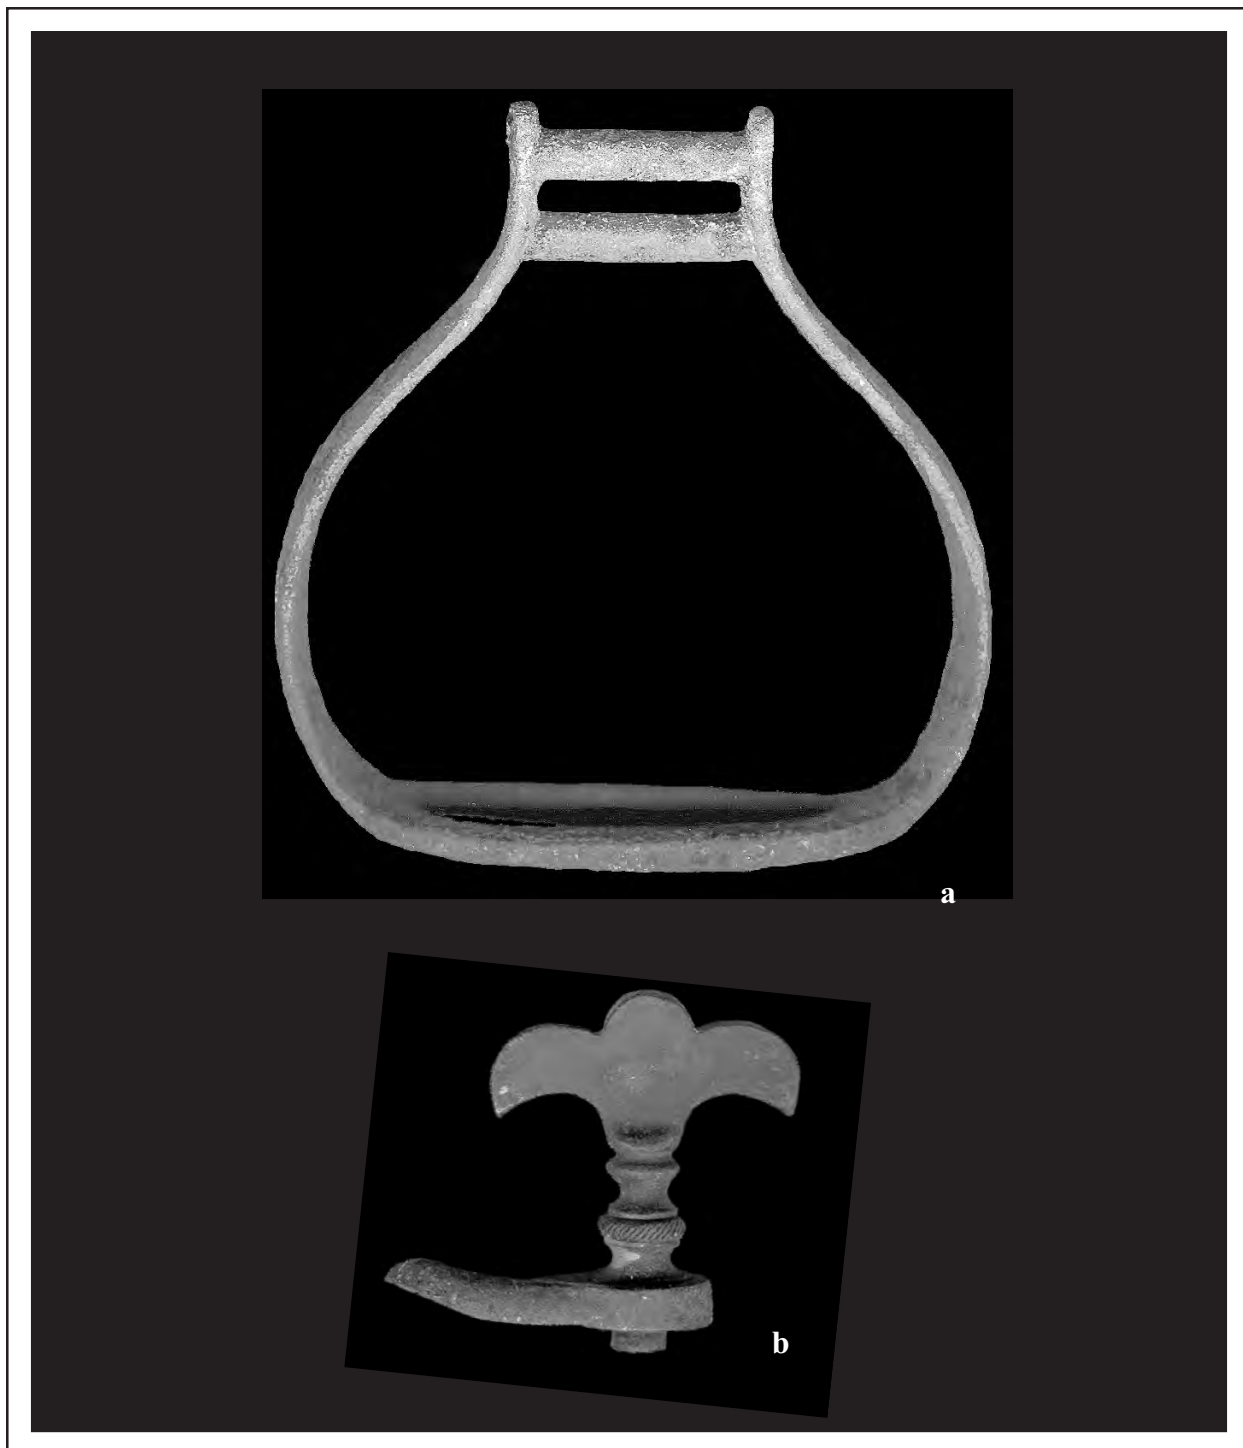
Figure 19. Transportation-related artifacts recovered in the North Room; (a) sidesaddle stirrup (field cat. #47); (b) carriage door latch (field cat. #64).

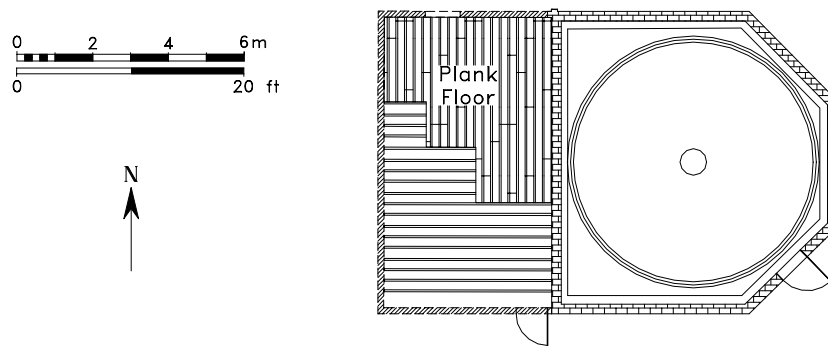
Figure 21. The Gas Holder floor plan as it may have existed in Period II (circa 1885-1893).

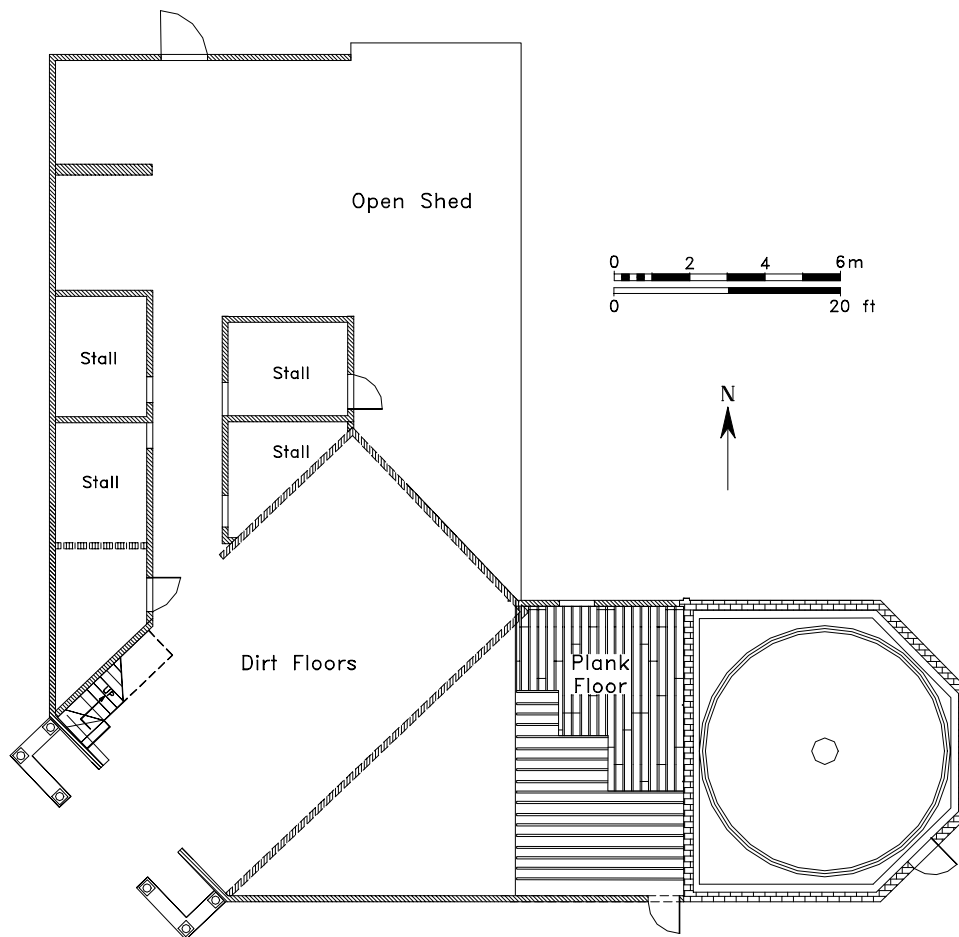
Figure 22. The Gas Holder/Carriage House floor plan during Period III (1893 to circa 1905).
